## **DELOITTE & TOUCHE INC.**

### **2005 ANNUAL GEOTECHNICAL EVALUATION AND INSTRUMENT REVIEW**

### **VARIOUS FACILITIES AT FARO MINE, YUKON**

PROJECT NO.: 0257-032-05  
DATE: FEBRUARY 22, 2006

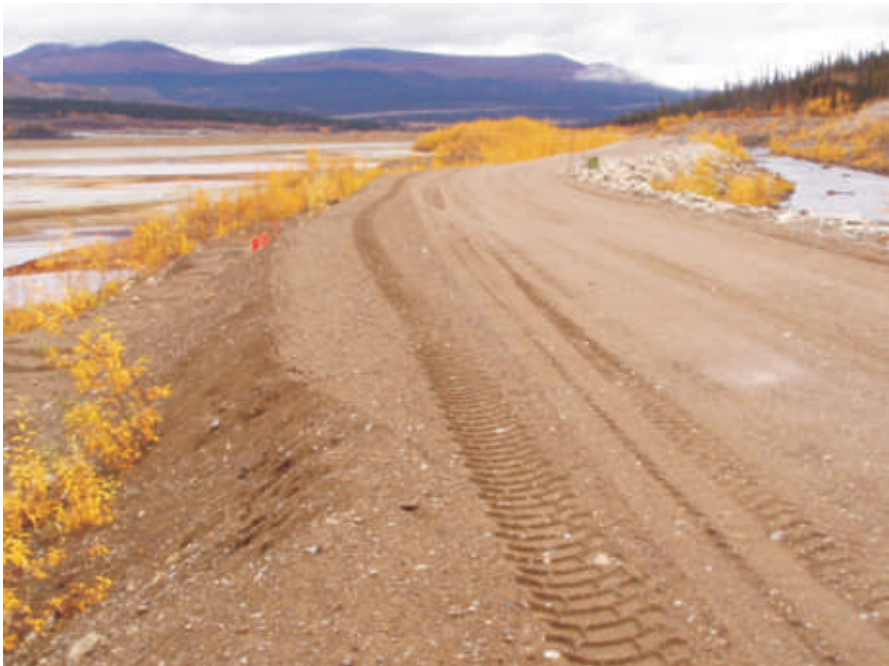
Photo shows a view of the regraded crest located at approximately CD-21. On the left can be seen 3 new instrumentation casings.

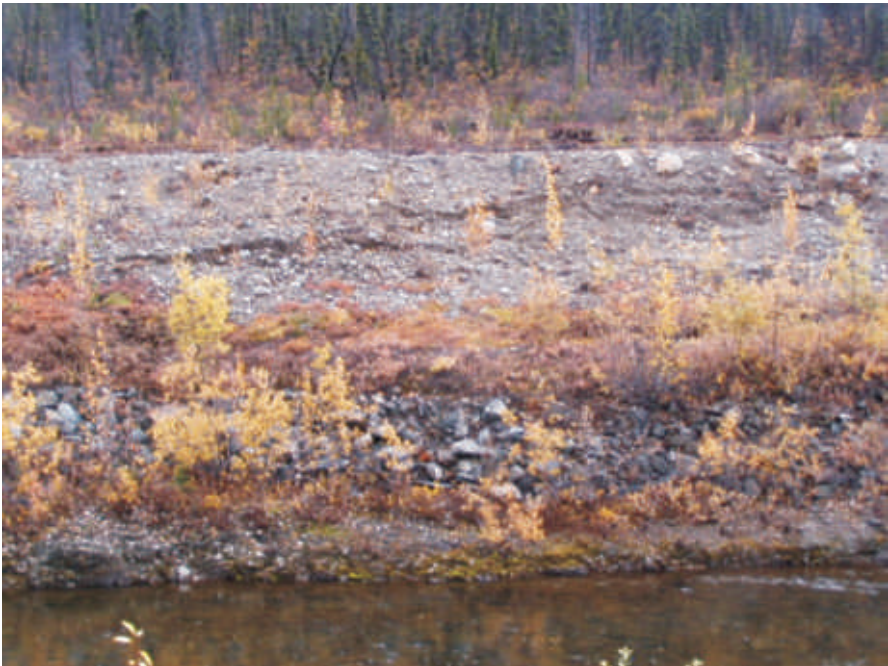
Photo shows some minor sloughing and a small scarp which is located on the backslope.

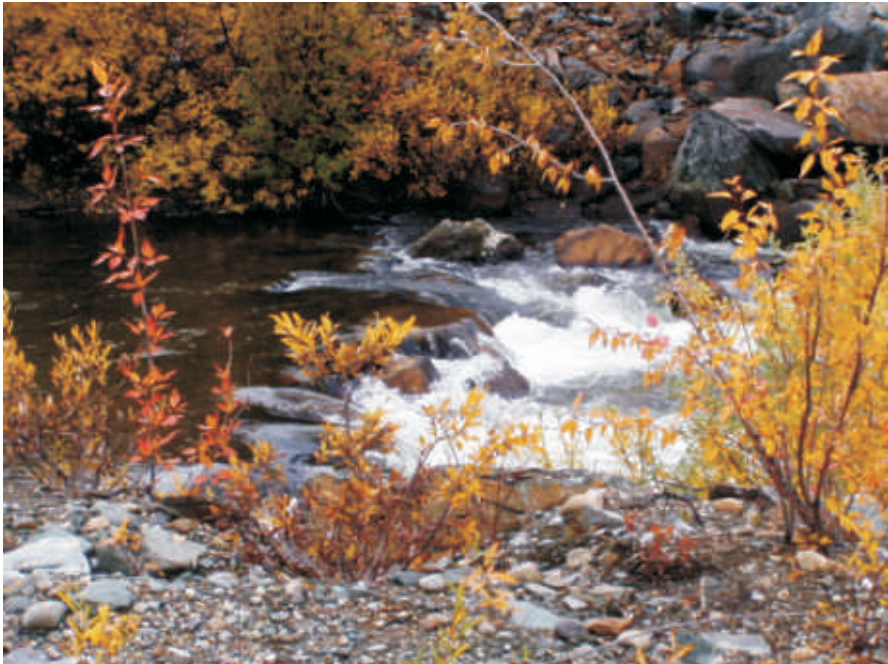
Photo shows a view of the water flowing over top of the first weir. The central boulders have been pushed out of the way but the weir is still effective in discharging energy.

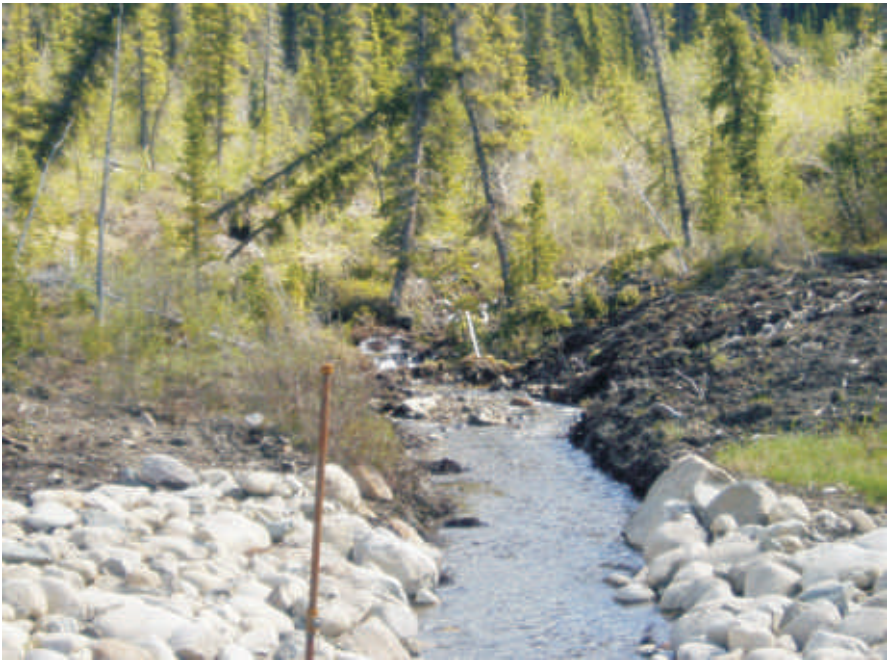
May: Photo shows the outfall section of the NVWID.

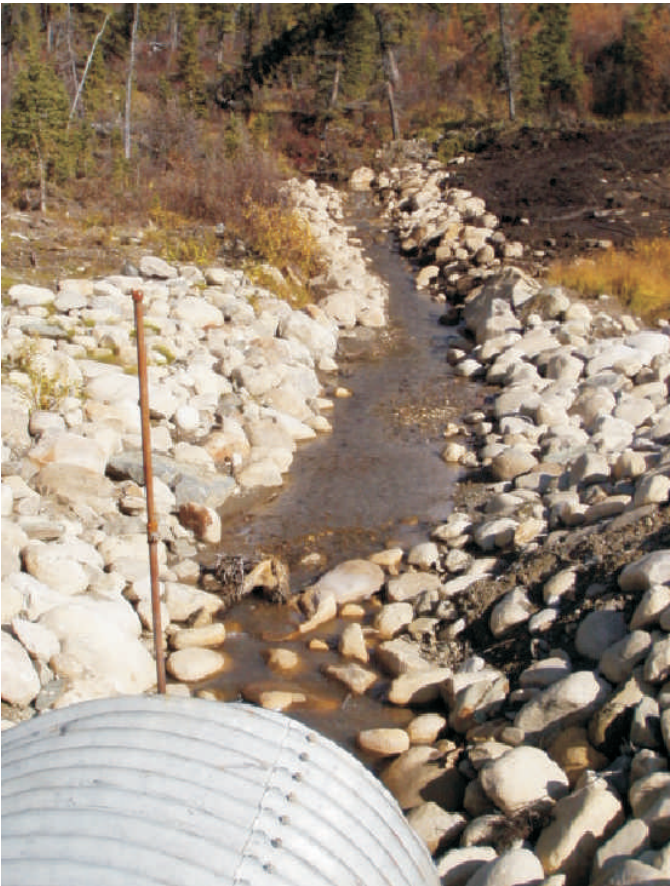
September: Photo shows the channel upstream of the culvert after the construction were undertaken in September.

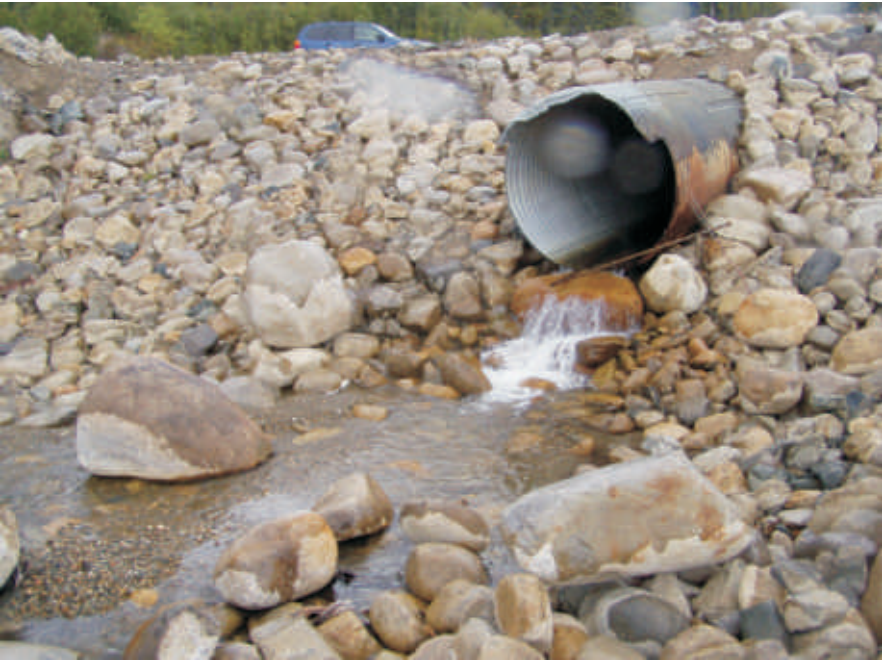
August: Photo shows a view of the outlet end of the culvert as the water cascades on top of the first rock. The large boulders which formed a break to water flow should be placed back into position.

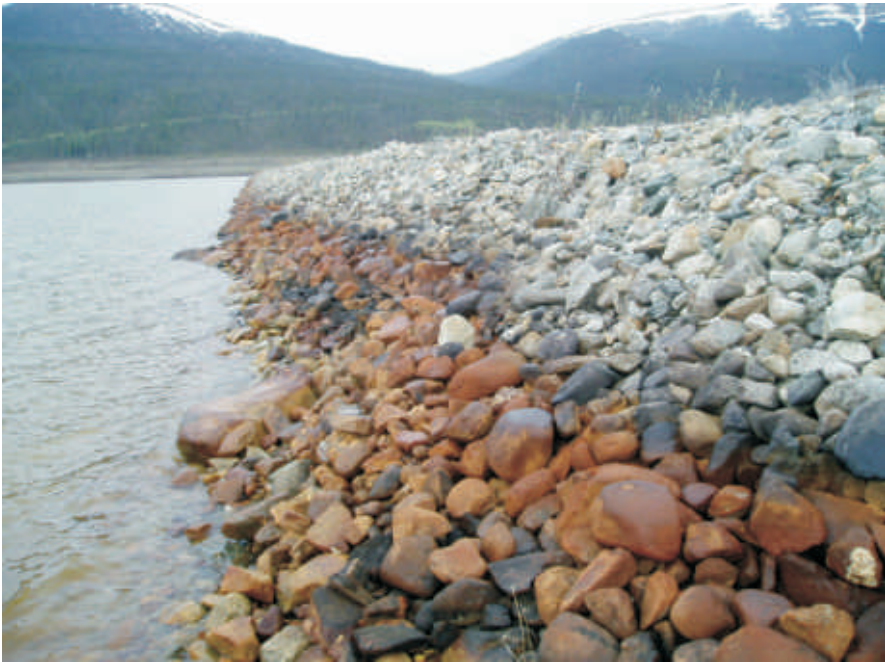
May: Photo shows the riprap on the upstream side.

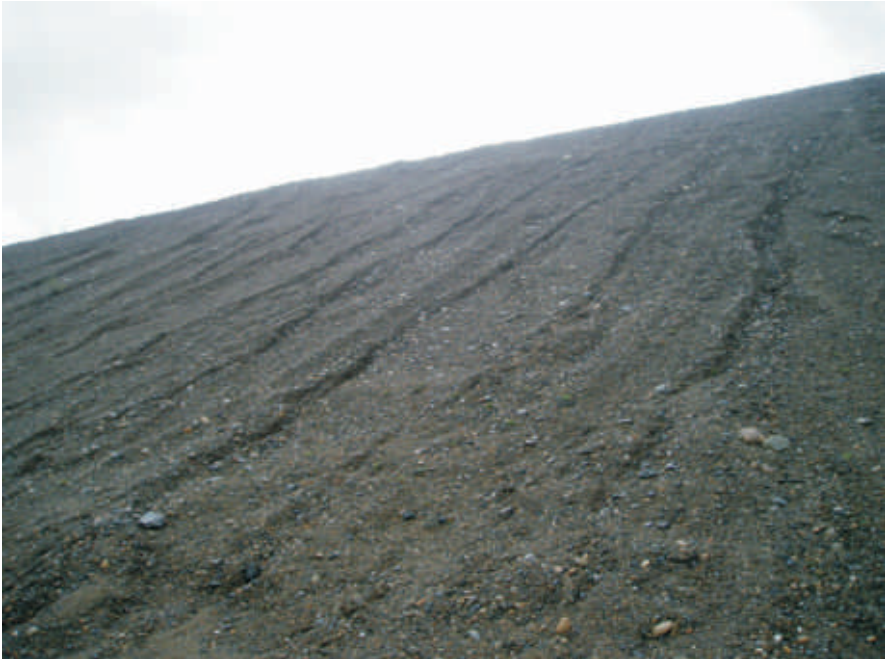
May: Photo shows a number of different sized erosional gullies on the downstream face.

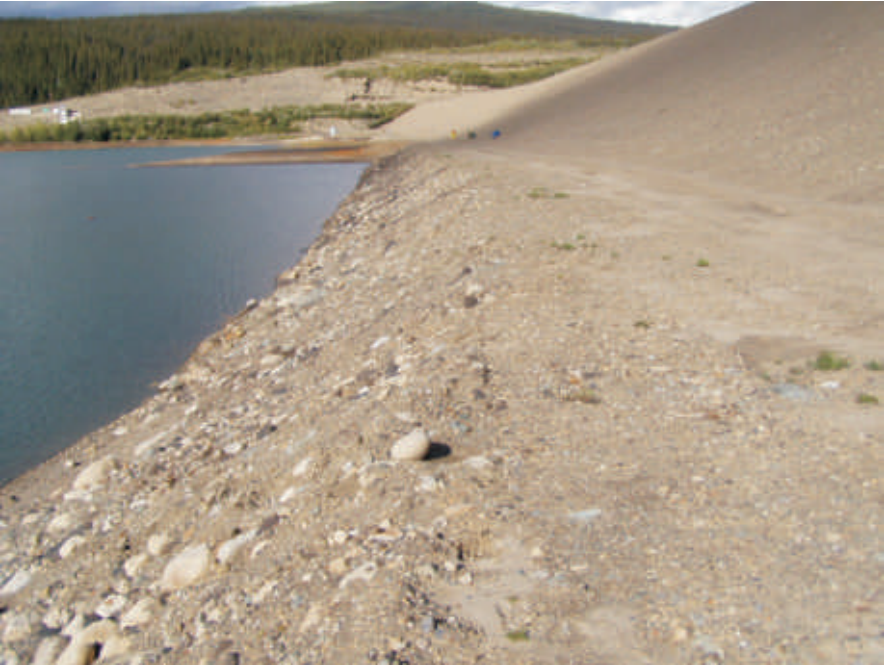
August: Photo shows a view looking along the edge of the Polishing Pond.

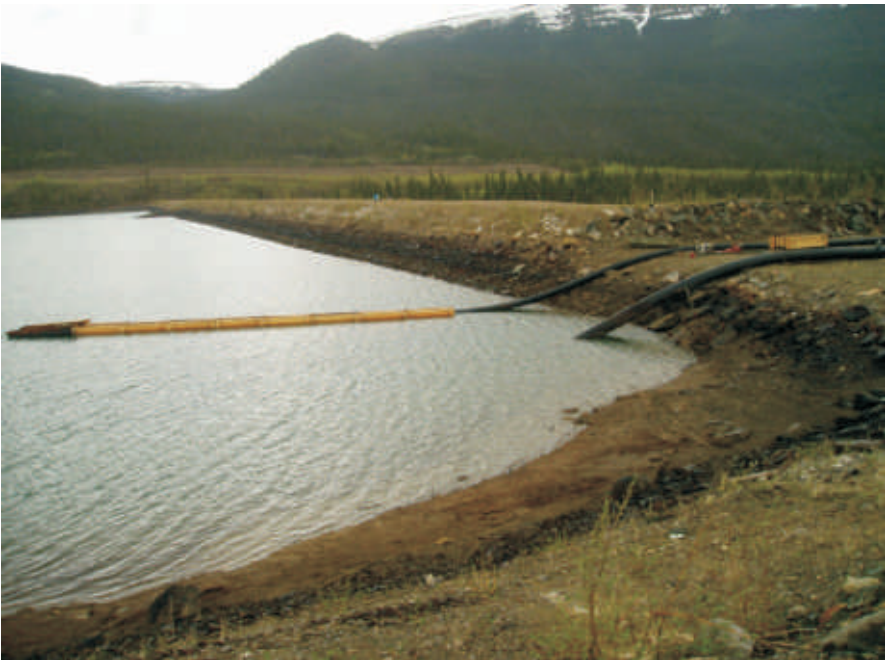
May: Photo shows the inlet into the spillway on the Cross Valley Dam and also the two siphon pipes.

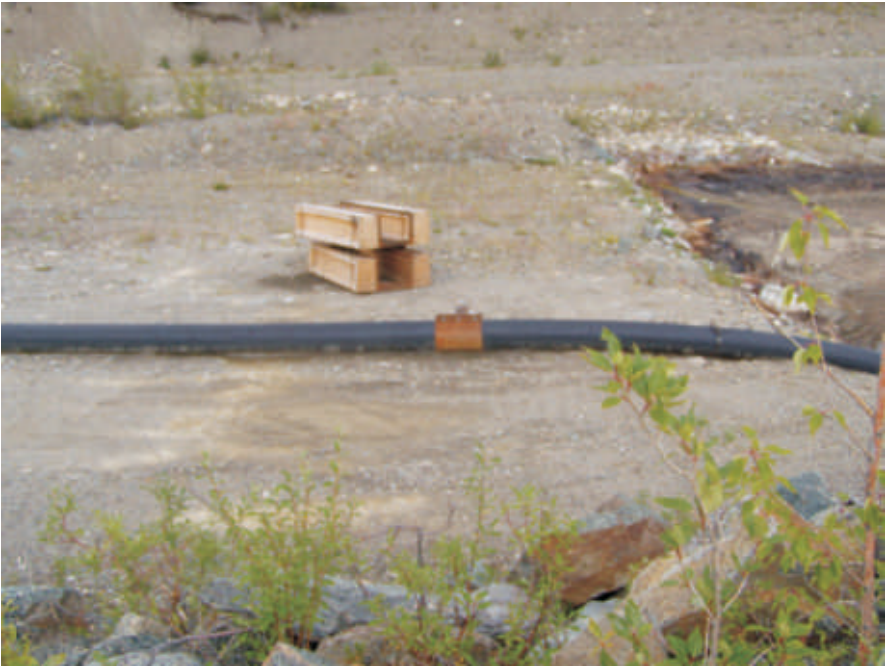
August: Photo shows a view of the Emergency Spillway on the Cross Valley Dam.

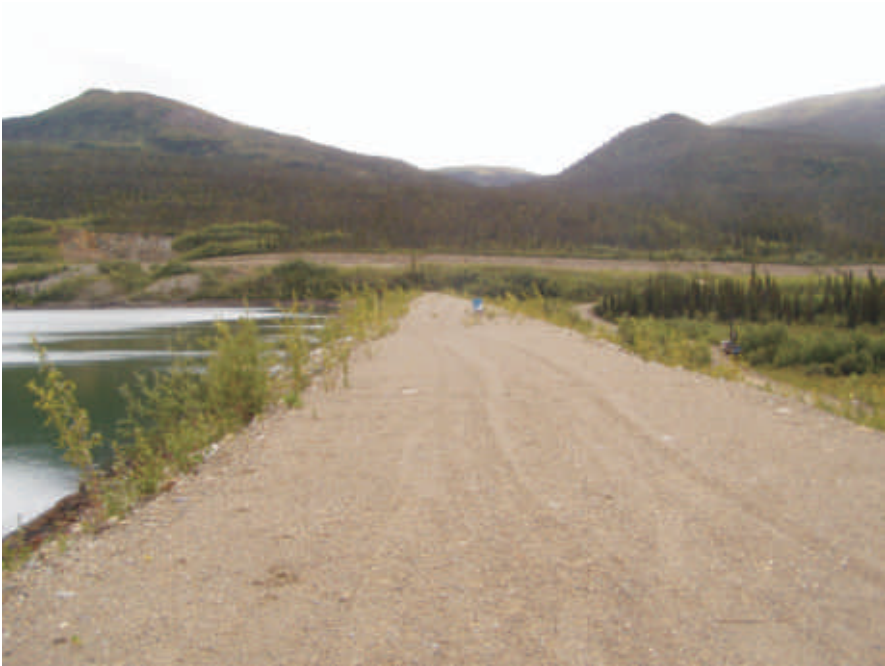
August: Photo shows a view of the crest of the dam.

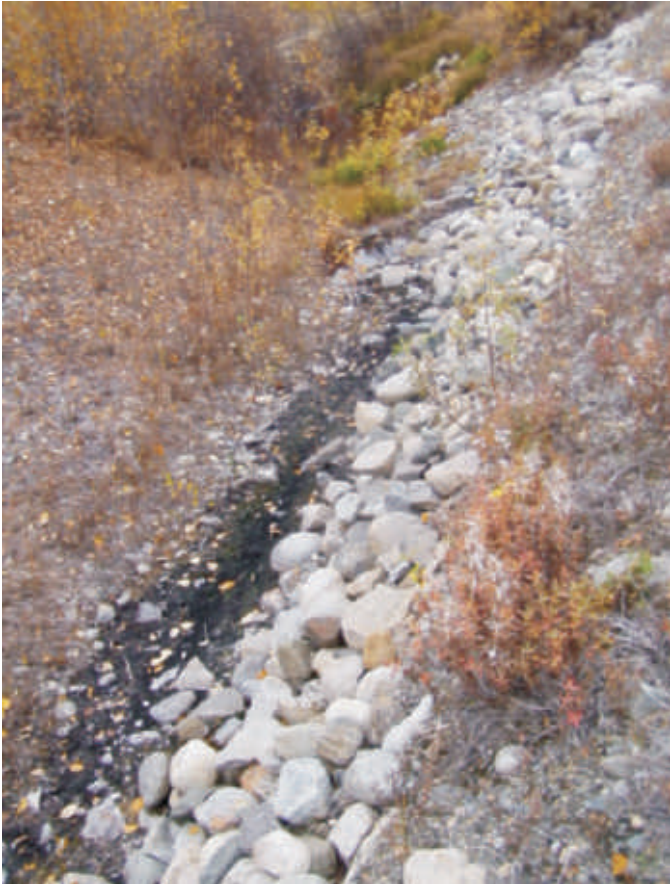
September: Photo shows the bottom of the seepage collection trench looking north towards the middle V-Notch Weir. As can be seen the bottom of the trench is relatively dry, possibly a result of the ongoing pump test.

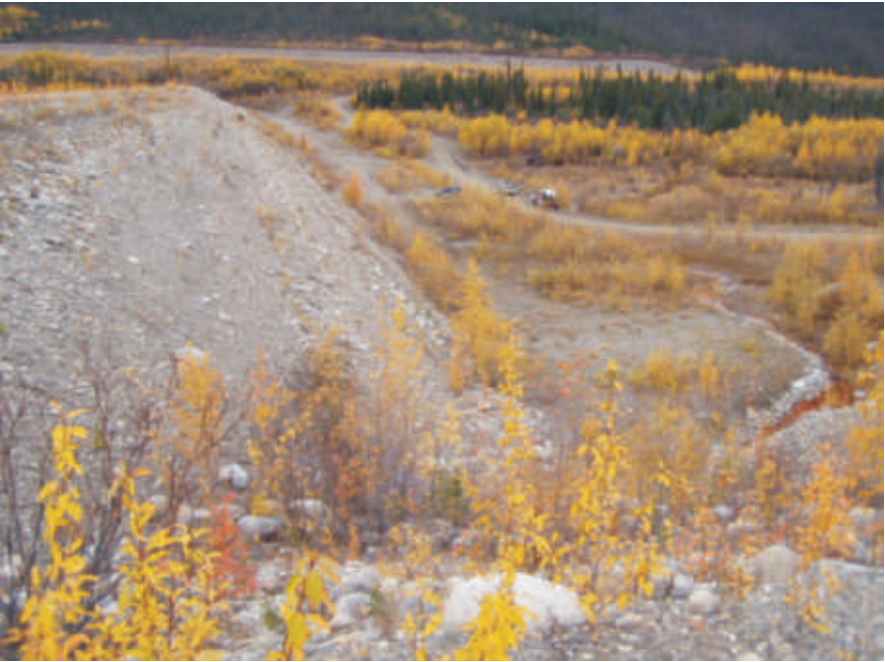
September: Photo shows a view of the downstream face and toe area where the pump test is ongoing. The seepage collection trench appears to be slightly drier than typical, likely in relation to the ongoing large scale pump test.

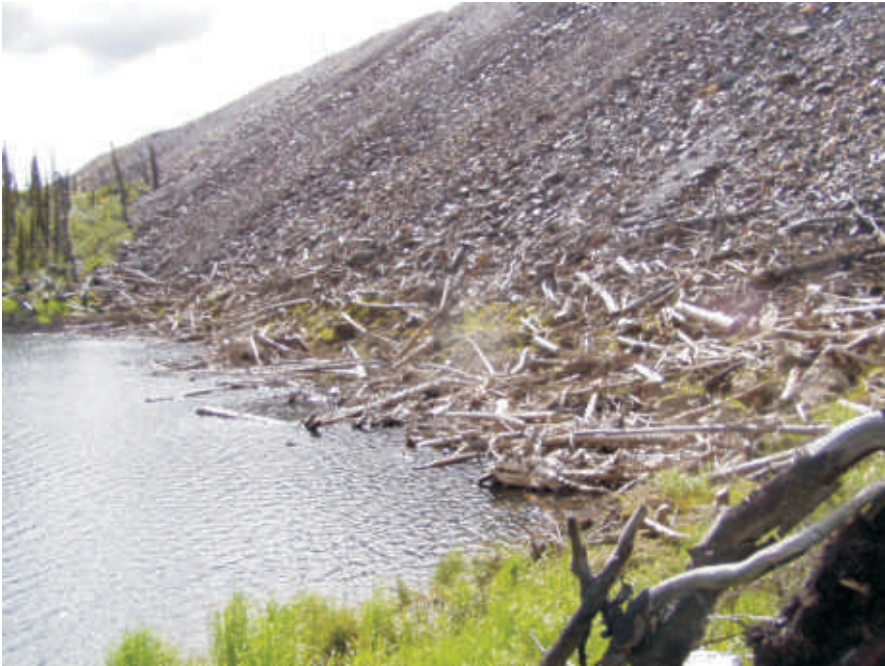
August: Photo looking along the upstream toe of the Rock Drain. Note the woody debris and grass growing on the face of the drain.

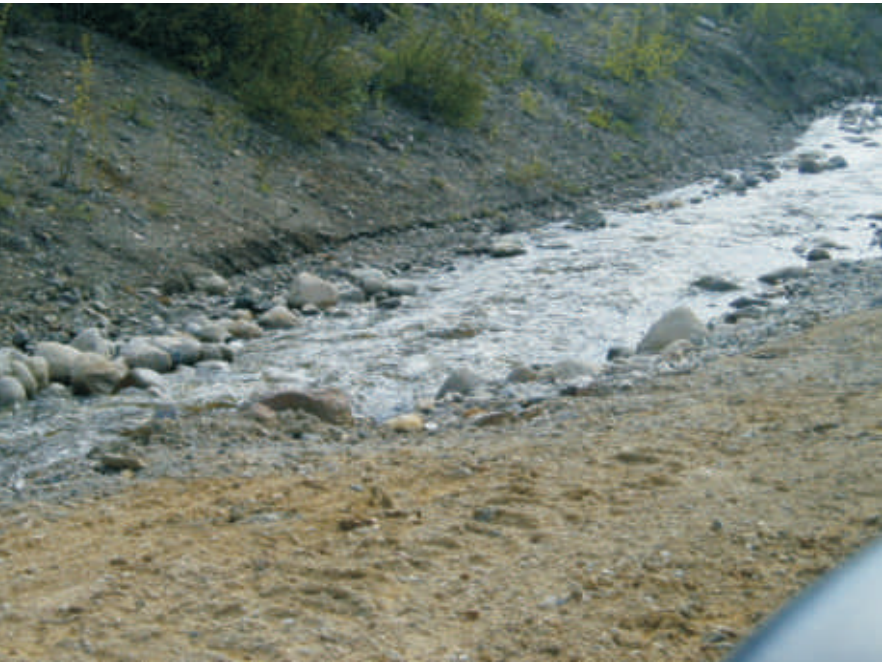
May: Photo shows a view of the Diversion Canal. There is a higher water mark located maybe 0.3 m higher up from the current water level.

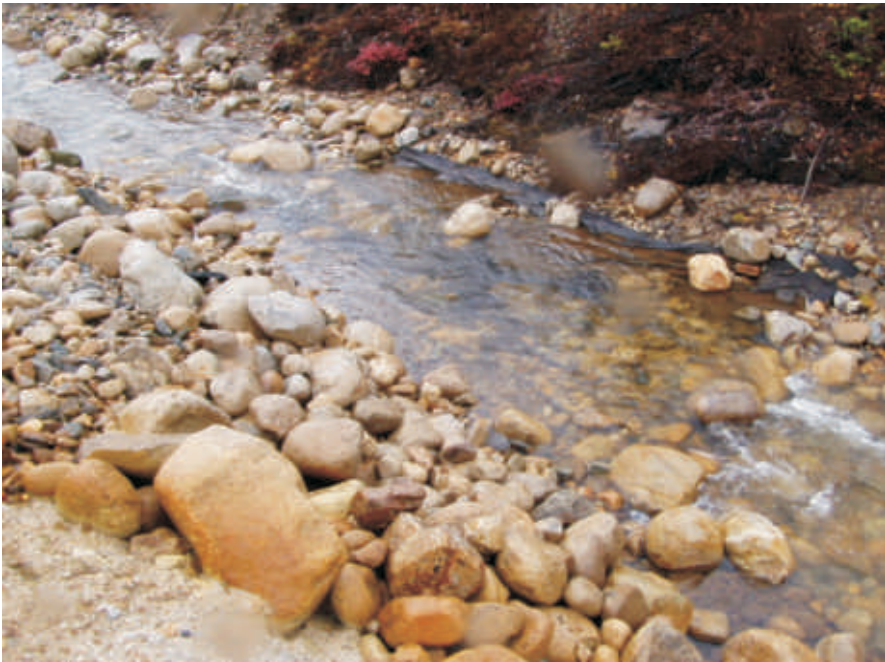
September: Photo shows an exposure of geotextile located under the riprap. This exposure is located several hundred metres before the bend in the Diversion Channel before it heads towards the east.

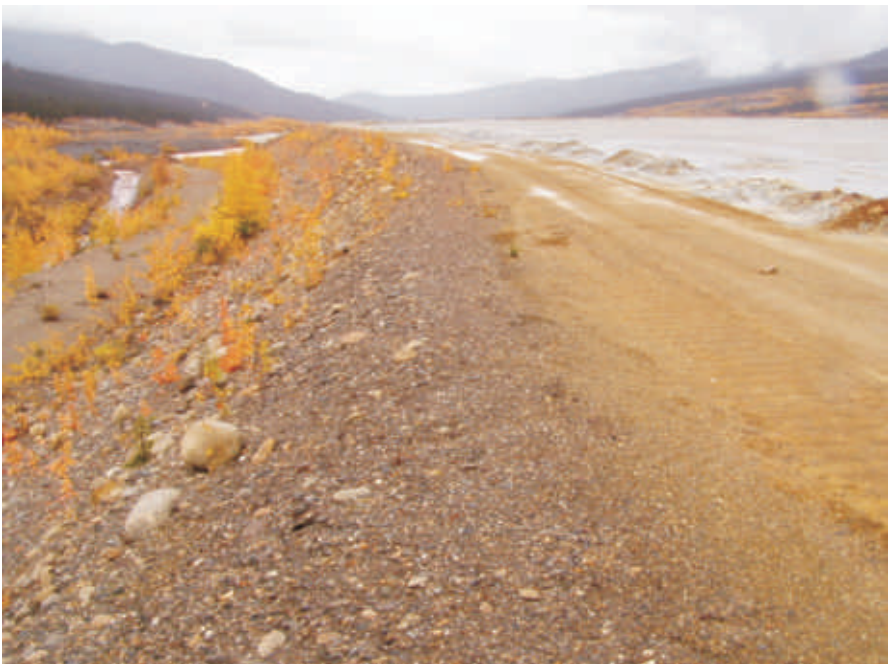
September: Photo shows the crest looking west towards the Intermediate Dam. This dam is constructed out of sand and gravel with armour on the downstream side consisting of large rounded cobbles and boulders. On the upstream side, tailings come close to the upstream crest of the dam.

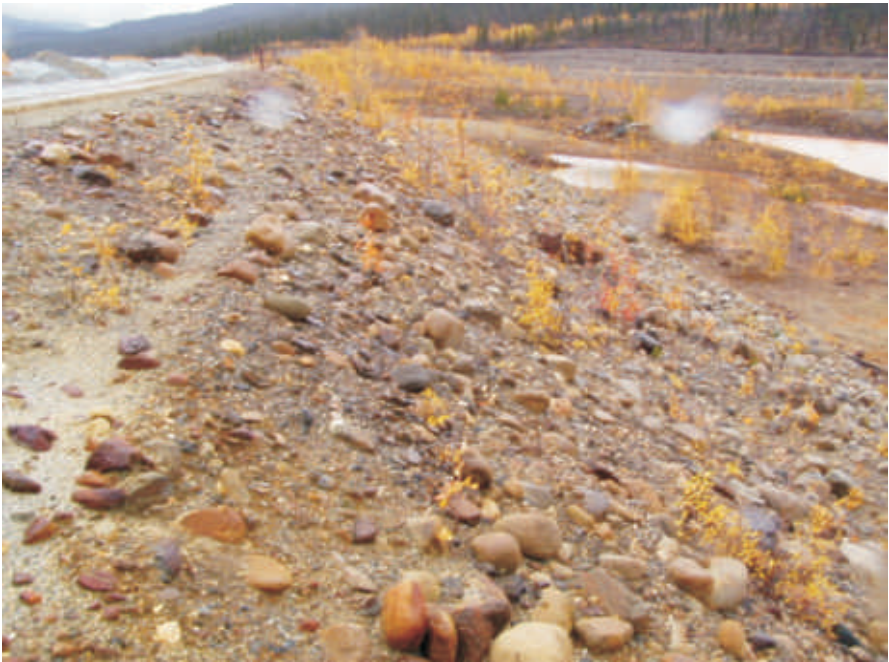
September: Photo shows a view of the downstream face of this dam. There is the occasional erosional gully but the coarse material appears to prevent any erosion of the face.

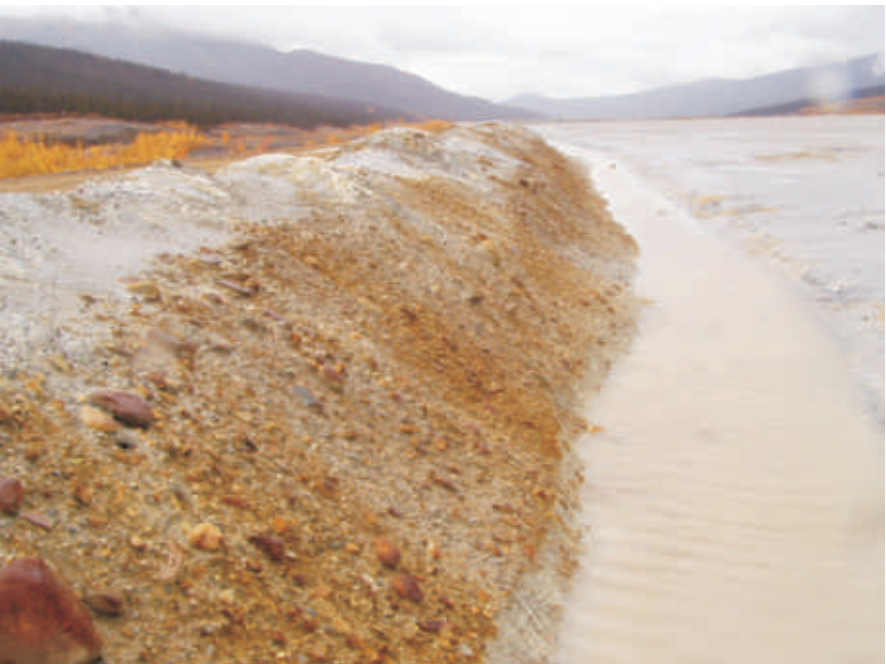
September: Photo shows a ditch on the upstream side of the Secondary Dam. There is approximately 1.2 to 1.5 m of freeboard from the ditch water level to the crest of the dike.

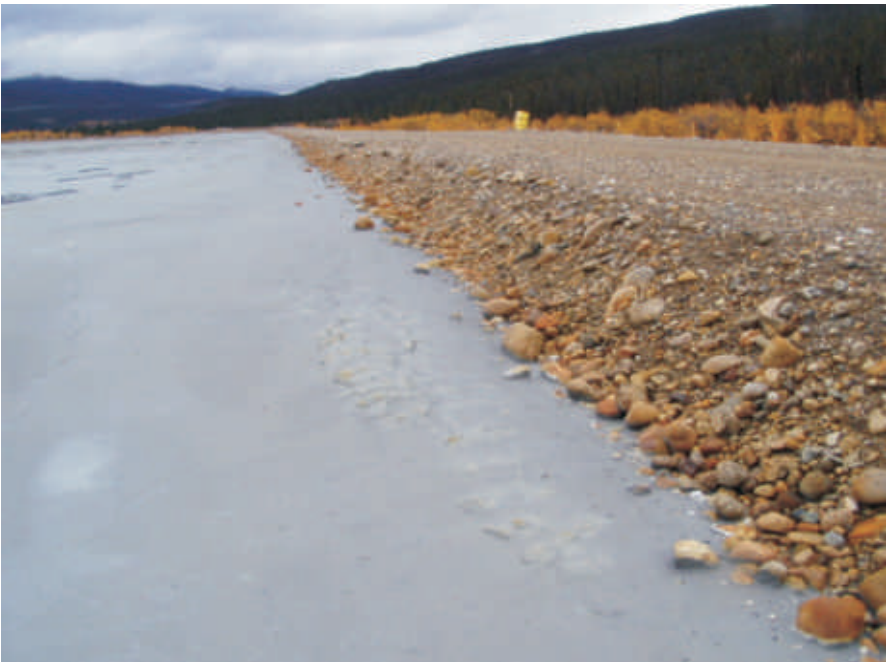
September: Photo shows the upstream side of this crest. Approximately 0.8 m to 1 m of freeboard exists from the tailings surface to the crest of the dam.

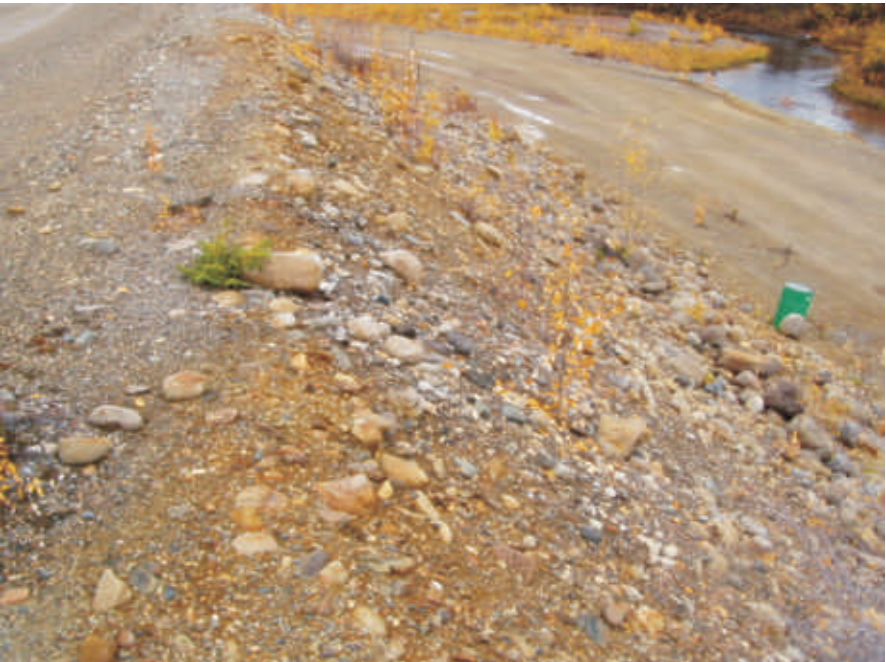
September: Photo shows the downstream face which is heavily armoured with gravel, cobbles and boulders.

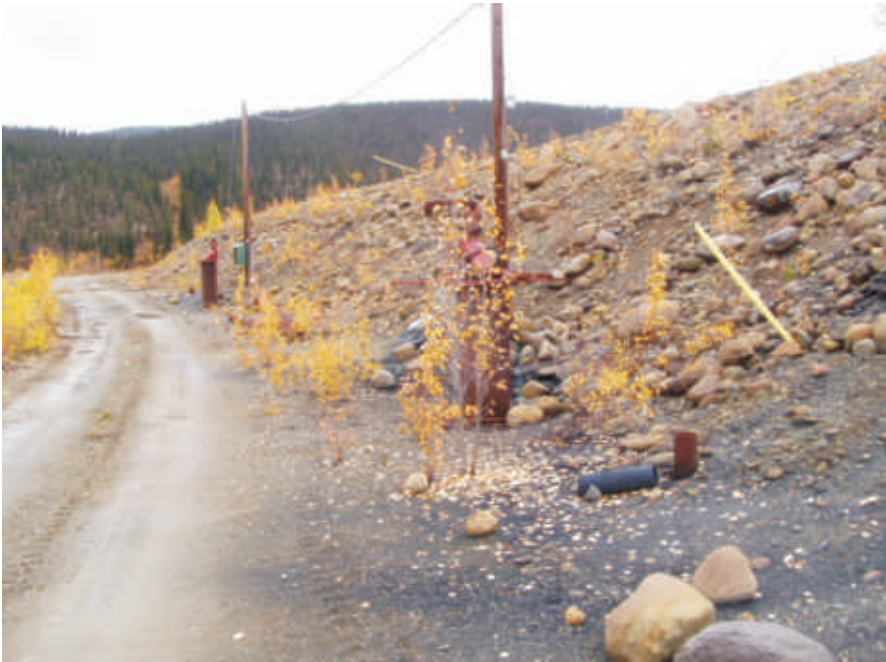
September: Photo shows the downstream face of the far eastern arm overlooking North Fork Rose Creek Diversion. There are cobbles and boulders up to approximately 3 feet in diameter.

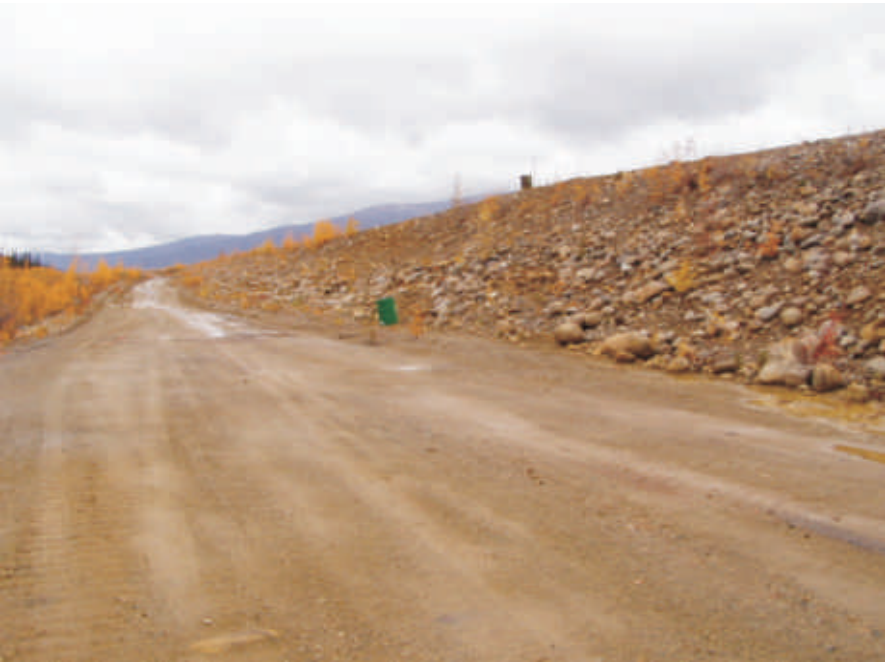
September: Photo shows another view of the downstream face of this dike looking towards the west. Large armouring from the cobbles and boulders is located on the face.

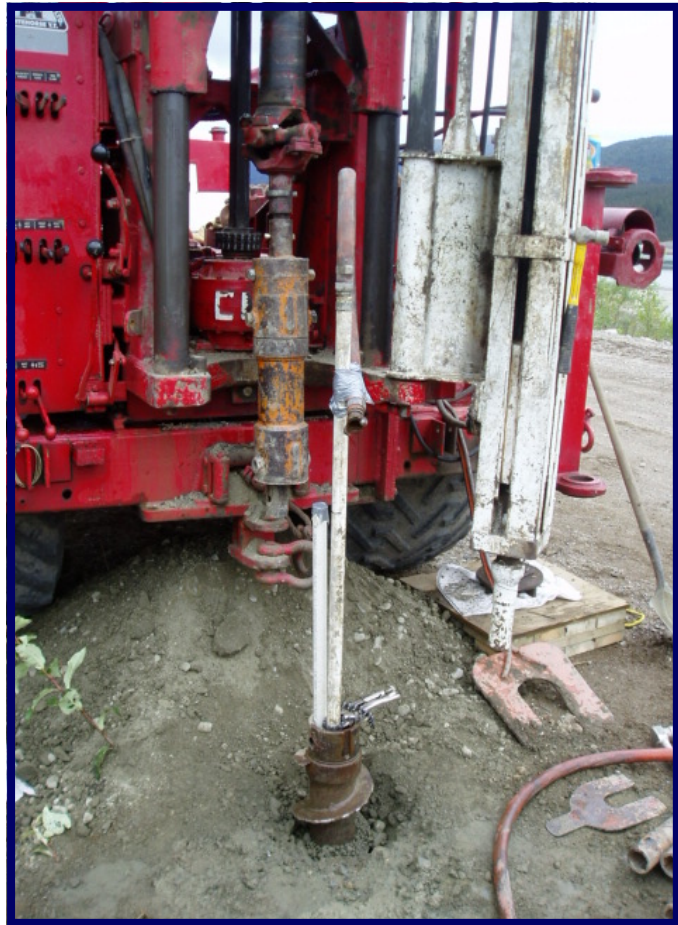
Photo 9 View of a nested pneumatic piezometer installation in BGC05-06.

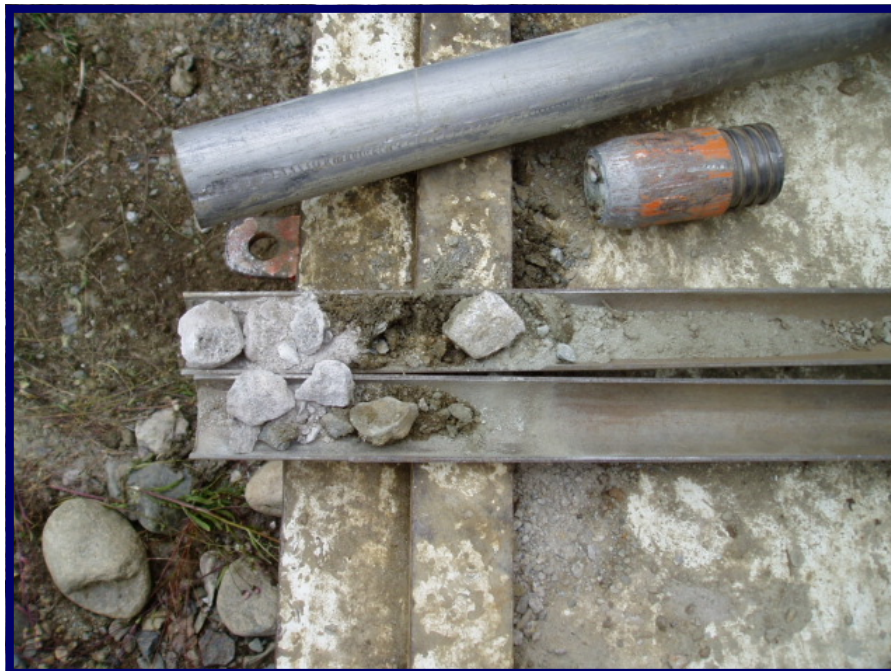
Photo 10 Close up view of sample JMS 21 retrieved from SPT spoon in BGC05-06 (9.75 m).

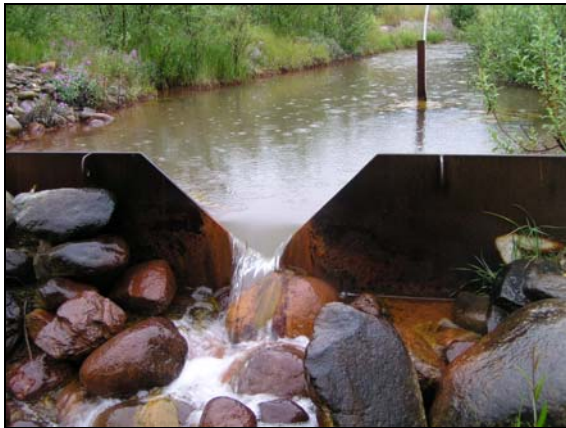
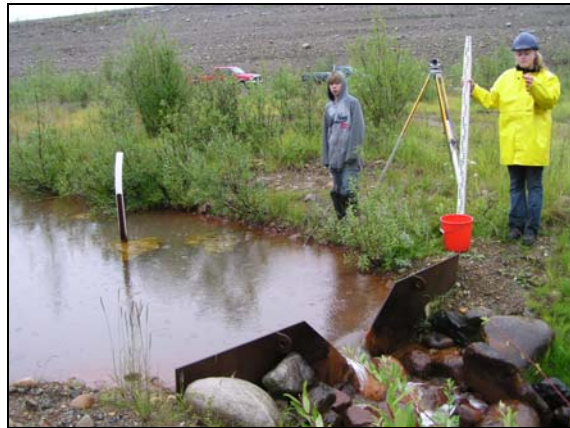
This weir was installed by Curragh and LES in 1996. It consists of a lined head pond and steel bulkhead with a 90 degree V-notch. It was leveled on July 13 2005. The top of the steel bulkhead on the left hand side looking downstream was 0.309m above the water surface. The staff gauge was reading 0.289m and the height of water over the V-notch was 0.224m. Applying the weir formula  $Q = 1.3629 \cdot H^{2.5}$ , the discharge was  $1.3629 \cdot 0.224^{2.5} = 32.4$  L/sec

The structure itself is performing well and does not need any physical work. Adjust the staff plate so that it reads the value H, or depth over the crest. The standard weir formula for 90° V-notch weirs has reported the same discharge compared with the salt slug injection in the past. (see memo to RGC May 29, 2005).

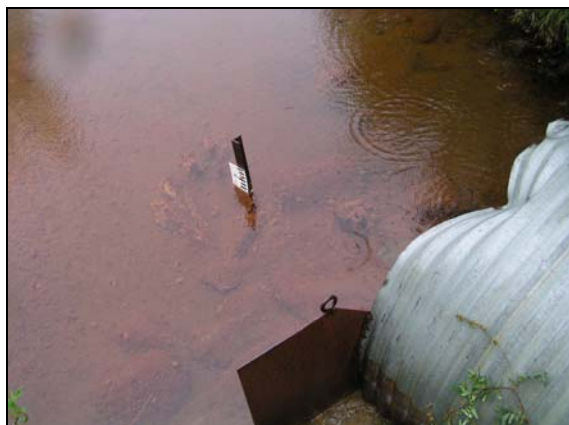
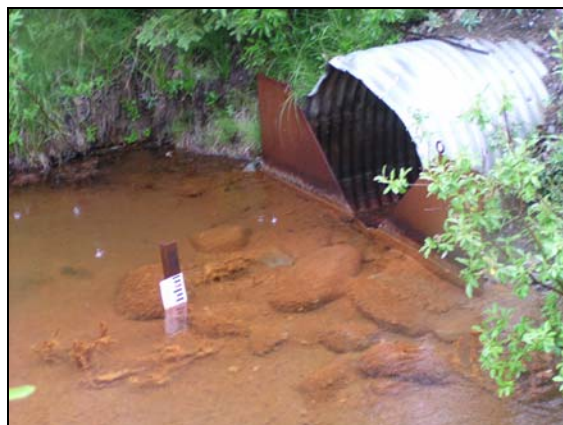
This weir is a steel bulkhead attached to the upstream end of a culvert. The head pond is still functioning but has in-filled over the years with sediment and stones from the road shoulder. This should not affect the performance of the weir as a measurement structure but it may be wise to bale out the head pond to ensure that the approach velocity is near zero. The discharge on July 13, 2005 was measured with a stopwatch and bucket, 4.35 L/sec. Applying the weir formula, the discharge was  $Q = 1.3629 (0.10^{2.5}) = 4.31$  L/sec.

Bale out the headpond. Attach a new staff plate to the angle iron so that the staff reads the same as the H value above the notch. Run an axe file over the sharp edge.

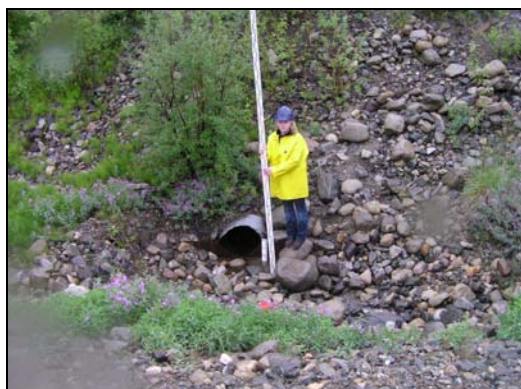
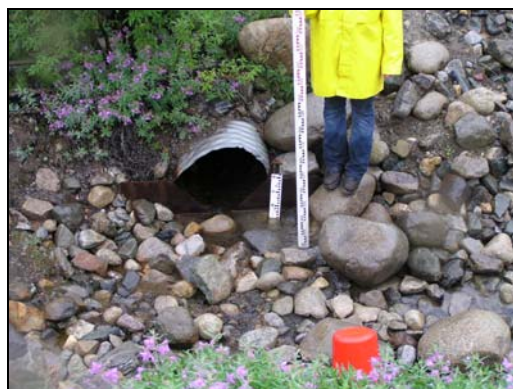
X\_12 is a small steel bulkhead with a 90° V-notch bolted onto the upstream end of a culvert. The headpond is filling up and needs to be baled out. On July 13 the top of the steel bulkhead was 0.161m above the square shaped bench mark at the side of the weir, and 0.237m above the water surface. The measured H was 0.064m and the staff was reading 0.113m. Discharge was measured volumetrically at 1.25 L/sec (see calcs. below). Using the weir formula;  $Q = 1.3629 (.0064^{2.5}) = 1.41$  L/sec. The higher result for the formula indicates that the approach velocity is too high.

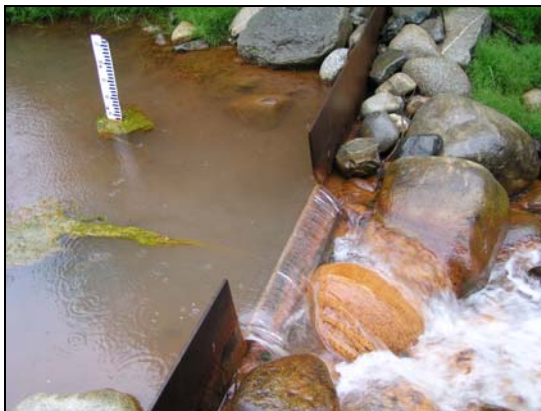
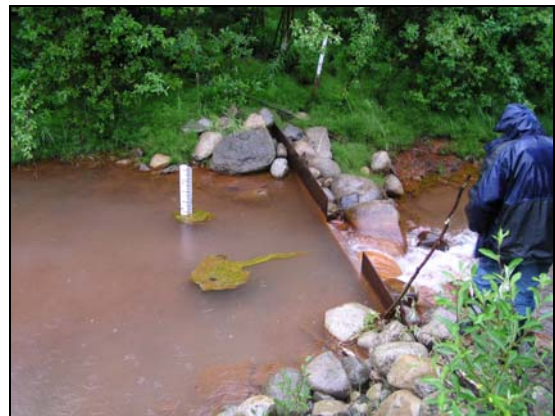
X\_13 is the combined seepage of X\_11 and X\_12. This weir is a rectangular sharp crested weir with a width of 0.915m. The weir is slightly slanted so that the H value varies from one side to the other. On July 13 the H on the RHS looking downstream was 60mm and 86mm on the LHS. The staff gauge was reading 0.260m. Using the formula in metric units for a sharp crested rectangular weir;  $Q = 1.8363 LH^{3/2}$ , the discharge was  $1.8363 \times 0.915 \times 0.074^{3/2} = 33.8 \text{ L/sec}$ . (This compares with the sum of X\_11 and X\_12;  $32.4 + 1.25 = 33.65 \text{ L/sec}$ ).

Try to level the weir, so that it has the same H across the crest. Adjust the staff so that it reads the same as the crest H. (Note that at this site it is preferable to measure the H using a steel tape because of precision).

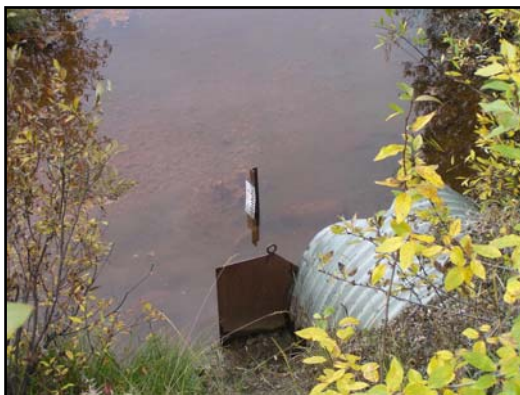
**Weir #3 or CVS\_6 - 90° V-notch weir upstream end culvert**

This weir is a steel bulkhead welded to the upstream end of a culvert. The head pond is still functioning but has in-filled over the years with sediment and stones from the road shoulder. The discharge on July 13, 2005 was measured with a stopwatch and bucket, 4.35 L/sec. Applying the weir formula, the discharge was  $Q \text{ L/sec} = 1362.9 (0.10^{2.5}) = 4.31 \text{ L/sec}$ . On September 2<sup>nd</sup>, the existing staff gauge read 0.13 m and H was measured at 0.092 m. The volumetric discharge was 3.8 L/sec and the formula discharge was  $Q \text{ L/sec} = 1362.9 (0.092^{2.5}) = 3.52 \text{ L/sec}$ . The staff gauge was set to read H or 0.092 m.

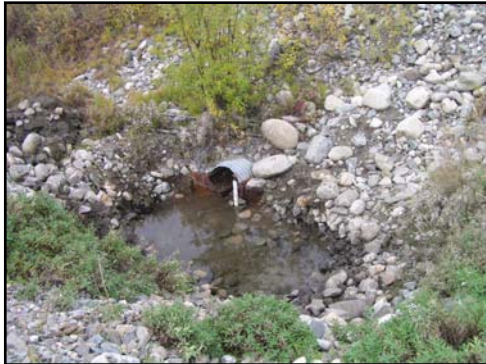
### **X\_12 or CVS\_6 - 90° V-notch weir upstream end culvert**

X\_12 is a small steel bulkhead with a 90° V-notch welded onto the upstream end of a culvert. The headpond was cleaned out and the edge sharpened on September 1, 2005. On September 2 the measured H was 0.033 m and the staff was reading 0.09 m. Discharge was measured volumetrically at 0.26 L/sec. Using the weir formula;  $Q \text{ L/sec} = 1362.9 (.033^{2.5}) = 0.27 \text{ L/sec}$ . The staff gauge was adjusted to read H, or 0.033 m.

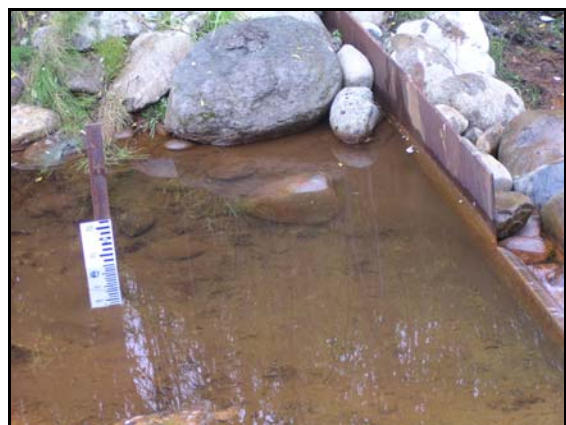
**X\_13 showing staff gauge set at average H**

The staff gauge was adjusted to reflect the average H over the crest, or 0.060 m on September 2, 2005. When reading this weir, it is prudent to measure the depth over the crest on the LHS and RHS using a set square or ruler for better precision.
