### **2006 ANNUAL GEOTECHNICAL EVALUATION AND INSTRUMENT REVIEW**

### **VARIOUS FACILITIES AT FARO MINE, YUKON**

PROJECT NO.: 0257-039-05  
DATE: FEBRUARY 14, 2007

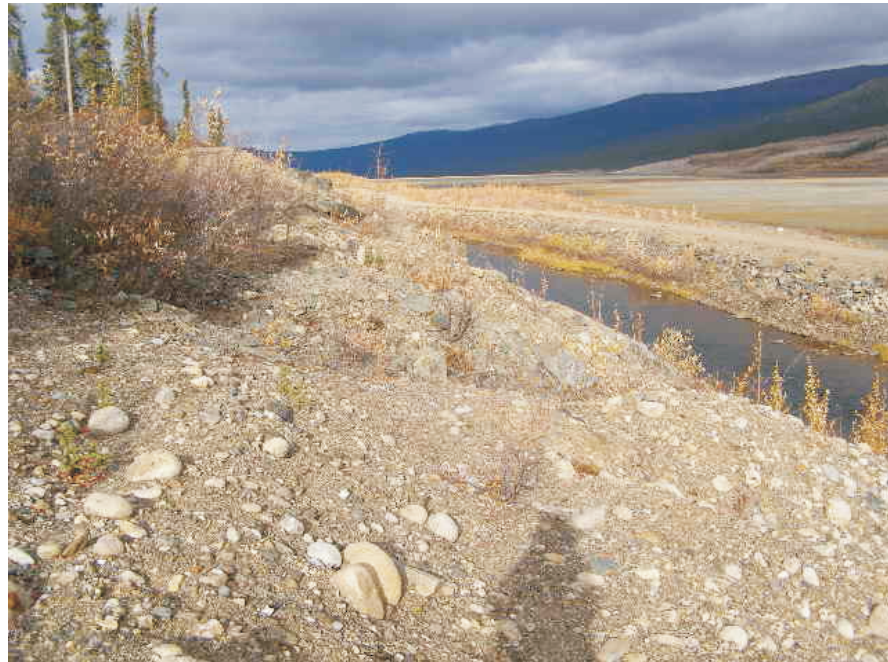
September: shows the erosional gullies and small instability which previously occurred on the backslope, just west of Goodall Creek.

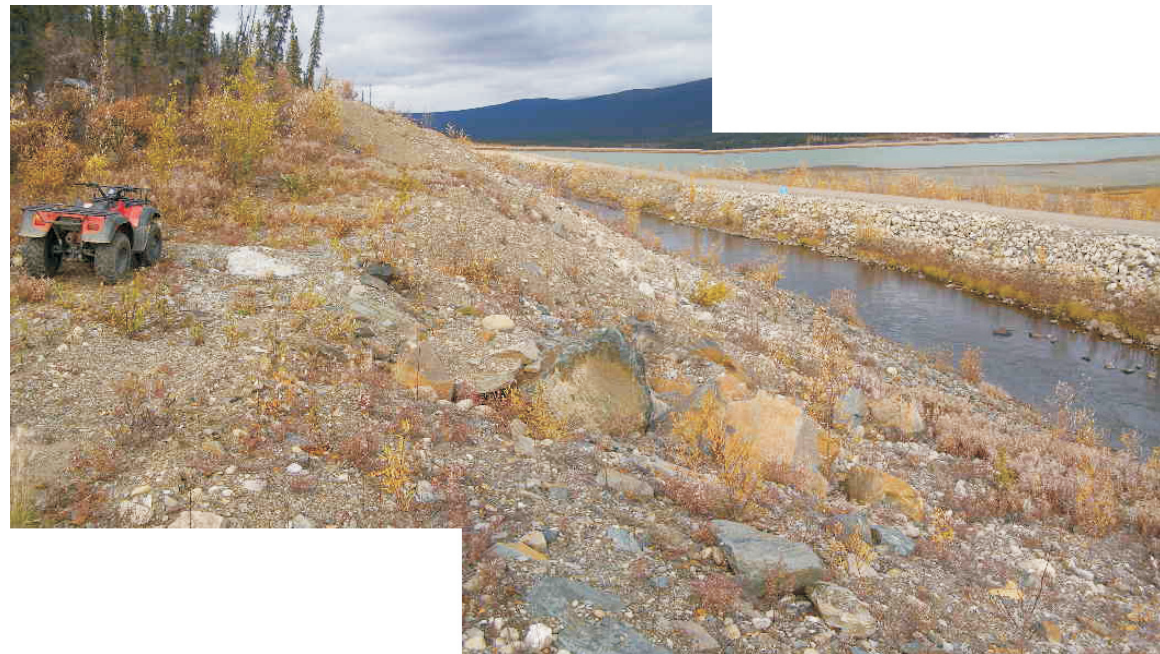
September: show a panoramic view of the thermal protection berm along with the large riprap which was previously placed within a erosional gully. At the bottom of the slope there is a significant amount of vegetation in the erosion gullies indicating water flow.

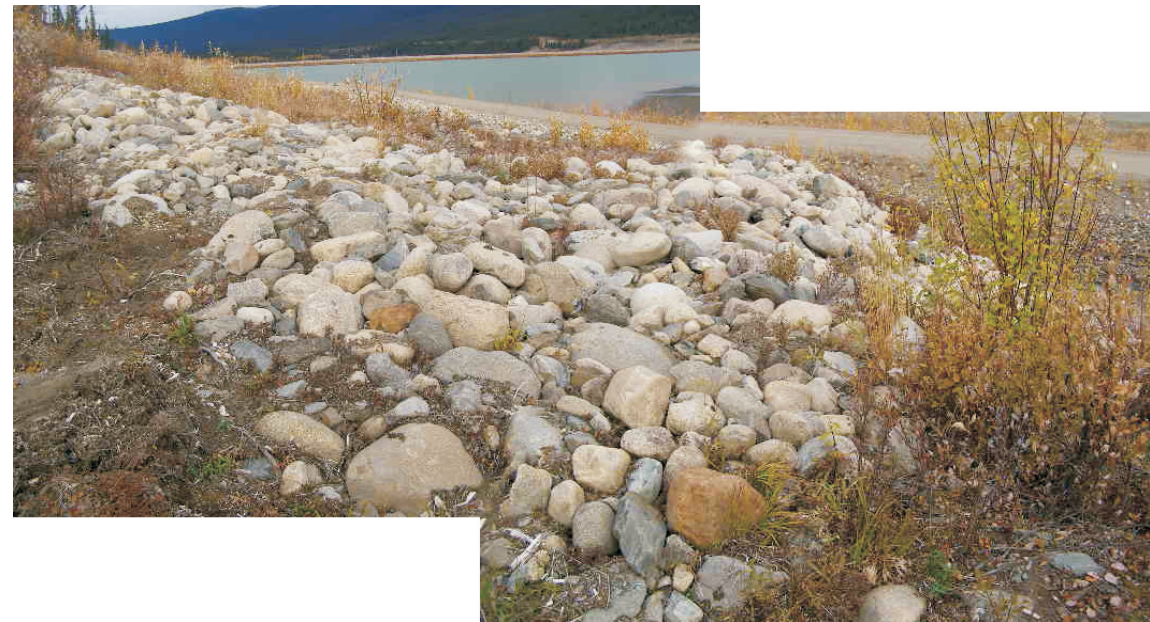
September: shows the placed riprap blanket which was placed on an old slough on the backslope.

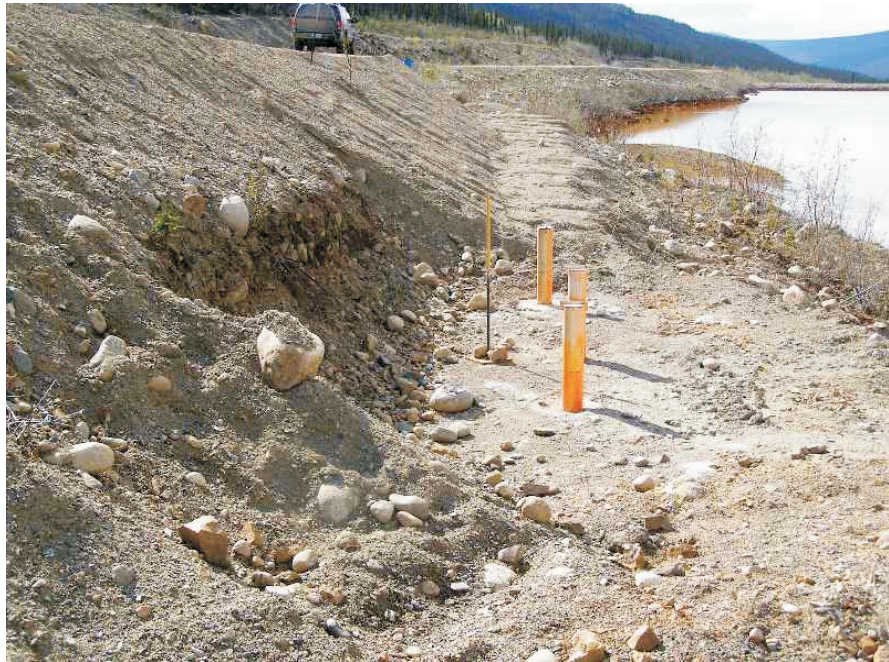
June: A view of three instruments installed in 2005. The oversteepened slope in this area should be backfilled to buttress the slope.

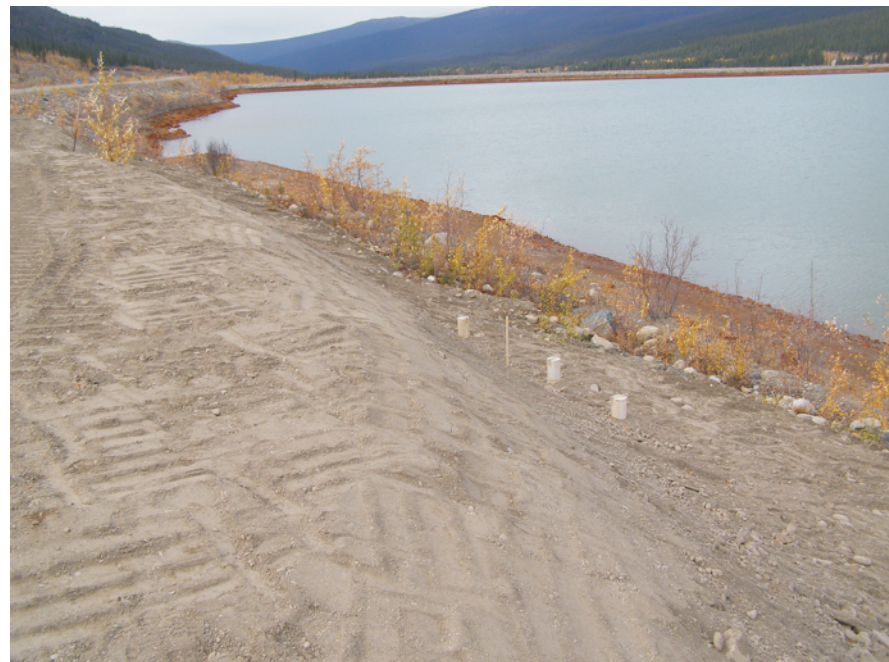
September: same location as in the photo above. Note that the oversteepened slope has been backfilled.

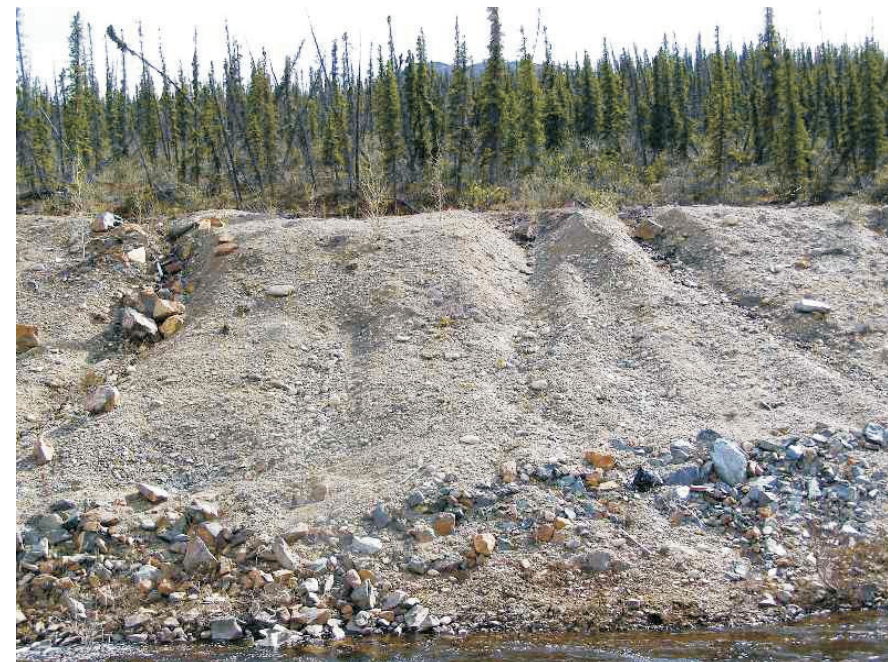
June: Shows the erosion gullies that have formed in the thermal protection berm above the boreholes drilled in 2005.

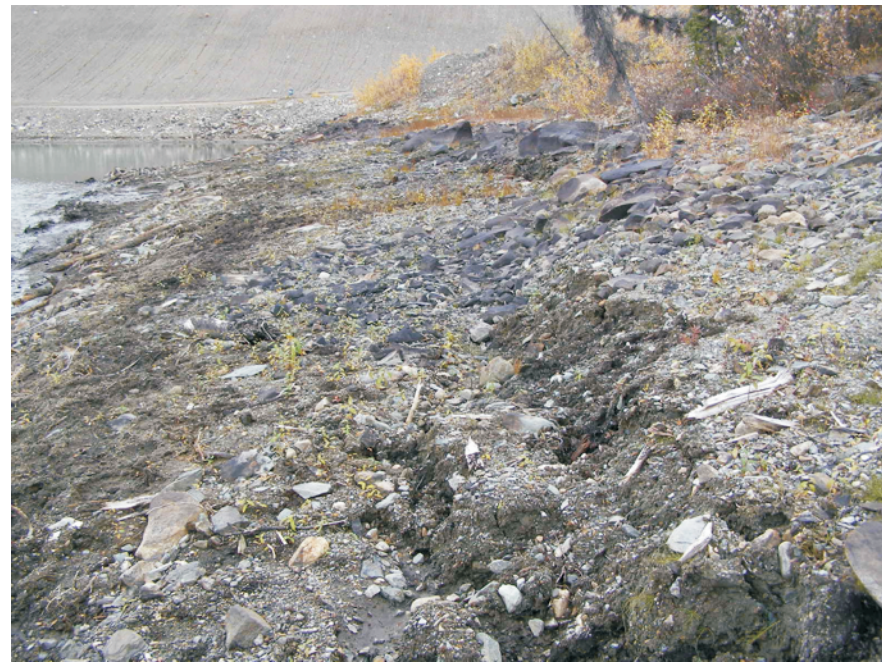
September: headscarp in seepage area on the southern limit of the Polishing Pond.

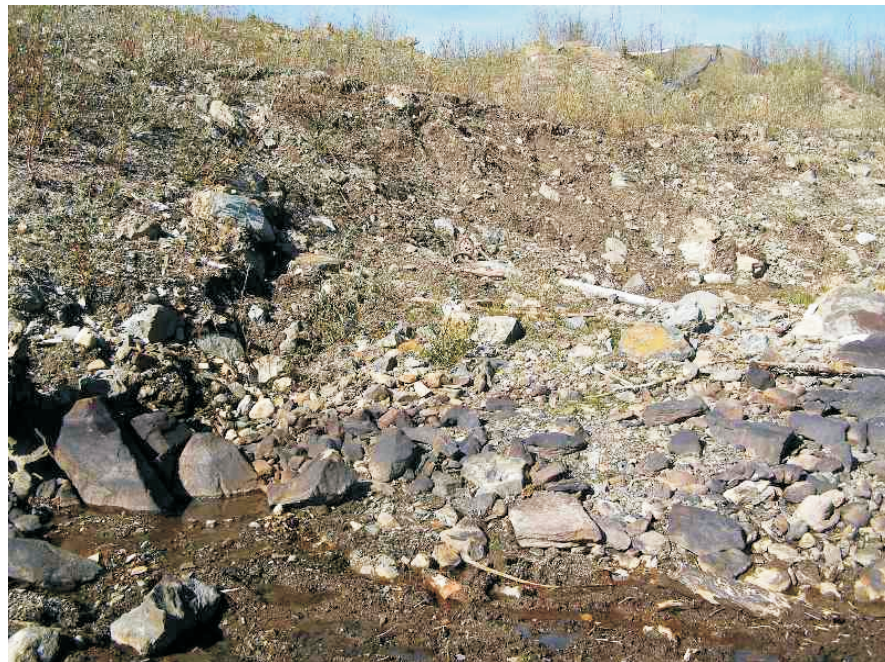
June: Headscarp formed near seepage discharge.

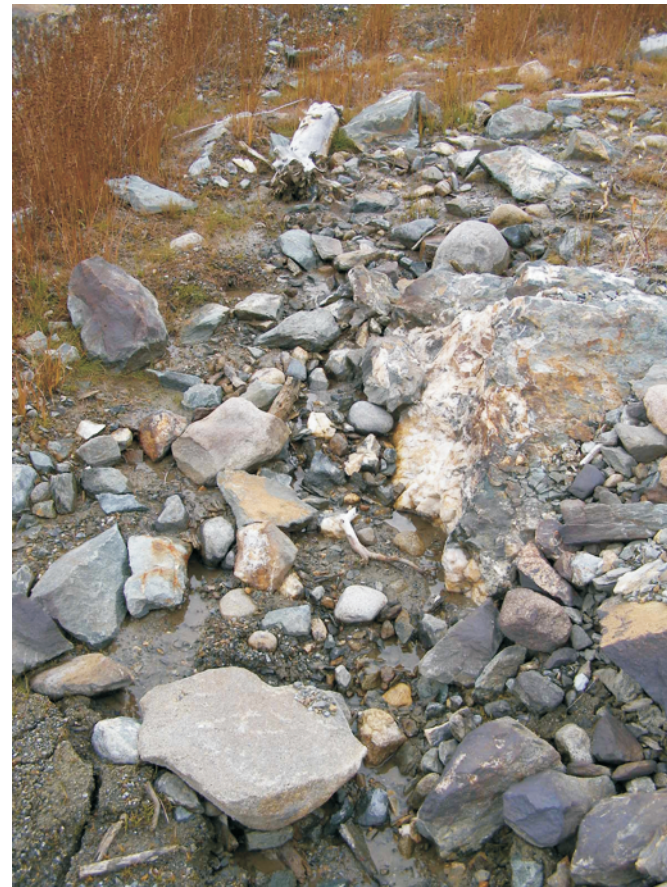
September: seepage discharge.

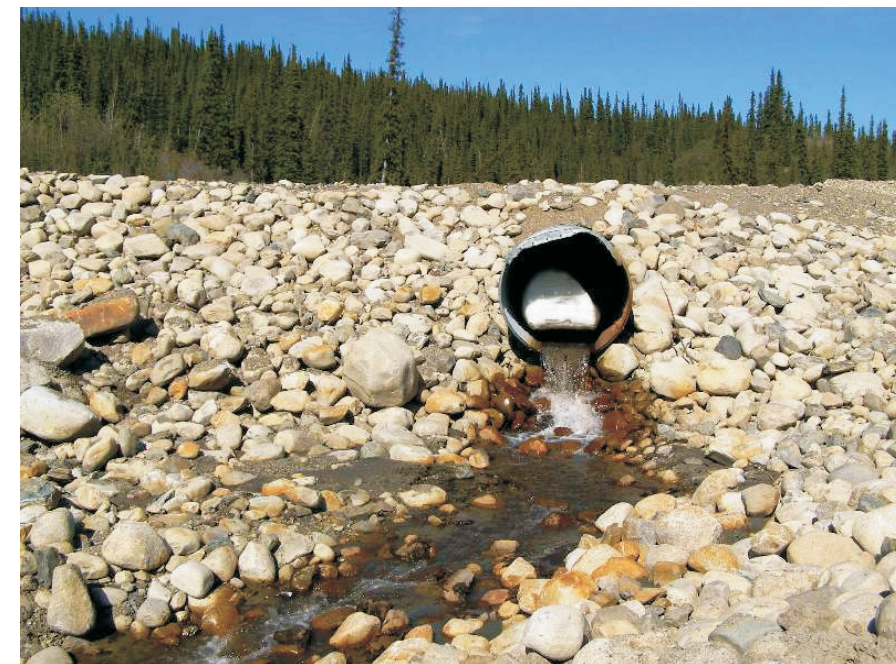
June: Culvert outlet, note the ice partly plugging the culvert.

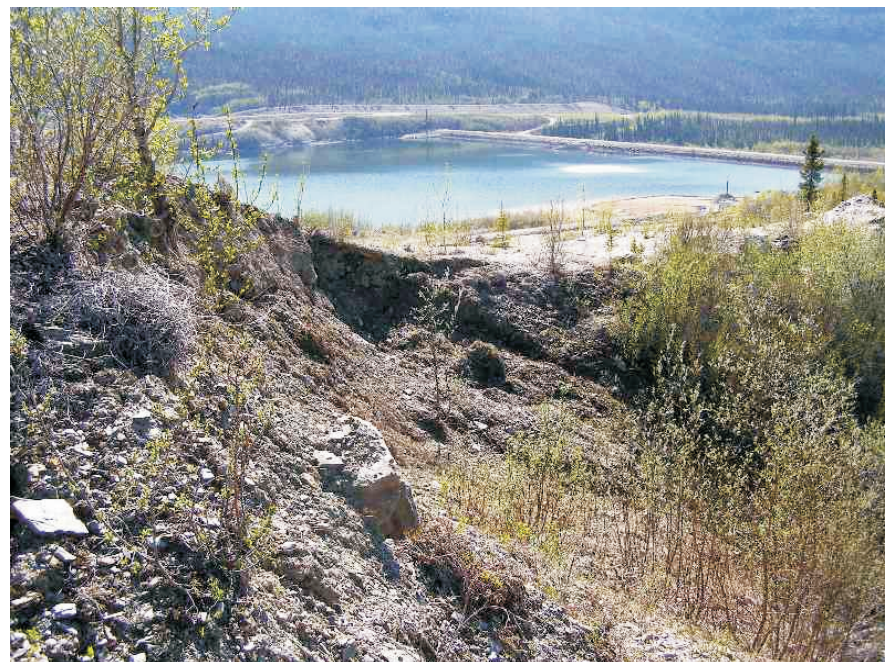
June: Sloughing of the berm near the steep section of the channel upslope from the Intermediate Dam.

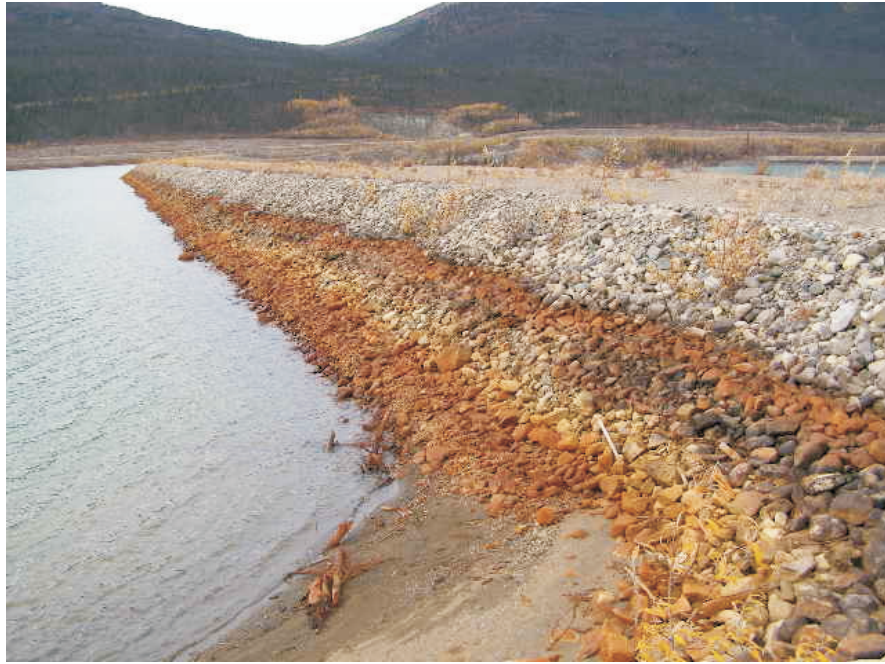
September: Shows the upstream side of the Intermediate Dam including the exposed riprap due to the low level of the pond.

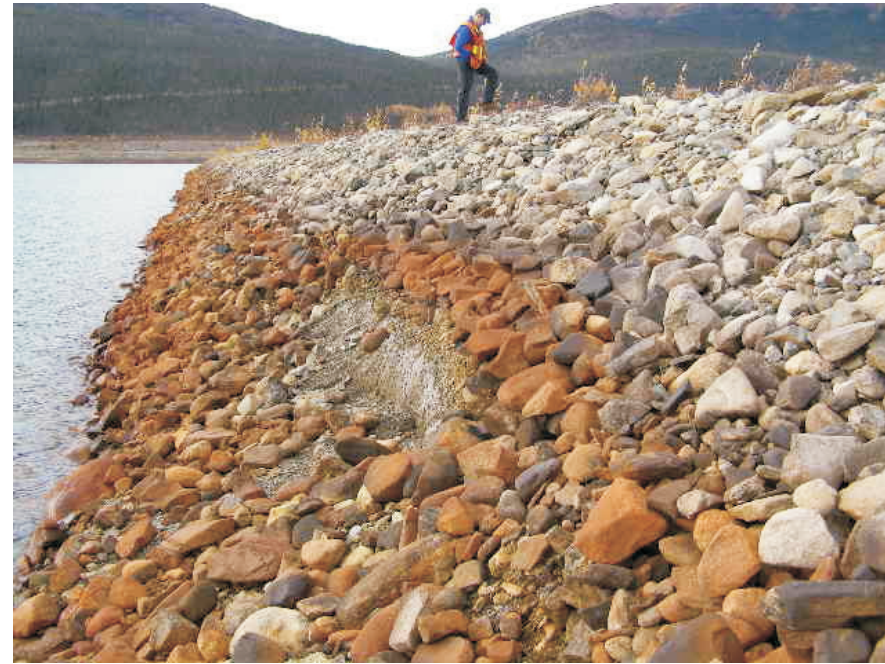
September: shows a small scarp formed on the riprap.

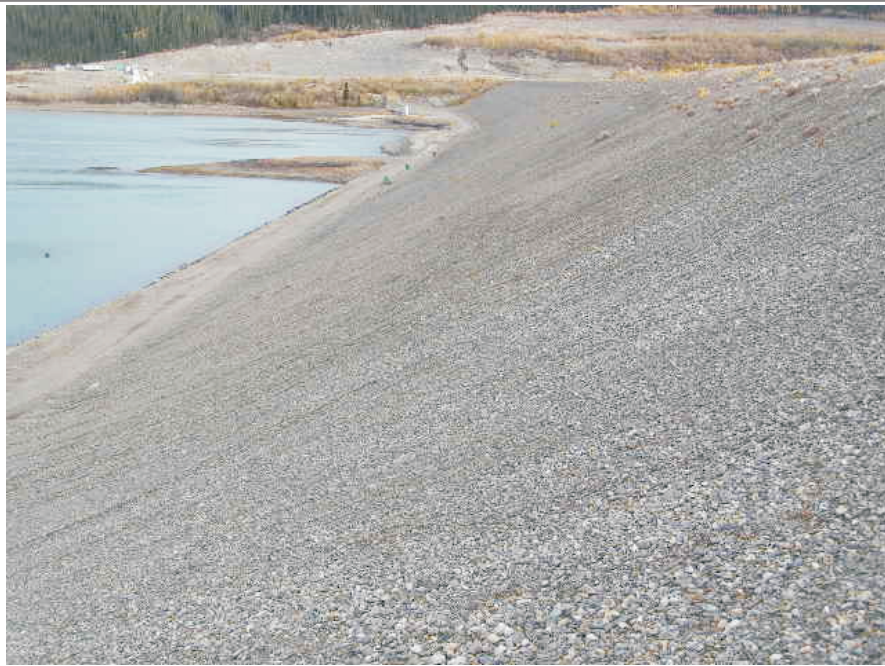
September: a view of the downstream side of the dam. The slope has a good, even, consistent grade with no signs of bulging, deformation or erosion. Minor amount of vegetation catching on upper portion of the slope.

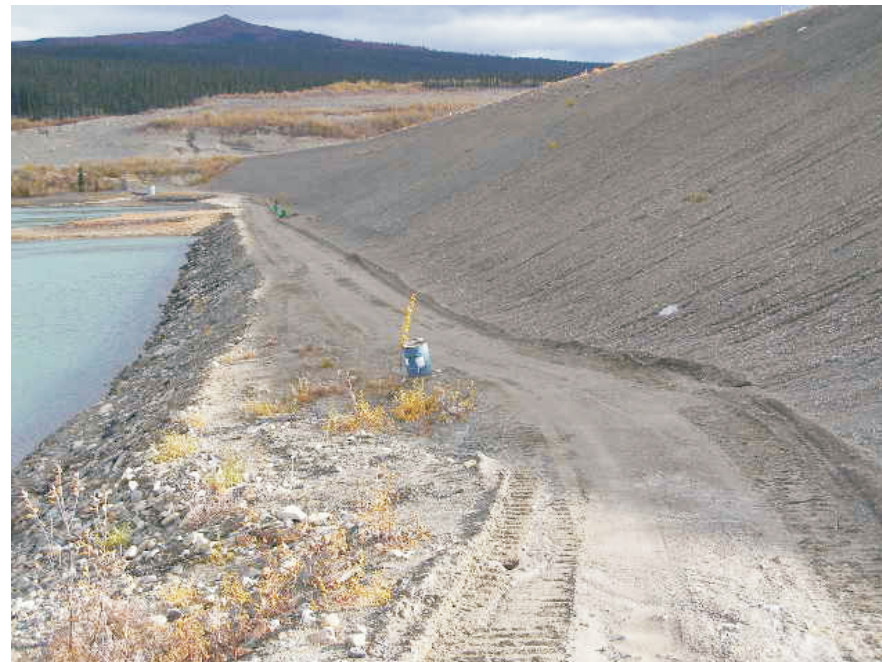
September: taken along the toe looking towards the north abutment. From this perspective, there are no signs of seepage discharge on the toe berm road.

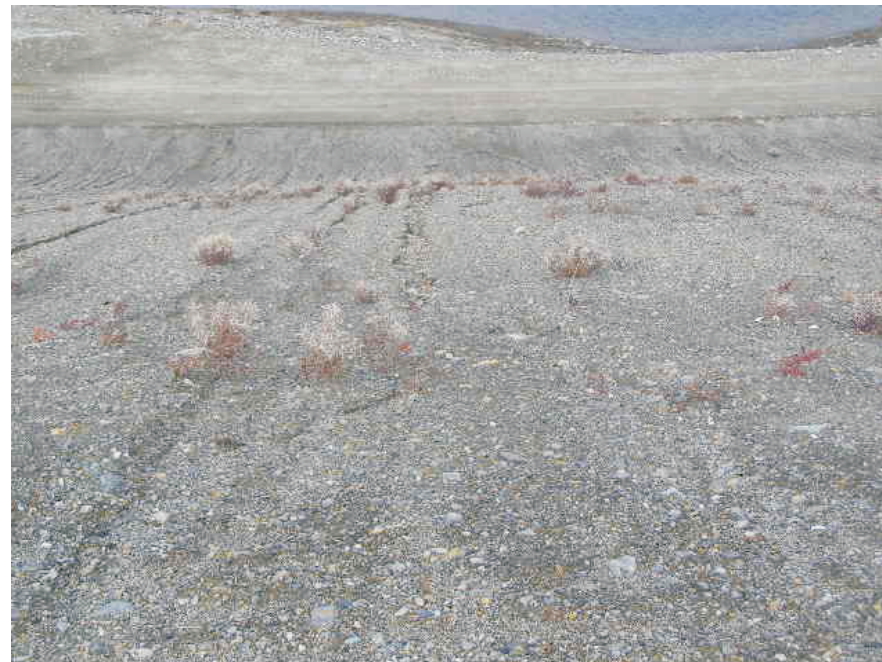
September: shows the minor erosional rills located on the downstream face.

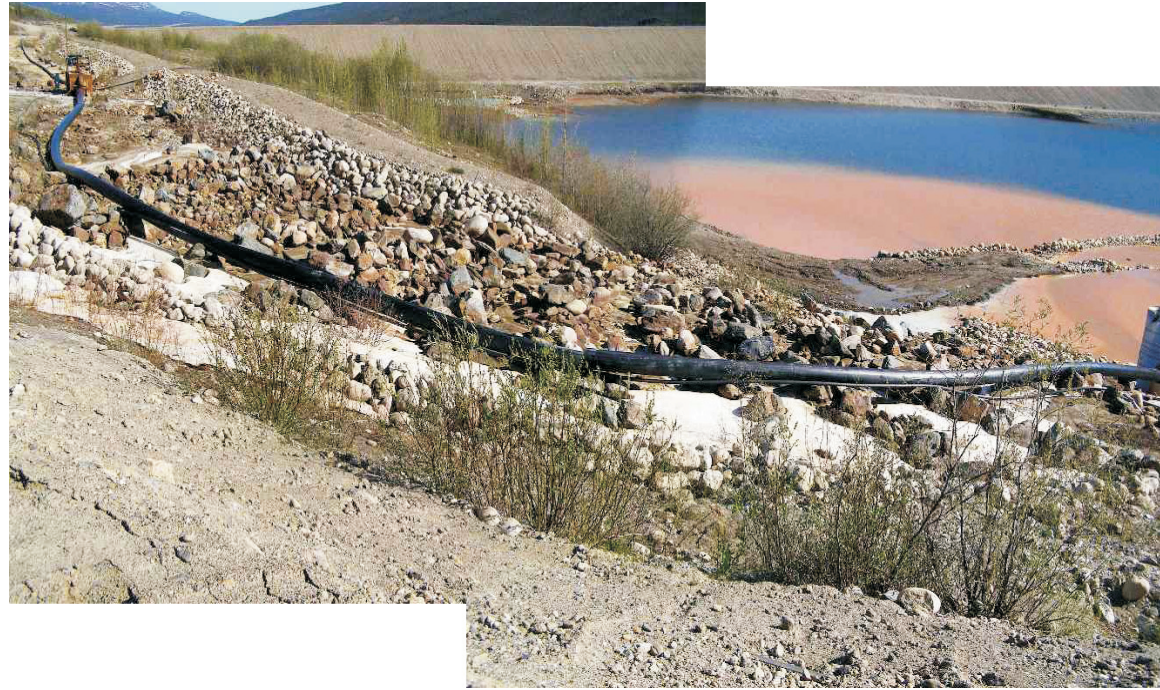
June: Two shot panorama showing the lower steep section of the Intermediate Dam Spillway. Note the riffle/pool form of this section of the spillway.

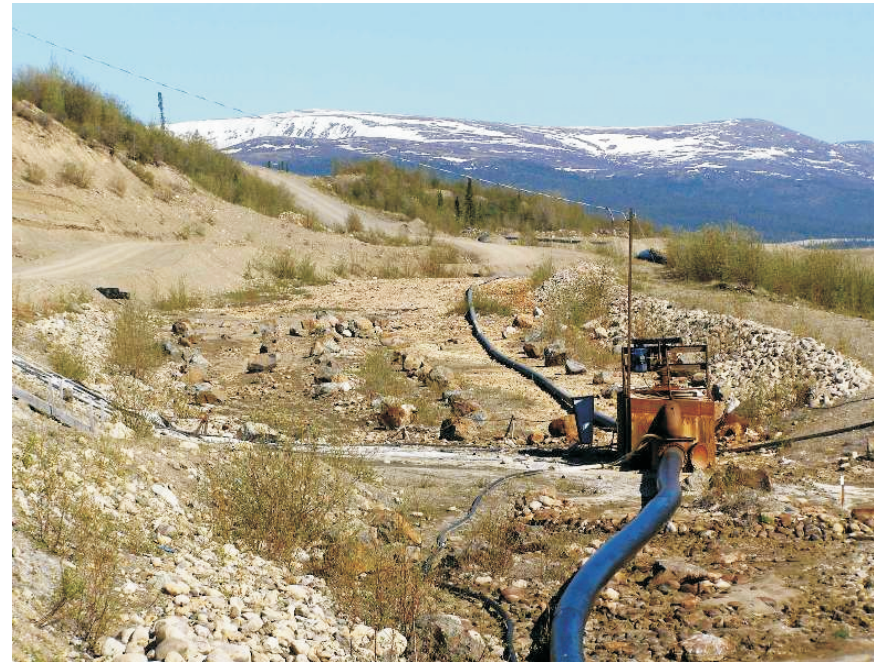
June: Middle portion of spillway, including large boulders.

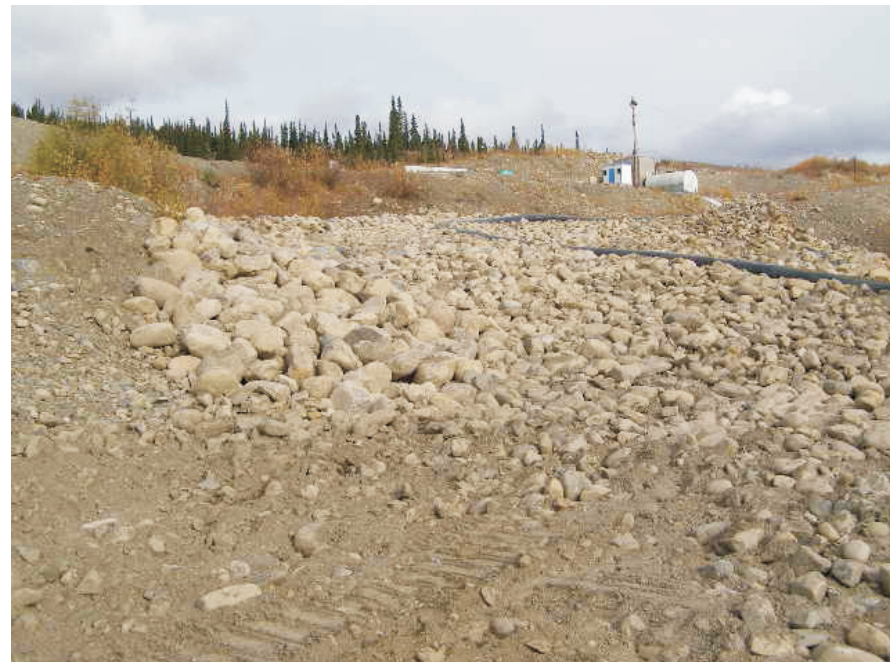
September: looking upstream in the spillway at the recent completed regrading of the riprap.

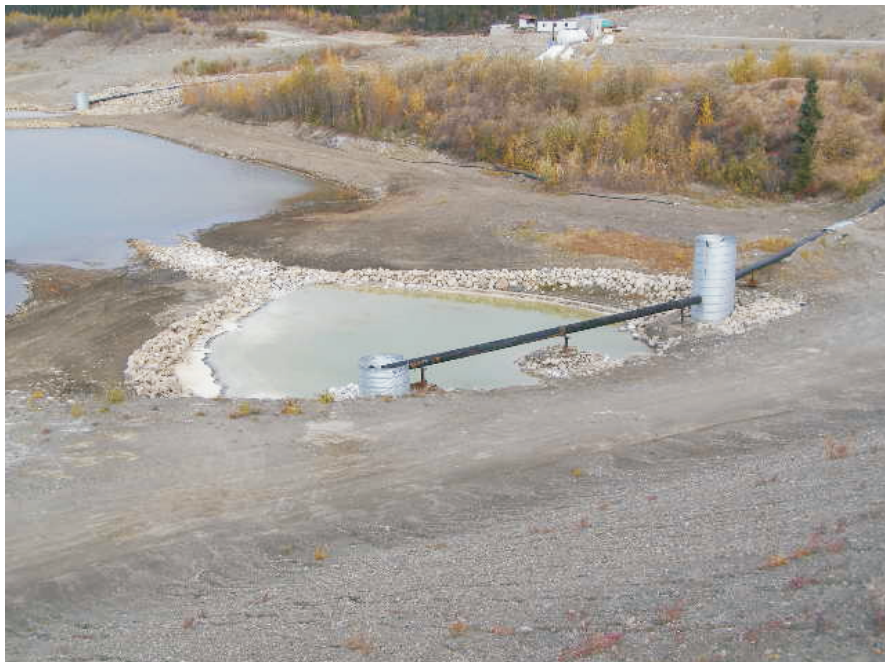
September: shows the sump arrangement located at the toe of the north abutment of the Intermediate Dam.

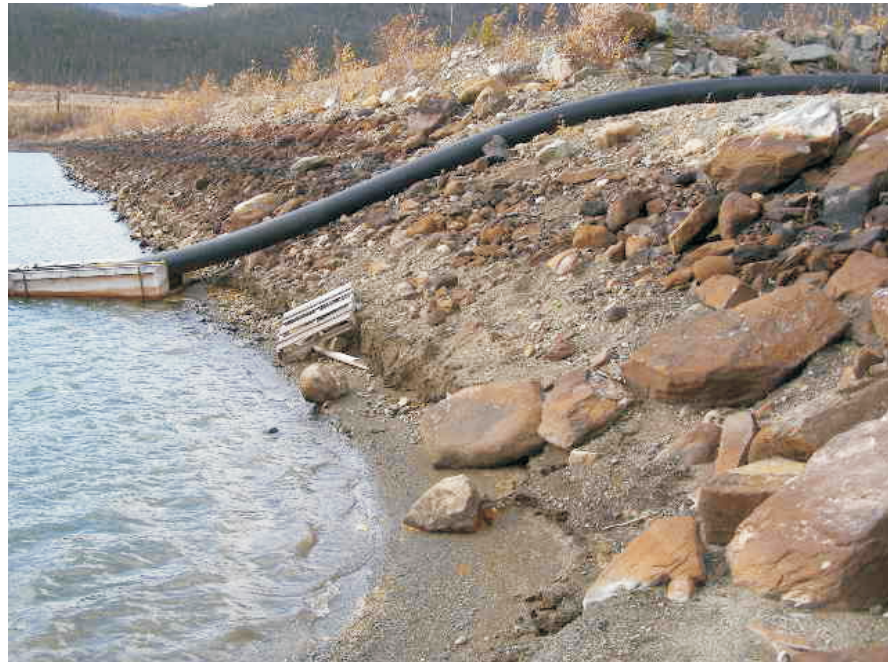
September: shows a view of the riprap on the upstream side. A small scarp which has formed at the pond level due to the lack of riprap.

- The water elevation in the Polishing Pond appears to be lower than typical due to the release of water through the siphon pipe. The water level appears to have been held lower than the lowest elevation of the rip rap for some time this year. An erosion scarp has formed on the face of the dam below the lowest elevation of the rip rap. The water level in the pond should be maintained such that the water is within the zone protected by rip rap. Two courses of action are available: either buttress the scarp to stop rip rap movement or await the movement and then repair the rip rap.

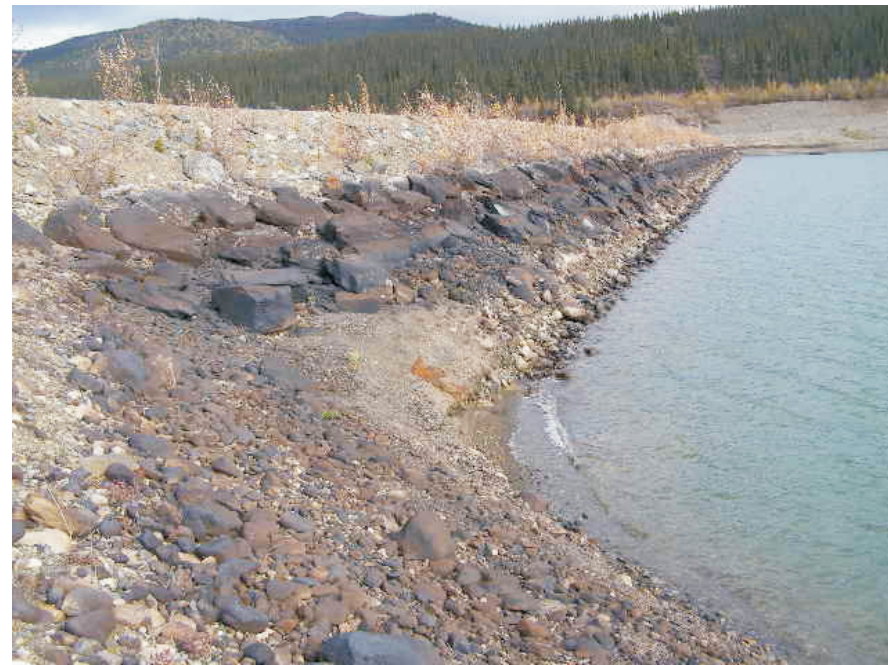
September: shows a view of the upstream side looking towards the north abutment. Some rather large riprap is evident in the mid section of the slope. In the foreground we can see some erosion at the lower pond level, where there is no riprap.

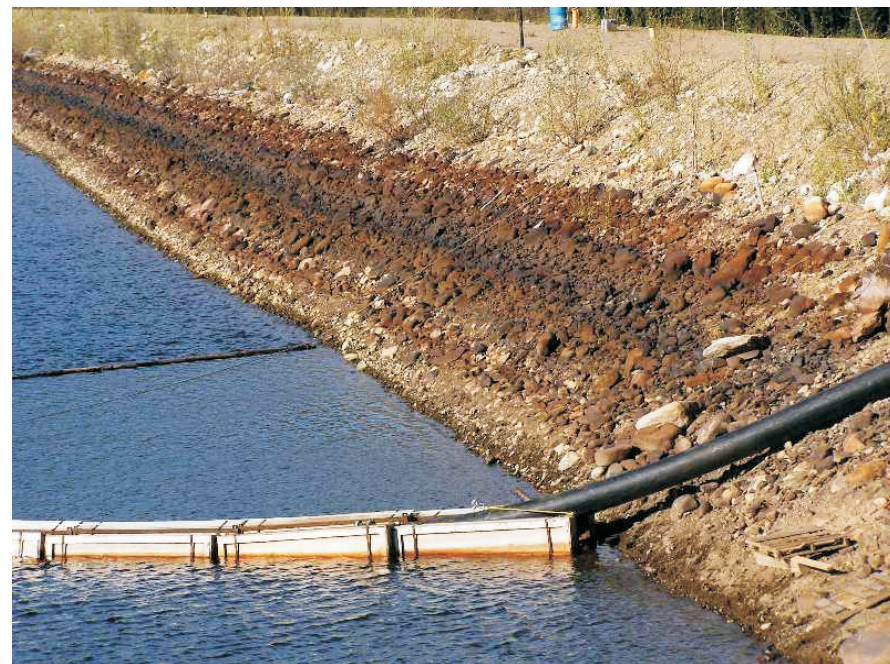
June: Water level is below the lowest elevation of the riprap protection.

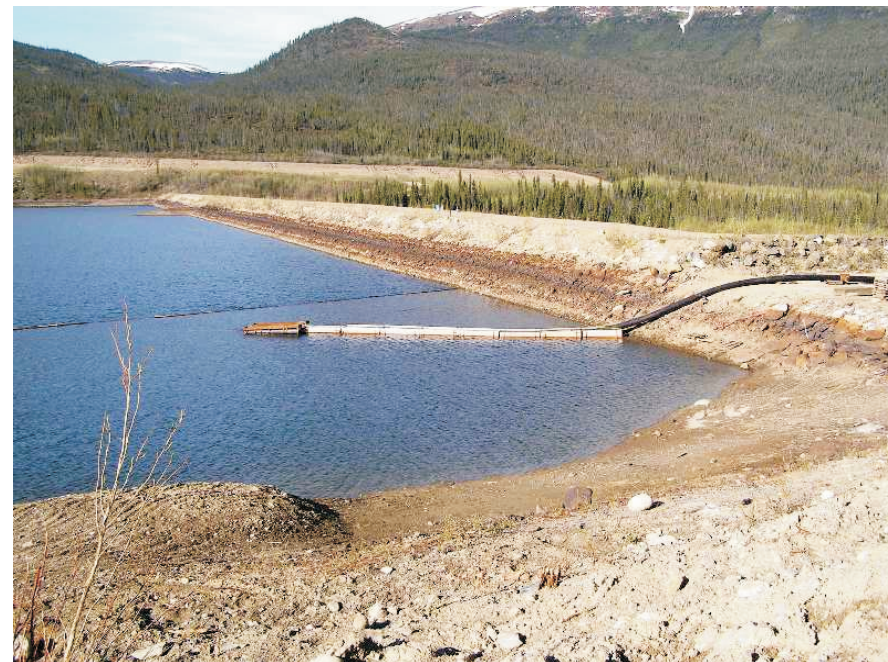
June: Siphon system in the spillway.

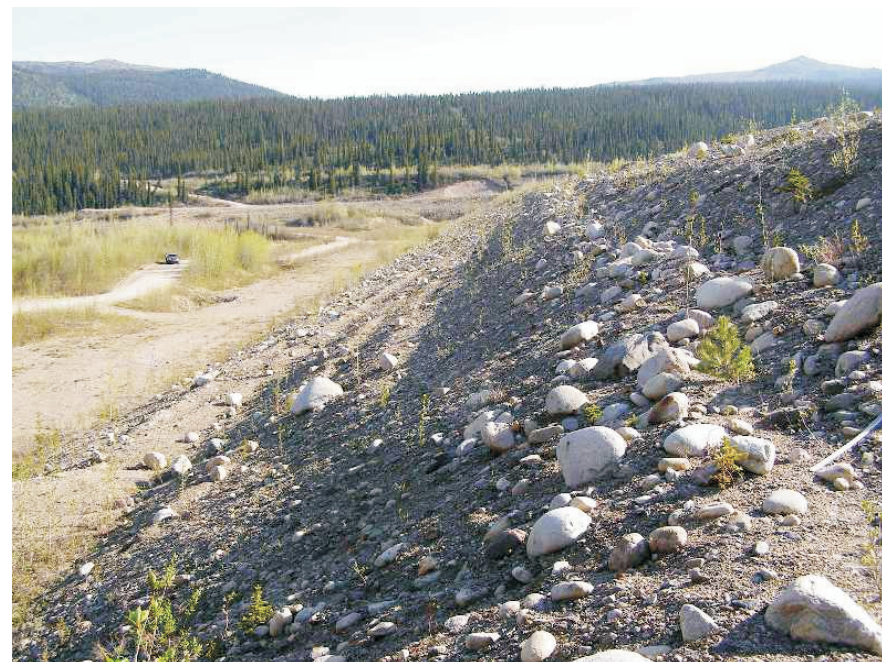
June: View along downstream face of the dam.

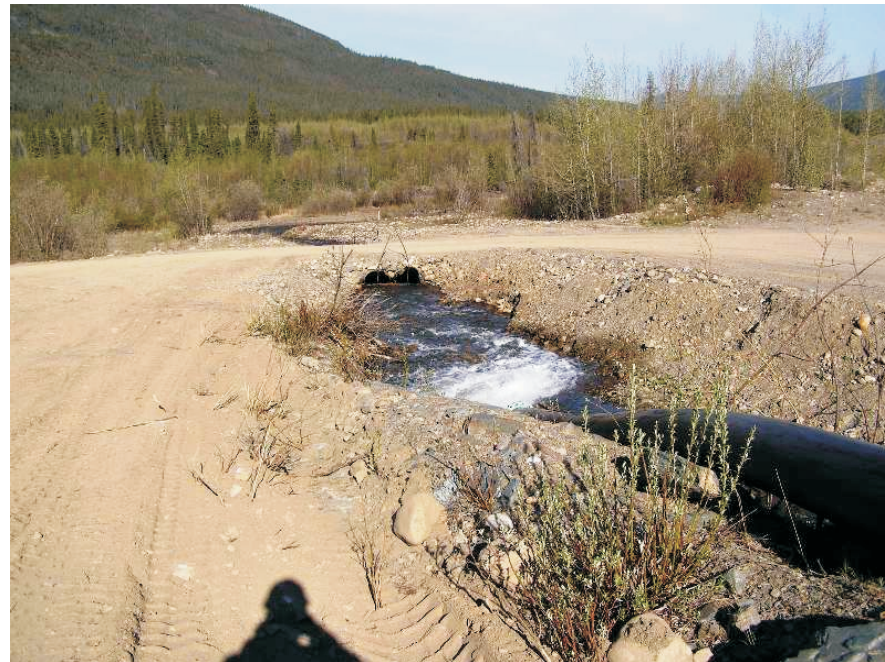
June: Siphon discharge at lower end of spillway.

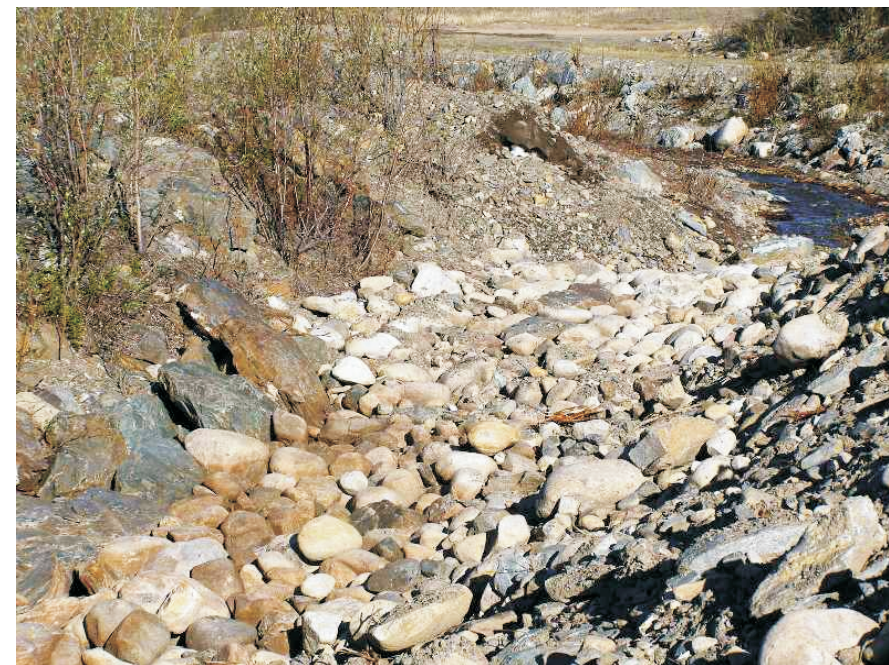
June: View of riprap in the decant of the Cross Valley Dam spillway.

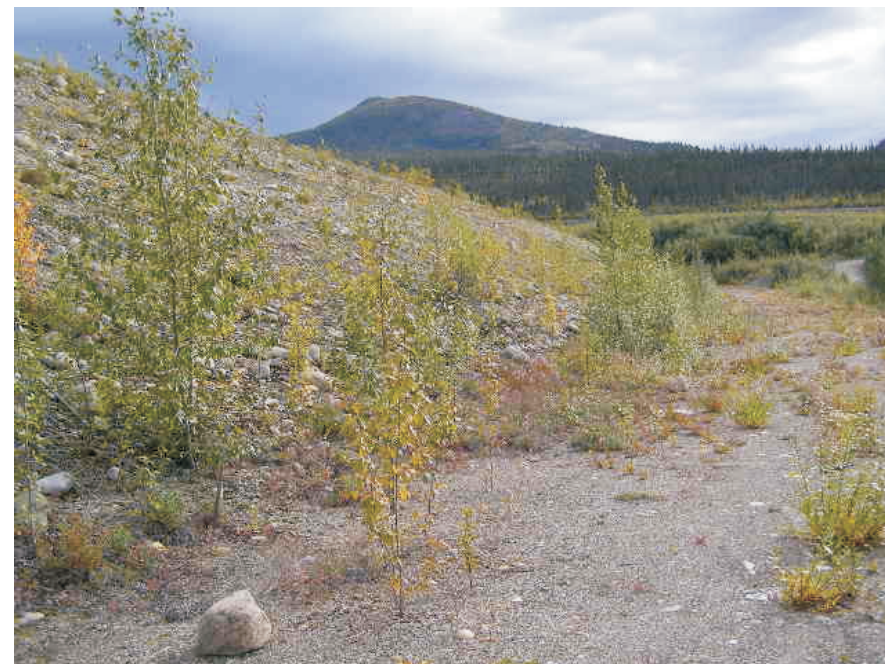
August: looking at downstream face.

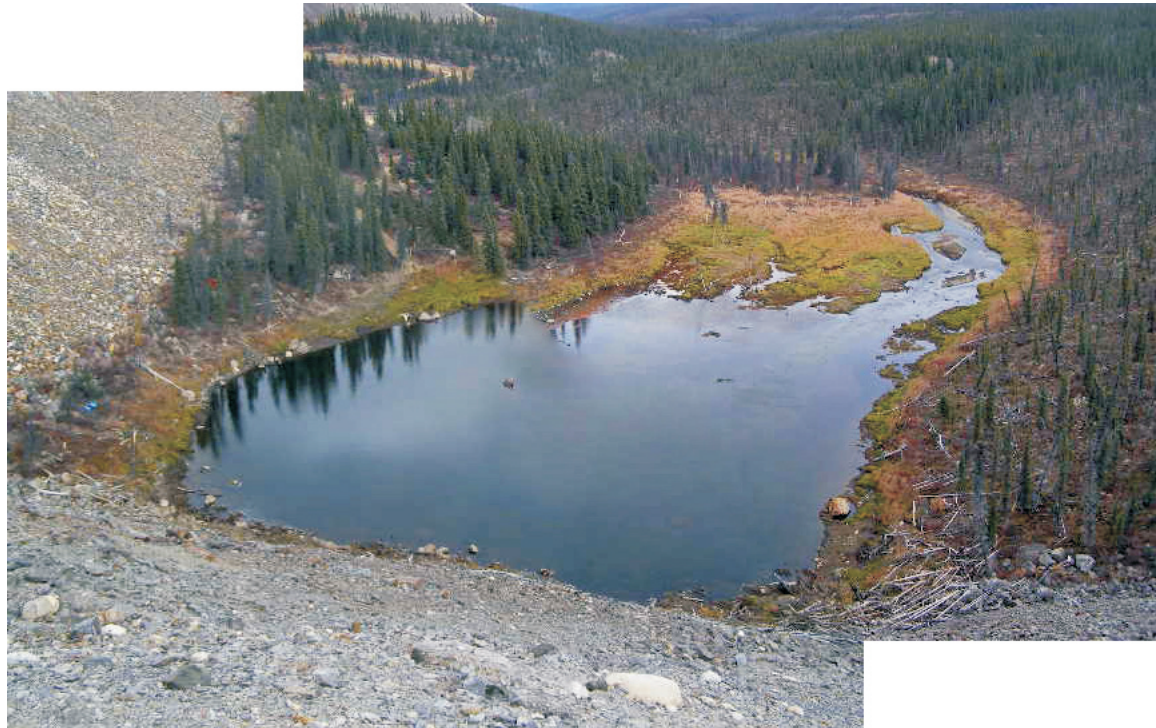
September: a panoramic showing the head pond on the upstream side of the North Fork Rock Drain. The pond appears slightly lower than last year at this time. From this perspective, there does not appear to be any signs of significant sloughing or erosion ongoing.

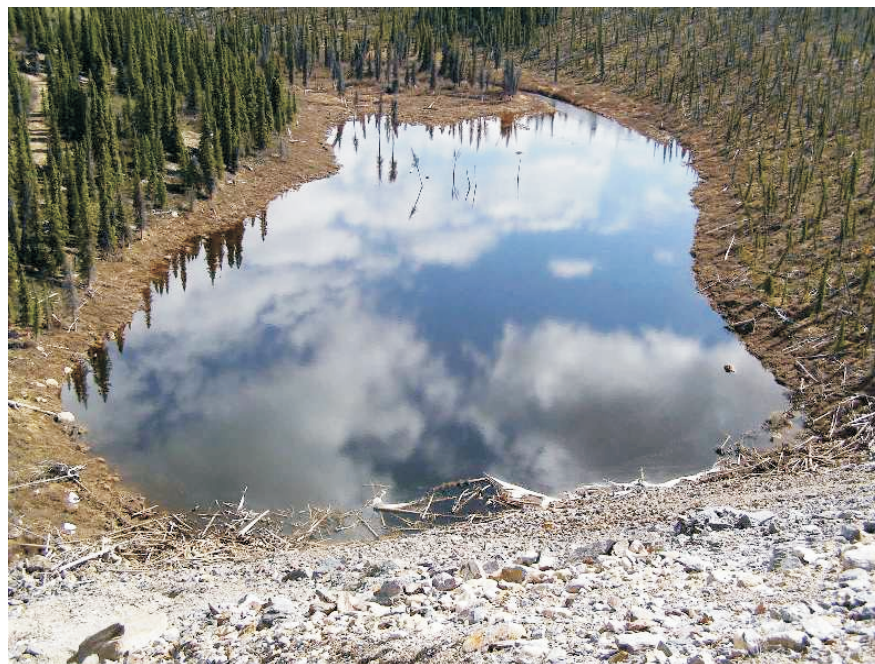
June: shows a view of the upstream side of the pond upstream of the Rock Drain.

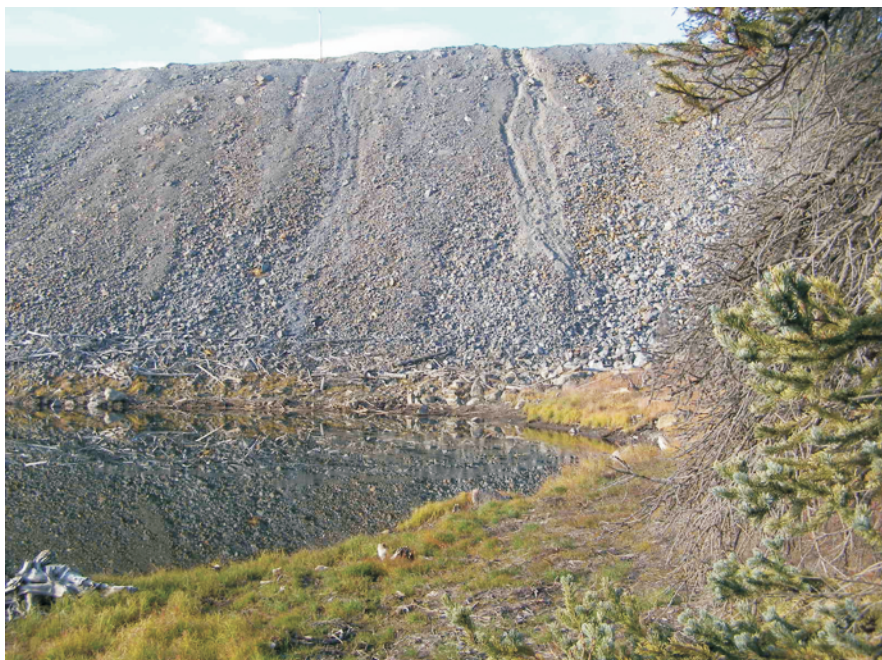
September: view of the upstream side of the North Fork Rock Drain. Note that some of the driftwood below the water line has been removed.

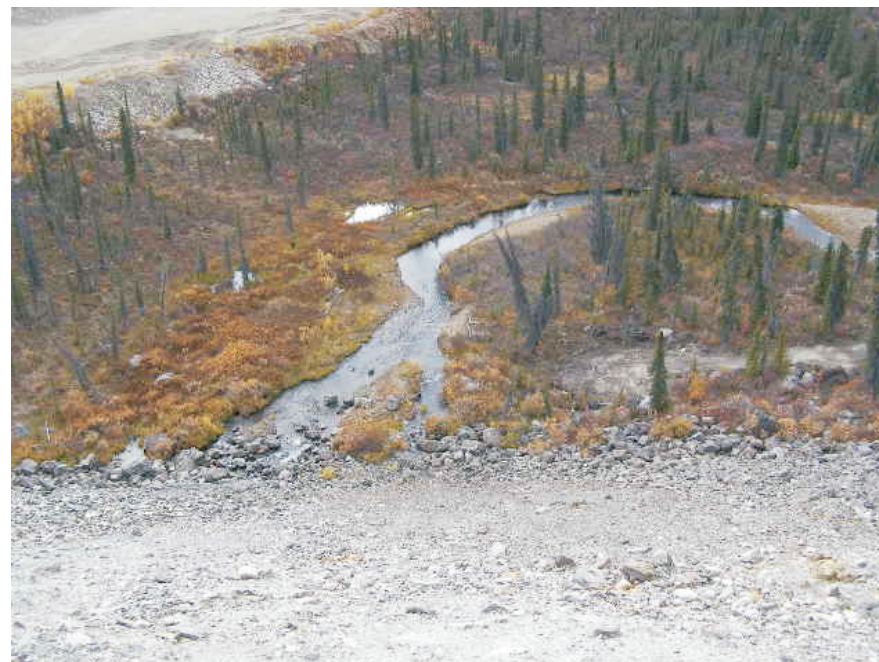
September: shows the discharge emerging from the bottom of the rock drain. The creek configuration appears consistent with previous years. There are no signs of sloughing or ongoing problems with stability.

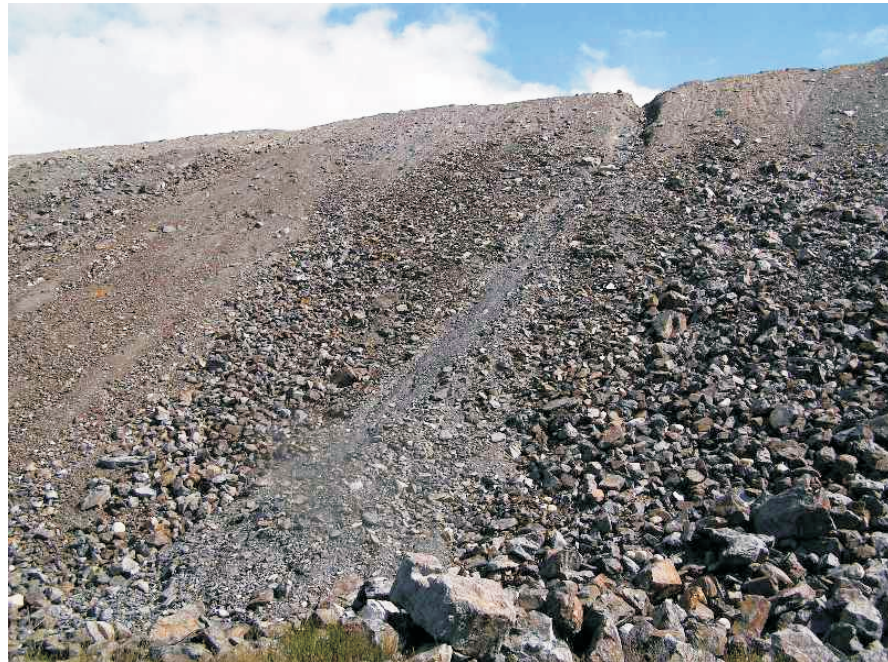
June: shows a view of the upper portion of the downstream face. Note the two areas with finer grained material covering coarser rock. This is due to erosion gullies coming off the haul road surface on the crest.

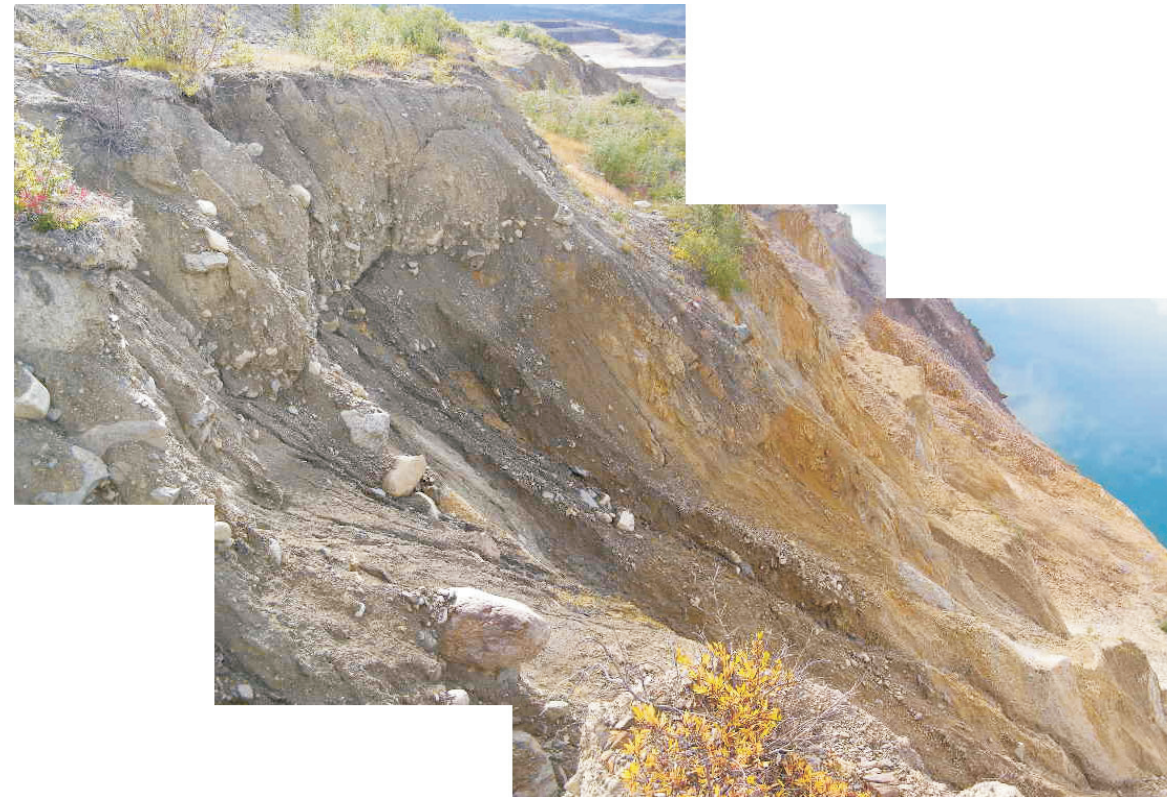
September: Three shot panoramic of seepage discharge area in Faro Pit wall.

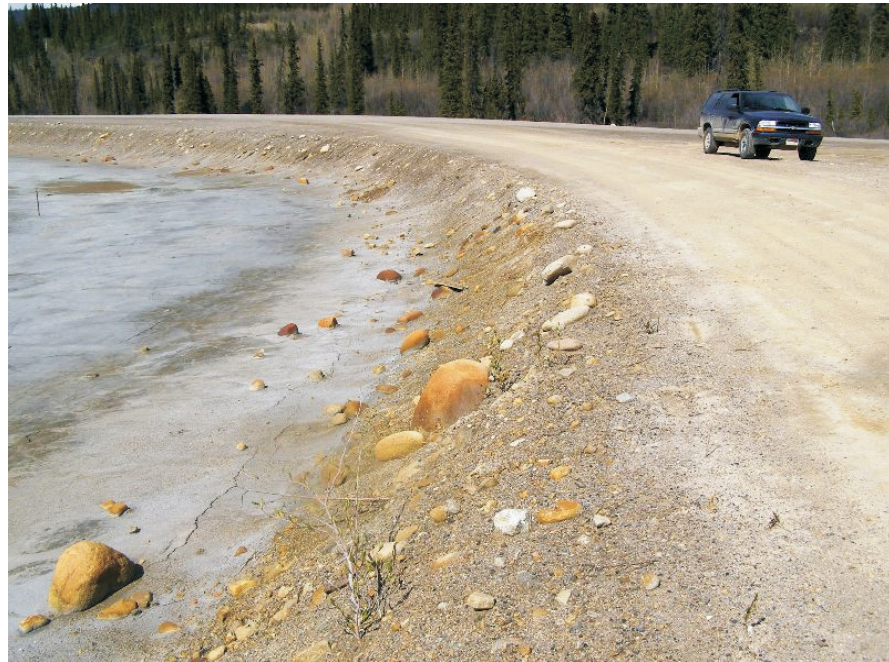
June: shows a view of the abutment of the Secondary Tailings Impoundment as it meets the main road.
