### **2006 ANNUAL GEOTECHNICAL EVALUATION AND INSTRUMENT REVIEW**

### **VARIOUS FACILITIES AT FARO MINE, YUKON**

PROJECT NO.: 0257-039-05  
DATE: FEBRUARY 14, 2007

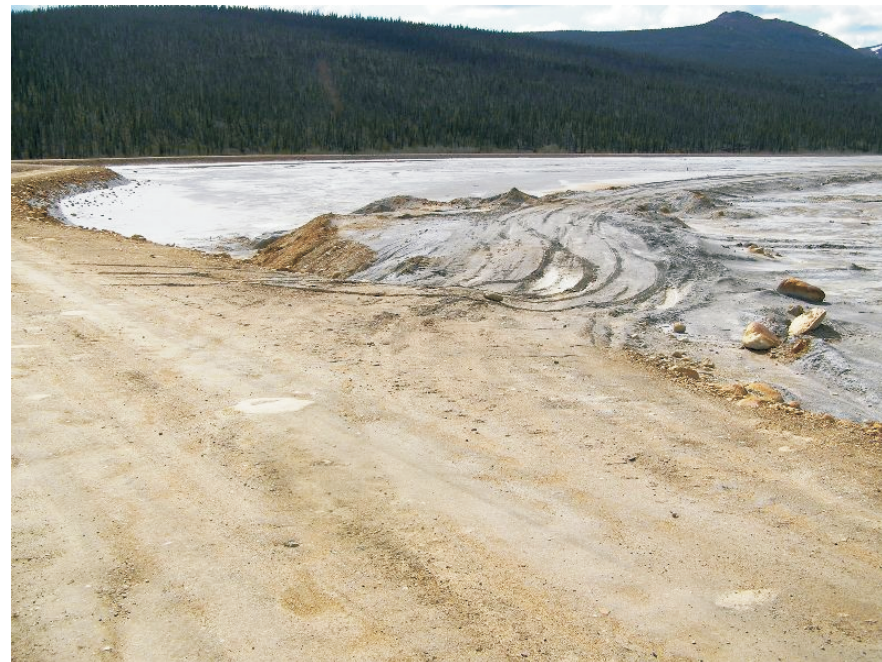
June: shows a view of the Original Tailings Impoundment inside the Secondary Tailings Dike.

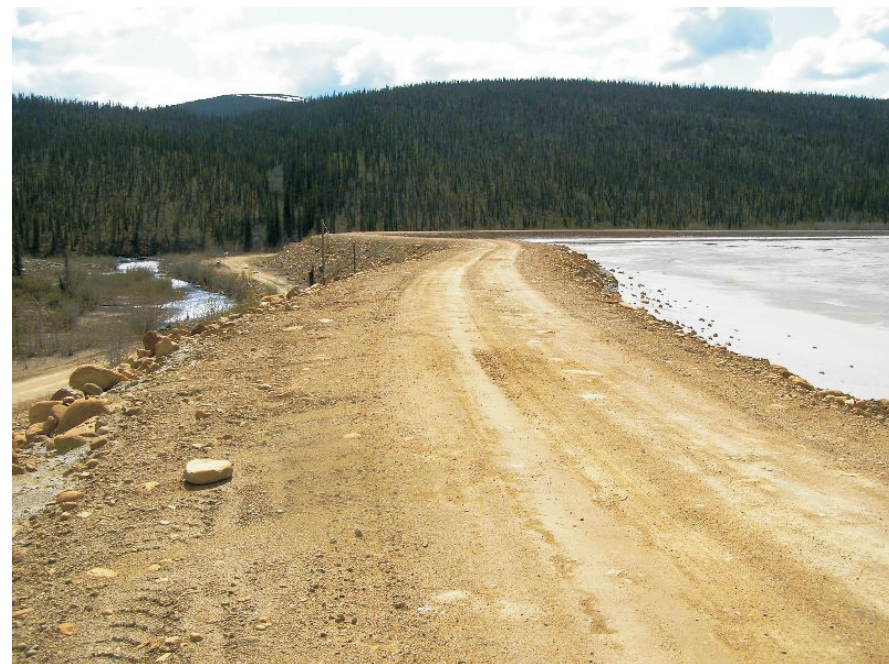
June: shows a view of the crest of the dike the Secondary Tailings Dam looking towards the south. This shows the location where the North Fork Rose Creek Diversion flows near the toe of the dam.

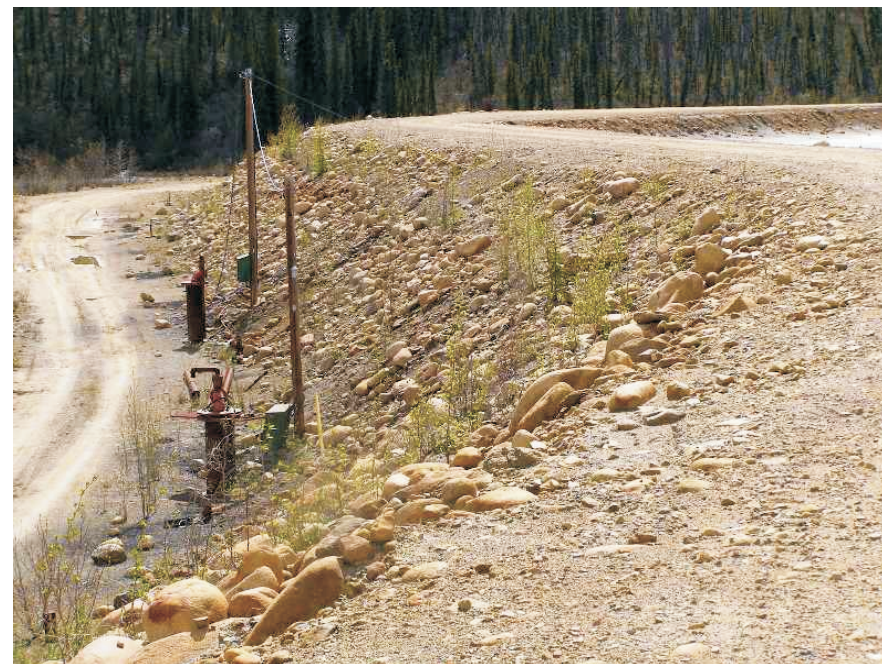
June: shows a view of the Secondary Tailings Impoundment immediately above previously used pumping wells.

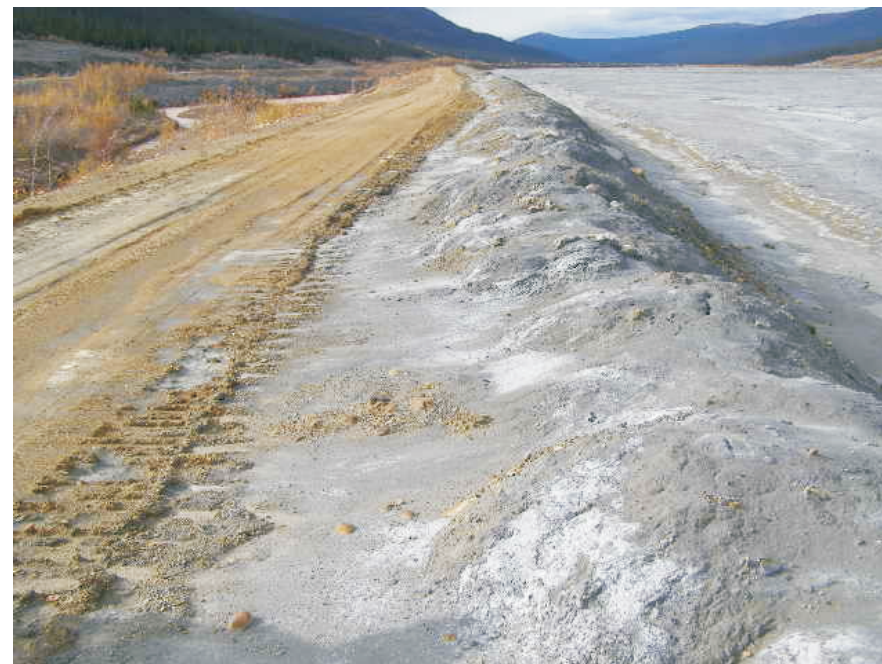
September: photo shows a view of the crest looking towards the west. At the current time there is no standing water on the upstream side.

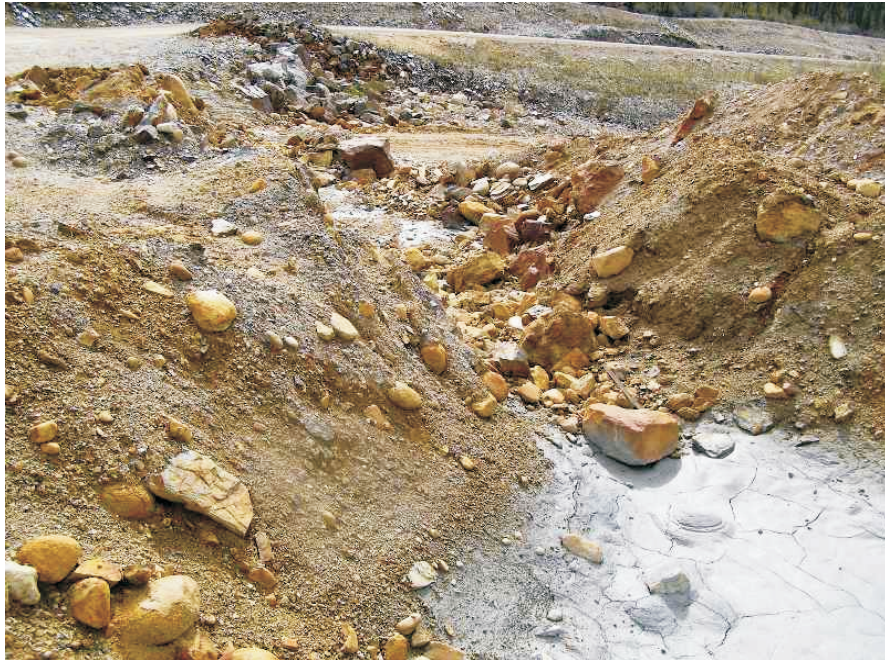
June: shows a view of this breach in the Secondary Tailings Dam. The tailings were washed into the Intermediate Impoundment.

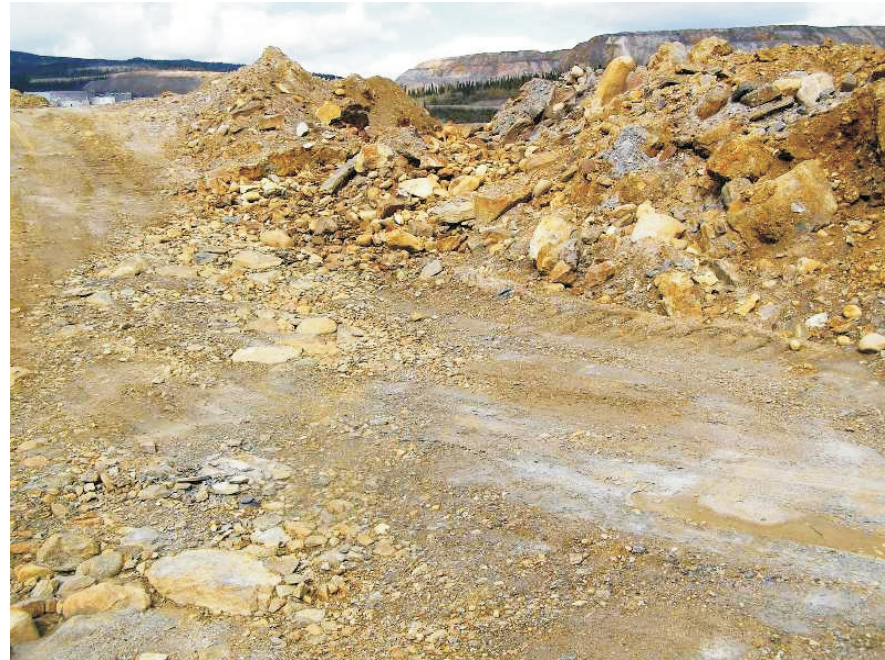
June: shows a view looking upslope towards the main part of the breach in the dam. Note, in the foreground, the appearance of tailings.

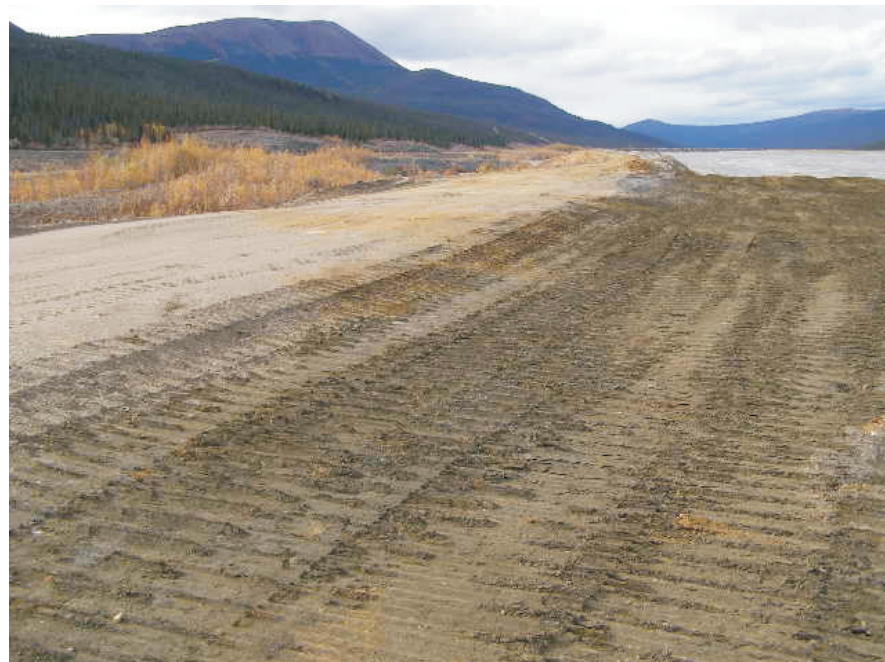
September: shows the re-graded crest on the Secondary Impoundment Dike where, it connects to the road coming from the Diversion Dam. The ditch line that was in here has now been backfilled over with sand and gravel.
