2008 ANNUAL GEOTECHNICAL EVALUATION AND INSTRUMENT REVIEW

VARIOUS FACILITIES AT FARO MINE, YUKON

PROJECT NO.: 0257-051-05
DATE: FEBRUARY 13, 2009

**RE: 2008 ANNUAL GEOTECHNICAL EVALUATION AND INSTRUMENT REVIEW
VARIOUS MINE WASTE FACILITIES AT FARO MINE, YUKON**

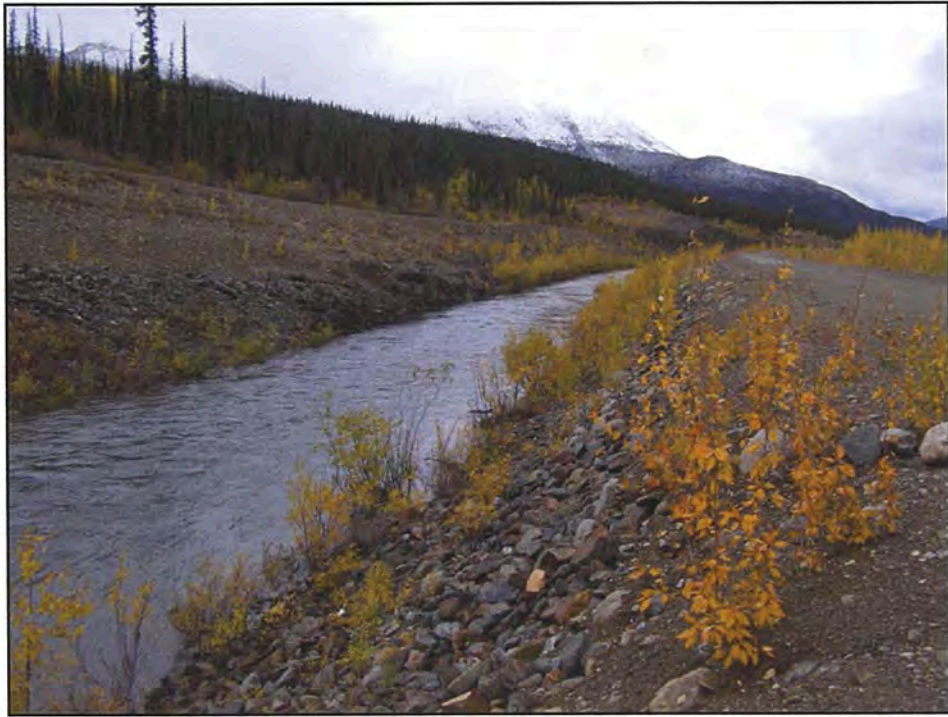
September: shows the water flowing in the channel section, looking in the downstream direction from downstream of the Diversion Dam.

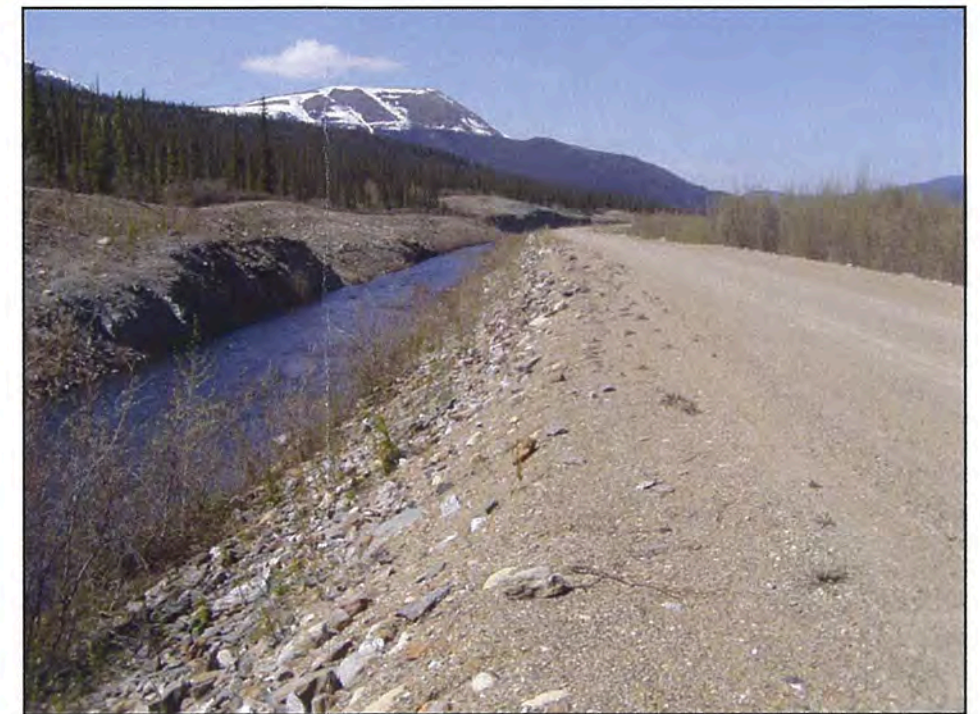
June: a view of the Diversion looking downstream. Note the bedrock outcrop on the left bank.

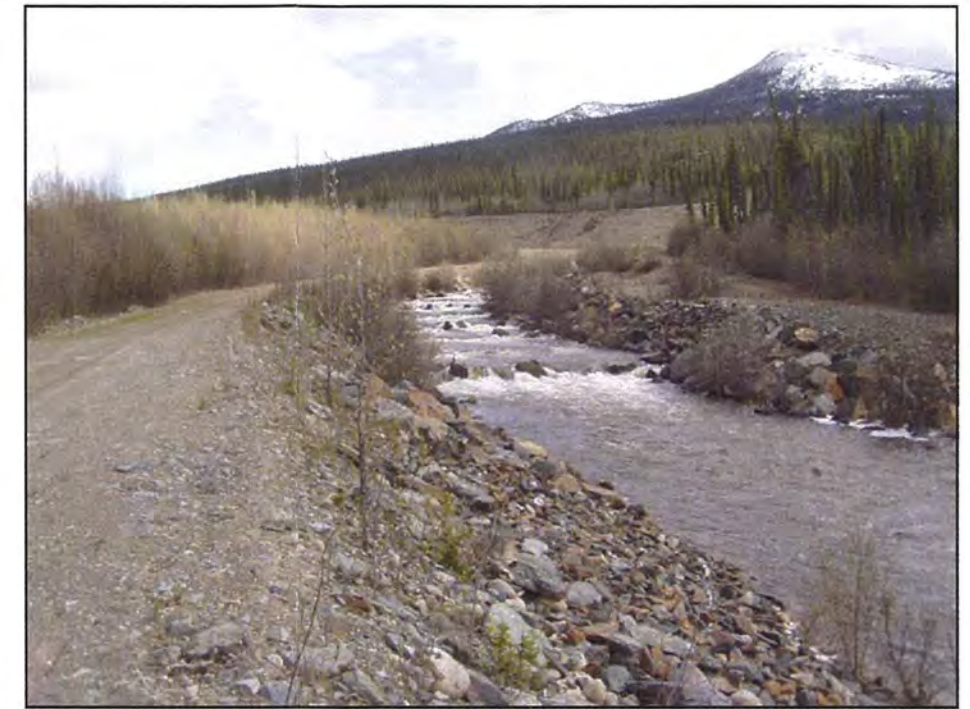
May: shows an upstream view of the upper weir section of the canal, looking towards Cornish Creek.

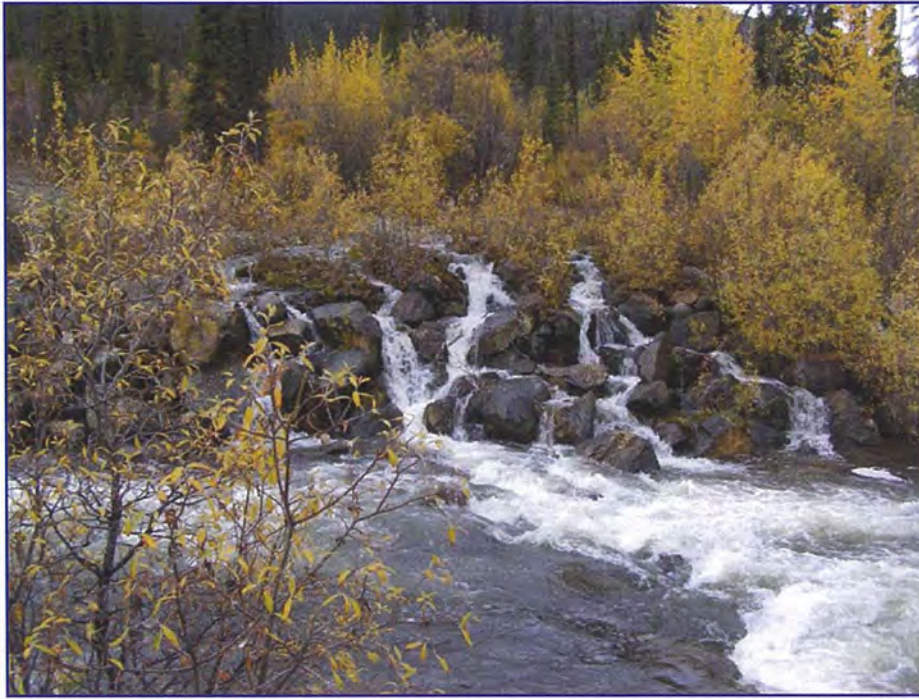
September: view of the left bank riprap in lower weir section, this is where Severin Creek enters the Diversion Canal.

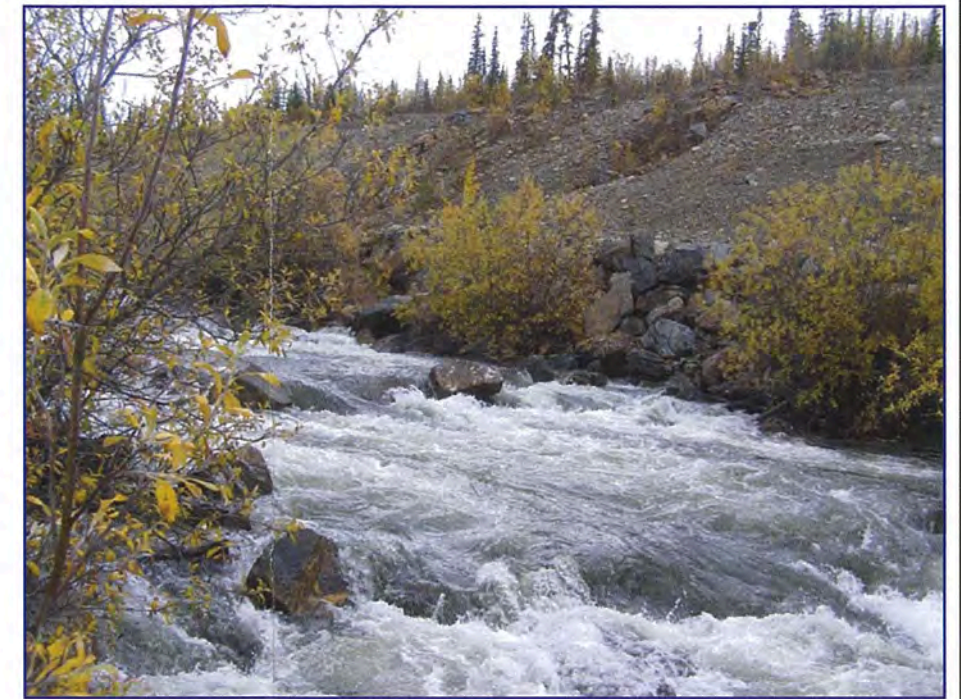
September: view of the upper weir section, looking upstream from Cornish Creek.

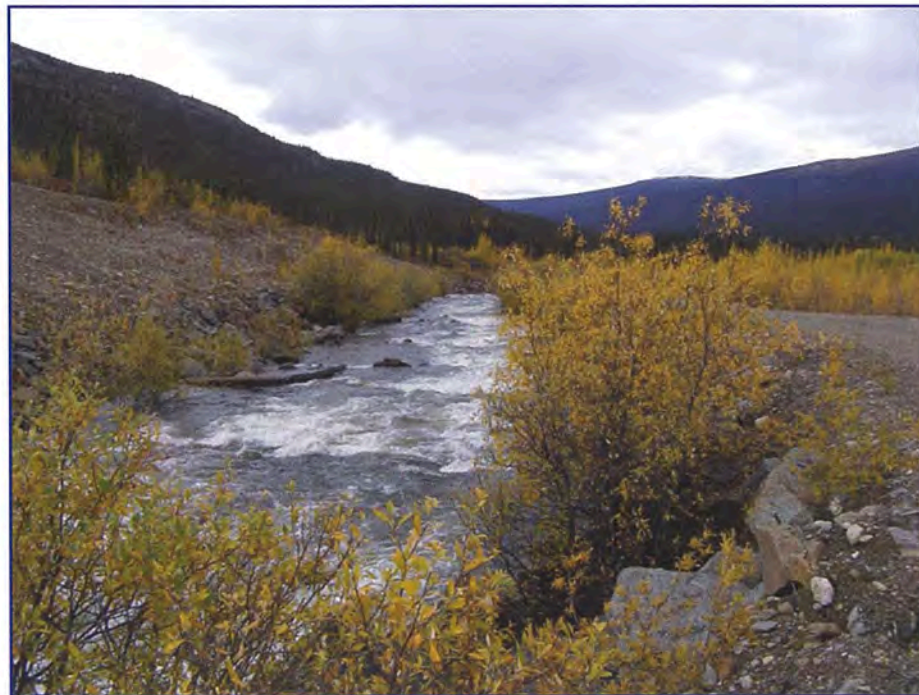
September: shows the upper weir section, looking downstream

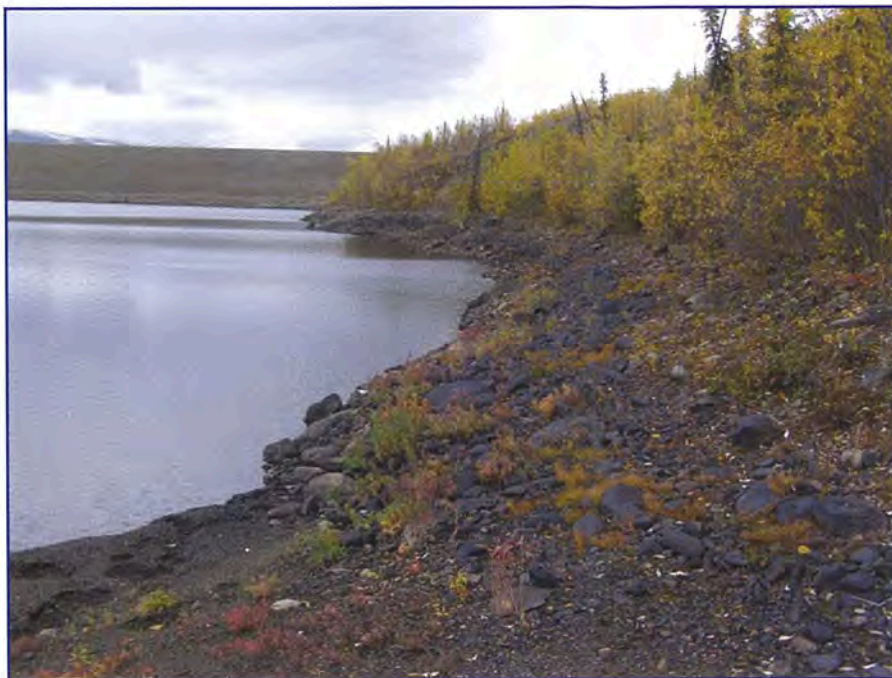
September: a view of the toe of the spoil pile. There were 25 seepage discharge locations. The pond level is 1.9 m lower than usual.

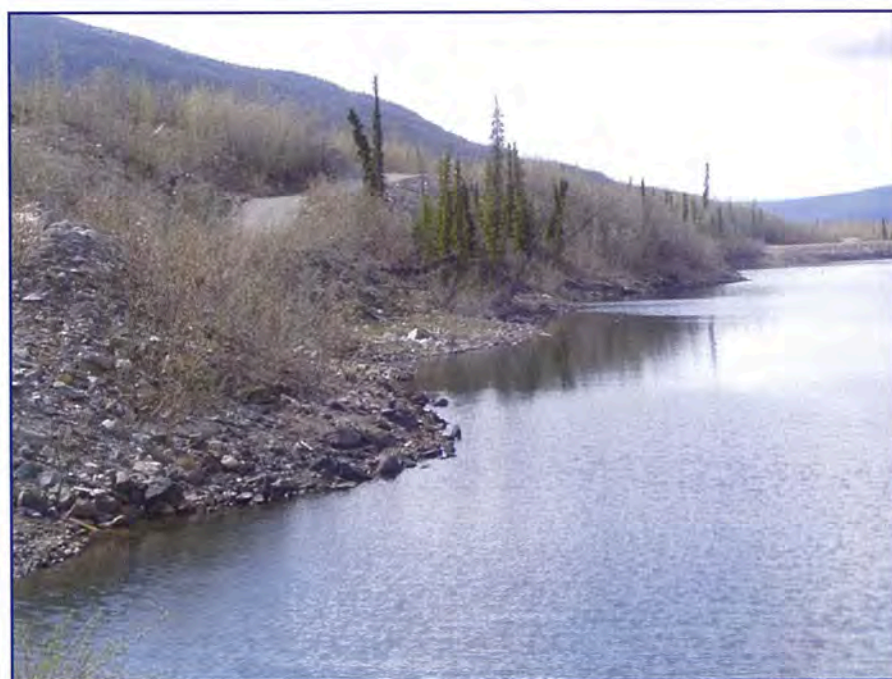
May: view of the polishing pond shoreline, which is formed by the spoil pile base. Note that this is an area of slumping and seepage.

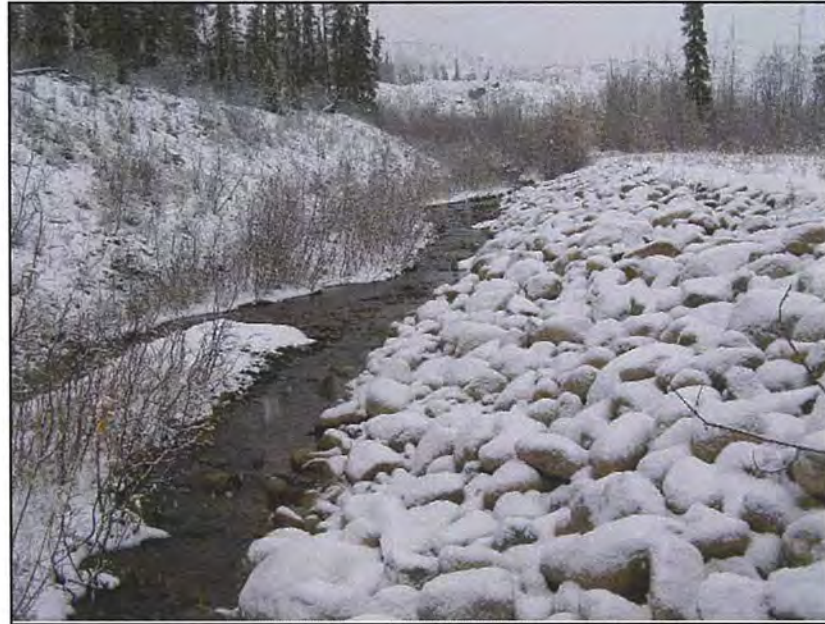
September: shows the start of the north Valley Interceptor Ditch just uphill from the guard house gate. This is the area the dike was repaired before and the riprap is obvious on the right hand side of the photo. After inspection of this section, it appears that the channel is flowing quite well with no signs of erosion or blockages.

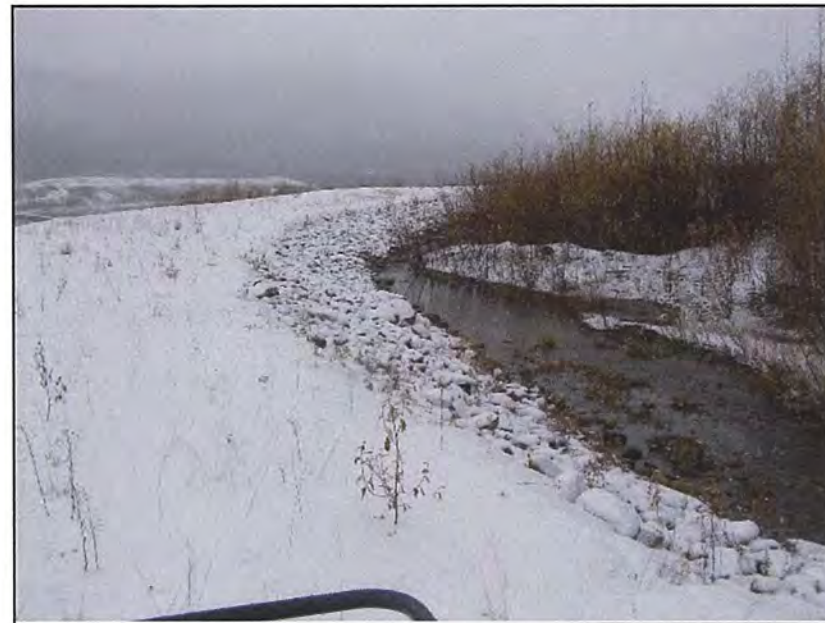
September: shows where the Interceptor Ditch comes up against the berm located proximal to the access road. We can see here that the water is adequately deflected and there does not appear to be any signs of erosion or deformation on this berm.

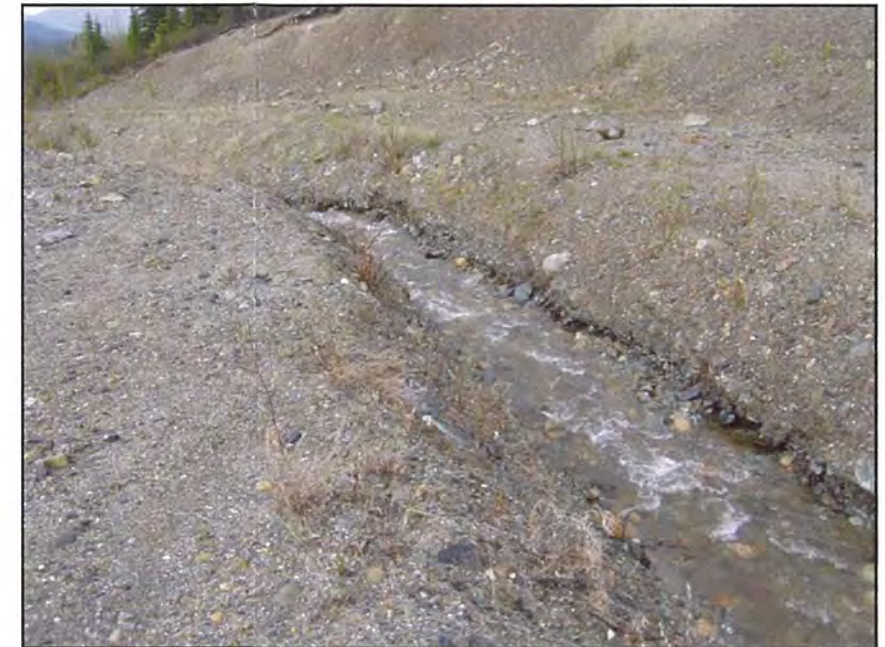
May: a downstream view of the North Valley Interceptor Ditch, downstream from the culvert.

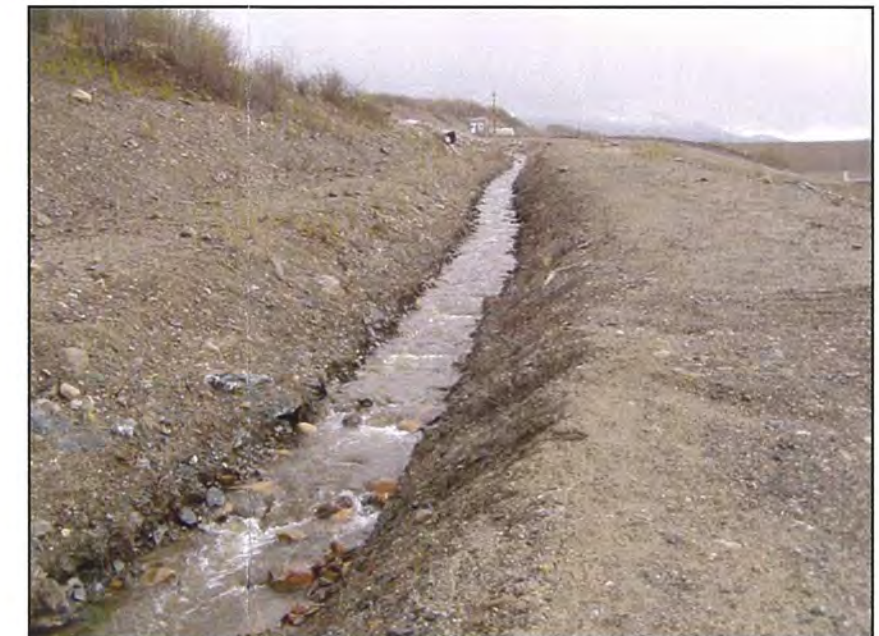
May: an upstream view of the North Valley Interceptor Ditch towards the culvert.

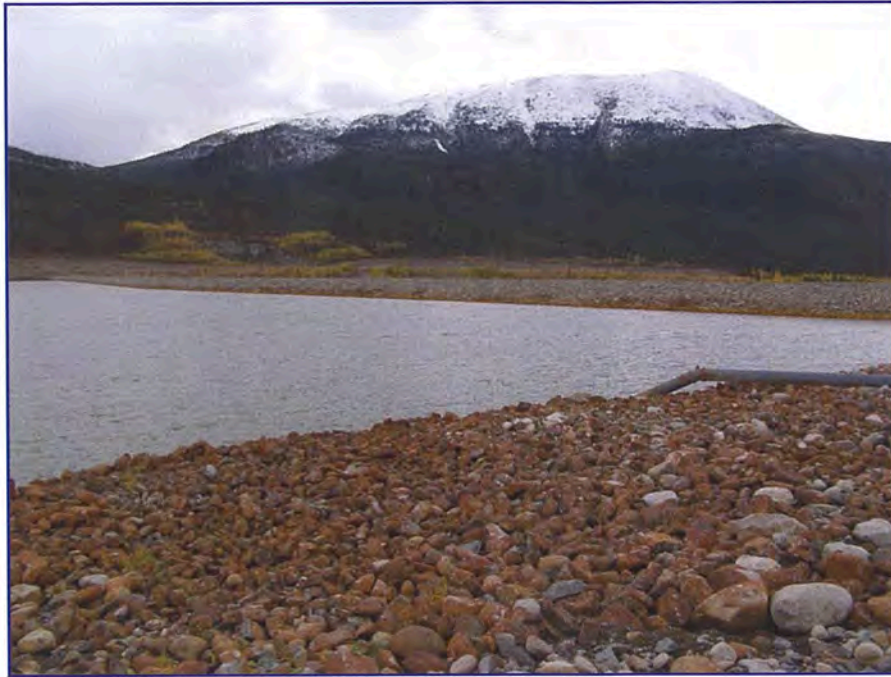
September: shows a view of the upstream face of the dam.

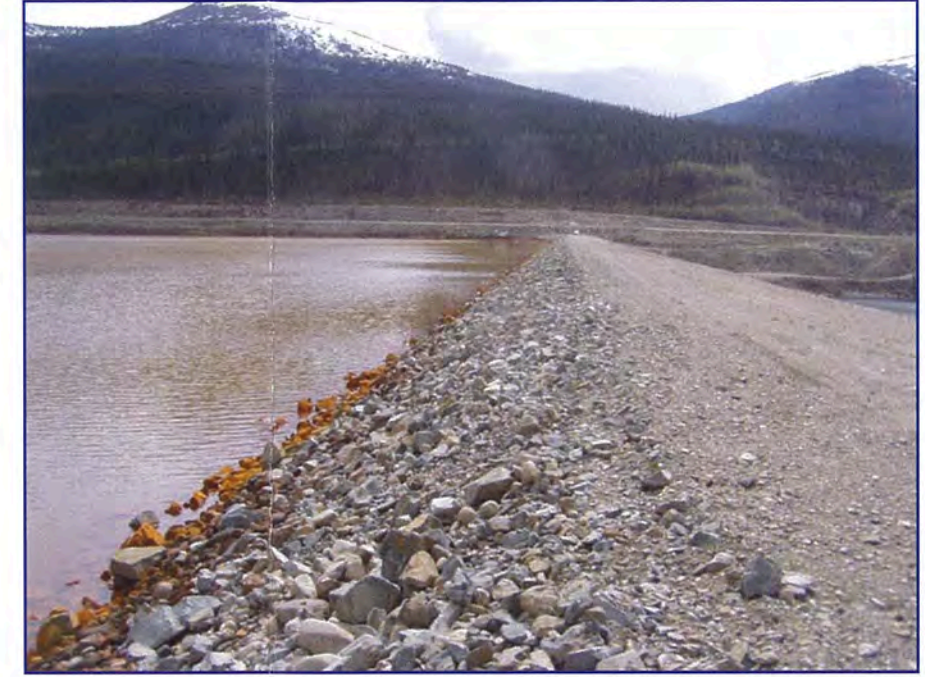
May: a view looking south along the upstream face. Note that the pond level appears to be close to the high water mark.

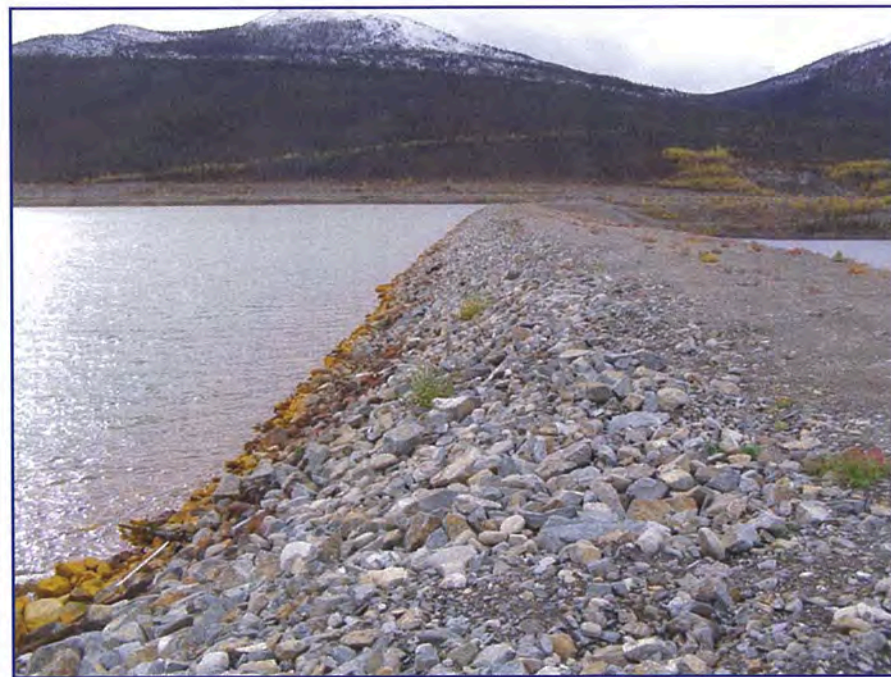
September: shows a view of the upstream face which was repaired in July 2007. Appears to be in good condition with no wave erosion occurring.

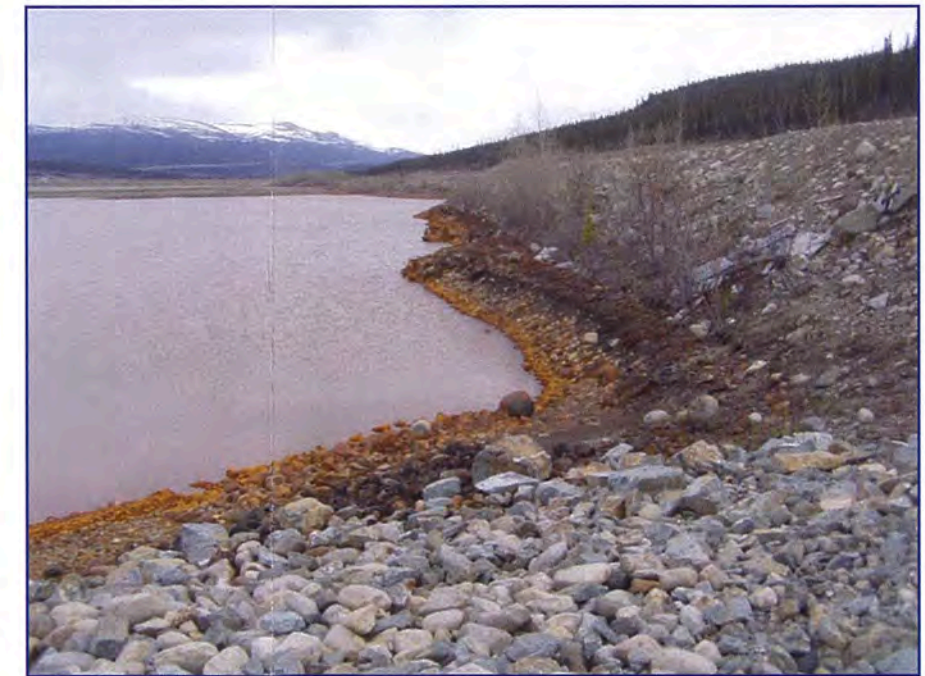
May: shows the shoreline of the pond from the left abutment. Canal Dike is on the extreme right of this photo.

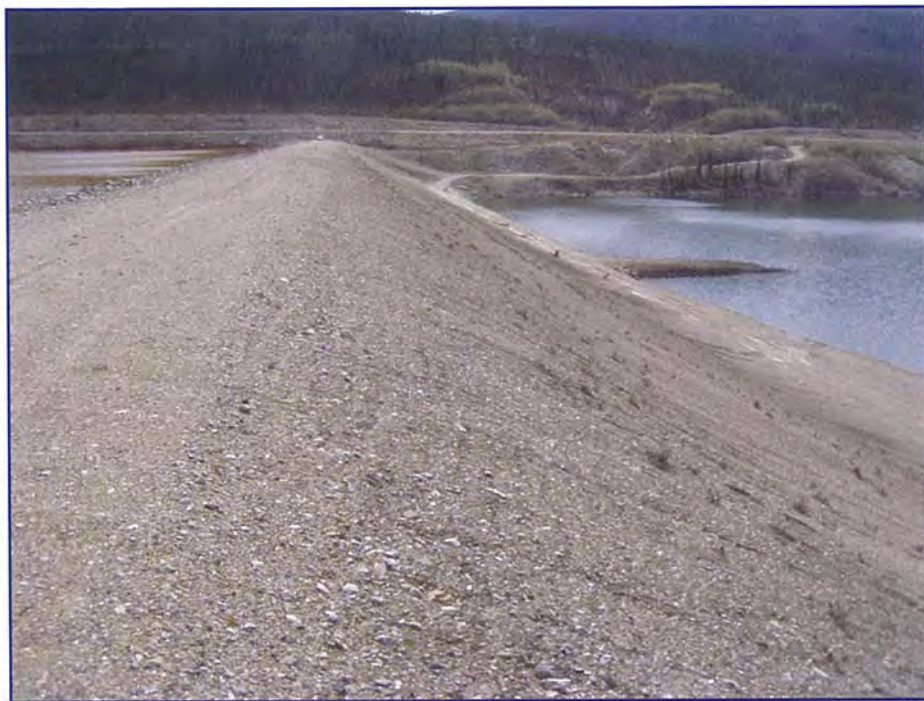
May: showing a view looking south along the downstream dam face.

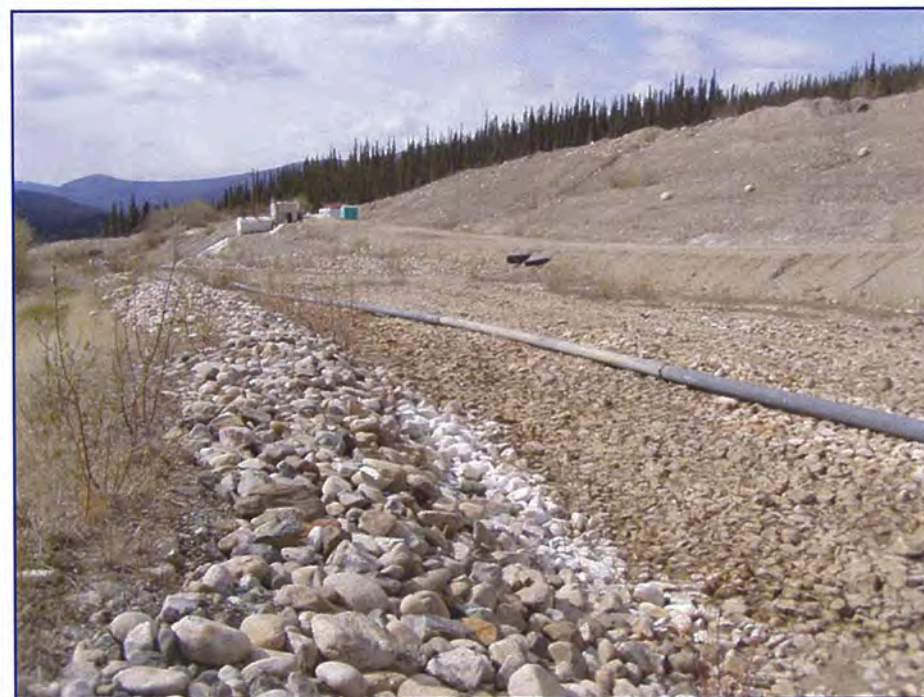
May: looking downstream in the dam spillway.

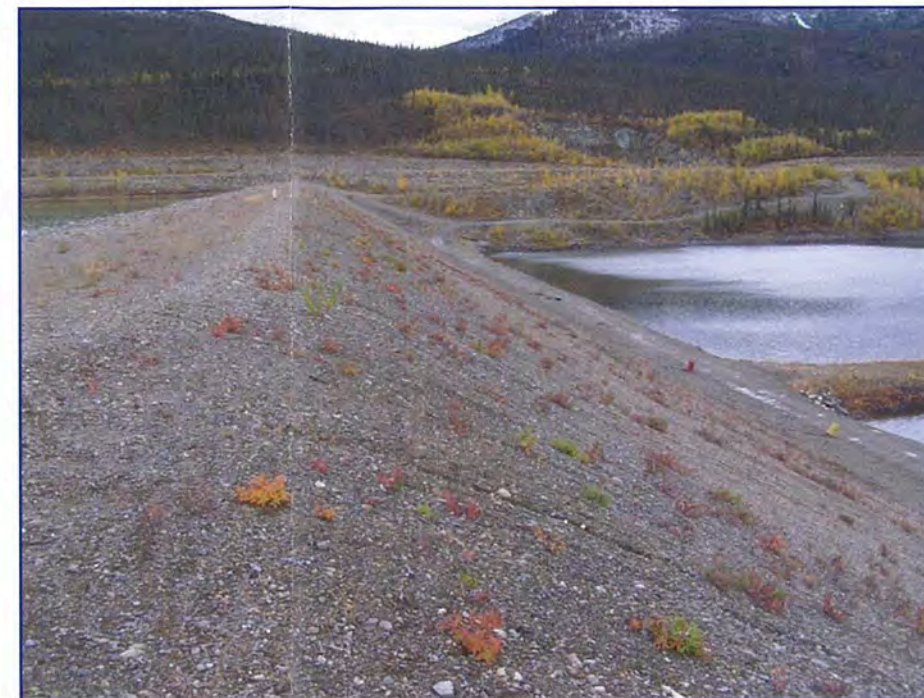
September: a view from the crest of the Intermediate dam looking at the downstream face.

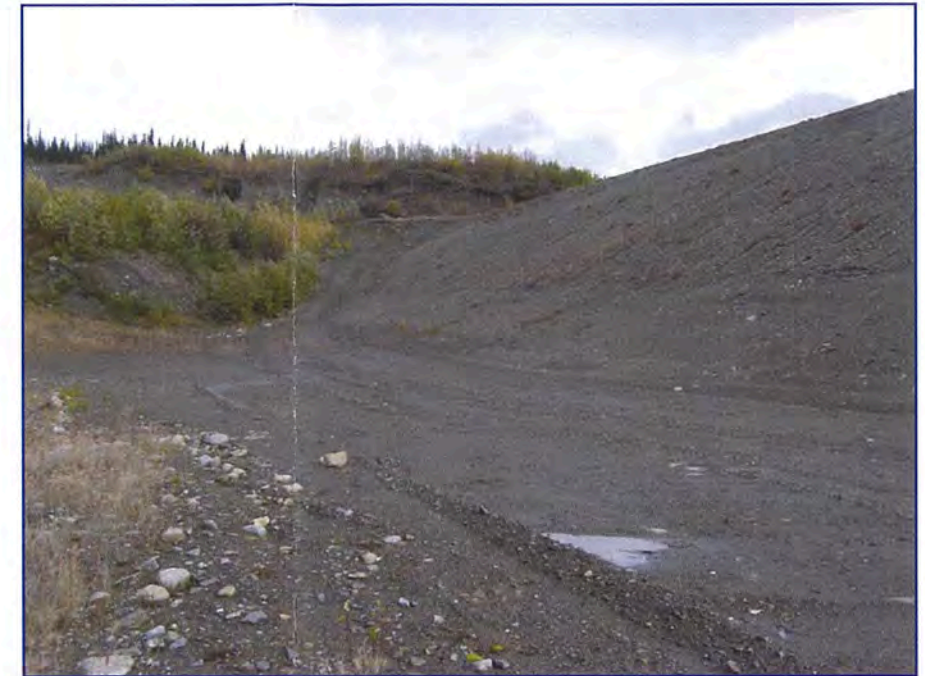
September: shows the intersection of the downstream face with the north abutment. Vegetation was removed and the area was graded for construction access in 2007.

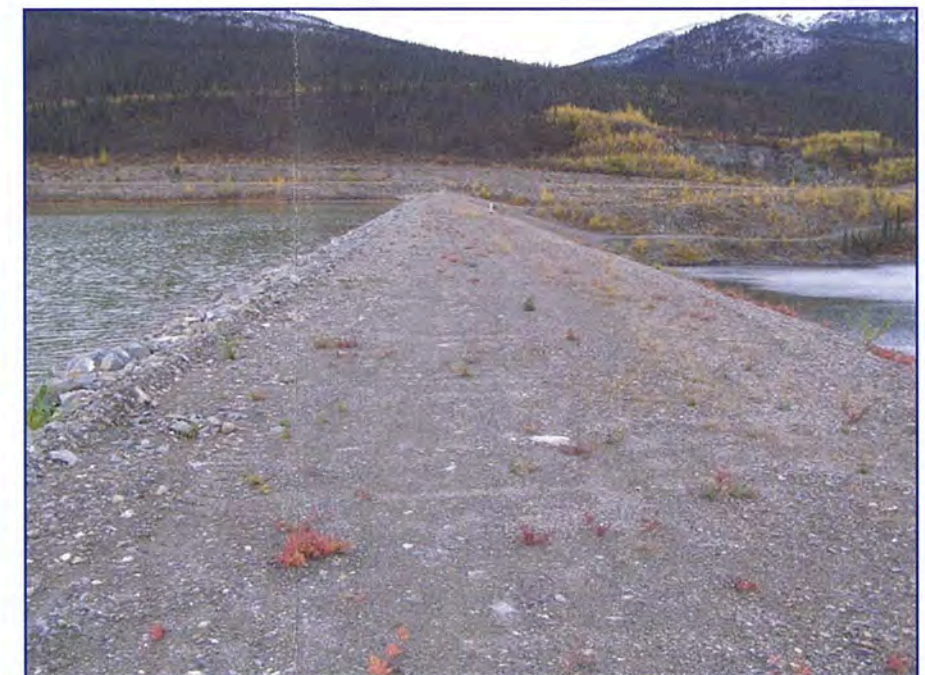
September: a view of the dam crest, note that there is a small amount of vegetation growing after removal in 2007.

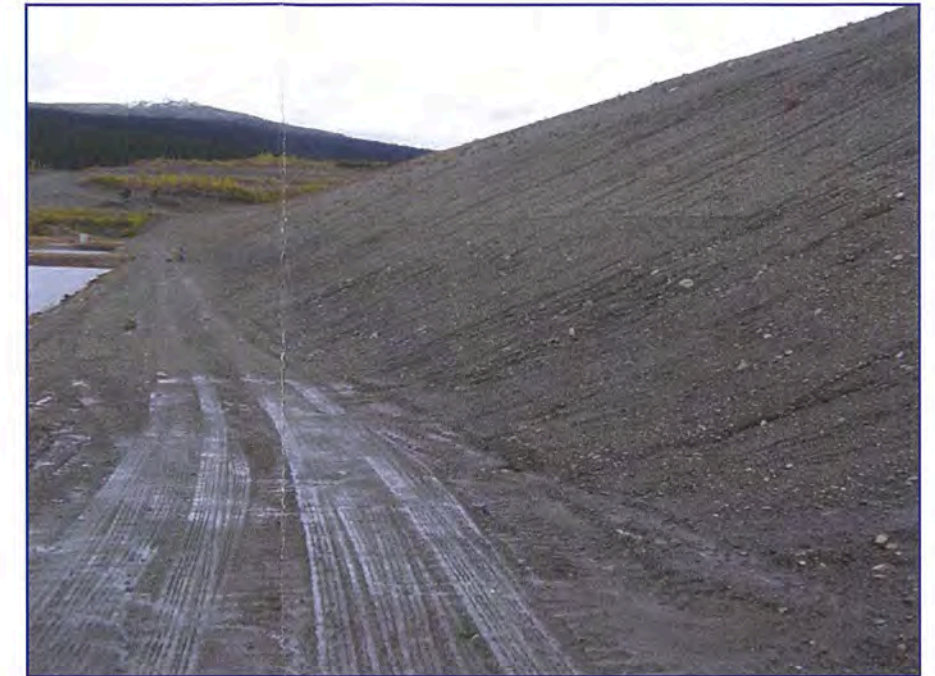
September: shows a view looking towards the right abutment down the lower road.

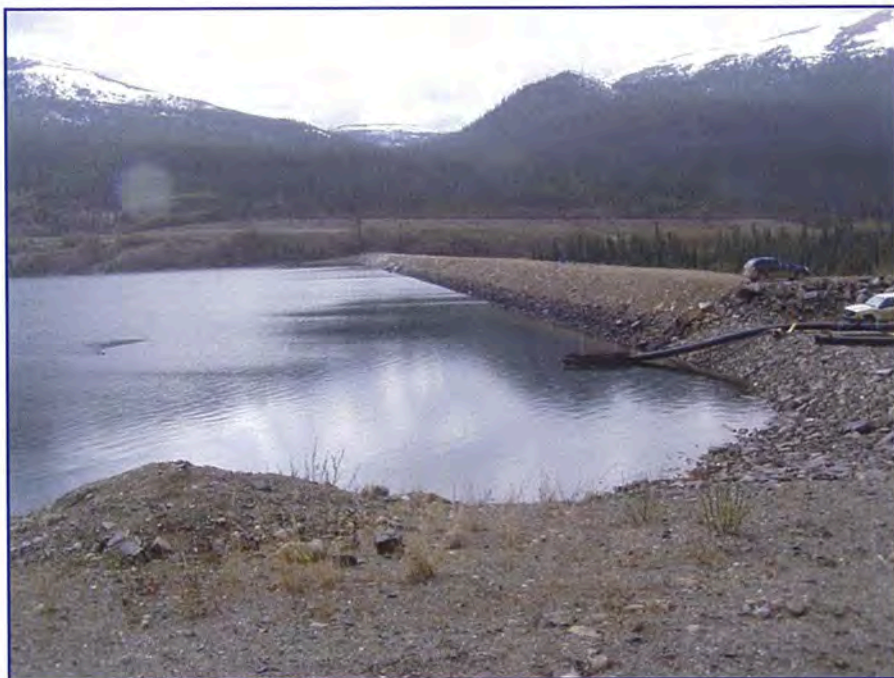
May: shows the upstream face of the Cross Valley Dam

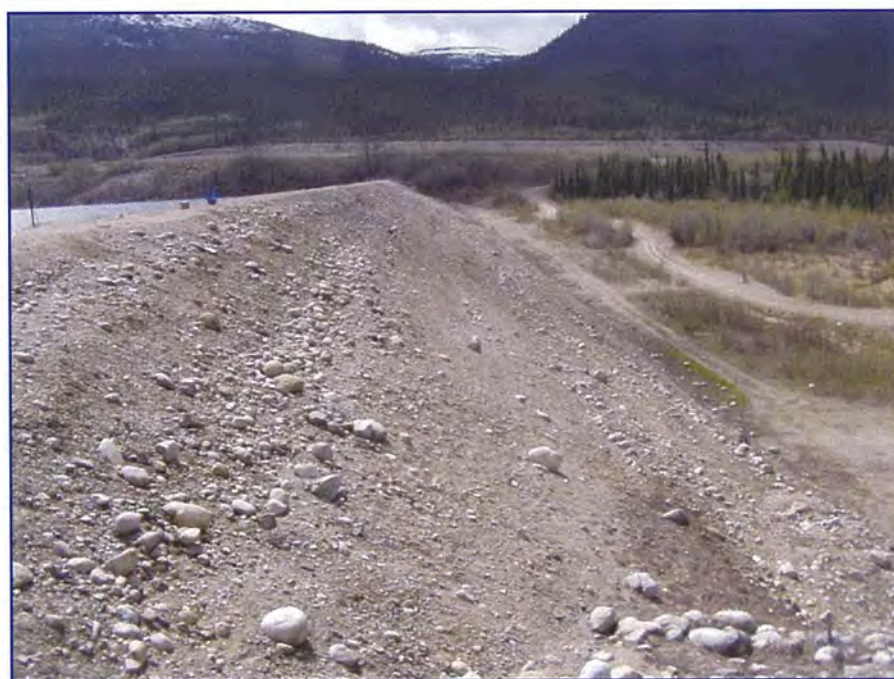
May: looking at the downstream face of the dam from the right abutment.

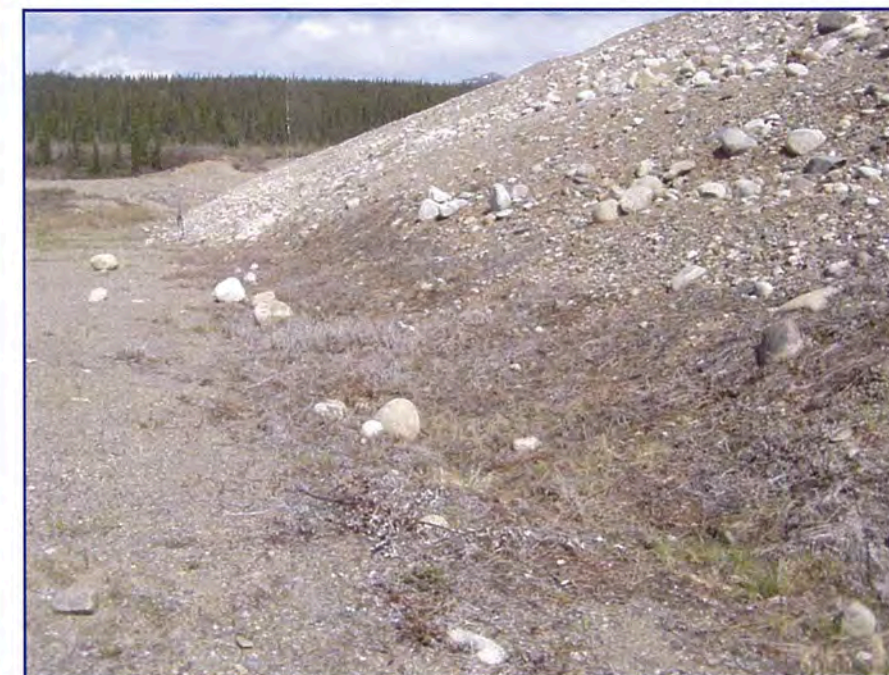
May: shows a view of the toe of the downstream side of the dam with some water loving plants present, which likely indicated seepage. Note that the ground appears to be softer at the intersection of the dam and the drain.

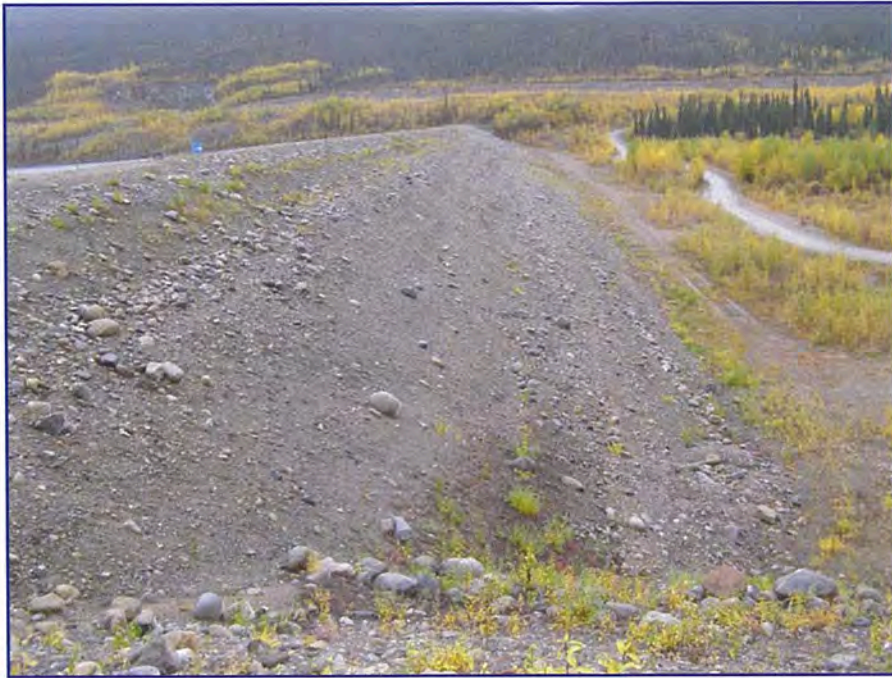
September: shows a view of the downstream shell of the Cross Valley Dam.

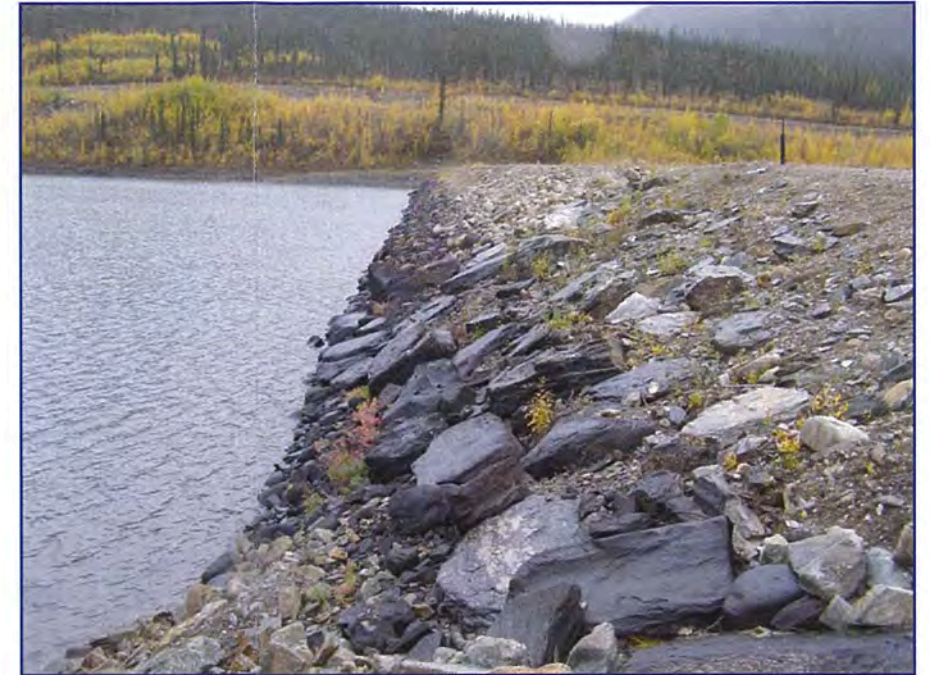
September: shows a view of the upstream face riprap and pond level.

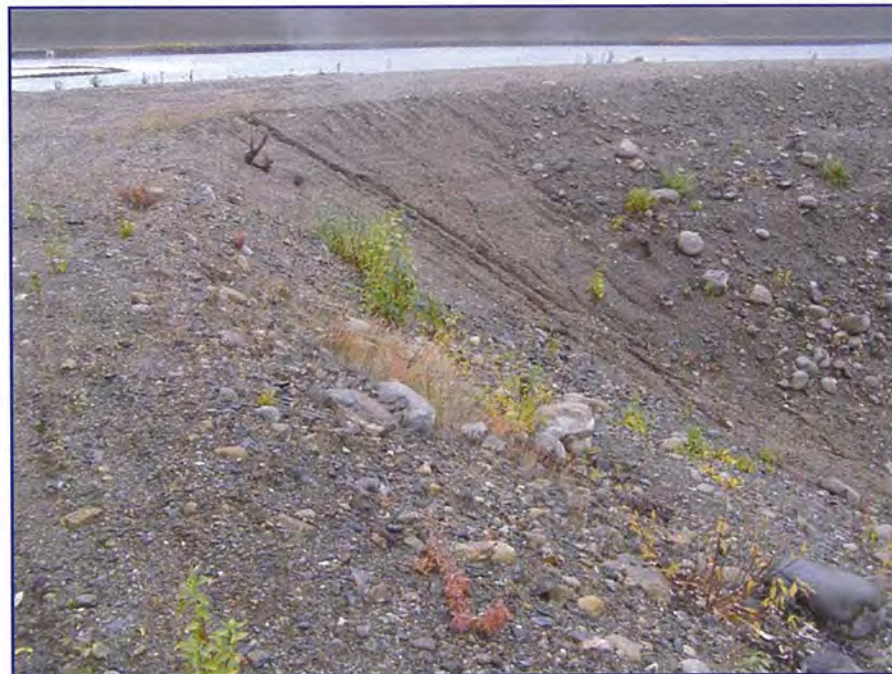
September: shows a view of some of the minor erosion that is occurring at the intersection of the crest and the left bank of the emergency spillway.

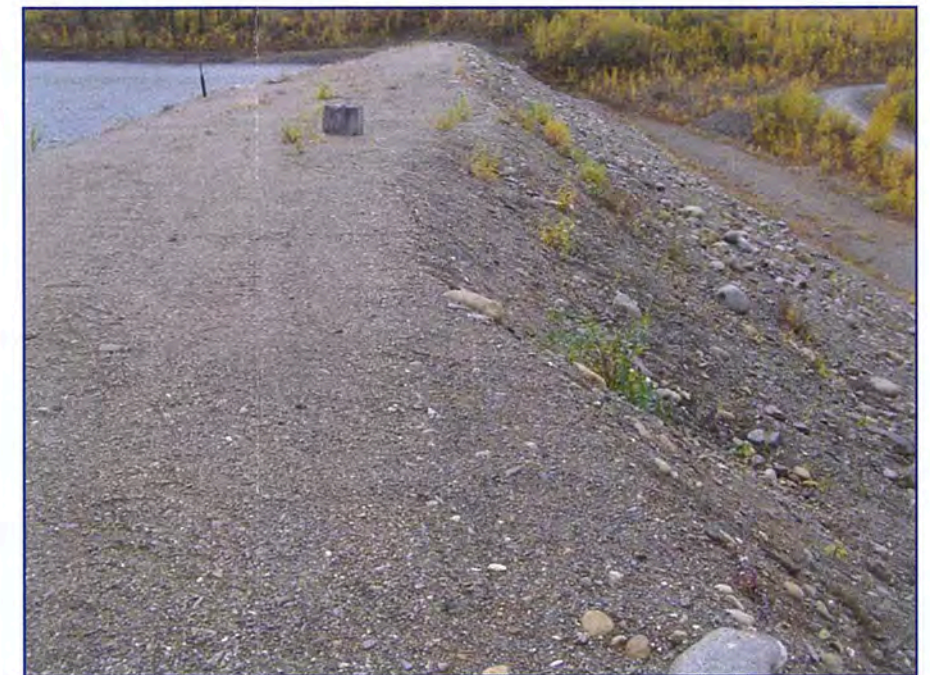
September: shows a view of the crest and downstream face with an area that needs to be filled in to re-establish the design crest width.

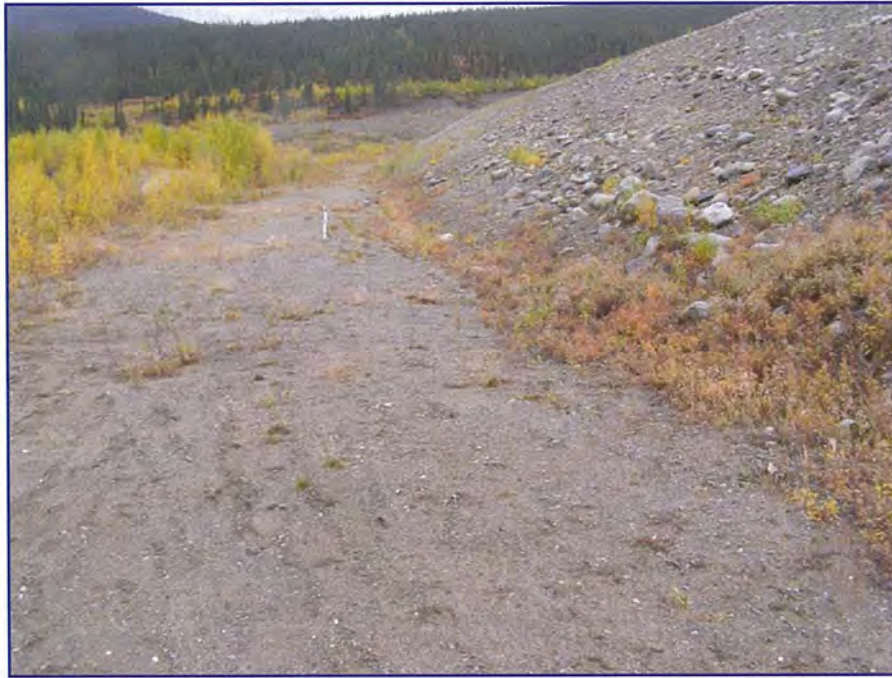
September: shows a view of the downstream toe, some vegetation remains after the 2007 removal, but is low priority to be removed.

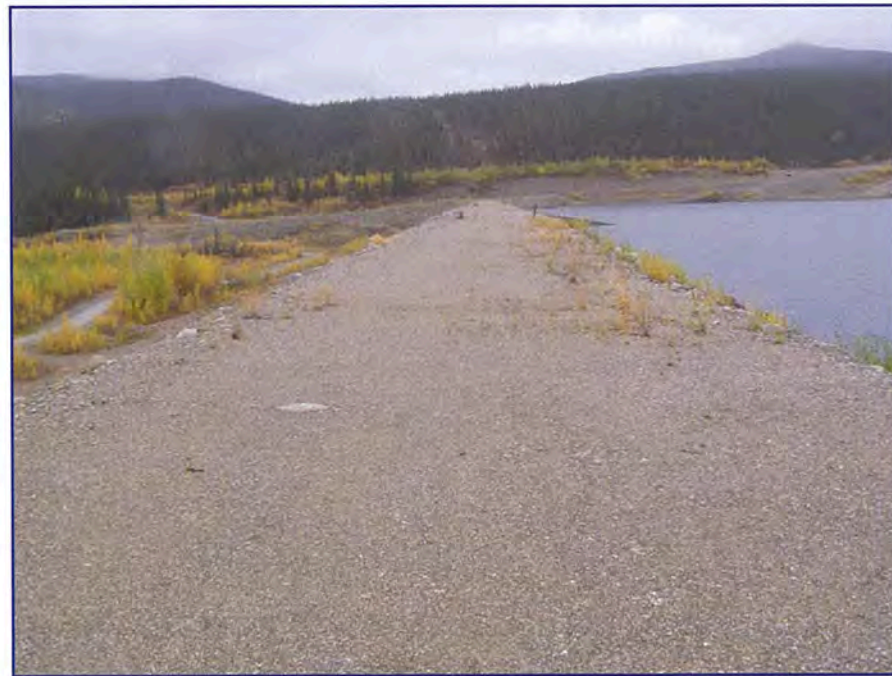
September: shows the crest of the dam, note that vegetation was removed in 2007.

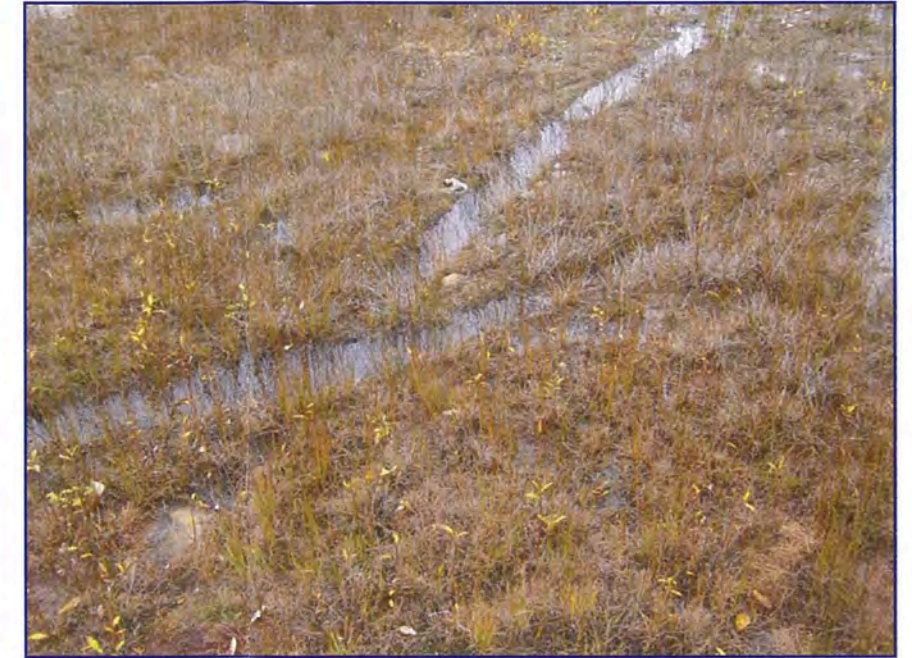
September: shows seepage water exiting the downstream toe about 12-14 m downstream of the seepage collection ditch. This area is slightly lower in elevation than the main channel containing seepage water but likely part of the same seepage path. Site staff to watch this area carefully in the winter.

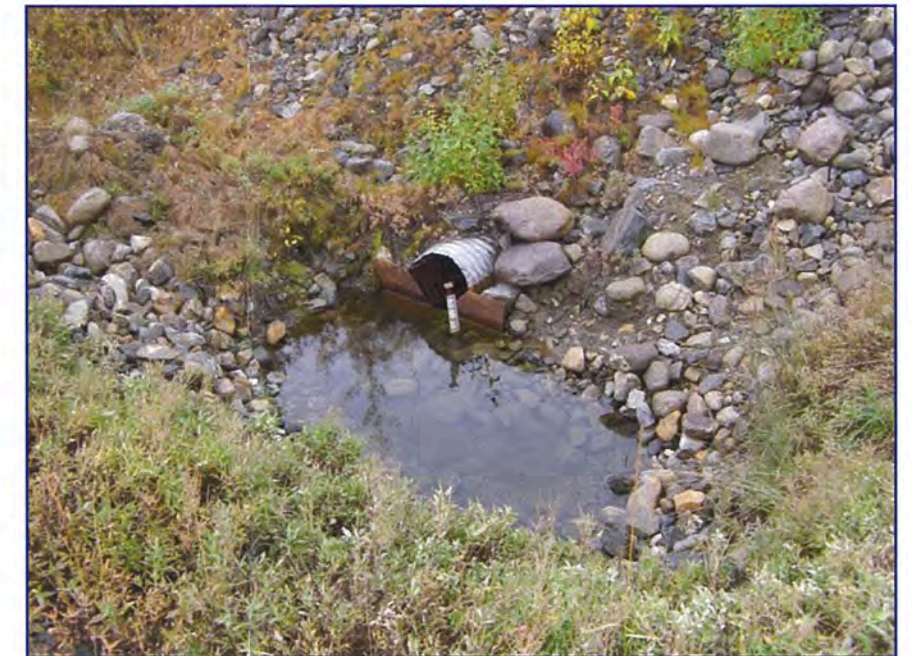
September: shows the seepage discharge weir and staff gauge. Staff gauge read 0.072 m.

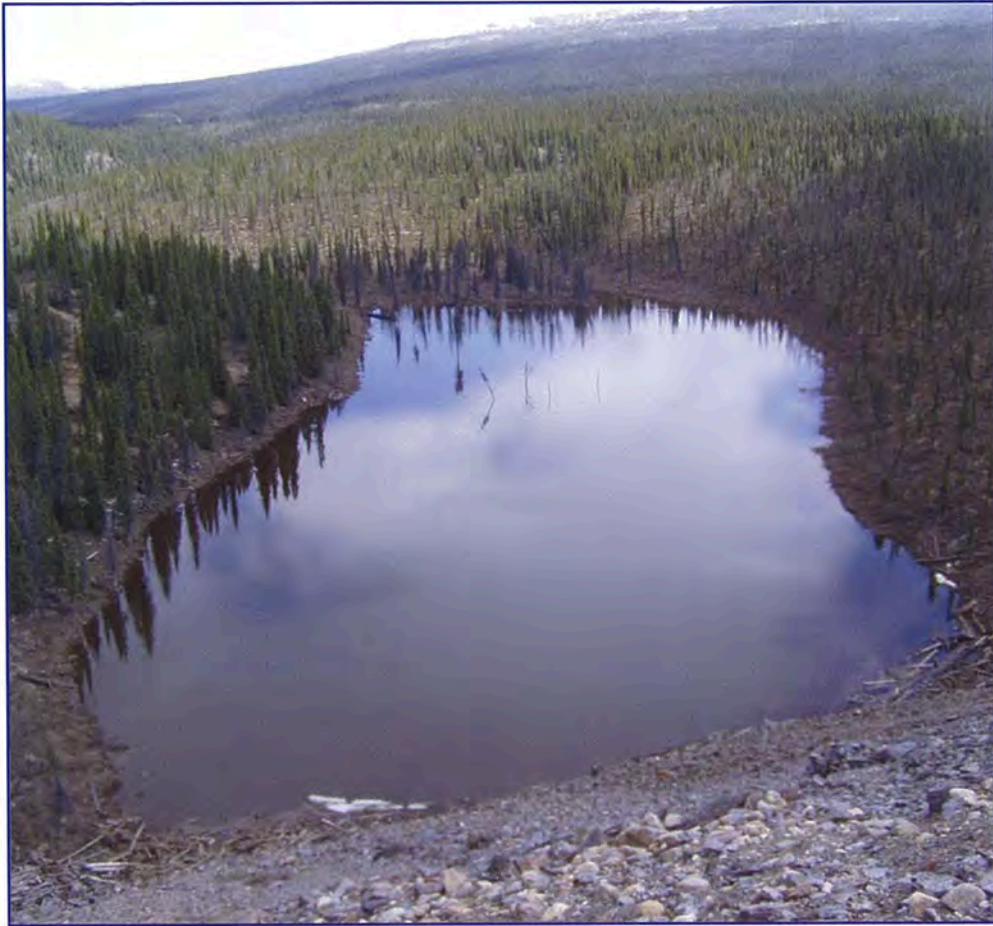
May: shows a panorama view of the upstream head pond of the North Fork Rock Drain.
