2008 ANNUAL GEOTECHNICAL EVALUATION AND INSTRUMENT REVIEW

VARIOUS FACILITIES AT FARO MINE, YUKON

PROJECT NO.: 0257-051-05
DATE: FEBRUARY 13, 2009

**RE: 2008 ANNUAL GEOTECHNICAL EVALUATION AND INSTRUMENT REVIEW
VARIOUS MINE WASTE FACILITIES AT FARO MINE, YUKON**

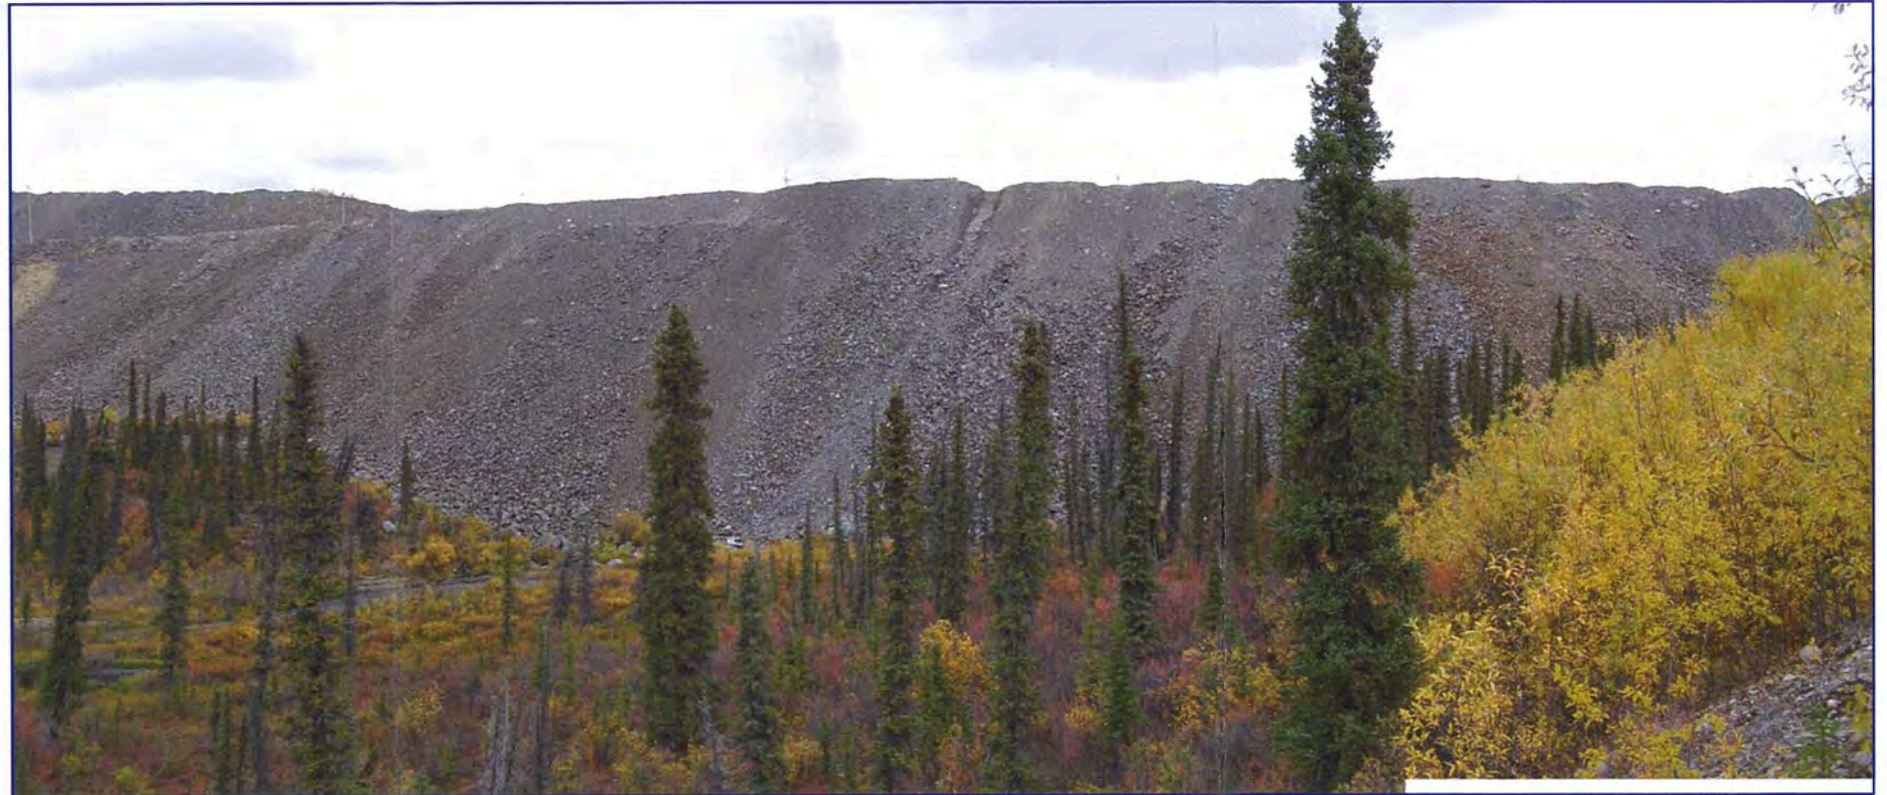
September: shows a panorama view of the downstream side of the North Fork Rock Drain

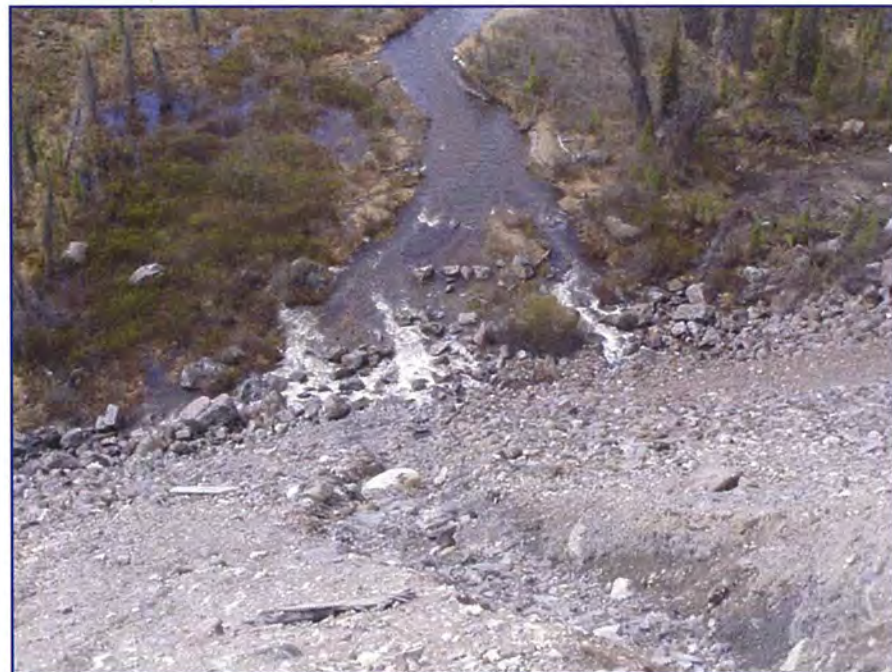
May: a view looking down from the crest at the discharge of the Rock Drain.

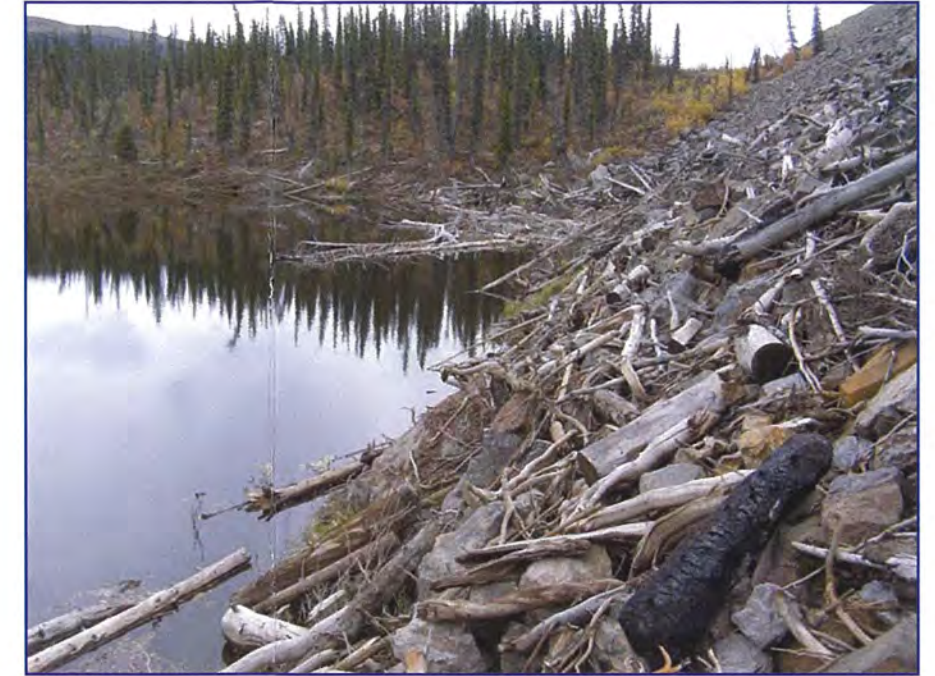
September: looking towards the east limit of the upstream pond. Note that the water level is approximately 3 m below the high water mark that is indicated by debris deposited on the face of the drain.

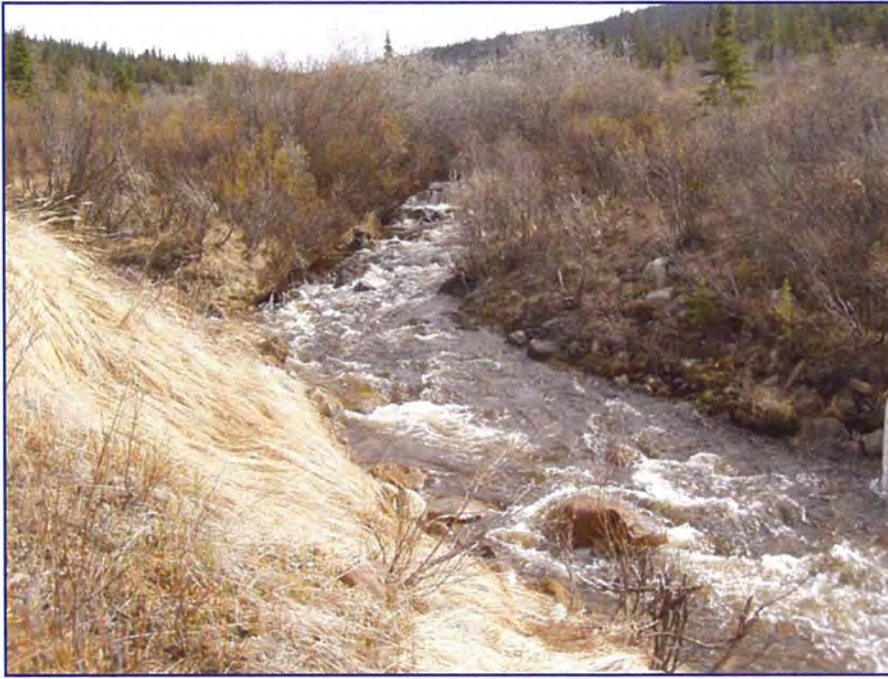
May: an upstream view of the starting area of the diversion.

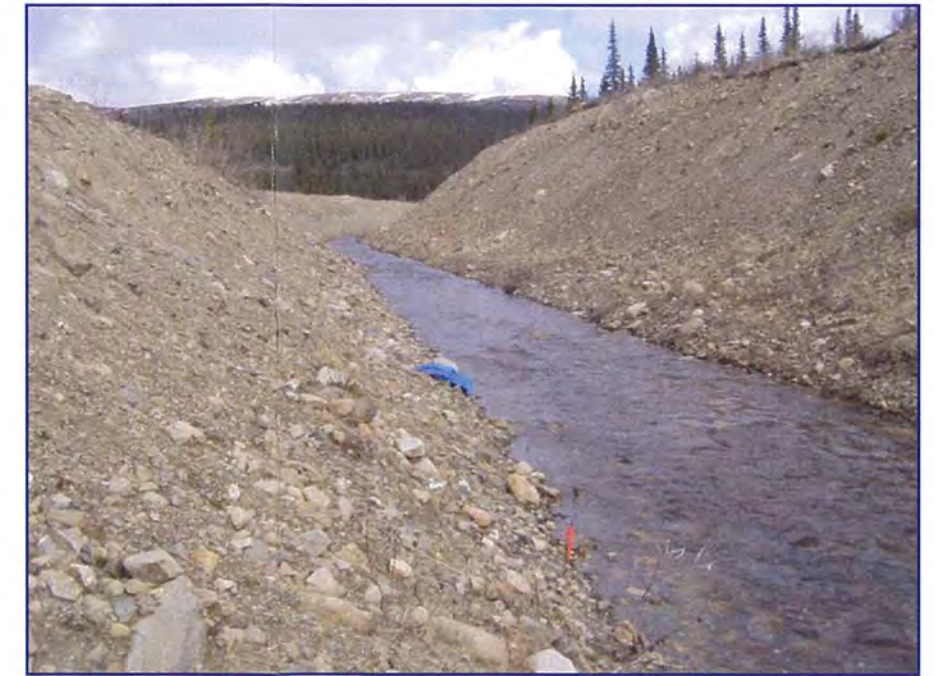
May: an upstream view of the channel, banks appear to be in good condition.

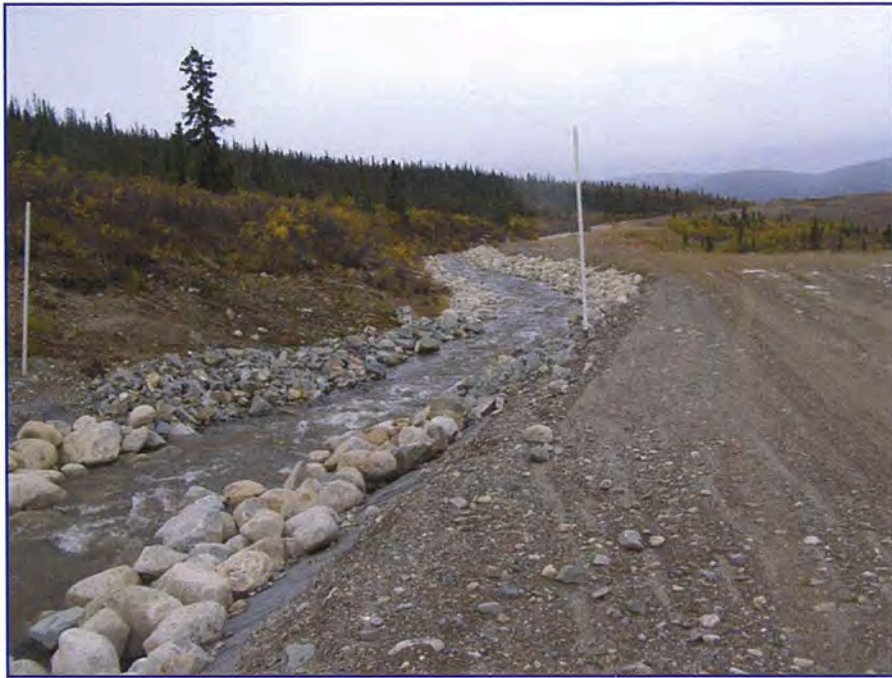
September: shows a view of Faro Creek Diversion Channel looking downstream.

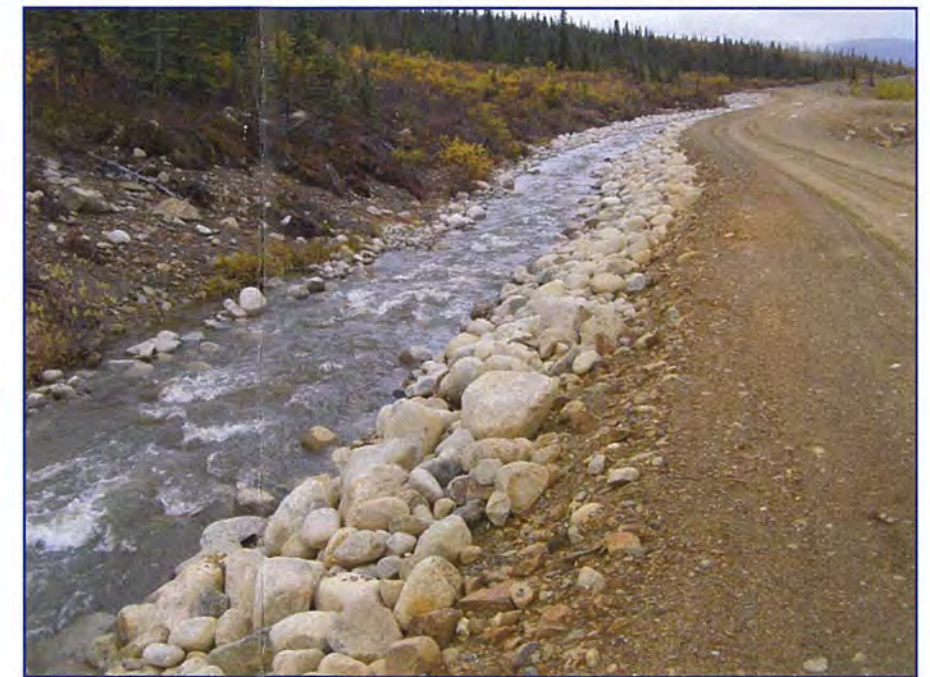
September: shows a view of Faro Creek Diversion looking upstream.

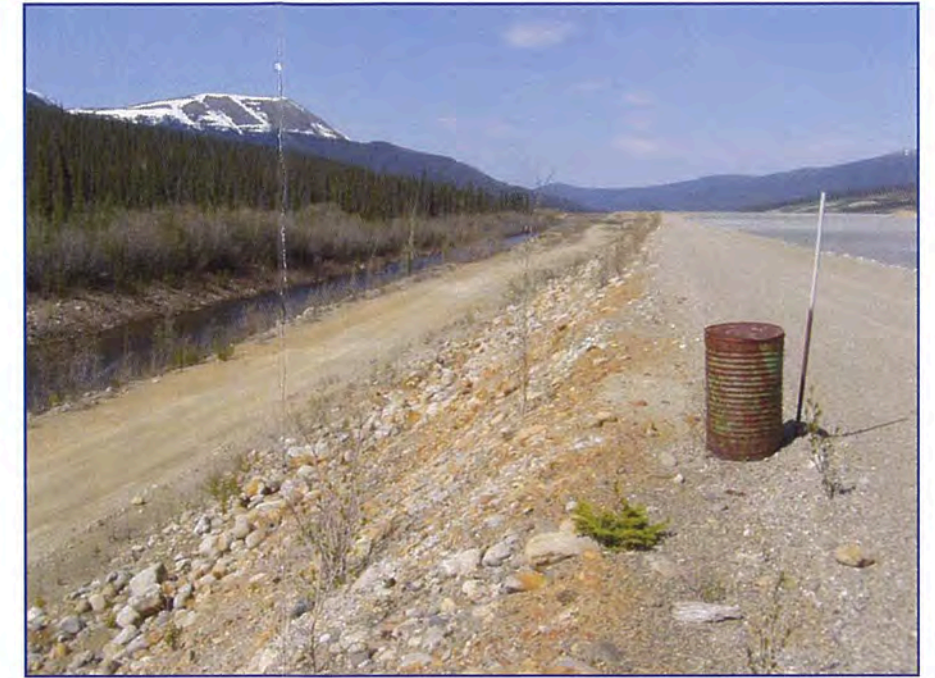
June: a view of the downstream face of the dam with the diversion channel on the left side of the photo.

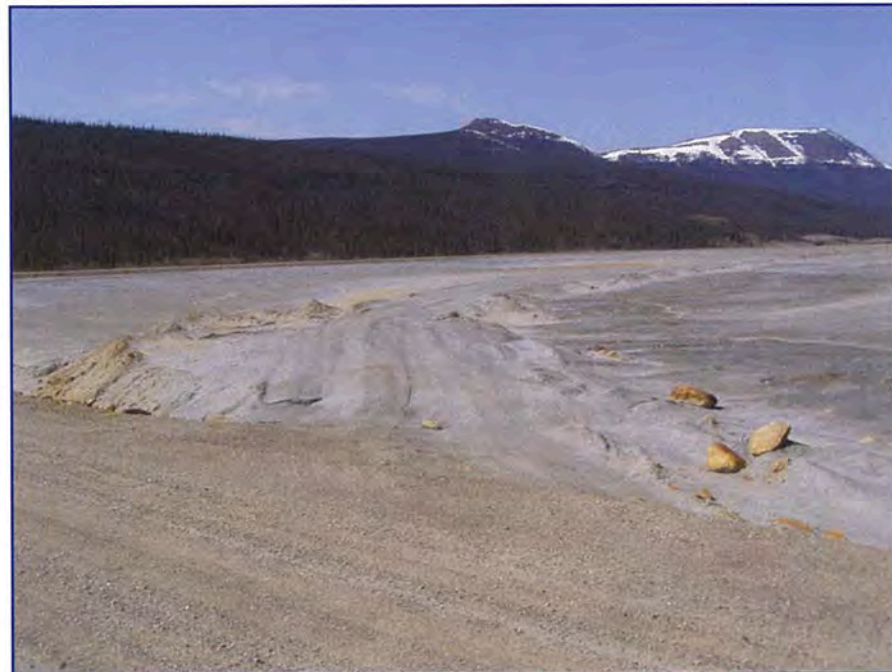
June: shows a view of the Primary tailings dam crest.

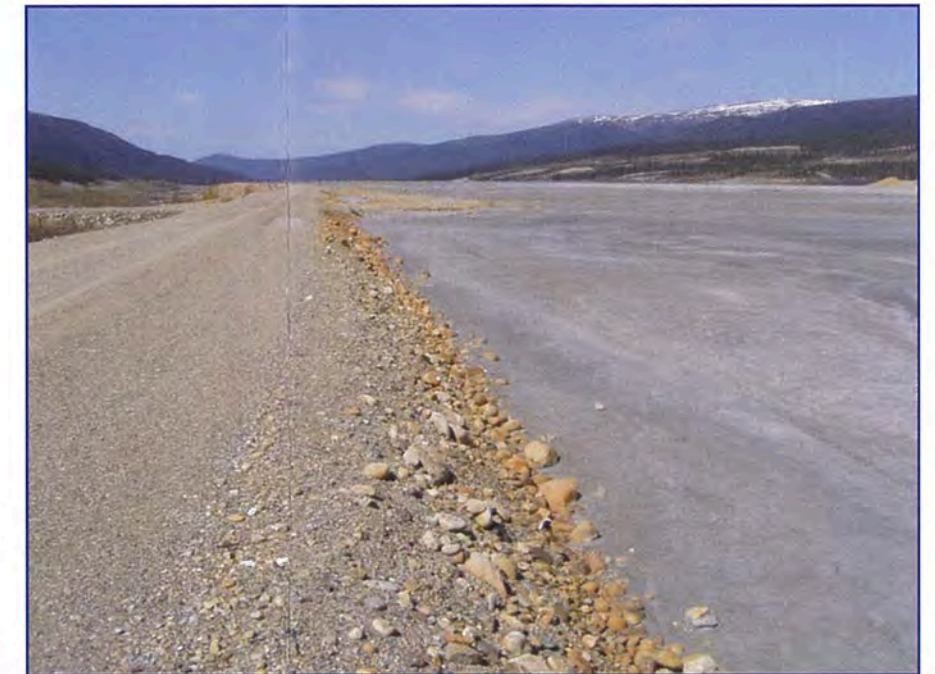
June: looking down the upstream face from the crest of the dam.

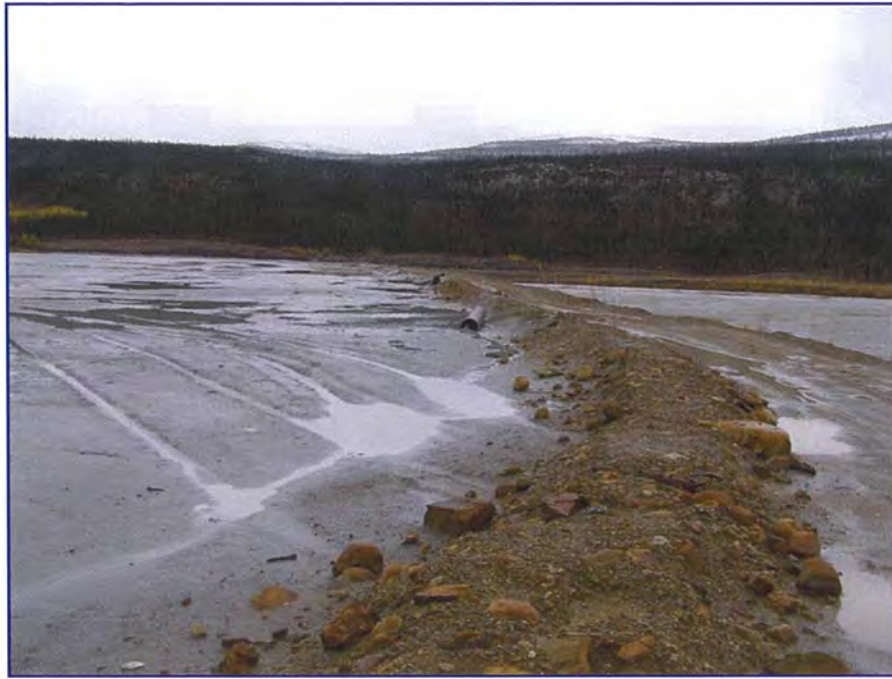
September: shows the upstream side of the Secondary Dam. Note the water ponded near the small berm on the upstream side of the crest.

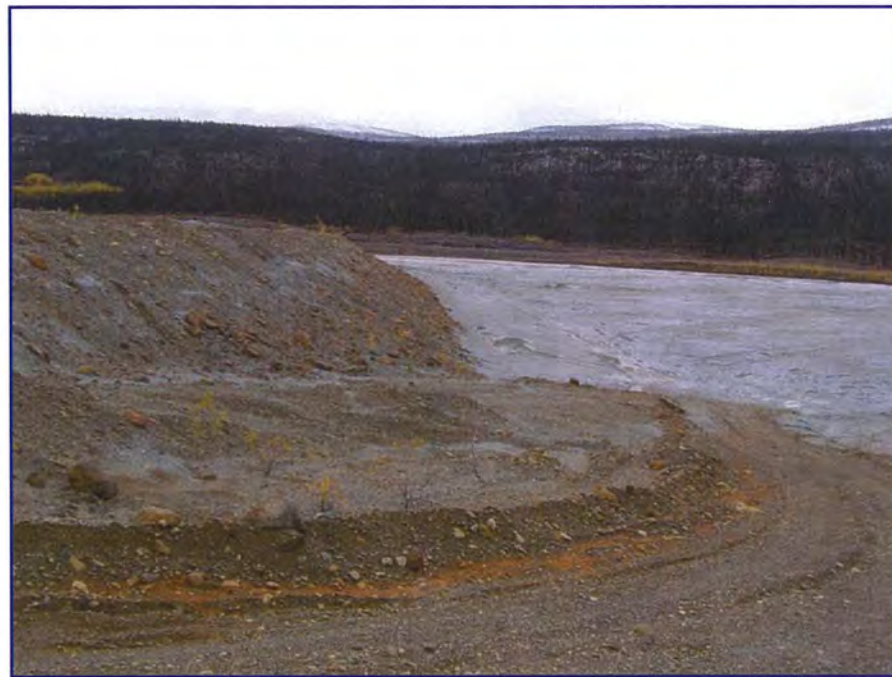
September: shows the downstream face of the Secondary Dam.

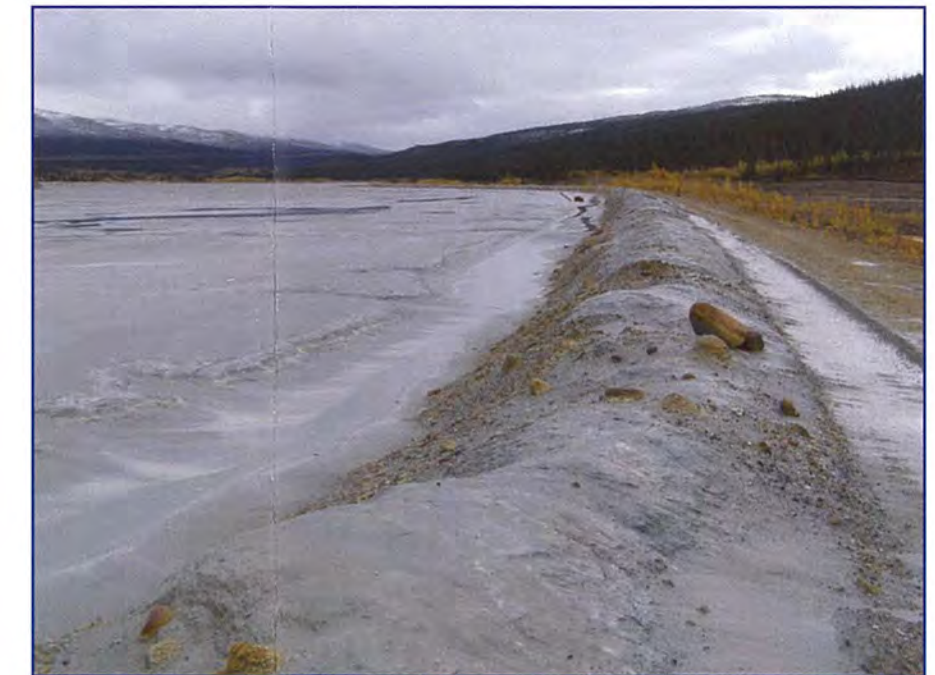
September: shows the upstream side of the dam with a piled tailings.

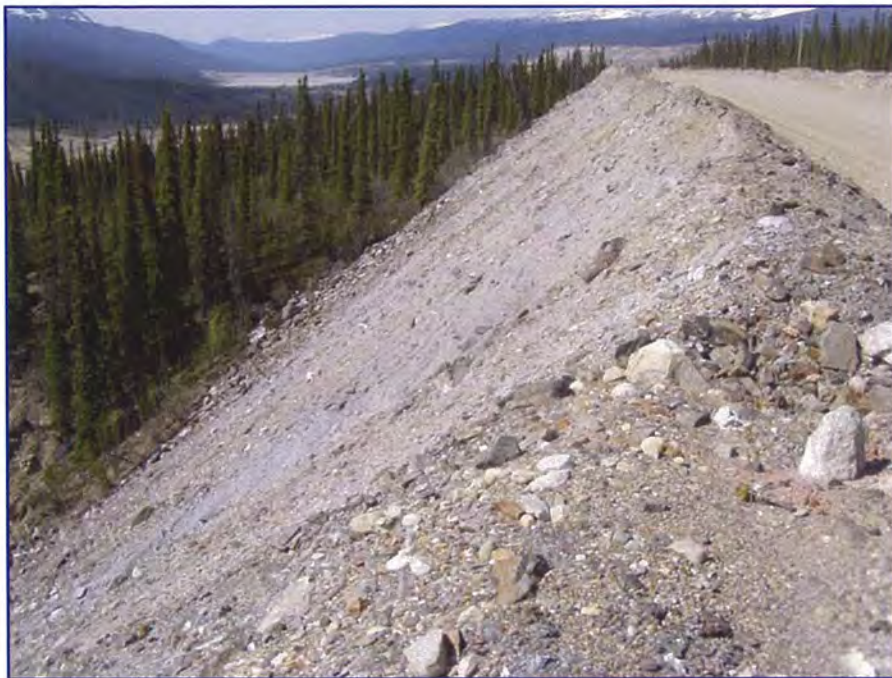
June: shows the overall slope of the downstream side of the rock drain

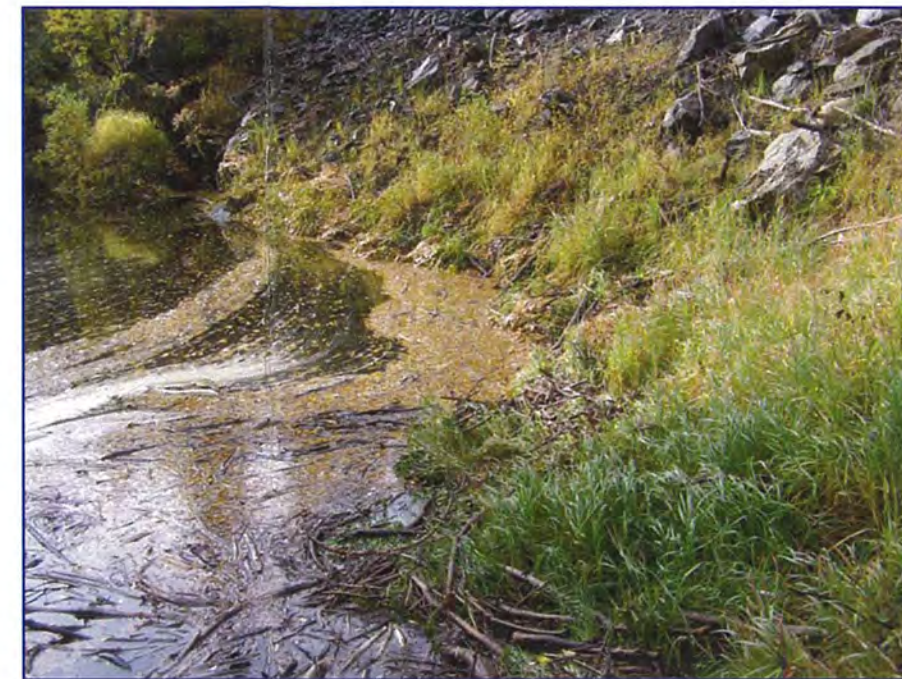
September: a view of the sediment and grass that is present on the upstream face of the rock drain.

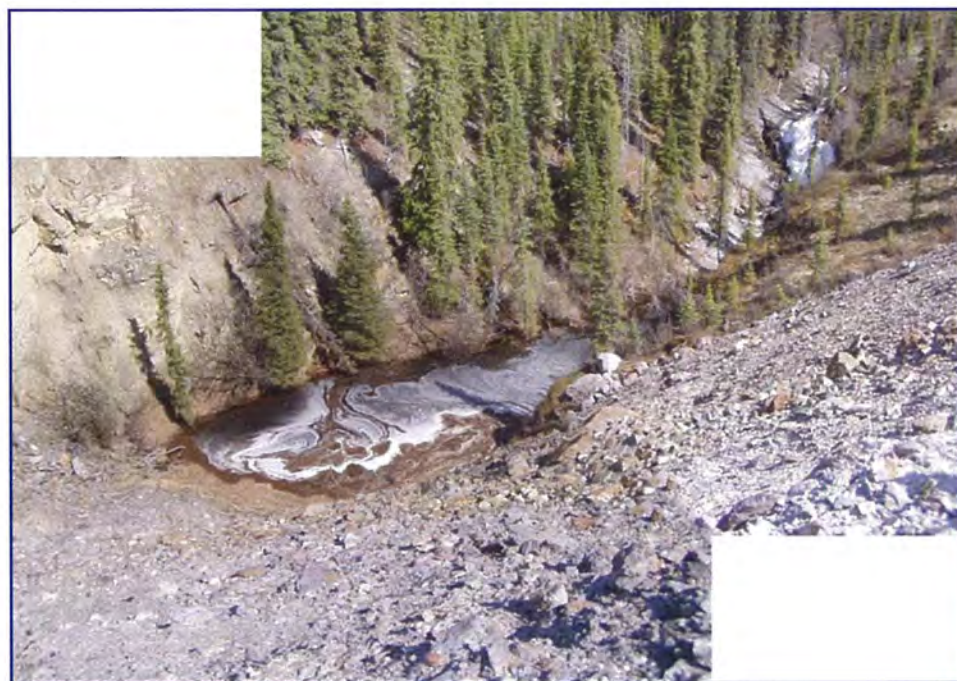
June: a view looking down the upstream face of the rock drain at the upstream pond.

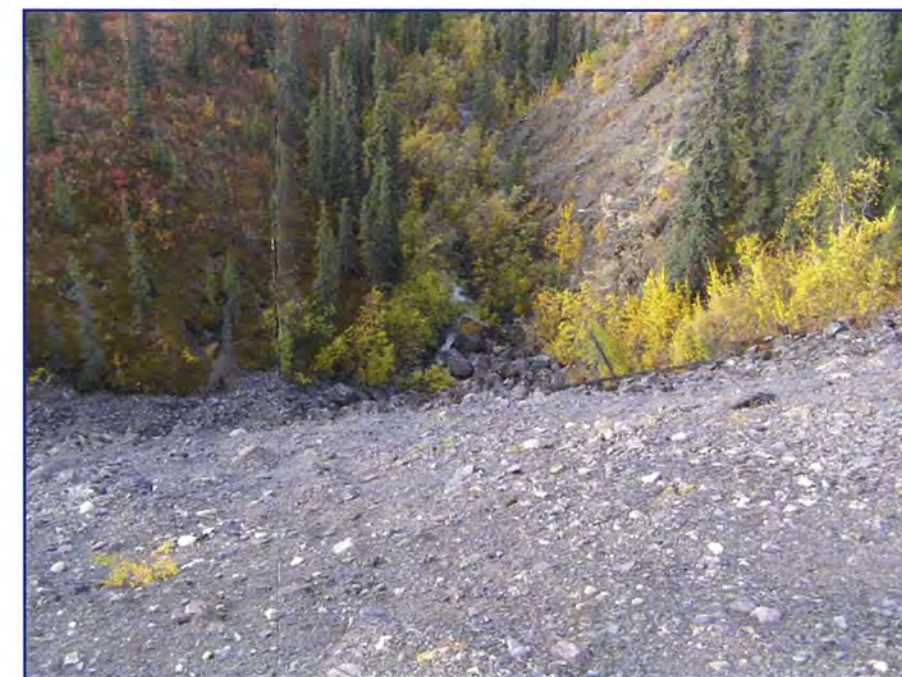
September: shows the downstream face of the rock drain with water flowing clearly from the toe.
