2009 ANNUAL GEOTECHNICAL EVALUATION AND INSTRUMENT REVIEW

VARIOUS FACILITIES AT FARO MINE, YUKON

PROJECT NO.: 0762-002-05
DATE: FEBRUARY 26, 2010

**RE: 2009 ANNUAL GEOTECHNICAL EVALUATION AND INSTRUMENT REVIEW
VARIOUS MINE WASTE FACILITIES AT FARO MINE, YUKON**

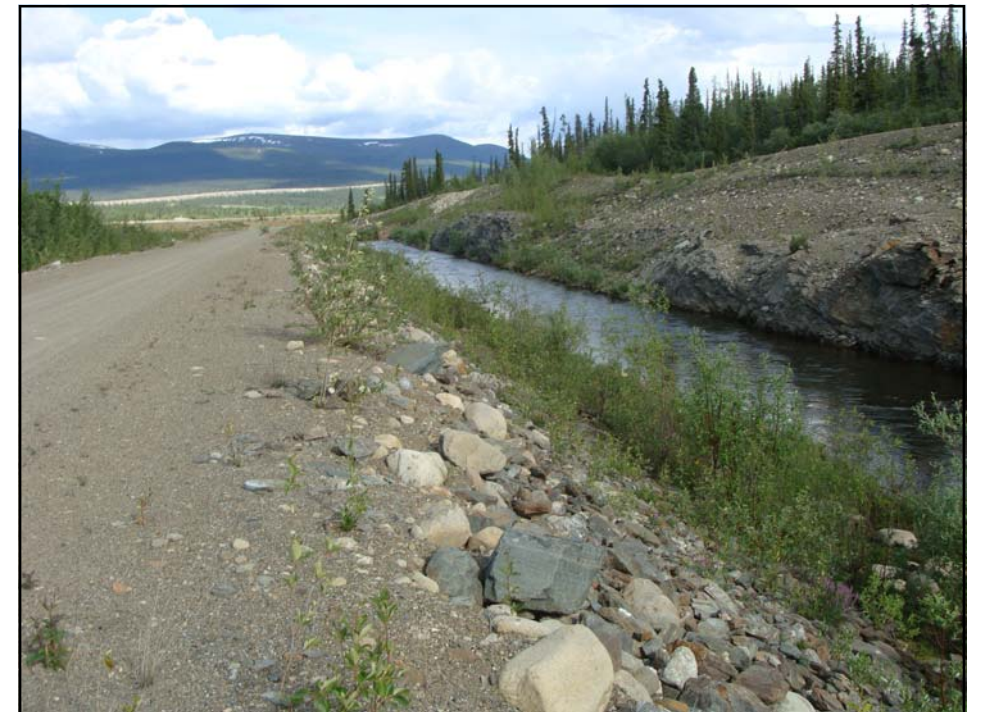
July: a view of the Diversion looking downstream. Note the bedrock outcrop on the right bank.

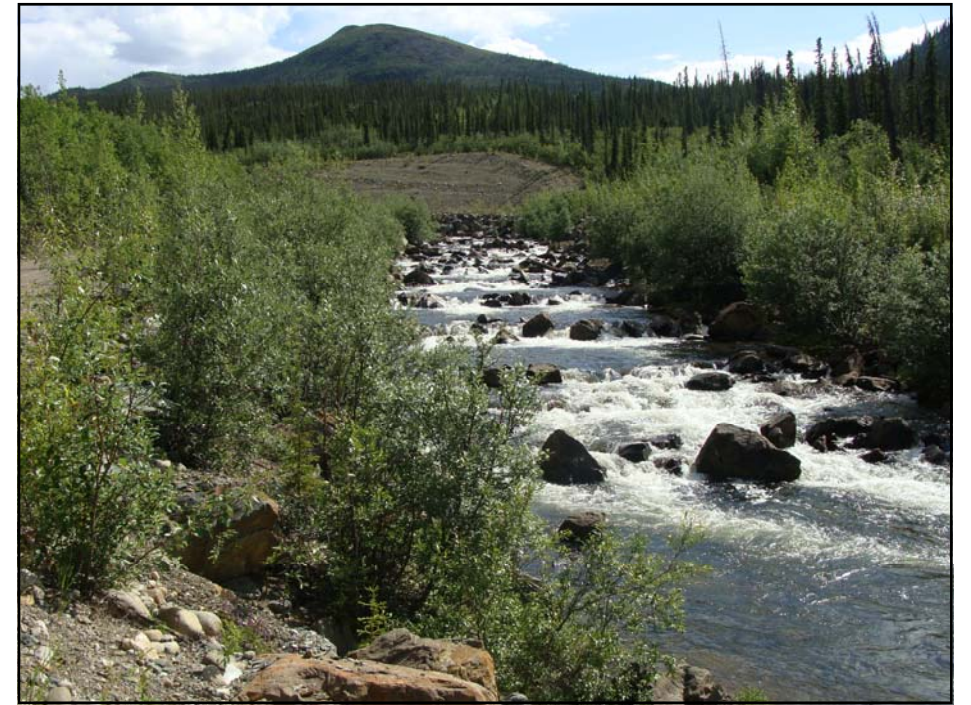
July: shows an upstream view of the upper weir section of the canal, looking towards Cornish Creek.

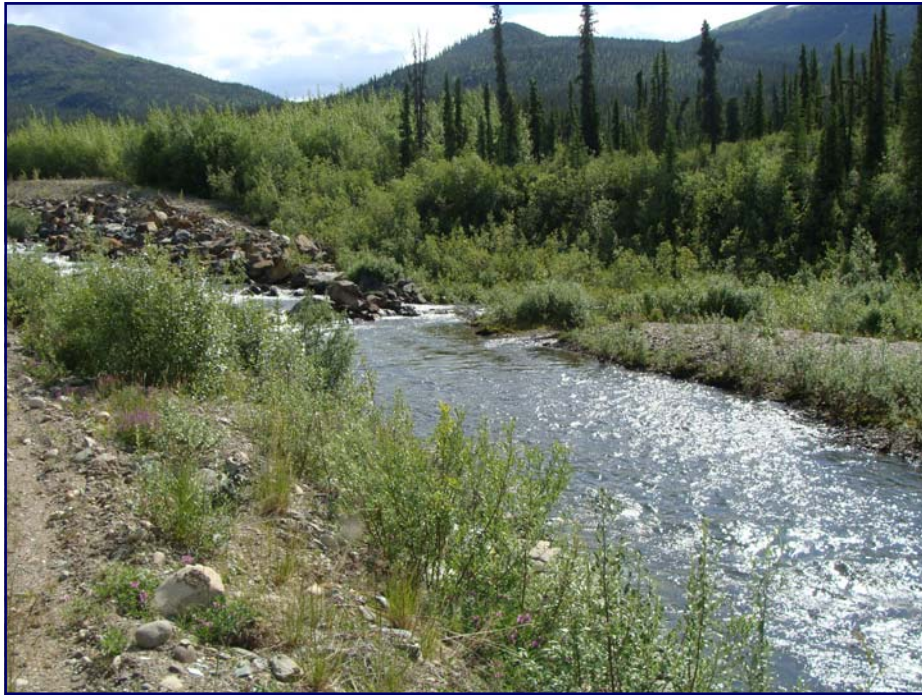
July: view of the lower weir section, this is where Severin Creek enters the Diversion Canal.

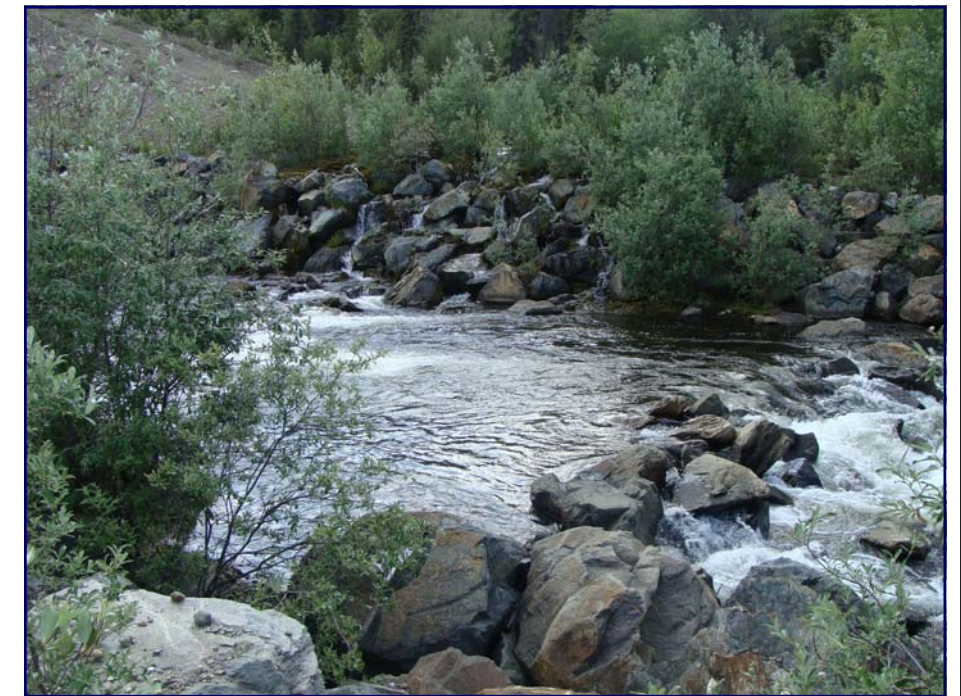
July: view of the upper weir section, looking upstream at the point where Cornish Creek flows into the canal.

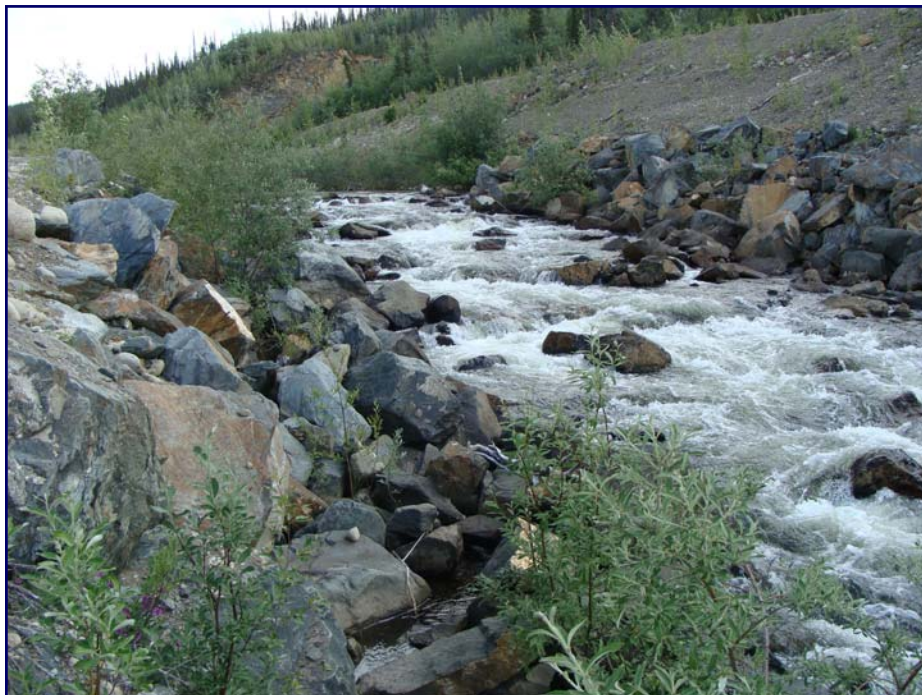
July: shows the start of the upper weir section, looking upstream

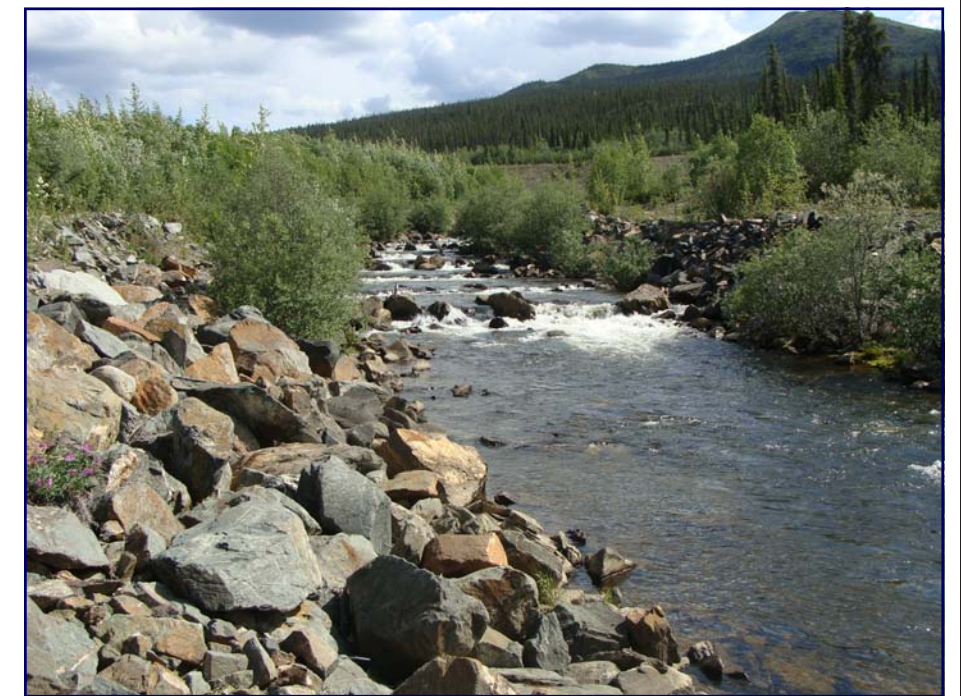
July: a view looking upstream from the lower end of the upper weir section.

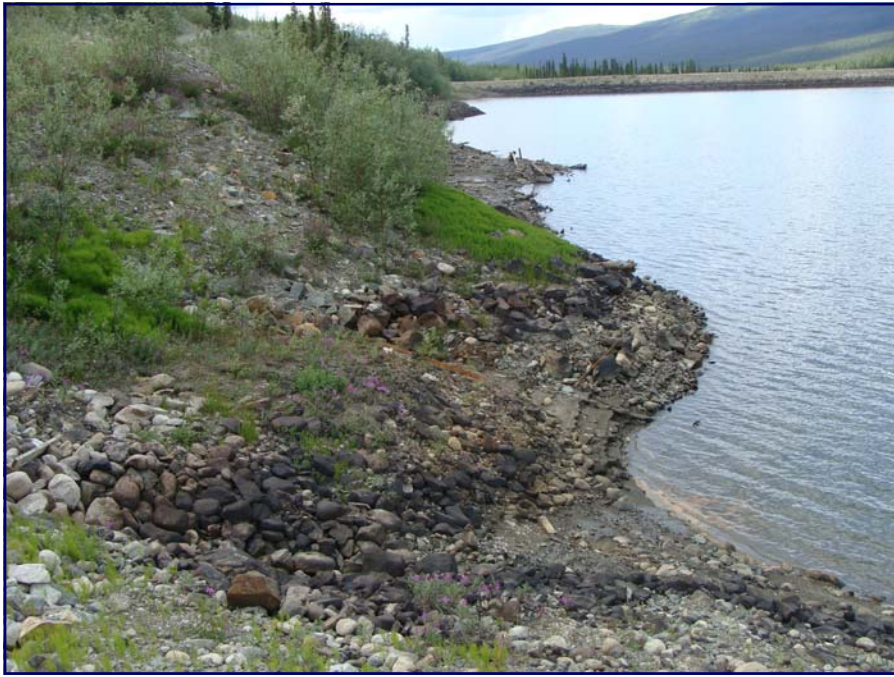
July: a view of the toe of the spoil pile. The pond level is lower than usual, as shown by the high water marks.

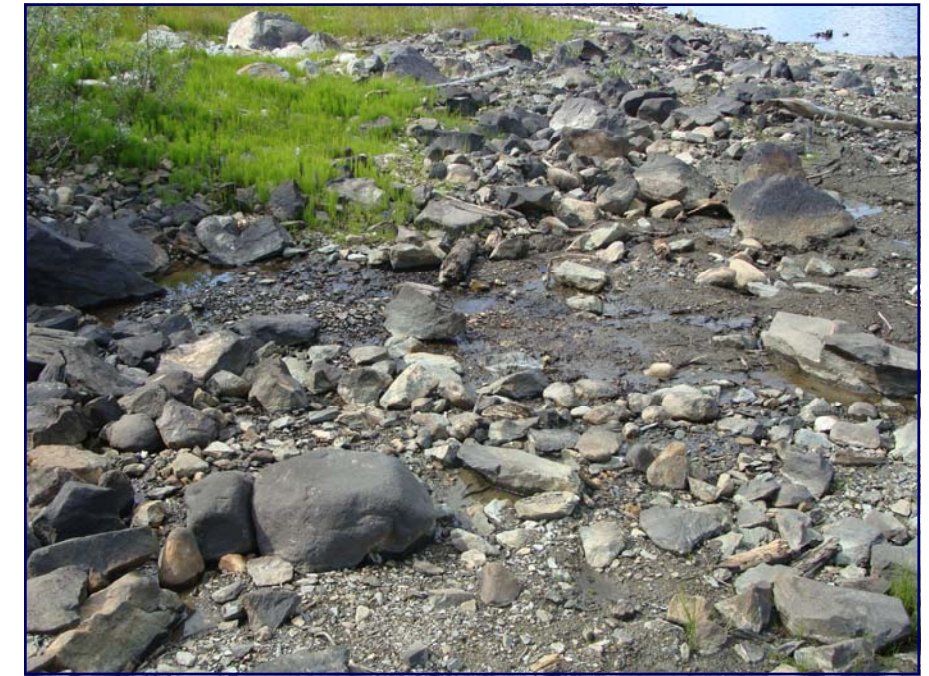
July: view of one of the larger seepage points in the spoil toe.

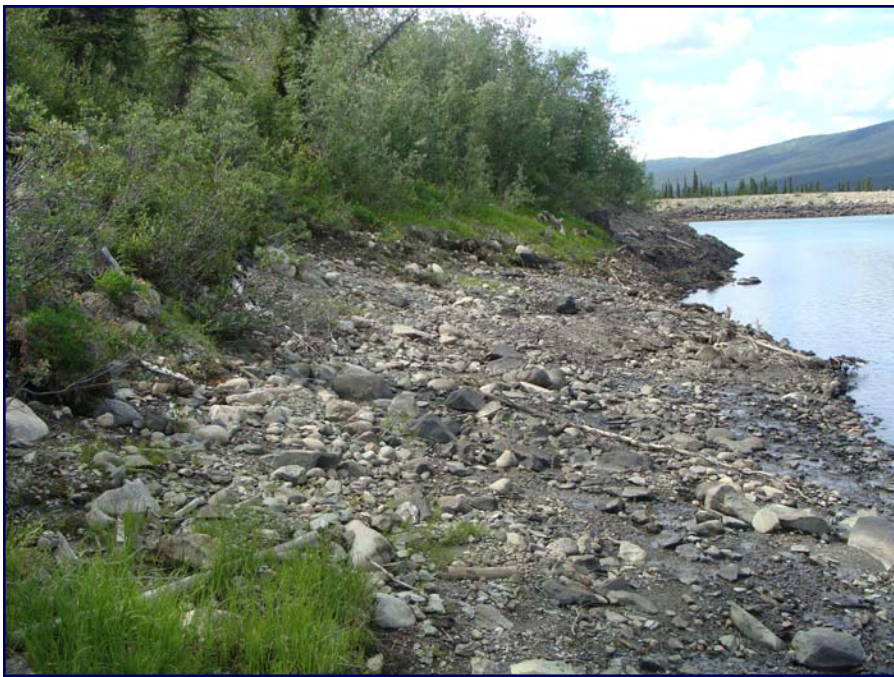
July: view of the polishing pond shoreline, which is formed by the spoil pile base. Note that this is an area of slumping and seepage.

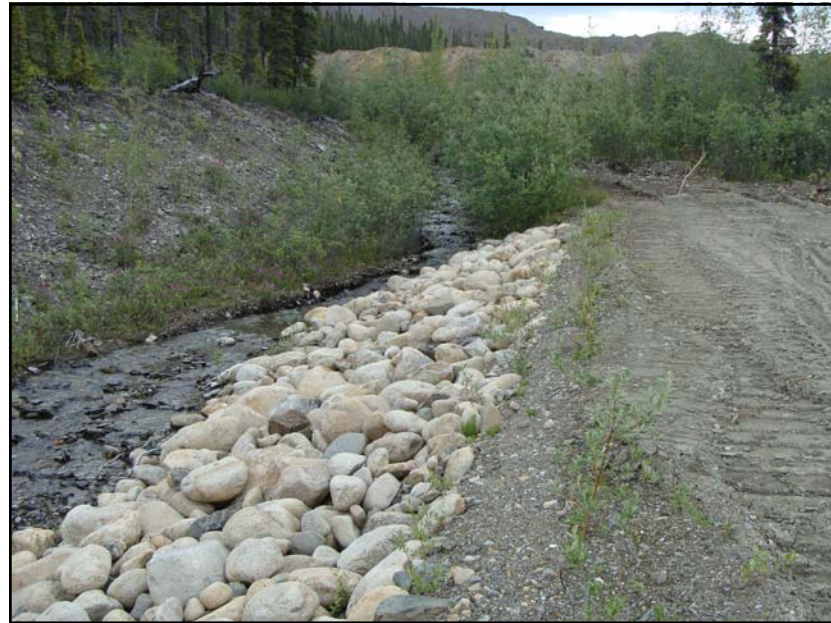
July: shows the start of the North Valley Interceptor Ditch just uphill from the guard house gate. This is the area the dike was repaired before and the riprap is present in the photo. After inspection of this section, it appears that the channel is flowing well with no signs of erosion or blockages.

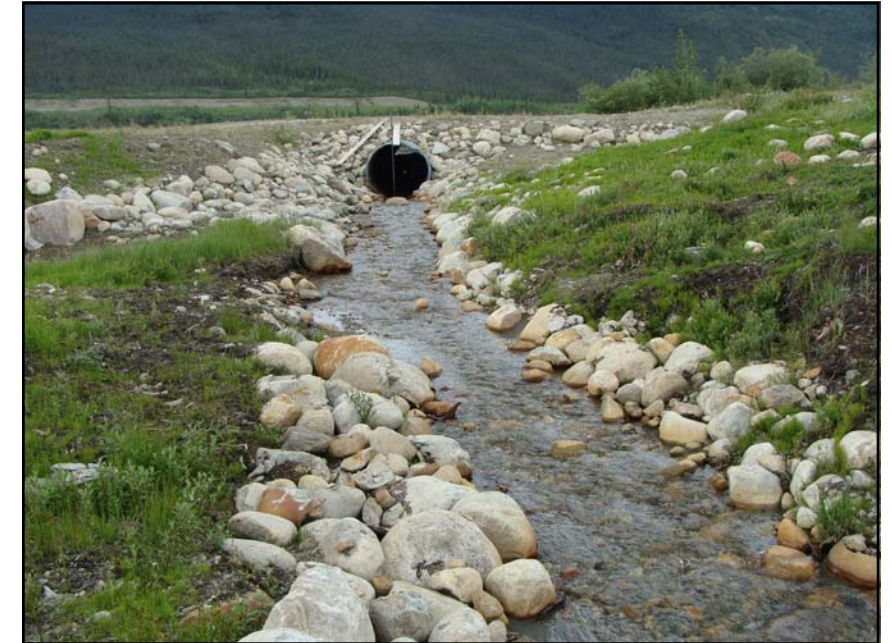
July: a downstream view of the North Valley Interceptor Ditch, looking at the culvert.

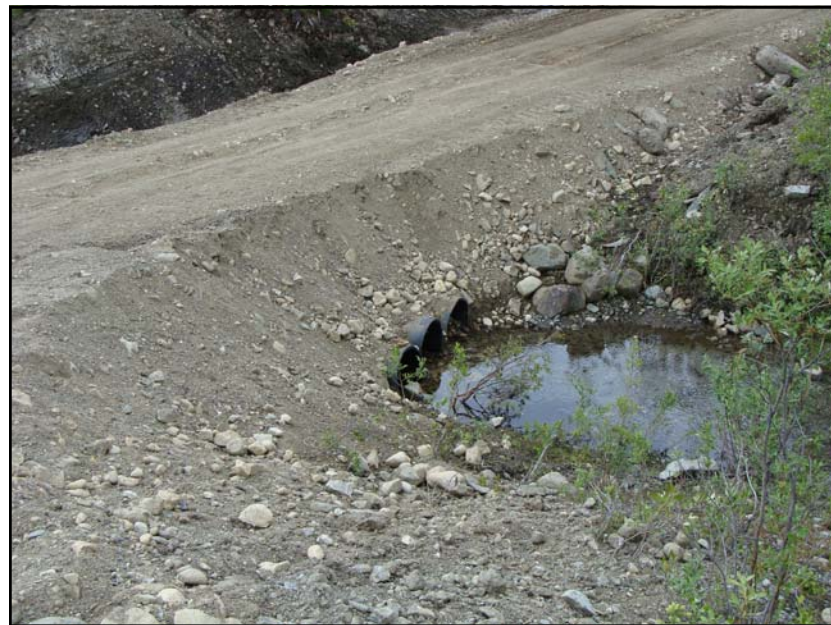
July: shows a new crossing that has been made over the North Valley Interceptor Ditch. Culverts were installed to allow water to flow though.

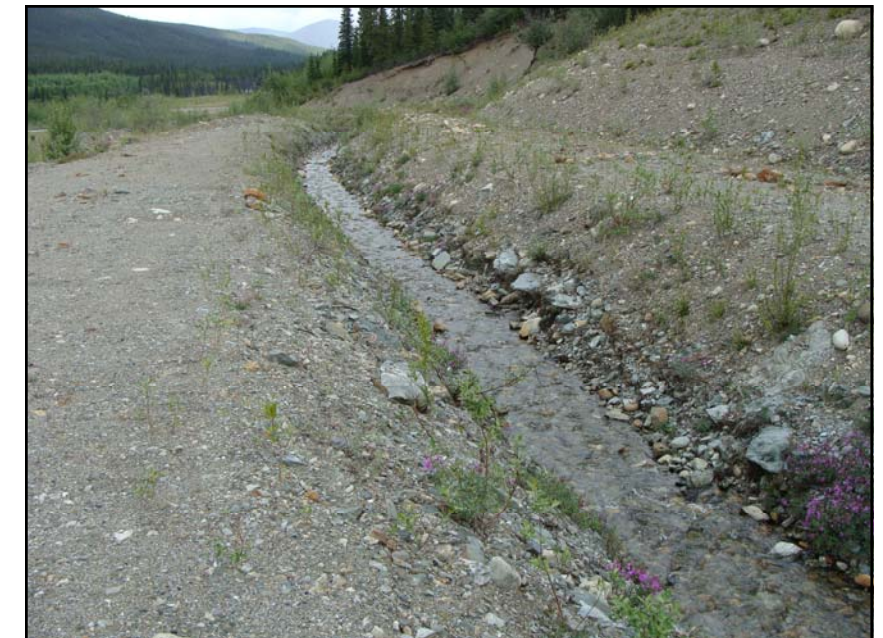
July: a downstream view of the North Valley Interceptor Ditch downstream of the culvert.

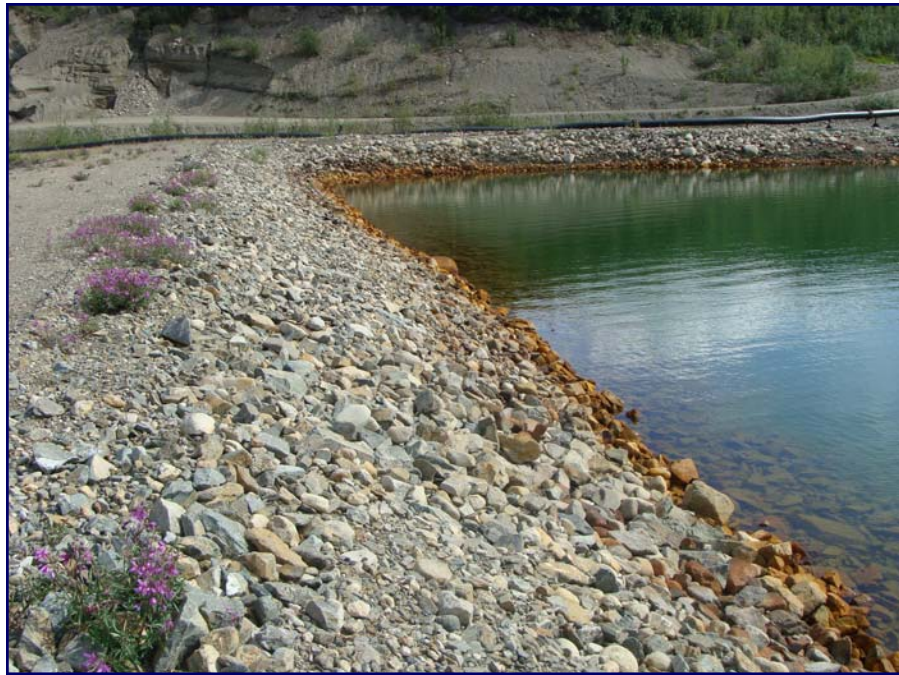
July: shows a view of the riprap near the spillway.

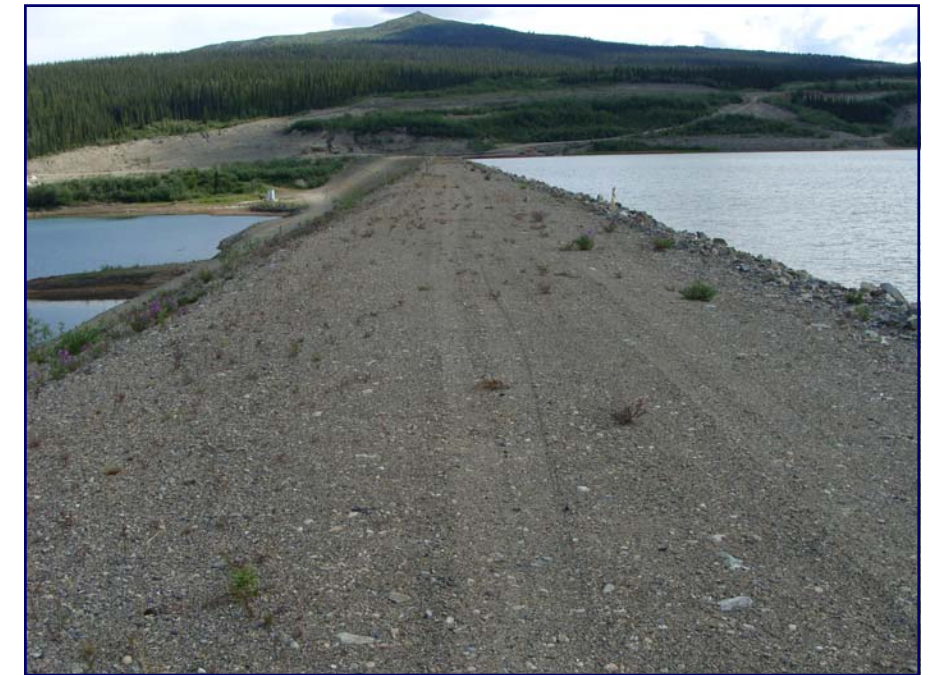
July: a view looking south along the crest of the dam.

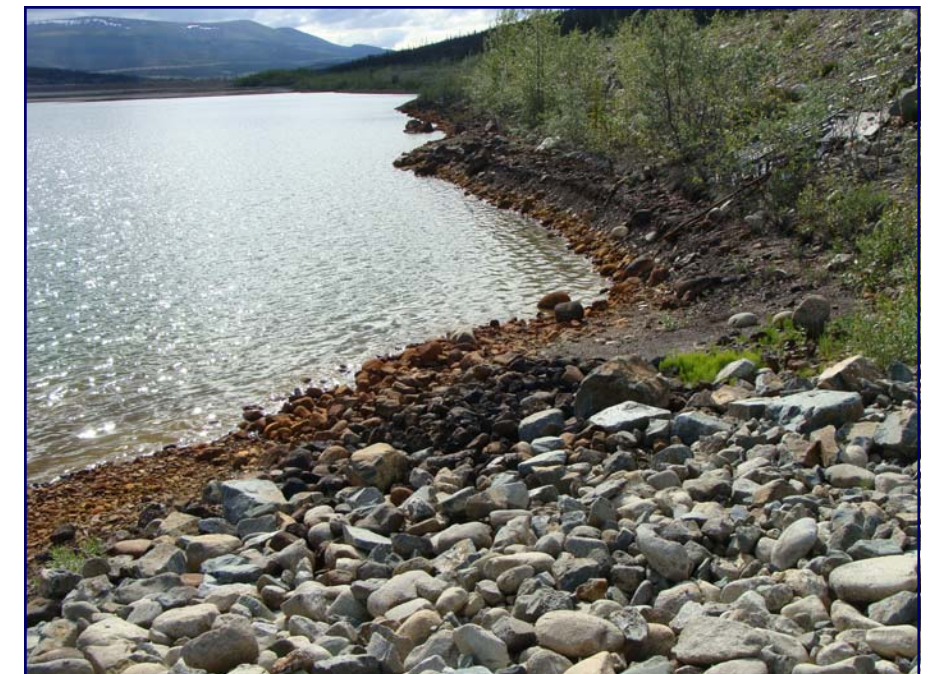
July: shows the shoreline of the pond from the left abutment. Canal Dike is on the extreme right of this photo.

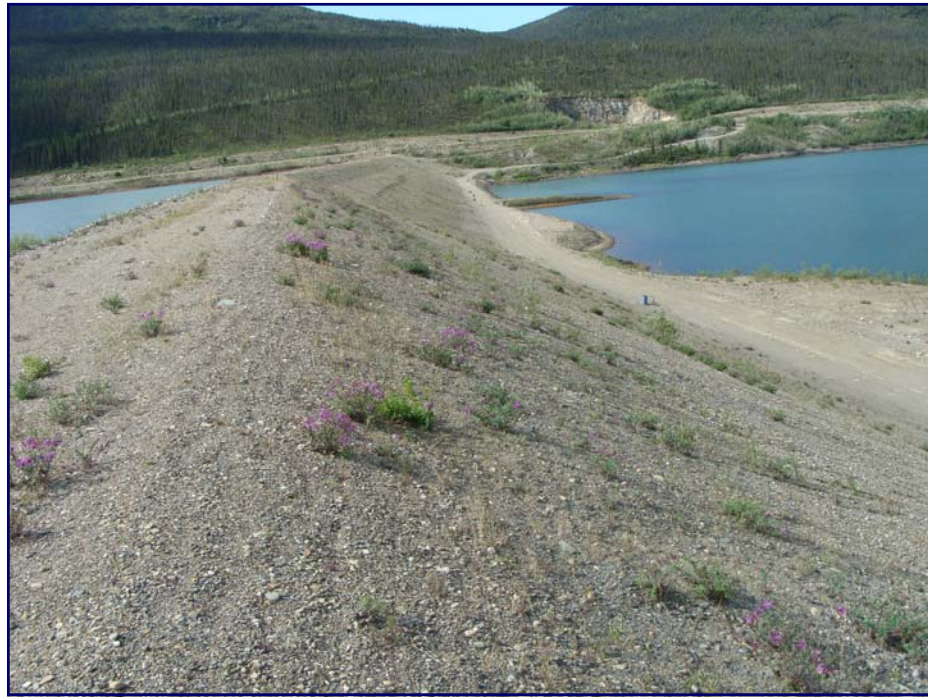
July: showing a view looking south along the downstream dam face.

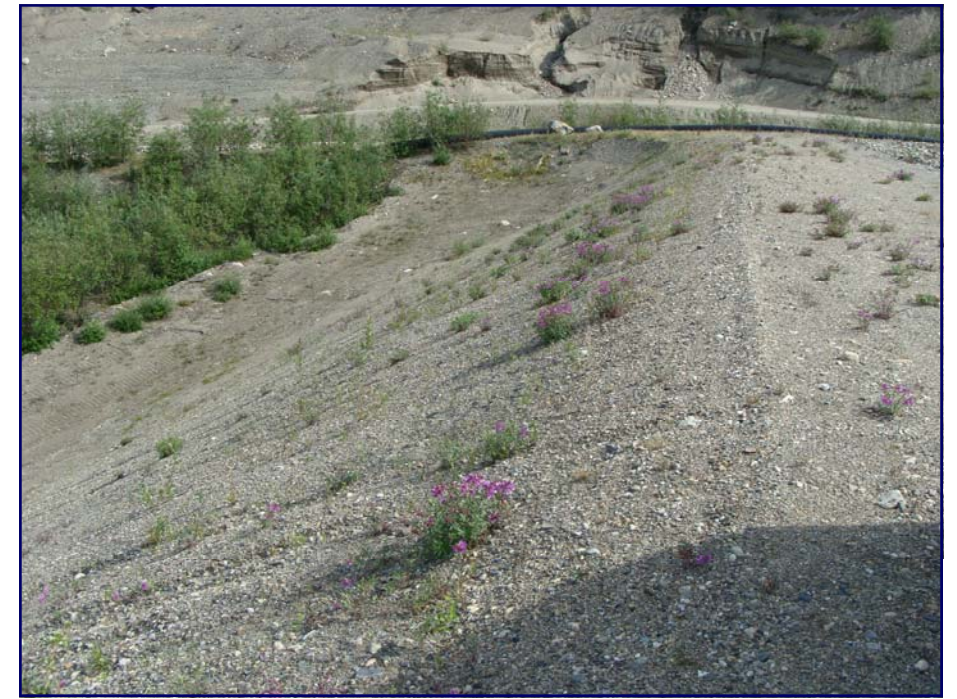
July: a view of the North Abutment contact.

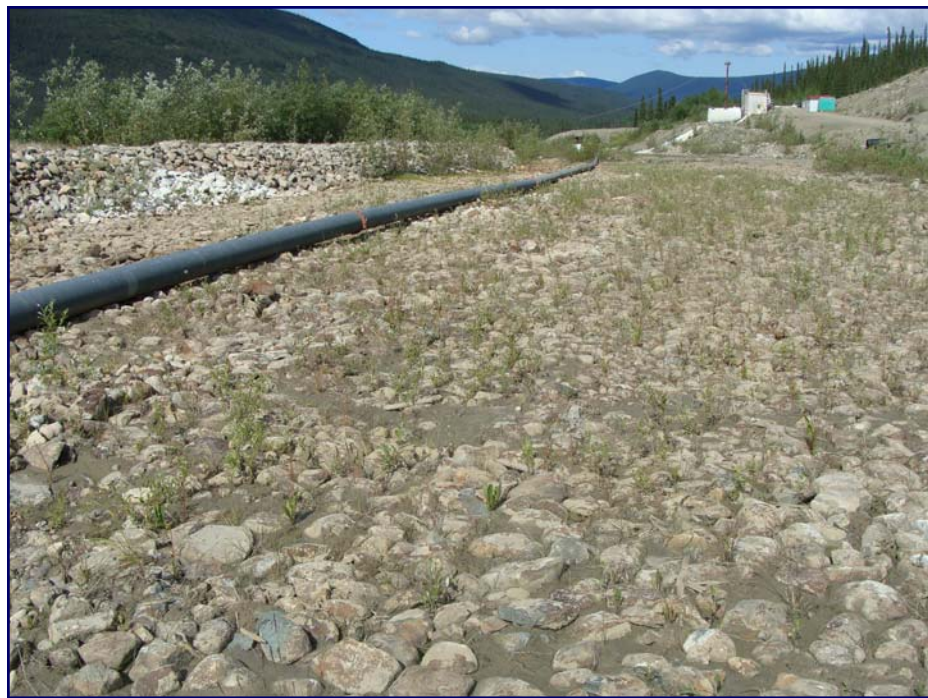
July: looking downstream in the spillway.

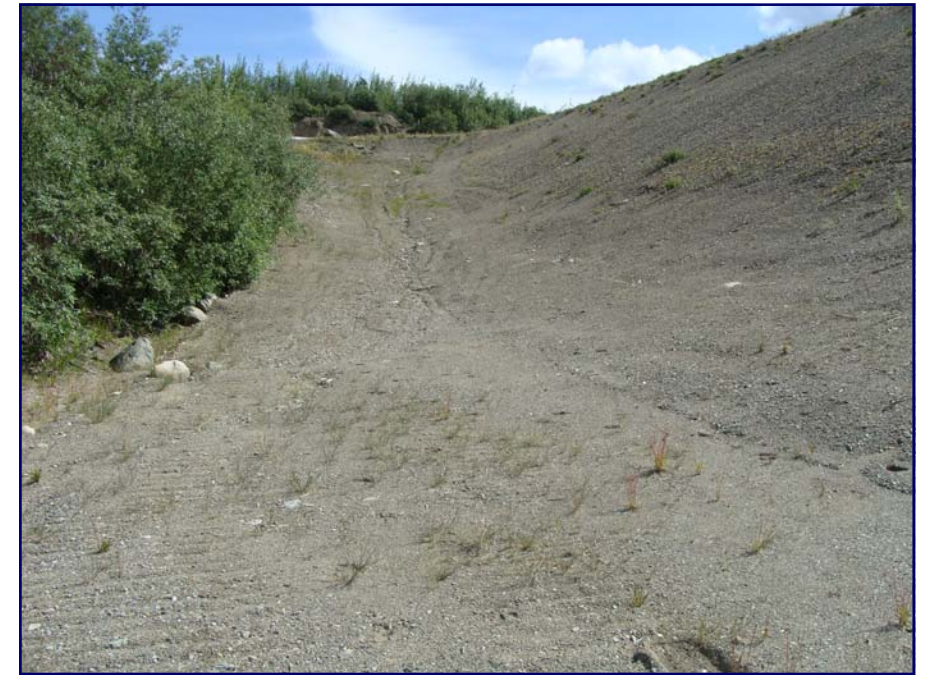
July: shows the intersection of the downstream face with the north abutment. Vegetation was removed and the area was graded for construction access in 2007.

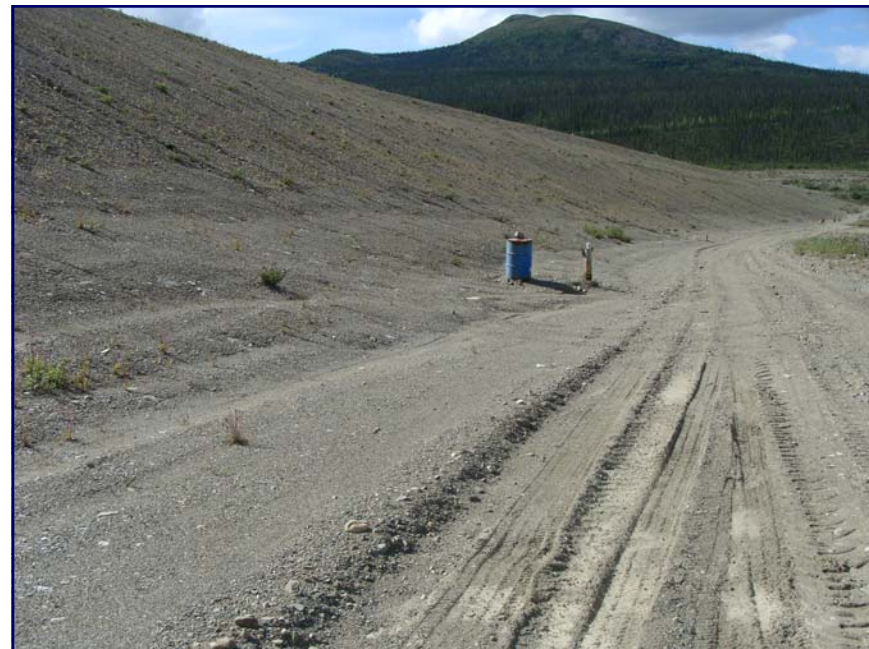
July: shows a view of the toe of the dam at the lower road. Note slough material at the toe.

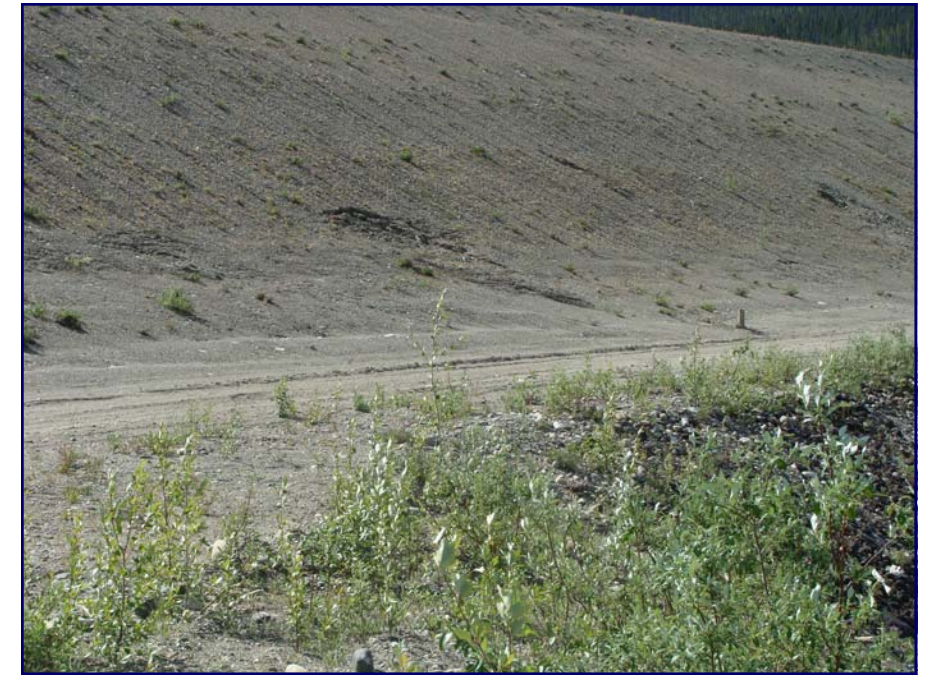
July: shows some minor slumping that is occurring on the face of the downstream side of the dam.

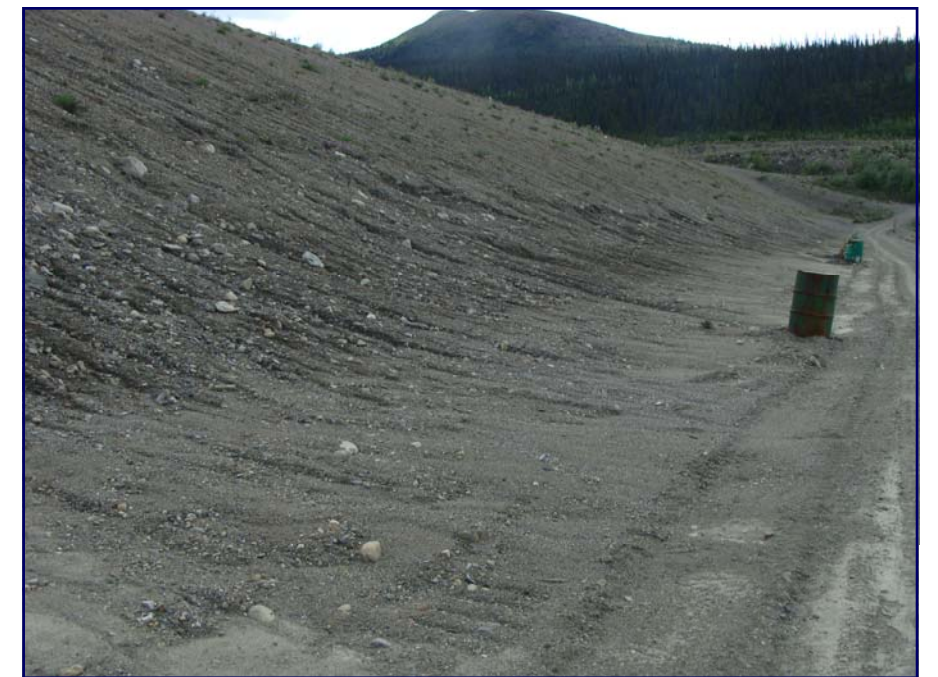
July: a view of the downstream face with the left abutment on the Intermediate Dam in the background.

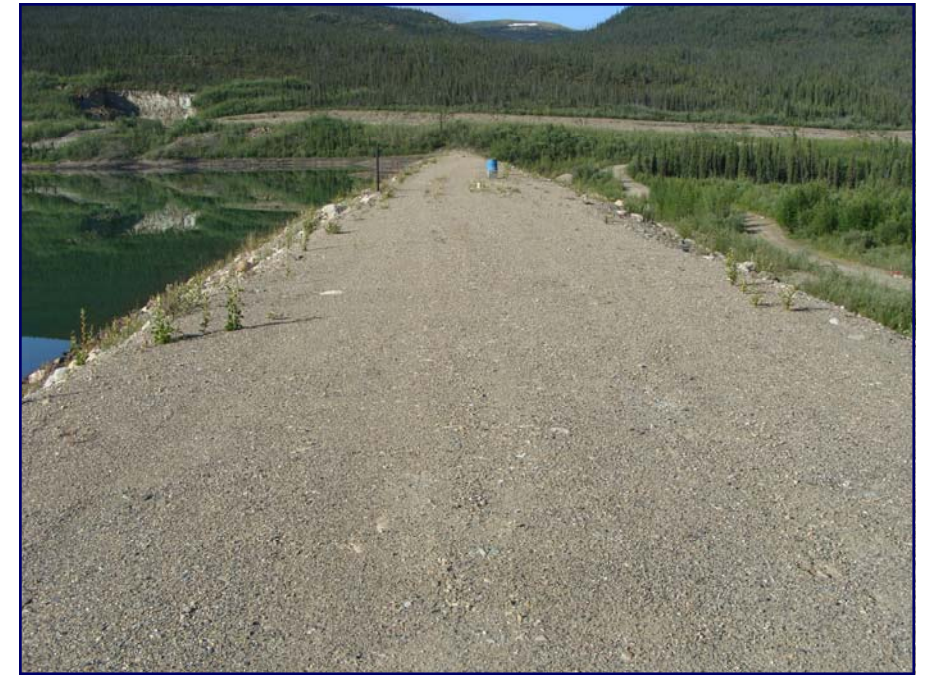
July: shows a view of the crest of the dam.

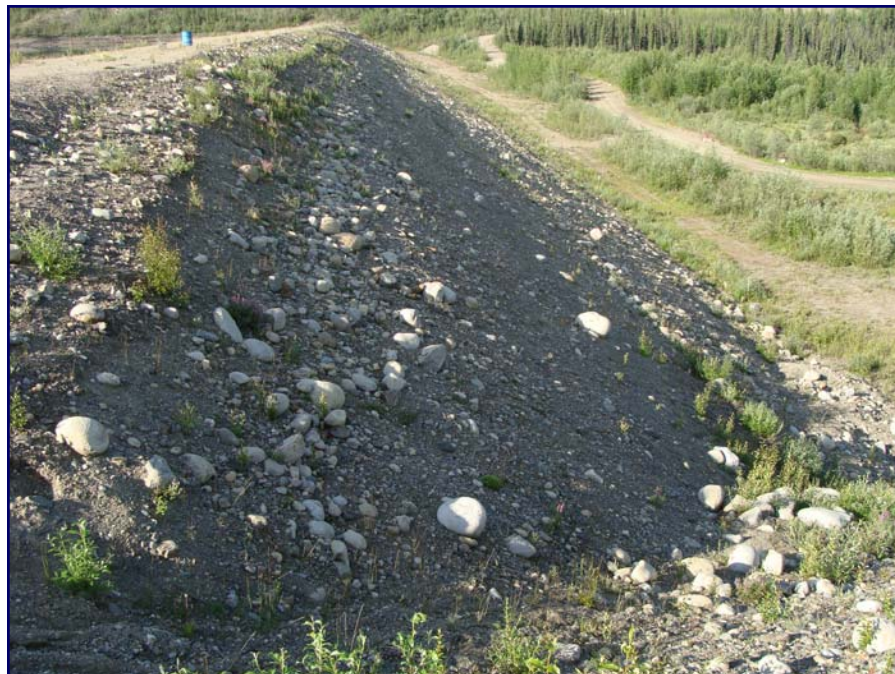
July: shows a view of the downstream shell of the Cross Valley Dam.

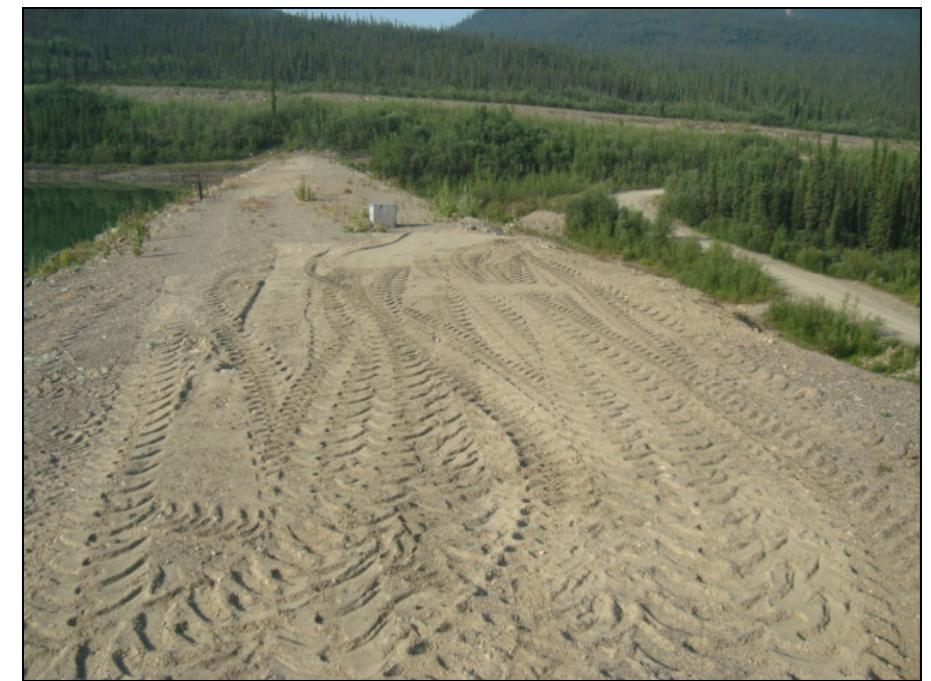
Site Staff Photo, July: shows a view of the crest and downstream face with re-graded compacted surface.

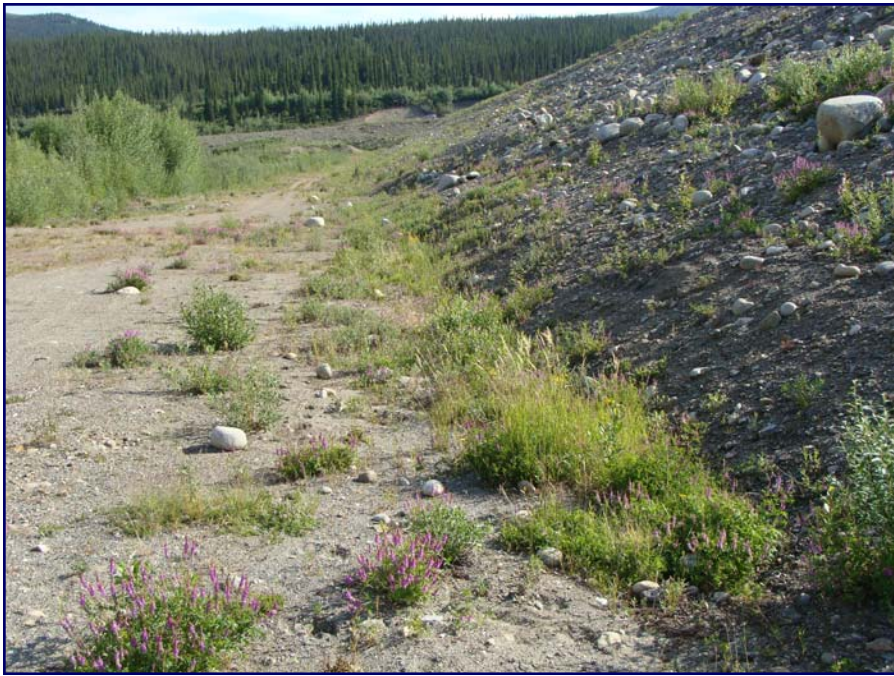
July: shows a view of the downstream toe. Note the concentration of vegetation at the toe. This should be removed.

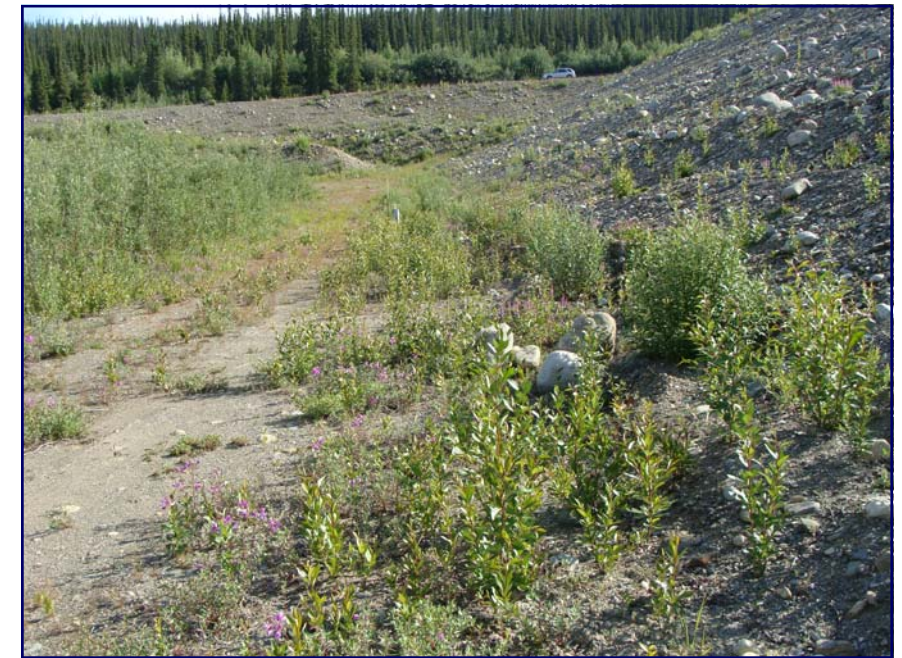
July: view of the wet location located on the right side of the dam toe.

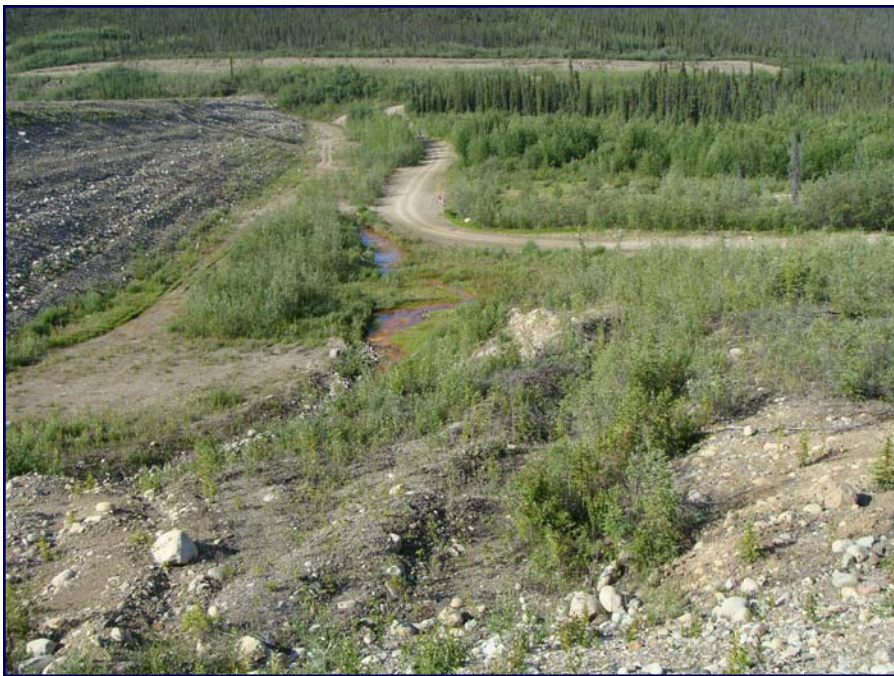
July: Overview of the downstream toe area of the dam.

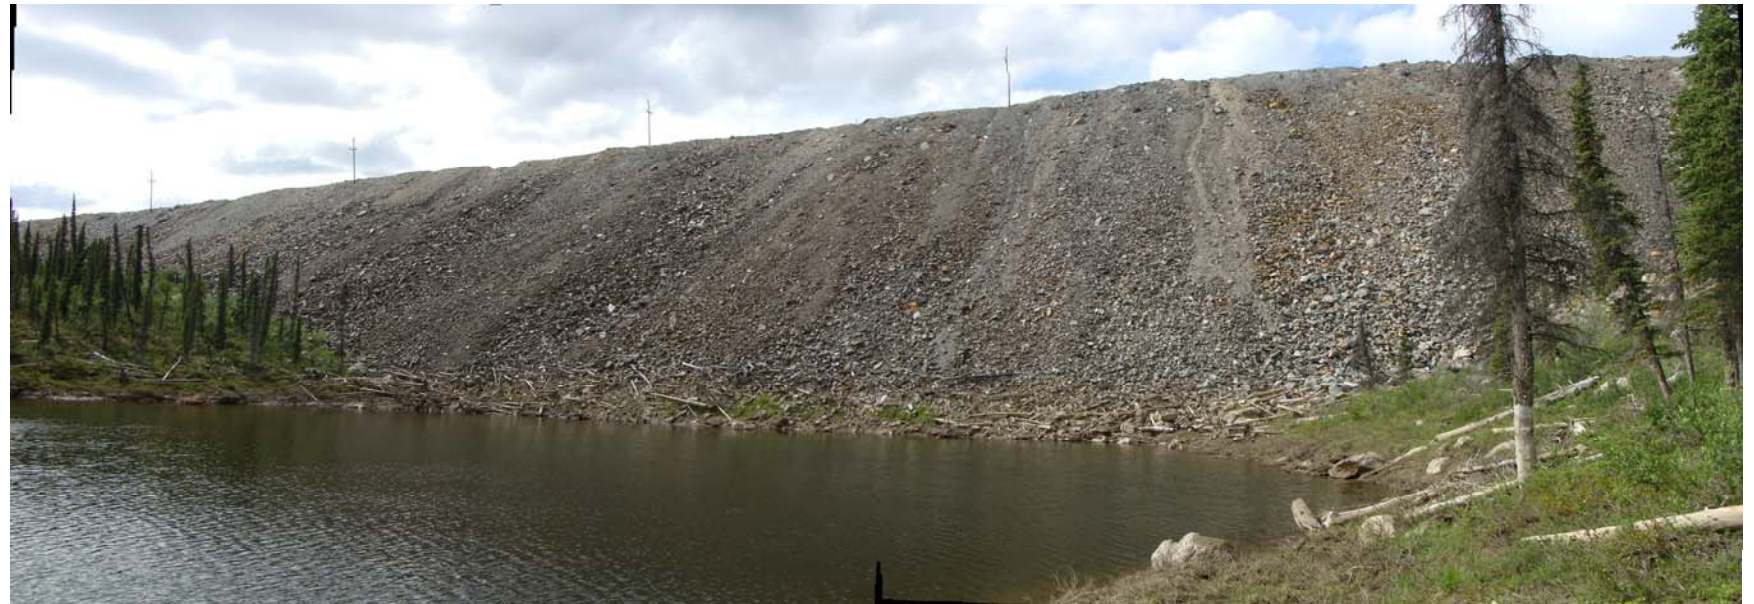
June: shows a panorama view of the upstream side of the North Fork Rock Drain

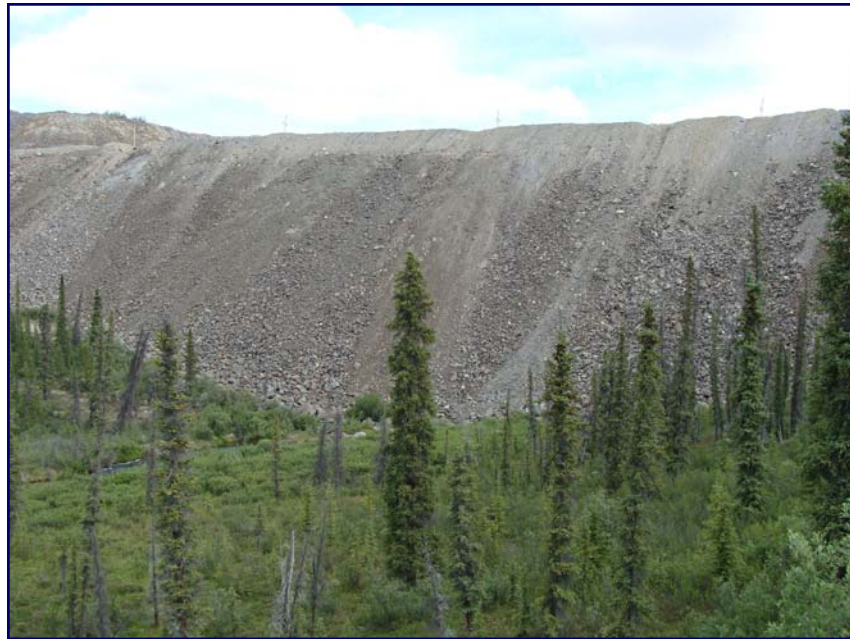
July: shows an overview of the downstream side of the North Fork Rock Drain. Note the erosion gully on the face.

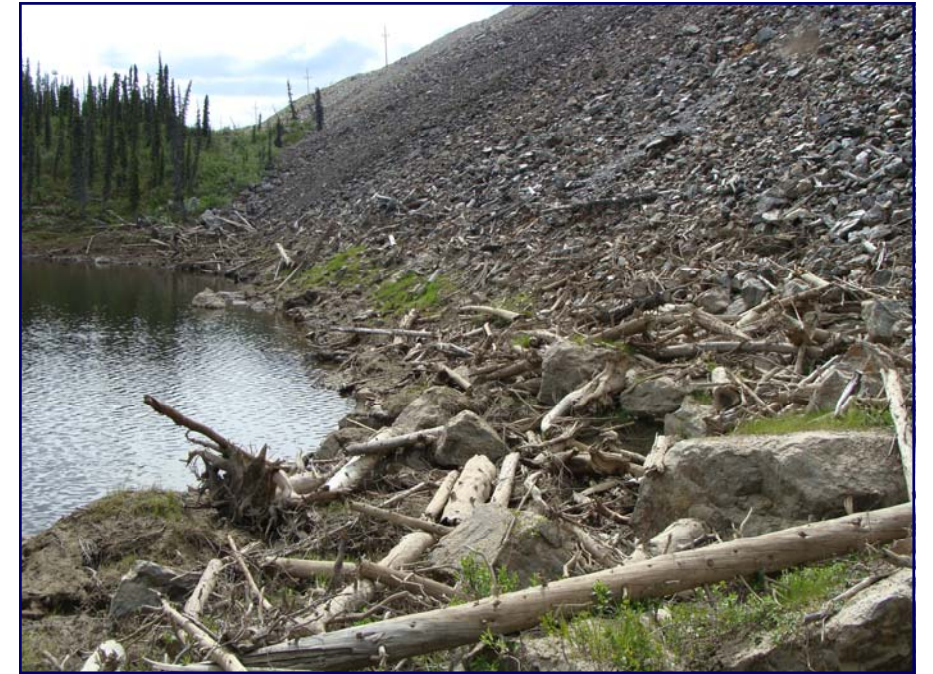
July: looking towards the east limit of the upstream pond. Note that the water level is approximately 3 m below the high water mark that is indicated by debris deposited on the face of the drain.

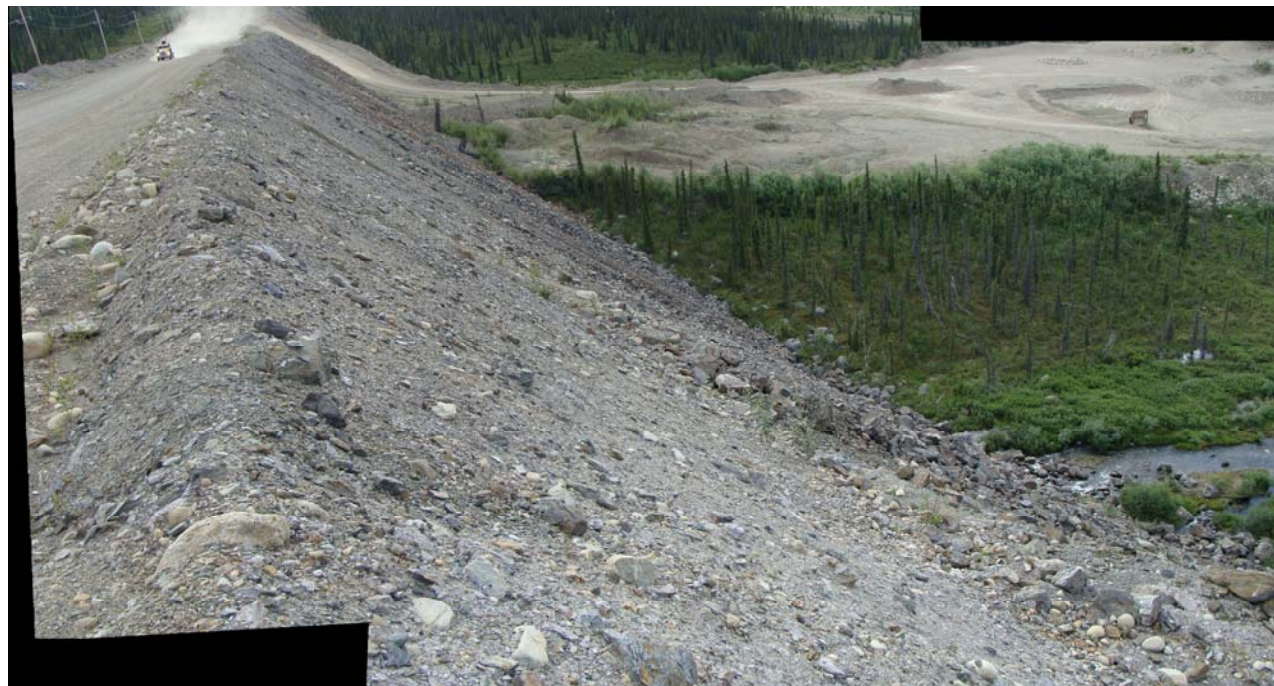
July: a panorama view looking down from the crest of the Rock Drain.

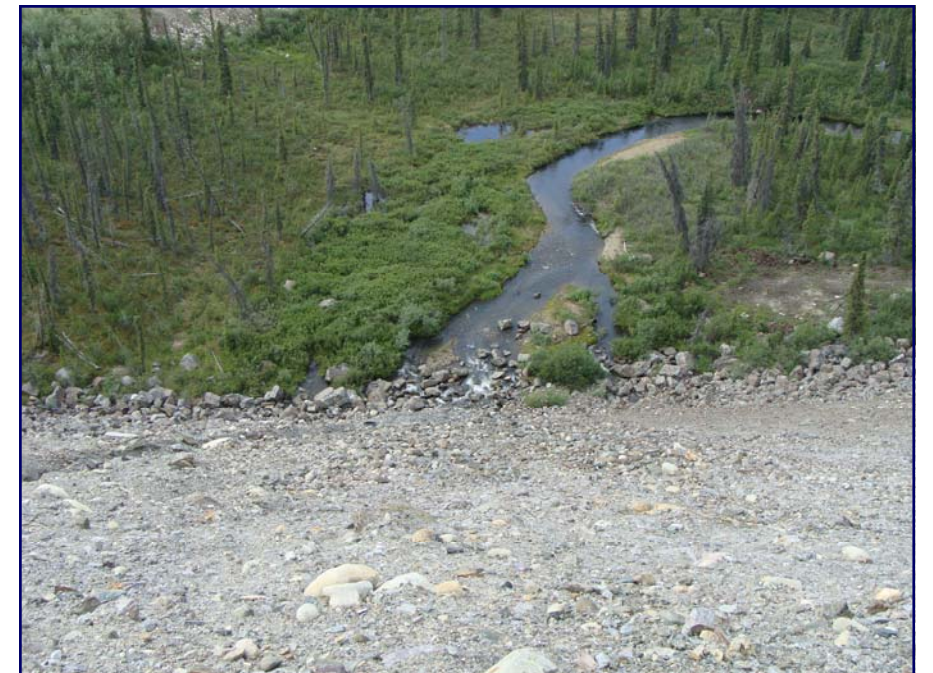
July: Looking at the downstream drain from the crest.

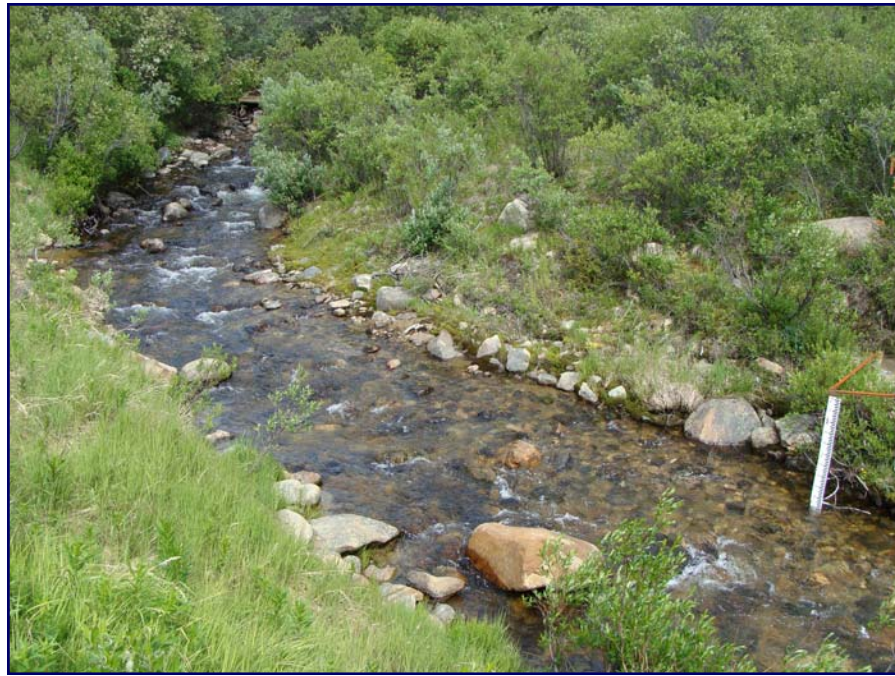
June: an upstream view of the starting area of the diversion.
