2009 ANNUAL GEOTECHNICAL EVALUATION AND INSTRUMENT REVIEW

VARIOUS FACILITIES AT FARO MINE, YUKON

PROJECT NO.: 0762-002-05
DATE: FEBRUARY 26, 2010

**RE: 2009 ANNUAL GEOTECHNICAL EVALUATION AND INSTRUMENT REVIEW
VARIOUS MINE WASTE FACILITIES AT FARO MINE, YUKON**

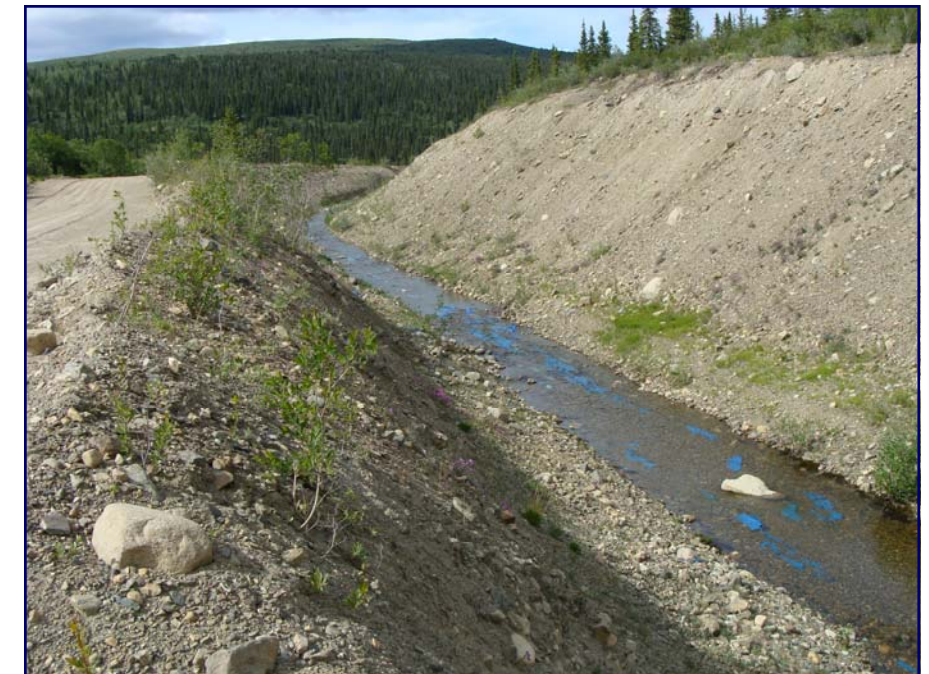
June: an upstream view of the channel, banks appear to be in good condition.

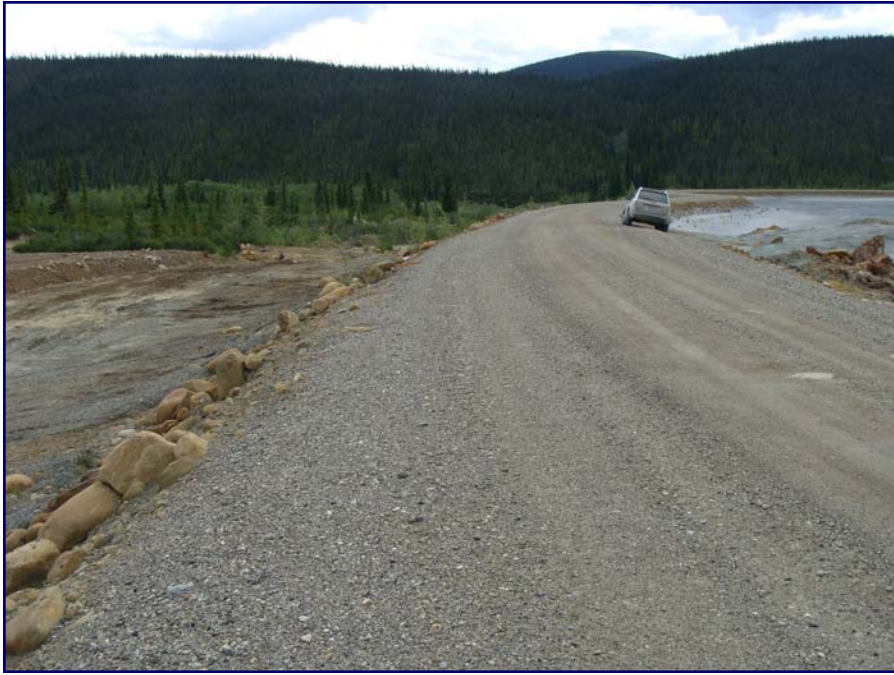
July: shows a view looking South down the crest of the Secondary Dam.

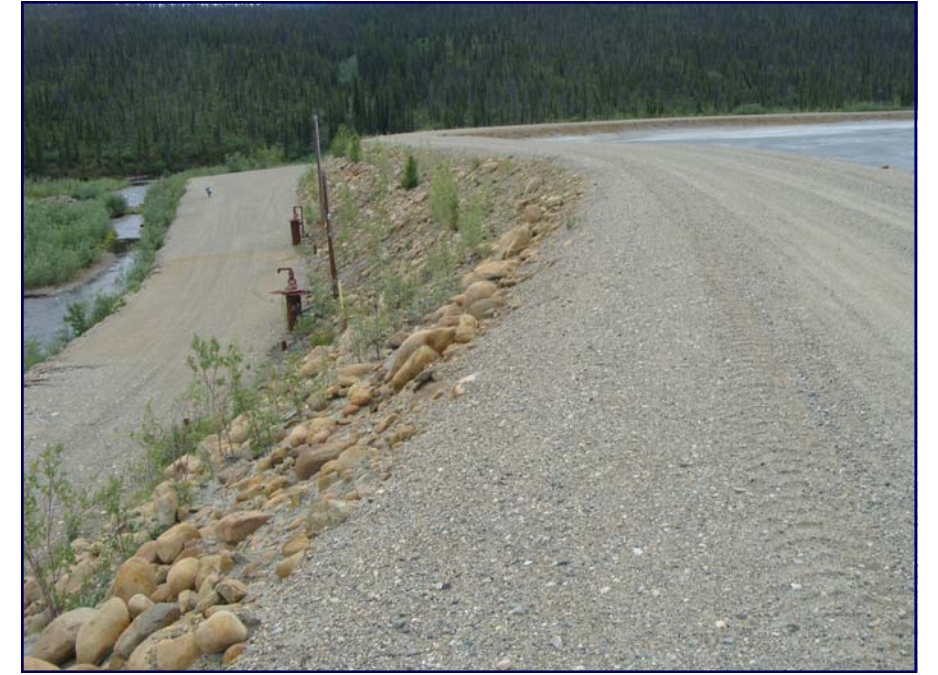
July: a view of the downstream face of the dam with the diversion channel on the left side of the photo.

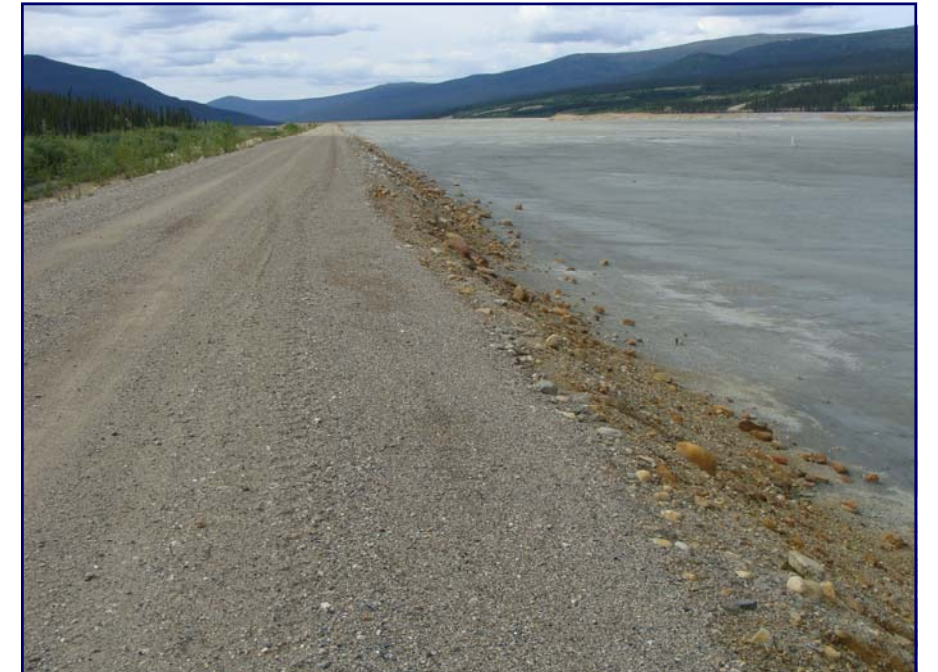
July: looking down the upstream face from the crest of the dam.

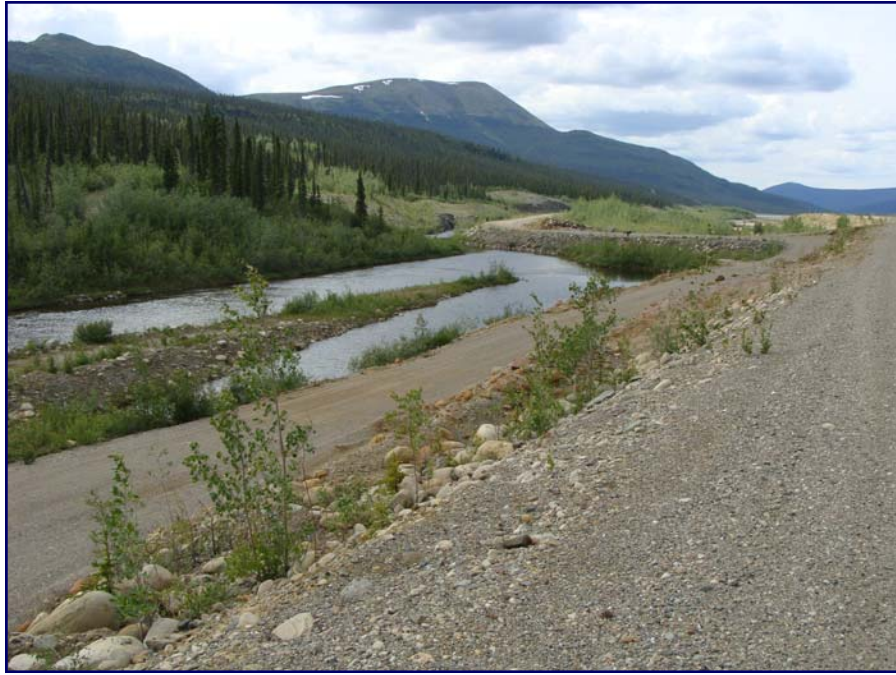
July: shows the downstream side of the Secondary Dam. Note the pond at the Diversion Dam in the background.

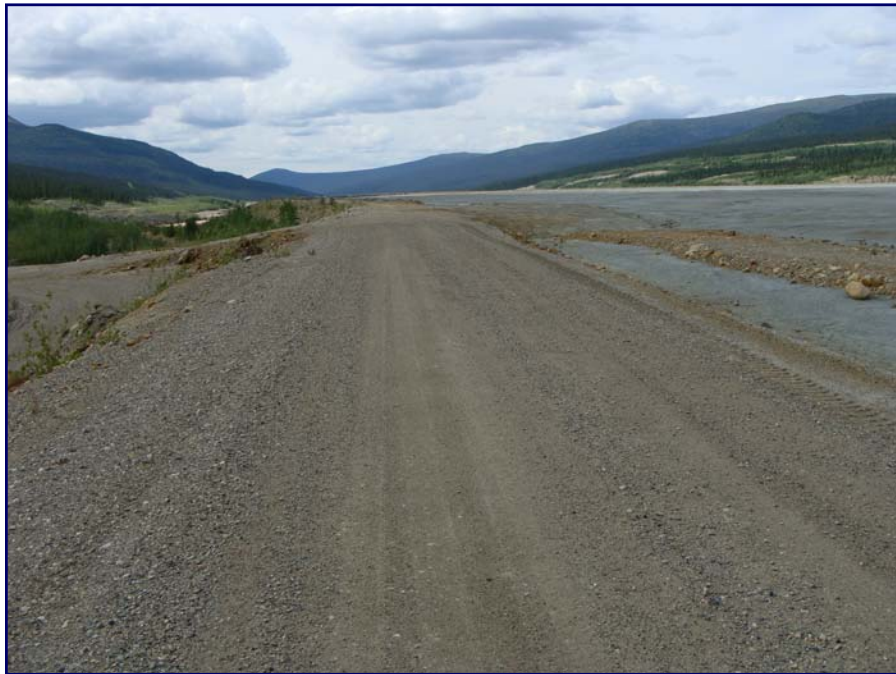
July: shows the crest of the Secondary Dam.

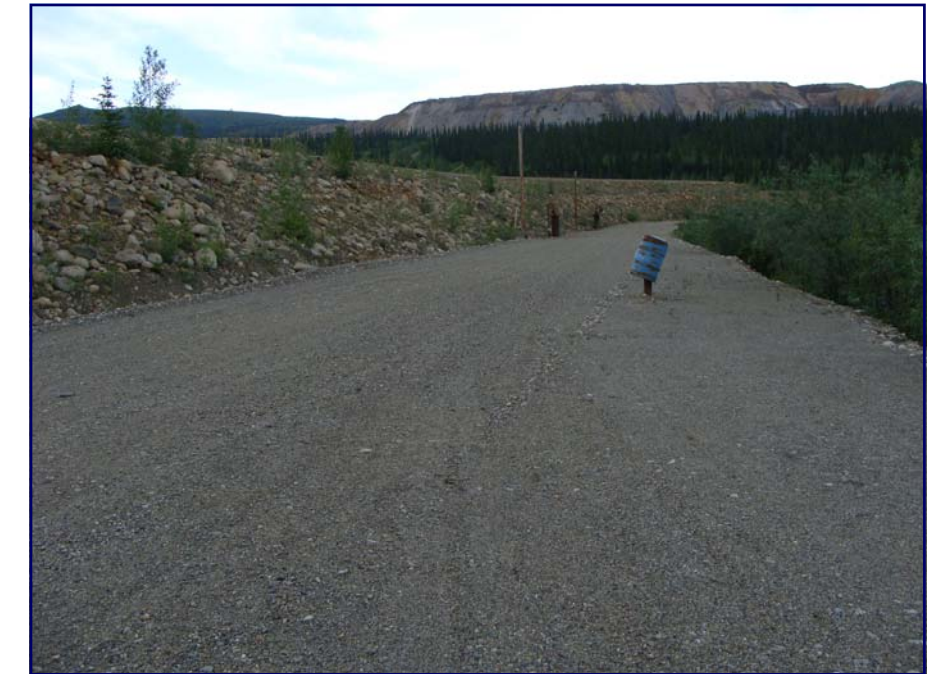
July: shows the downstream face of the Secondary Dam.

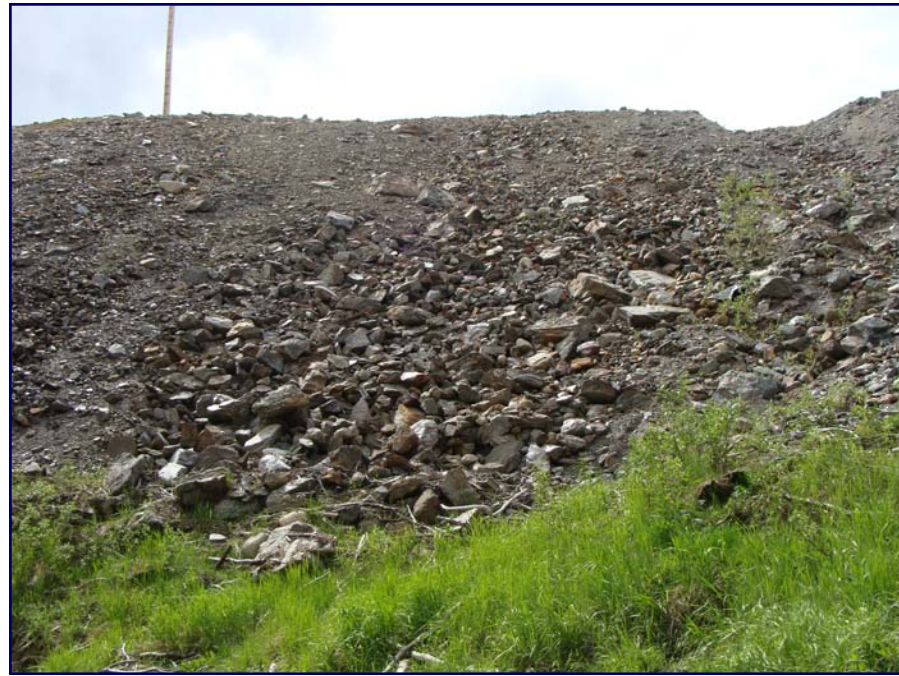
June: shows the face of the upstream side of the rock drain

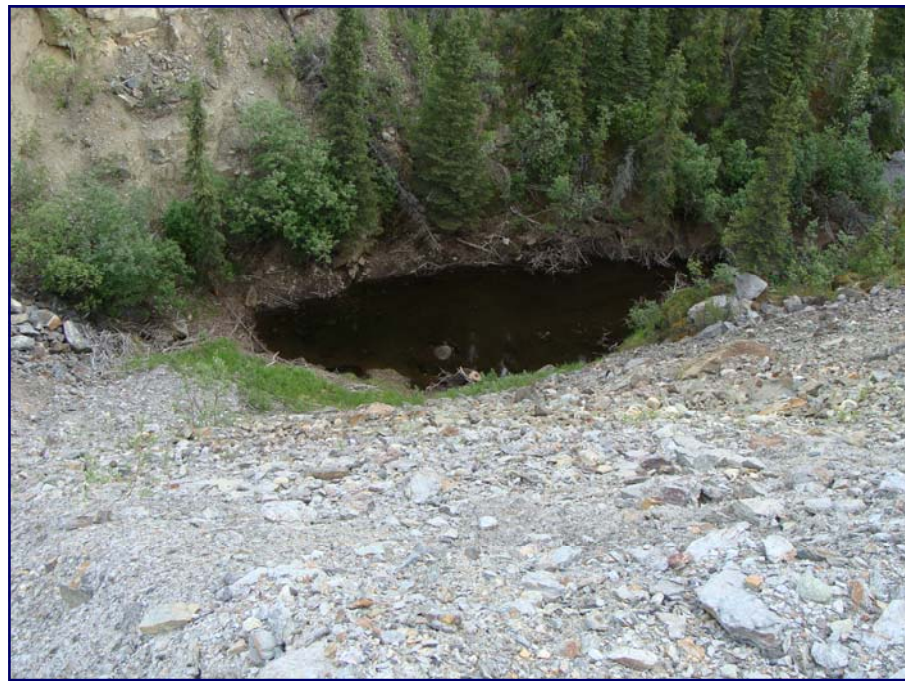
June: a view looking down the upstream face of the rock drain at the upstream pond.

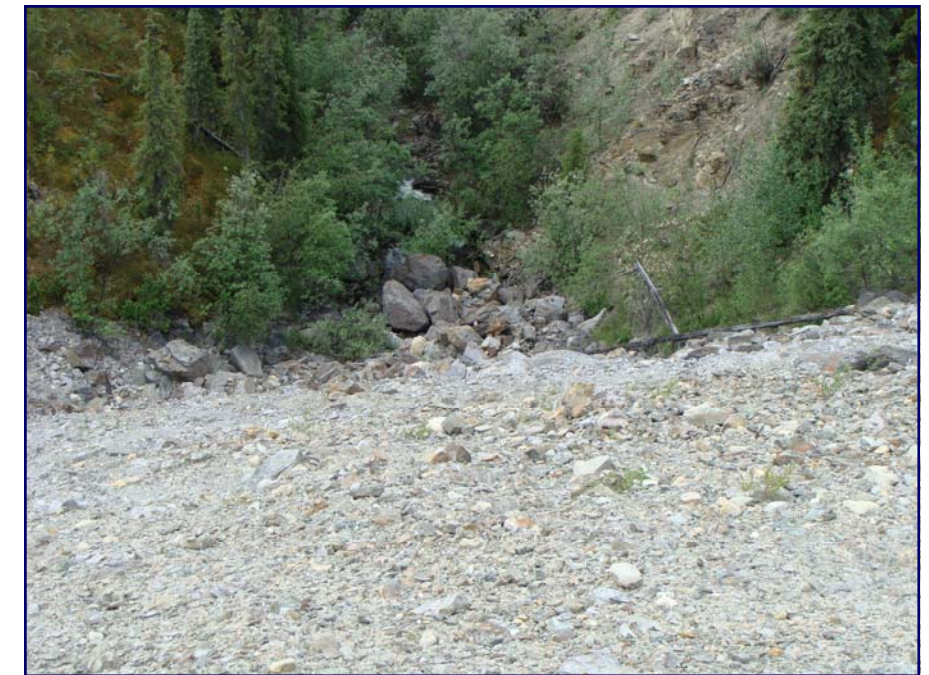
June: shows the downstream face of the rock drain with water flowing clearly from the toe.
