Klohn Crippen Berger

Faro Mine Complex

2012 Annual Geotechnical Review

March 28, 2013

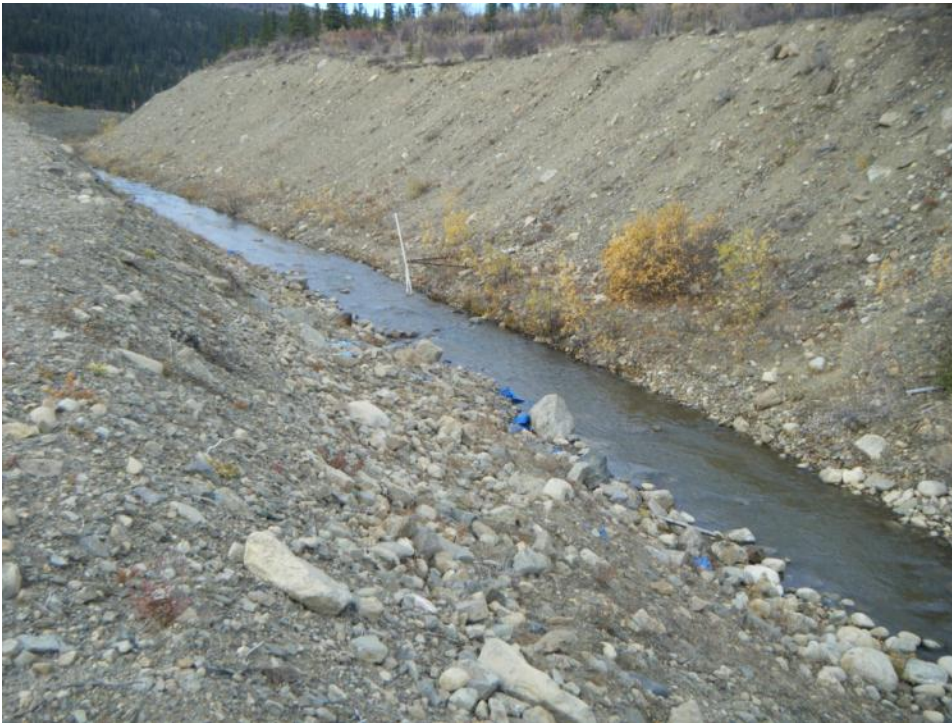
Photo 3 Faro Creek Diversion Ditch above Faro Pit, looking upstream (September 19, 2012)

- Continue visual monitoring of diversion channel and any seepage from the channel to the Faro Pit wall with photos taken at strategic locations.
- Cover exposed geotextile/bentomat in the diversion channel with rock armour. Replace damaged geotextile/bentomat prior to rock armour placement.

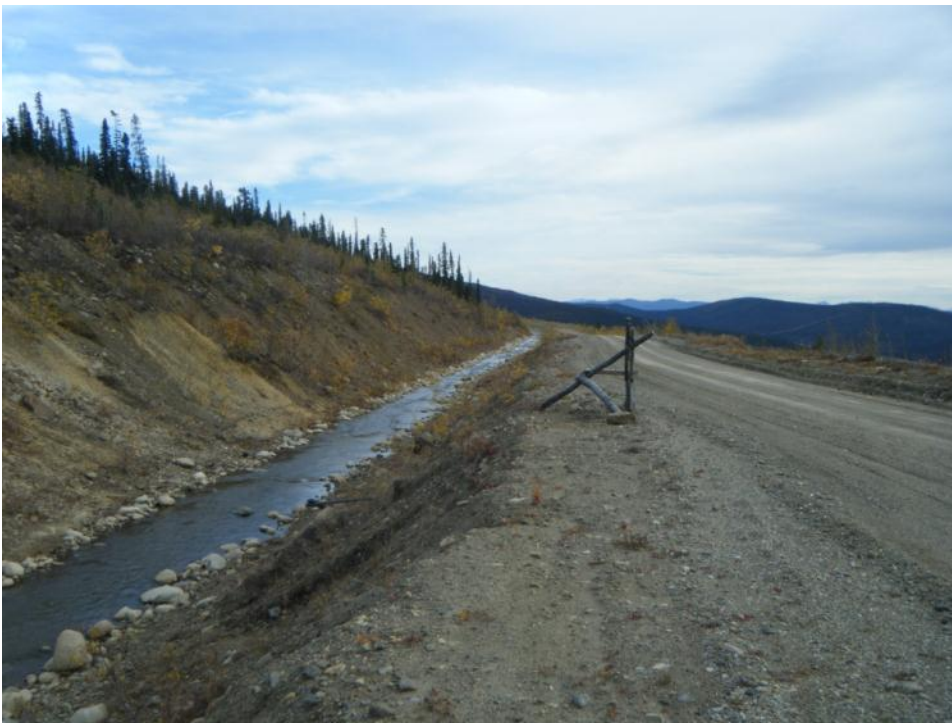
Photo 4 Faro Creek Diversion Ditch above Faro Pit, looking downstream (September 19, 2012)

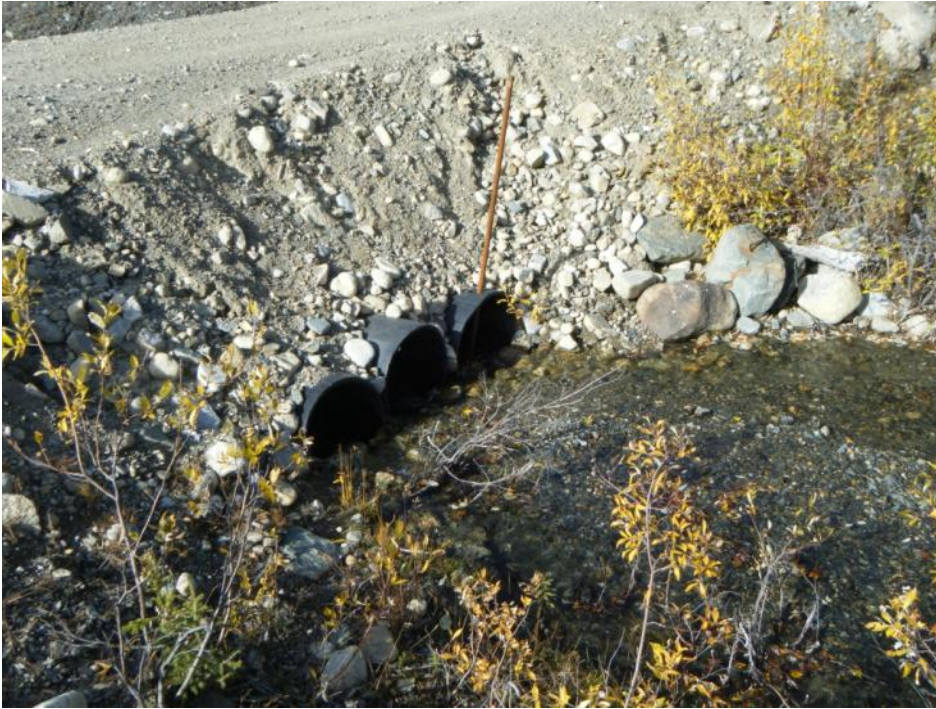
- Moderate flow in channel at time of inspection.
- The channel and side slopes appeared to be stable.
- Sedimentation deposition was observed both up and down gradient from the well-access road crossing.
- There was moderate to heavy vegetation growth in upper and middle constructed channel reaches.

Photo 5 Interceptor Ditch upper reach at access road to potable water well upstream end of culverts (September 19, 2012)

- Monitor channel sedimentation condition at the well-access road crossing, and remove sediments if the accumulation becomes excessive.
- Clear vegetation along the upper and middle constructed channel reaches. Clearing should also include the access road and berm along the channel to facilitate future inspection.

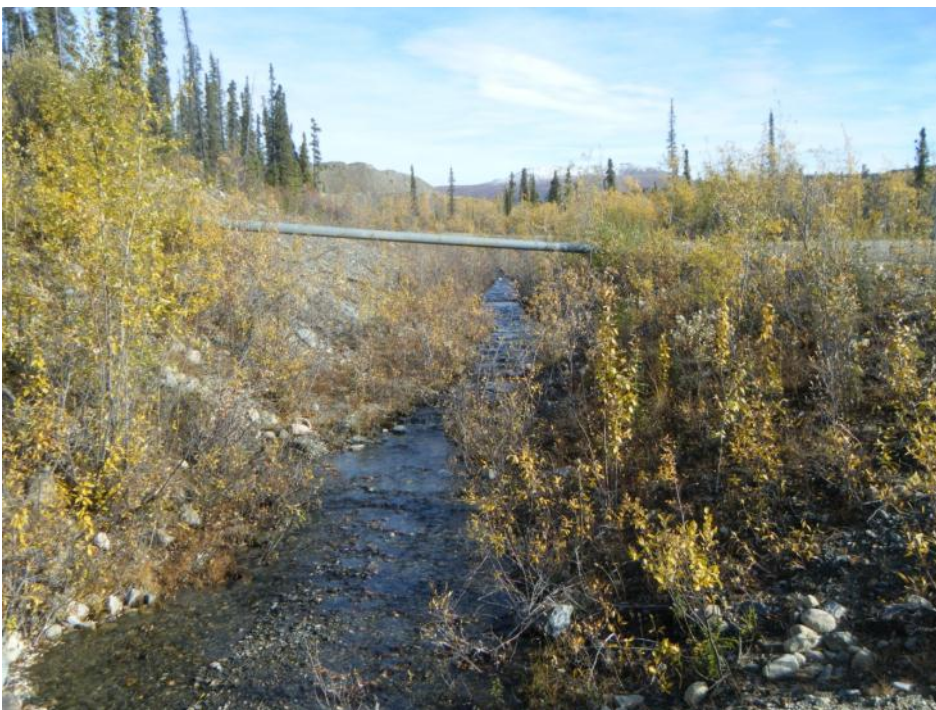
Photo 6 Upper reach of Interceptor Ditch looking upstream from well access road. (September 19, 2012)

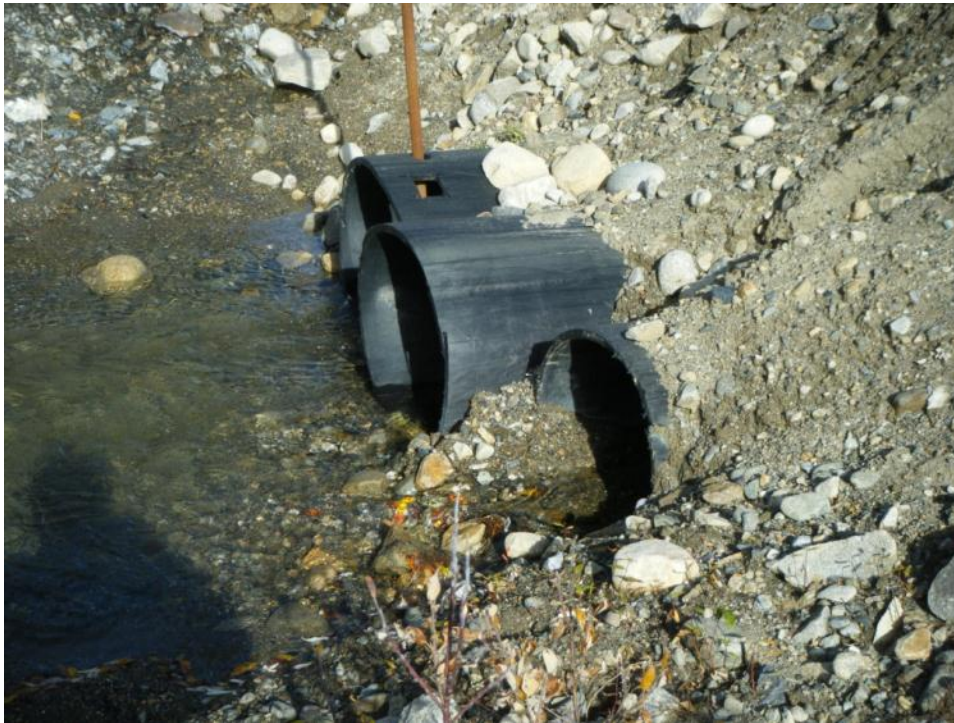
Photo 7 Downstream end of culverts at well access road (September 19, 2012)

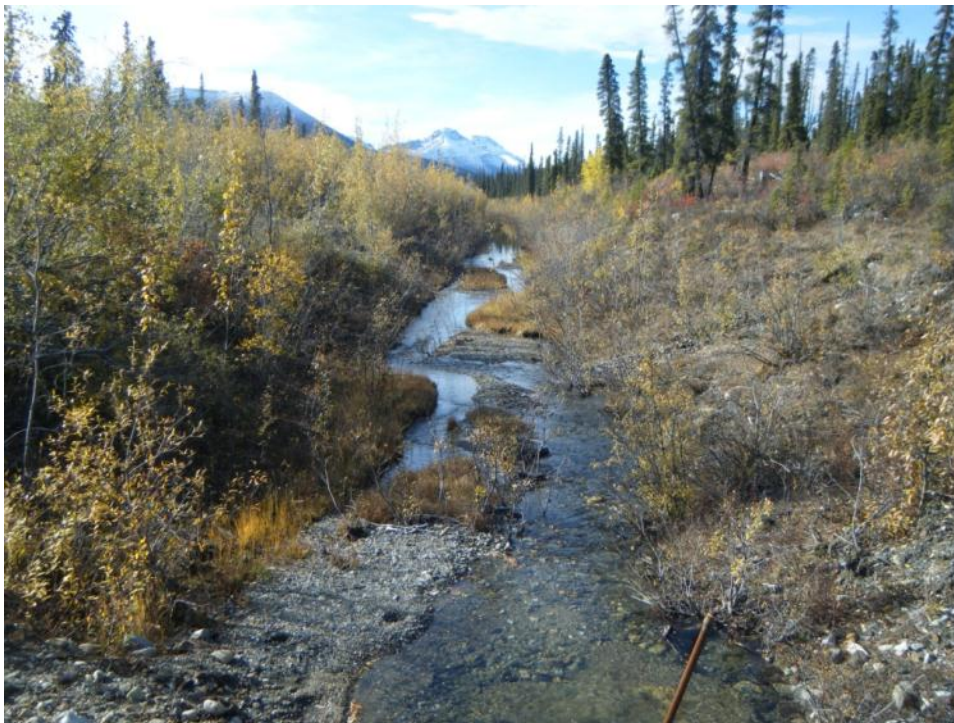
Photo 8 Upper reach of Interceptor Ditch looking downstream from well access road (September 19, 2012)

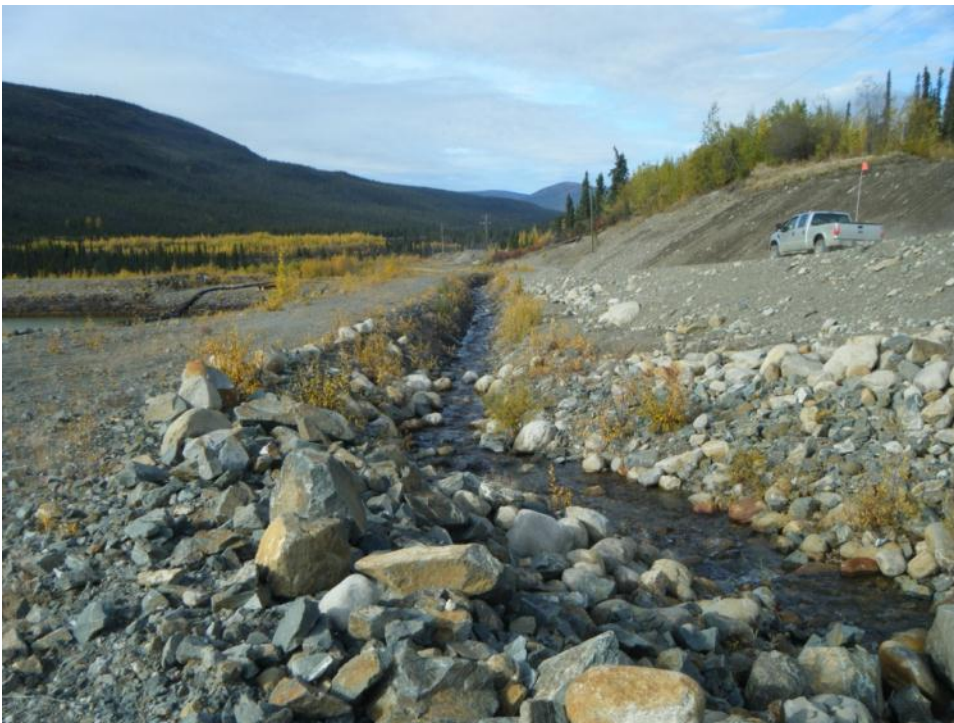
Photo 10 Lower reach of Interceptor Ditch adjacent to Cross Valley Dam - looking downstream (September 19, 2012)

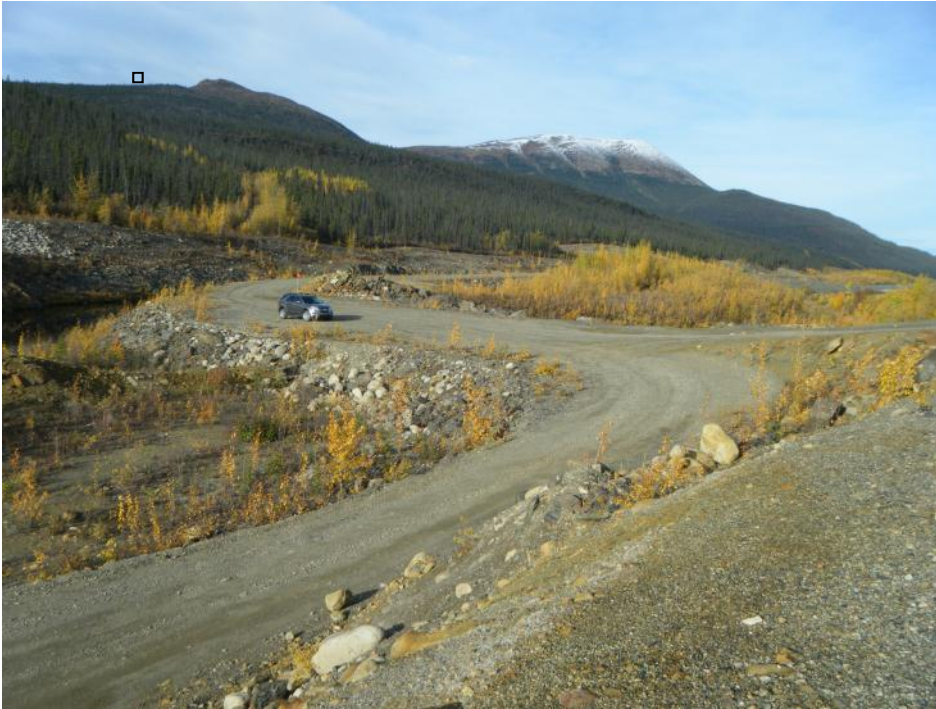
- Moderate flow in channel at time of inspection.
- The channel and side slopes appeared to be stable with satisfactory rock armour conditions.
- Moderate vegetation growth in lower channel reaches.
- Minor seepage from the RCDC at base of spoil piles into Polishing Pond was reported previously, but could not be located during the fall inspection.

Photo 11 Rose Creek Diversion Channel fuse plug - looking towards Canal Dyke from Secondary Dam (September 19, 2012)

- Continue to check and remove vegetation in the diversion channel periodically.
- Continue to monitor instrumentation on a regular basis.
- Conduct geotechnical inspection of the diversion channel during spring peak flow condition.

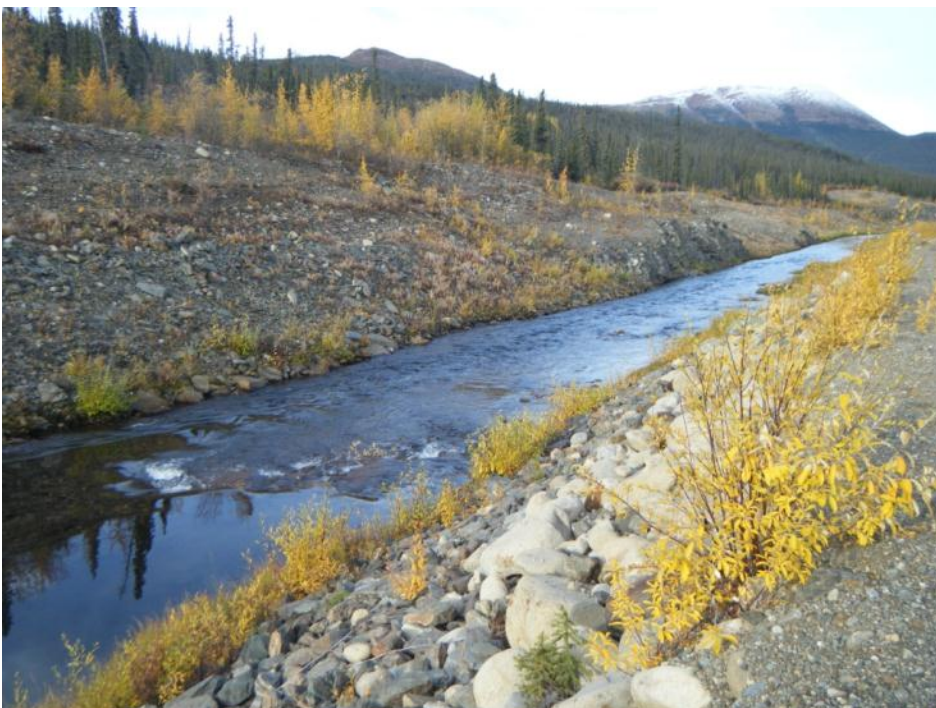
Photo 12 Rose Creek Diversion Channel downstream of fuse plug (September 19, 2012)

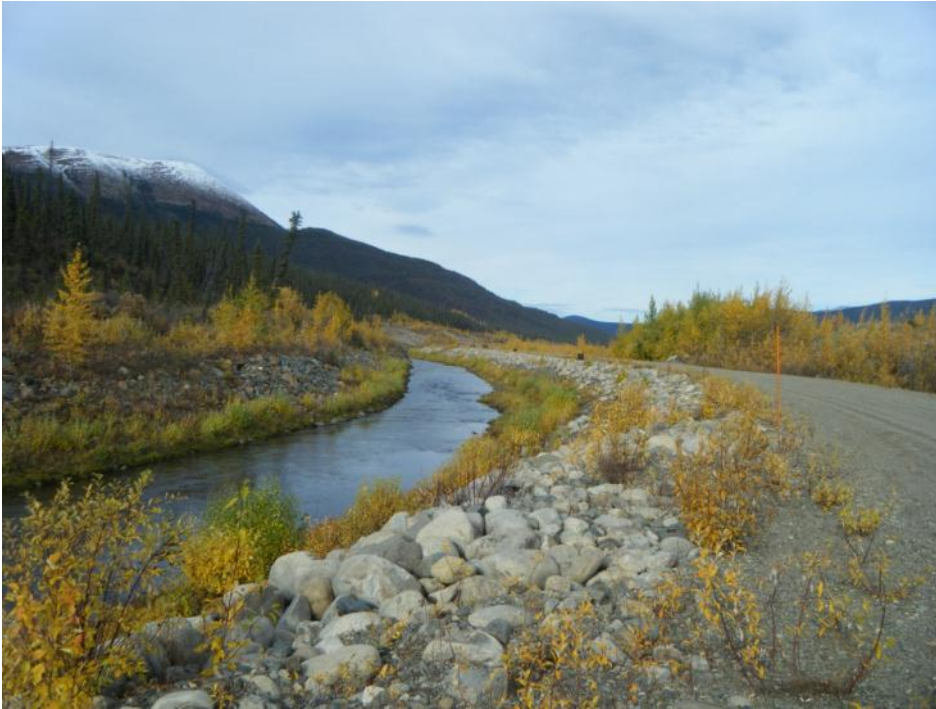
Photo 13 **Rose Creek Diversion Channel adjacent to tailings impoundment
(September 19, 2012)**

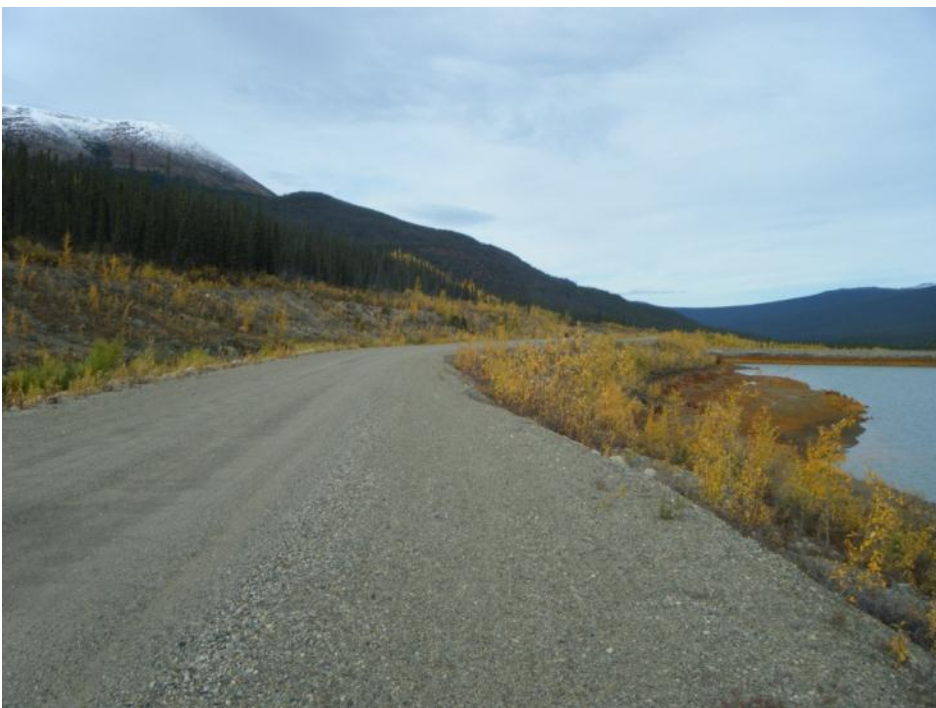
Photo 14 **Rose Creek Diversion Channel (canal) dyke adjacent to Intermediate Dam
(September 19, 2012)**

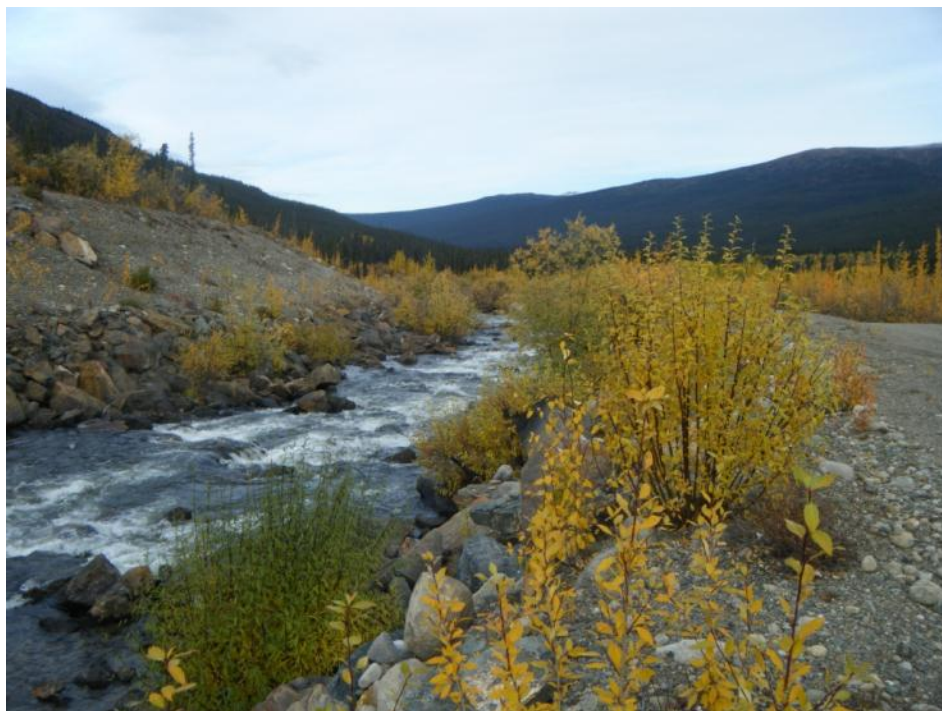
Photo 16 **Rose Creek Diversion Channel near Cross Valley Dam - looking downstream
(September 19, 2012)**

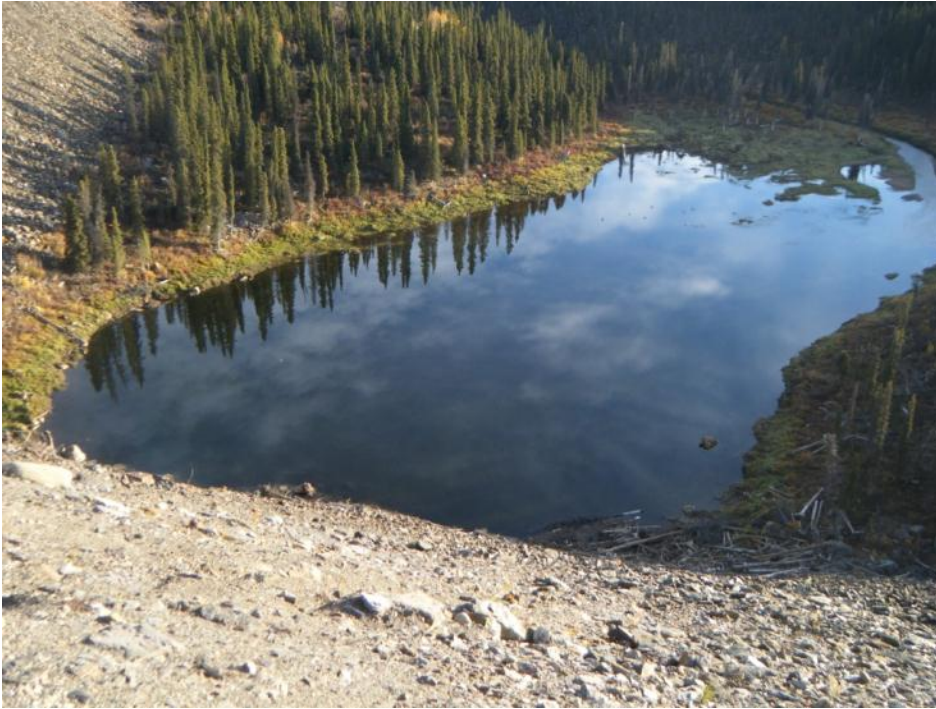
- Stable crest and side slope of mine haul road. Minor slumping of downstream face has occurred but is not a cause for concern at this time.
- Downstream drainage condition is acceptable with three braided channels combined to form one channel at the location of water-level monitoring and water sampling.

Photo 17 North Fork Drain upstream pool at access road between Faro and Vangorda Plateau (September 20, 2012)

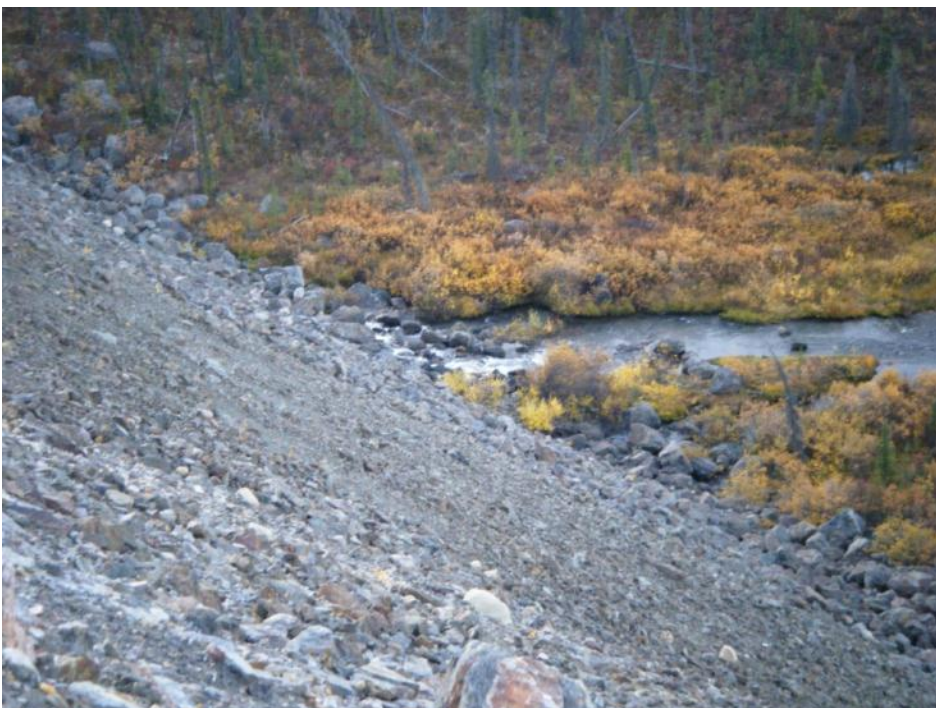
Photo 18 North Fork Drain outlet - downstream slope of access road between Faro and Vangorda Plateau (September 20, 2012)

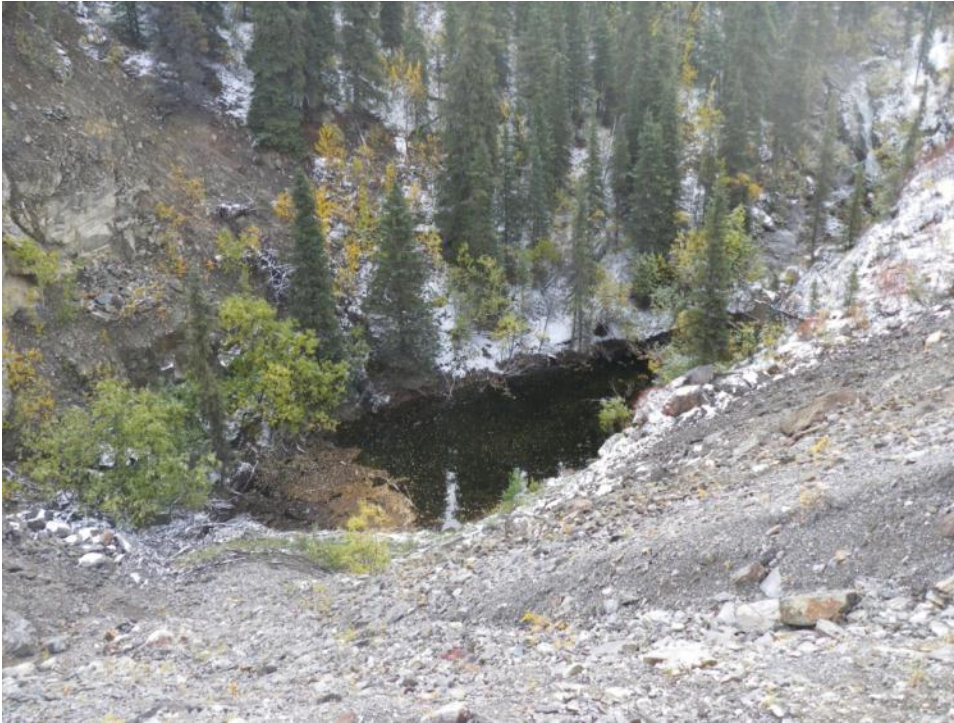
Photo 19 K8 Drain upstream pool (September 11, 2012)

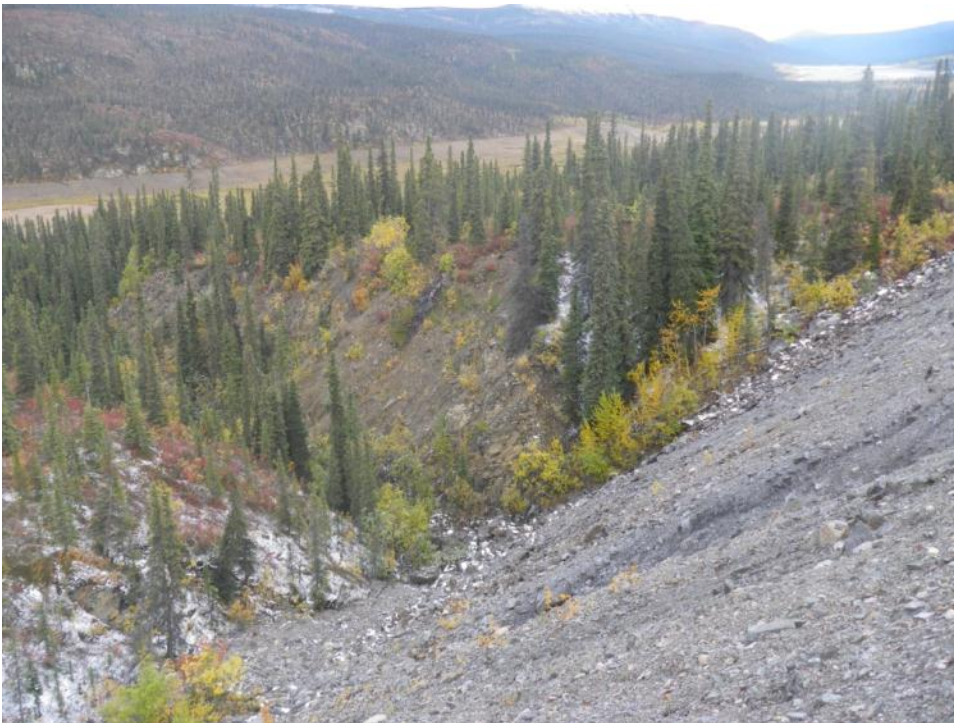
Photo 20 K8 Drain downstream outlet (September 11, 2012)

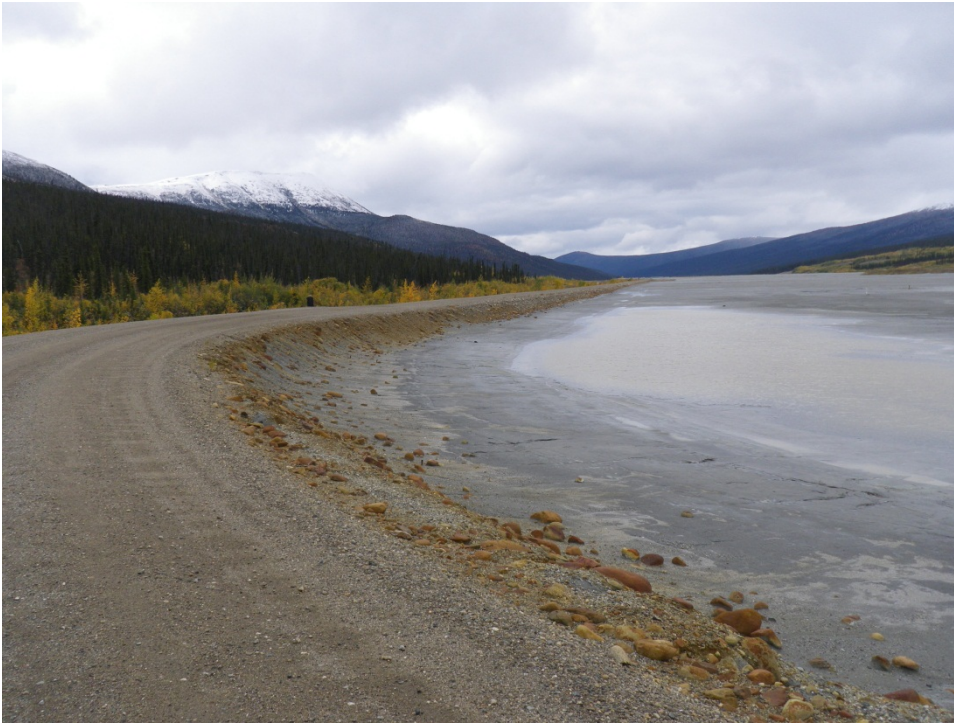
Photo 21 Southeast corner of Secondary Dam (September 11, 2012)

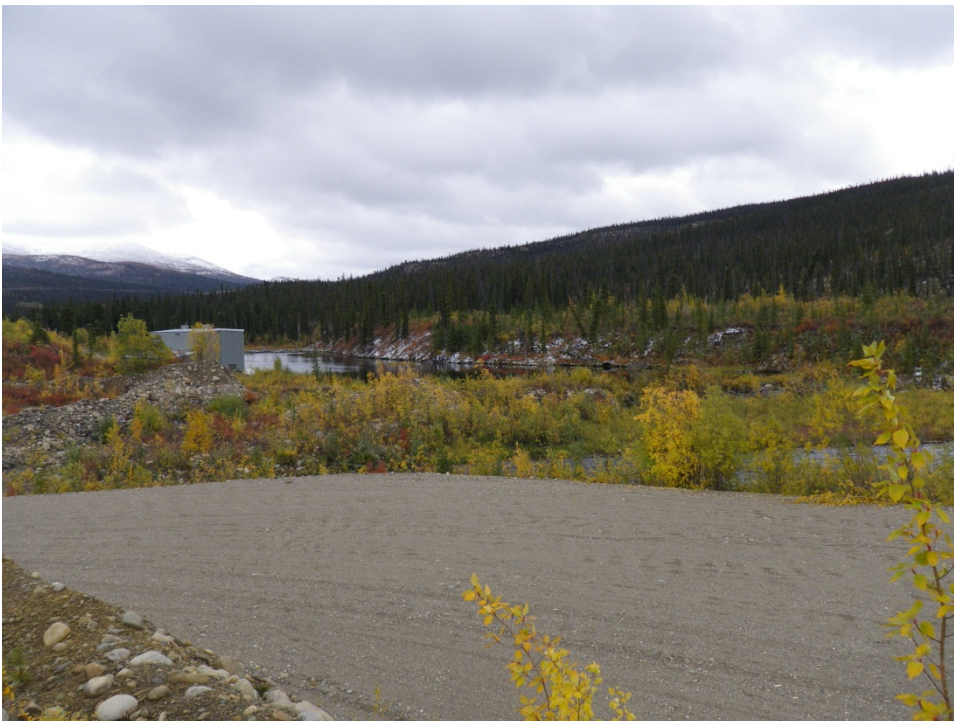
- The crest, upstream and downstream slopes appeared to be stable.
- No evidence of seepage along the downstream slope.
- Lower road conditions were satisfactory.
- A row of tailings piles was located on the upstream shoulder of the crest along the southwest portion of the dam. Tailings deposits covering the dam crest in the area were eroded by runoff from this row of tailings piles.
- Cracks that were observed in May 2012 along the downstream road in the vicinity of the upstream end of the Rose Creek Diversion Channel were not seen (see Photo 22), indicating that the temporary presence of cracks in the spring is related to seasonal thawing.

Photo 22 Downstream berm surface at southeast corner of Secondary Tailings Dam (September 11, 2012)

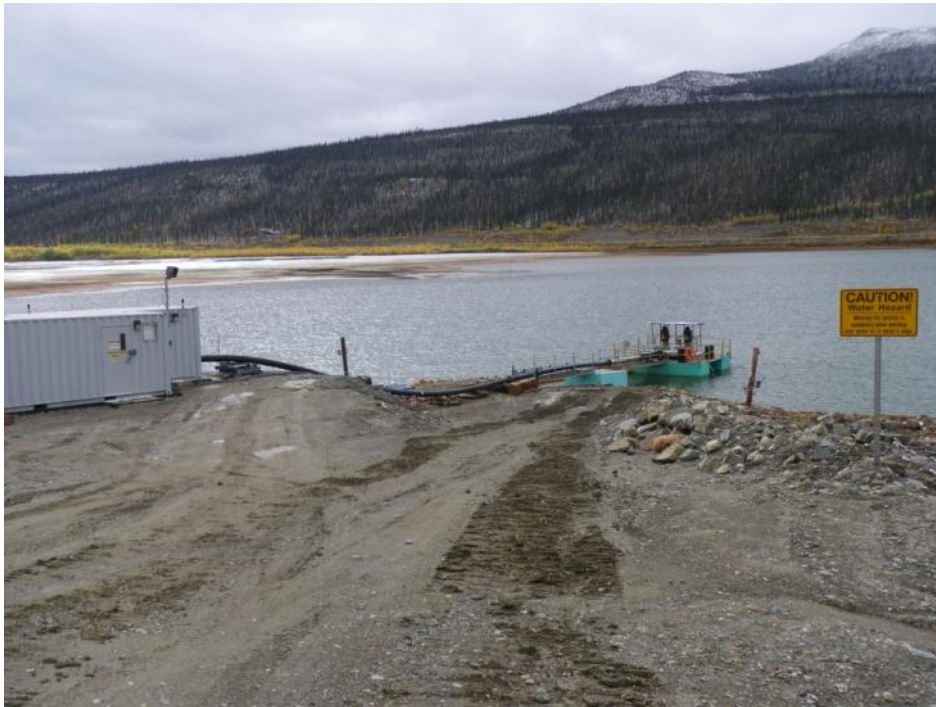
Photo 23 Upstream pump barge at northeast abutment (September 11, 2012)

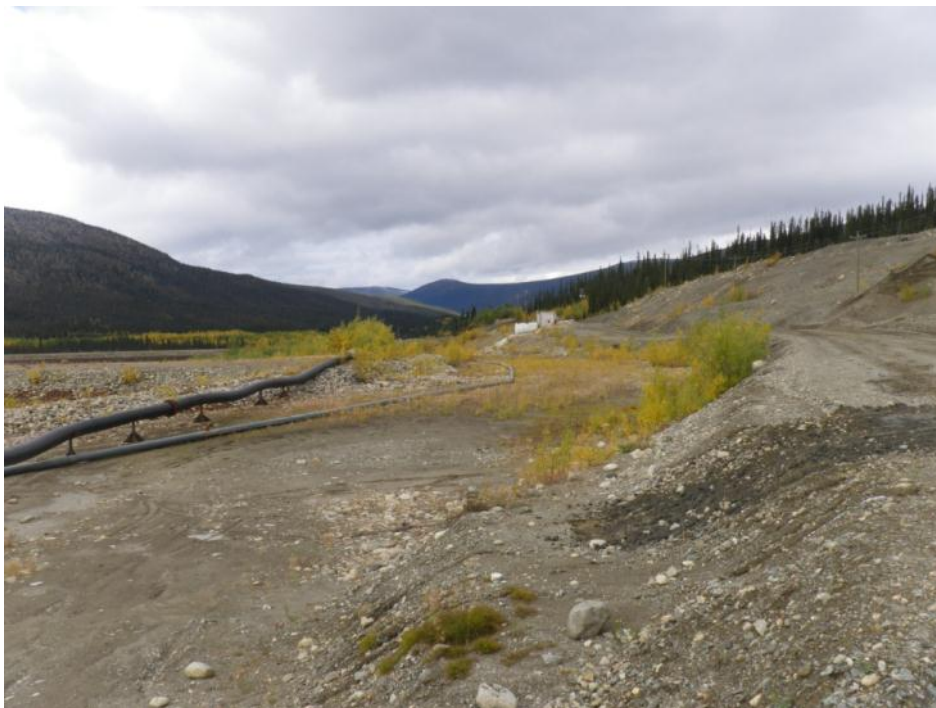
Photo 24 Spillway channel – looking downstream (September 11, 2012)

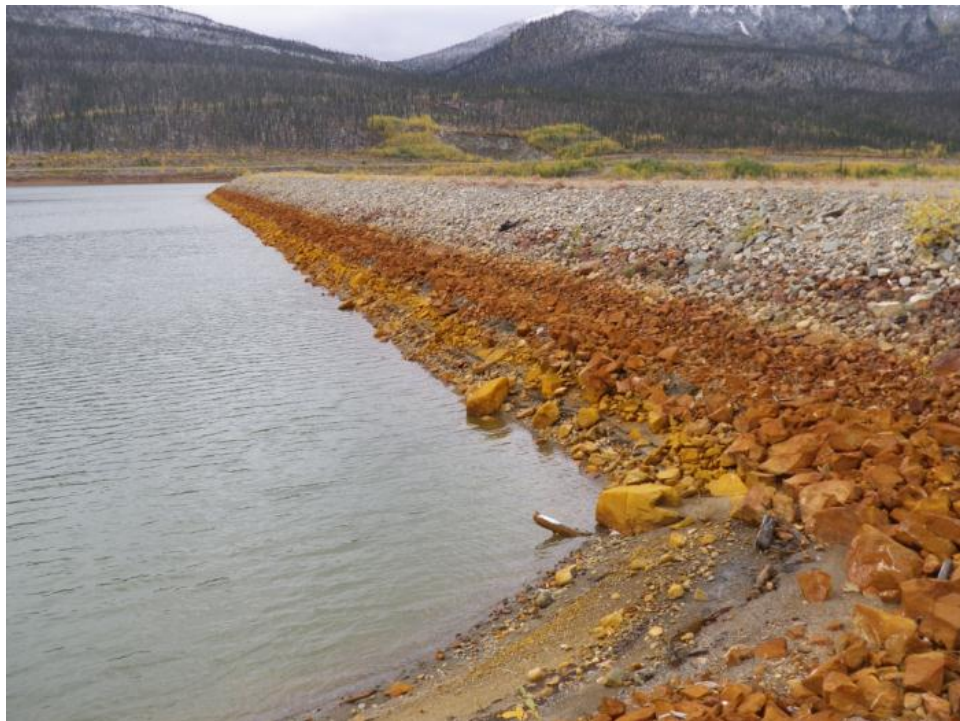
- Wave erosion of upstream slope in the vicinity of three markers were closely inspected at different elevations (see Photos 25 to 27 and 29). These markers appear to be reinforcing bars and do not look like the monitoring posts installed by Brodie (2010), see Photo 28. However, no posts similar to that shown on Photo 28 have been observed in our spring and fall visits in 2012. It is unclear whether the 2012 observed reinforcing bars are the 2010 monitoring posts or not.

Photo 25 Upstream slope of Intermediate Dam – looking southwest (September 11, 2012)

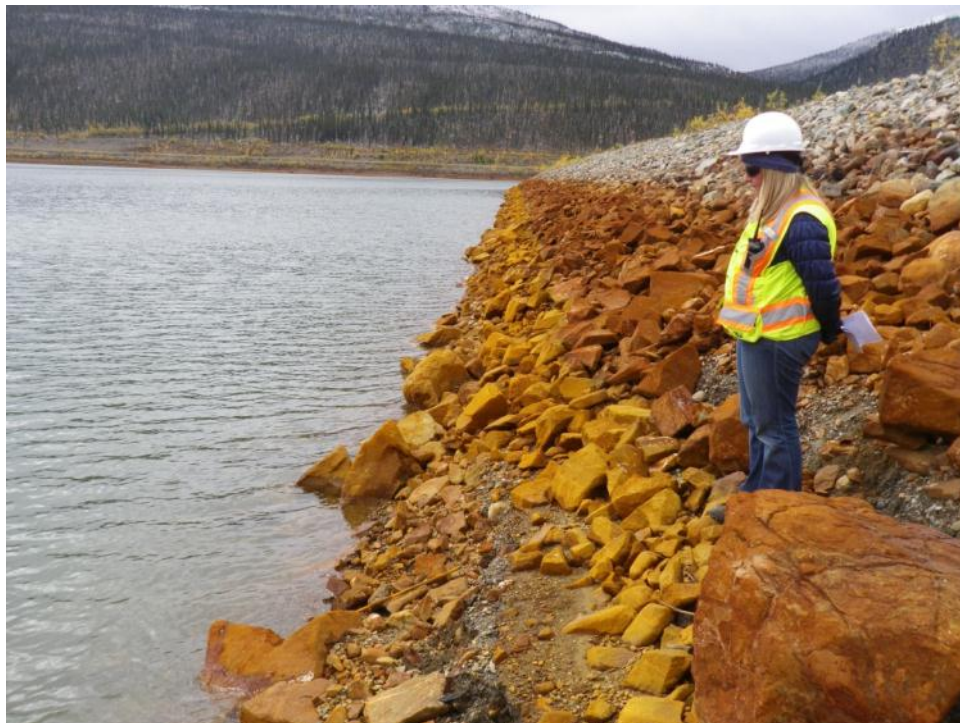
Photo 26 Wave erosion zone on upstream slope – note marker rod installed by Brodie in 2010 in the foreground (September 11, 2012)

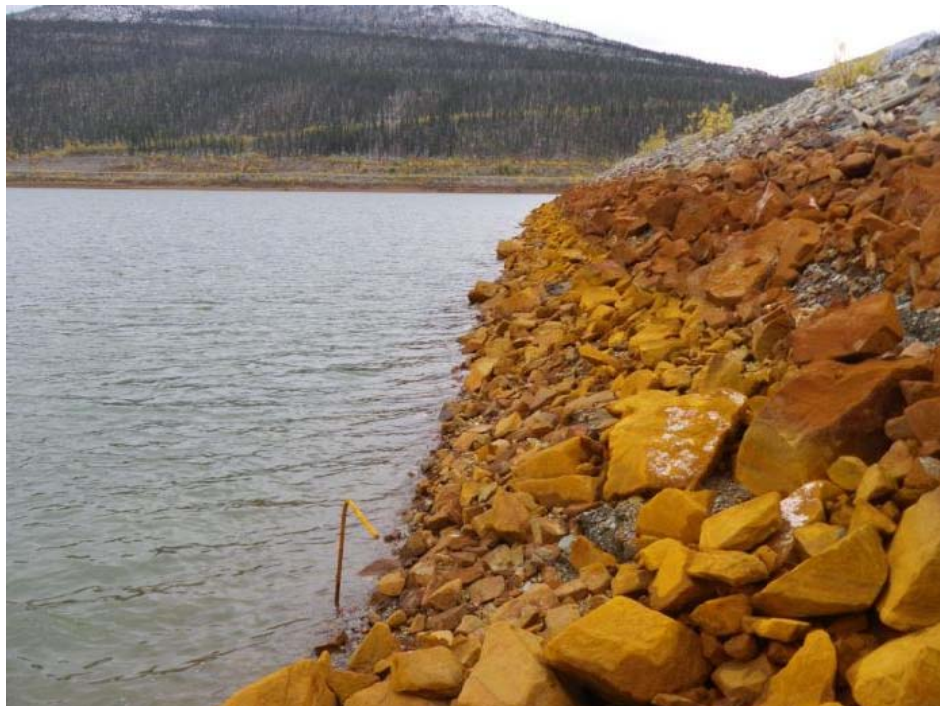
Photo 27 Wave erosion zone on upstream slope – note second marker rod installed by Brodie in 2010 in the foreground (September 11, 2012)

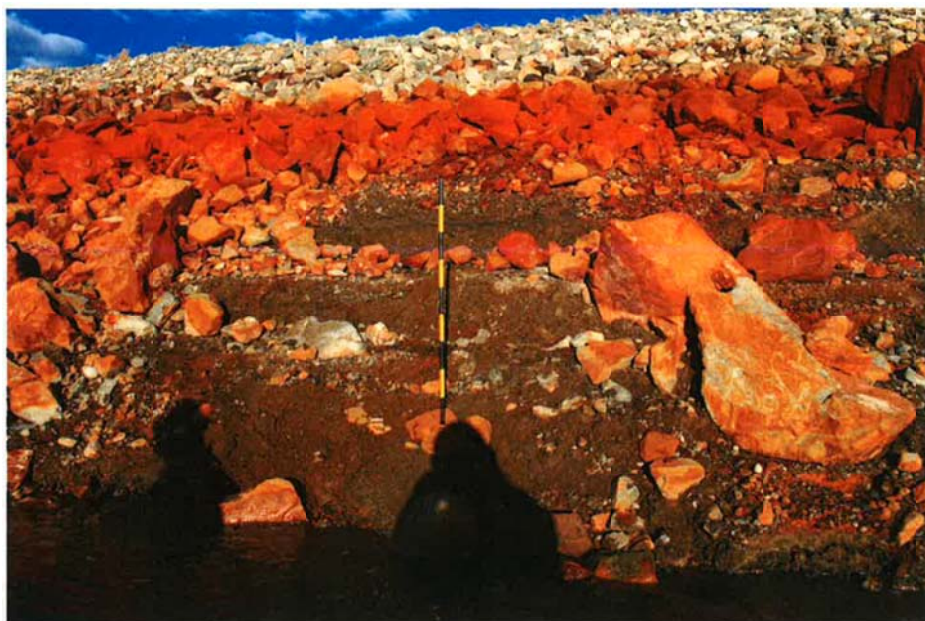
Photo 28 Monitoring post installed on September 14, 2010 (Brodie 2010)

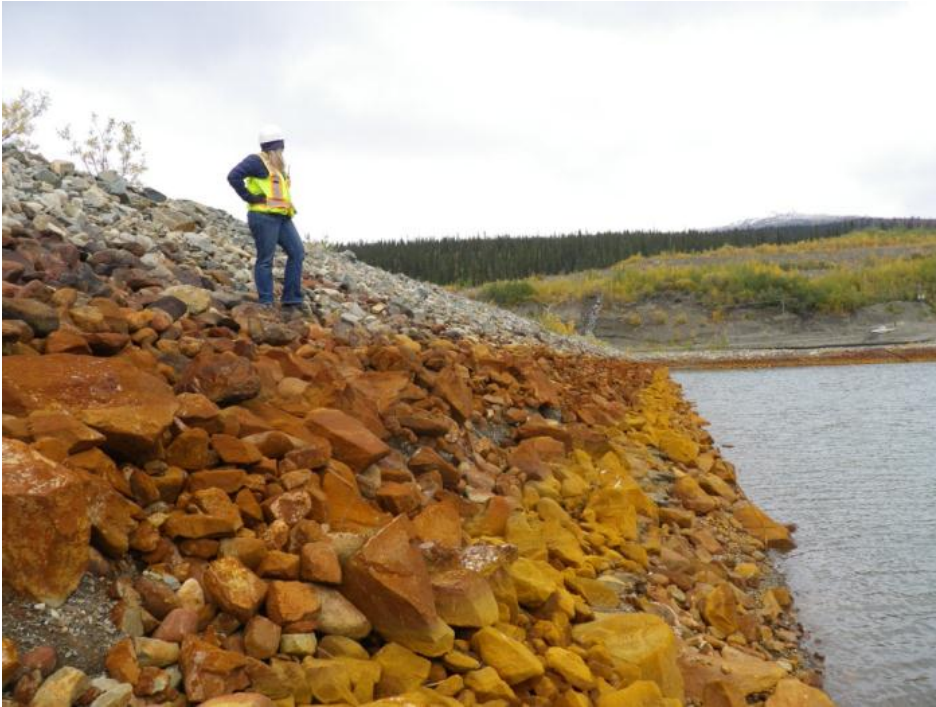
Photo 29 Wave erosion zone on upstream slope – note third marker rod installed by Brodie in 2010 in the foreground (September 11, 2012)

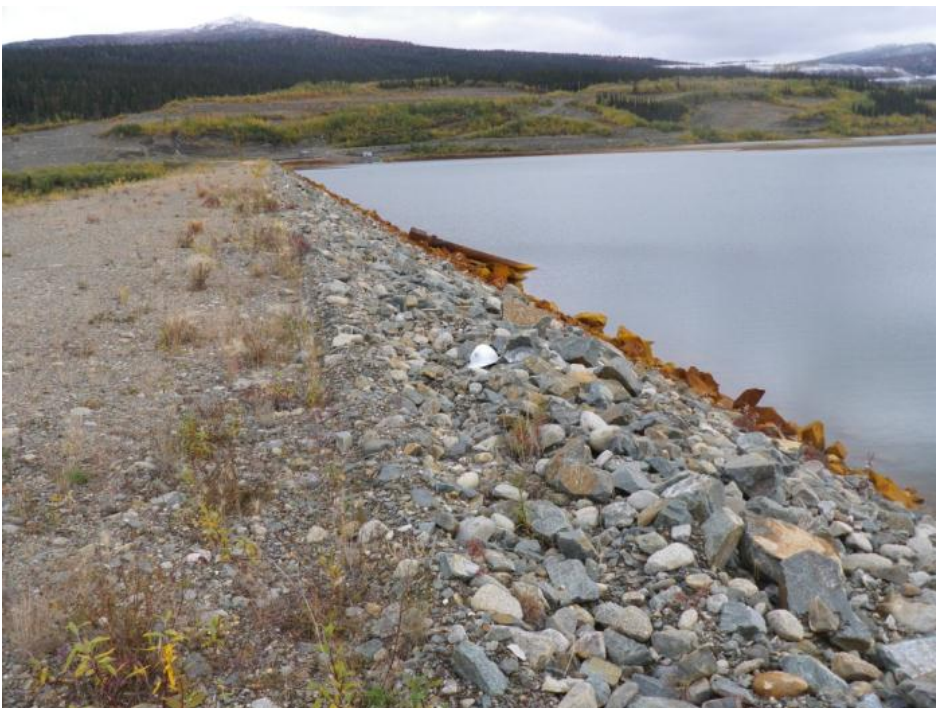
- Pond level was drawn down.
- Stable crest, upstream and downstream slopes and spillway channel, in general.
- Near south abutment, minor upstream slope fill adjustment was noted (see Photo 30).

Photo 30 Dam crest and upstream slope – note fill adjustment near crest shoulder marked by hard hat (September 11, 2012)

- Continue to monitor minor damfill adjustment of the upstream slope near the south abutment (see Photo 30).
- Repair minor shoulder erosion of the downstream berm (see Photo 36).

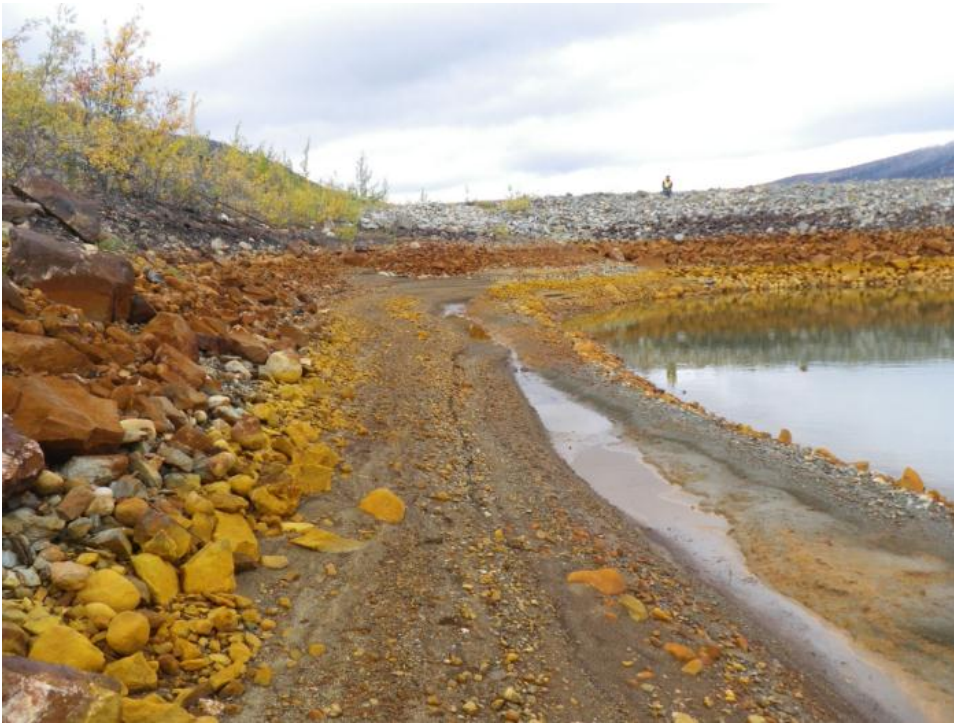
Photo 31 Northeast abutment of upstream slope (September 11, 2012)

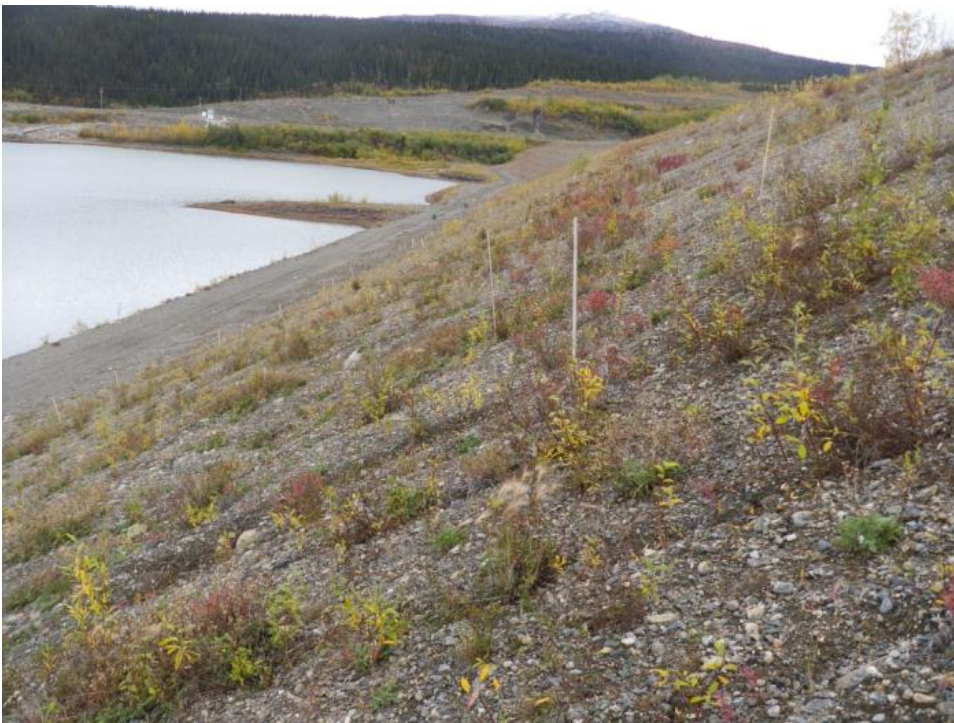
- Downstream slope is experiencing extensive rill erosion (see Photos 32 to 37), with longitudinal cracks and minor slope slumps developing (see Photos 32 and 33), and eroded materials are depositing on the downstream berm.

- DES placed wooden stakes in 2011 on the downstream slope in the southwest dam segment to assist ongoing monitoring (see Photos 32 to 34).
- Eroded debris from the downstream slope often pushed the above-ground portion of existing instruments (see Photo 37), and the tilted instruments should be restored.

Photo 32 Rill erosion along lower portion of downstream slope (September 11, 2012)

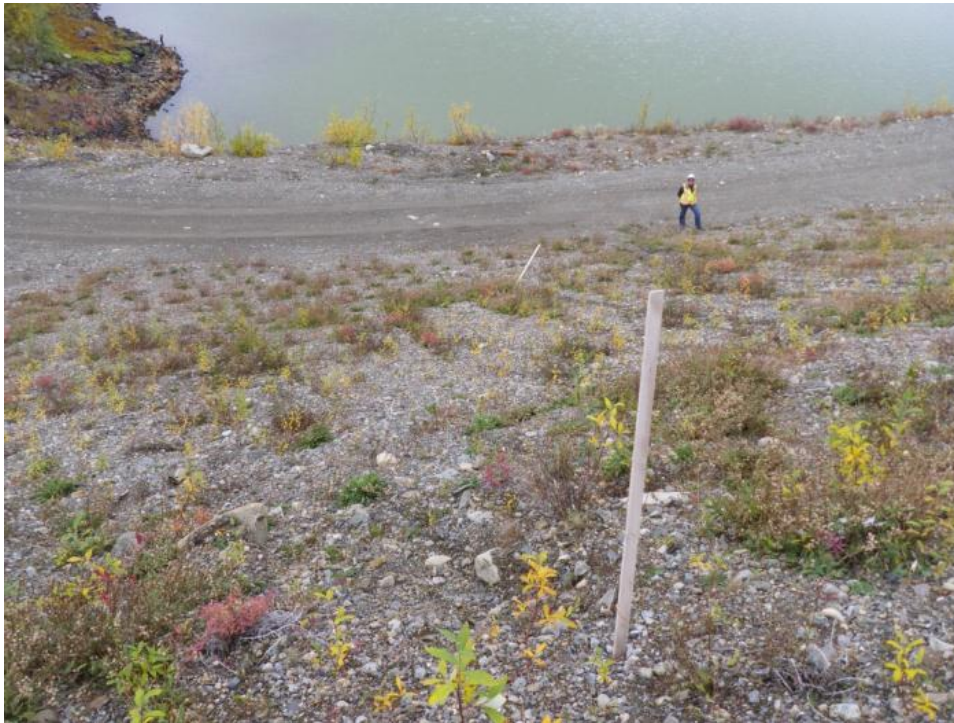
Photo 33 Lower portion of downstream slope – looking downslope (September 11, 2012)

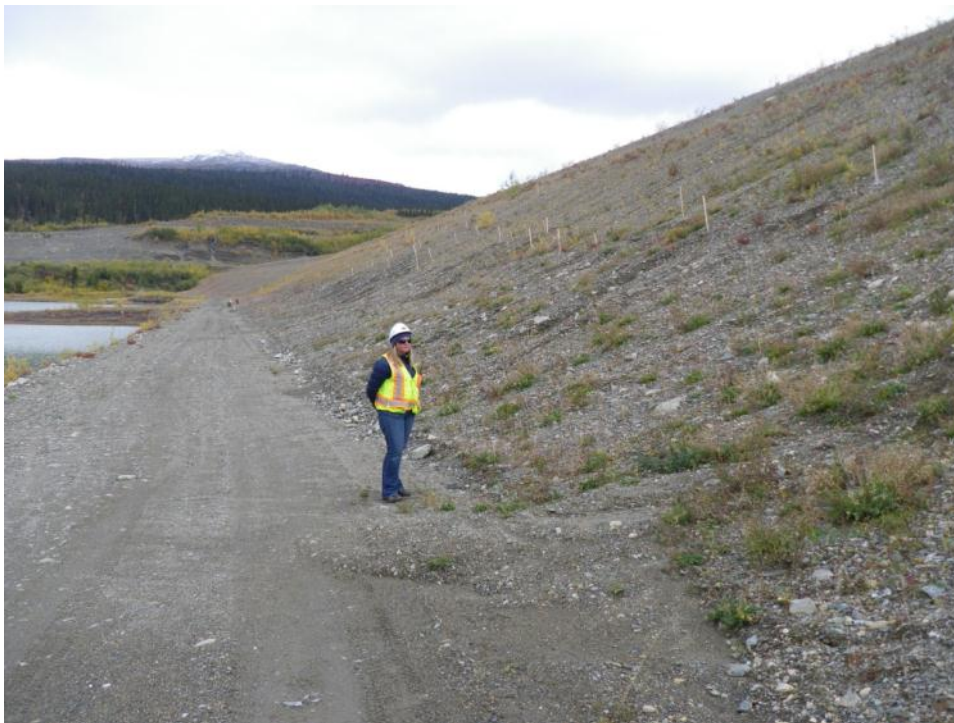
Photo 34 Downstream dam slope – looking northeast along toe (September 11, 2012)

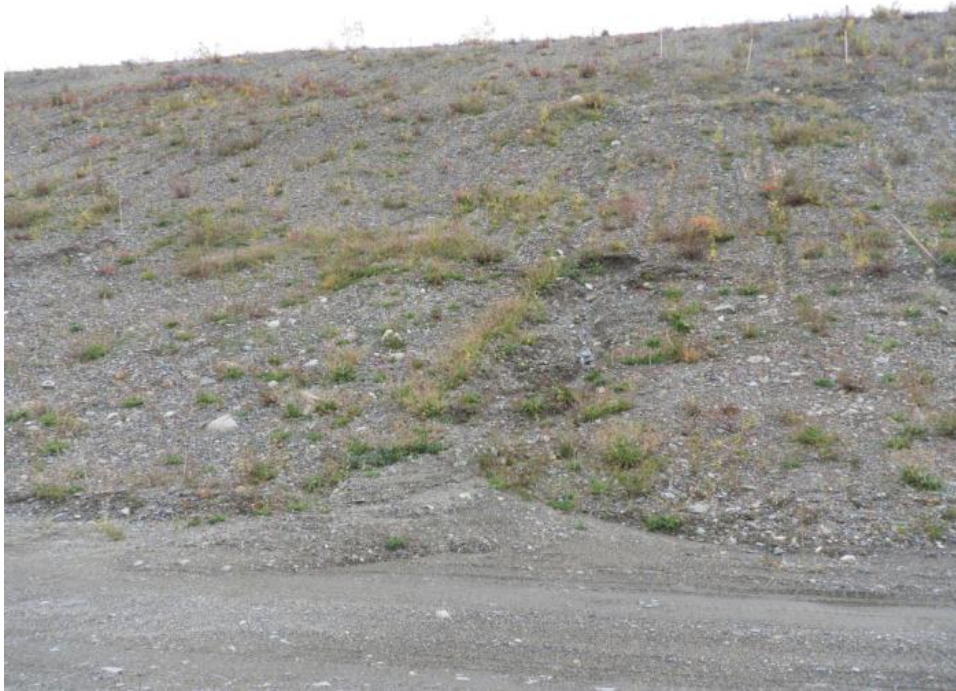
Photo 35 Downstream dam slope – looking up from downstream berm (September 11, 2012)
