Klohn Crippen Berger

Faro Mine Complex

2012 Annual Geotechnical Review

March 28, 2013

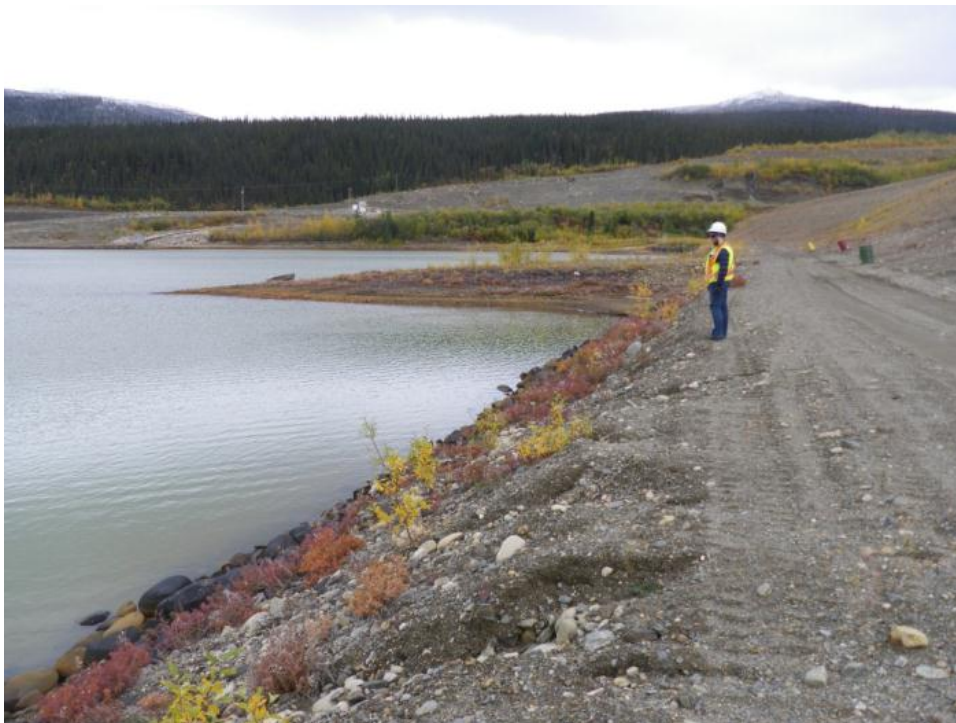
- Downstream slope is experiencing extensive rill erosion (see Photos 32 to 37), with longitudinal cracks and minor slope slumps developing (see Photos 32 and 33), and eroded materials are depositing on the downstream berm.

Photo 36 Downstream berm - note rill erosion on berm shoulder in the foreground (September 11, 2012)

- Continue to monitor minor damfill adjustment of the upstream slope near the south abutment (see Photo 30).
- Repair minor shoulder erosion of the downstream berm (see Photo 36).

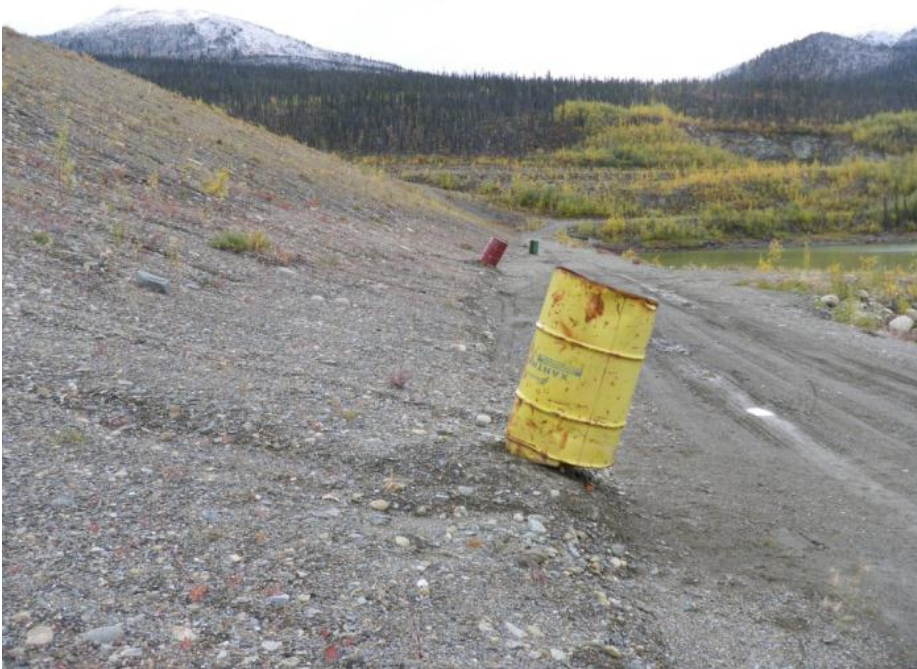
- DES placed wooden stakes in 2011 on the downstream slope in the southwest dam segment to assist ongoing monitoring (see Photos 32 to 34).
- Eroded debris from the downstream slope often pushed the above-ground portion of existing instruments (see Photo 37), and the tilted instruments should be restored.

Photo 37 Southwest portion of downstream slope – note rill erosion at toe and tilted instrument-protection barrel (September 11, 2012)

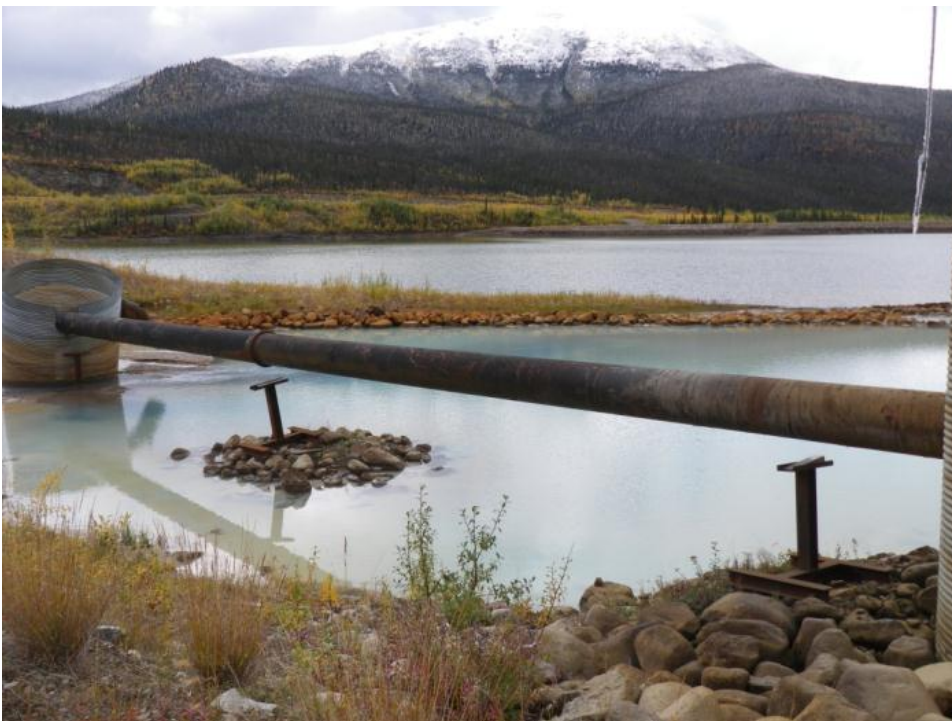
Photo 38 Discharge pipeline of treated water – note separation of pipeline and its intermediate supports)

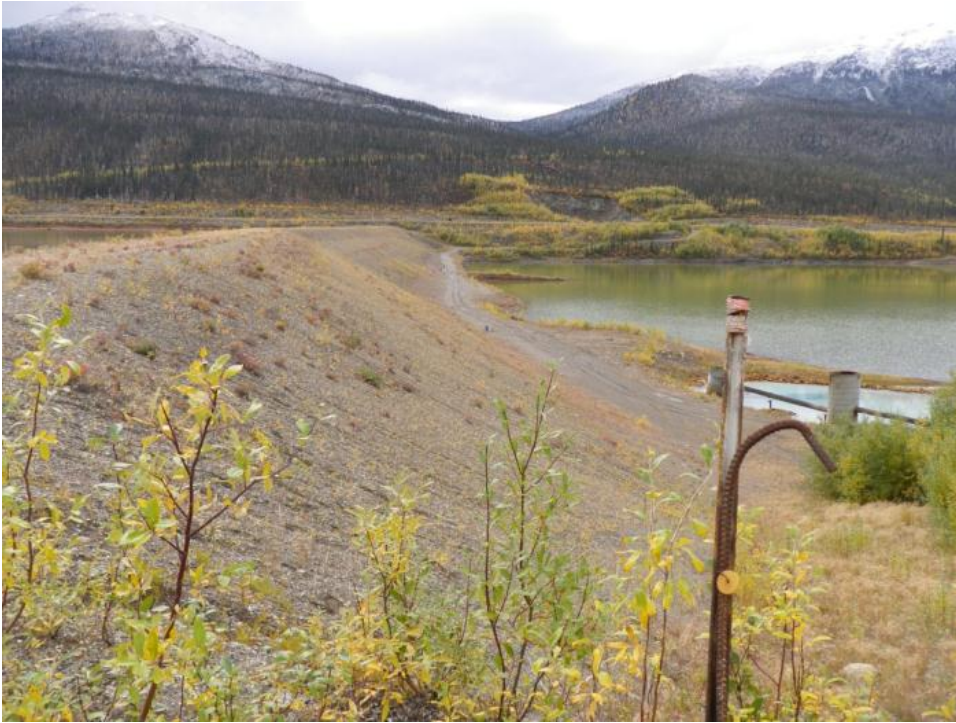
Photo 39 Downstream dam slope – looking from northeast abutment (September 11, 2012)

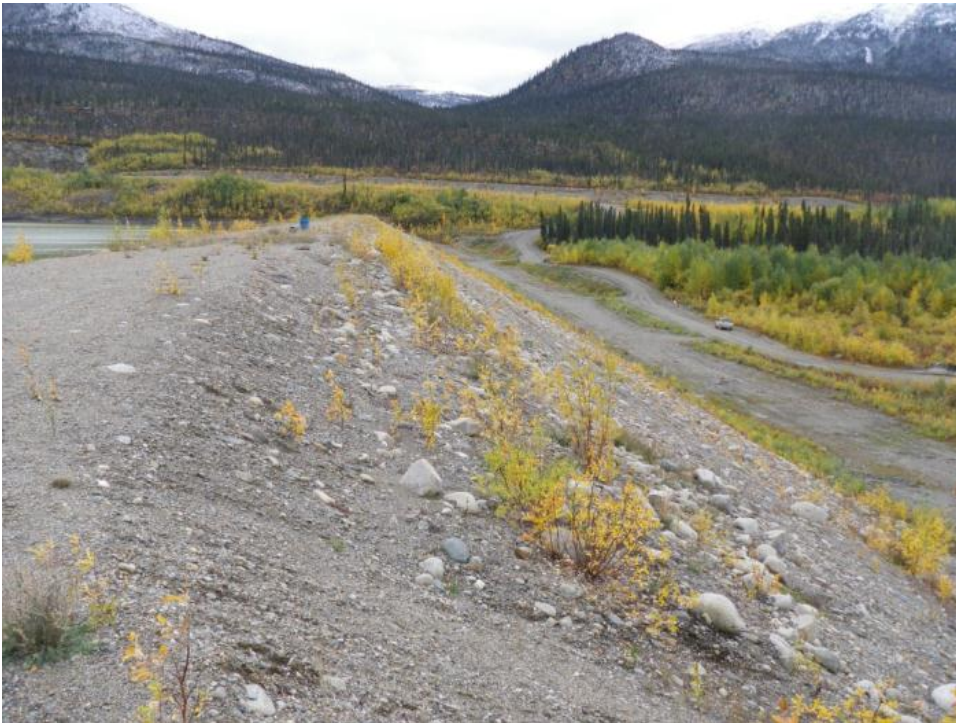
Photo 40 Crest and downstream slope - looking southwest (September 11, 2012)

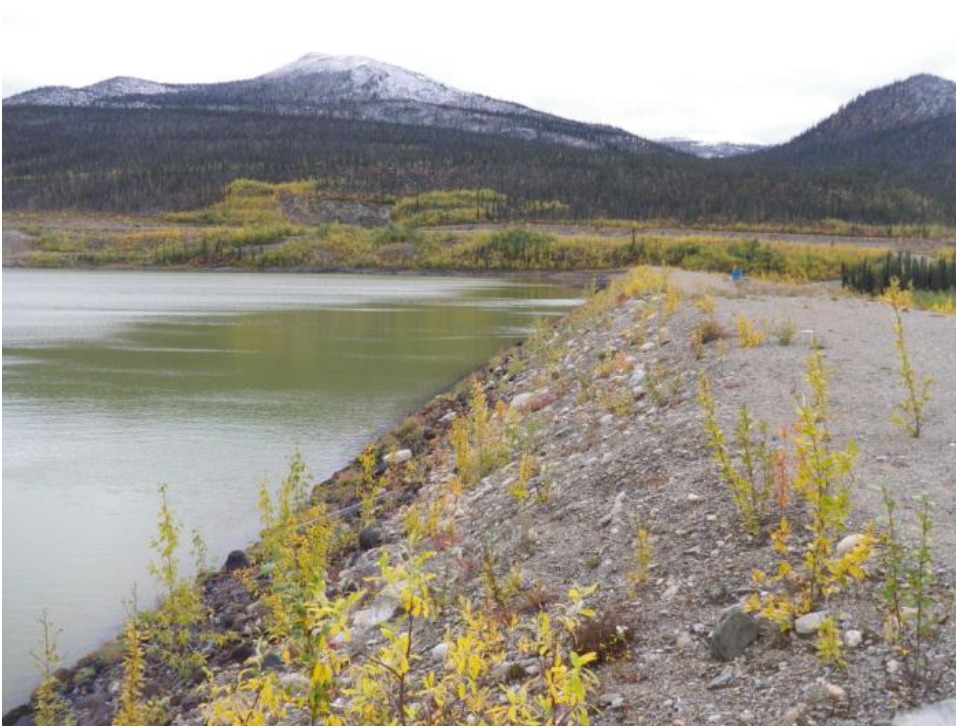
Photo 41 Crest and upstream slope – looking southwest (September 11, 2012)

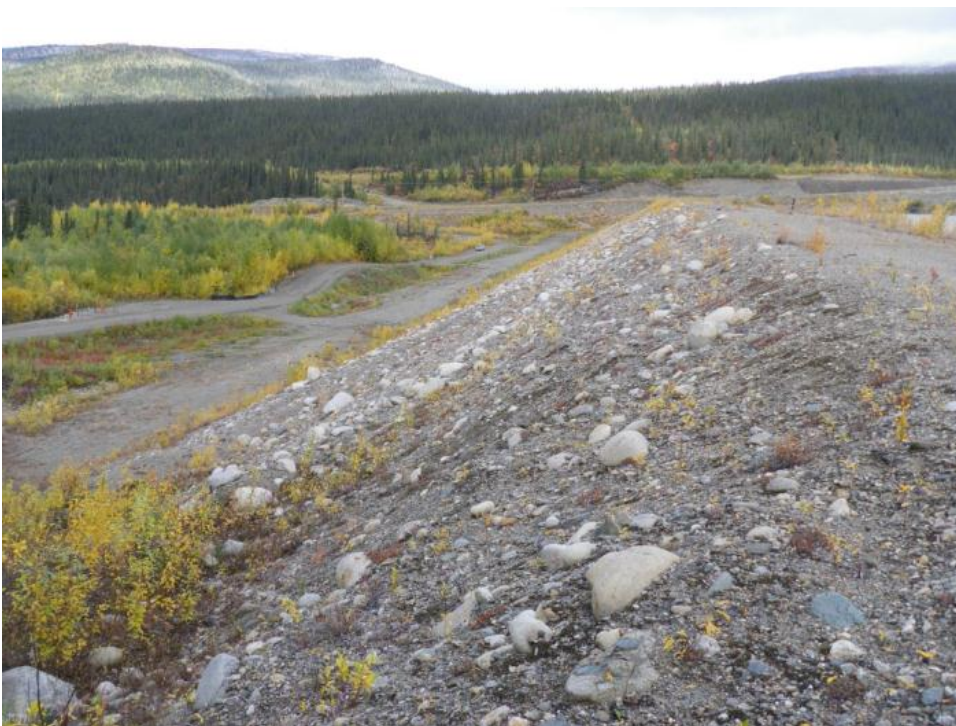
Photo 43 Crest and downstream slope - looking northeast (September 11, 2012)

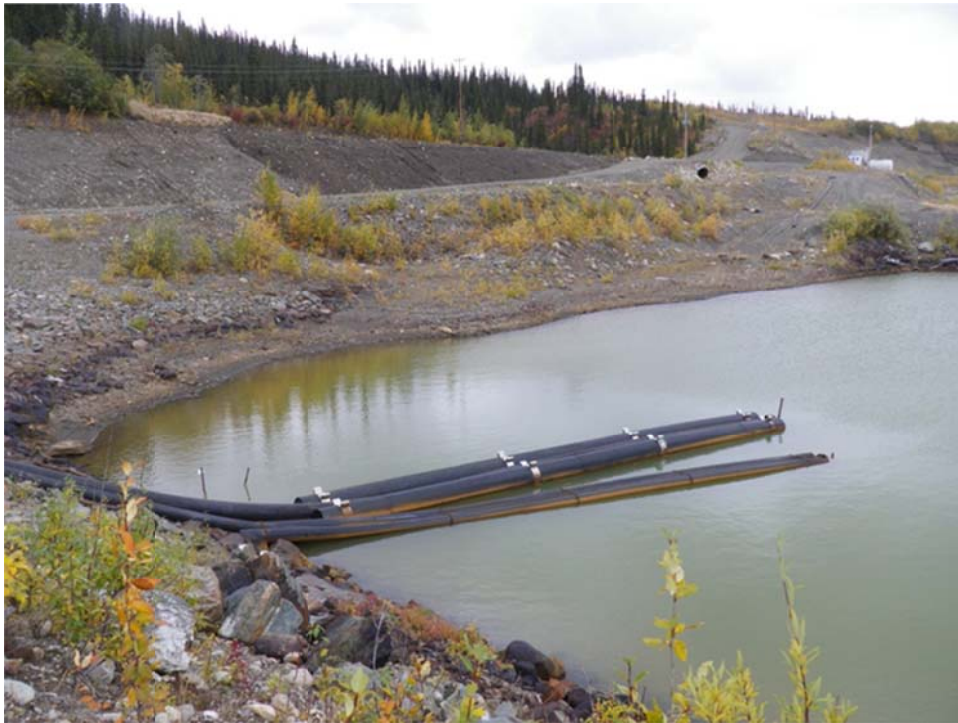
Photo 44 Cross Valley Pond siphon pipelines intake (September 11, 2012)

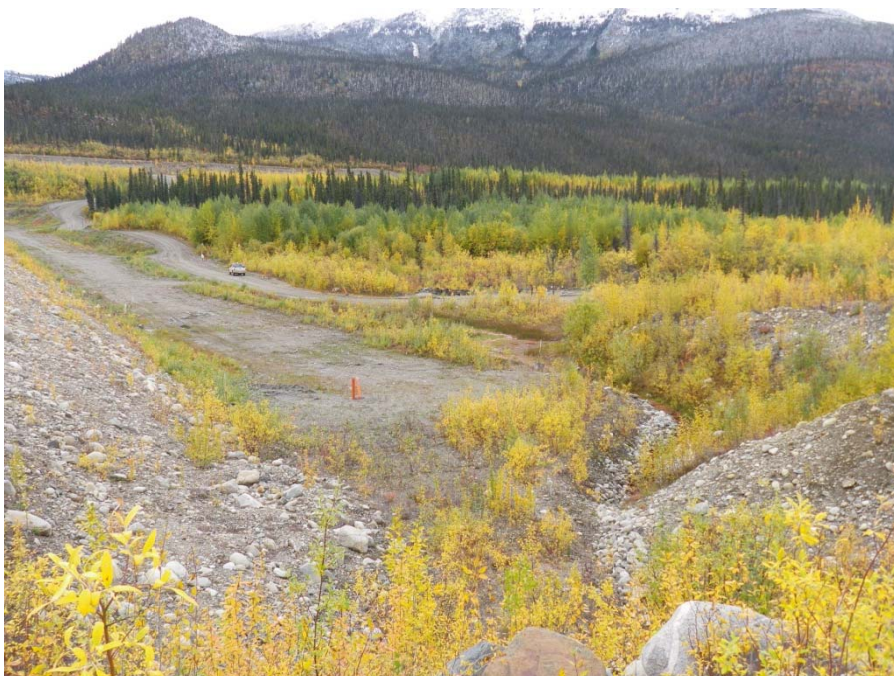
Photo 45 Downstream slope and berm – looking from northeast abutment (September 11, 2012)

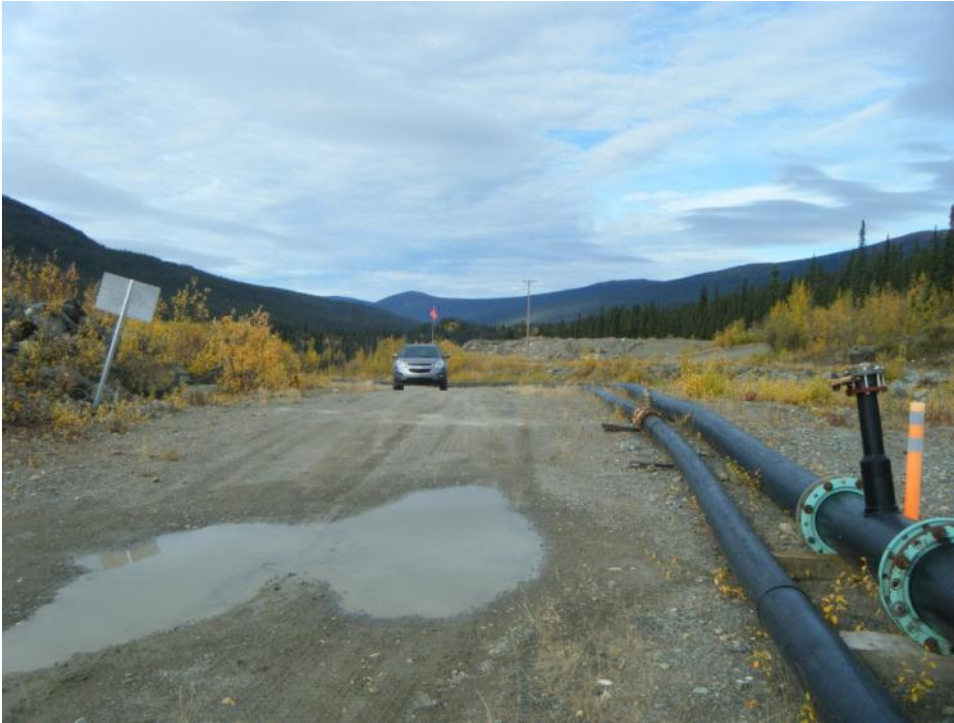
Photo 46 Cross Valley Pond siphon pipeline on spillway channel (September 19, 2012)

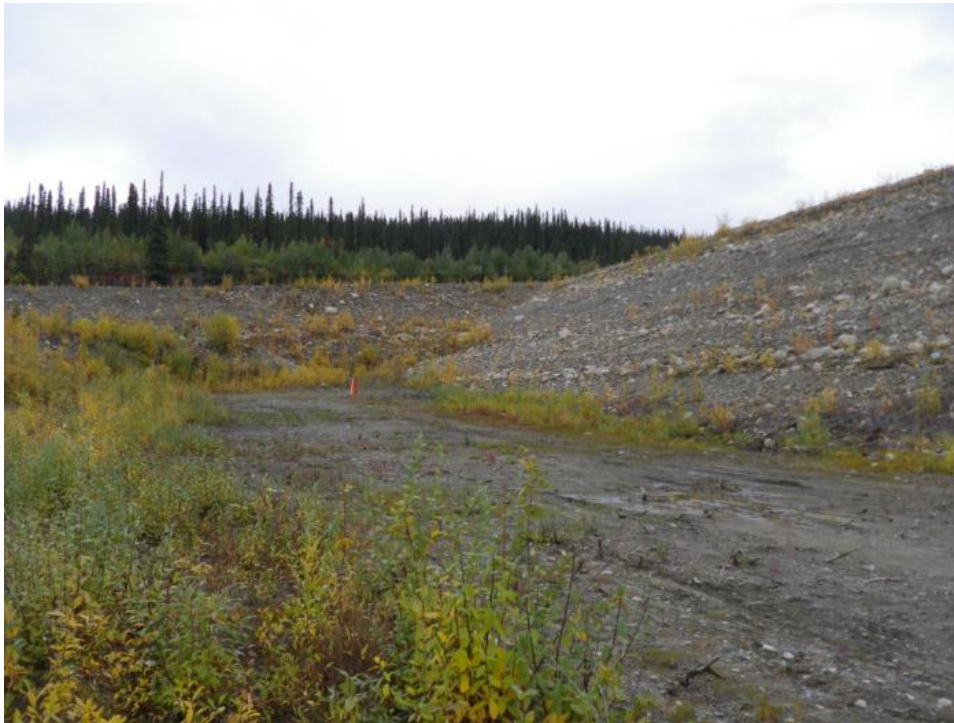
Photo 48 Downstream slope and berm – looking towards northeast (September 11, 2012)

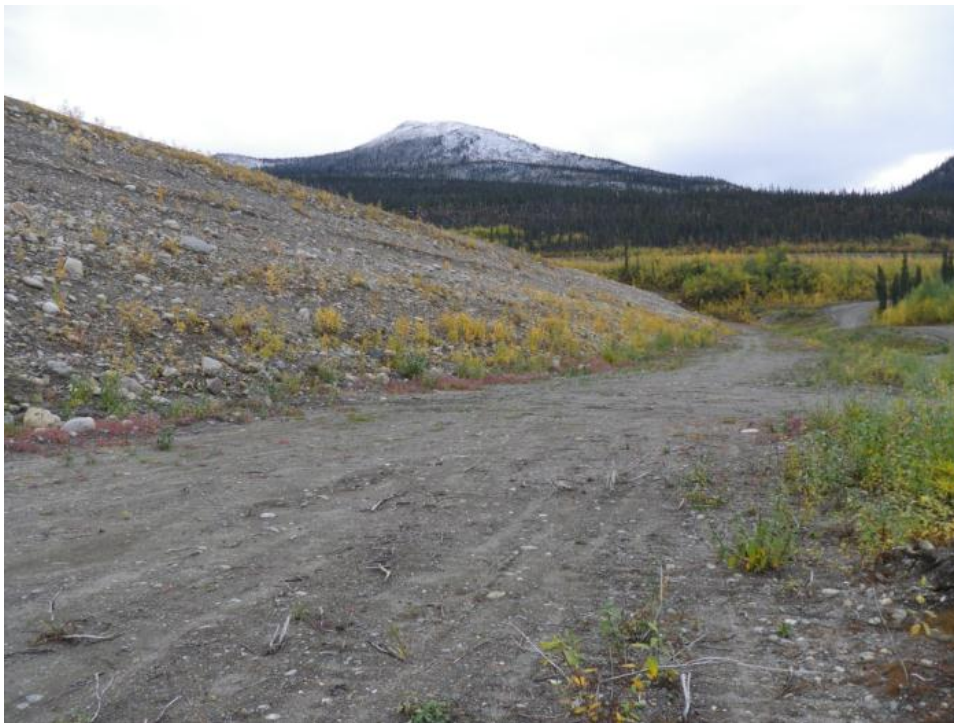
Photo 49 Downstream slope and berm – looking southwest (September 11, 2012)

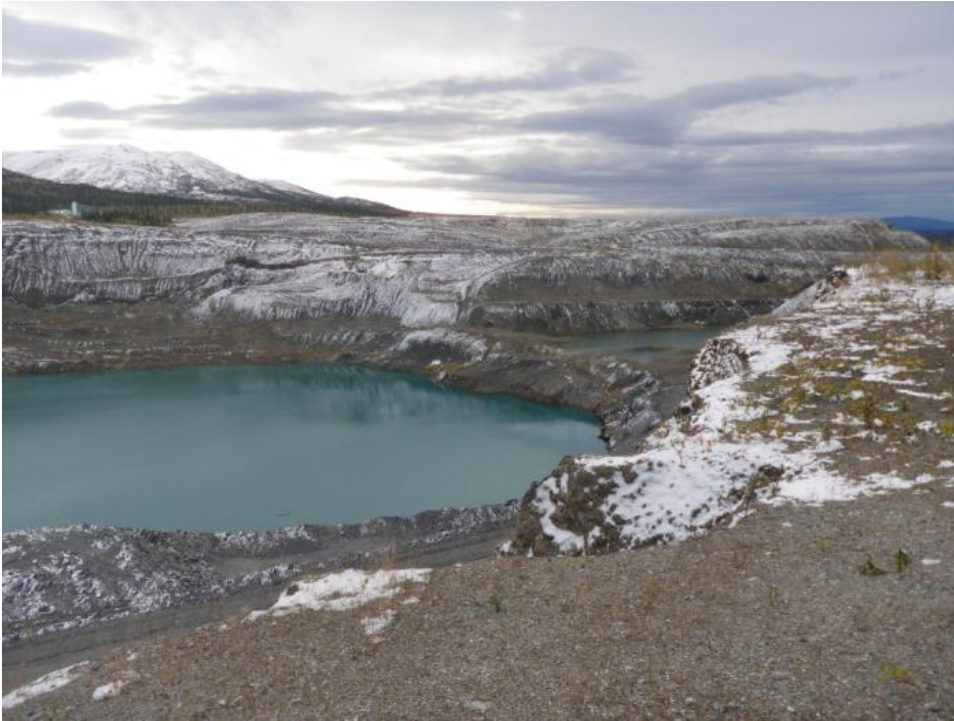
Photo 50 Grum Pit as seen from northwest wall – Grum Slot at middle right (September 12, 2012)

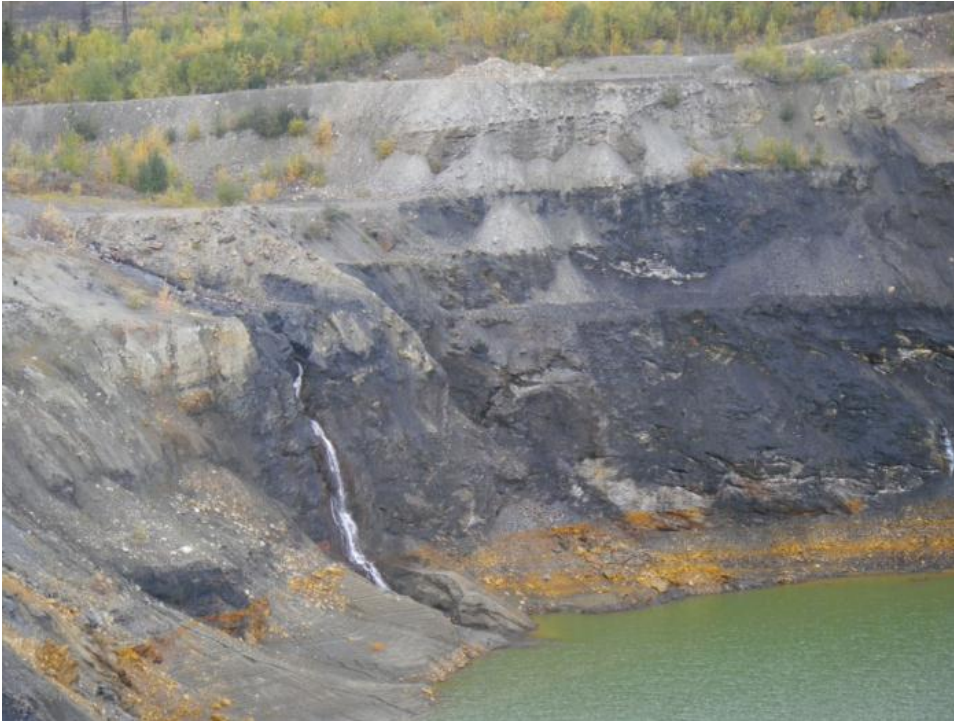
Photo 54 Pit northwest wall (September 12, 2012)

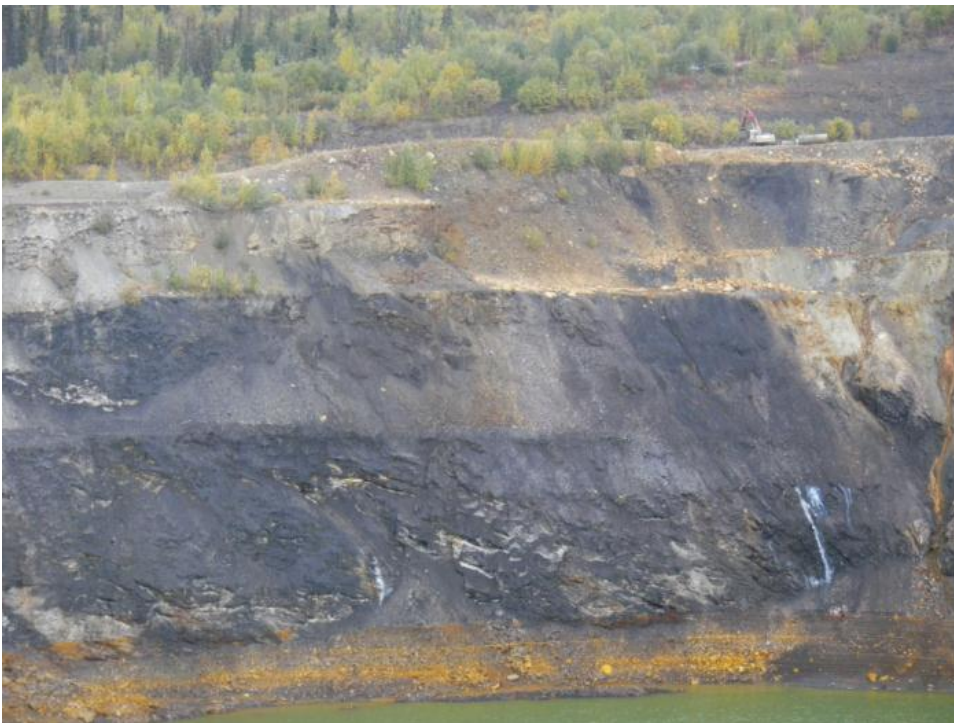
Photo 55 Pit north wall (September 12, 2012)

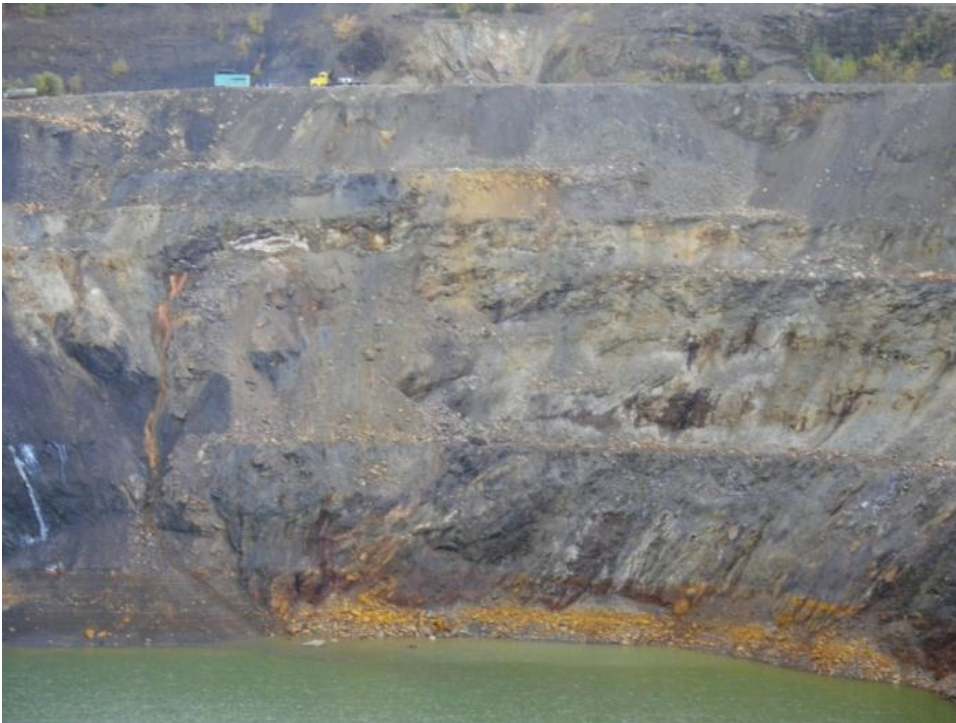
Photo 56 Pit northeast wall (September 12, 2012)

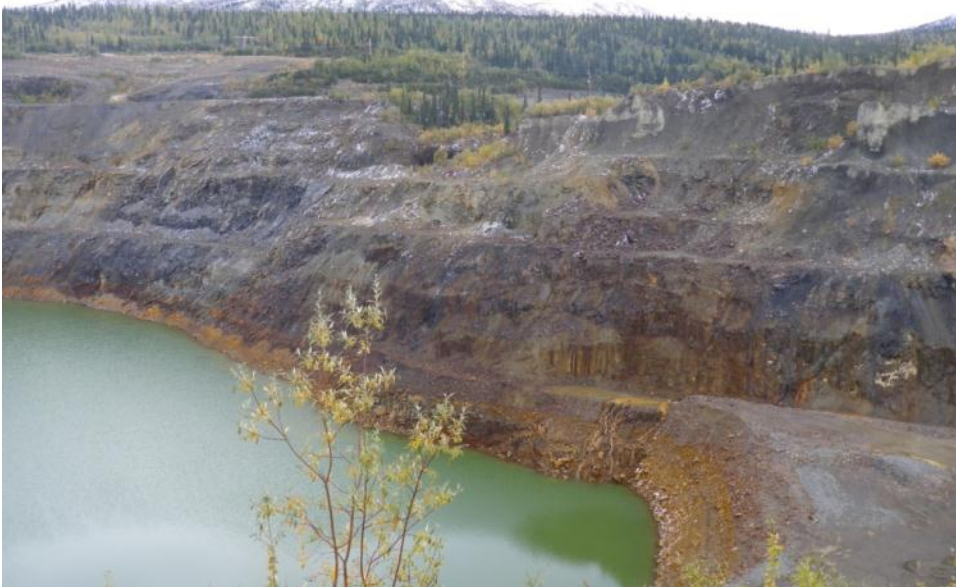
Photo 57 Pit southeast wall (September 12, 2012)

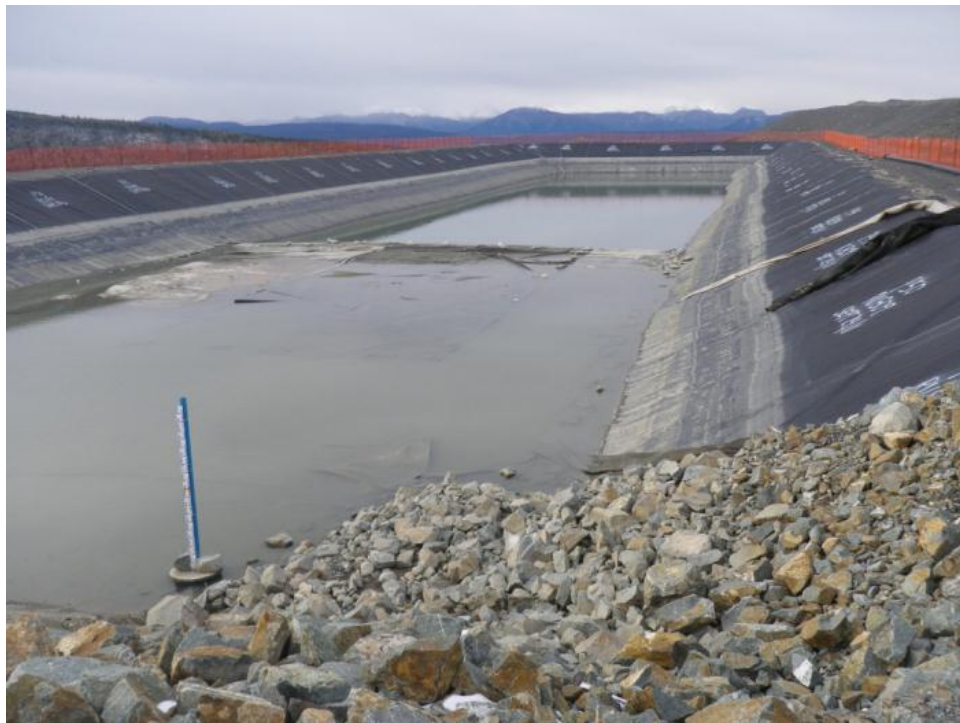
Photo 58 Grum Sulphide Cell water storage pond constructed in 2011 – view in longitudinal direction (September 12, 2012)

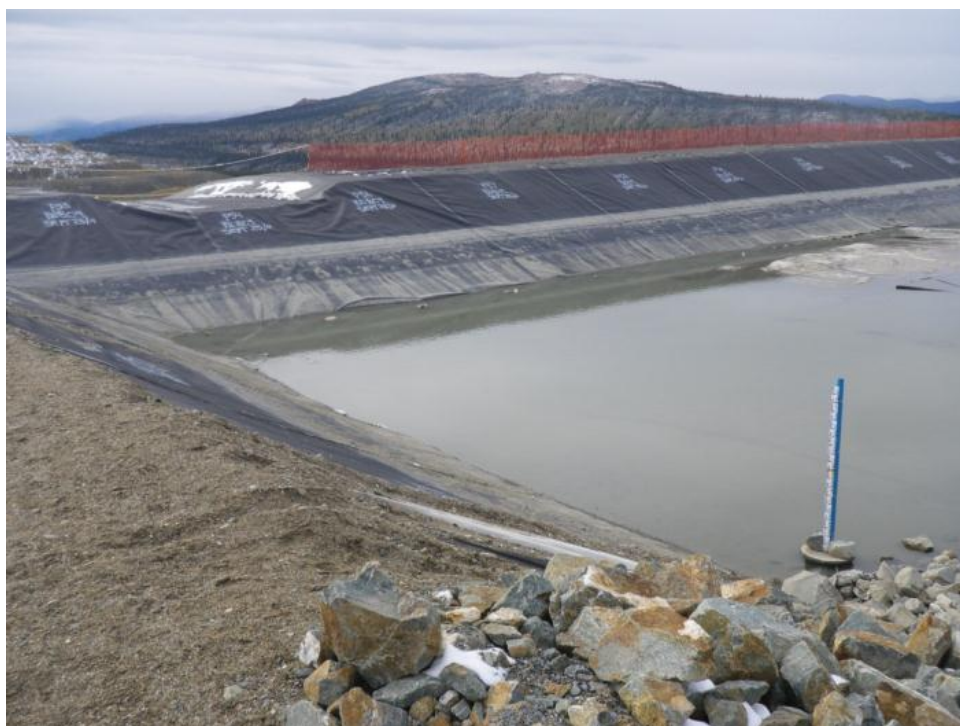
Photo 59 Grum Sulphide Cell water storage pond – side view (September 12, 2012)

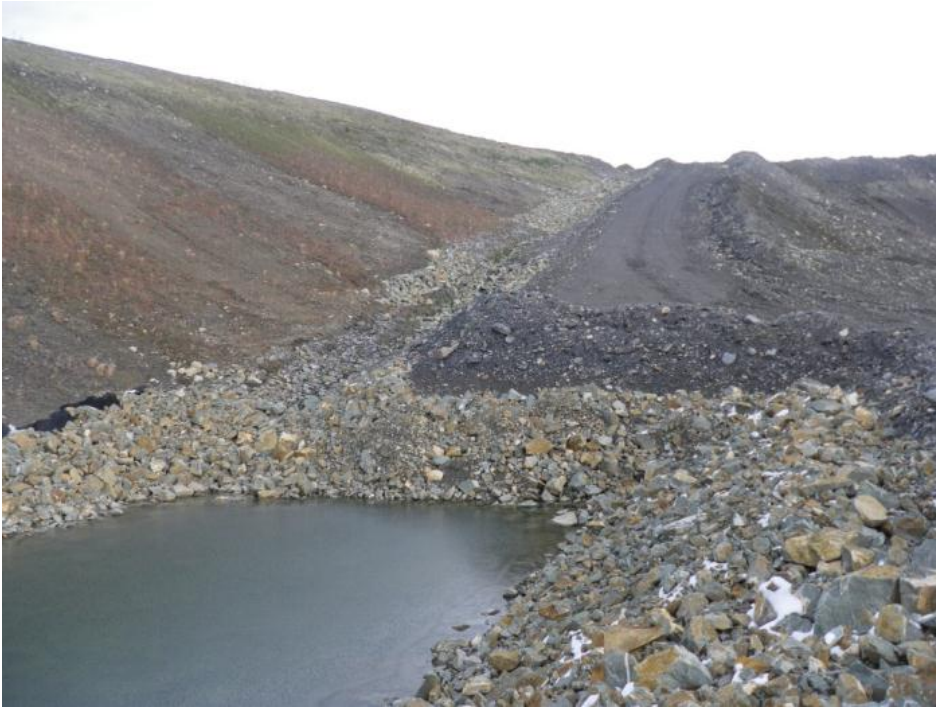
Photo 60 Dump side slope, water retention pond on bench and access ramp
(September 12, 2012)

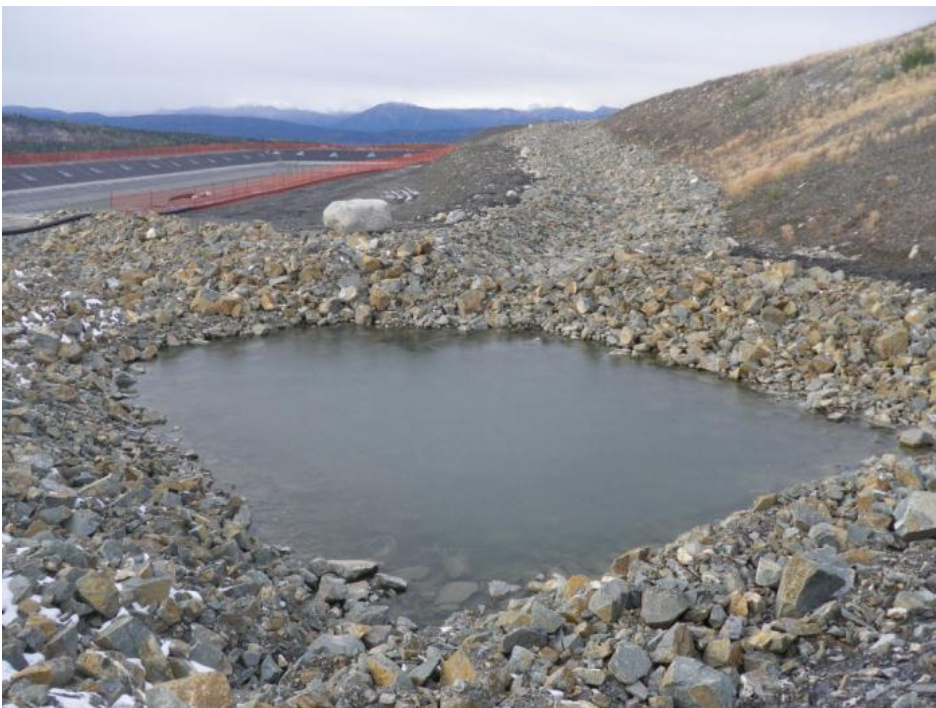
Photo 61 Water retention pond on bench – Grum Sulphide Cell in background
(September 12, 2012)

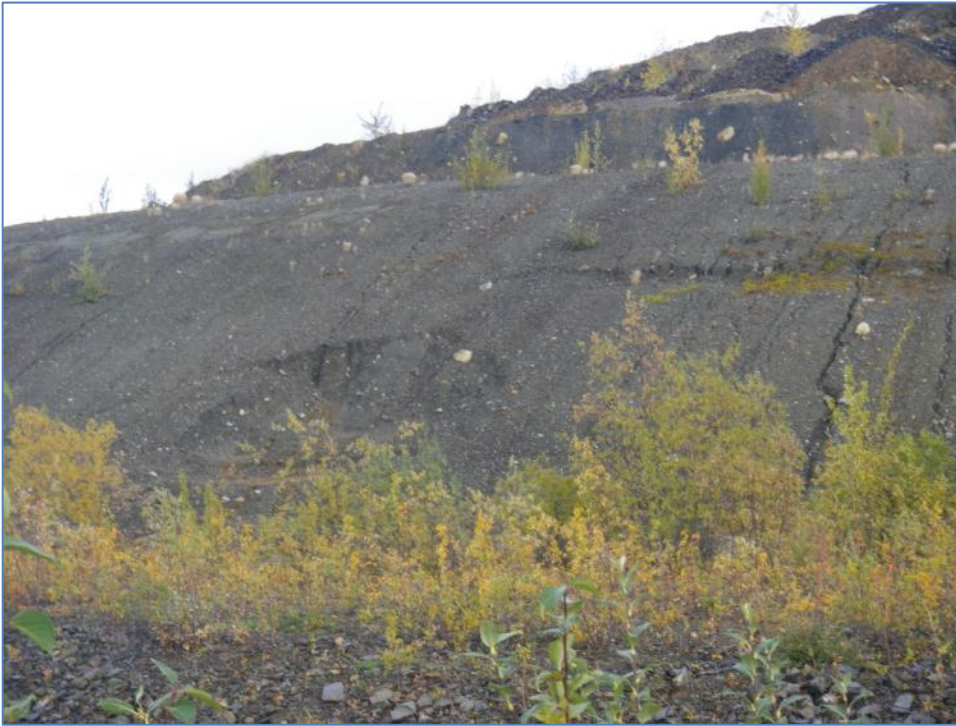
Photo 64 Waste Dump slope with old scarp and rill erosion (September 13, 2012)

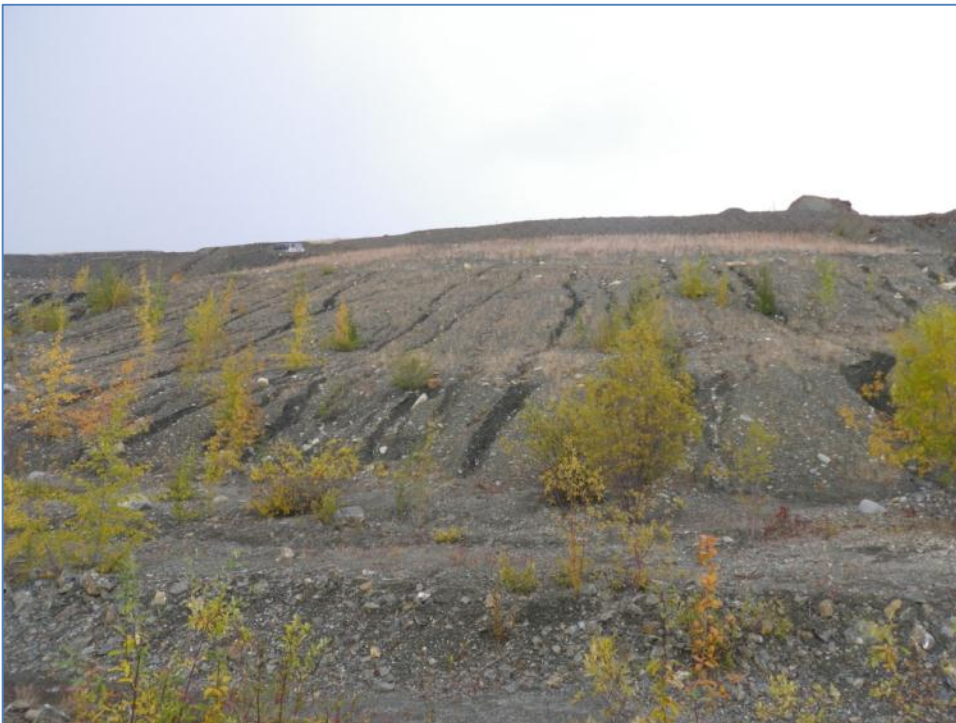
Photo 65 Waste Dump slope with rill erosion (September 13, 2012)

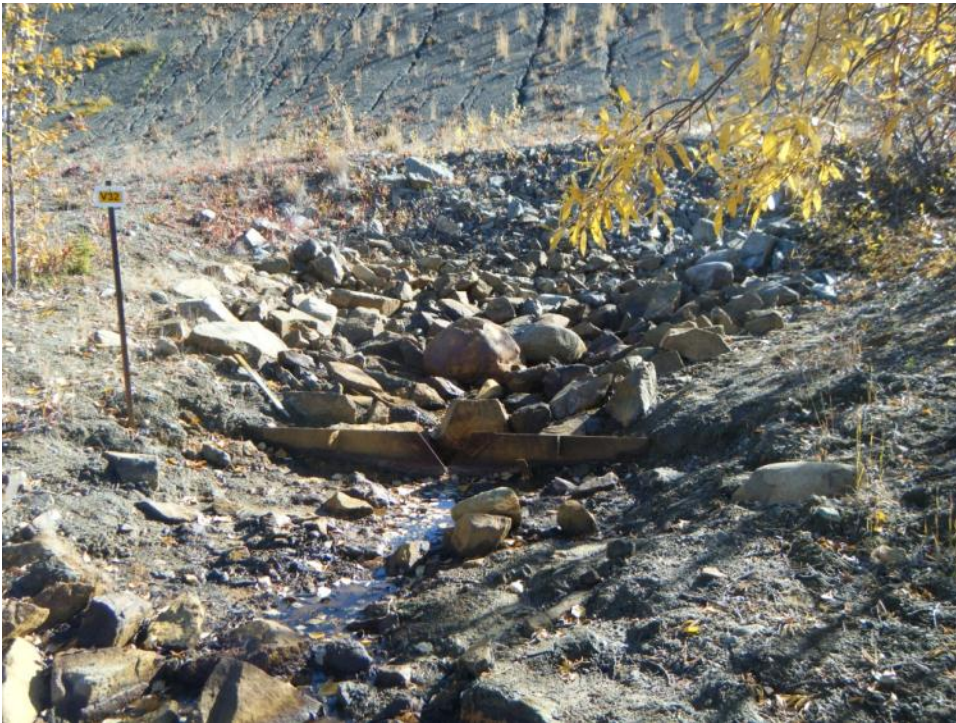
Photo 67 Vangorda Waste Dump Drain No. 5. Weir – looking upstream (September 20, 2012)

- Vangorda Waste Rock Dump:
 - ◆ At Drain No. 5 – Weir plate should be repaired. Boulders in the upstream pool should be removed and the channel invert immediately downstream of the weir should be lowered slightly to provide good free flow conditions required for flow measurement.

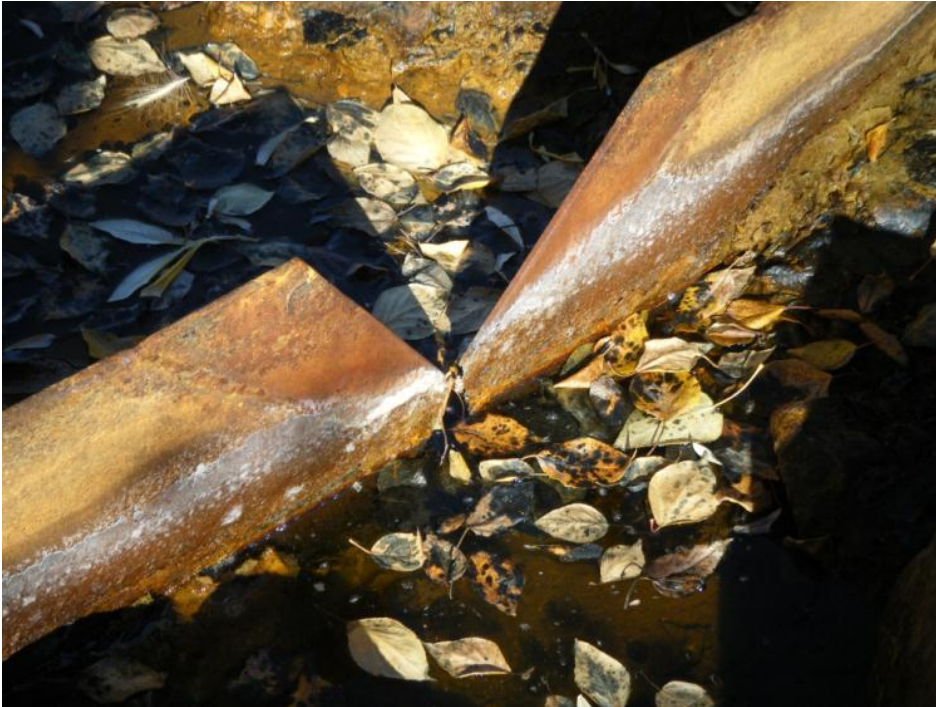
Photo 68 Vangorda Waste Dump Drain No. 5. Weir – weir plate split into two pieces at the V-notch (September 20, 2012)

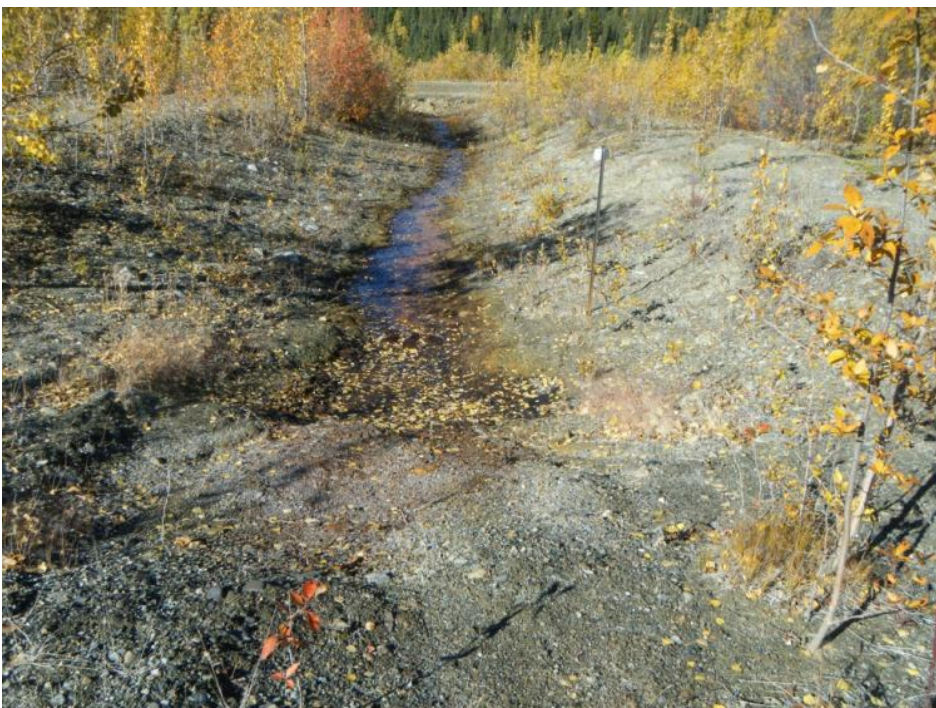
Photo 69 Vangorda Waste Dump Drain No. 4 looking downstream - no weir at this drain (September 20, 2012)

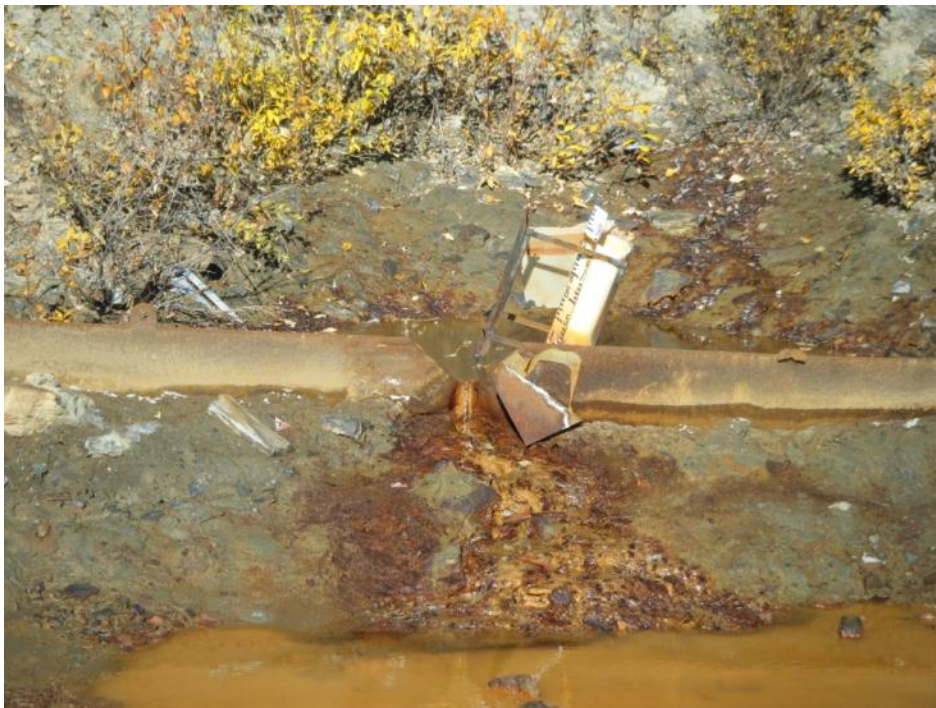
Photo 71 Vangorda Waste Dump Drain No. 3 weir - note delaminated weir plate and crooked staff gauge (September 20, 2012)

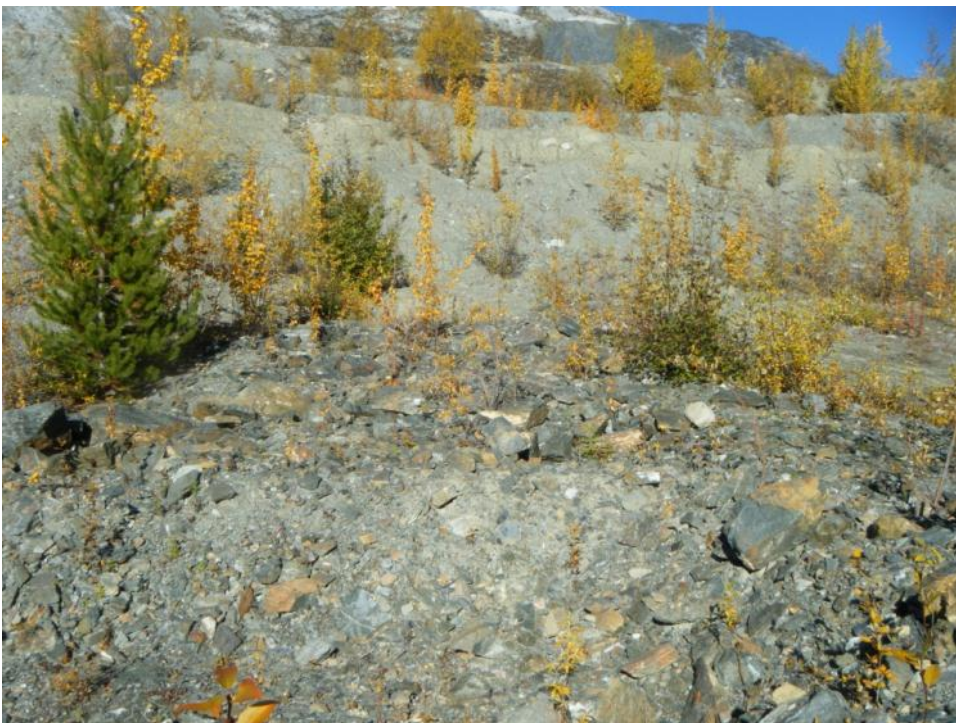
Photo 75 Vangorda Waste Dump Drain No. 1 – no weir at this drain (September 20, 2012)

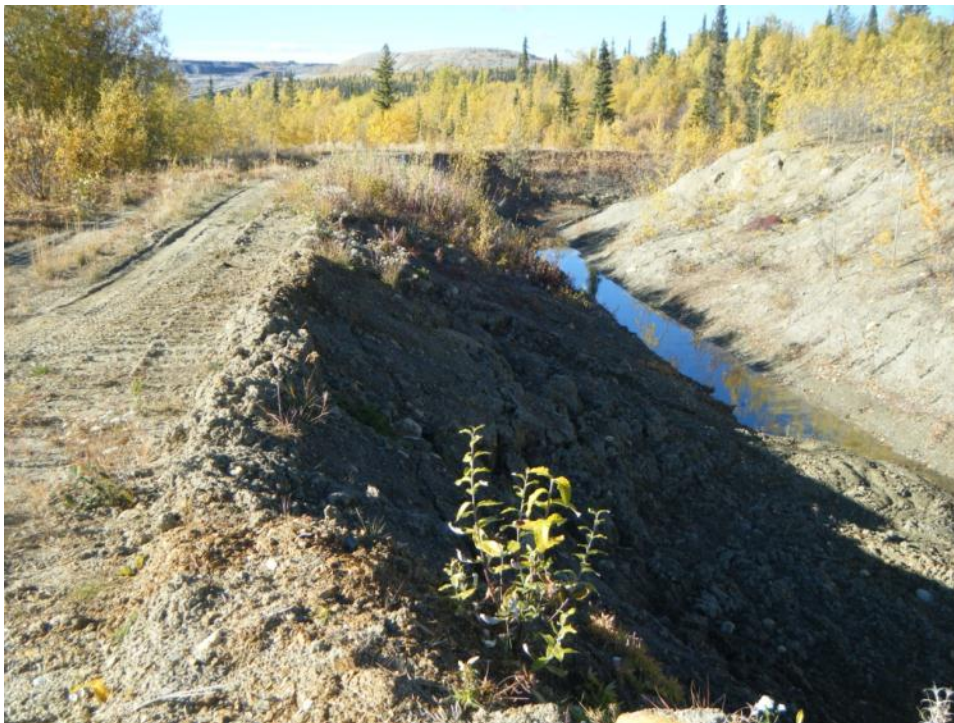
Photo 83 Interceptor Ditch – looking upstream, note slumped road slope (September 20, 2012)

- North-East Interceptor Ditch above Vangorda Pit:
 - ◆ Continue to monitor ditch side slopes, especially along reaches with slope slumps, and repair slumped ditch sections to maintain flow capacity, especially prior to spring freshet.

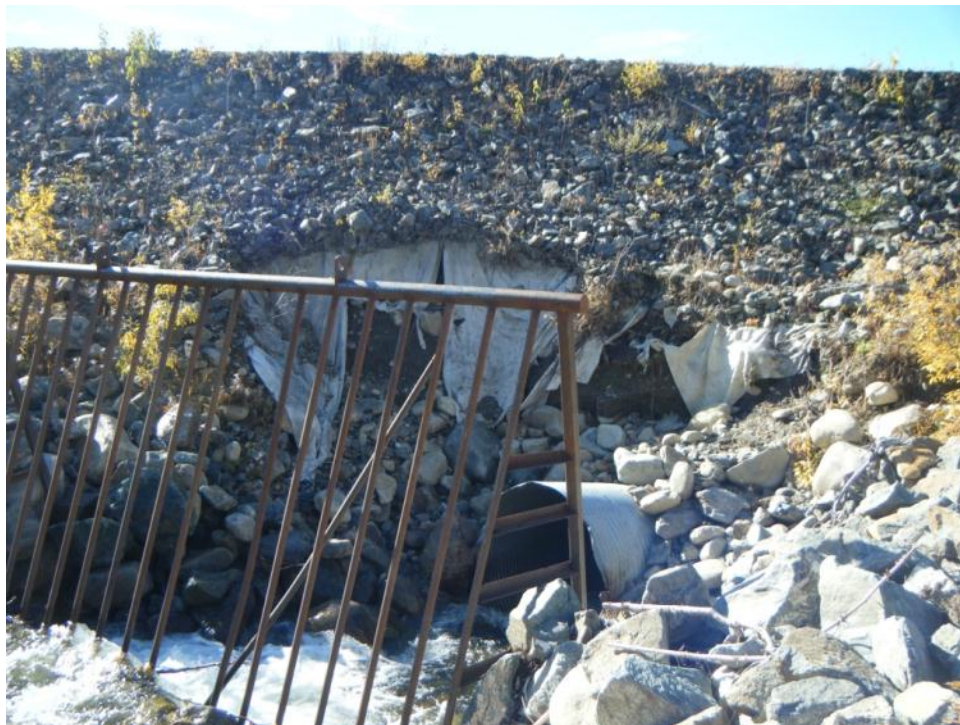
Photo 85 Vangorda Flume intake culvert – note considerable embankment toe erosion around culvert (September 20, 2012)

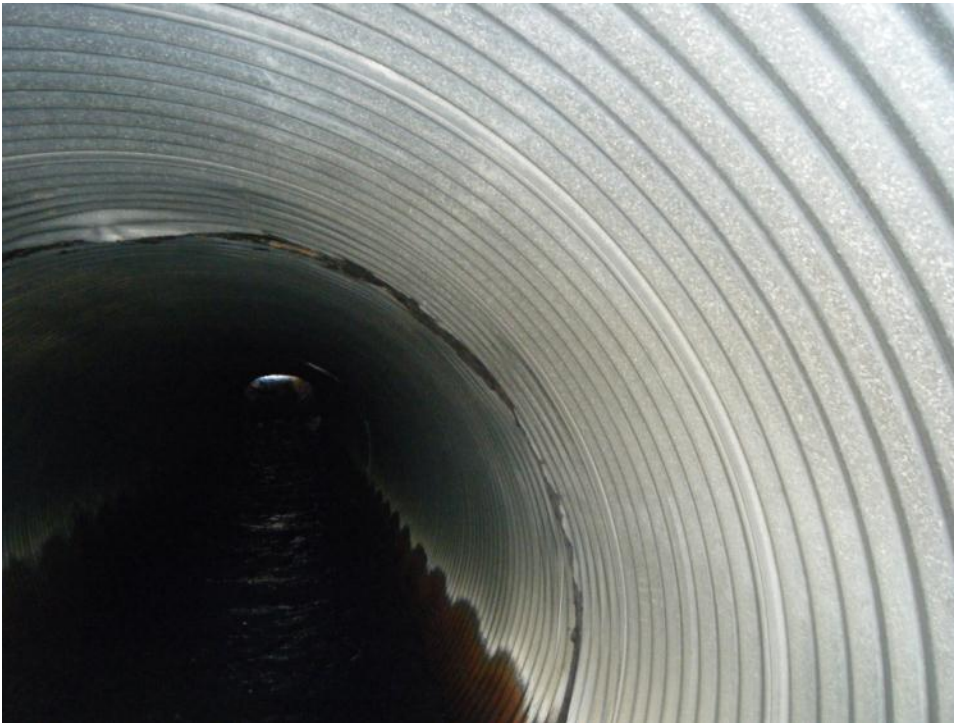
Photo 88 Flume intake culvert as seen from downstream end - first pipe joint appears to be separated (September 20, 2012)

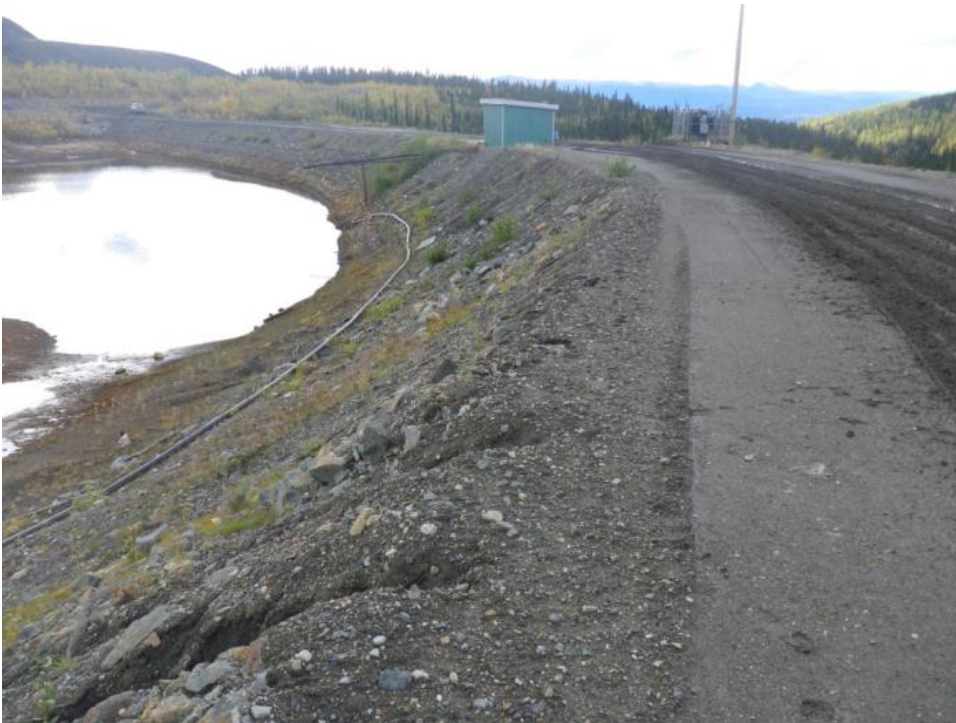
Photo 97 Dam crest and upstream slope - rill erosions in the foreground (September 13, 2012)

- Little Creek Dam:
 - ◆ Monitor ongoing rill erosion along the downstream and upstream slopes.
 - ◆ Consider repair or restoration of the dam slopes at the locations of rill erosion, especially in the foundation area of the transformer located on the downstream crest shoulder.
