Klohn Crippen Berger

Faro Mine Complex

2012 Annual Geotechnical Review

March 28, 2013

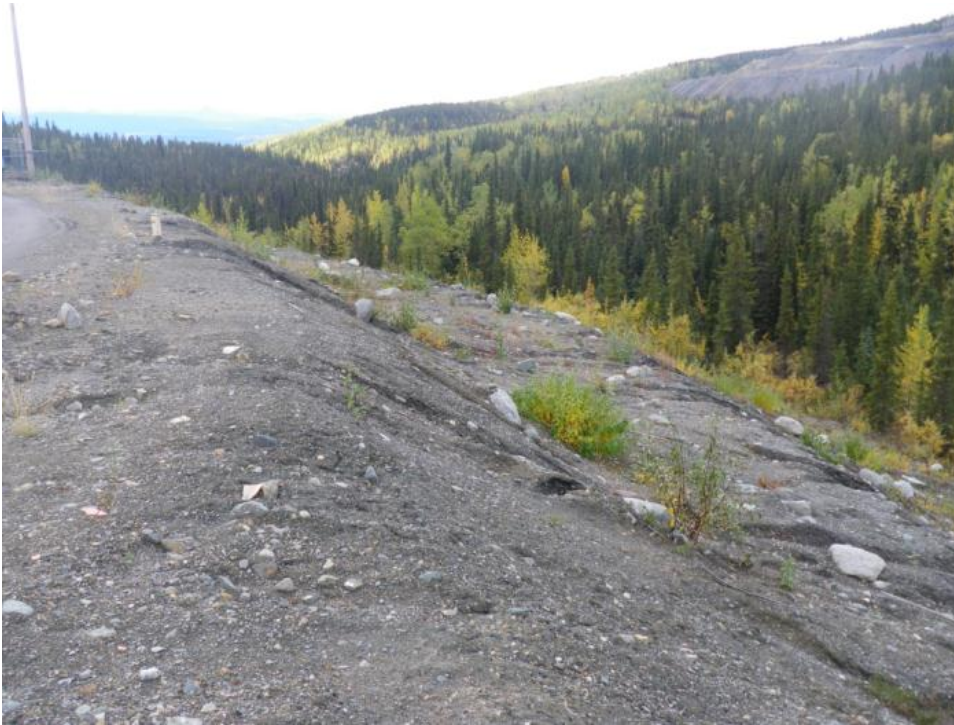
Photo 98 Rill erosions on downstream slope (September 13, 2012)

- Little Creek Dam:
 - ◆ Monitor ongoing rill erosion along the downstream and upstream slopes.
 - ◆ Consider repair or restoration of the dam slopes at the locations of rill erosion, especially in the foundation area of the transformer located on the downstream crest shoulder.

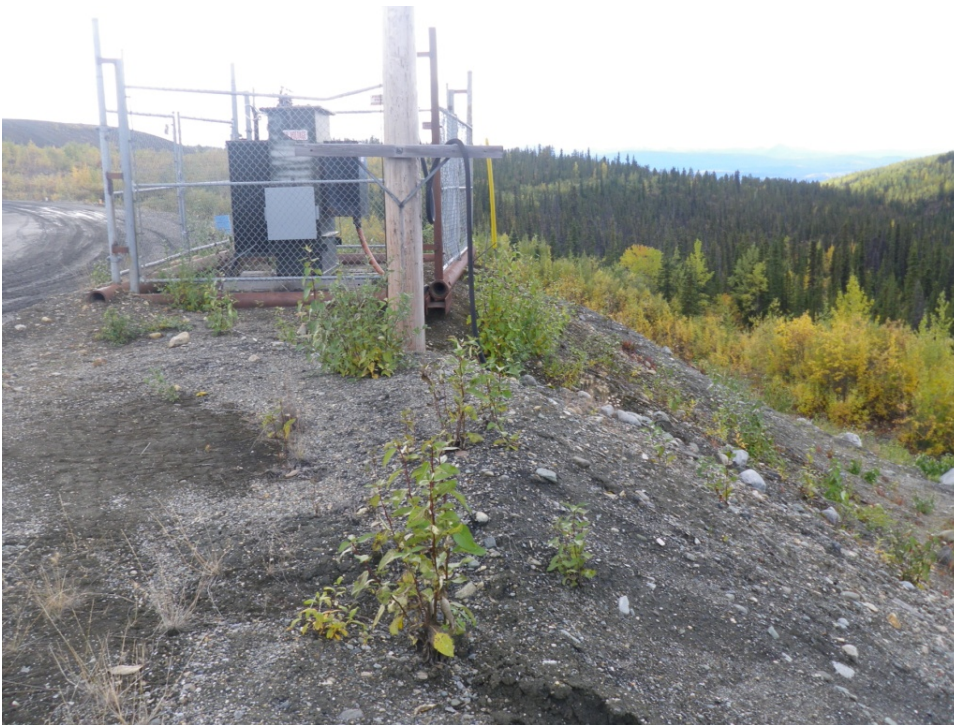
- Stable dam slopes with rill erosions developed on the downstream and upstream crest shoulders and slopes.
- A rill erosion began to undermine the foundation of the transformer situated at the downstream crest shoulder (see Photos 99 and 100).
- Pond level drawn down prior to removal of submersible pump in preparation for the winter.
- Culvert spillway in good condition.
- There are cracks in the ground at the downstream end of the spillway outfall channel (see Photos 105 and 106), at the top of bank slope above Vangorda Creek.

Photo 99 Rill erosions near transformer on dam crest (September 13, 2012)

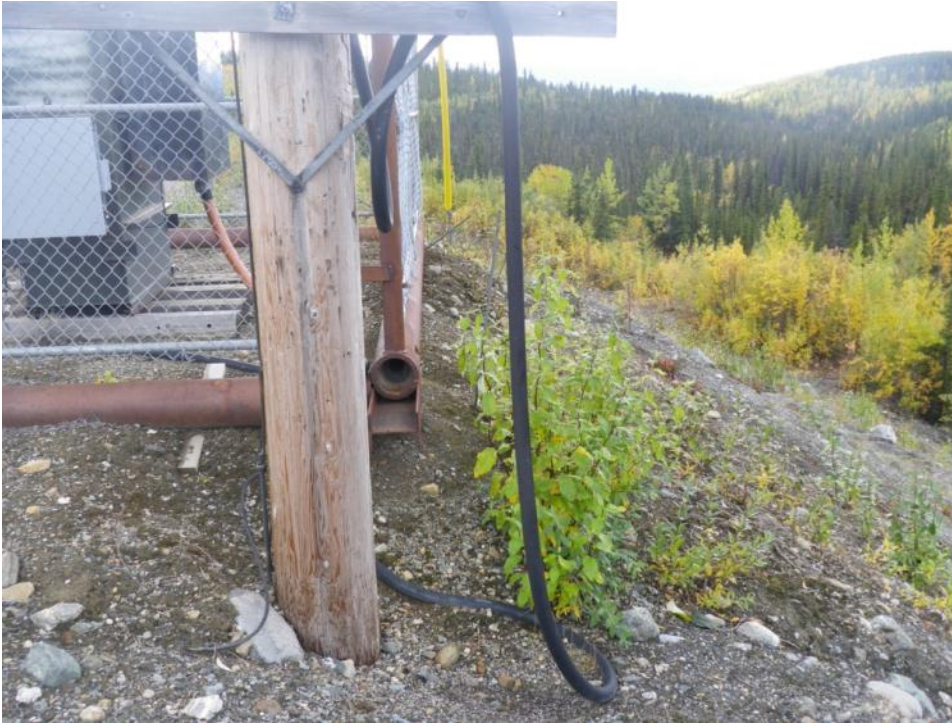
Photo 100 Close up of dam crest at base of transformer shown on Photo 98

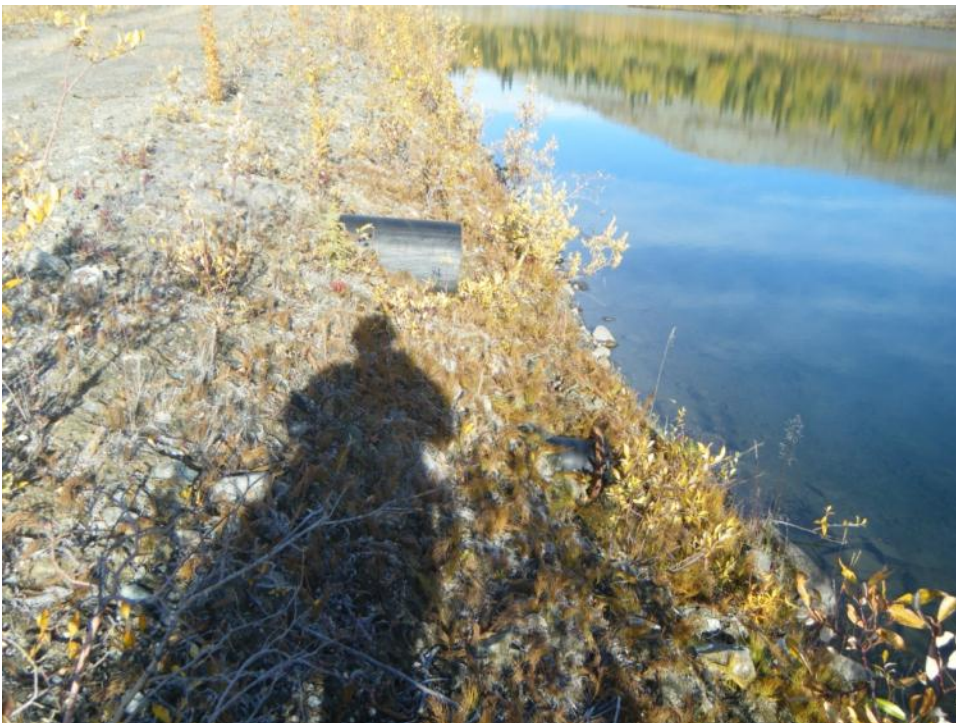
Photo 111 Culvert spillway for Lower Sheep Pad Pond (September 20, 2012)

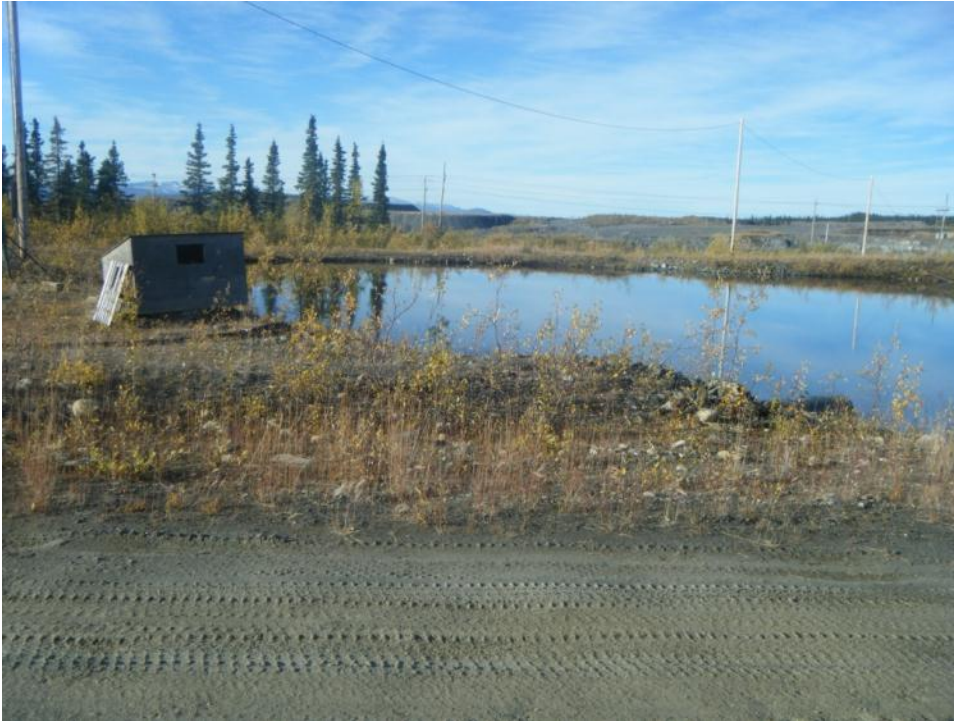
Photo 112 Grum Settling Pond (September 20, 2012)

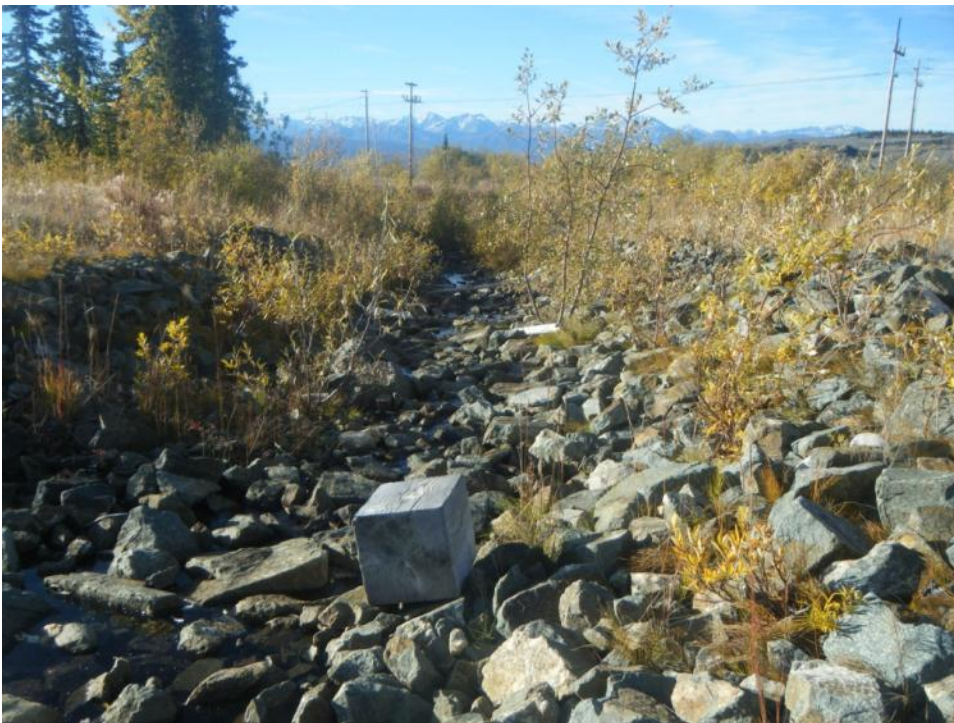
Photo 113 Pond spillway channel, looking downstream towards Grum Interceptor Ditch (September 20, 2012)

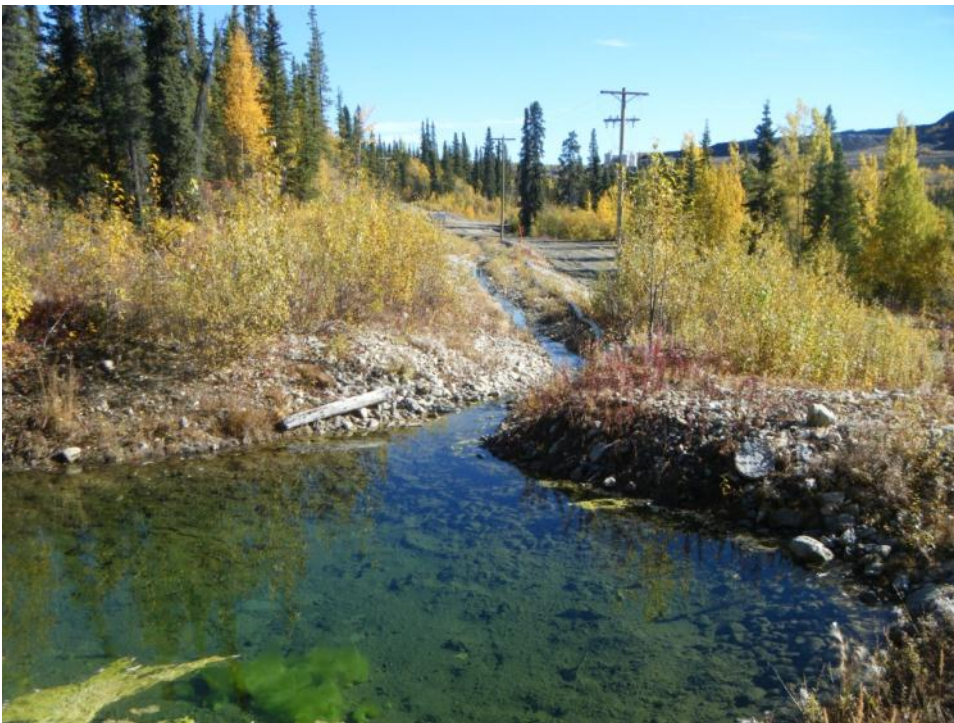
Photo 115 V-15 Diversion Ditch to Moose Pond (September 20, 2012)

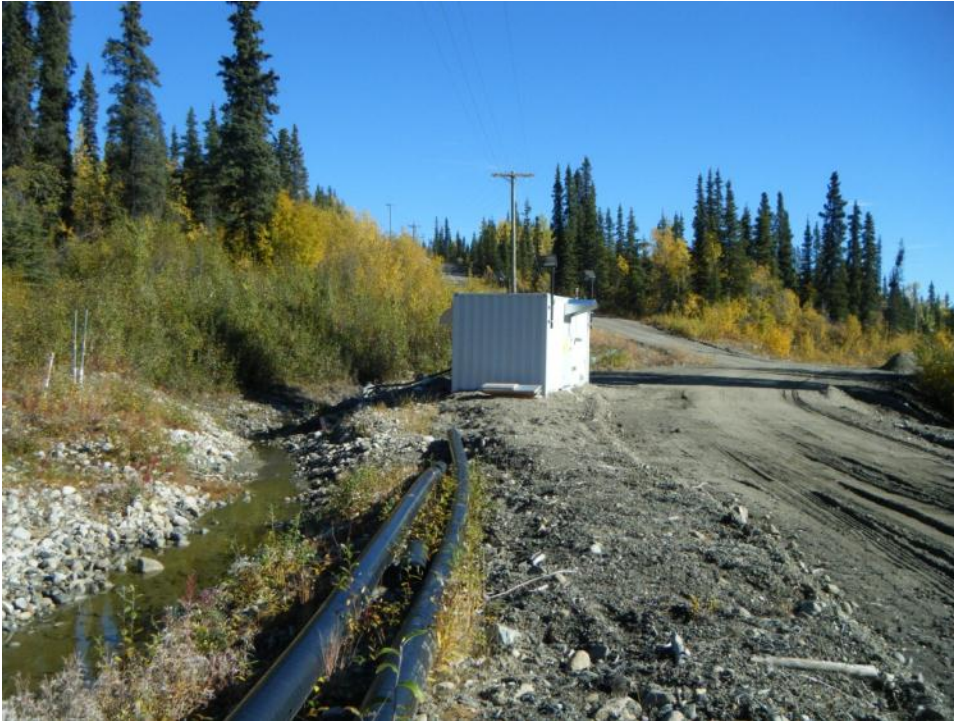
Photo 116 V-15 Pumphouse (September 20, 2012)

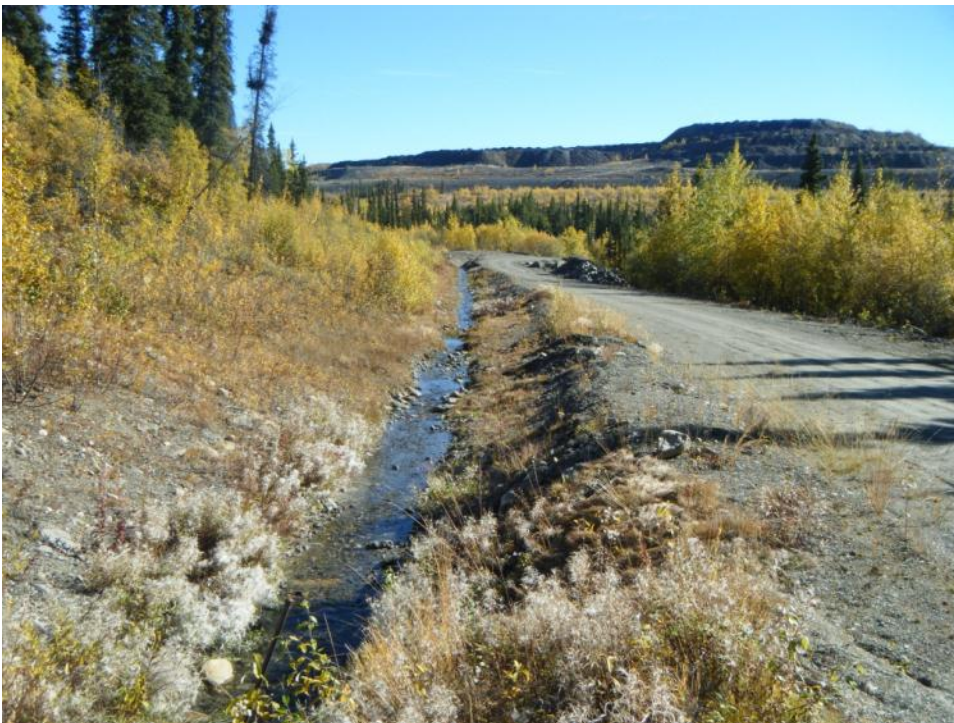
Photo 117 V-15 Diversion Ditch looking downstream towards Moose Pond (September 20, 2012)

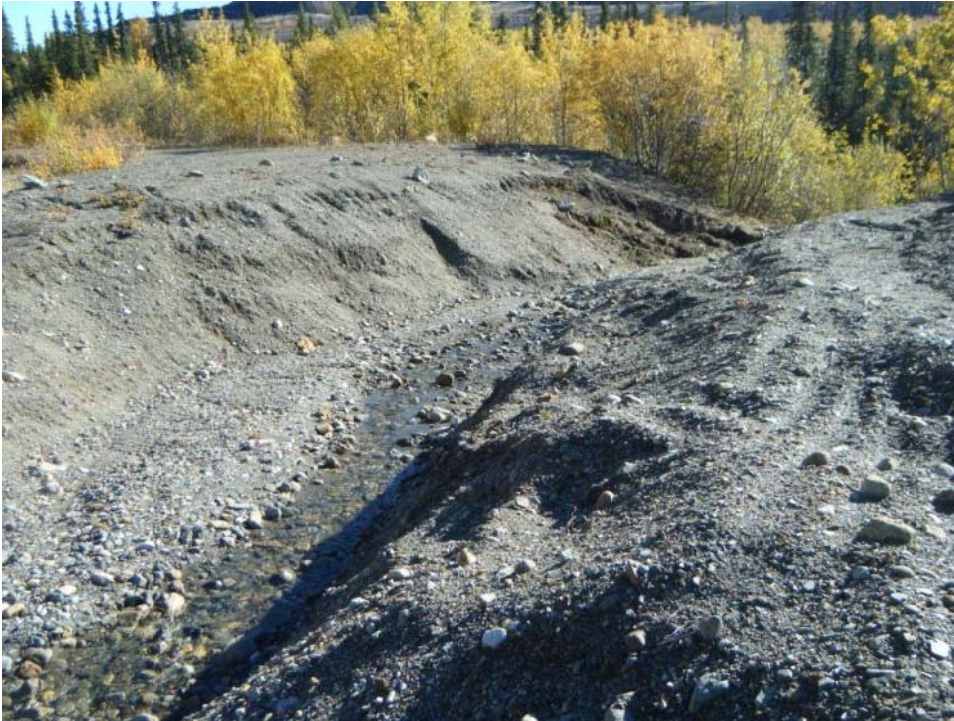
- 2011 excess inflow into Moose Pond caused the following changes: deposition of silt sediment (see Photo 120), raised pond level and slumps of the downstream slope of a retaining esker at the locations of 2011 raised seepage exit.
- Exfiltration from Moose Pond since 2011 has likely changed from the original pond bottom to bank slope at higher elevations. However, this change has not been verified by the comparison of Moose Pond levels before and after the 2011 excess inflow event.
- Significant erosion and slumping of the sides of the V-15 diversion channel was observed at the location where the ditch entered into a steep reach upstream of Moose Pond (see Photos 118 and 119).

Photo 118 V-15 Diversion Ditch at its downstream end near Moose Pond (September 20, 2012)

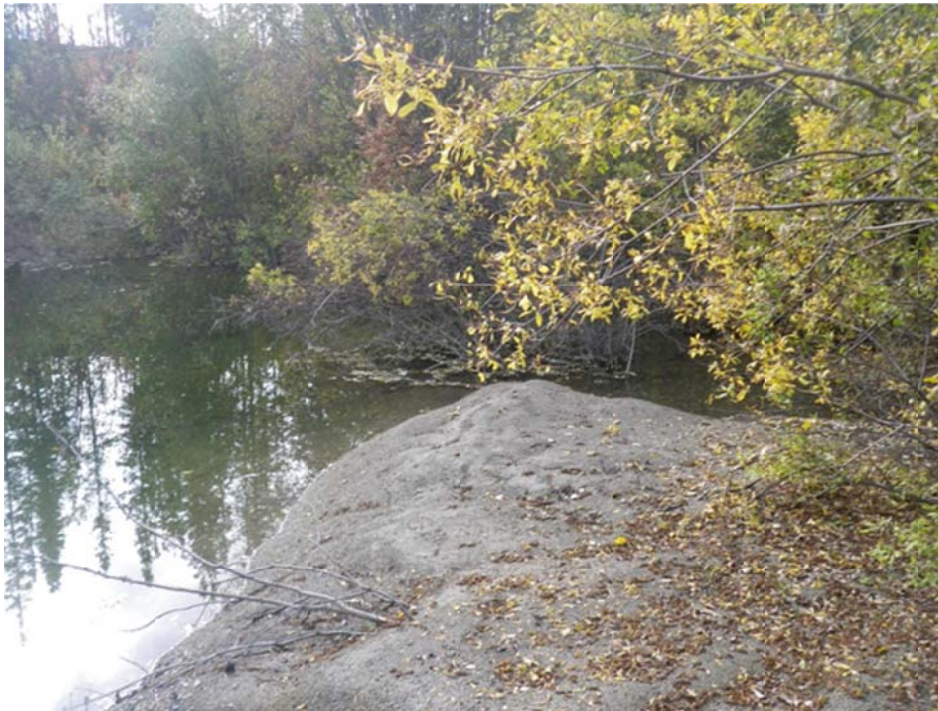
Photo 120 Sediments deposited during 2011 spring excess runoff (September 13, 2012)

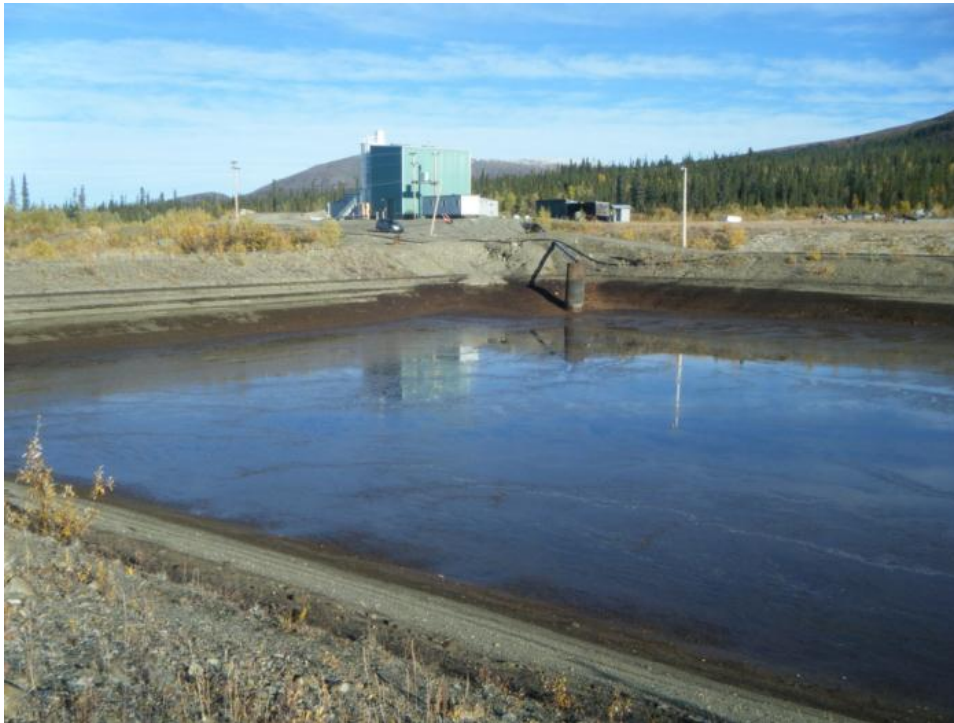
Photo 122 Grum Sludge Pond (September 20, 2012)

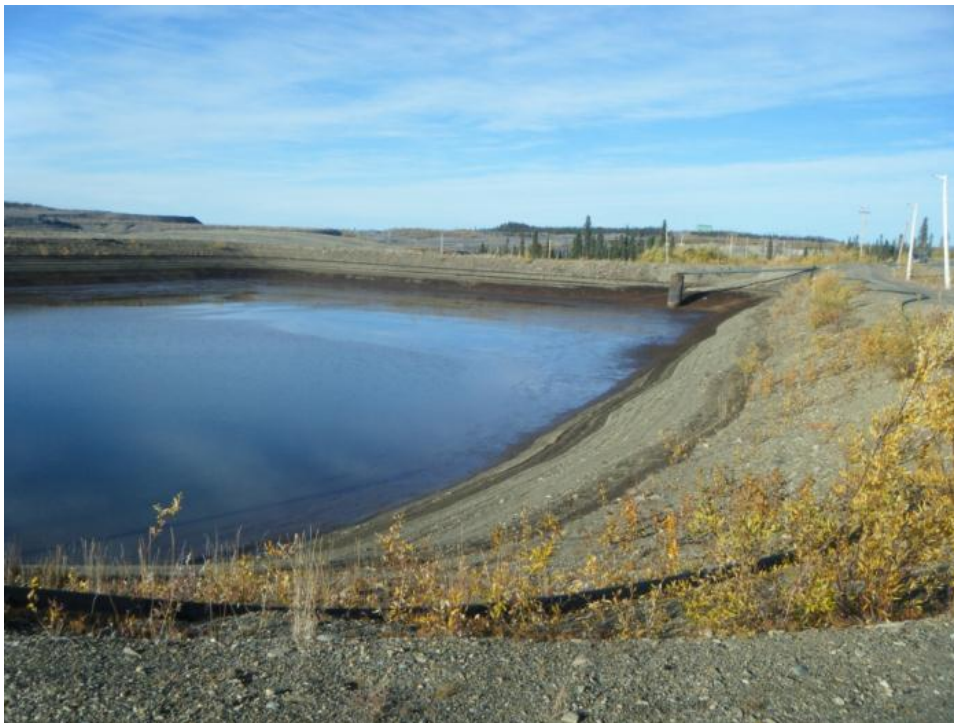
Photo 123 Grum Sludge Pond (September 20, 2012)

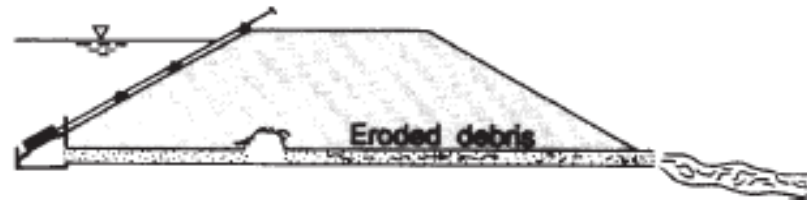
A - Hole develops in conduit, eroding embankment

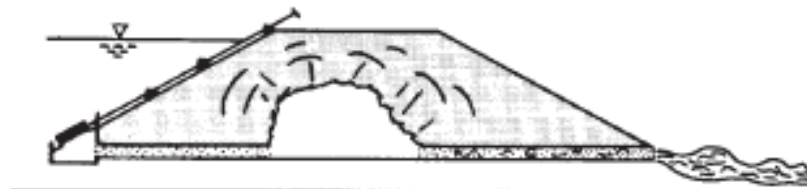
*B - Hole in Conduit enlarges, cavity develops.
Debris partially blocks outlet.*

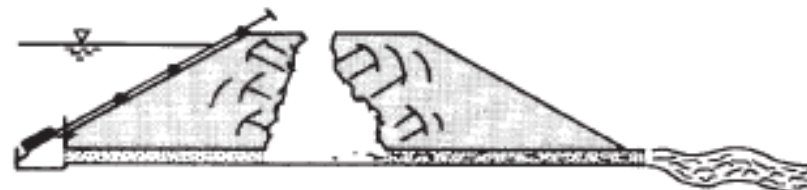
C - Sinkhole develops, complete failure is probable.

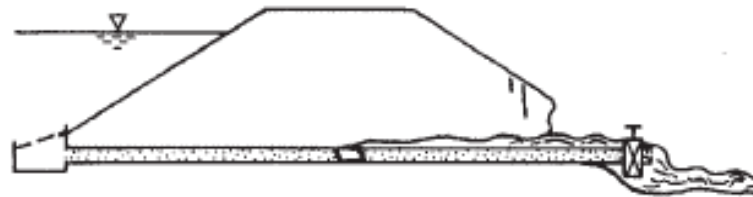
B - Hole enlarges allowing increased flow and a piping failure begins.
