Klohn Crippen Berger

Faro Mine Complex

2016 Annual Geotechnical Review

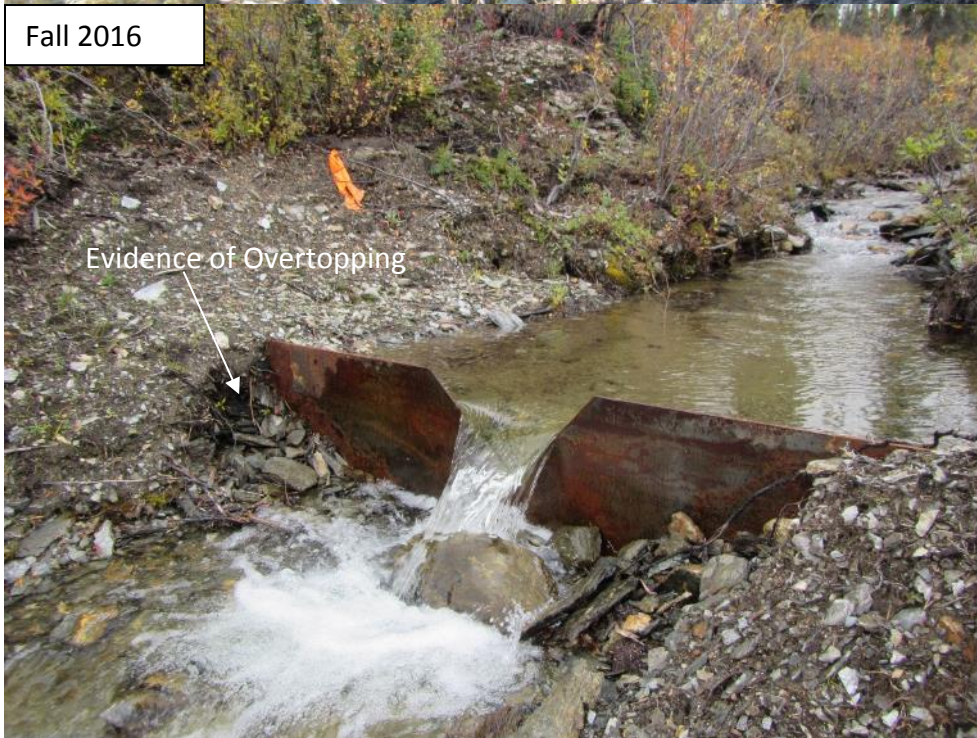
Photograph 6 Interceptor Ditch upstream of upper man-made reach at new weir location. Evidence of overtopping on right abutment.

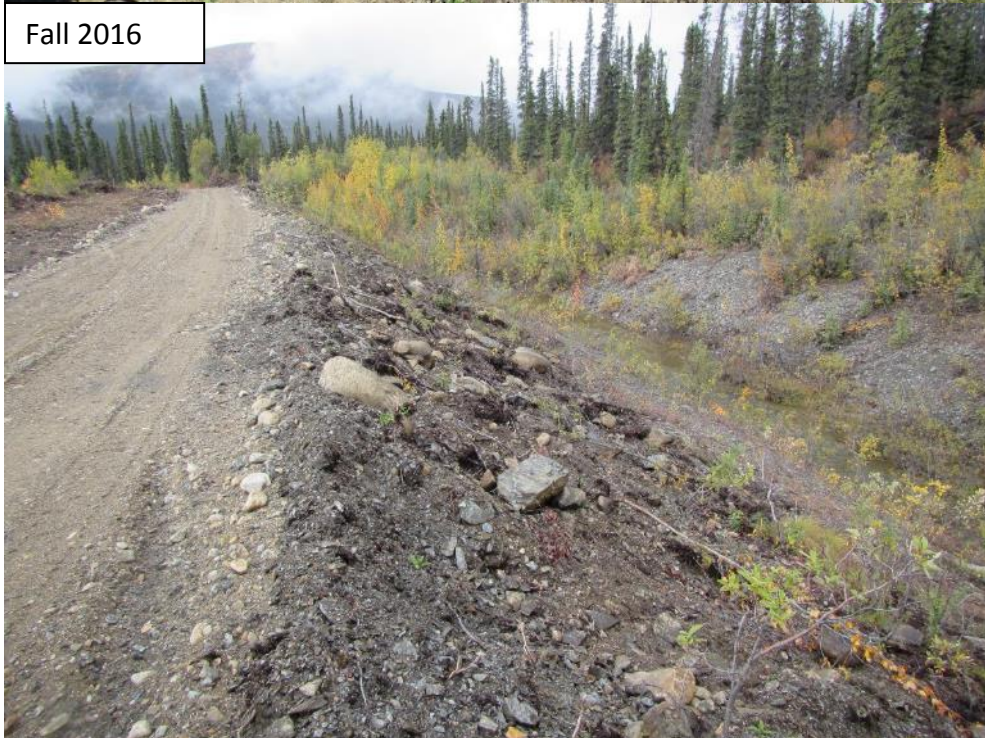
Photograph 7 Interceptor Ditch upper man-made reach - vegetation roots were removed in fall 2016. Erosion control measures should be implemented in spring 2017. Approximately 565 m from the diversion inlet.

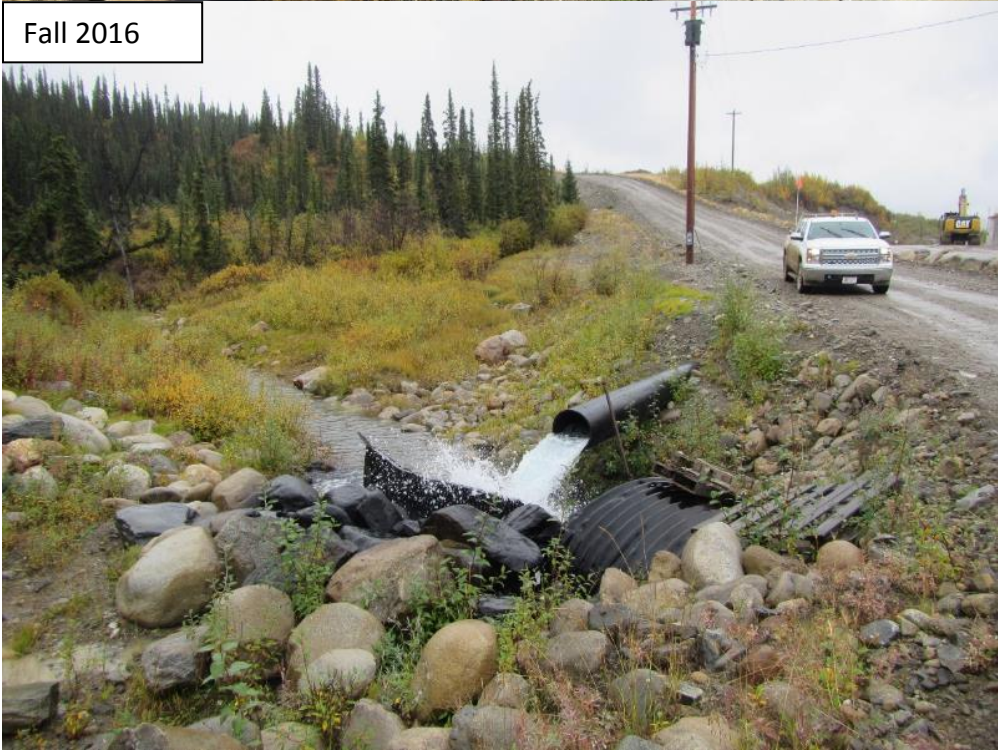
Photograph 11 Culvert between middle reach to lower reach of ditch – water treatment release pipeline. Direct discharge in fall. Approximately 2600 m from the diversion inlet.

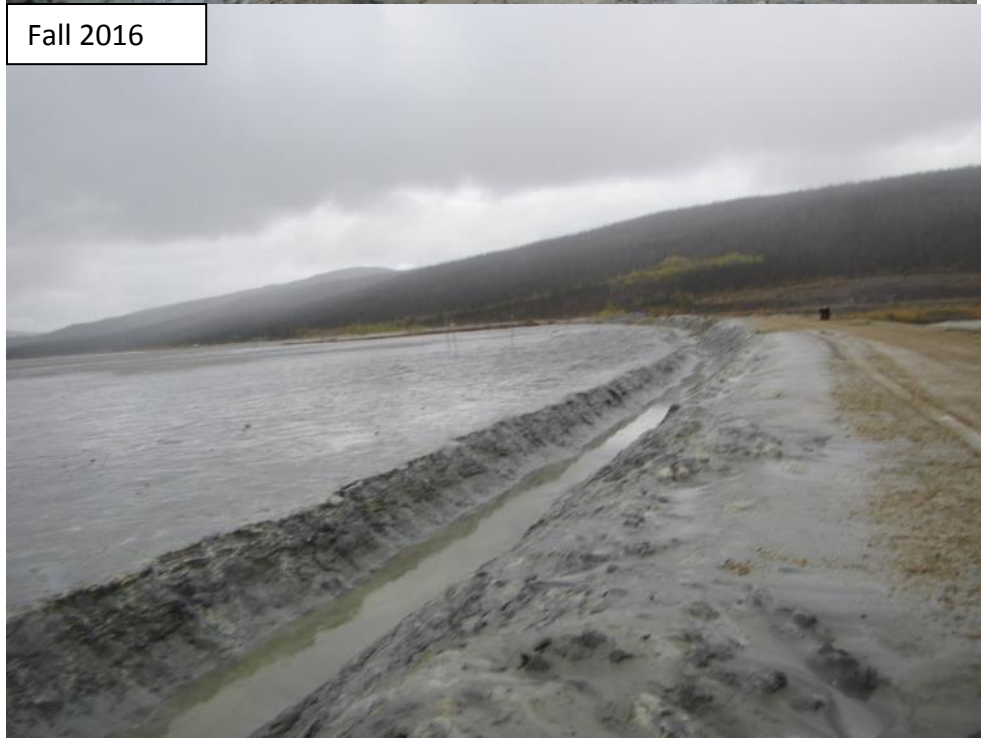
Photograph 23 Secondary Tailings Dam upstream ditch looking south. Ditch appears deeper since spring.

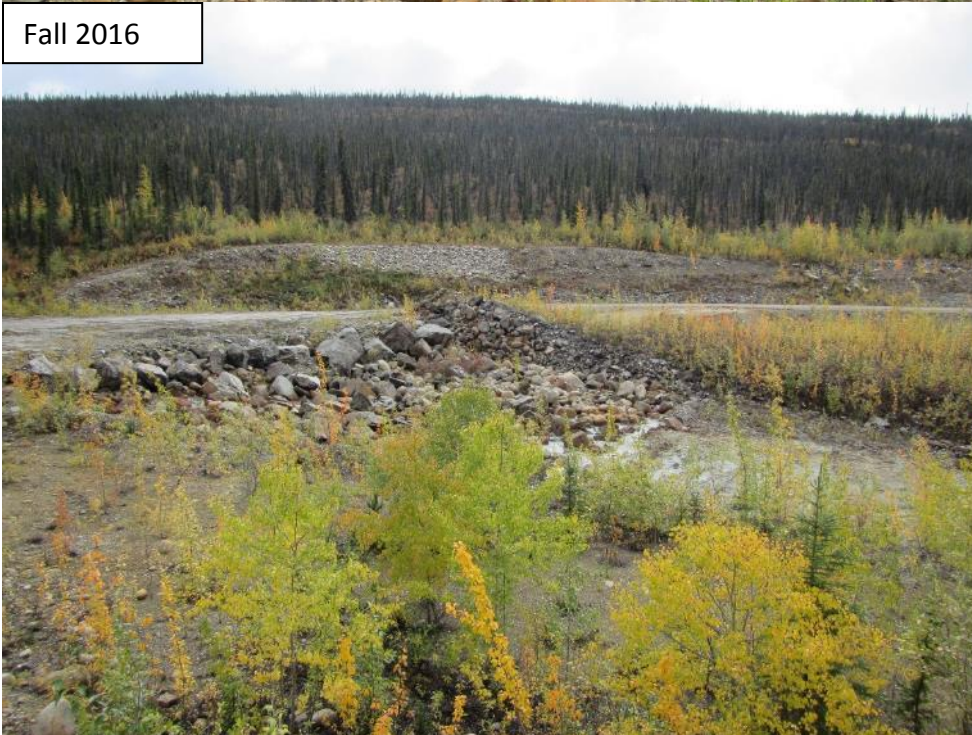
Photograph 24 Fuse plug of Canal Dyke, looking upstream. Vegetation on downstream slope of Secondary Tailings Dam should be removed.

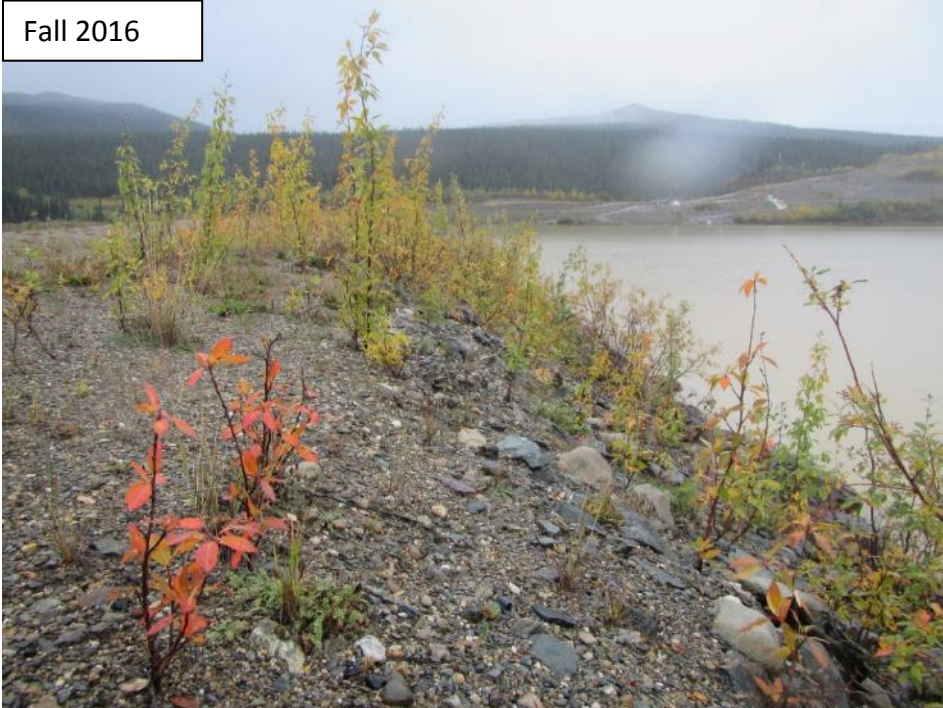
Photograph 31 Upstream slope (looking north), vegetation growth. Trees should be removed.

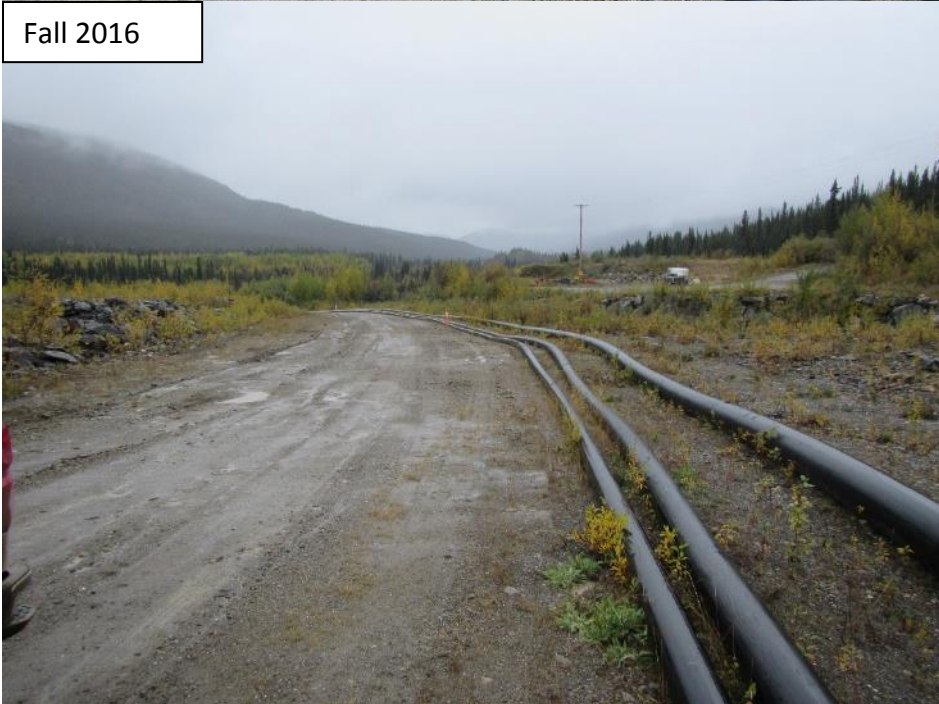
Photograph 32 Siphon pipelines in spillway, looking downstream

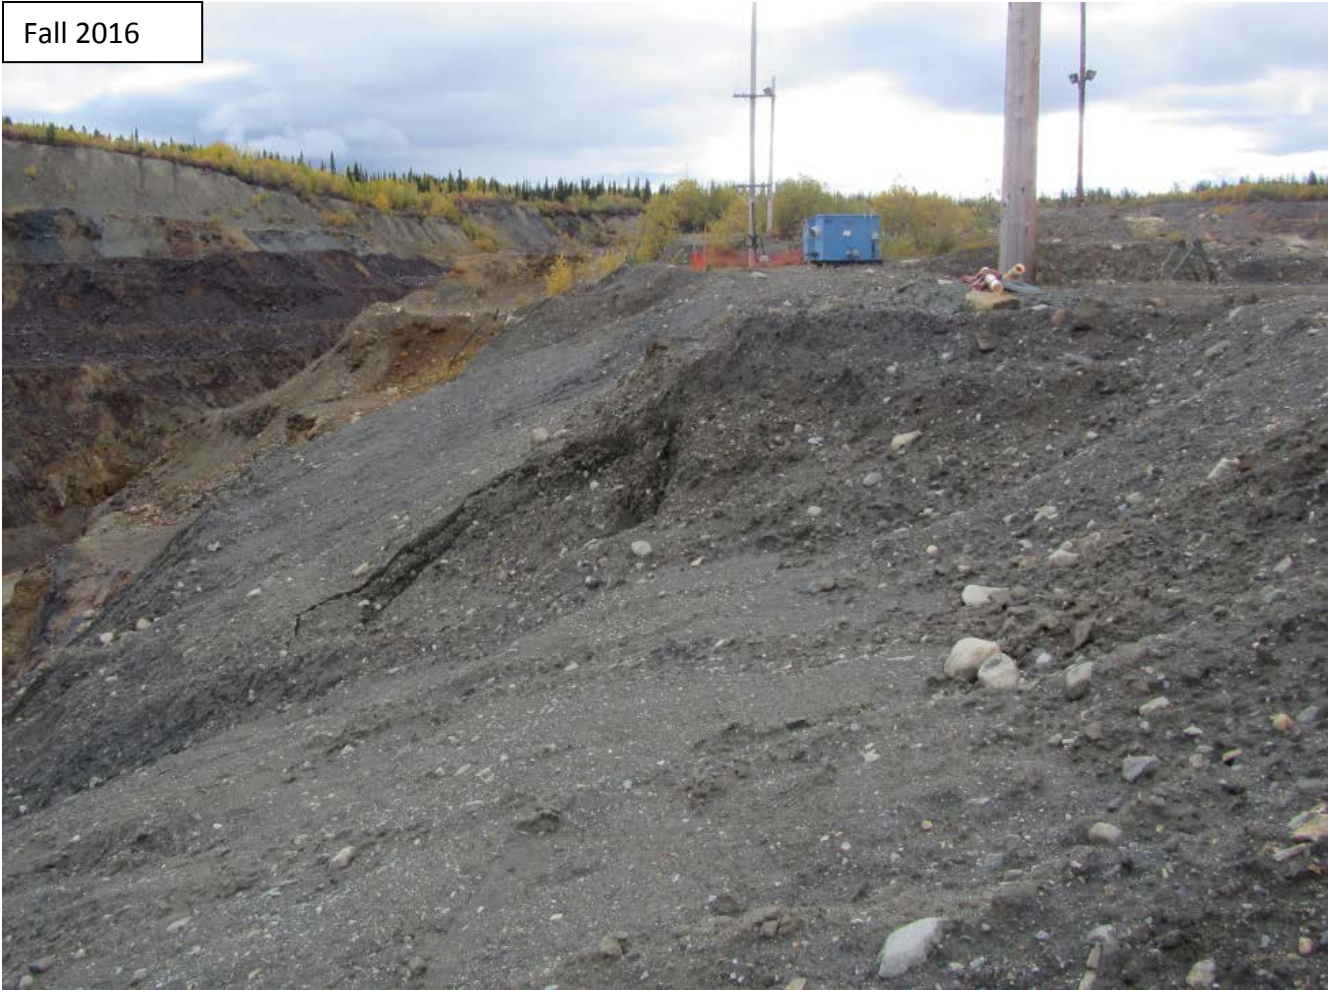
Photograph 36 Vangorda Diversion Sinkhole showing signs of settlement.

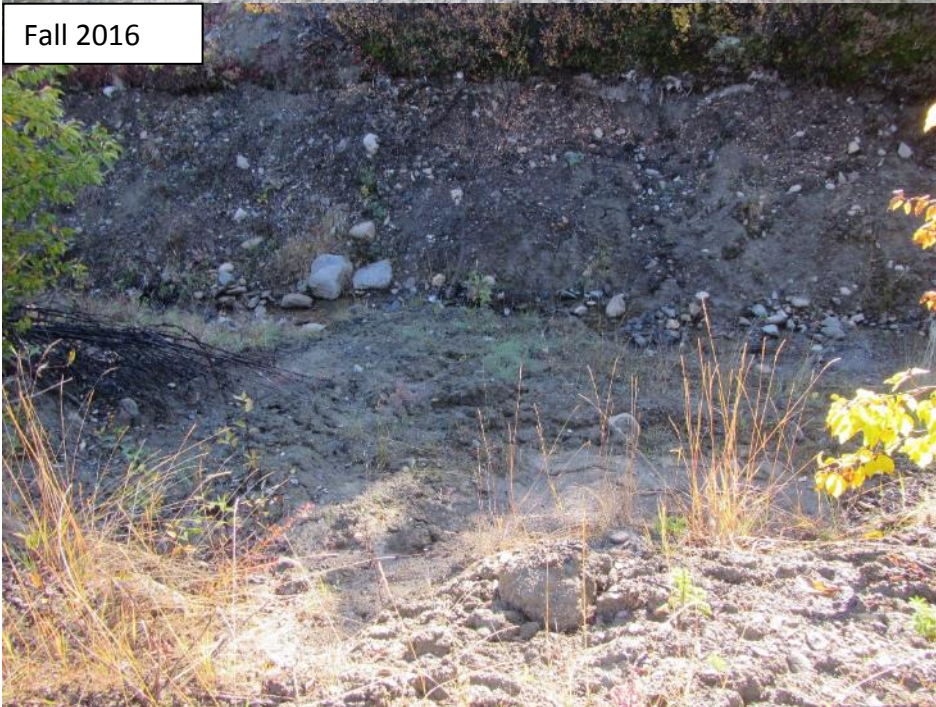
Photograph 44 Slumping on road slope. Progressed slightly since spring.

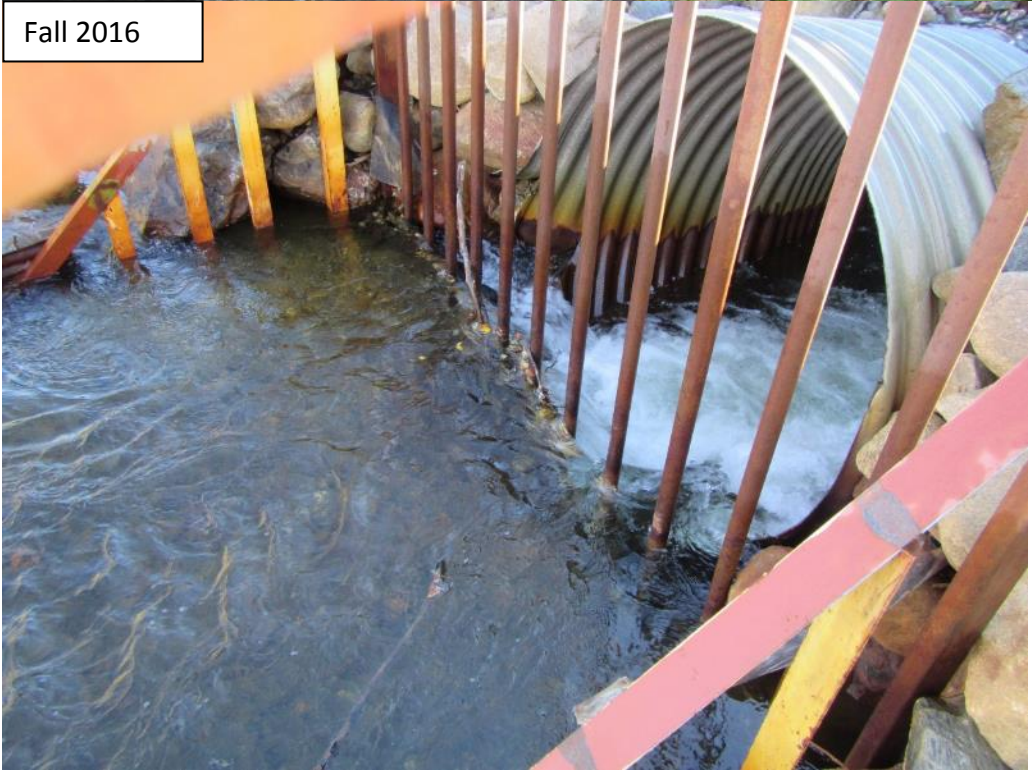
Photograph 52 Outlet to Flume Plunge Pool - trash rack. Leaves and woody debris accumulate on the trash rack and need to be removed as part of regular maintenance.

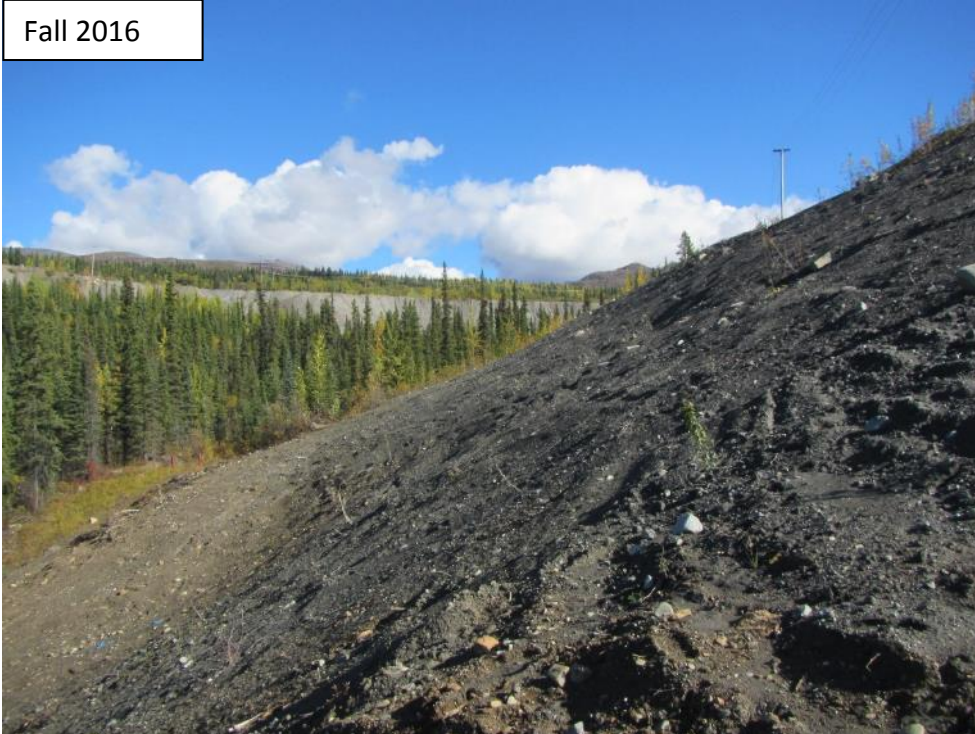
Photograph 57 Rill erosion on downstream berm slopes. To be graded in the fall and revegetated in the spring.

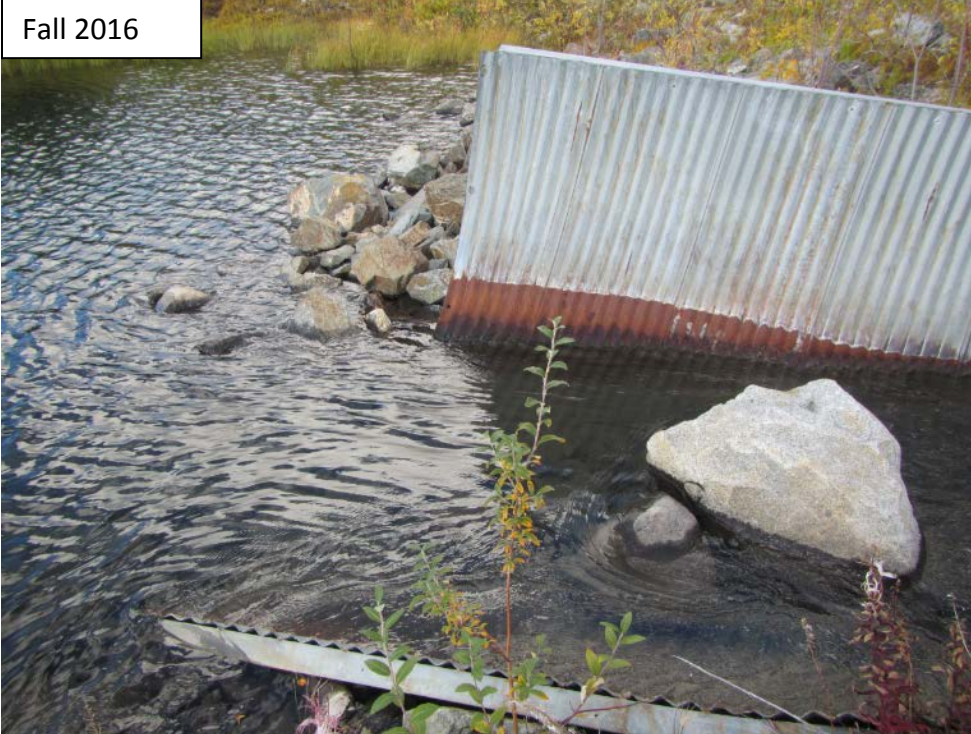
Photograph 59 Upper end of spillway from the Upper to Lower Sediment Pond. Boulders impeding flow.

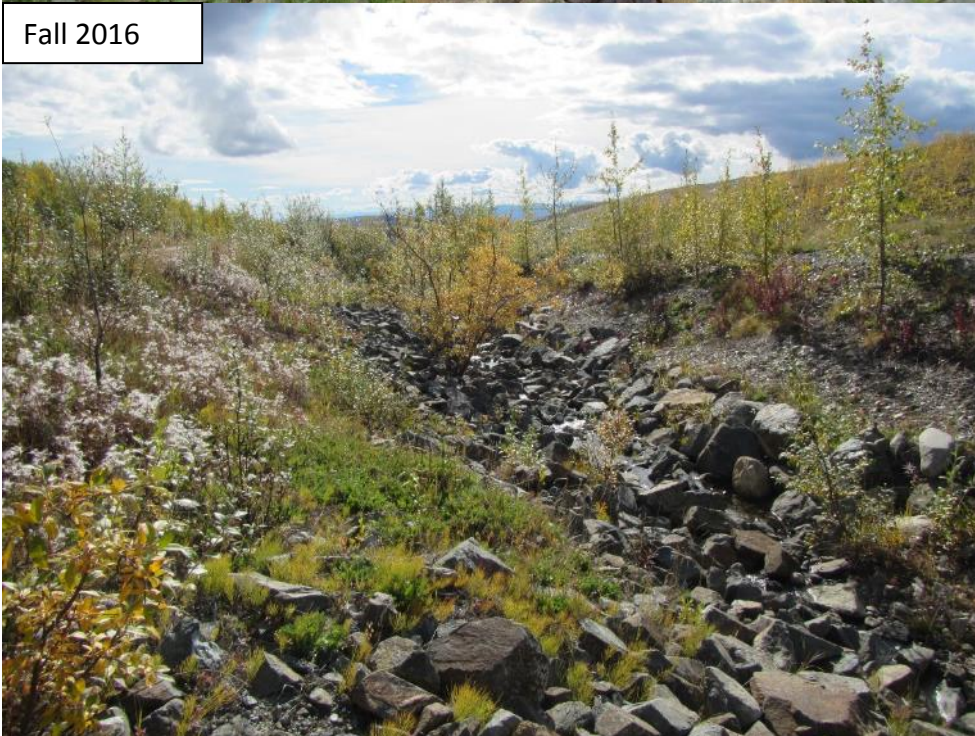
Photograph 61 Pond spillway channel, looking downstream towards Grum Interceptor Ditch. Trees on embankment and in spillway should be removed.

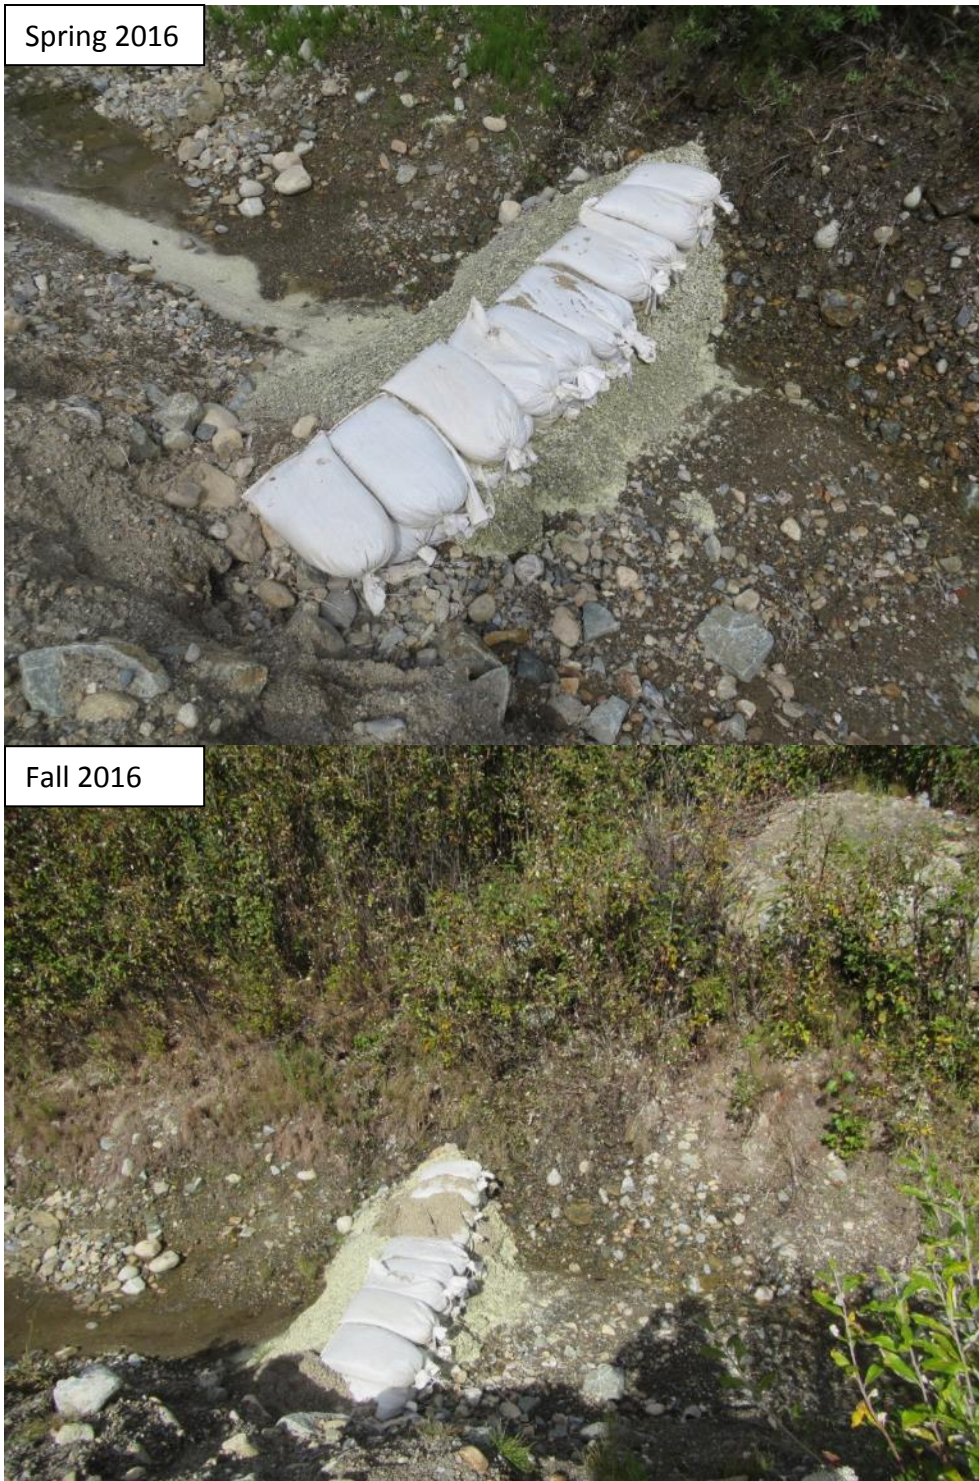
Photograph 62 Sand bags and bentonite are blocking most of the seepage to Moose Pond.

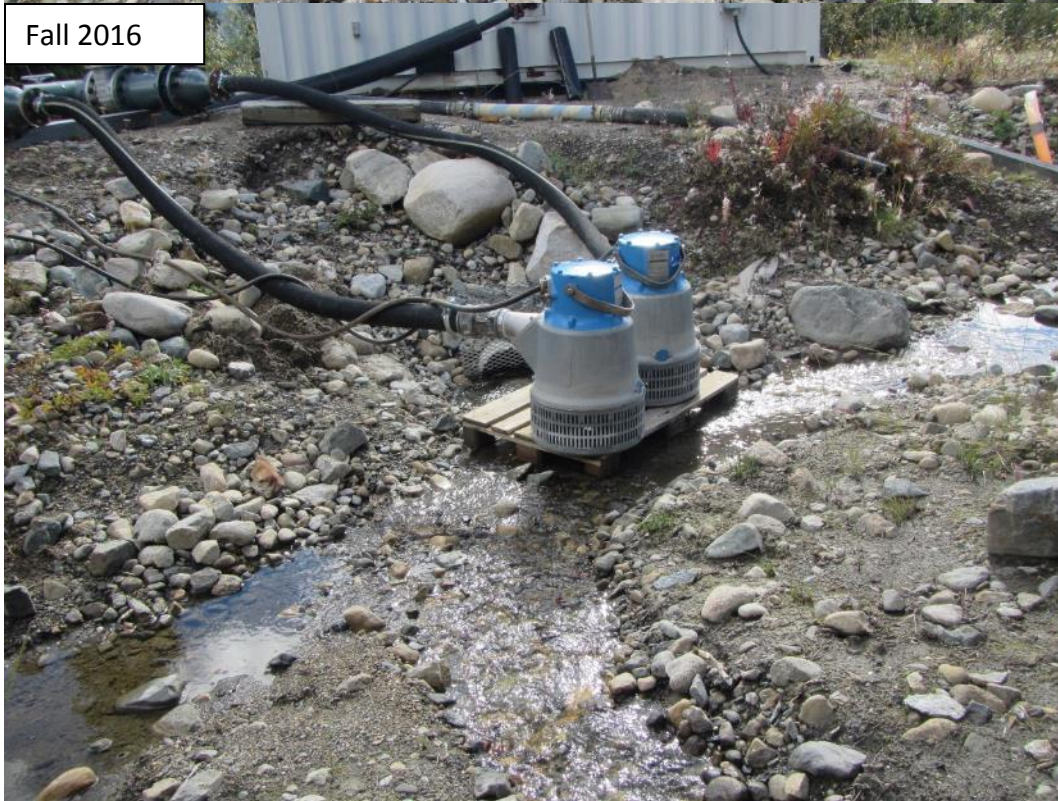
Photograph 63 V-15 ditch and pumps, water pumped out before reaching Moose Pond

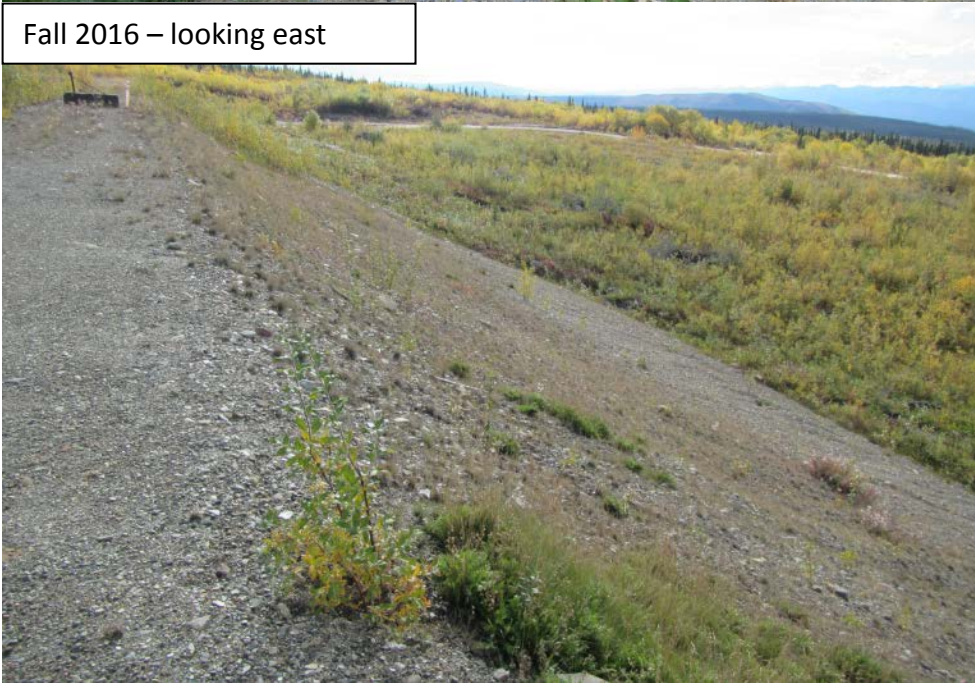
Photograph 66 Clarification pond, dyke crest and downstream slope. Some trees to be removed.
