**1999 Annual Inspection  
Waste and Water Management  
Facilities Vangorda Mine  
Yukon Territory**

**Report No. 1CD003.02**

**December, 1999**

**STEFFEN ROBERTSON AND KIRSTEN (CANADA) INC.**

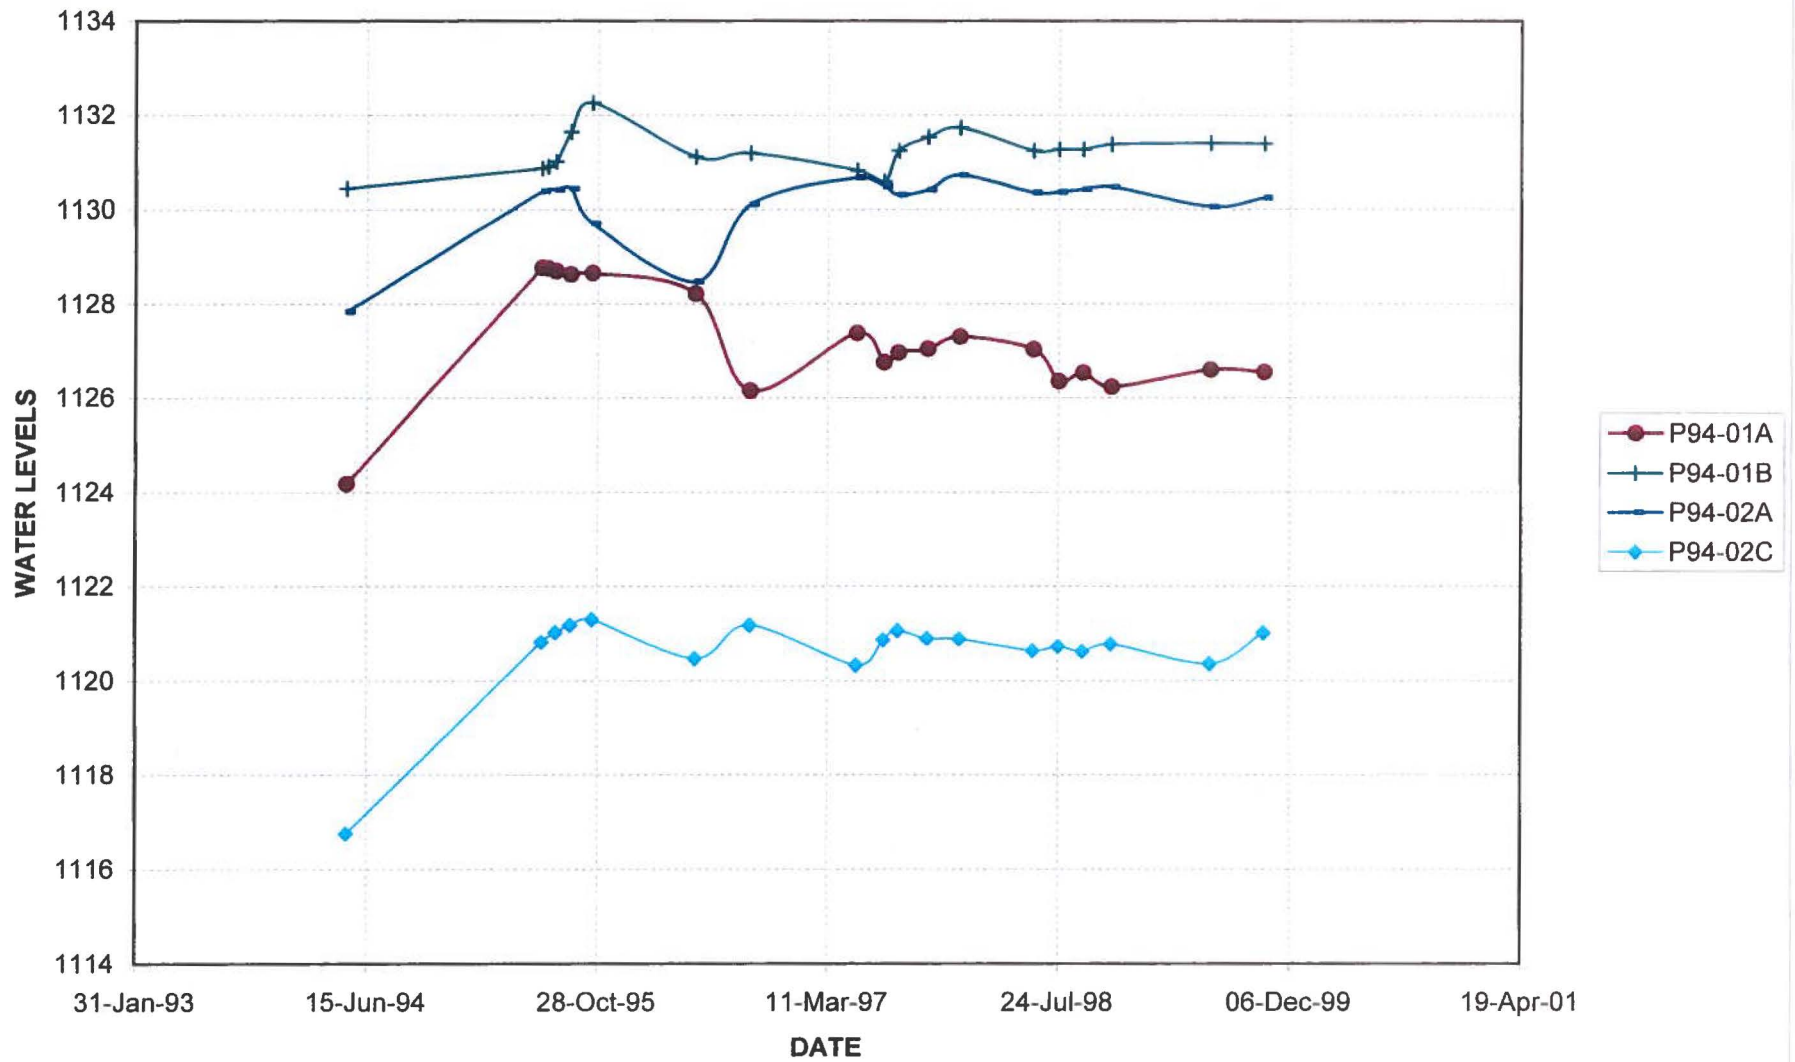
FIGURE 5: PIEZOMETER LEVELS - VANGORDA WASTE DUMP

DTI has been taking water level readings from the nine piezometers and four of the five groundwater wells around and within the facility. A summary of the water level readings taken to date in both the piezometers and the groundwater wells is presented in Table 1. Water levels, as recorded on October 12, 1999 in Piezometers P94-01A, 01B, 02A and 02B, are shown in Figures 3 and 4. A plot of the historical readings for these piezometers is shown on Figure 5. The water levels in the piezometers continue to remain generally static with minor fluctuations. Figure 6 presents a plot of the levels in the groundwater wells around the dump.

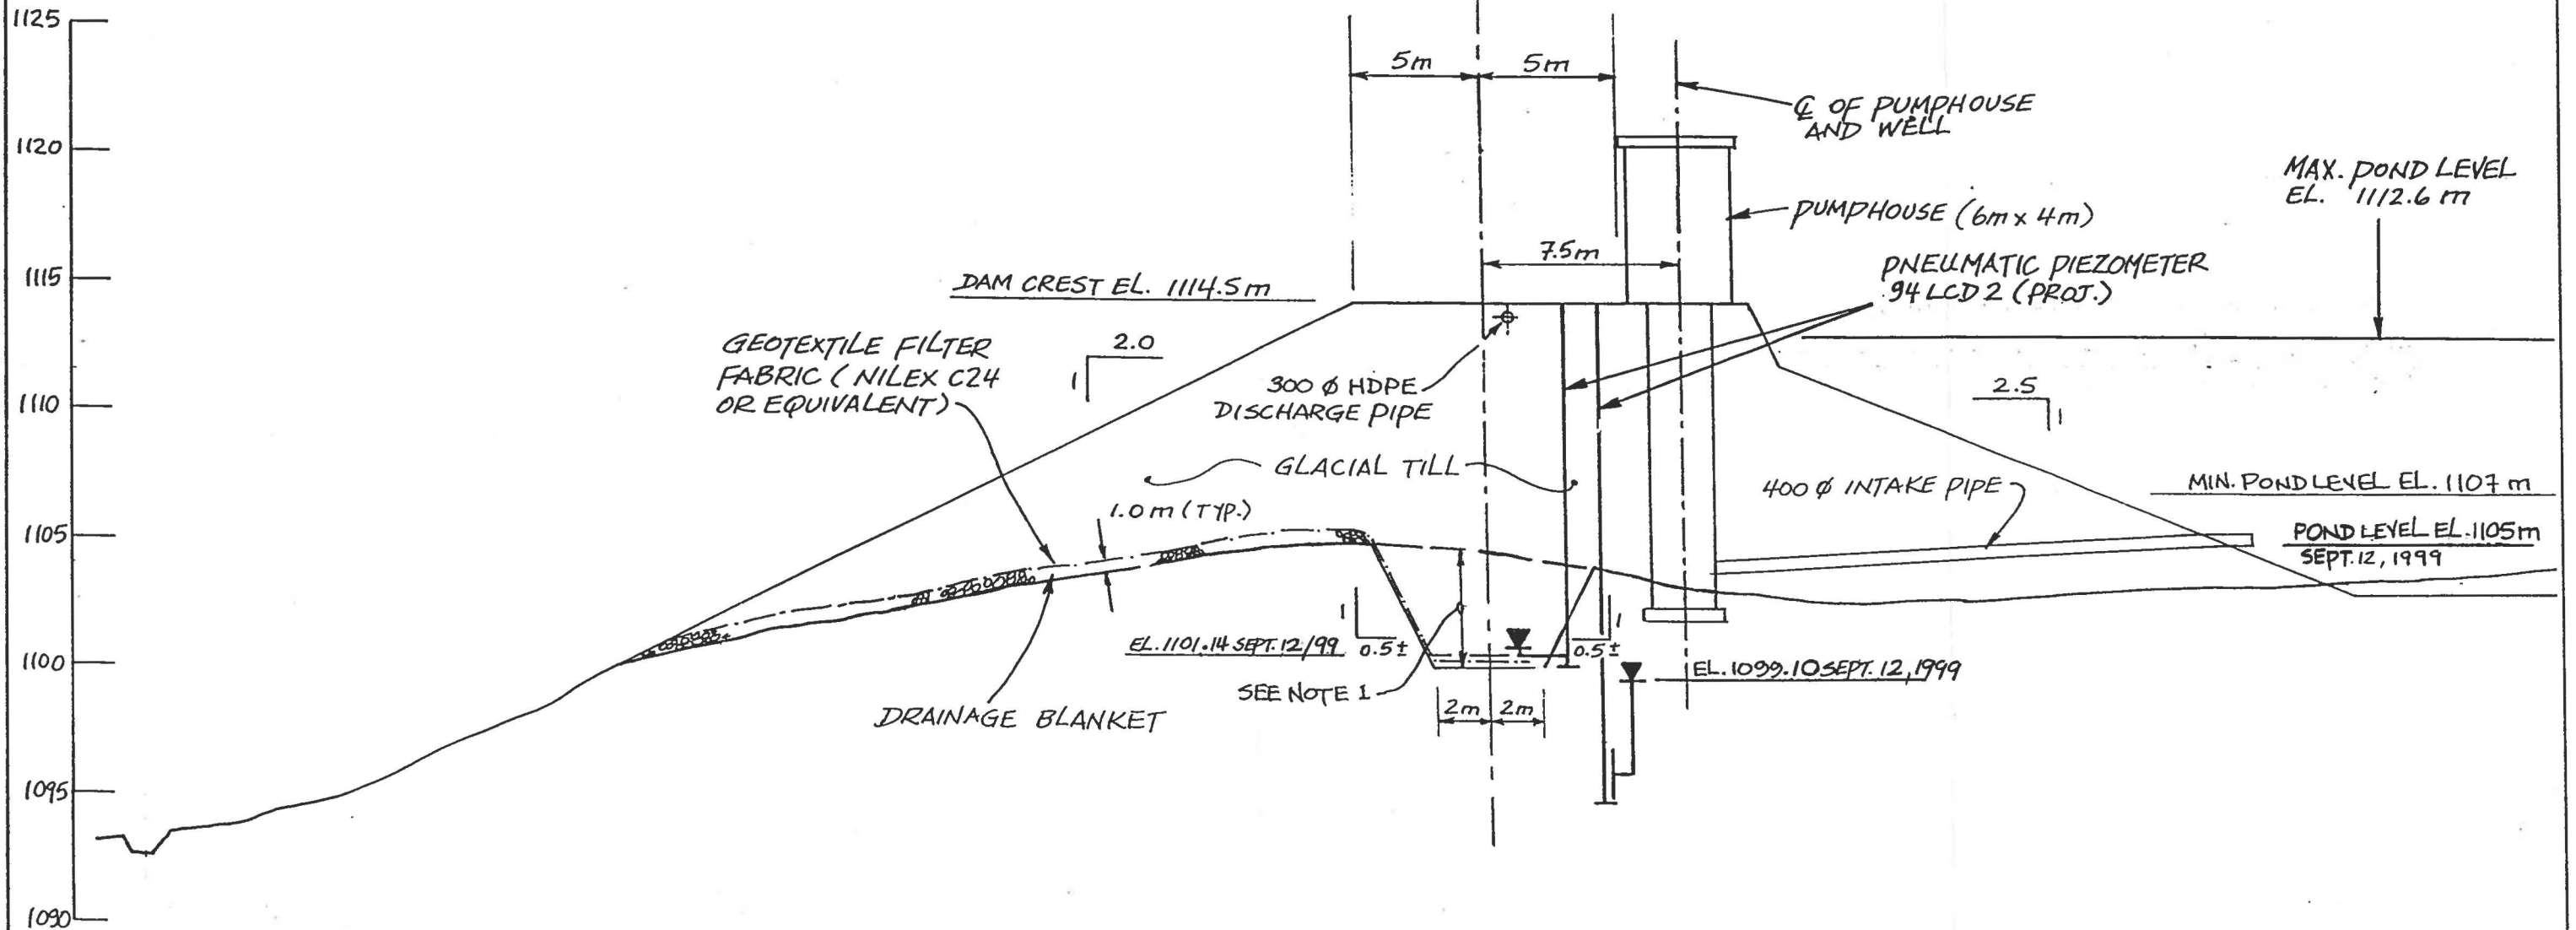
SRK CONSULTING Consulting Engineers	VANGORDA PLATEAU MINE		
	LITTLE CREEK DAM SECTION B-B		
DELOITTE & TOUCHE LTD.	PROJECT NO. 1CA003.02	DATE DEC. 1999	APPROVED  FIGURE 8

In 1994, six pneumatic piezometers and three thermistors were installed along the crest of the Little Creek dam. The six piezometers are located at three separate locations; two piezometers, one deep and one shallow, at each location. The location of the piezometers and thermistors are shown on Figure 7 and the most recent 1999 piezometric levels are shown in section on Figures 8 and 9. Actual readings are presented in Appendix B.

SRK recommends that the pneumatic piezometers and thermistors are monitored on a semi-annual basis and the results compiled and forwarded to SRK.

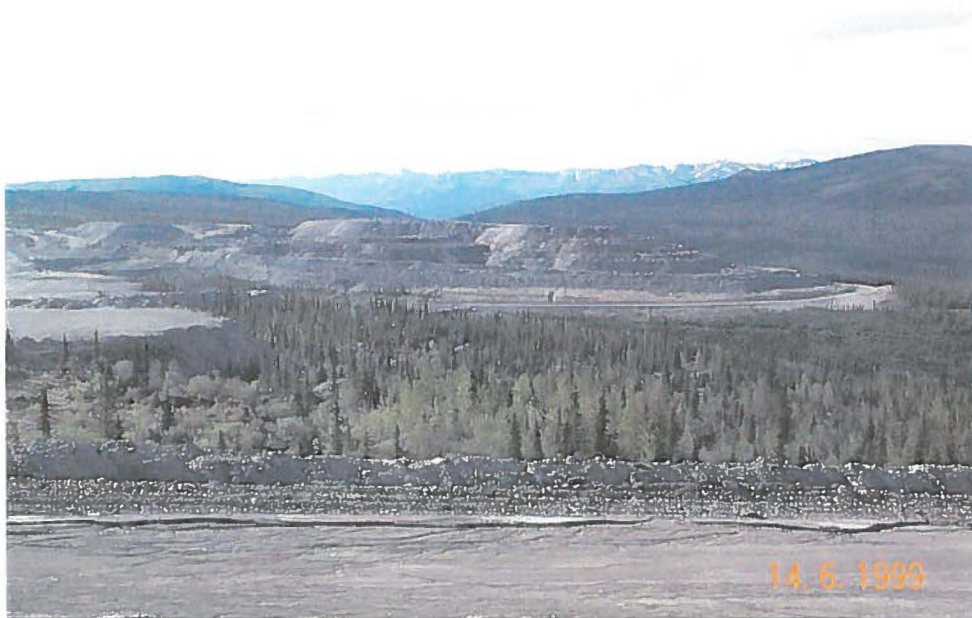
Photo 1: A view overlooking the Vangorda Waste Dump and the Seepage Collection Ditch

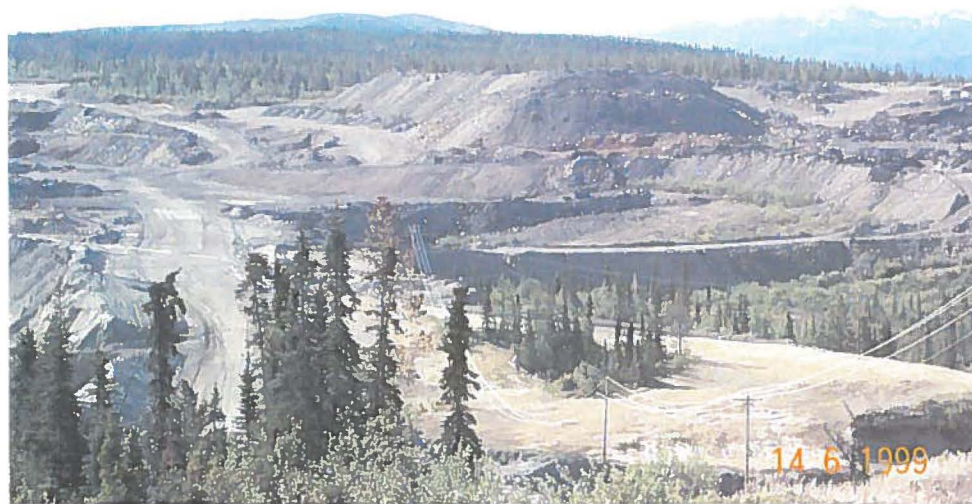
Photo 2: View of the Till Stockpile and Pelley Pond.

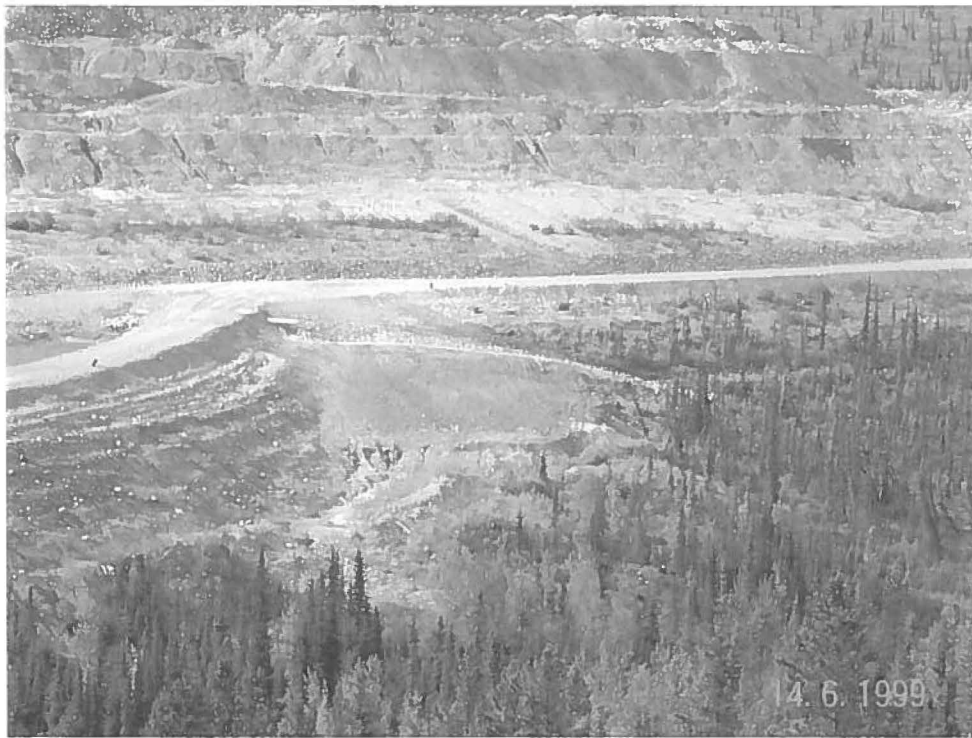
A view of the dam and the new emergency spillway are shown on Photos (8 and 9). Runoff from the eastern approach road (Photo 11) continues to cause erosion of the road embankment sideslopes. Two erosion gullies (photo 13), which are in places 1m deep, are located on the upstream face of the approach road. Runoff from the road flows through the two gullies and over the sideslopes. These gullies pose no immediate threat to the stability of the dam itself but if allowed to go unchecked could result in loss of a section of the road.

Photo 8: CSP Culvert Spillway in Little Creek Dam

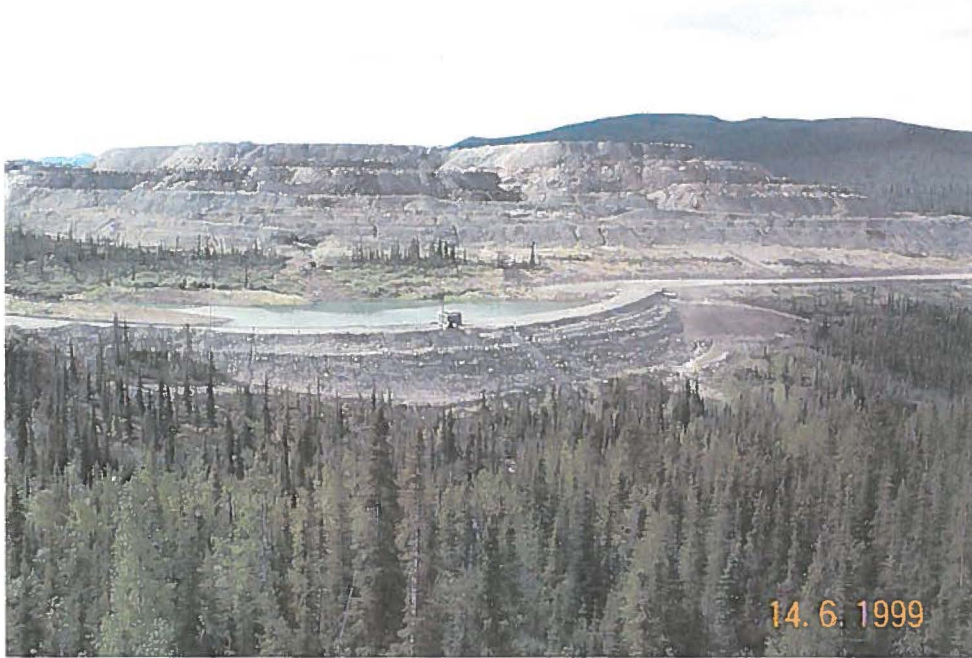
Photo 9: Little Creek Dam

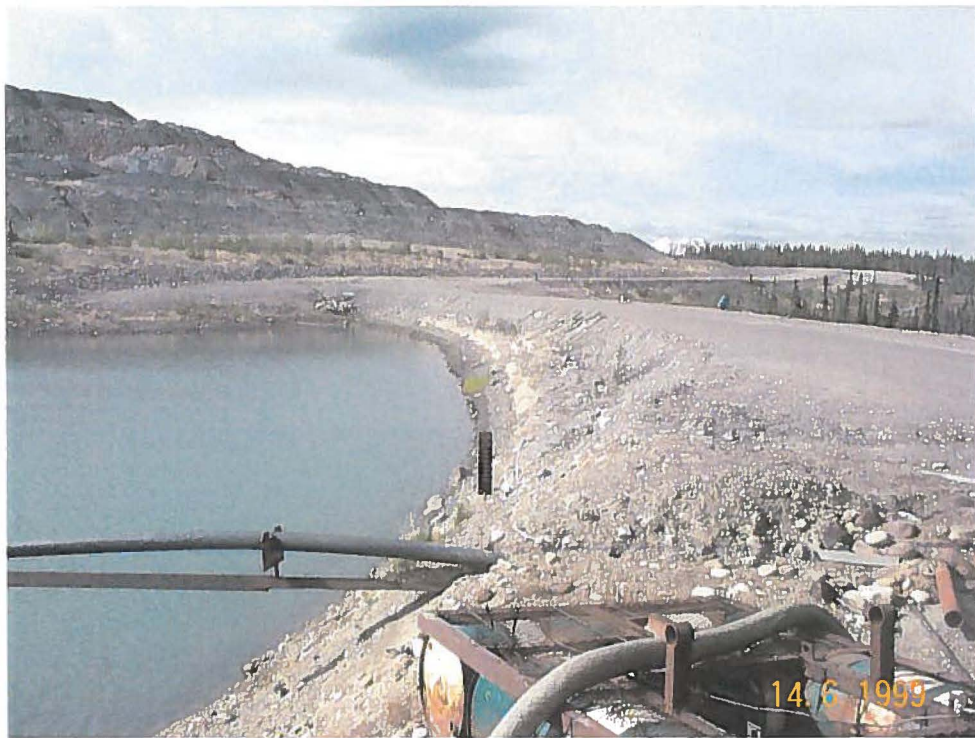
Water level in the pond during our inspection was recorded at about 1110.5m (Photo 10). The mine periodically pumps water from the pond to Vangorda Pit. However, at the time of our inspection no water was being pumped from the pond. Small erosion gullies were observed along the upstream face (Photo 12) of the dam resulting from runoff from the crest. No cracks or major settlement of the dam were observed and there was no noticeable seepage along the toe.

Photo 12: Upstream Face of Little Creek Dam

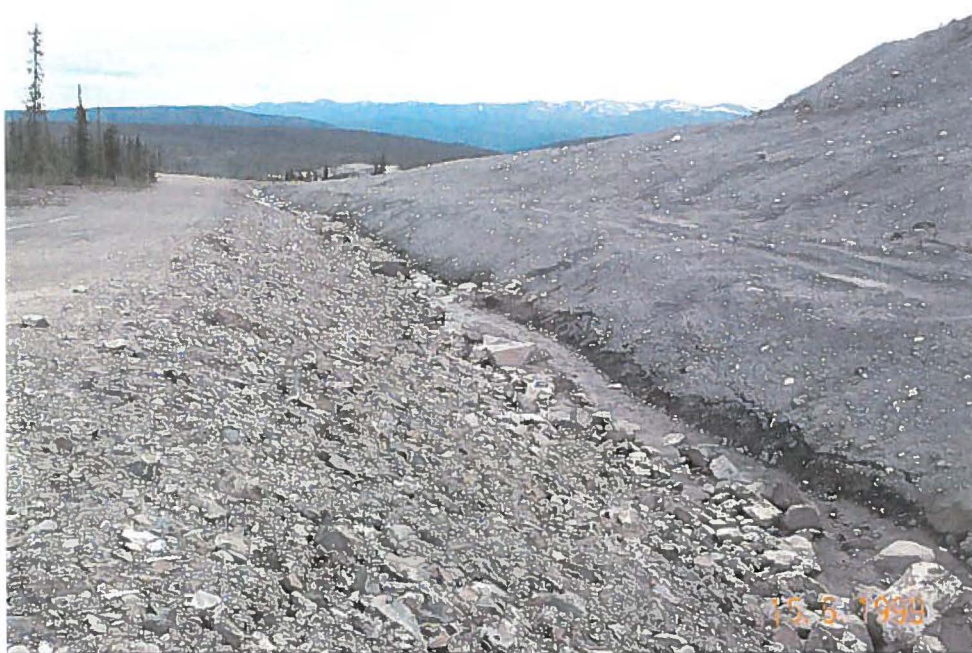
In the upper reaches of the GID, the slopes have performed well and the vegetation is providing effective erosion control of the sideslopes (Photo 28). Inlets and outlets of some of the culverts are silted up and require cleaning. Below the treatment plant, however, there are sections of the ditch where the grade steepens and the sideslopes have subsided narrowing the channel (photo 29 and 30). This subsidence results in an increase in the sediment load reporting to the Sheep Pad ponds. No riprap has been placed on the sideslopes in this area. During the inspection it was noted that the culvert that conveys flow from the GID into the sediment ponds has been damaged and the road fill above the culvert is badly eroded. However, in September 1999 DTI removed the road and the culvert (Photo 30).

Photo 30: Grum Interceptor Ditch

- Place riprap (shotrock) around inlets and outlets of all culverts where applicable to prevent erosion and sediment build-up. Geotextile should be placed against the exposed soil prior to placing the riprap;
- Monitor for tension cracks in the settling pond dykes, on the crest and on the upstream and downstream slopes;
- Monitor for seeps that develop along the toe of the dykes;
- Clean out the fine material in the two small sediment ponds at the base of the channel.
