2000 Annual Inspection Waste and Water Management Facilities Vangorda Mine Yukon Territory

February, 2001

**2000 ANNUAL INSPECTION
WASTE AND WATER MANAGEMENT FACILITIES
VANGORDA MINE
YUKON TERRITORIES**

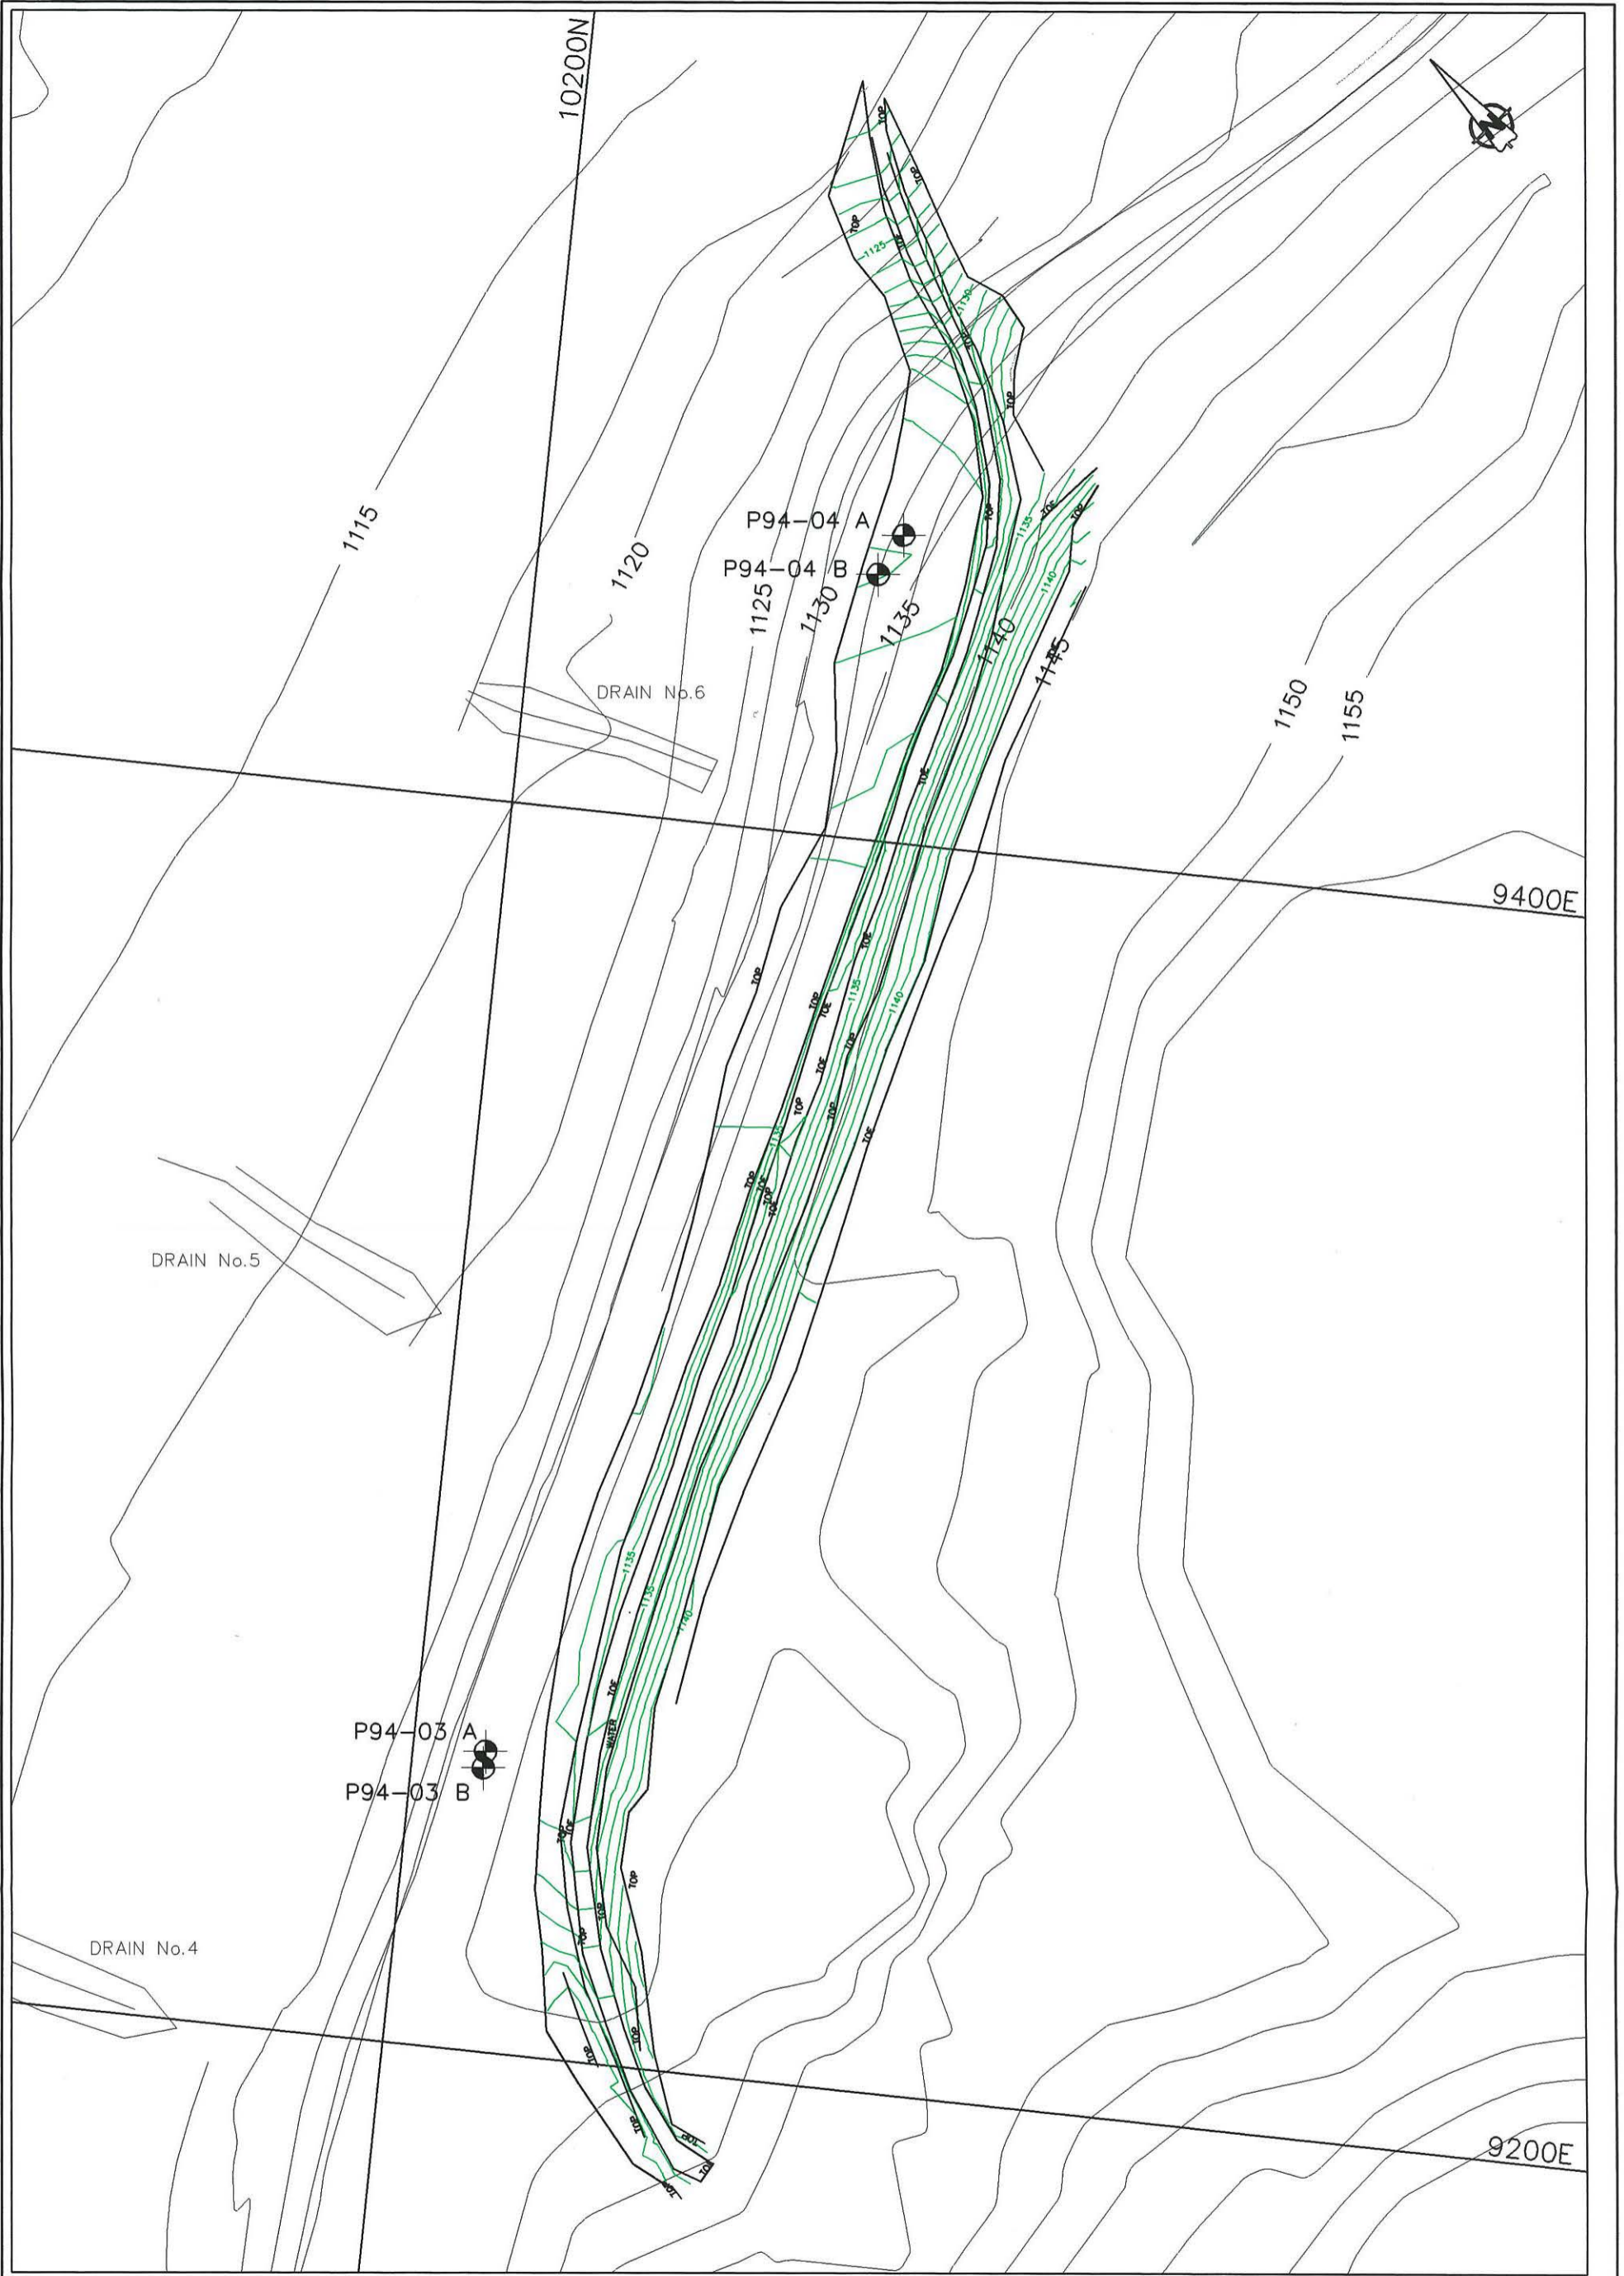
SRK Consulting <small>Engineers and Scientists</small>	VANGORDA PLATEAU MINE			
	STARTER DYKE DIVERSION DITCH PLAN			
DELOITTE & TOUCHE	FILE REFERENCE DIVERSION.DWG	PROJECT NO. 1CD003.03	DRAWING NO. 3	REV.

In an attempt of control runoff and instability of the area above the weir at Drain 6, a ditch was excavated within the crest of the till starter dyke along the north side of the Vangorda Waste dump in September 1999. The depth of the excavation varied from about 1 to 4 m. The sideslopes of the ditch were vertical in most places and had sloughed in at several locations causing water to pool in the ditch. The excavated material had been placed on the downstream slope of the starter dyke resulting in an oversteepening of the upper section of the slope (See photos 5 to 9). Figure 3 shows a

SRK was asked to inspect the ditch during the site visit. SRK prepared an action plan for the ditch, which was presented to DT in a memo dated July 4, 2000. The recommendations included the following:

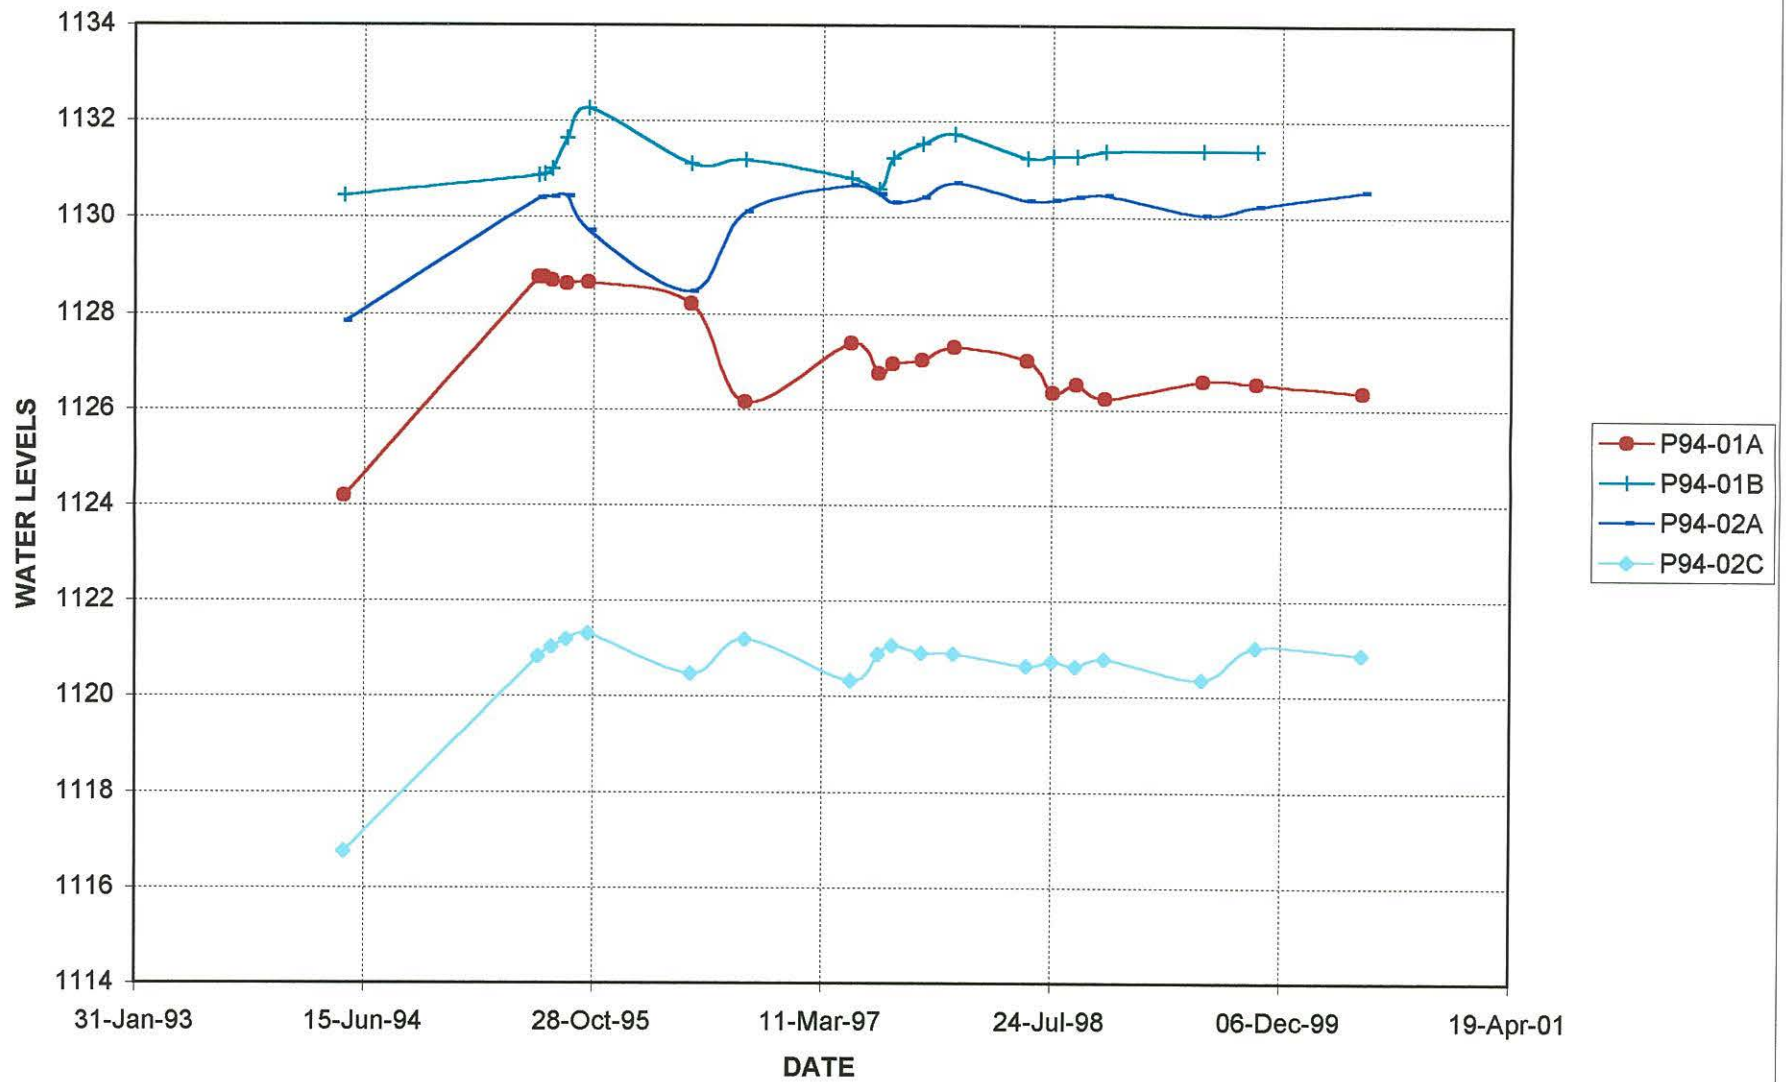
FIGURE 6: PIEZOMETER LEVELS - VANGORDA WASTE DUMP

DT has been taking water level readings from the nine piezometers and four of the five groundwater wells around and within the facility. A summary of the water level readings taken to date in both the piezometers and the groundwater wells is presented in Table 1. Water levels, as recorded on May 31, 2000 in Piezometers P94-01A, 01B, 02A and 02B, are shown in Figures 4 and 5. A plot of the historical readings for these piezometers is shown on Figure 6. The water levels in the piezometers continue to remain generally static with minor fluctuations. Figure 7 presents a plot of the levels in the groundwater wells around the dump.
