2001 Annual Inspection Waste and Water Management Facilities Vangorda Mine Yukon Territory

February, 2002

**2001 ANNUAL INSPECTION
WASTE AND WATER MANAGEMENT FACILITIES
VANGORDA MINE
YUKON TERRITORIES**

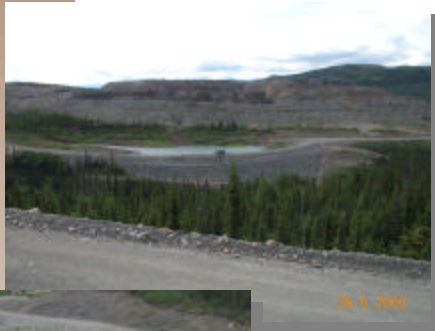
- Vangorda Waste Rock Containment Facility (Photo 1) including the seepage collection system ;
- Little Creek Dam;
- Vangorda Creek Diversion;
- Sludge Pond Embankments at the Water Treatment Plant,
- Grum Settling Pond ;
- The Grum Interceptor Ditch; and
- The Sheep Pad Sediment Ponds below the Overburden Stockpile.
