## 2008 Annual Inspection Waste and Water Management Facilities Vangorda Mine, Yukon Territory

*Project Reference Number  
SRK 1CD003.111*

*January 2009*

**Prepared by  
Peter Healey, P.Eng.**

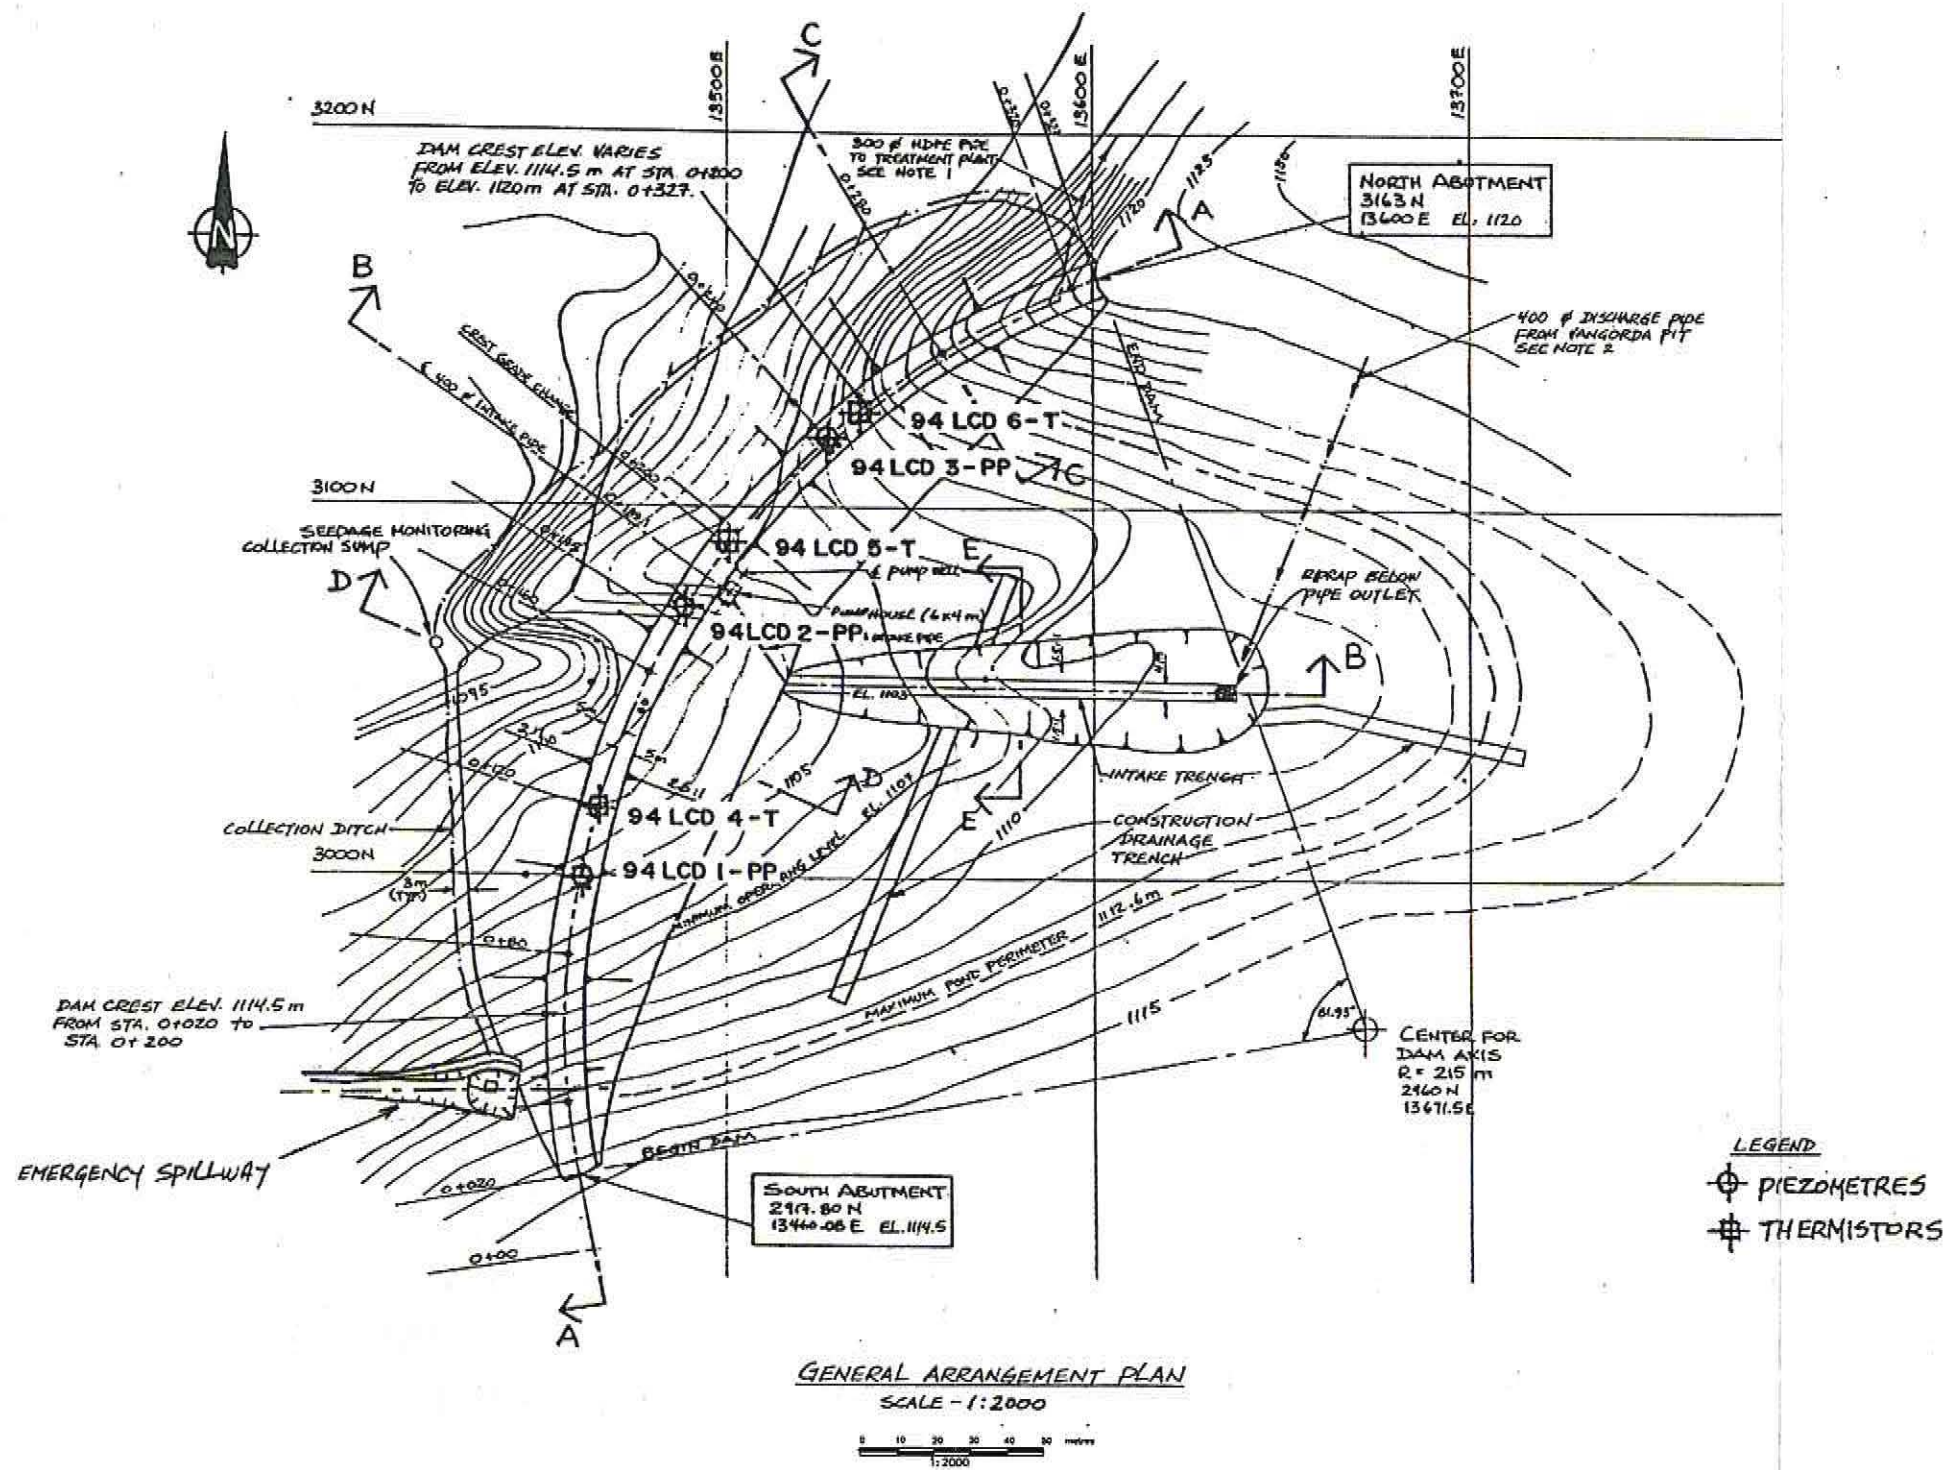
FIGURE: 6

In 1994, six pneumatic piezometers and three thermistors were installed along the crest of the Little Creek dam. The six piezometers are located at three separate locations; two piezometers, one deep and one shallow, at each location. The location of the piezometers and thermistors are shown on Figure 6 and the 2008 piezometric levels are shown in section on Figures 7, 8 & 9. Actual readings are presented in Appendix B. The levels are normally taken twice year in May and August. However, this year because of abnormal fluctuations that were noted in the piezometers last year, SRK requested that readings be taken twice a week over the period April to September. The results are provided in the Appendix B. No unusual behaviour was noted in the readings.

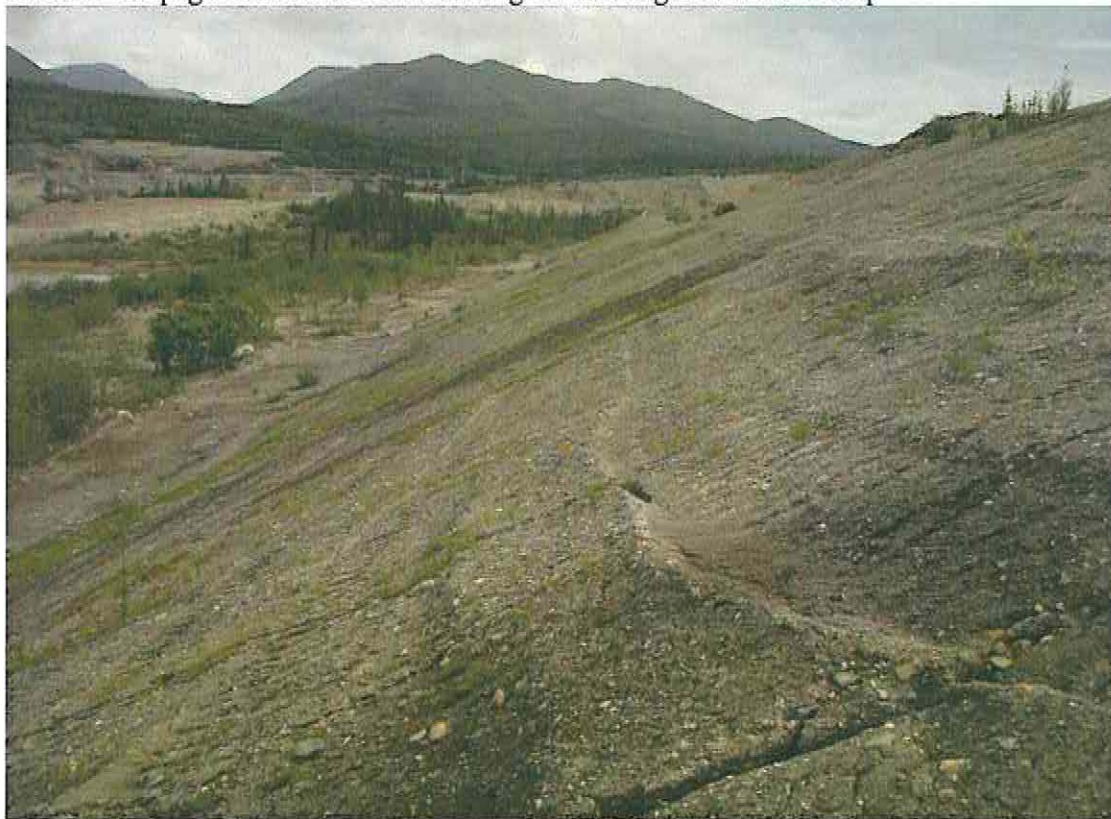
Photo 6: Till Slope above Weirs #5 and #6

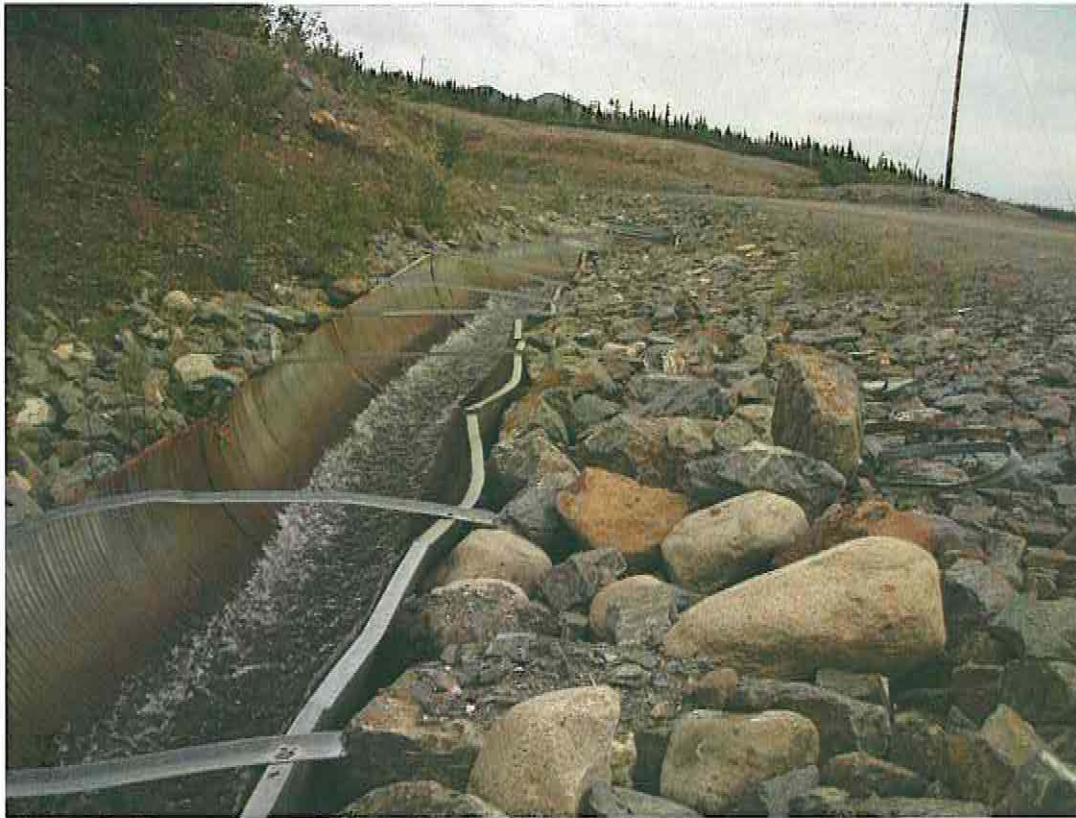
In accordance with a recommendation from SRK, an emergency overflow spillway (2x1m diameter CSP's) was installed at the headworks of the diversion in August 2005 (Photo 14). DTI continues to maintain the 2.4m diameter flume to ensure safe passage of flow in Vangorda Creek. Boulders that fall into the flume (Photo 15) are periodically removed. There are no signs of instability or settlement of the embankment at the headworks of the diversion. However, the cross braces that support the flume continue to deteriorate and water continues to escape through cracks in the flume.

Photo 15: Vangorda Creek Diversion (lower reaches)
