Denison
Environmental
Services

2009 Annual Inspection Waste and Water Management Facilities Vangorda/Grum

Faro Mine Complex, Yukon

February 2010

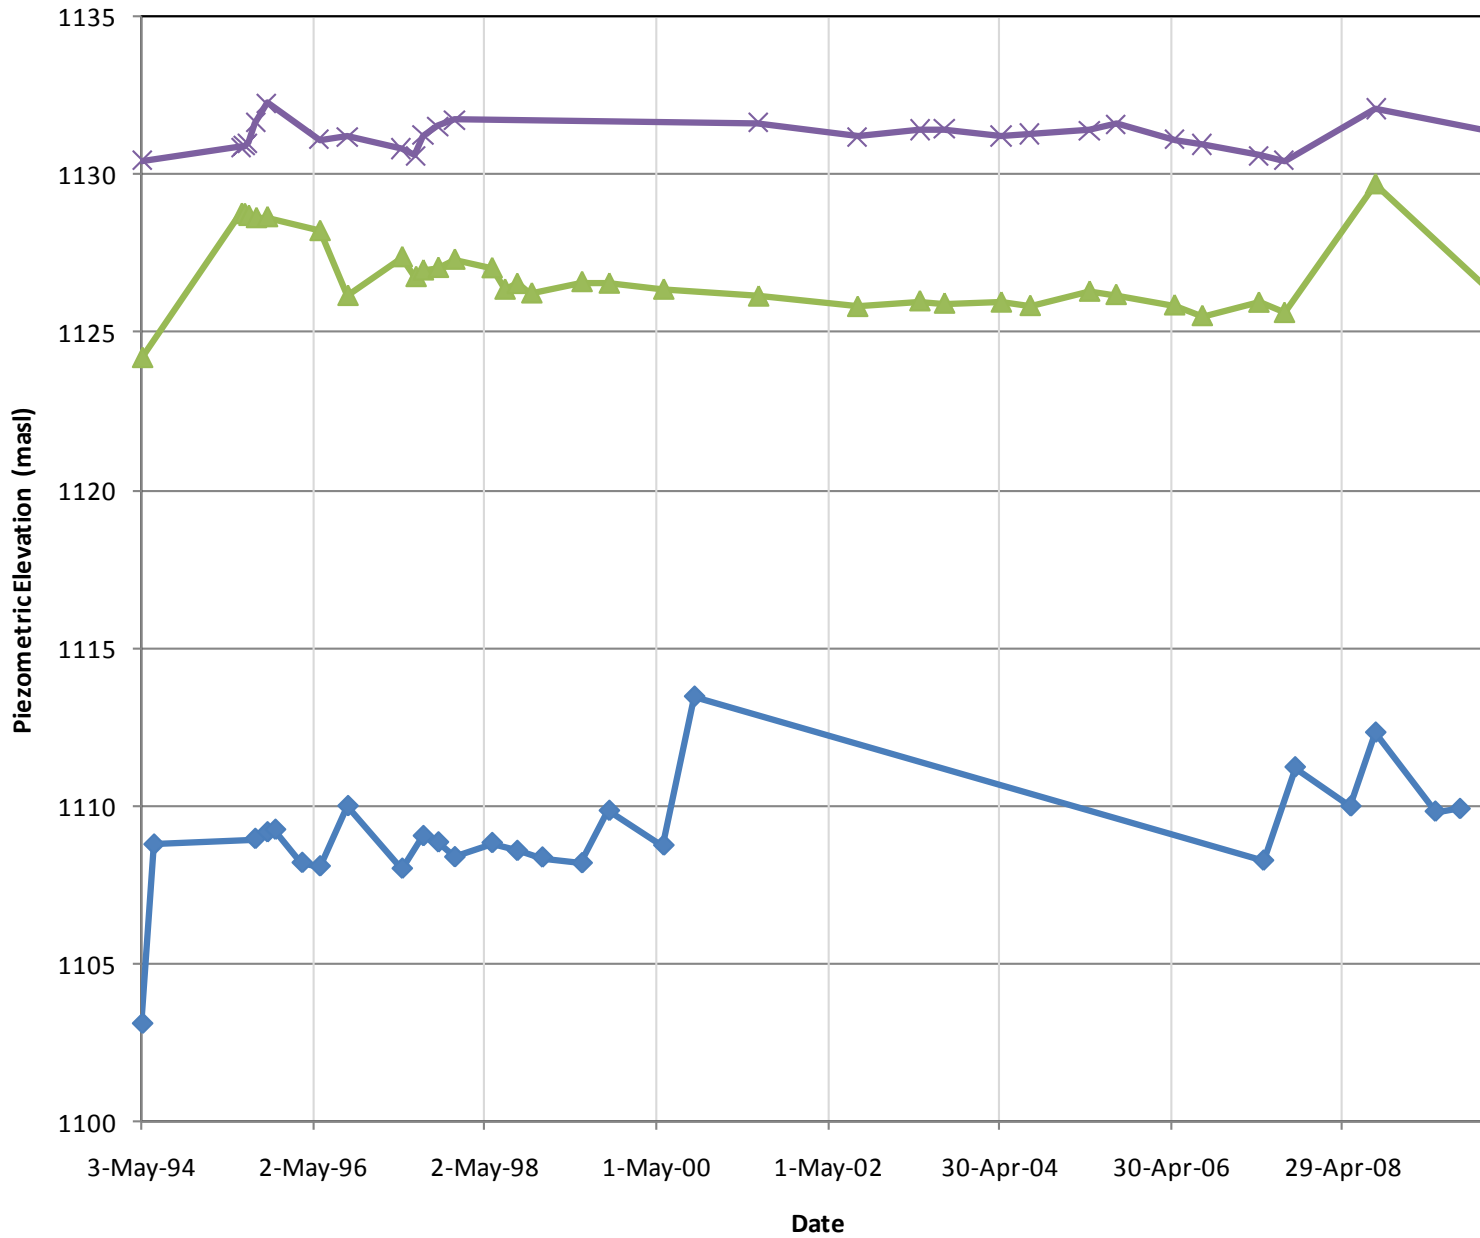
The 2008 levels recorded in these piezometers showed increases varying from 1 to 4m. However based on the recent set of levels taken by DES in February 2010, the water levels in the two piezometers above Weir 3 show a drop back to near the 2007 levels. This drop may, however, be a result of normal seasonal variations within the dump which one would expect in the winter. DES and YG continue their investigation to quantify seepage losses within the Vangorda Waste Rock Dump. A plot of the water levels in the two piezometers above Weir 3 over time is shown in Figure 5. The water level in a groundwater well (V35) located below the weir is also shown on Figure 5 to determine whether there is any hydraulic connection between the piezometers and the groundwater well. A similar comparison of Piezometers V44 and V45 and the groundwater well V37 is shown on Figure 6. The results do not show any clear trend at this stage.

SRK Consulting Engineers and Scientists VANCOUVER	  Denison Environmental Services	2009 Vangorda/Grum Annual inspection	
		Piezometer and Well Levels at Drain #3	
Job No: 1CD009.000 Filename: Figure 5_6_Graphs_20100218.ppt	Faro Mine Complex	Date: February 2010	Approved: _____ Figure: 5

Biannual monitoring of the 1994 Piezometers along the crest of the till dyke and the levels in the wells below the collection ditch is recommended to establish whether there is a trend or pattern in the water table behind the dyke and whether there is any hydraulic connection. Results should be forwarded to SRK.

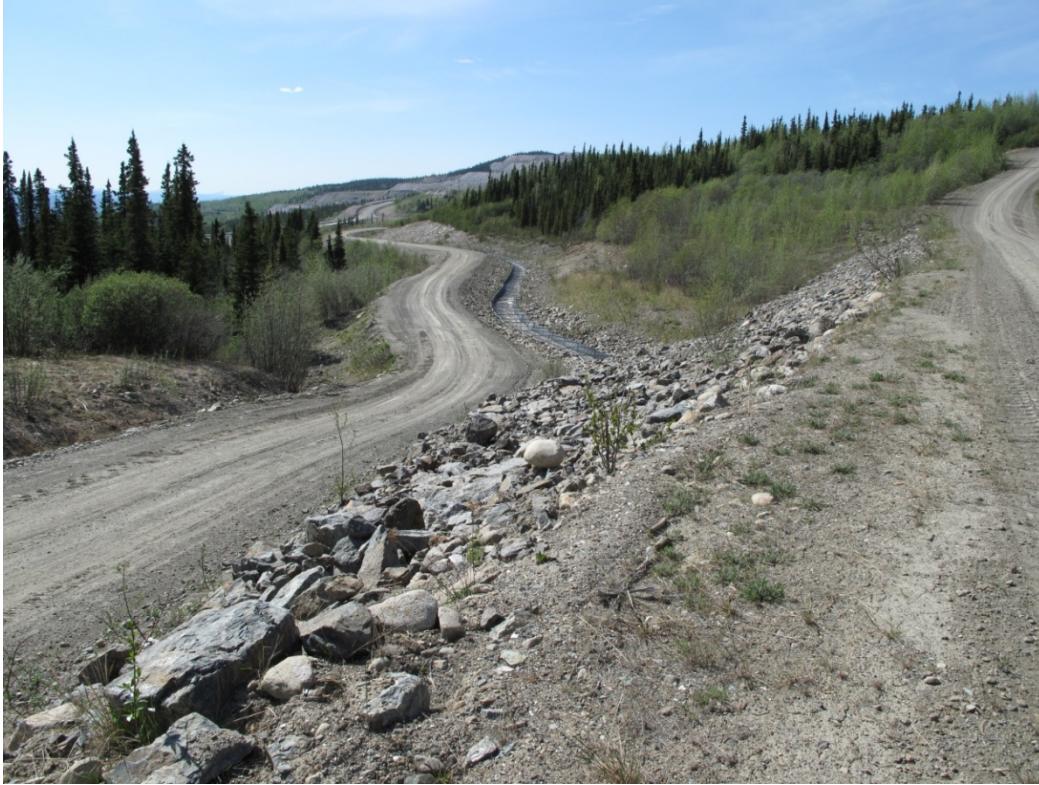
Photo 17: Vangorda Creek Diversion (upper reaches)

In accordance with a recommendation from SRK, an emergency overflow spillway (2x1m diameter CSP's) was installed at the headworks of the diversion in August 2005 (Photo 15). DES continues to maintain the trash rack at the headworks (Photo 16) and the 2.4m diameter flume (Photos 17) to ensure safe passage of flow in Vangorda Creek. Boulders that fall into the flume are periodically removed. There are no signs of instability or settlement of the embankment at the headworks (Photos 16 and 17) of the diversion. However, the cross braces that support the flume continue to deteriorate and water continues to escape through openings in the flume joints (Photos 18, 19 and 20).

DES should continue to monitor the sideslopes above the flume for sloughing and areas of instability and should top-up riprap along the flume where the material has settled below the rim of the culvert sections. Any debris or rock that accumulates in the flume, at the entrance to the 2m CMP or at the headwork's trashrack should be removed. SRK should be notified of any excessive seepage from the flume and increase of discharge into the pit. If any damage to the cross braces and if the structural integrity of any of the flume sections is compromised by ice formation or slides, DES should replace the impacted sections.

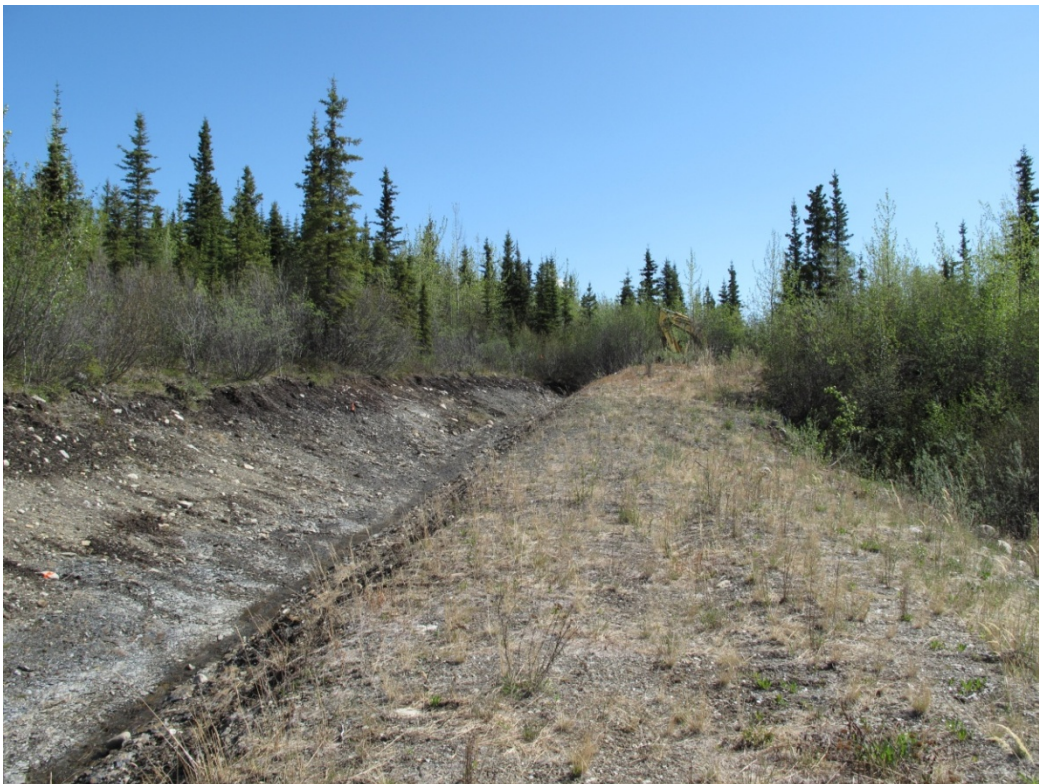
Photo 24: Upper reach of the Grum Interceptor ditch

In the upper reaches of the GID, the ditch slopes remain stable and the vegetation continues to provide effective erosion control of the ditch sideslopes (Photo 24 and 25). However, debris and the odd boulder are beginning to partly block culvert outlets and entrances along the route.
