2010 Annual Inspection Waste and Water Management Facilities Vangorda/Grum

Faro Mine Complex, Yukon

Project Reference Number
SRK 1CD009.003

February 2011

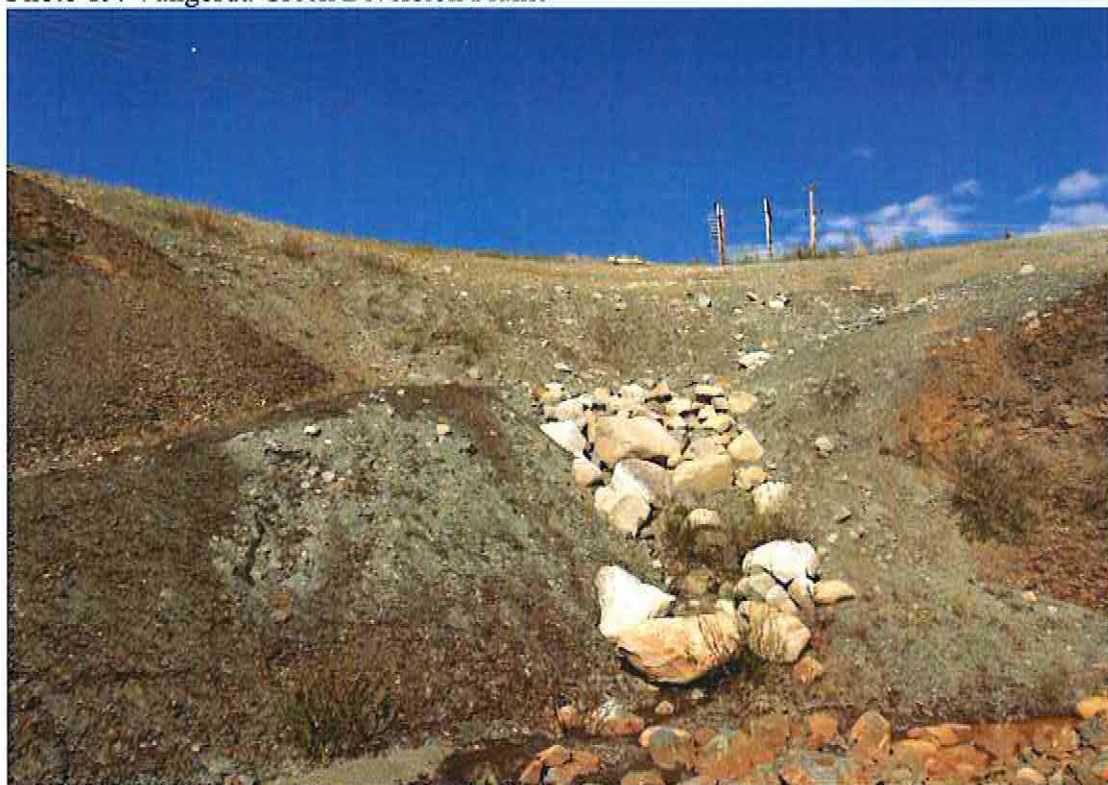
There is an area halfway along the flume that in the past has been unstable due to heavy seepage (Photo 20). Since the remedial work to control this seepage several years ago, no further instability has occurred.

Photo 20: Area of previous instability above the flume

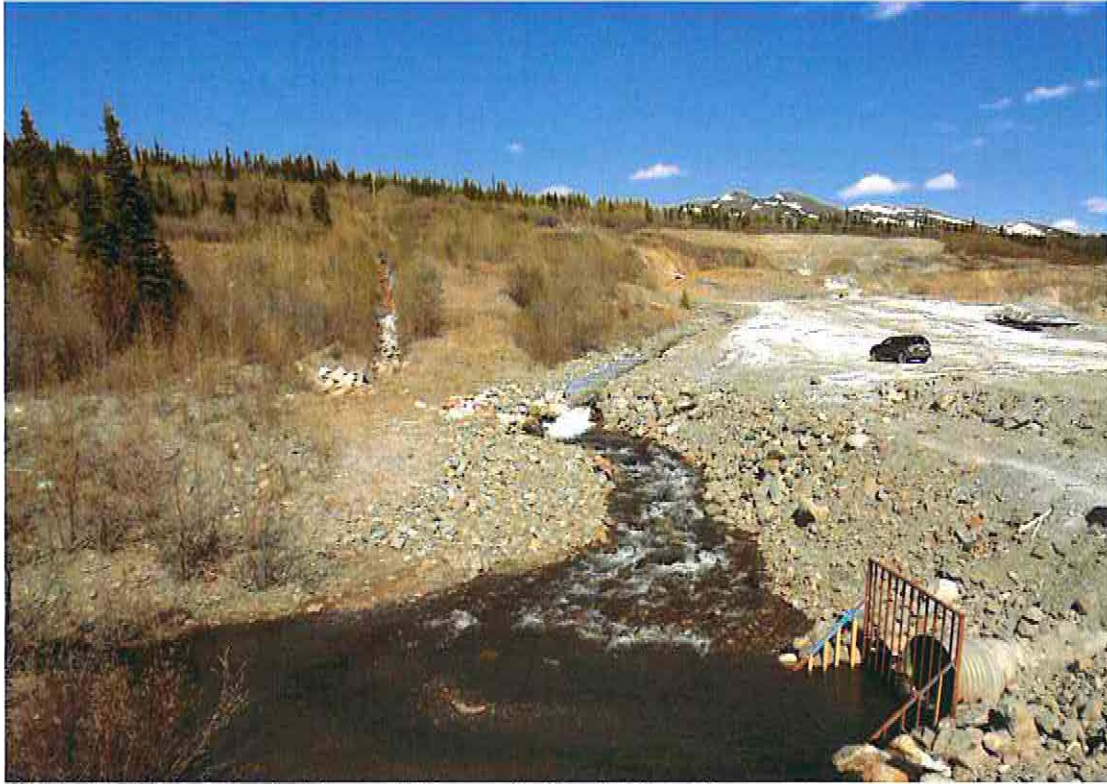
Photo 21: Plunge Pool at base of Vangorda Creek Diversion

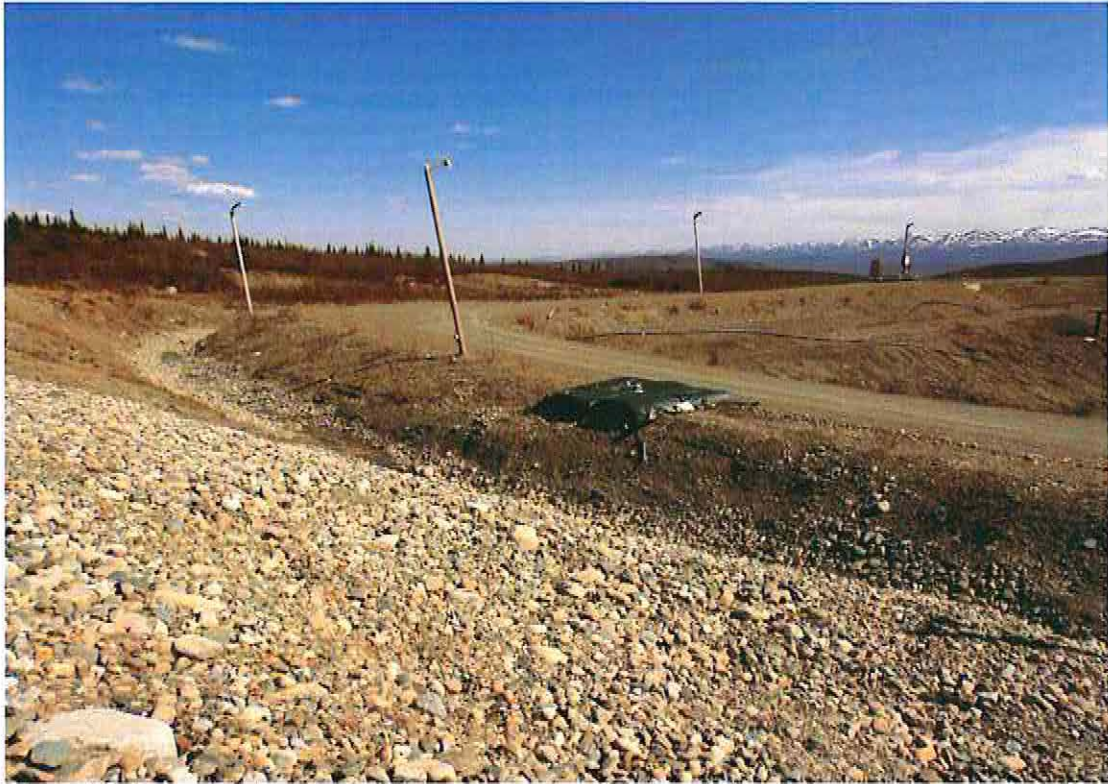
Photo 23: Proposed location of the emergency spillway at the sludge pond

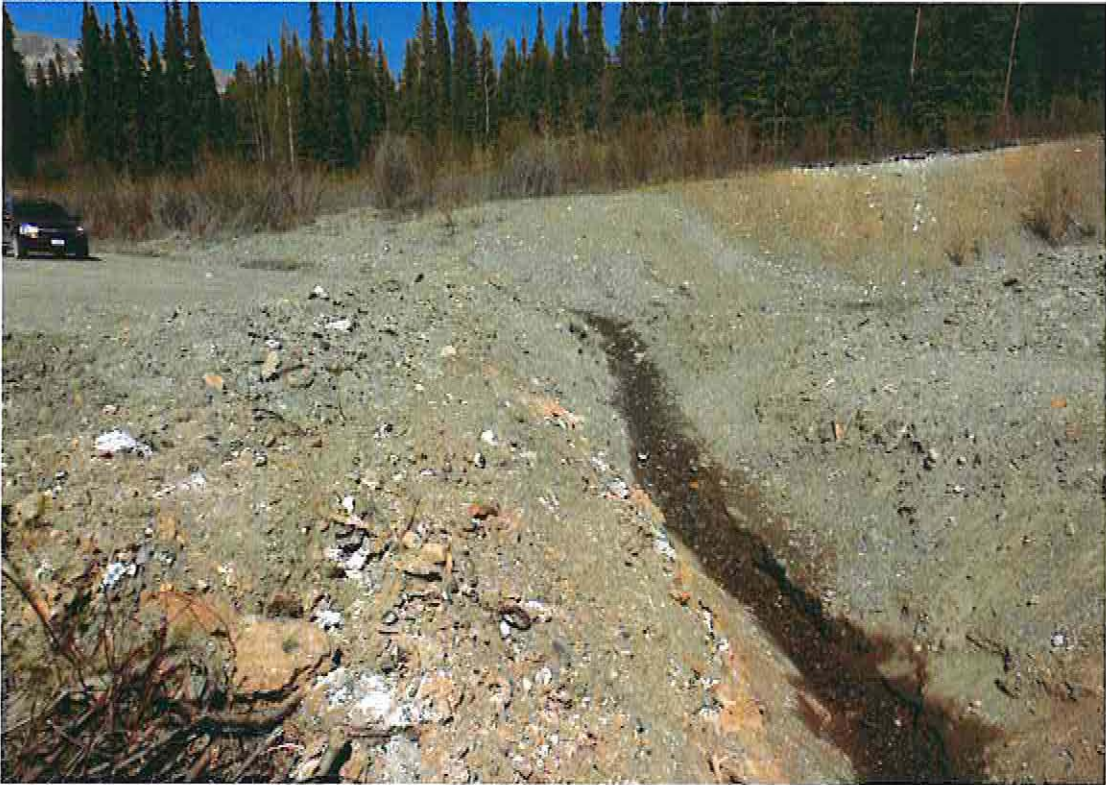
Further downstream of the culvert, DES had excavated a ditch across the roadway to redirect the flow into the Moose Pond. Previously this flow had been conveyed across the roadway in two small pipes. Continual freezing of these pipes was problematic which prompted the need to build an open channel. However, the ditch was hastily constructed and was unstable and had sideslopes that would gradually collapse (Photo 30). However, since SRK's visit, DES has deepened and increased the grade of the ditch and resloped the sideslopes to 2:1(H:V).

Photo 30: Diversion ditch to Moose Pond below V2A
