2011 Geotechnical Inspection Waste and Water Management Facilities Vangorda/Grum Faro Mine Complex, Yukon

Denison Environmental Services

SRK Consulting (Canada) Inc.
1CD009.005
August 2011

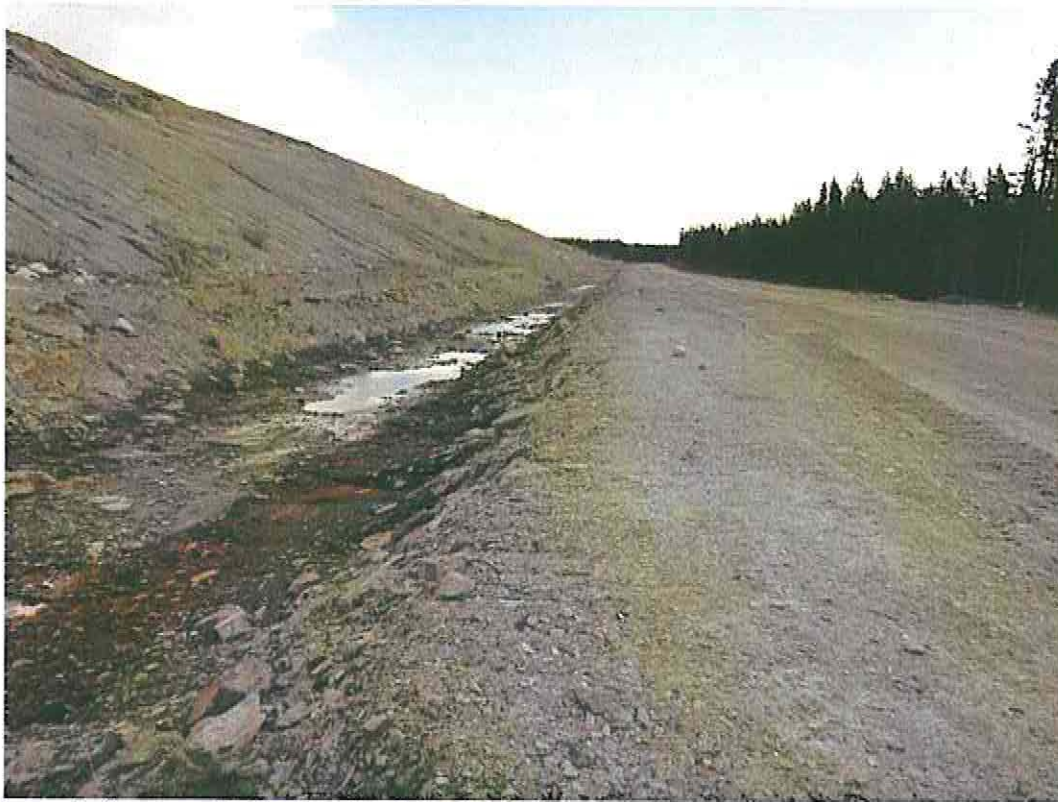
Photo 5: Seepage Collection Looking Back Towards Drain #2

As seen in the Photos 5, 6 and 7, seepage is collected in the Vangorda seepage collection channel around the Waste dump and discharges into Little Creek Pond.

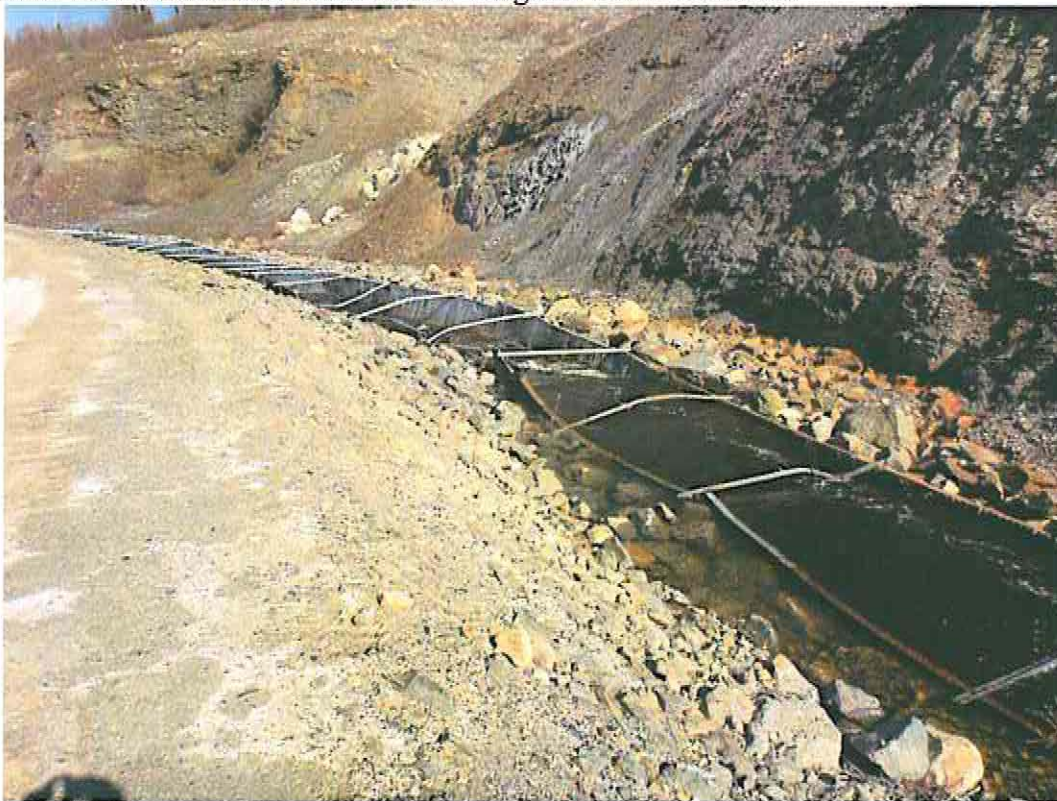
Photo 16: Vangorda Creek Diversion

In accordance with a recommendation from SRK, an emergency overflow spillway (2x1m diameter CSP's) was installed at the headworks of the diversion in August 2005 (Photo 14). DES continues to inspect the trash rack at the headworks (Photo 15) and the 2.4m diameter flume (Photos 16, 17 and 18) to facilitate safe passage of flow in Vangorda Creek. Boulders that fall into the flume are periodically removed. There are no signs of instability or settlement of the embankment at the headworks of the diversion. However, the cross braces that support the flume continue to deteriorate and water continues to escape through openings in the flume joints.

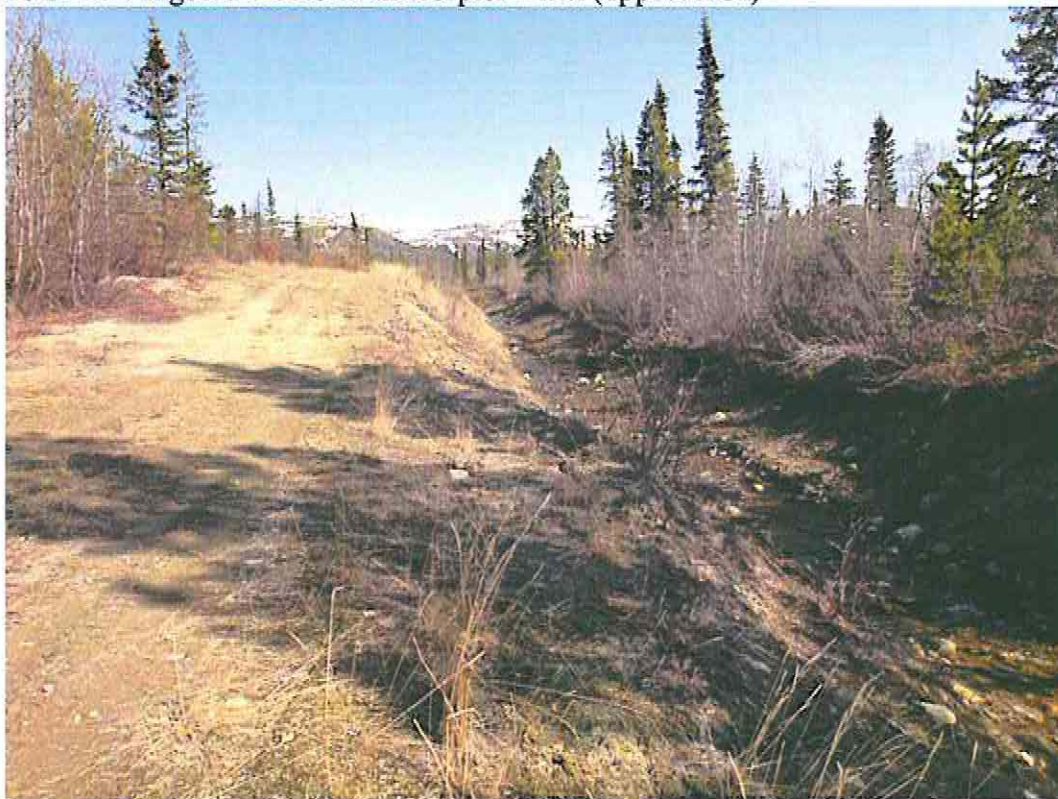
Photo 22: Vangorda Pit North Interceptor Ditch (lower reach)

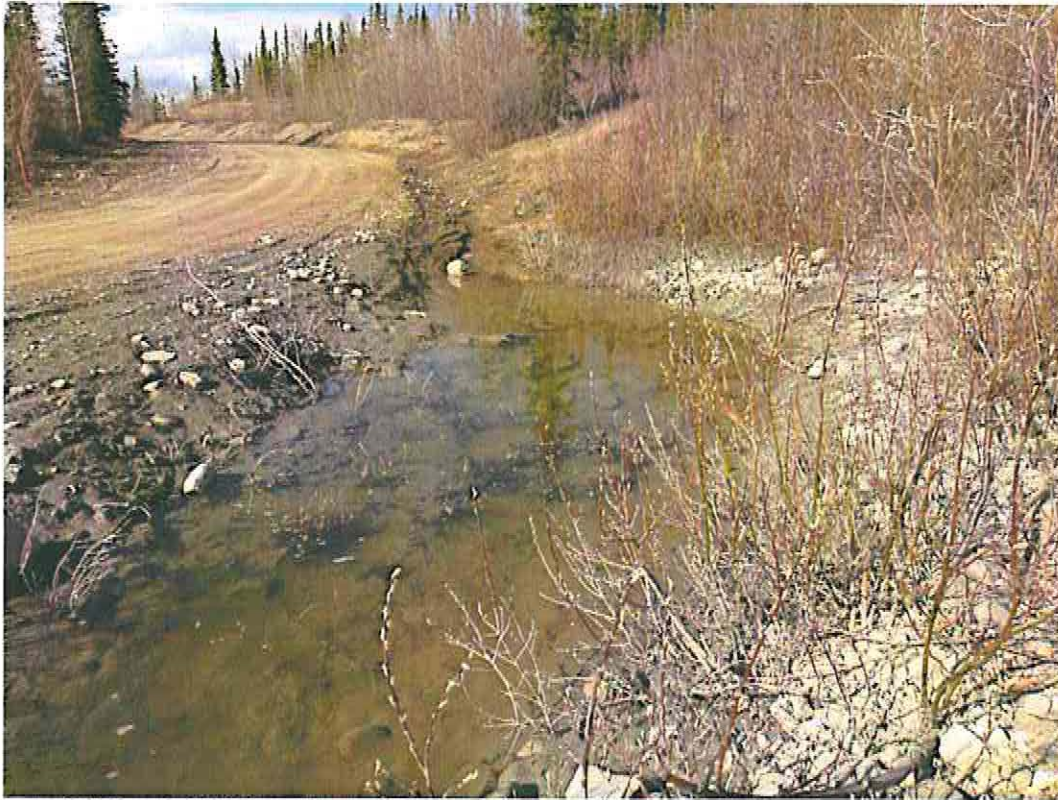
Photo 25 Ponded Water Above Blocked Culvert Below V-15 Pond

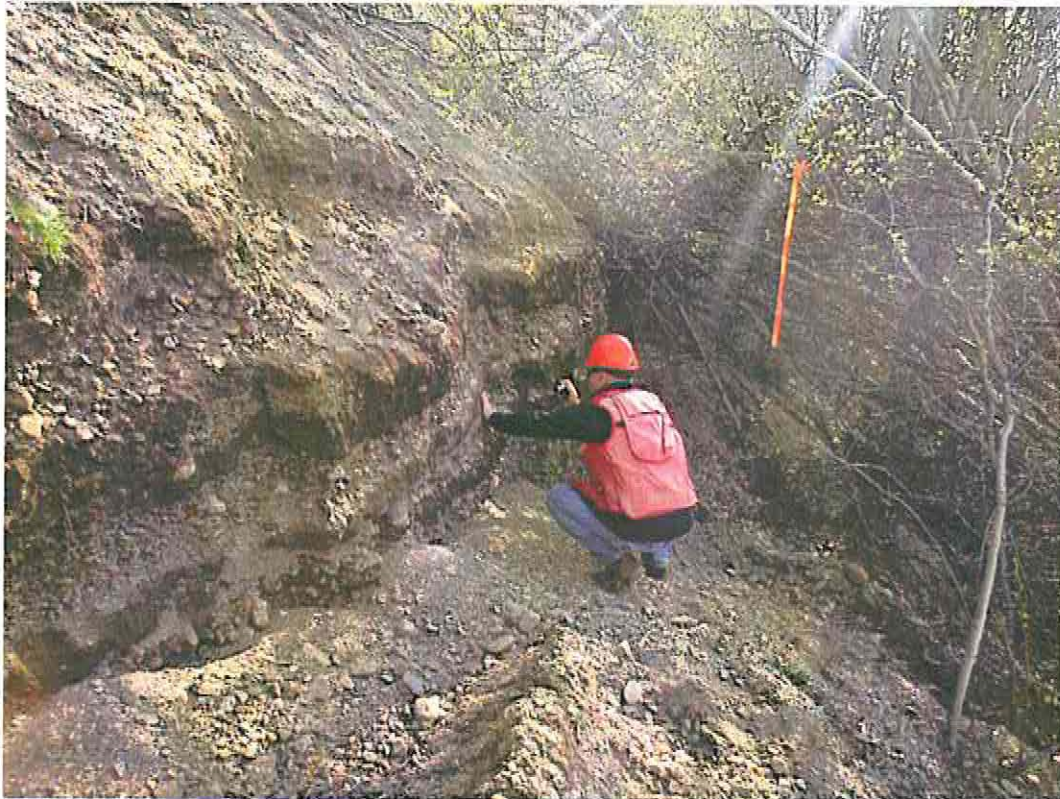
Photo 32: Seepage Zone Below Moose Pond

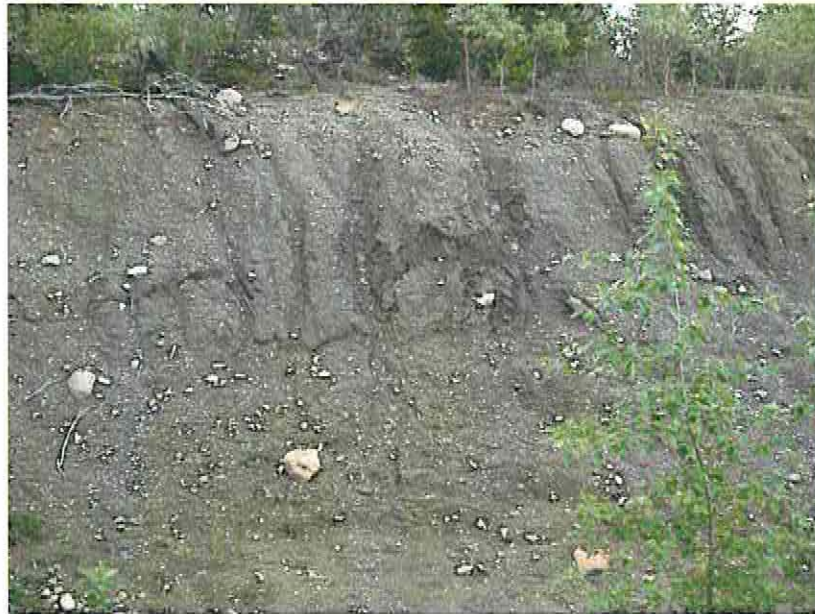
Photo 1: Erosion along Vangorda Interceptor East, upper section (June 26, 2011)

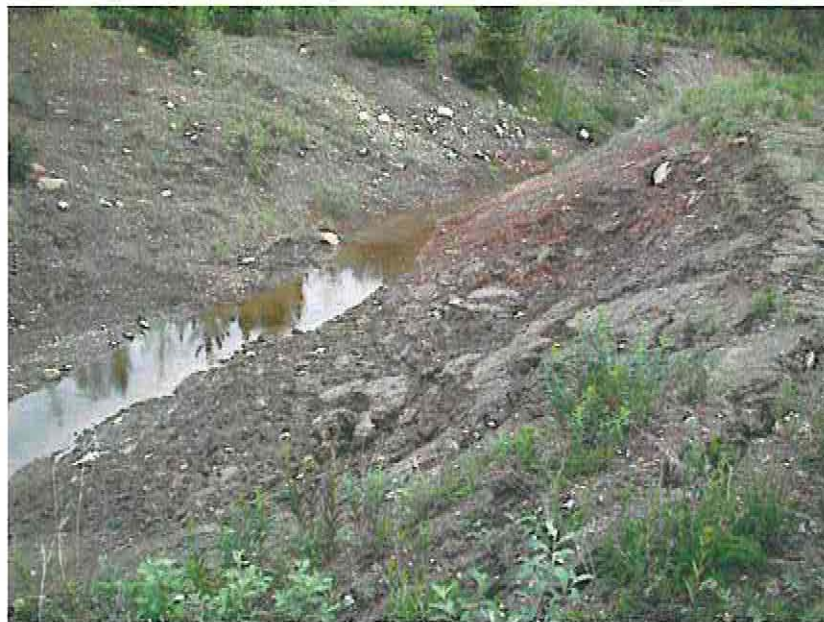
*Photo 2: slumping along Vangorda Interceptor East, lower section
(June 26, 2011)*

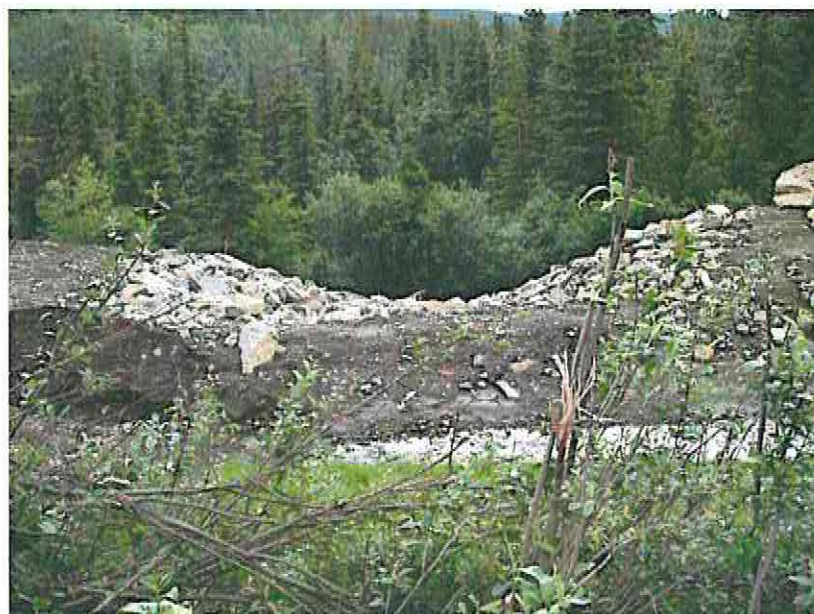
Photo 5: Temporary re-direction off flow blocked off; flow from V15 ditch is directed to Moose Pond (June 26, 2011)

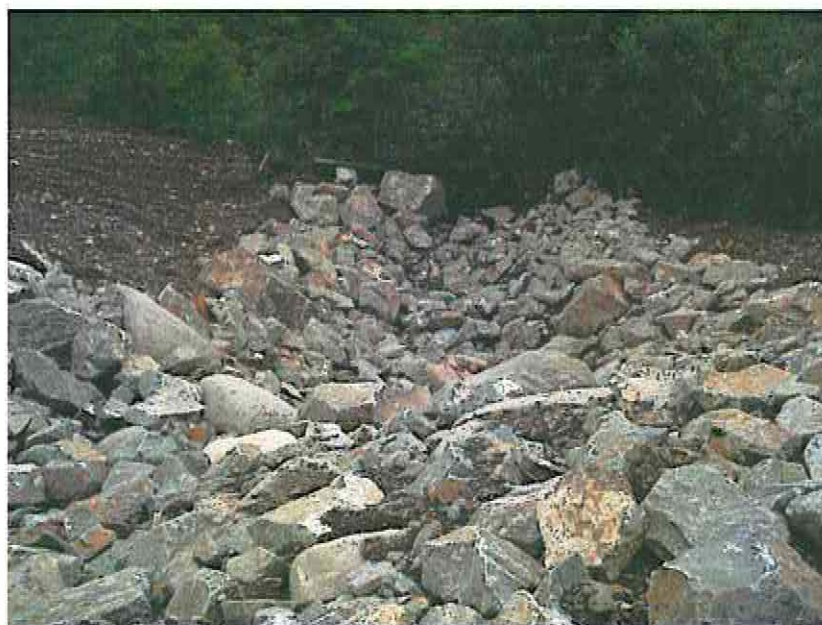
Photo 6: Rip rap on temporary flow path constructed mid-May (not in use at time of photo) (June 26, 2011)
