February 7, 2013

REPORT ON

Faro Mine Complex Annual Pit Slope Stability Inspection

Project Number: 1214260031-001-R-Rev0-6000

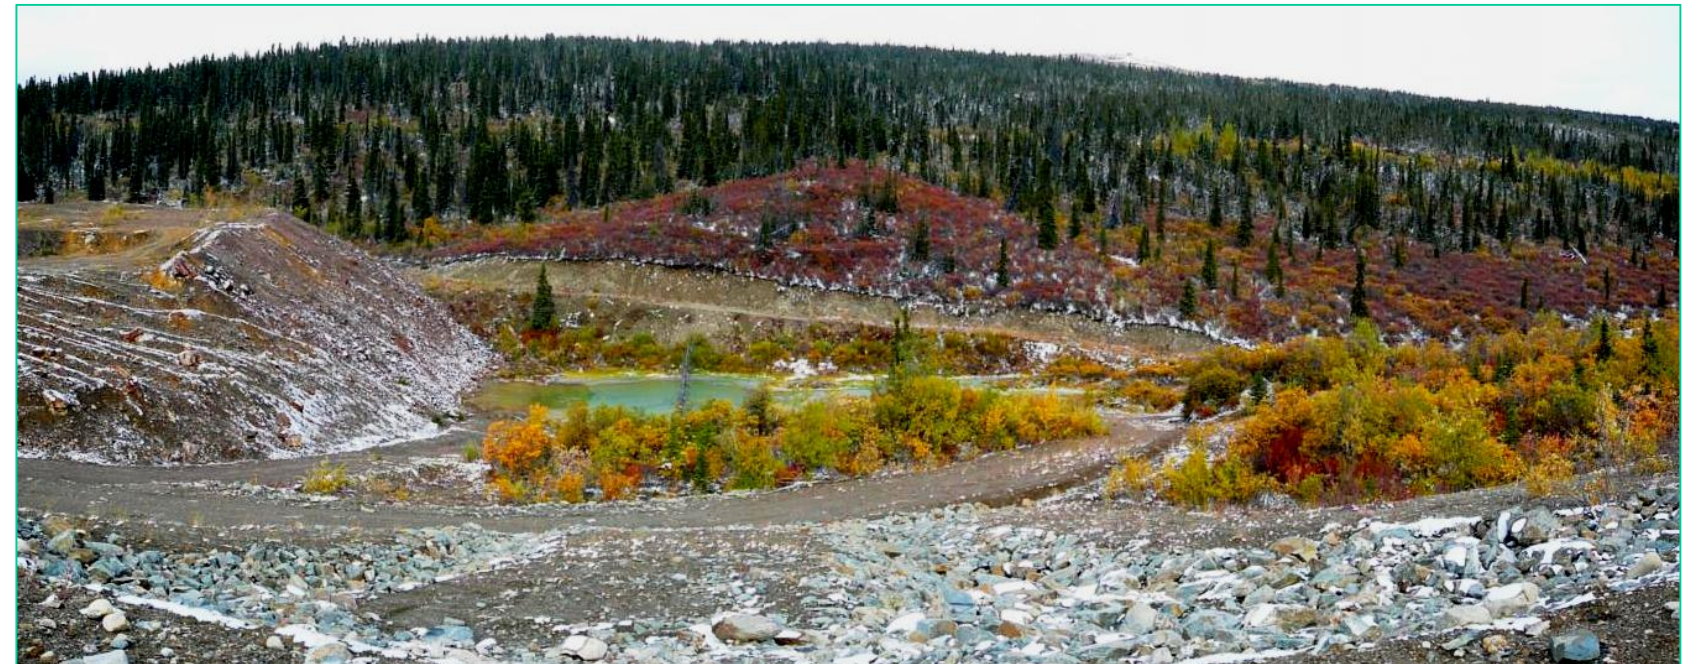
Photograph A-7
Faro Pit – North Instability Zone.
Pond of water to the north of the North Instability Zone. This water drains into a creek, which drains into the pit to the north of the North Instability Zone.

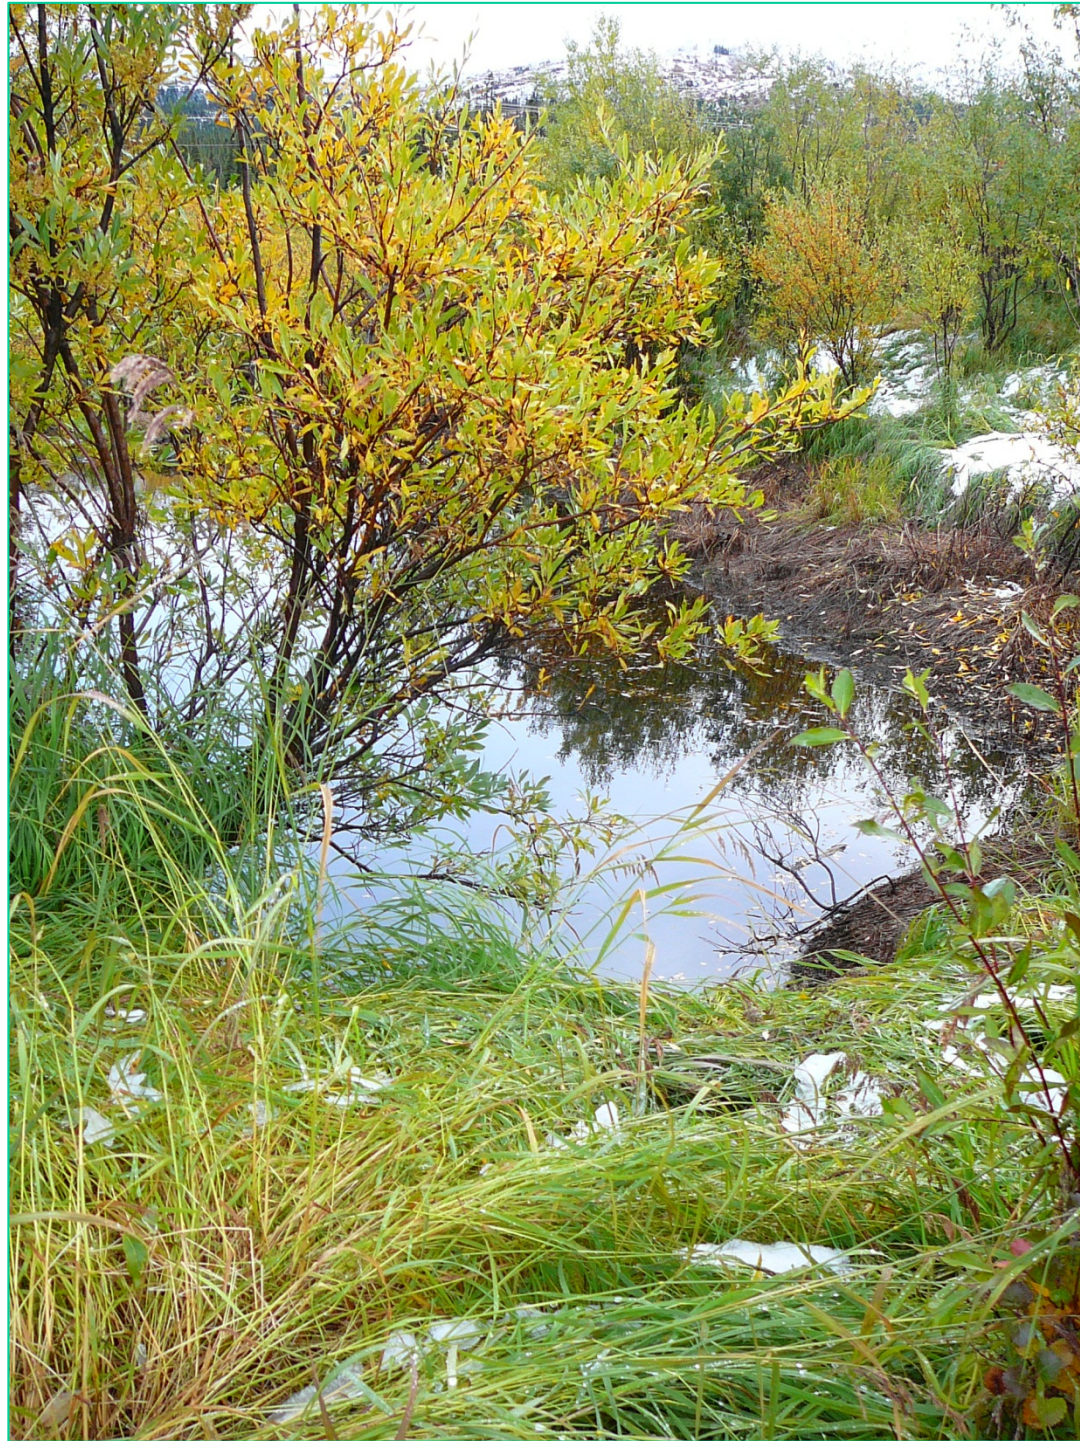
- No cracks were observed along the road behind the crest of the east wall.
- Several areas of ponded water were observed behind the crest, as shown on Photographs D-12 to D-15. Some were marked with GPS and are shown on Figure 3. Some of the ponds were located to the north of the instability zone.

Photograph D-14
Grum Pit - ponded water behind crest, in vegetated area. View looking east.

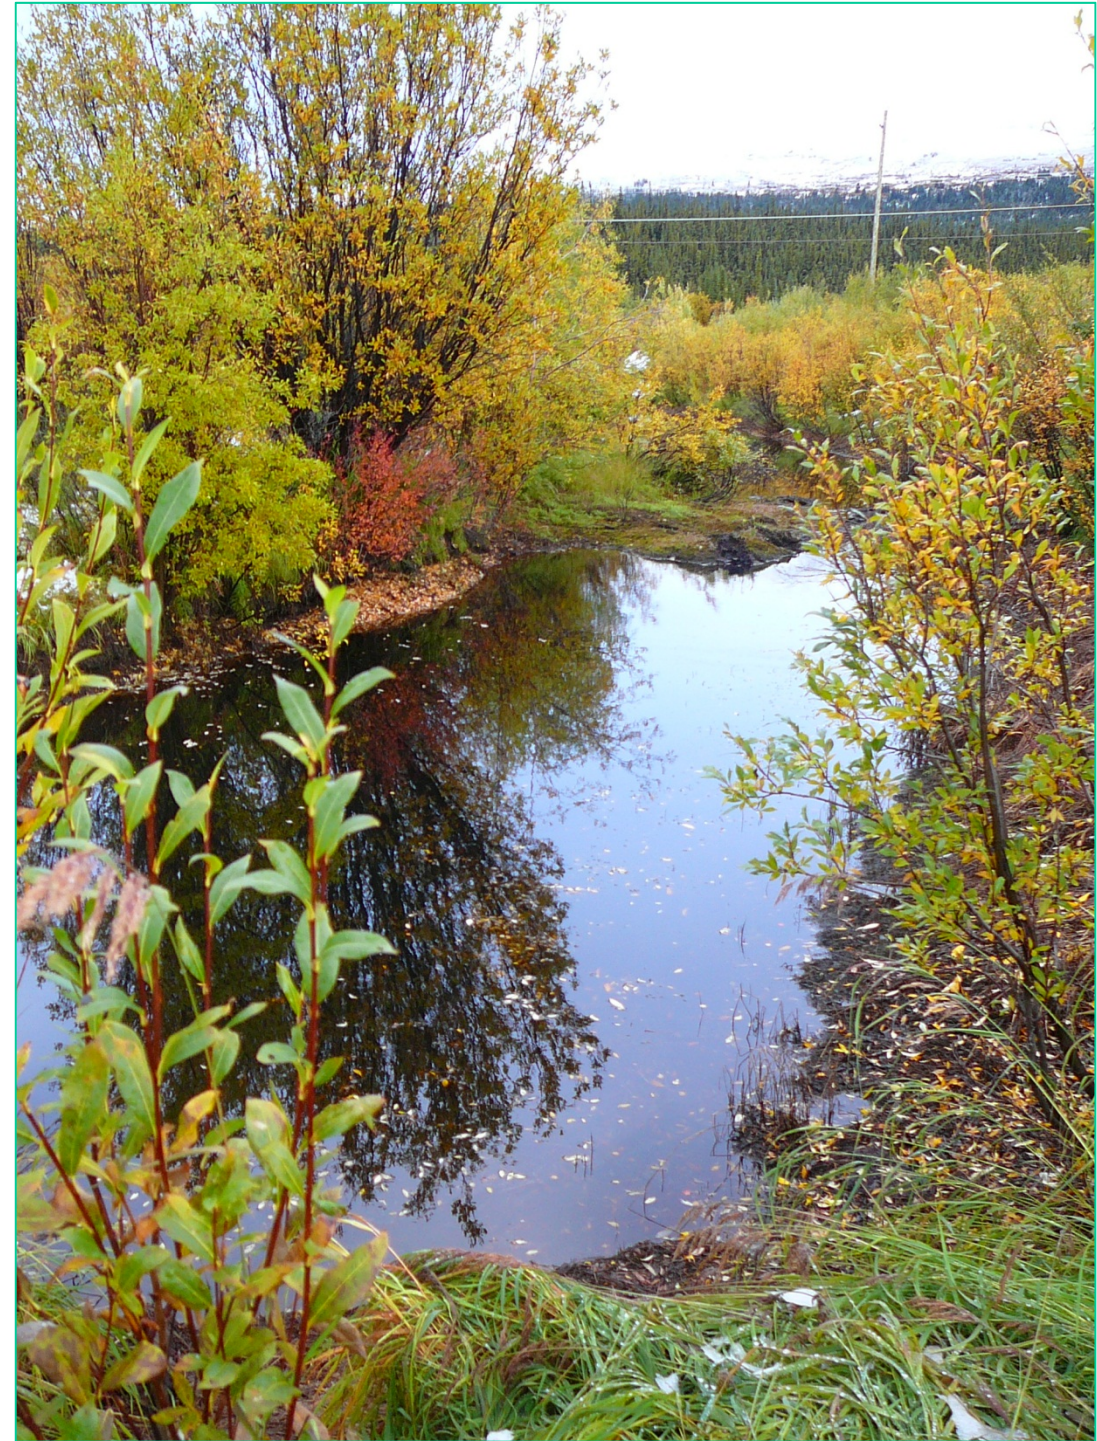
Photograph D-15
Grum Pit - ponded water behind crest, in vegetated area. View looking east.

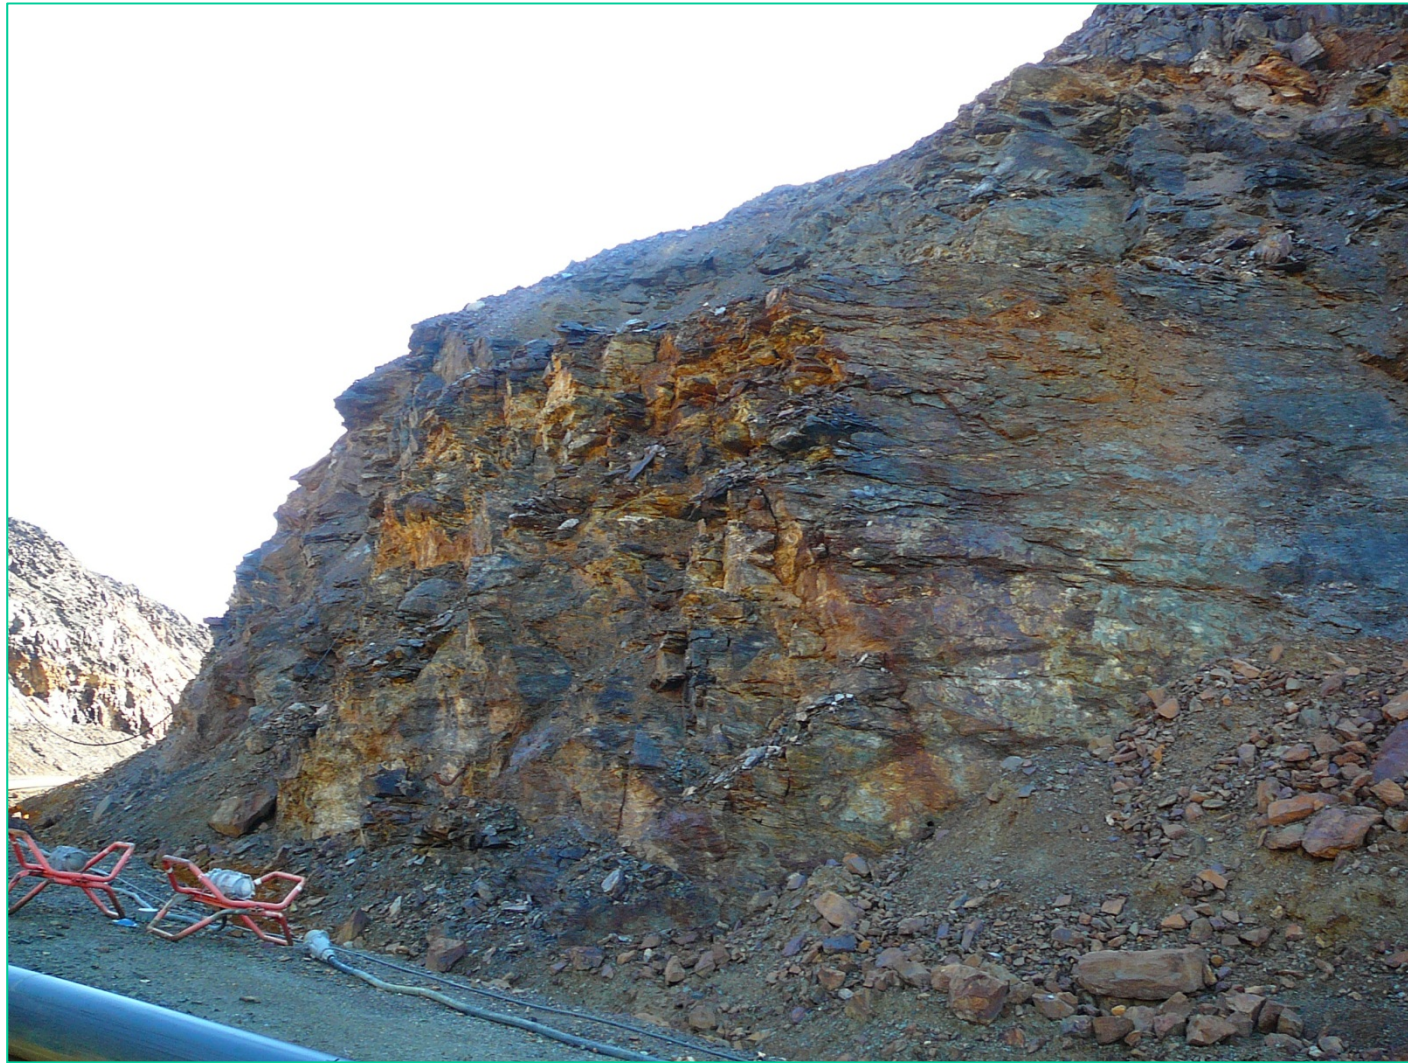
Photograph E-5
Vangorda Pit – Mapping Station 3. View looking south.

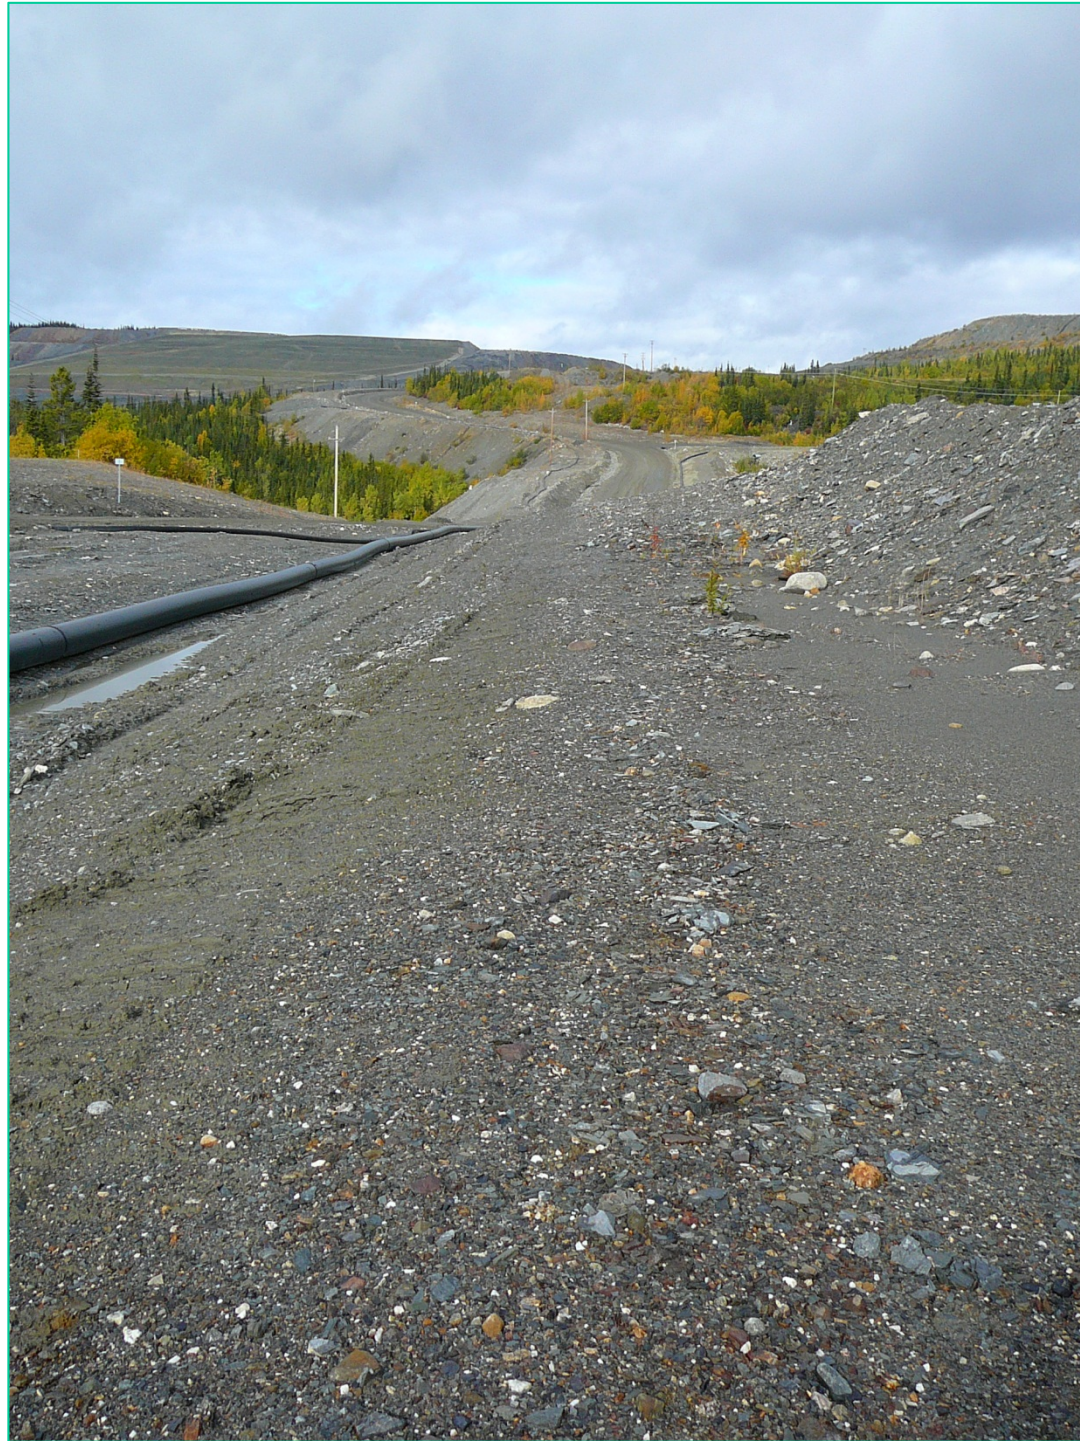
Photograph E-7
Vangorda Pit – access road on southwest side of pit. View looking northwest.

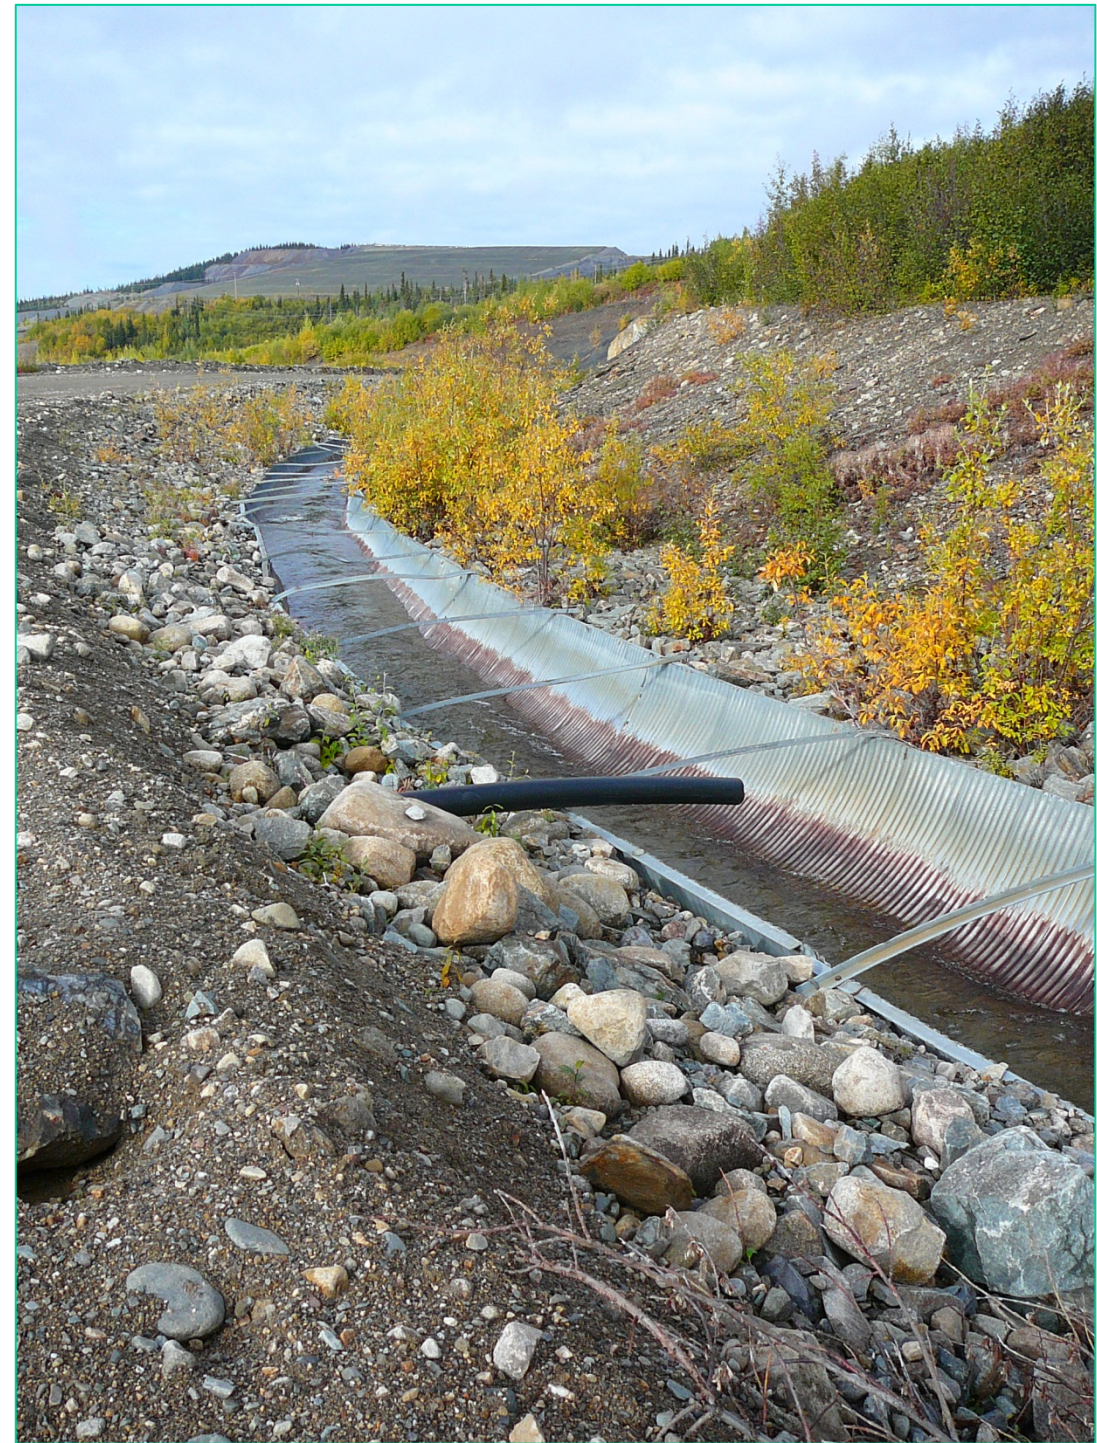
Photograph E-13
 Vangorda Pit – location of Vangorda Creek
 discharge into flume. View looking west.

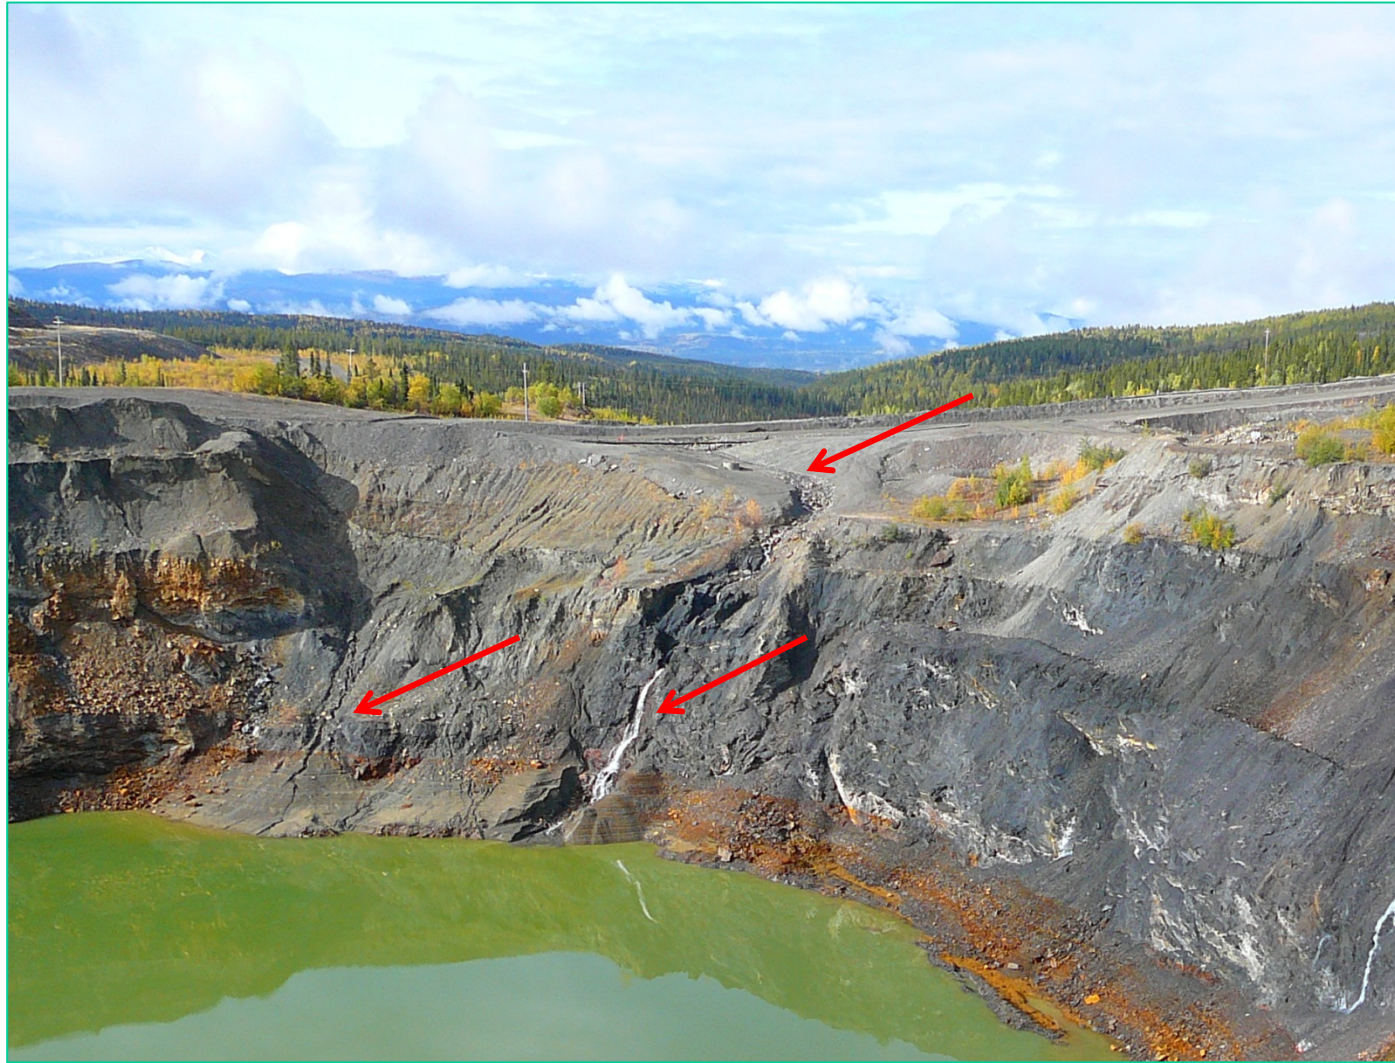
Photograph E-14
Vangorda Pit – Water flowing into pit in northwest corner.

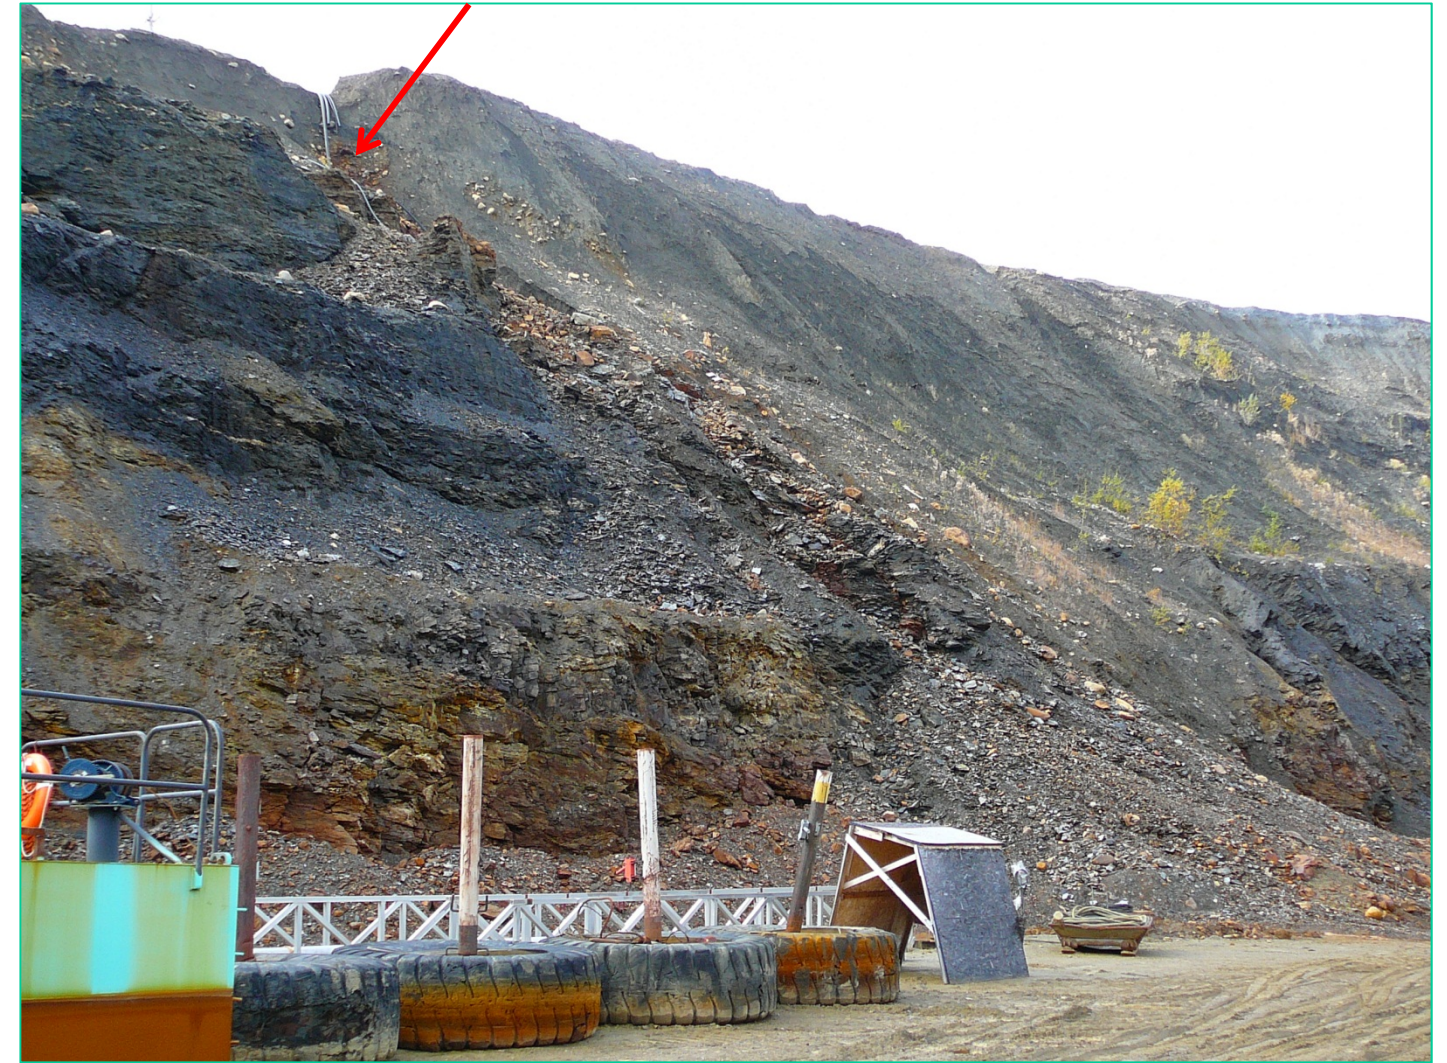
Photograph E-15
Vangorda Pit – Emergency discharge pipelines from the booster pump.

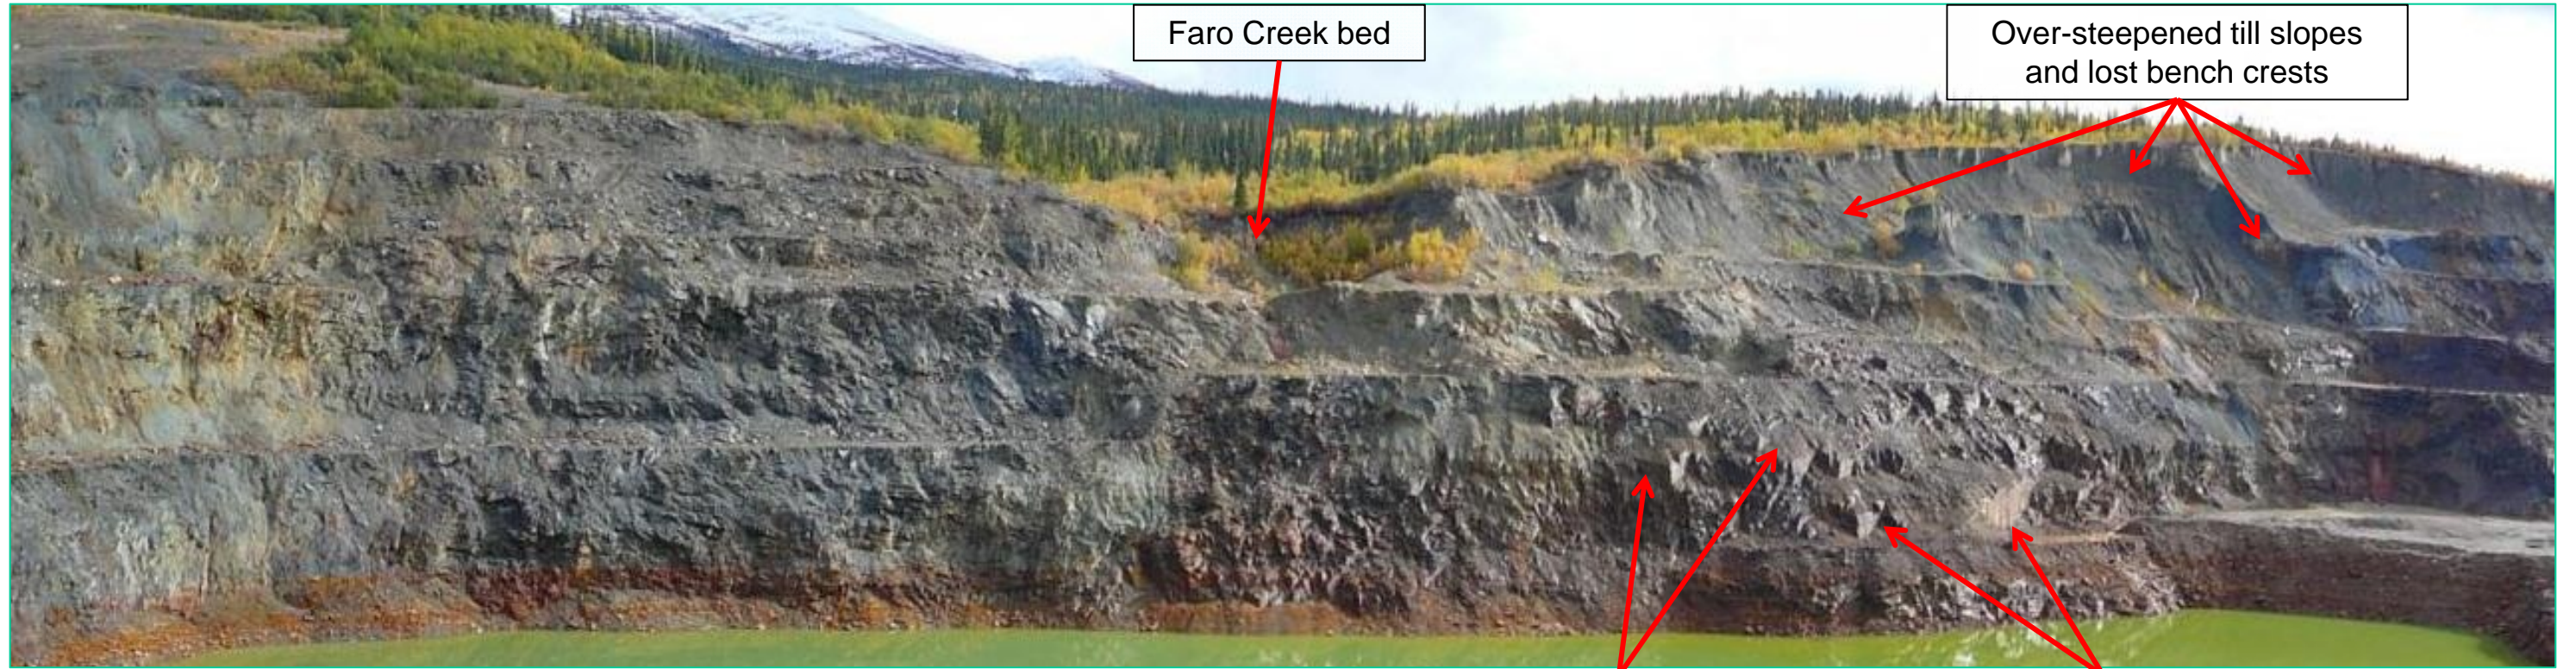
Photograph E-18
Vangorda Pit northeast wall. View looking northeast.

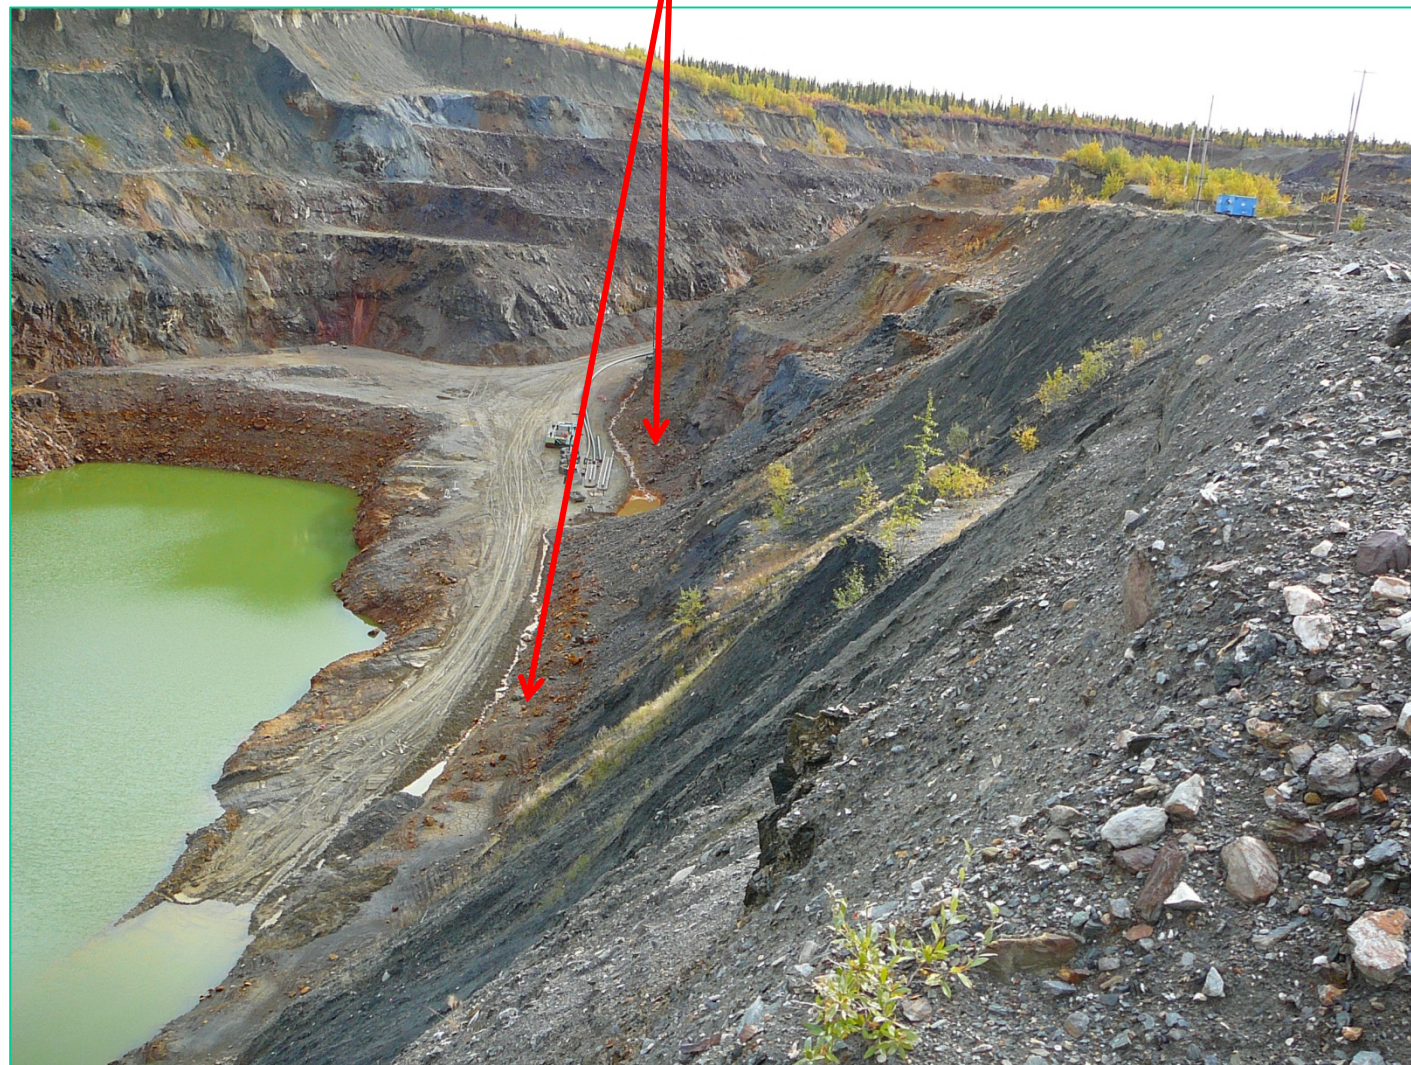
Photograph E-26
Vangorda Pit west wall. View looking southeast.

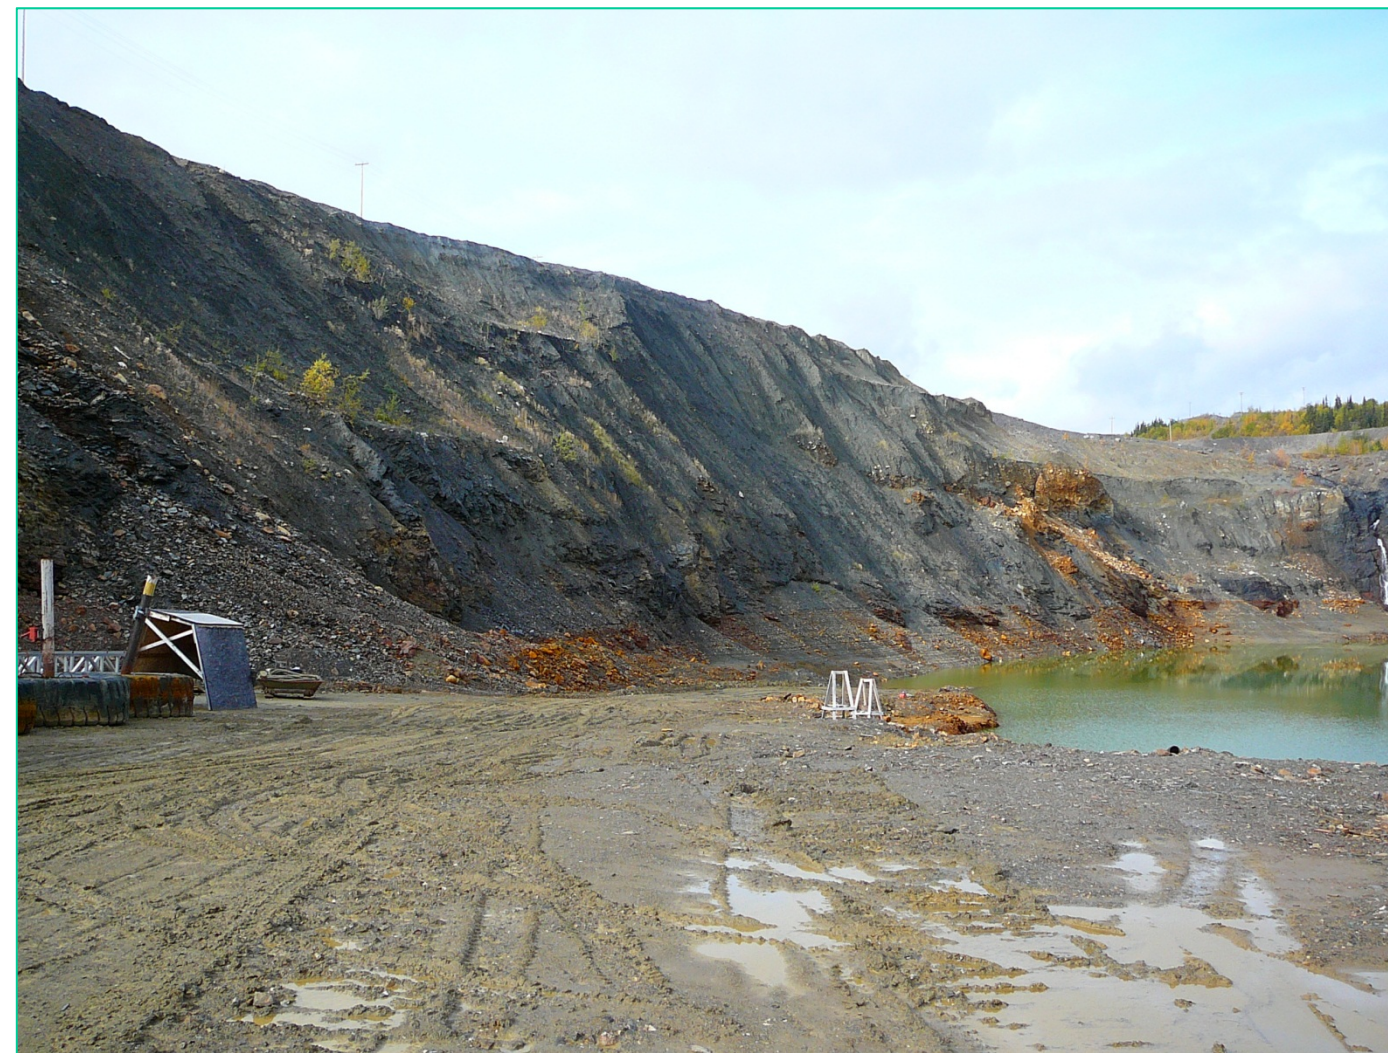
Photograph E-27
Vangorda Pit west wall. View looking northwest.
