FARO MINE COMPLEX

2014 Annual Pit Slope Stability Inspection

Reference Number: 1410944-002-R-Rev0-6000

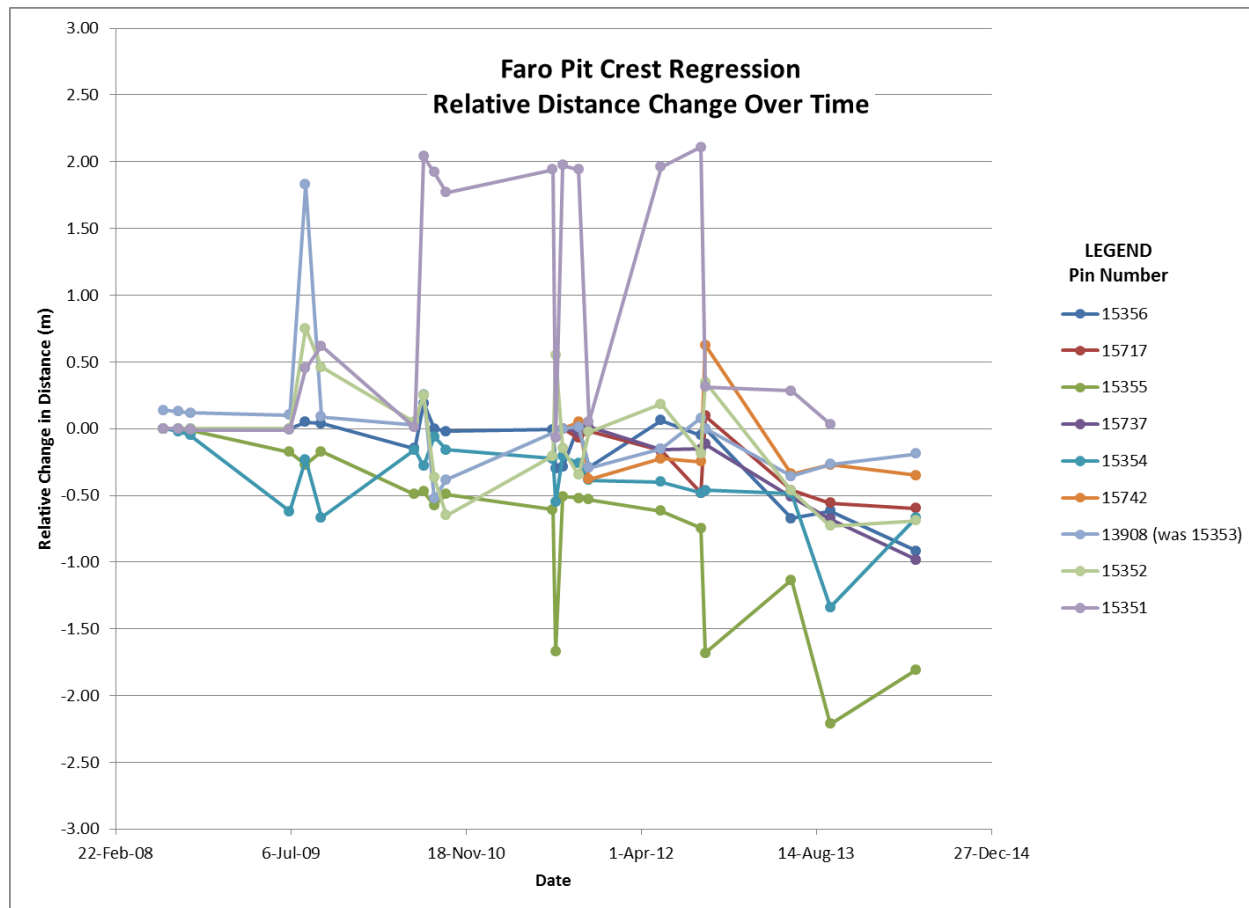
Plate 2: Relative Change in Distance, Faro Crest Regression Monitoring

Plate 2 shows a plot of the relative change in distance for each reference pin by date. The relative change in distance is defined as the difference between the current distance and the initial distance, and a negative distance indicates that the distance from the crest to the pin is decreasing. Because of the confusion with the pins, only the measurements provided by TEES have been plotted. The data from pins 15353 and 13908 and have been plotted together, assuming they are in fact the same pin.

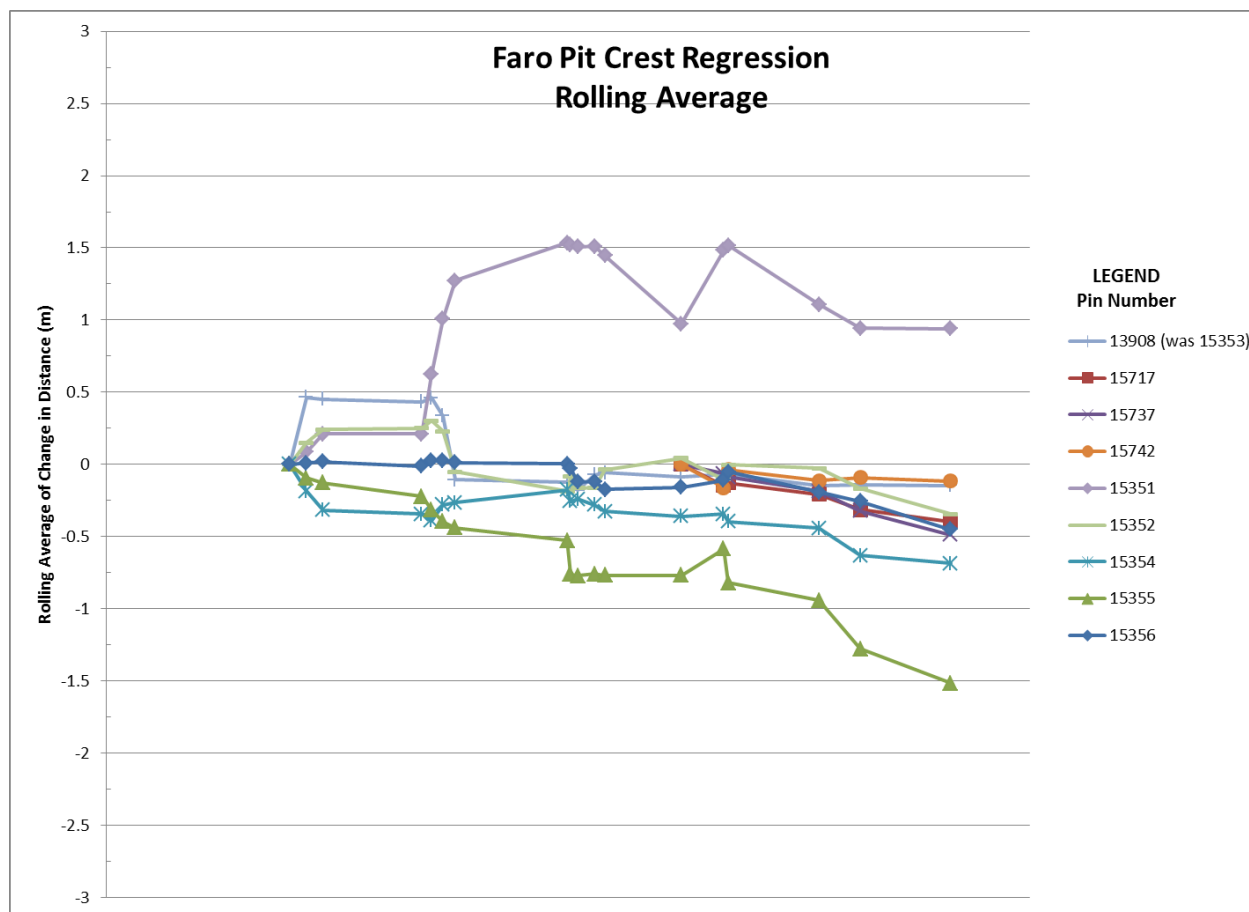
Plate 3: 5-Point Rolling Average of Faro Regression Monitoring Data

Plate 3 shows a 5-point rolling average to reduce the variability in the data. From this plot it is evident that there is a trend of decreasing relative distance for the majority of the reference pins to the crest, which indicates that crest regression is occurring. Crest regression appears to be occurring to a higher degree near reference pins 15354 and 15355. The measurements for these pins indicate crest loss of 0.5 and 2.0 metres, respectively. Pins 15353 and 15355 are near gullies that drain into the pit (Figure 1) and pin 15354 is in between these two pins. All three pins are located behind the steepest backscarps in the till and are also the closest to the access road.

Pins 15742 and 13908 appear to indicate minor crest regression of less than half a metre. Pin 15351 does not appear to have reliable data that can be interpreted.

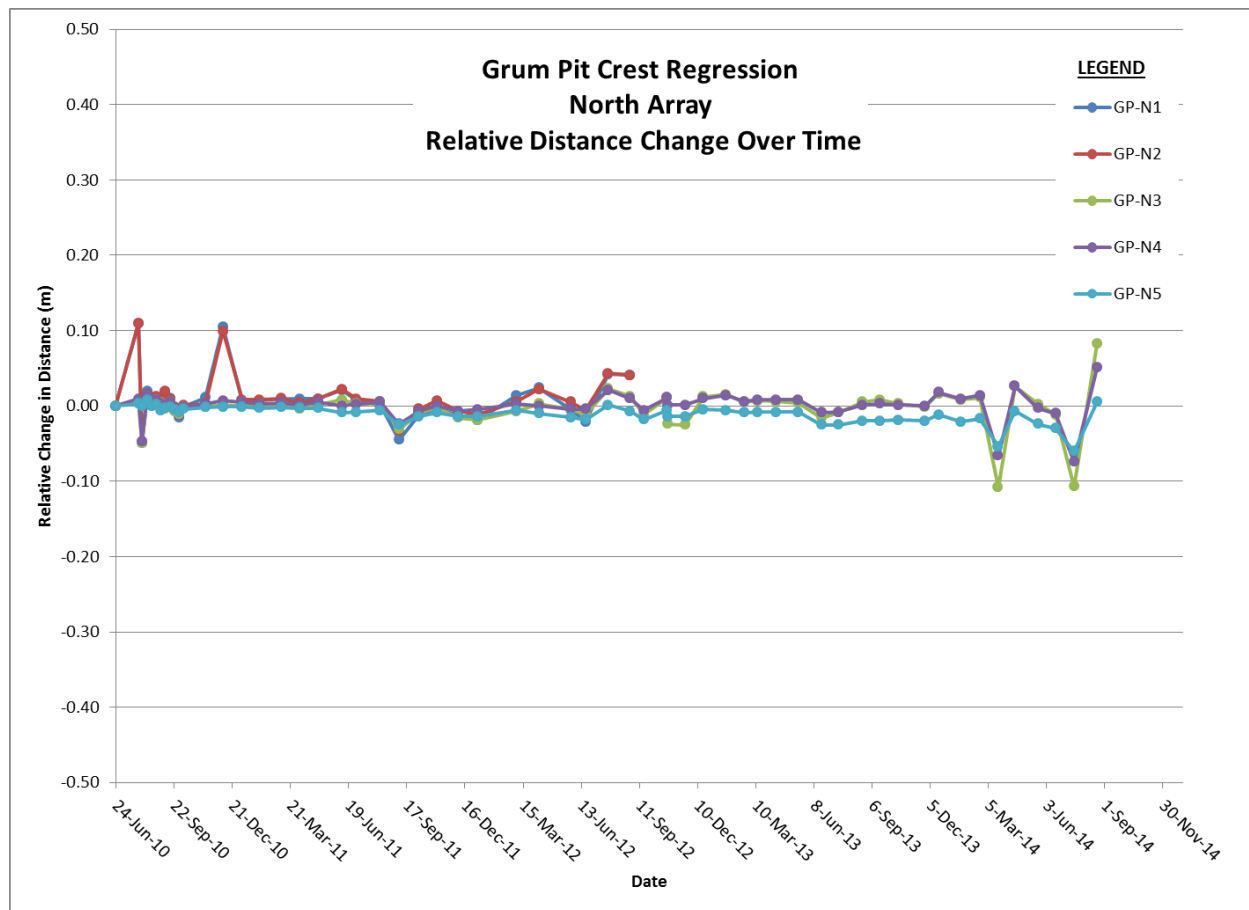
Plate 5: Grum Pit Crest Regression, North Array, Relative Change in Distance over Time

The plots indicate very little change in distance, with some minor variations in the measurements in 2014. When comparing to the plot of the Faro data, it is evident that the accuracy in measurement is significantly better in the Grum Pit. One likely reason is that having several bars in an array provides a reference to measure along the same bearing each time, while at the Faro Pit there is no reference point for measuring along the same bearing.

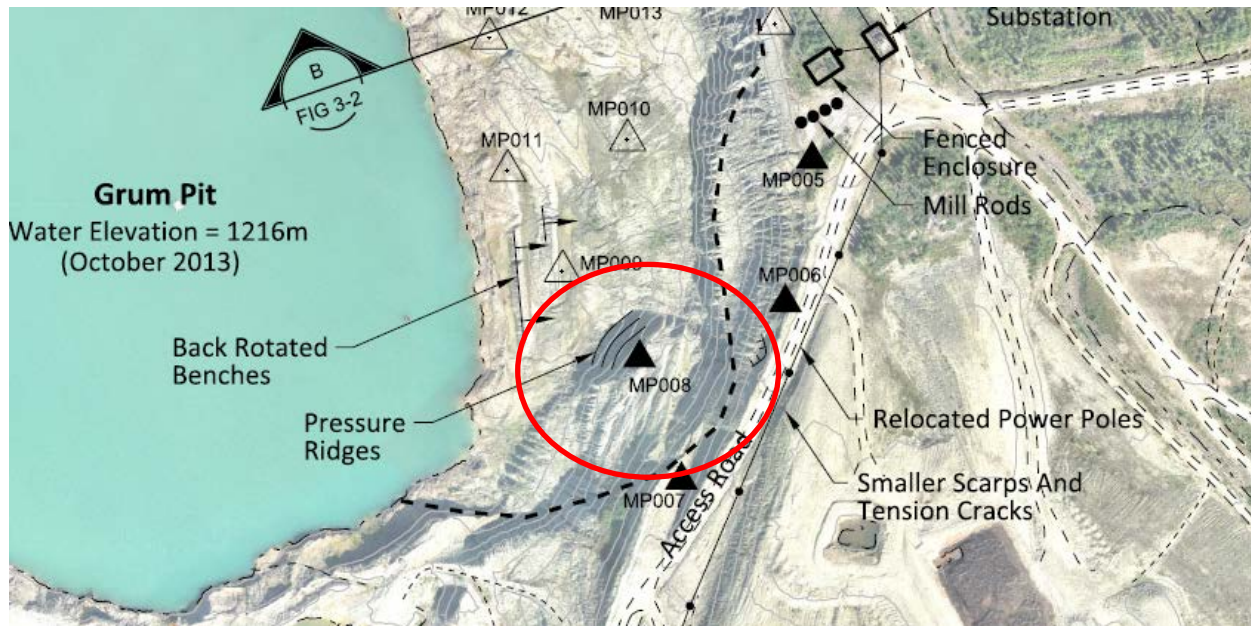
Plate 7: Grum Pit Monitoring Point MP008 Location
(CH2M HILL 2014)

- Monitoring points MP005 to MP007 exhibit little to no displacement (Figures D-11 to D-13).
- However, monitoring point MP008 exhibits a total displacement of 192 mm since 2013 (Figure D-14).

The vertical downward displacement of monitoring point MP008 is on the order of 165 mm, and the horizontal displacement is on the order of 99 mm. The wander plot indicates a displacement trend toward the northwest. This monitoring point is the only monitoring point located on the slope rather than at the crest of the east wall (Plate 7). It is not likely that the monitoring point was deliberately or accidentally moved because the method of installation (CH2M HILL 2013) would make it difficult to move the monument. Either the monitoring point is exhibiting real displacement of a portion of the slope that is slumping to the northwest, or there is an error in the survey. The surveys of the other Grum monitoring points appear to be reliable, but it is possible that while the prism was being set up on this particular point, the accuracy was compromised. It will require further surveys to determine whether the displacement is actually occurring. As with the Faro monitoring point data, it is recommended that the Grum survey data be plotted as soon as possible so that a survey can be repeated to confirm the accuracy if necessary.

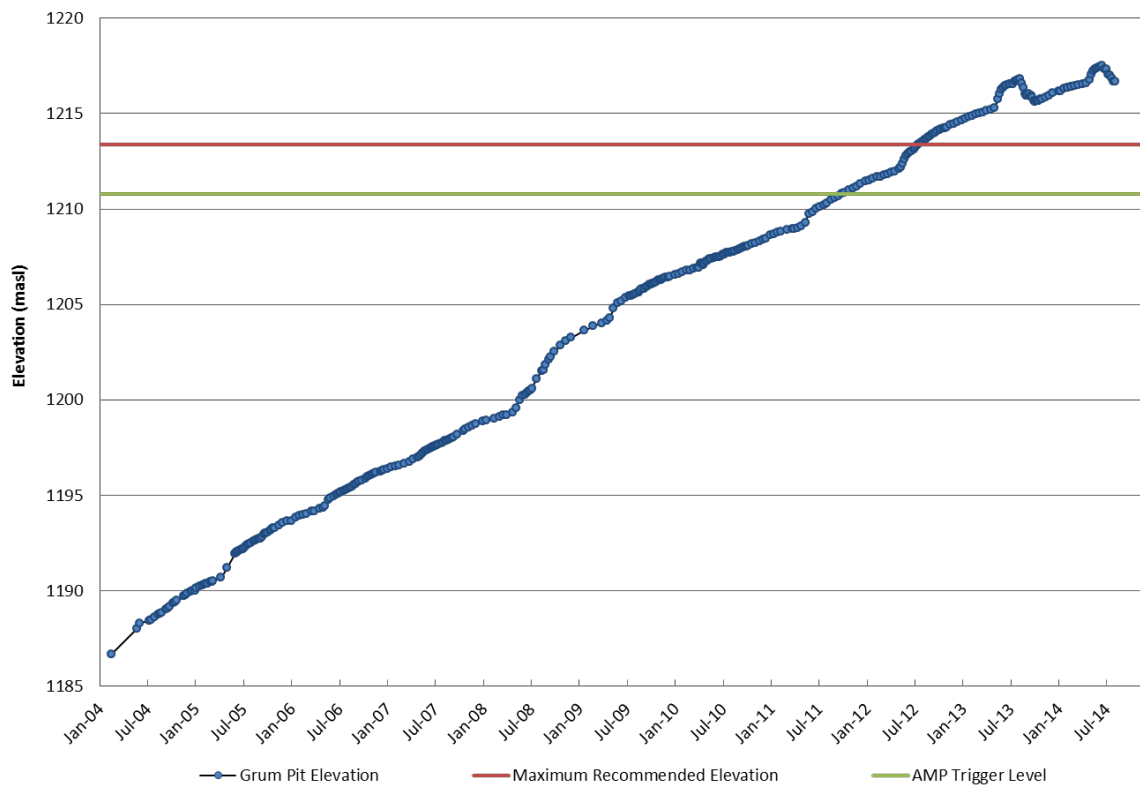
Plate 8: Grum Pit Lake Levels to August 11, 2014

Plate 8 shows the change in the Grum Pit lake level from January 2004 to August 2014. The Grum Pit lake level was reported to be at 1,186 masl in early 2004 and at 1,205 masl by mid-2009 (Golder 2010). As of September 2012, the water elevation was at approximately 1,212 masl. As of August 11, 2014, the pit lake level is at approximately 1,217 masl, which is 6 metres above the maximum recommended elevation of 1,211 masl, and 1 metre above the estimated elevation of the lowest contact between overburden and bedrock at approximately 1,216 masl (Klohn Crippen Berger 2014). In the Grum Pit, rising water levels have the potential to seep into the overburden and contaminate groundwater as well as to destabilize the old slide debris along the east wall. The pit overflow elevation is located on the south side of the pit, where the access ramp enters the pit, at approximately 1,230 masl.

Because pit lake levels fluctuate due to pumping water in and out of the pit, an important consideration for pit slope stability is the rate at which the lake level rises and falls. Rapid increases or decreases in the lake level should be avoided. Rapid changes in water levels can contribute to slope instability because an unsteady state is created in the groundwater conditions. As the groundwater adjusts to a new equilibrium, hydrodynamic pressures can create forces within a slope that can destabilize it.

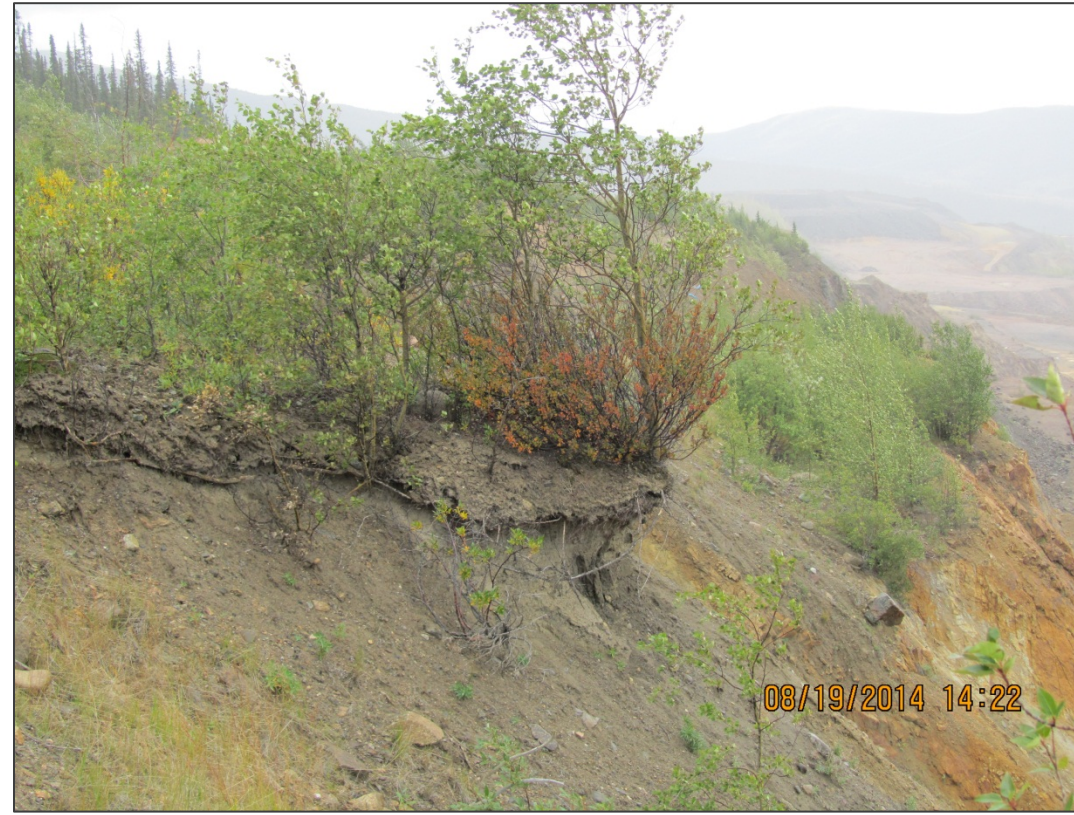
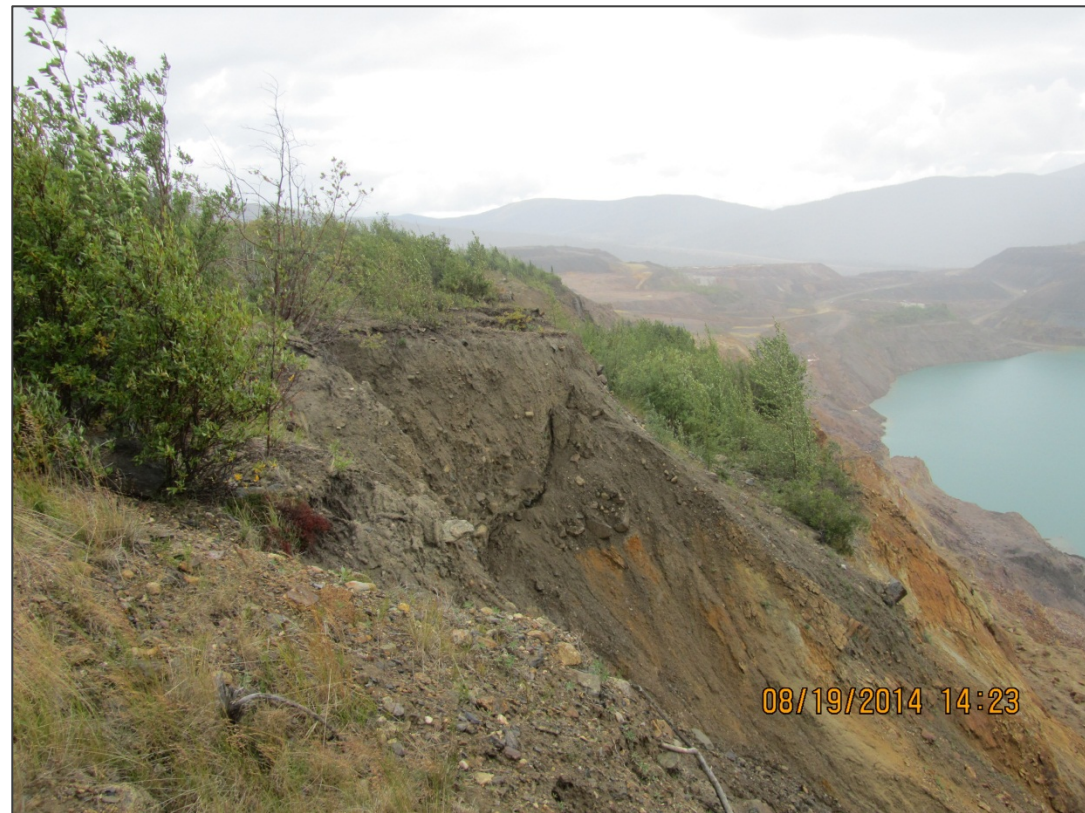
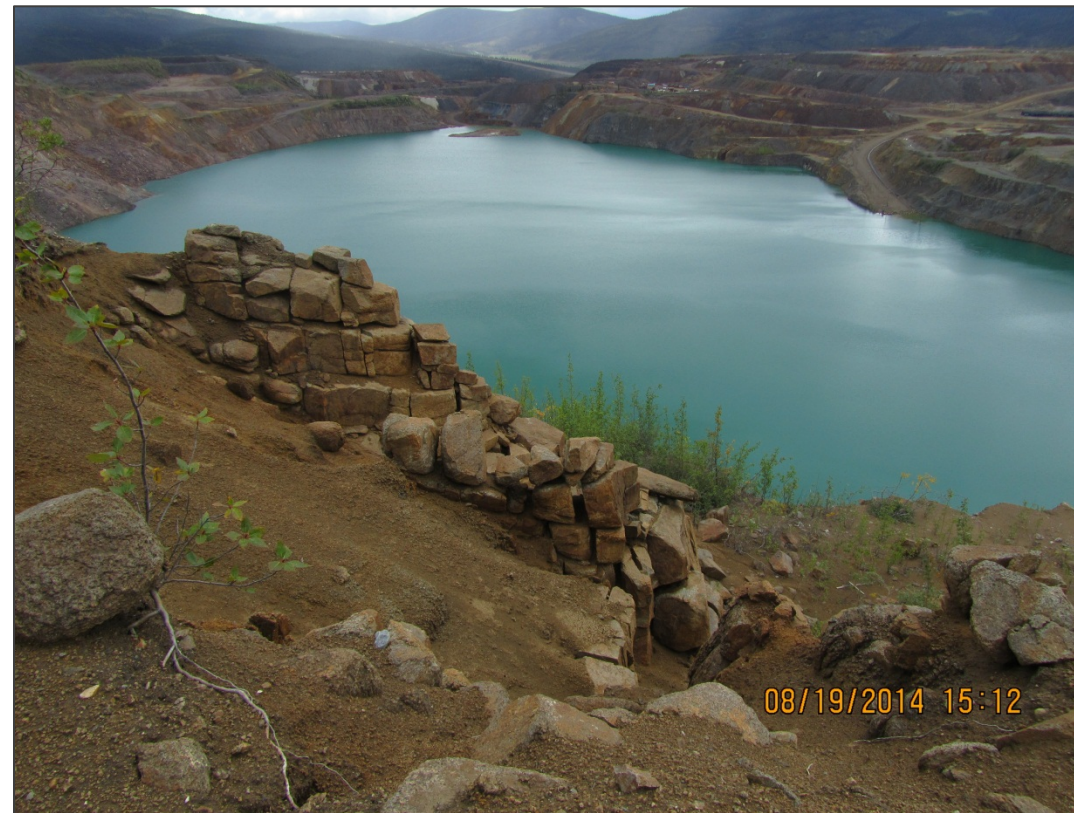
FIGURE No.
A-5

- The till and rock on the northwest side of the pit are slowly raveling and toppling (Figure A-5).
- There is ponded water behind the small dam (Figure A-6) as was observed and reported in 2012.

TILL SLOWLY ERODING AND RAVELING

BACKSCARP SLUMPING

ROCK TOPPLING

TITLE
 NORTHWEST WALL - RAVELING AND
 TOPPLING

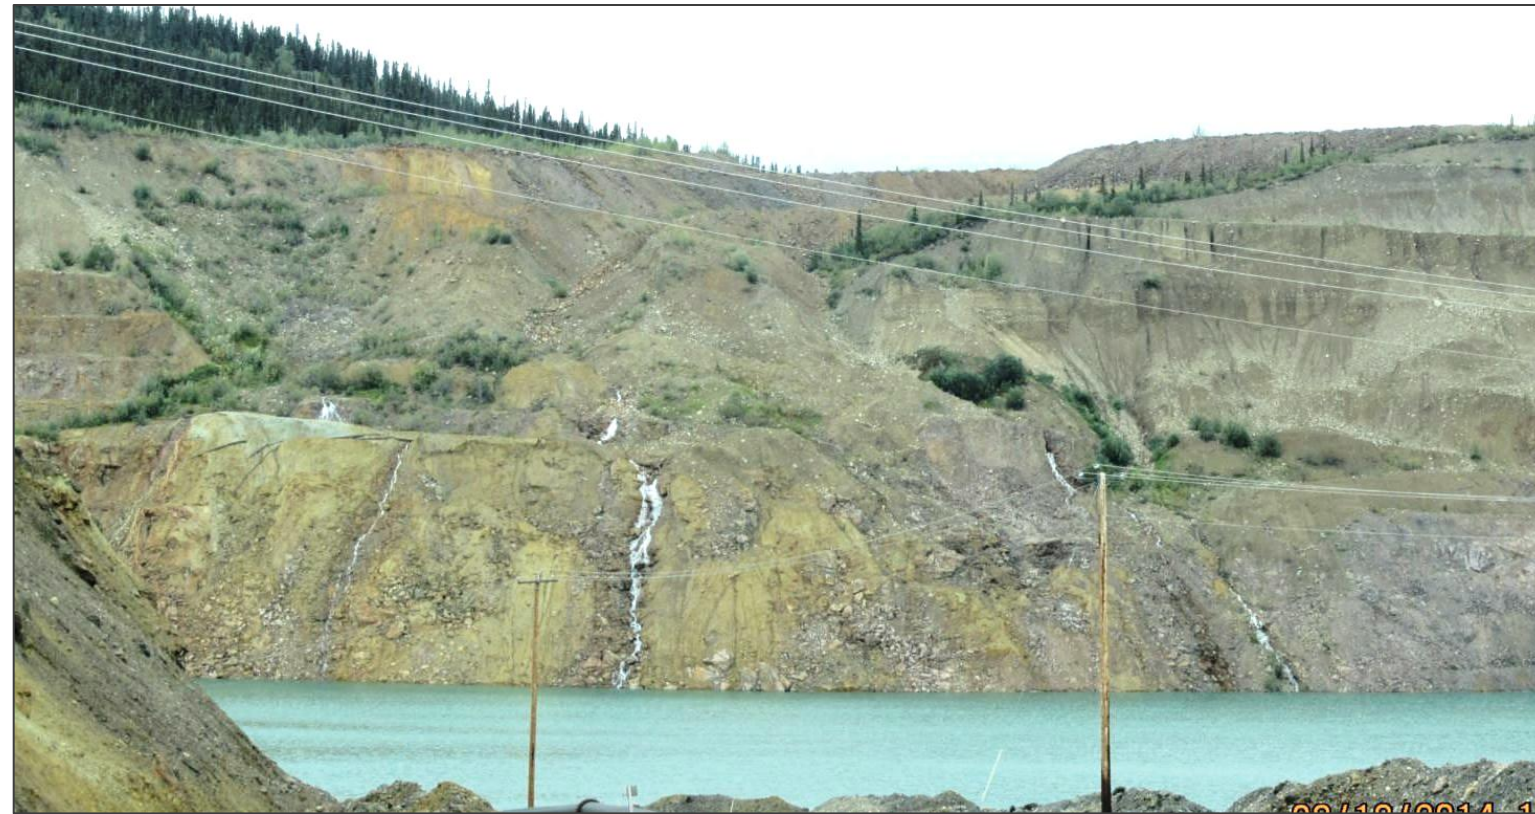
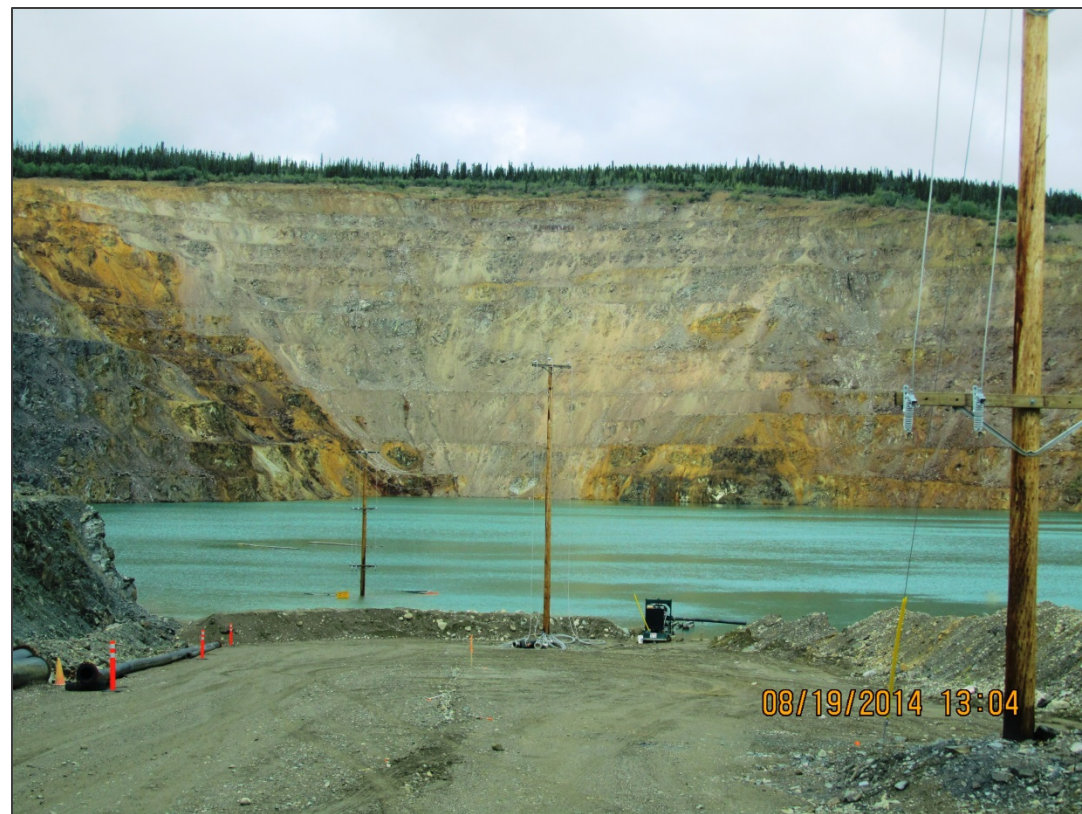
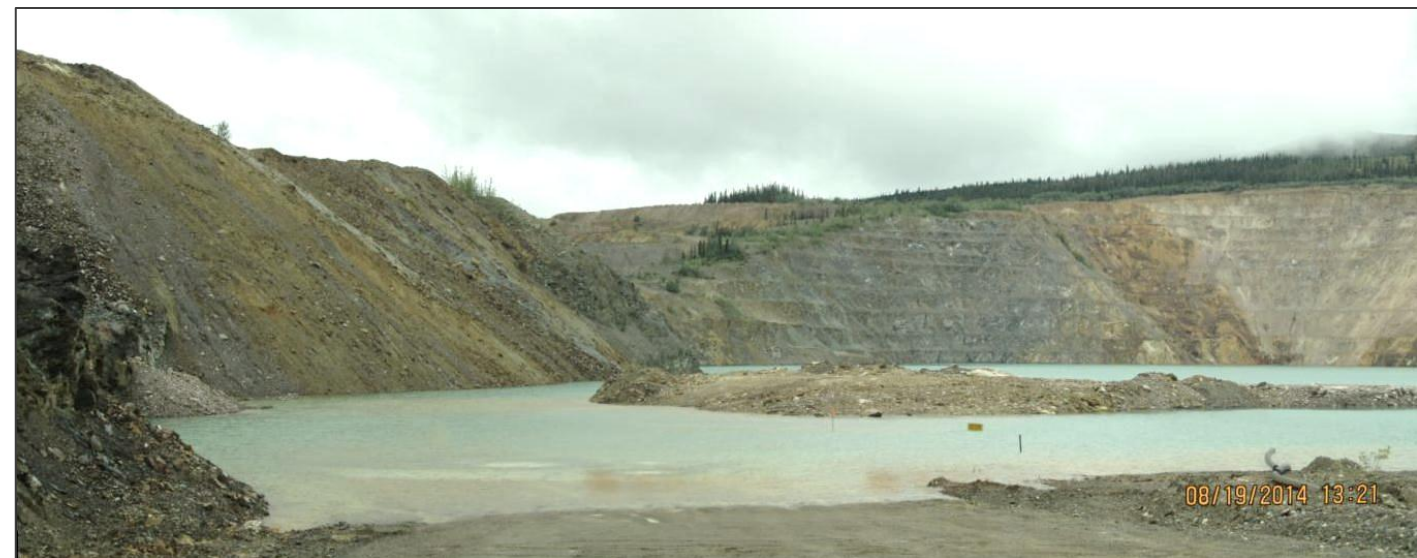
0	16/SEP14	FIGURE	JJR	JJR	AVC	AVC
REV	DATE	DESCRIPTION	DRW	DES	CHK	RVV
PROJECT		1410944/8000				
CLIENT		Yukon Government				
CONSULTANT		Golder Associates				
TITLE		FARO MINE COMPLEX 2014 PIT SLOPE INSPECTION				
		FARO PIT OBSERVATIONS				
		FIGURE No. A-10

- Seepage and water flow into the pit was observed to the north of the North Instability Zone. The water appears to be emanating from the overburden/bedrock contact (Figure A-10) and may be coming from the ponded water behind the crest. Compared to the 2012 photo, there appears to be little difference in the size and shape of the gullies, indicating minimal erosion.

SEEPAGE AND SURFACE RUNOFF

BERM AT END OF WEST ACCESS ROAD

NO BERM AT END OF ZONE 2 ACCESS ROAD

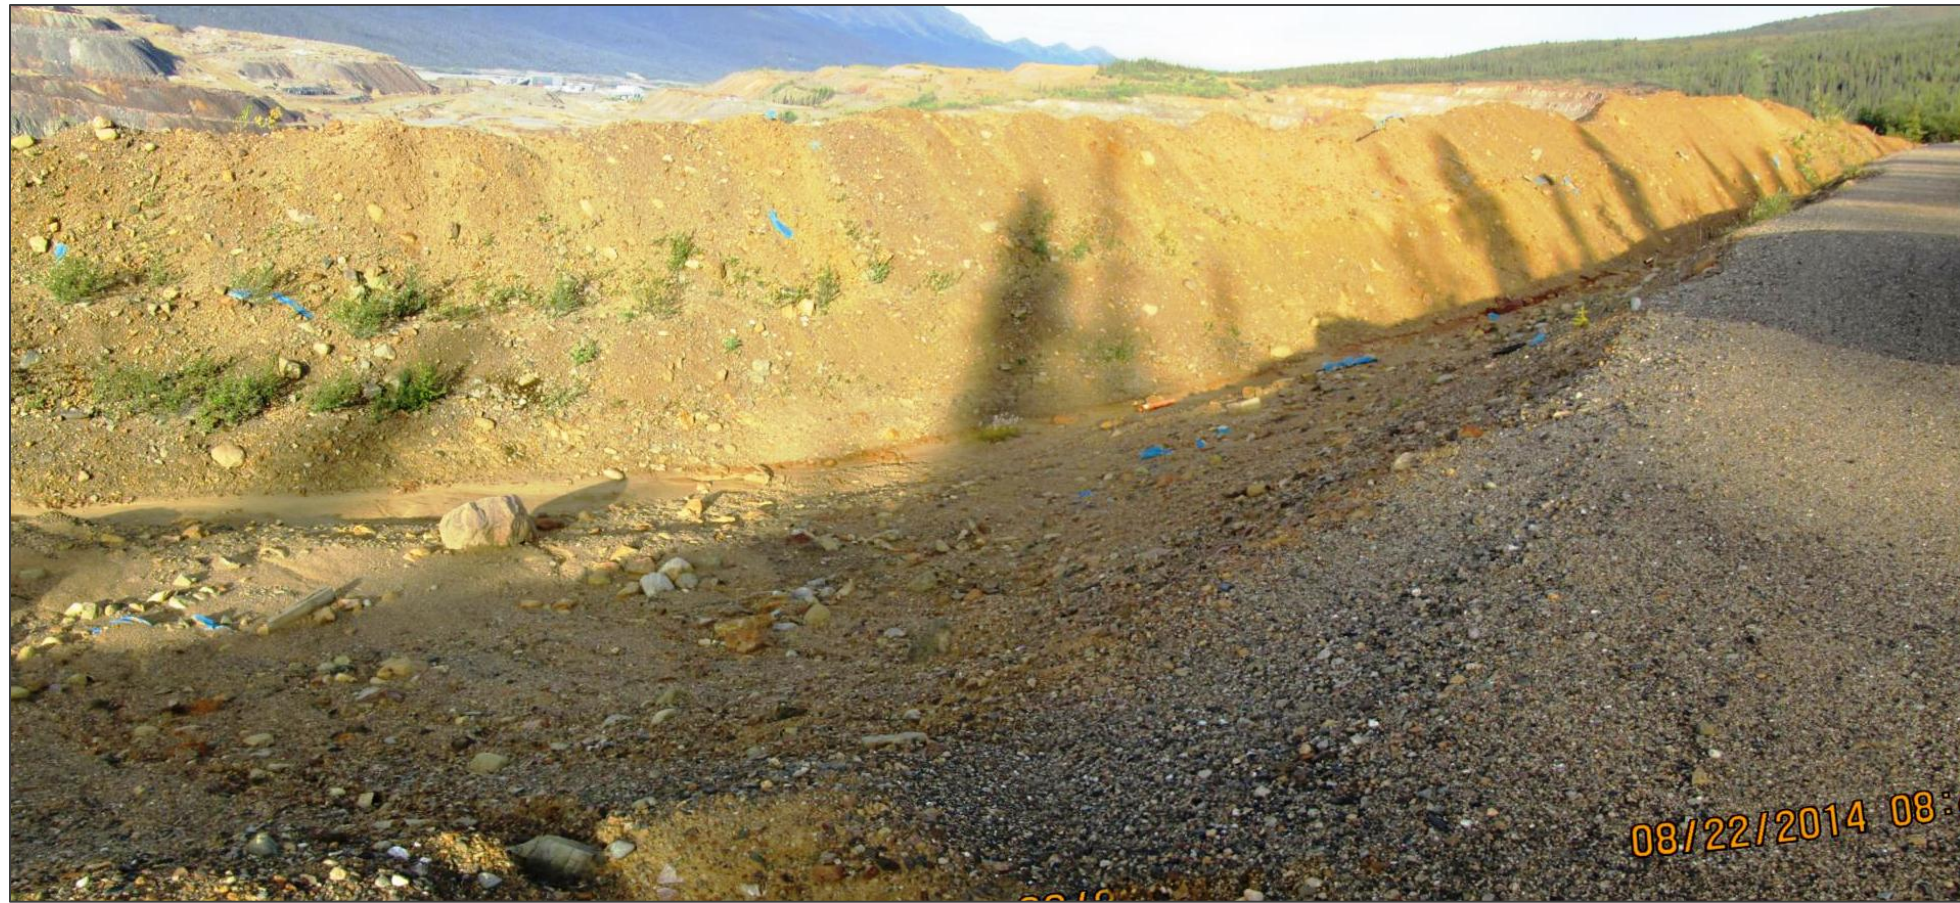
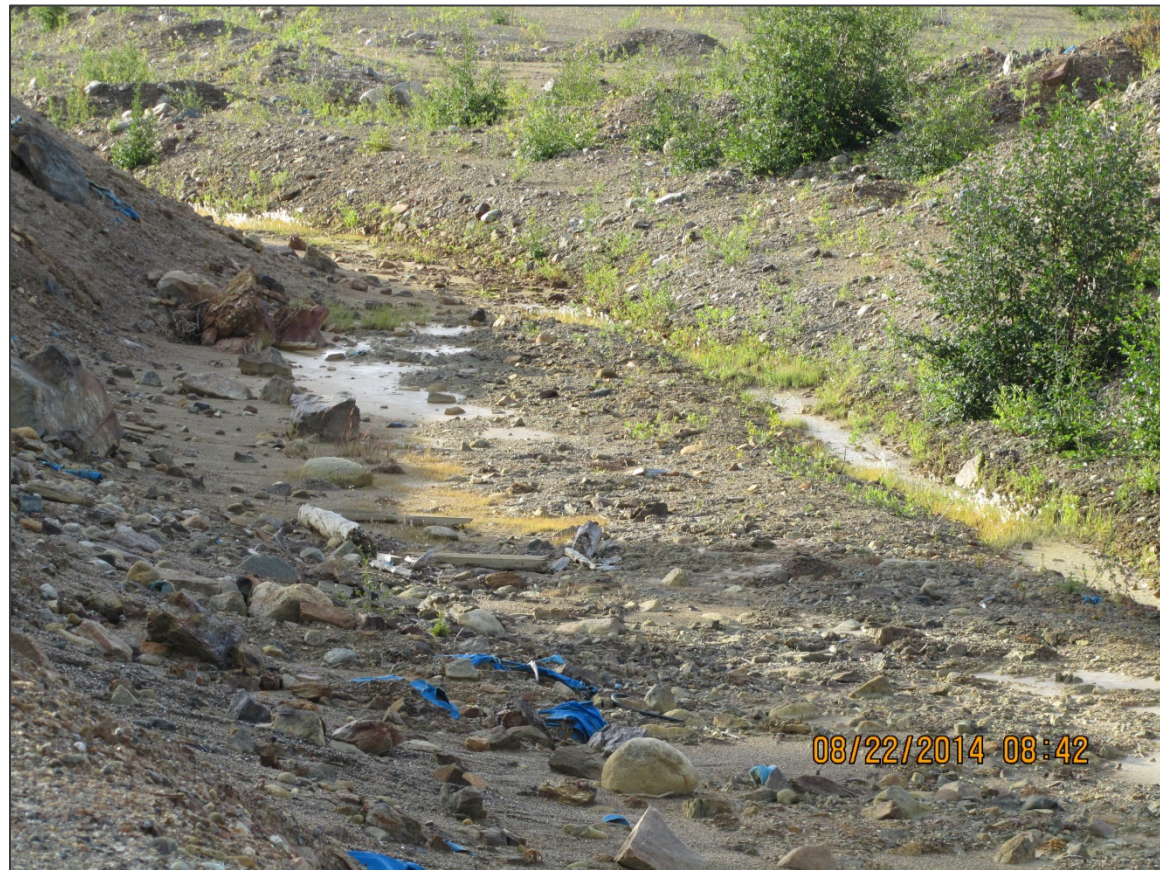
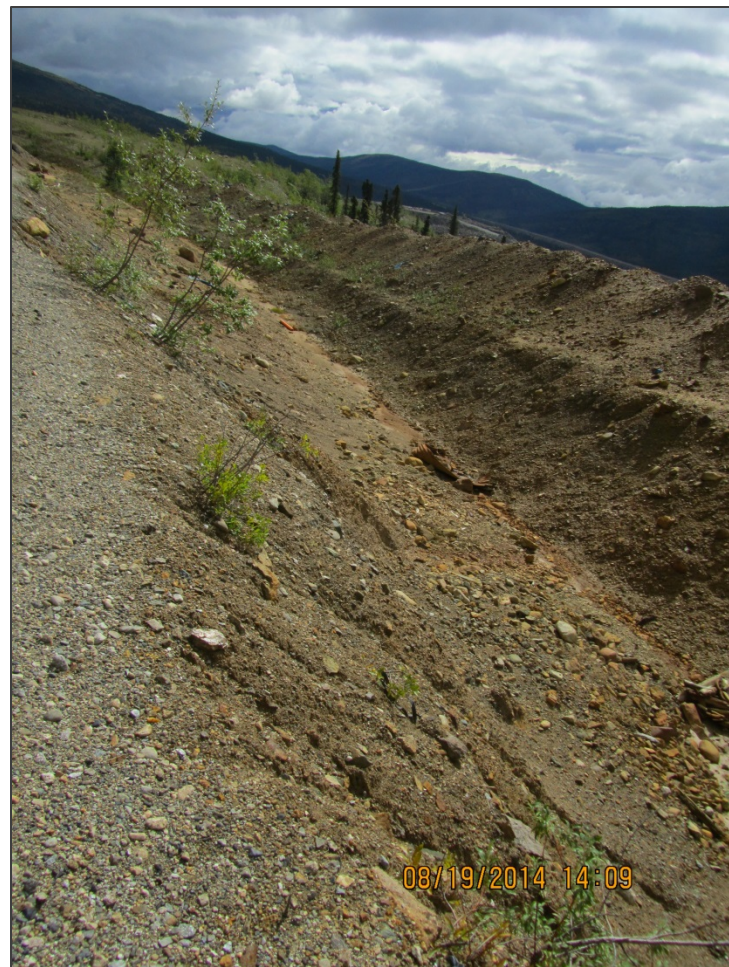
CLIENT		Yukon Government		YUKON GOVERNMENT		
CONSULTANT		Golder Associates		FIGURE No. A-11		
REV	DATE	DESCRIPTION	DRW	DES	CHK	RWW
0	16/SEP14	FIGURE	JJR	JJR	AVC	AVC
PROJECT			1410944/8000			
TITLE			FARO MINE COMPLEX 2014 PIT SLOPE INSPECTION			
TITLE			WATER IN DITCH AT CREST OF EAST WALL

- There is a large berm at the crest of the east wall, on the east side of the access road, behind the south instability zone. A ditch at the toe of the berm, whether by intention or not, is collecting rainwater and surface flow from the road that should be draining into the FCDC on the opposite side, and water is likely infiltrating into the slope (Figure A-11).

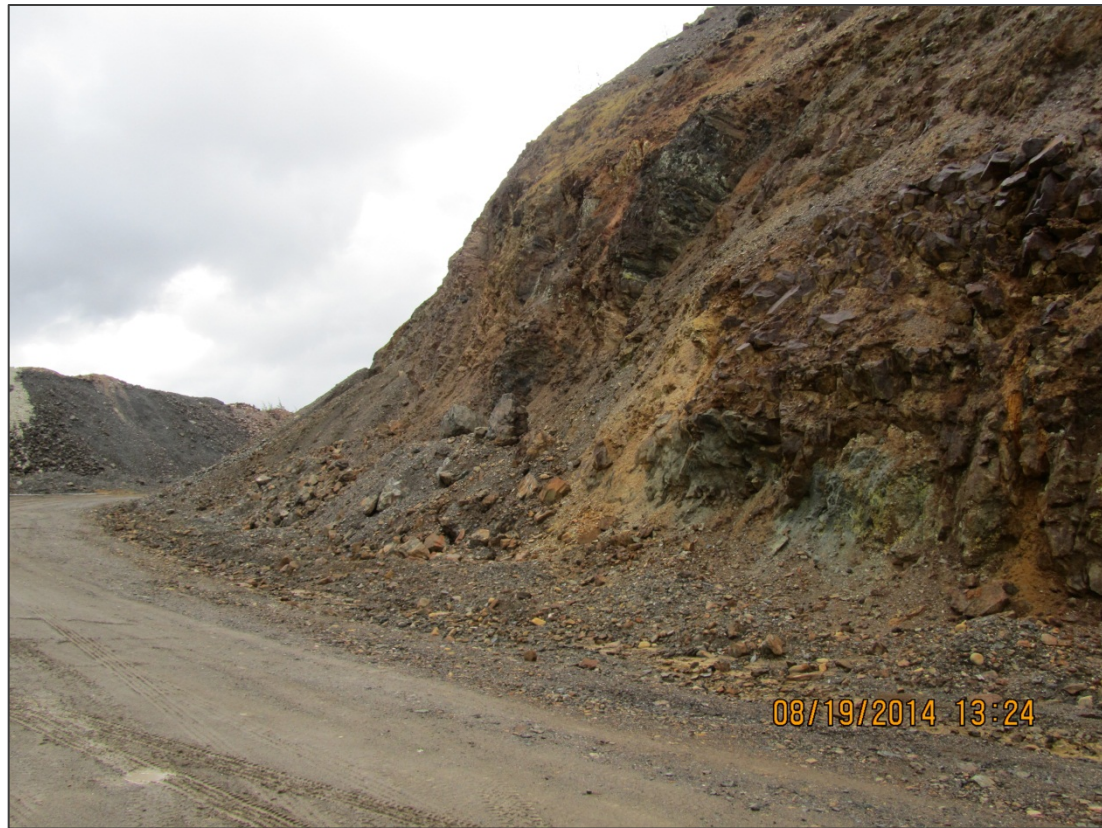
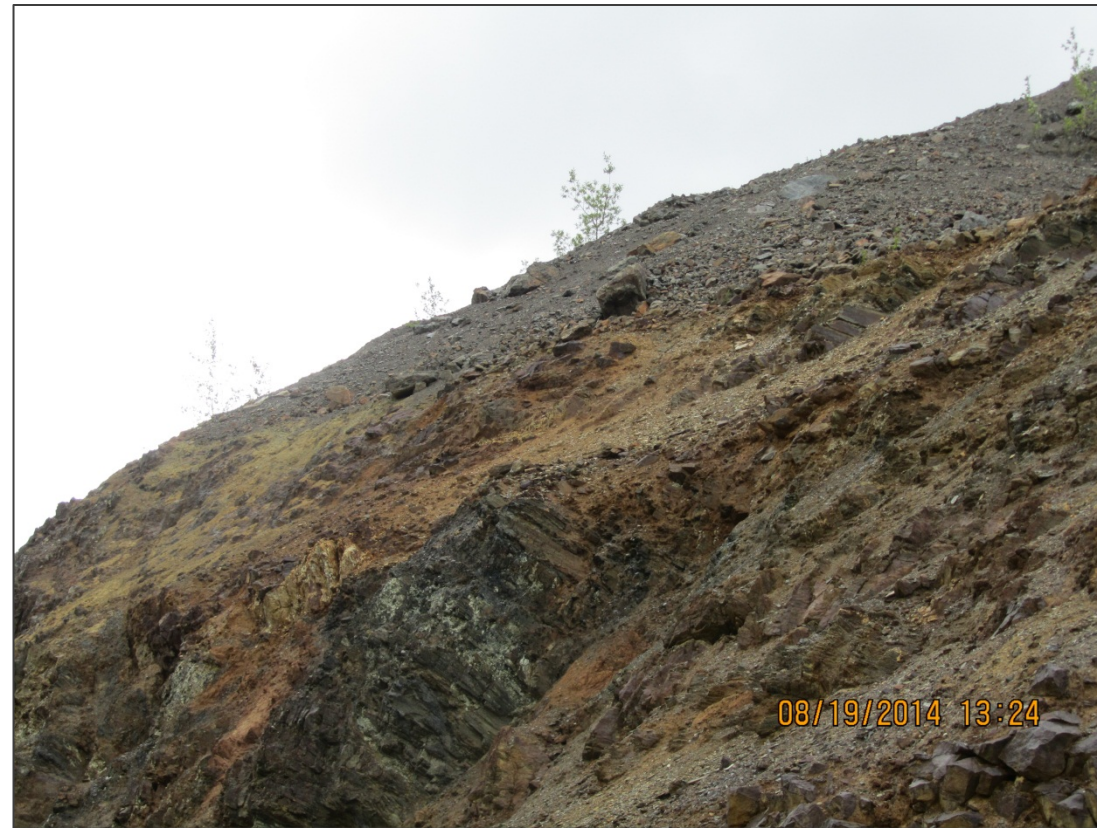
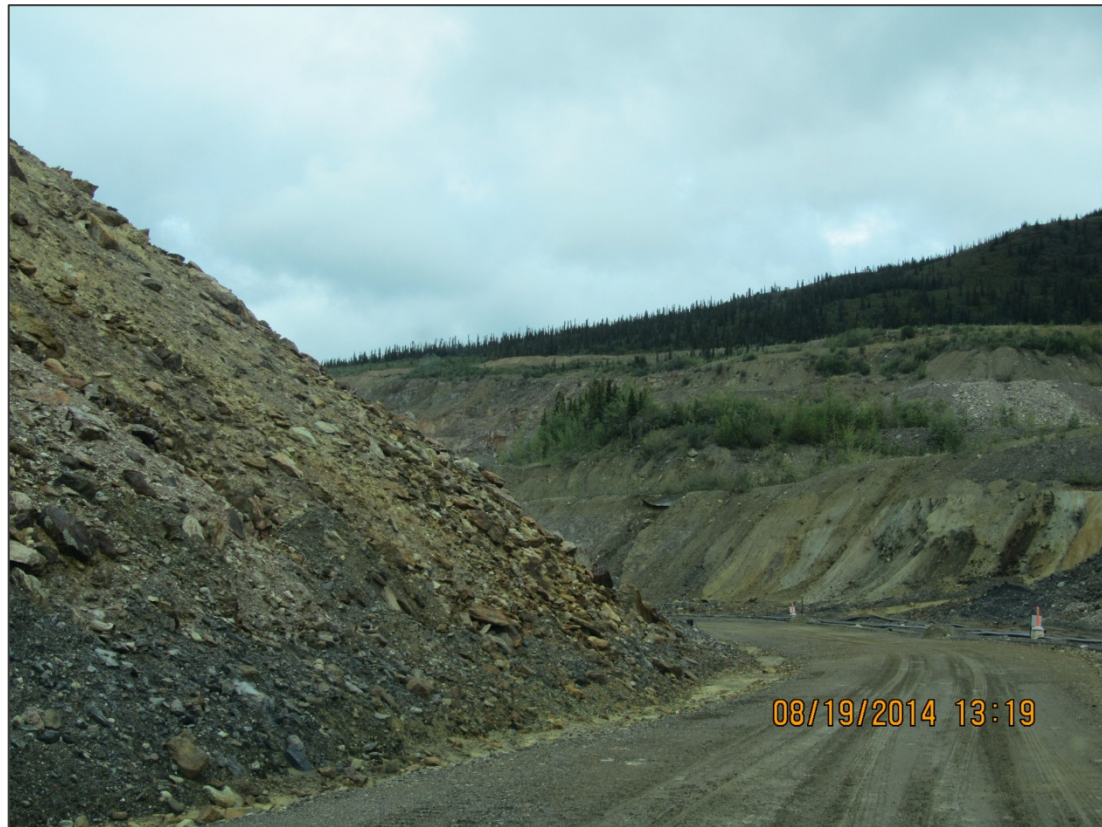
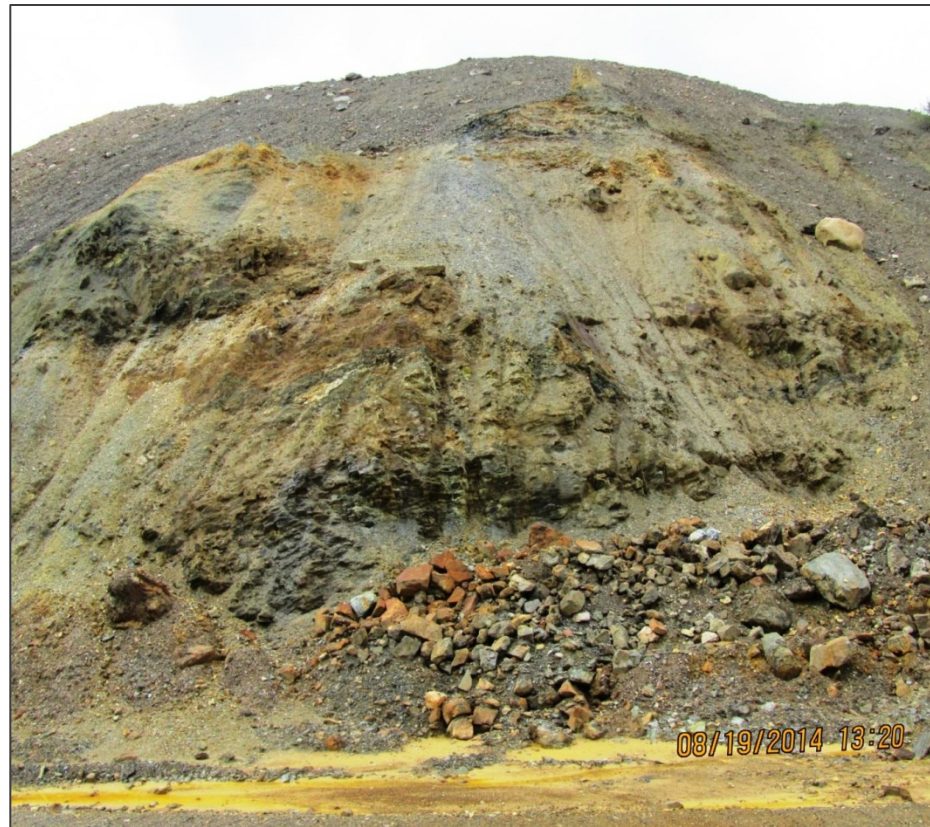
FIGURE No.
A-12

- There are areas of rockfall hazard on the west side of the Zone 2 access road (Figure 1) to the pit bottom (Figure A-12). To turn a vehicle around, one must drive directly beneath the unprotected slope at the bottom of the ramp.

TITLE
 AREAS OF ROCKFALL HAZARD
 WEST SLOPE - ZONE 2 ACCESS ROAD

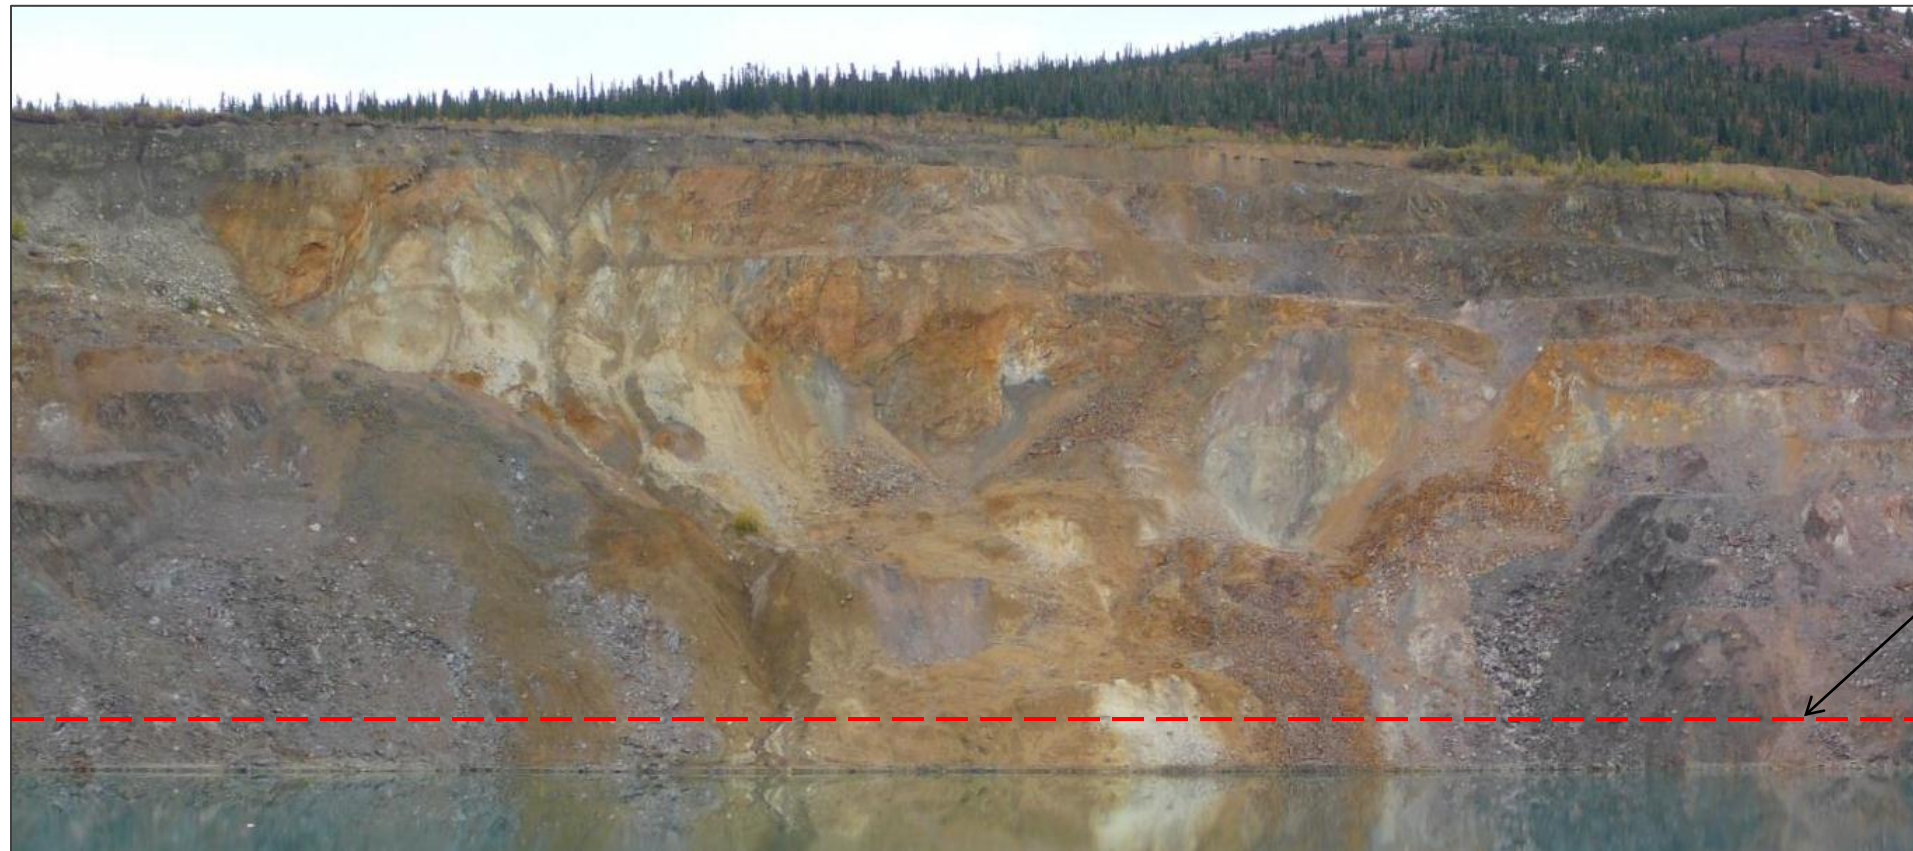
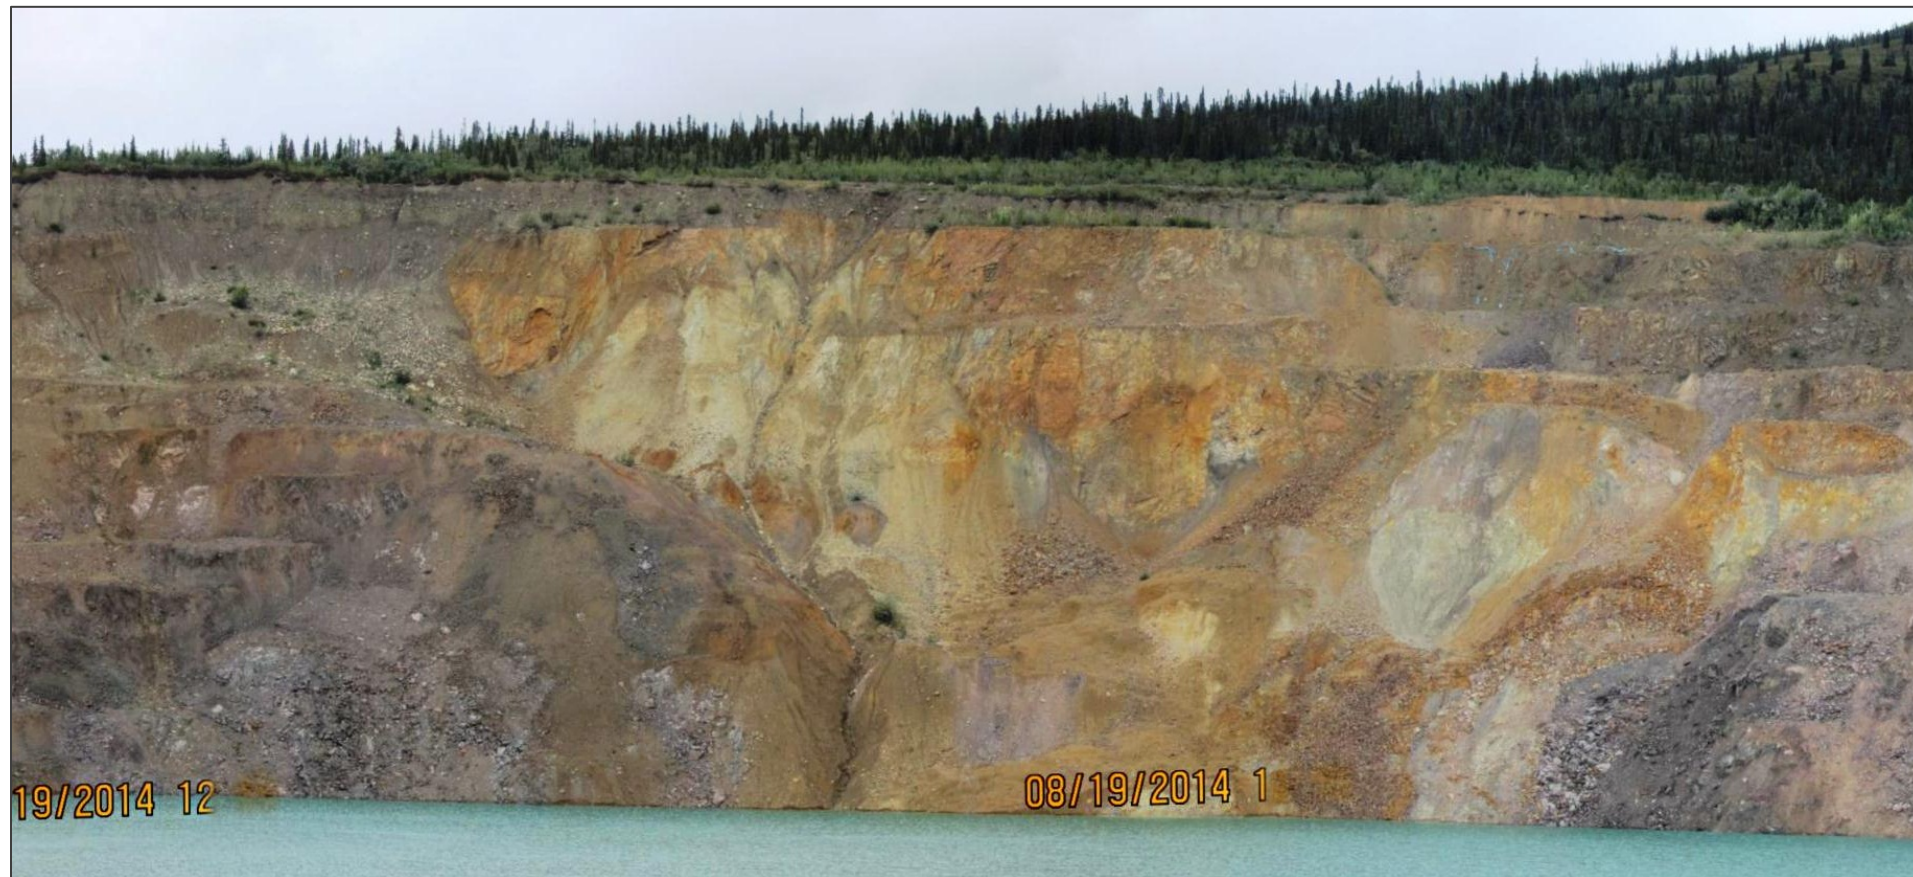
REV	DATE	DESCRIPTION	DRW	DES	CHK	RVV
0	16/SEP/14	FIGURE	JJR	JJR	AVC	AVC
PROJECT			1410944/8000			
CLIENT			YUKON GOVERNMENT			
CONSULTANT			Golder Associates			
TITLE			NORTH INSTABILITY ZONE PHOTO COMPARISON			
			FIGURE No. A-13

ESTIMATED 2014 PIT LAKE LEVEL
