FARO MINE COMPLEX

2014 Annual Pit Slope Stability Inspection

Reference Number: 1410944-002-R-Rev0-6000

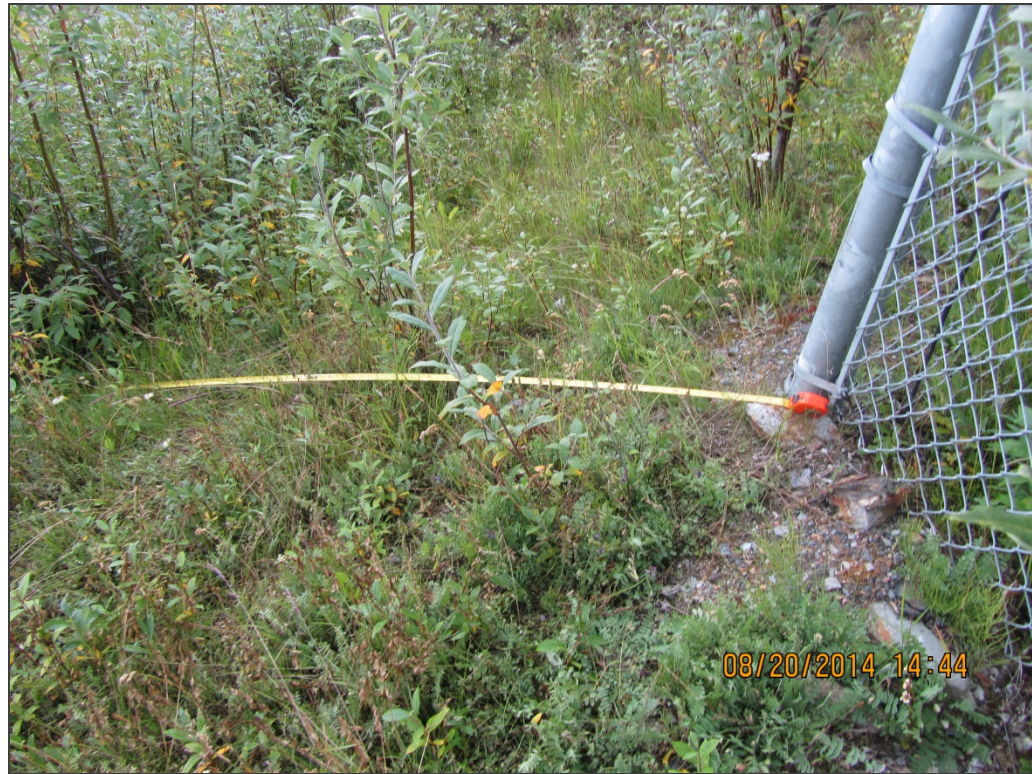
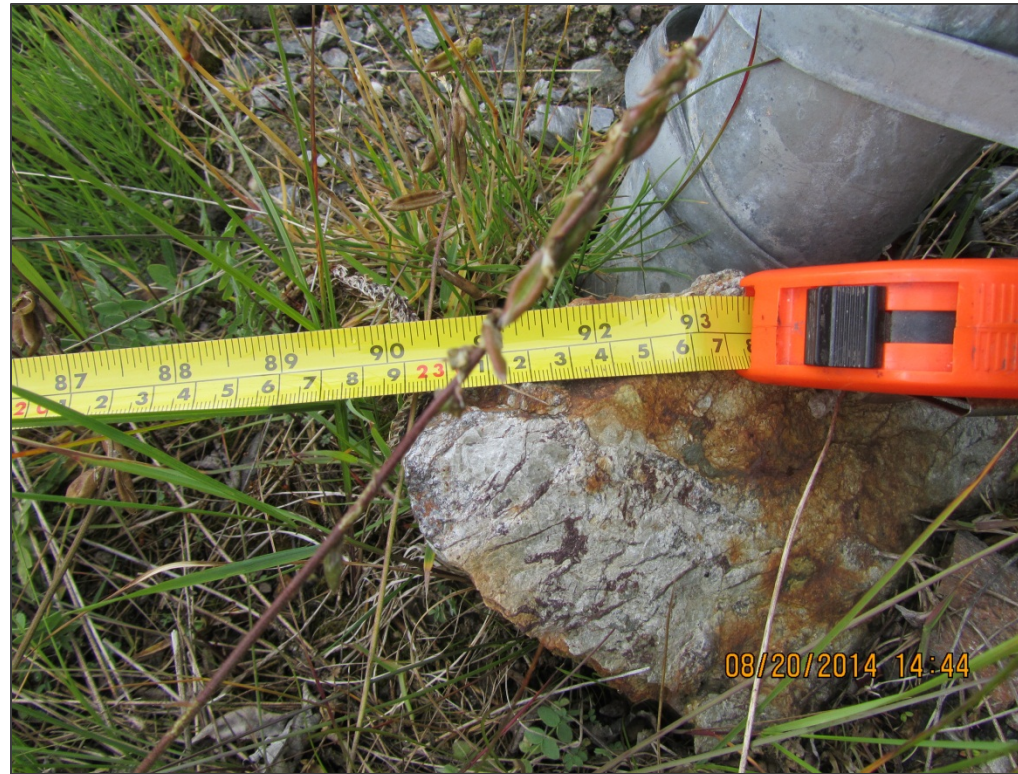
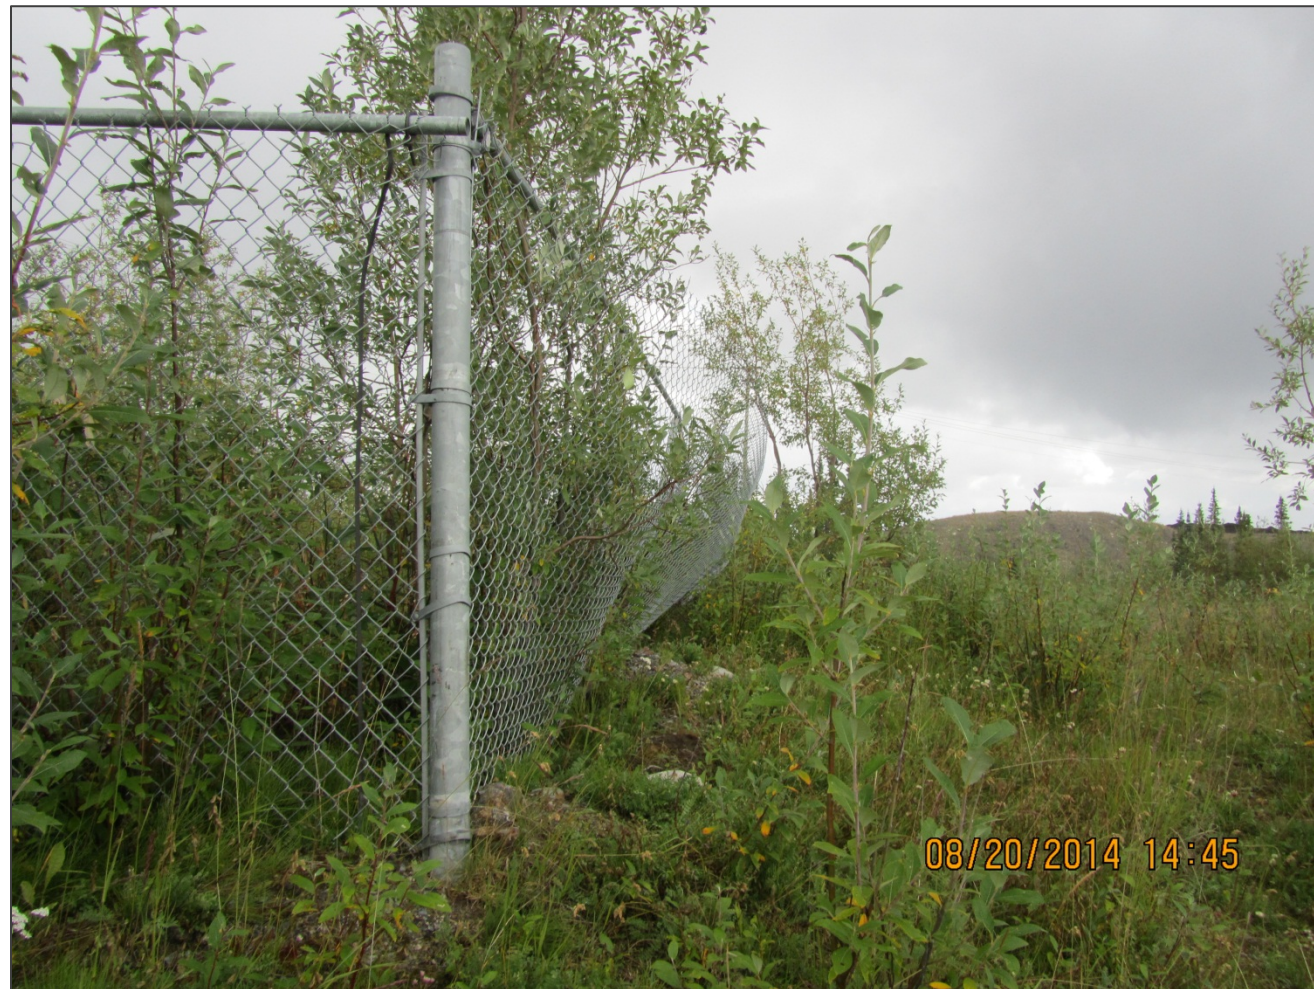
CLIENT		Yukon Government		YUKON GOVERNMENT	
CONSULTANT		Golder Associates		TITLE	
PROJECT		FARO MINE COMPLEX 2014 PIT SLOPE INSPECTION		FIGURE No.	
REV		DATE		DESCRIPTION	
DRW		DES		CHK	
RWW		AVC		AVC	
0		16/SEP14		FIGURE	
				JUR	
				JUR	
				AVC	
				AVC	
				1410944/8000	
				CRACKS IN TILL TO THE SOUTH OF THE INSTABILITY ZONE	
				B-3

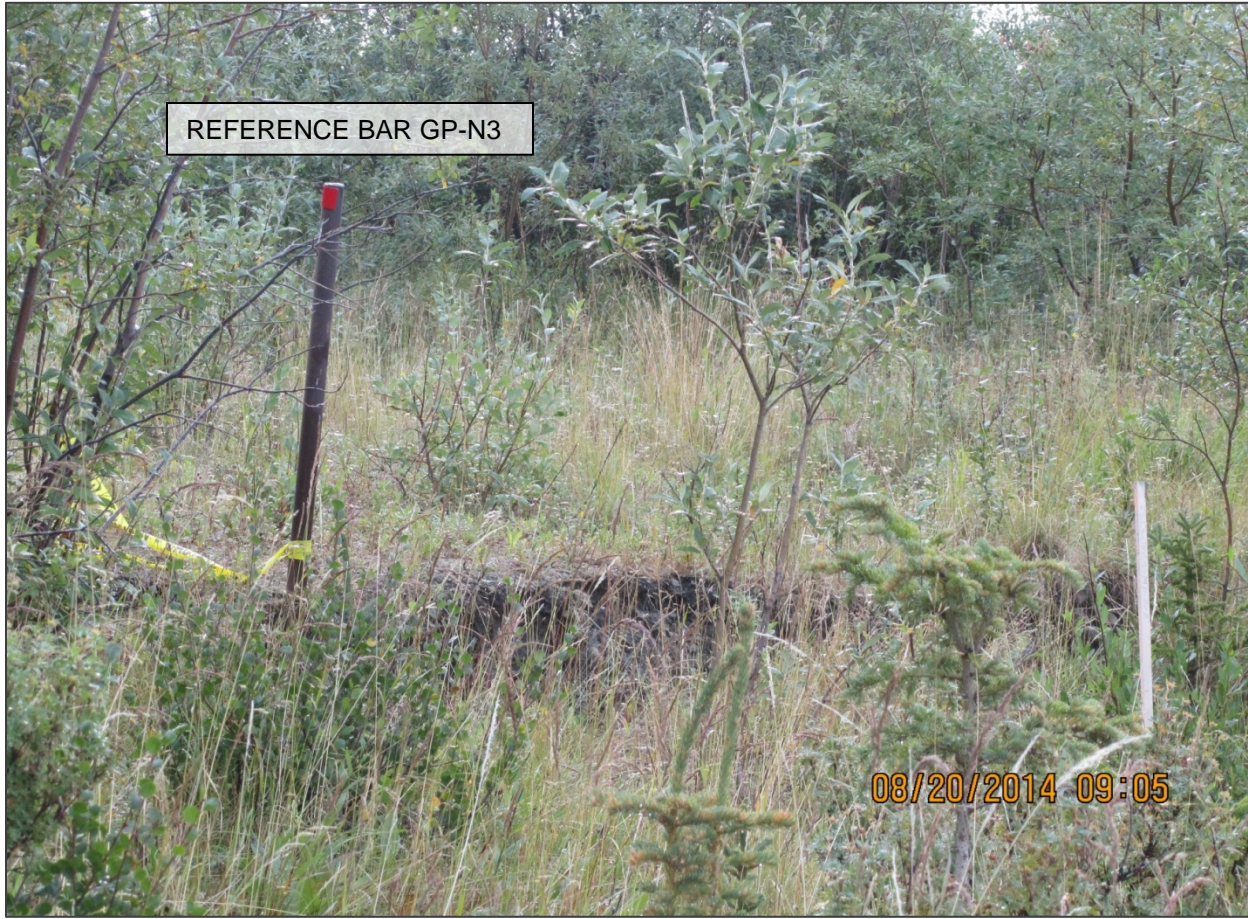
REFERENCE BAR GP-N3

0	16/SEP14	FIGURE	JJR	JJR	AVC	AVC
REV	DATE	DESCRIPTION	DRW	DES	CHK	RWW
PROJECT		1410944/8000				
CLIENT			YUKON GOVERNMENT			
CONSULTANT			Golder Associates			
TITLE			CHAIN LINK FENCE NEAR SOUTH ARRAY			
			FIGURE No. B-4

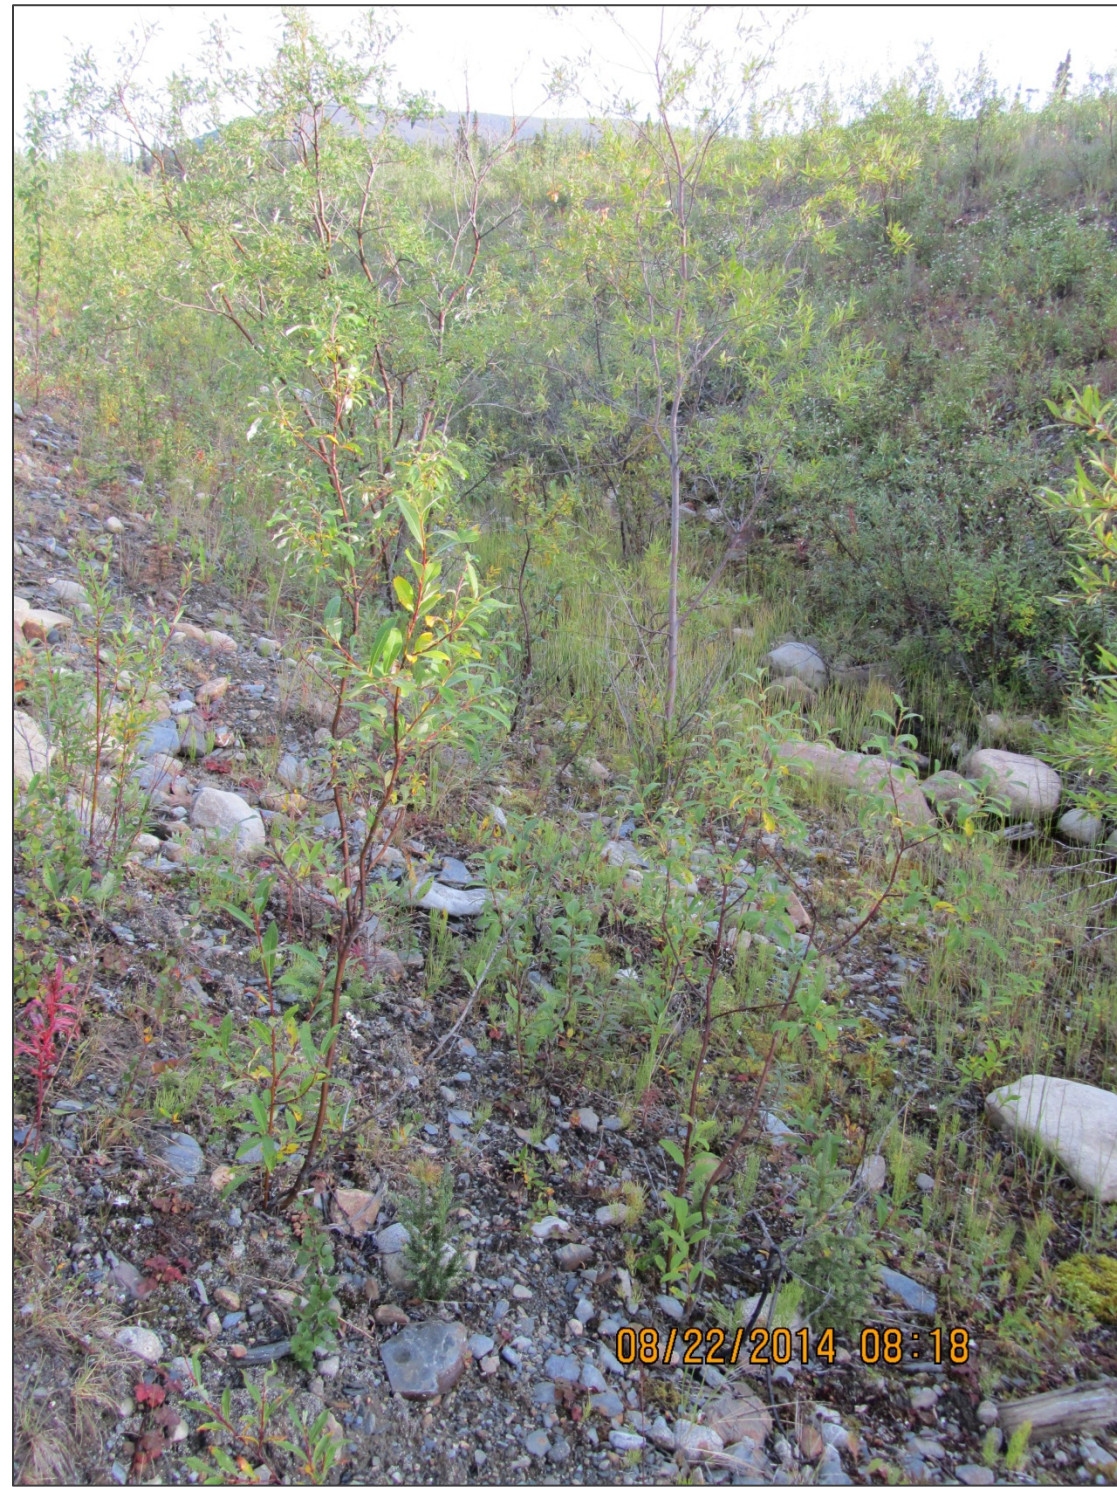
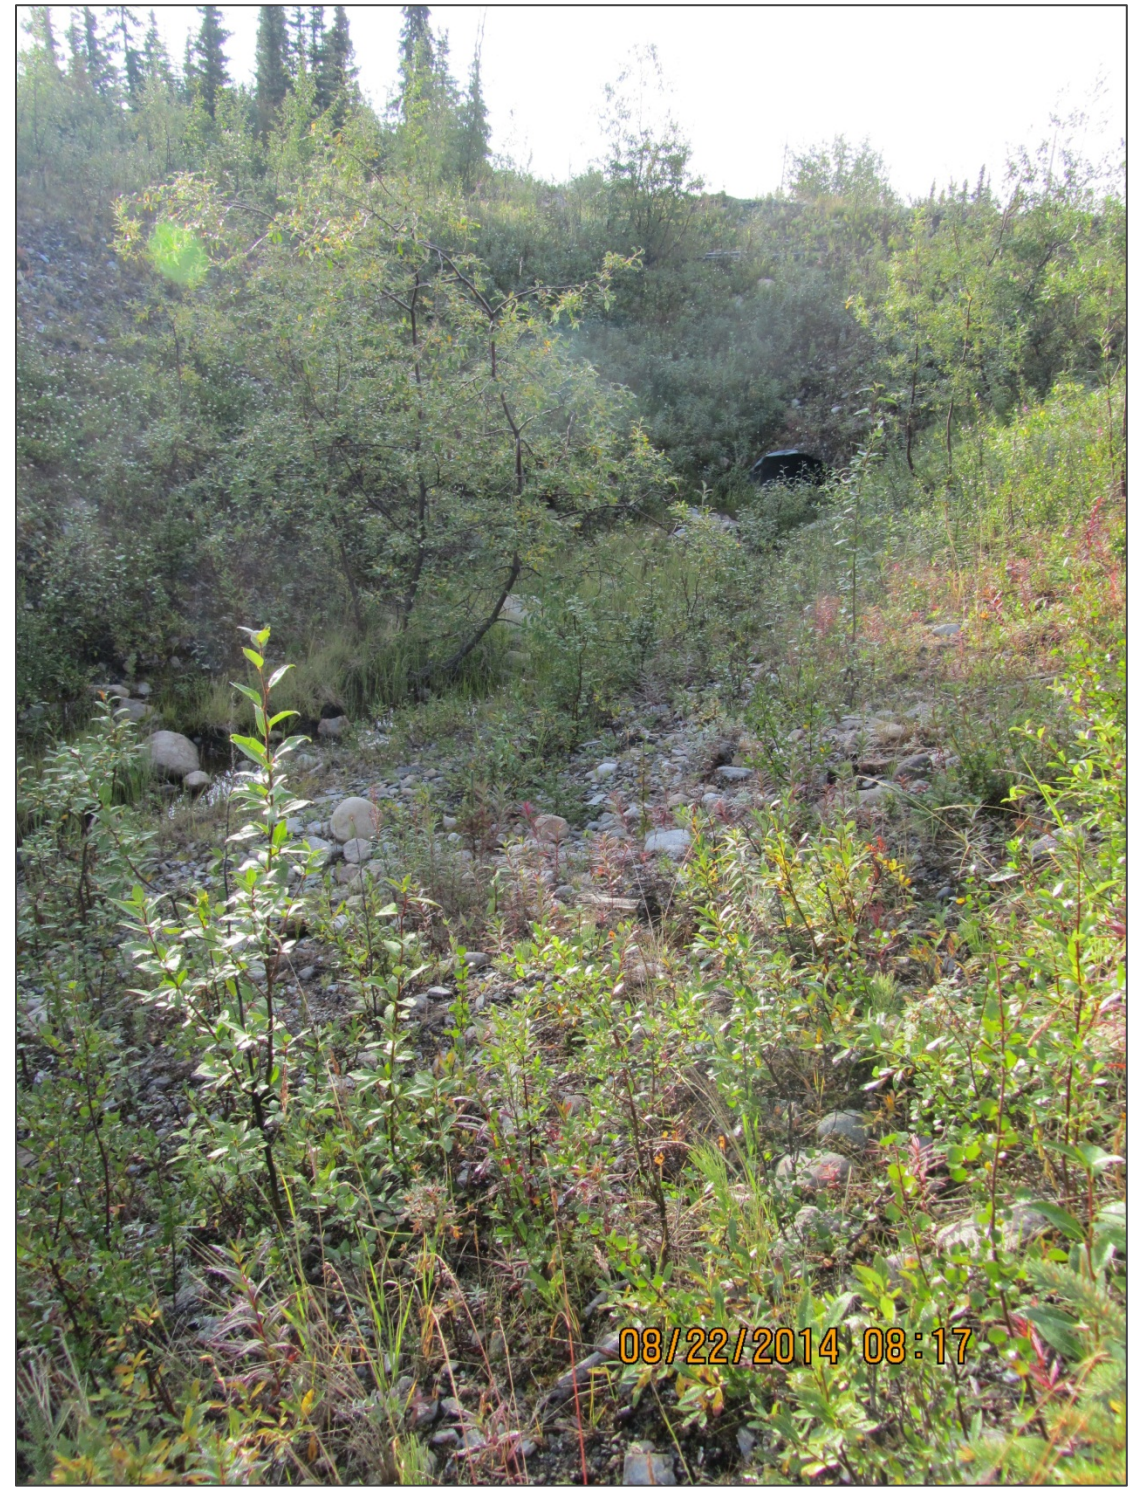
CRACK IN 2014

CRACK IN 2012

0	16/SEP14	FIGURE	JJR	JJR	AVC	AVC
REV	DATE	DESCRIPTION	DRW	DES	CHK	RWW
PROJECT		1410944/8000				
CLIENT			YUKON GOVERNMENT			
CONSULTANT			Golder Associates			
TITLE			AREA OF DEFORMATION AT GP-N3			
			FIGURE No. B-5

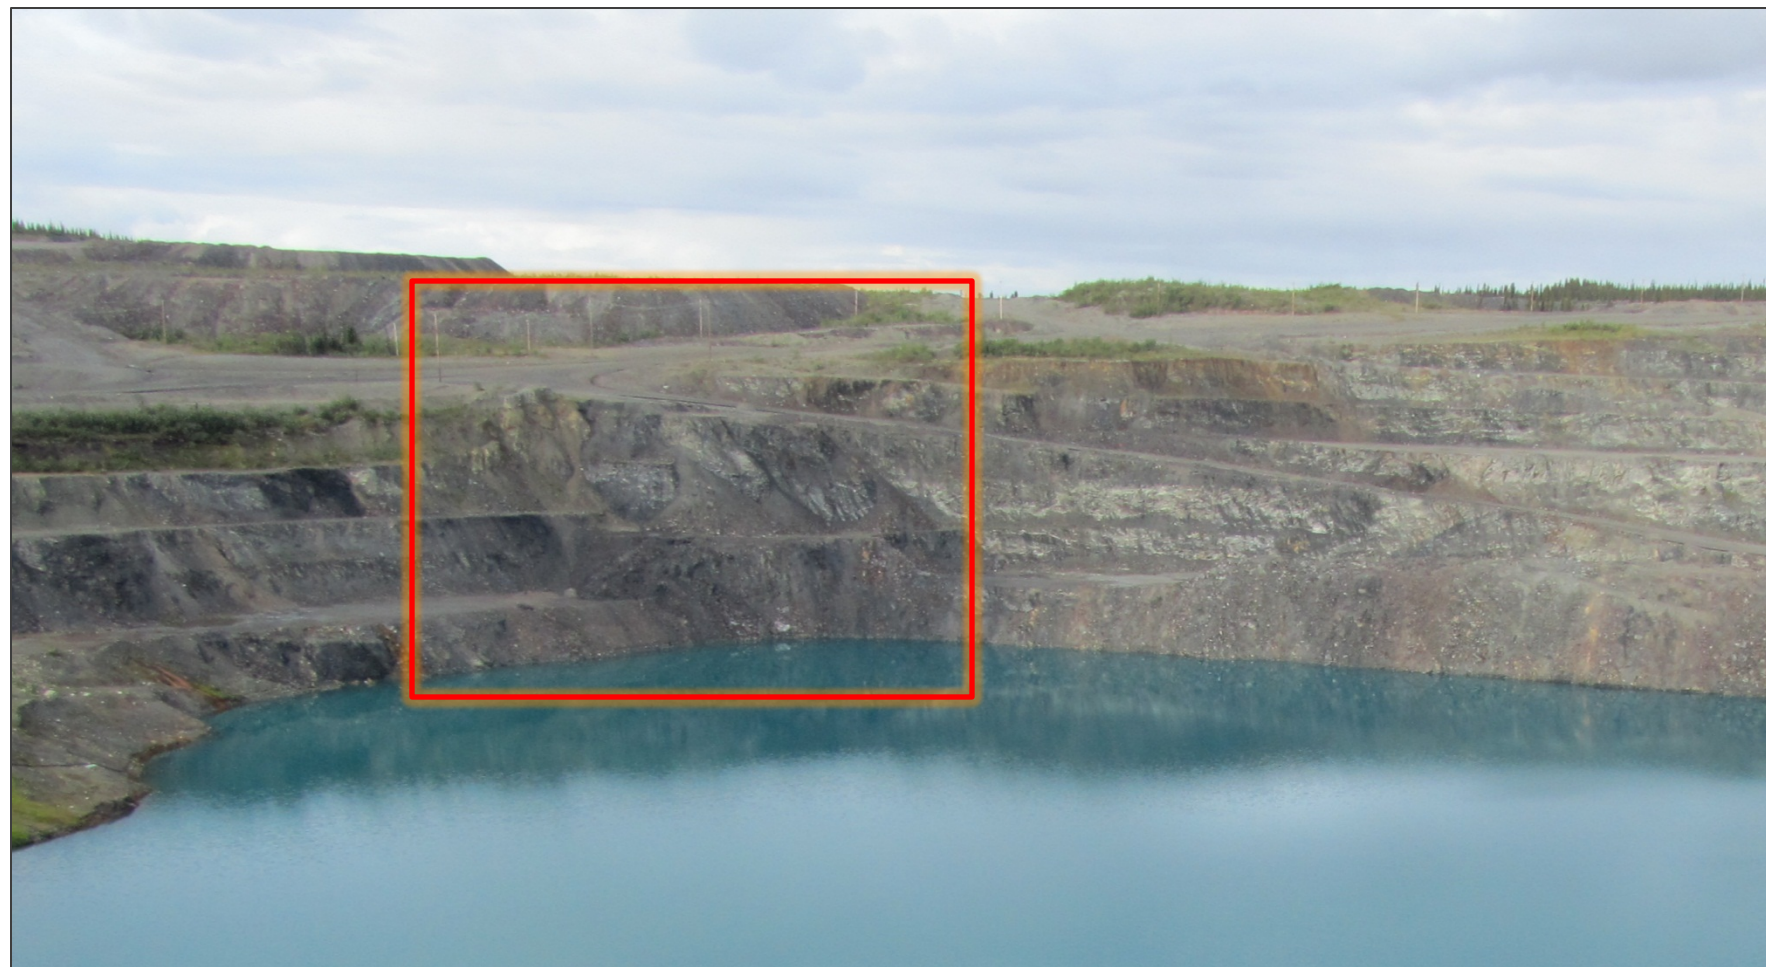
0	16/SEP14	FIGURE	JJR	JJR	AVC	AVC
REV	DATE	DESCRIPTION	DRW	DES	CHK	RWW
PROJECT		1410944/8000				
CLIENT		YUKON GOVERNMENT				
CONSULTANT		Golder Associates				
TITLE		SLUMPING AREA IN SOUTHWEST CORNER				
FIGURE No.		B-9

Visually monitor the area that appears to be slumping in the southwest corner of the pit, and take periodic photographs from the same location to determine if there is continued displacement.	High - Long Term
	Repair reference bar GP-S4.	Medium - Short Term
	If large areas of ponded water are observed behind the crest of the east wall, grade the area to minimize ponded water and infiltration into the slope as well as to control runoff onto the slope face.	Medium - Long Term
	Clear the vegetation from the south end of the Grum Interceptor Ditch.	Low - Long Term
Vangorda	Cracks were observed in 2013 and 2014 in the face and at the crest of the till slope in the northwest corner of the pit that had not been observed in 2012. Carry out a periodic visual assessment of the cracks to determine if there are any significant changes in the size or intensity of the cracks. Carry out a visual assessment any time personnel will enter the pit. If the cracks increase in size or intensity, it is recommended that a geotechnical engineer review the stability of the slope.	High - Short Term

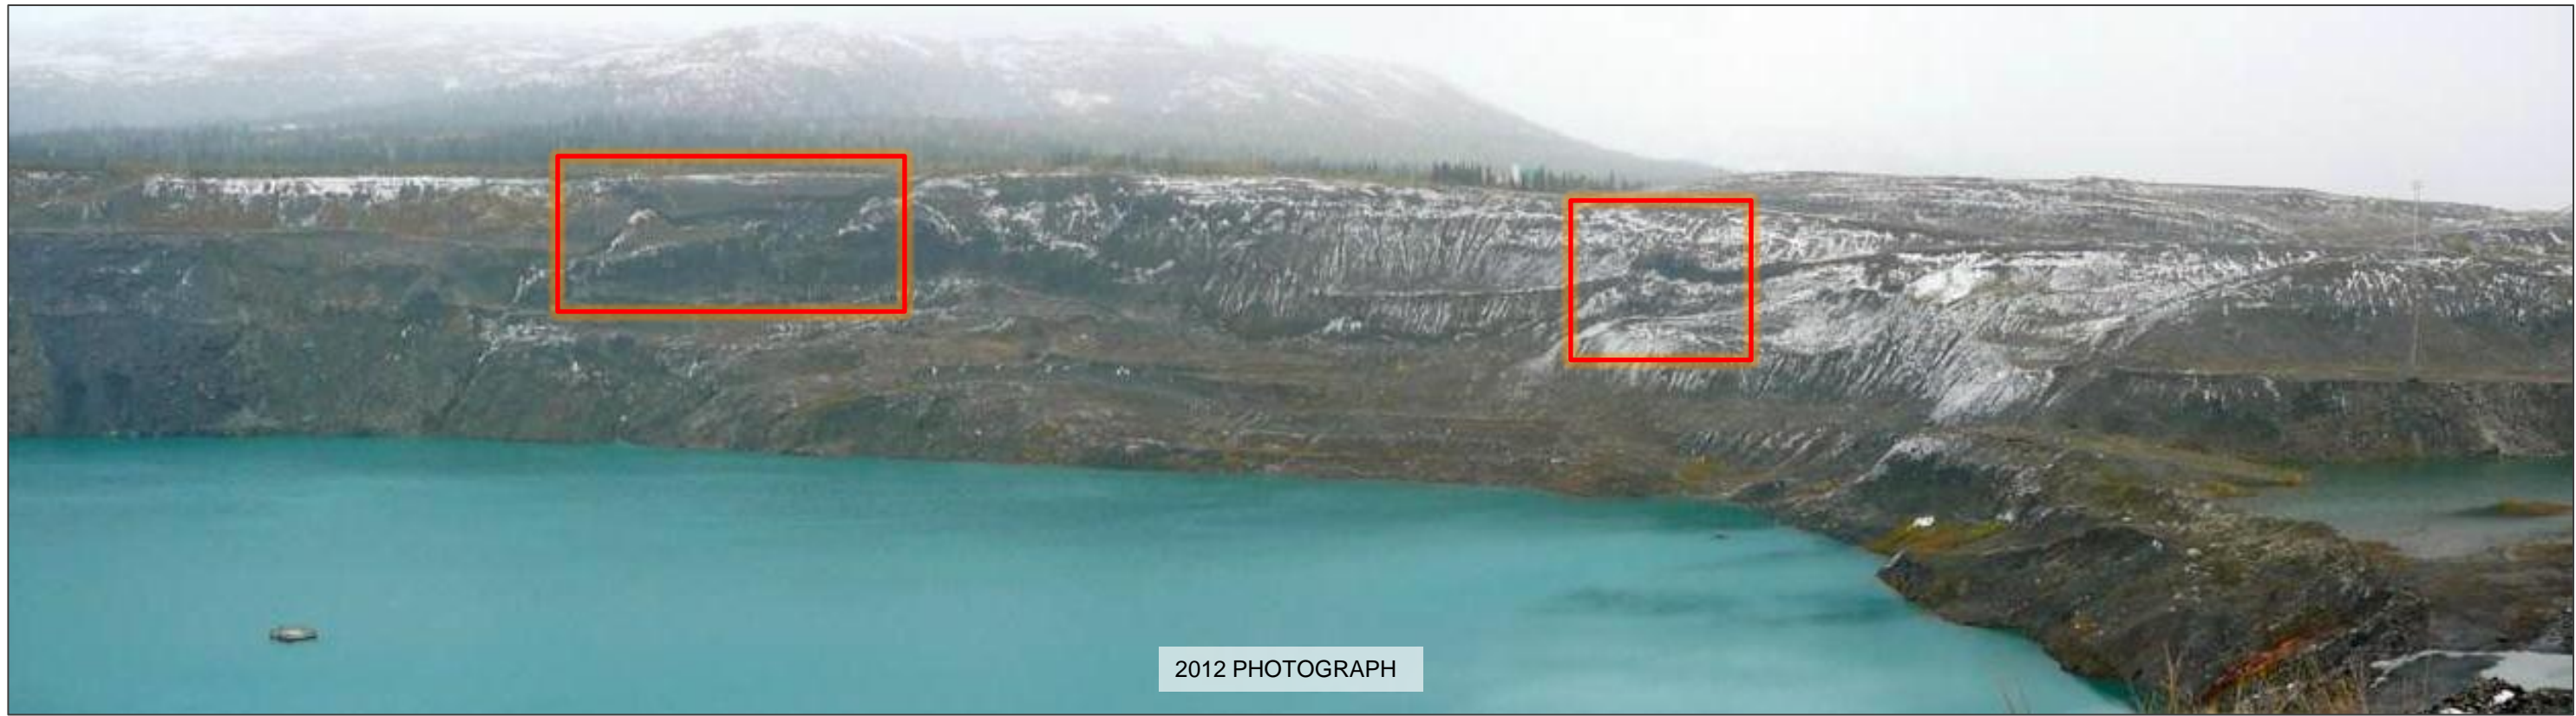
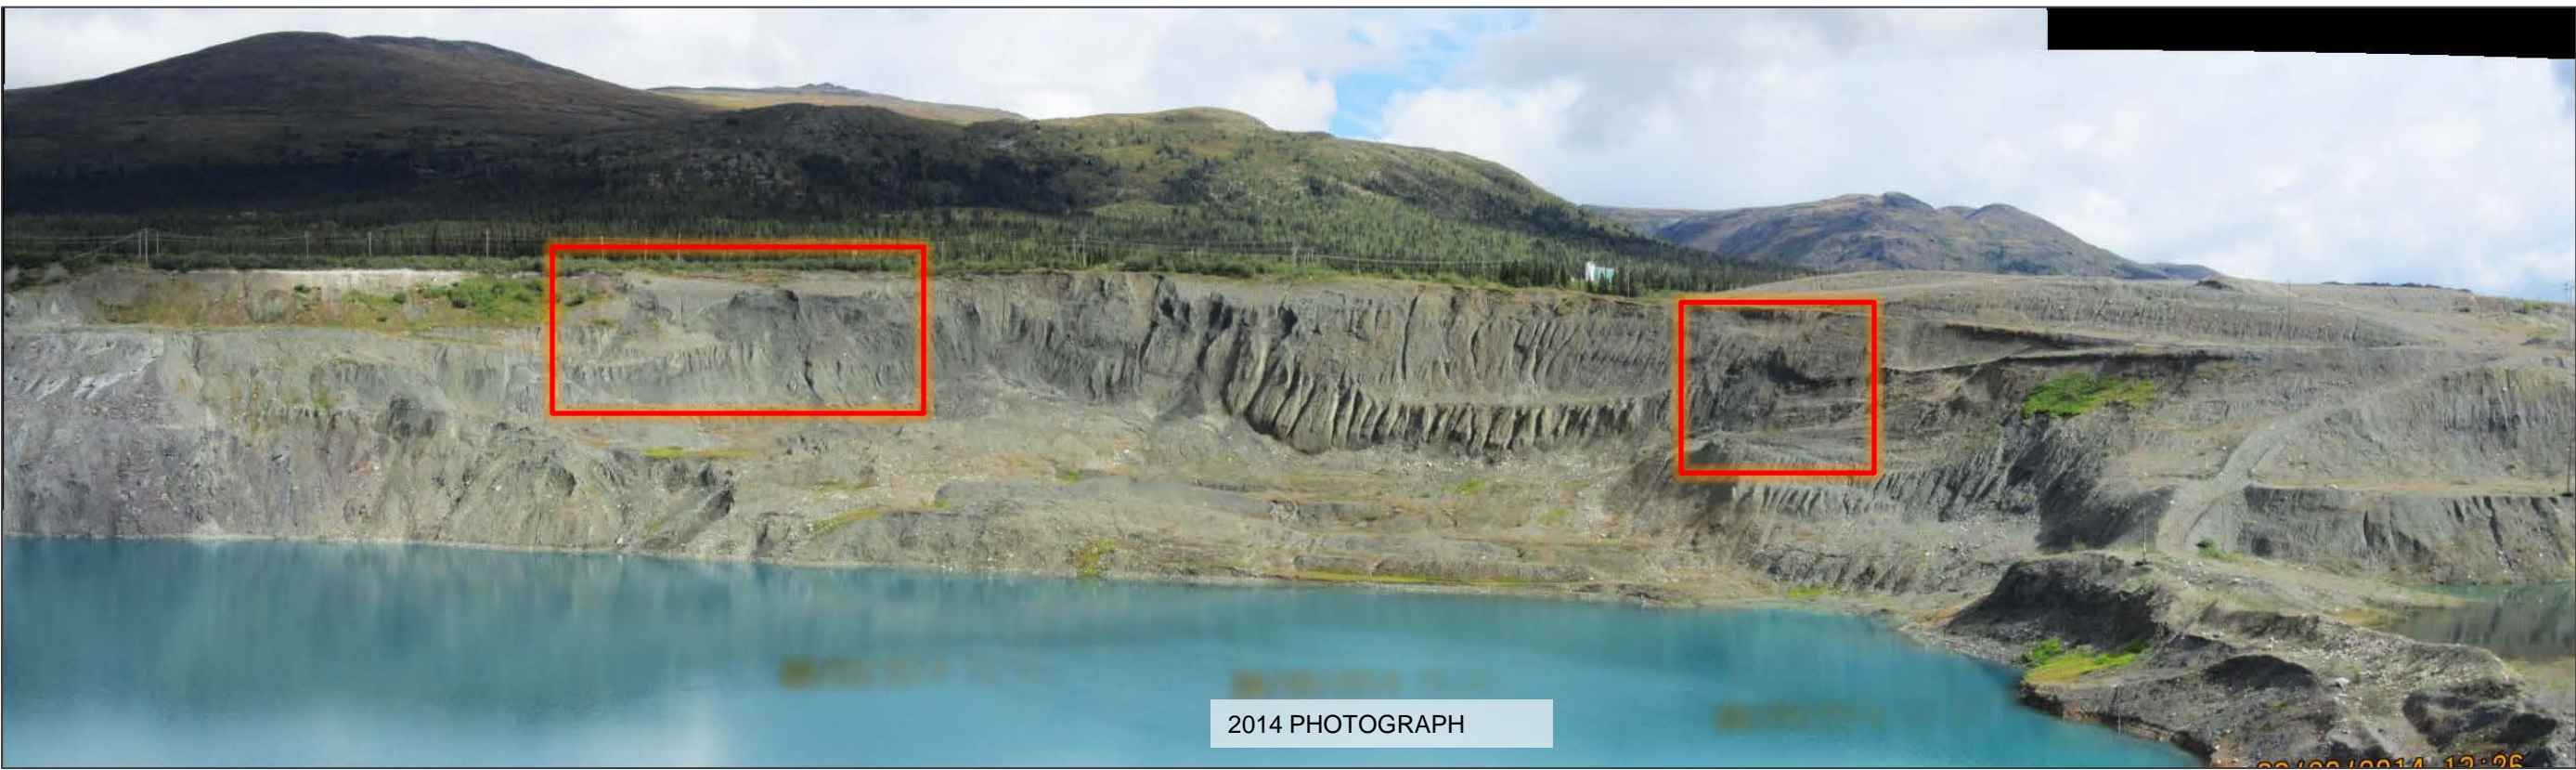
TITLE
 NORTH SLOPE ABOVE GRUM SLOT CUT

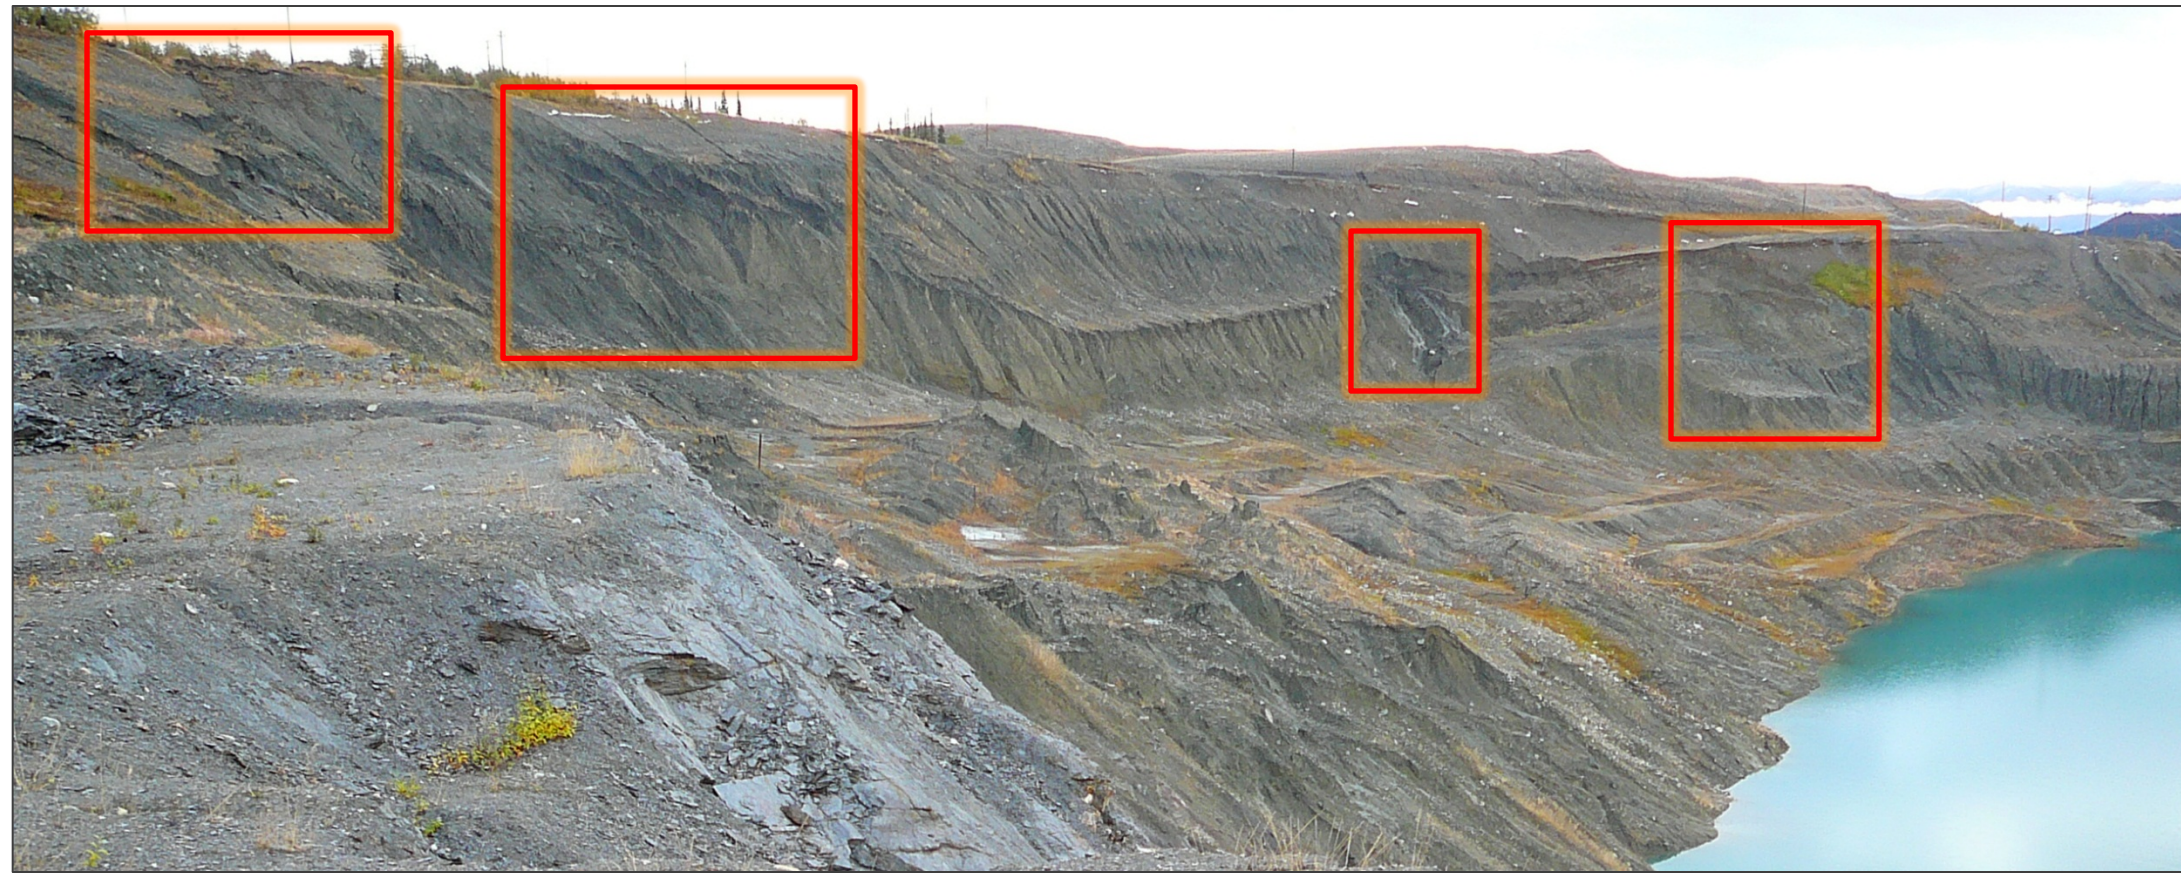
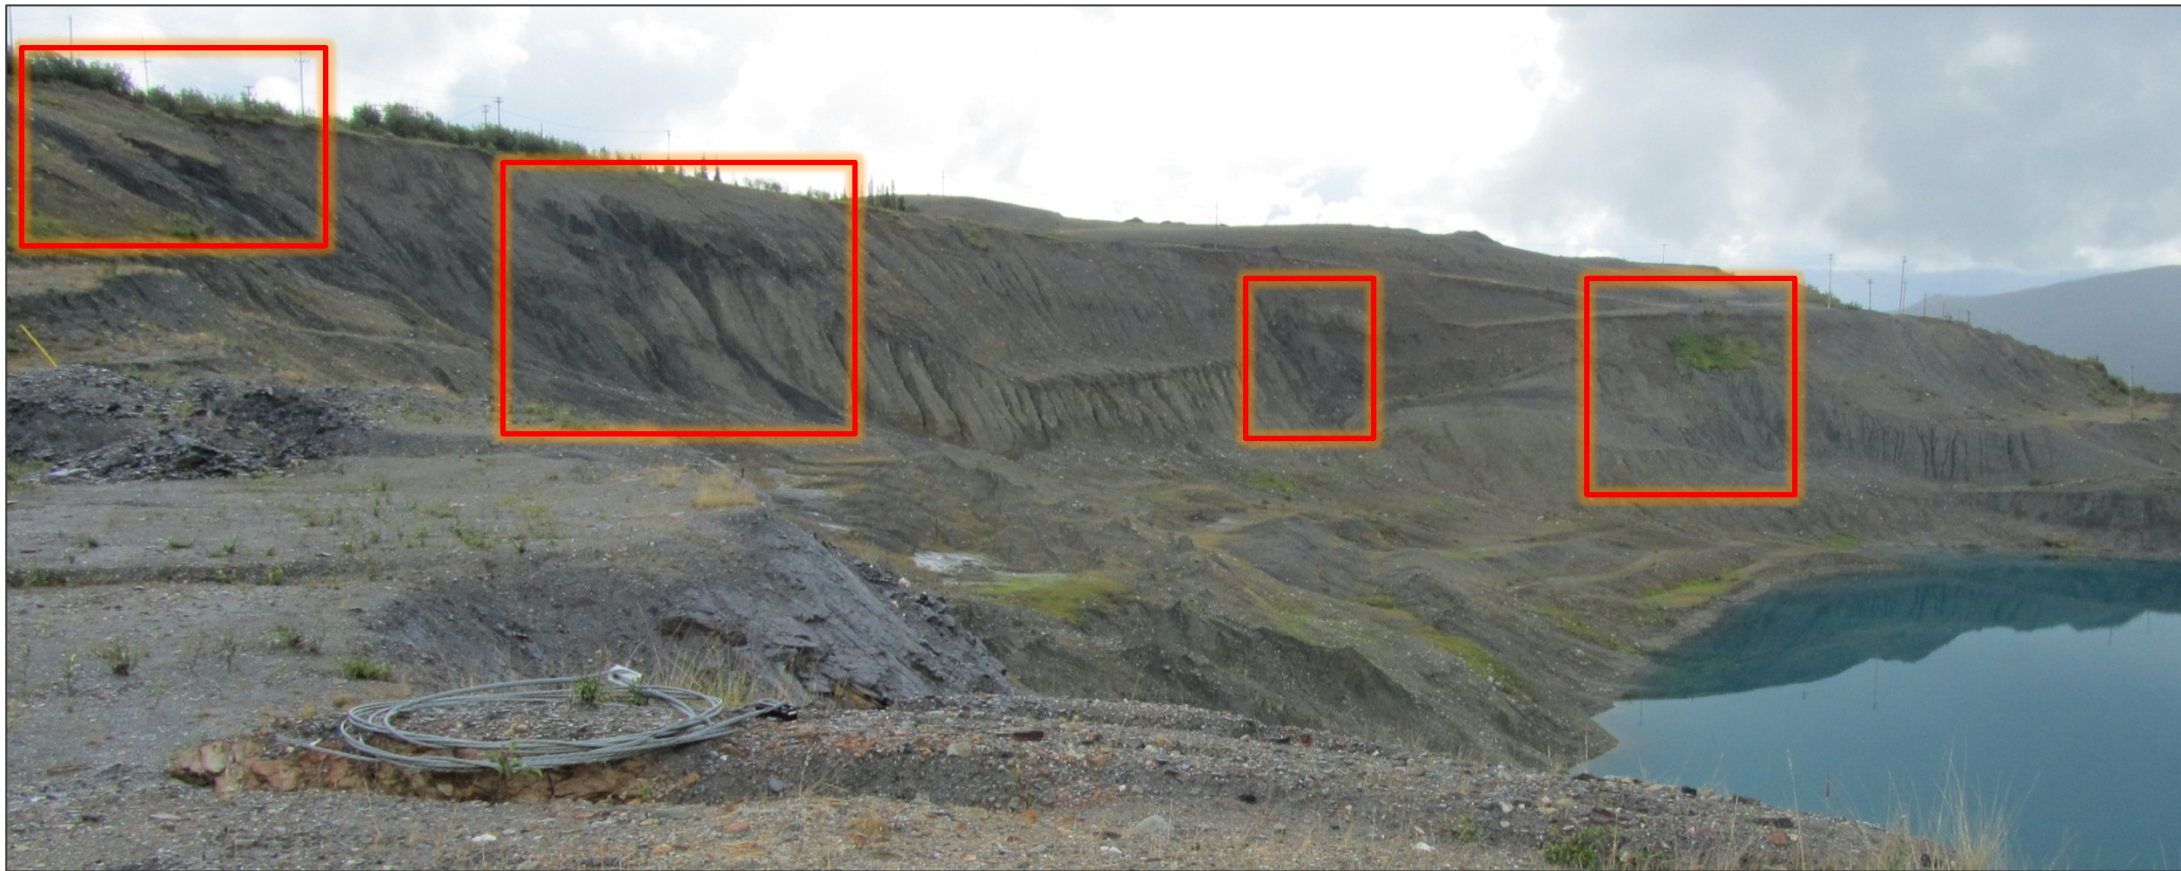
TITLE
 INSTABILITY ZONE PHOTO COMPARISON
 VIEW FACING EAST

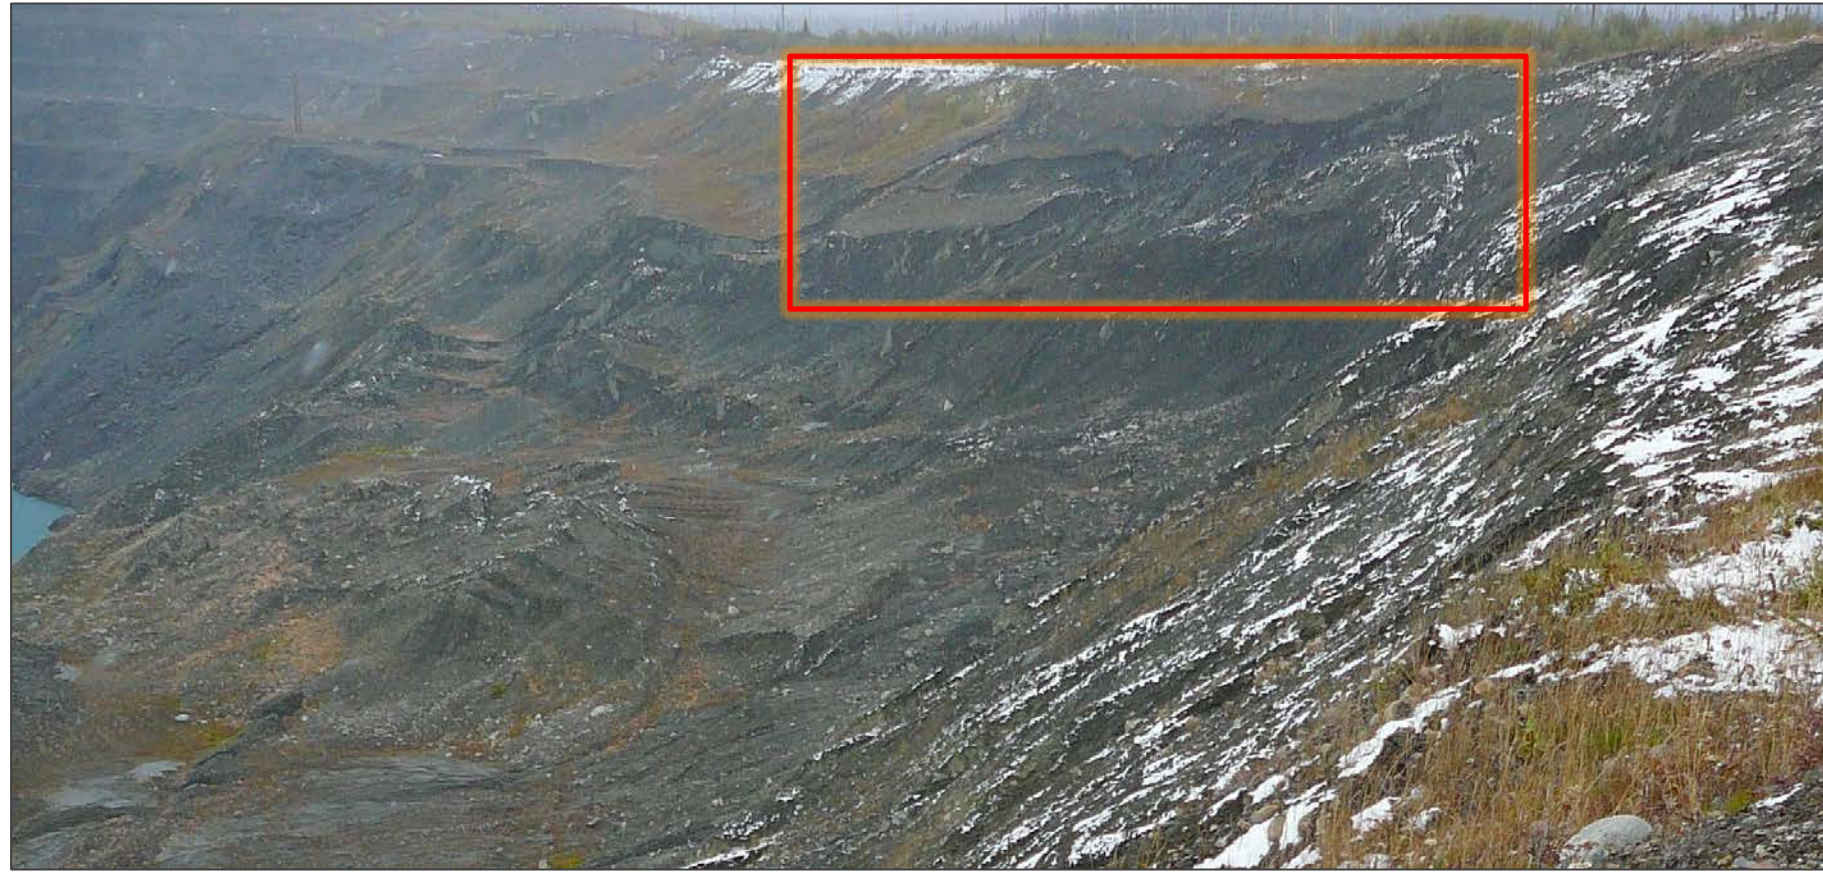
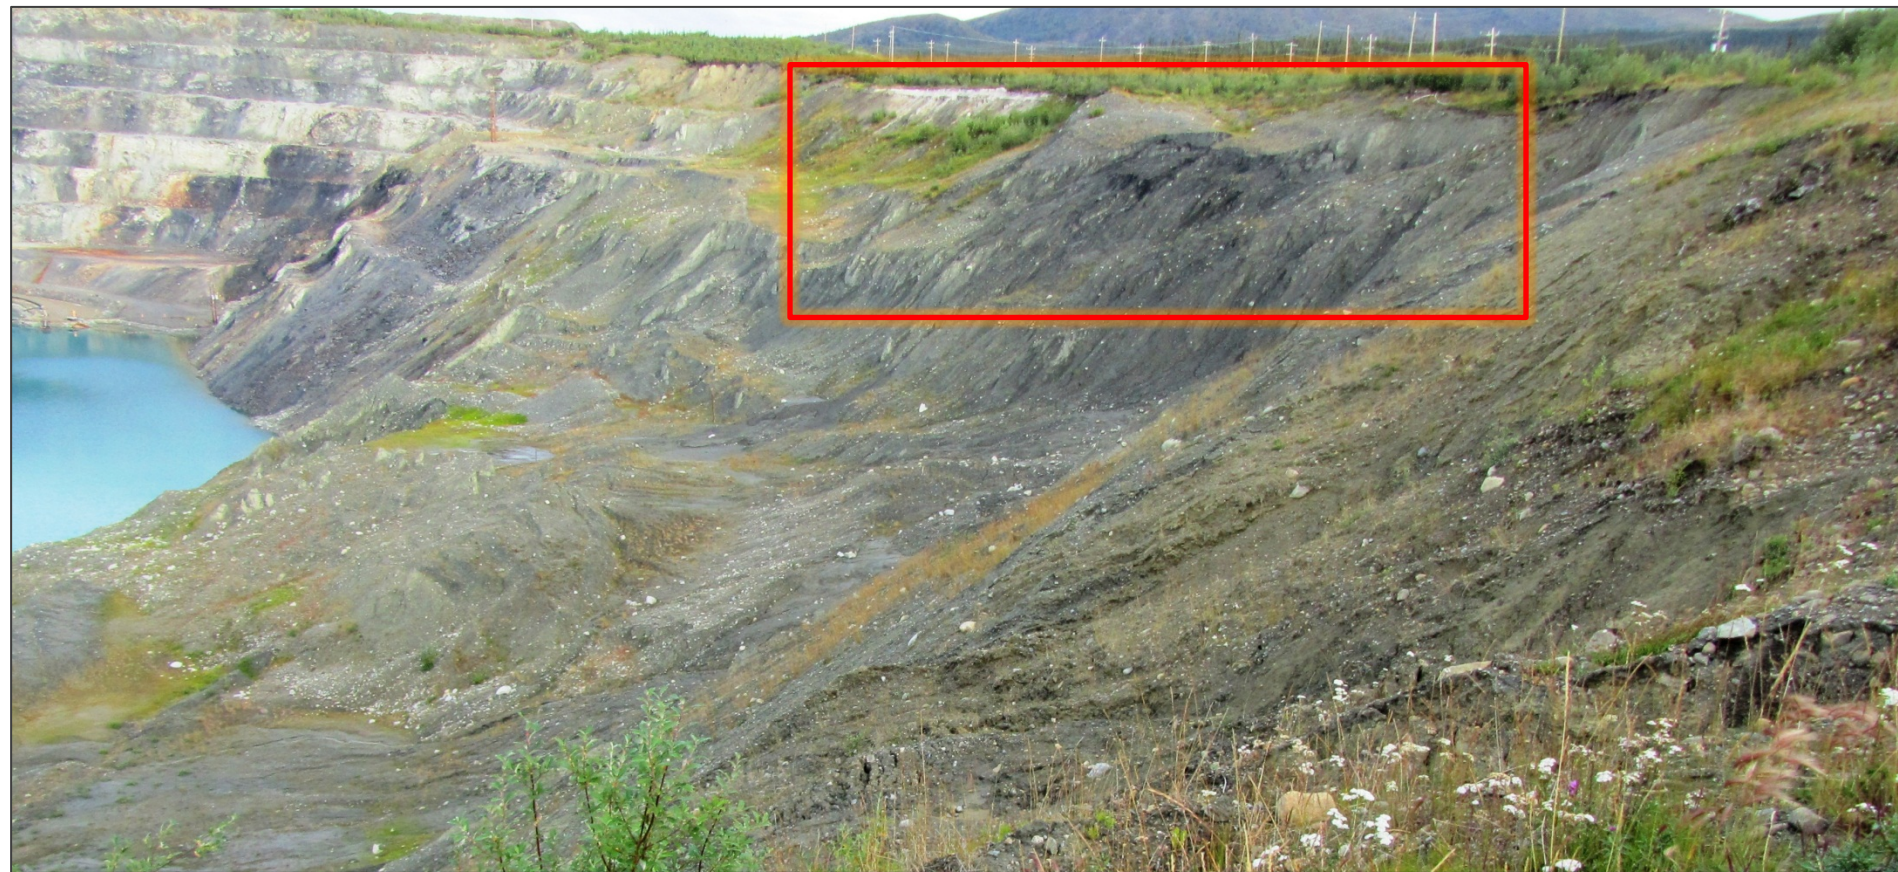
0	16/SEP14	FIGURE	JJR	JJR	AVC	AVC
REV	DATE	DESCRIPTION	DRW	DES	CHK	RVV
PROJECT		1410944/0000				
CLIENT		YUKON GOVERNMENT				
CONSULTANT		Golder Associates				
TITLE		FARO MINE COMPLEX 2014 PIT SLOPE INSPECTION				
TITLE		INSTABILITY ZONE PHOTO COMPARISON VIEW FACING SOUTH				
FIGURE No.		B-12

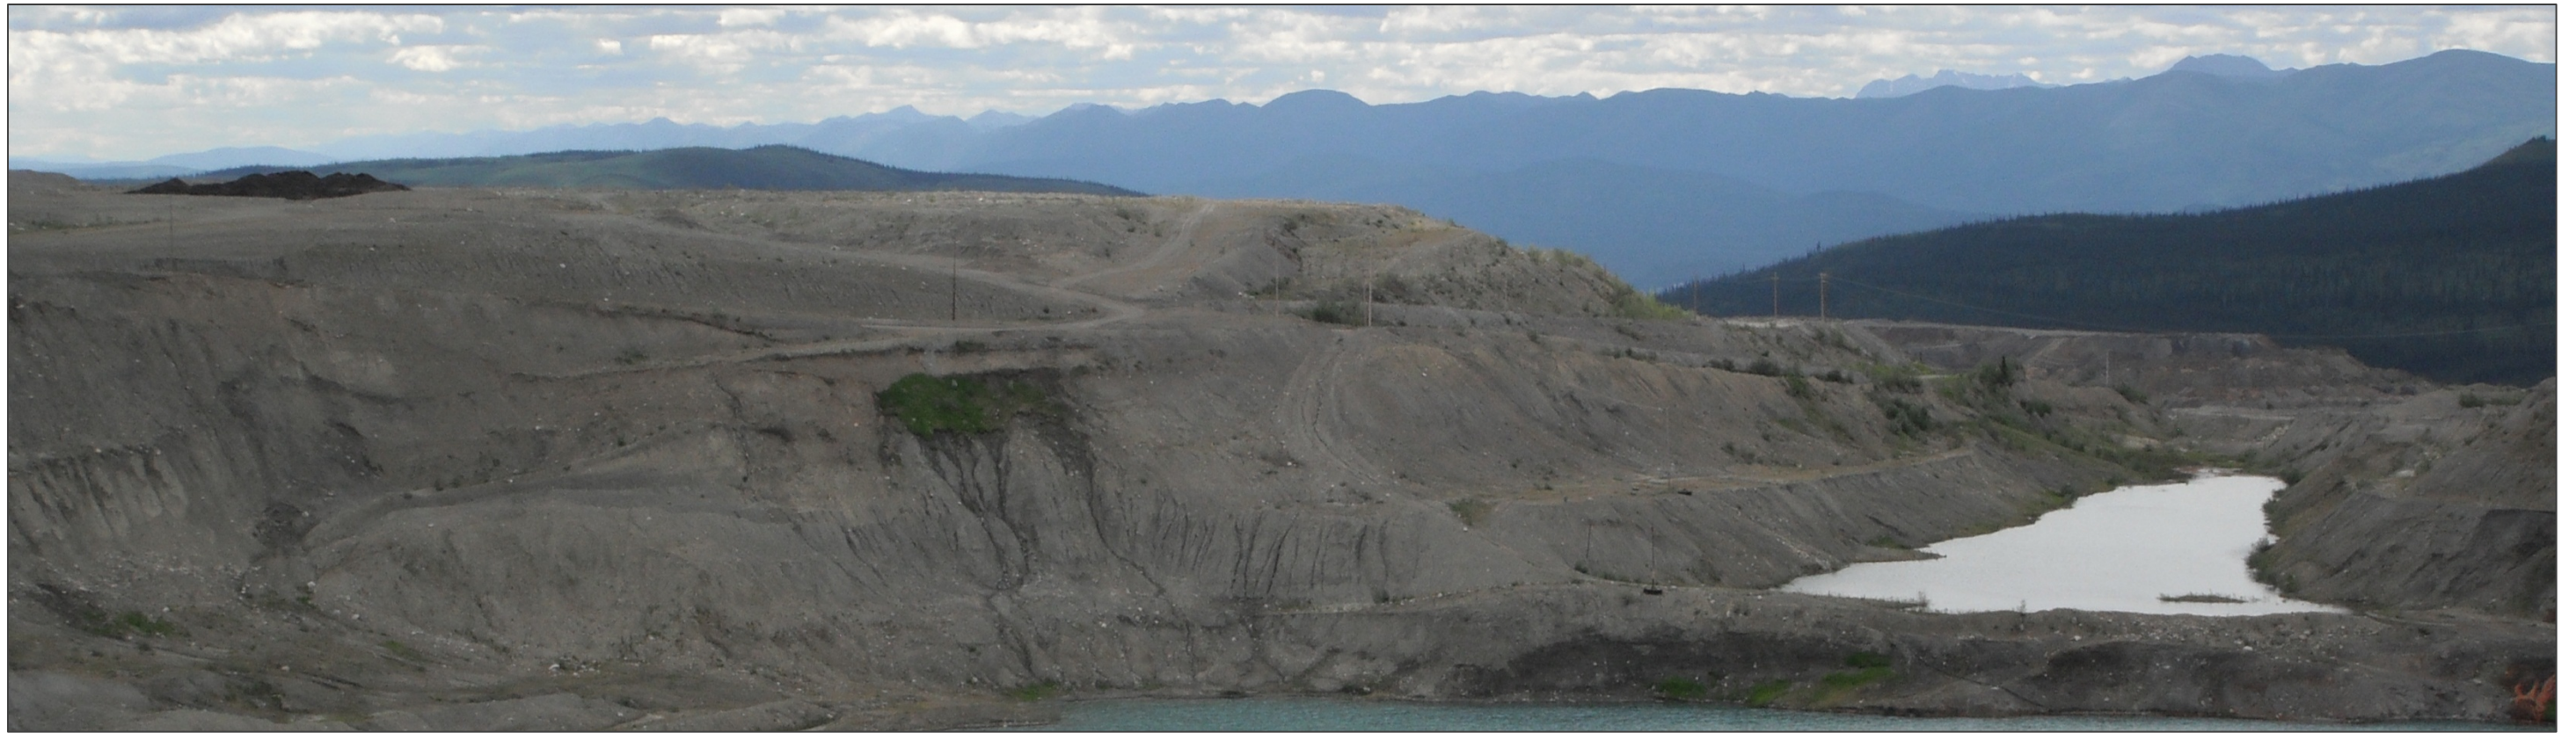
CLIENT		FIGURE		JJR	JJR	AVC	AVC
Yukon Government		YUKON GOVERNMENT		DRW	DES	CHK	RWW
CONSULTANT		PROJECT		1410944/8000			
Golder Associates		TITLE		FARO MINE COMPLEX 2014 PIT SLOPE INSPECTION			
		TITLE		SEEPAGE IN SLOPE SOUTH OF INSTABILITY ZONE			
		FIGURE No.		B-14
