FARO MINE COMPLEX

2014 Annual Pit Slope Stability Inspection

Reference Number: 1410944-002-R-Rev0-6000

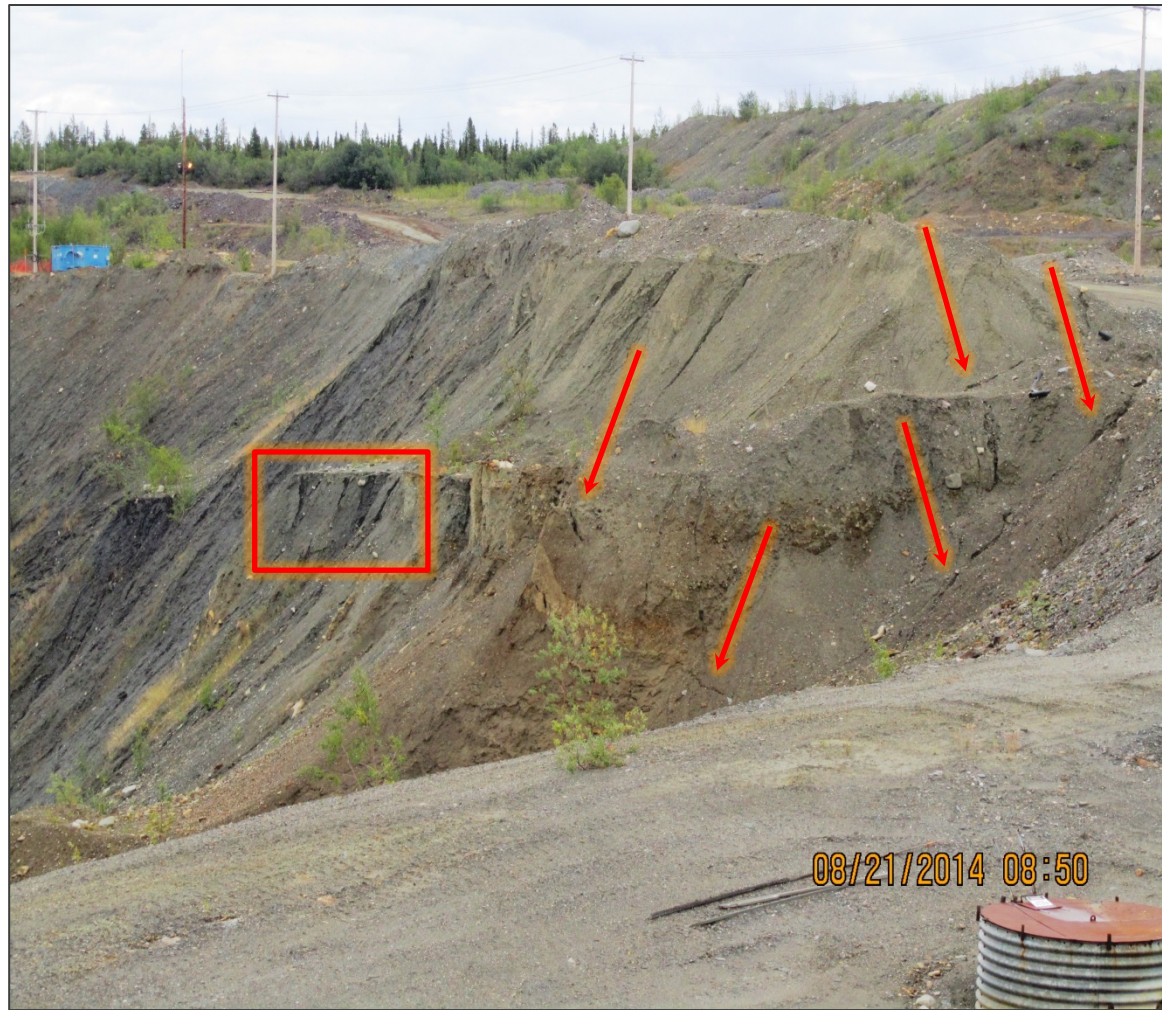
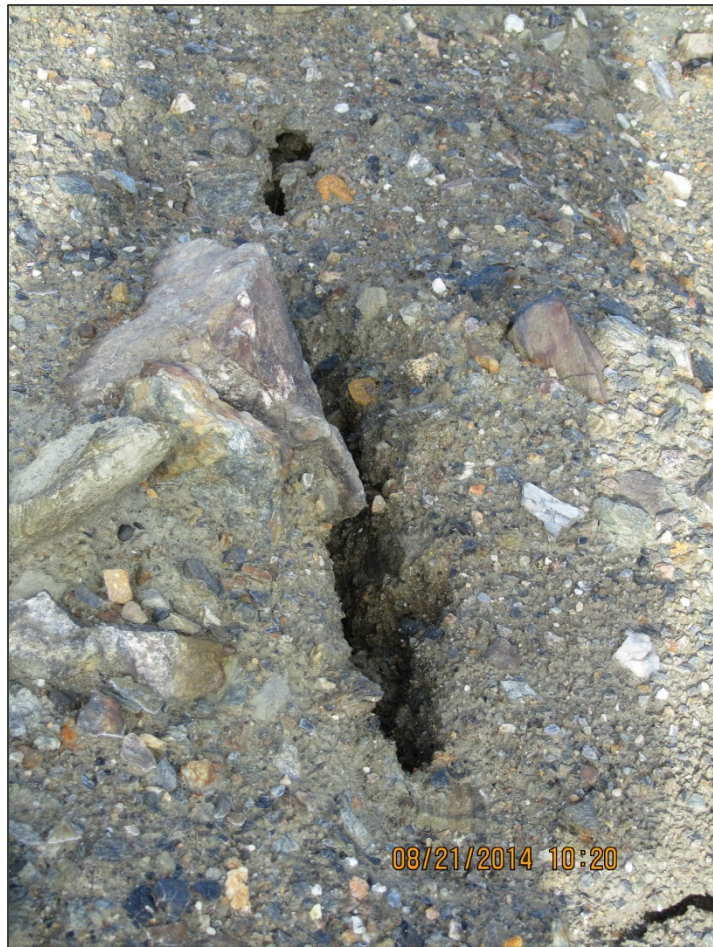
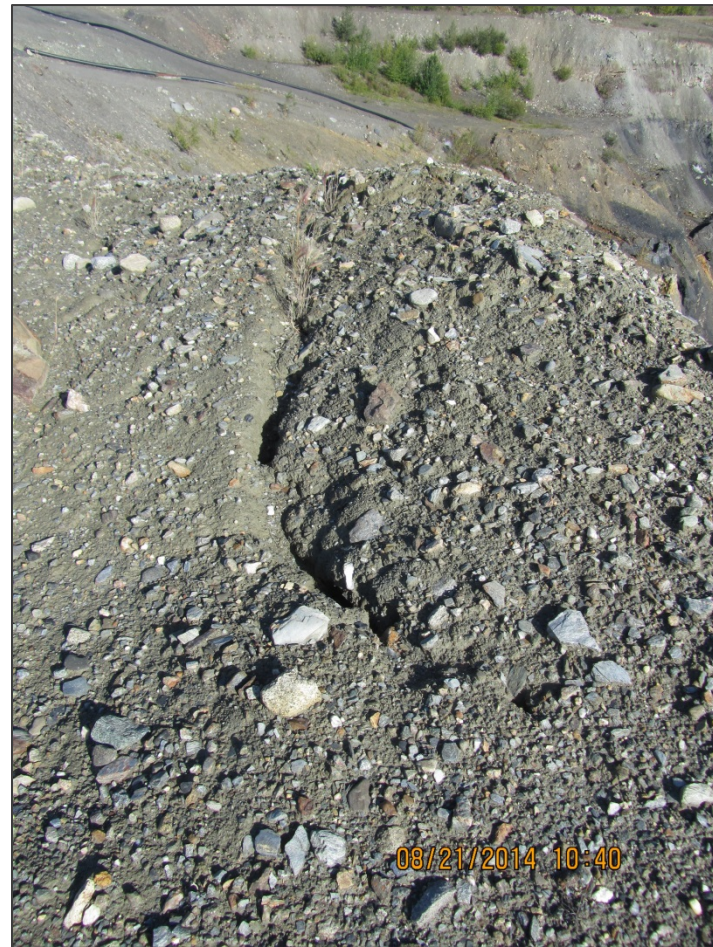
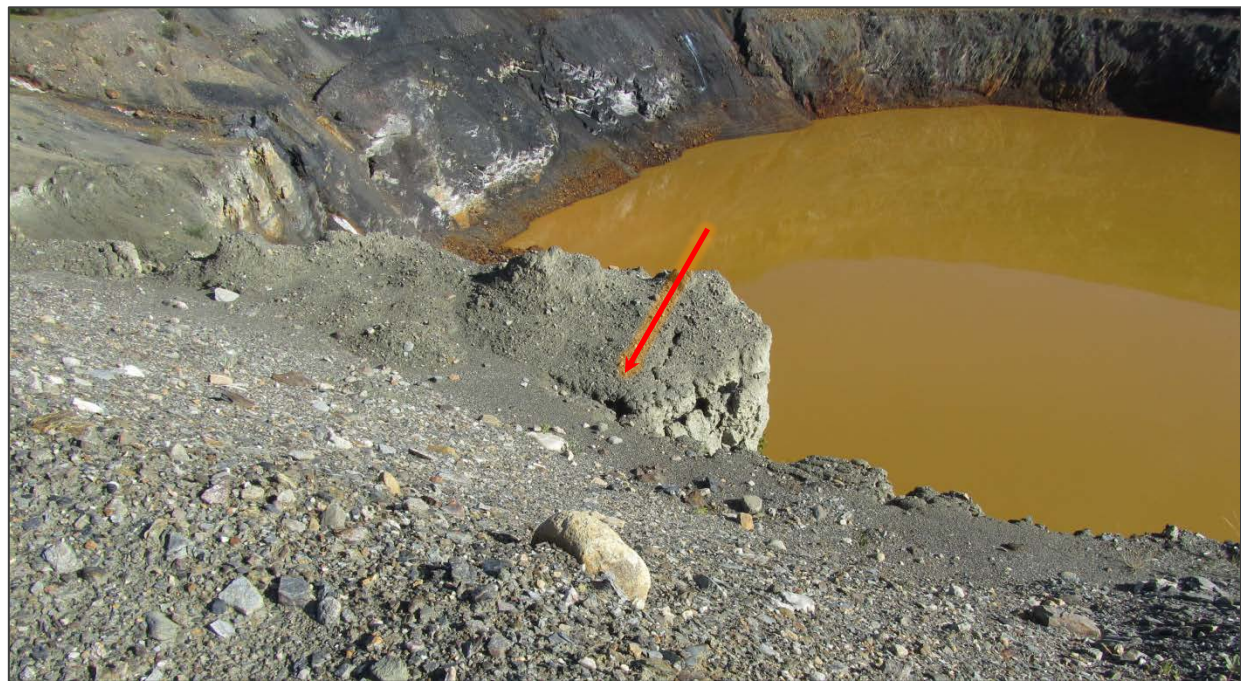
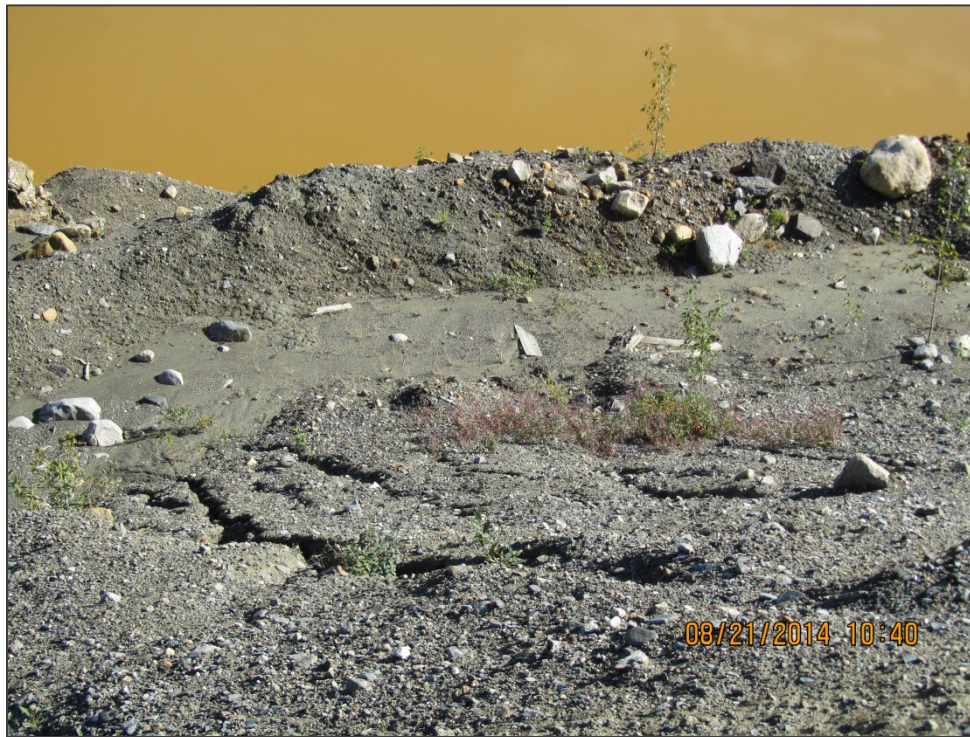
CLIENT		Yukon Government		YUKON GOVERNMENT	
CONSULTANT		Golder Associates		FIGURE No. C3	
0	16/SEP14	FIGURE	JJR	JJR	AVC
REV	DATE	DESCRIPTION	DRW	DES	CHK
PROJECT		FARO MINE COMPLEX		1410944/8000	
		2014 PIT SLOPE INSPECTION			
TITLE		MATERIAL SLOUGHING OFF TILL SLOPE

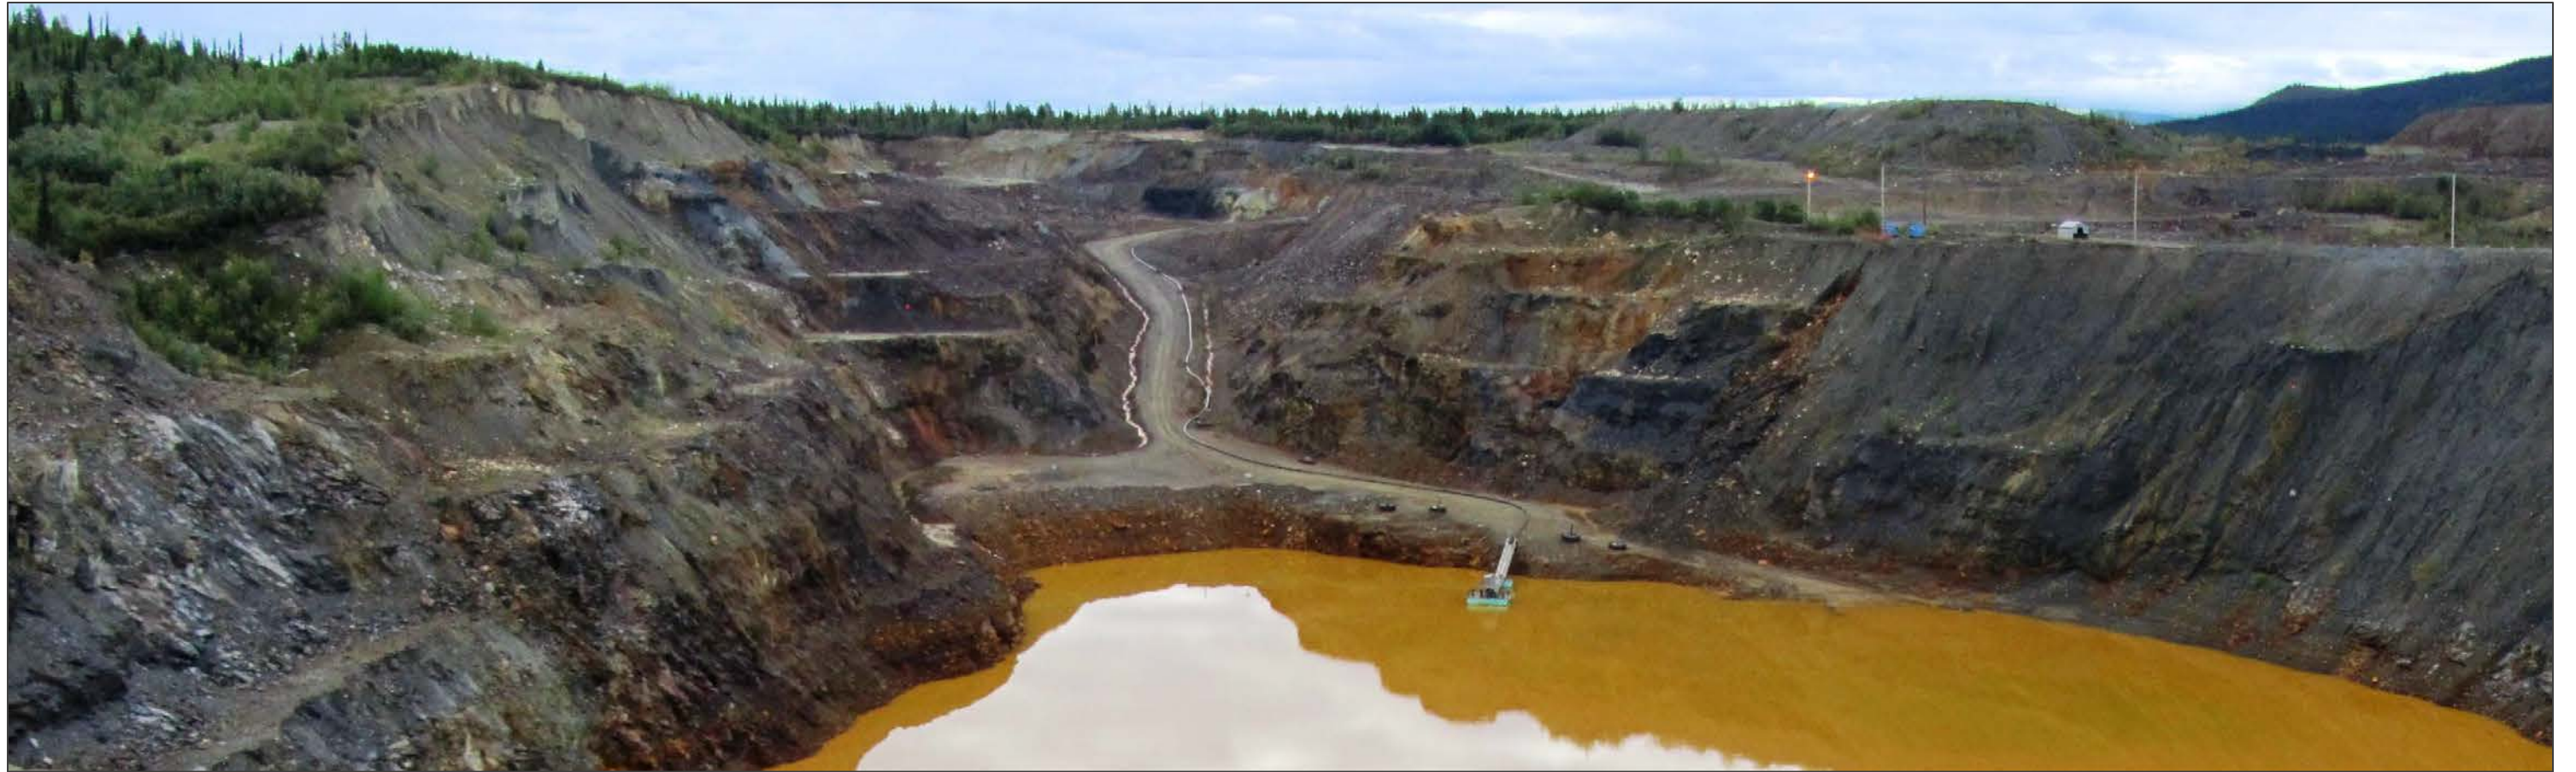
- Cracks were observed in 2013 and 2014 in the face and at the crest of the till slope in the northwest corner of the pit that had not been observed in 2012. The care and maintenance contractor should carry out a periodic visual assessment of the cracks to determine if there are any significant changes in the size or intensity of the cracks, and complete a visual assessment any time personnel will enter the pit. If the cracks increase in size or intensity, it is recommended that a geotechnical engineer review the stability of the slope.

REV	DATE	DESCRIPTION	JUR	JUR	AVC	AVC
0	16/SEP/14	FIGURE	JJR	JJR	AVC	AVC
PROJECT			DRW	DES	CHK	RWW
FARO MINE COMPLEX 2014 PIT SLOPE INSPECTION			1410944/8000			
TITLE			FIGURE No.			
CRACKS IN TILL SLOPE, NORTHWEST WALL			C4

- If there are significant changes in the condition of the till slope, retain a geotechnical engineer to carry out a full stability assessment, which may require field investigations and stability analyses.

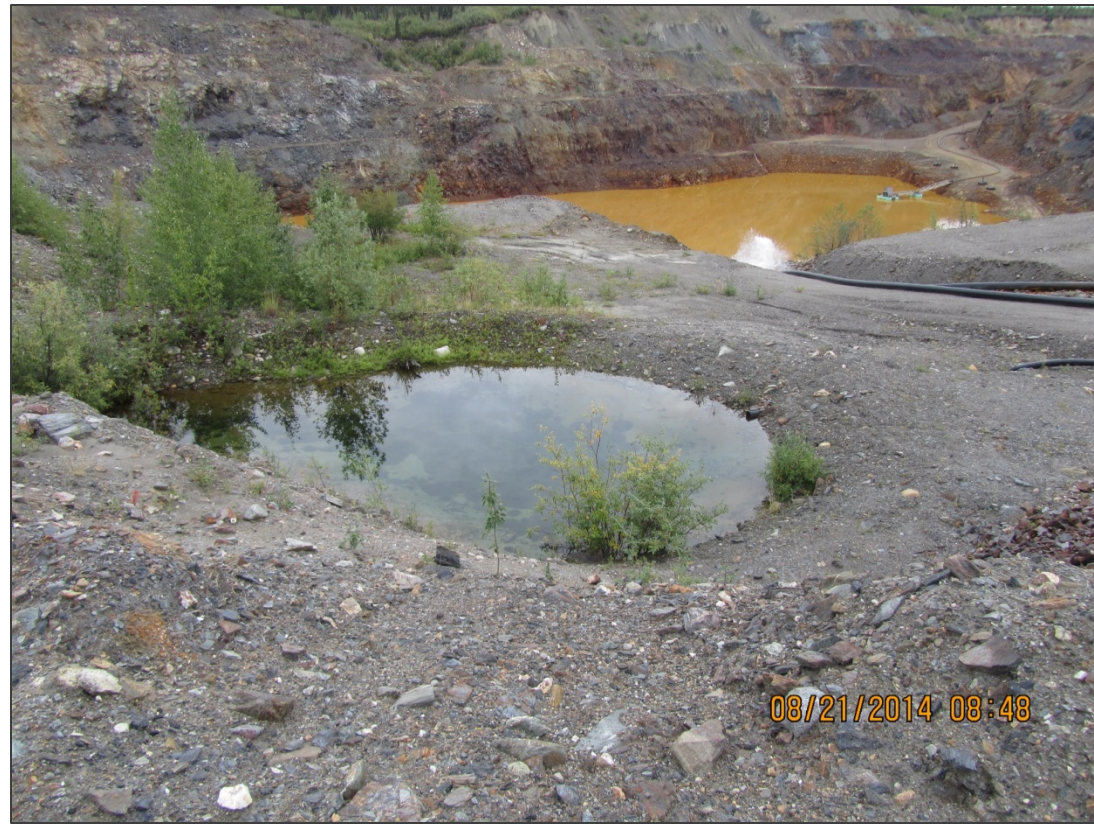
SMALL POND ON NORTHWEST SIDE OF PIT CREST

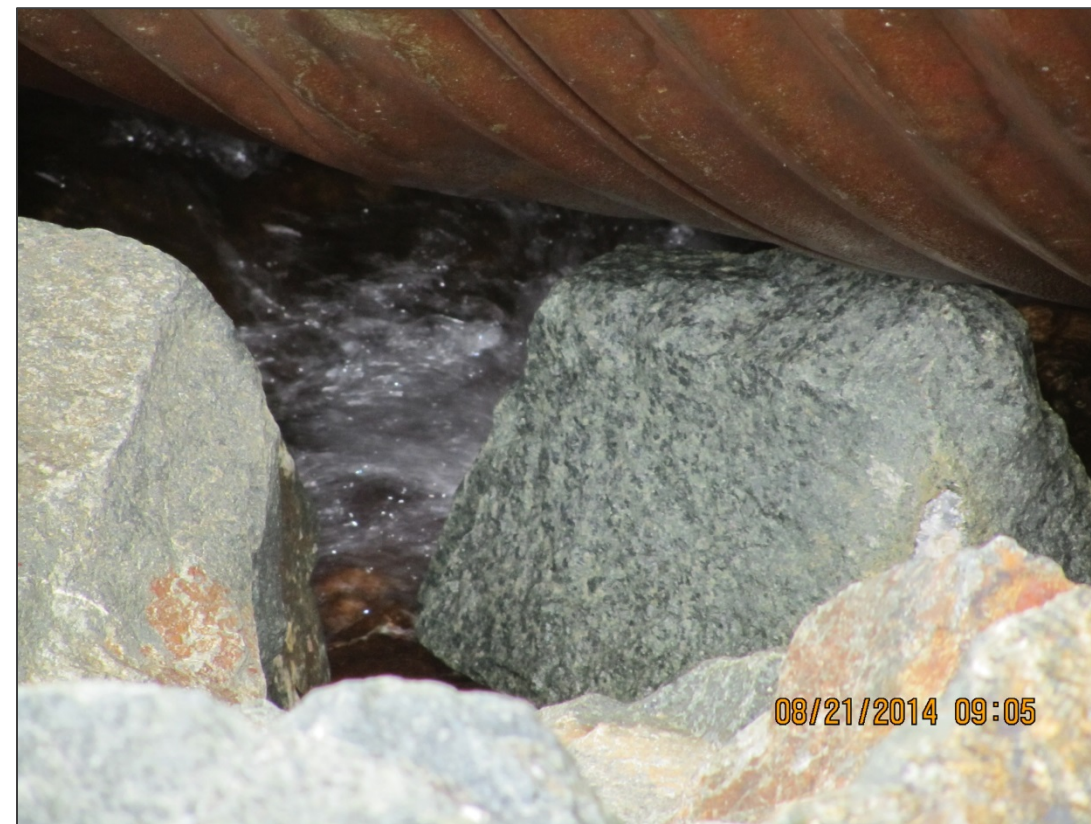
WATER FLOWING BENEATH VANGORDA FLUME

- Repair or replace the Vangorda Flume as soon as practicable to limit the amount of water that is seeping into the slope on the north side.
- As recommended in 2012, construct a berm on the west side of the access road and in the southeast corner to provide rockfall protection to personnel working near the slope. Conversely, deepen the ditch at the toe of the slope so that it acts not only as a drainage ditch but also a catch-ditch for falling rocks. If no rockfall protection is constructed, a minimum setback distance of 10 metres is recommended for any work carried out in the area. Install a sign to inform of rockfall hazard and required setback distance.

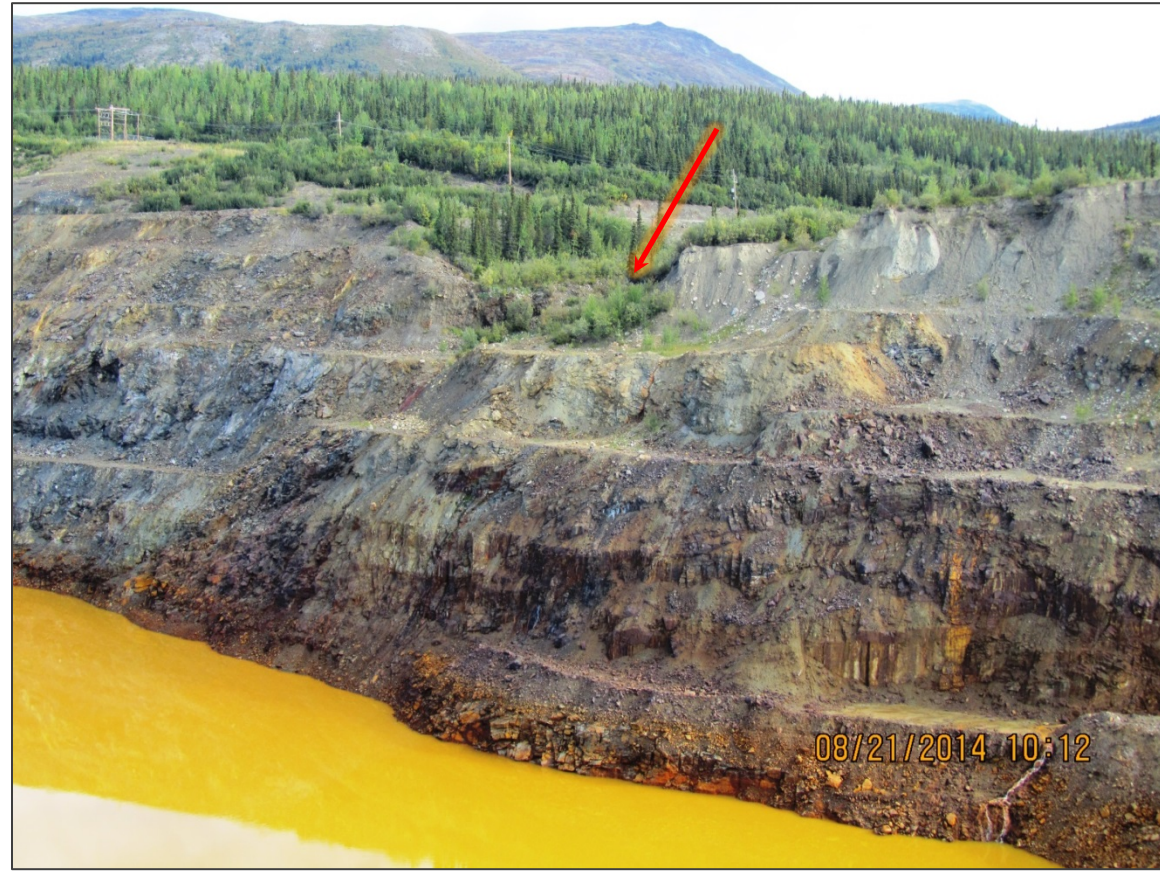
ORIGINAL VANGORDA CREEK CHANNEL.

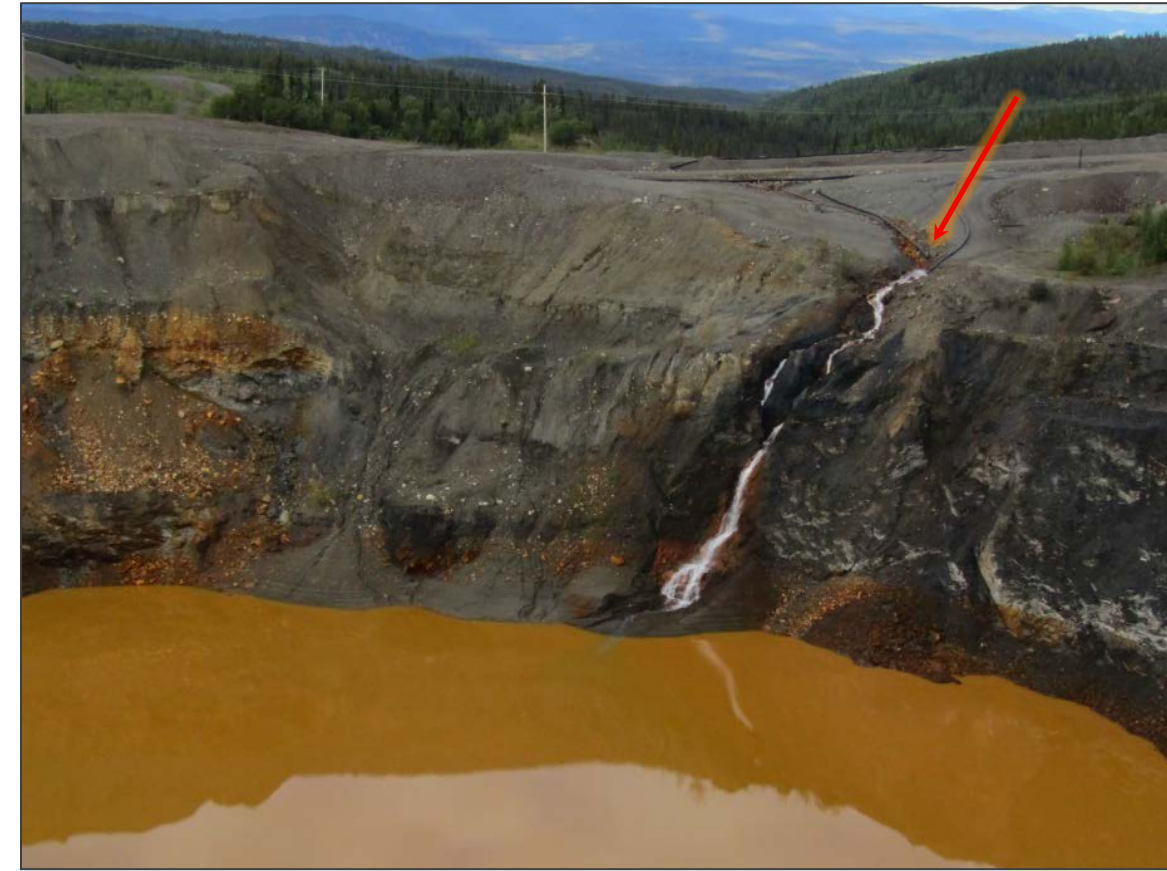
DISCHARGE ON NORTHWEST WALL

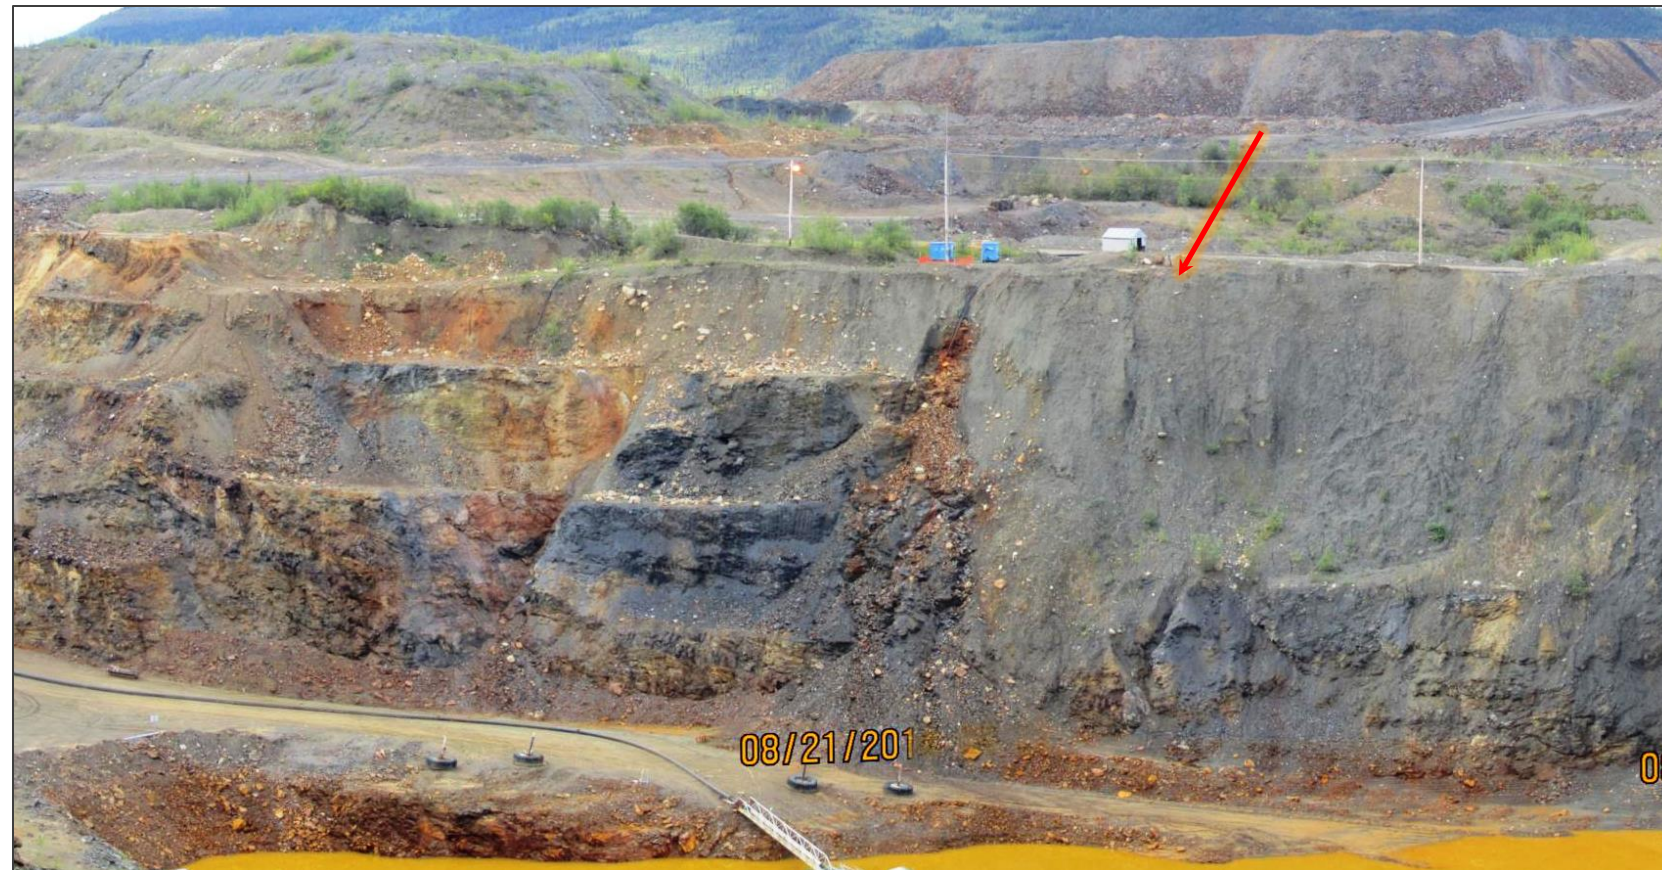
EMERGENCY DISCHARGE ON SOUTHWEST WALL

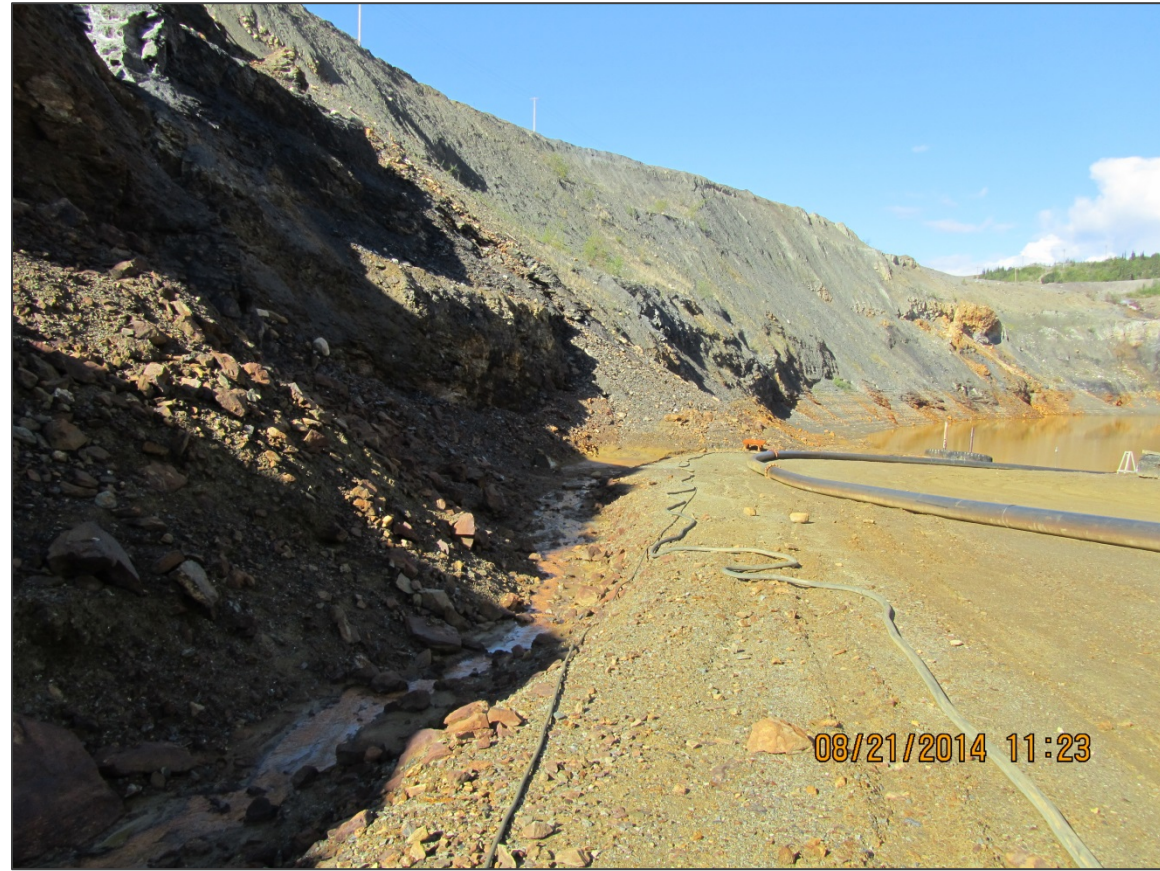
CABLES AT TOE OF SLOPE

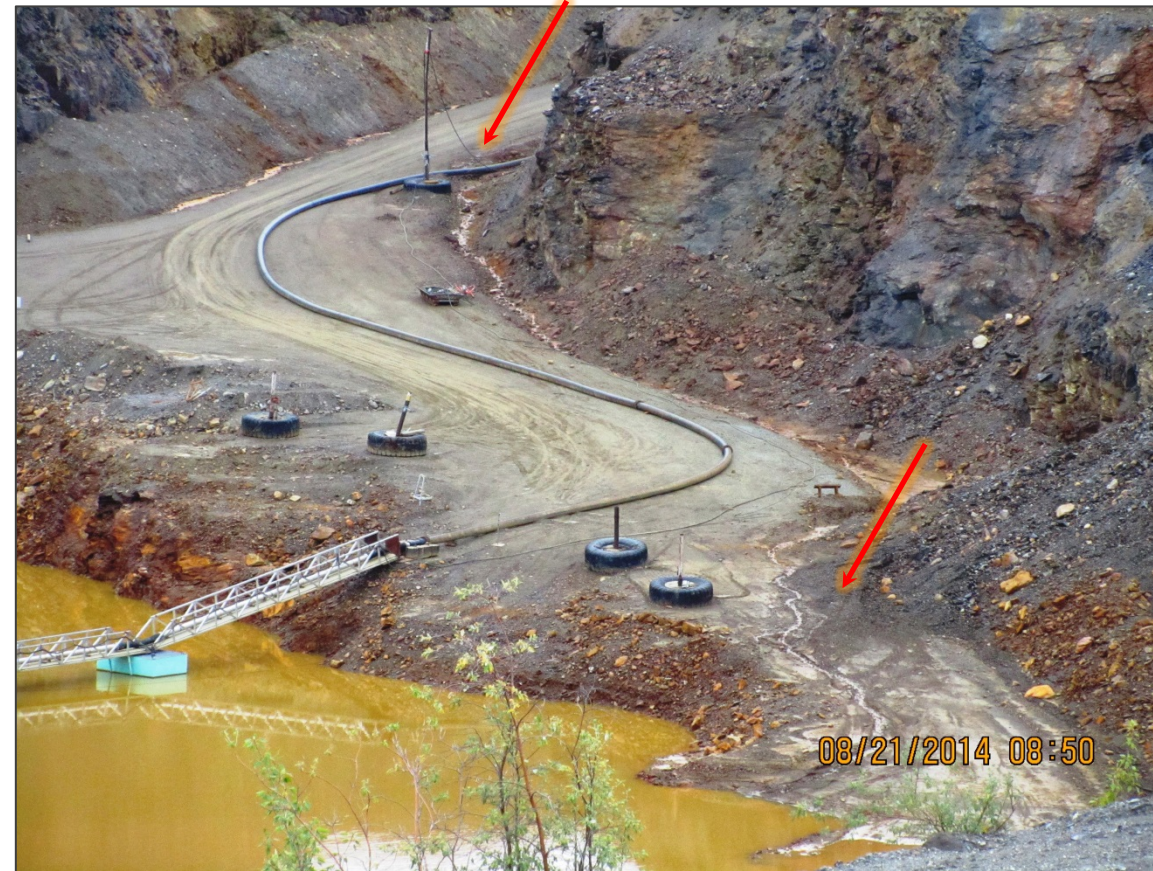
POWER POLE AND CABLES NEAR SLOPE, AREA WITH NO BERM OR DITCH

As recommended in 2012, construct a berm on the west side of the access road and in the southeast corner to provide rockfall protection to personnel working near the slope. Conversely, deepen the ditch at the toe of the slope so that it acts not only as a drainage ditch but also a catch-ditch for falling rocks. If no rockfall protection is constructed, a minimum setback distance of 10 metres is recommended for any work carried out in the area. Install a sign to inform of rockfall hazard and required setback distance.	High - Short Term
	If there are significant changes in the condition of the till slope on the west side of the pit, retain a geotechnical engineer to carry out a full stability assessment, which may require field investigations and stability analyses.	High - Long Term
	Repair or replace the Vangorda Flume as soon as practicable to limit the amount of water that is seeping into the slope on the north side.	High - Long Term

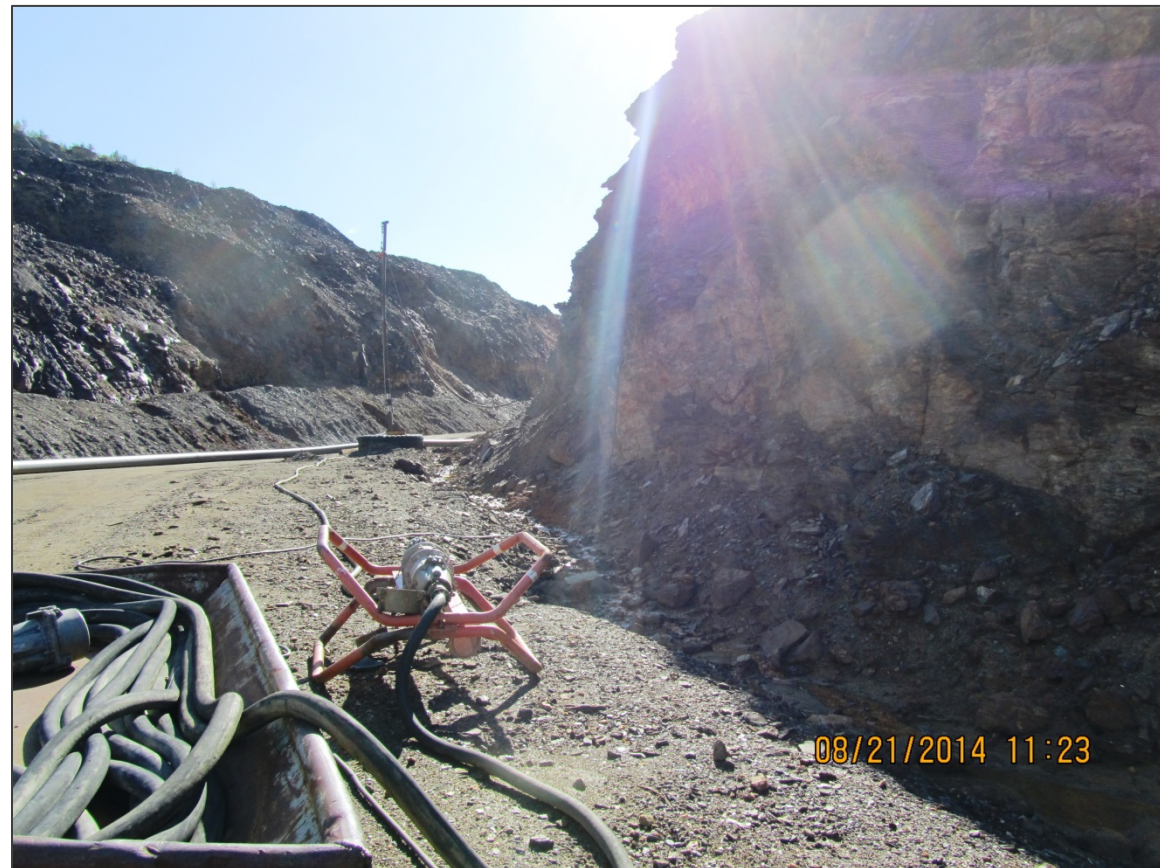
EQUIPMENT NEAR SLOPE

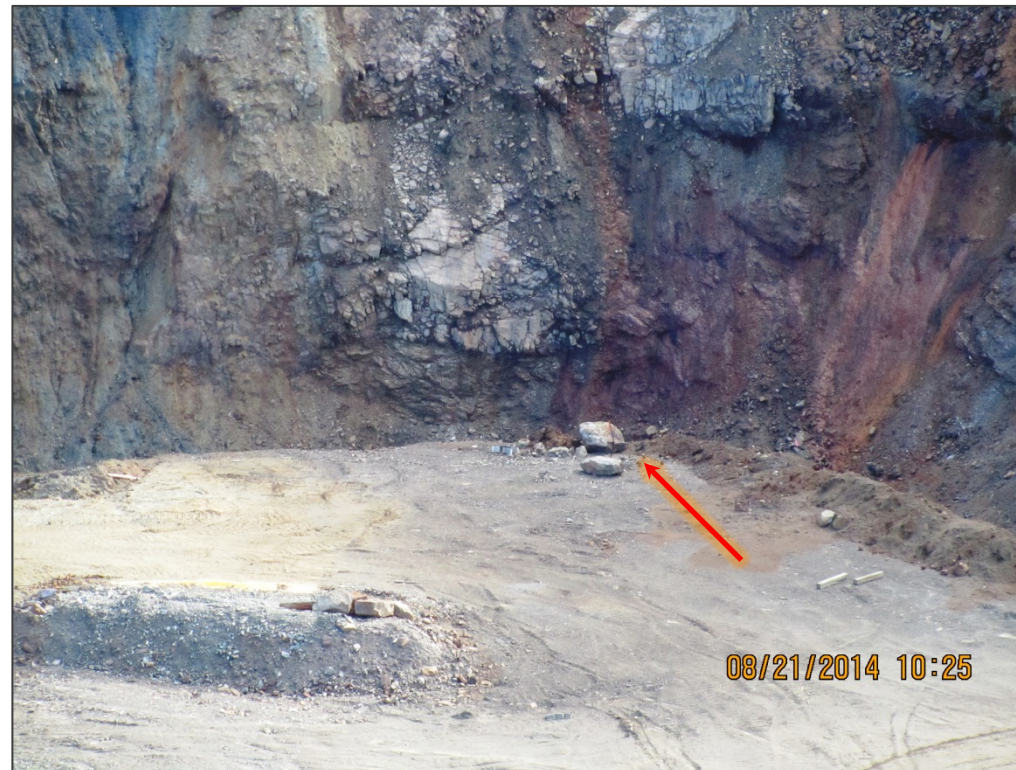
BOULDERS AT TOE OF SLOPE
SOUTHEAST SIDE

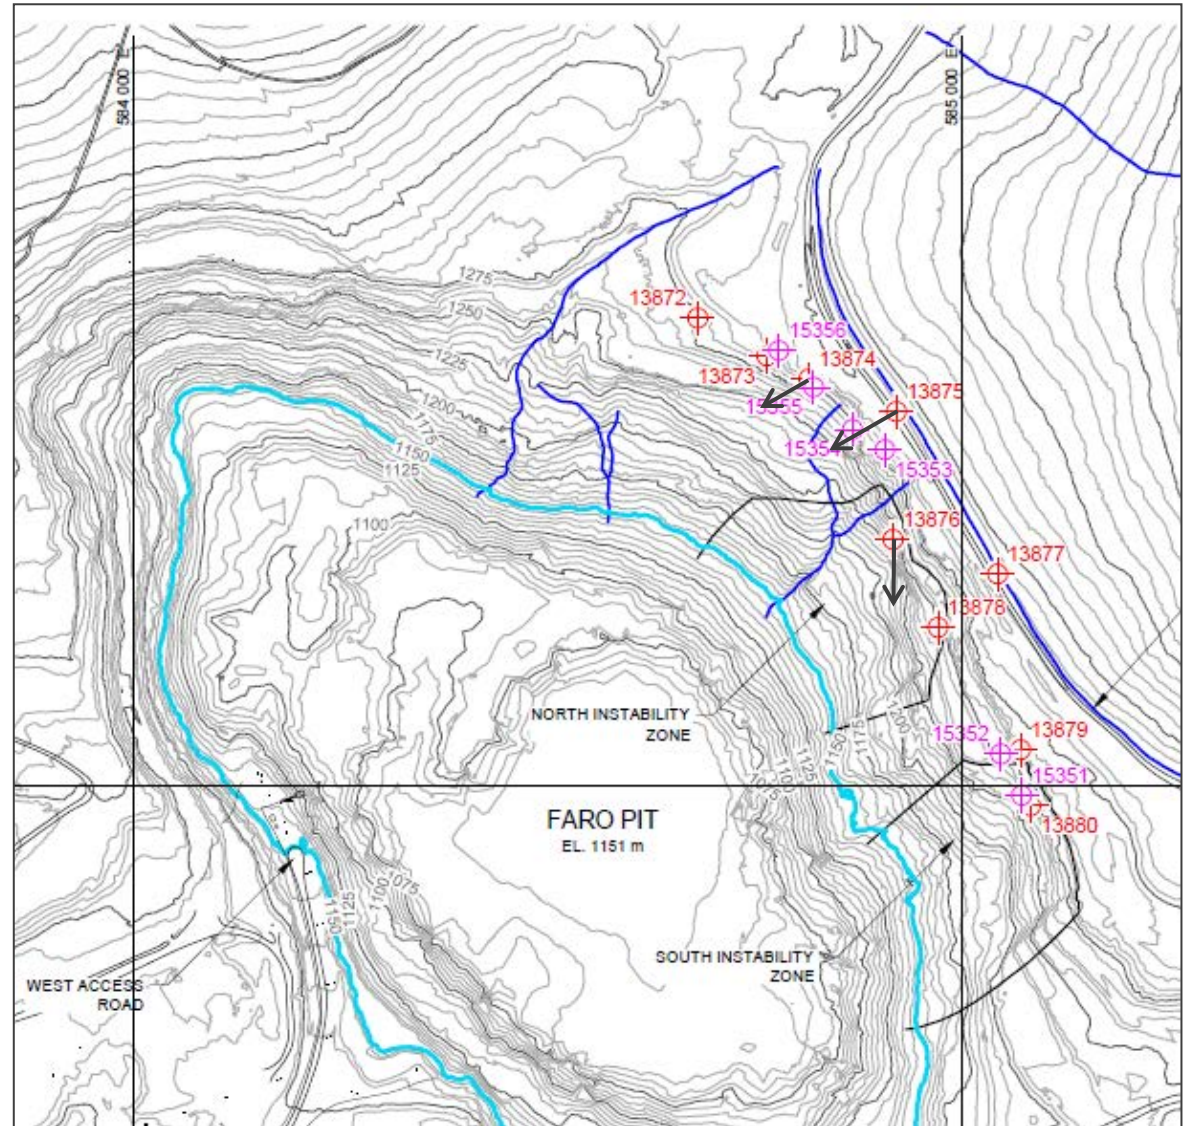
TITLE
 TOTAL CUMULATIVE DISPLACEMENT VECTORS
 FARO MONITORING POINTS 13874, 13875, & 13876
 FIGURE No.
 D-10

MONITORING POINT	TOTAL CUMULATIVE DISPLACEMENT (mm)	NET AZIMUTH (deg.)	NET PLUNGE (deg.)
13874	66.9	237.7	-50.8
13875	91.8	241.2	-40.4
13876	81.7	180.9	-62.0
