## FARO MINE COMPLEX

# 2015 Pit Slope Stability Review

**Reference Number: 1410944-007-R-Rev0-2015**

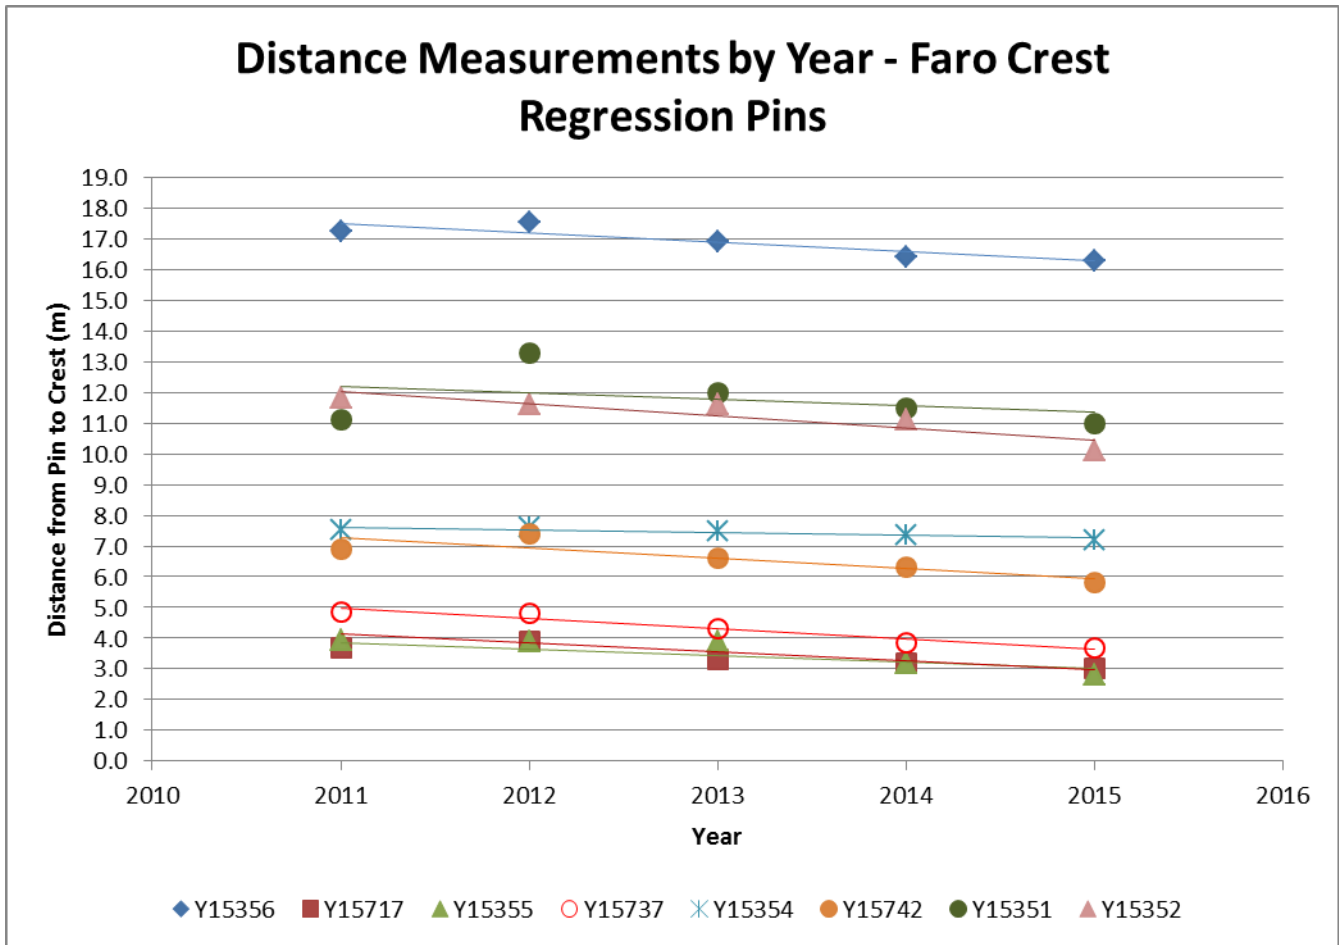
Plate 2: Annual Distance Measurements by YES, Faro Crest Regression Monitoring

Trendlines have been added to the data from each pin in Plate 2. Assuming the measurements were made along the same bearing each year, the trendlines indicate that, on average, the distance from the crest to each pin is decreasing from year to year, which reflects the crest regression that is occurring, as discussed below.

Plate 2 indicates that the pins with the shortest distance to the crest are 15717, 15355, and 15737, with distances between 3 and 4 metres. These pins are located behind a large gully in the North Instability Zone that is losing approximately 30 cm of crest each year. However, based on site drawings, these three pins are approximately 40 metres away from the FCDC. Therefore, at the present rate of crest regression, it would take more than 130 years to undermine the FCDC.

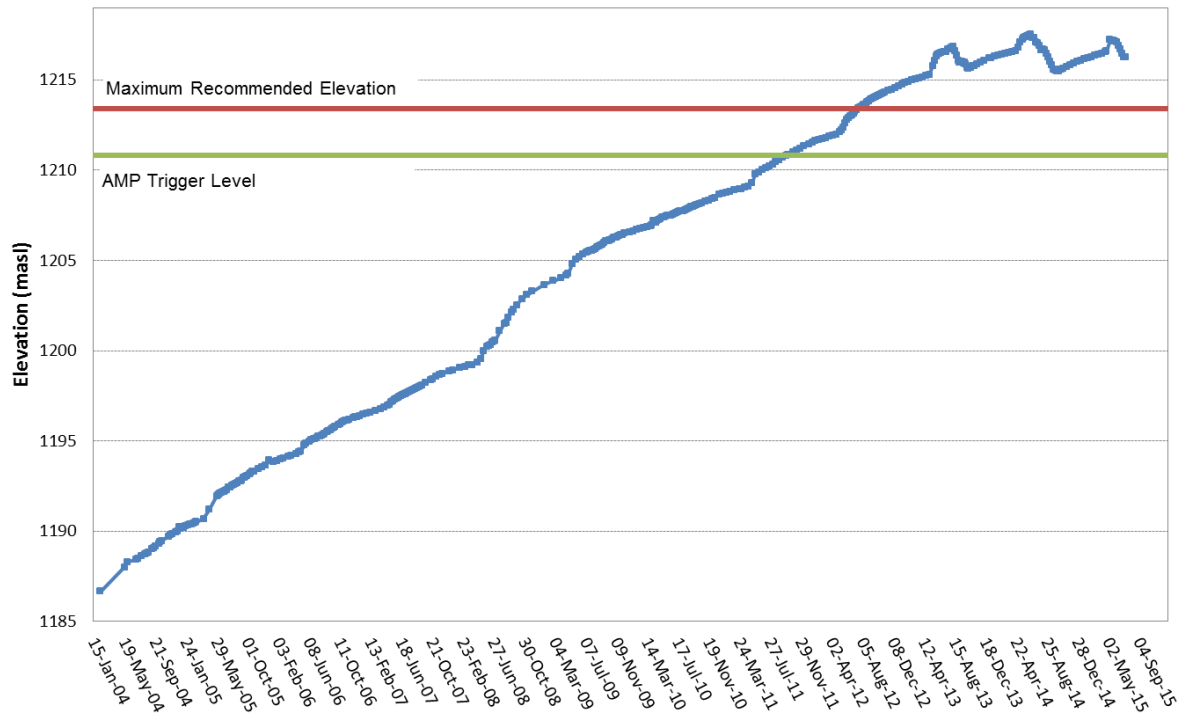
Plate 5: Grum Pit Lake Levels to July 13, 2015

Water level data for the Grum Pit were provided by YG. Plate 5 shows the fluctuations in the Grum Pit lake level from January 2004 to July 2015. The Grum Pit lake level was reported to be at 1,186 masl in early 2004 and at 1,205 masl by mid-2009 (Golder 2010). Water levels reached a peak on June 23, 2014, at 1,217 masl. As of July 13, 2015, the pit lake level is at approximately 1,216 masl. This is 5 metres above the maximum recommended elevation of 1,211 masl, and equal to the estimated elevation of the lowest contact between overburden and bedrock (Klohn Crippen Berger 2014). In the Grum Pit, rising water levels have the potential to seep into the overburden and contaminate groundwater along the south side of the pit, as well as to destabilize the old slide debris along the east wall. The pit overflow elevation is located on the south side of the pit, where the access ramp enters the pit, at approximately 1,230 masl.

Because pit lake levels fluctuate due to pumping water in and out of the pit, an important consideration for pit slope stability along the east wall is the rate at which the lake level rises and falls. Rapid increases or decreases in the lake level should be avoided. Rapid changes in water levels could contribute to additional slope instability along the east wall due to high water levels being maintained in the overburden.

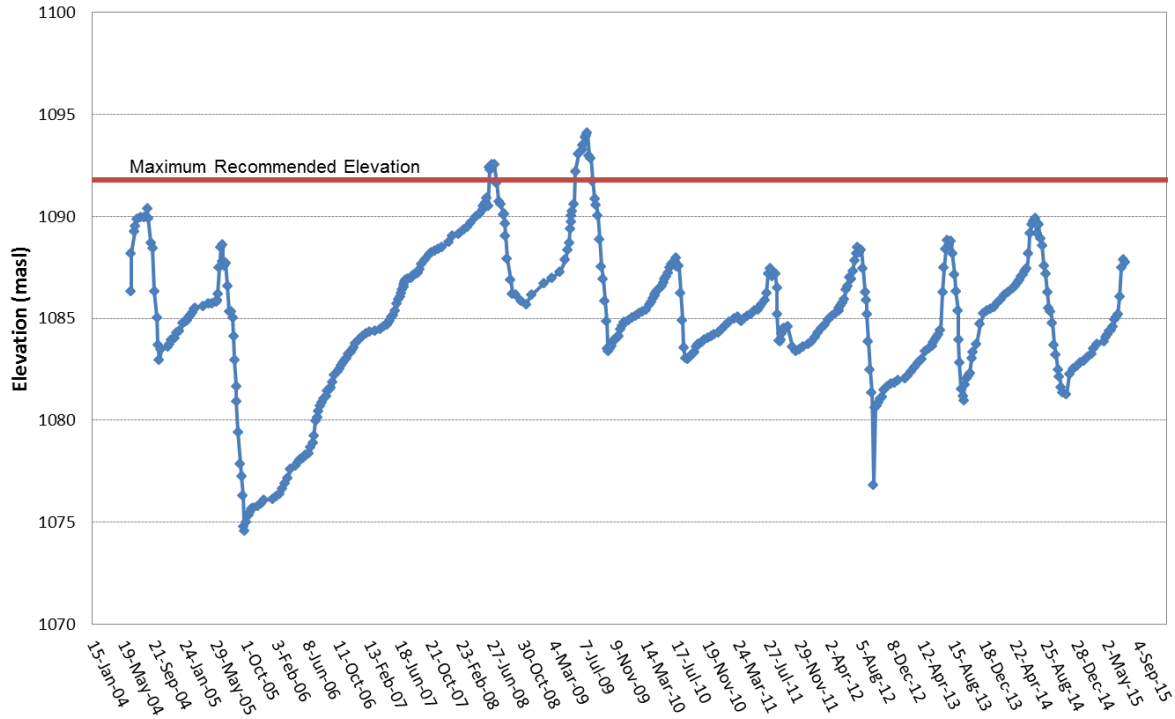
Plate 6: Vangorda Pit Lake Levels to July 13, 2015

Water level data for the Vangorda Pit were provided by YG. Plate 6 shows the fluctuations in the Vangorda Pit lake level from June 2004 to July 2015. The plot shows that lake levels have remained well below the maximum recommended elevation except on two occasions in June of 2008 and June of 2009. The Vangorda Pit lake level was measured at 1,086.2 masl on July 13, 2015, and water level was rising. However, this is 5.5 metres below the maximum elevation of 1091.8 masl and is not a concern.

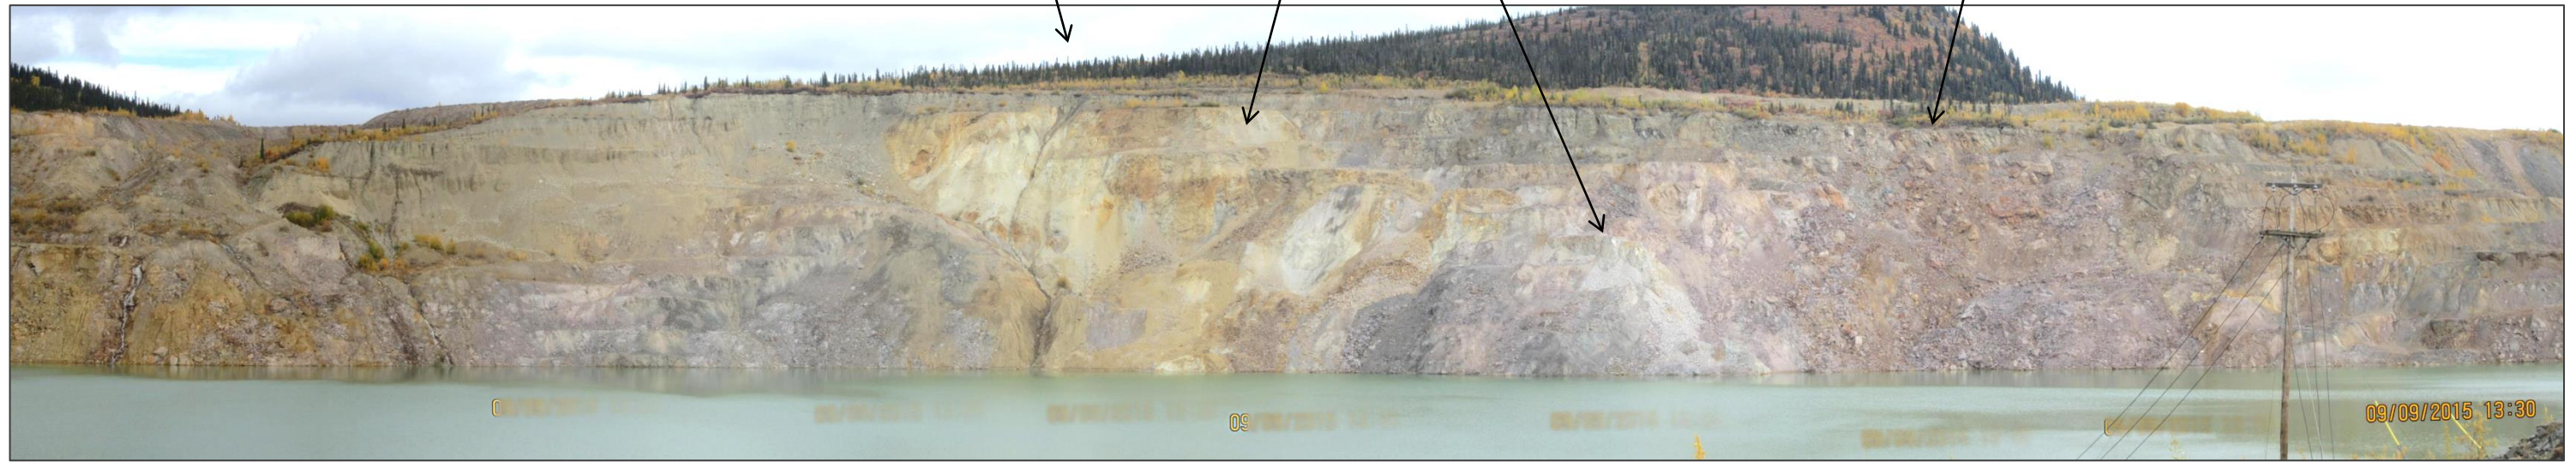
CLIENT		Yukon Government		YUKON GOVERNMENT		FIGURE	JUR	JUR	AVC	AVC
REV	DATE	DESCRIPTION		DRW	DES	CHK	RVW	PROJECT		
0	29/SEP15							1410944/2015		
CONSULTANT		Golder Associates		TITLE		FARO MINE COMPLEX 2015 PIT SLOPE STABILITY REVIEW				
				FARO PIT EAST WALL		FIGURE No. A-1

The Big Indian Fault is the most dominant structural feature observed in the east wall (Figure A-1 in Appendix A). This fault strikes roughly north–south and dips toward the west at an inclination of approximately 60 degrees. The west boundary of the north–south trending band of calc-silicate rock in the east wall is defined by the Big Indian Fault.

NORTH AND SOUTH INSTABILITY ZONES, EAST WALL,  
VIEW LOOKING EAST

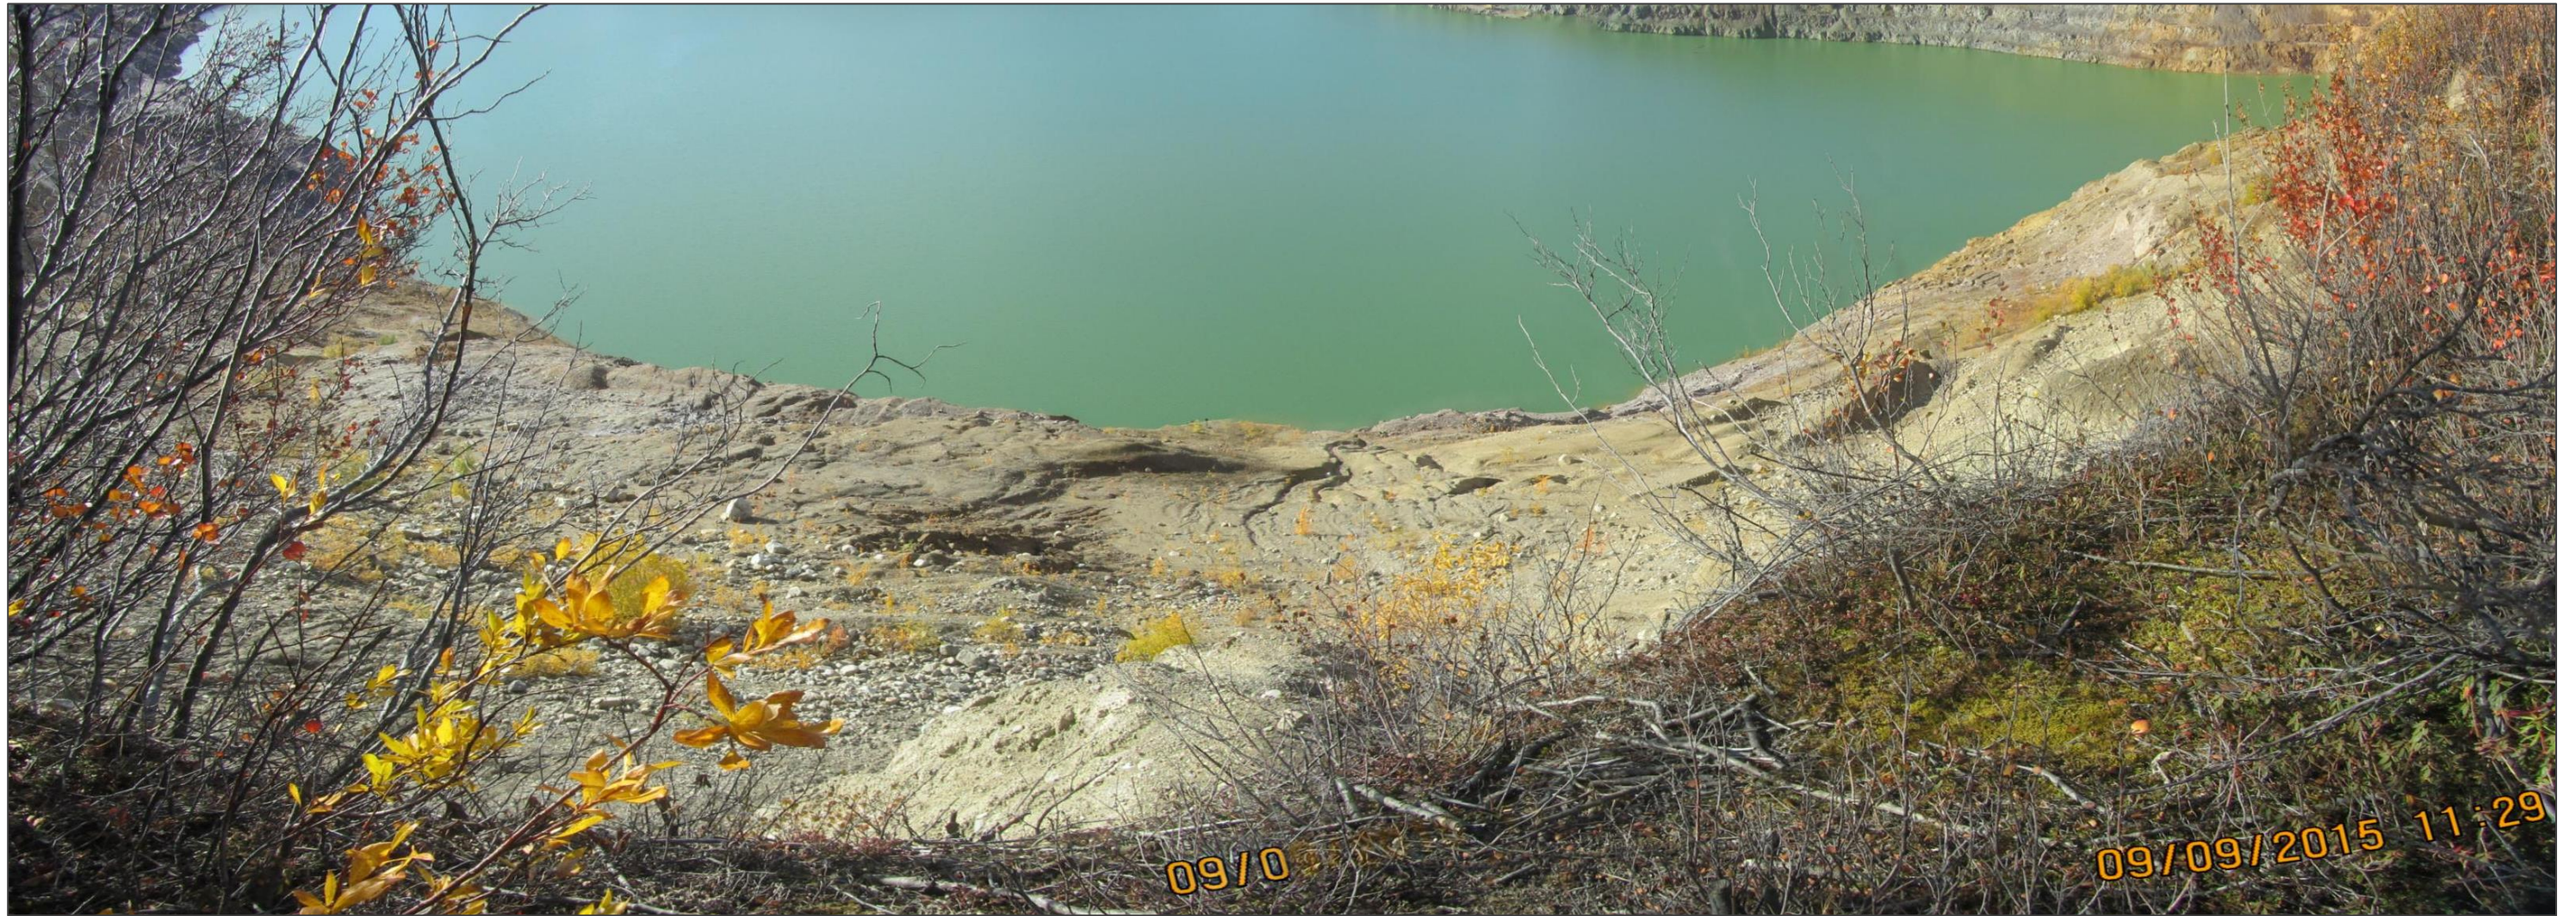
CLIENT		FIGURE		JUR	JUR	AVC	AVC
Yukon Government		DESCRIPTION		DRW	DES	CHK	RVW
YUKON GOVERNMENT		PROJECT		1410944/2015			
CONSULTANT		TITLE		FIGURE No.			
Golder Associates		FARO MINE COMPLEX 2015 PIT SLOPE STABILITY REVIEW		A-4			
		FARO PIT NORTH INSTABILITY ZONE VIEW FROM BEHIND BACKSCARP

- No recent cracks were observed either behind the crest of the east wall or behind the backscarps of the instability zones (Figure A-4).
- No cracks were observed along the road behind the crest of the east wall.

NORTH INSTABILITY ZONE, VIEW LOOKING WEST FROM CREST

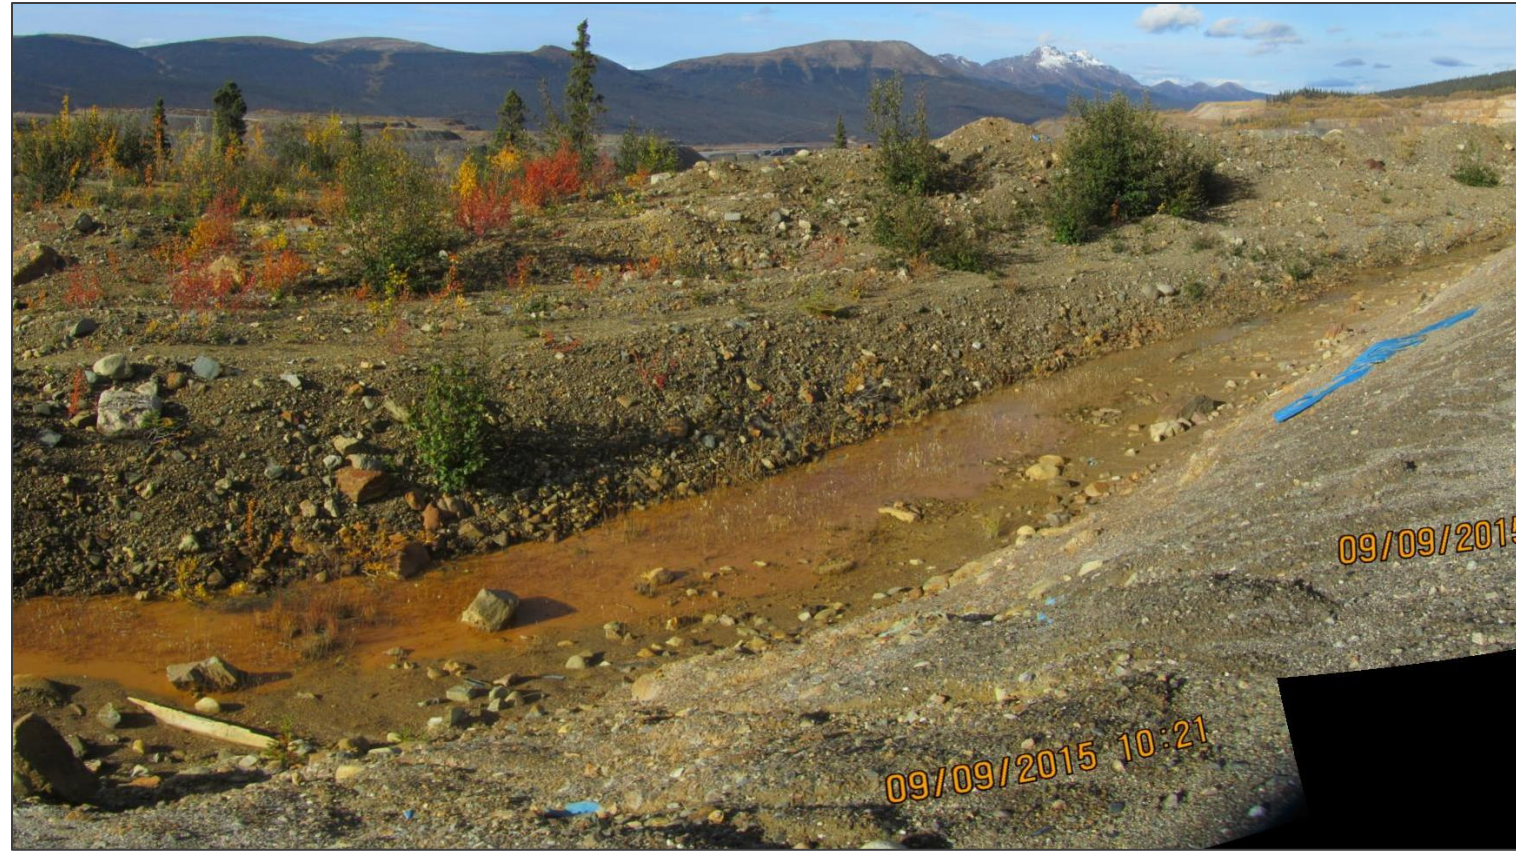
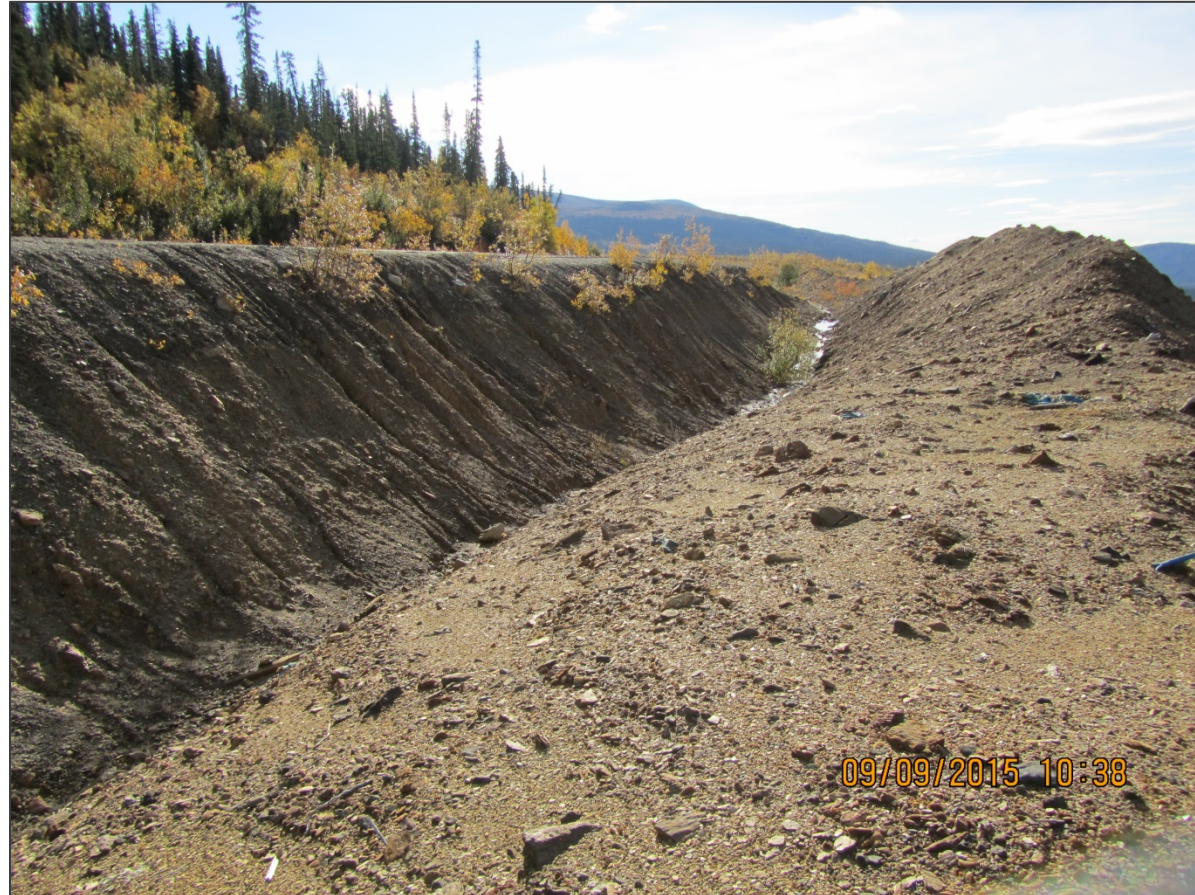
REV	DATE	FIGURE DESCRIPTION	JUR	JUR	AVC	AVC
0	29/SEP15					
CLIENT		Yukon Government		YUKON GOVERNMENT		
CONSULTANT		Golder Associates		FARO MINE COMPLEX 2015 PIT SLOPE STABILITY REVIEW		
PROJECT		FARO PIT WATER IN DITCH AT CREST OF EAST WALL		1410944/2015		
		FIGURE No.		A-5

- There is a large berm at the crest of the east wall, on the east side of the access road, behind the south instability zone. Water was observed in a ditch at the toe of the berm, and this may be contributing to water infiltrating into the slope (Figure A-5).

BERM AT CREST OF EAST WALL, ON WEST SIDE OF ROAD, VIEW LOOKING NORTHWEST

BERM AT CREST OF EAST WALL, ON WEST SIDE OF ROAD, VIEW LOOKING SOUTH

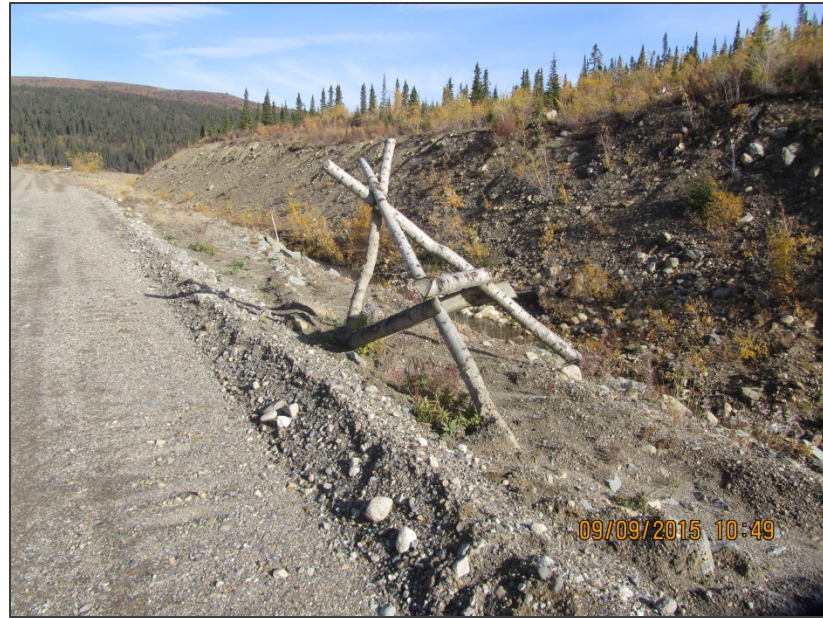
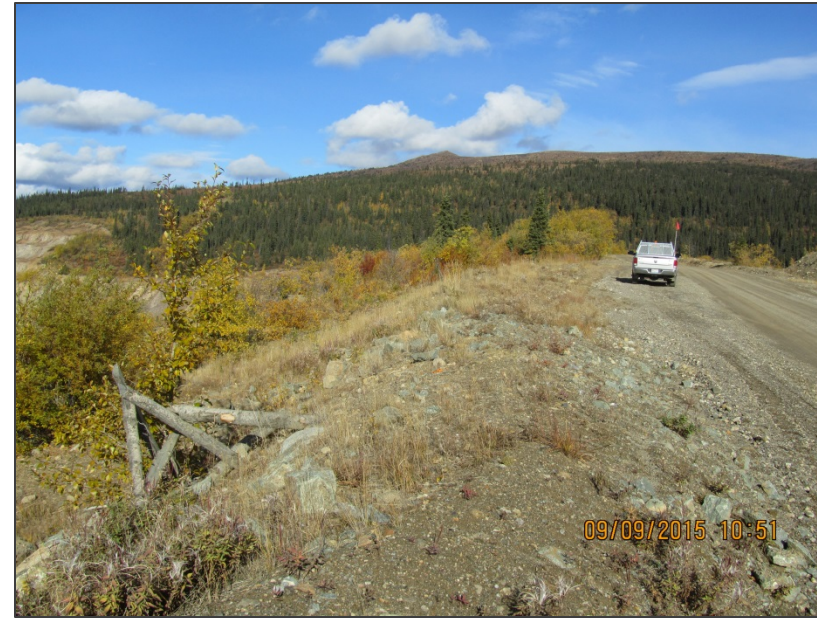
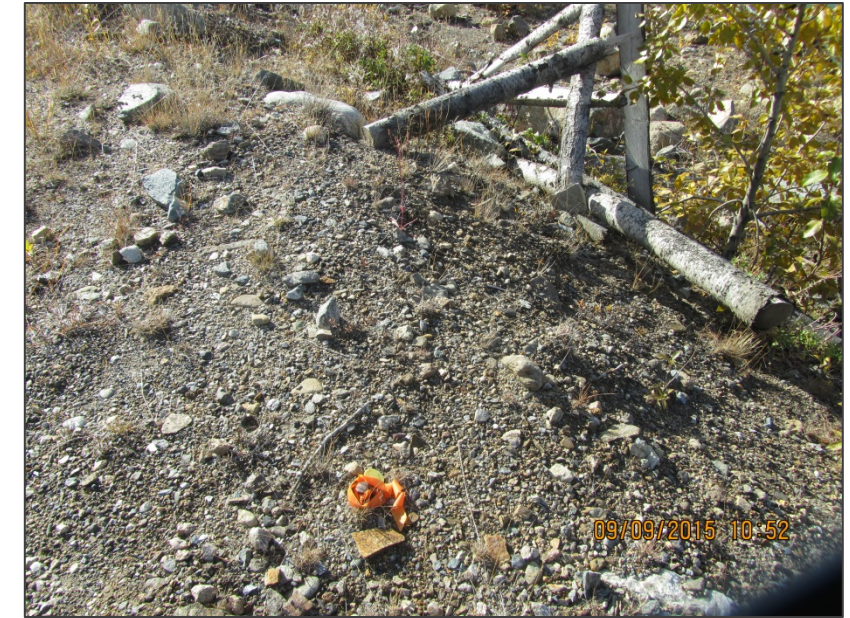
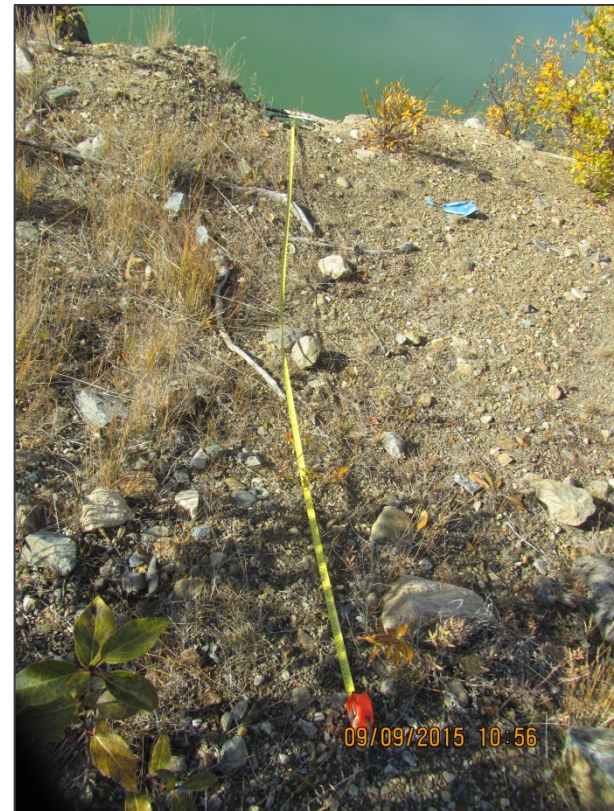
- The monitoring pins and regression pins that were observed appear to be in poor to good condition (Figure A-6). These are discussed further in Section 3.4.2 of this report.

PIN 13908 – STRUCTURE STILL STANDING, BUT  
COULD NOT FIND PIN

STRUCTURE FOR PIN 15742

PIN 15742 NEAR STRUCTURE

DISTANCE FROM CREST TO EDGE OF BERM IS  
APPROXIMATELY 3 METRES NEAR PIN 15742

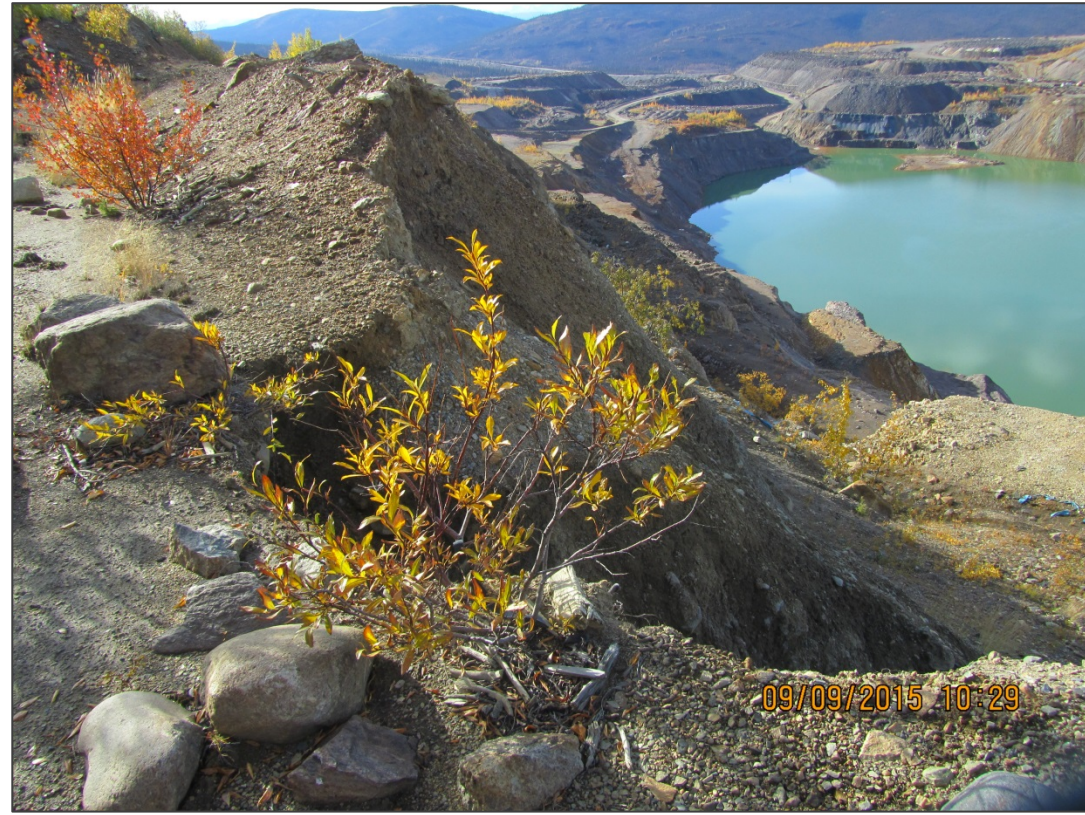
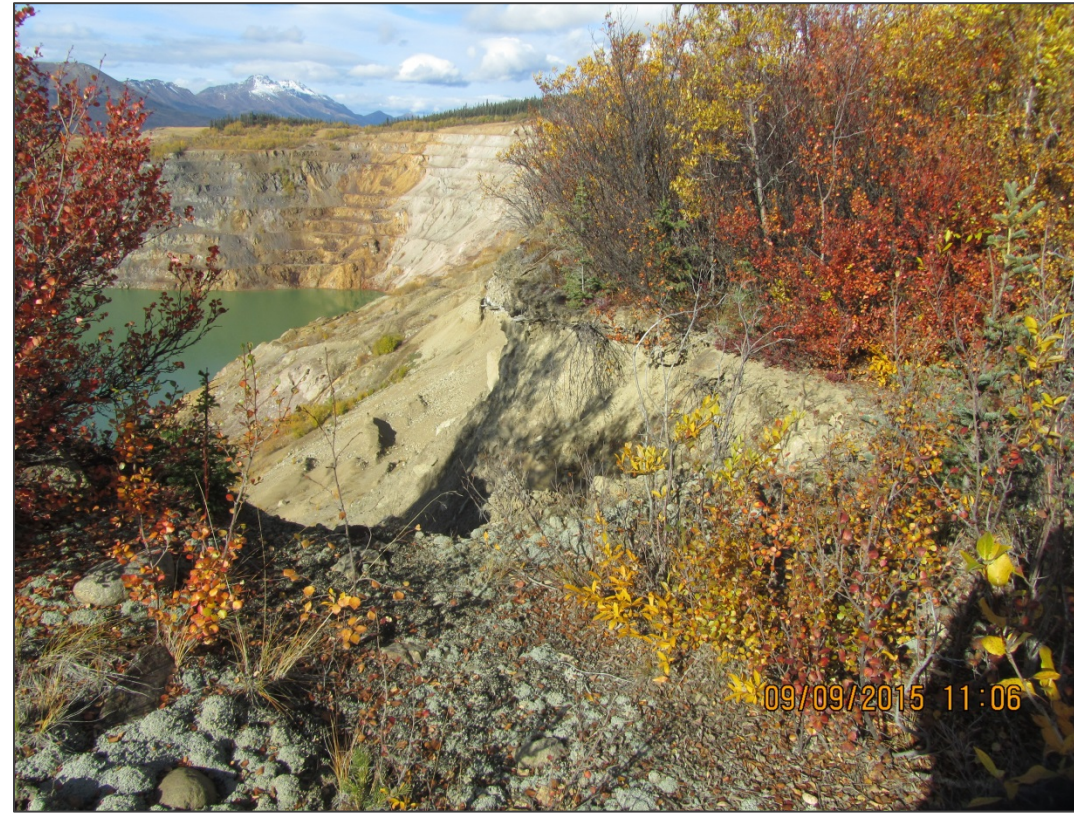
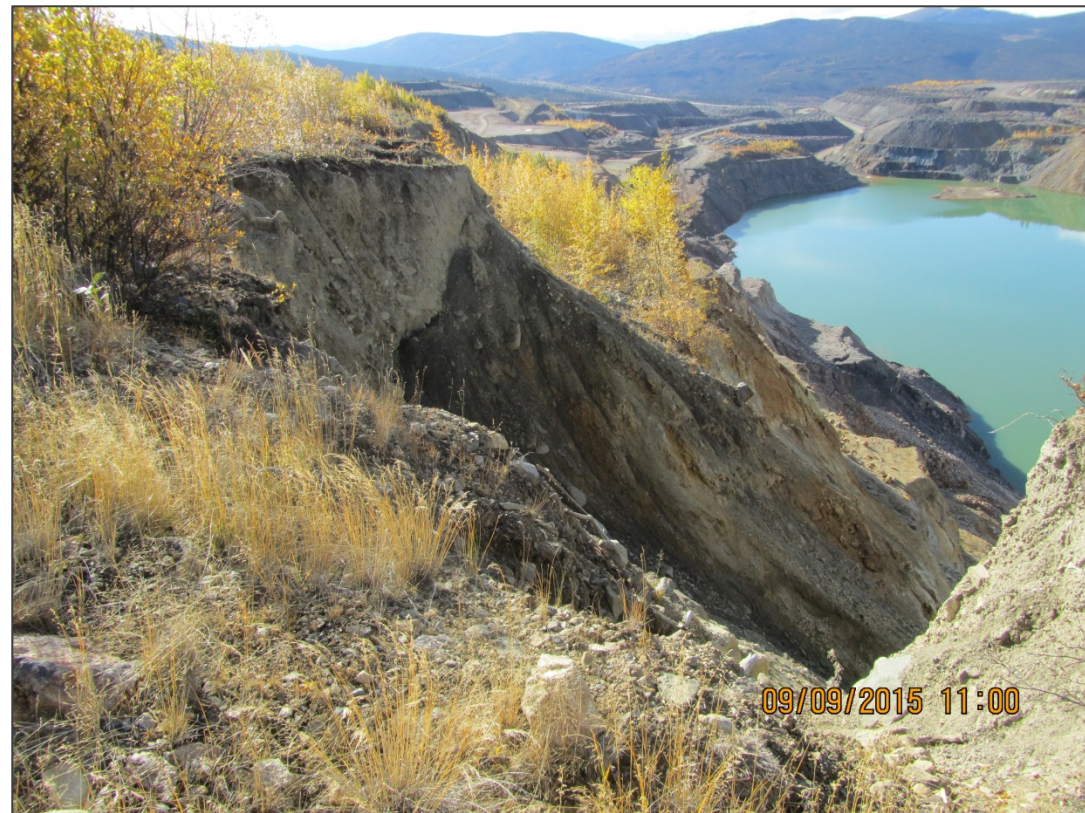
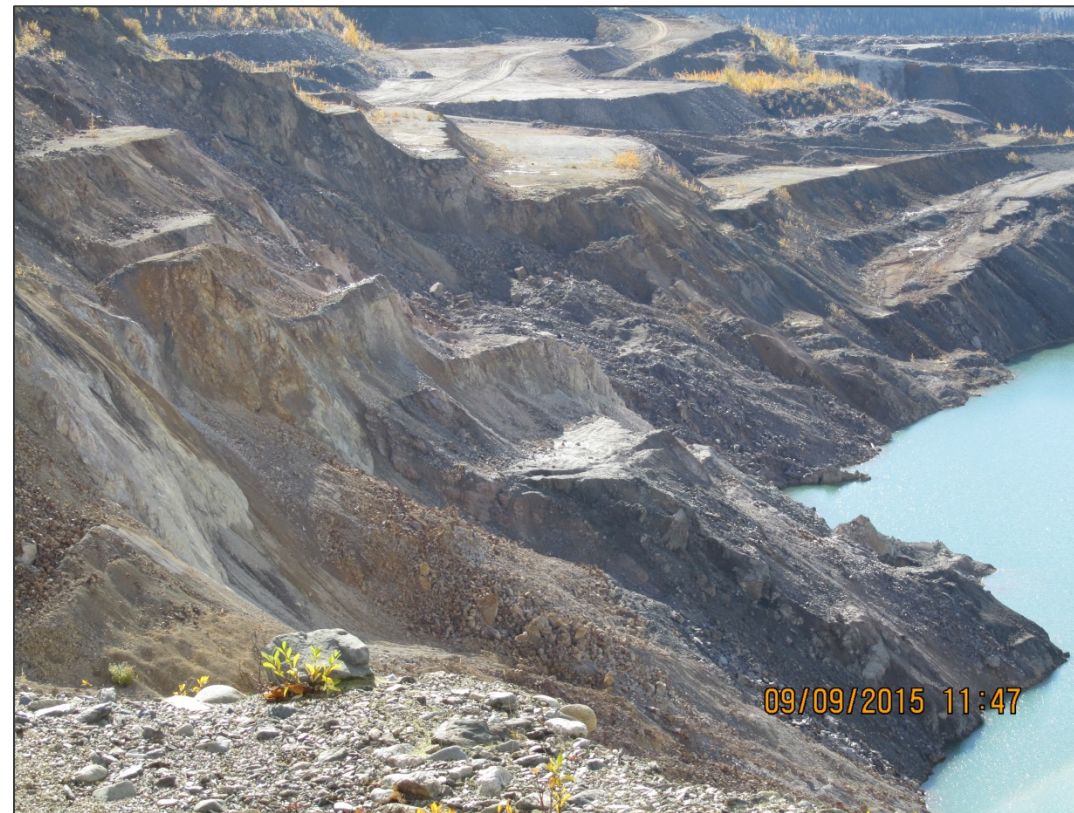
REV	DATE	FIGURE DESCRIPTION	JUR	JUR	AVC	AVC
0	29/SEP15		DRW	DES	CHK	R/W
PROJECT		FARO MINE COMPLEX 2015 PIT SLOPE STABILITY REVIEW		1410944/2015		
TITLE		FARO PIT NORTHEAST WALL - RAVELING AND SLUMPING				
		FIGURE No. <b>A-7</b>

TILL SLOWLY ERODING AND RAVELING

BACKSCARP SLUMPING

RAVELING ON BENCHES

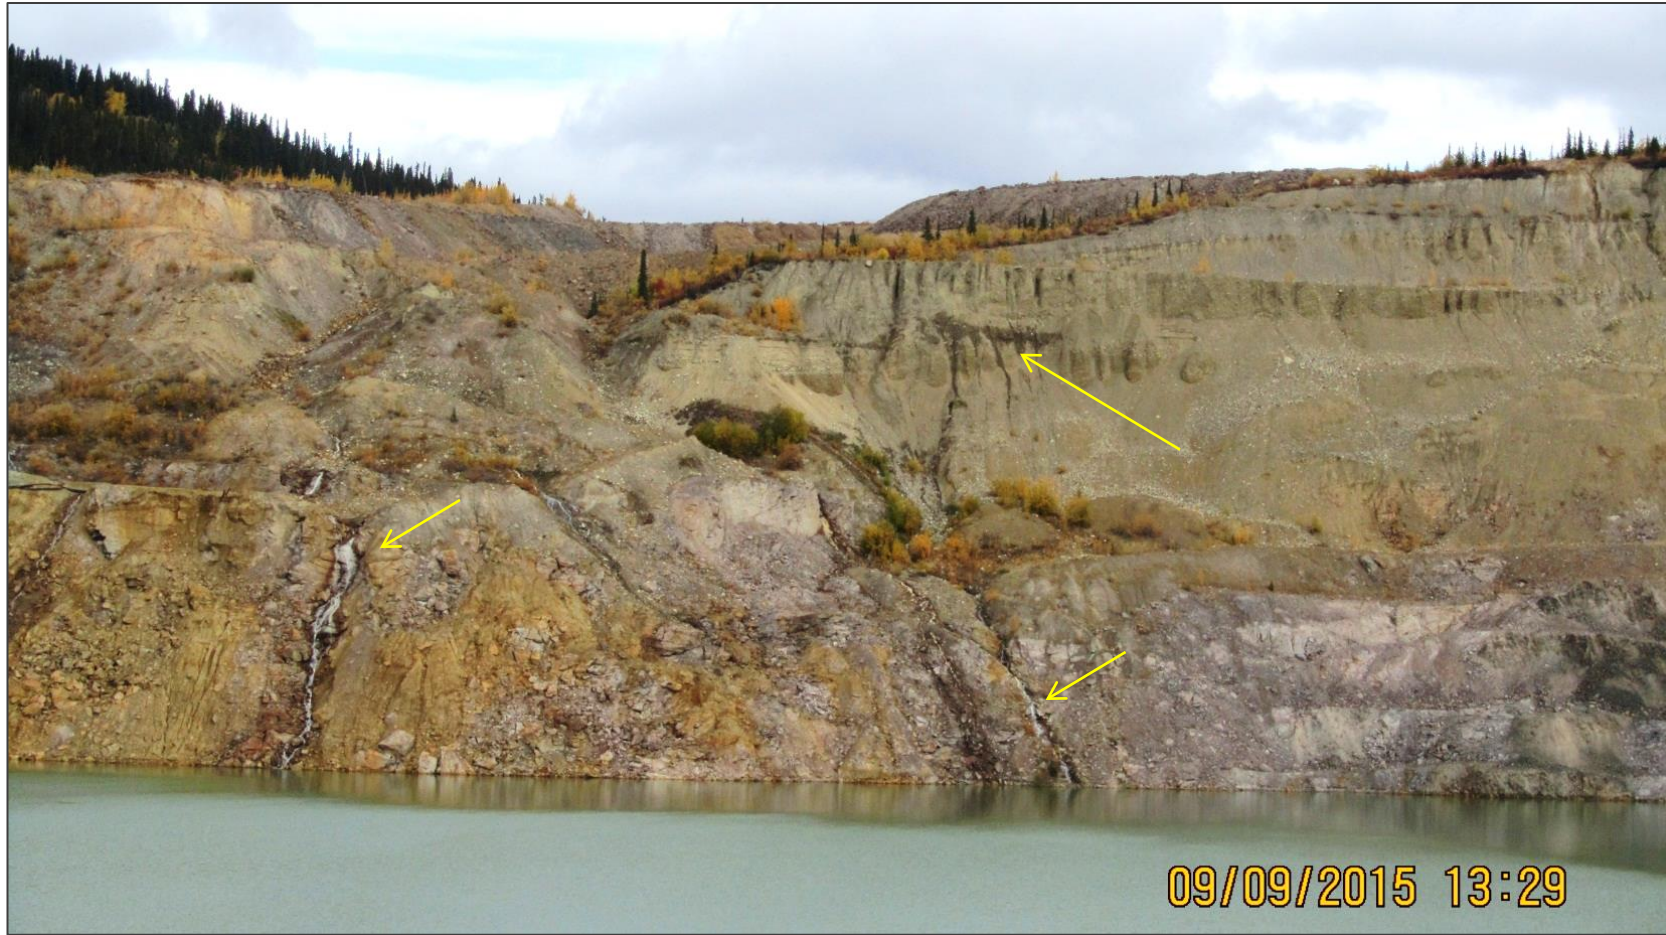
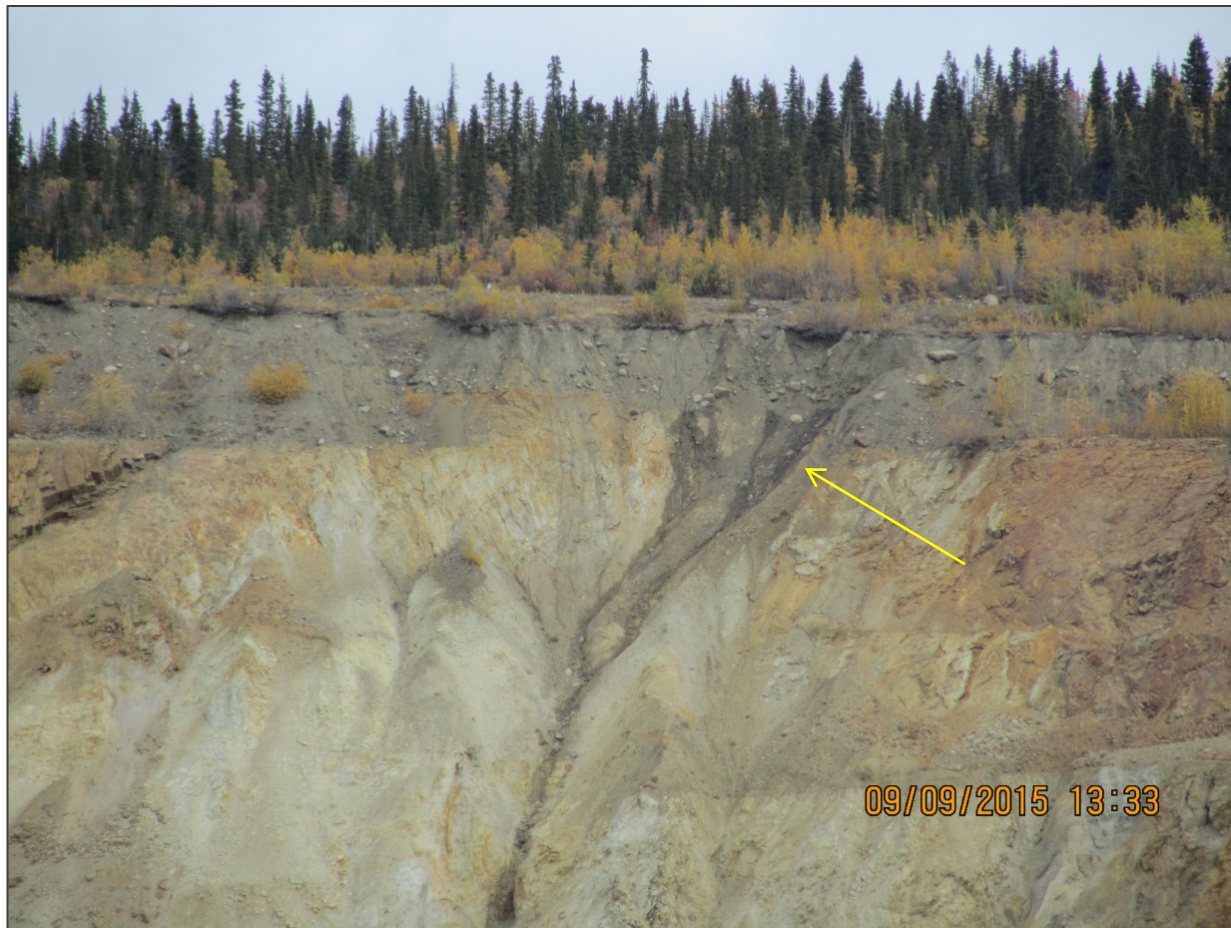
0	29/SEP15	FIGURE	JJR	JJR	AVC	AVC
REV	DATE	DESCRIPTION	DRW	DES	CHK	RVW
PROJECT		1410944/2015				
CLIENT		Yukon Government				
CONSULTANT		Golder Associates				
TITLE		FARO MINE COMPLEX 2015 PIT SLOPE STABILITY REVIEW				
TITLE		FARO PIT SEEPAGE ON EAST WALL				
FIGURE No.						A-8

- Seepage and water flow into the pit was observed to the north of the North Instability Zone. The water appears to be emanating from the overburden/bedrock contact (Figure A-8, top photograph), some of which may be coming from the ponded water behind the crest, discussed in the next point.

SEEPAGE AND SURFACE RUNOFF ON NORTH SIDE OF NORTH INSTABILITY ZONE, VIEW LOOKING EAST

SEEPAGE AT TILL / BEDROCK CONTACT, EAST WALL, VIEW LOOKING EAST

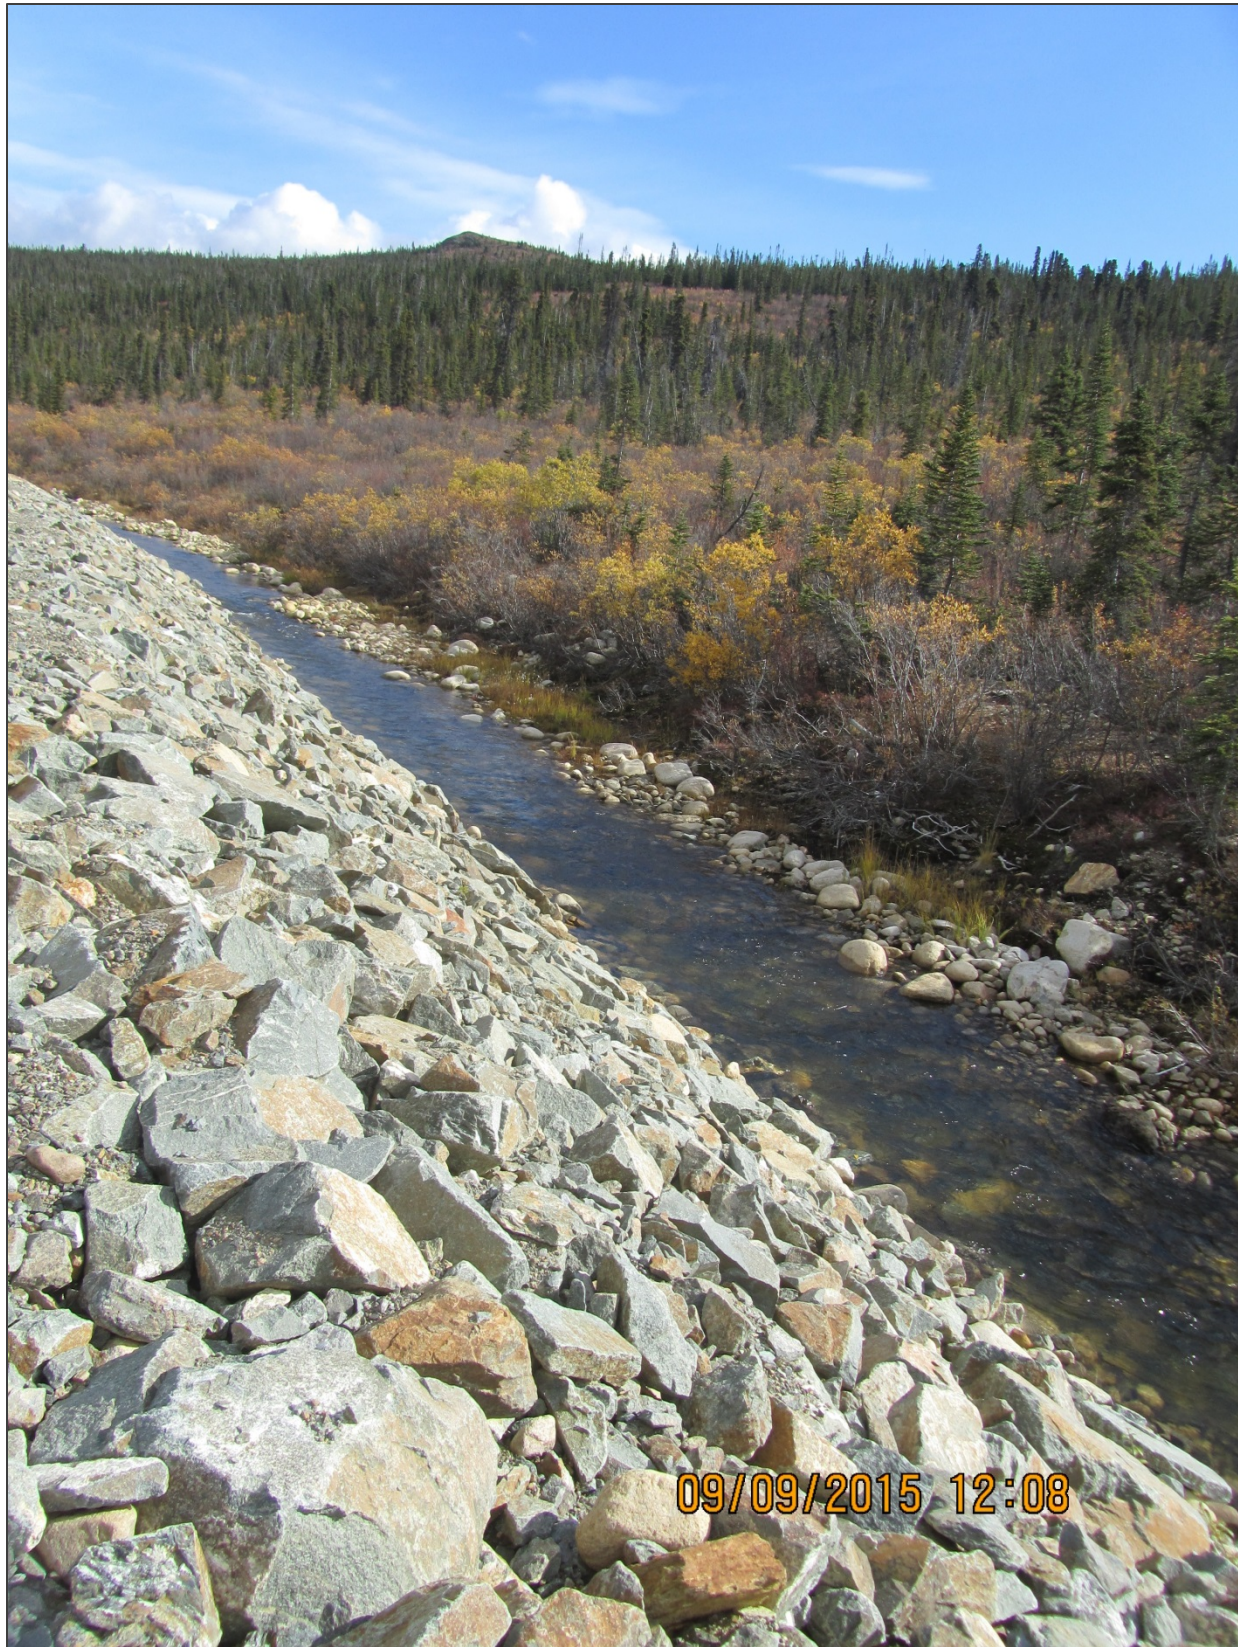
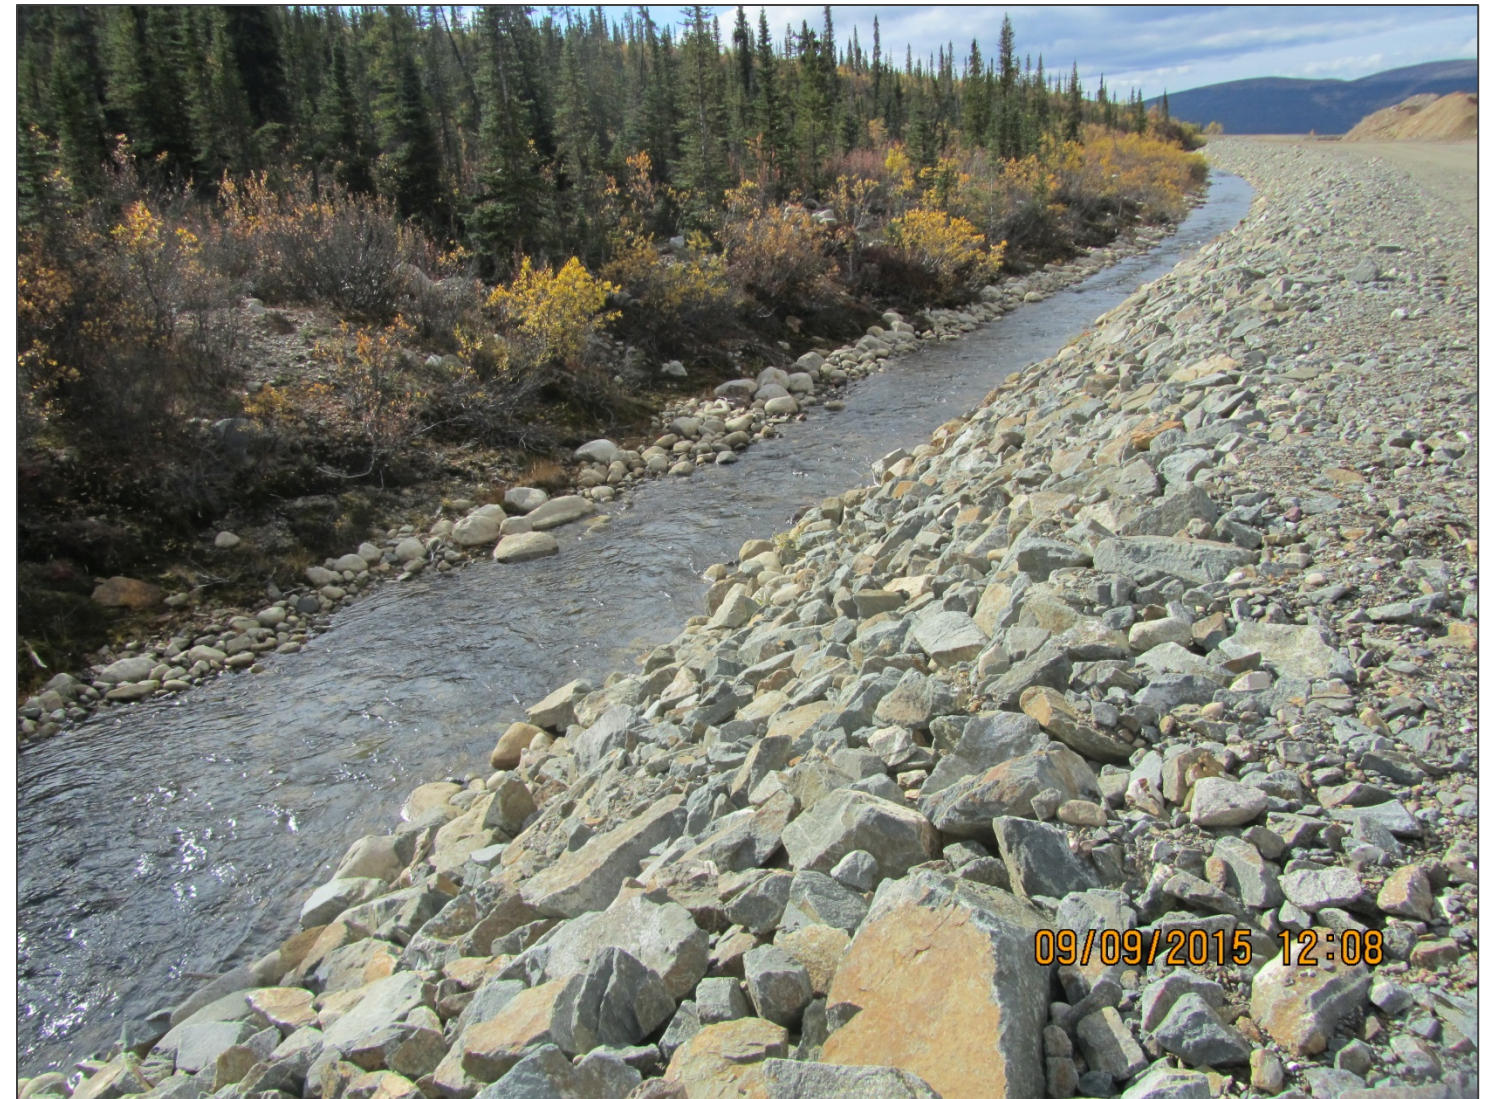
CLIENT	Yukon Government	YUKON GOVERNMENT	FIGURE	JUR	JUR	AVC	AVC
CONSULTANT	Golder Associates		DESCRIPTION	DRW	DES	CHK	RVW
			PROJECT	1410944/2015			
			TITLE	FARO MINE COMPLEX 2015 PIT SLOPE STABILITY REVIEW			
				FARO CREEK DIVERSION CHANNEL			
			FIGURE No.	A-10

- The FCDC was conveying water at the time of the site visit. The side slopes appeared to be in good condition and no cracks or offsets in the geometry were observed. The FCDC appears to be diverting the majority of the water away from the crest of the east wall (Figure A-10). Although some water in the FCDC still continues to seep into the ground, based on visual observations, the volume is likely small in comparison to all the other sources of water that flow to the pit from the east side of the pit. Therefore, the ditch seepage is not a concern with respect to slope stability.
