## FARO MINE COMPLEX

# 2015 Pit Slope Stability Review

**Reference Number: 1410944-007-R-Rev0-2015**

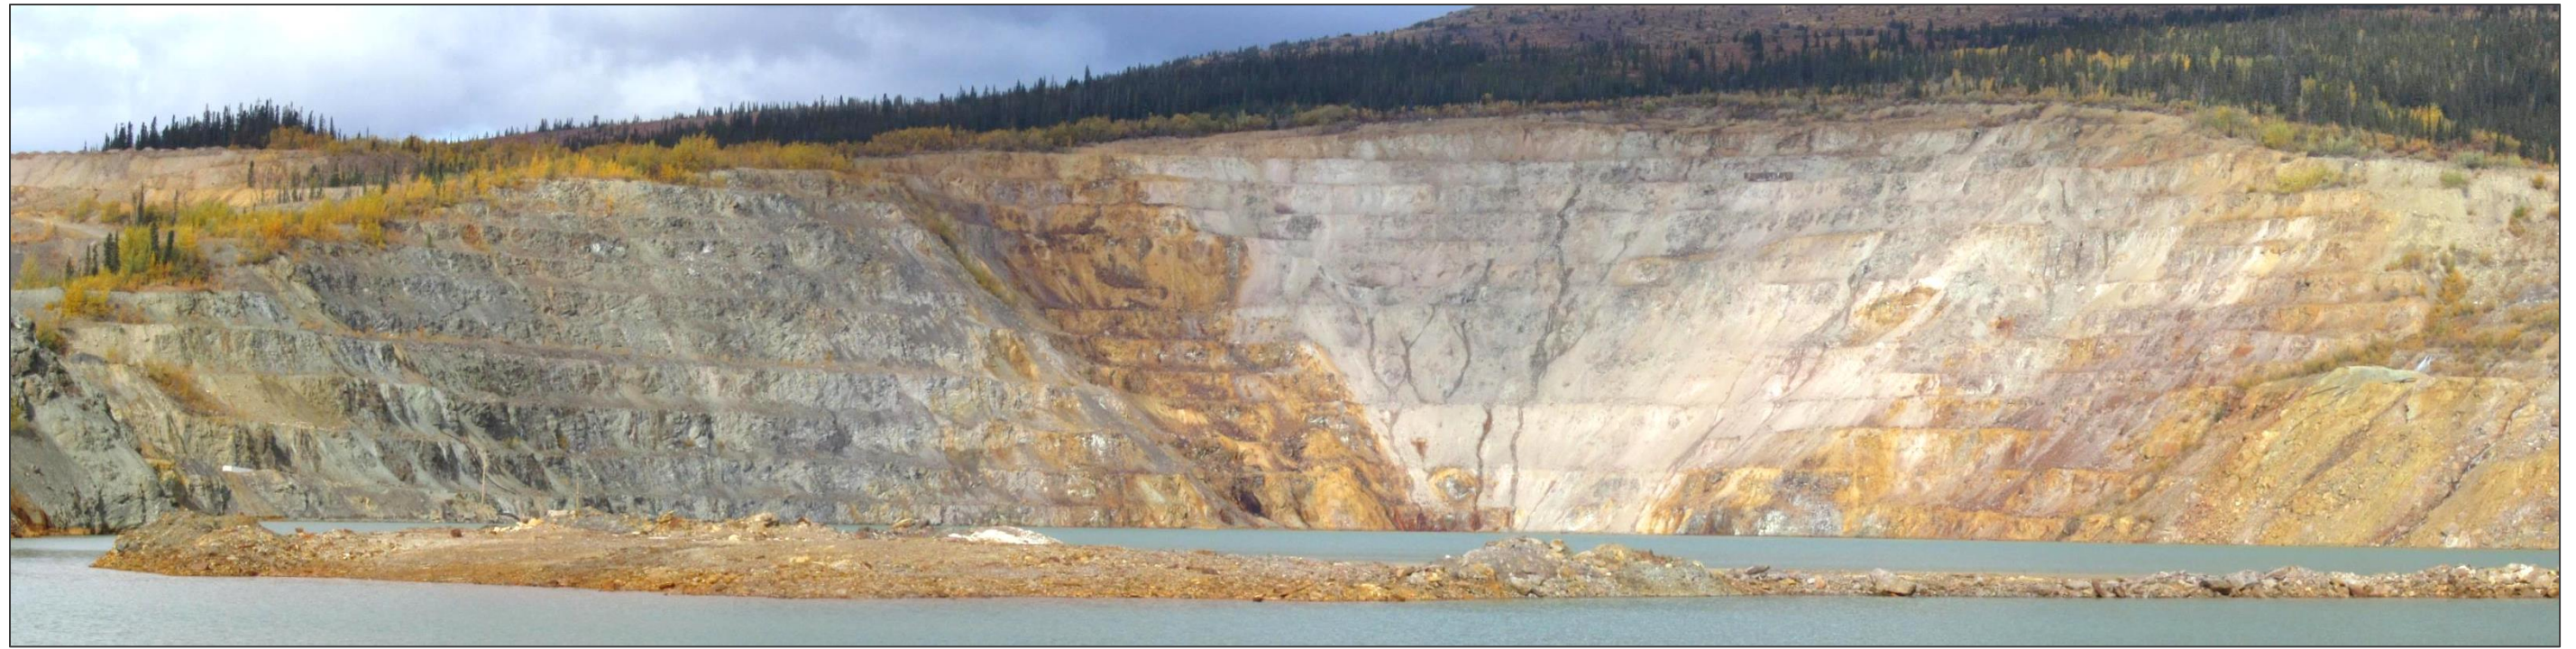
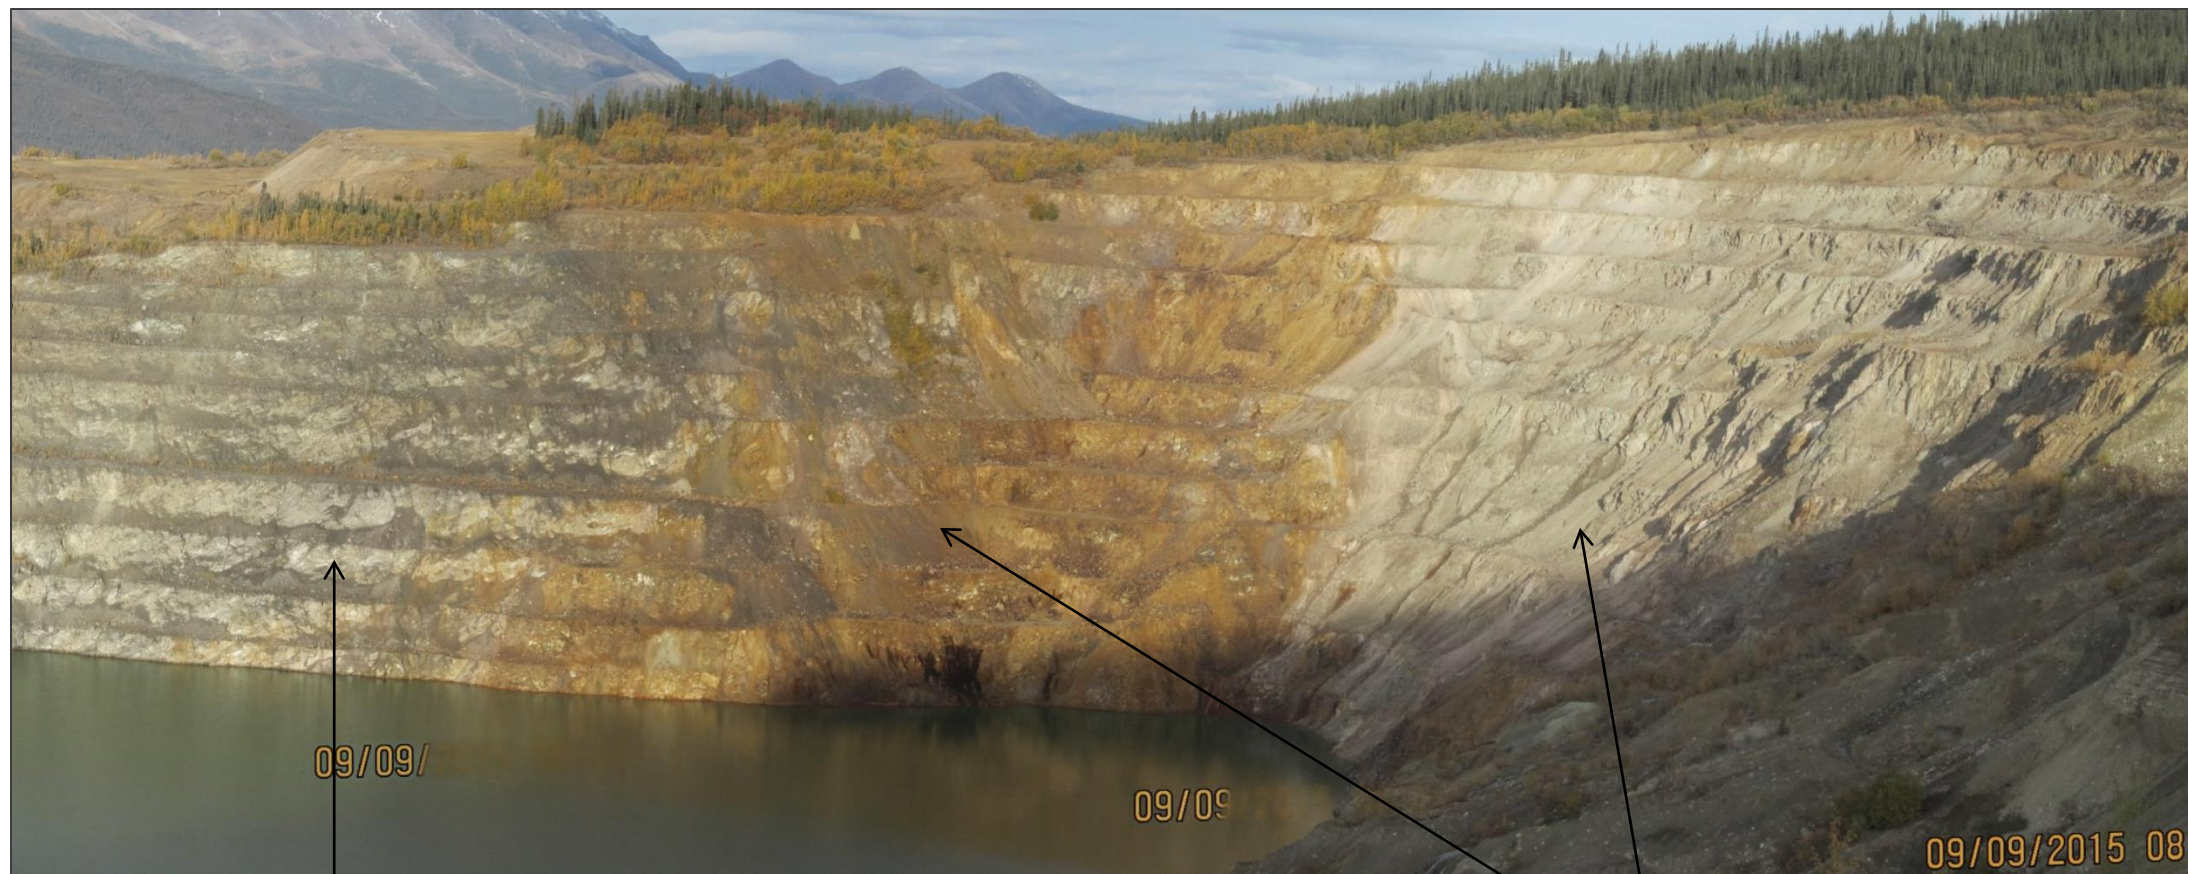
REV	DATE	FIGURE DESCRIPTION	JUR	JUR	AVC	AVC
0	29/SEP15					
PROJECT			1410944/2015			
TITLE			FARO MINE COMPLEX 2015 PIT SLOPE STABILITY REVIEW			
PROJECT			FARO PIT NORTH AND NORTHWEST WALLS			
FIGURE No.			A-11

BENCH CRESTS INTACT IN MORE COMPETENT ROCK

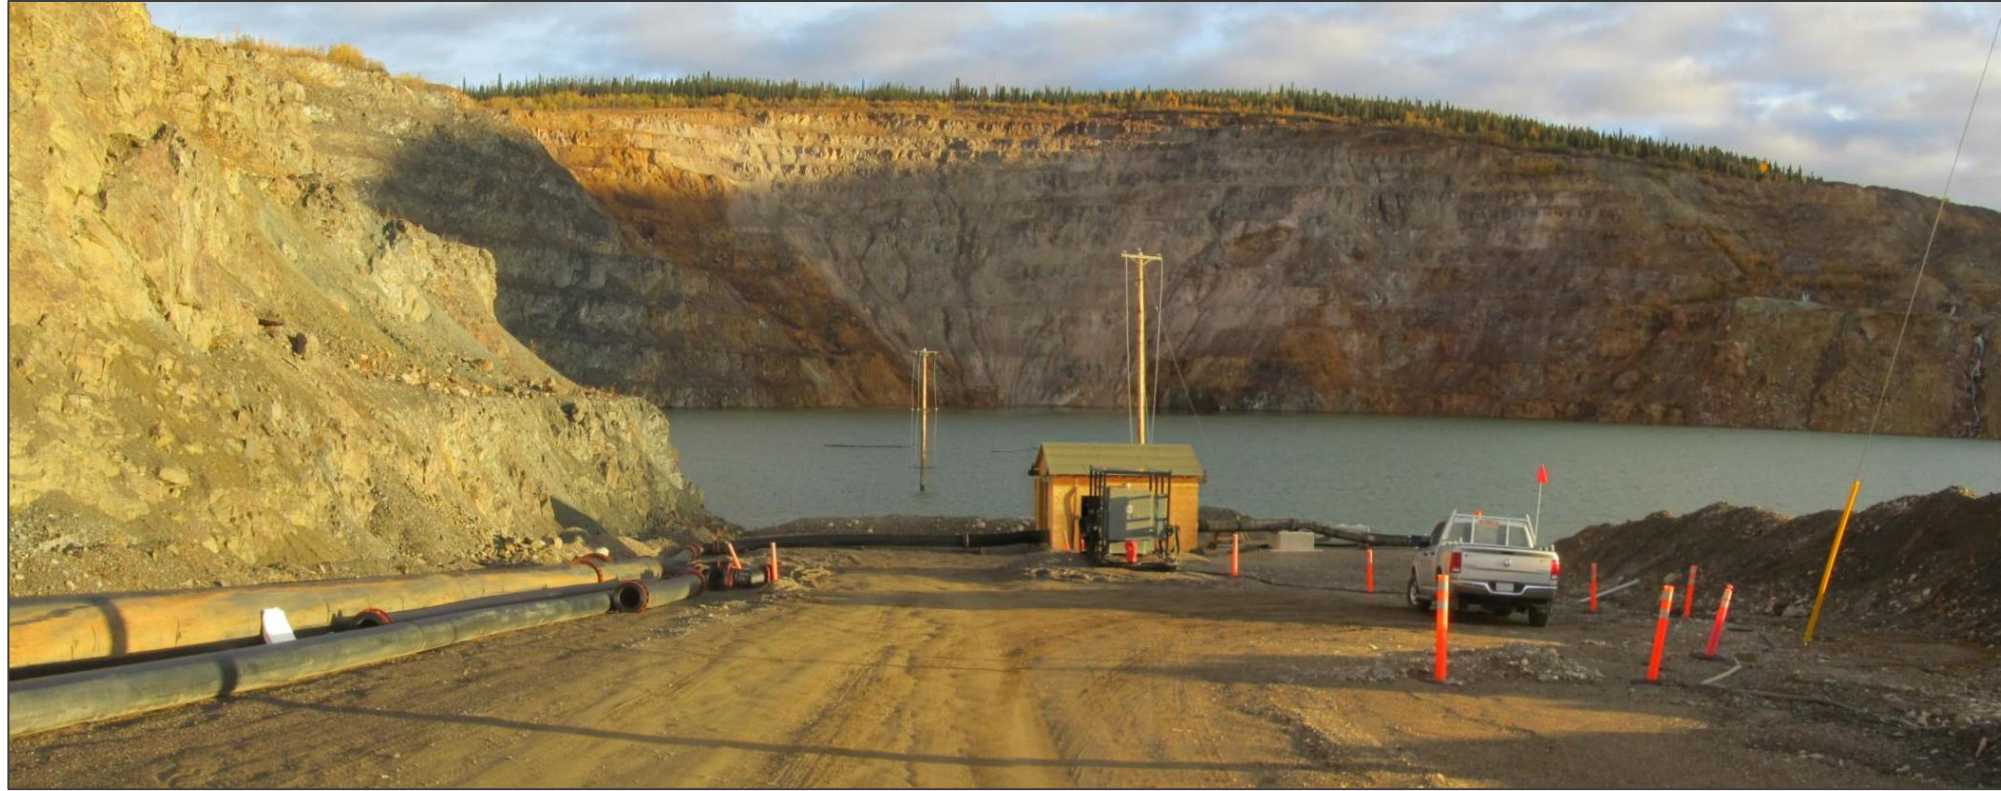
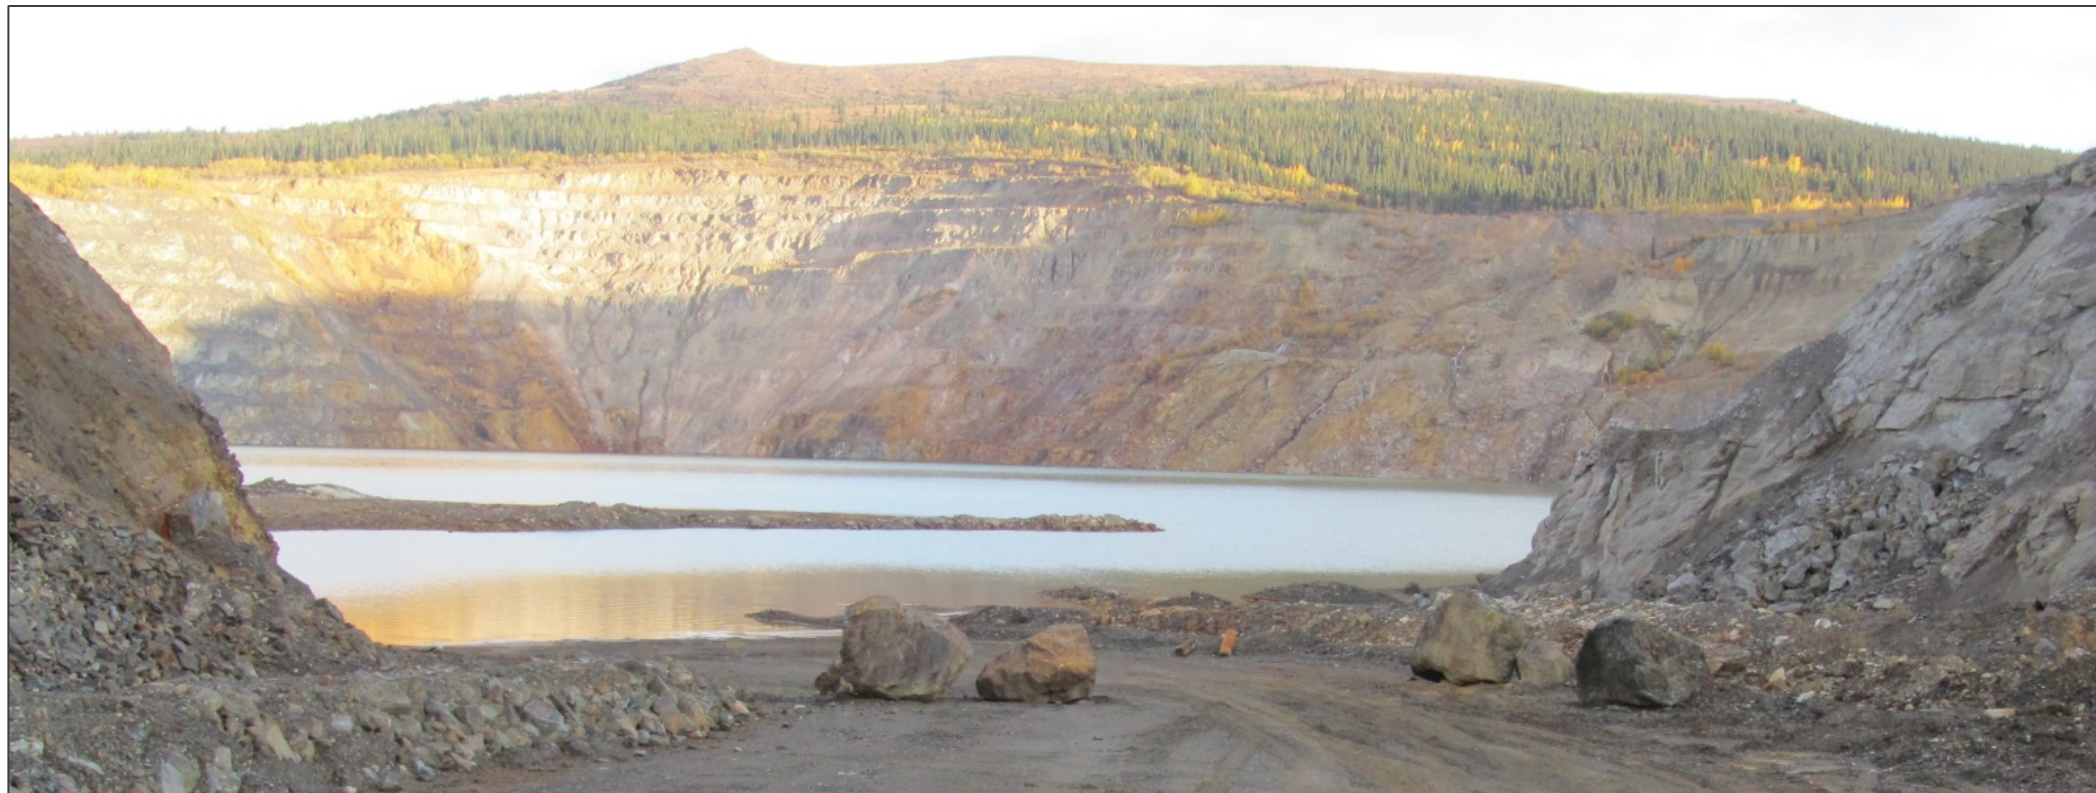
Golder Associates				
TITLE		FARO MINE COMPLEX 2015 PIT SLOPE STABILITY REVIEW				
TITLE		FARO PIT ACCESS ROADS				
FIGURE No.						A-12

- Golder recommended a barrier at the end of the Zone 2 access road after the 2014 site visit. Boulders have since been placed at the end of the Zone 2 access road and are moved as needed to act as barriers (Figure A-12).

BOULDERS AT END OF ZONE 2 ACCESS ROAD,  
SOUTH SIDE OF PIT, VIEW LOOKING NORTH

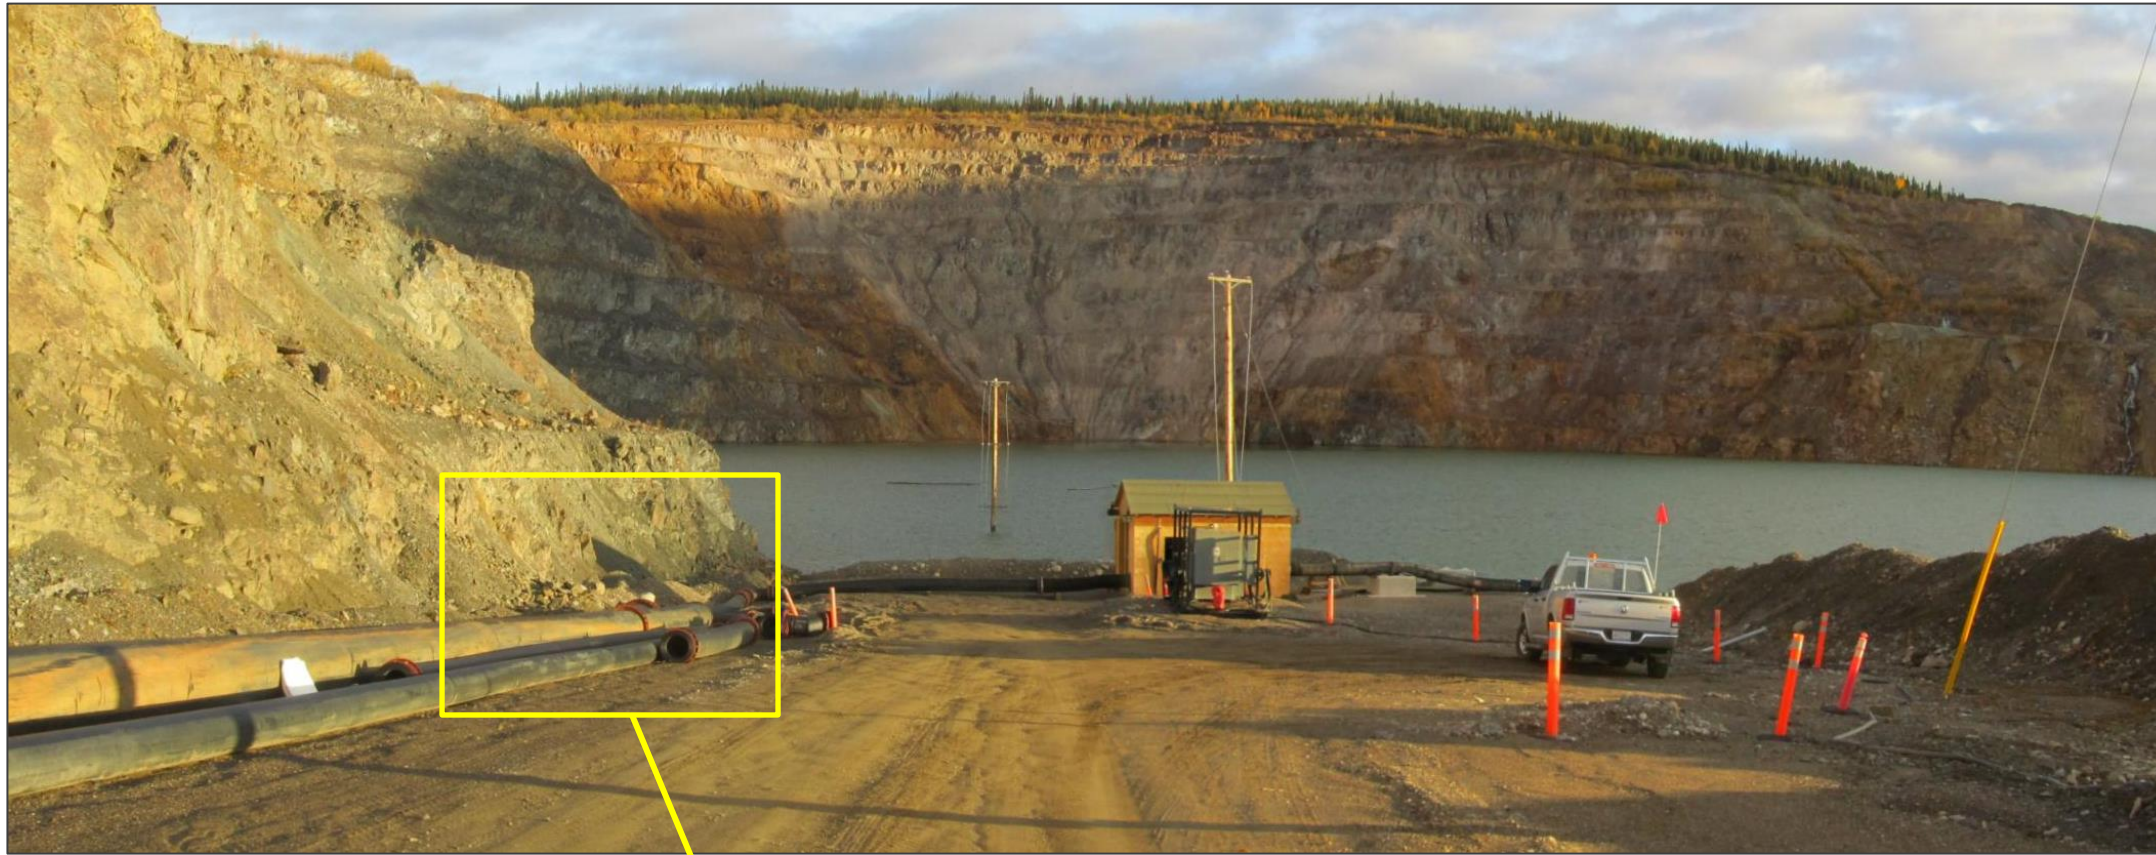
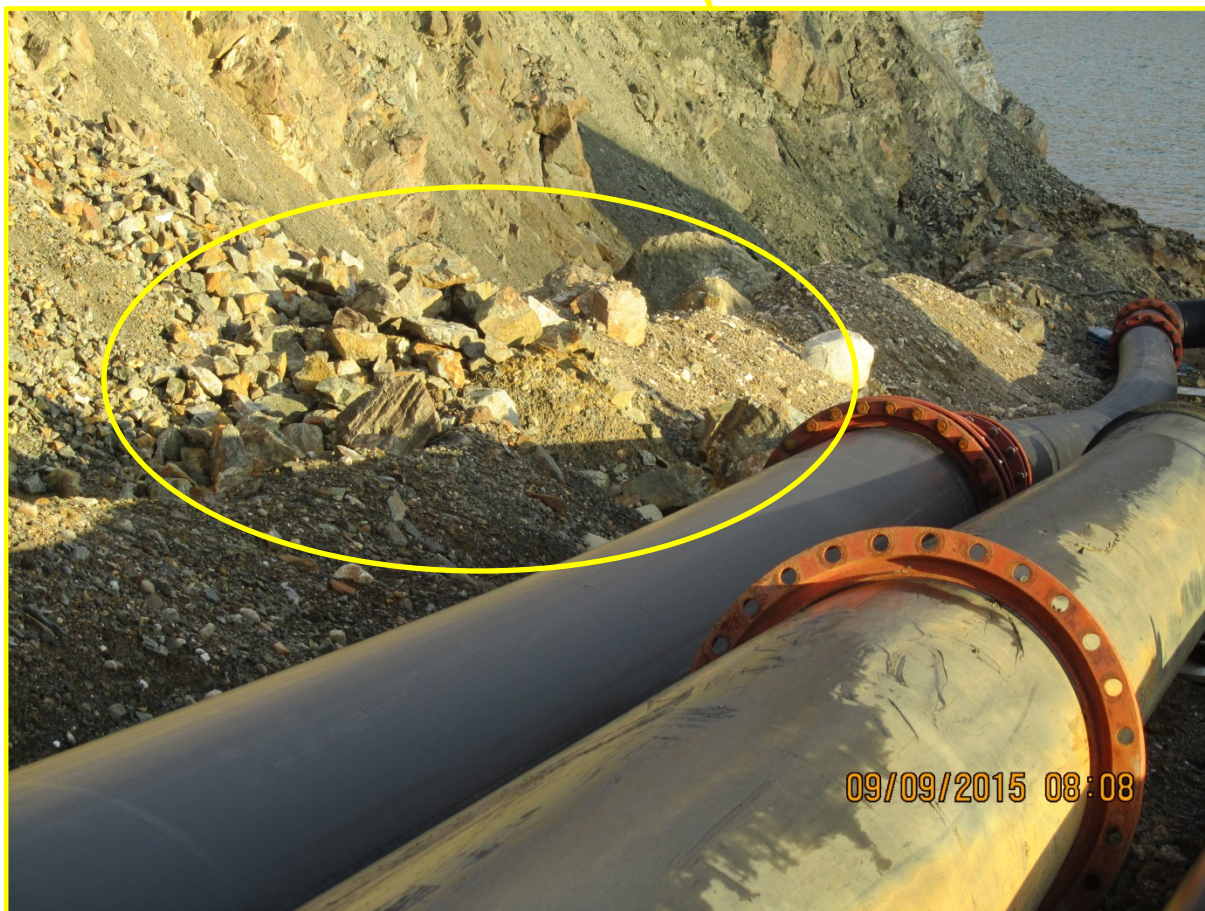
REV	DATE	FIGURE DESCRIPTION	JUR	JUR	AVC	AVC
0	29/SEP15					
PROJECT			1410944/2015			
TITLE			FARO MINE COMPLEX 2015 PIT SLOPE STABILITY REVIEW			
TITLE			FARO PIT WEST ACCESS ROAD			
FIGURE No.			A-13

WEST ACCESS ROAD,  
WEST SIDE OF PIT, VIEW LOOKING NORTH

REMOVE MATERIAL BEHIND BERM TO RE-ESTABLISH  
ROCKFALL CATCHMENT

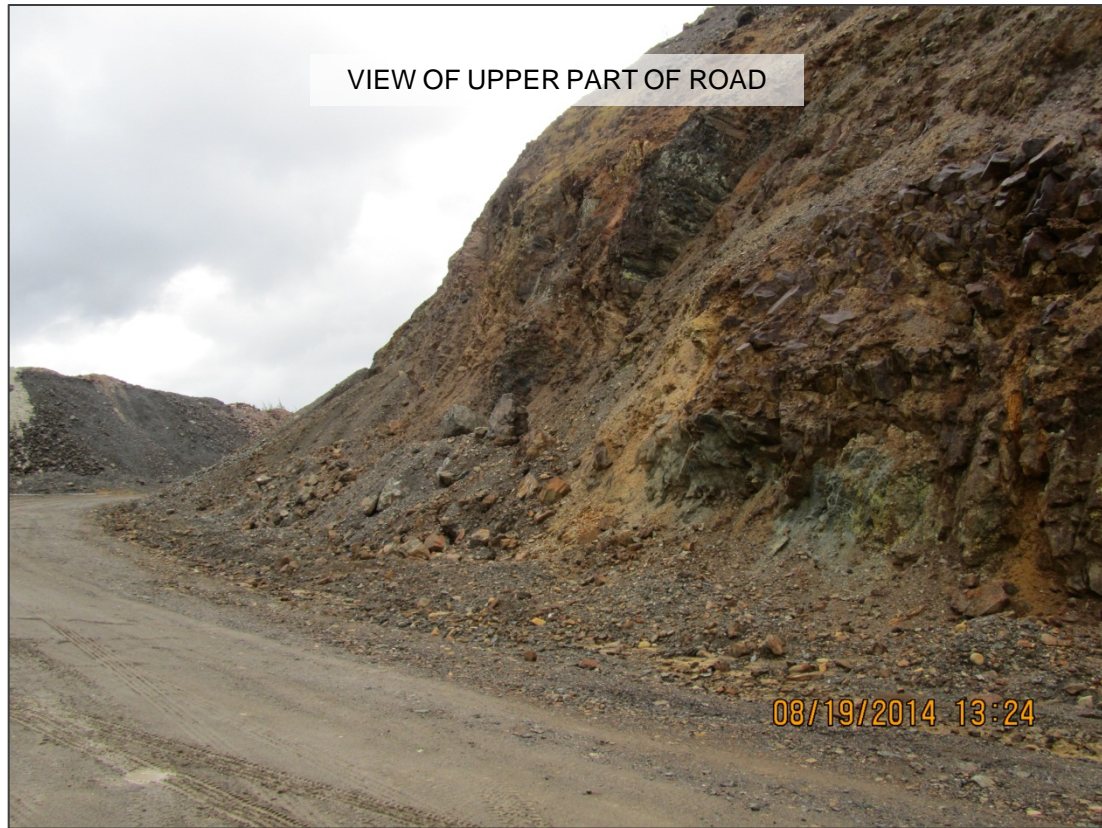
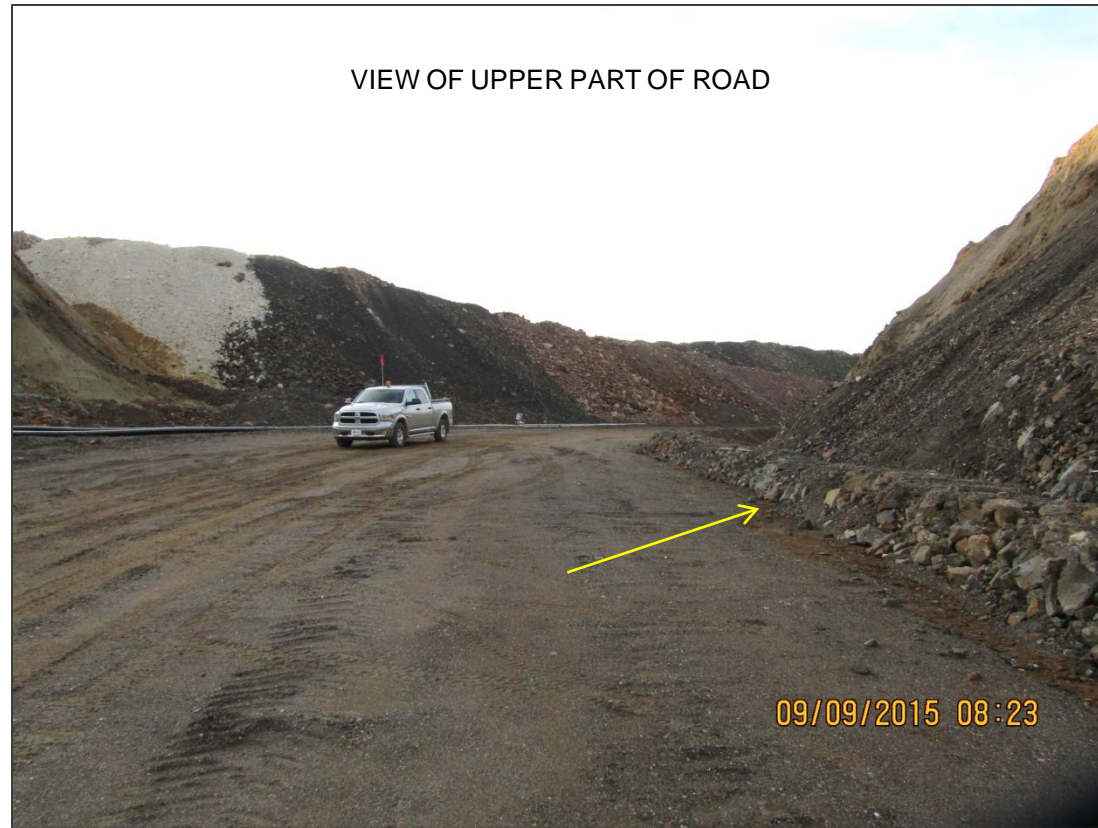
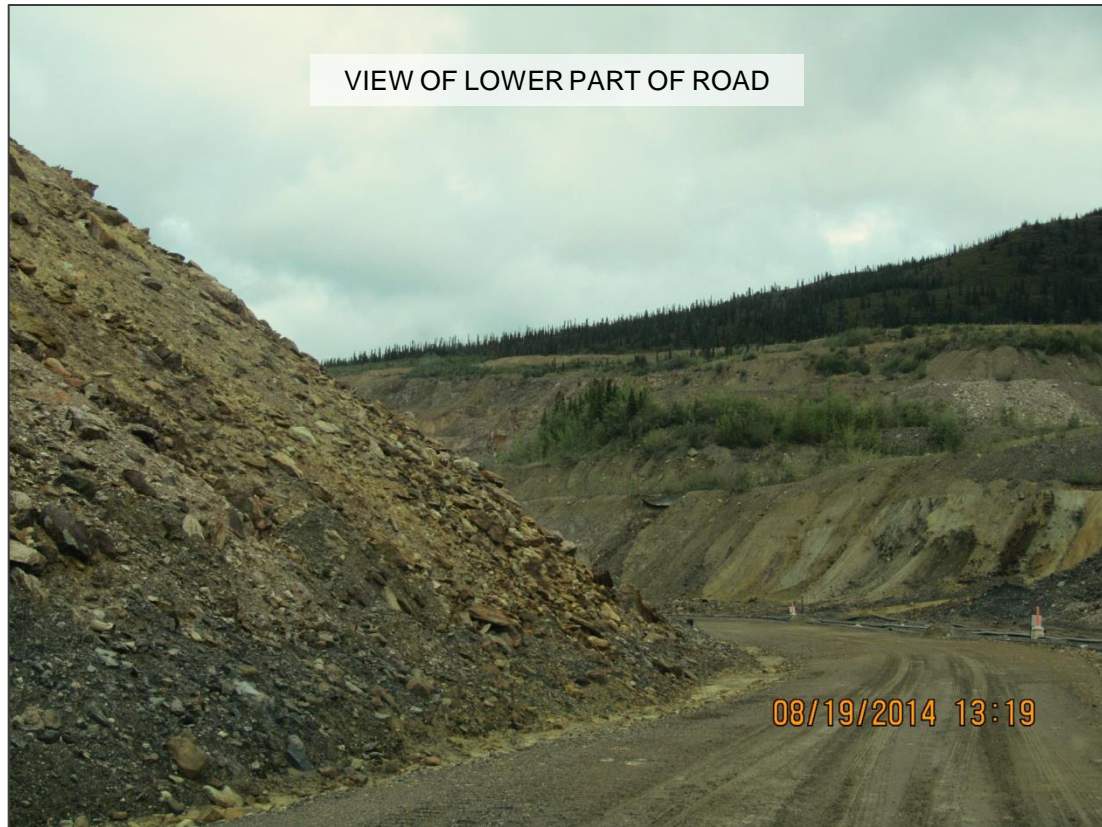
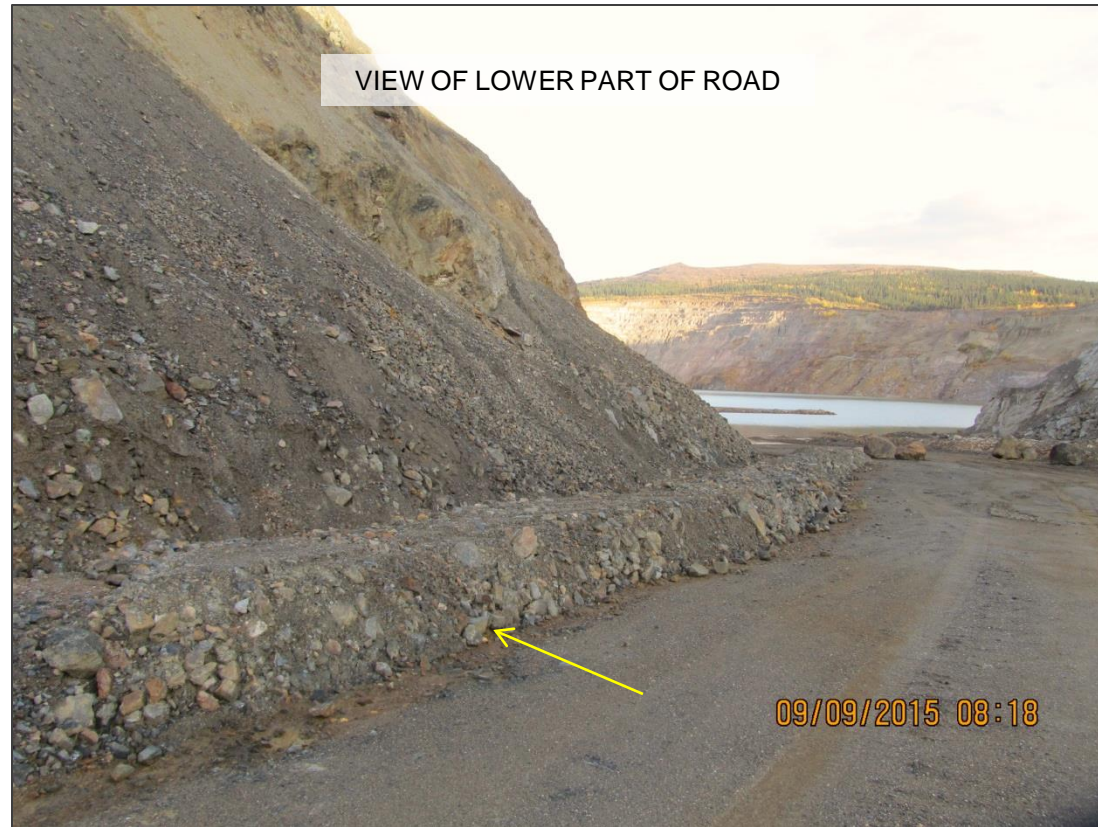
REV	DATE	FIGURE DESCRIPTION	JUR	JUR	AVC	AVC
0	29/SEP/15					
PROJECT			1410944/2015			
TITLE			FARO MINE COMPLEX 2015 PIT SLOPE STABILITY REVIEW			
TITLE			FARO PIT - AREAS OF ROCKFALL HAZARD WEST SLOPE - ZONE 2 ACCESS ROAD			
FIGURE No.			A-14

- Rockfall berms have been placed at the base of the slopes on the west side of the Zone 2 access road (Figure 1) as per Golder's 2014 recommendations (Figure A-14).

BOTH PHOTOS ABOVE:  
2014 – NO ROCKFALL BERM

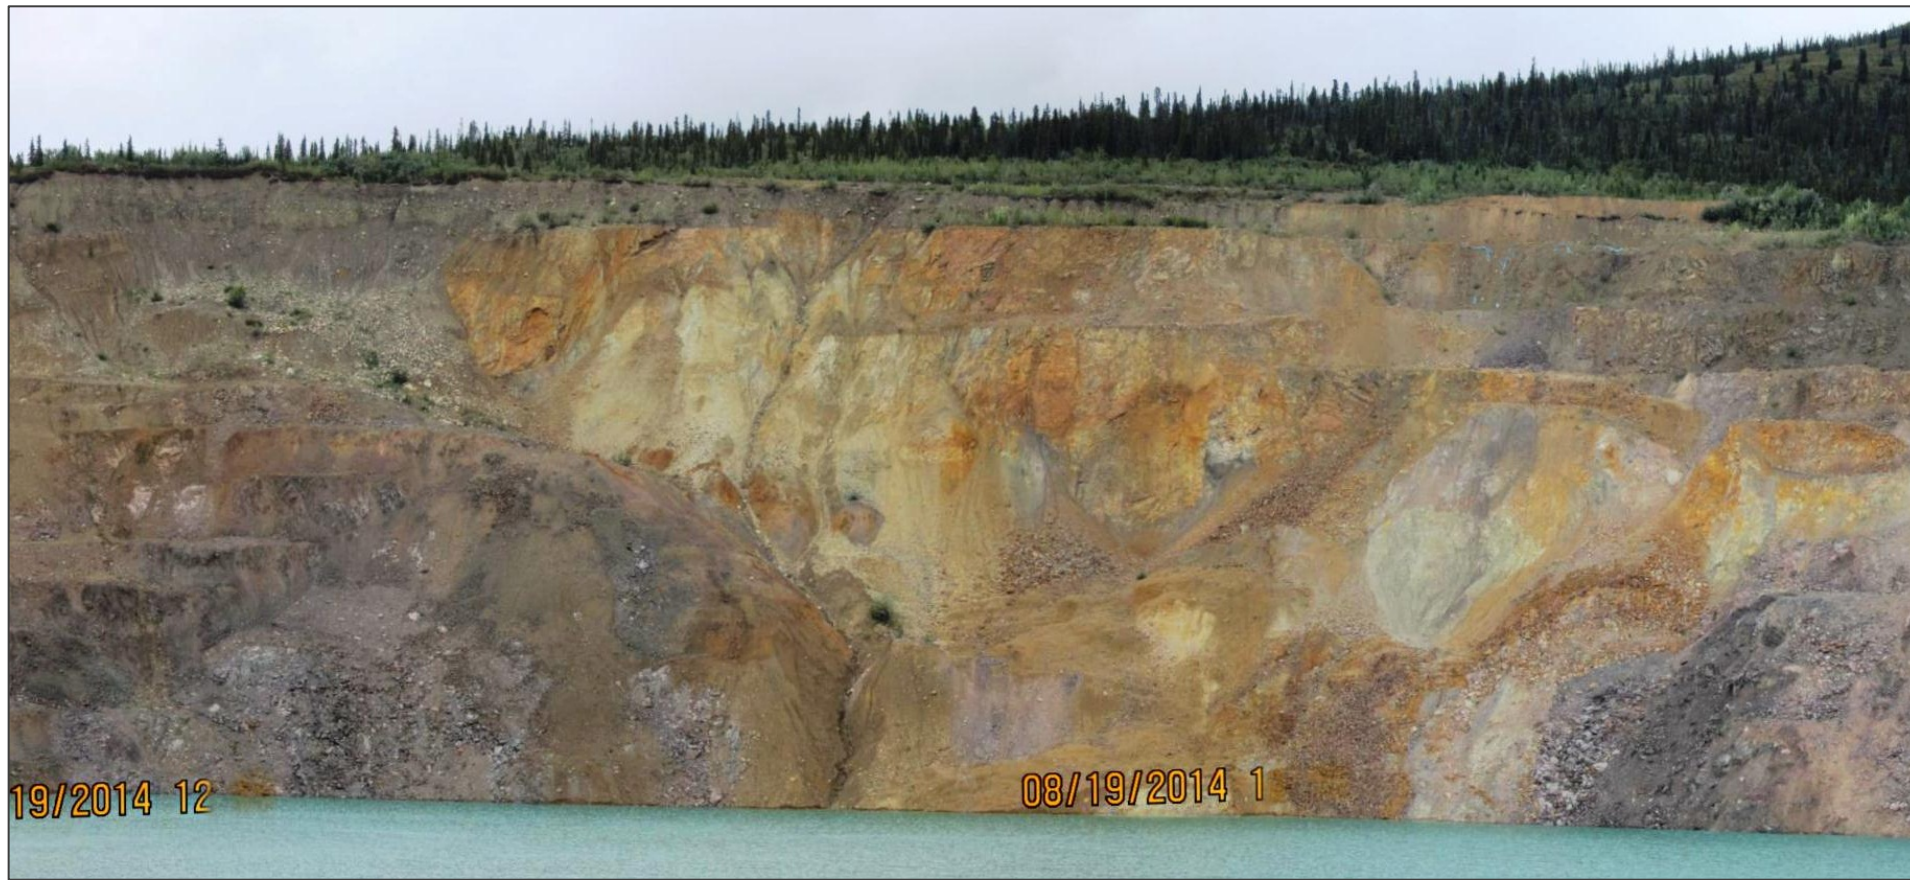
Figures A-15 and A-16 in Appendix A show comparison photographs from 2014 and 2015 of the North and South Instability Zones on the east wall, respectively. Several features in each instability zone were identified in both photographs and compared. The 2015 photos were also compared to the 2012 photos. The crest continues to erode and ravel, particularly in the till slopes, and the large erosion zones and gullies continue to grow. However, no significant changes in the crest, backscarp, slide material or bedrock were noted between the 2012, 2014, and 2015 photographs.

2014 PHOTOGRAPH OF NORTH INSTABILITY ZONE,  
VIEW LOOKING EAST

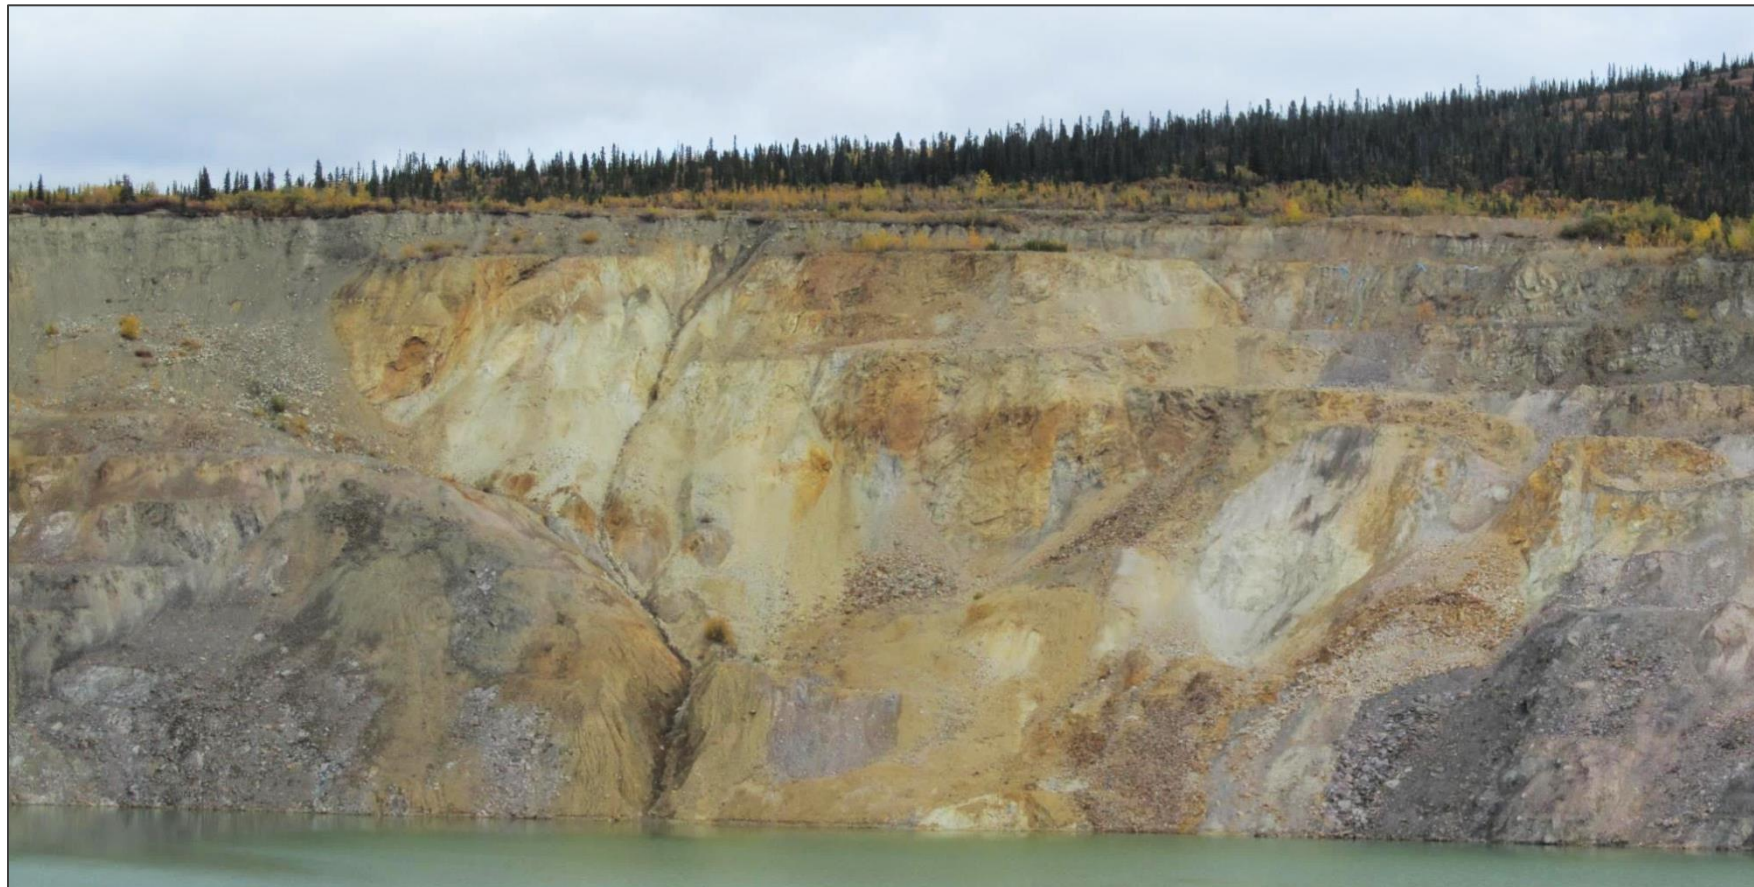
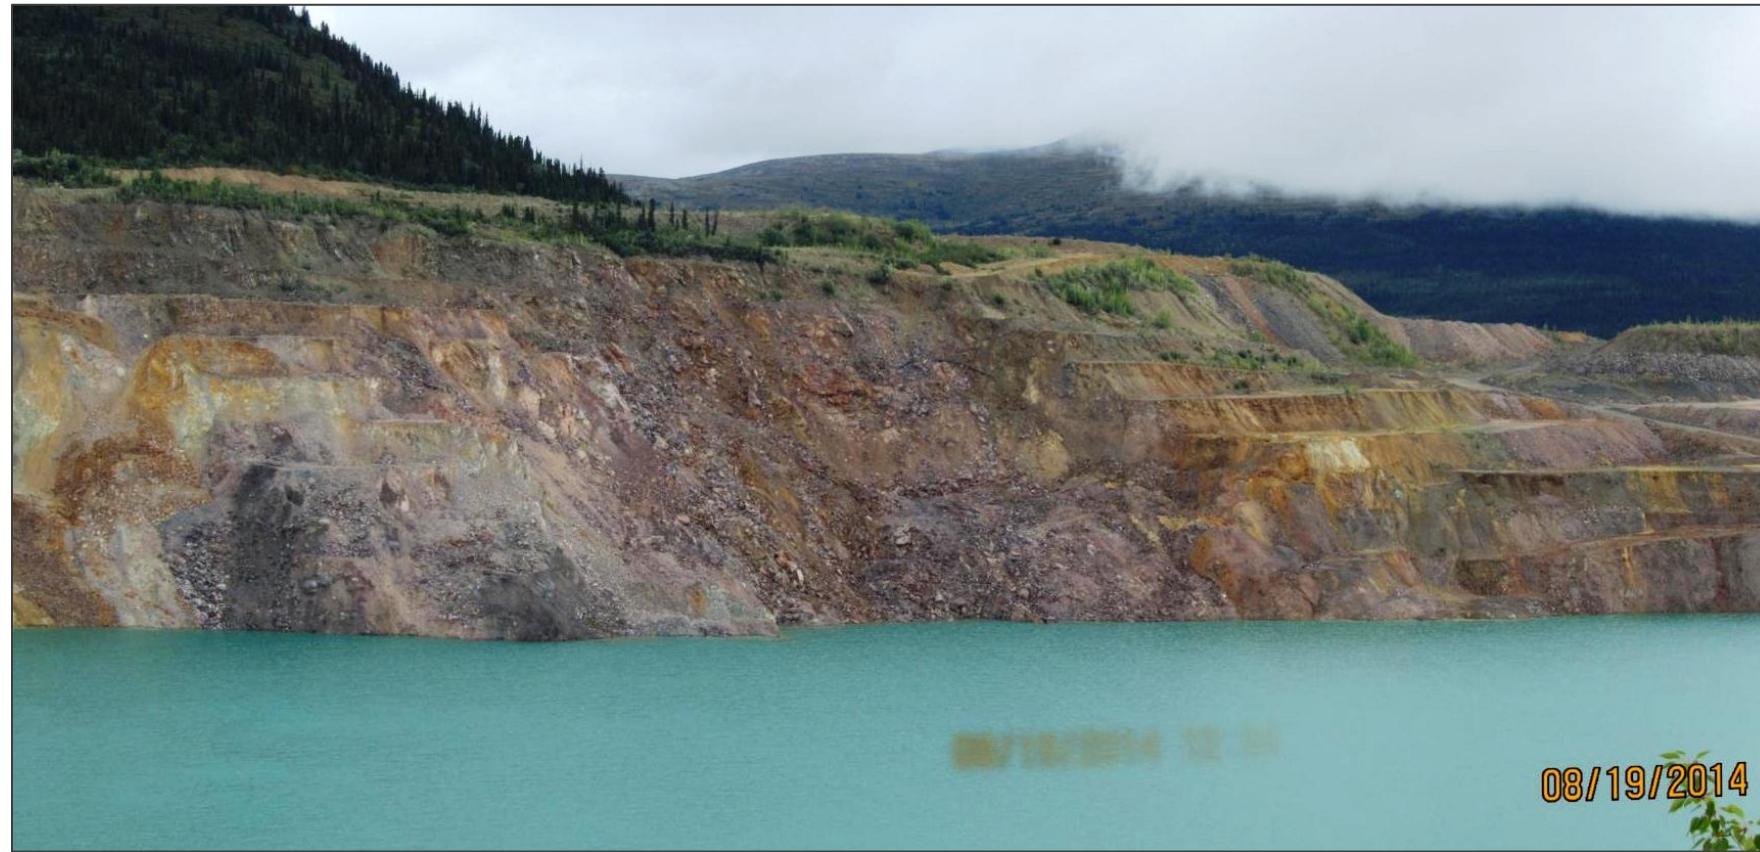
2015 PHOTOGRAPH OF NORTH INSTABILITY ZONE,  
VIEW LOOKING EAST

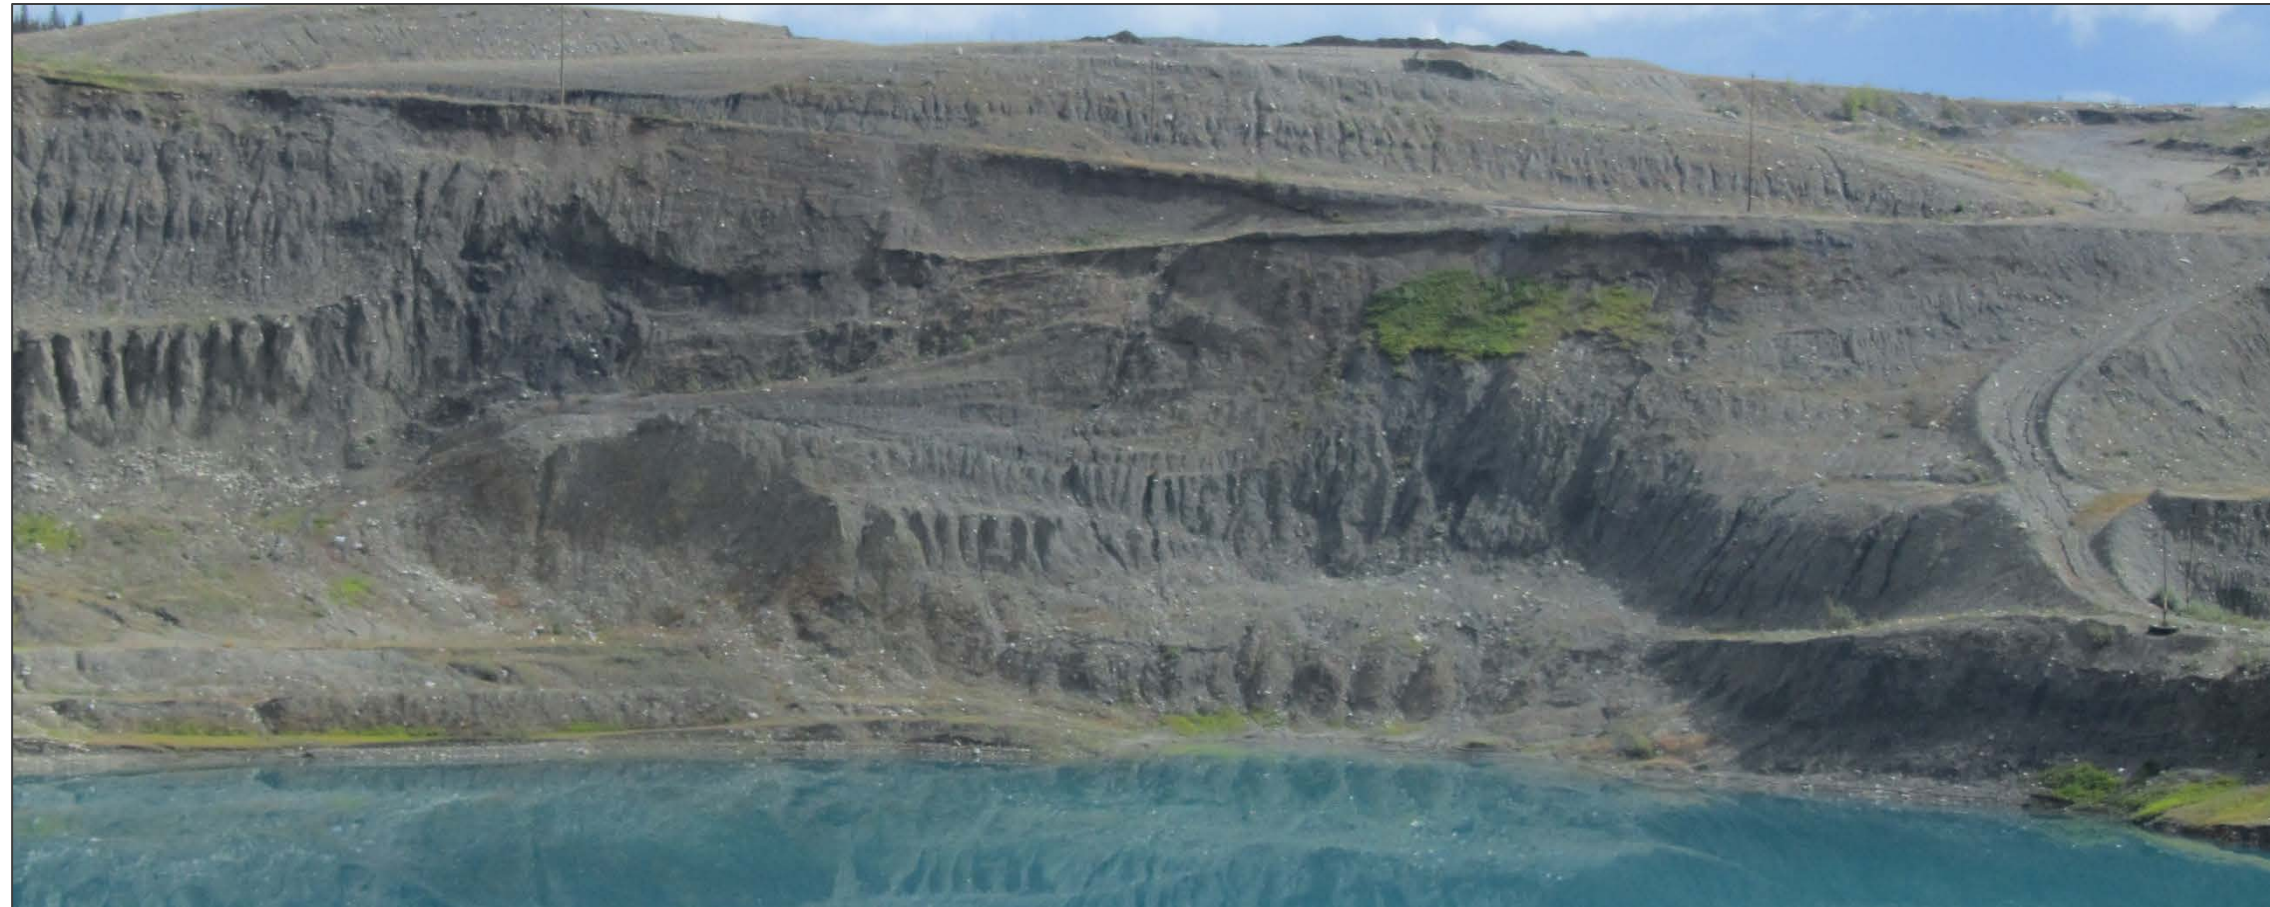
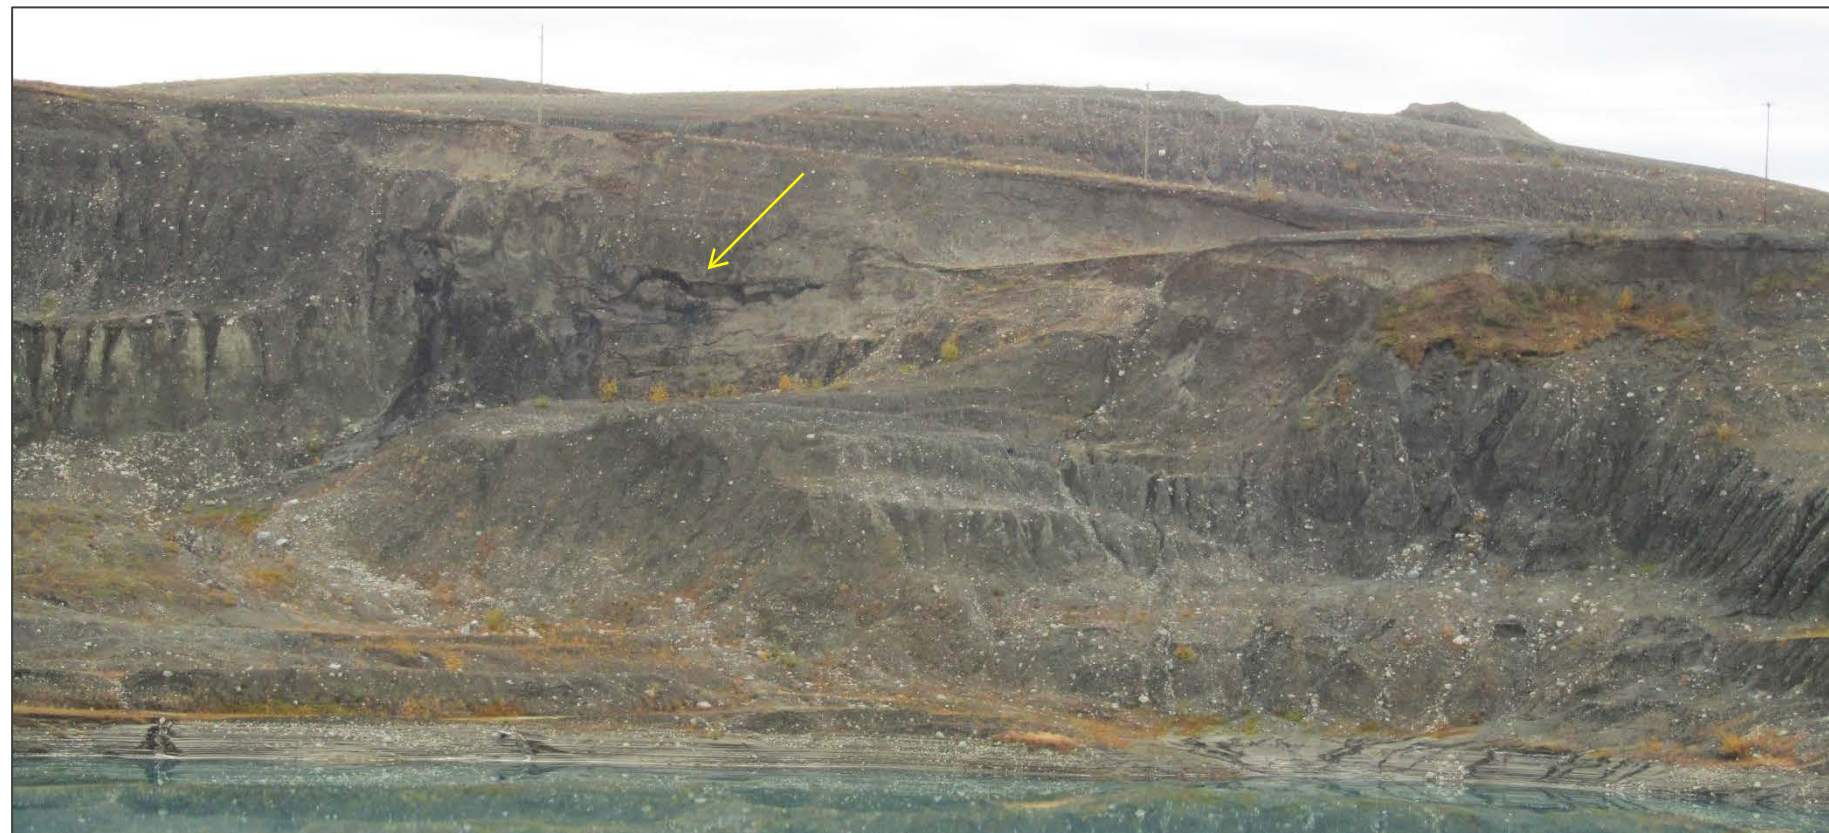
2014 PHOTOGRAPH OF INSTABILITY ZONE, VIEW LOOKING EAST

2015 PHOTOGRAPH OF INSTABILITY ZONE, VIEW LOOKING EAST
