## FARO MINE COMPLEX

# 2015 Pit Slope Stability Review

**Reference Number: 1410944-007-R-Rev0-2015**

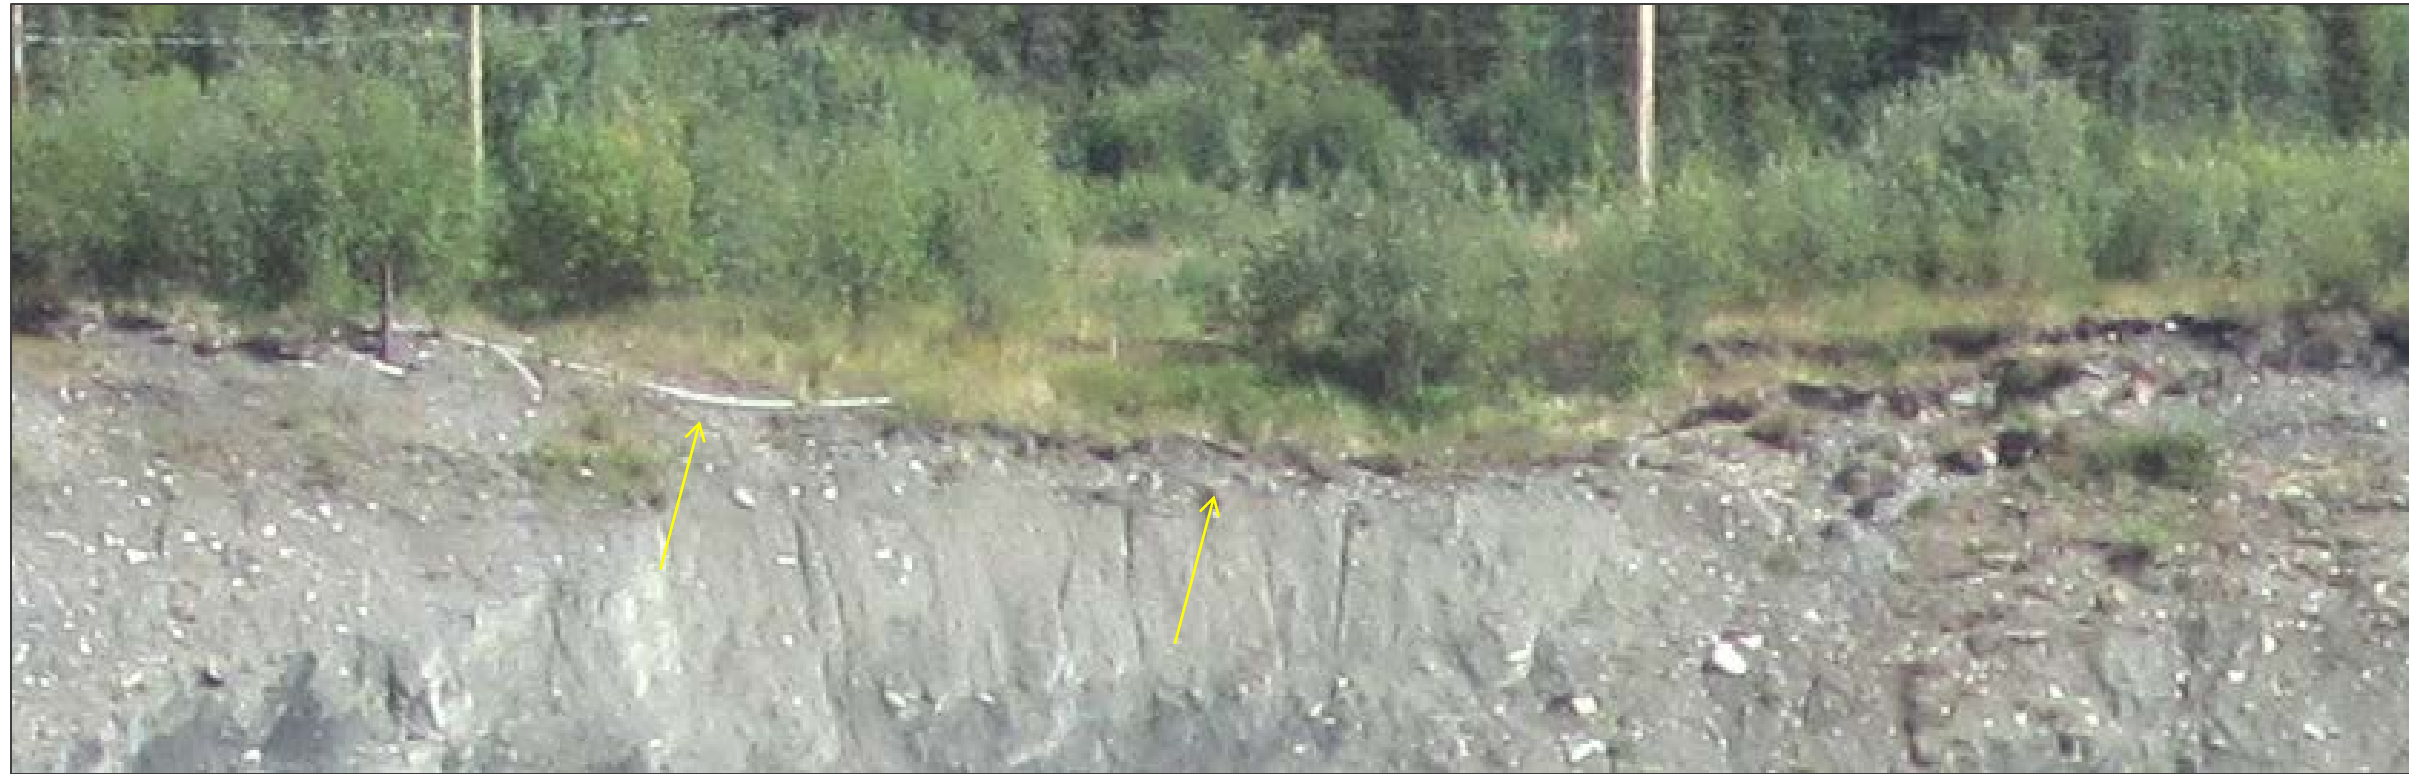
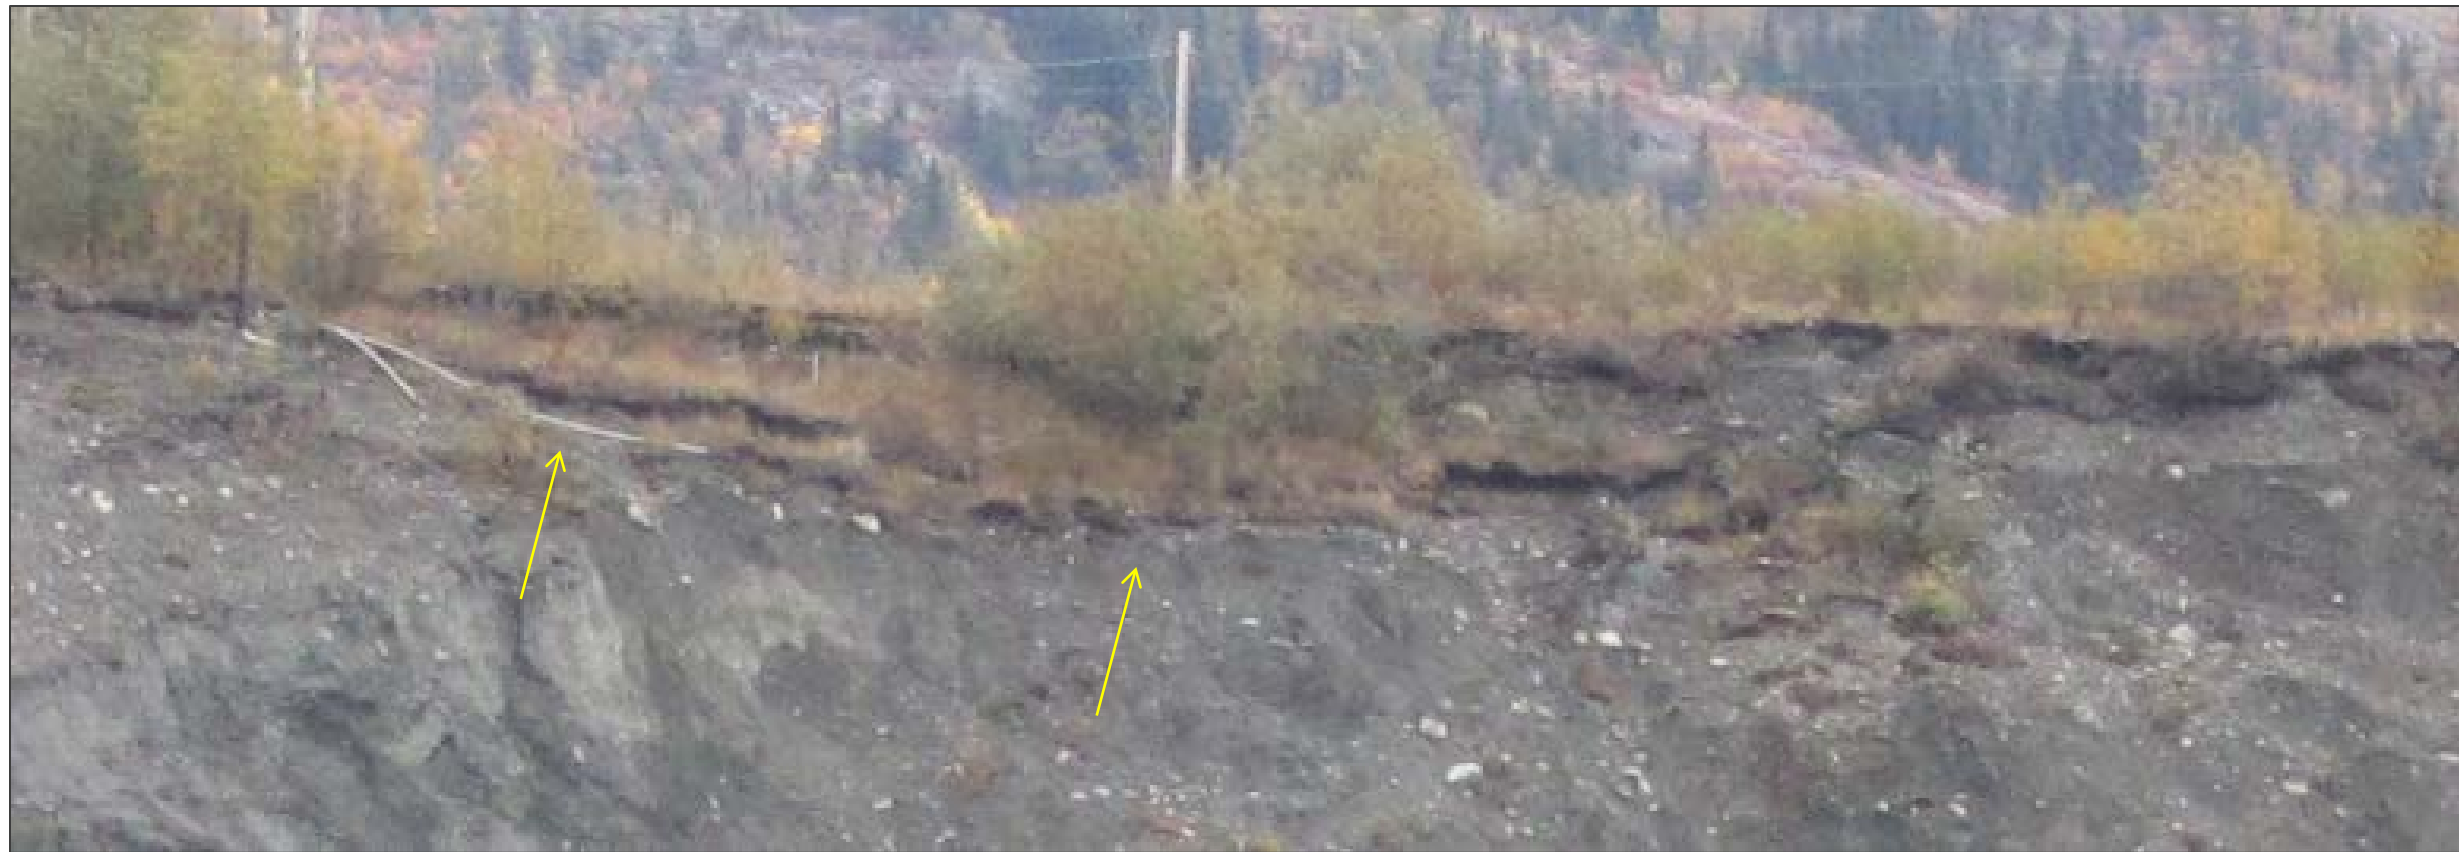
2014 PHOTOGRAPH OF CREST OF EAST WALL, BACKSCARP OF INSTABILITY ZONE, VIEW LOOKING EAST

2015 PHOTOGRAPH OF CREST OF EAST WALL, BACKSCARP OF INSTABILITY ZONE, VIEW LOOKING EAST

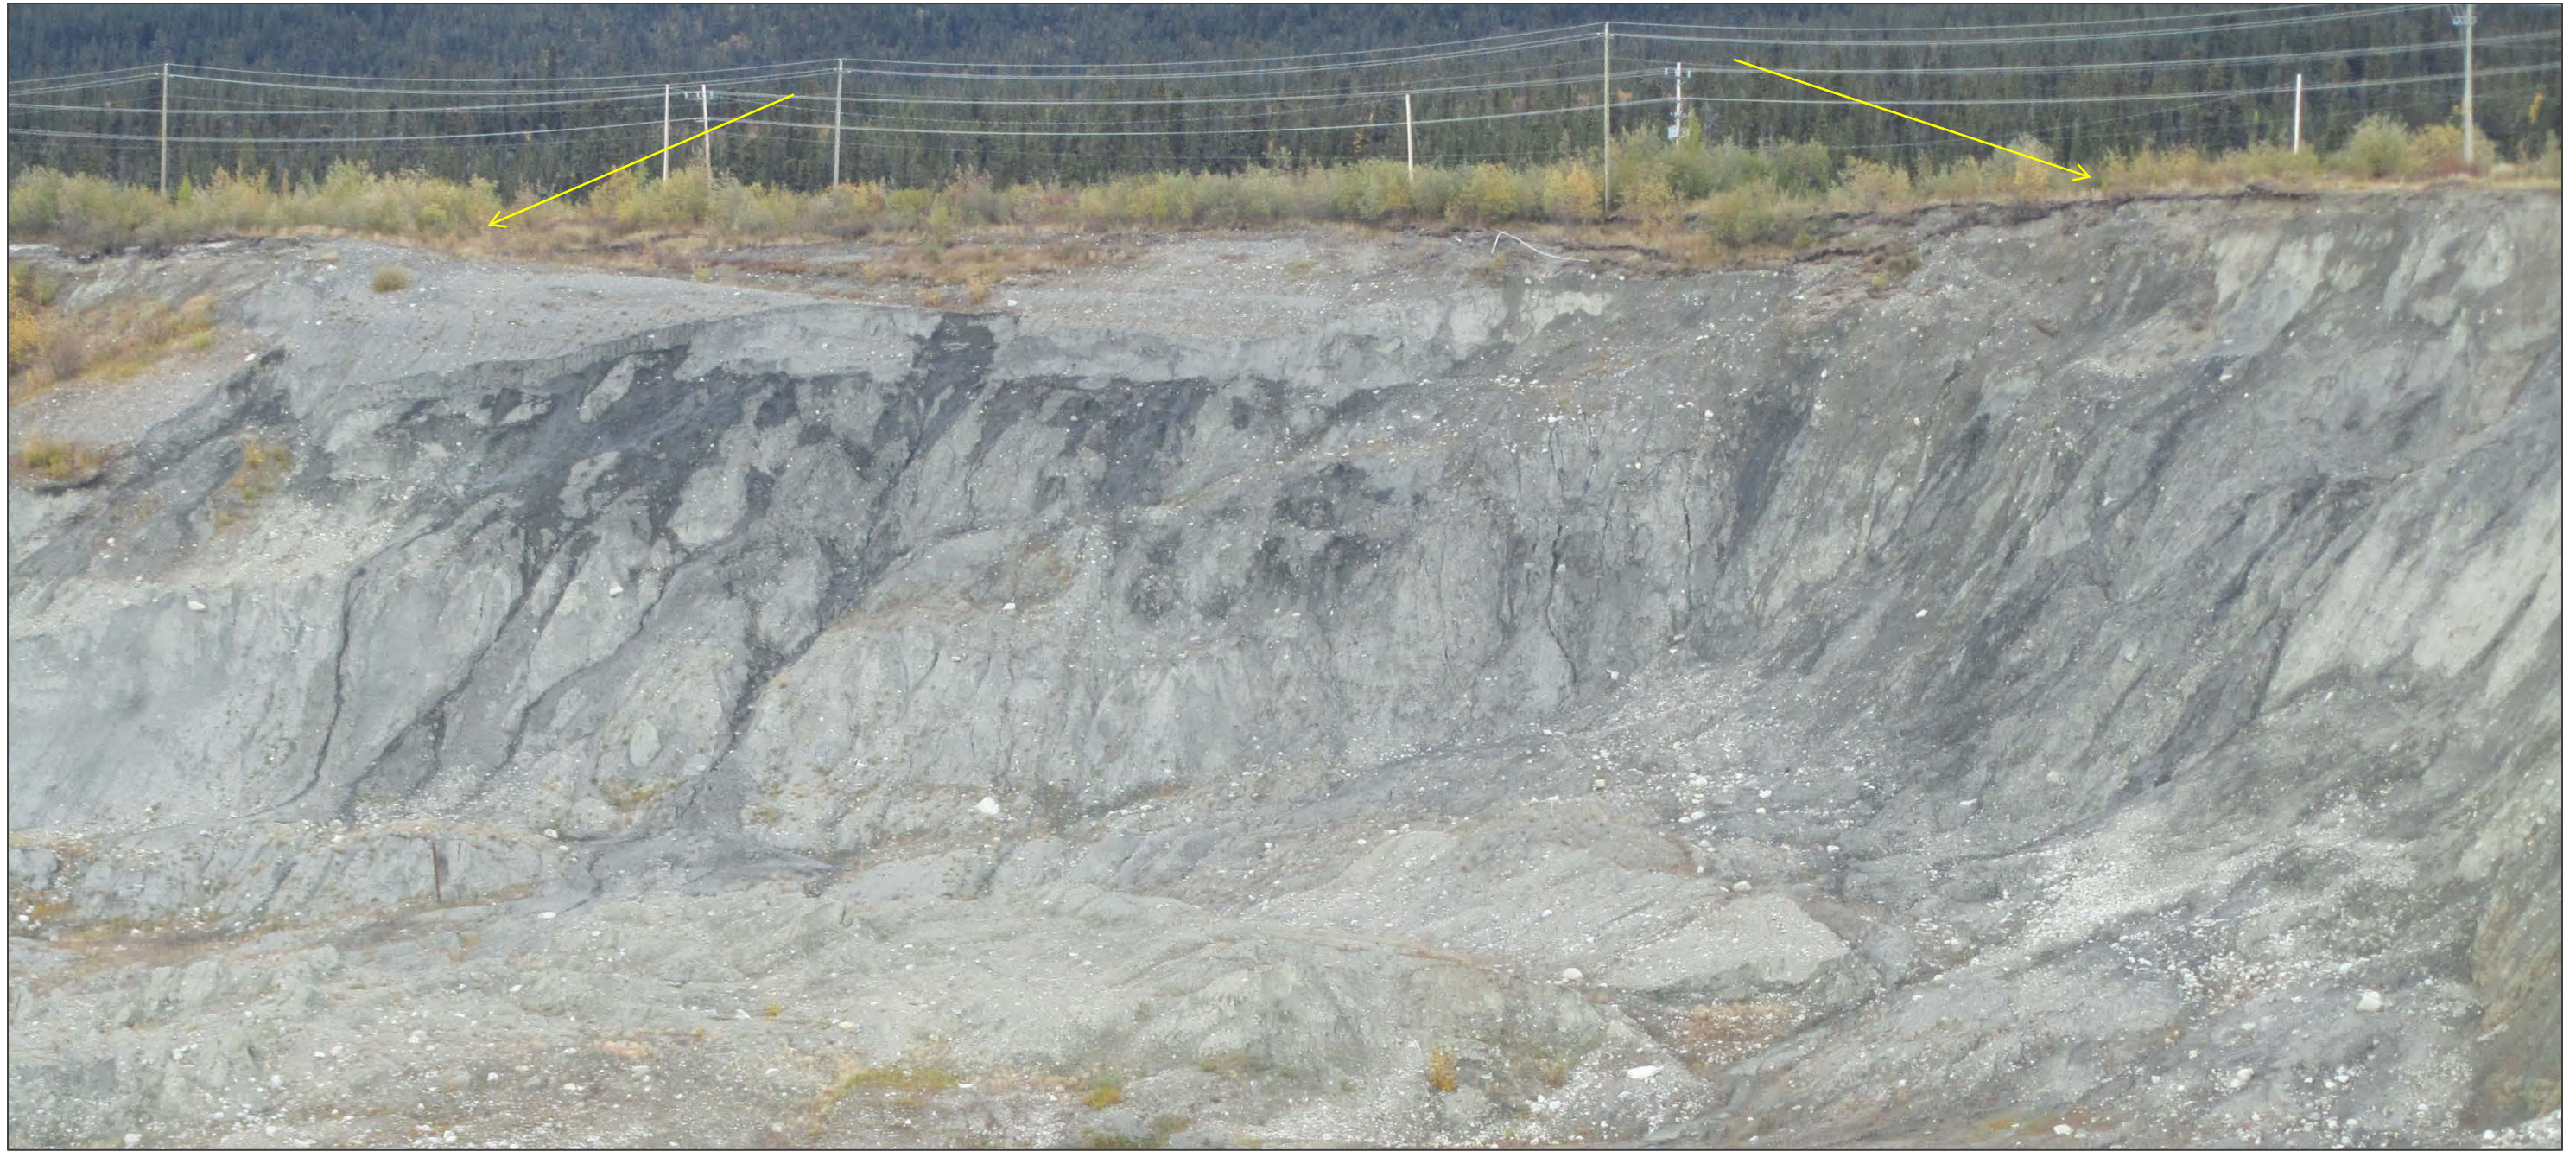
INSTABILITY ZONE, EAST WALL, VIEW LOOKING  
NORTHEAST

- ESTIMATED LATERAL EXTENT OF CRACKS INDICATED BY ARROWS
- WATER SEEPING THROUGH TILL DESTABILIZES SLOPE
- CRACKS ARE NOT CONTINUOUS

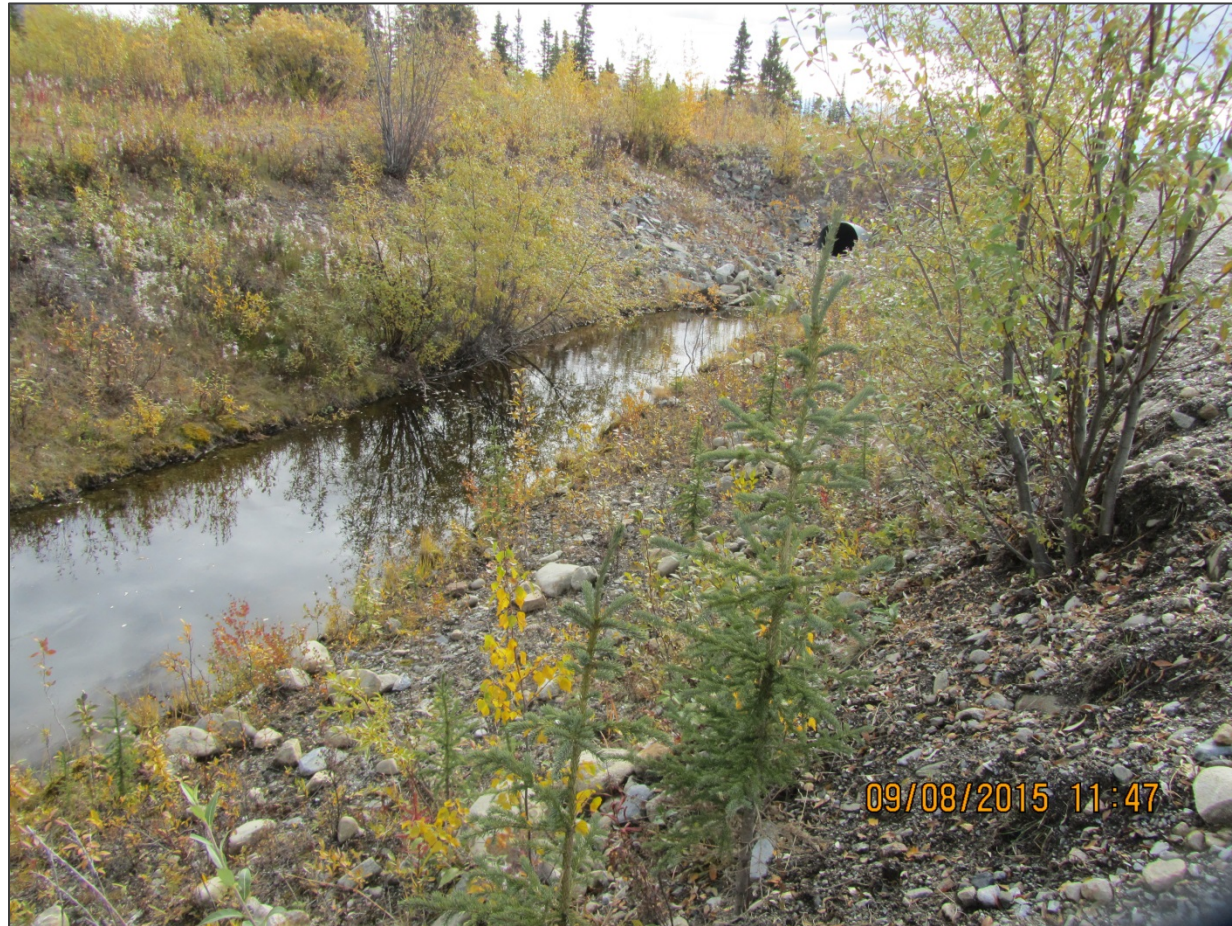
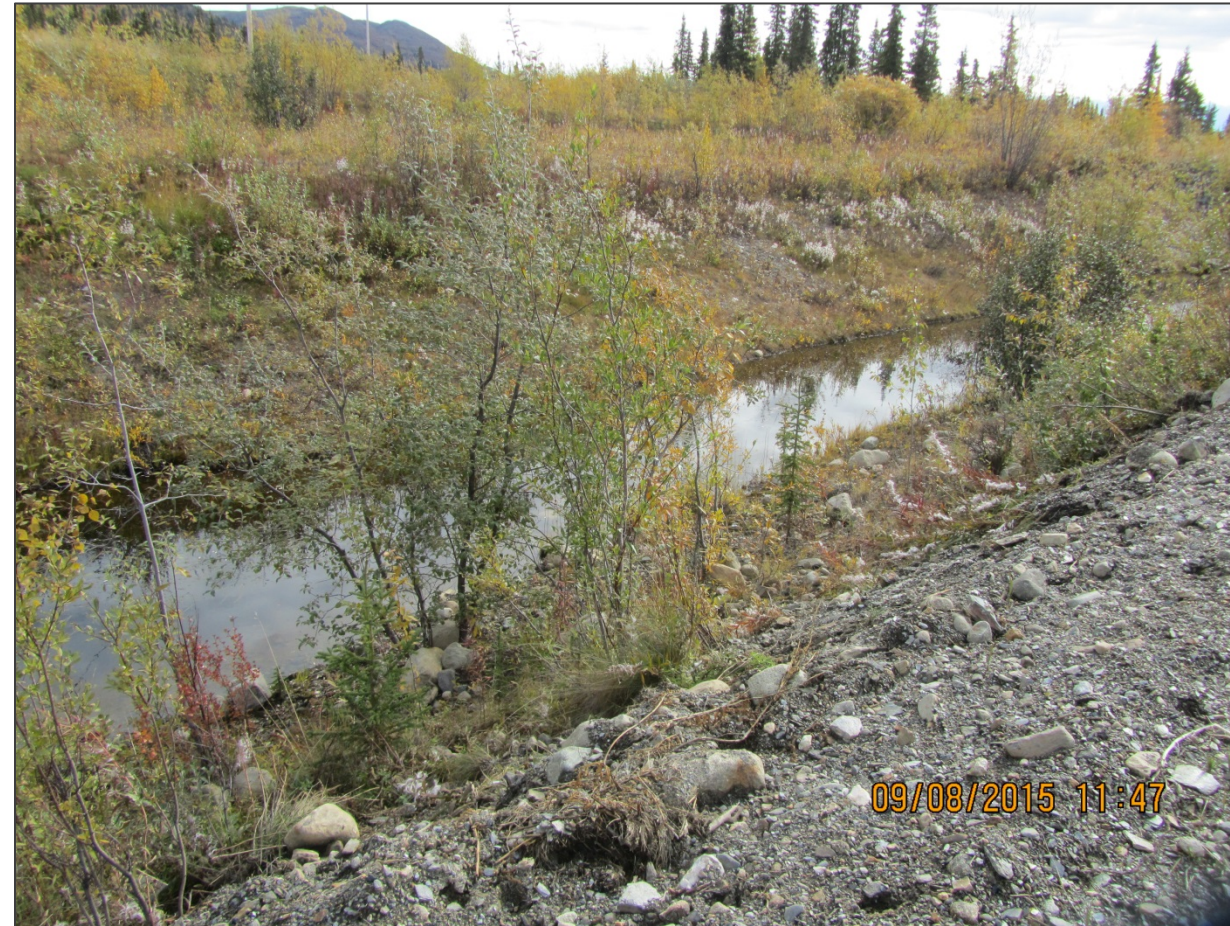
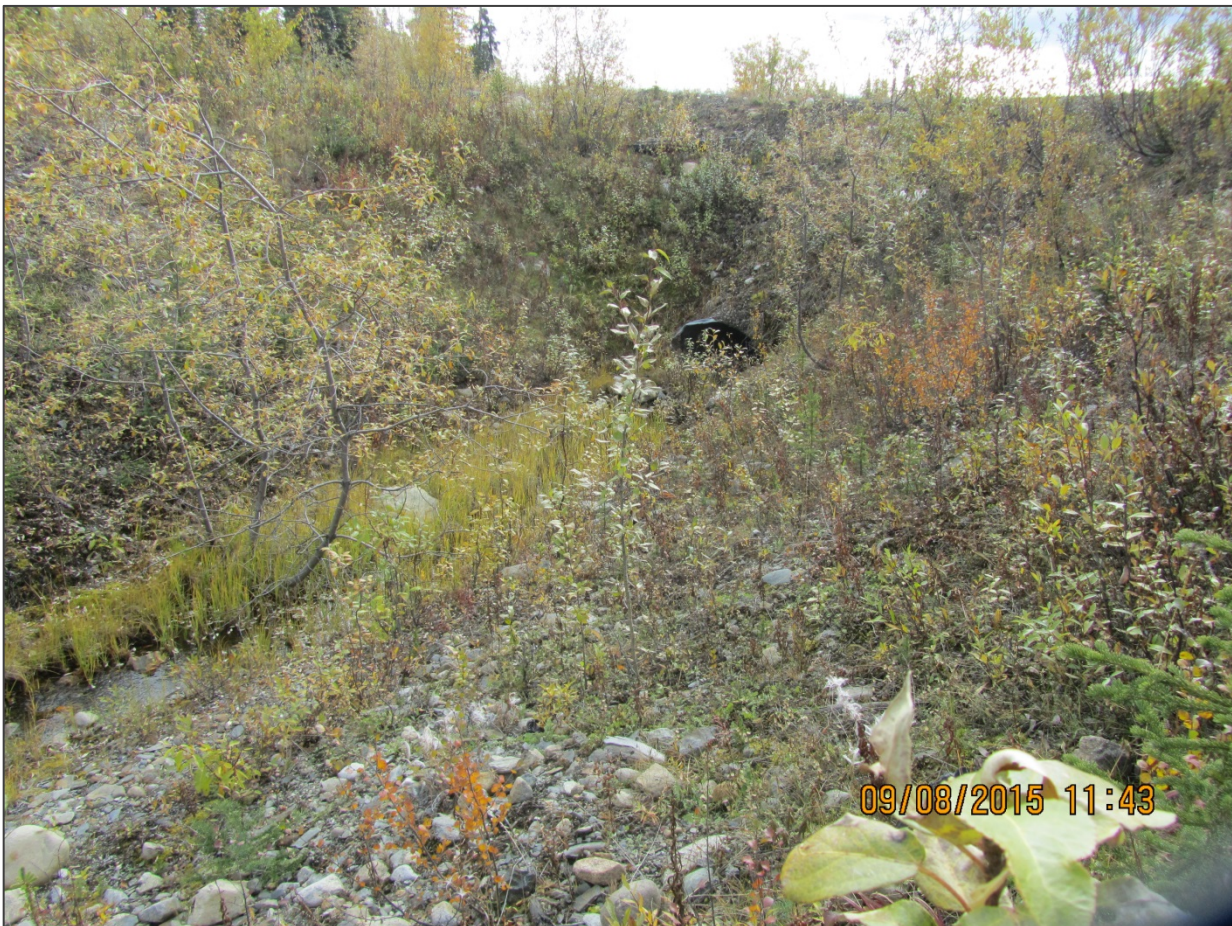
- BOTH PHOTOS ABOVE: WATER IS PONDED IN DITCH BECAUSE CULVERT IS HIGHER THAN WATER LEVEL. DITCH IS LOCATED BEHIND THE EAST WALL OF THE GRUM PIT. VIEW LOOKING SOUTHEAST.
- PHOTO TO THE LEFT: SECTIONS OF GRUM DITCH TO THE NORTH AND SOUTH OF PONDED SECTION ARE FLOWING AND DRAINING ADEQUATELY. VIEW LOOKING SOUTHEAST.

<ul style="list-style-type: none"> <li>If the old power pole on the dropped portion of the crest of the east wall (Figure B-7) is supporting a live wire, consider relocating the pole behind the instability zone. Alternatively, if it is not supporting a live wire, then it is not necessary to relocate or remove it.</li> </ul>	Medium - Short Term
	<ul style="list-style-type: none"> <li>Extend the berm at the end of the access ramp into the pit beyond the power poles. If the berm is not extended, a minimum setback distance of 10 metres is recommended for any work carried out in the area of the rockfall zone. Install a sign to inform workers of rockfall hazard and the required setback distance.</li> </ul>	High - Short Term
	<ul style="list-style-type: none"> <li>Relocate the power pole on the north slope above the Grum Slot Cut to a more stable location.</li> </ul>	Medium - Short Term
	<ul style="list-style-type: none"> <li>Lower the culvert shown in Figure B-13 to allow water to drain along the full length of the Grum Interceptor Ditch.</li> </ul>	Medium - Short Term

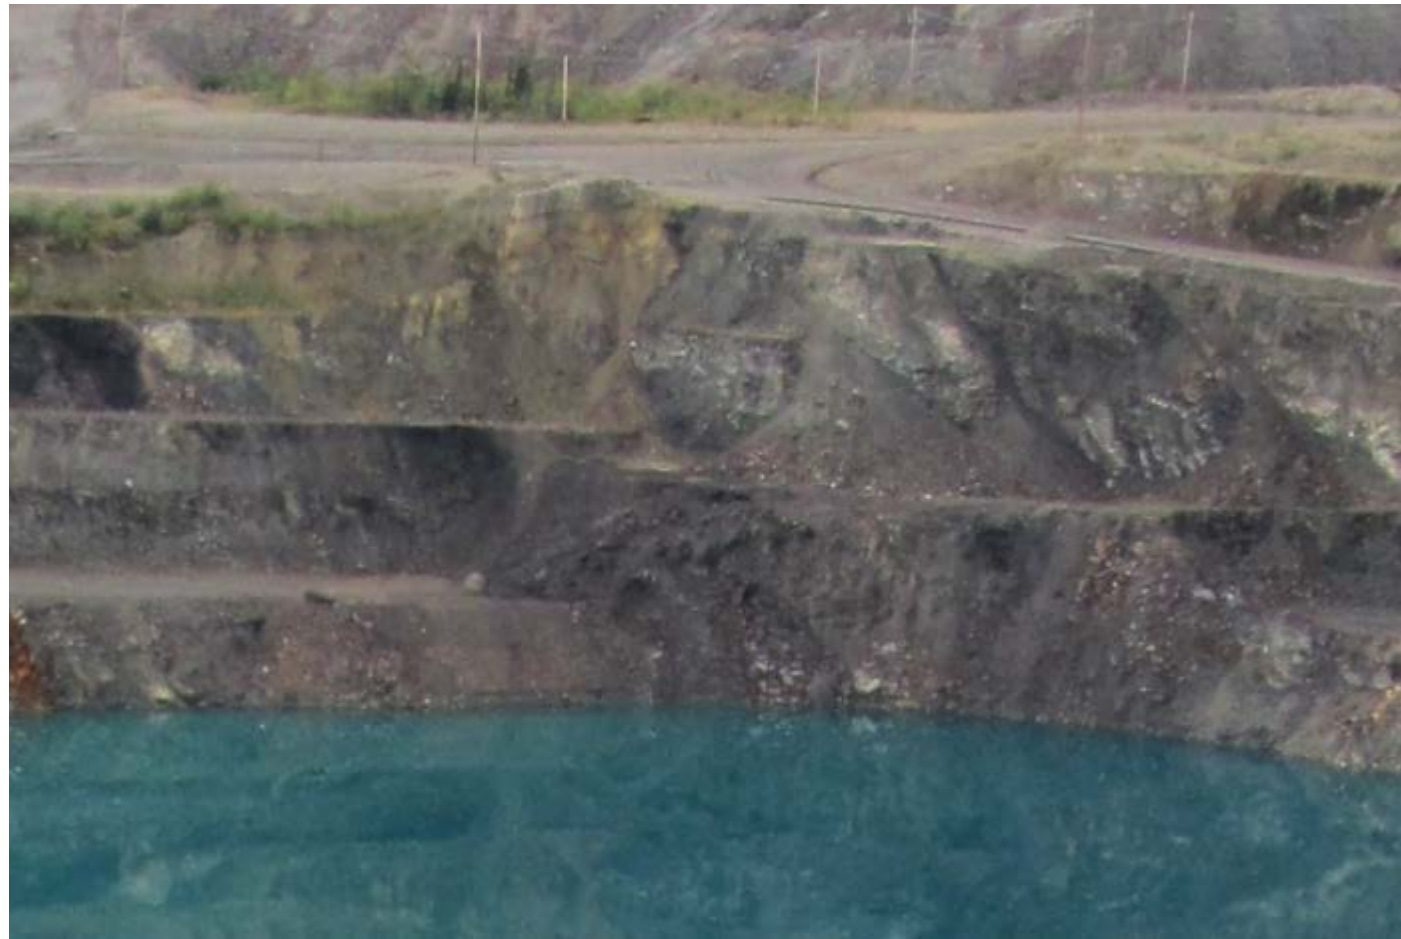
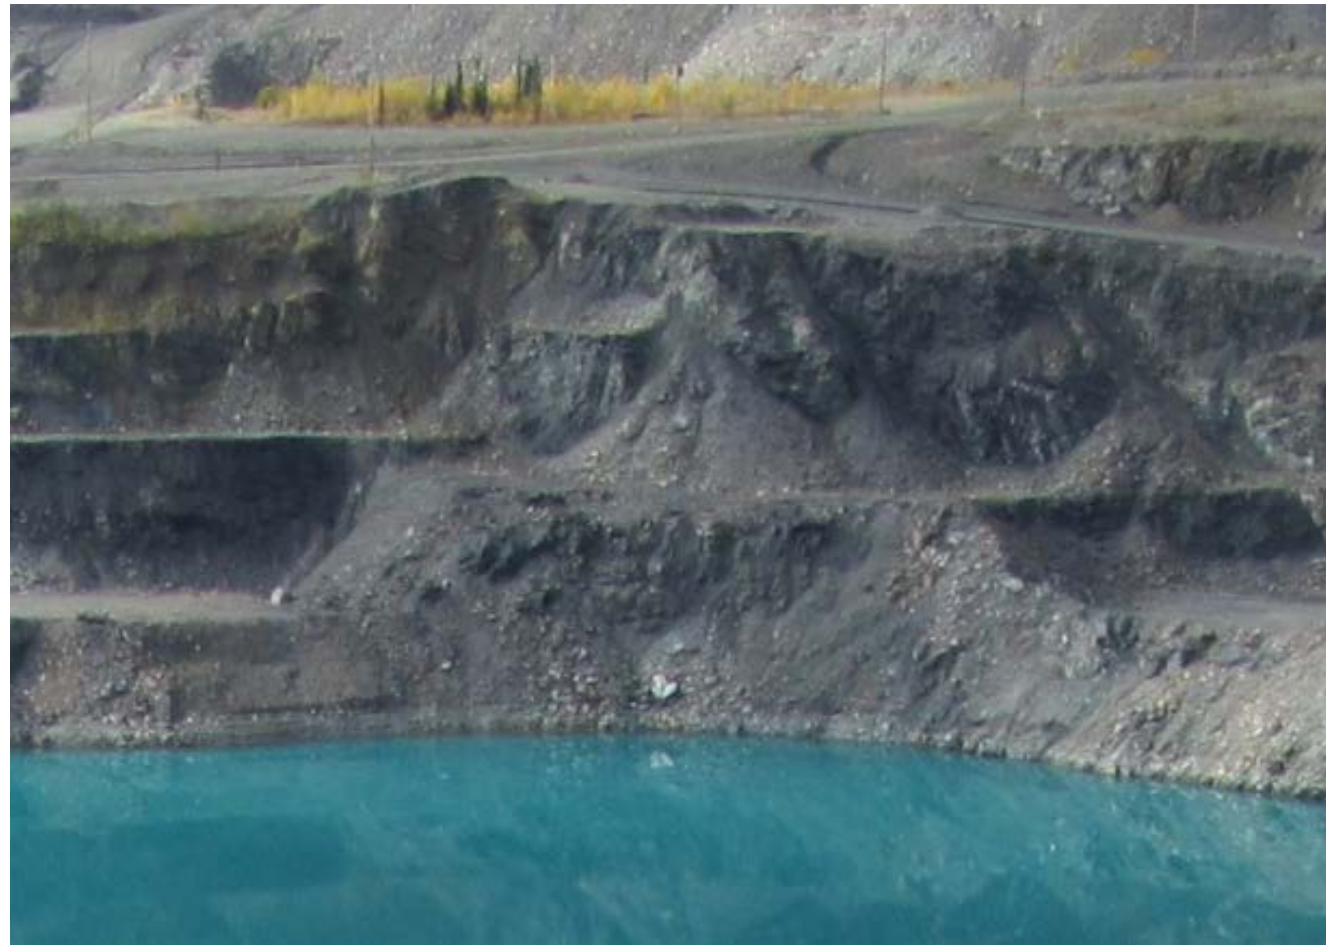
2014 PHOTOGRAPH OF ROCK SLOPE IN  
SOUTHWEST CORNER OF GRUM PIT. VIEW  
LOOKING SOUTHWEST.

2015 PHOTOGRAPH OF ROCK SLOPE IN  
SOUTHWEST CORNER OF GRUM PIT. VIEW  
LOOKING SOUTHWEST.

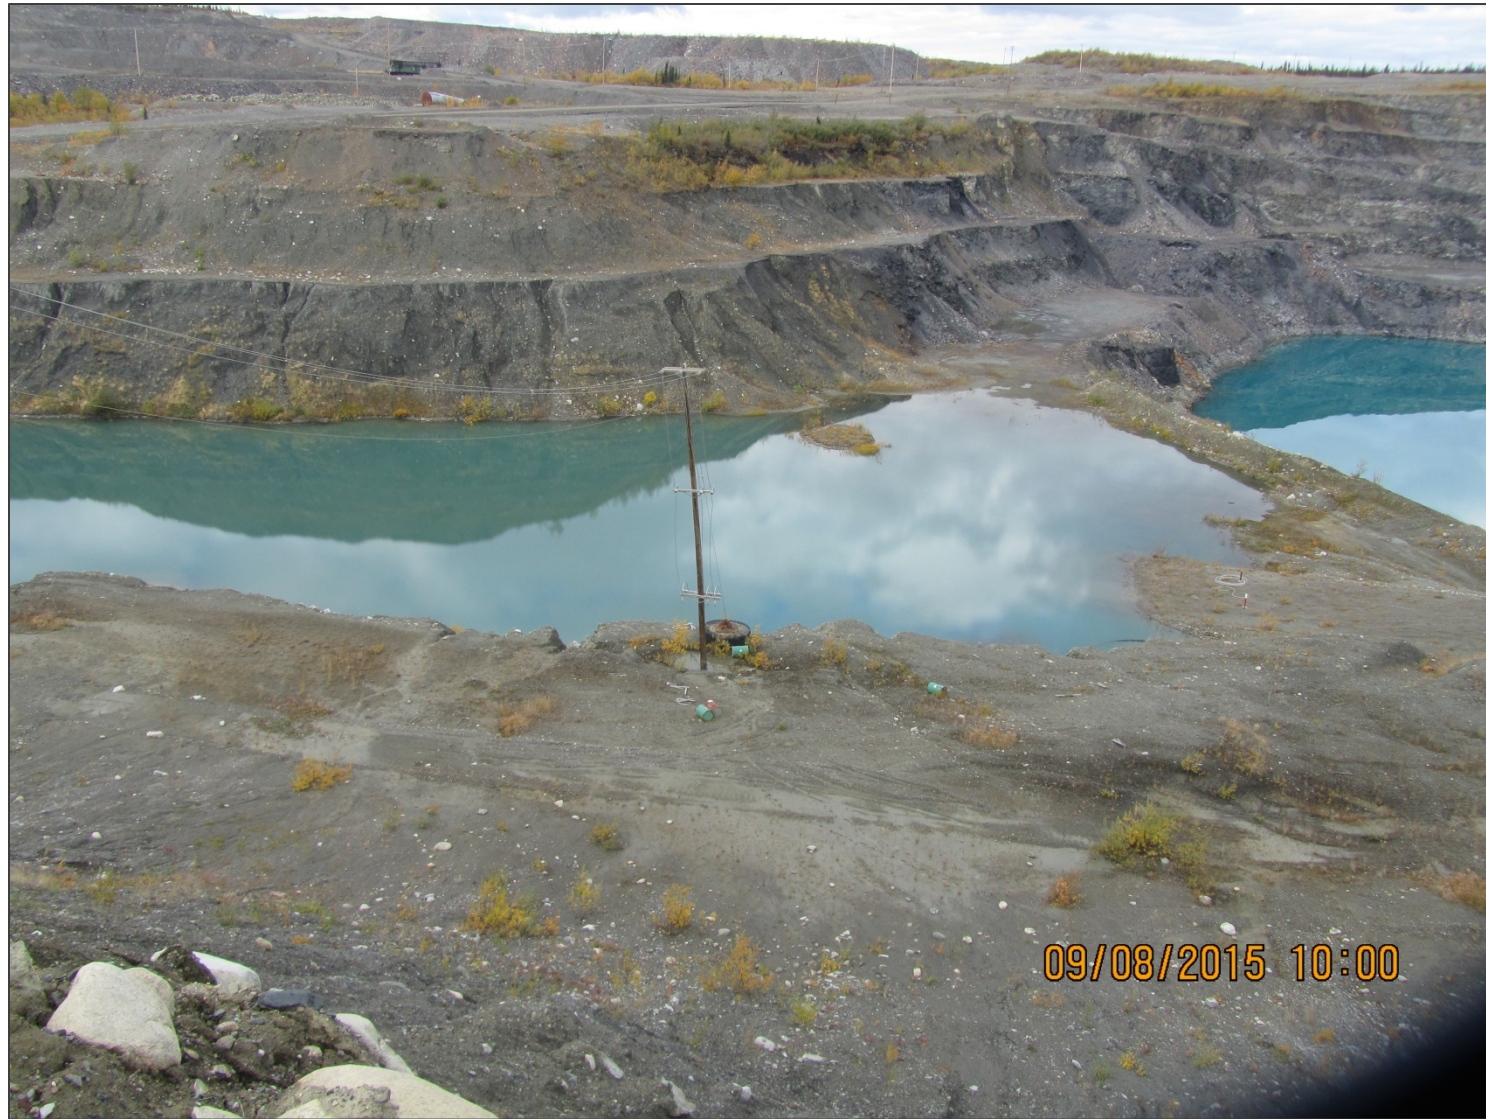
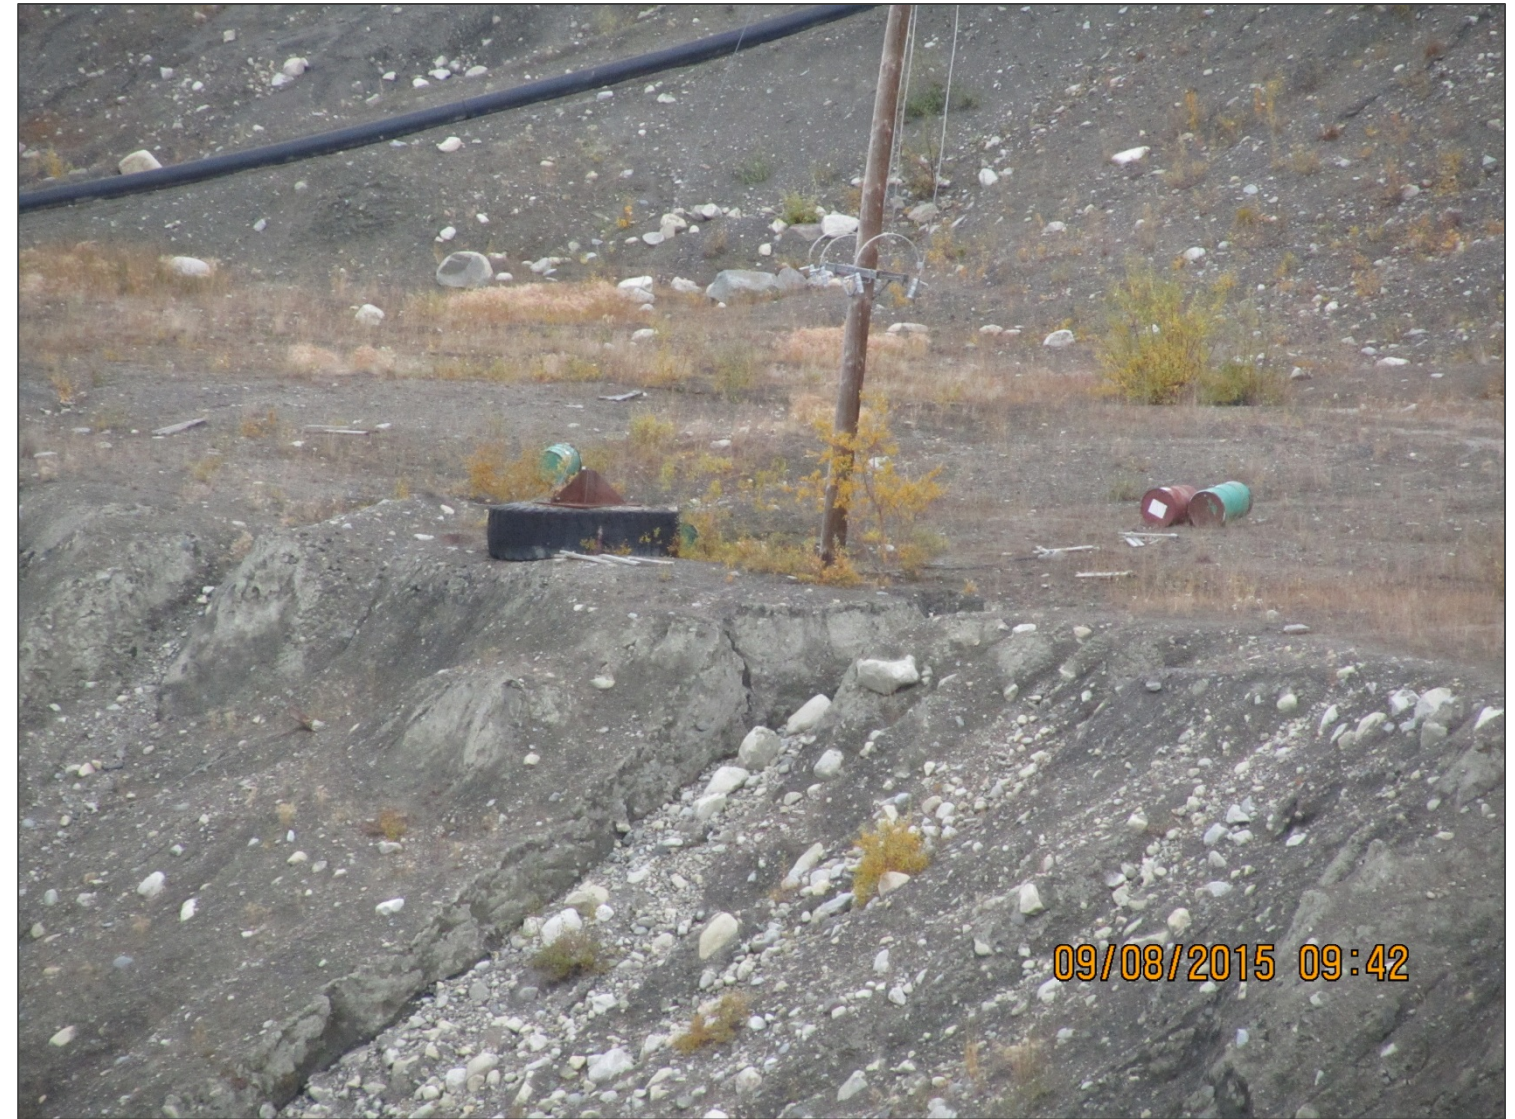
POWER POLE ON EDGE OF EAST SLOPE OF GRUM SLOT CUT. VIEW LOOKING WEST.

CLOSE UP OF POWER POLE ON EDGE OF EAST SLOPE OF GRUM SLOT CUT. VIEW LOOKING NORTHEAST.

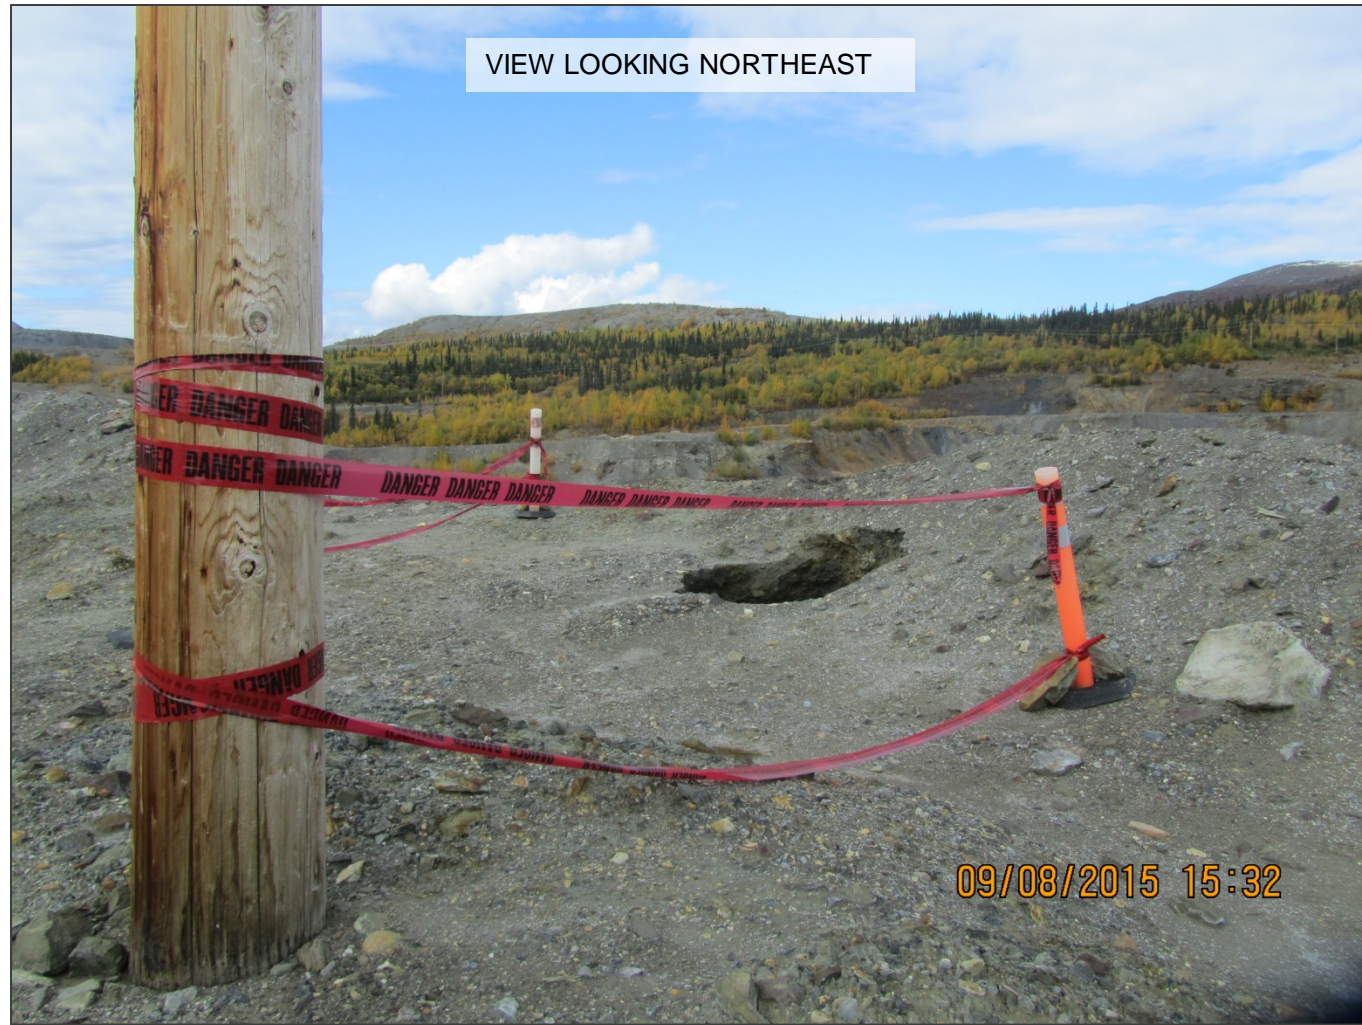
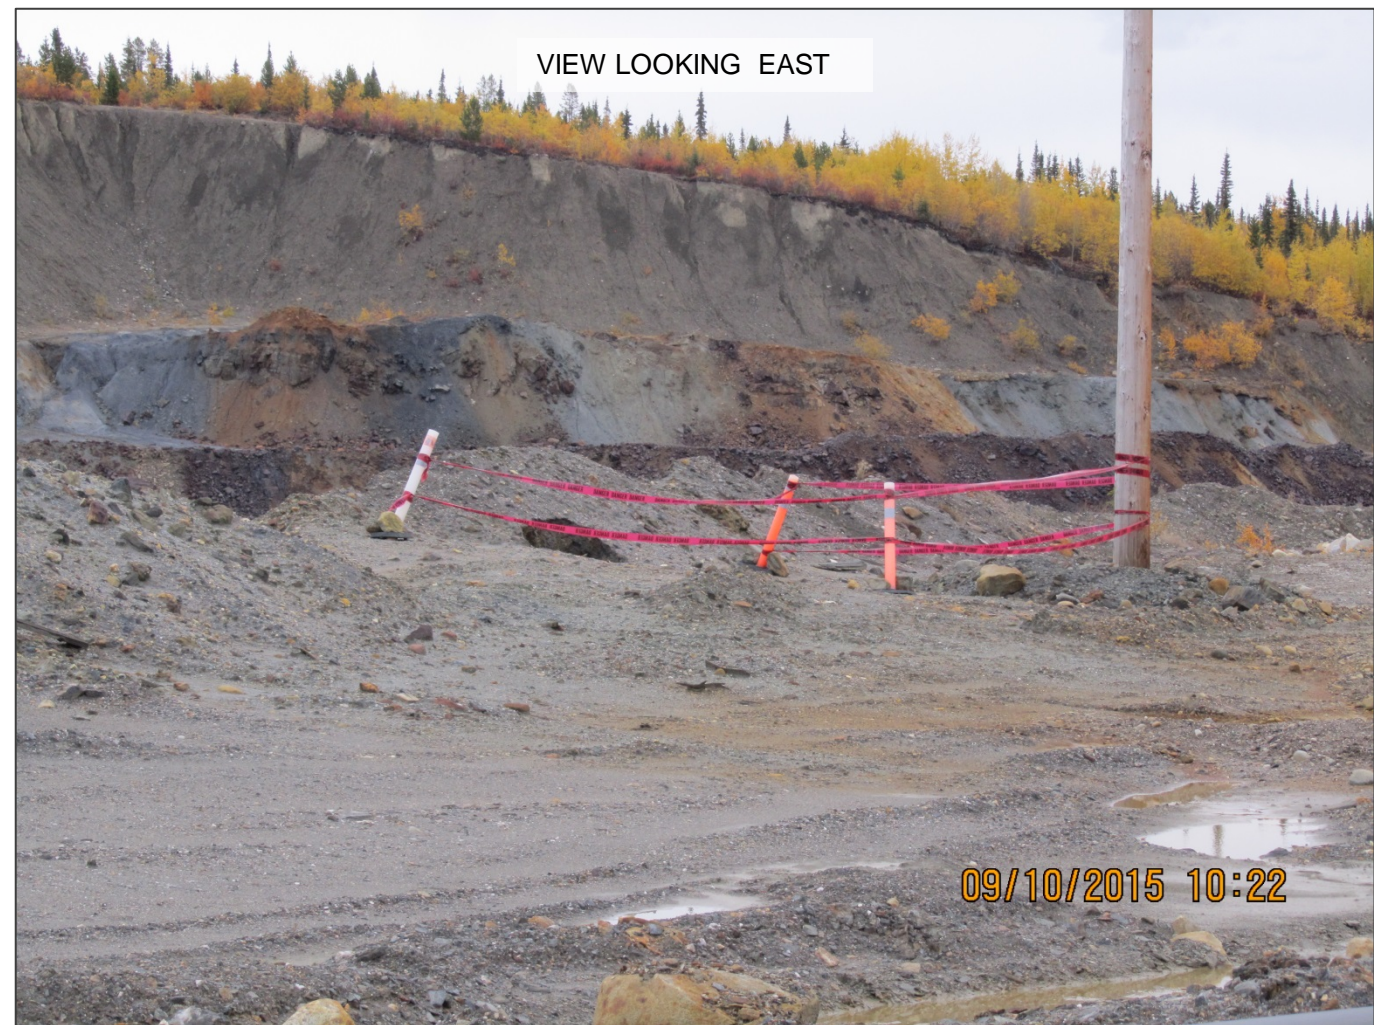
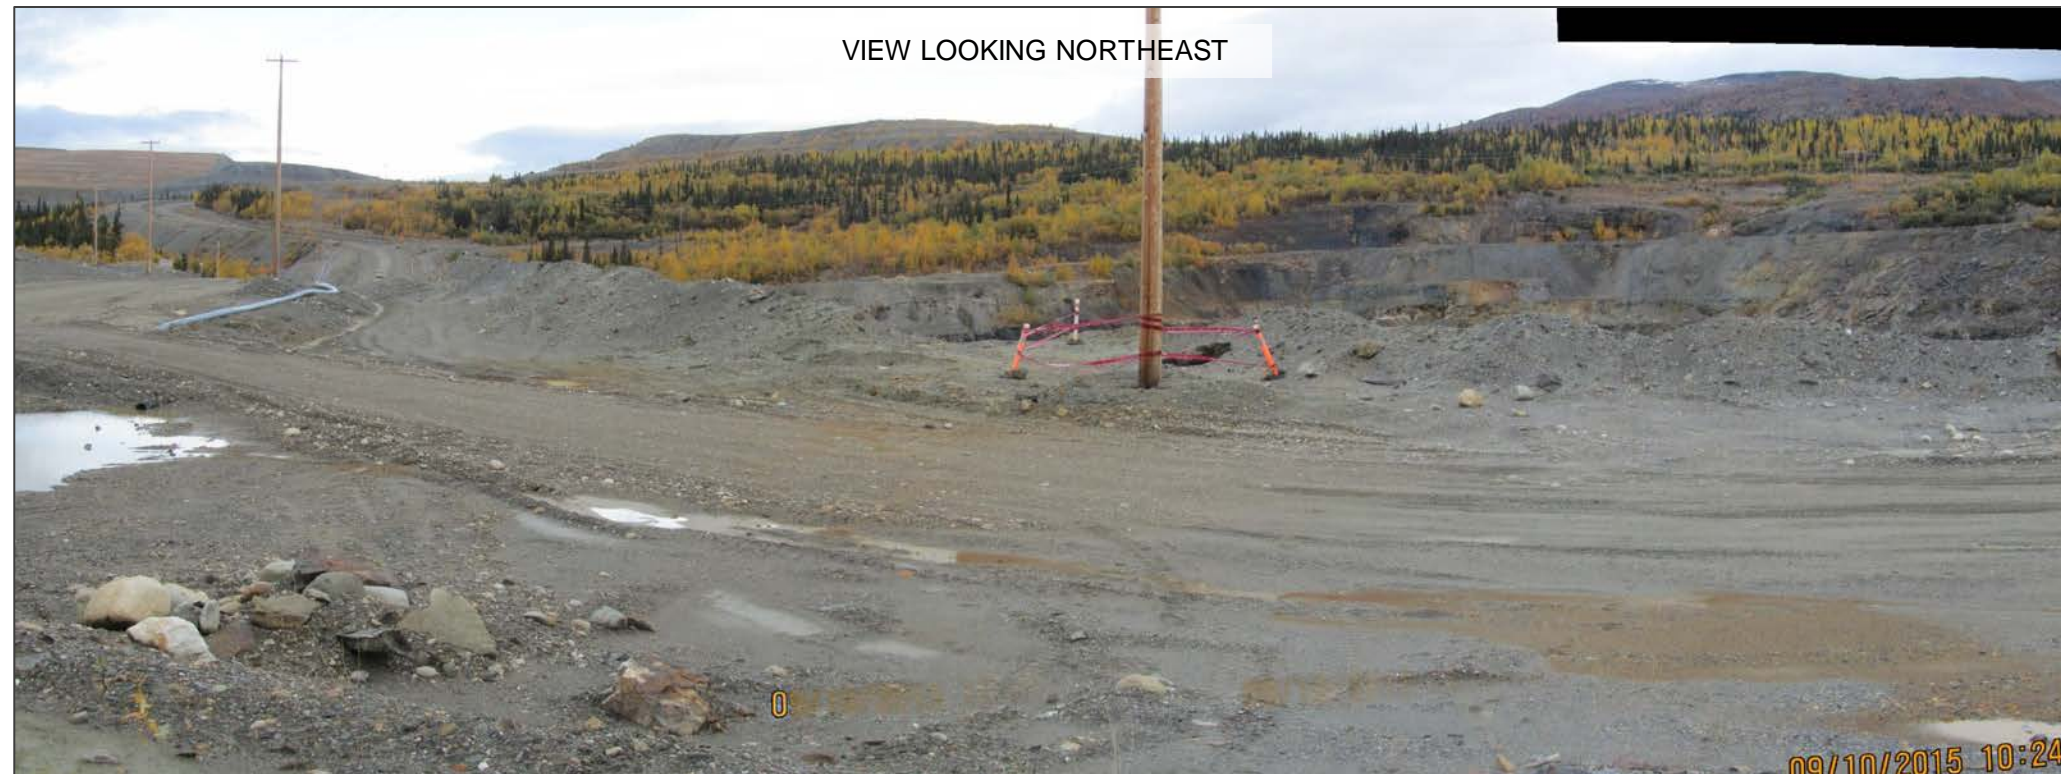
VIEWS OF SINKHOLE IN WEST WALL, TAKEN FROM THE SOUTH SIDE OF THE WALL AT THE CREST

In addition to the above, Golder recommends that the north portion of the west wall also be re-sloped as cracks and slumping were observed in this part of the wall. Although personnel do not work beneath this part of the slope, a sudden failure of material into the pit lake could result in a wave that could impact personnel working inside the pit.
