## FARO MINE COMPLEX

# 2015 Pit Slope Stability Review

**Reference Number: 1410944-007-R-Rev0-2015**

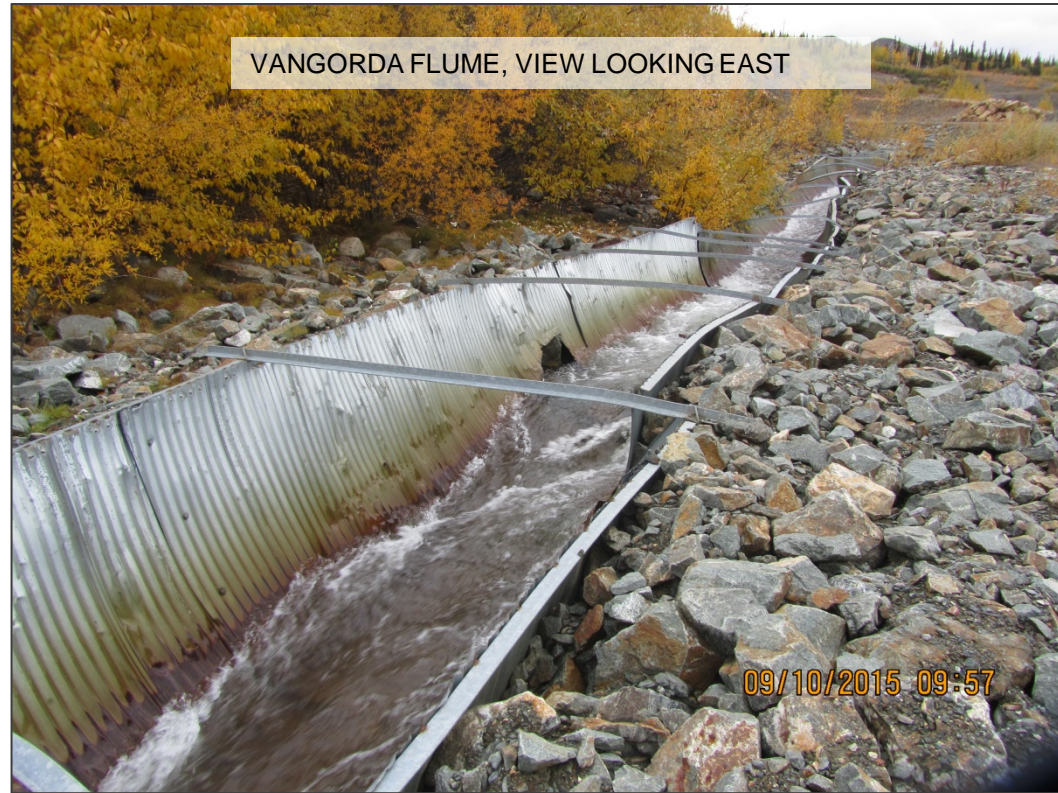
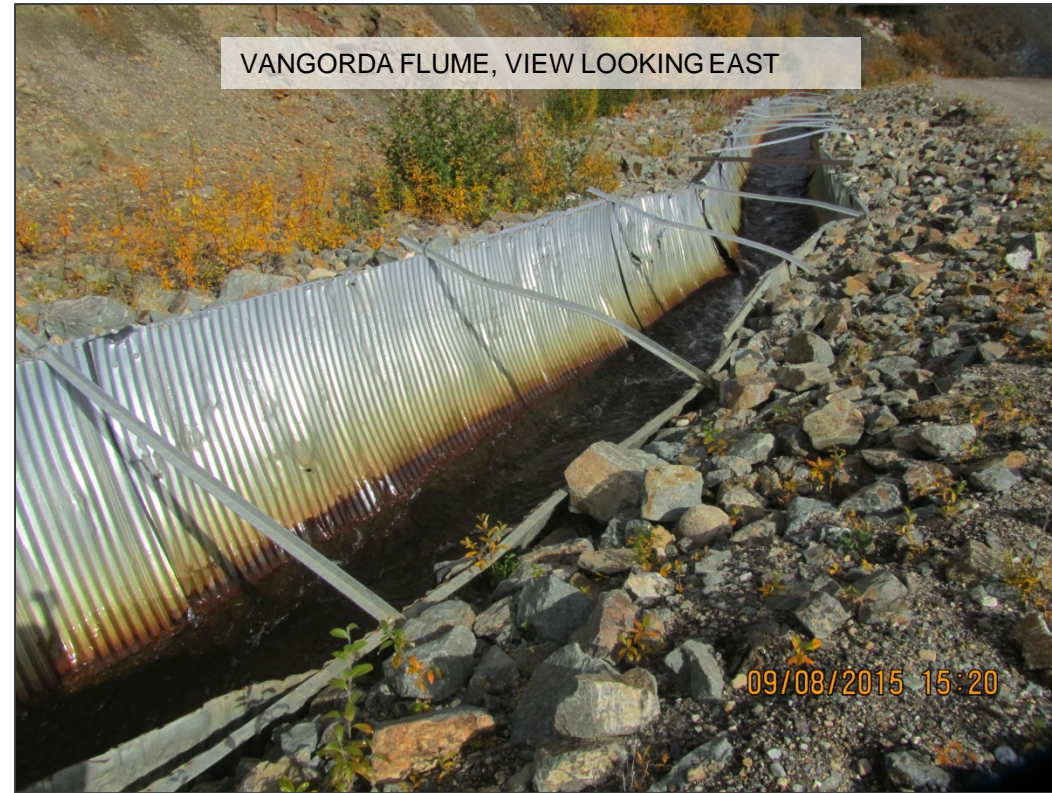
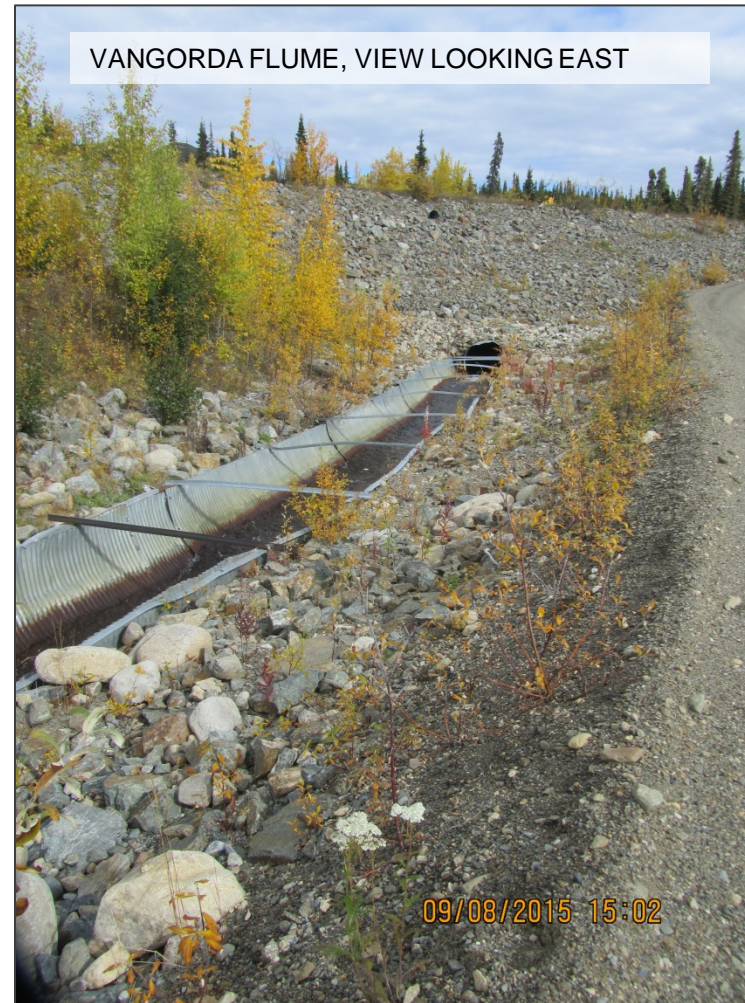
VANGORDA FLUME, VIEW LOOKING EAST

- Repair or replace the Vangorda Flume as soon as practicable to limit the amount of water that is seeping into the slope on the north side.
- Golder previously recommended that a berm be developed on the west side of the access road as rockfall protection (Golder 2014). A berm has been developed on the west side of the upper part of the access road (Figure C-9, upper right); however, this berm does not continue along the lower part of the road (Figure C-9, lower left). Rather, a small ditch serves as catchment for rockfall. However, there is equipment close to the base of the slope, and it is recommended that the berm be extended all the way down the west side of the road to the end of the road. Alternatively, when personnel are working near this slope, they should visually inspect the slope for possible rockfall before beginning work, and should consider using a spotter. Figure C-10 shows the part of the road where the berm should be extended on the west side of the access road.

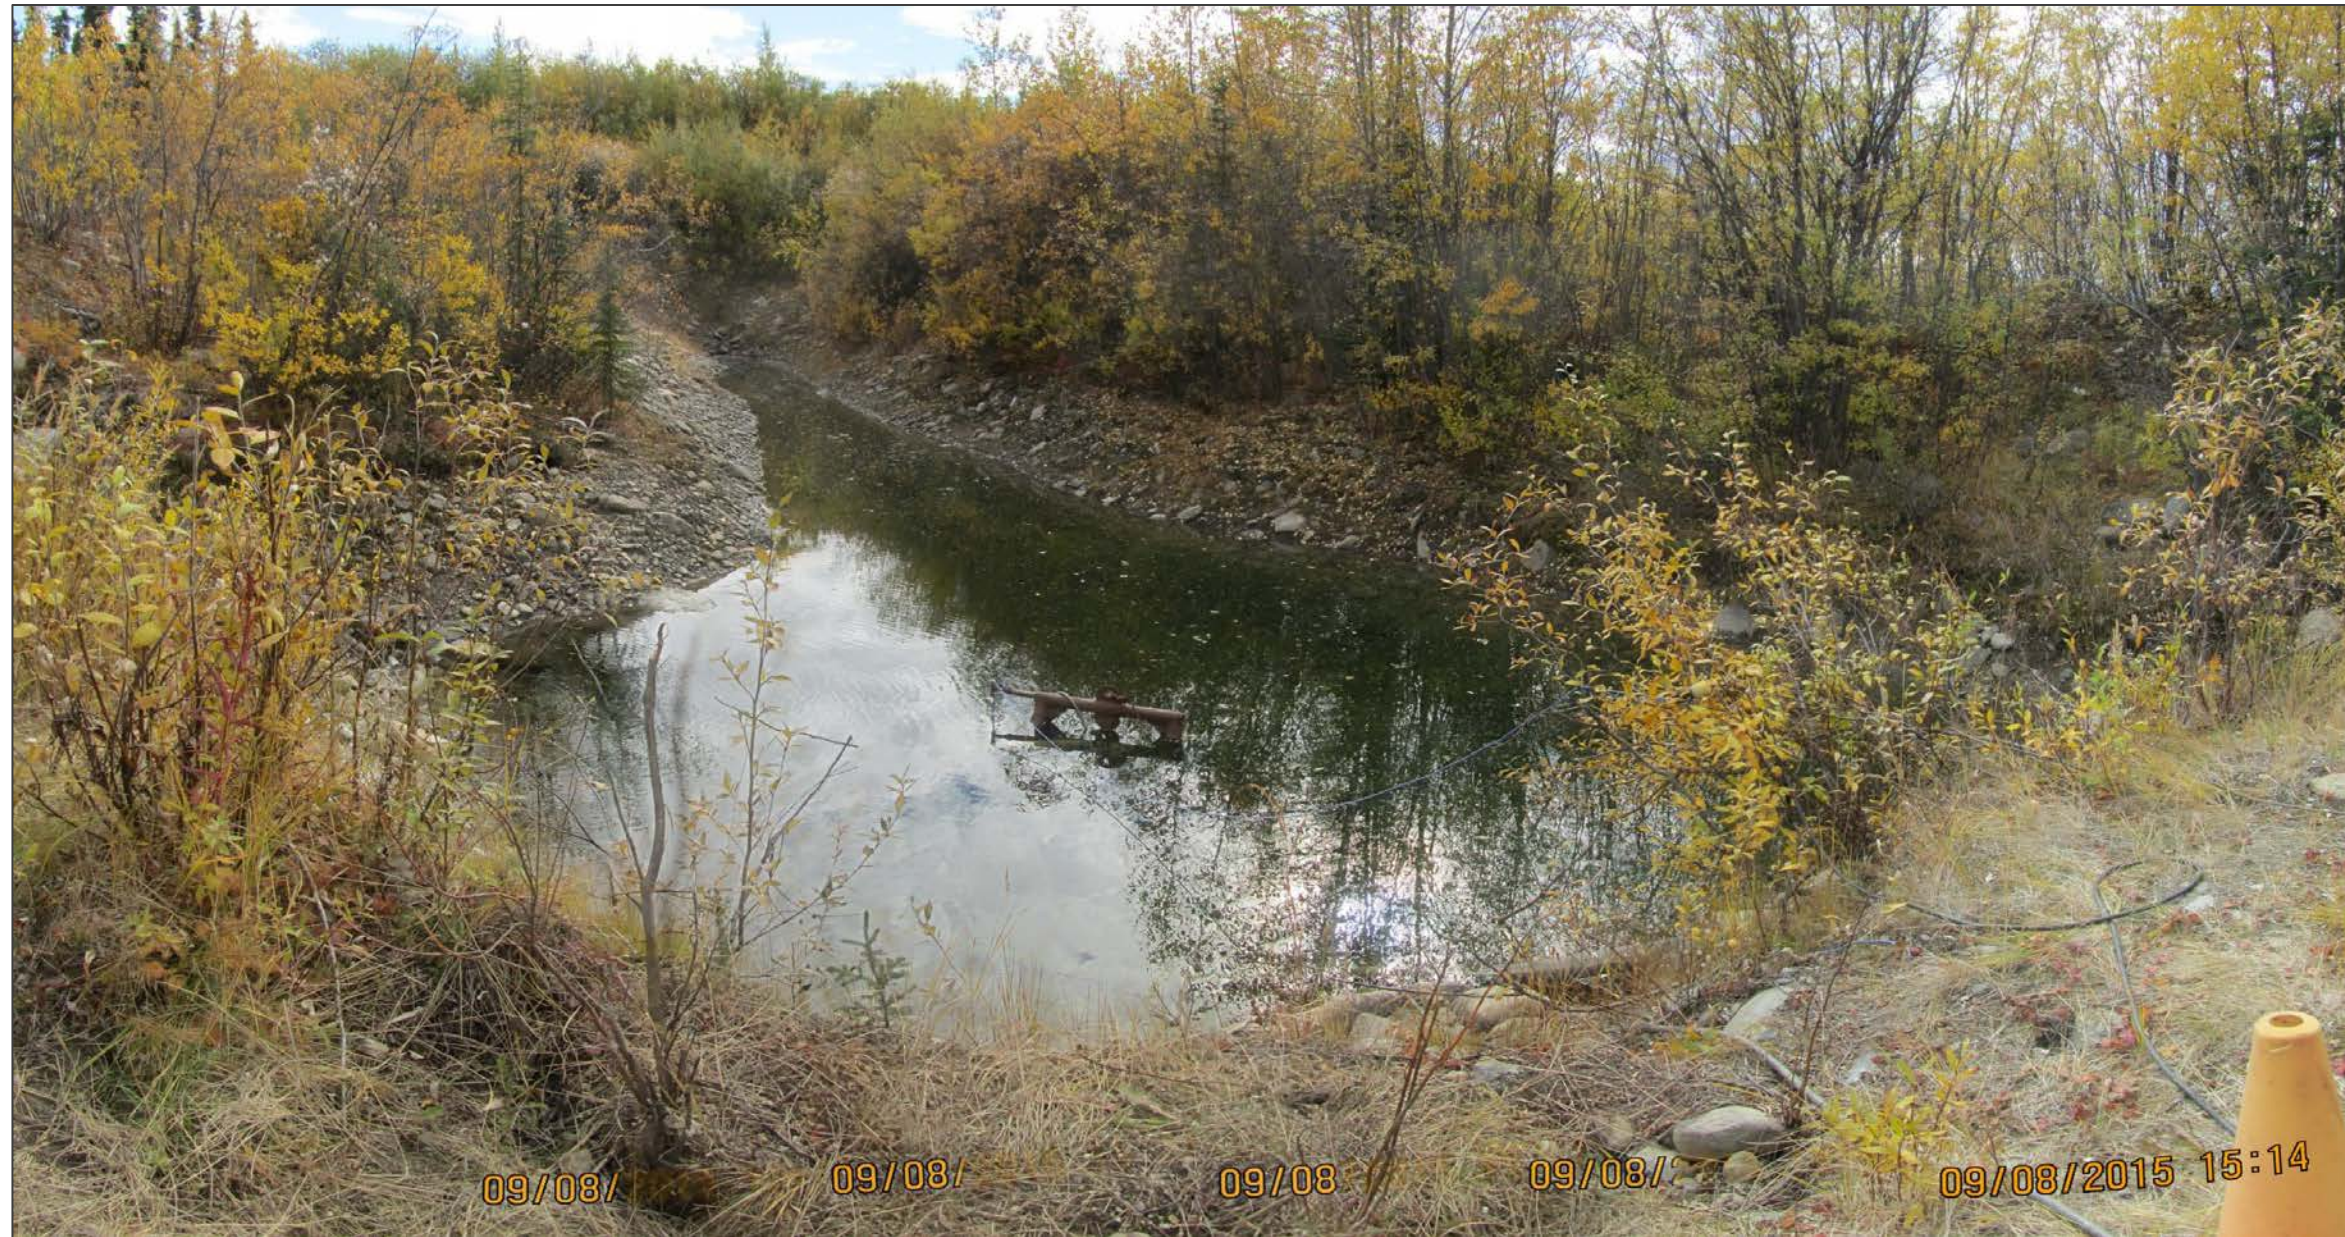
POND BEHIND CREST OF EAST WALL OF VANGORDA PIT, VIEW LOOKING SOUTH

<ul style="list-style-type: none"> <li>If large areas of ponded water are observed behind the crest of the east wall, grade the area to minimize ponded water and infiltration into the slope as well as to control runoff onto the slope face.</li> </ul>	Medium - Long Term
	<ul style="list-style-type: none"> <li>Monitor the waste material at the end of the Grum Slot Cut for erosion and possible breaching.</li> </ul>	Medium - Long Term
	<ul style="list-style-type: none"> <li>Clear the vegetation from the south end of the Grum Interceptor Ditch.</li> </ul>	Low – Long Term
Vangorda	<ul style="list-style-type: none"> <li>Reslope the north side of the upper west wall, similar to what has been done on the south side. The central portion is not oversteepened and can remain in its current configuration.</li> </ul>	High - Long Term
	<ul style="list-style-type: none"> <li>Repair or replace the Vangorda Flume as soon as practicable to limit the amount of water that is seeping into the slope on the north side.</li> </ul>	High - Long Term

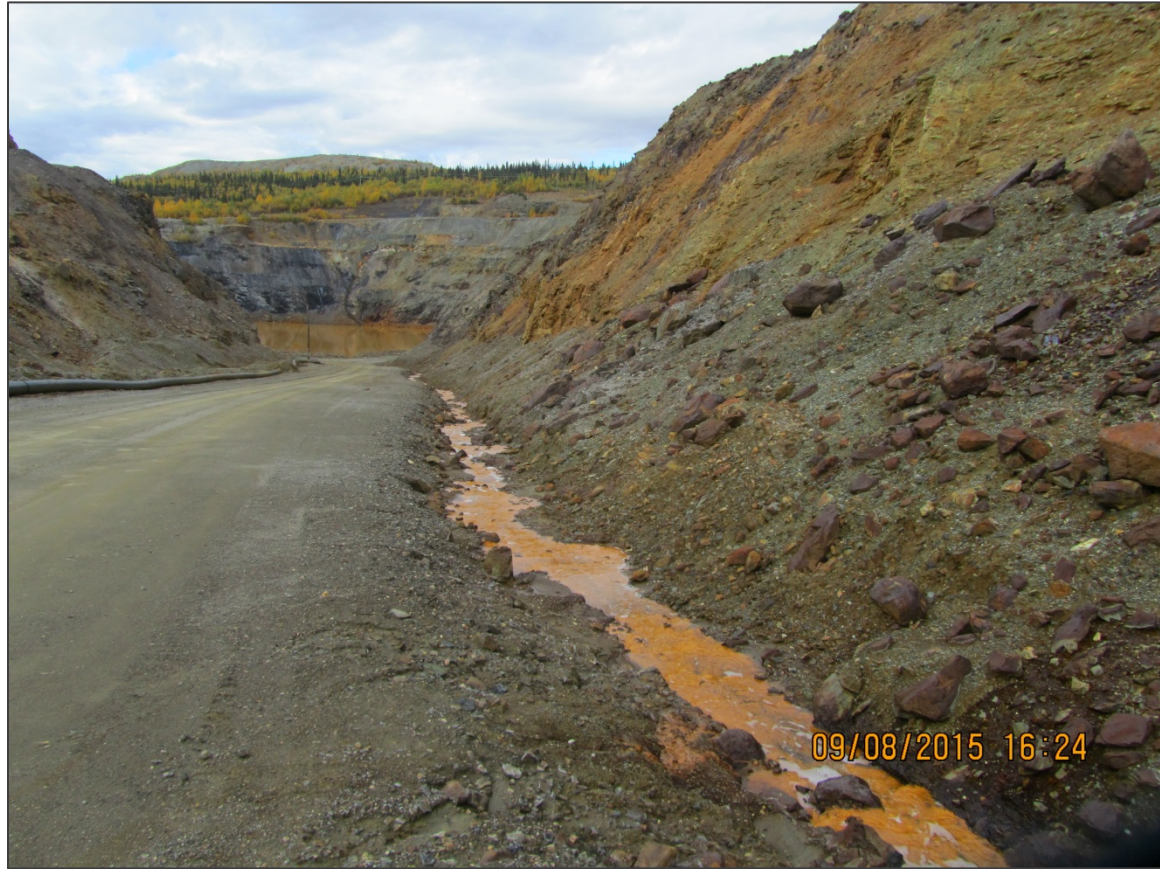
DITCH SERVES AS ROCKFALL CATCHMENT ON EAST SIDE OF ACCESS ROAD, VIEW LOOKING NORTH

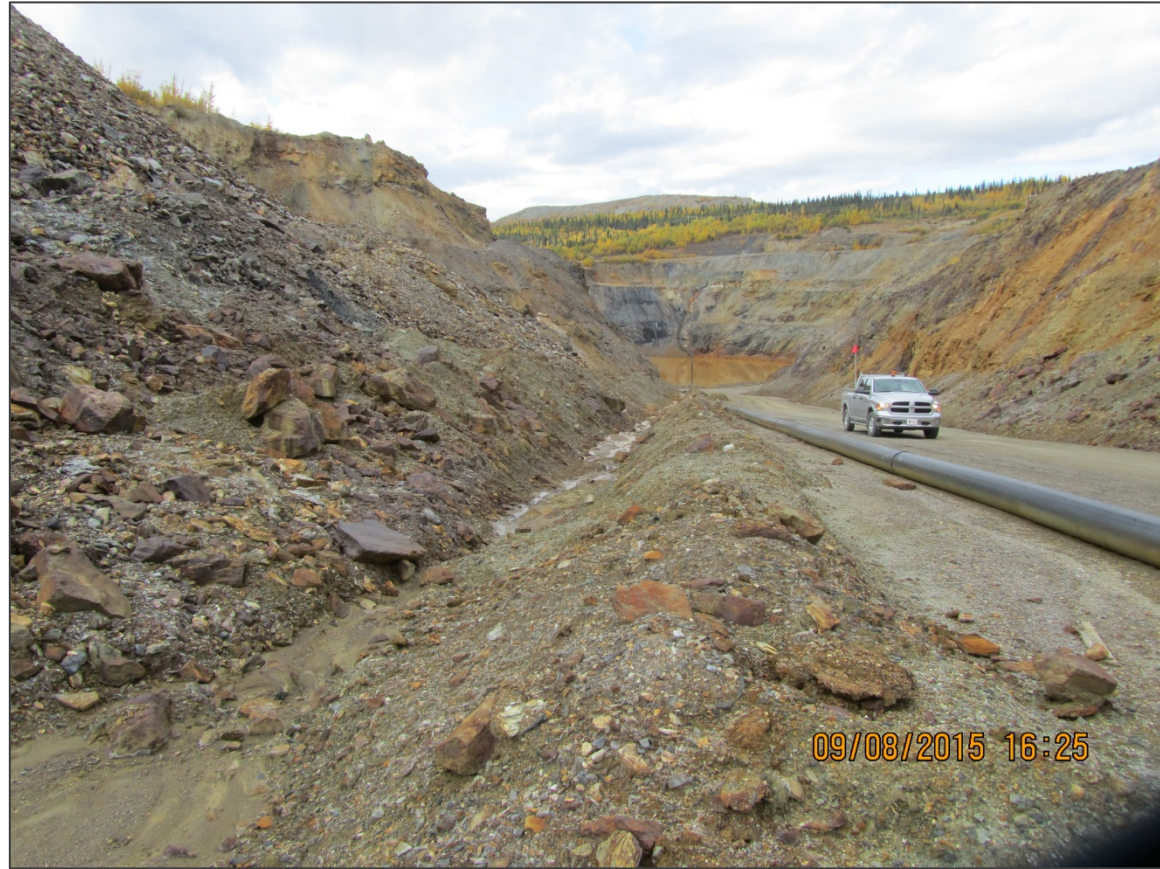
BERM ON UPPER PART OF ACCESS ROAD, WEST SIDE, VIEW LOOKING NORTH

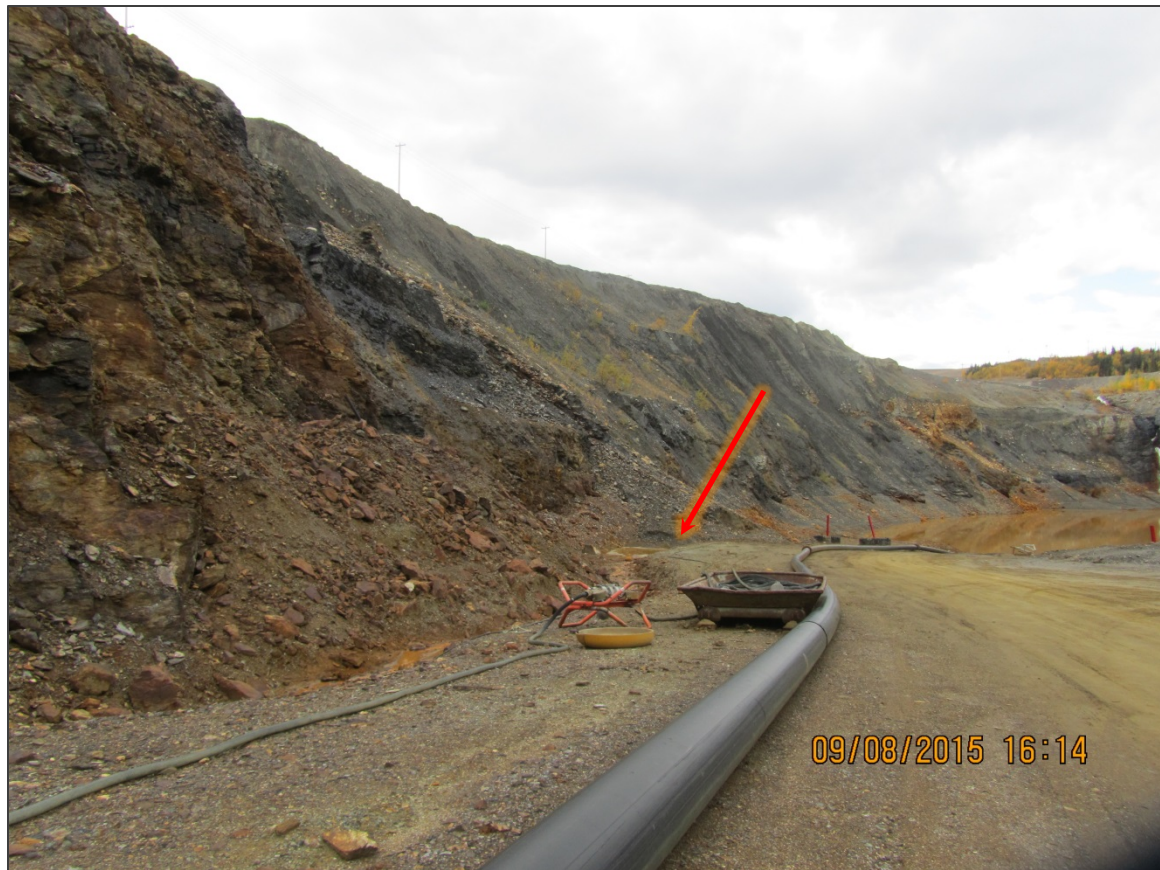
SOME EQUIPMENT CLOSE TO SLOPE IN AREA WITH NO BERM, WEST SIDE OF ACCESS ROAD, LOWER SECTION (SEE NEXT FIGURE). VIEW LOOKING NORTH

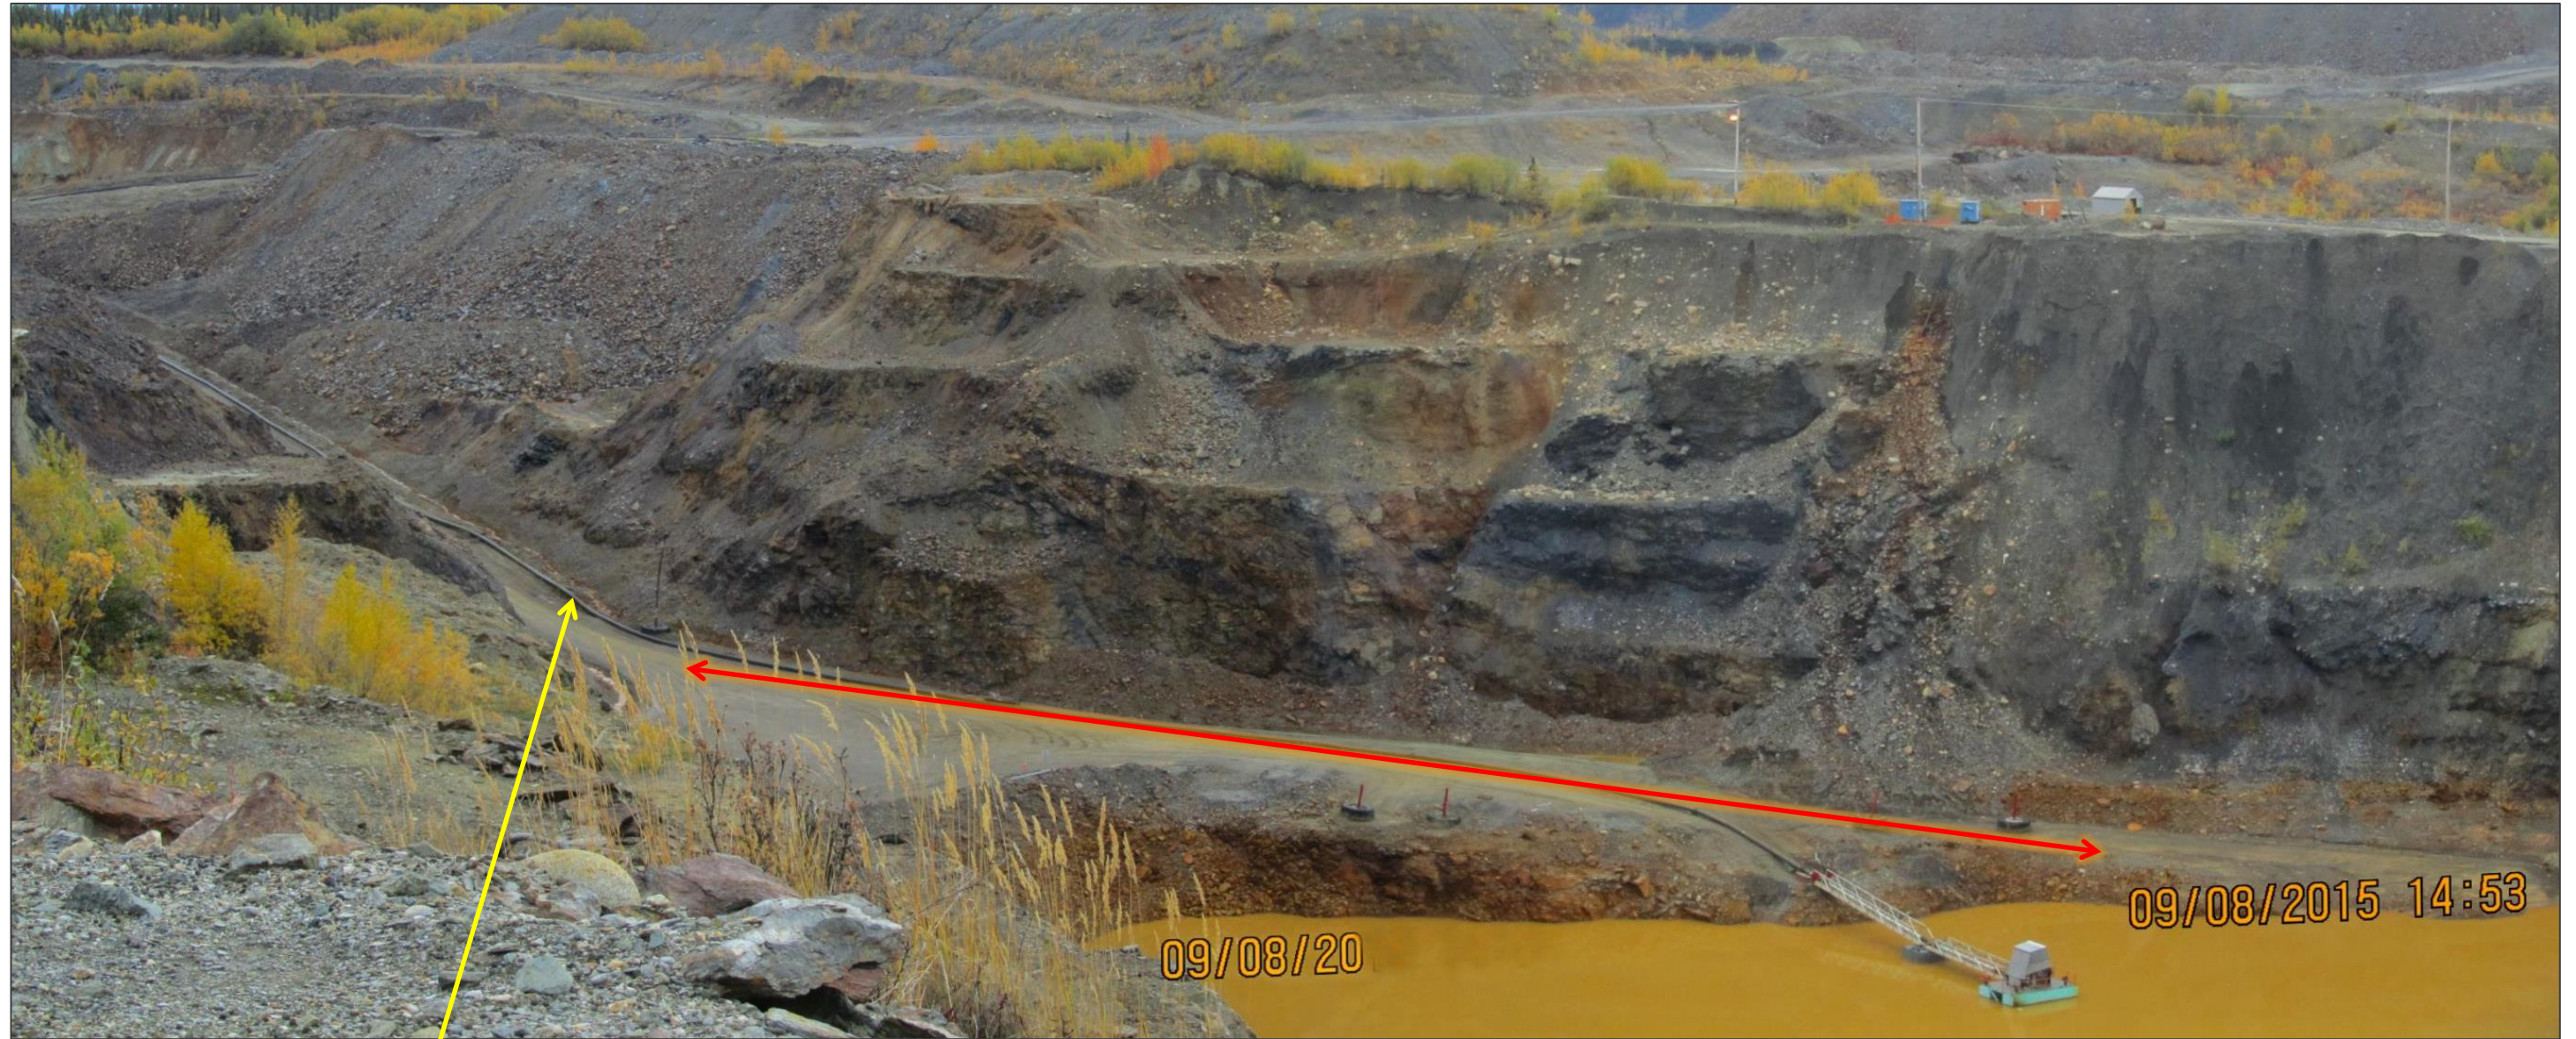
IN-PIT ACCESS ROAD, SOUTH SIDE OF PIT,  
VIEW LOOKING SOUTHWEST

BERM ENDS APPROXIMATELY HERE.

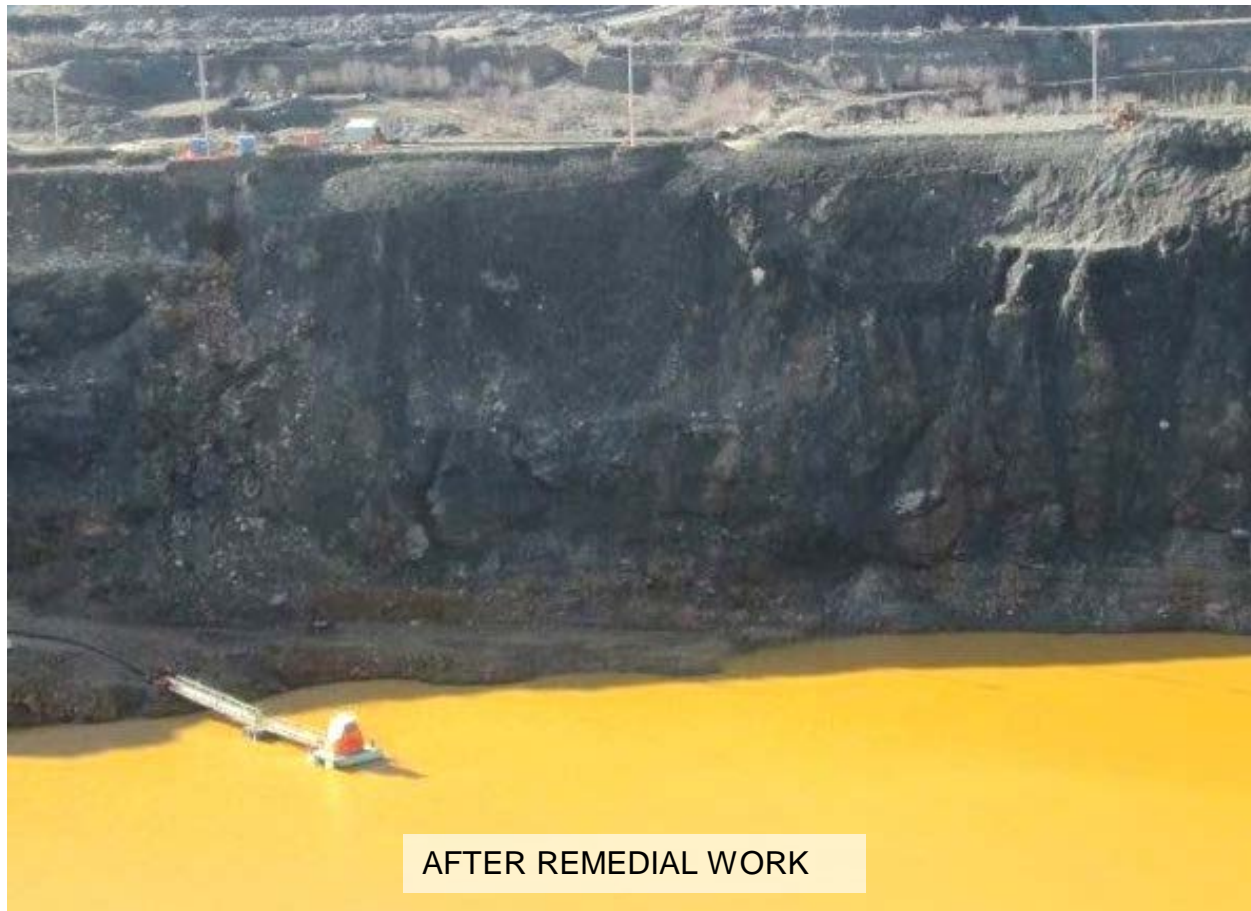
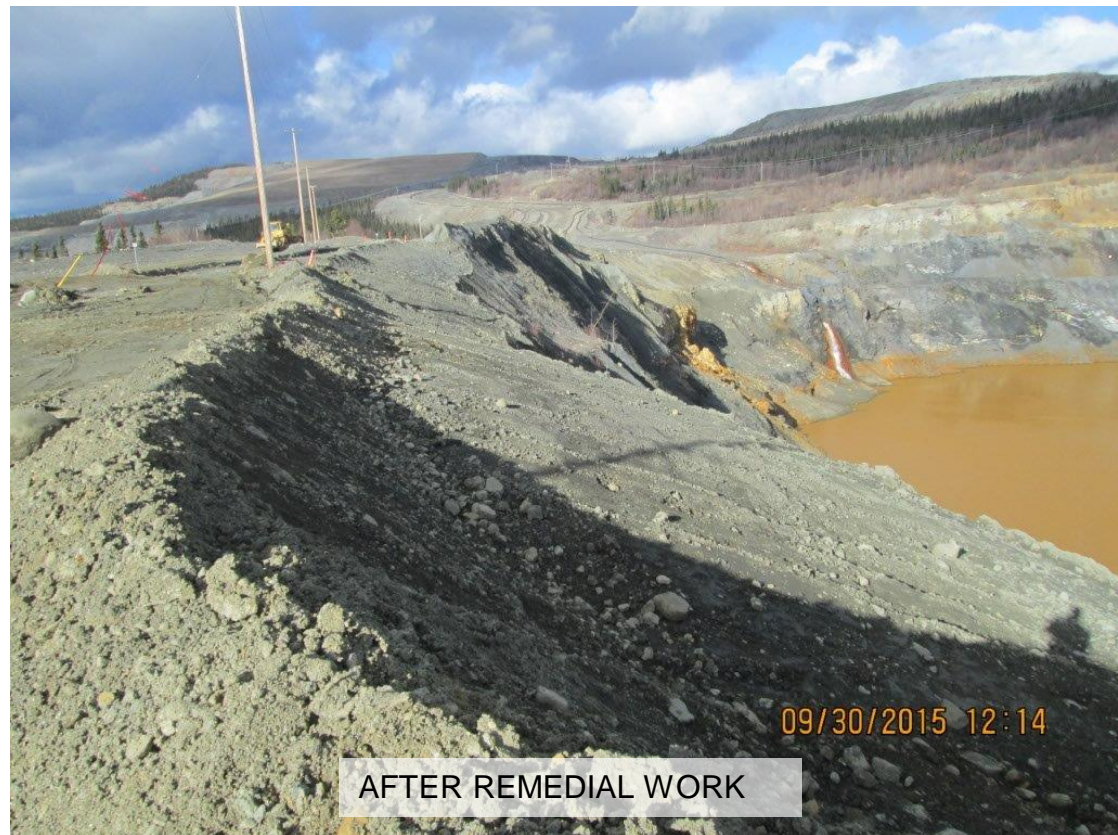
AFTER REMEDIAL WORK
