Arctic Gold and Silver Tailings Site Monitoring Report TA005 October 2009

Prepared by:
**Indian and Northern Affairs
Waste Management Program
Yukon Region**

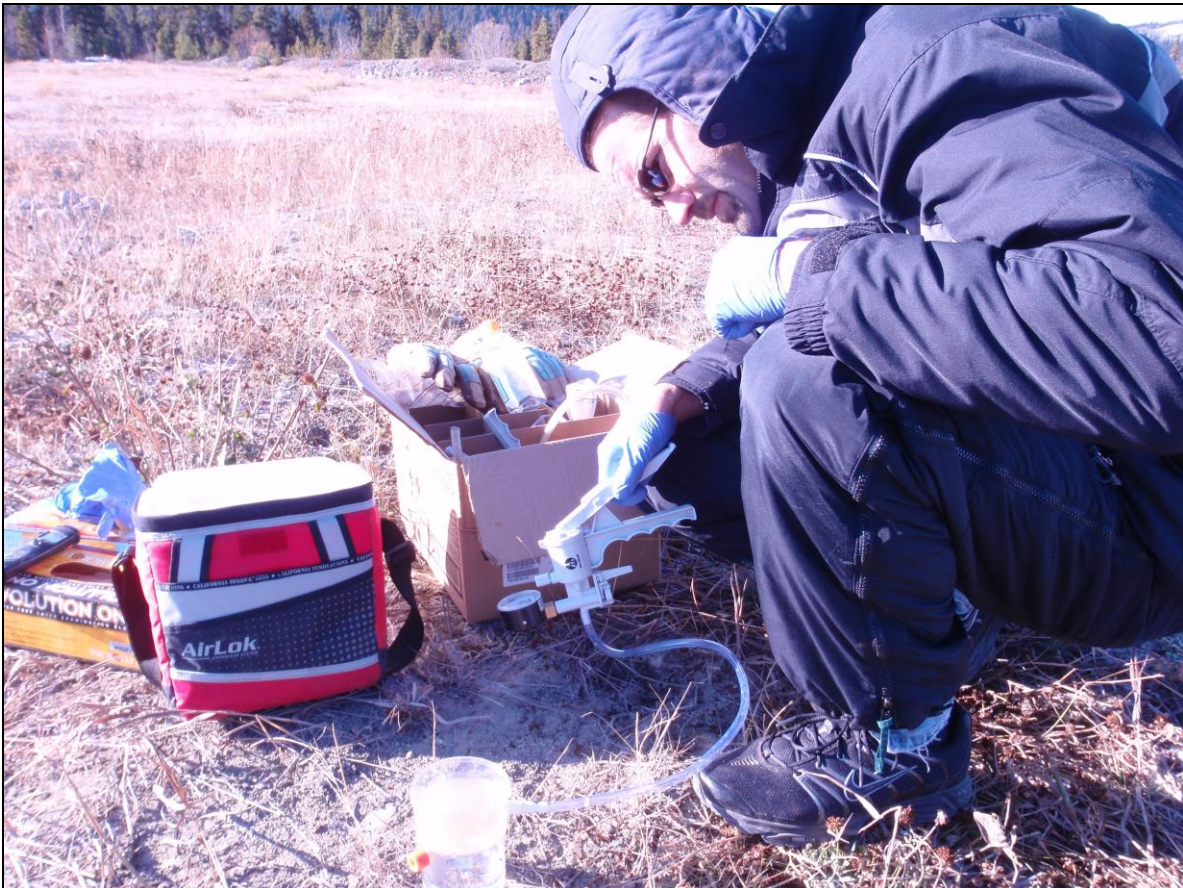
Photograph 3: Waste Management Personnel using a pressurized pump to filter water samples.

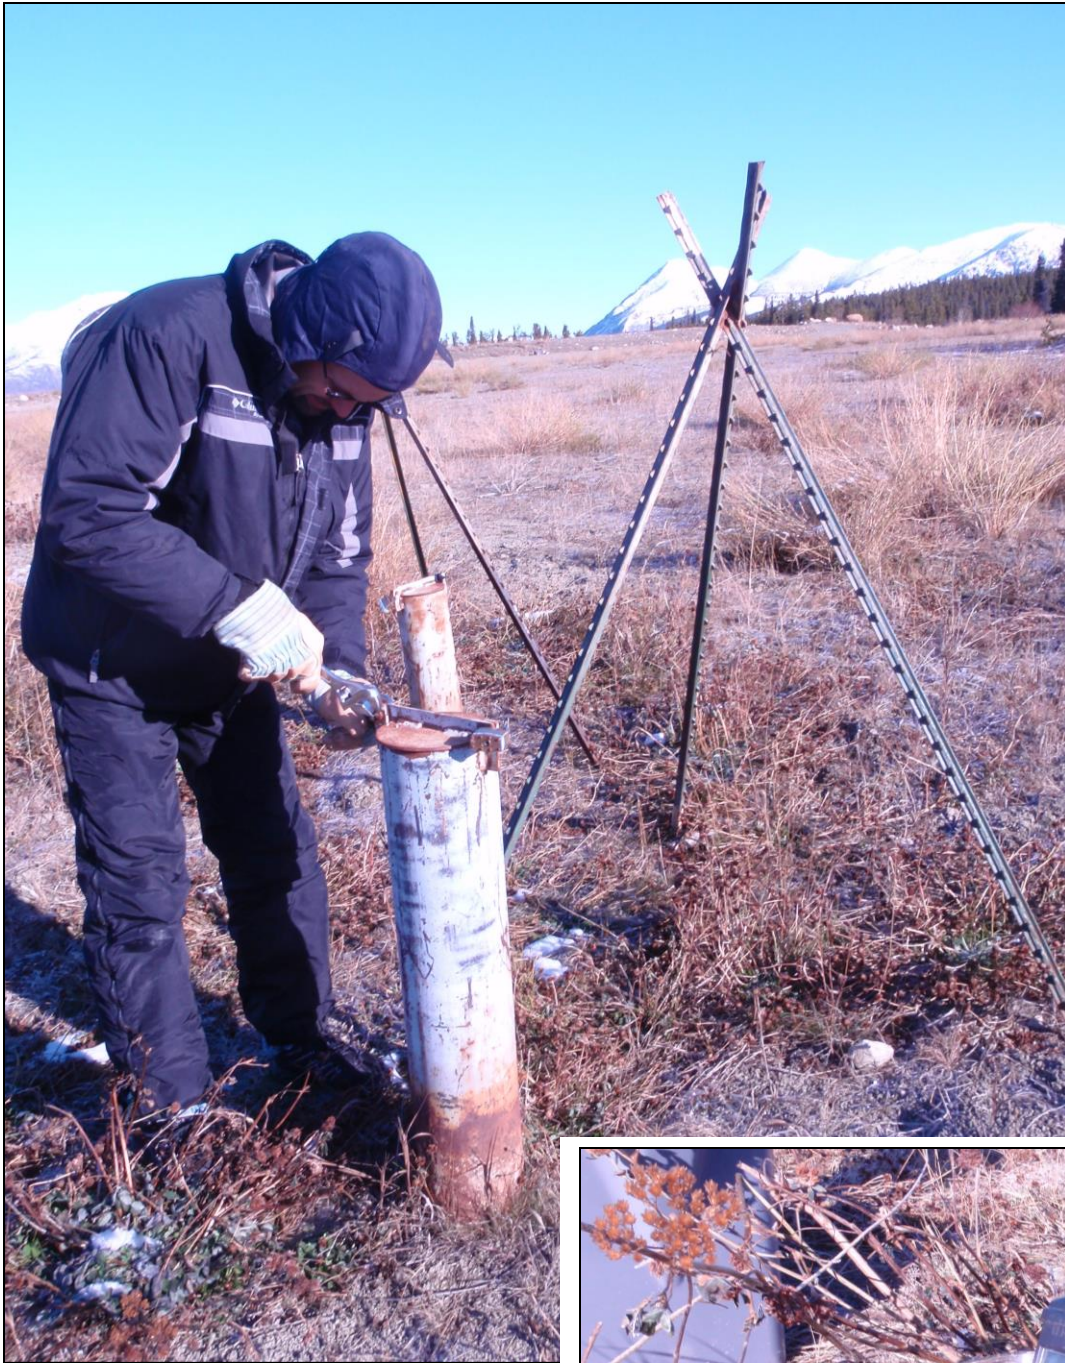
Photograph 4 & 3: Top-Waste Management Personnel removing the top from the monitoring well.
Bottom- Multi-checker taking sample readings from (MW-1D) monitoring well

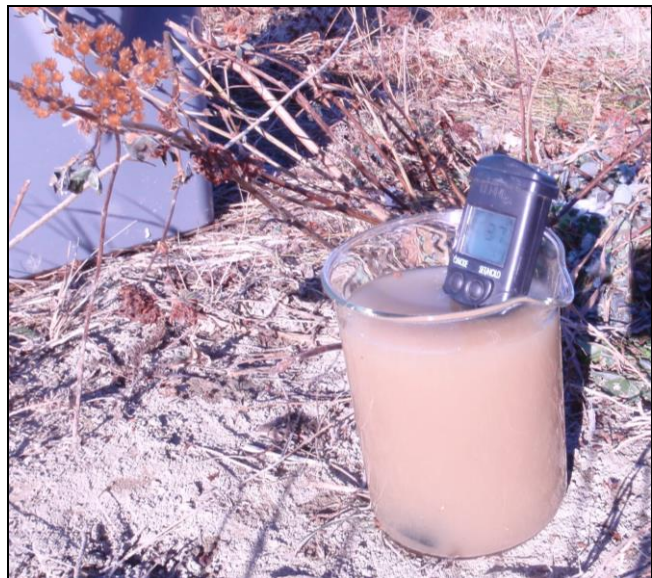
Figure 2: Water Sampling Locations modified from PWGS base drawing (EBA, 2001).

Surface water samples were taken from Tank Creek (See Fig.2) at the inflow (AGS-1) and outflow (AGS-2) of the Unnamed Lake and also at the point of seepage from the tailings pile (AGS-0). Water quality data recorded on site is shown in Table 1 and sampling locations on Figure 2. For quality assurance purposes, a second sample was collected from the outflow of the Unnamed Lake (AGS-D). All water quality data was measured using the HANNA waterproof Combo pH & EC multi-checker # H198129. All samples collected were filtered (0.45 μm) using a pressurized hand pump and preserved with nitric acid. Samples were sent to Taiga laboratory in Yellowknife, North West Territories for dissolved metals analysis.

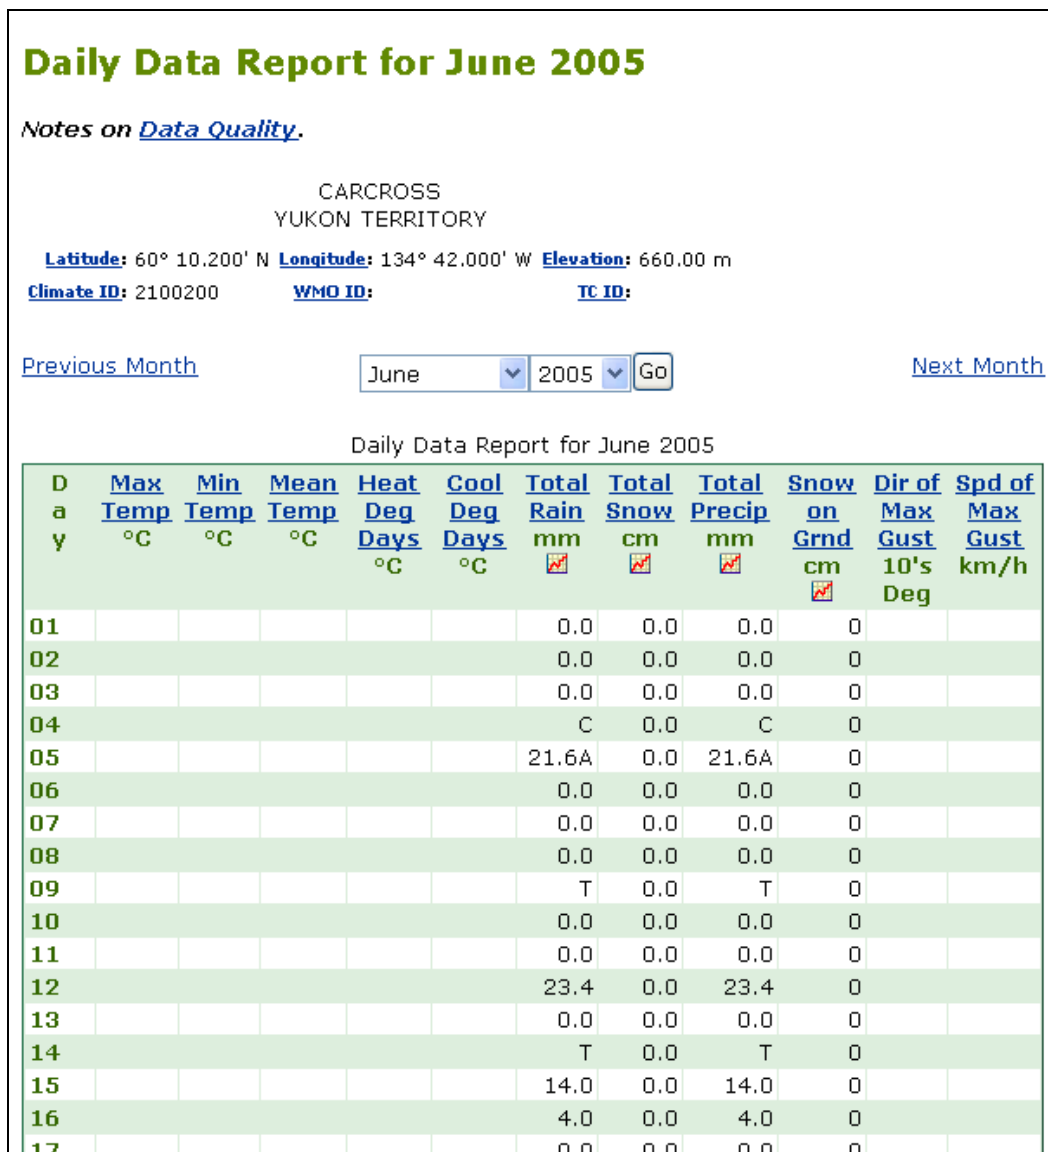
Figure 3: Daily Data Report for June 2005, Carcross, Yukon (Environment Canada, 2009). *T = Trace Amounts of Rain recorded*

concentrations was detected in samples taken on June 16, 2005, prior to a rain event on June 15, 2005. The Carcross station near the site received 14.0 mm of rain (see Figure 3). In addition to this, on June 12, 2005 the Carcross station received 23.4 mm of rain. It may be possible that the high spike in the sample readings on June 16, 2005 may be correlated to the heavy rain event, which occurred on the previous day. However, no other sample readings are known to have been taken days after a major rain event to compare these findings.

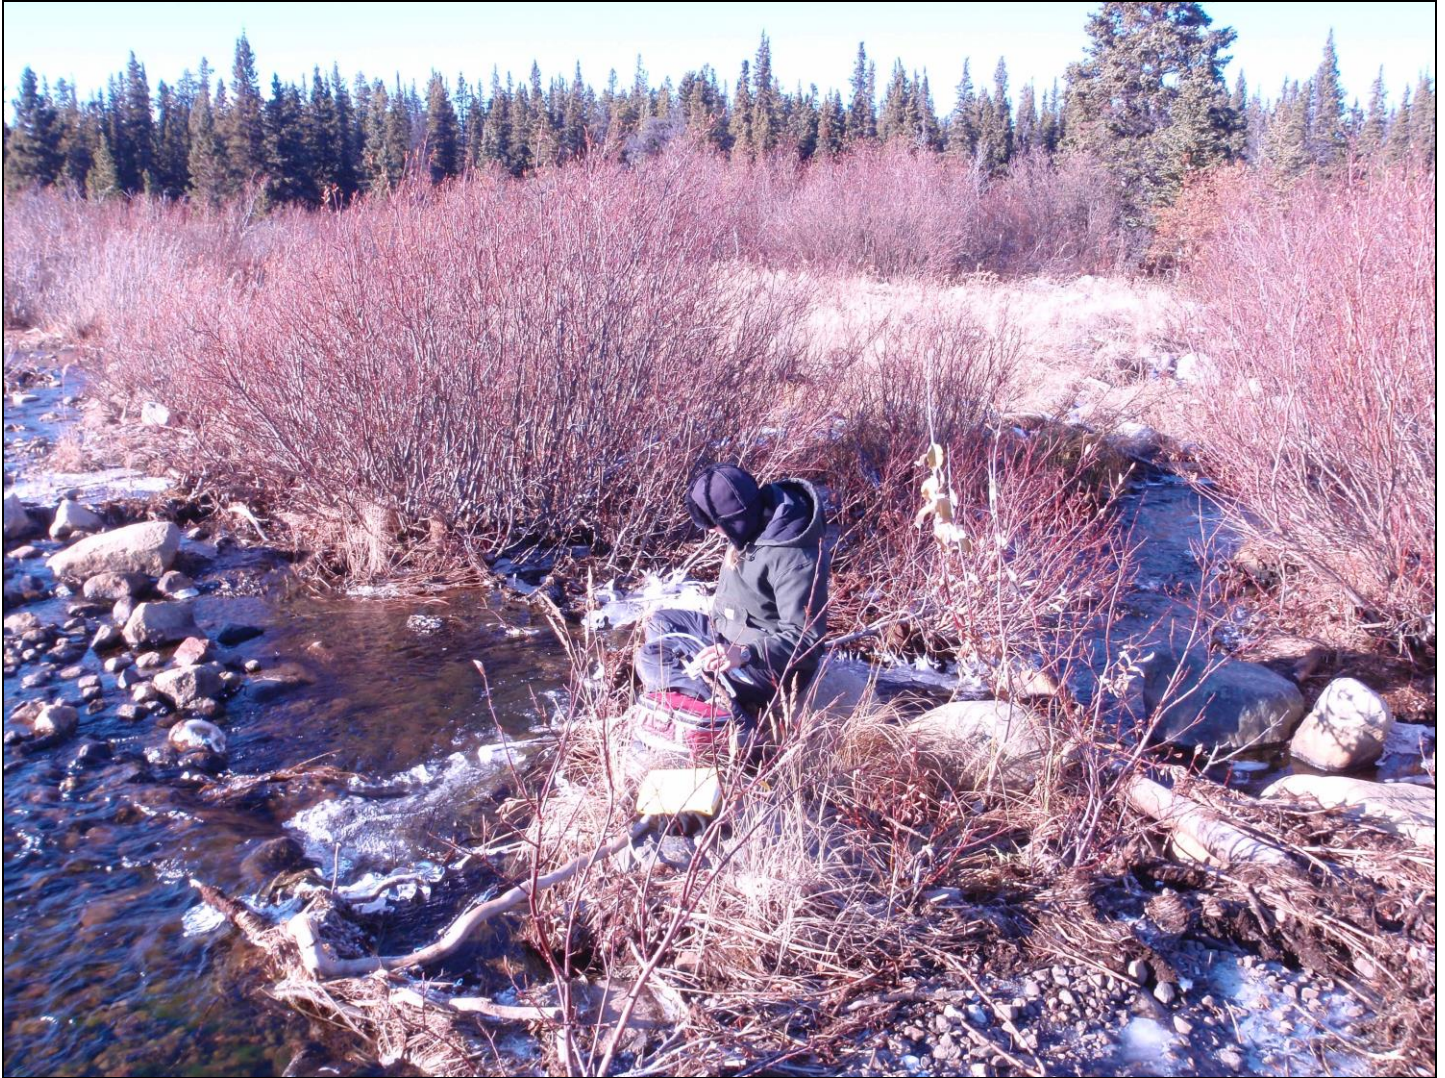
Photograph 10: Waste Management Personnel taking readings from outflow (AGS-2) of the Unnamed Lake

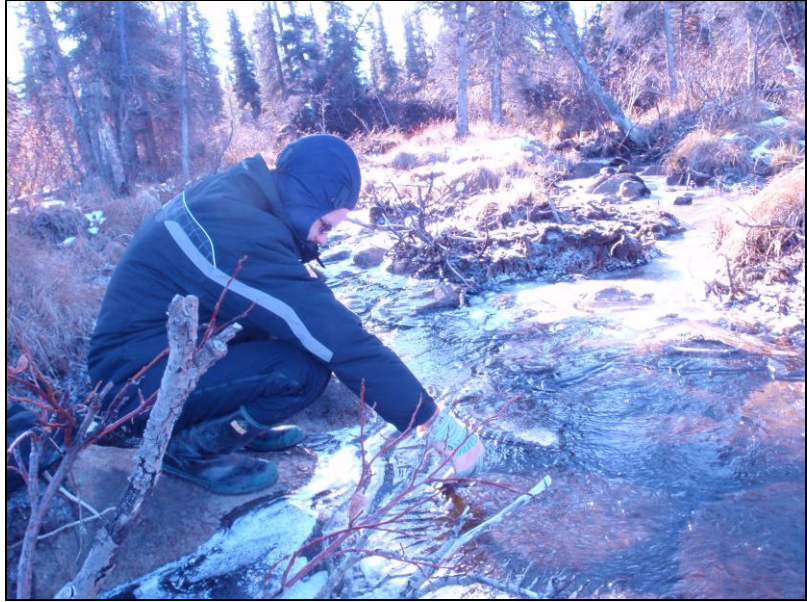
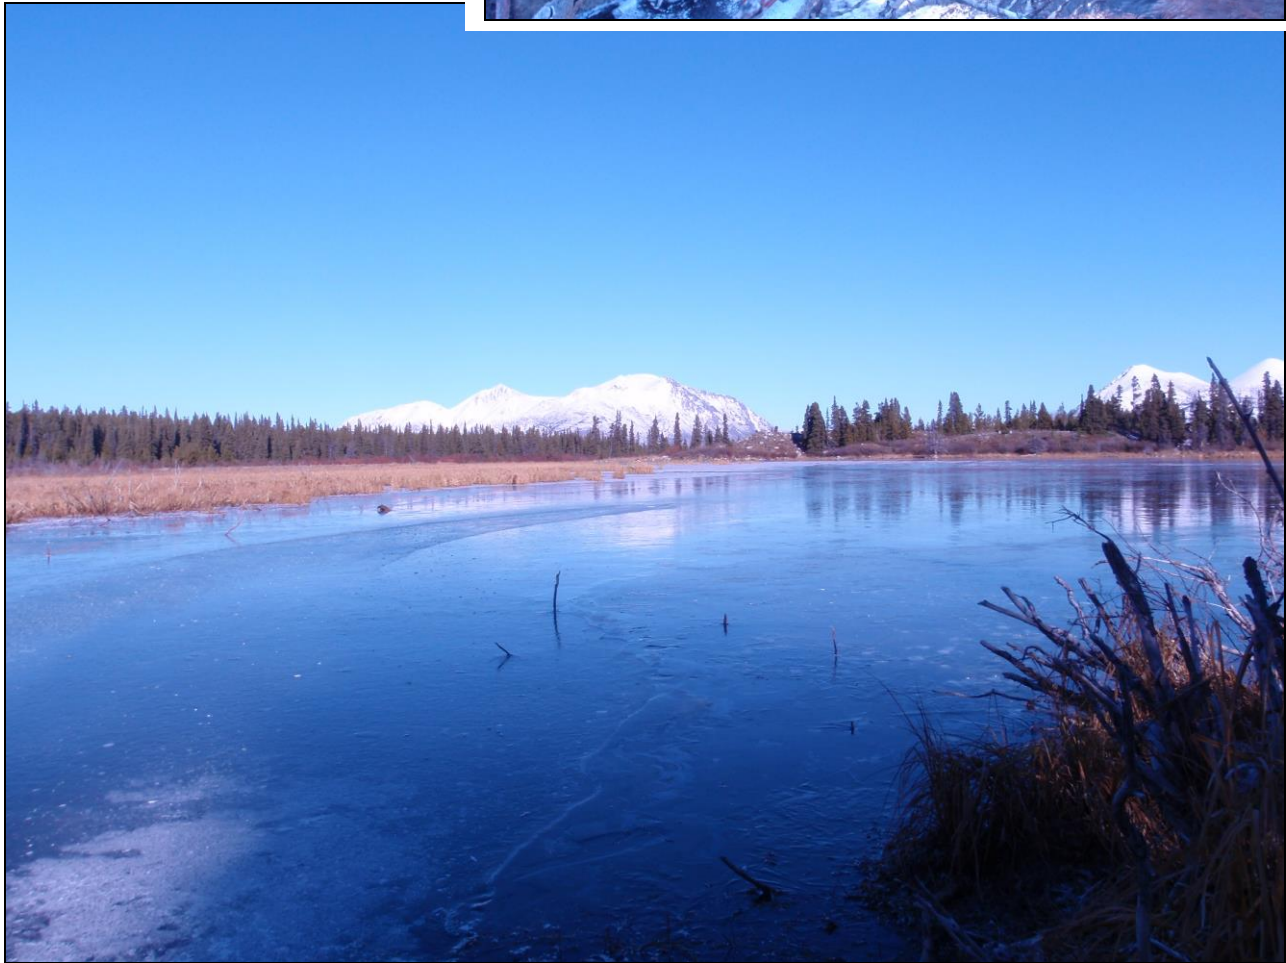
Photograph 11 & 12: Top-
Waste Management Personnel
taking readings from inflow
of the Unnamed Lake (AGS-1)
Bottom- Looking out onto the
Unnamed Lake from the inflow
