Re: Final Report for 2004/05 Care and Maintenance Activities, Keno Hill Property

Care and Maintenance of Keno Hill Mining Property,

Keno Hill, Yukon

2004-2005 FINAL PROJECT REPORT

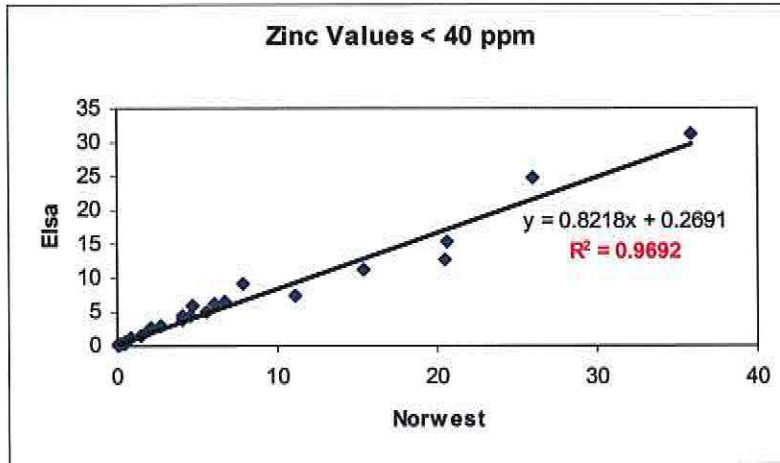
Figure 4 Regression Analysis for Zn Concentrations <40ppm - Paired Values for Norwest and Elisa Analysis

ACG also conducted simple statistical analysis of the correlation between internal and external laboratory analytical results of samples analyzed at each lab. The graphical results are shown in Figures 4 and 5. Paired values are plotted for results of samples collected at sites on the same day, in many cases by the same sampler and split into two aliquots for separate analysis. Figure 4 shows excellent correlation (i.e. similarity) of analysis for samples under 40 ppm total Zn. Figure 5 illustrates how this correlation deteriorates significantly above 40 ppm concentration.

immediate succession of each other may vary significantly in Zn concentration. This could serve to explain poor correlation in results over 40 ppm. ACG has ordered fresh standard solutions for on site instrument calibration at all concentration ranges to further minimize potential analytical error.

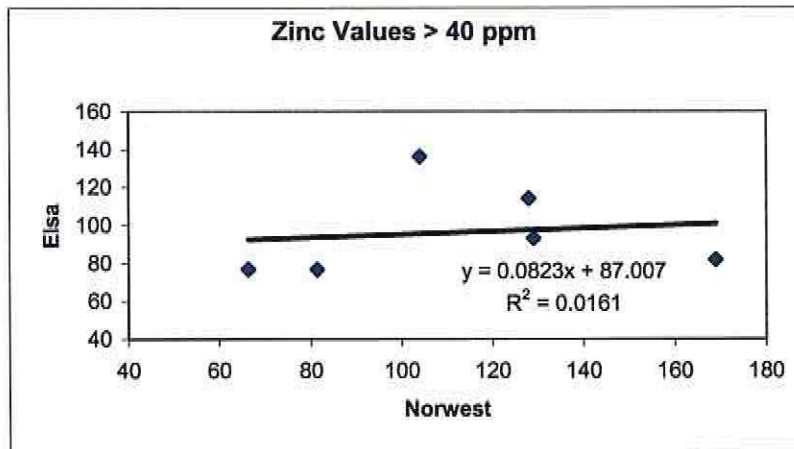
Figure 5 Regression Analysis for Zn Concentrations >40ppm - Paired Values for Norwest and Elisa Analysis

The high potential for variability in actual sample Zn concentration associated with the degree of iron floc presence (from Galkeno 300 samples, primarily) means that samples collected in

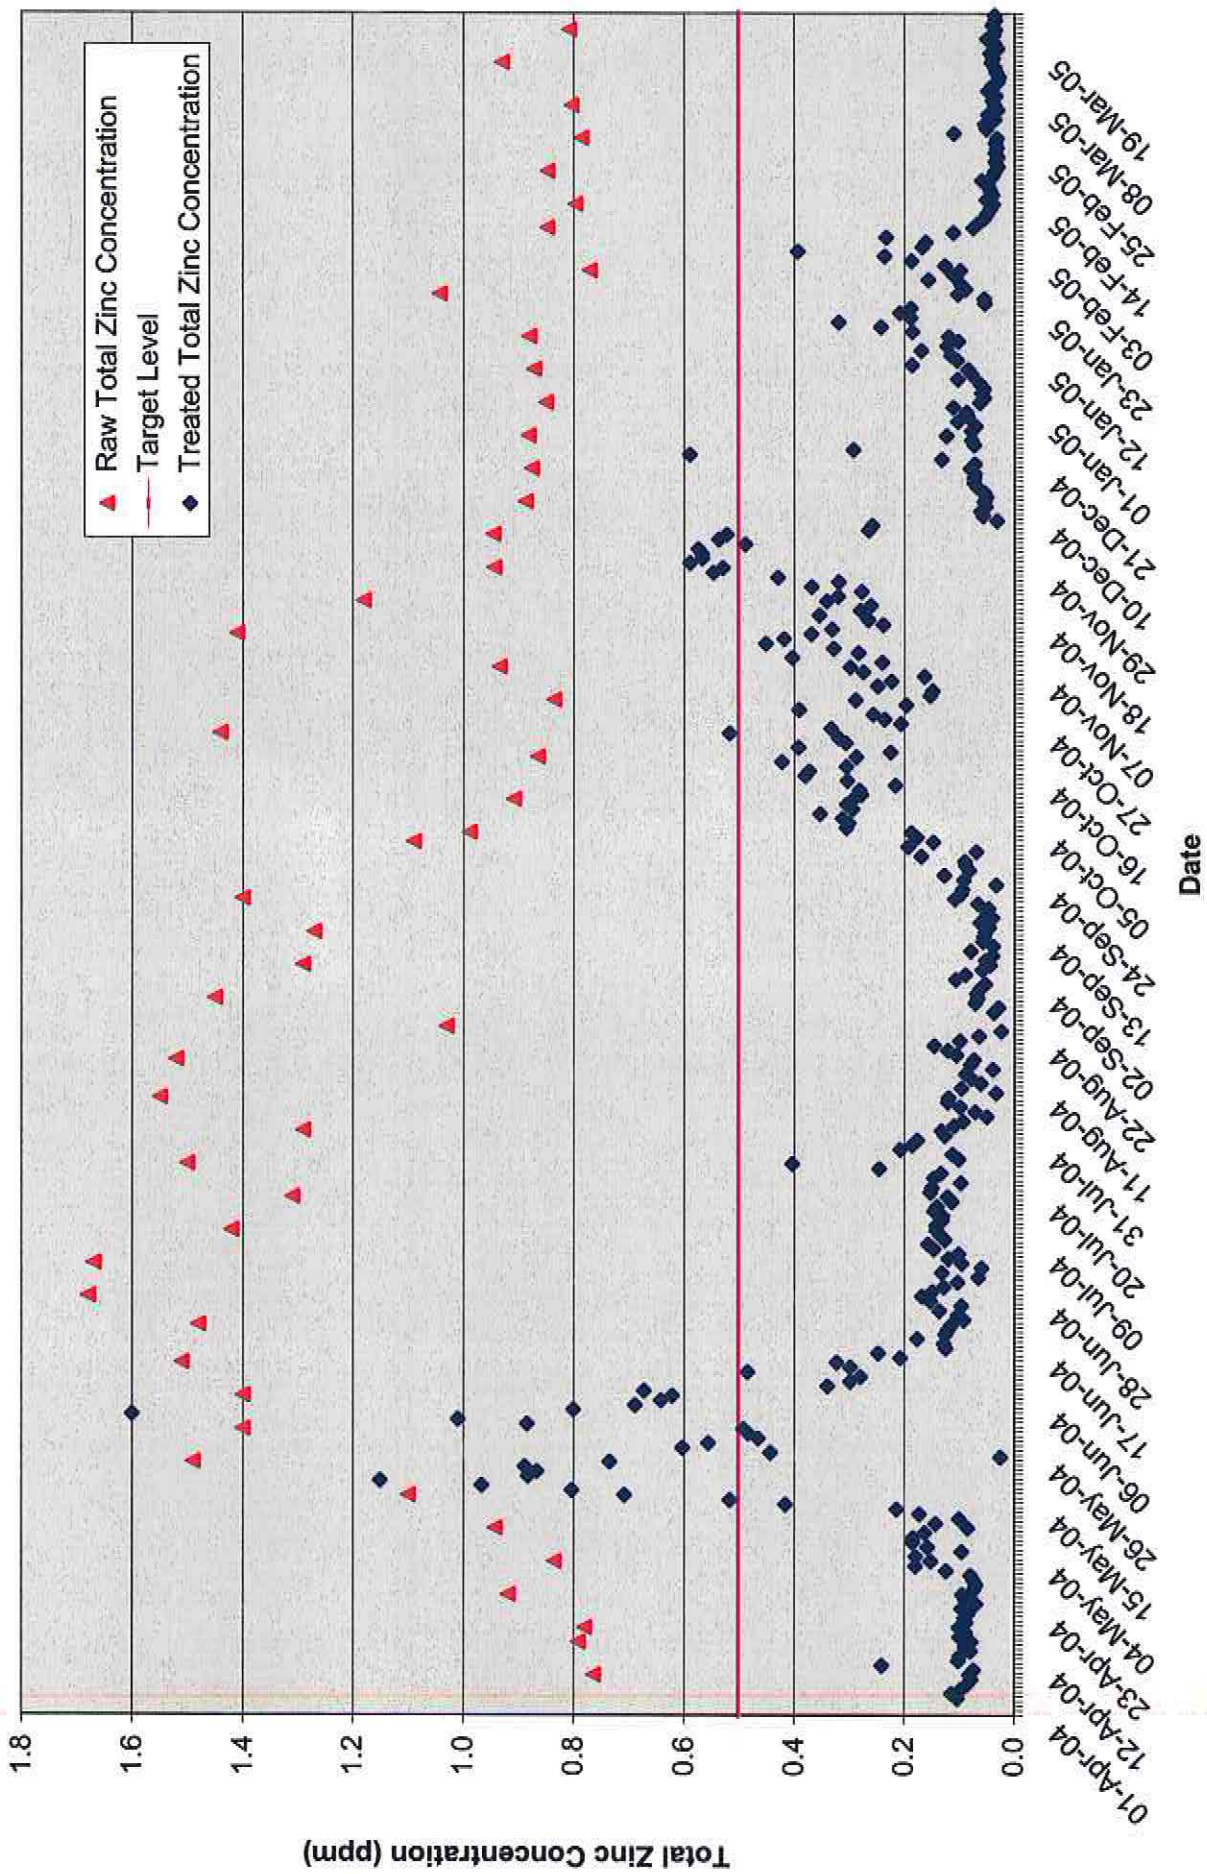
Figure 6 - Silver King Adit Total Zinc Results

The treatment system at Silver King has operated well, and is expected to continue being the easiest site to keep in compliance. This is attributed to low flow levels and very low zinc content in the adit discharge (see Figure 6), as well as an operational secondary settling pond that

provides longer residency time for zinc and lime precipitation. Non-compliant zinc discharges observed in late May and early June of 2004 could be attributed to elevated flows associated with spring freshet, and an error in adjusting the lime addition rate at the adit on May 31st. Portal water flow rates at Silver King showed minor variation and were estimated using bucket/timing methods at 1.5 - 3 litres/sec. Mean untreated pH and total zinc levels were calculated at 7.5 and 1.10 ppm respectively, and the mean pH and total zinc concentrations of the treated water were 8.5 and 0.20 ppm respectively, over the contract period. The current lime slurry flow rate is 13.3 ml/sec.

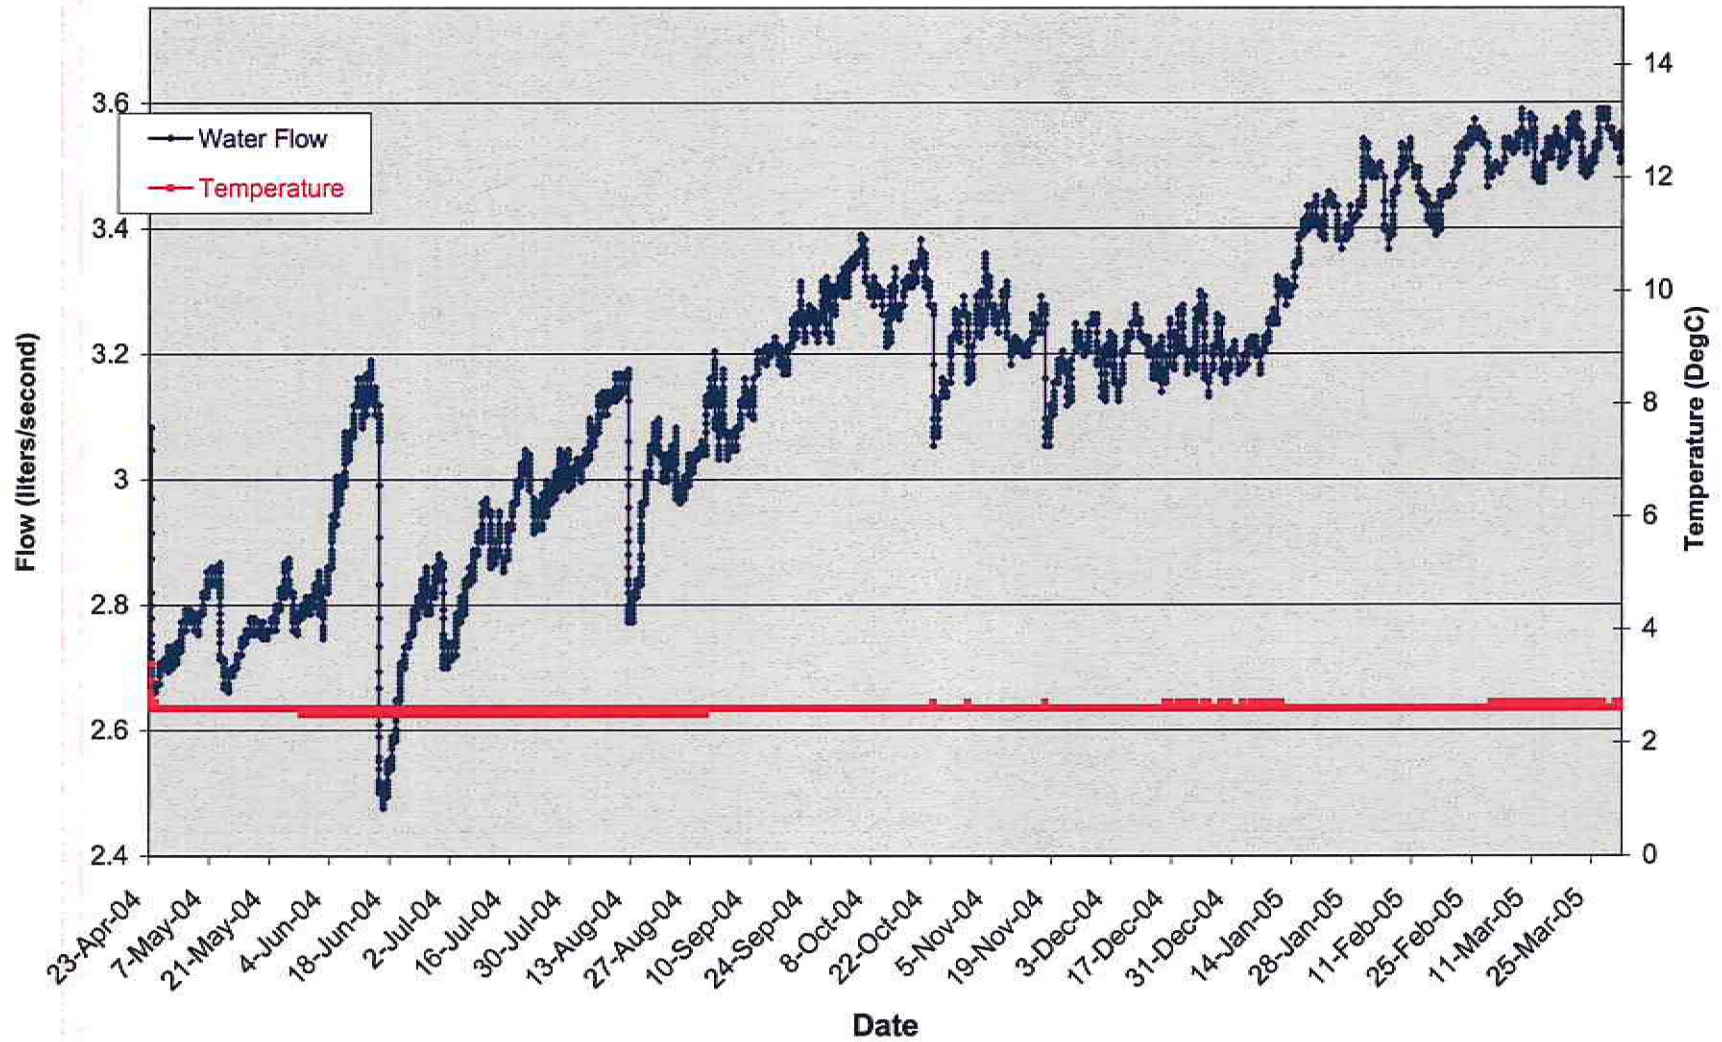
Figure 7 - Water Discharge Rate and Temperature at Galkeno 900 Adit

Raw (untreated) portal water flow averaged 3.0 litres/sec (Figure 7), with an average pH of 7.6 and a mean total zinc concentration of 6.79 ppm. The current, optimum lime slurry flow rate is 13.3 ml/sec. Primary decant (treated) pH and zinc concentrations averaged 8.5 and 0.070 ppm respectively over the contract term. Total zinc concentrations for Galkeno 900 are displayed in Figure 8.

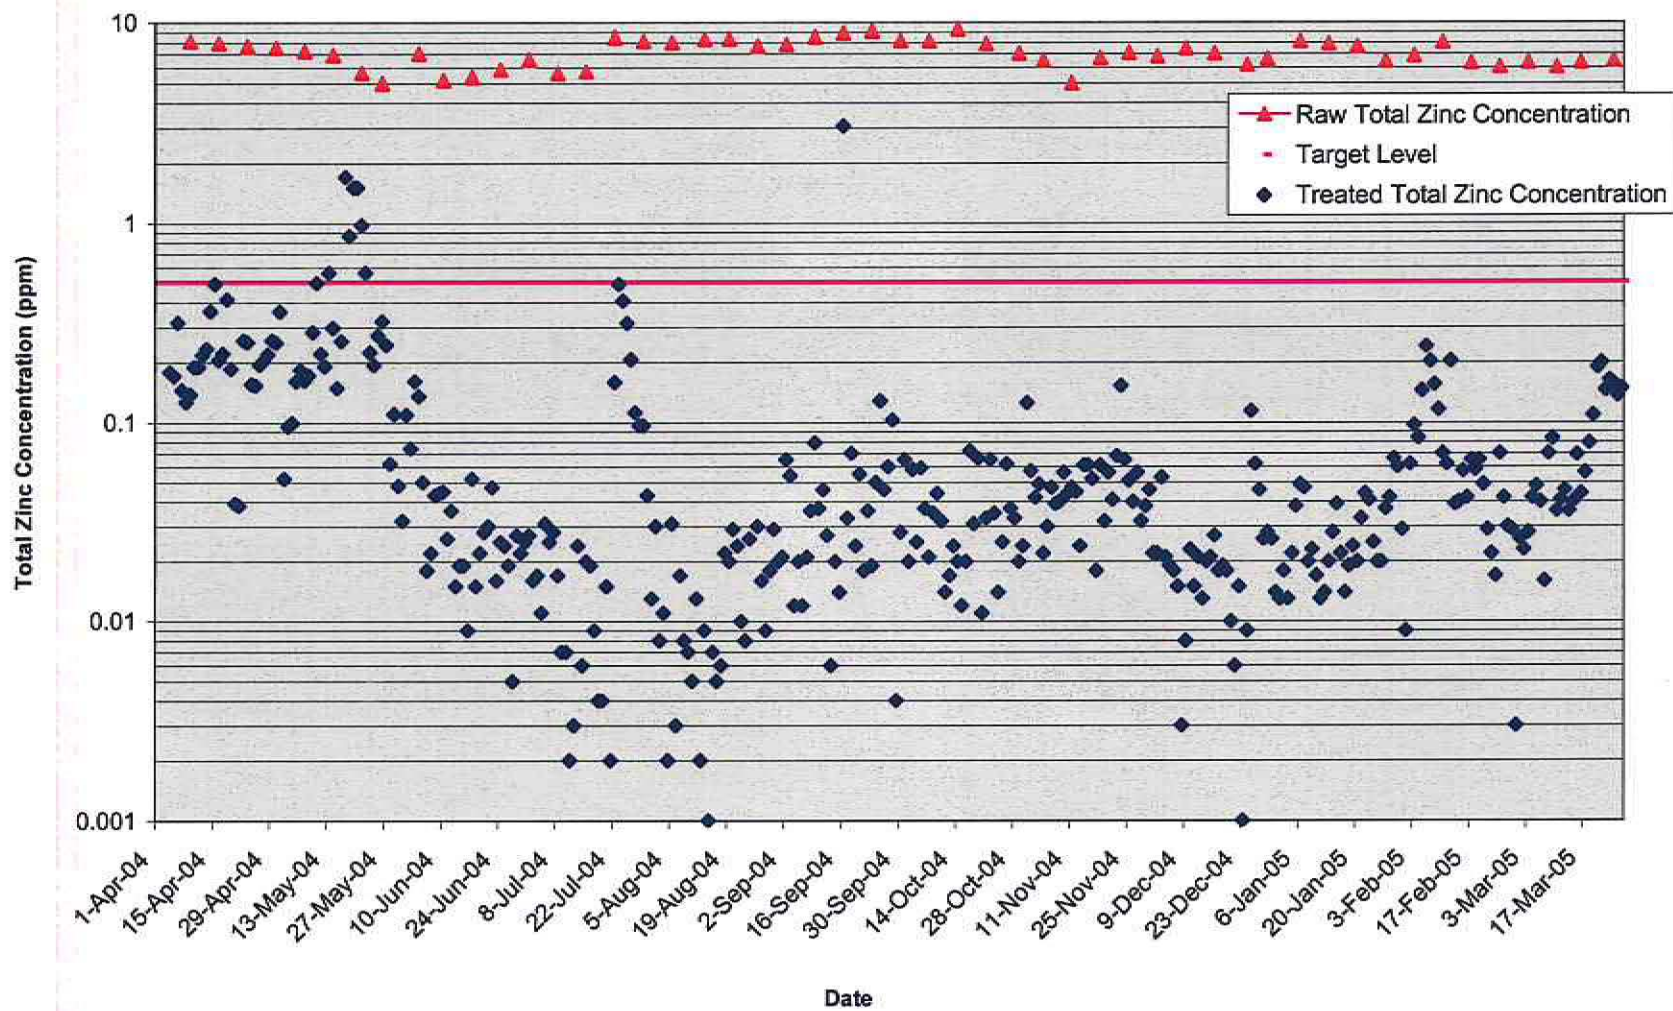
Figure 9 - Total Zinc Concentrations at Bellekeno 600

Portal water flow at Bellekeno over the 04/05 contract term averaged at 1.5 – 2.0 litres/sec, with an average untreated pH of 8.1, and zinc levels of 7.91 ppm. The current, optimum lime slurry flow rate is 5.6 ml/sec. Effluent in the secondary pond (treated), had a mean pH of 9.3, and a mean total zinc concentration of 0.10 ppm. Figure 9 shows the treated and raw total zinc concentrations at the Bellekeno 600 treatment site for the 2004/05 term.

In recognition of the poor seep water quality, ACG has discussed this issue with site operators and implemented an increase of lime addition in an interim method of increasing the buffering capacity of the treated discharge en route to the seep point. The current monitoring and reporting regime (which includes monitoring of zinc concentrations of the untreated adit water, the treated pond water, and the seep) will be maintained for the time being, and discussions with the appropriate regulatory authorities will continue, with aim to identify and evaluate new approaches to addressing the seep discharge.

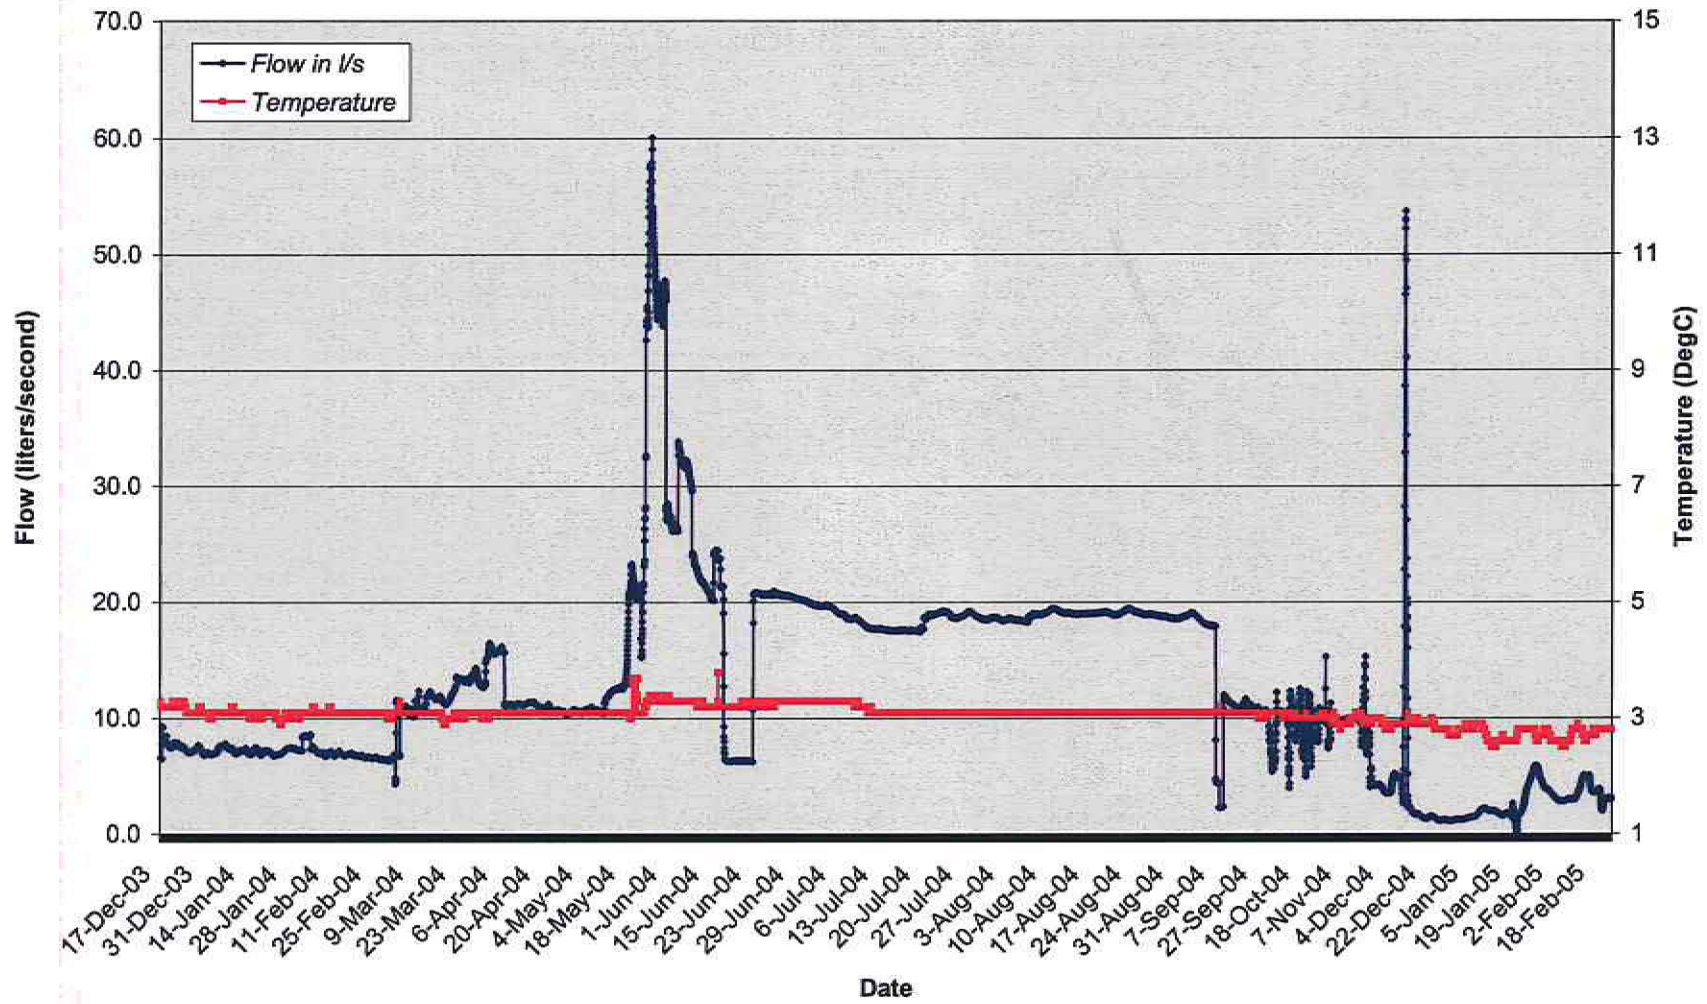
Figure 10 - Water Discharge Rate and Temperature at Galkeno 300 Adit

The Galkeno 300 treatment system currently consumes a vast majority of the lime used on the property in order to maintain water quality objectives. This is due to the higher portal water discharge rate (along with significant fluctuations in flow), and significantly higher total aqueous zinc concentrations than any of the other flow treatment sites. Portal water flow averaged 15.2 litres/sec (Figure 10), with an average untreated pH of 7.3, and a mean total zinc concentration of 107 ppm. Average primary decant (treated) pH and total zinc concentrations were 8.6 and 41.9 ppm respectively. The trends for raw and treated water total zinc concentrations are displayed in Figure 13 and discussed further in Section 2.1.4.3. The current, optimum lime slurry flow rate at the Galkeno 300 treatment site is 100.0 ml/sec.

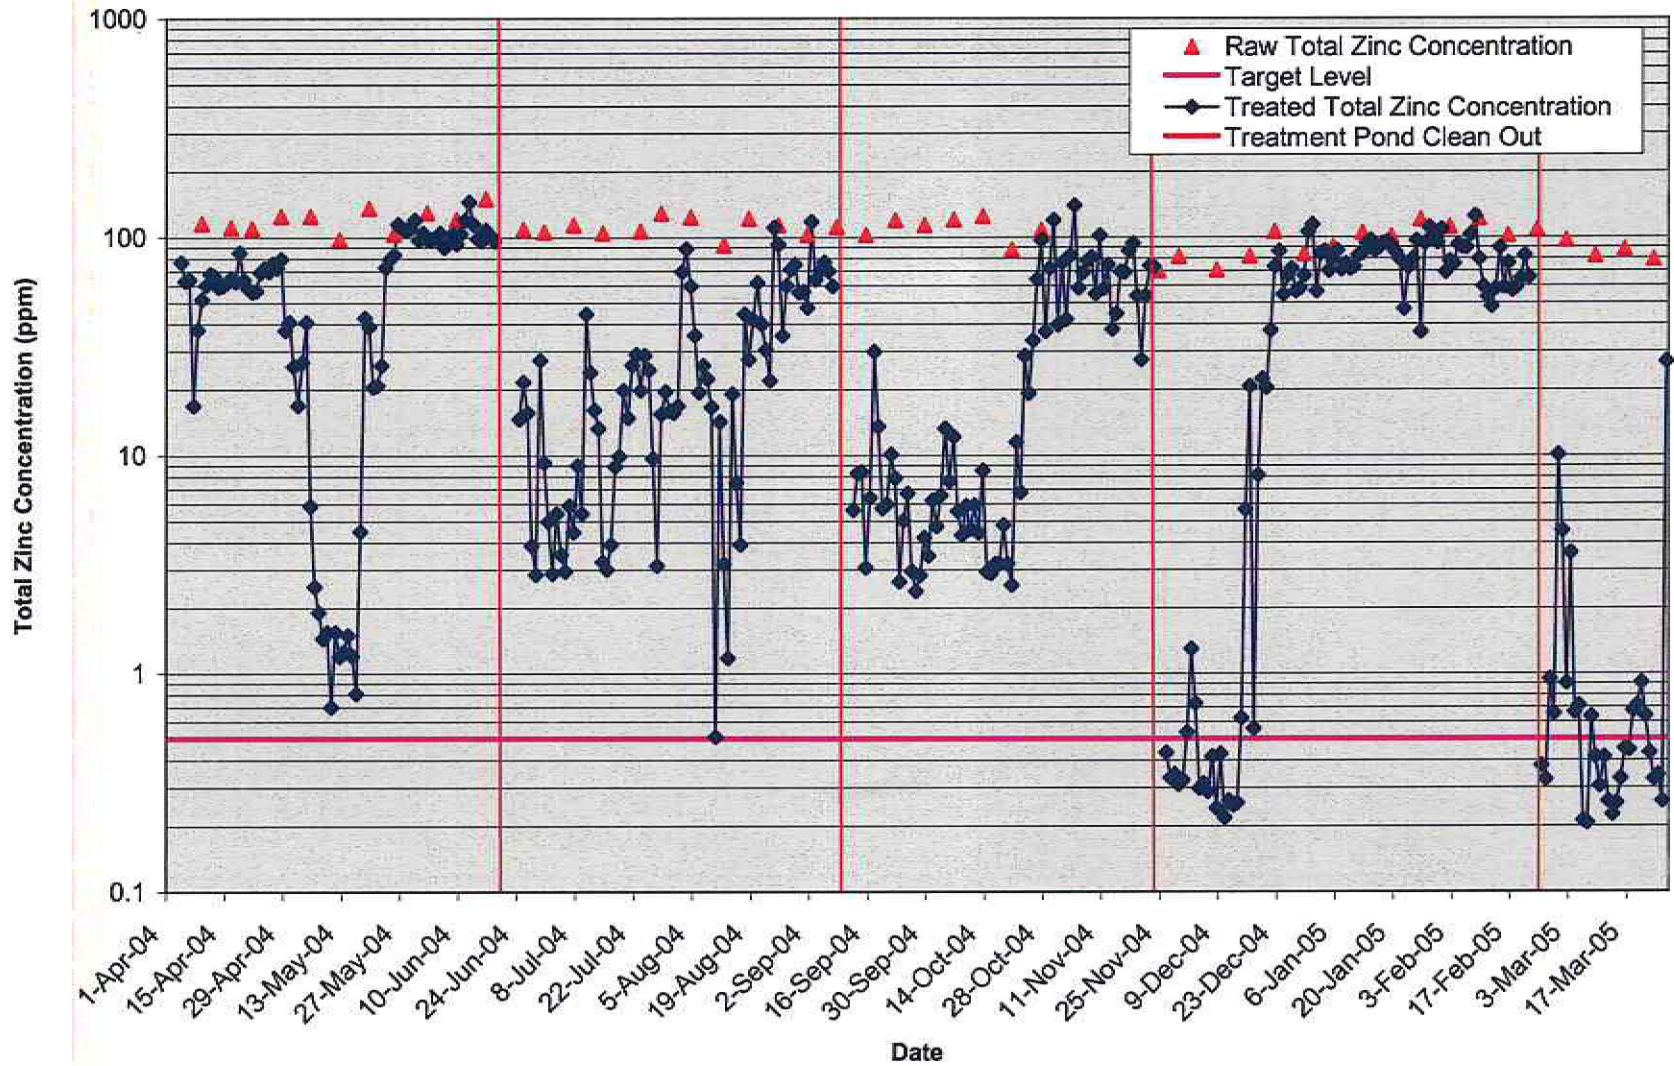
Figure 13 - Total Zinc Concentrations at Galkeno 300 (Raw Adit and Treated Effluent) from April 1, 2004 - March 26, 2005

Although it was anticipated that the system would be replaced by July of 2004, it continues to be in use, and requires clean out on an approximately 6-8 week cycle. Lime particulates and other precipitate matter is common in primary settling pond samples, and when the system nears capacity, total zinc levels spike to near untreated discharge levels.

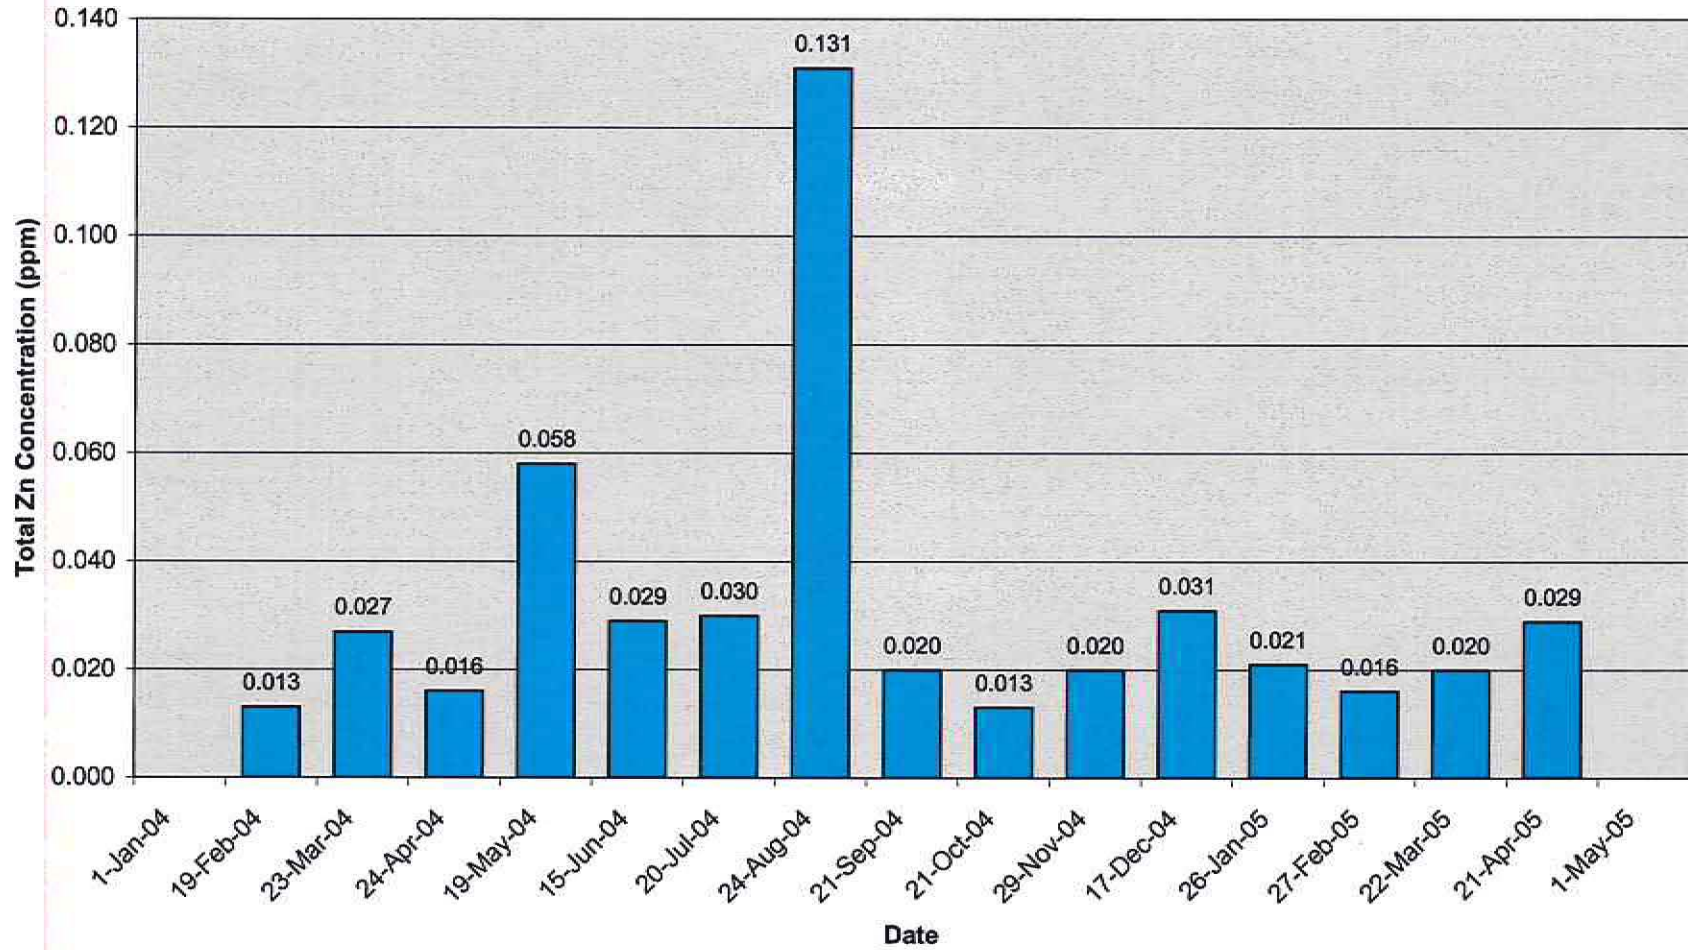
Figure 20 - Monthly Total Zn Concentration For South McQuesten River Upstream of Christal Creek (KV-1)

Figure 20 shows the background South McQuesten River total zinc concentrations at site KV-1. The August result for this site is suspect, not being in line with those concentrations normally seen at this site. Figure 21 and Figure 22 chart the total zinc concentrations at the sites along the South McQuesten River below the influence of Galkeno 300 flow via Christal Creek. Of note is that at both sites since June 2004, the total zinc concentrations have almost exclusively been below the Canadian Council of the Ministers of the Environment (CCME) standard for the protection of aquatic life (0.1 ppm).

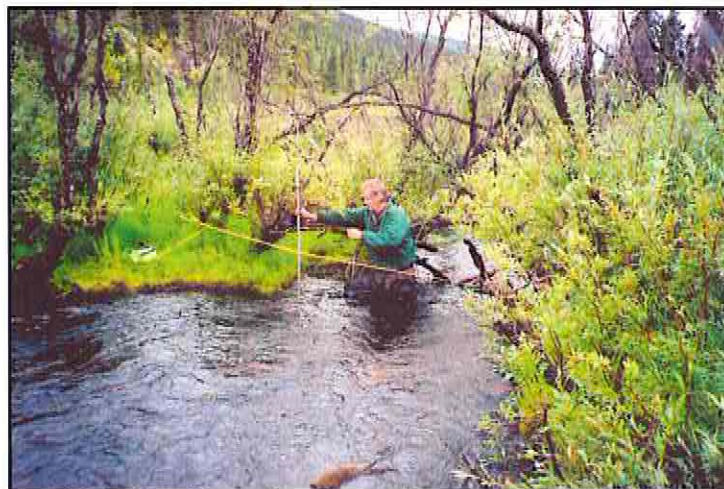
Plate 13 – Measuring stream flow parameters at KV-9

From the data gathered, it is concluded that the treated effluent flowing from the G300 treatment pond is still having an effect on Christal Creek and the South McQuesten River. CCME guidelines for aqueous zinc were exceeded at the downstream sites in both the total and dissolved phases. However, the upstream site KV-1 also exceeded the guideline in July 2004 (total sample only), suggesting input of metals-laden water from a source other than G300. When viewed in its entirety, the data set appears to present a trend towards declining metals concentrations in the receiving waters. It should be noted that there have been periodic spikes in metals concentrations over this time period, particularly at the sites close to Galkeno 300. Overall, concentrations were considerably lower back in August 2003 prior to the fugitive flow of Galkeno 300 creating any impacts.

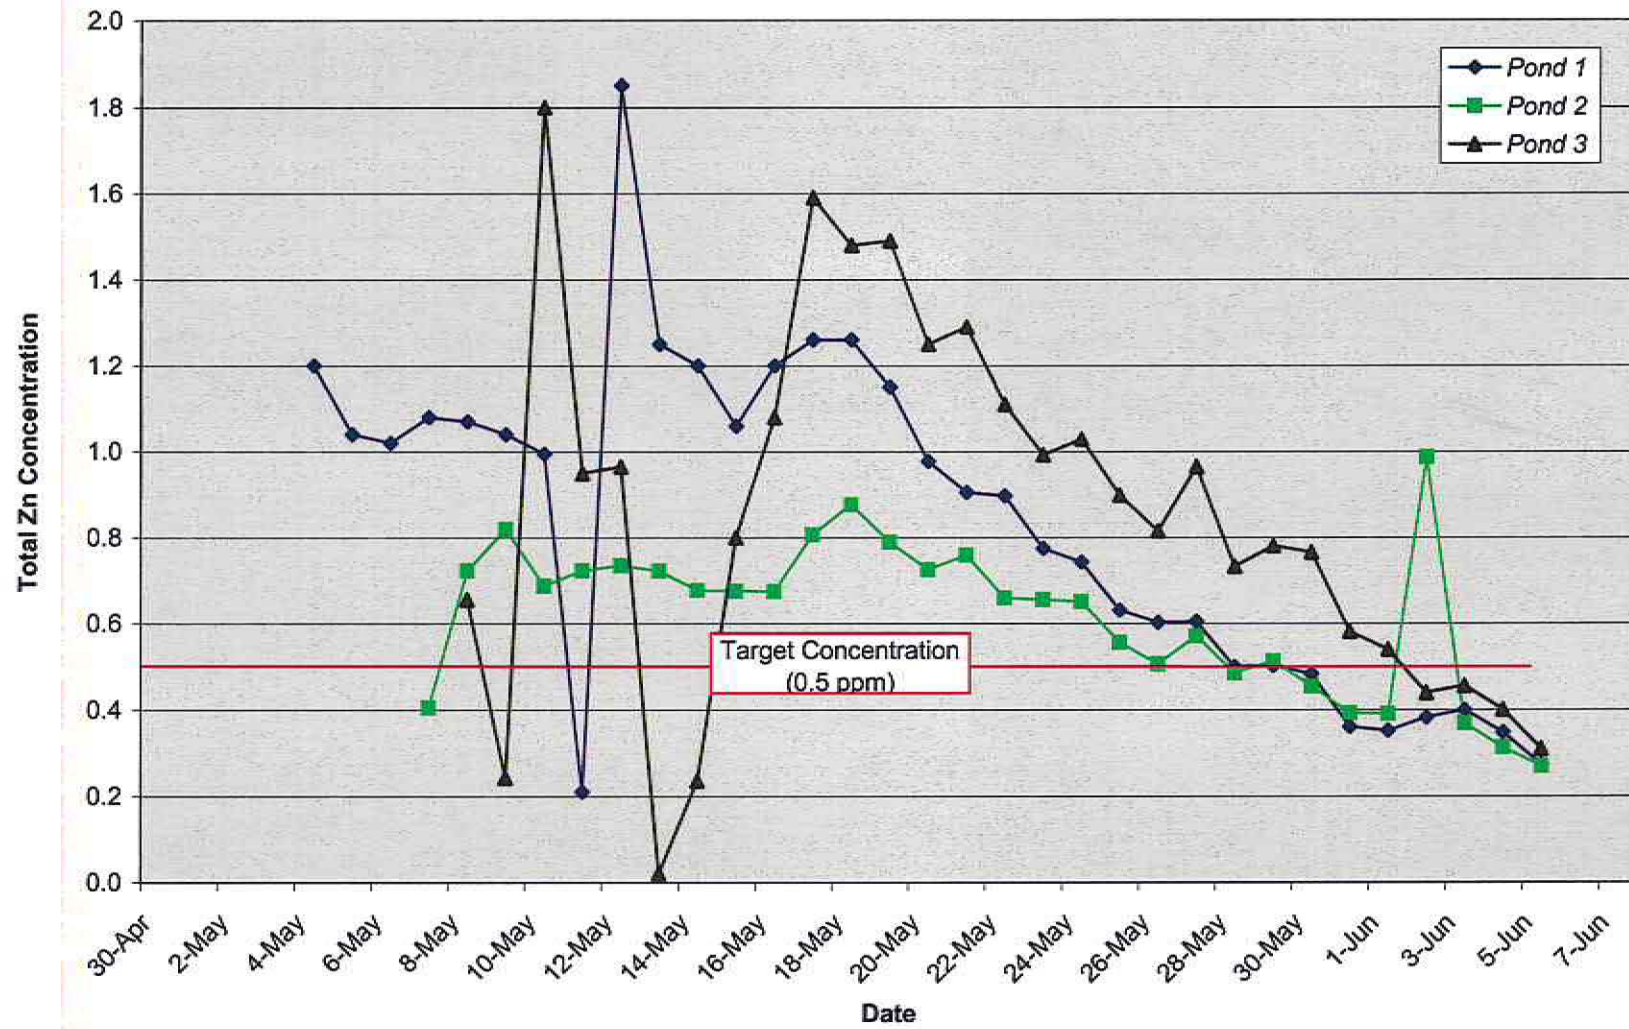
Figure 23 - Total Zn Concentrations at Valley Tailings Facility, Spring 2004

Twice daily sampling and staff gauge readings were conducted, and analytical staff analyzed and reported results for the VTF water on a daily basis. Water from the Pond No.3 decant ceased in July with the end of spring freshet, but was decanted again several times throughout the summer when high rainfalls raised the level of the tailings ponds. All decanting stopped for the year on August 10, 2004, when water levels dropped considerably until the next spring. From June 2 to August 10, 2004, the period in which the Tailings Pond No. 3 was decanting, the average pH and total zinc concentrations of the discharge were 8.9 and 0.09 ppm respectively.
