**GOVERNMENT OF YUKON ENERGY, MINES AND RESOURCES -  
ASSESSMENT AND ABANDONED MINES**

# **Clinton Creek Engineering Review and Assessment**

## **Part 1**

307071-00997-00-SS-REP-0001

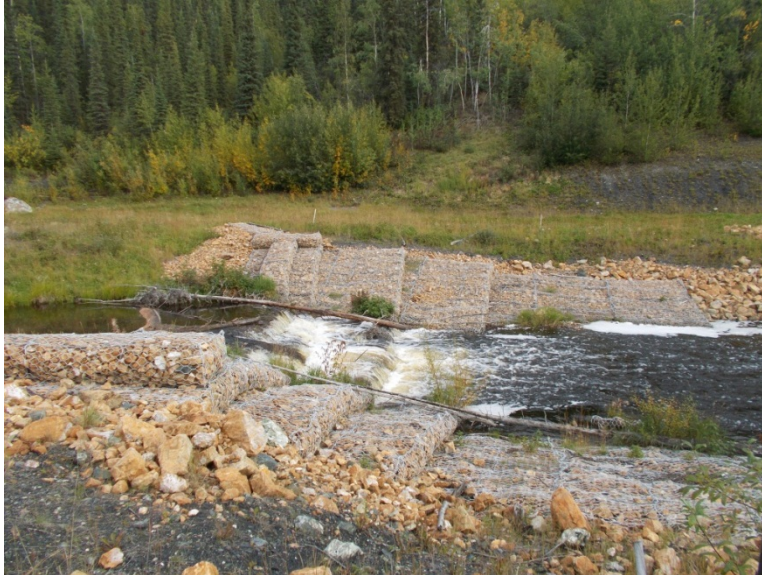
**Photo 24: DS1 looking north.**

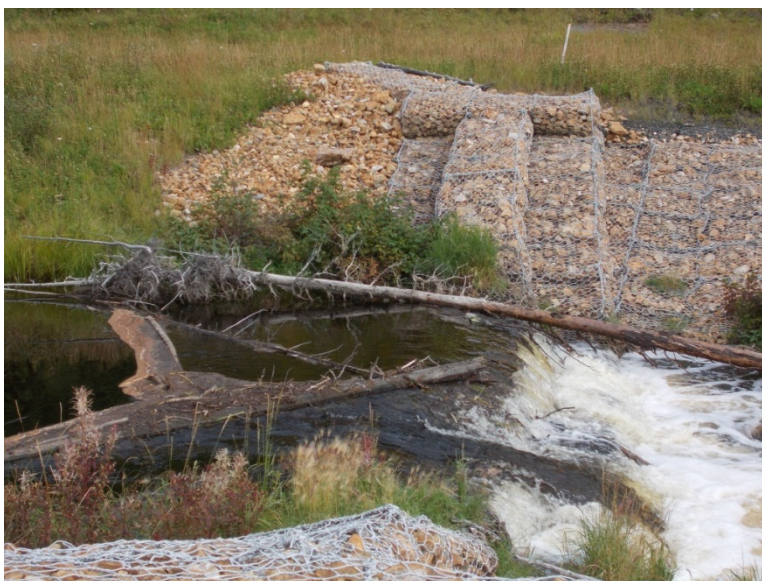
**Photo 25: DS1 looking north.**

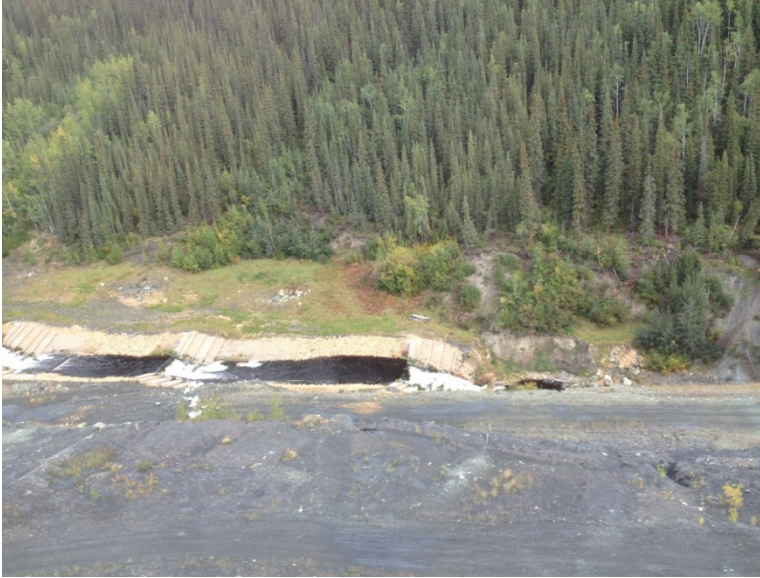
**Photo 46: Drop structures looking north.**

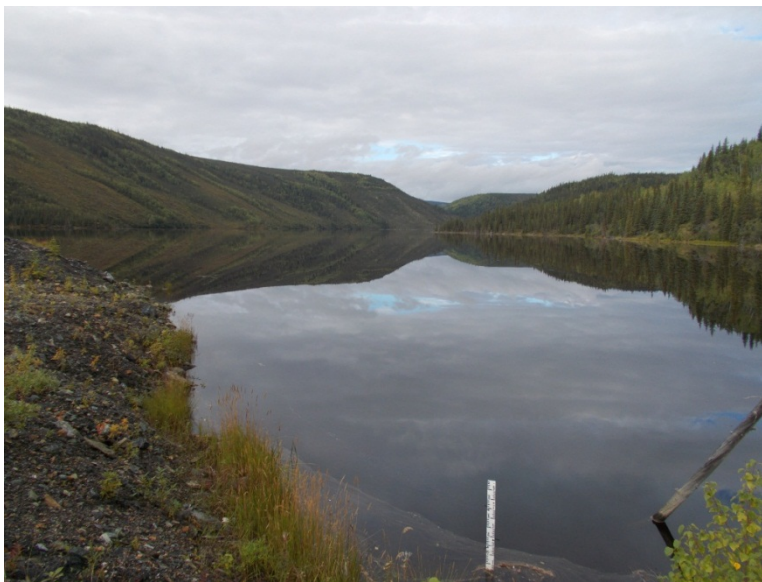
**Photo 51: Hudgeon Lake water level gauge looking west.**
