**GOVERNMENT OF YUKON ENERGY, MINES AND RESOURCES -  
ASSESSMENT AND ABANDONED MINES**

# **Clinton Creek Engineering Review and Assessment**

## **Part 2**

307071-01014-00-SS-REP-0001

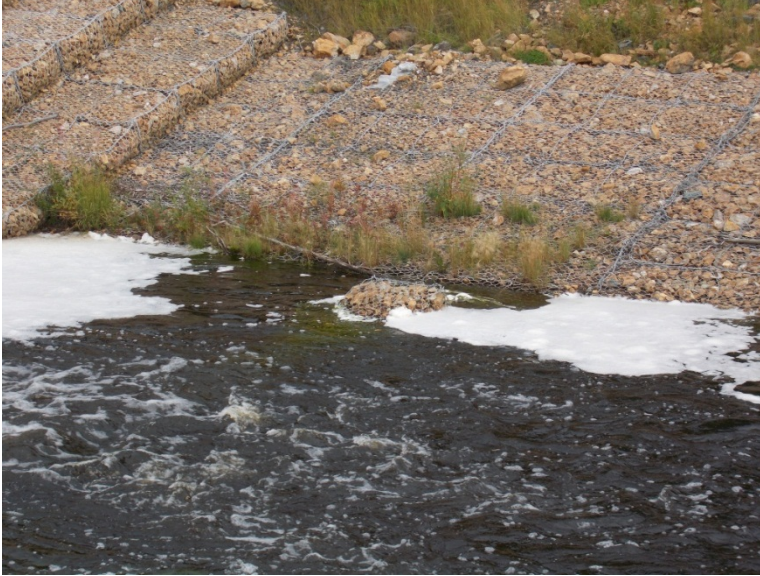
**Photo 32: Vertically displaced gabion basket at DS3 looking north.**

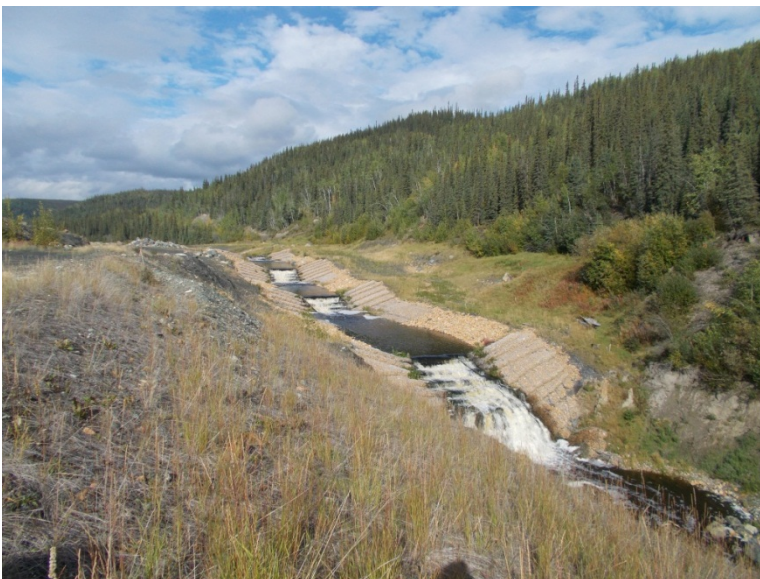
**Photo 43: Drop structures looking northwest.**

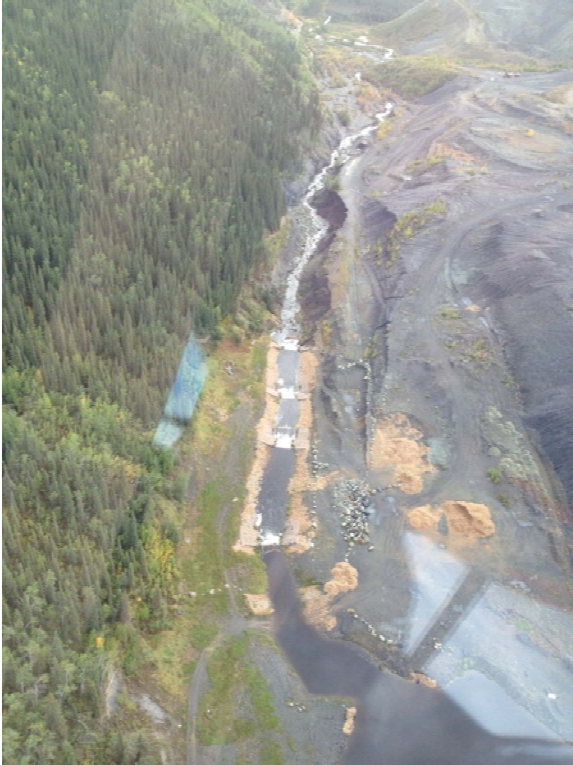
**Photo 44: Drop structures looking east.**

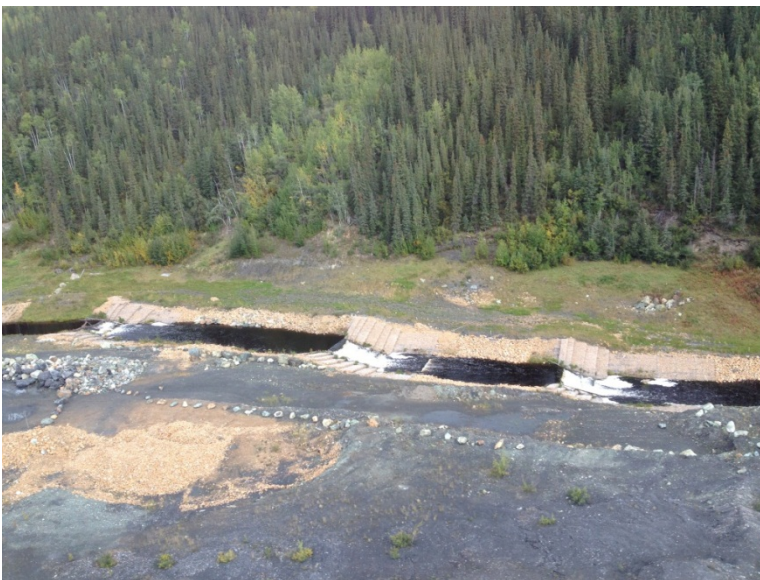
**Photo 45: Drop structures looking north.**

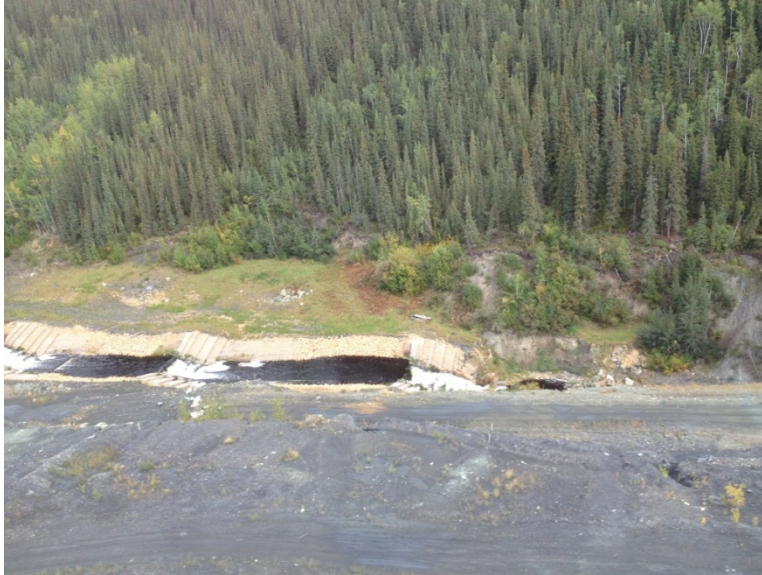
**Photo 46: Drop structures looking north.**

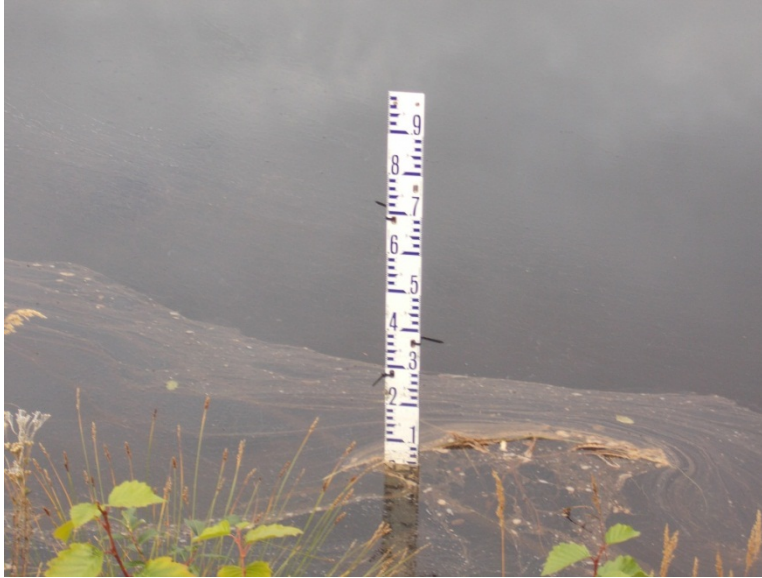
**Photo 50: Hudgeon Lake water level gauge looking west.**

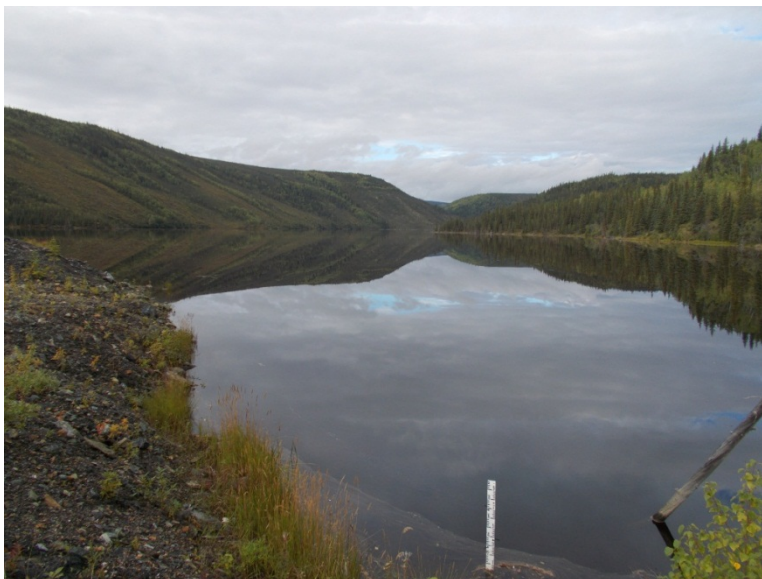
**Photo 51: Hudgeon Lake water level gauge looking west.**

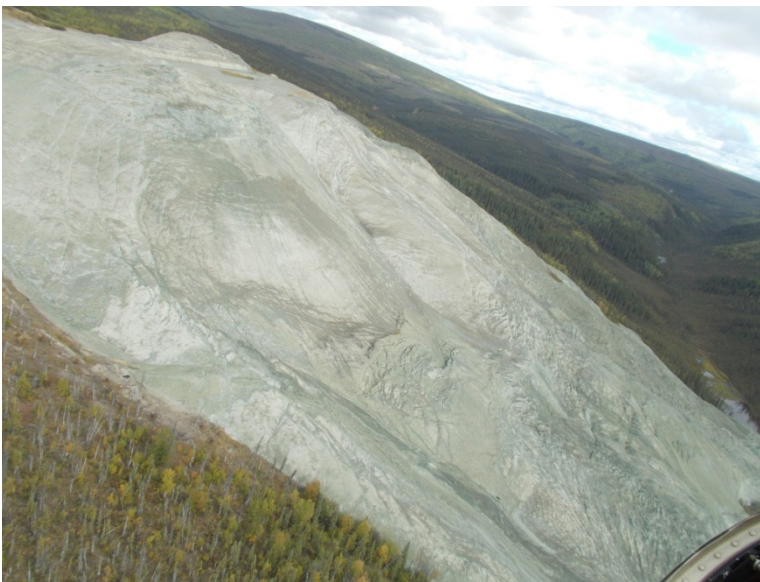
**Photo 55: Tailings slope looking north.**

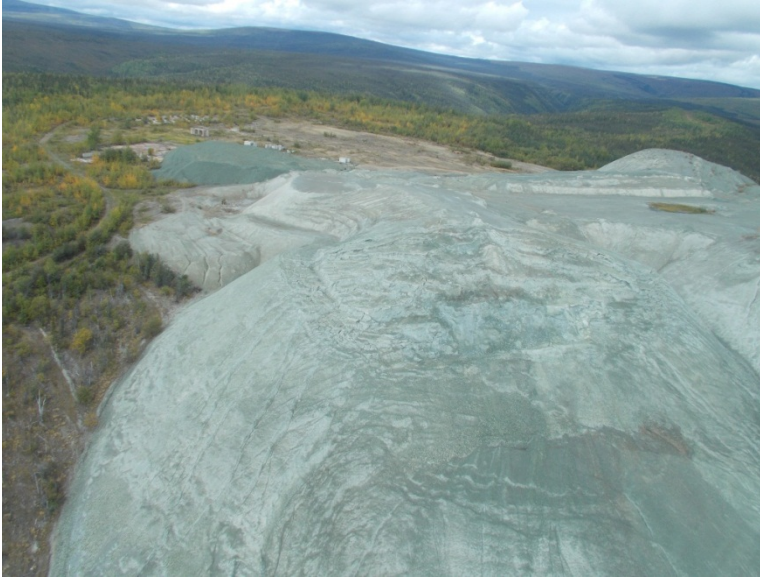
**Photo 56: Tailings slope looking west.**

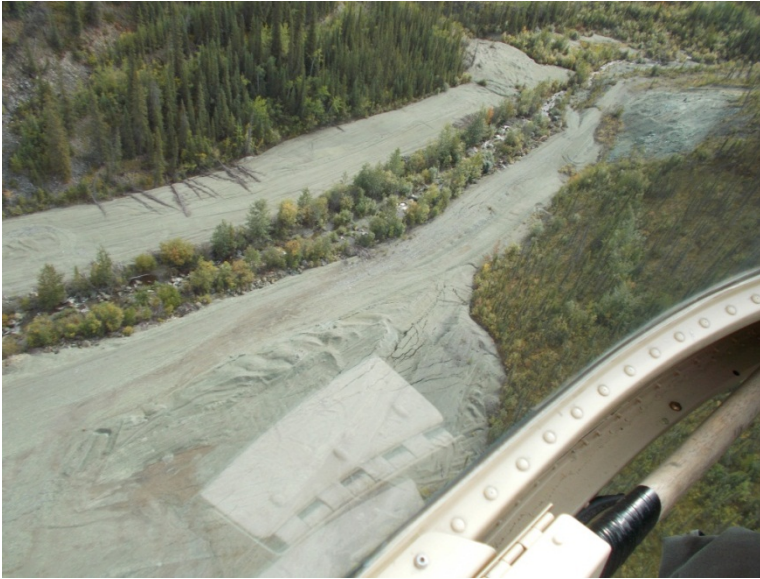
**Photo 58: Tailings slope and Wolverine Creek looking southeast.**

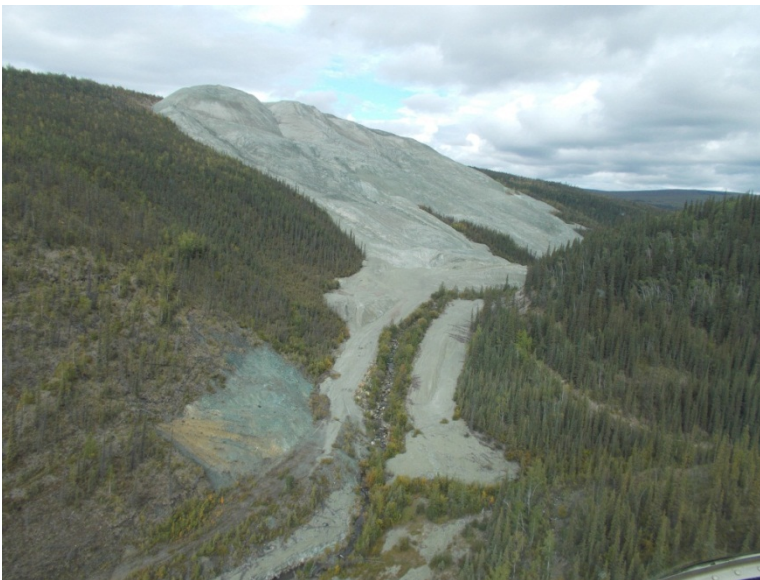
**Photo 59: Tailings slope looking northwest.**

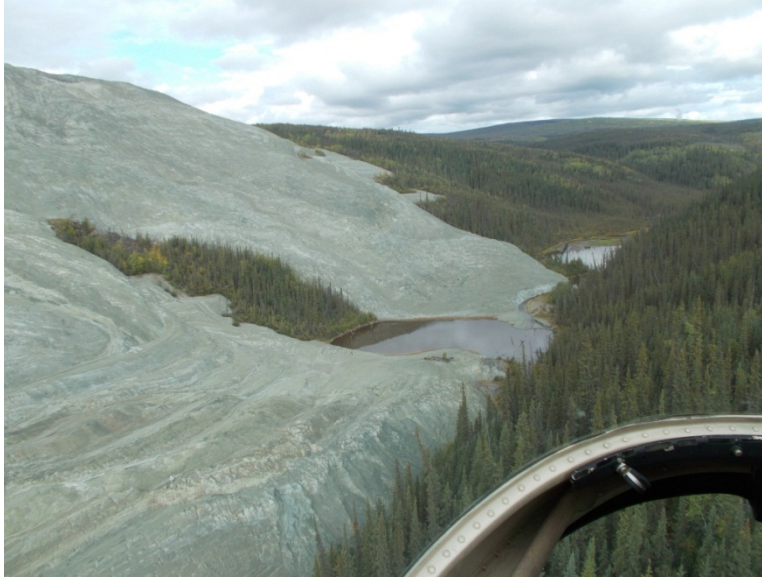
**Photo 60: Tailings slope looking northwest.**

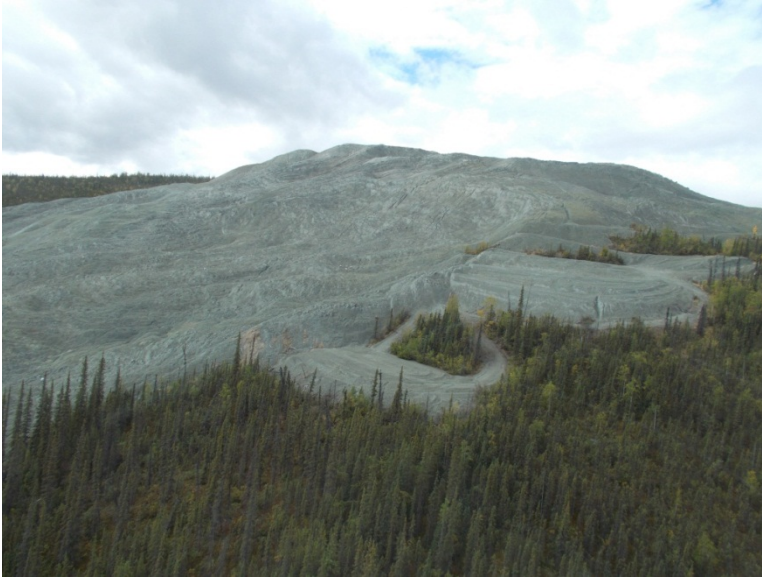
**Photo 62: Tailings slope looking southwest.**

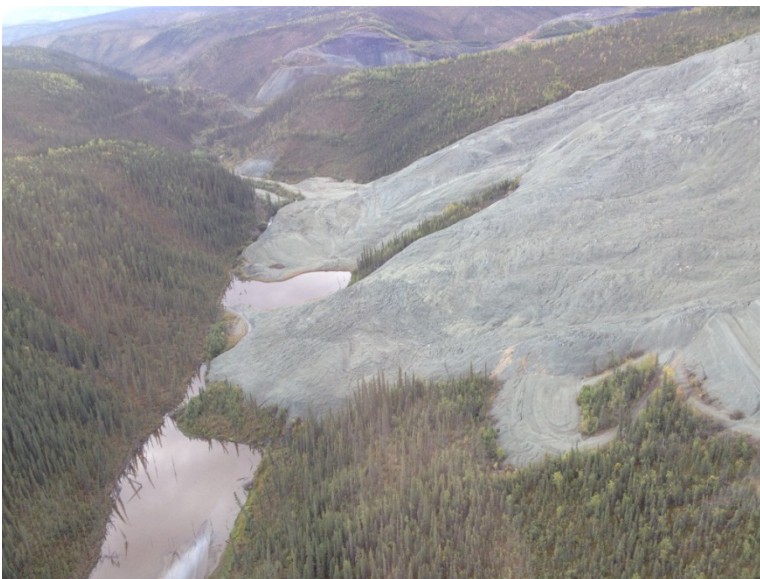
**Photo 65: Tailings slope and tailings pond looking south.**

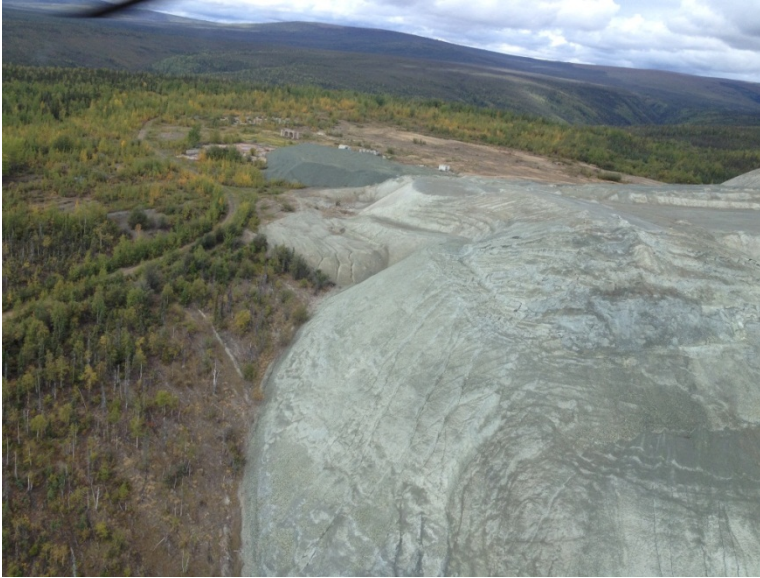
**Photo 66: Tailings slope looking southwest.**

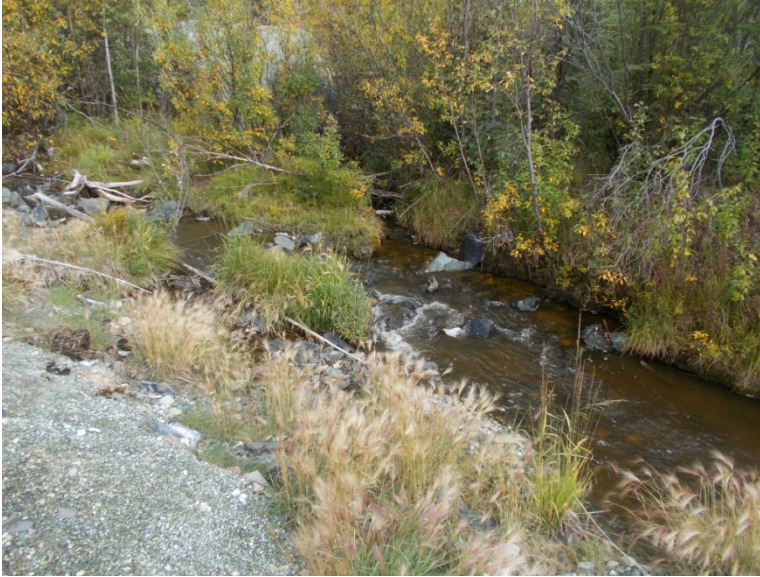
**Photo 72: Wolverine Creek near confluence with Clinton Creek looking south (downstream toward access road).**

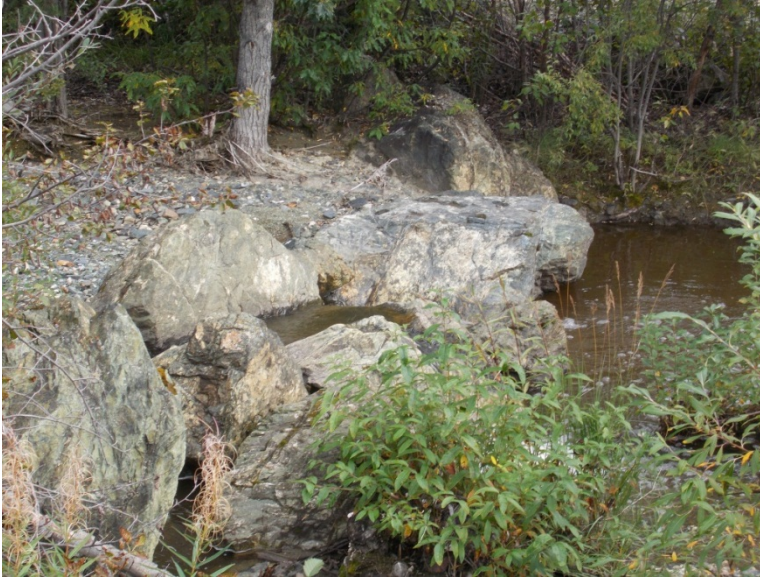
**Photo 77: Wolverine Creek north of confluence with Clinton Creek looking east.**

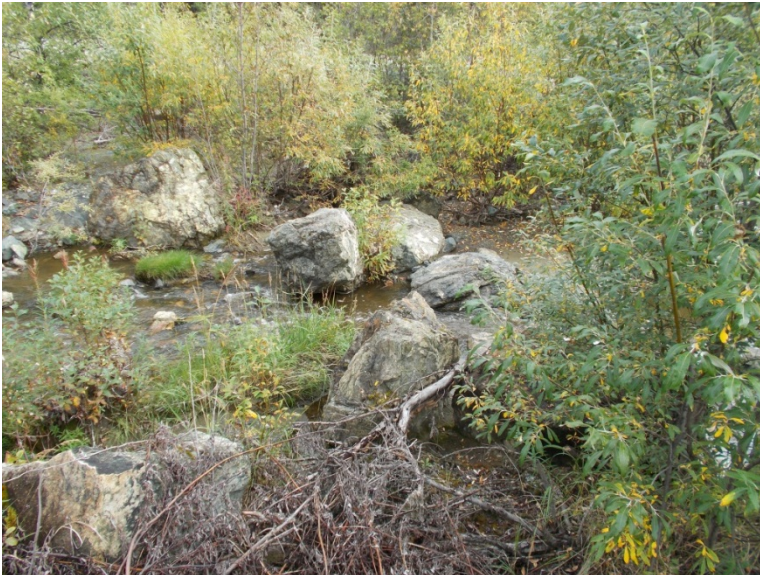
**Photo 78: Wolverine Creek north of confluence with Clinton Creek looking east.**

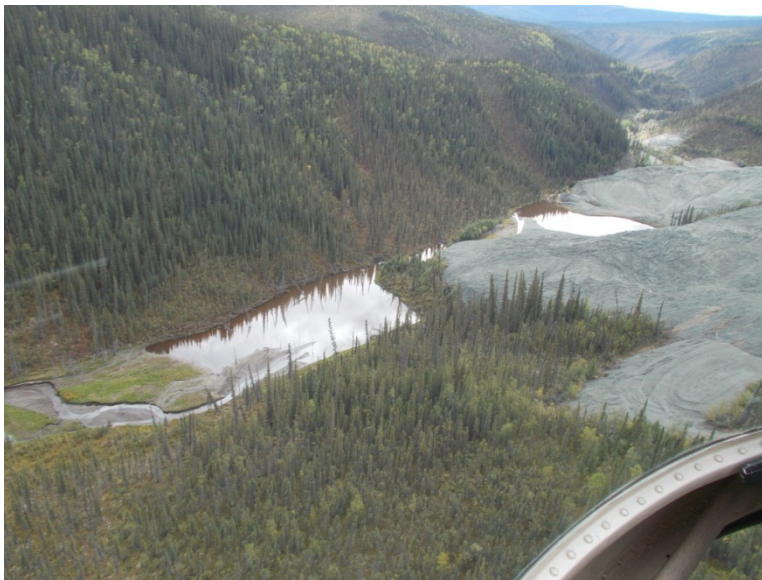
**Photo 81: Wolverine Creek tailings ponds looking southeast.**
