Clinton Creek Long-Term Performance Monitoring Program

2016 Survey Results

December 12, 2016

307071-01132-00-GT-REP-0001

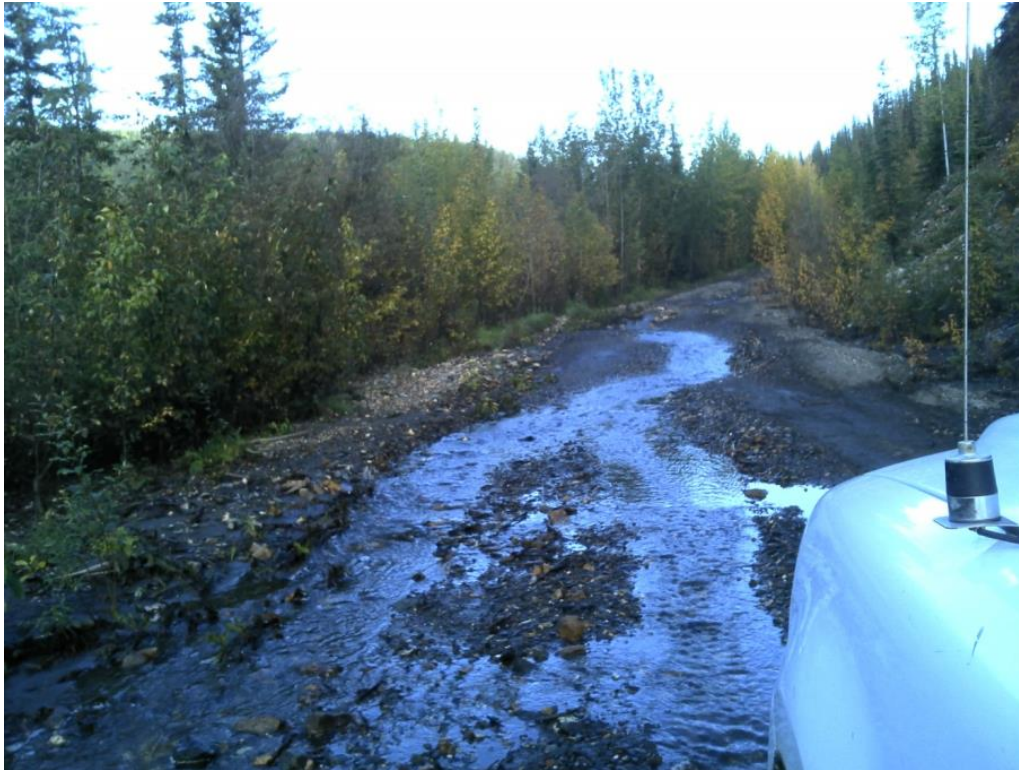
The site access road appeared in relatively good shape in June, 2016 aside from two washed out culverts, which have since been repaired. However, several landslides and erosion caused by runoff across the road were observed at the end of August. These slides were likely to have occurred during or shortly after heavy rainfall recorded on August 6, 2016 (23 mm in one hour).

Photo B **Clinton Creek Site Access Road – Erosion (August 29, 2016)**

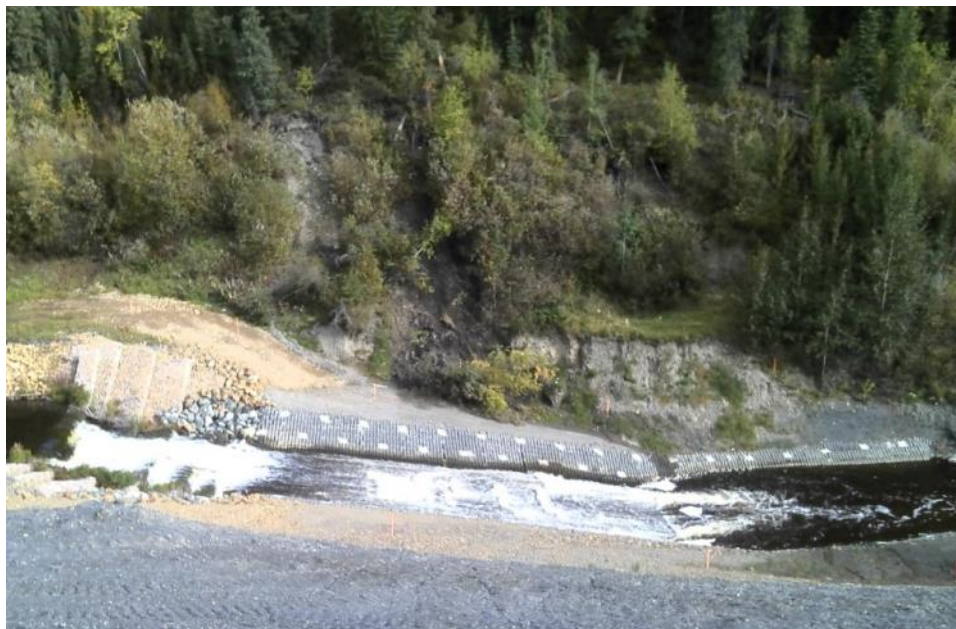
On the Drop Structure 4 (DS4) ACB channel, centreline mats fourth through eighth from the top have experienced some degree of sliding or buckling. This occurred in late April, 2016 during peak freshet flows. The duckbill anchors now appear to be engaged and securing the mats in place. Some erosion of the stabilized slope to the south of DS4 was observed in September, 2016 and was likely caused by either the heavy rain recorded on August 6, 2016 or an issue with the runoff diversion ditch at the crest of the slope. The hazard associated with this erosion is the subsequent deposition of eroded fines into Clinton Creek. A landslide was also observed in September and likely occurred during or shortly after the heavy rain on August 6, 2016. The landslide does not appear to have impacted the ACB channel.

Photo G Landslide near DS4, looking north (August 31, 2016)

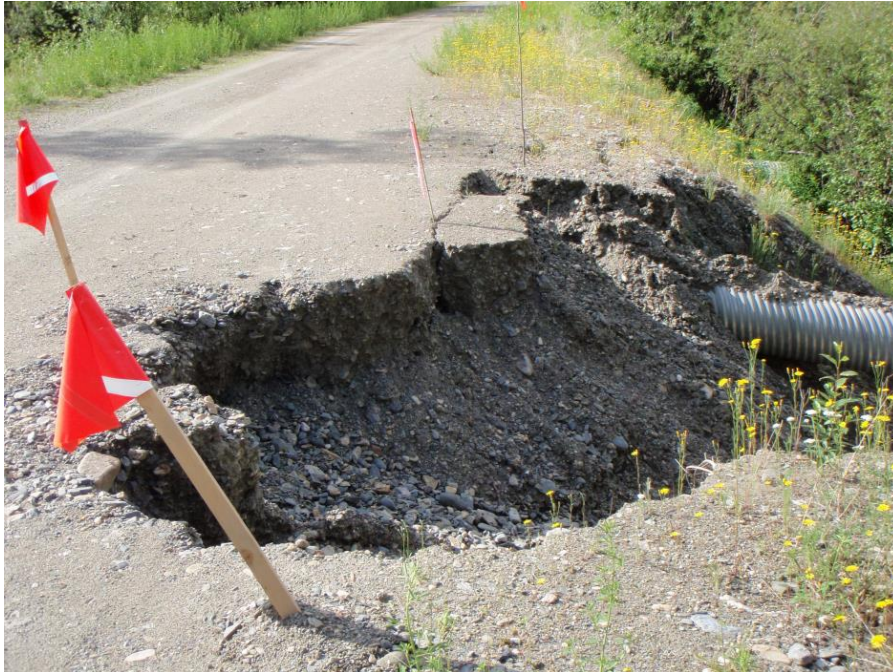
Photo 1 **Washed out Culvert (looking at outlet) 500 m south of Forty Mile Bridge**

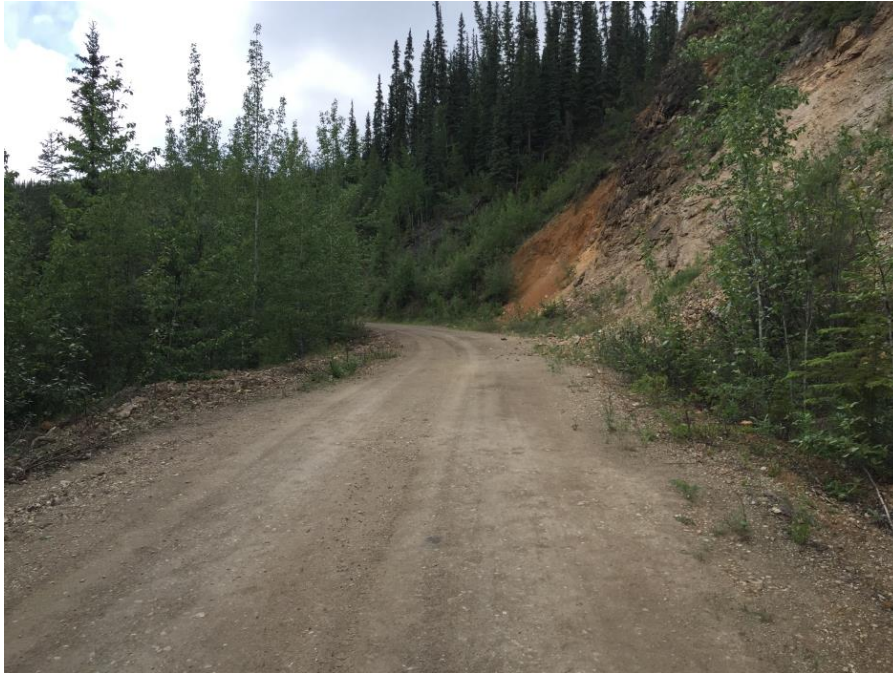
Photo 2 Typical Road Conditions

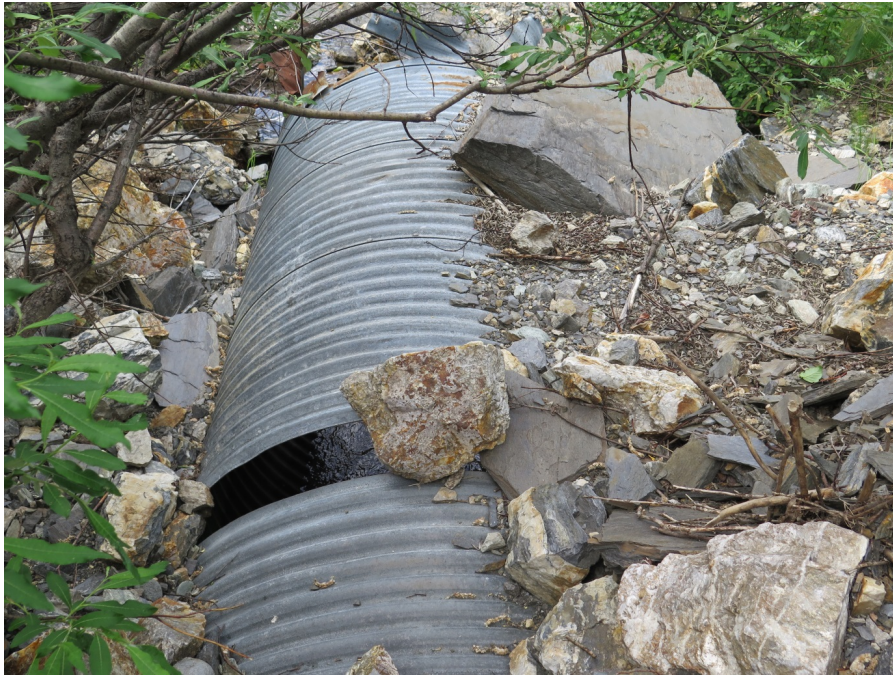
Photo 4 **Washed out Culvert (looking at outlet) 5 km from the
Forty Mile Bridge**

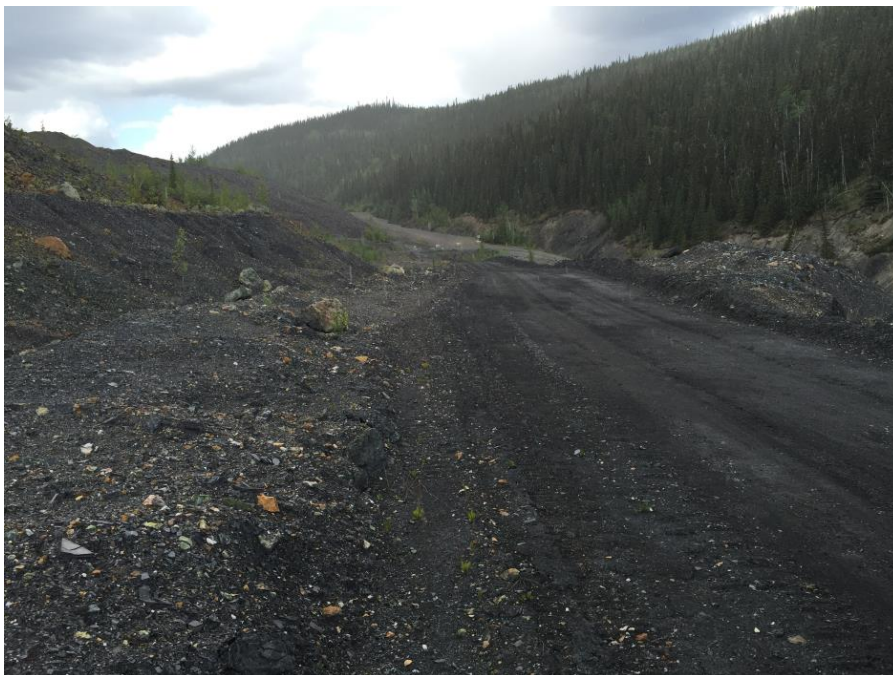
Photo 6 **Typical Road Conditions (looking west towards closed road)**

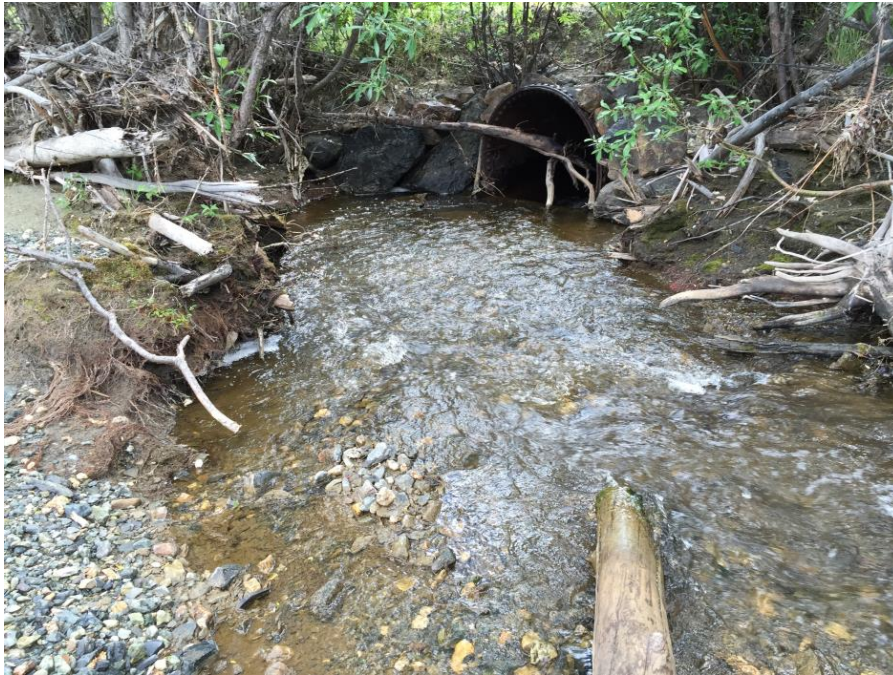
Photo 7 Wolverine Creek low flow culvert, inlet – lodged debris

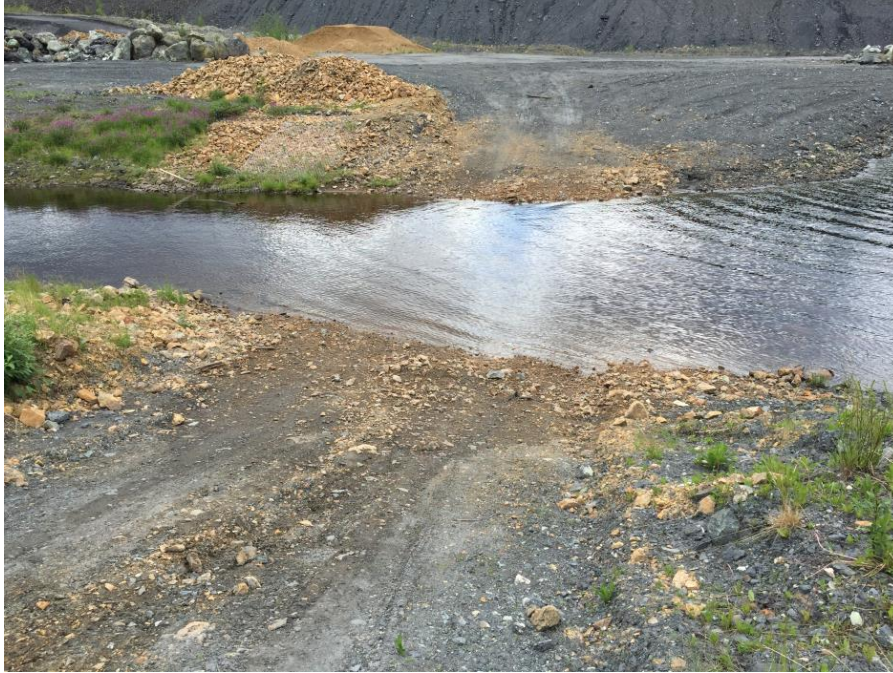
Photo 8 **Fording No. 2 looking south**

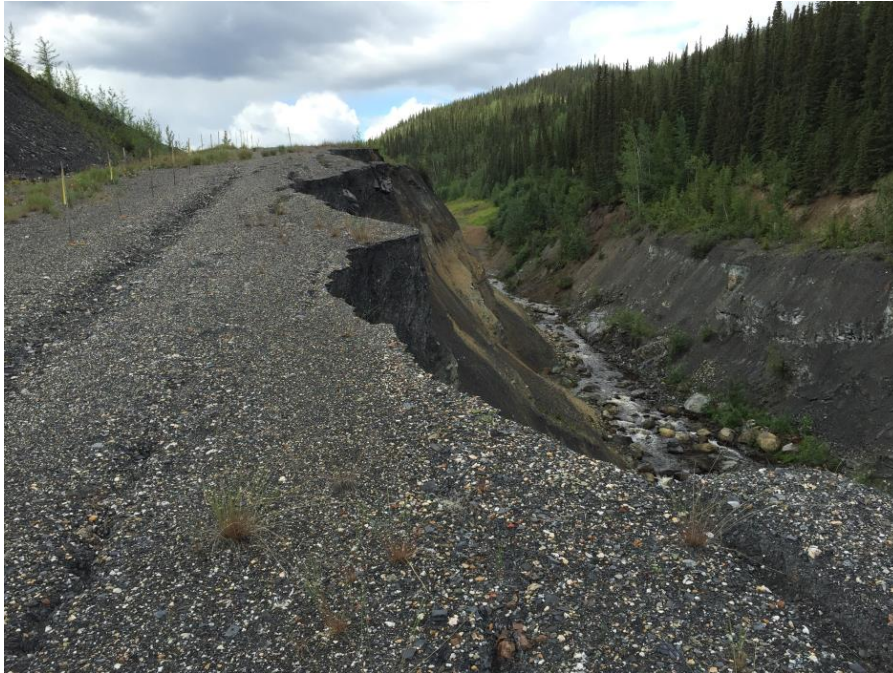
Photo 9 **Closed access road looking west – slope continues to slide into Clinton Creek**

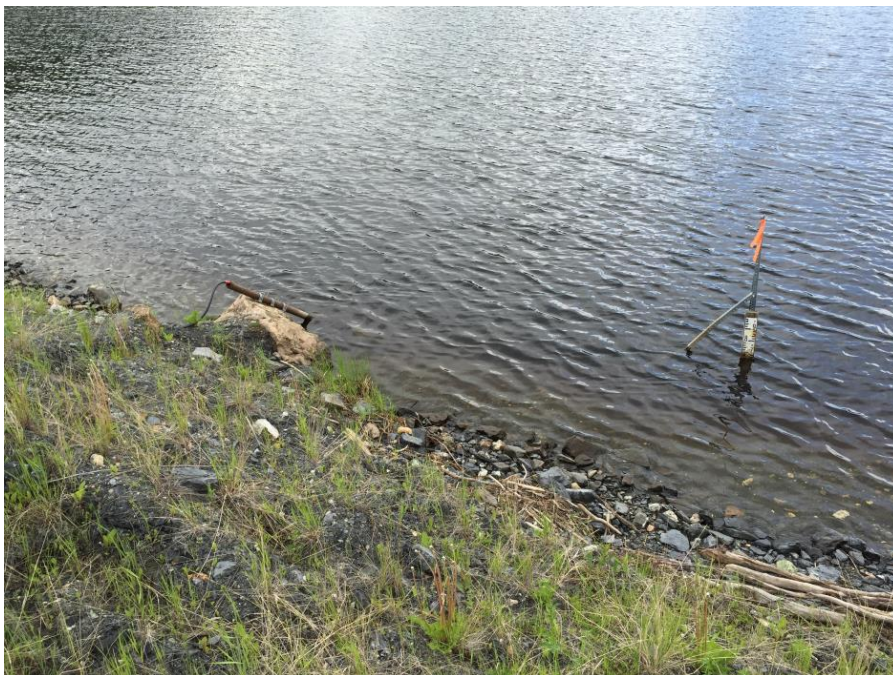
Hugdeon Lake Outlet	<p>The lake outlet is clear with the exception of a piece of rusted metal near the north bank. The Hugdeon Lake pressure transducer and data logger appear in good condition.</p>
Log Booms	<p>The booms have numerous scratches and gouges up to an estimated 1 cm deep. However, this depth is a small fraction of the HDPE wall thickness of approximately 9 cm (800 cm OD, DR9). No other evidence of structural damage was observed on the booms. There appears to be some cracking in the seals at the ends of each boom where the HDPE pipe fits into the steel sleeve (Photo 15 in Appendix 3). It cannot be confirmed from this inspection whether the booms are watertight. However, the booms are filled with polystyrene and should float even in the event of a leak.</p> <p>No evidence of structural damage or wear was observed on the log boom abutments. Little to no evidence of erosion or loss of rock armouring around the boom abutments was observed. Top of sediment was measured to be at an elevation of approximately 411.53 cm at the north bank abutment and 411.44 cm at the south bank abutment. Small cracks observed in the soil around the north bank abutment (Photo 13 in Appendix 3) may be an indication of movement or subsidence of the abutment area. These cracks were not noted in the 2015 LTPMP report.</p>

Photo 11 **Level logger and staff gauge installed in Hugdeon Lake in 2015**

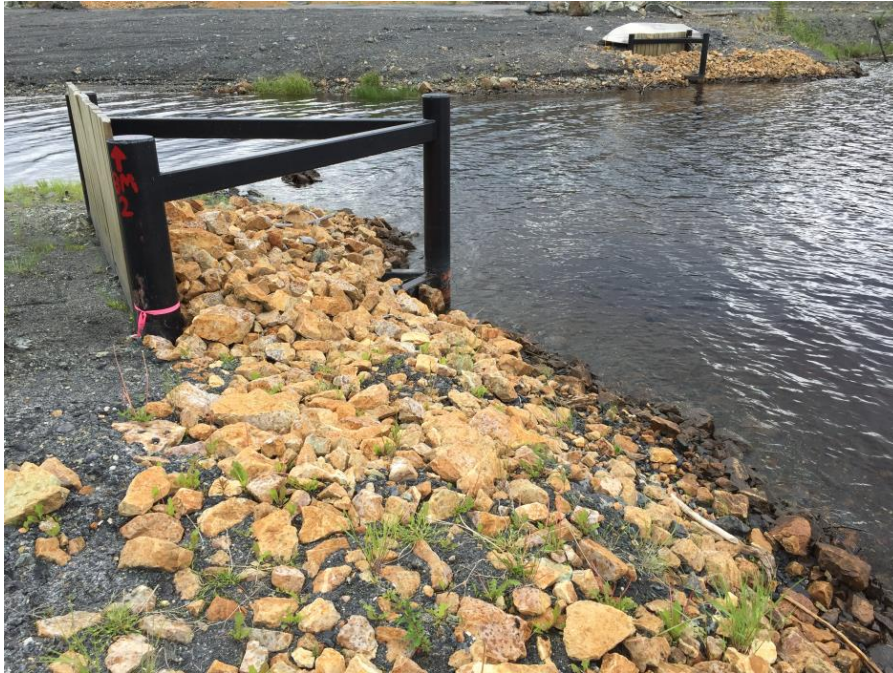
Photo 12 North Boom Abutment, looking south

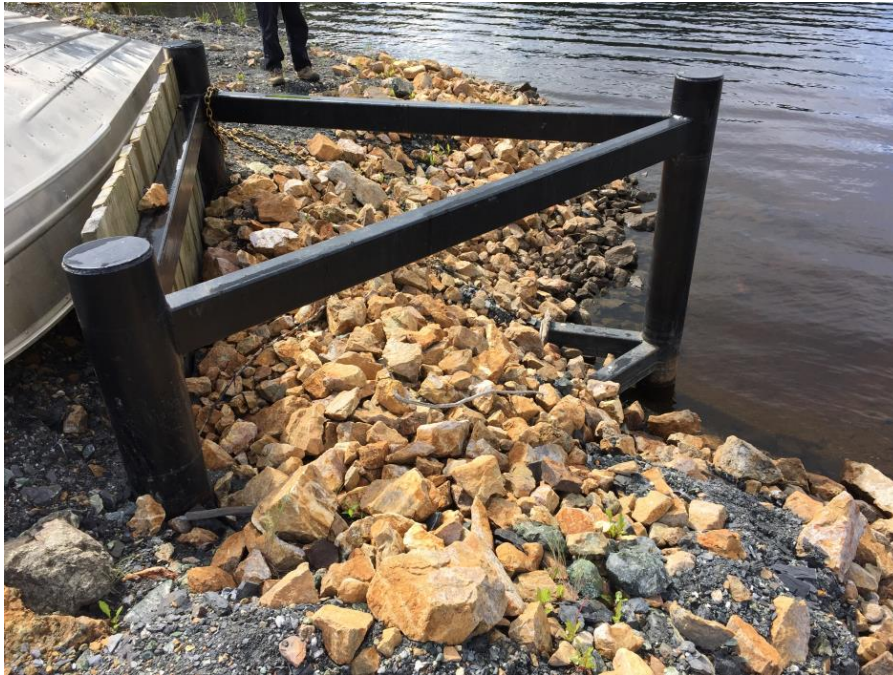
Photo 14 **South Boom Abutment, looking west**

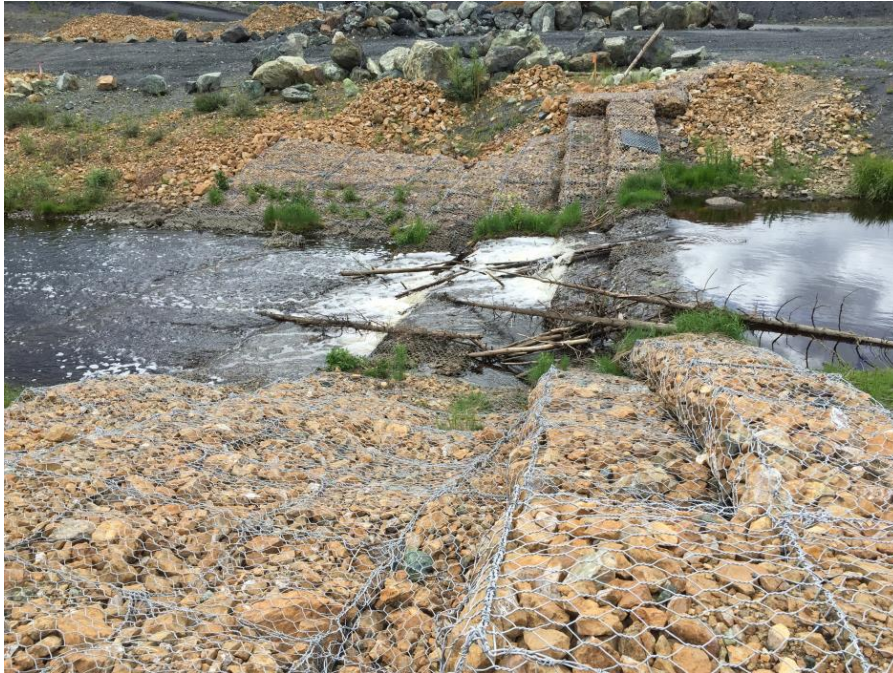
Photo 17 Drop Structure 1, looking south

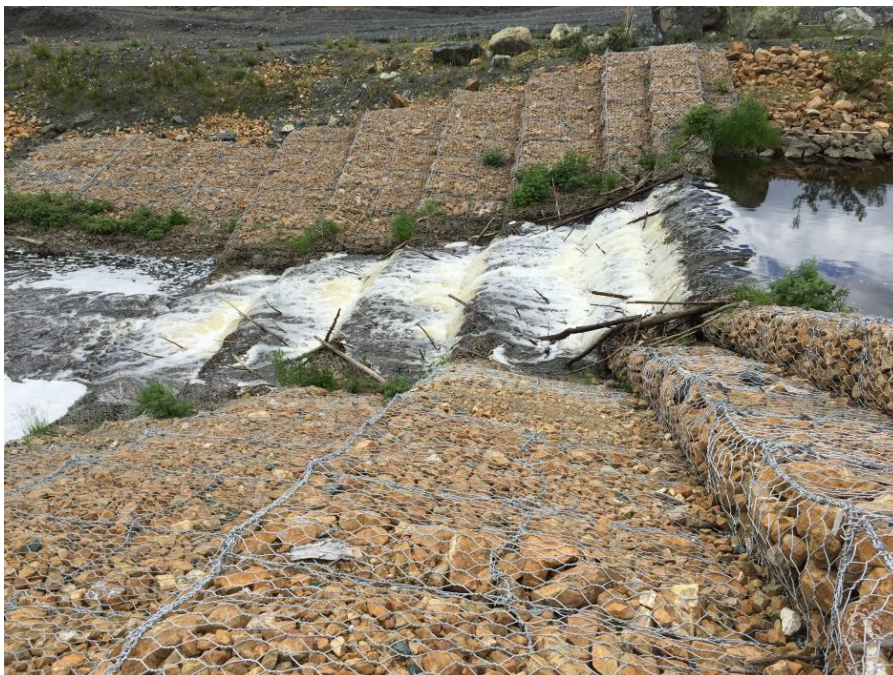
Photo 18 Drop Structure 2, looking south

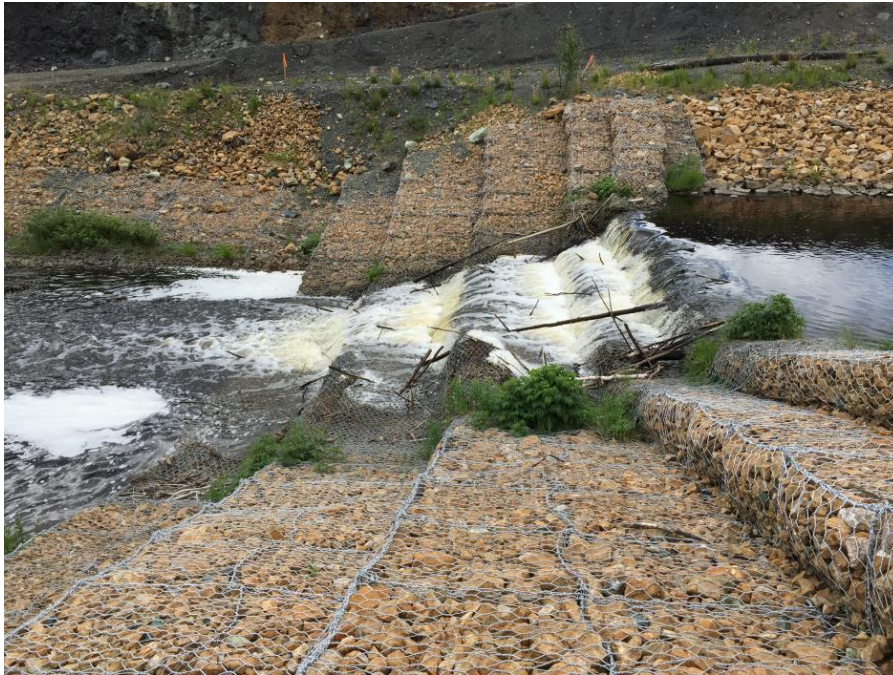
Photo 19 **Drop Structure 3, looking south**

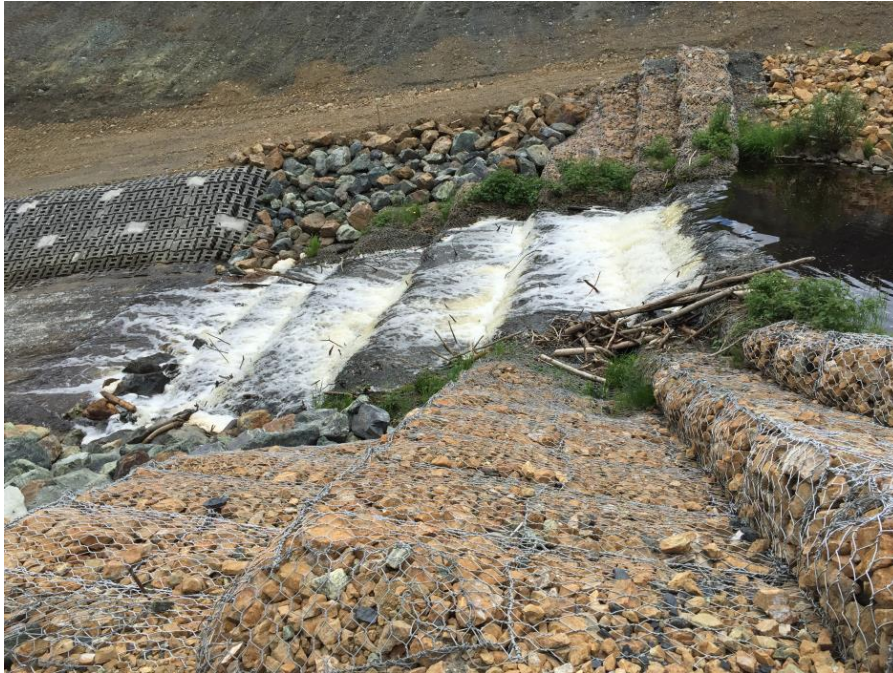
Site Component	Observations
Drop Structure 4	<p>On June 21, 2016 several potential issues with the DS4 articulated concrete block (ACB) mats, constructed in September, 2015, were noted. Photos 20 to 26 in Appendix 3 show the condition of the ACB channel. Observations of DS4 include the following:</p> <ul style="list-style-type: none"> ▪ The stabilized slope to the south of DS4 was in good condition with no signs of erosion. ▪ Individual concrete blocks appear to be in similar condition as installed. No instances of significant concrete cracking or spalling beyond the acceptable limits outlined in the construction specifications were observed. ▪ No signs of erosion were observed immediately downstream of DS4 when compared with photos from September, 2015, suggesting adequate energy dissipation in the stilling basin. ▪ Some small debris was lodged in the concrete blocks, including broken fragments that may have been a part of larger debris, similar to what was observed in the gabion drop structures. ▪ The centre mat fourth from the top appears to have shifted downstream by approximately one block width (0.4 m) at the channel centreline, but is held in place along the edges, which are secured with rebar and grout. The centre mat fifth mat from the top has buckled as a result. The duckbill anchors appear to be engaged and, in conjunction with the grouted edges, are holding both mats in place. ▪ The centre mat seventh from the top has buckled slightly and is held in place by the duckbill anchors and grout along the edges. ▪ Two blocks on the left bank mats eighth and tenth from the top are partially overturned, potentially as a result of the buckled mats directing more flow towards the left bank. ▪ The upstream edges of centre mats sixth and eighth from the top have lifted slightly, possibly as a result of impinging flow caused by the buckled mats upstream. ▪ The two grouted trenches running parallel to the channel banks appear to be in good condition.

Photo 20 Drop Structure 4, looking south

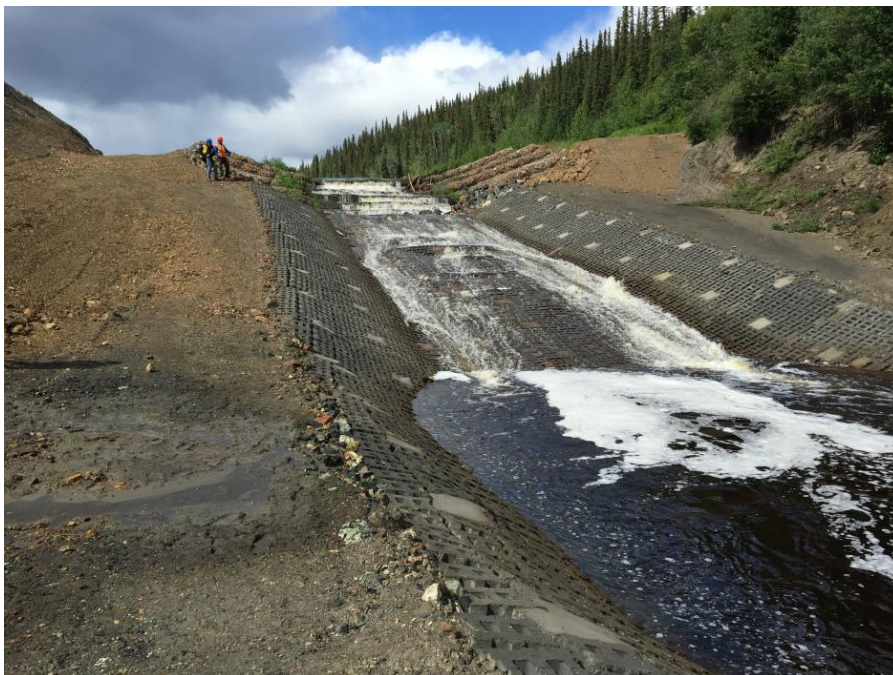
Photo 21 DS4 Repair – ACB Channel looking west

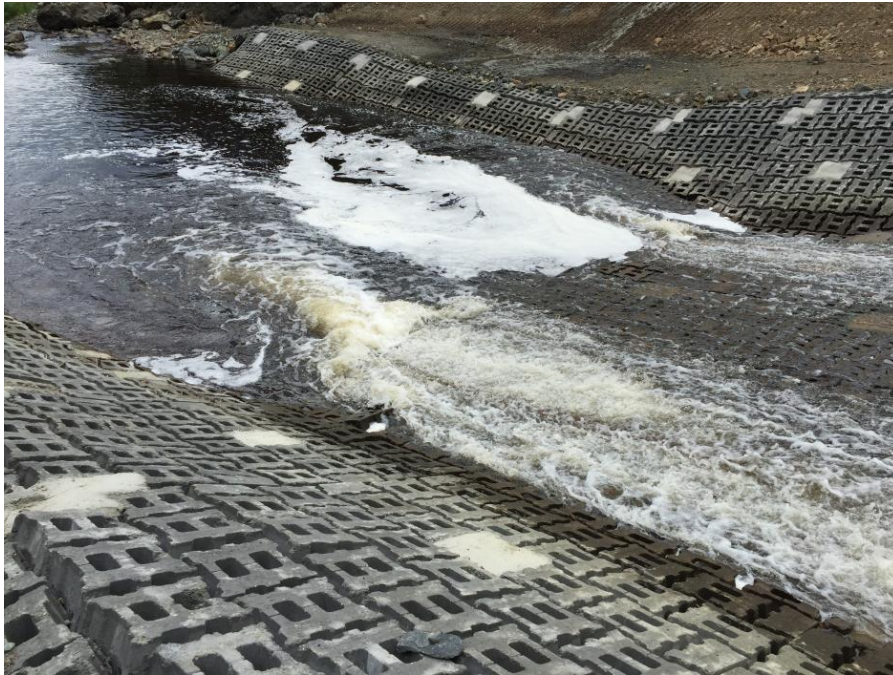
Photo 24 **DS4 Repair – ACB Channel looking southeast at Stilling Basin**

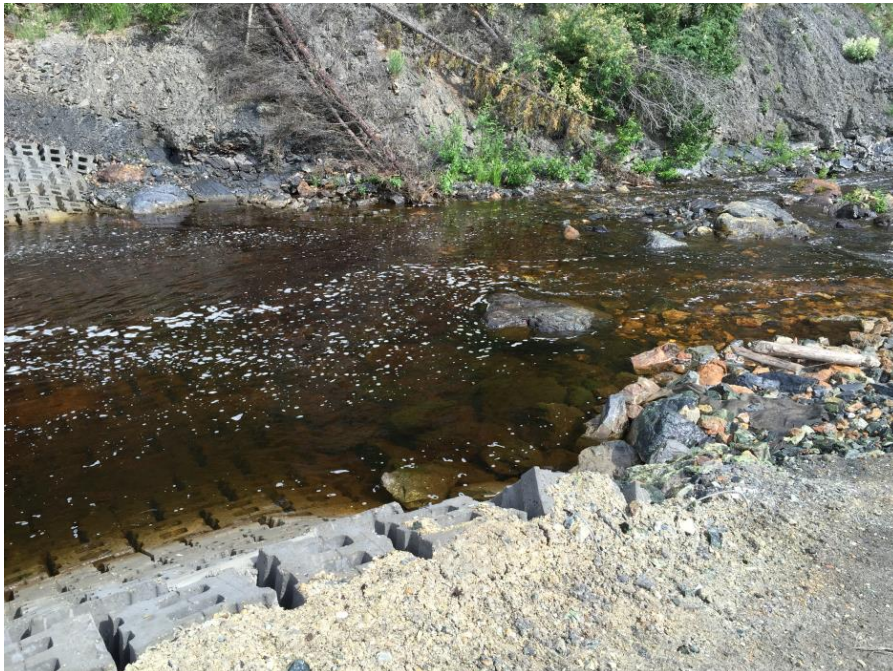
Photo 25 **DS4 Repair – ACB channel looking north at outlet**

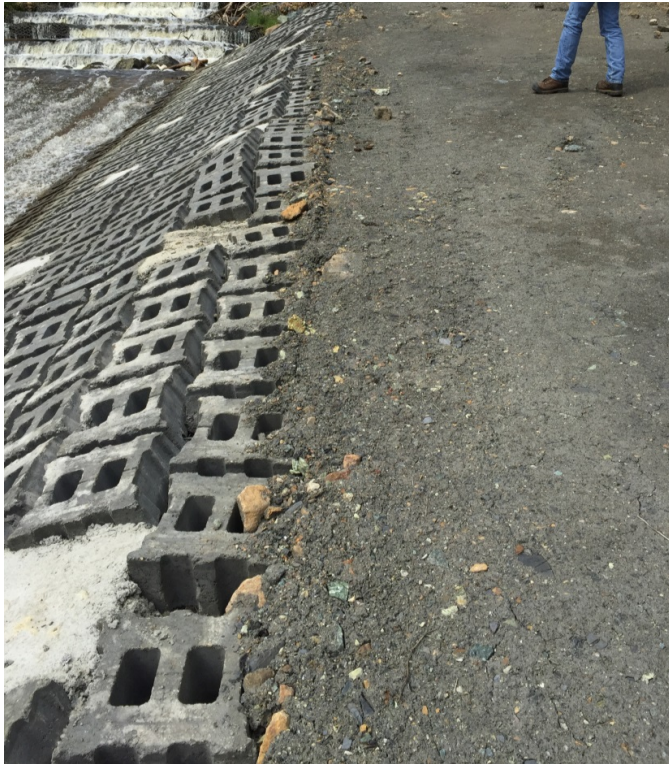
Photo 26 **DS4 repair – ACB channel Anchor Trench**

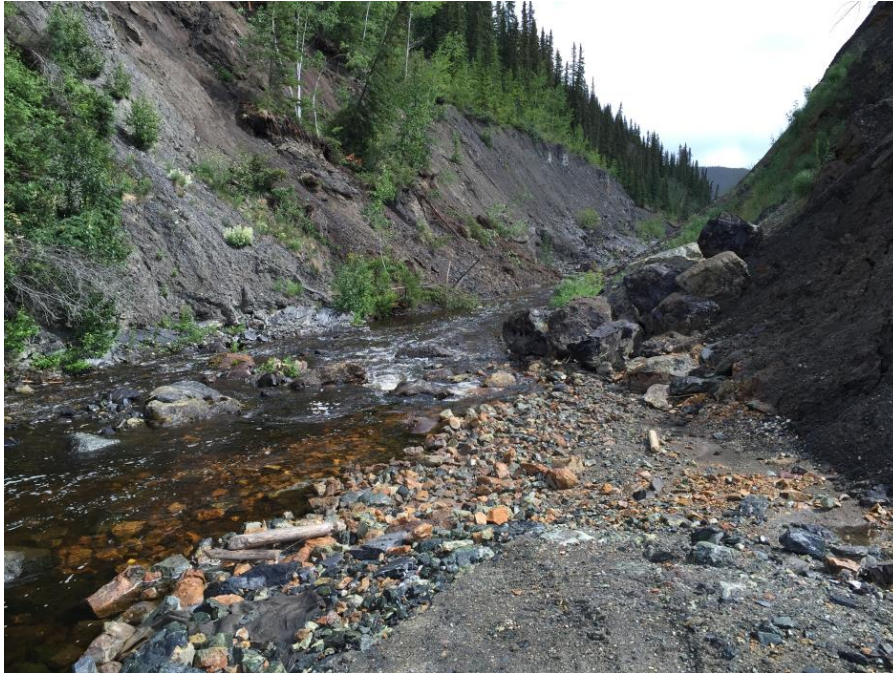
Photo 27 Downstream of DS4, looking downstream

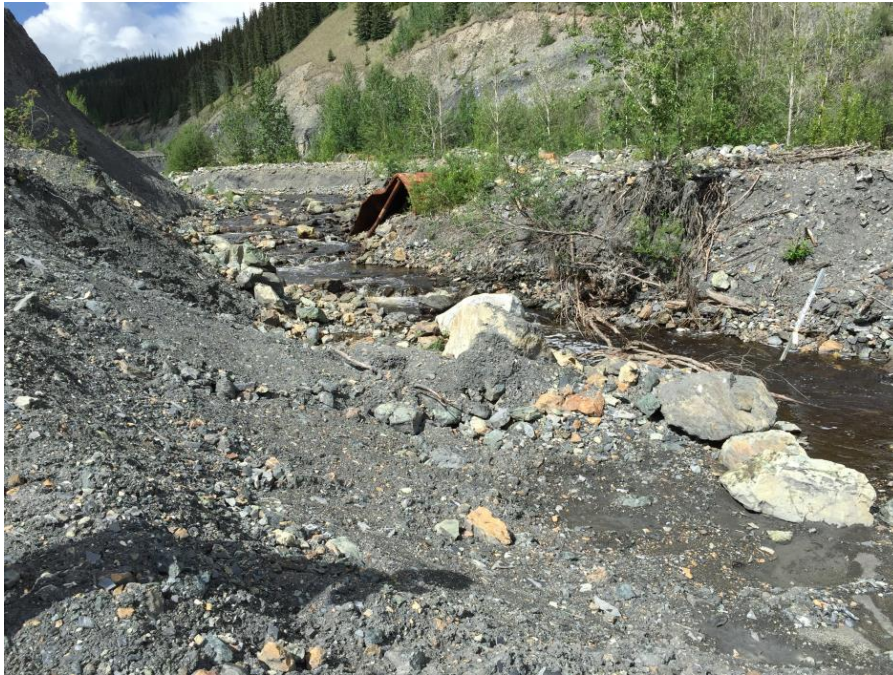
Photo 31 **Upstream of Fording No. 1, looking upstream**

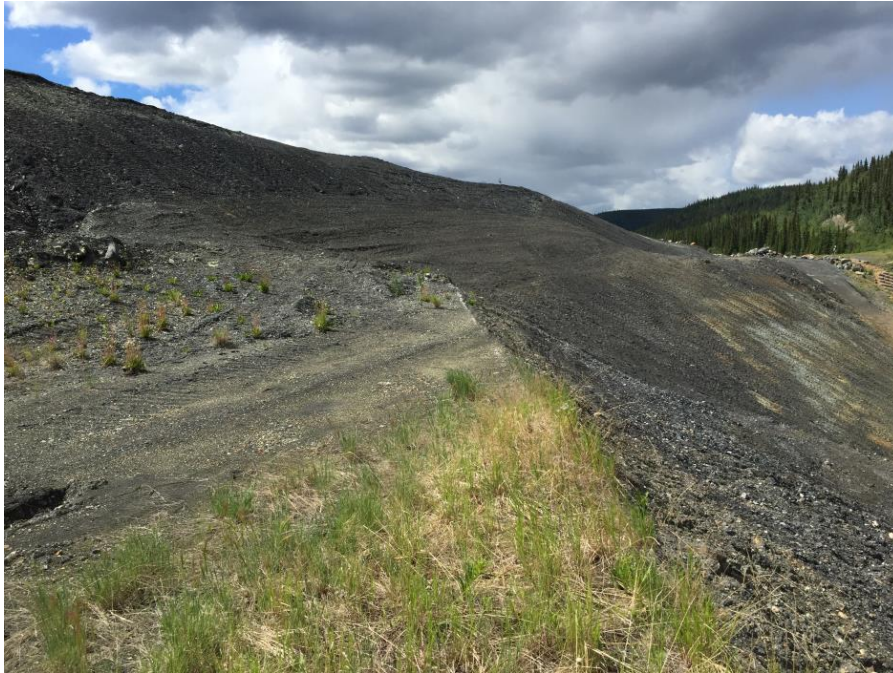
Photo 33 **Stabilized Slope south of DS4, looking west**

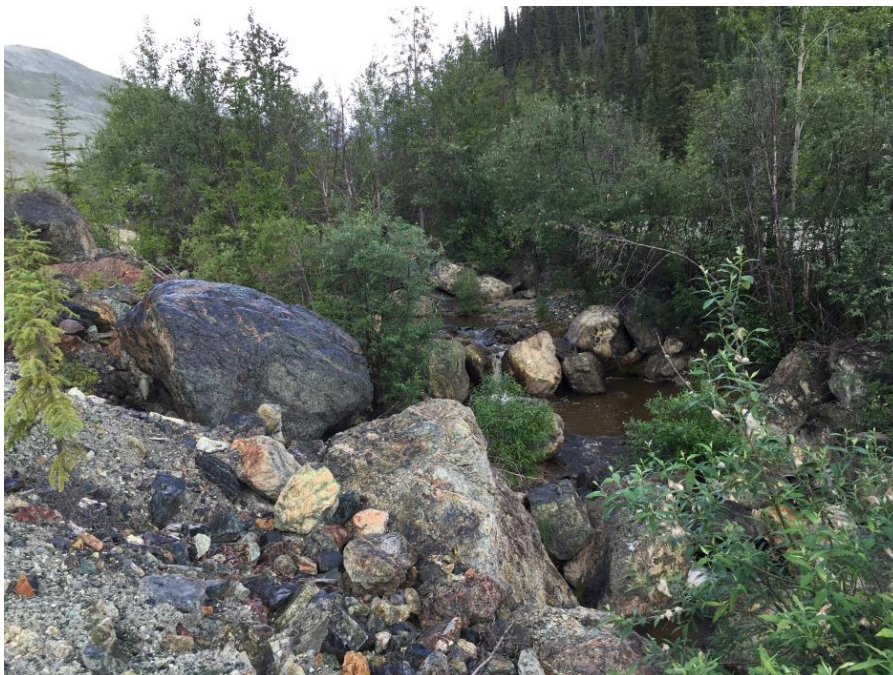
Photo 38 Mid Wolverine Creek looking upstream – rock weirs

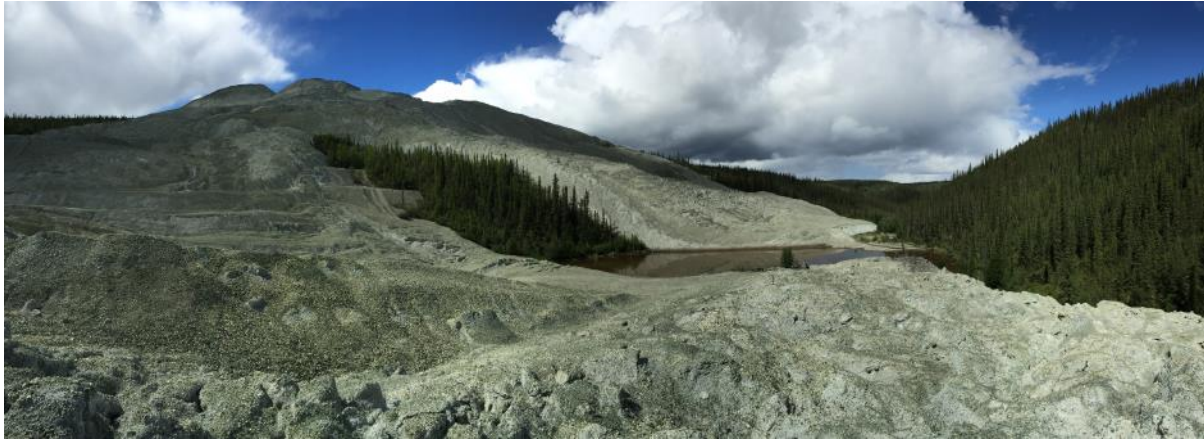
Photo 42 Tailings Pile Panorama from base of slope
