Clinton Creek Waste Dump

### Inspection of the Clinton Creek Valley

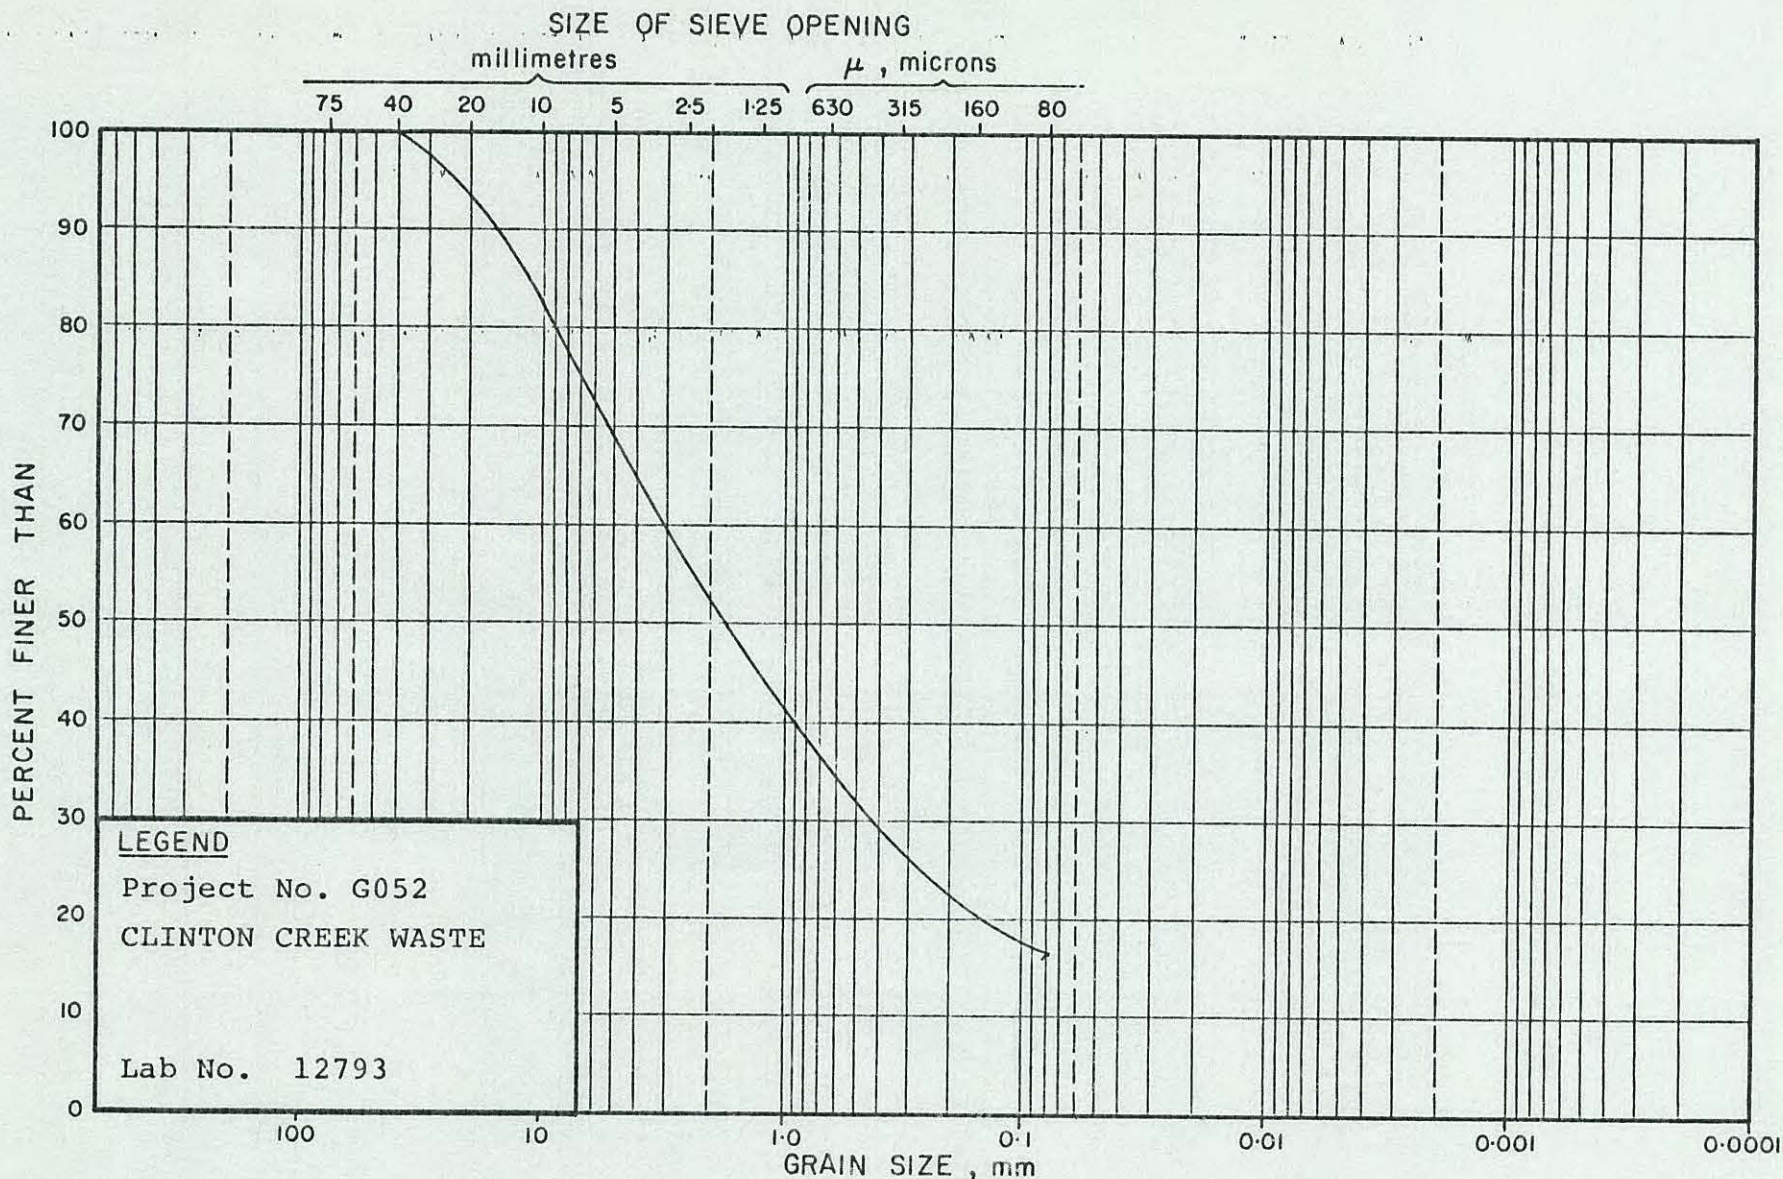
Figure 1

A specimen of waste has been secured from the toe area of the dump and the grain size analysis result is shown on Figure 1.

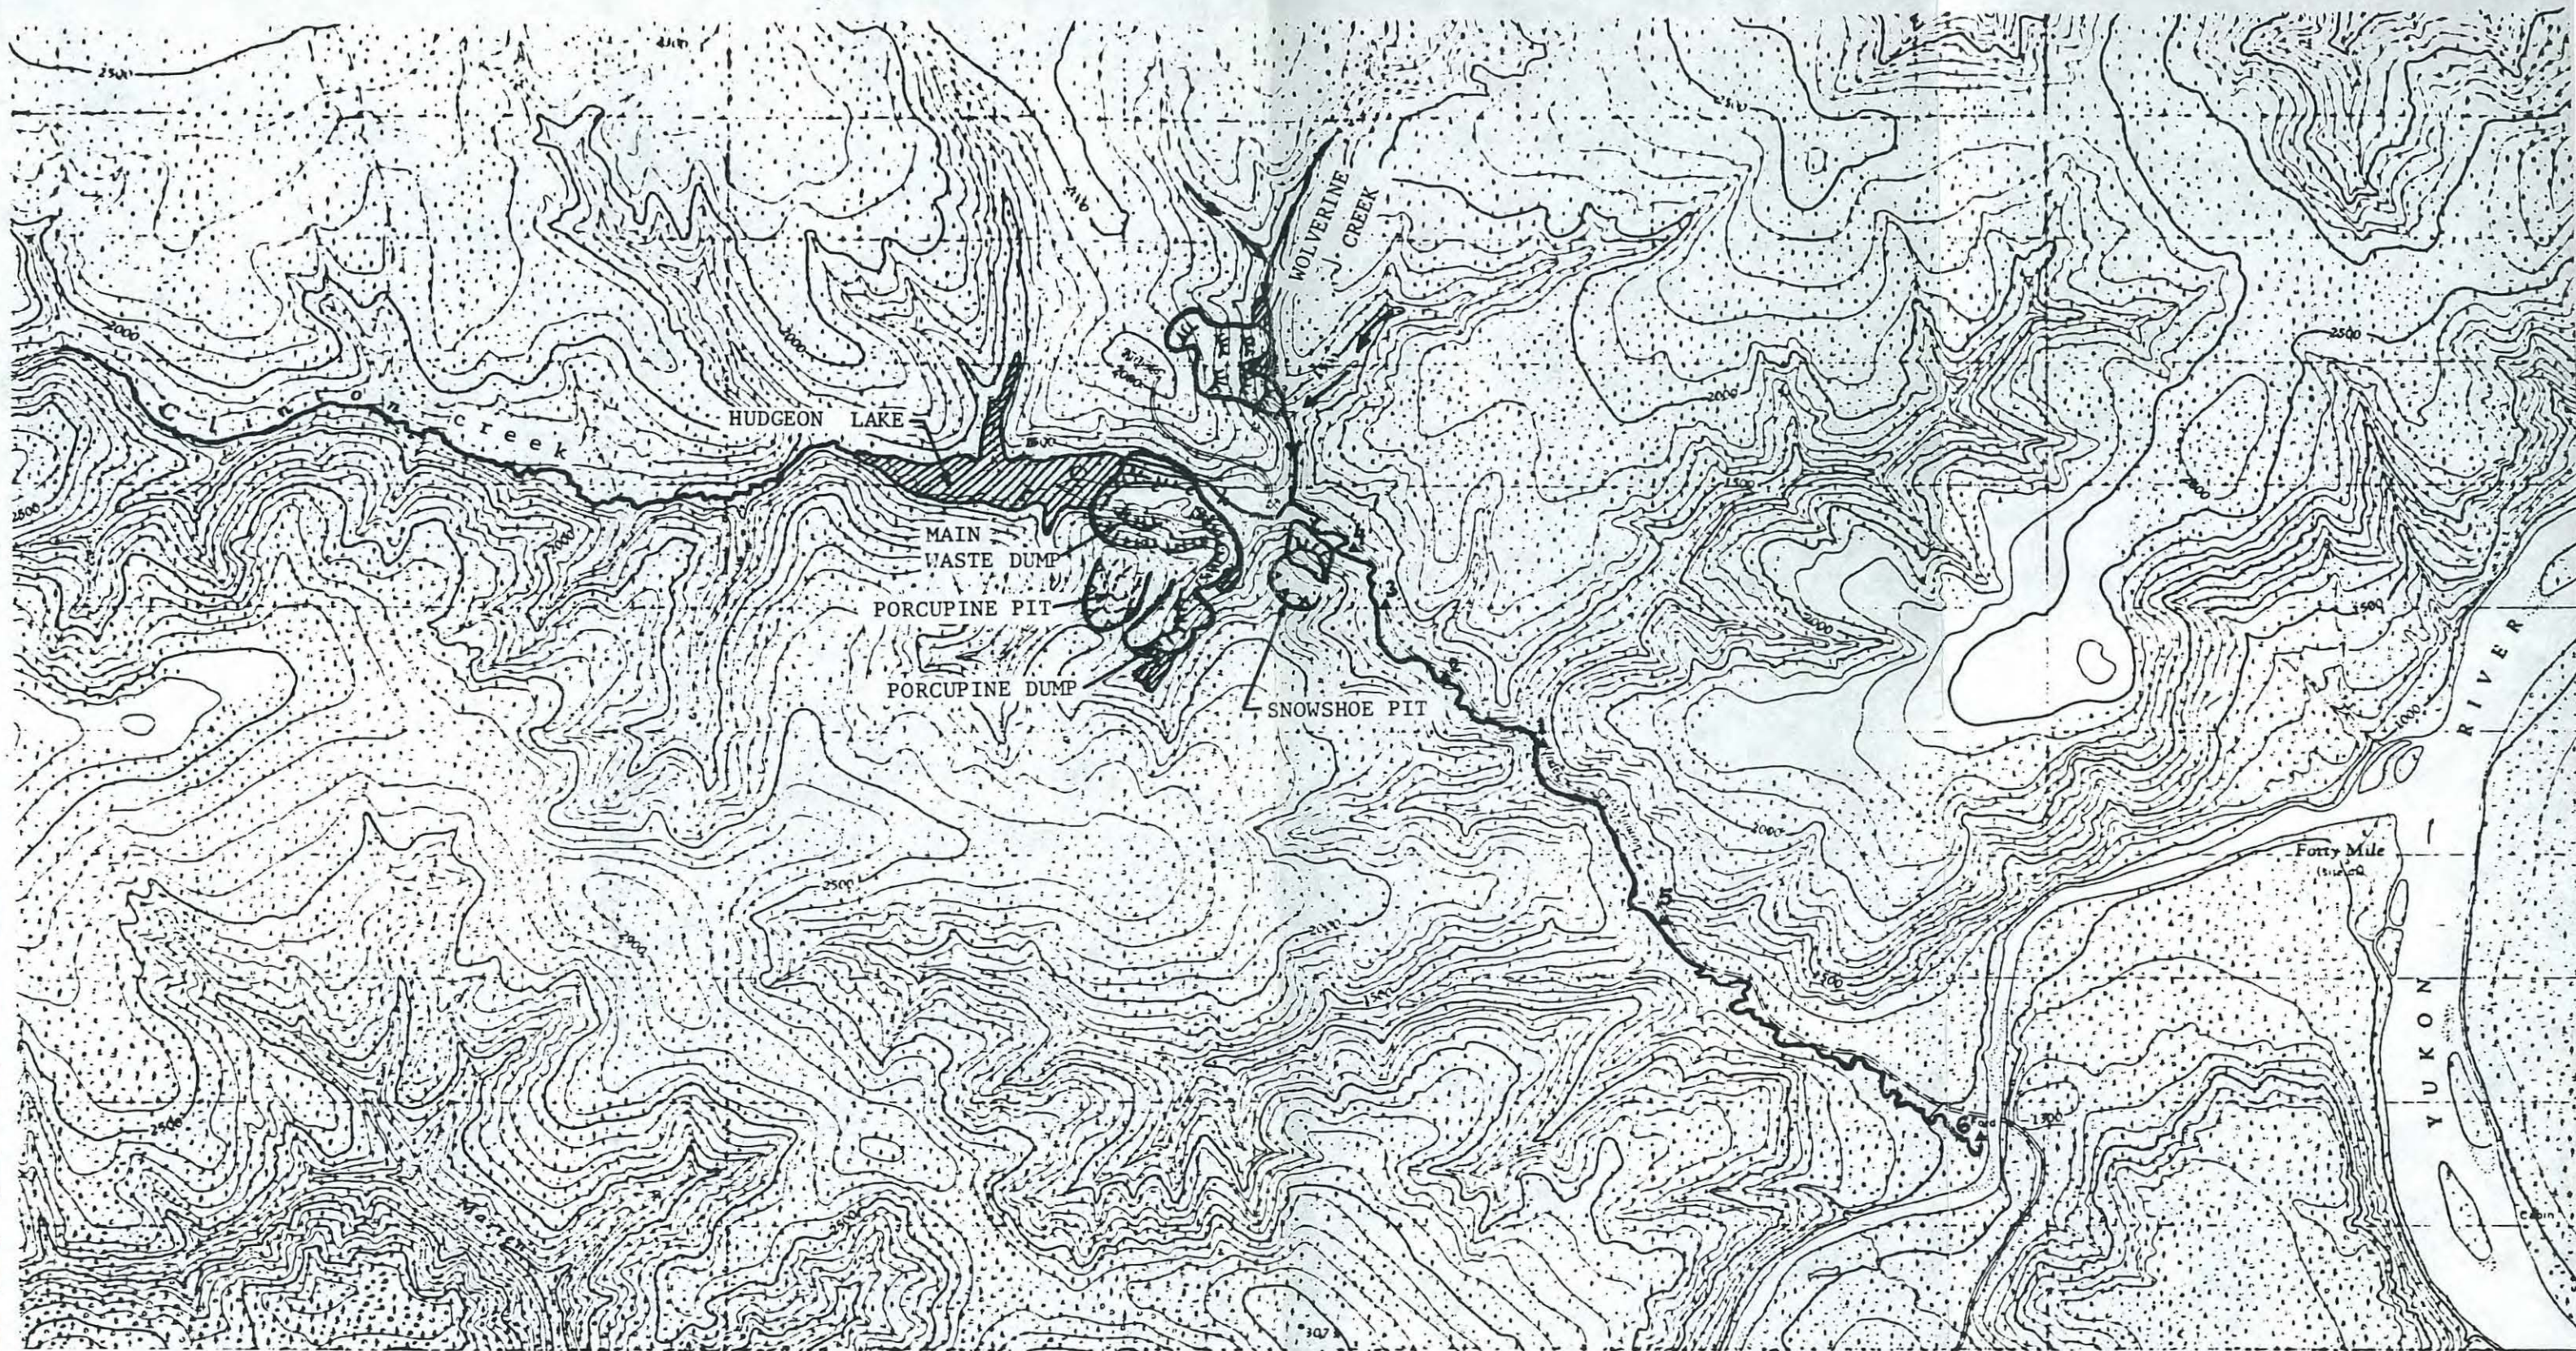
<b>CASSIAR ASBESTOS MINE</b>		
TITLE	LOCATION PLAN	
SCALE 1: 50 000	PROJECT No G 052-2	FIGURE 2.

The Clinton Creek Valley downstream from its junction with Wolverine Creek was examined to determine the extent of sediment transport after the 1974 tailings pile failure (south lobe) and breach of the valley blockage. Inspection sites are shown on Figure 2.
