ABANDONED CLINTON CREEK ASBESTOS MINE

**REPORT
ON
SITE INSPECTION**

Prepared for:
NORTHERN AFFAIRS PROGRAM
Whitehorse, Y.T.

May 1993
G052

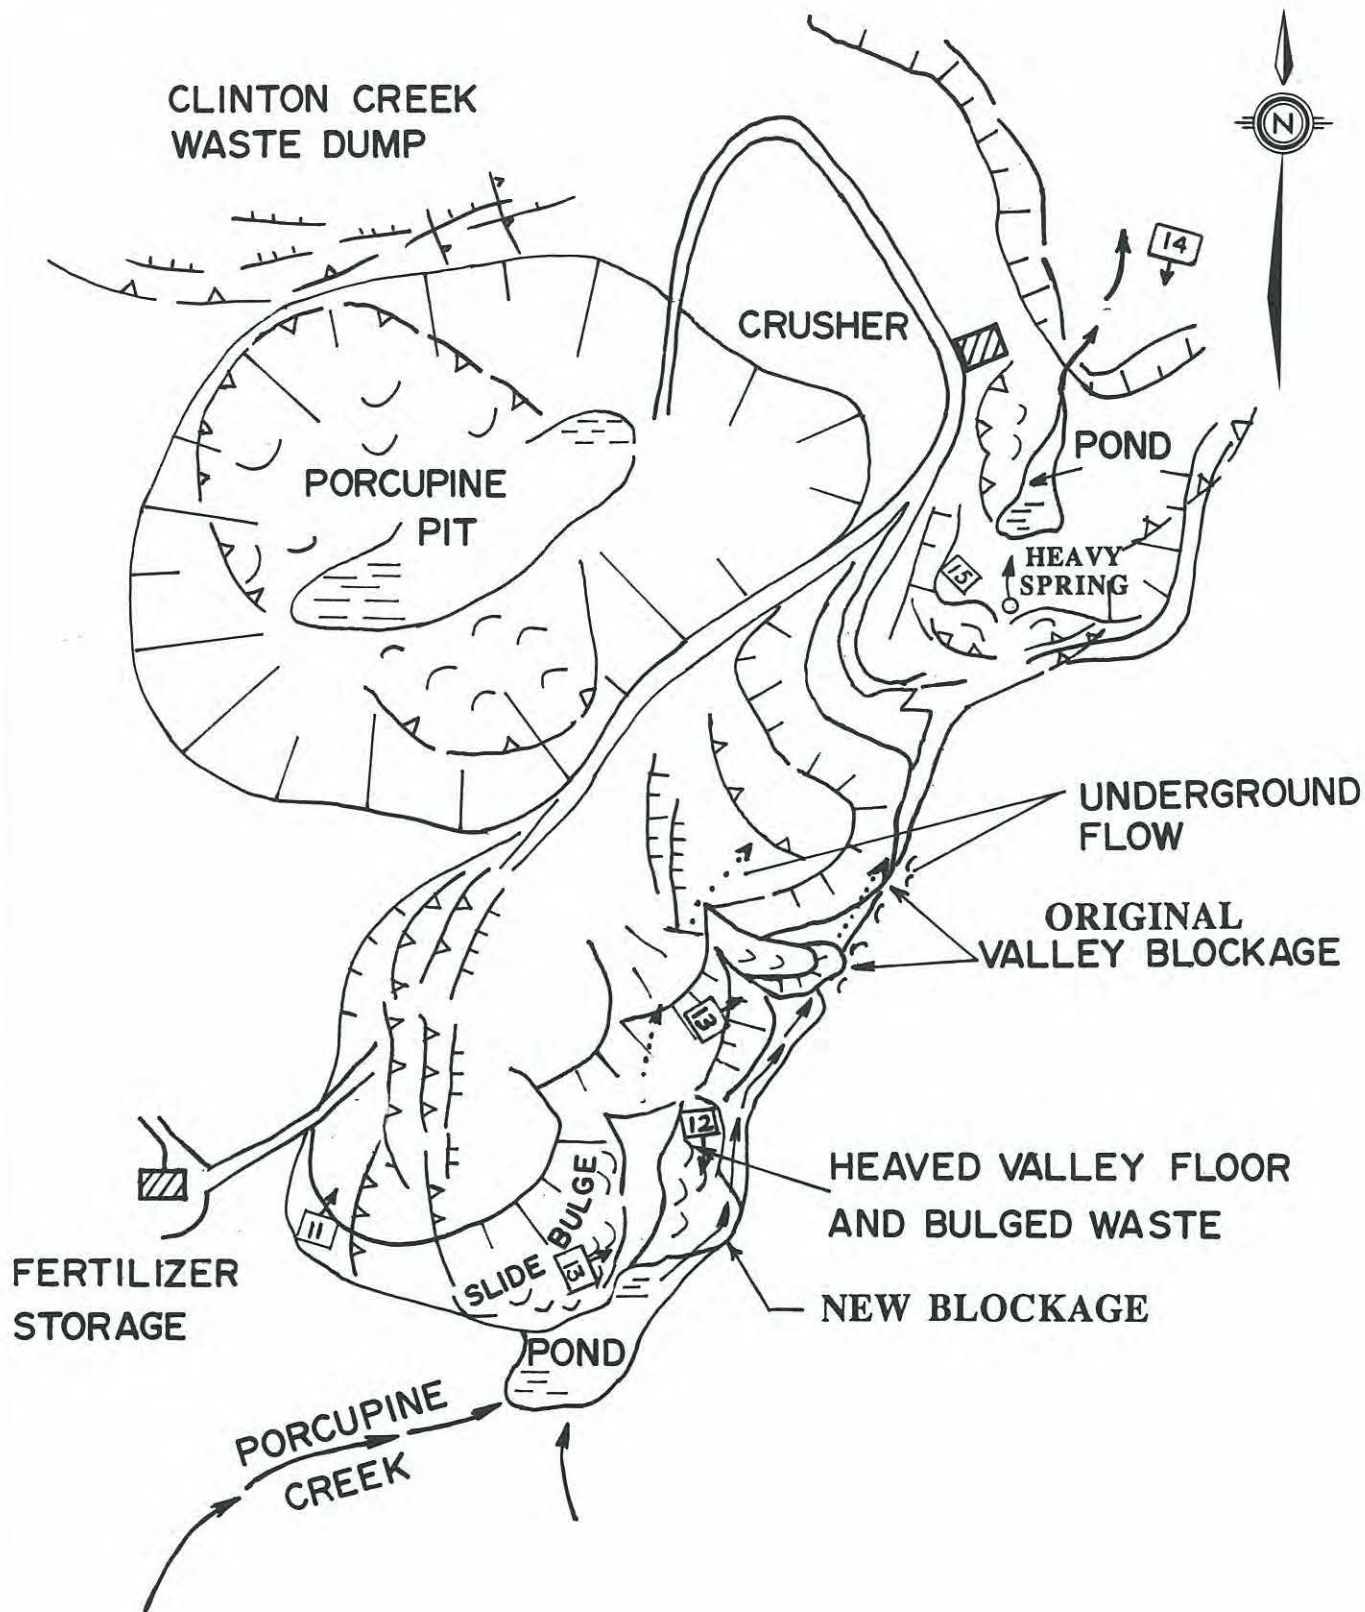
PORCUPINE CREEK WASTE DUMP
SCHEMATIC PLAN

The movement of this waste dump into the Porcupine Creek valley continues. It is apparent that the rate of movement of its individual sectors varies. The southern segment of the dump appeared to be, at the time of the site visit, more active than the northern one (Photo 11). As usual, the movement is better defined (by fresh scarps and fissures) along the upper reaches of the dump than at its toe.

The original valley blockage appears to be wider than before and its crest is probably slightly higher than in 1990 (Photo 13). There was no surface flow through the old channel, downstream from the blockage and along the east side of the waste dump. All water discharging from the lake infiltrated, in August 1992, into the dump and seeped through the waste rock. The discharge points at the north end of the dump have changed as well. Previously observed springs located above the access road on the north slope of the dump were dry while heavy flow, forming a small stream (Photo 14), daylighted at the toe of the waste dump. This discharge is concentrated and occurs along the natural ground and waste material interface. The seepage path through the waste dump has been apparently modified and its overall gradient, near the discharge point, is now bigger. However, the discharge flow was clear without suspended solids.

The changes in the dump configuration and Porcupine Creek regime do not indicate, in our opinion, that a major dump failure or flooding would occur in the near future. The Porcupine Creek watershed upstream from the dump is less than 2.5 km² and the valley blockage is wide, relative to the lake head and volume.
