Government of Yukon

Former Clinton Creek Asbestos Mine 2009 Site Inspection

AECOM

March, 2010

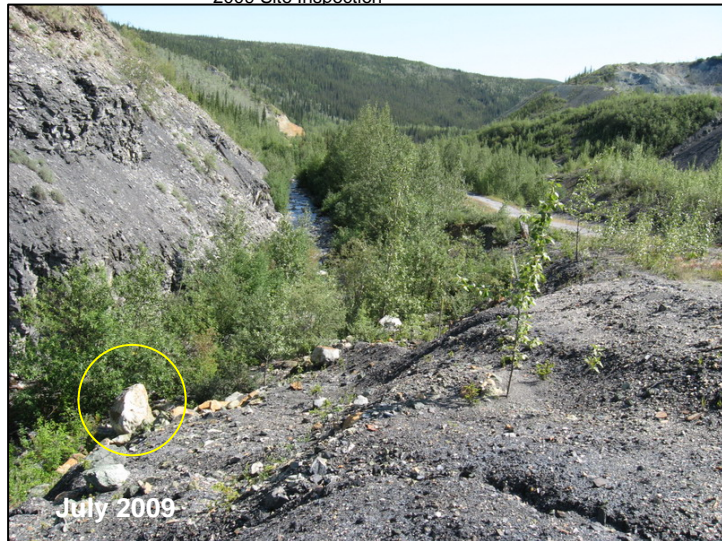
Figure 07 Station 0+560 in 2007 (left) and at WP 341 in 2009 (right), view D/S

Farther upstream, at approximately Station 0+560, the physical features and vegetation along the LHS and RHS of the channel, as well as the channel bottom do not appear to have significantly changed from 2007 to 2009 as seen on Figures 05, 06 and 07 taken from WP 341. A similar set of photos were taken at WP 342, located at approximately Station 0+470 in the 2007 and 2009 in an upstream direction (Figure 08), cross-channel (Figure 09) and downstream (Figure 10); No significant changes in the condition of the channel over this time period were noted.

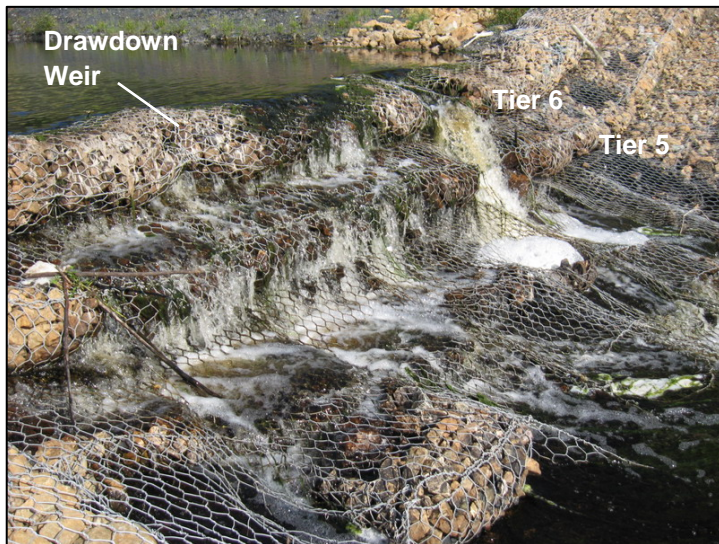
Figure 18 DS #4 Tier 5 and Tier 6 in 2009, view N

Drop Structure #4 consists of a drawdown weir with 6 tiers that provide a 2.5 m drop in channel grade and an end sill on the bottom tier. Figure 17 compares the overall condition of the structure in 2007 and the damage resulting from the spring freshet in 2009. Of the overall damage to the stabilized channel section, the most significant occurred to Drop Structure #4. Several of the wire baskets at the top of the structure including the drawdown weir and tiers 4, 5 and 6 were deformed with some of the baskets having been torn open with the rock fill partially or completely missing (Figures 18 and 19). In many cases, it appeared that some of the stainless steel retaining clips used to close the baskets failed allowing the seam along the downstream edge of the basket to open enough to allow the rocks to be pulled out by tractive forces during high flows.

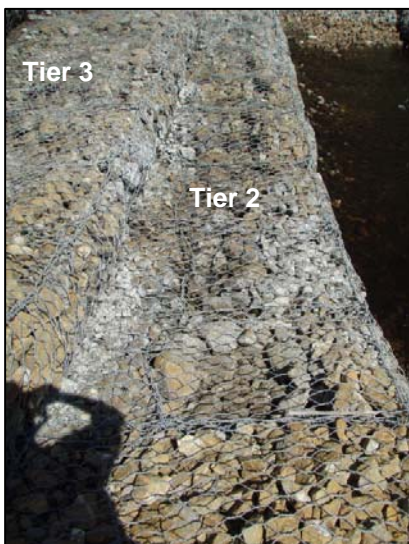
Figure 20 DS #4 Tier 2 and Tier 3 & End Sill in 2007, view N

The damage extends across Tiers 2 and 3 where several baskets were open with rock missing. A section in the middle of the end sill was missing and presumed to have washed downstream. The condition of the lower section of the drop structure (Tier 1) and end sill in 2007 and after the spring freshet in 2009 is illustrated on Figures 20 (2007) and 21 and 22 (2009).

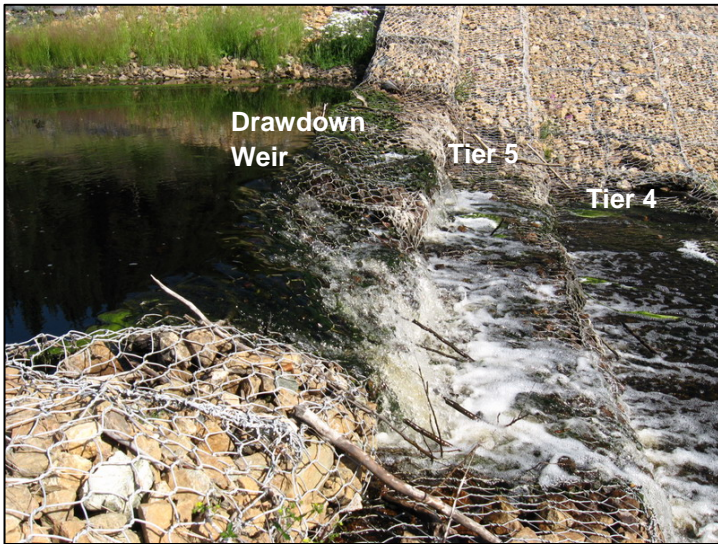
Figure 25 DS #3 Weir, Tier 4 and 5 in 2009, view N

Drop Structure #3 consists of a drawdown weir with 5 tiers that provide a 2 m drop in channel grade and an end sill on the bottom tier. Figure 23 illustrates the overall condition of the structure in 2007 and the damage resulting from the spring freshet in 2009. A cross-channel view of the structure is shown on Figure 24. Most of the damage to Drop Structure #3 involved deformation of the baskets including the drawdown weir which was leaning forward with the downstream edge about 300 mm lower than as-constructed (Figure 25). There were some small holes in the tops or downstream sides of individual baskets in Tiers 2, 3 and 4 although most of the rock was still inside of the baskets (Figure 26). The end sill was badly deformed but intact, having bulged at least 300 mm downstream as shown on Figure 27. The channel banks between DS#3 and #4 are in good condition. It appears that the high water mark on the channel side slope was about 1.5 m higher than observed at the time of the inspection (Figure 28).

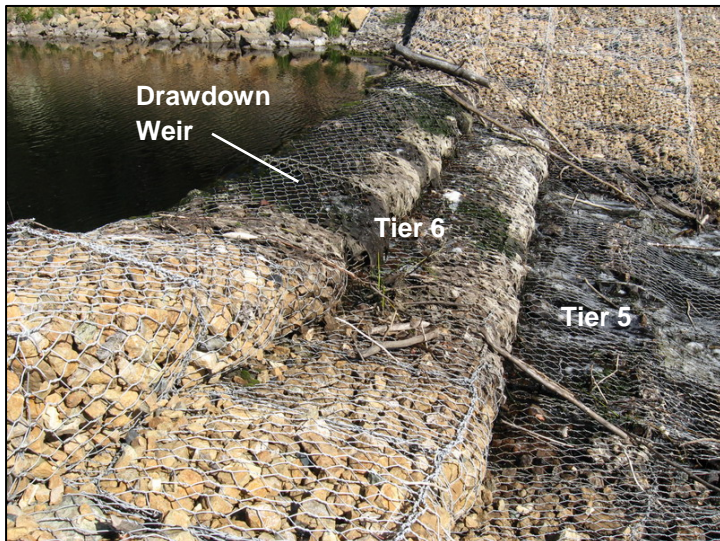
Figure 30 DS #2 Weir, Tier 5 and 6 in 2009, view N

Drop Structure #2 consists of a drawdown weir with 6 tiers that provide a 2.5 m drop in channel grade and an end sill on the bottom tier. A comparison of the structure in 2007 and 2009 is illustrated on Figure 29. The observed damage includes the drawdown weir which was leaning downstream by about 200 mm (Figure 30) and several of the baskets on Tiers 2, 3 and 5 which were opened up with some loss of the rock fill material (Figures 30, 31 and 32). The end sill was partially submerged but appeared to be deformed with considerable loss of rock fill (Figure 33).
