KENO HILL PROPERTY

ADIT DISCHARGE SURVEY

2007

March 2008

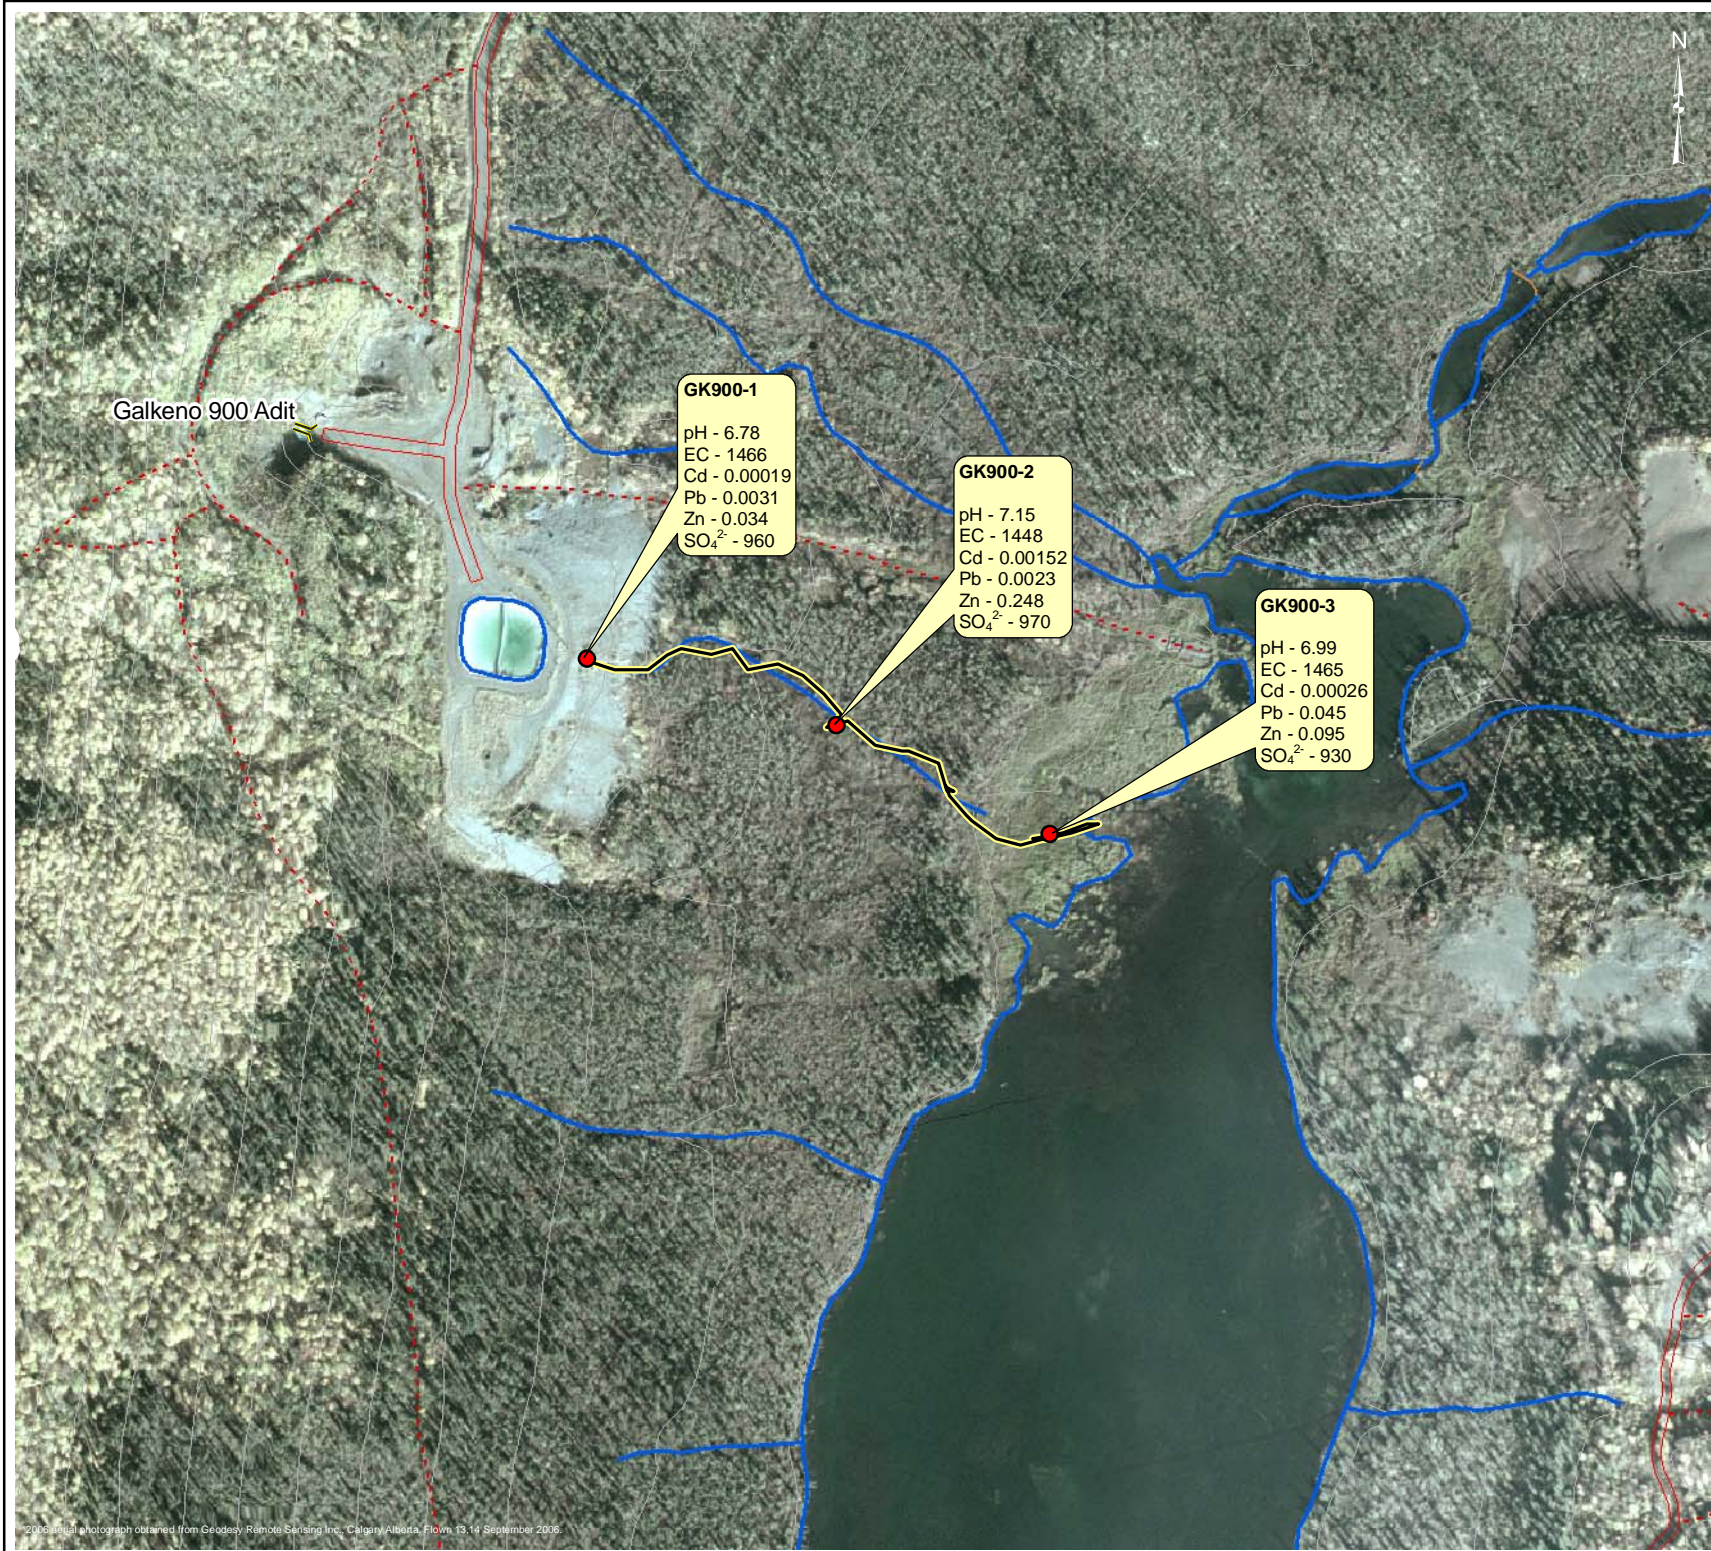
Galkeno 900 Adit

GK900-1
 pH - 6.78
 EC - 1466
 Cd - 0.00019
 Pb - 0.0031
 Zn - 0.034
 SO₄²⁻ - 960

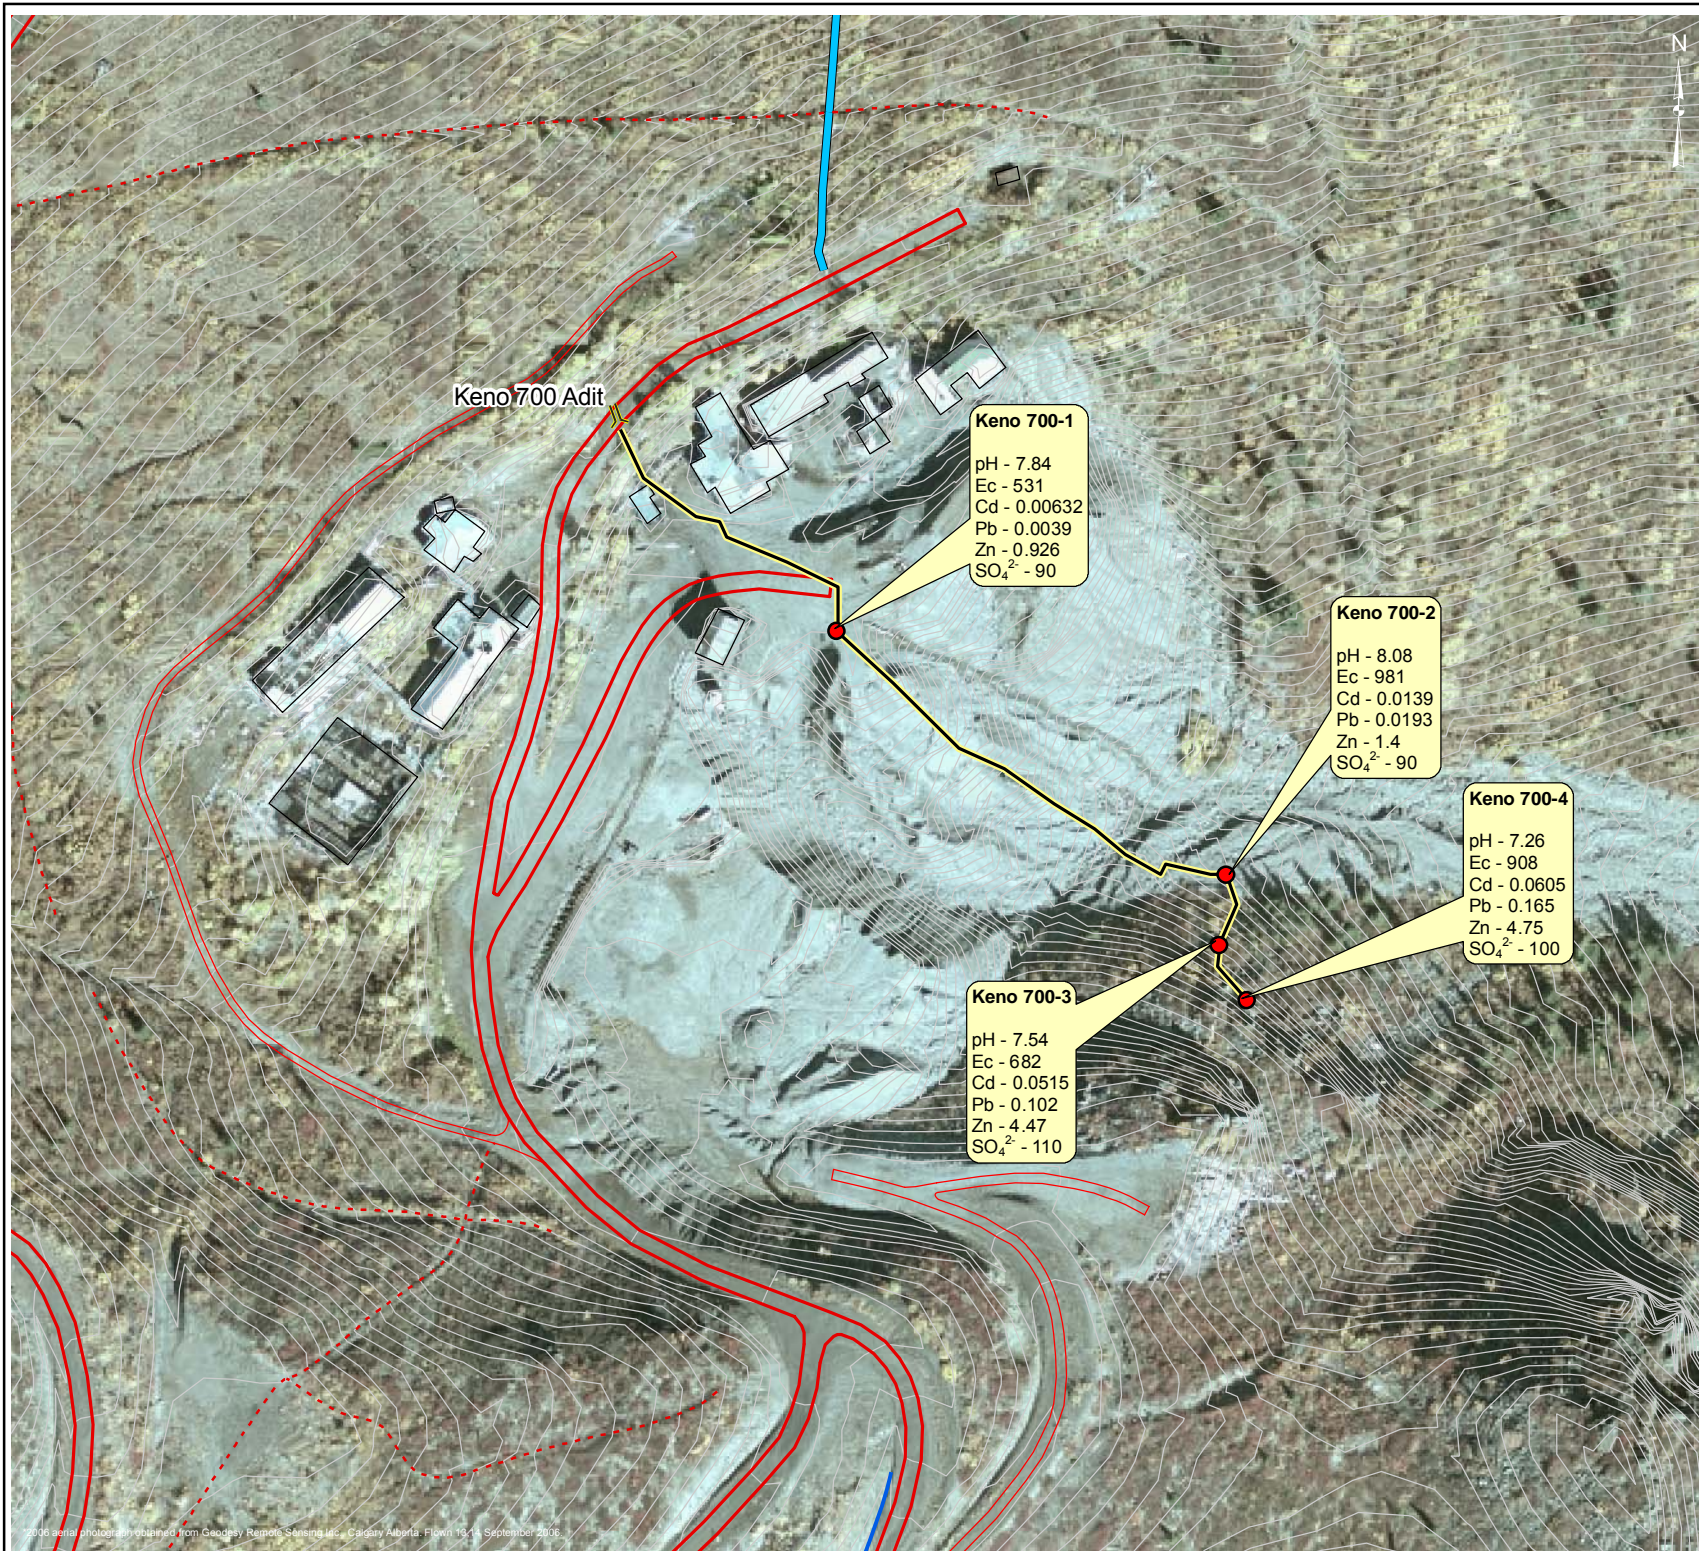
Table 8 presents the water quality results for selected parameters contrasted with the Water Use Licence standards and the CCME guidelines. Refer to Figure 10 for sample station locations. For a full listing of water quality results at Keno 700 look to Appendix B, Water Quality Data.

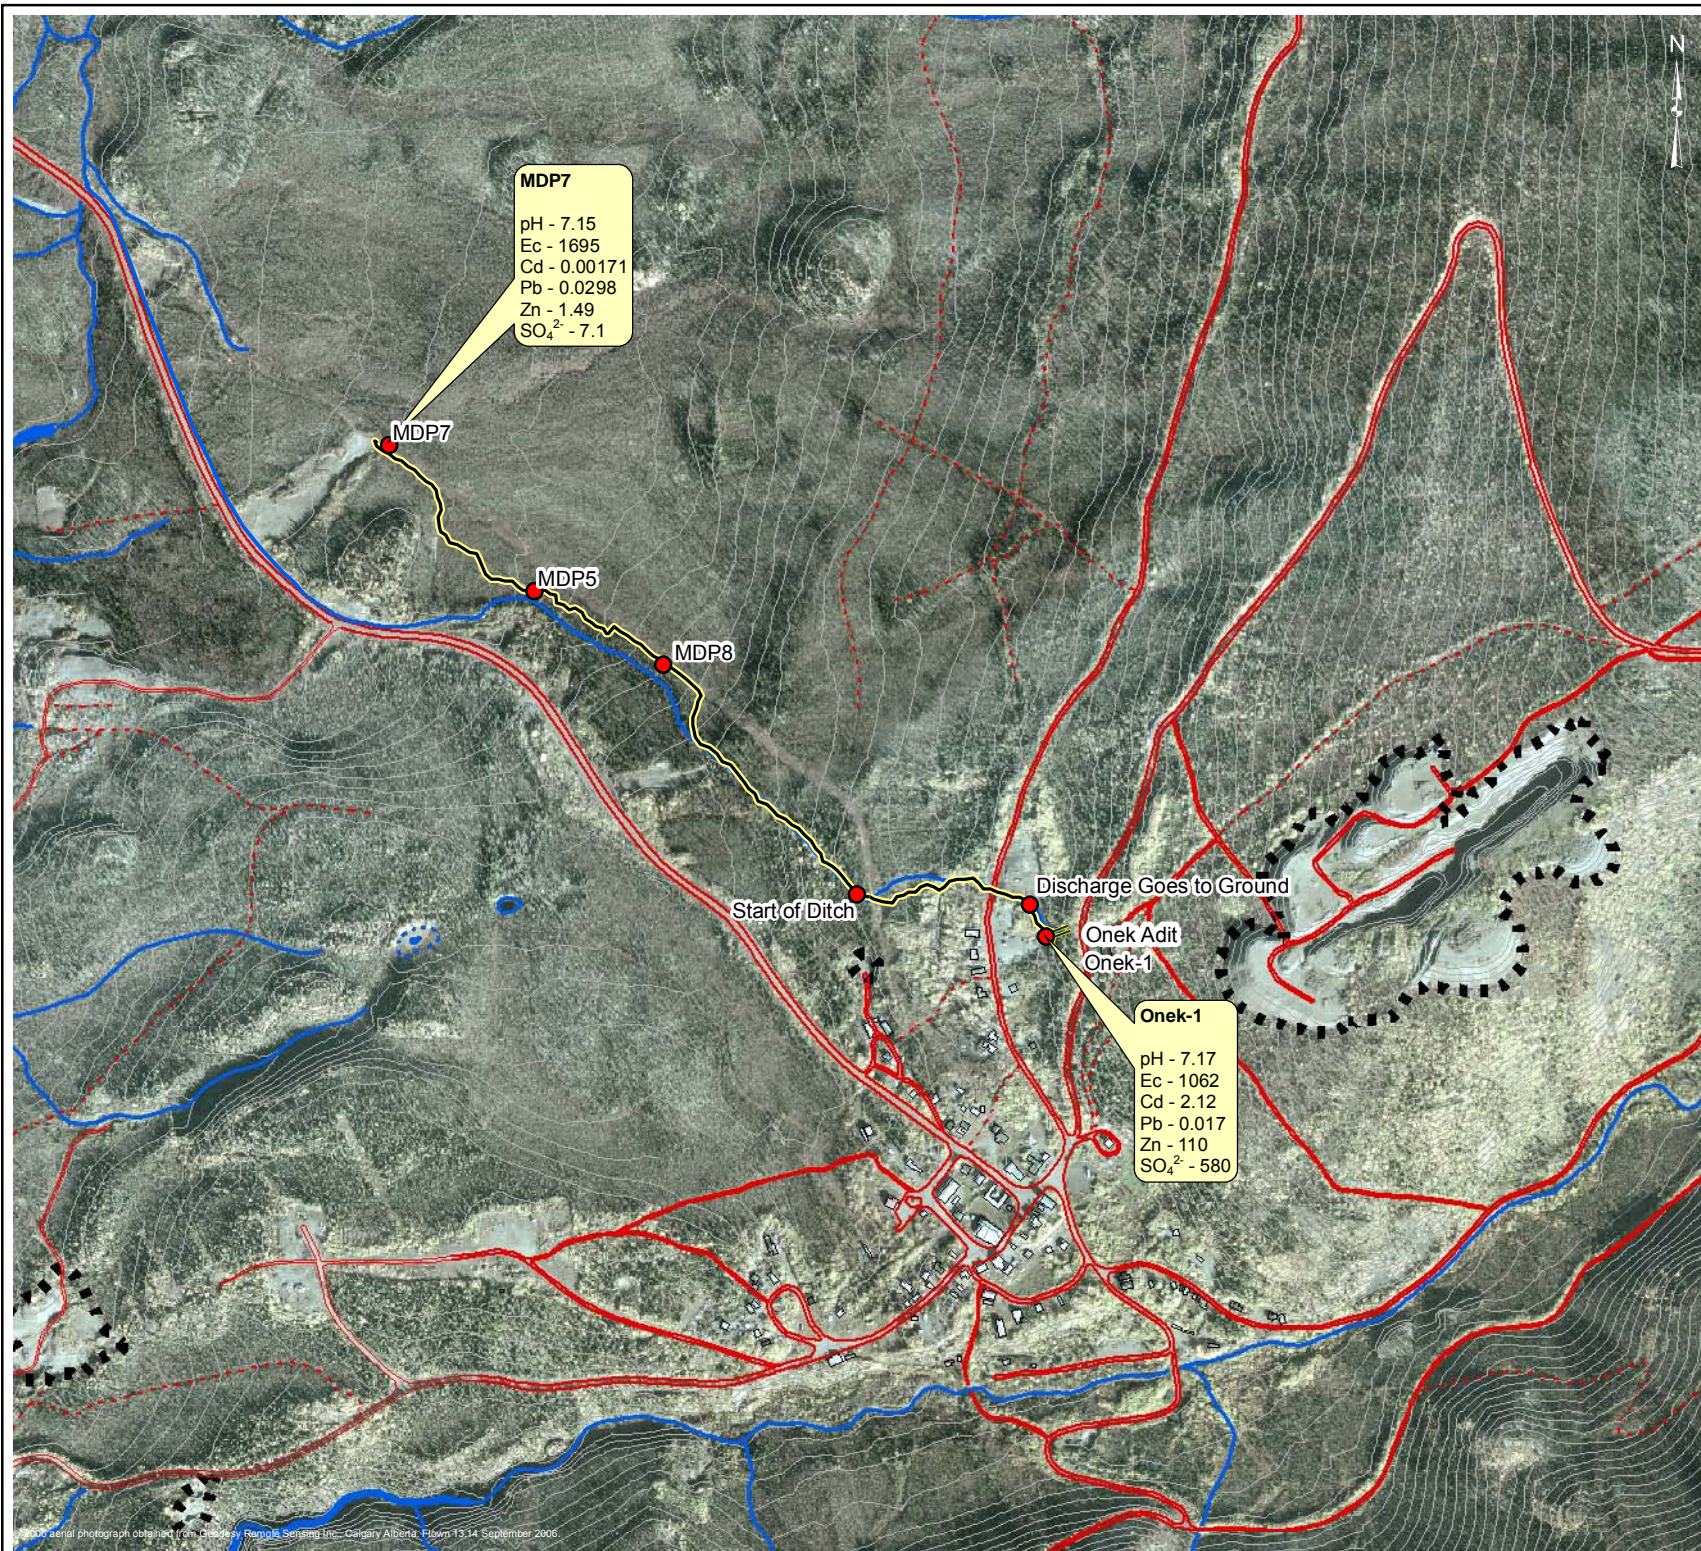
MDP7
 pH - 7.15
 Ec - 1695
 Cd - 0.00171
 Pb - 0.0298
 Zn - 1.49
 SO_4^{2-} - 7.1

Onek-1
 pH - 7.17
 Ec - 1062
 Cd - 2.12
 Pb - 0.017
 Zn - 110
 SO_4^{2-} - 580

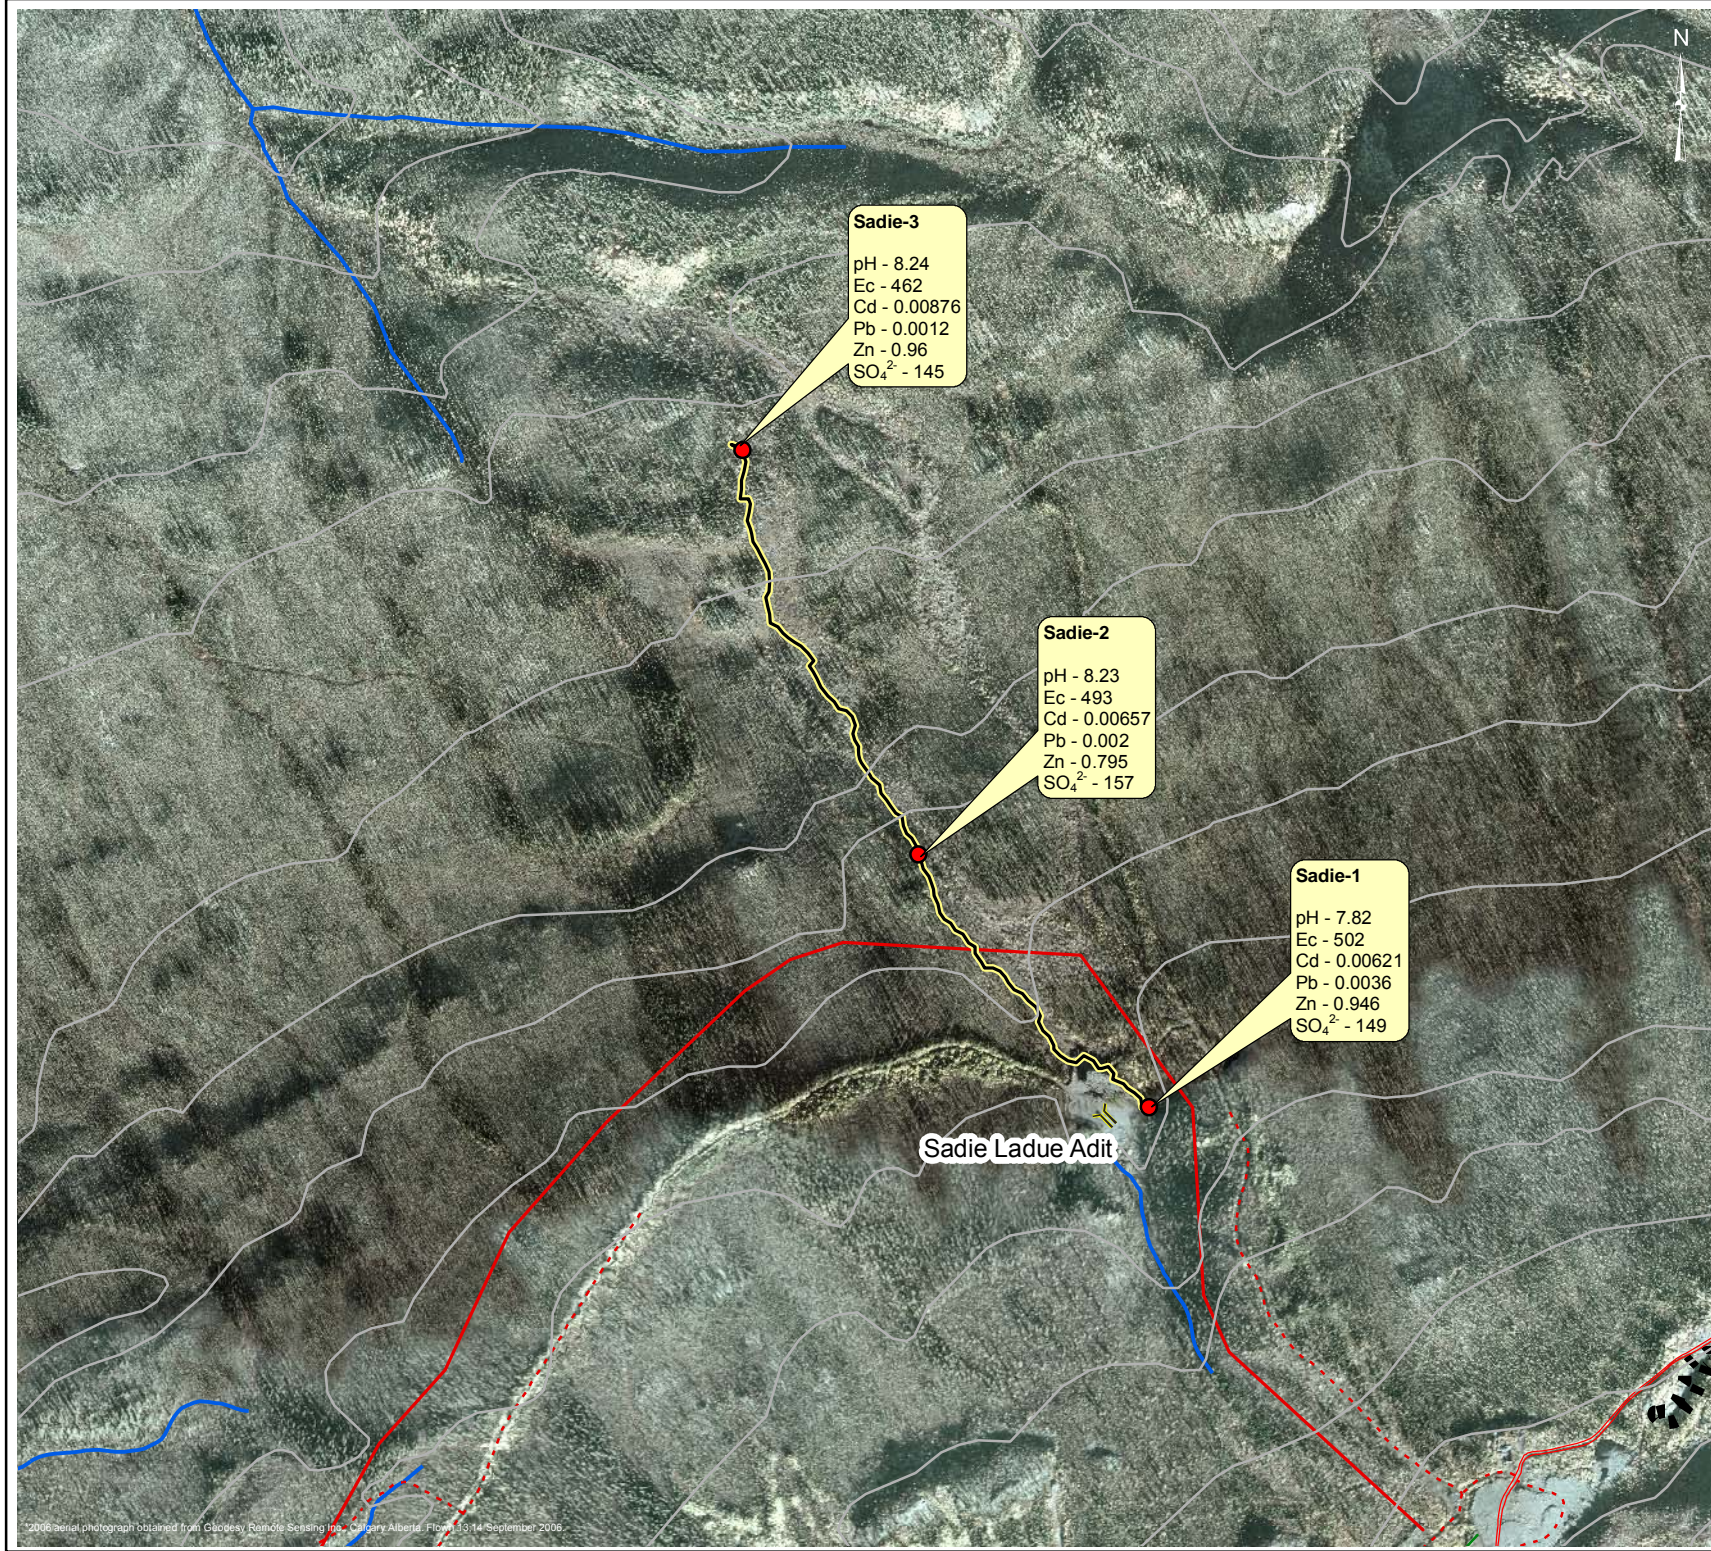
Sadie-3
 pH - 8.24
 Ec - 462
 Cd - 0.00876
 Pb - 0.0012
 Zn - 0.96
 SO_4^{2-} - 145

Sadie-2
 pH - 8.23
 Ec - 493
 Cd - 0.00657
 Pb - 0.002
 Zn - 0.795
 SO_4^{2-} - 157

Table 10 presents the water quality results for selected parameters contrasted with the Water Use Licence standards and the CCME guidelines. Refer to Figure 12 for sample station locations. For a full listing of water quality results at Sadie Ladue look to Appendix B, Water Quality Data.
