Government of Yukon
Former Clinton Creek Asbestos Mine
Long Term Performance Monitoring - 2007

UMA Project No.: 6029 009 00 (4.6.1.1)

July 2008

Re: Former Clinton Creek Asbestos Mine – Long Term Performance Monitoring - 2007

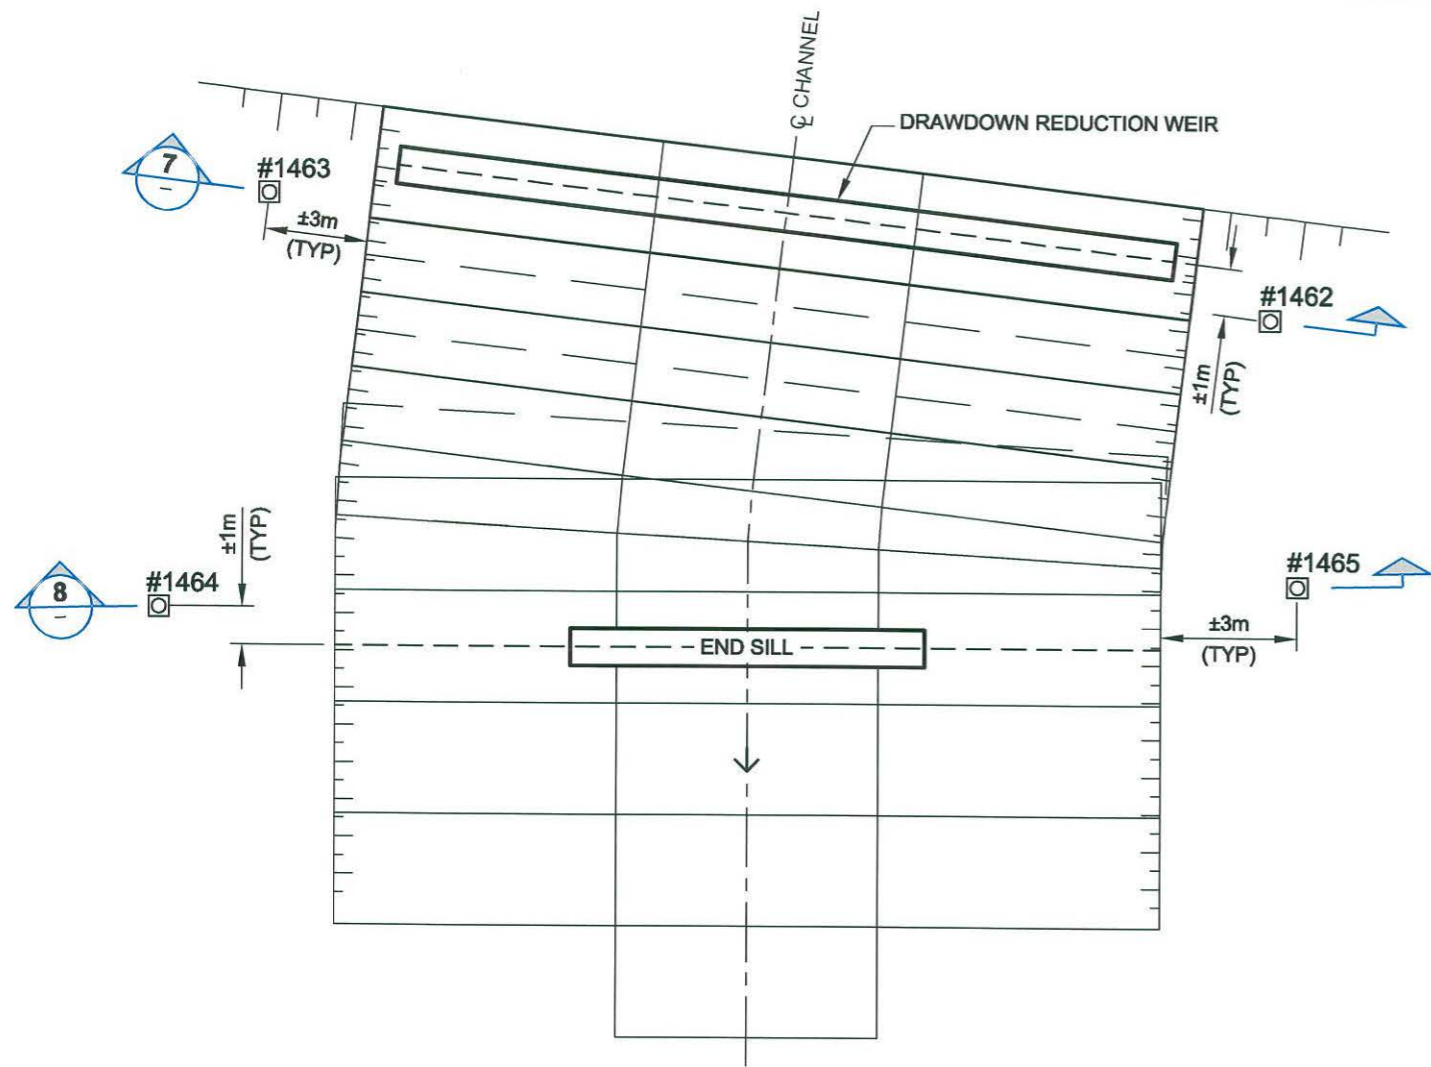
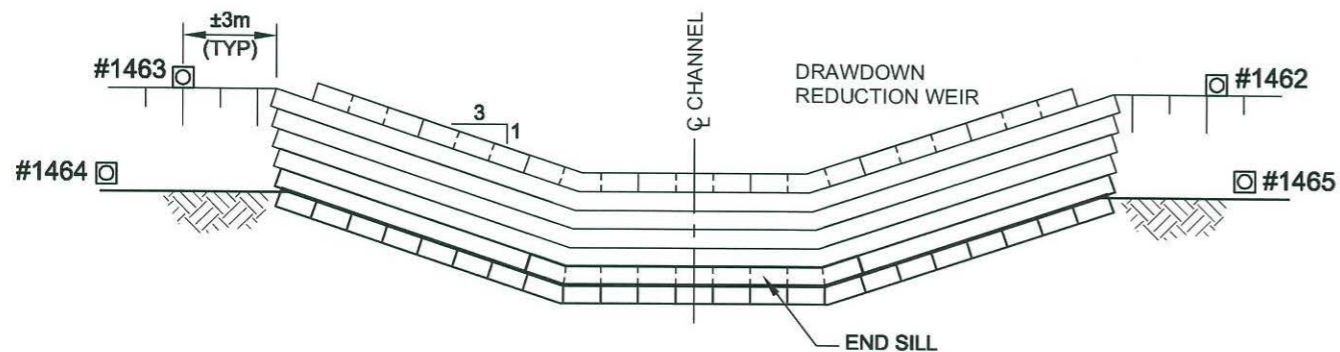
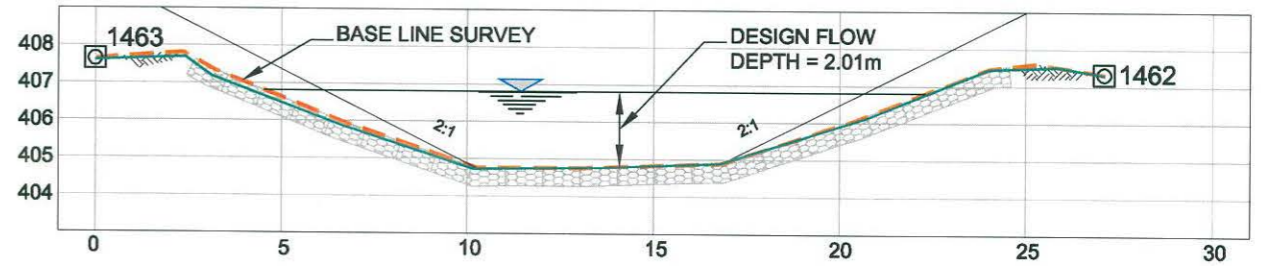
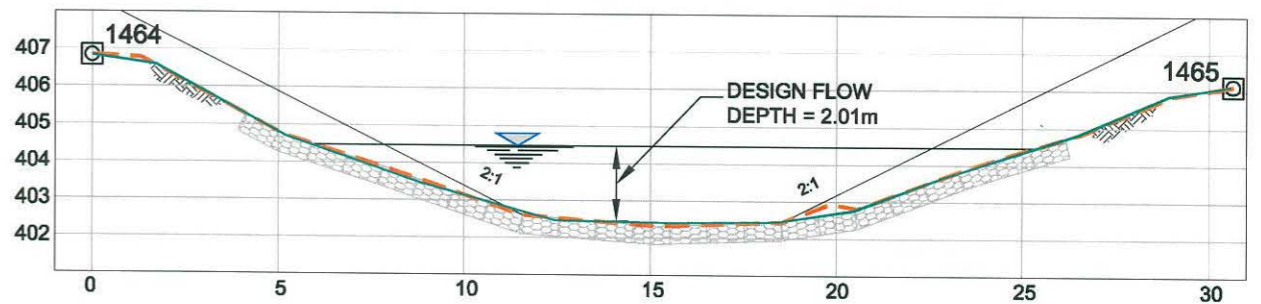
Drop Structure #3

The results of the performance monitoring suggest that the largest movements of the waste rock pile and the drop structures is occurring in the area of Drop Structures #3 and #4. The waste rock above the drop structures at this location is oversteepened and likely contributing to the observed movements. The impact and feasibility of regrading the waste rock in this area should be considered. Representative cross-sections of the area would be required to do this work and should be surveyed in 2008 during the next performance monitoring event.

- Drop Structure #2: Place a patch over the hole on Tier #4 (middle step of the drop structure).
- Drop Structure #3: Remove the cobbles and boulders resting against the outside edges of the end sill. Water flowing over the drop structures, particularly at higher flows, may produce a 'rocking action' of the cobbles and boulders that could result in abrasion of the PVC coating on the gabions and expose the wire mesh leading to abrasion of the galvanized wire and premature corrosion.

- Drop Structure #3: remove the cobbles and boulders resting against the outside edges of the end sill. Water flowing over the drop structures, particularly at higher flows, may produce a 'rocking action' of the cobbles and boulders that could result in abrasion of the PVC coating on the gabions and expose the wire mesh leading to abrasion of the galvanized wire and premature corrosion.
