**Government of Yukon  
Former Clinton Creek  
Asbestos Mine  
Overview Report**

**AECOM Canada Ltd.**

6029 013 00 (4.6.1)

July, 2009

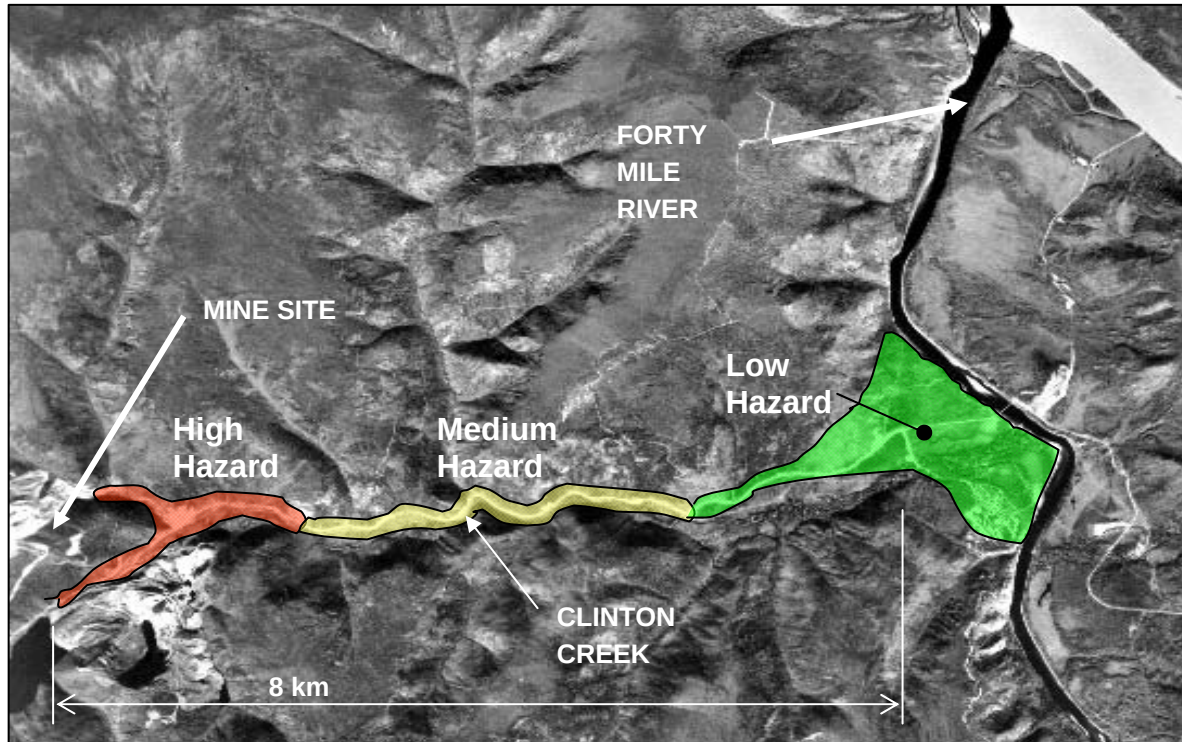
**Figure 09 Downstream Hazard Mapping**

In terms of public safety, the level of risk downstream of the mine site should a breach of the waste rock plug occur was categorized as high, medium or low based on the severity of flooding in each zone (Figure 09). The inherent risk to humans and the potential for loss-of-life is dependent upon the likelihood of exposure (occupancy) within these zones. The potential for loss-of-life is greatest immediately downstream of the mine site in the area potentially inundated by a breach of the Hudgeon Lake outlet. Farther downstream along Clinton Creek, the risks are reduced, as the high water levels will be confined to the creek valley below the road where human exposure is less likely. The risk is considered low at the next most likely downstream area of occupancy in the vicinity of the former Clinton Creek Town Site where the valley widens considerably. Aquatic life and mammals downstream of the mine site are potentially at risk from the redistribution of eroded waste rock. The largest risk is believed to be from a sudden breach of the waste rock dump resulting in fisheries habitat loss through downstream smothering and flooding.

- Preventing vehicle access to high hazard areas,
- Prohibiting camping in high hazard areas,
- Posting warning signs, and
- Providing camping facilities on sufficiently high ground within low or medium hazard areas.

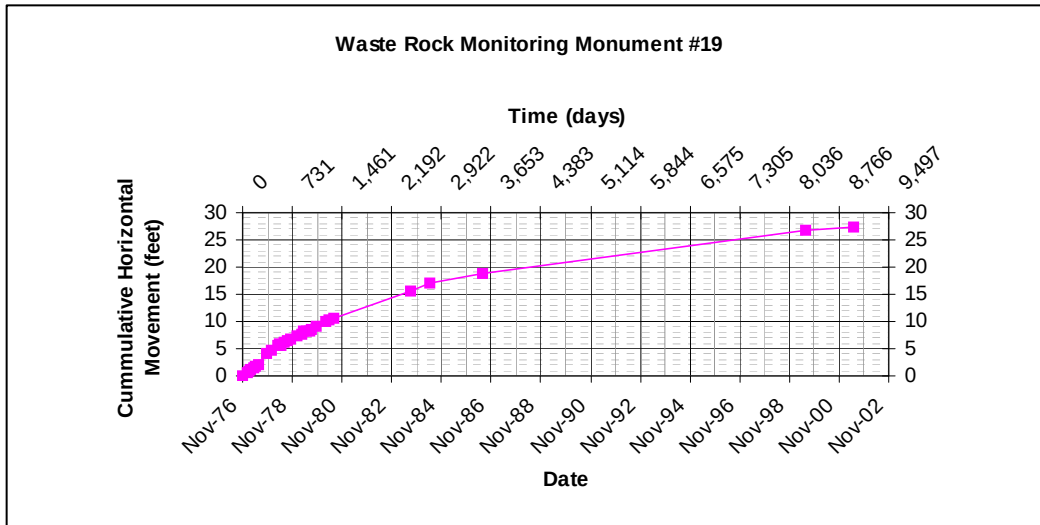
**Figure 10 Example of Movement Monitoring Data**

Subsequent to preparation of the Conceptual Design Report, waste rock movement monitoring and a detailed survey of the Hudgeon Lake outlet were carried out by UMA in June 2001. Over the two-year period from July 1999 to June 2001, annual horizontal movements ranging from 1 to 11 cm were observed, or an average annual rate of 7 cm. Over the same time period, the average rate of vertical settlement appeared to be in the order of 7 cm. These movements confirmed previous observations that waste rock pile movements were small (in comparison to movements prior to 1986) and perhaps decreasing with time. The movements were interpreted as small constant strain rates or strain rates that are decreasing with time, and as such are referred to as creep movements (as compared with the large movements observed prior to 1986). There were no signs to indicate strain rates were increasing, observations that would be expected if large movements of the waste rock were imminent. An example of the monitoring results is shown on Figure 10.

It was considered likely that these creep movements would continue at similar strain rates for many more years, and in particular, the horizontal movements may be susceptible to channel erosion (i.e. down cutting) along the north edge of the waste rock. Based on the observed waste rock movements and the comparatively lower capital costs, channel stabilization was selected as the preferred remedial option to address the hazards associated with a breach of the waste rock at the Hudgeon Lake outlet and to reduce the chronic erosion of waste rock material. Providing that channel stabilization measures could be constructed to accommodate anticipated creep movements, waste rock stabilization was not considered necessary in the short term, in particular given the possibility of further reductions in these movements. With

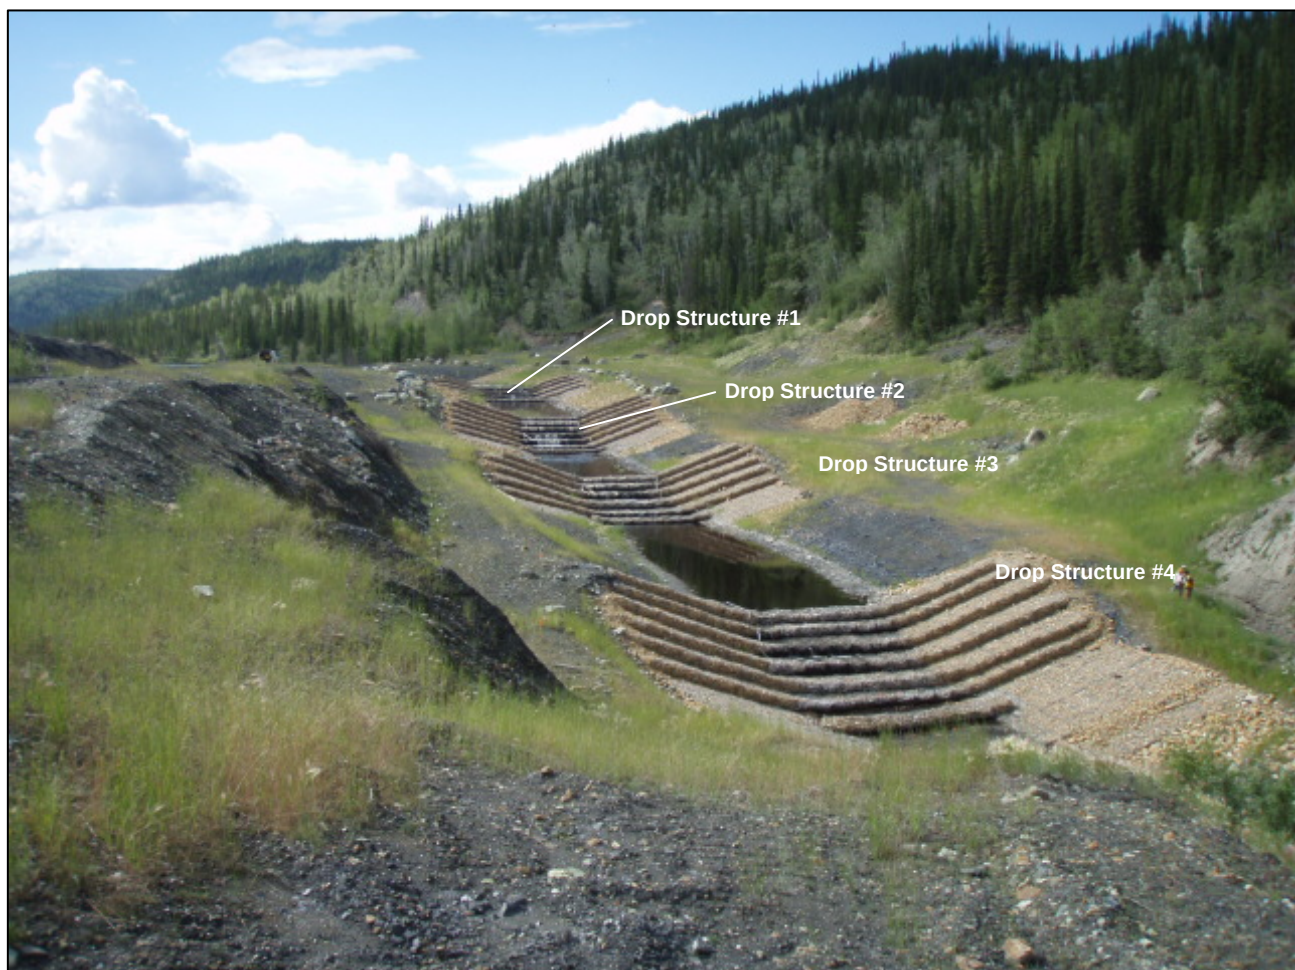
**Figure 17 Stabilized Channel Section at Hudgeon Lake Outlet (2007)**

Inspections showed that the gabion drop structures were performing well with grass and other vegetation becoming established around the channel (Figure 17). An erosion gully was noted on the north side of the access road. The results from the horizontal measurements taken across each structure and the movement monitors located at the four corners of each drop structure confirmed that the width of the gabion drop structures was decreasing with time at a current rate (2006-2007) of approximately 10 cm/yr. The largest movement to that date (July 2007) was 27 cm at Drop Structure #3. Other than the previous observation regarding a freeboard deficiency at Drop Structure #1, no deformations were observed that would compromise the drop structures ability to pass the expected design flow from Hudgeon Lake i.e. no trigger levels were reached. The rate of change of the drop structure width was of the same order of magnitude as the waste rock movement monitors located directly south of the stabilized creek channel. No significant channel erosion along Clinton Creek was observed, including the stretch downstream of the boulder transition where 0.2 to 0.3 m was measured in the previous year.

Future work recommended included another round of performance monitoring in 2008 (as per the Long Term Performance Monitoring Plan), evaluation of regrading waste rock above Drop Structure #'s 3 and 4 where steeper slopes were thought to be contributing to somewhat higher movements (closure) of the structures, hydraulic modeling to estimate the risk of a breach of the rock lined section of Wolverine Creek and the surveys necessary to complete the modelling.

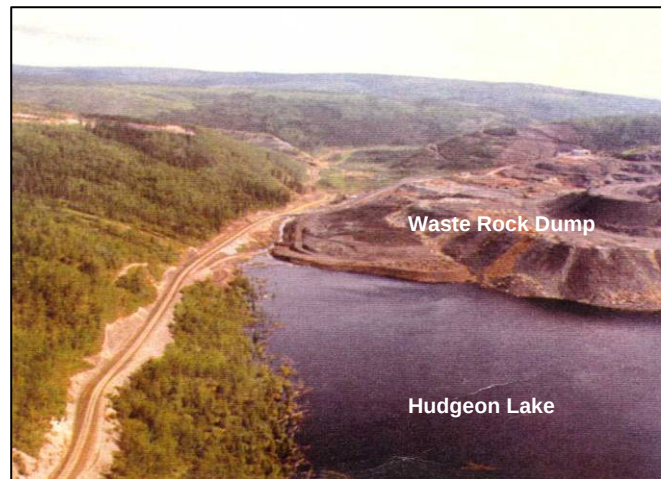
**Figure 21 Clinton Creek Waste Rock Dump (1974)**

The Clinton Creek valley during the initial stages of waste rock disposal is shown on Figure 18. A slope failure of the waste rock dump into the Clinton Creek valley occurred during active mining in 1974 (Figure 19). The resulting landslide dam blocked natural drainage through the valley creating a 74 ha lake (Hudgeon Lake) as shown in Figures 19 to 21. It was postulated that a weak foundation material contributed to the continued horizontal displacements following the initial failure of the waste rock dump (Golder, 1978). The loss of strength was believed to be related to a number of geological conditions unique to the site including ice content, soil type and the relationship between the rate of permafrost thawing and dissipation of excess pore-water pressures. It was also considered likely that disturbance to the thermal regime, in particular thawing of permafrost beneath the dump, has resulted from filling of the upstream reservoir (Hudgeon Lake).

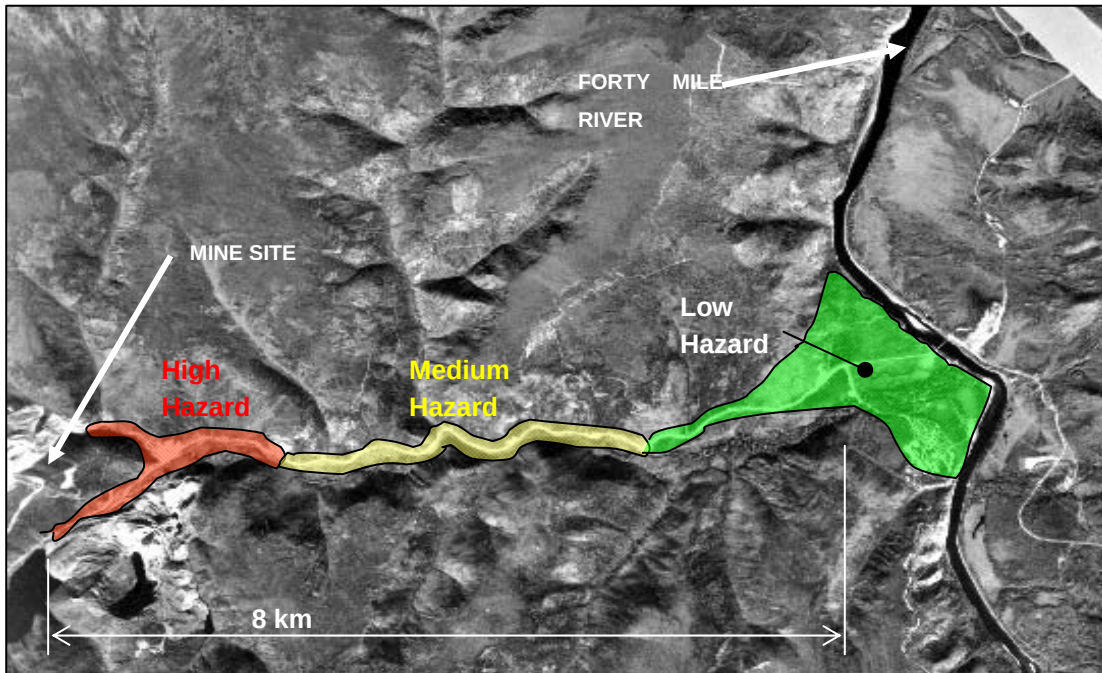
**Figure 28 Downstream Hazard Map**

Before the Clinton Creek channel stabilization repairs were completed, the conditions at the former mine site potentially exposed individuals, property and the environment to an unacceptable risk mainly associated with flooding. Using available information, a qualitative assessment of risk scenarios and human and ecological exposure levels associated with a breach of the lake outlet was possible. A quantitative estimate of risk was not considered appropriate given the considerable uncertainty in parameters necessary to arrive at precise predictions of risk under various scenarios and circumstances. There was however, sufficient reliability in the results to determine the acceptability of potentially hazardous activities and develop guidelines for appropriate risk management strategies. In this regard, the level of risk downstream of the mine site was categorized as high, medium or low based on the severity of flooding within each zone (Figure 28). The

The potential for loss-of-life associated with a breach is greatest immediately downstream of the mine site before a constriction in the Clinton Creek valley. Farther downstream along Clinton Creek, the risks are reduced, as the high water levels will be confined to the creek valley below the road where human exposure is less likely. The risk is considered low at the next most likely downstream area of occupancy in the vicinity of the former Clinton Creek Town-site where the valley widens considerably. Aquatic life and mammals downstream of the mine site are also potentially at risk from the redistribution of eroded waste rock. The largest risk is believed to be from a sudden breach of the waste rock dump (i.e. Hudgeon Lake outlet) resulting in fisheries habitat loss through downstream smothering and flooding. There is still however, a continued risk to aquatic and terrestrial life due to the chronic erosion and redistribution of waste rock downstream of the mine site.

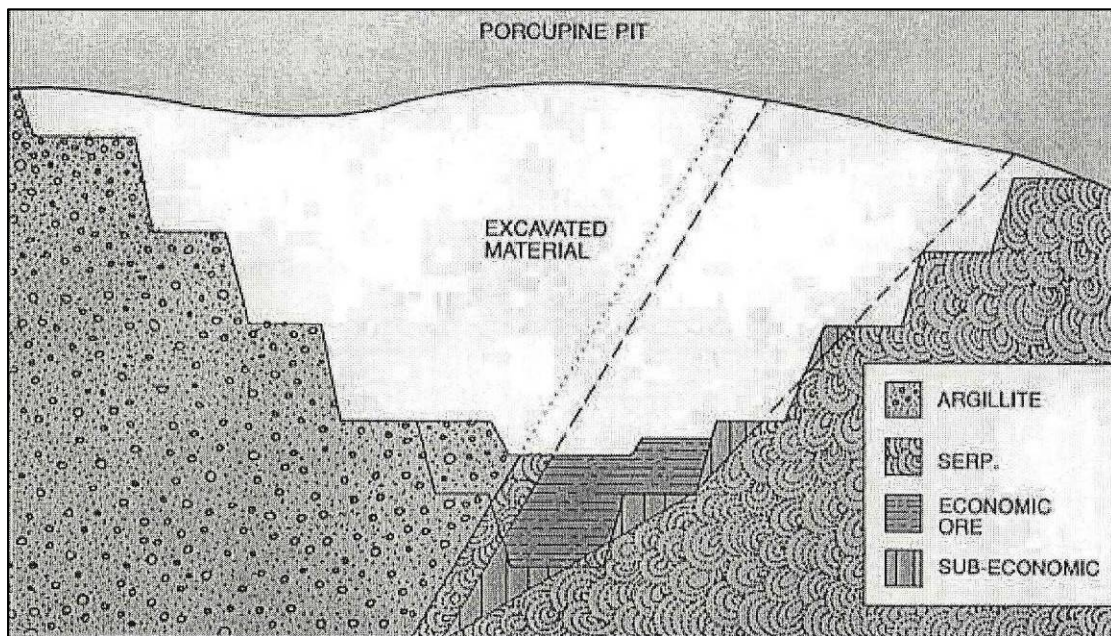
Figure 29 Porcupine Pit Cross Section (view NE)

The three principal chrysotile asbestos ore bodies within the overall Clinton Creek Mine were named Porcupine, Snowshoe and Creek. Development of the three open pits is not well documented in the available reports. It does however appear that movements of the west wall of the Porcupine Pit may have contributed to the decision to terminate ore recovery in this pit. A generalized section through the Porcupine Pit (taken from an untitled brochure prepared by Cassiar), shows the geological fault and ore body in comparison to the argillite and serpentine overburden materials destined to the waste rock dump (Figure 29).

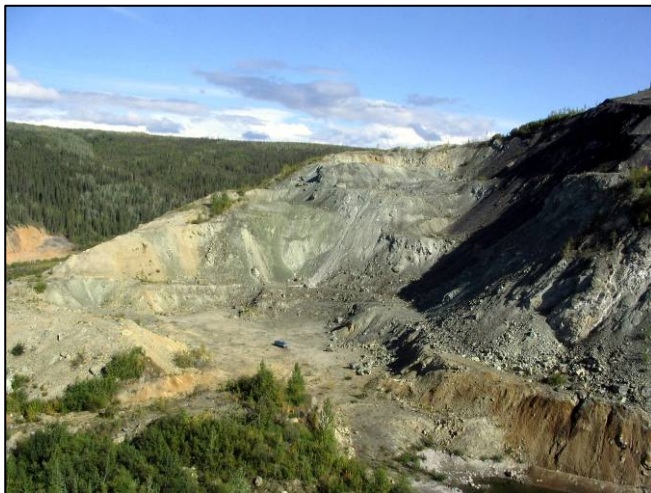
**Figure 31 Snowshoe Pit (2003)**

The physical condition of the open pits has not been evaluated as frequently as the waste rock dumps and tailings piles. The last physical inspection was carried out during the hazard assessment program completed in 2003 (UMA 2004). The most recent survey of a few existing pit wall monitors at the Porcupine Pit was completed in 2008 as part of the Long term Performance Monitoring program (AECOM 2009). Pit wall instabilities are evident at all three pits with visible tension cracking and slumping of large sections of ground around the pit perimeters (Figures 30, 31 and 32). In 2003, many of these instabilities and associated movements appeared recent and during the site reconnaissance, small active slides were observed in the northwest corner of the Porcupine Pit. All three pits have ponded water.

General care and maintenance of the three open pits at the former Clinton Creek Asbestos Mine currently consists of restricting vehicle access to the open pit areas. Without measures to physically alter the open pit slopes i.e. slope flattening or constructing toe berms, stability of the pit walls will only be achieved when they eventually reach a stable angle which will take many tens or hundreds of years. This natural process is well underway as evidenced by the ravelling of pit walls, in particular at the Porcupine Pit (Figure 30). It is recommended that future site inspections include the open pits and that additional movement monitoring points be installed to help assess the performance of the pit walls.

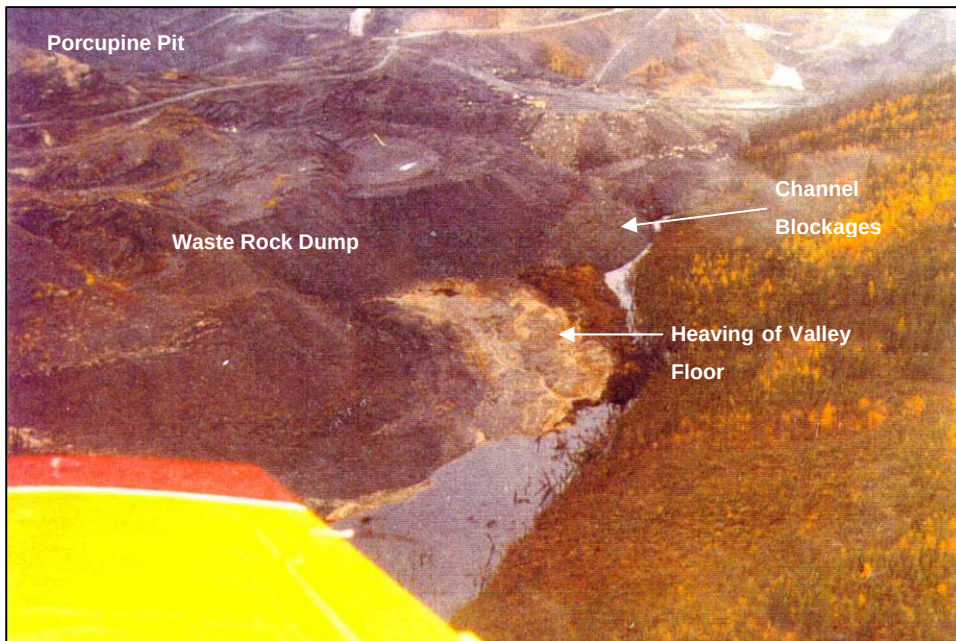
**Figure 33 Porcupine Cr. Waste Rock Dump (1977)**

Waste rock was placed across the Porcupine Creek valley slope as shown on Figure 33, one of the earliest aerial photographs taken of the area in 1976 or 1977 (Hardy, 1977). The most northerly section of the dump was placed at least partially up the east valley slope and this area has remained relatively stable. Sections near the centre of the dump which were placed farther away from the east valley toe, however, experienced slumping that created blockages to creek flow at two locations. Both blockages behave as permeable dams with creek flow through or beneath the rock fill.
