Report No. 118014/1

**2008 GROUNDWATER REVIEW**  
**ANVIL RANGE MINING COMPLEX, YUKON TERRITORY**

**Faro Mine Closure Planning Office**

**February 2009**

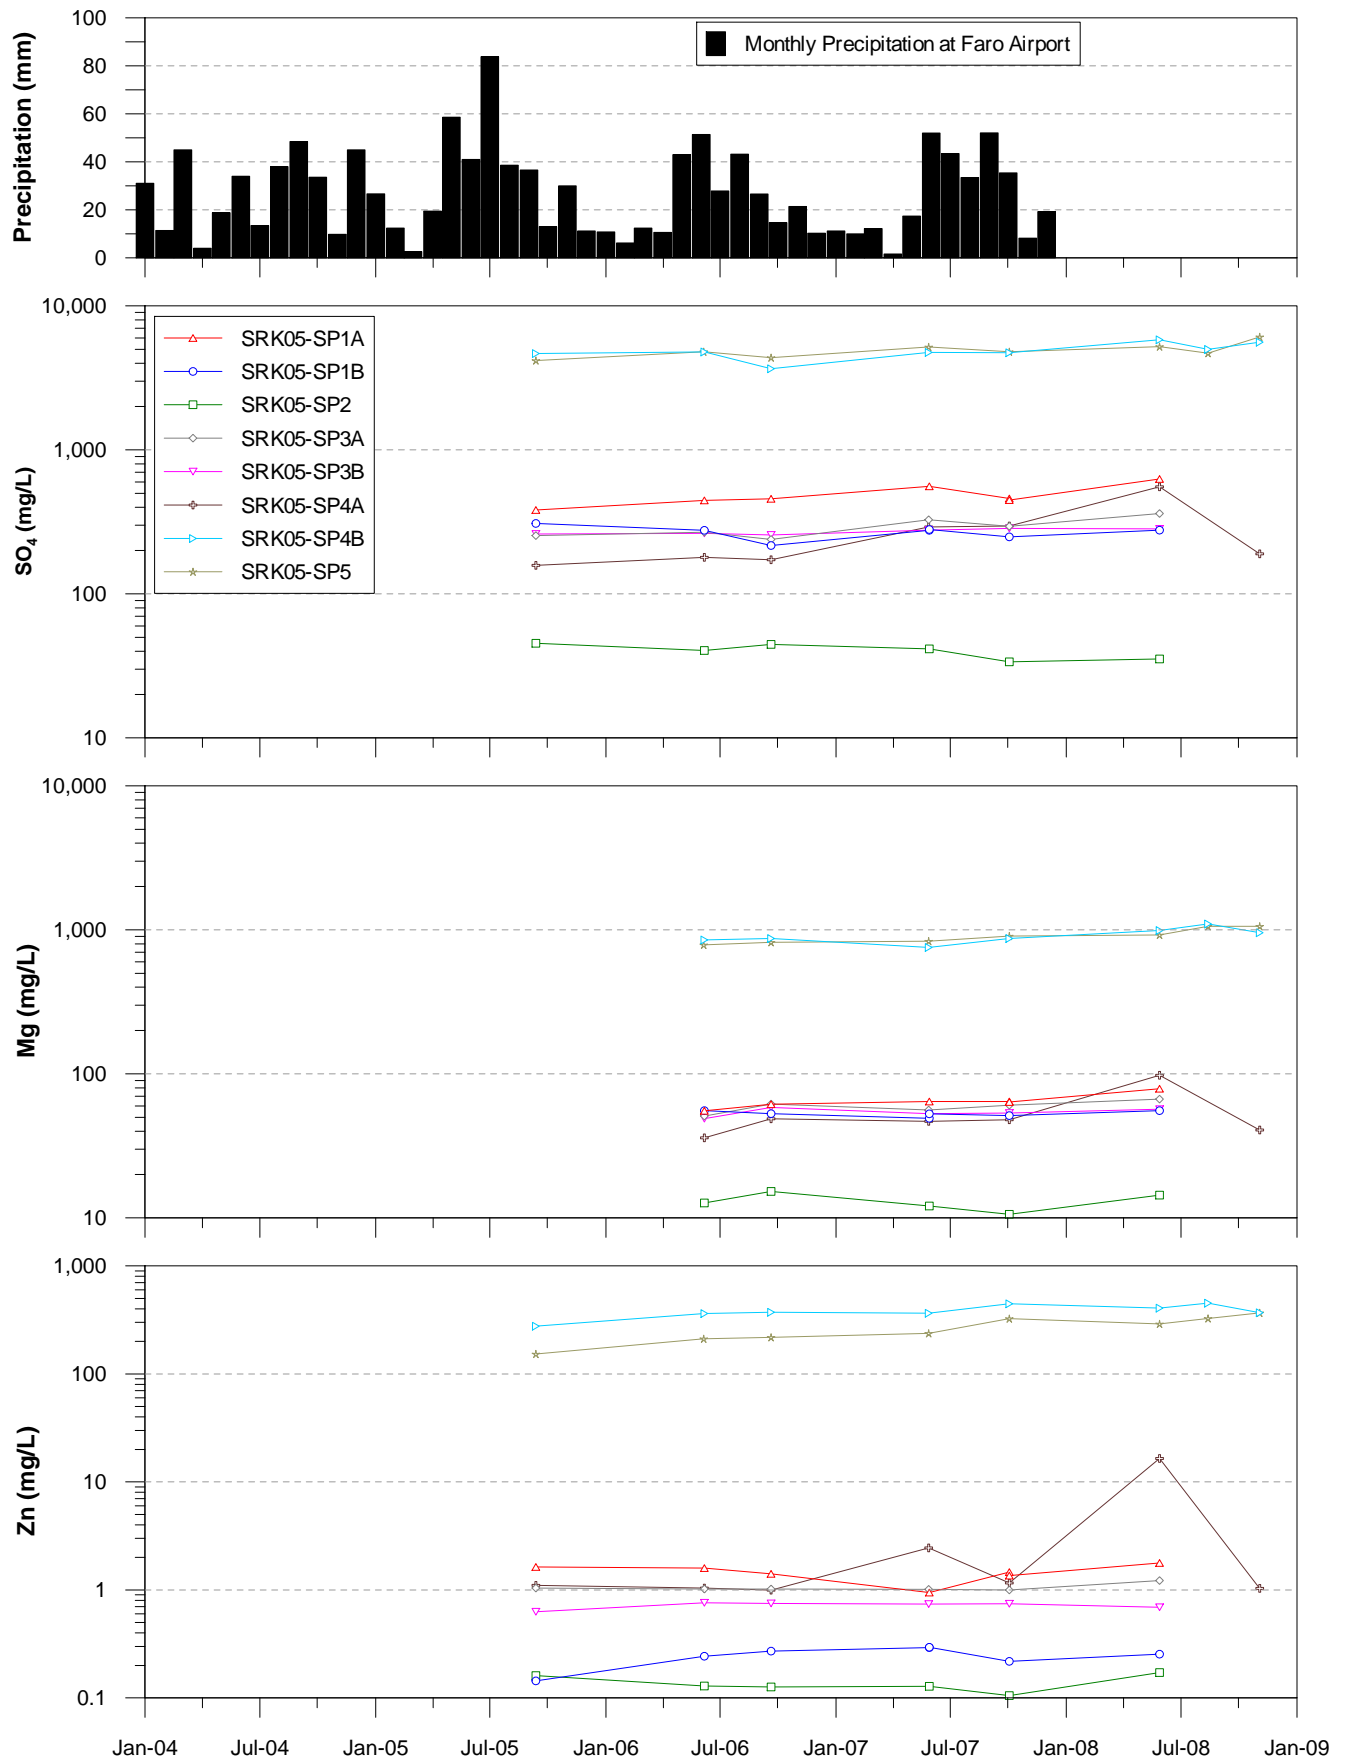
Figure 2-7a. Precipitation and water quality (SO<sub>4</sub>, Mg and Zn) in SRK Wells in S-Cluster Area.

The groundwater quality in several wells located in the S-cluster area continued to deteriorate over the monitoring period, supporting earlier recommendations that seepage interception in this area should be prioritized;

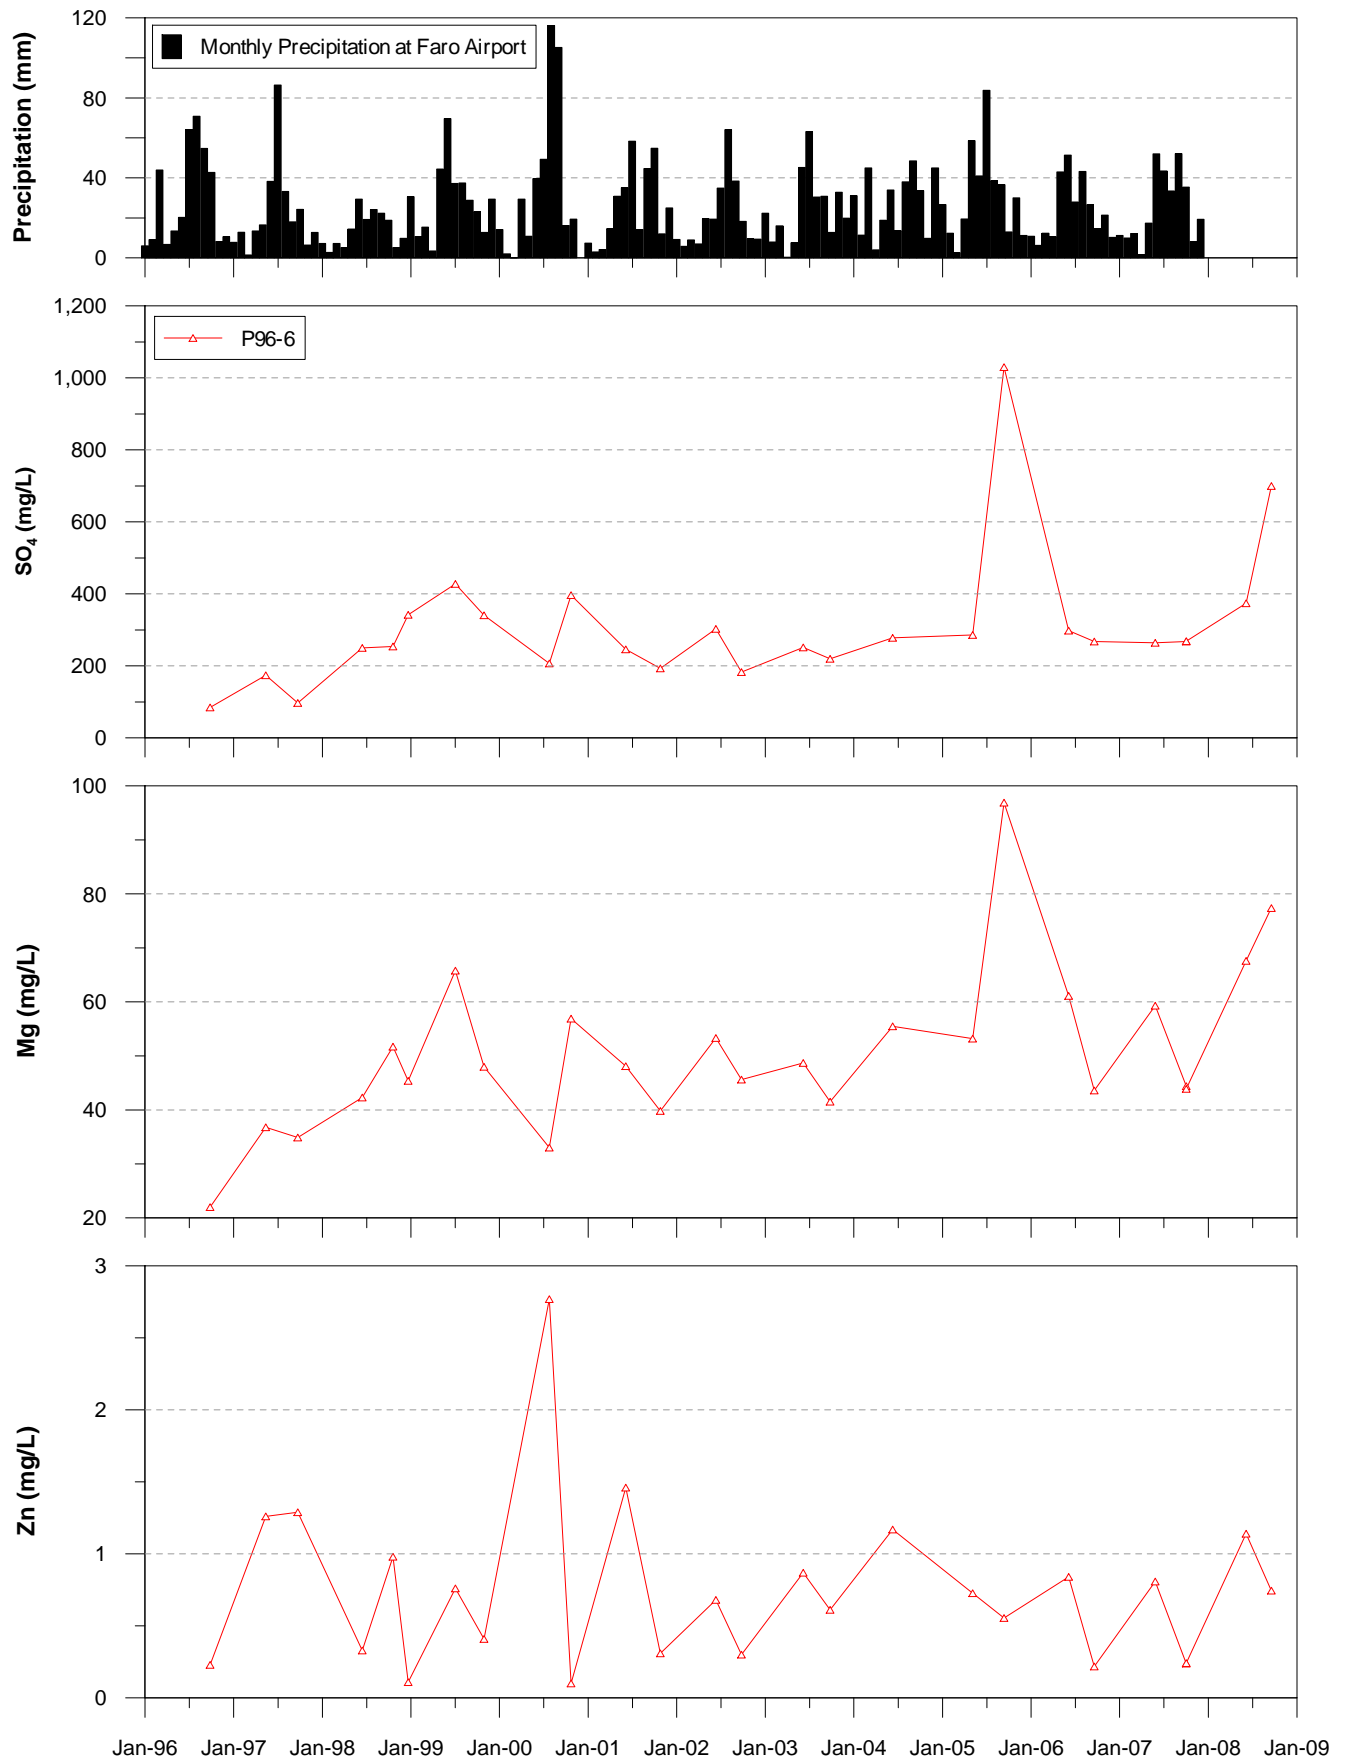
Figure 2-12a. Precipitation and water quality (SO<sub>4</sub>, Mg and Zn) at toe of Intermediate Dump (P96-6).

Figure 2-12a/b shows selected water quality time trends for P96-6. This well is located along the toe of the Intermediate Dump and monitors groundwater flowing from the Intermediate Dump towards the NFRC. Similar to selected wells in the S-cluster area (e.g. SRK05-SP1A, -SP3A, SP3B and -SP4A), groundwater quality in this monitoring well is considered “moderately-impacted” by seepage. In 2008, the concentrations of  $\text{SO}_4$  and Mg also increased in P96-6. These increases may be indicative of increased seepage from the Intermediate Dump and could precede similar increases in the concentrations of dissolved metals.

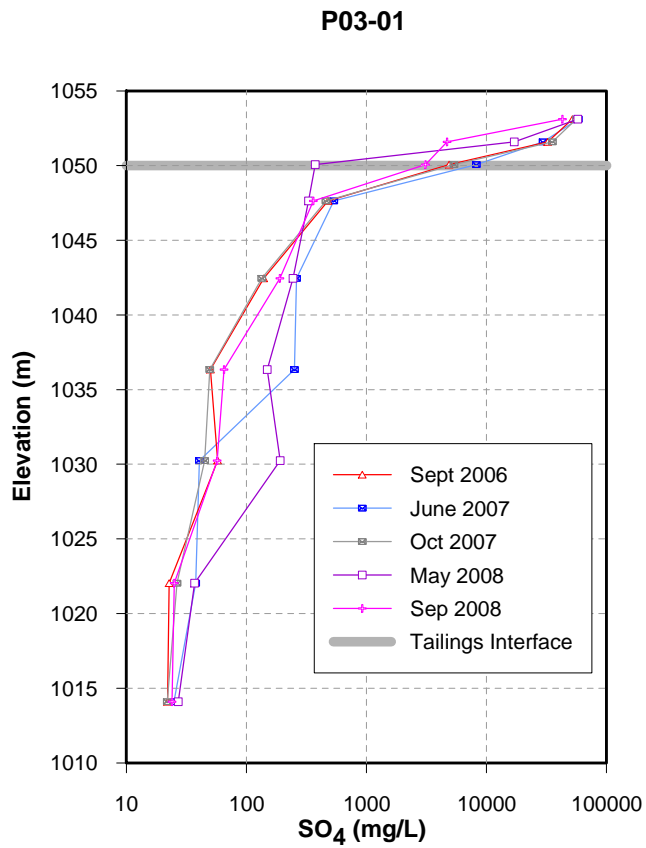
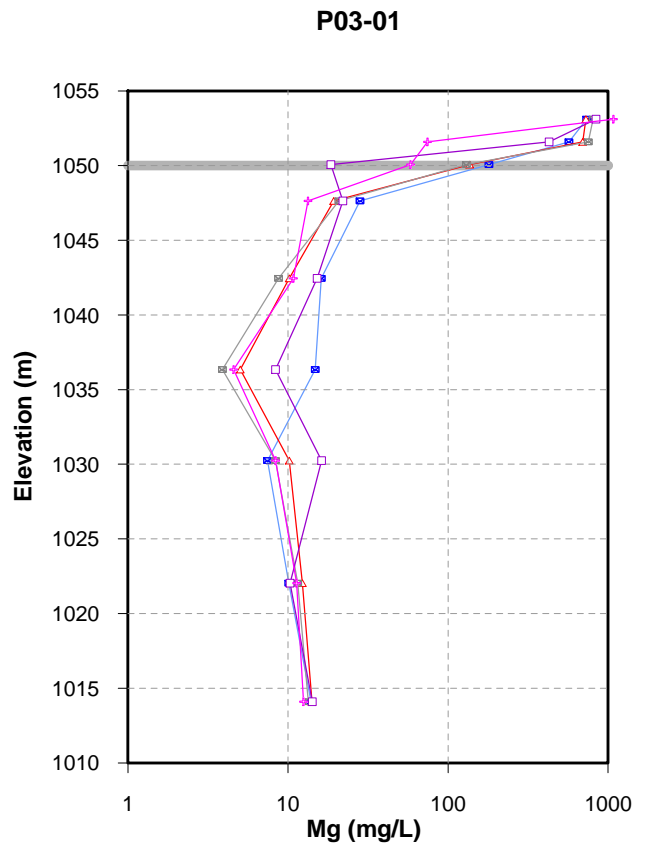
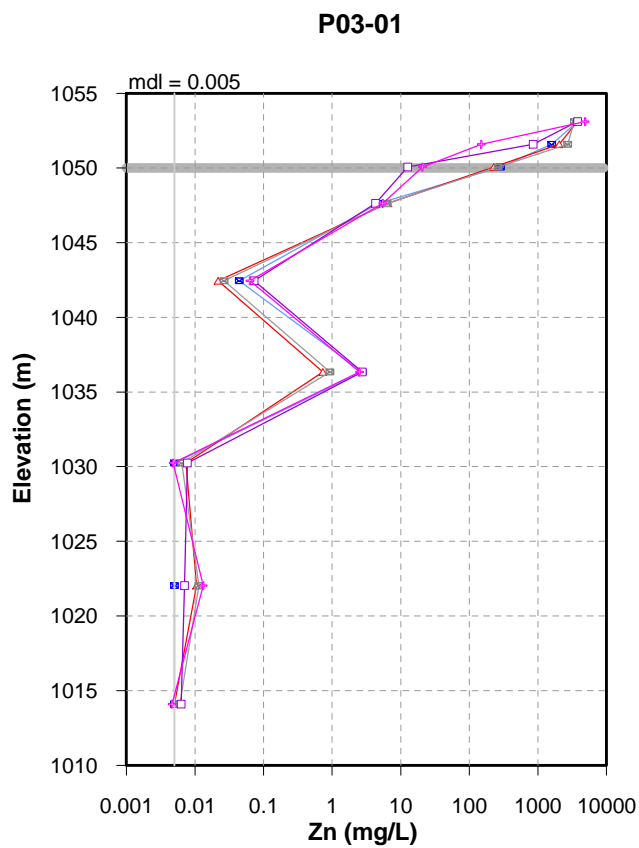
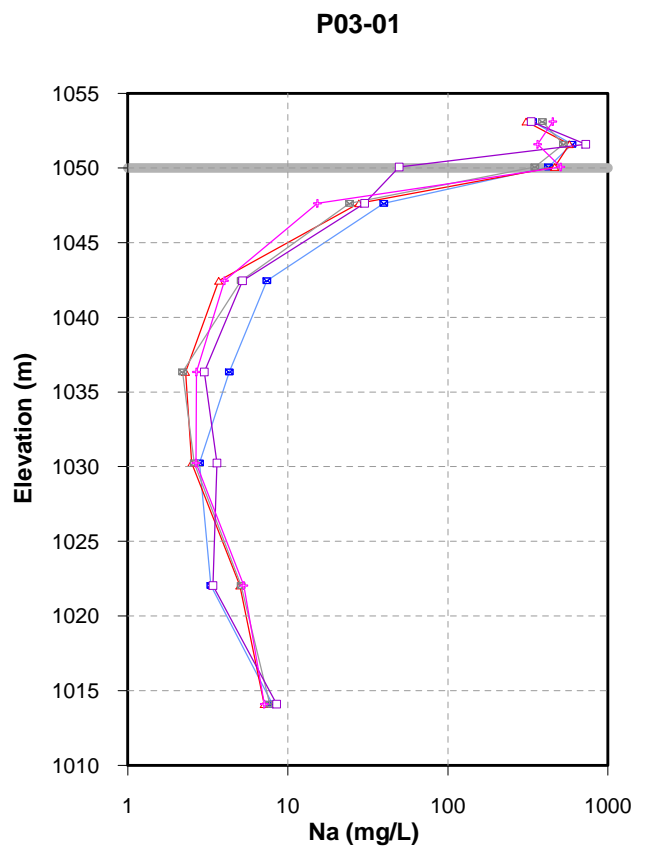
Figure 3-3a. Water quality depth profiles of SO<sub>4</sub>, Mg, Zn and Na in P03-01 (Second Impoundment).

Six multi-level wells (P03-01 to P03-06) were installed within the footprint of the Second Impoundment in 2003. Water quality depth profiles for these wells are illustrated in Figures 3-3a/b to 3-8a/b. The general shapes of the depth profiles observed during the current monitoring period are very similar to those observed in previous monitoring campaigns. In accordance with previous
