Report No. 118017/1

**2009 GROUNDWATER QUALITY REVIEW
ANVIL RANGE MINING COMPLEX, YUKON TERRITORY**

Faro Mine Closure Planning Office

February 2010

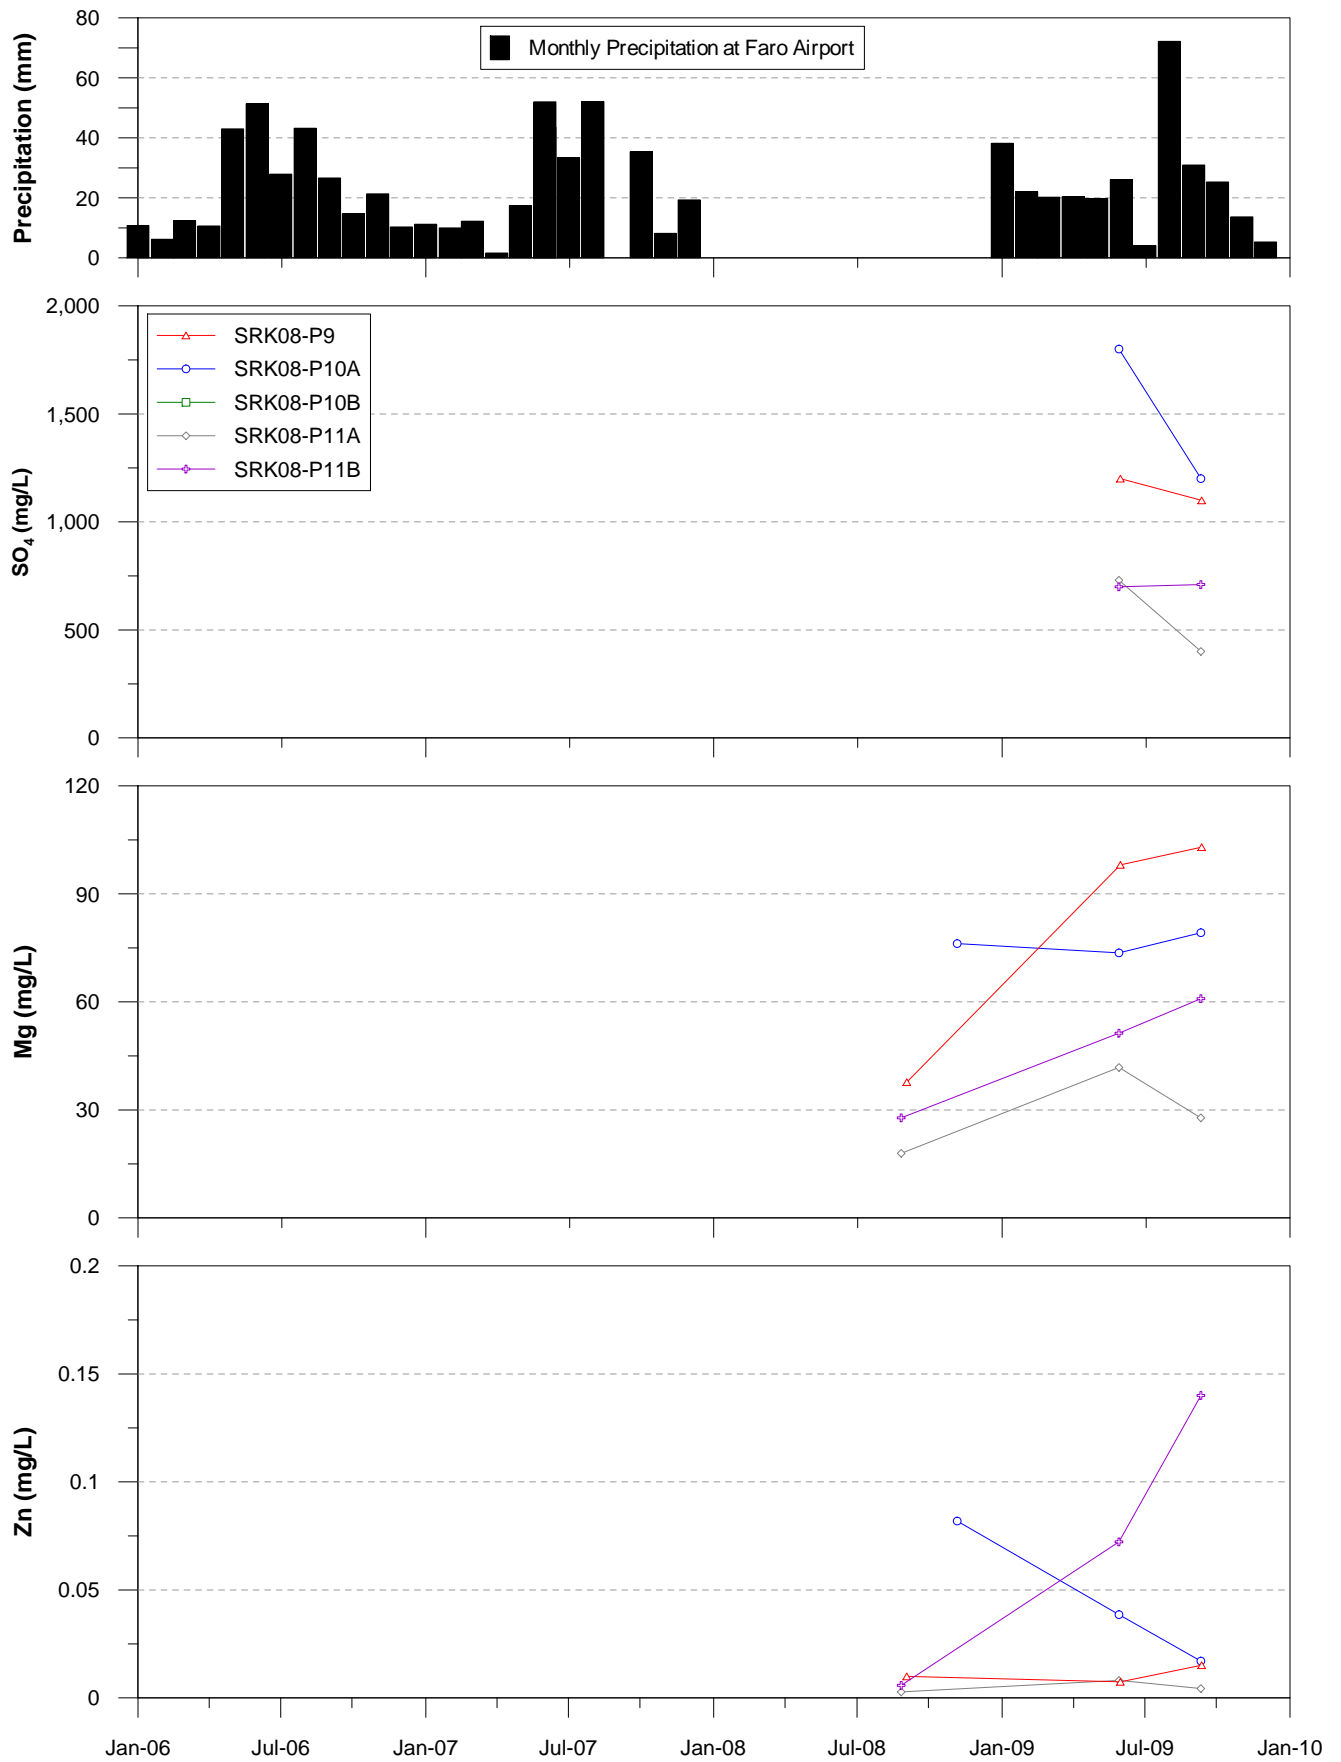
Figure 2-3c. Time trends for SO_4 , Mg and Zn in SRK08 wells located in Main Rock Dump and Mill Site areas

Wells SRK08-P09, SRK08-P10A/B, and SRK08-P11A/B are each located in the Mill Site area (Figure 2-1). Specifically, SRK08-P09 is located below the toe of the Main WRD to the southeast of the mill. SRK08-P10A/B is located downgradient of the mill near the ETA and SRK08-P11A/B is located near Guardhouse Creek (Table 2-1). Elevated SO₄ concentrations are observed in each of these wells but Zn concentrations remain low (< 0.15 mg/L) (Figure 2-3c/d). Concentrations of SO₄, Zn, and other metals have not increase substantially since 2008 and hence groundwater quality appears to be relatively stable in the mill area. Of particular interest are the low concentrations of Zn and metals of interest in well SRK08-P9, which suggest that seepage from the Main WRD has not yet affected groundwater in this area to the same extent as groundwater near wells P96-8A/B.

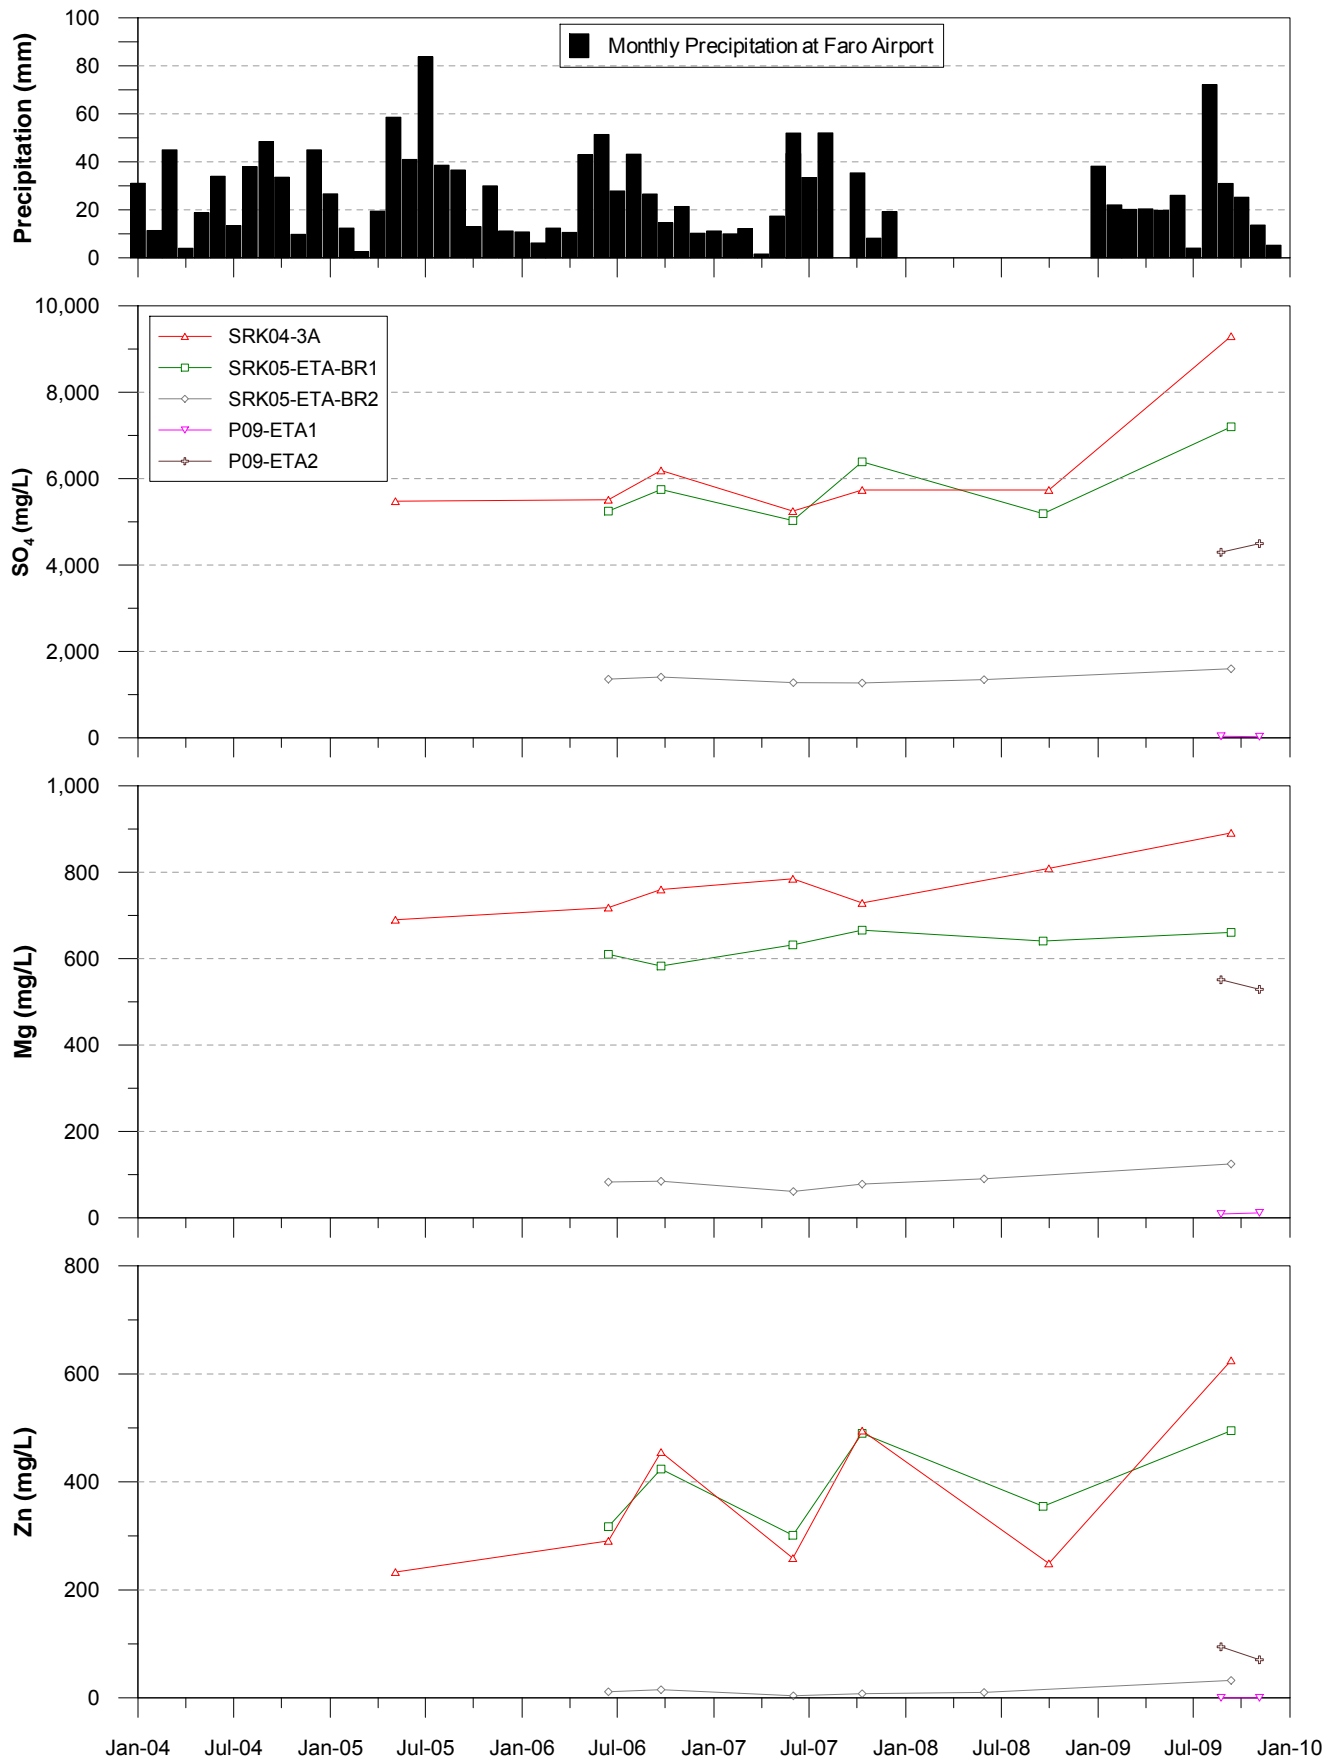
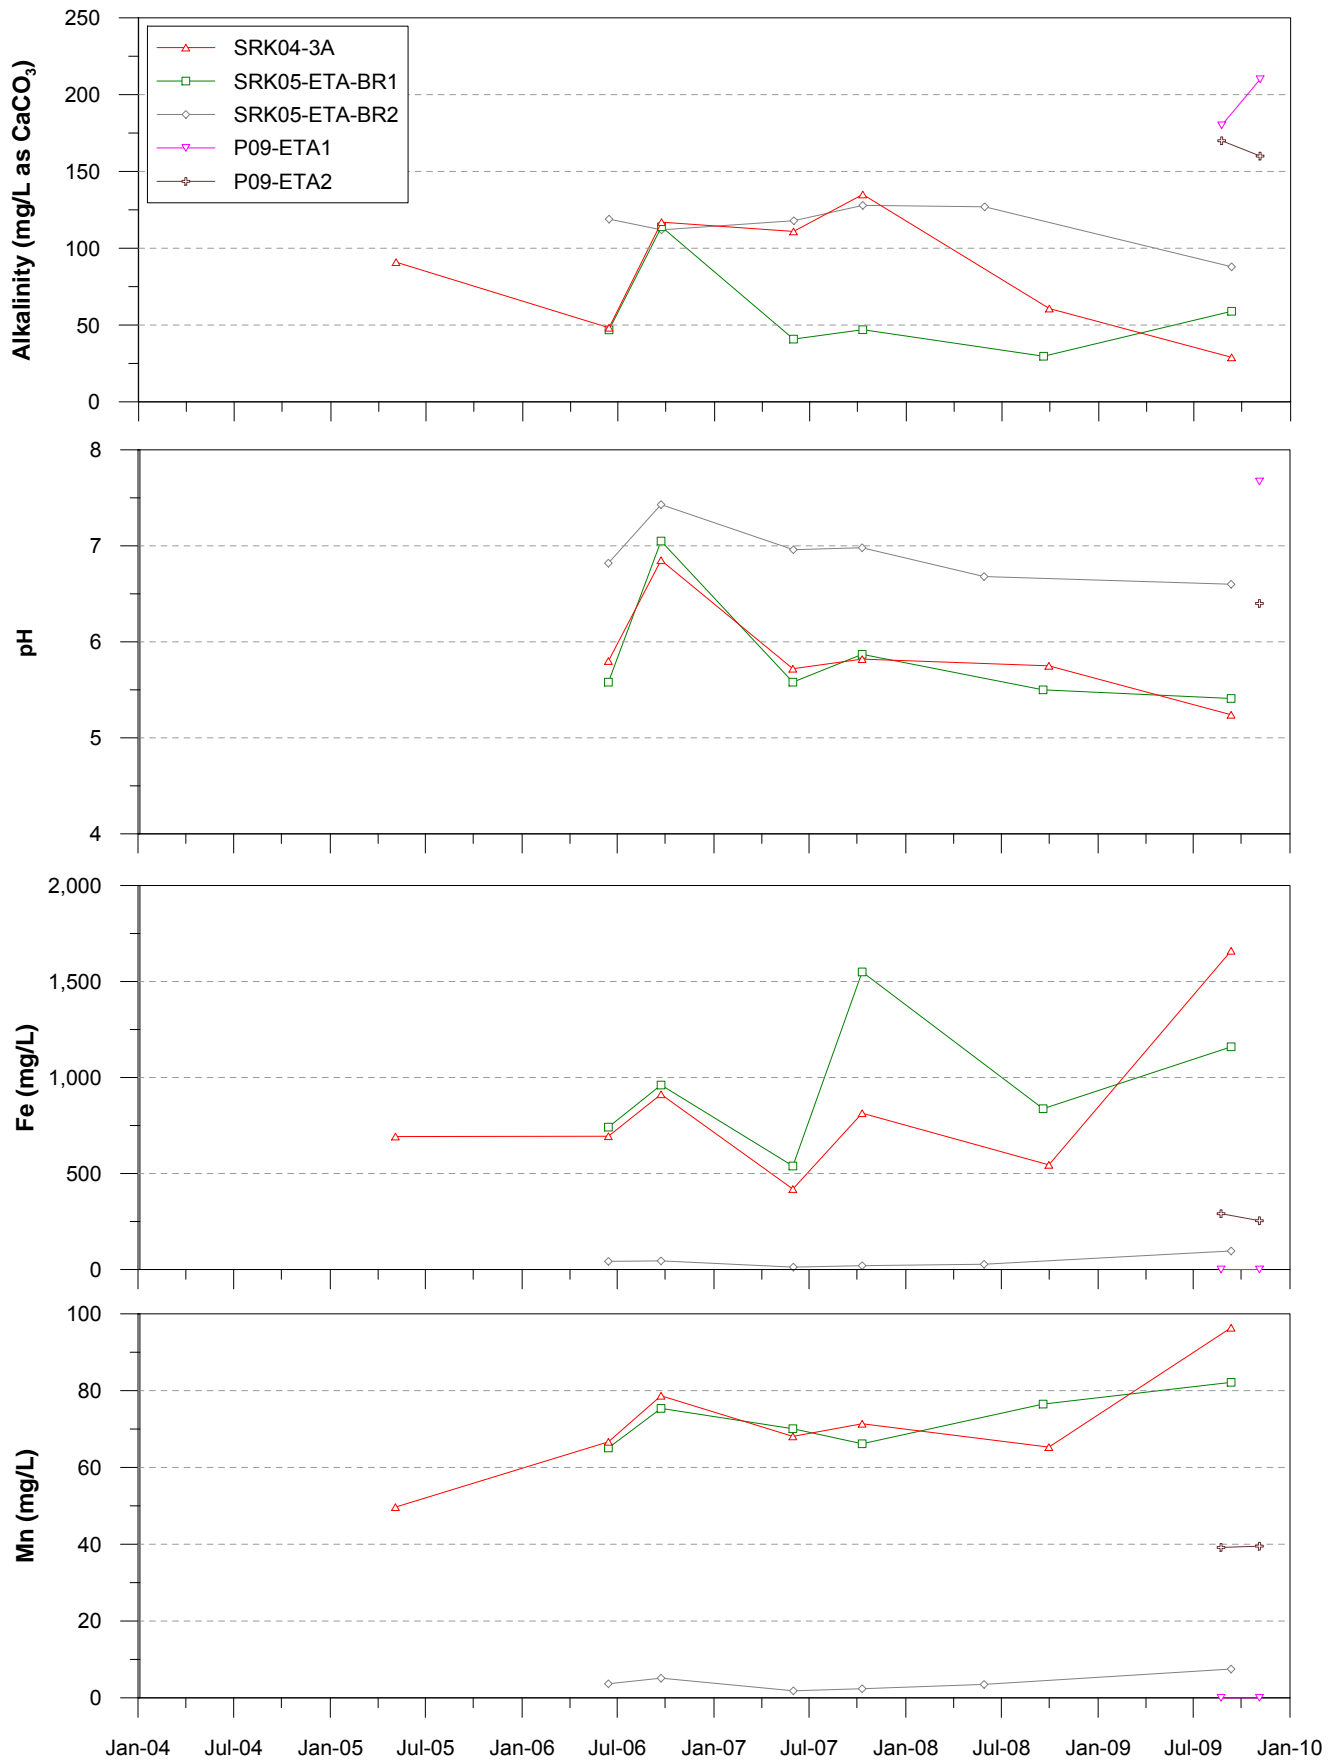
Figure 2-4a. Time trends for SO_4 , Mg and Zn in SRK wells in ETA area

Figure 2-4a/b shows time trends for pH, alkalinity, selected major ions, and metals of interest in the four monitoring wells (wells SRK04-3A, SRK04-3B, SRK05-ETA-BR1, and SRK05-ETA-BR2) located up-gradient of the mine access road in the ETA and the two new wells near the mouth of Faro Creek canyon (wells P09-ETA-1 and P09-ETA-2). Groundwater in wells screened in the alluvial sediments of the Faro Creek channel (wells SRK04-3A and SRK05-ETA-BR1) or in a mixture of tailings and alluvial sands (well SRK04-3B) is characterized by slightly lower pH values and alkalinity concentrations and significantly higher concentrations of SO₄, Mg, and metals of concern (Zn, Fe, and Mn) than groundwater that resides in bedrock beneath the alluvium at well SRK05-ETA-BR2. These differences in groundwater quality indicate that groundwater in deep bedrock within the ETA is much less affected by mine waste seepage than the overlying alluvial channel (which is highly-impacted). Nonetheless, metal concentrations in deeper groundwater in the ETA area (e.g. 10 mg/L of Zn) are higher than natural background levels for groundwater at the ARMC and have risen slightly in the last two years.

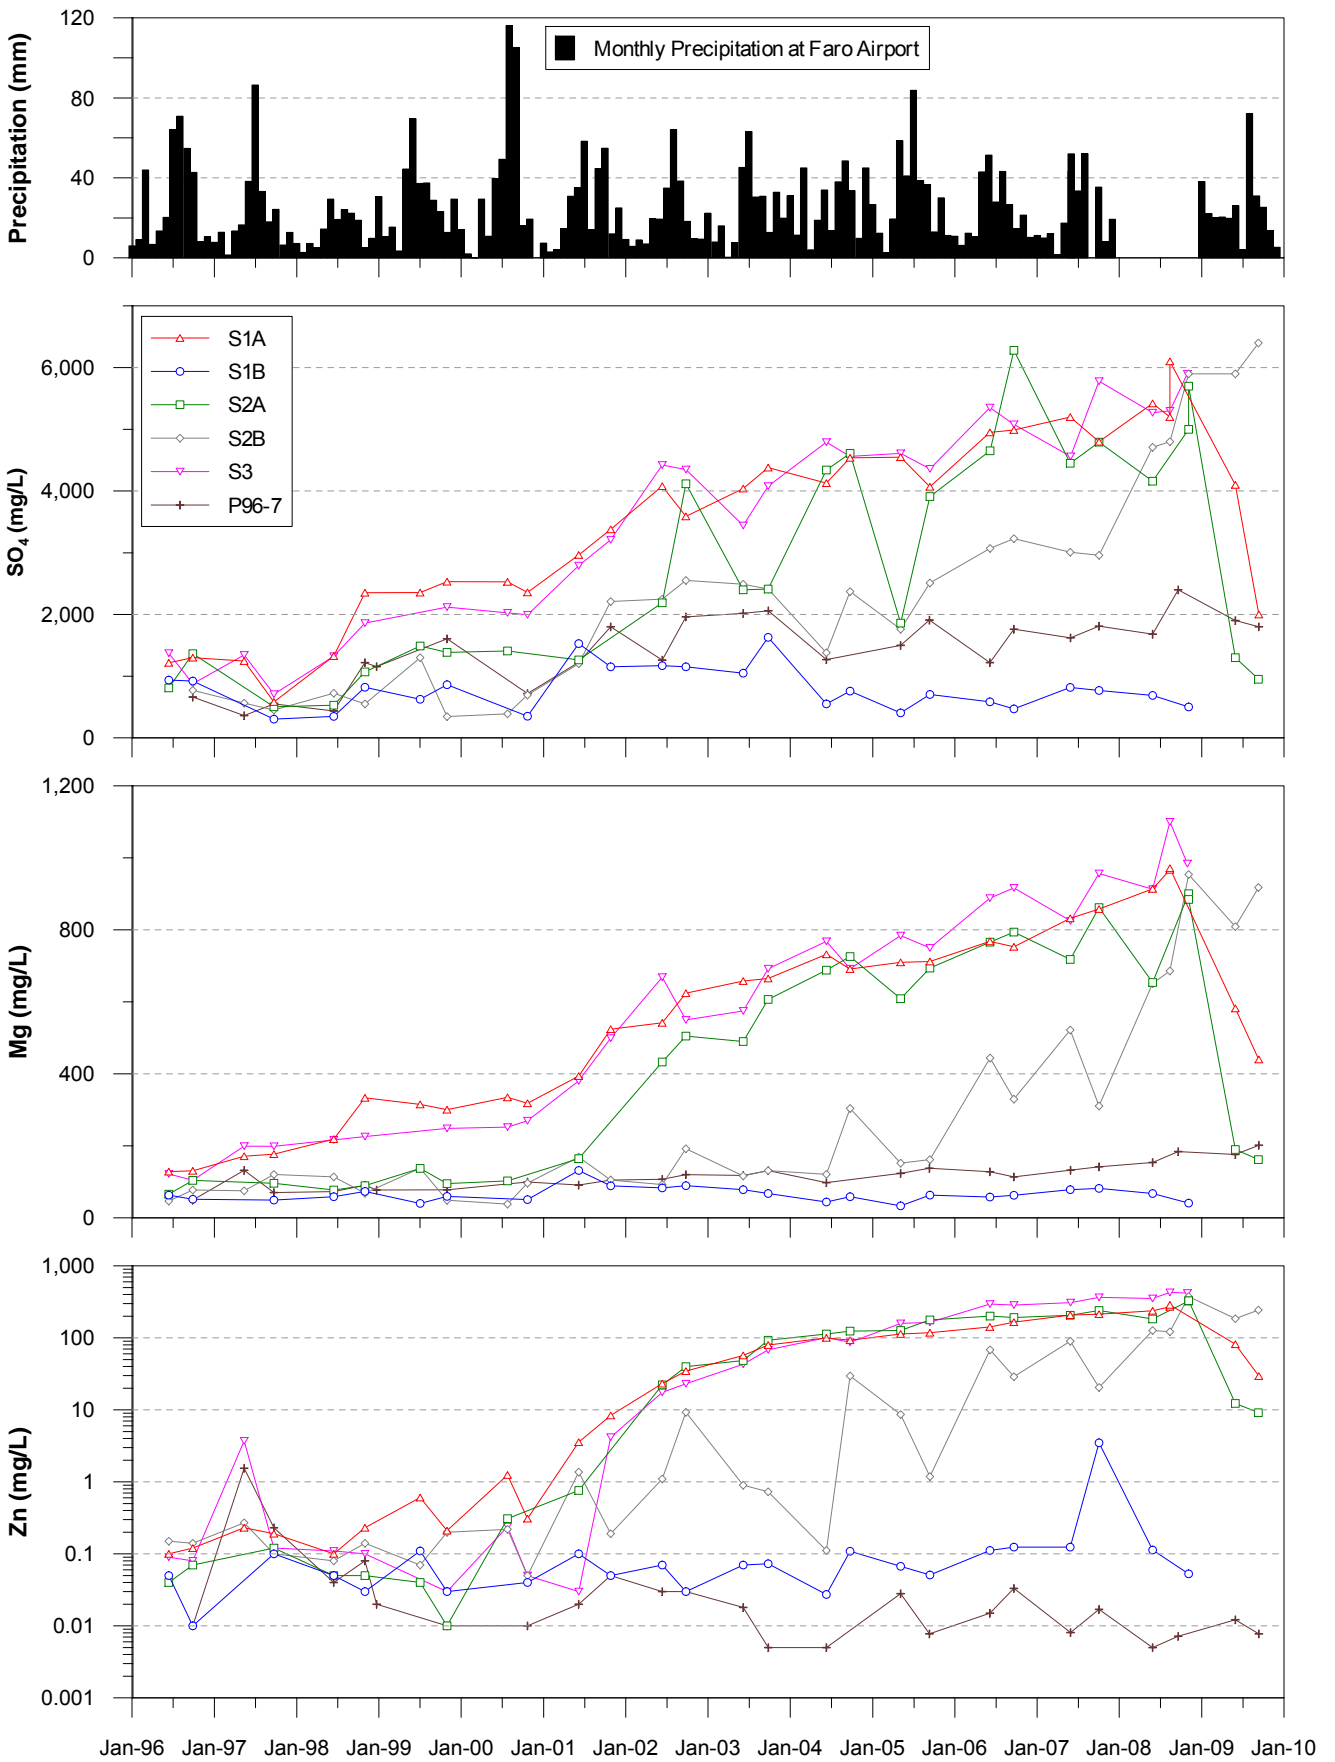
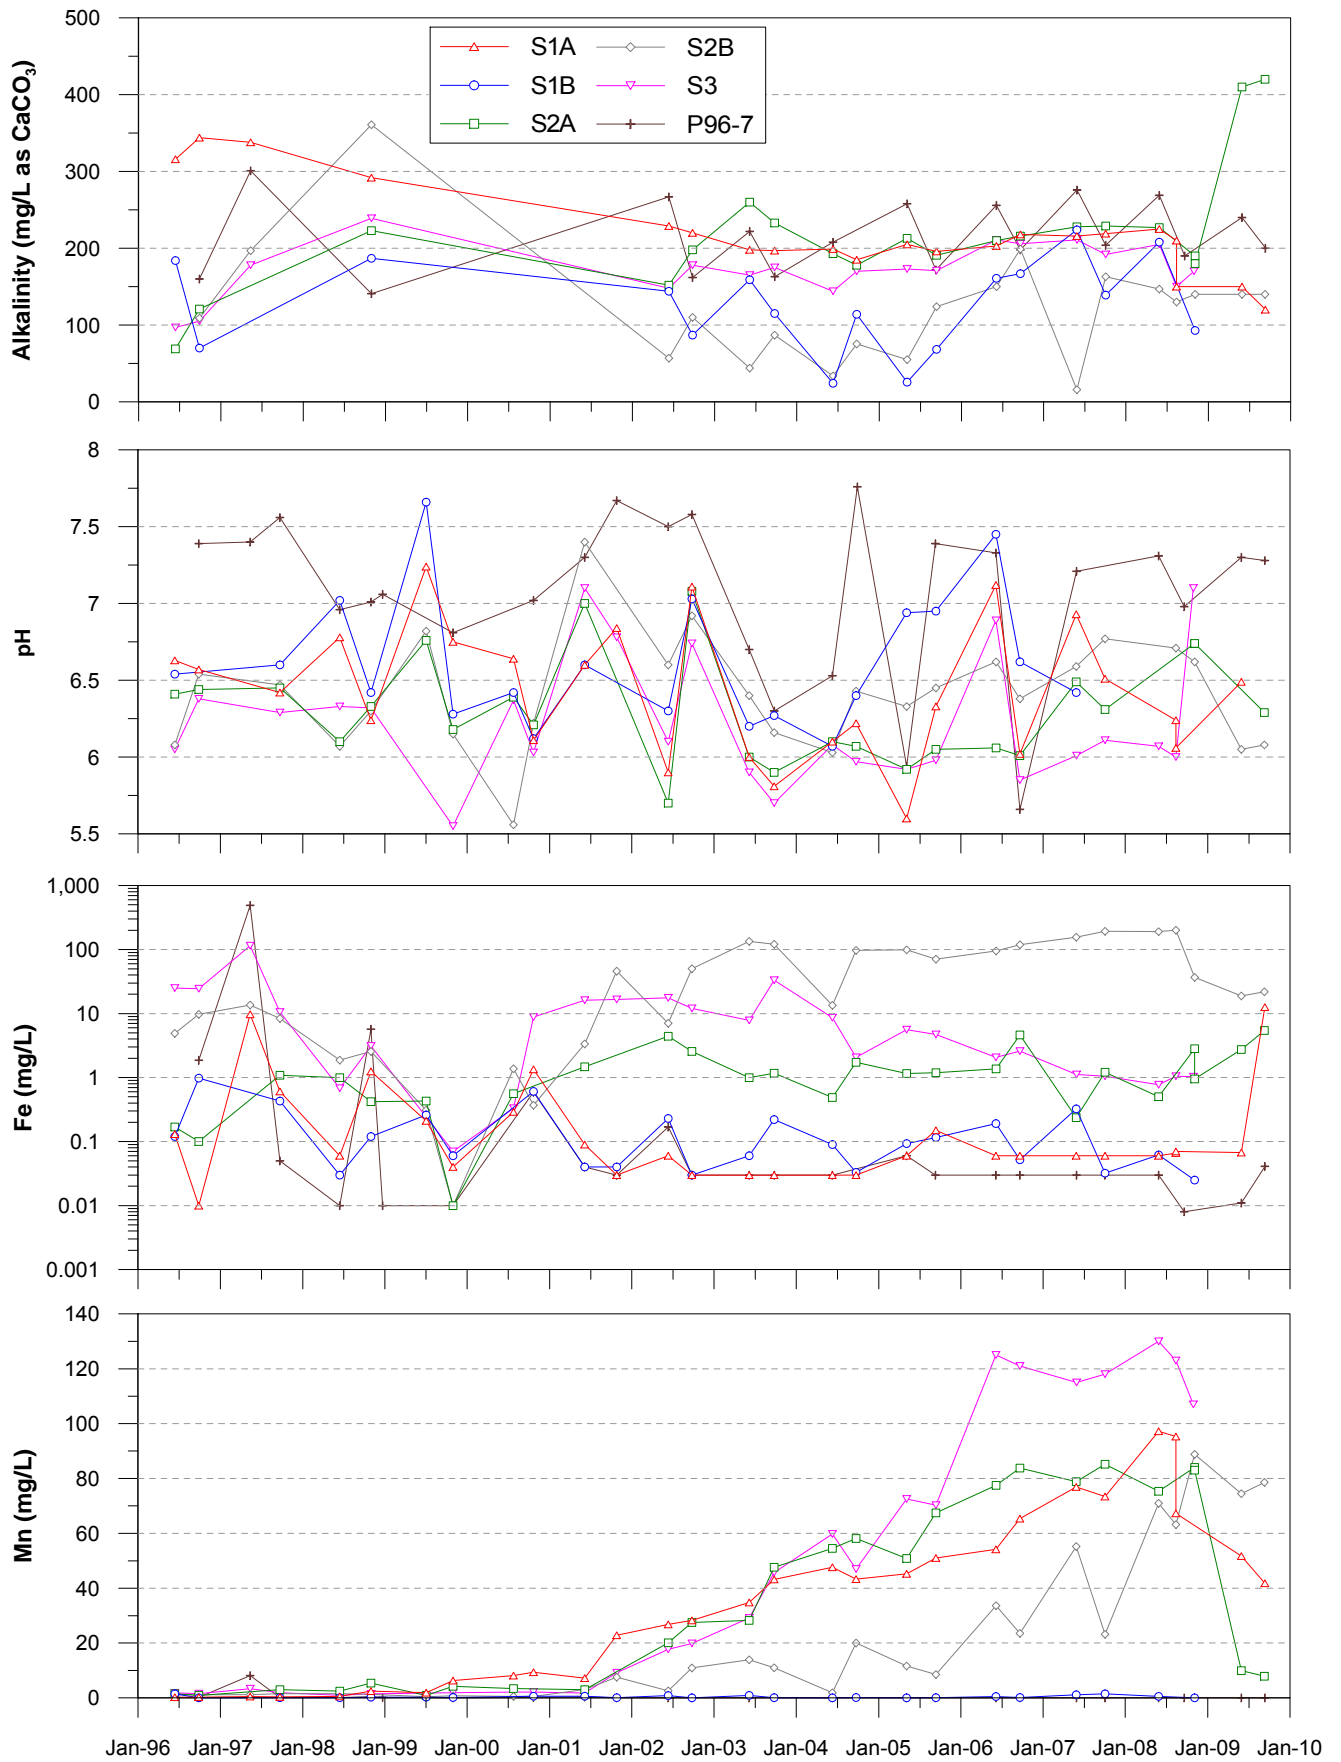
Figure 2-6a. Time Trends for SO₄, Mg and Zn in S-Cluster Wells

Figures 2-6a/b shows the time trends for pH, alkalinity, selected major ions, and metals of interest in groundwater from the historic 'S' wells and well P96-7. Similar time trend plots for the 'SRK05-SP' and 'P09-SIS' well series are shown in Figure 2-7a/b and Figure 2-7c/d, respectively. Time trend plots for the recently installed bedrock wells in the S-cluster area ('SBR' series) and monitoring wells further downgradient of the SIS (SRK08-SP7A/B and SRK08-SP8A/B) are shown in Figure 2-8a/b and Figure 2-8c/d, respectively

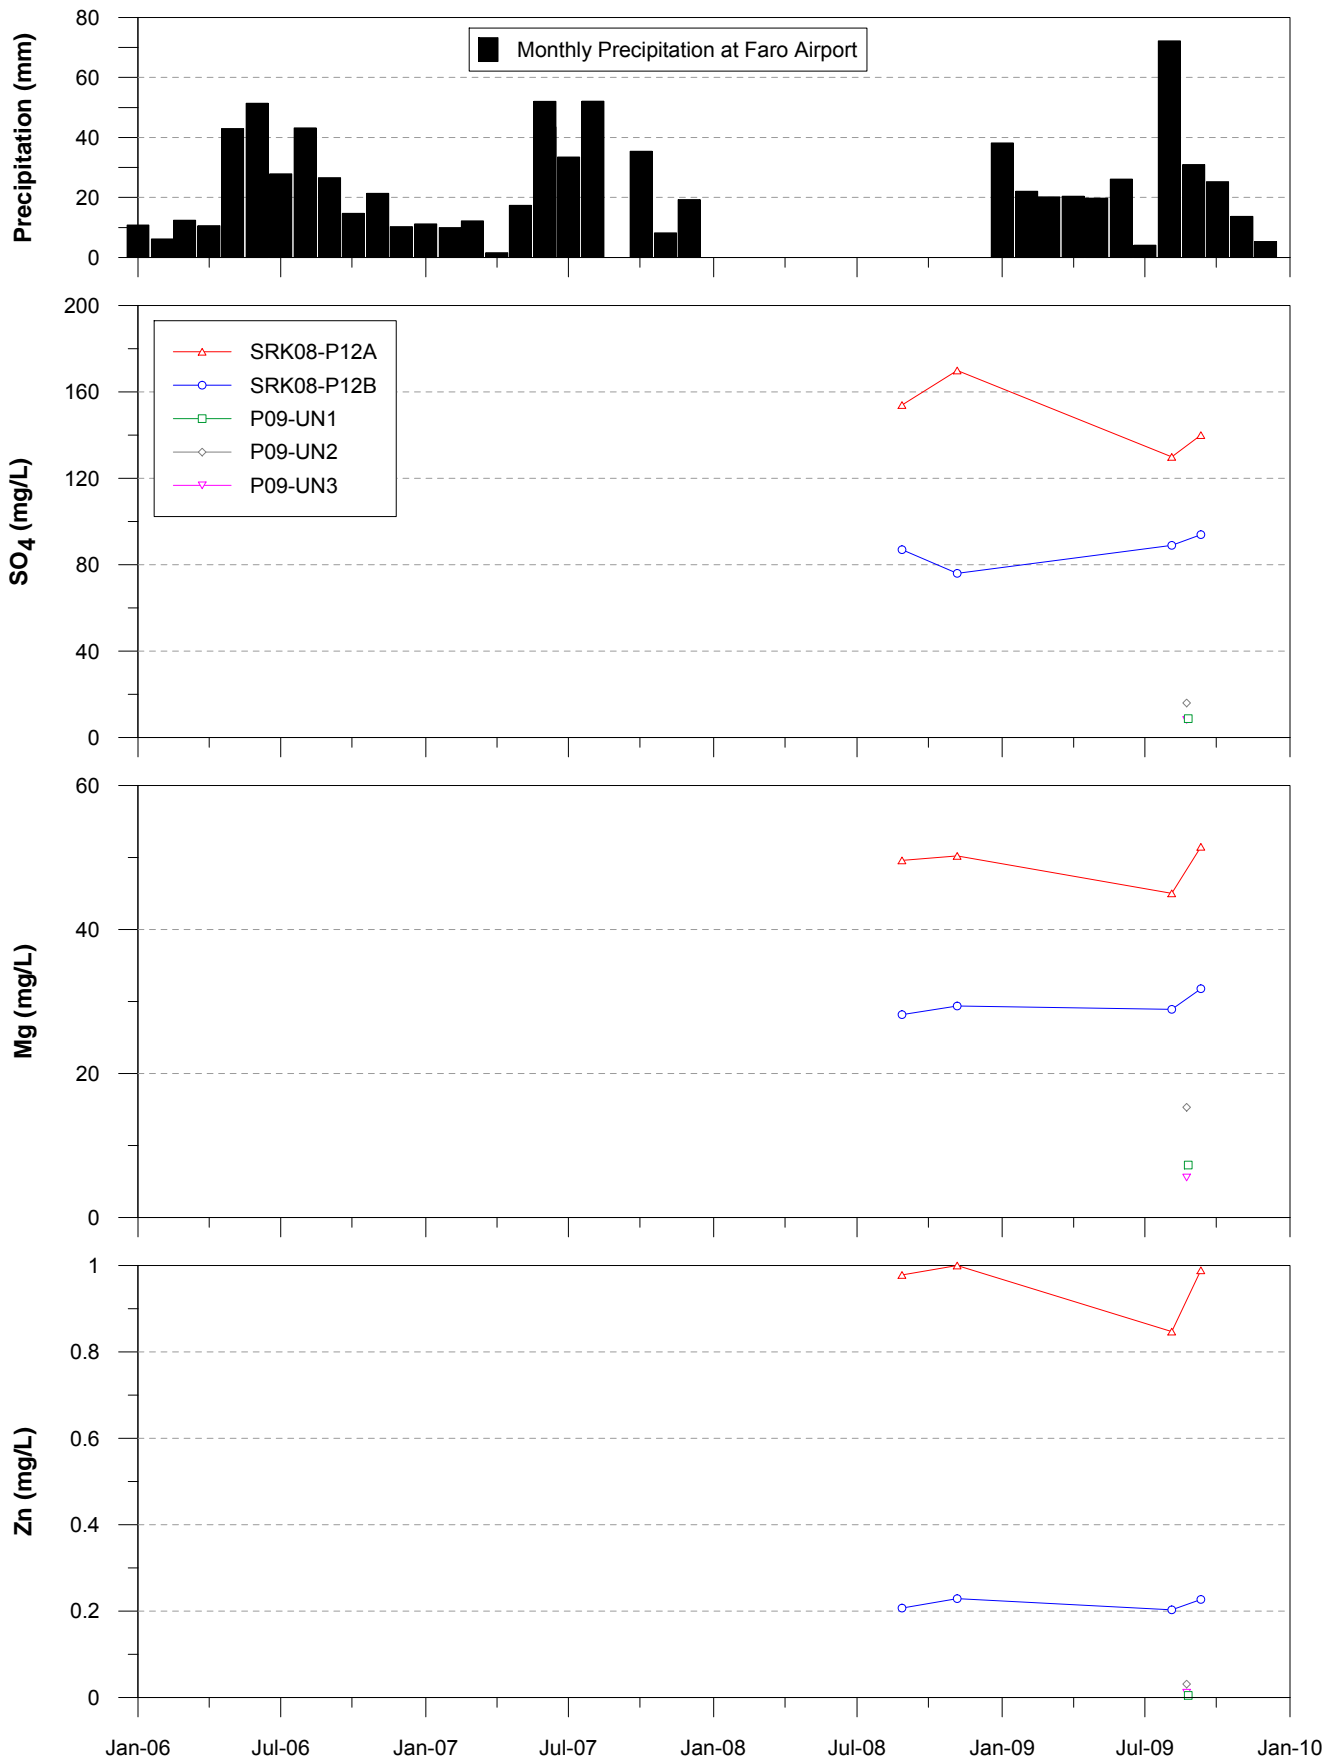
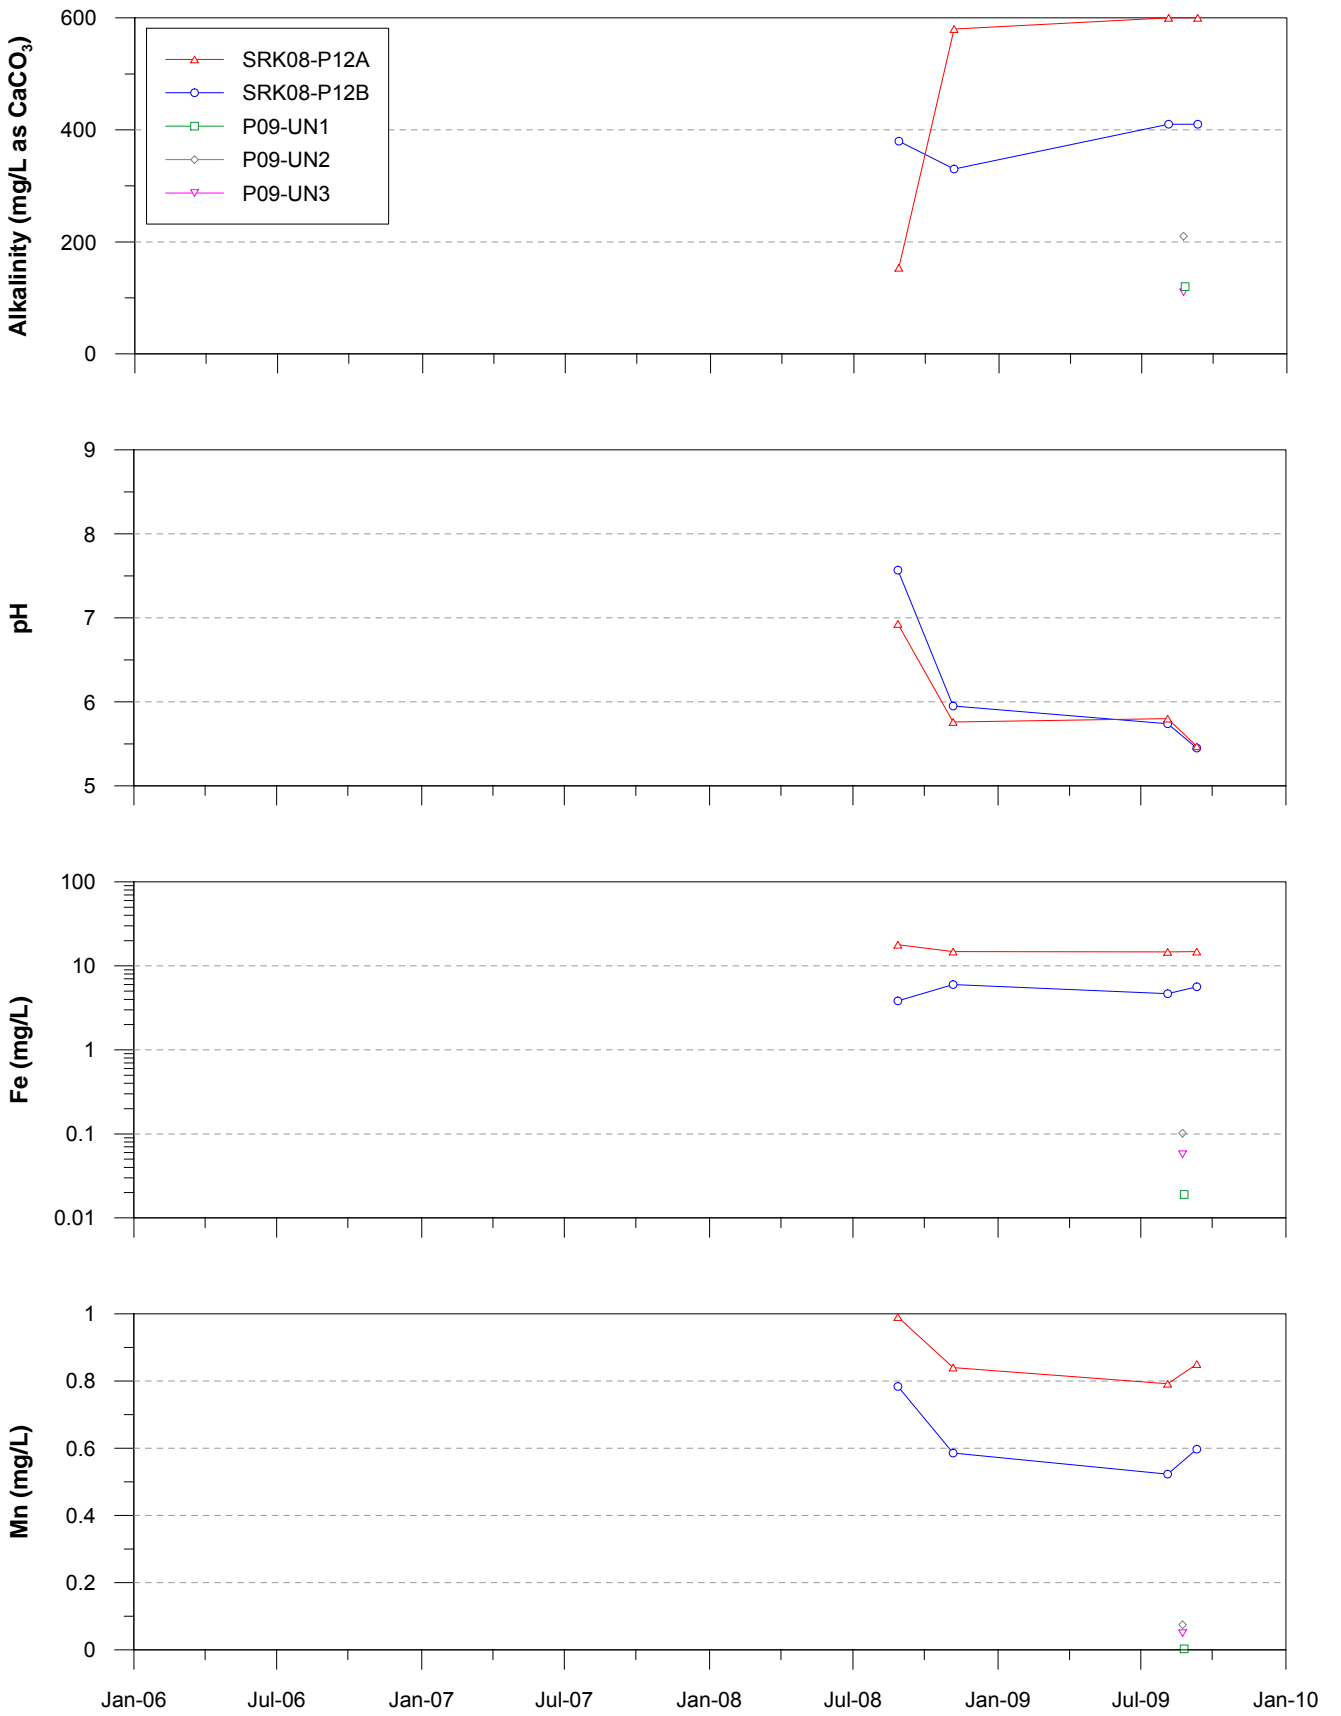
Figure 2-11a. Time trends for SO₄, Mg, Na and Zn in P09-UN and SRK08-P12A/B wells

Time trends for pH, alkalinity, selected major ions, and metals of interest for the 'P09-UN' wells series are shown in Figure 2-11a/b. Water quality time trends for monitoring wells SRK08-P12A/B, located immediately upstream of the Zone 2 Pit Outwash area are shown for comparison. SO₄ concentrations in each of the 'P09-UN' wells are low (< 20 mg/L) and concentrations of metals of interest (Fe, Mn, and Zn) are less than 0.05 mg/L. These concentrations are representative of background groundwater quality at the ARMC and suggest that groundwater near the confluence of NFRC and the Faro Creek diversion is unimpacted by mine waste seepage at this time.

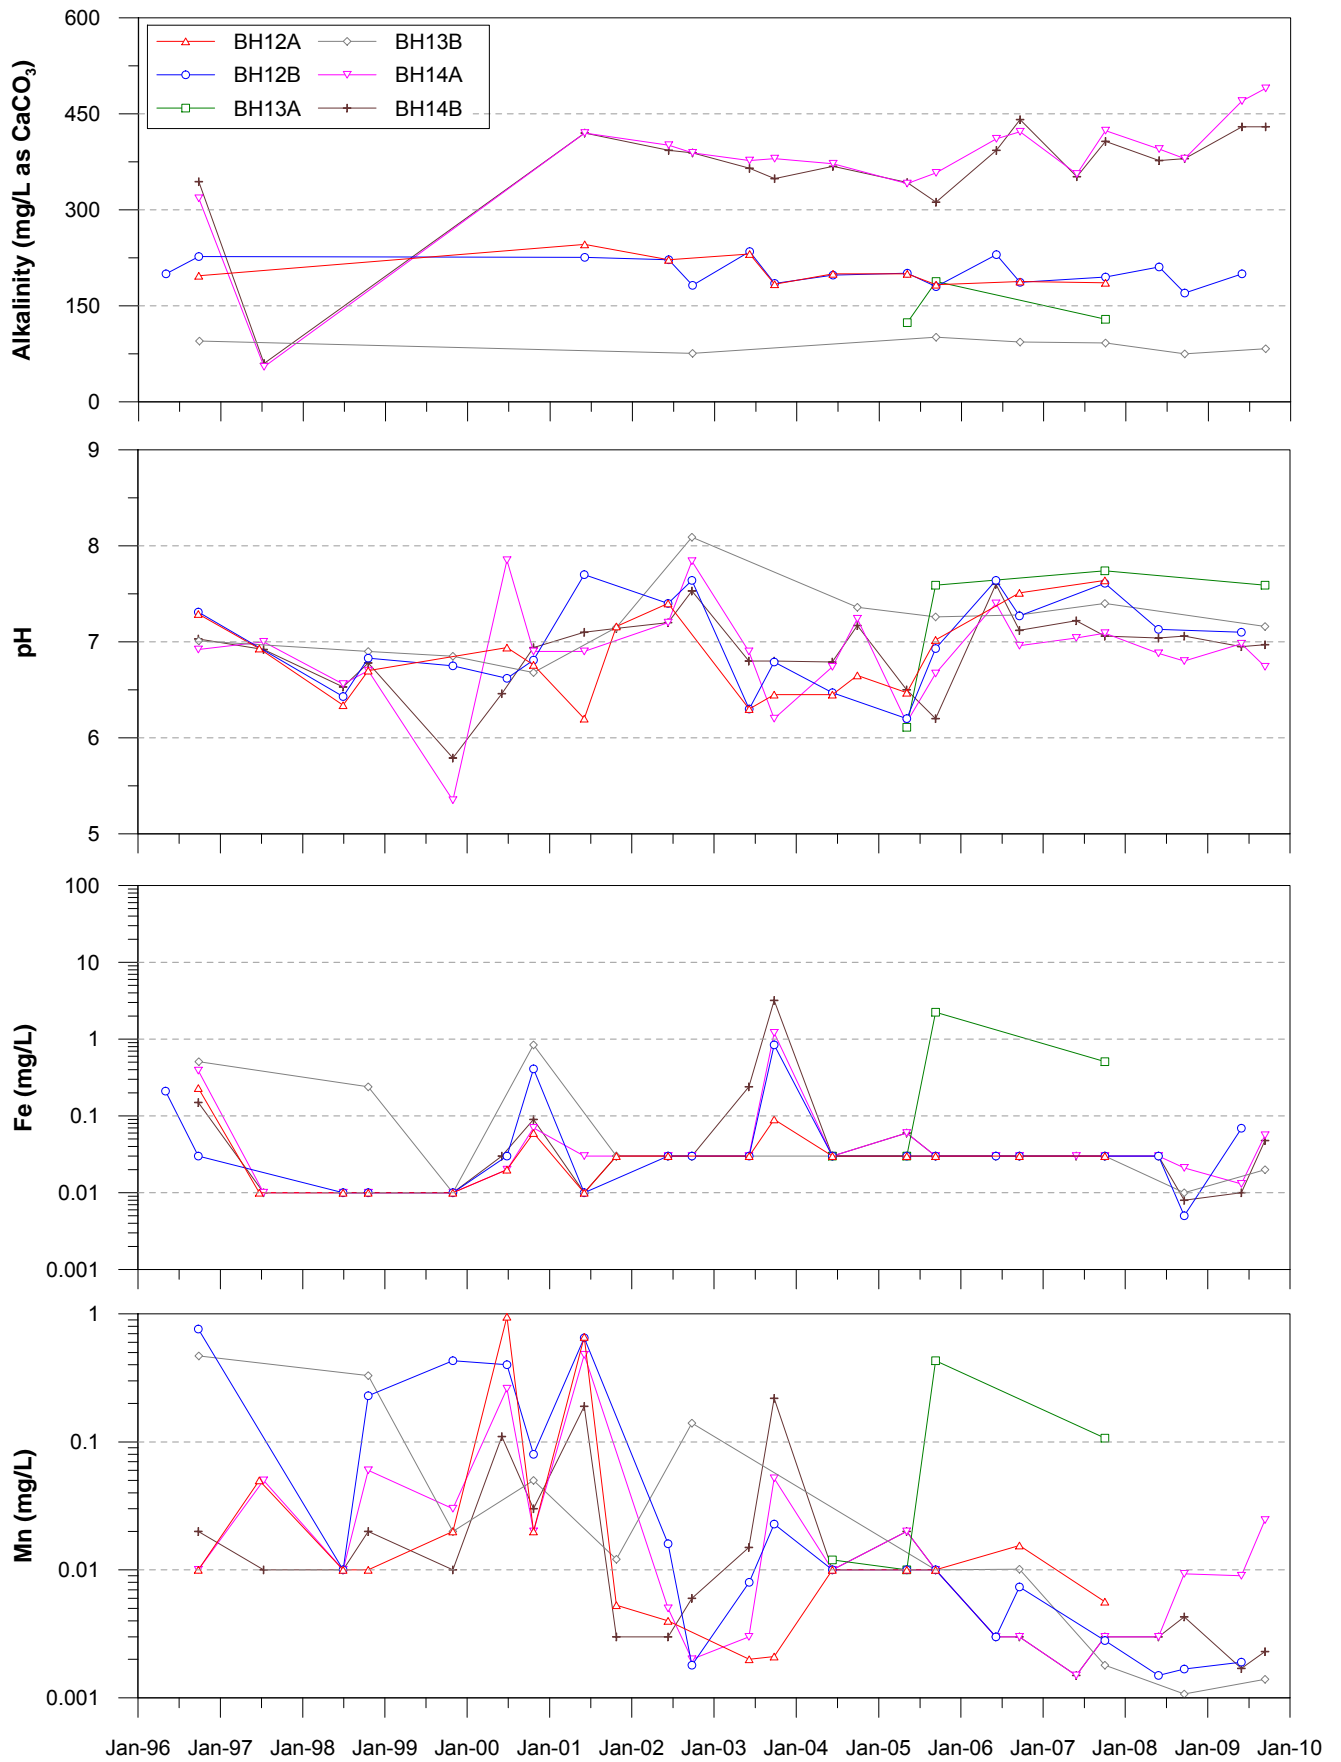
Figure 2-12b. Time trends for alkalinity, pH, Fe and Mn in wells at the toe of Northeast Rock Dump

Near the toe of the Northeast Rock Dump (at wells BH14A/B), SO₄, Mg, and metals of interest concentrations in groundwater continued to increase in 2009 likely due to seepage from sulphide-rich waste rock in the Northeast Rock Dump. The trend towards higher concentrations of SO₄ and metals of interest in this area is cause for concern because it appears that a substantial load of waste rock seepage is delivered to groundwater near NFRC (at wells SRK08-P12A/B).

Time trends for pH, alkalinity, selected major ions, and metals of interest in groundwater from wells BH12A/B, BH13A/B, and BH14A/B are shown in Figure 2-12a/b. Each of these wells is located along the toe of the Northeast Rock Dump (Figure 2-9).

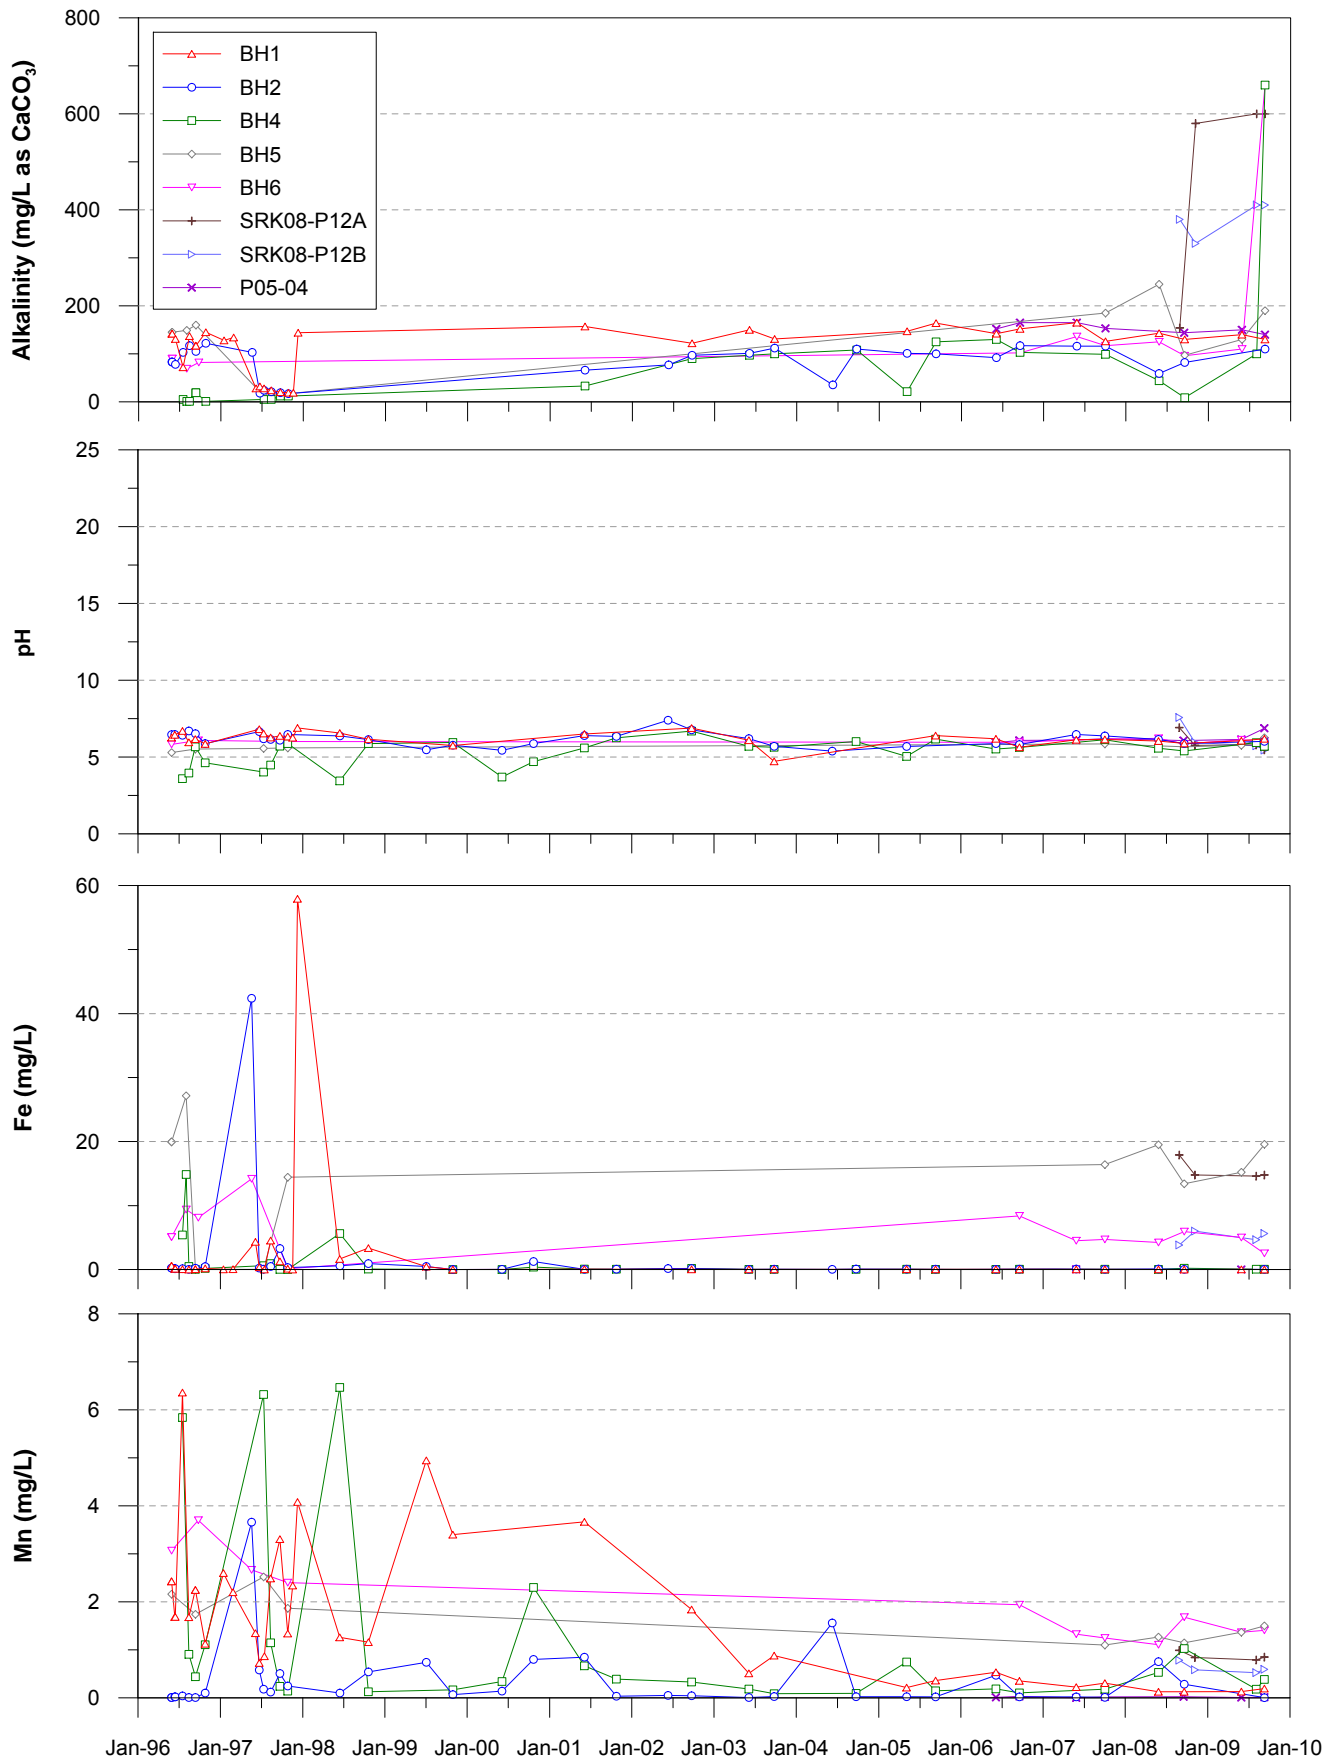
Figure 2-13b. Time trends for alkalinity, pH, Fe and Mn for wells in Zone 2 Pit outwash area

In the Zone 2 Pit outwash area, groundwater remains impacted by seepage but groundwater quality did not deteriorate further in 2009.

Figure 2-13a/b shows the time trends for pH, alkalinity, selected major ions, and metals of interest in monitoring wells located within the Zone 2 Pit outwash area. Figure 2-14a/b shows time trends for pH, alkalinity, selected major ions, and metals of interest in Zone 2 Pit water and for wells screened in in bedrock.
