Report No. 118017/1

**2009 GROUNDWATER QUALITY REVIEW
ANVIL RANGE MINING COMPLEX, YUKON TERRITORY**

Faro Mine Closure Planning Office

February 2010

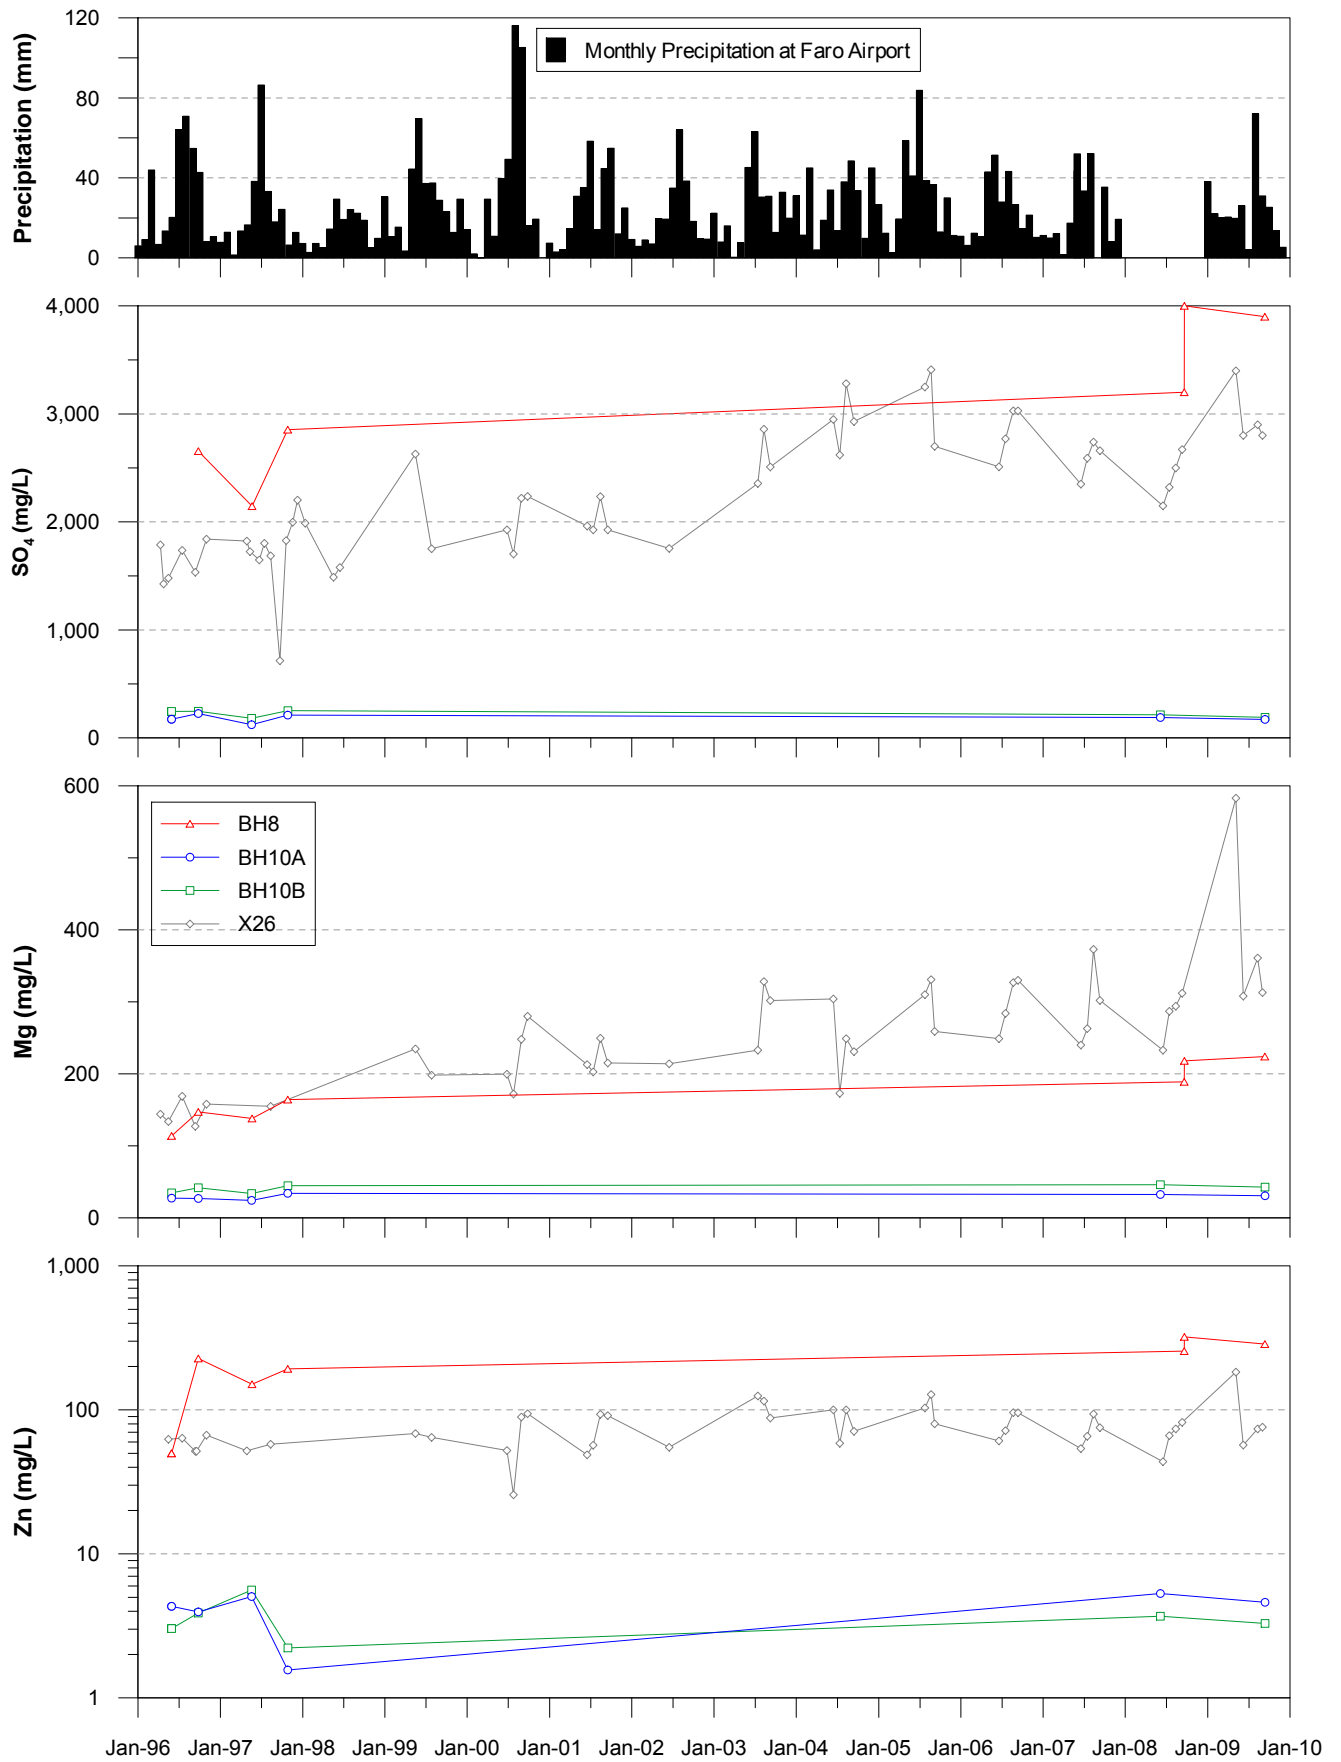
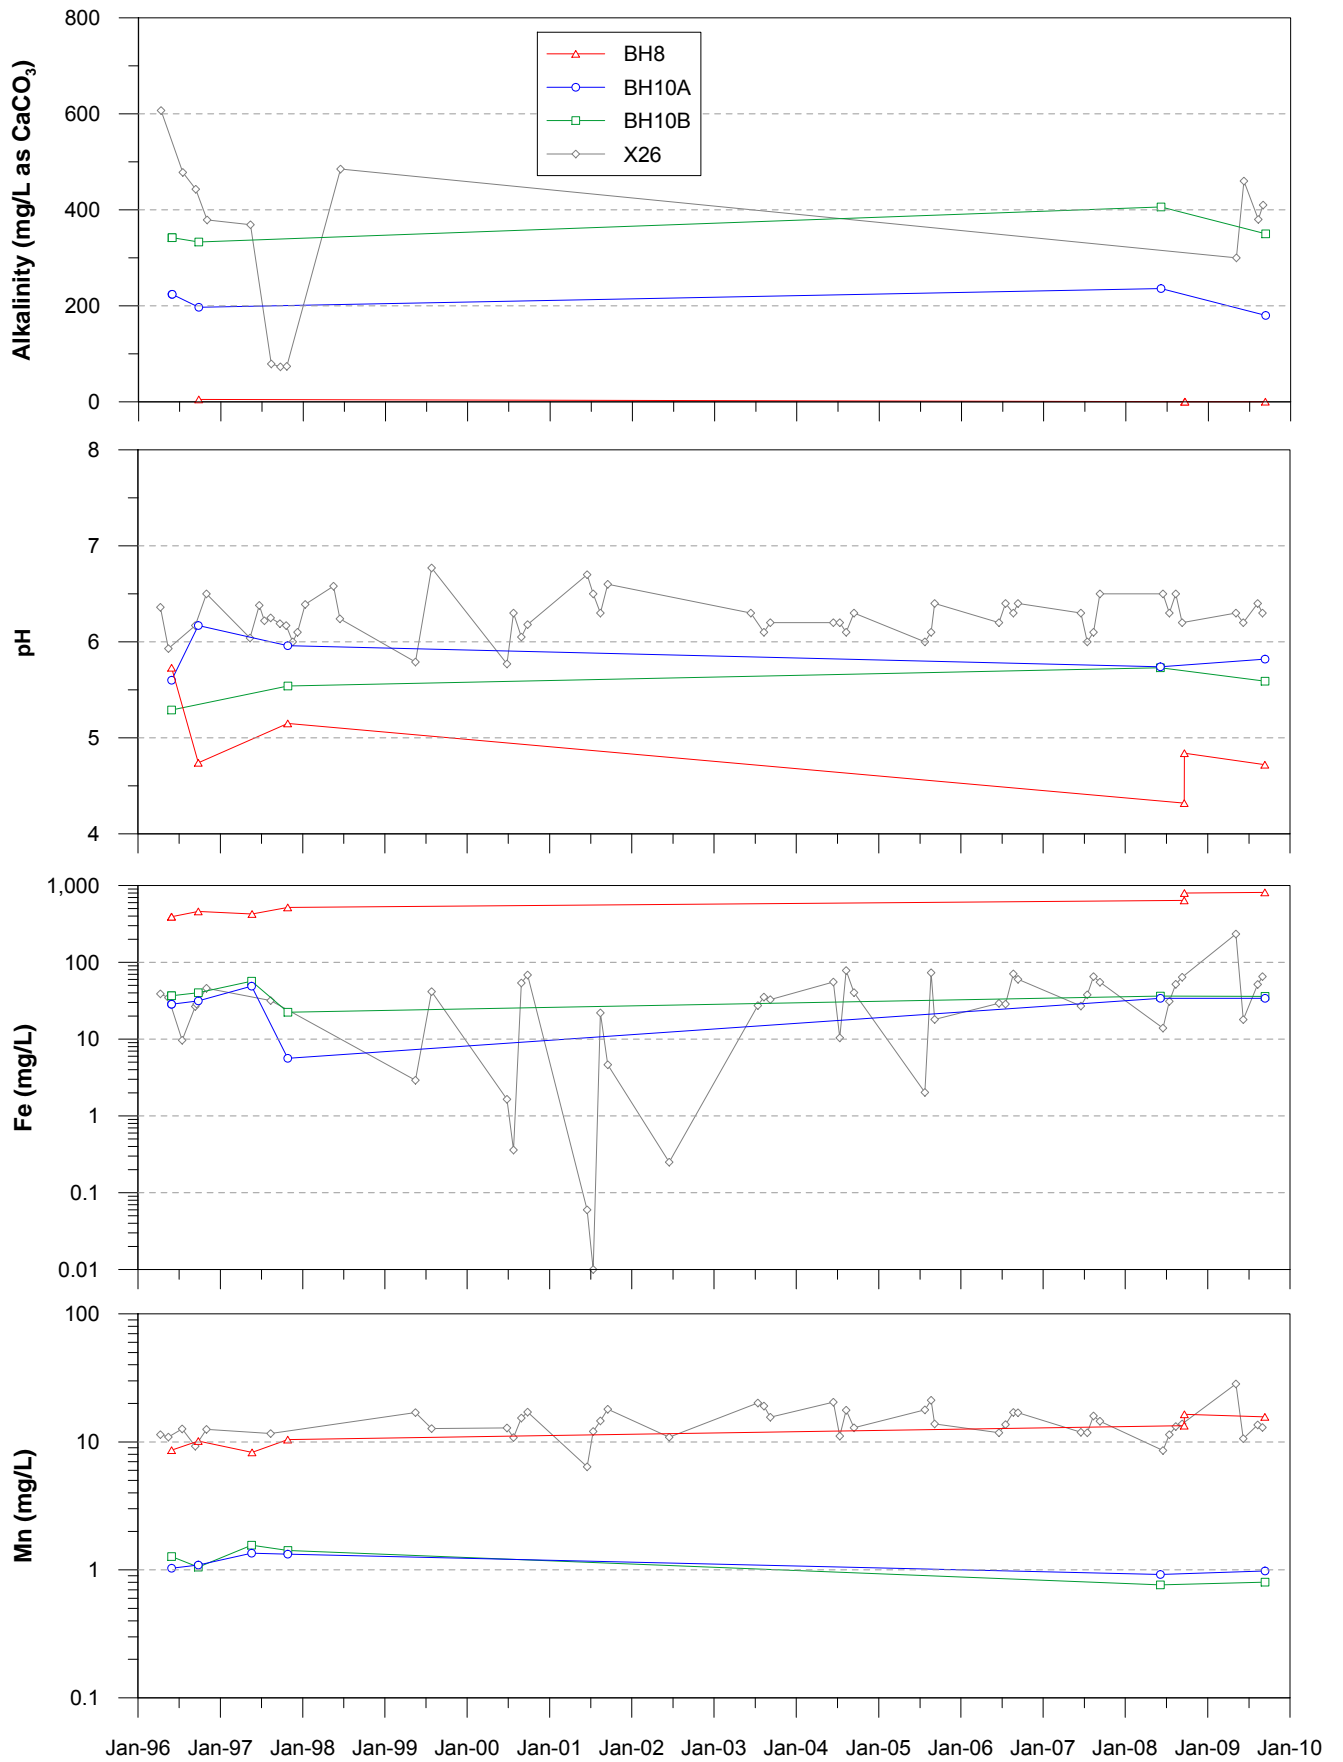
Figure 2-14a. Time trends for SO₄, Mg and Zn for Zone 2 Pit and bedrock wells

Figure 2-13a/b shows the time trends for pH, alkalinity, selected major ions, and metals of interest in monitoring wells located within the Zone 2 Pit outwash area. Figure 2-14a/b shows time trends for pH, alkalinity, selected major ions, and metals of interest in Zone 2 Pit water and for wells screened in in bedrock.

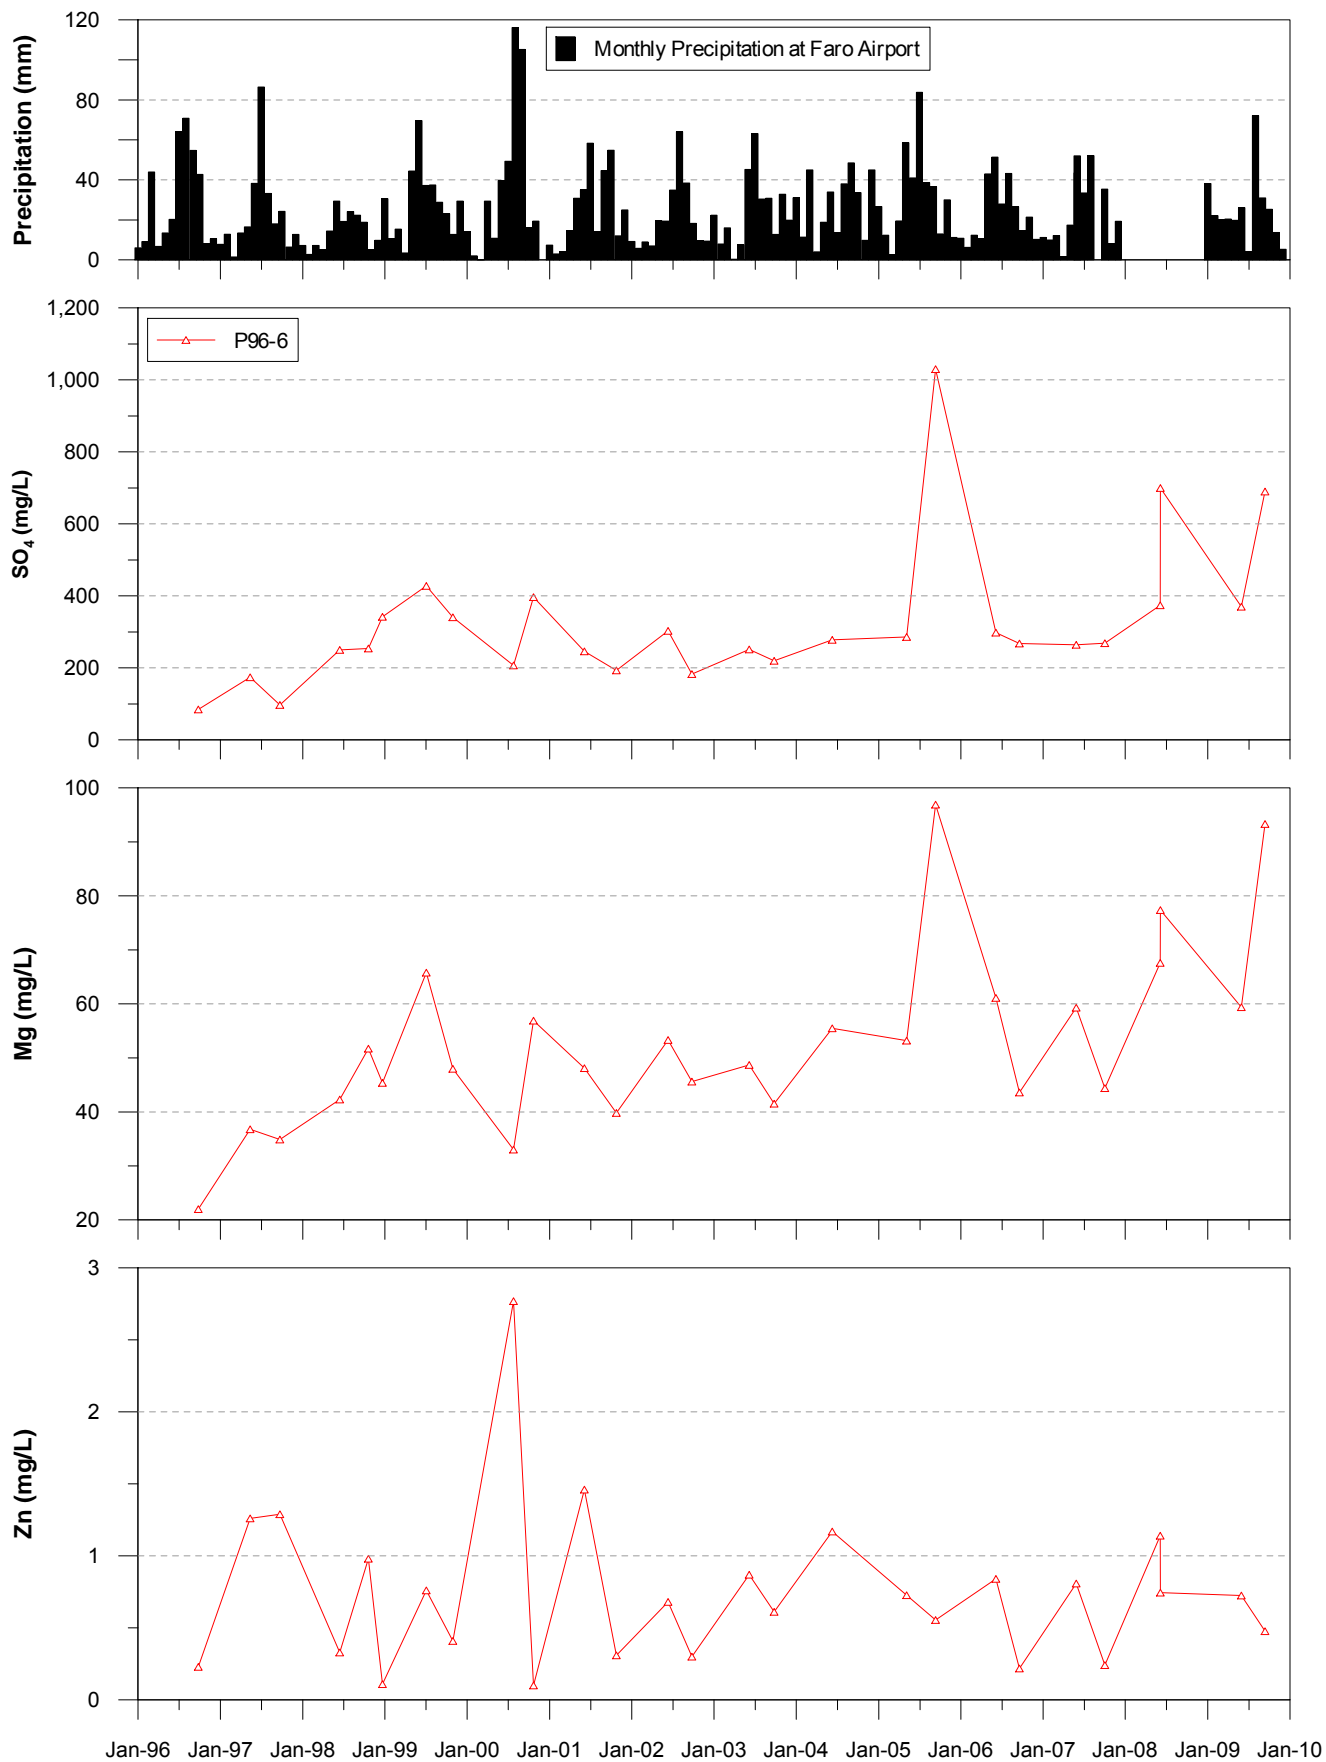
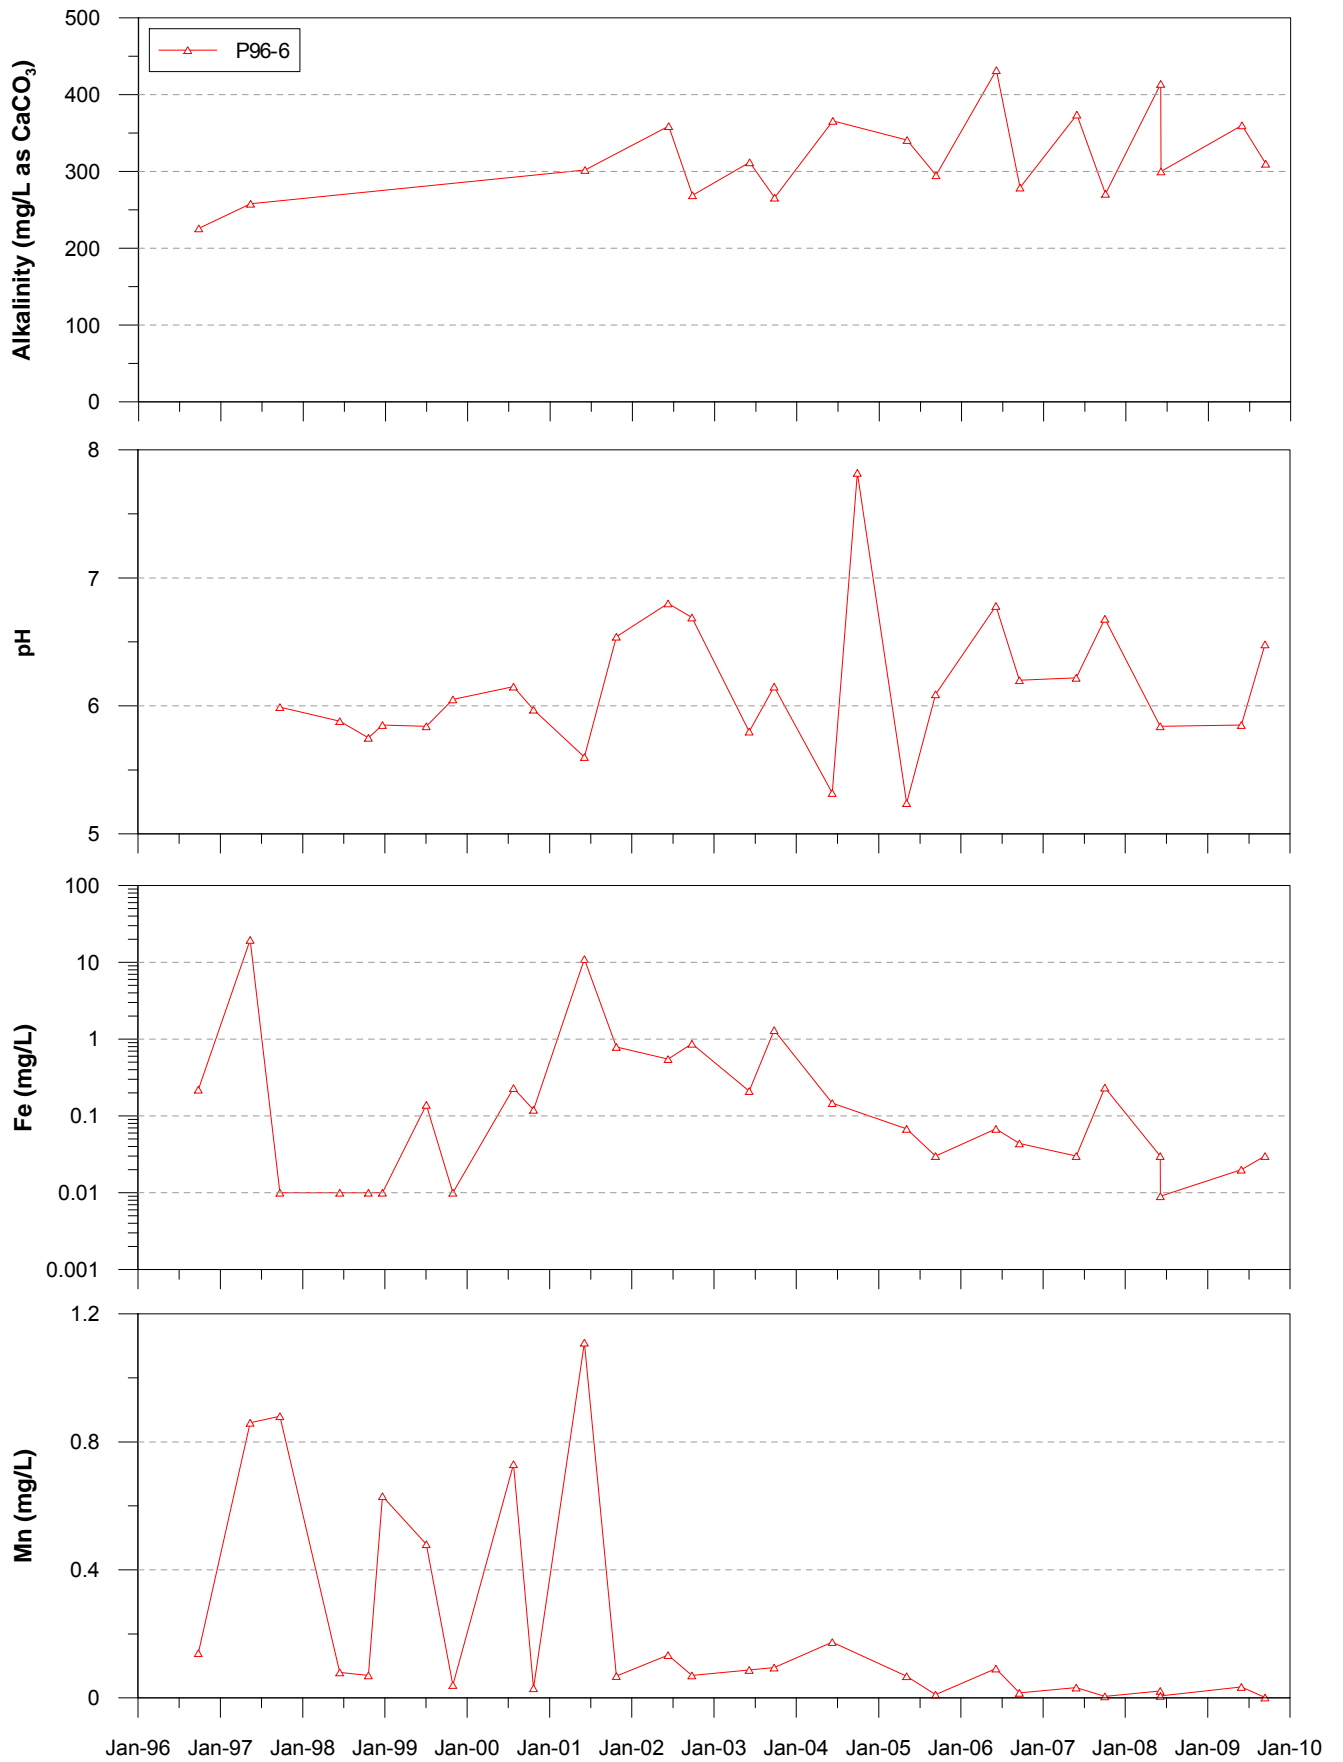
Figure 2-15a. Time trends for SO₄, Mg and Zn in P96-6 at the toe of Intermediate Rock Dump

Figure 2-15a/b shows time trends for pH, alkalinity, selected major ions, and metals of interest for well P96-6. This well is located along the toe of the Intermediate Dump and monitors the quality of

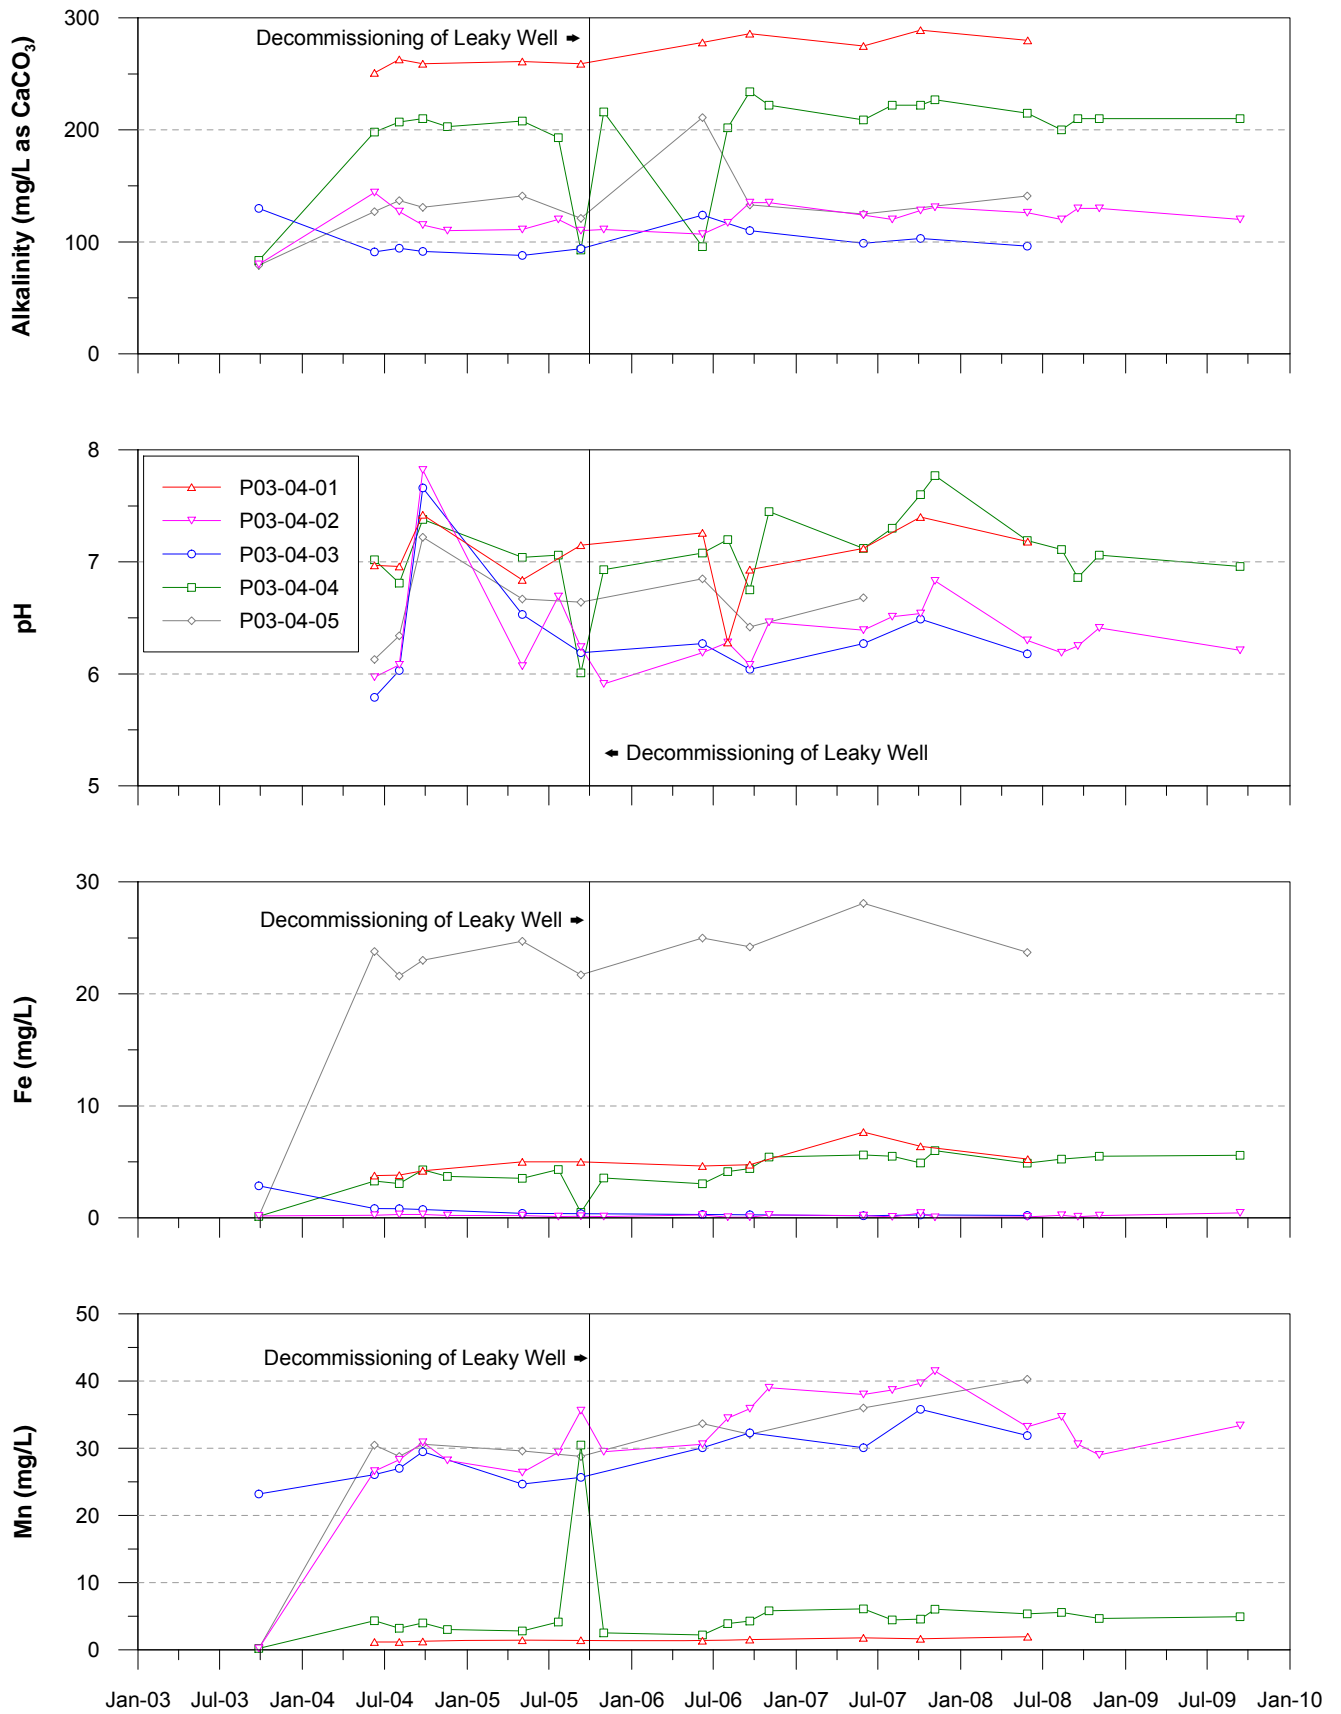
Figure 3-10b. Time trends for alkalinity, pH, Fe and Mn in P03-04 (aquifer only)

Figure 3-10a/b shows time trends for pH, alkalinity, selected major ions, and metals of interest in well P03-04 (located ~140 m downgradient of the decommissioned wells P01-07). At this location, the shallow piezometer P03-04-06 (screened near the interface with the tailings) had shown an improvement in groundwater quality since decommissioning of well P01-07 but this trend did not continue in 2009. Instead, slight increases in the concentrations of SO_4 and each of the metals of interest were observed. These increases were small in magnitude and future monitoring will be required to assess whether groundwater quality in this reach of the RCAA is further deteriorating over time.

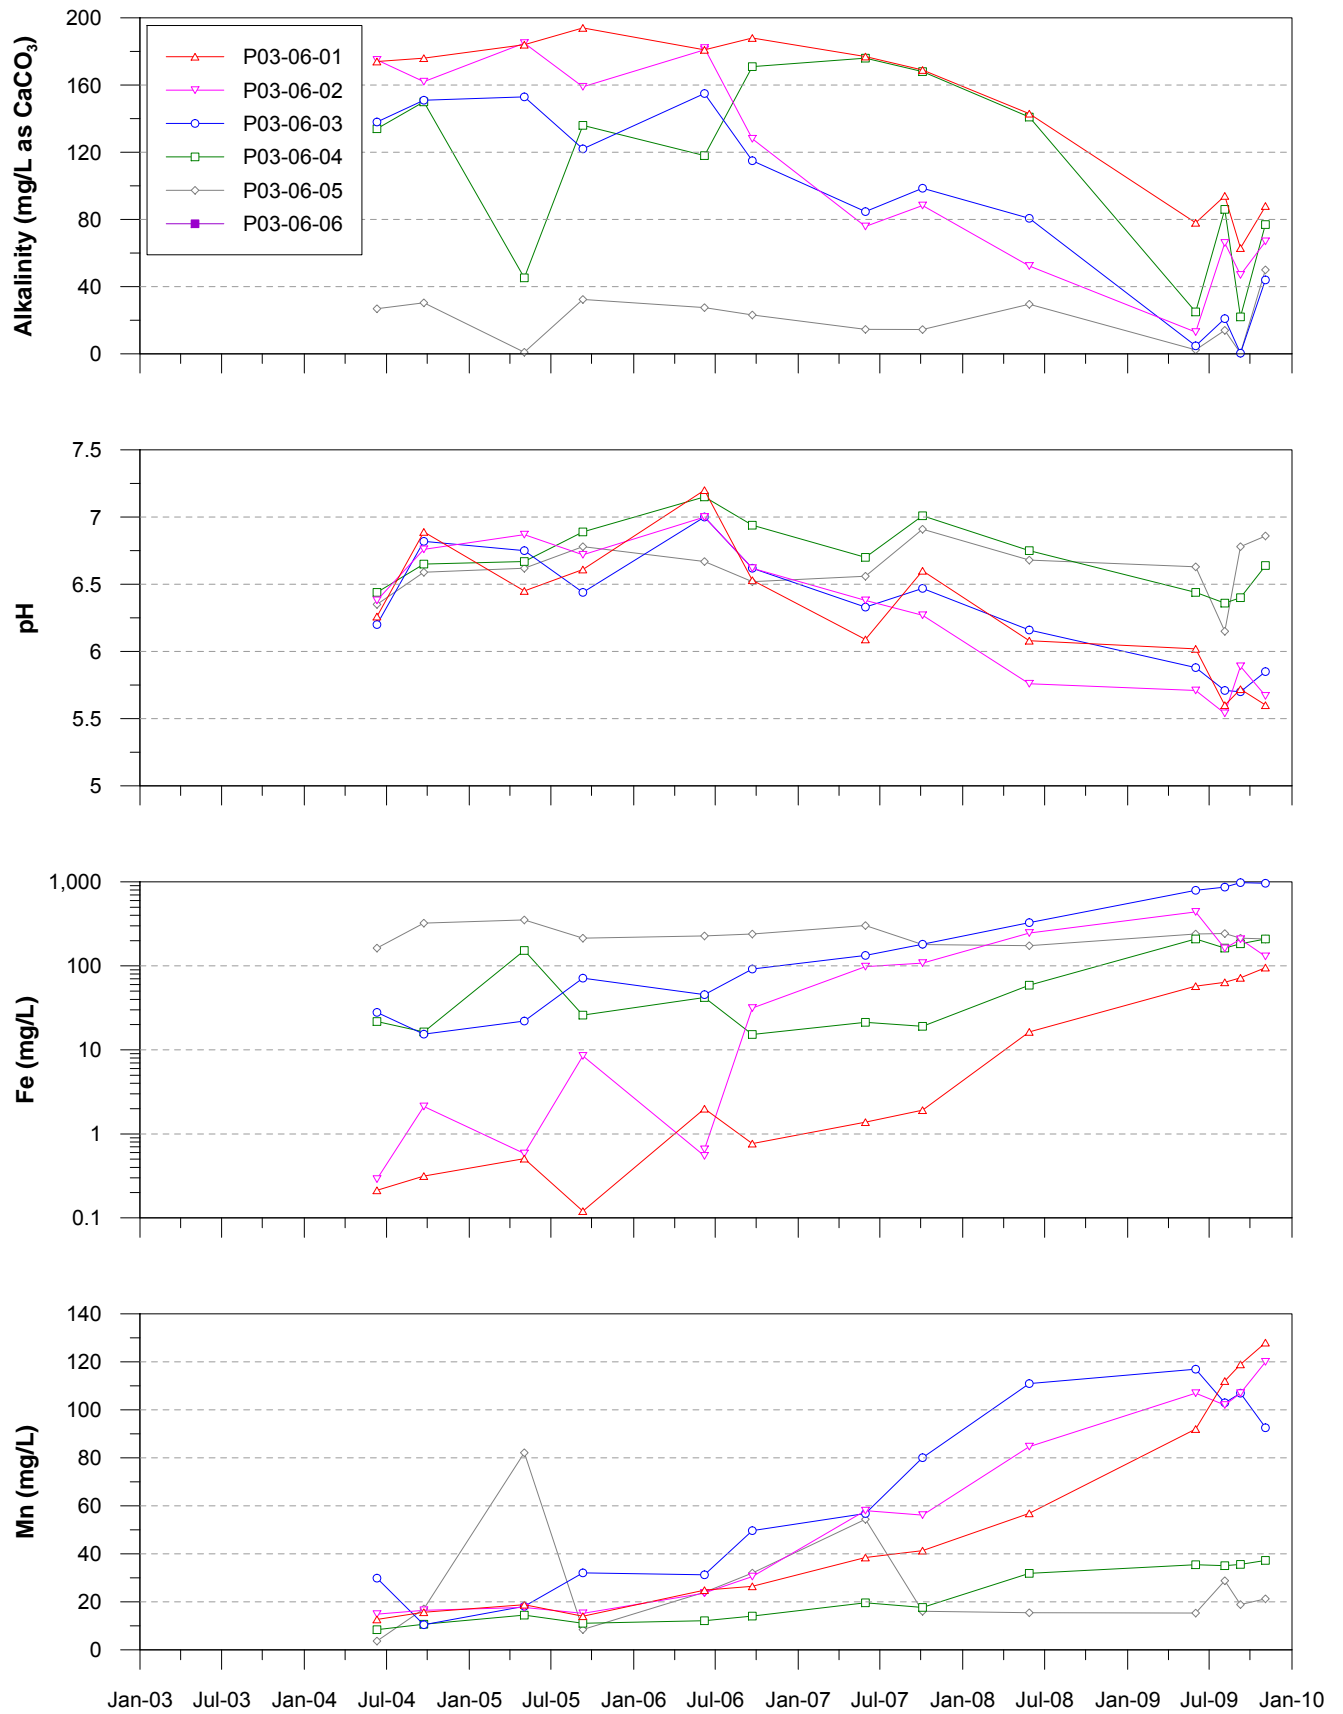
Figure 3-10d. Time trends for alkalinity, pH, Fe and Mn in P03-06 (aquifer only)

Figure 3-10c/d shows the time trends for pH, alkalinity, selected major ions, and metals of interest in groundwater at well P03-06. This well is located in the northwest portion of the Second Impoundment near the mouth of Faro Creek canyon. Previous reports have identified substantial increases in the concentrations of SO_4 and metals of interest at this location since 2005 and particularly at greater depths in the aquifer (RGC, 2008; 2009). In 2009, SO_4 concentrations in piezometers P03-06-02 and P03-06-03 decreased, whereas the concentrations of metals in these wells (and most others) remained relatively unchanged. A gradual rise in Zn concentrations in prior years has been a matter of particular concern but Zn concentrations appear to have stabilized in 2009. Mn concentrations in piezometers P03-06-01 and P03-06-02 did, however, increase in 2009.

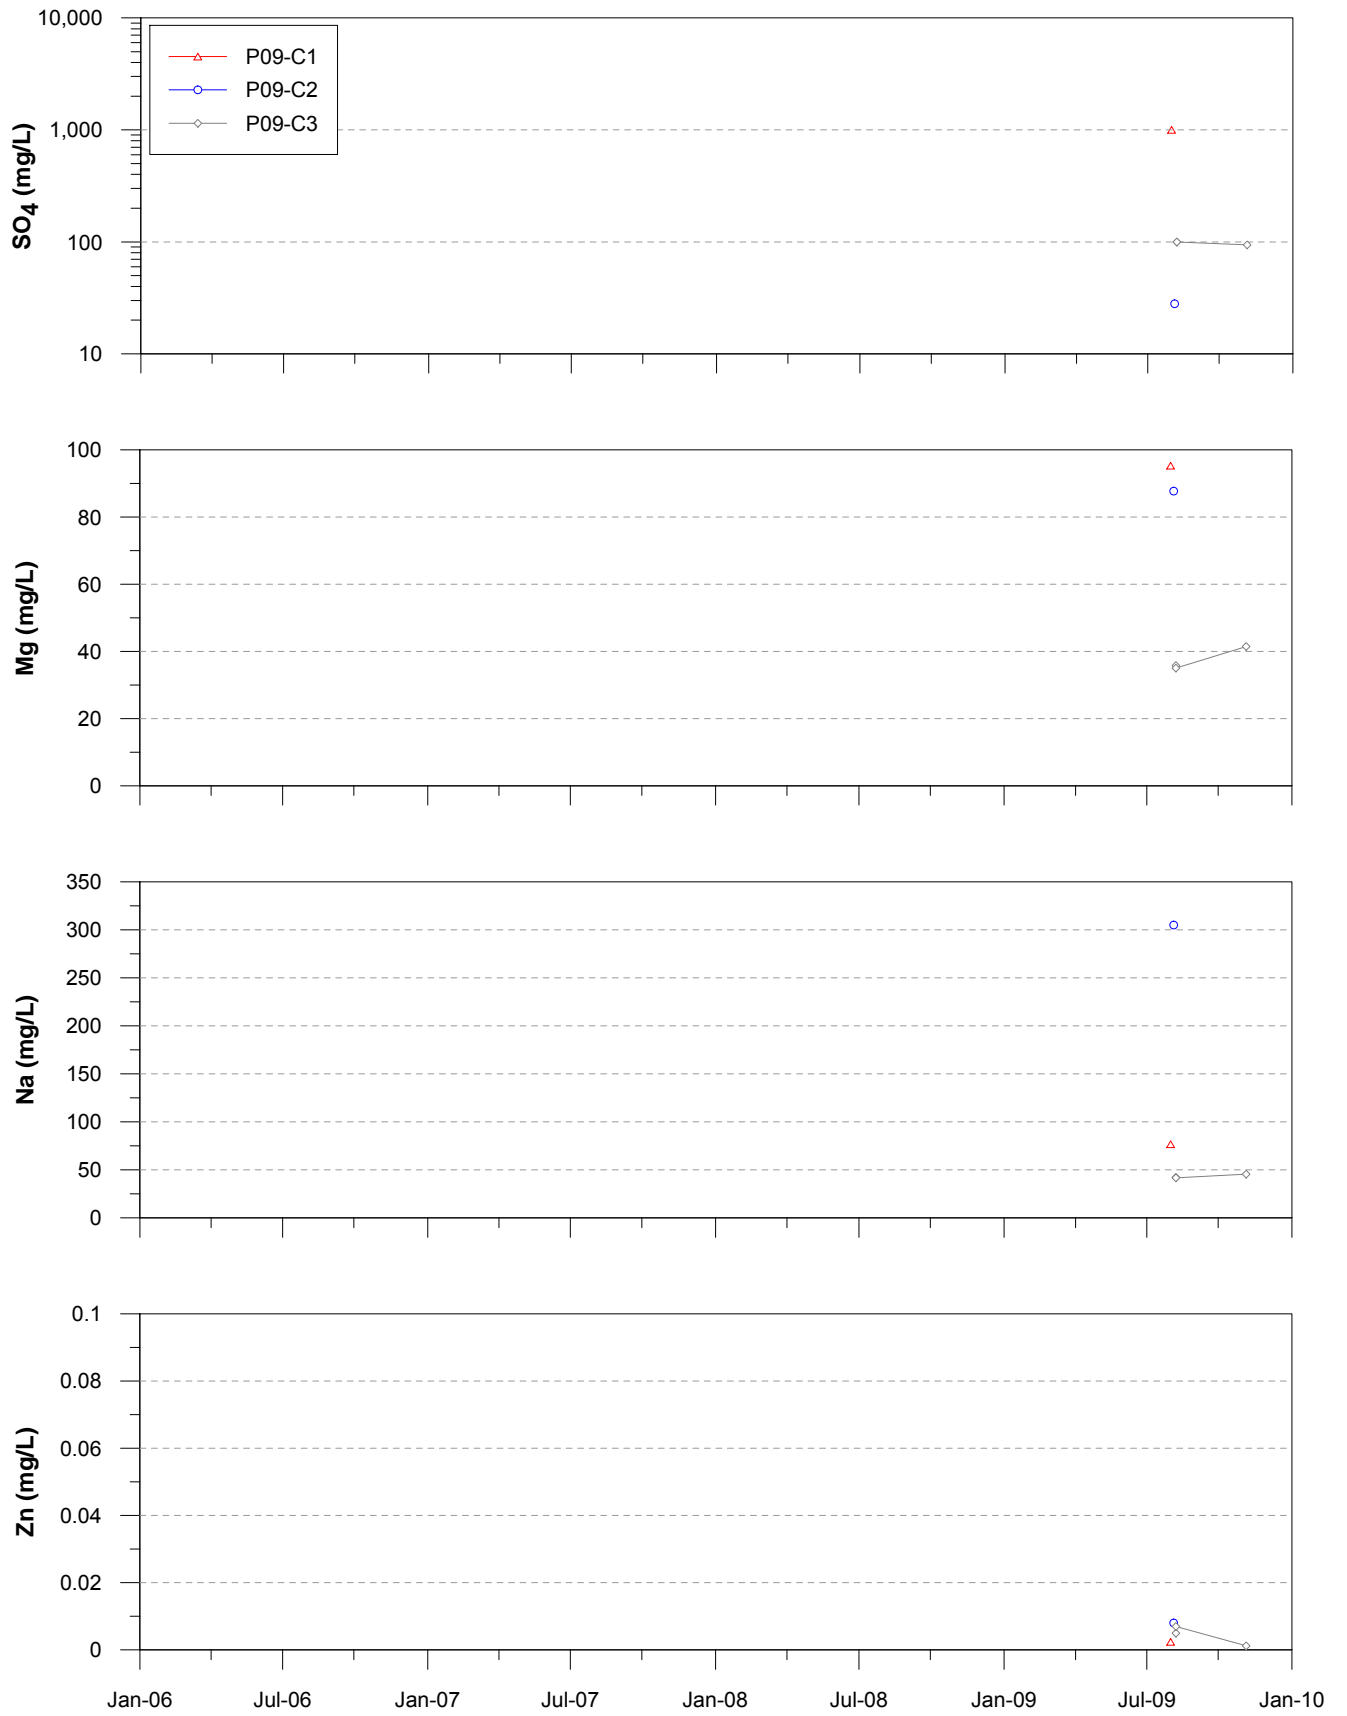
Figure 3-18a. Time trends for SO₄, Mg, Na and Zn in bedrock wells at toe of Cross Valley Dam

Time trends for pH, alkalinity, selected major ions, and metals of interest in wells P09-C1, P09-C2, and P09-C3 are shown in Figure 3-18a/b. At well P09-C1 (located near the northern side of the Rose Creek valley), SO₄, Mg, Fe and Mn concentrations are comparable to concentrations in shallow impacted groundwater in this area and are much higher than in well P09-C2 and P09-C3. Note that Zn concentrations in well P09-C1 are, however, very low (< 0.01 mg/L). These data suggest that groundwater in deep bedrock near the northern end of the Cross Valley Dam is impacted to a similar extent as the RCAA in this area but that groundwater near the southern side of the Rose Creek valley remains unaffected by mine waste seepage.

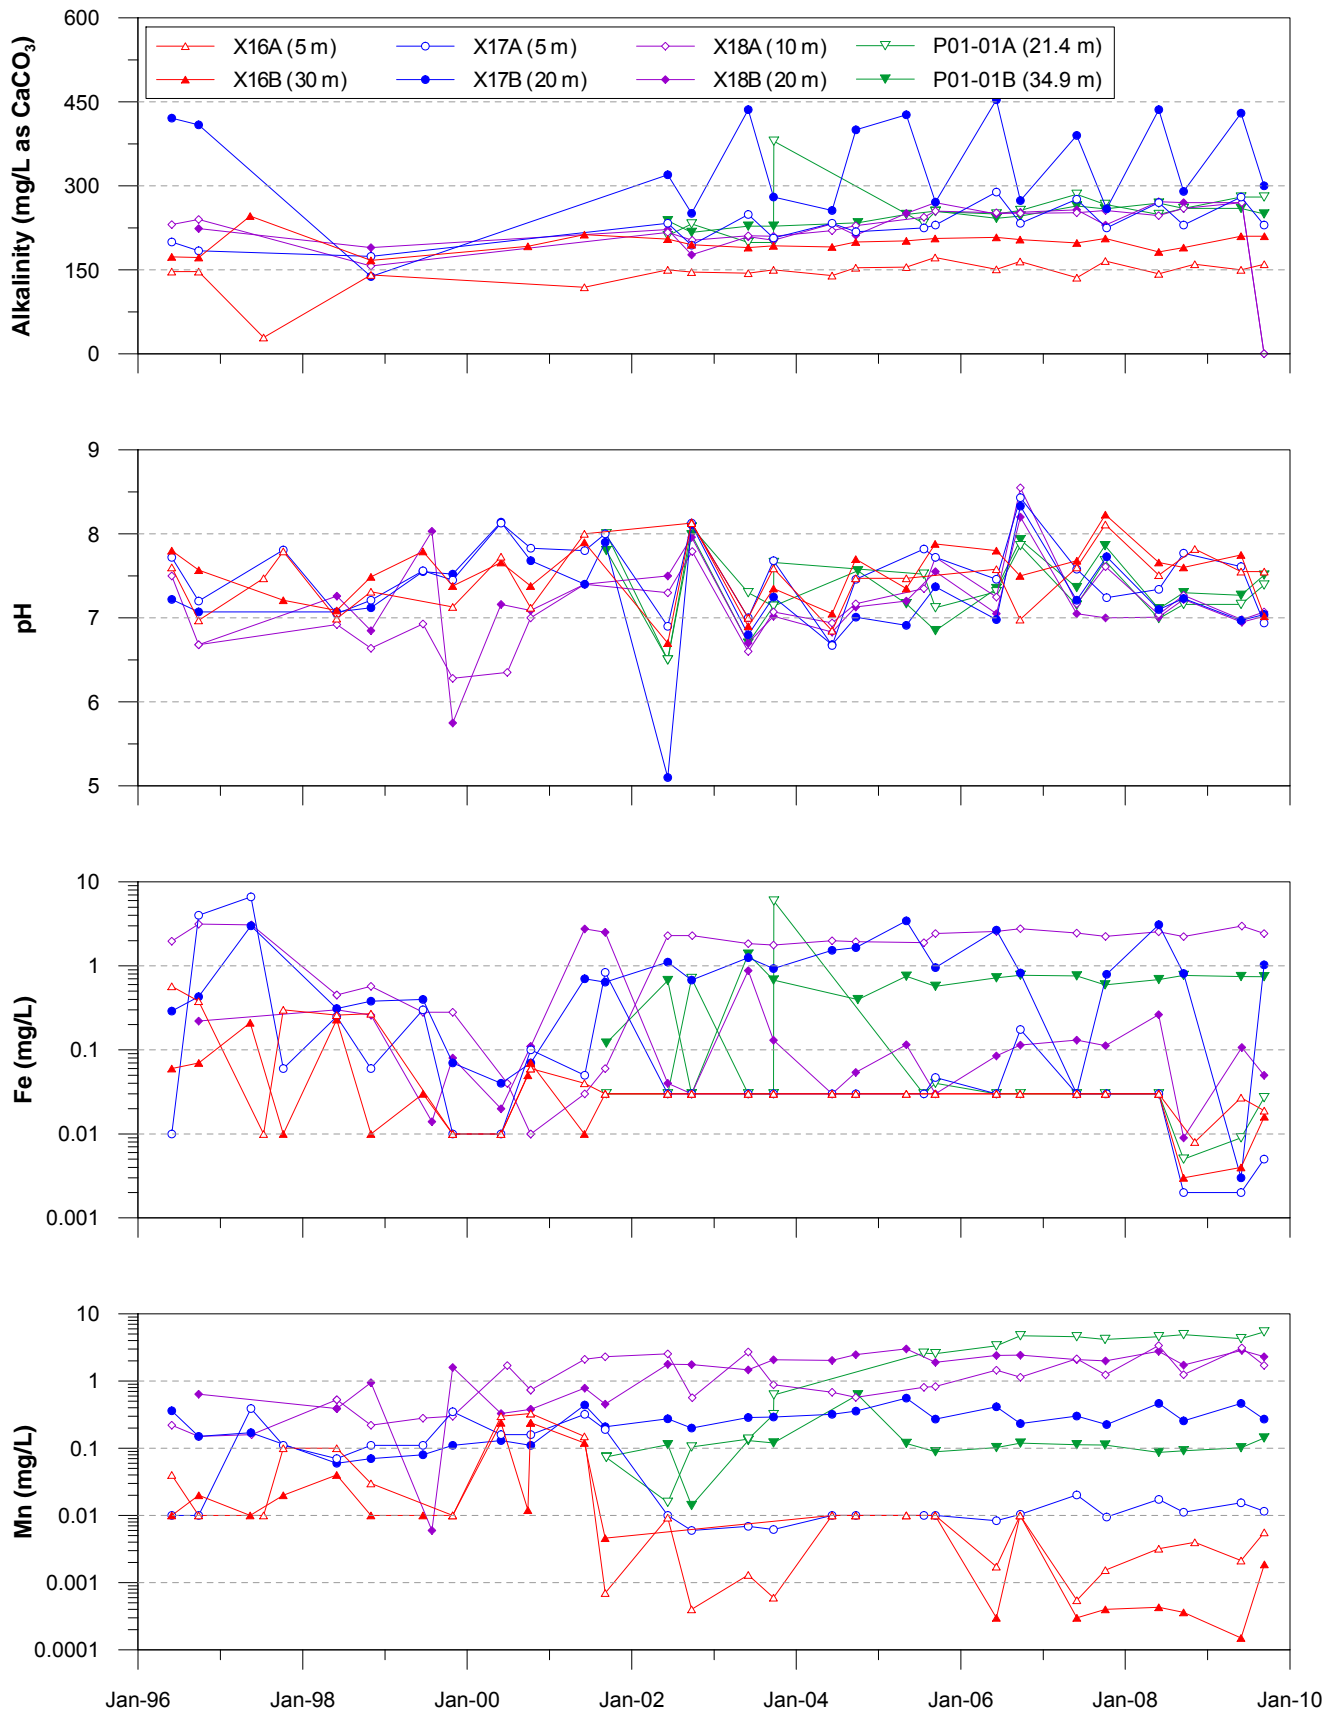
Figure 3-19b. Time trends for alkalinity, pH, Fe and Mn in wells down-gradient of Cross Valley Dam

Figures 3-19a/b show time trends for pH, alkalinity, selected major ions, and metals of interest in wells X16A/B, X17A/B, X18A/B and P01-01A/B. In wells X18A/B and P01-01A/B (both located on the northern side of Rose Creek valley), concentrations of SO₄ and Mg continued to increase in 2009, yet concentrations of Zn remained low (< 0.1 mg/L). The increase in SO₄ and Mg in this area is thought to be caused by the leading edge of the breakthrough that has been observed upgradient near the northern end of the Cross Valley Dam (at wells P01-11, P05-01) and near the Intermediate Dam at well X24.

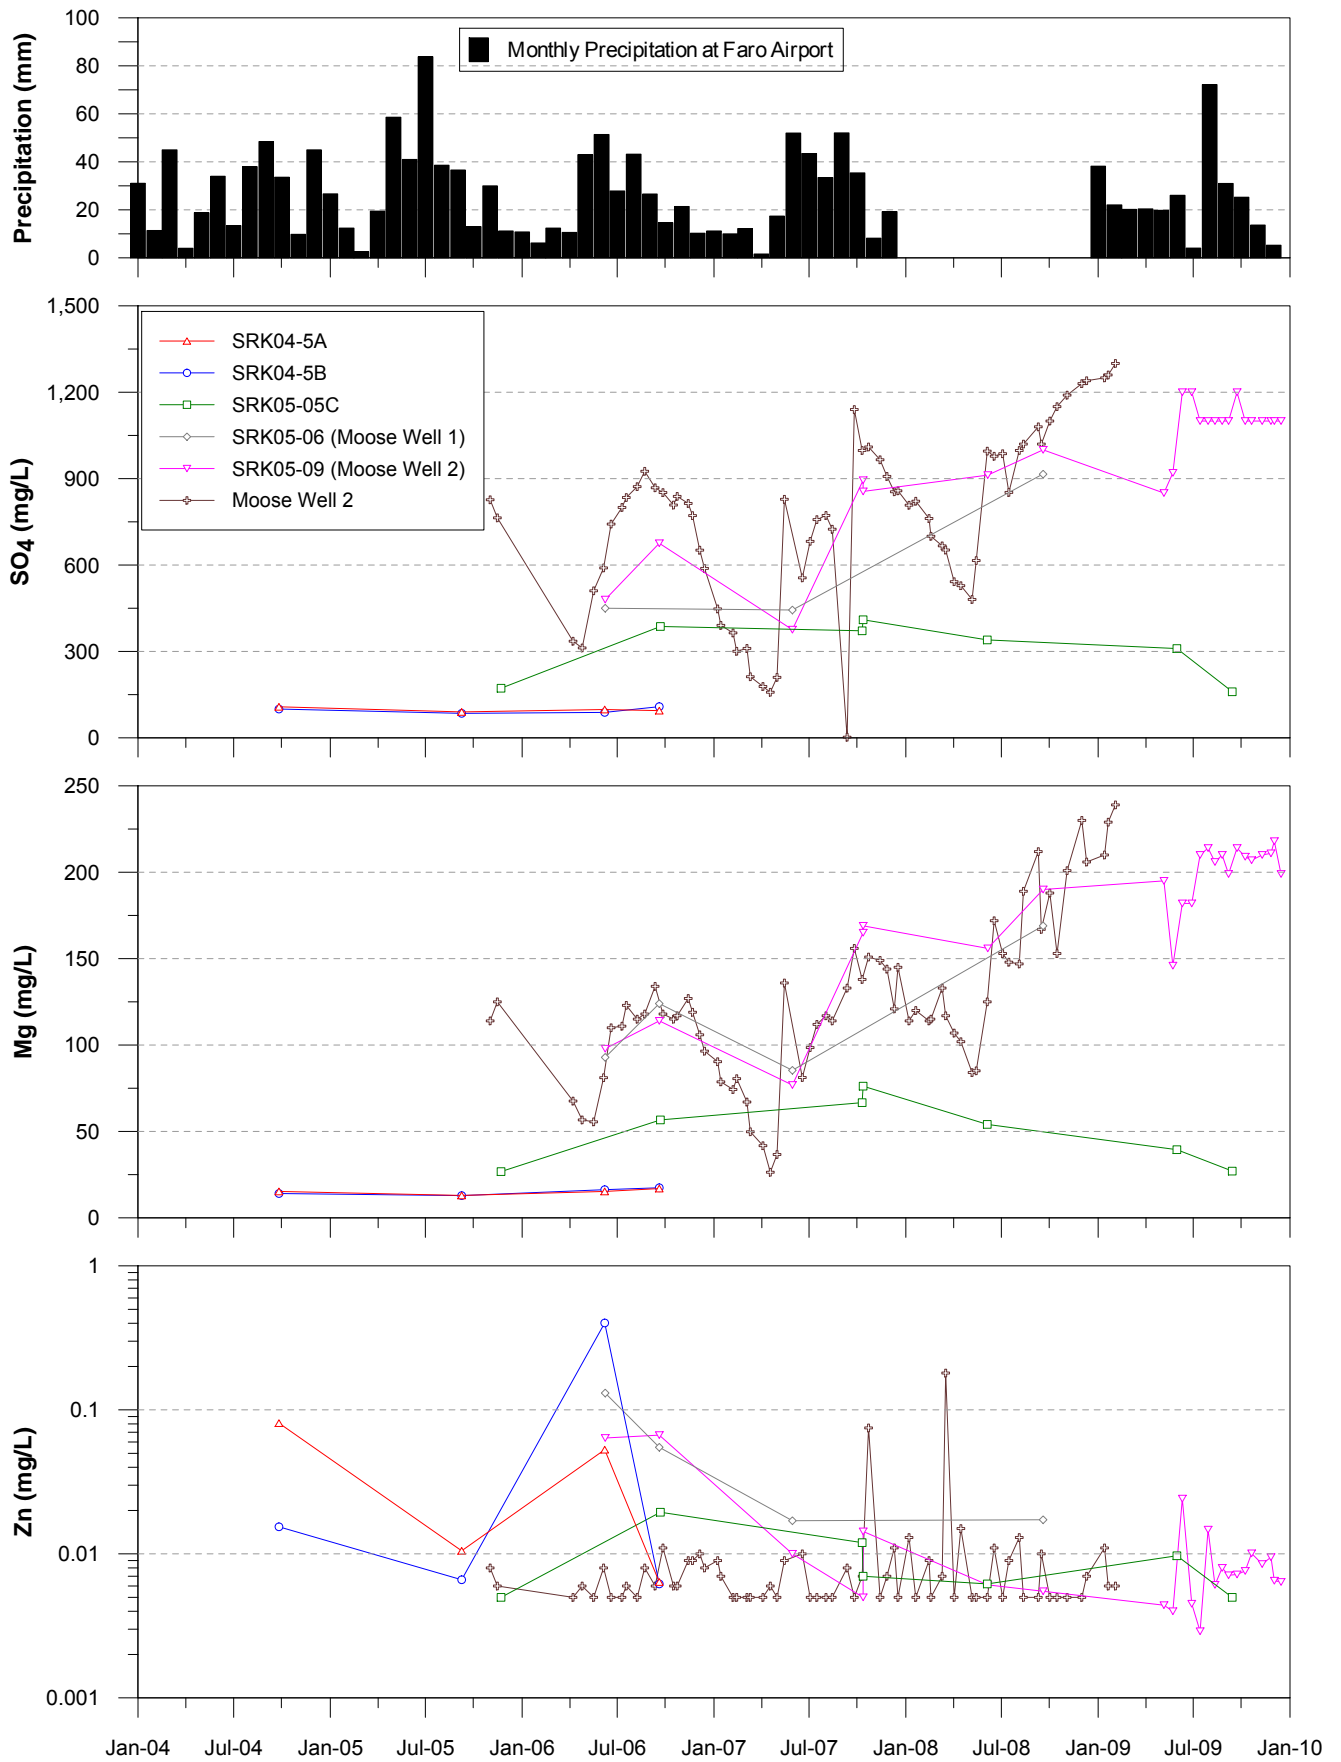
Figure 4-3a. Time trends for SO₄, Mg and Zn in wells in Grum Creek drainage

Figure 4-3a/b shows time trends for pH, alkalinity, selected major ions, and metals of interest for the monitoring wells located near Grum Creek and down-gradient of the Moose Pond. SO₄ and Mg concentrations in SRK05-09 (Moose Well #2) increased in 2009 but Fe, Mn, and Zn concentrations remained low. Groundwater quality in this well is likely impacted by seepage from Moose Pond (Station V2A), which collects seepage from the Grum Rock Dump (RGC, 2008). The recent increase in SO₄ and Mg likely reflects higher source concentrations in the Moose Pond located immediately upgradient.
