Report No. 118017/1

**2009 GROUNDWATER QUALITY REVIEW
ANVIL RANGE MINING COMPLEX, YUKON TERRITORY**

Faro Mine Closure Planning Office

February 2010

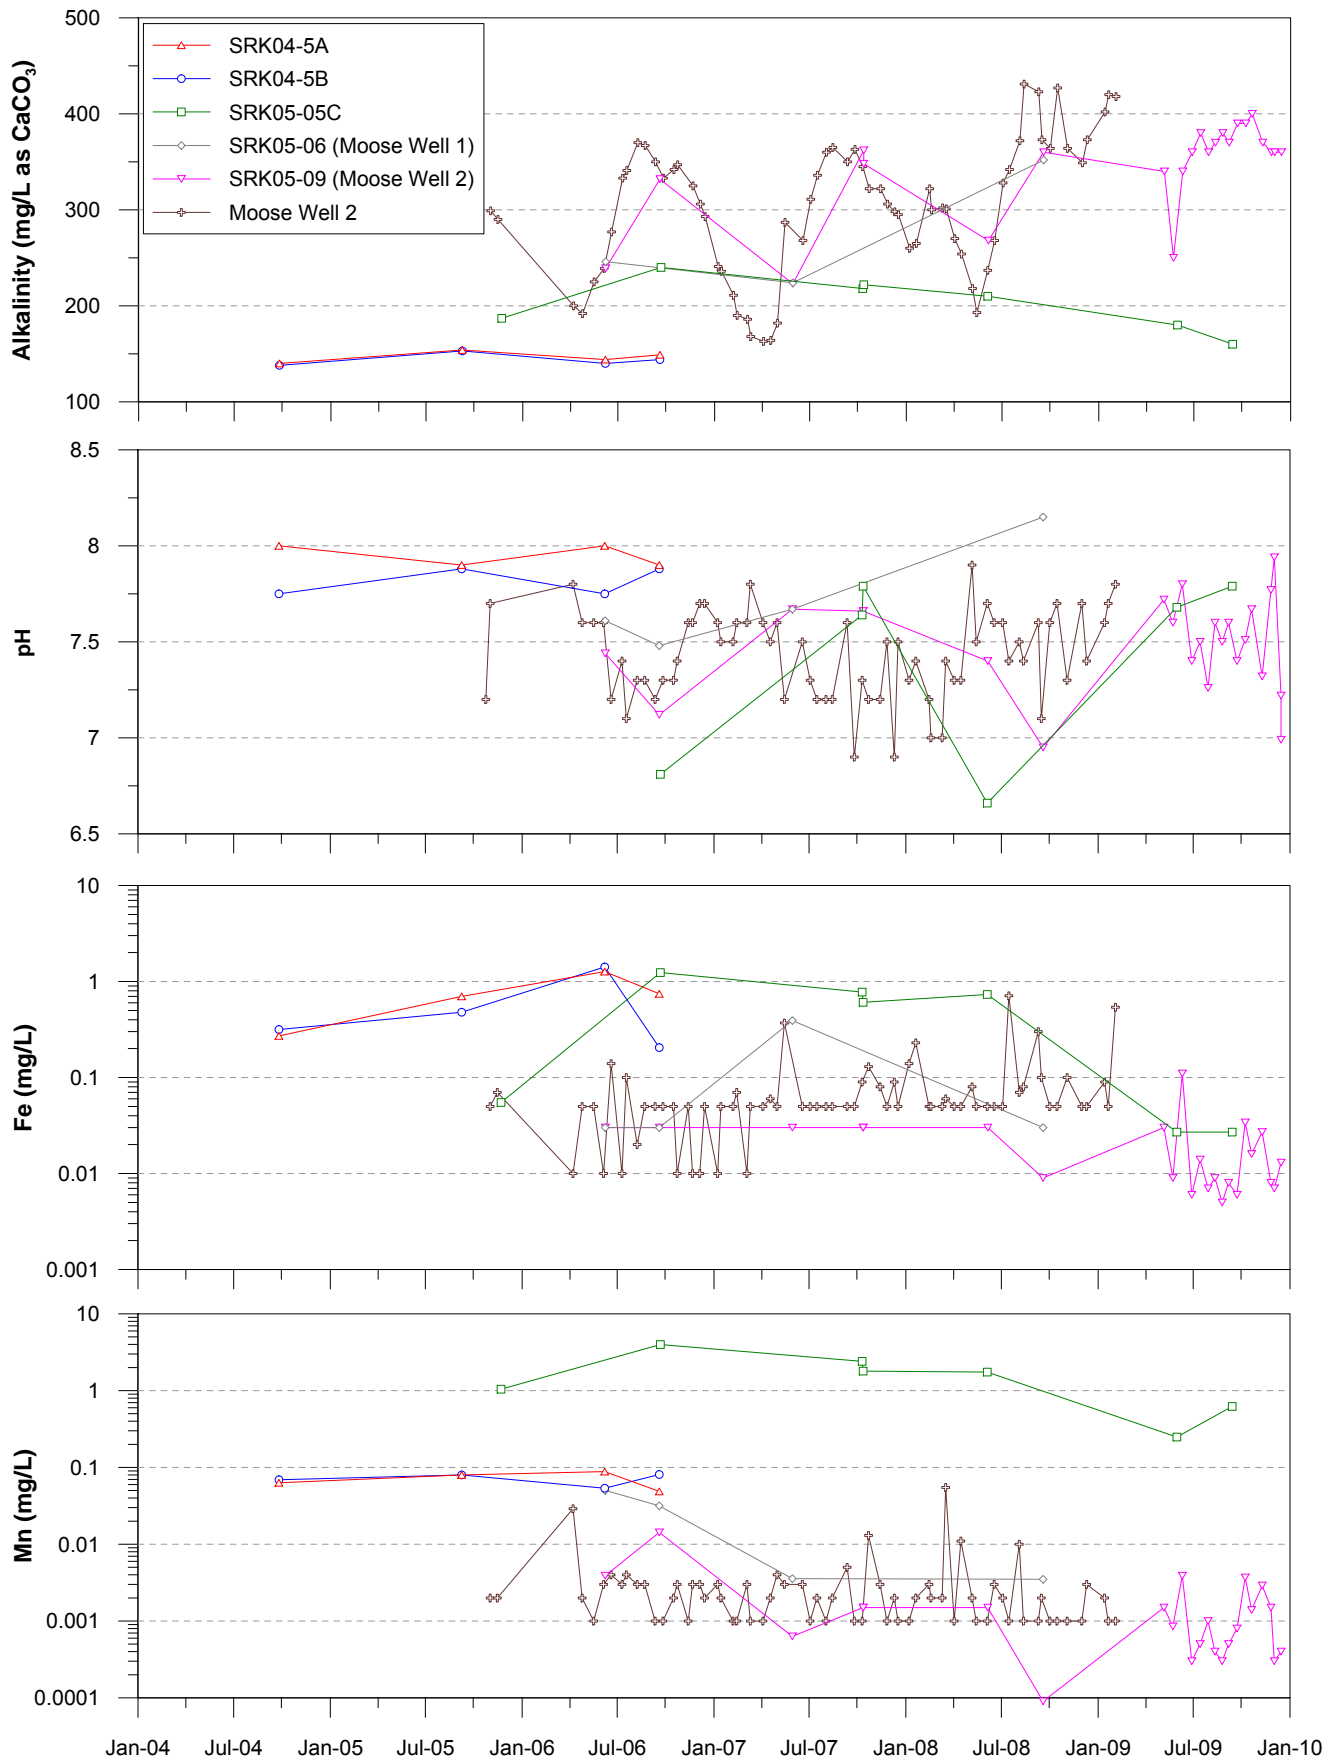
Figure 4-3b. Time trends for alkalinity, pH, Fe and Mn in wells in Grum Creek drainage

Figure 4-3a/b shows time trends for pH, alkalinity, selected major ions, and metals of interest for the monitoring wells located near Grum Creek and down-gradient of the Moose Pond. SO₄ and Mg concentrations in SRK05-09 (Moose Well #2) increased in 2009 but Fe, Mn, and Zn concentrations remained low. Groundwater quality in this well is likely impacted by seepage from Moose Pond (Station V2A), which collects seepage from the Grum Rock Dump (RGC, 2008). The recent increase in SO₄ and Mg likely reflects higher source concentrations in the Moose Pond located immediately upgradient.

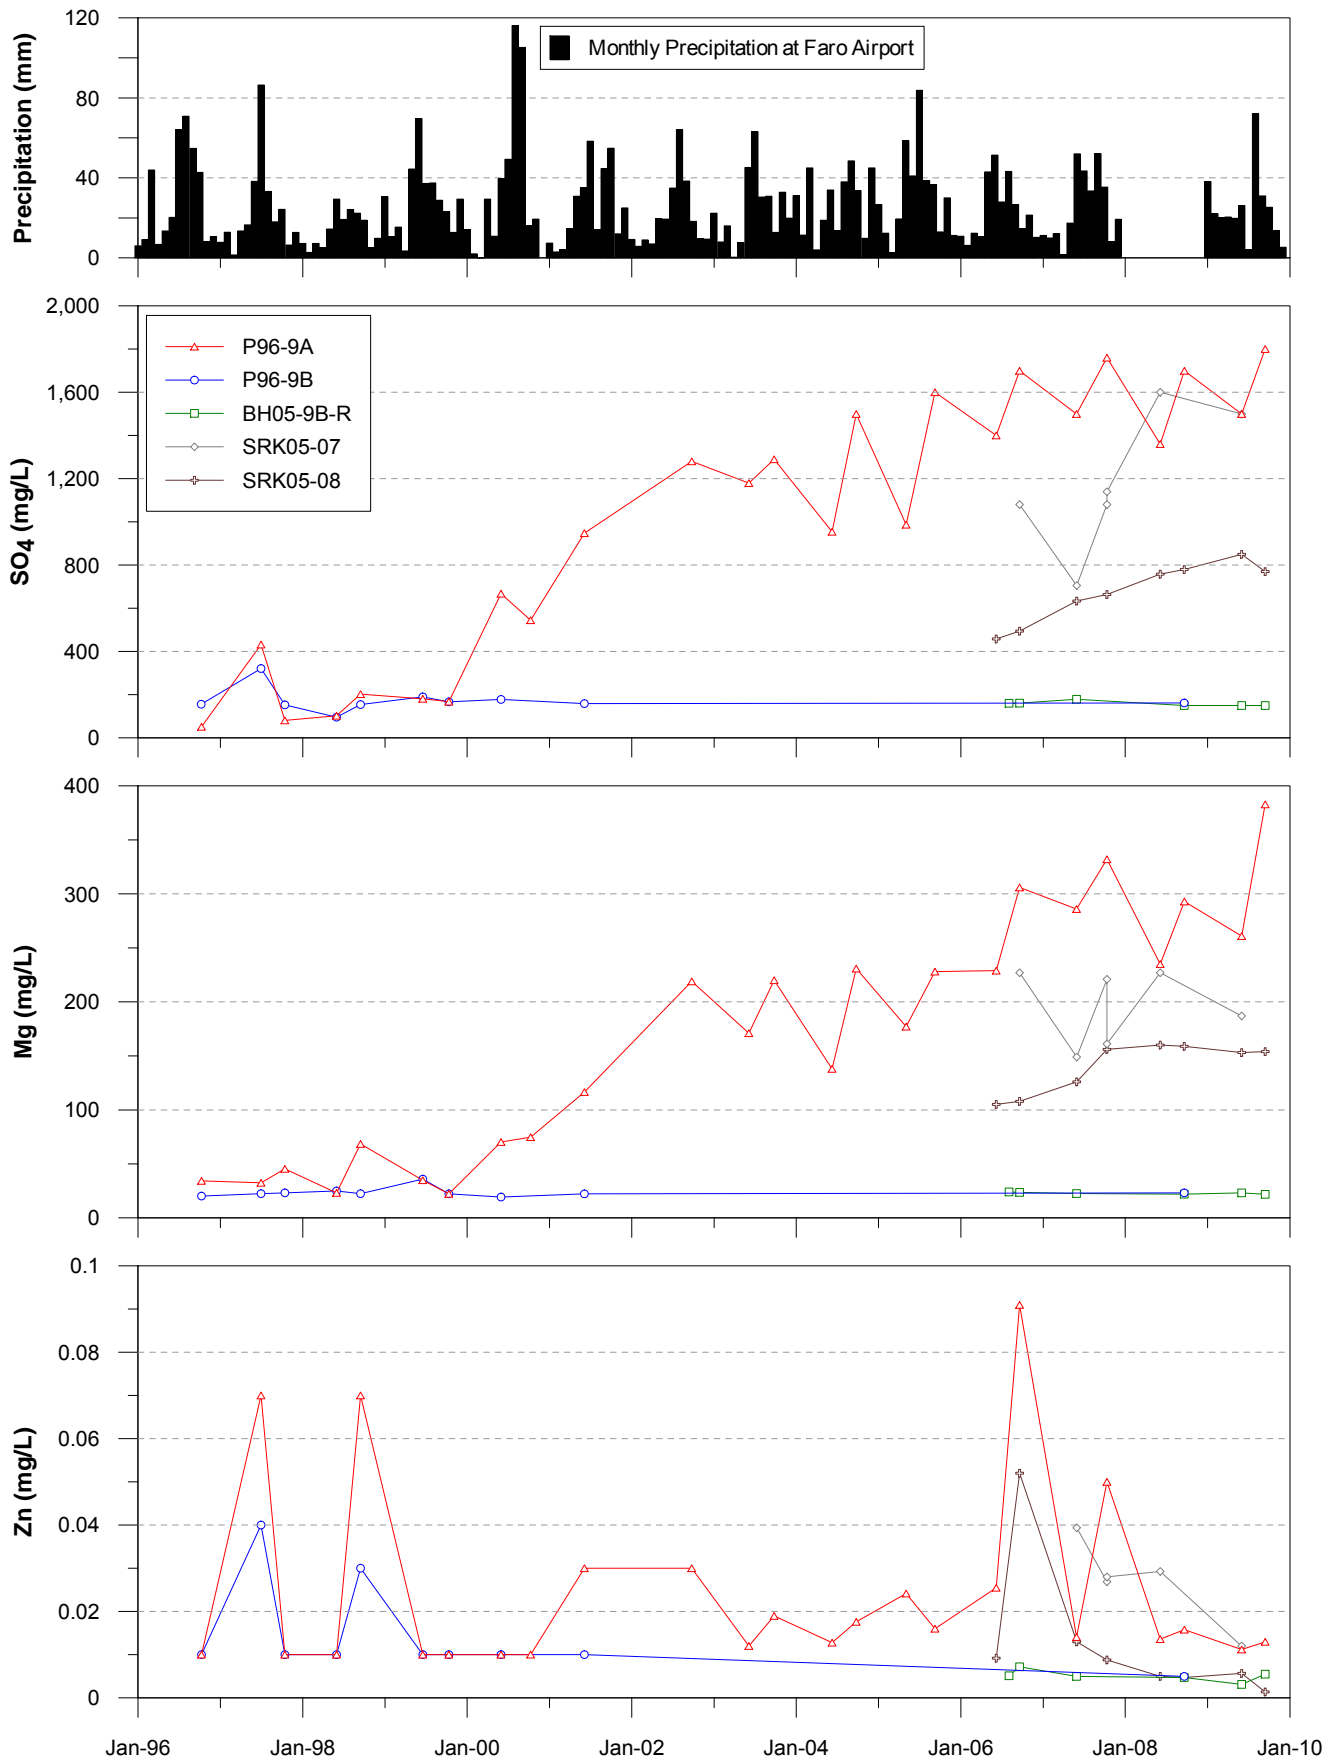
Figure 4-4a. Time trends for SO₄, Mg and Zn in wells located west of Grum Creek

Time trends for pH, alkalinity, selected major ions, and metals of interest in wells located west of Grum Creek are shown in Figure 4-4a/b. SO₄ and Mg concentrations in well P96-9A (screened in alluvial sediments in a narrow side drainage from Grum Creek) have been increasing since the year 2000 and continued to do so in 2009. The concentrations of SO₄ and Mg in November 2009 were the highest on record at ~1800 mg/L and 390 mg/L, respectively. Zn concentrations in P96-9A increased temporarily in early 2007 but have since decreased again to less than 0.02 mg/L. Mn and Fe concentrations also remained low in P96-9A. Because the concentrations of Fe, Mn, and Zn remain low, there is little cause for concern at this time but groundwater quality in P96-9A should continue to be monitored.

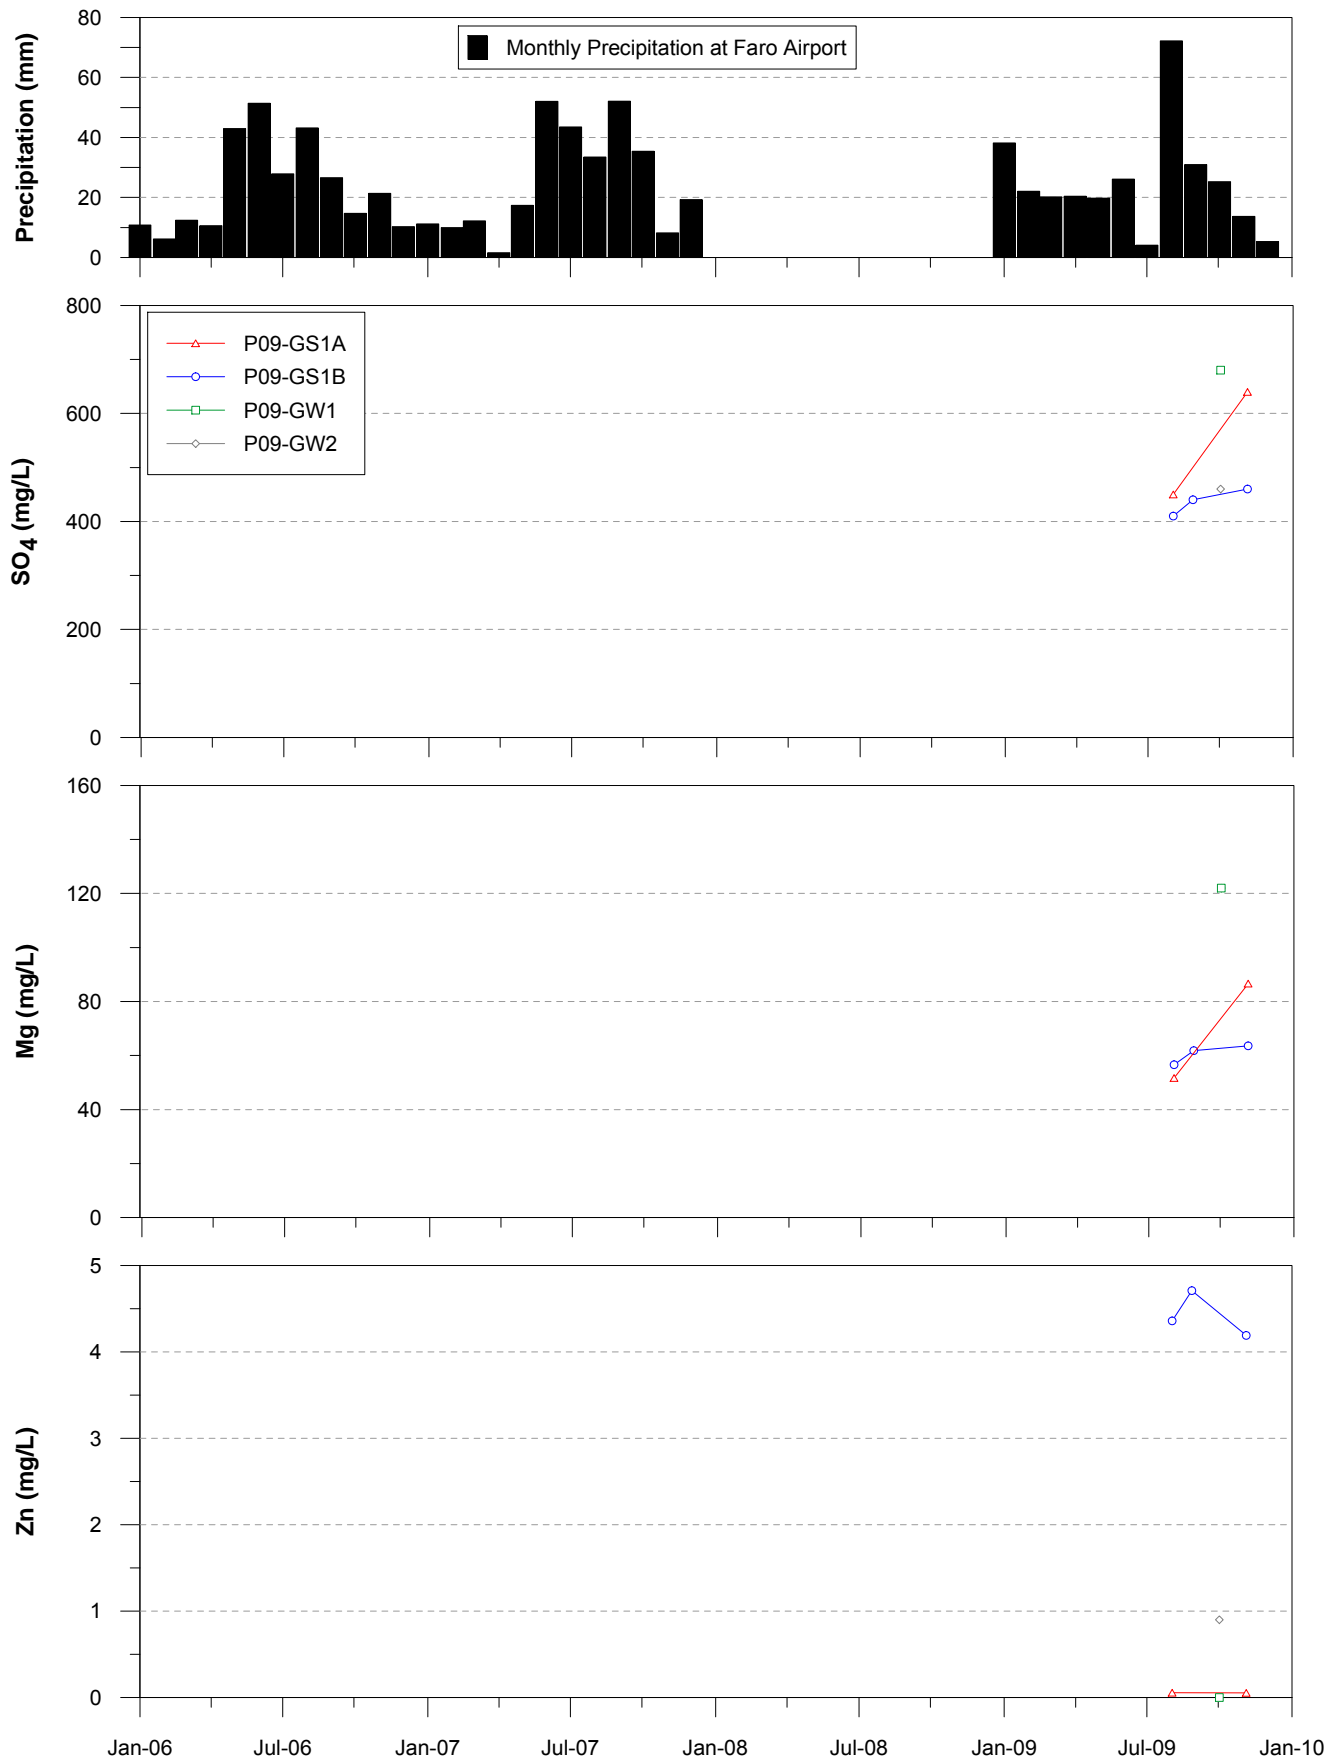
Figure 4-5a. Time trends for SO₄, Mg, Na and Zn in wells located near Grum Slot and west of Grum Dump

Time trends for pH, alkalinity, selected major ions, and metals of interest in wells located near Grum Slot and west of the Grum Dump are shown in Figure 4-5a/b. As only one or two samples were collected from the 'P09-GS' and 'P09-GW' well series in 2009, an additional year of monitoring data is required to establish time trends for these wells. However, the 2009 data indicate that groundwater from wells P09-GS1A and P09-GS1B is moderately-impacted by mine waste seepage. Specifically, SO_4 concentrations in groundwater from both wells are elevated (400 to 600 mg/L) and higher than in standing water from the Grum Slot. Note that the Zn concentration in well P09-GS1B (screened in overburden) is 4 to 5 mg/L or about two orders of magnitude higher than in groundwater from P09-GS1A. These high Zn concentrations are likely a result of *in situ* leaching of mineralized waste rock observed in the drill cuttings of P09-GS2 (SRK, 2010).

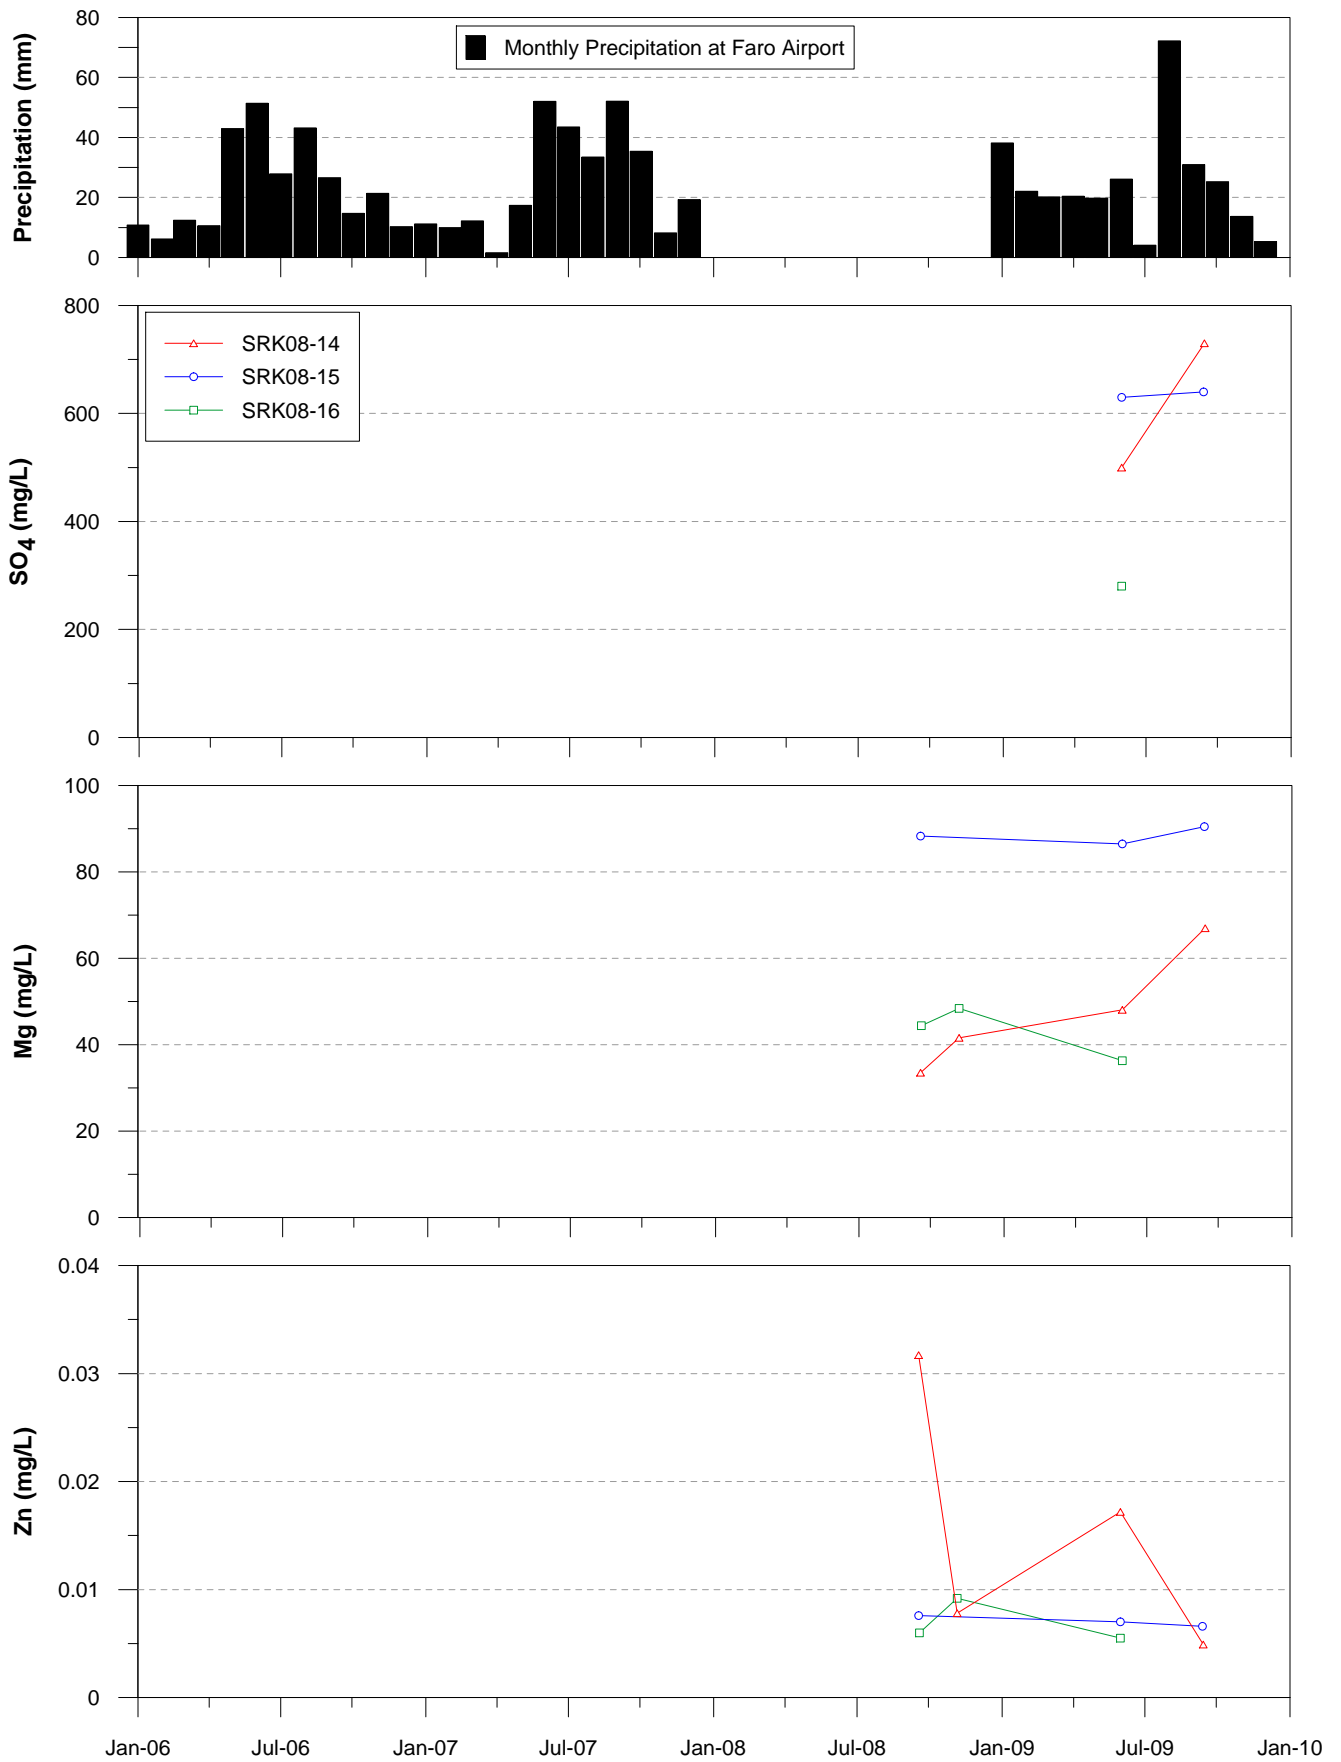
Figure 4-5c. Time trends for SO₄, Mg, Na and Zn in SRK08 wells located southwest of Grum Dump

Wells SRK08-P14, SRK08-P15, and SRK08-P16 are located along the southwest toe of the Grum Dump (Figure 4-2). Time trends for pH, alkalinity, selected major ions, and metals of interest in these wells are shown in Figure 4-5c/d. SO_4 concentrations in these wells are elevated (300 to 800 mg/L) but pH remains circum-neutral (pH 7.5 to 8.0) and metals concentrations are very low (i.e. < 0.03 $\mu\text{g/L}$ Zn). These trends are consistent with the presence of mine waste seepage in this area but at this point only the breakthrough of conservatively-transported ions has occurred. Future monitoring

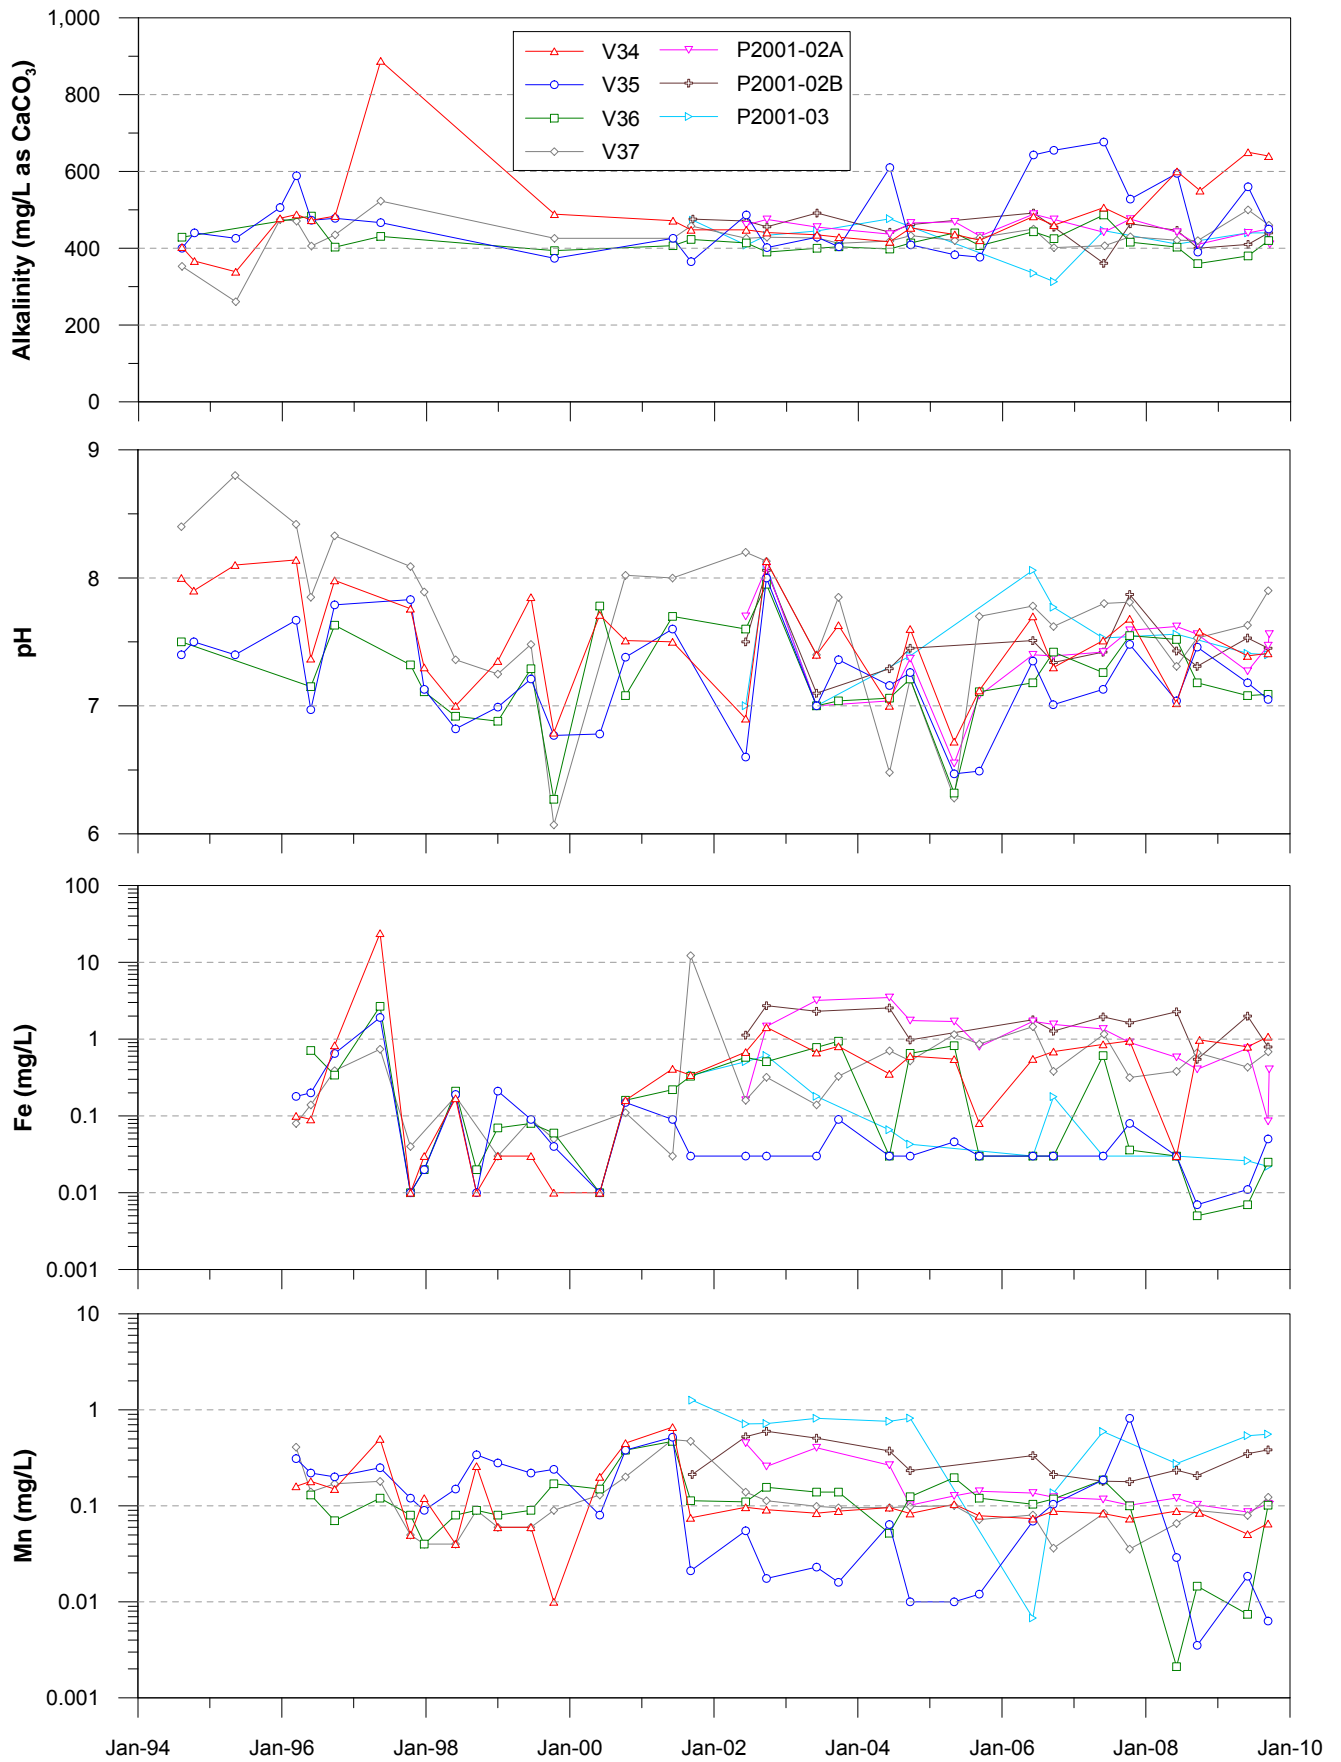
Figure 4-7b. Time trends for alkalinity, pH, Fe and Mn in wells downgradient of Vangorda Rock Dump

Time trends for pH, alkalinity, selected major ions, and metals of interest in monitoring wells located down-gradient of the Vangorda Rock Dump are shown in Figure 4-7a/b. In general, groundwater quality time trends observed in 2009 generally conformed to previously-established time trends. Specifically, SO_4 , and Mg concentrations continued to increase in all monitoring wells located downgradient of the Vangorda Rock Dump. However, these gradual increases in major ions (and sometimes alkalinity) were typically not associated with an increase in the concentrations of any metals of interest. This suggests the ongoing attenuation of metals along the groundwater flowpath. The notable exception is well V36, which is located on the western side of Vangorda Rock Dump and continued to show a gradual increase in Zn concentrations over time. Zn concentrations are relatively low (~ 0.05 mg/L) in this area but concentrations are expected to increase over time and should be monitored closely.

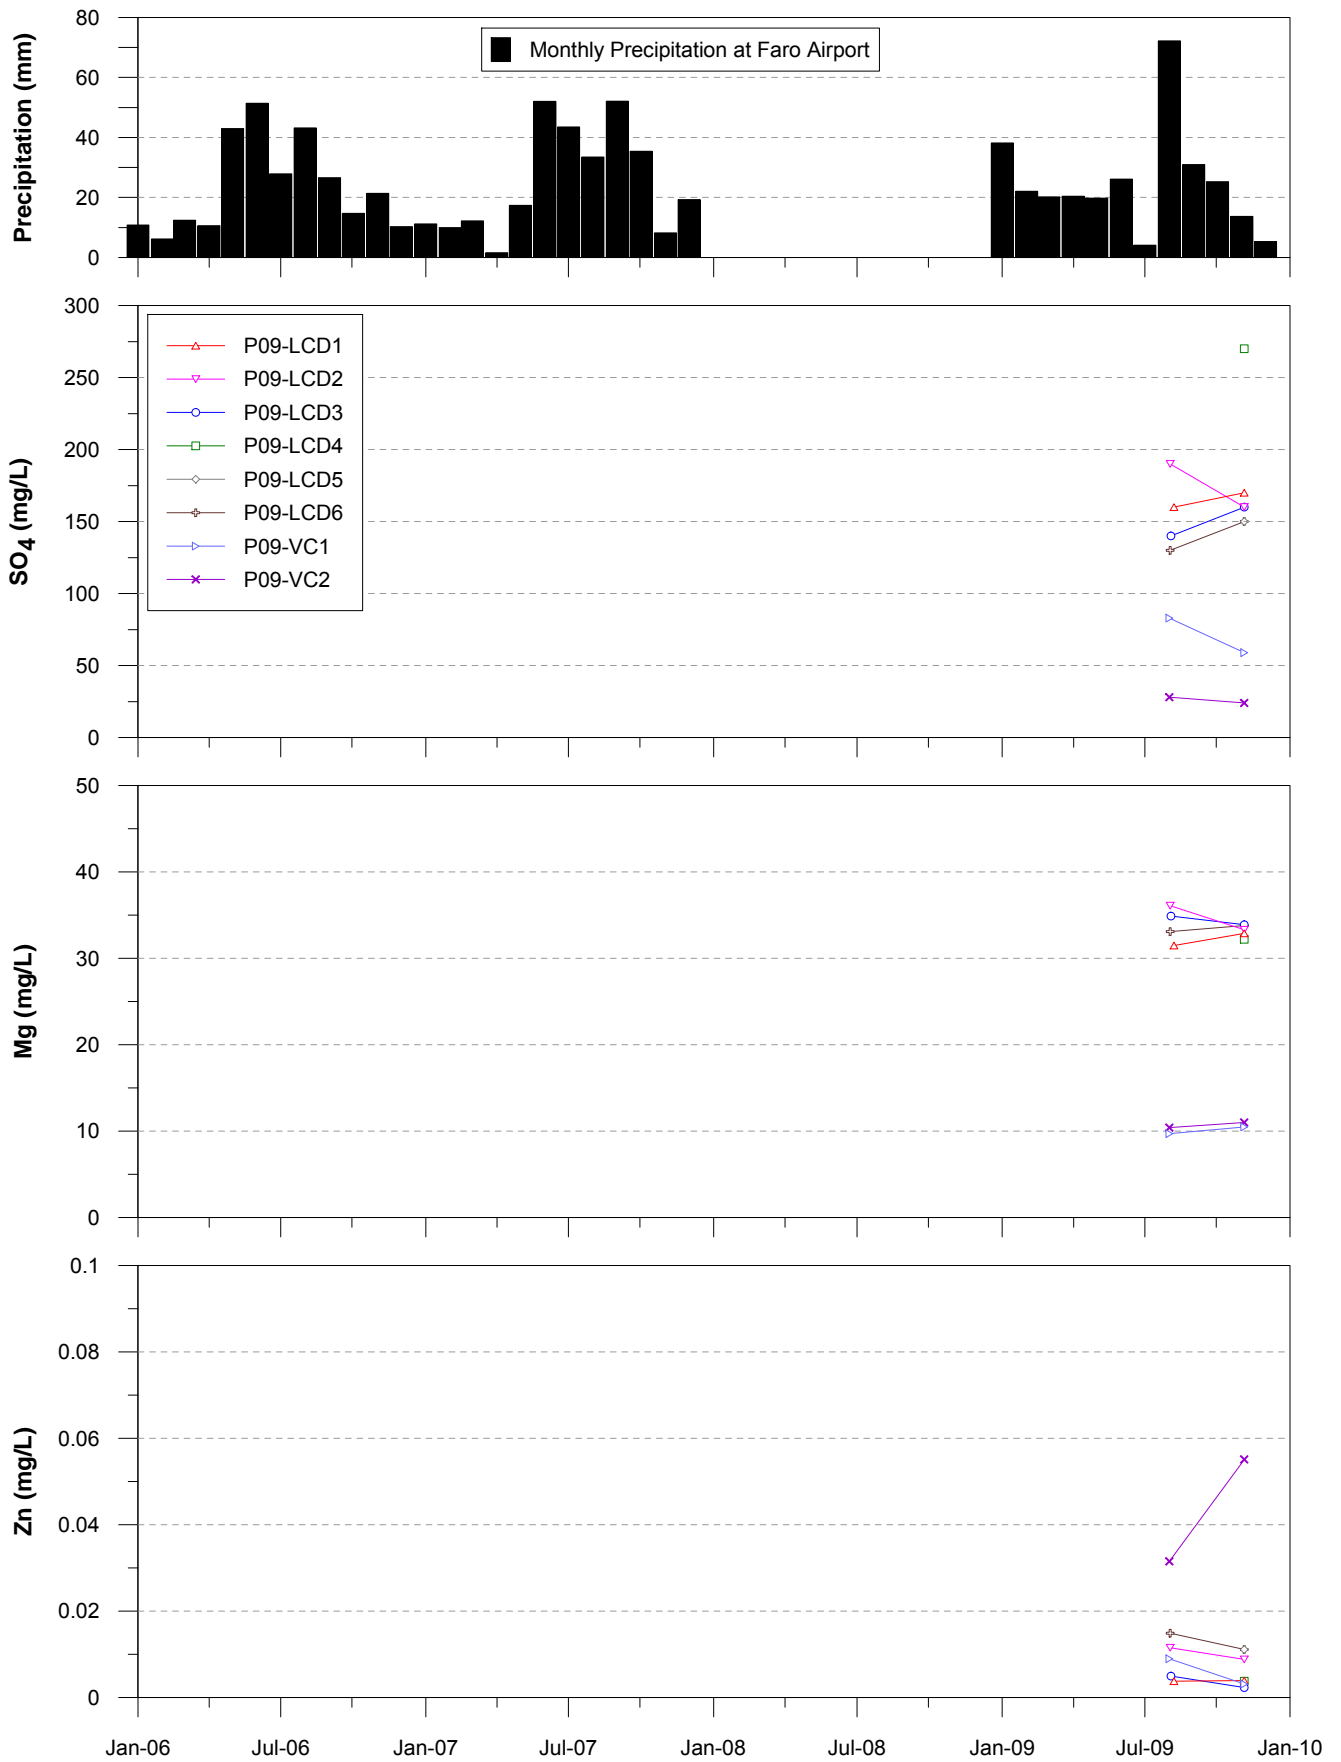
Figure 4-8a. Time trends for SO₄, Mg, Na and Zn in wells near Vangorda Creek and Little Creek Dam

Time trends for pH, alkalinity, selected major ions, and metals of interest in monitoring wells located in the LCD area and near Vangorda Creek are shown in Figure 4-8a/b. SO_4 and Mg concentrations in groundwater from the 'P09-VC' and 'P09-LCD' well series were lower than in the other wells near the Vangorda Rock Dump. For the 'P09-LCD' wells series, small differences were observed between wells screened in overburden and bedrock but major ion and metal concentrations in each of the wells was generally consistent with groundwater that is moderately-impacted by seepage from the LCD (i.e. elevated SO_4 but low concentrations of metals). Future monitoring data will be required to better assess the impact of LCD on groundwater in this area.
