Report No. 118018/1

**2010 GROUNDWATER QUALITY REVIEW  
ANVIL RANGE MINING COMPLEX, YUKON TERRITORY**

**Assessment and Abandoned Mines**

March 2011

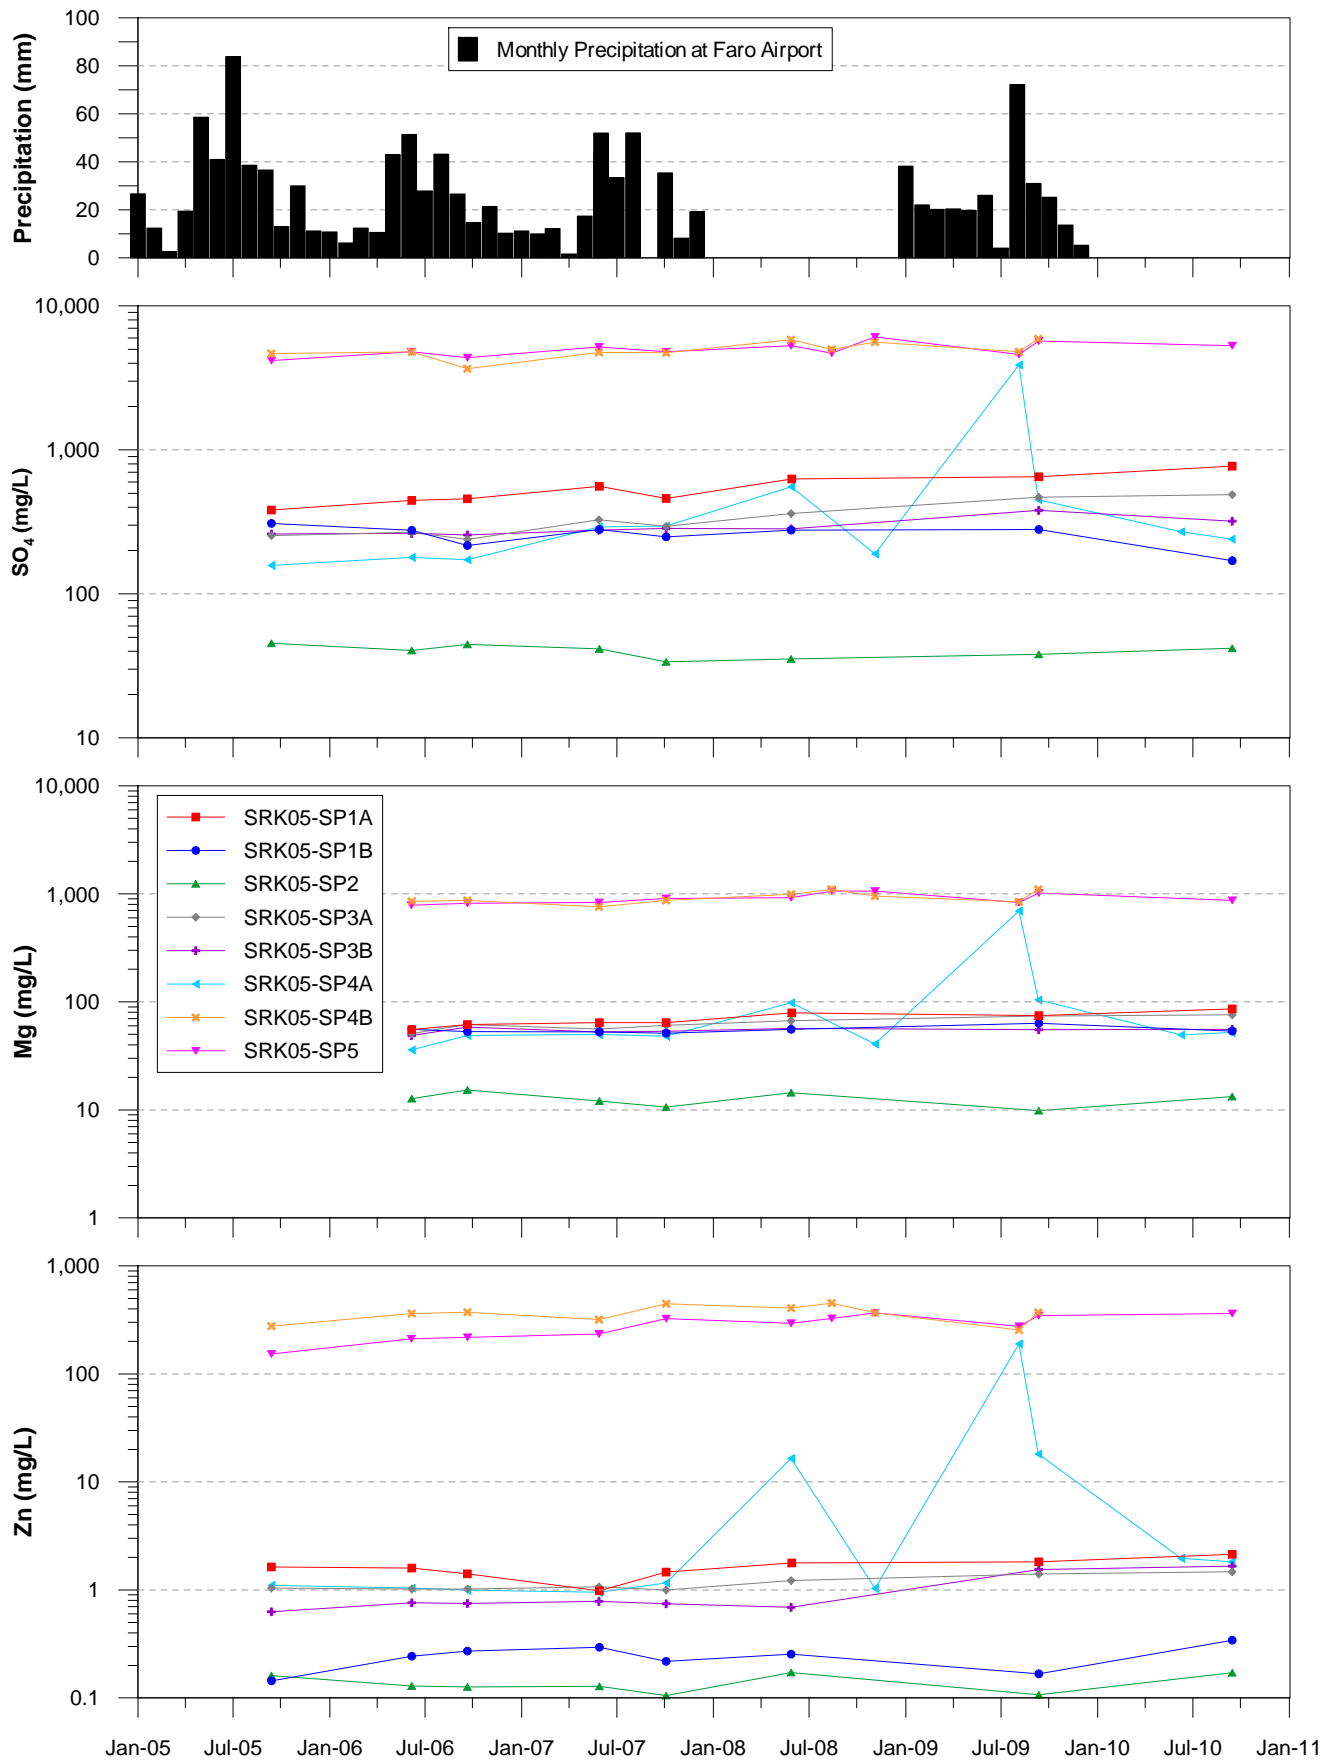
Figure 2-7a. Time trends for  $SO_4$ , Mg and Zn in SRK-05 wells in S-Cluster Area

Figures 2-6a/b shows time trends for pH, alkalinity, selected major ions, and metals of interest in groundwater from the historic 'S' wells and well P96-7. Similar time trend plots for the 'SRK05-SP' and 'P09-SIS' well series are shown in Figure 2-7a/b and Figure 2-7c/d, respectively. Time trends for the recently installed bedrock wells in the S-Cluster area ('SBR' series) and wells further downgradient of the SIS (wells SRK08-SP7A/B and SRK08-SP8A/B) are shown in Figure 2-8a/b and Figure 2-8c/d, respectively

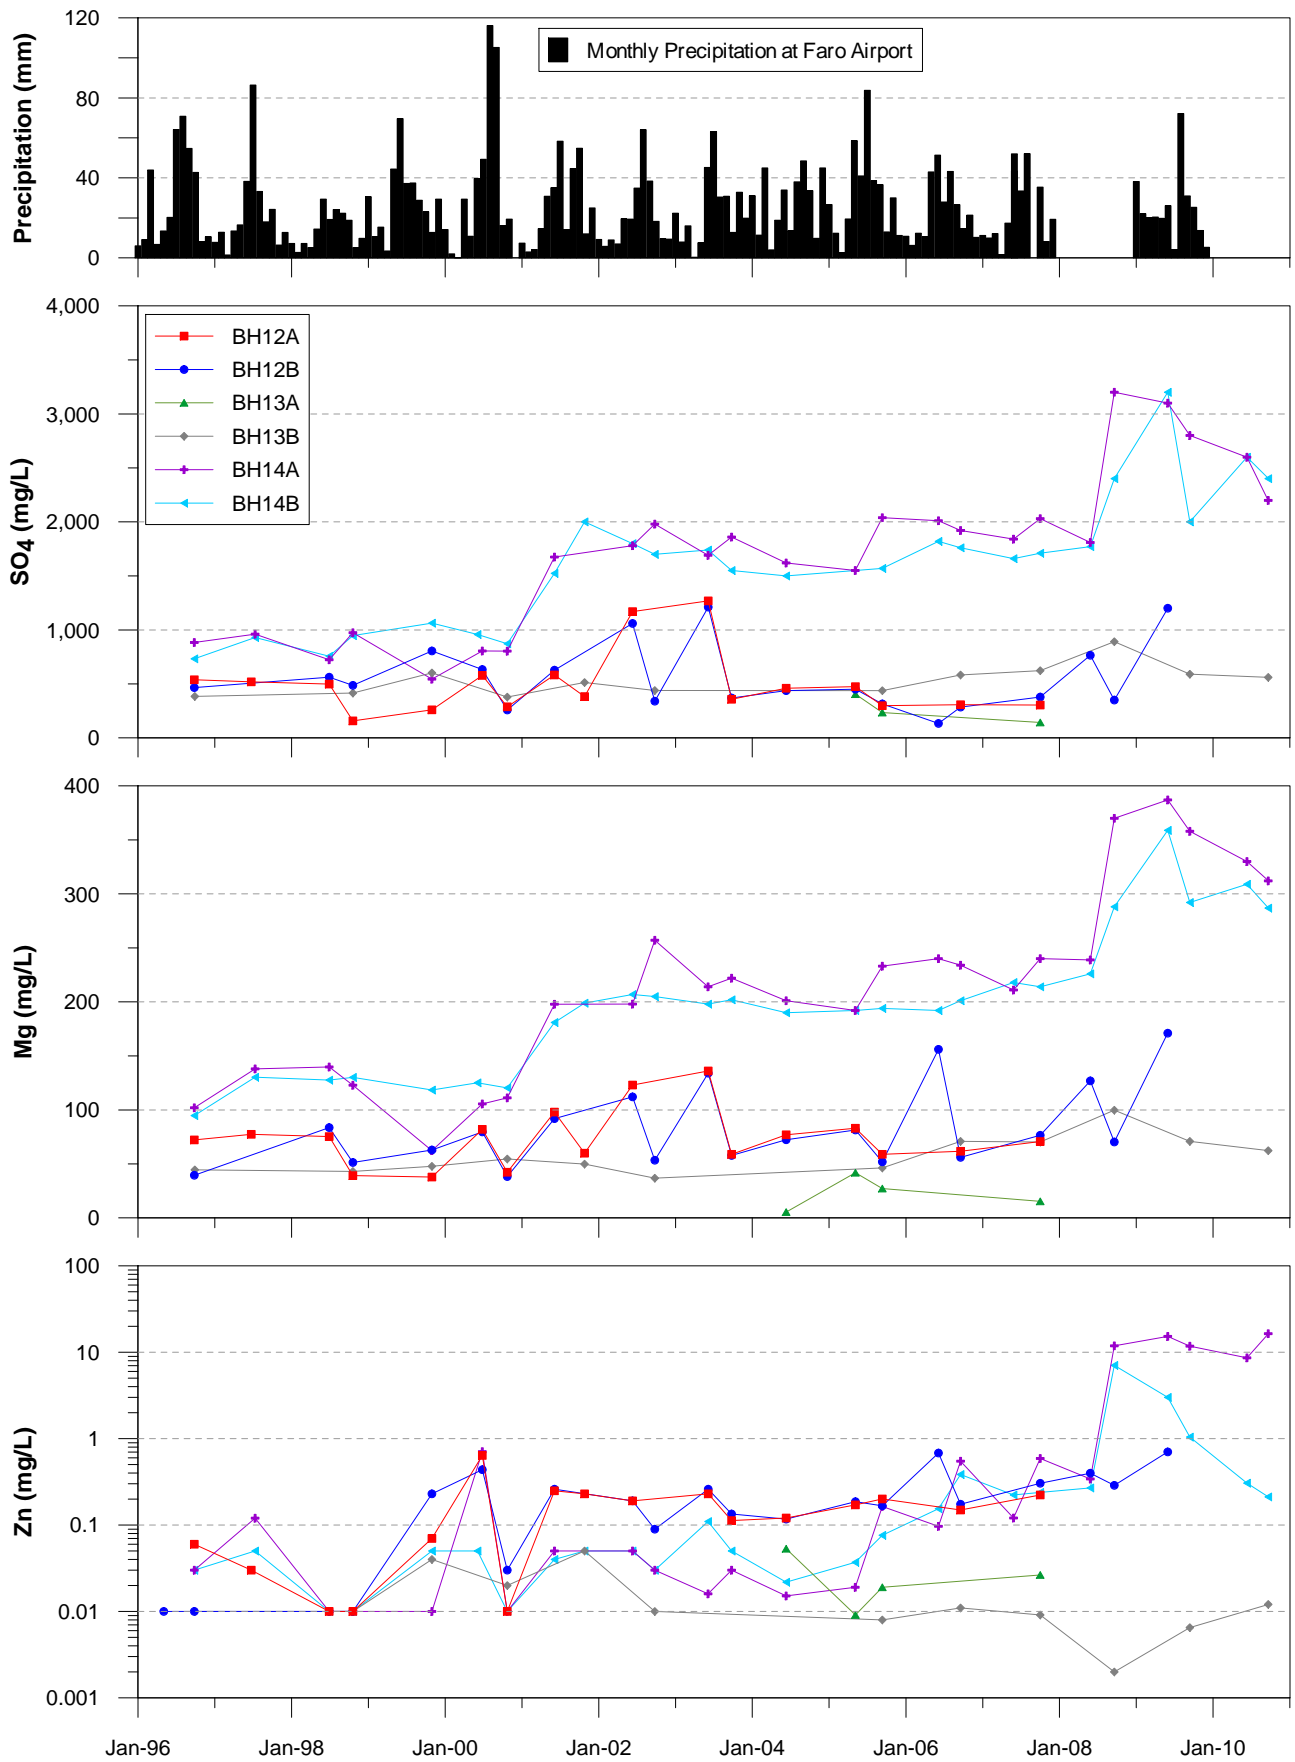
Figure 2-12a. Time trends for  $\text{SO}_4$ , Mg and Zn in wells at the toe of Northeast Rock Dump

Time trends for pH, alkalinity, selected major ions, and metals of interest in groundwater from wells BH12A/B, BH13A/B, and BH14A/B are shown in Figure 2-12a/b. Each of these wells is located along the toe of the Northeast Rock Dump (see Figure 2-9).

Historically, groundwater from well BH14A/B has been more impacted by ARD than groundwater from wells BH12A/B and BH13A/B. Moreover  $\text{SO}_4$ , Mg, Mn, and Zn concentrations in wells BH14A/B increased substantially during the previous monitoring period and concentrations of each contaminant had reached all-time highs in 2009. While  $\text{SO}_4$  and Mg have declined somewhat in both wells again during the 2010 monitoring period they remain higher than in earlier years. More importantly, zinc concentrations in BH14A have remained significantly elevated (at around 10 mg/L) suggesting a gradual breakthrough of waste rock seepage over the long-term (see Figure 2-12a/b).

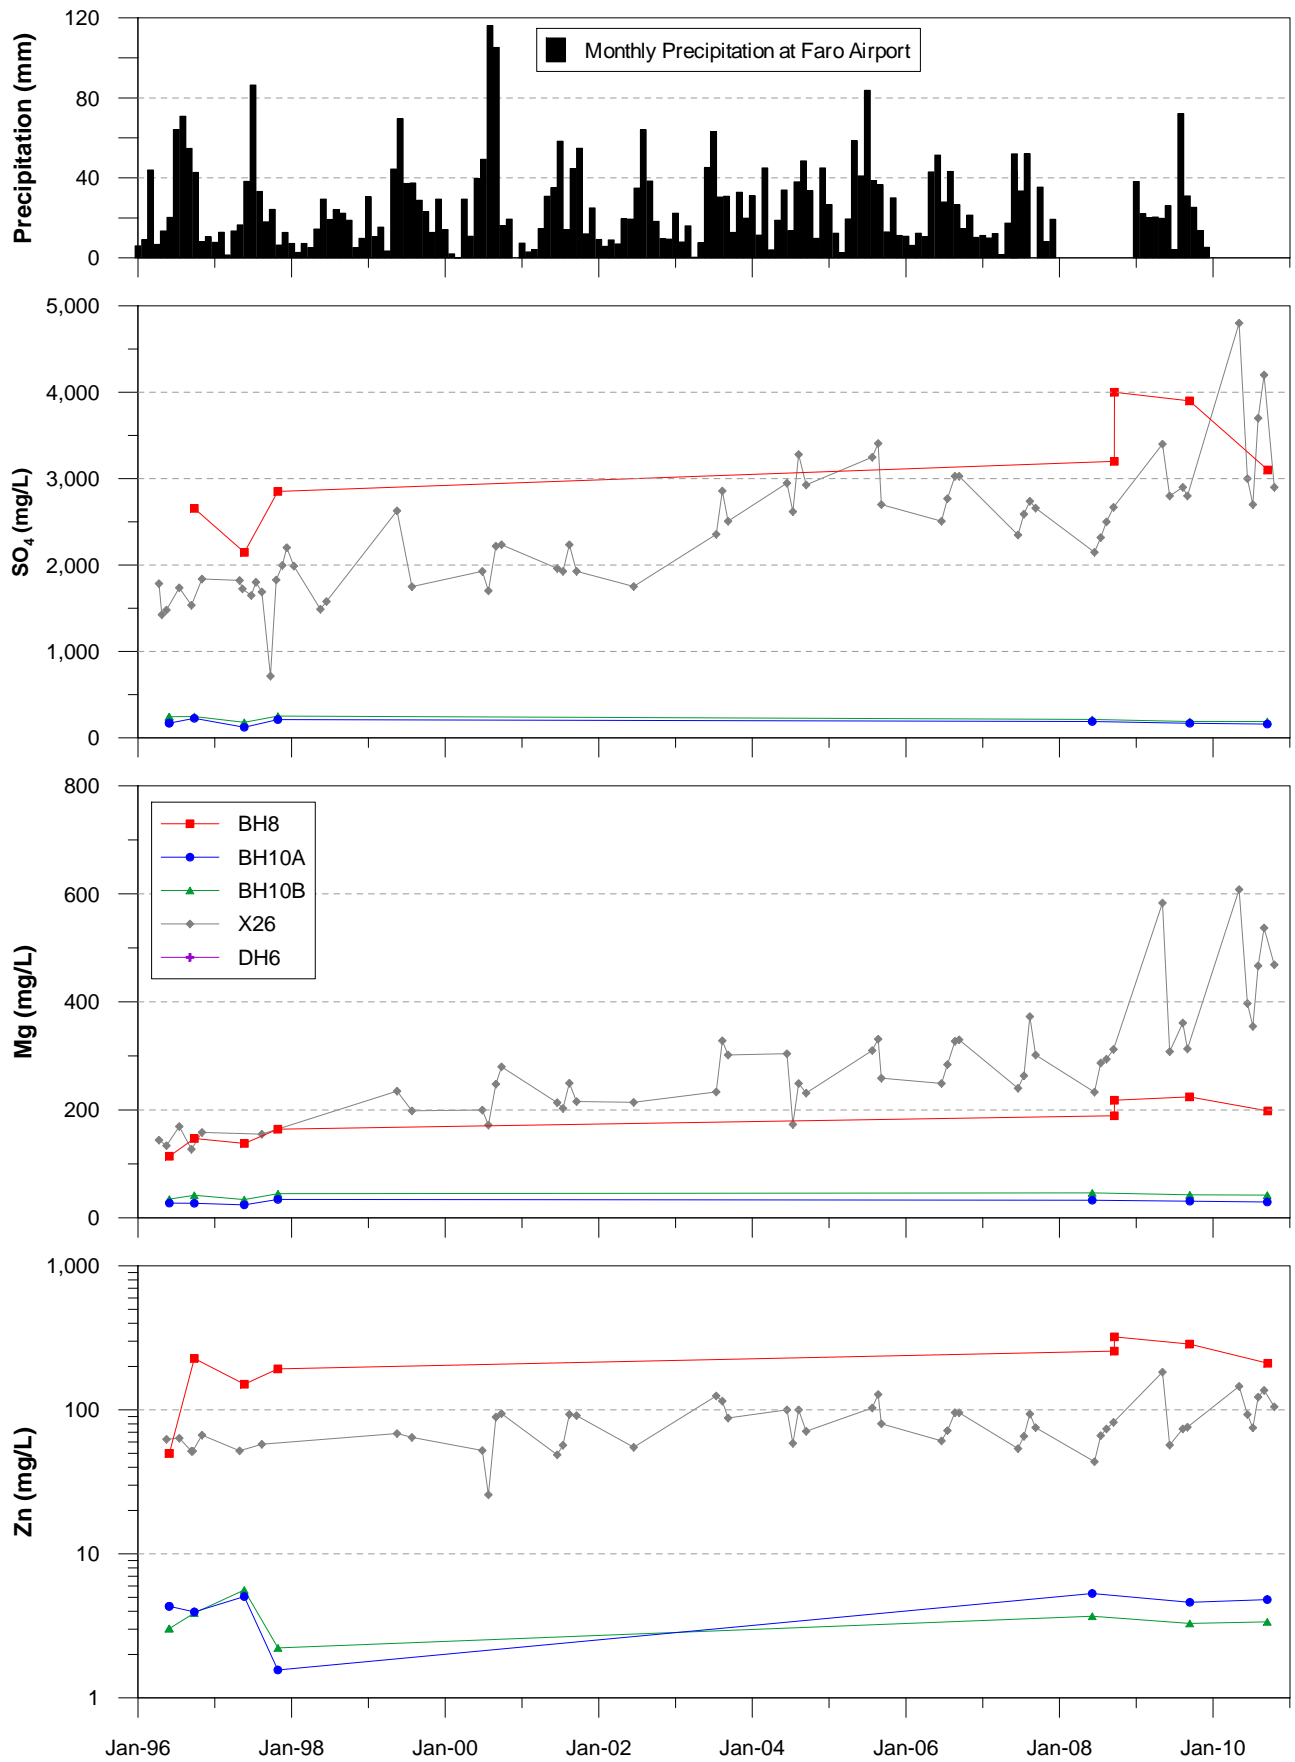
Figure 2-13a. Time trends for SO<sub>4</sub>, Mg and Zn for Zone 2 Pit and bedrock wells

Figure 2-13a/b shows the time trends for pH, alkalinity, selected major ions, and metals of interest in Zone 2 Pit water and groundwater from wells screened in bedrock near the toe of the backfilled pit. Figure 2-14a/b shows the same time trends but for monitoring wells located further downgradient in the Zone 2 Pit outwash area.

The Zone 2 Pit outwash area is located immediately downgradient of the backfilled (waste rock) Zone 2 Pit. Concentrations of SO<sub>4</sub>, Mg, and metals of interest in samples from pumping well X26 reflect the condition of water that accumulates in the backfilled Zone 2 Pit. Seasonal variations in the concentrations of these ions and metals of interest are evident at well X26 due to dilution during periods of recharge in the spring. Note from Figure 2-13a/b that contaminant concentrations in Zone 2 pit water have been relatively stable in recent years but SO<sub>4</sub> and Mg concentrations did increase during the current monitoring period (and were more variable than in the past). Metals of interest concentrations were also rather variable but no trend towards higher concentrations is yet apparent.

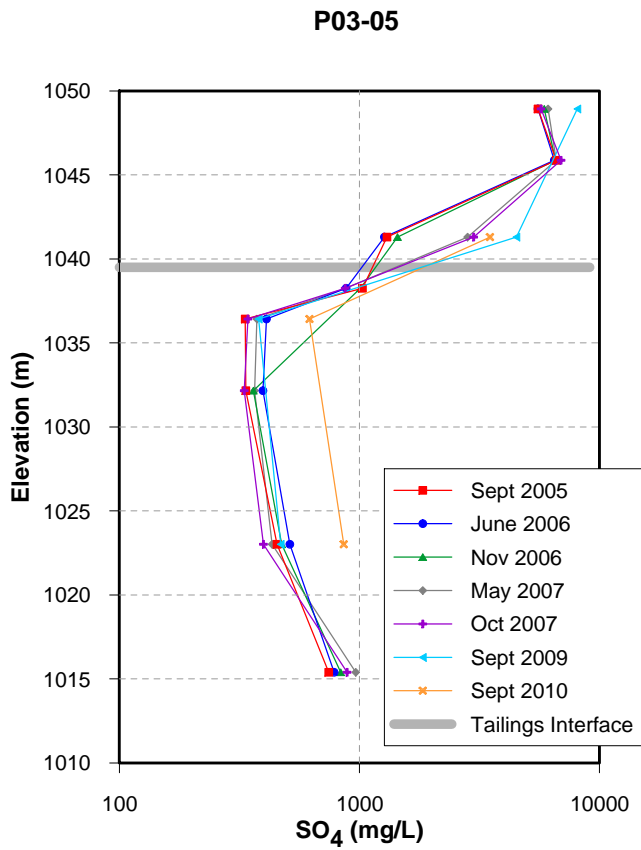
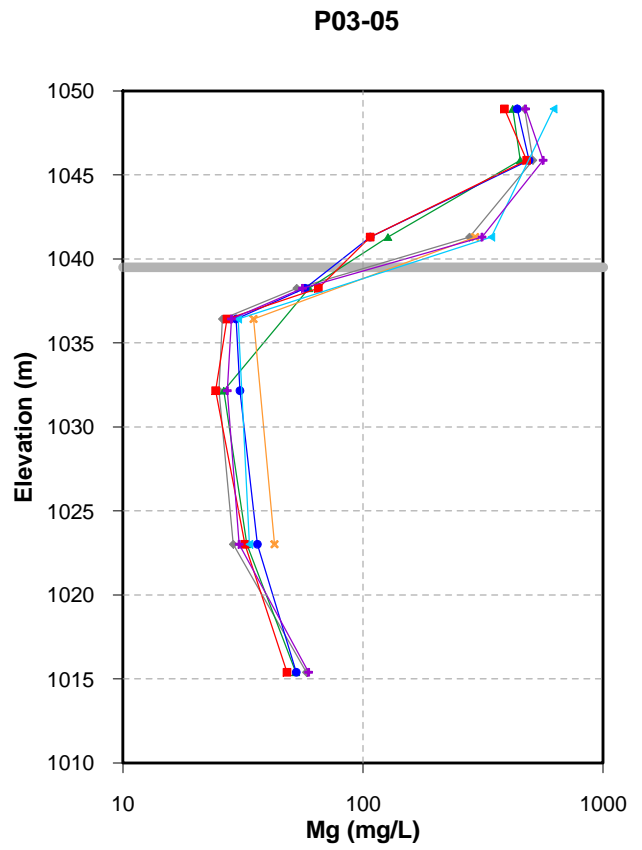
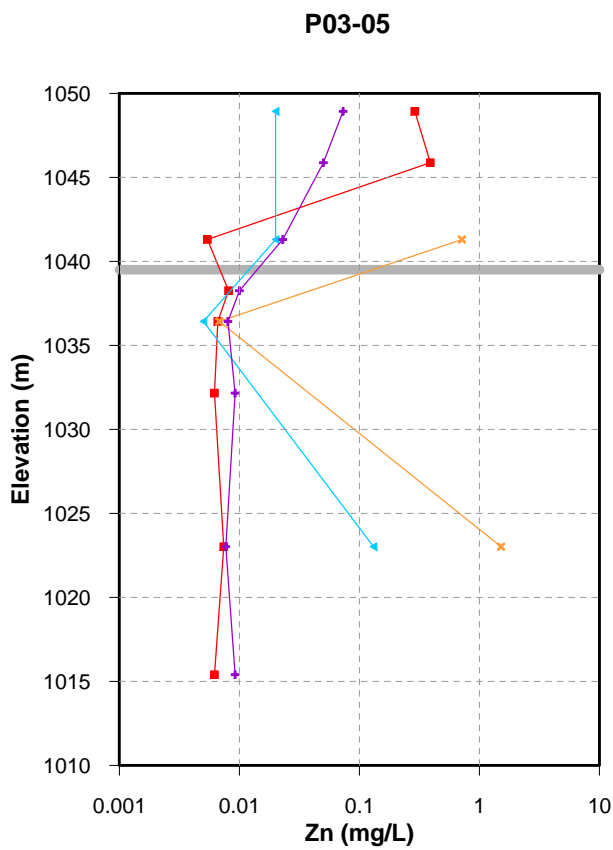
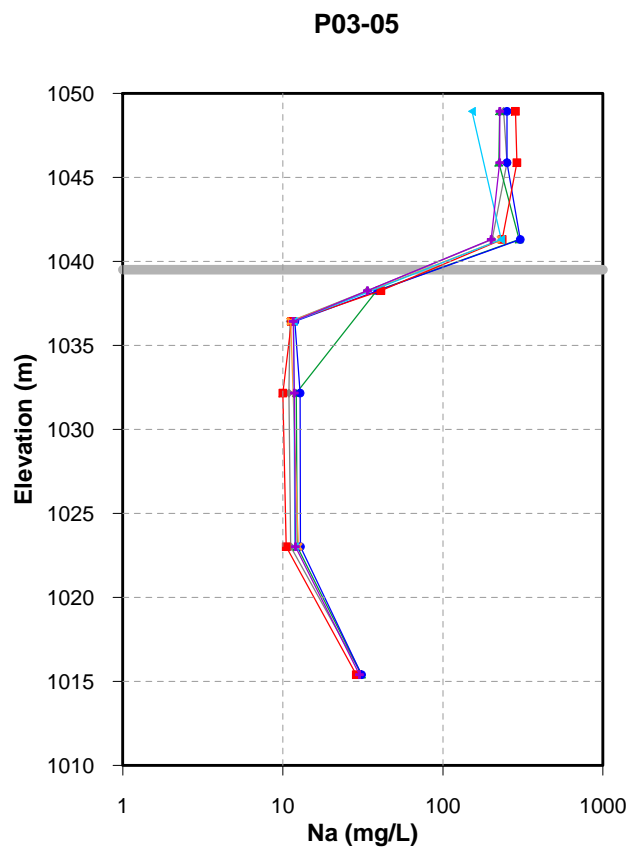
Figure 3-7a. Depth profiles for SO<sub>4</sub>, Mg, Zn and Na in P03-05 (Second Impoundment)

Note that monitoring well P03-05, located about 500m downgradient of P03-03, has also shown a significant increase in sulphate and zinc over the last two years at greater depth (~15m below the original ground surface) (Figure 3-7). It is likely that this recent “breakthrough” of sulphate, zinc and other metals (including Fe and Mn) represents the leading edge of the contaminant plume observed at the upgradient well P03-03 (at similar depth). The earlier breakthrough observed at greater depth of the alluvial aquifer at P03-03 and P03-05 may be a result of the presence of a high-permeability layer (such as a coarse paleochannel) rather than historic “leakage” of highly contaminated seepage from any of the “leaky wells” screened at greater depth.

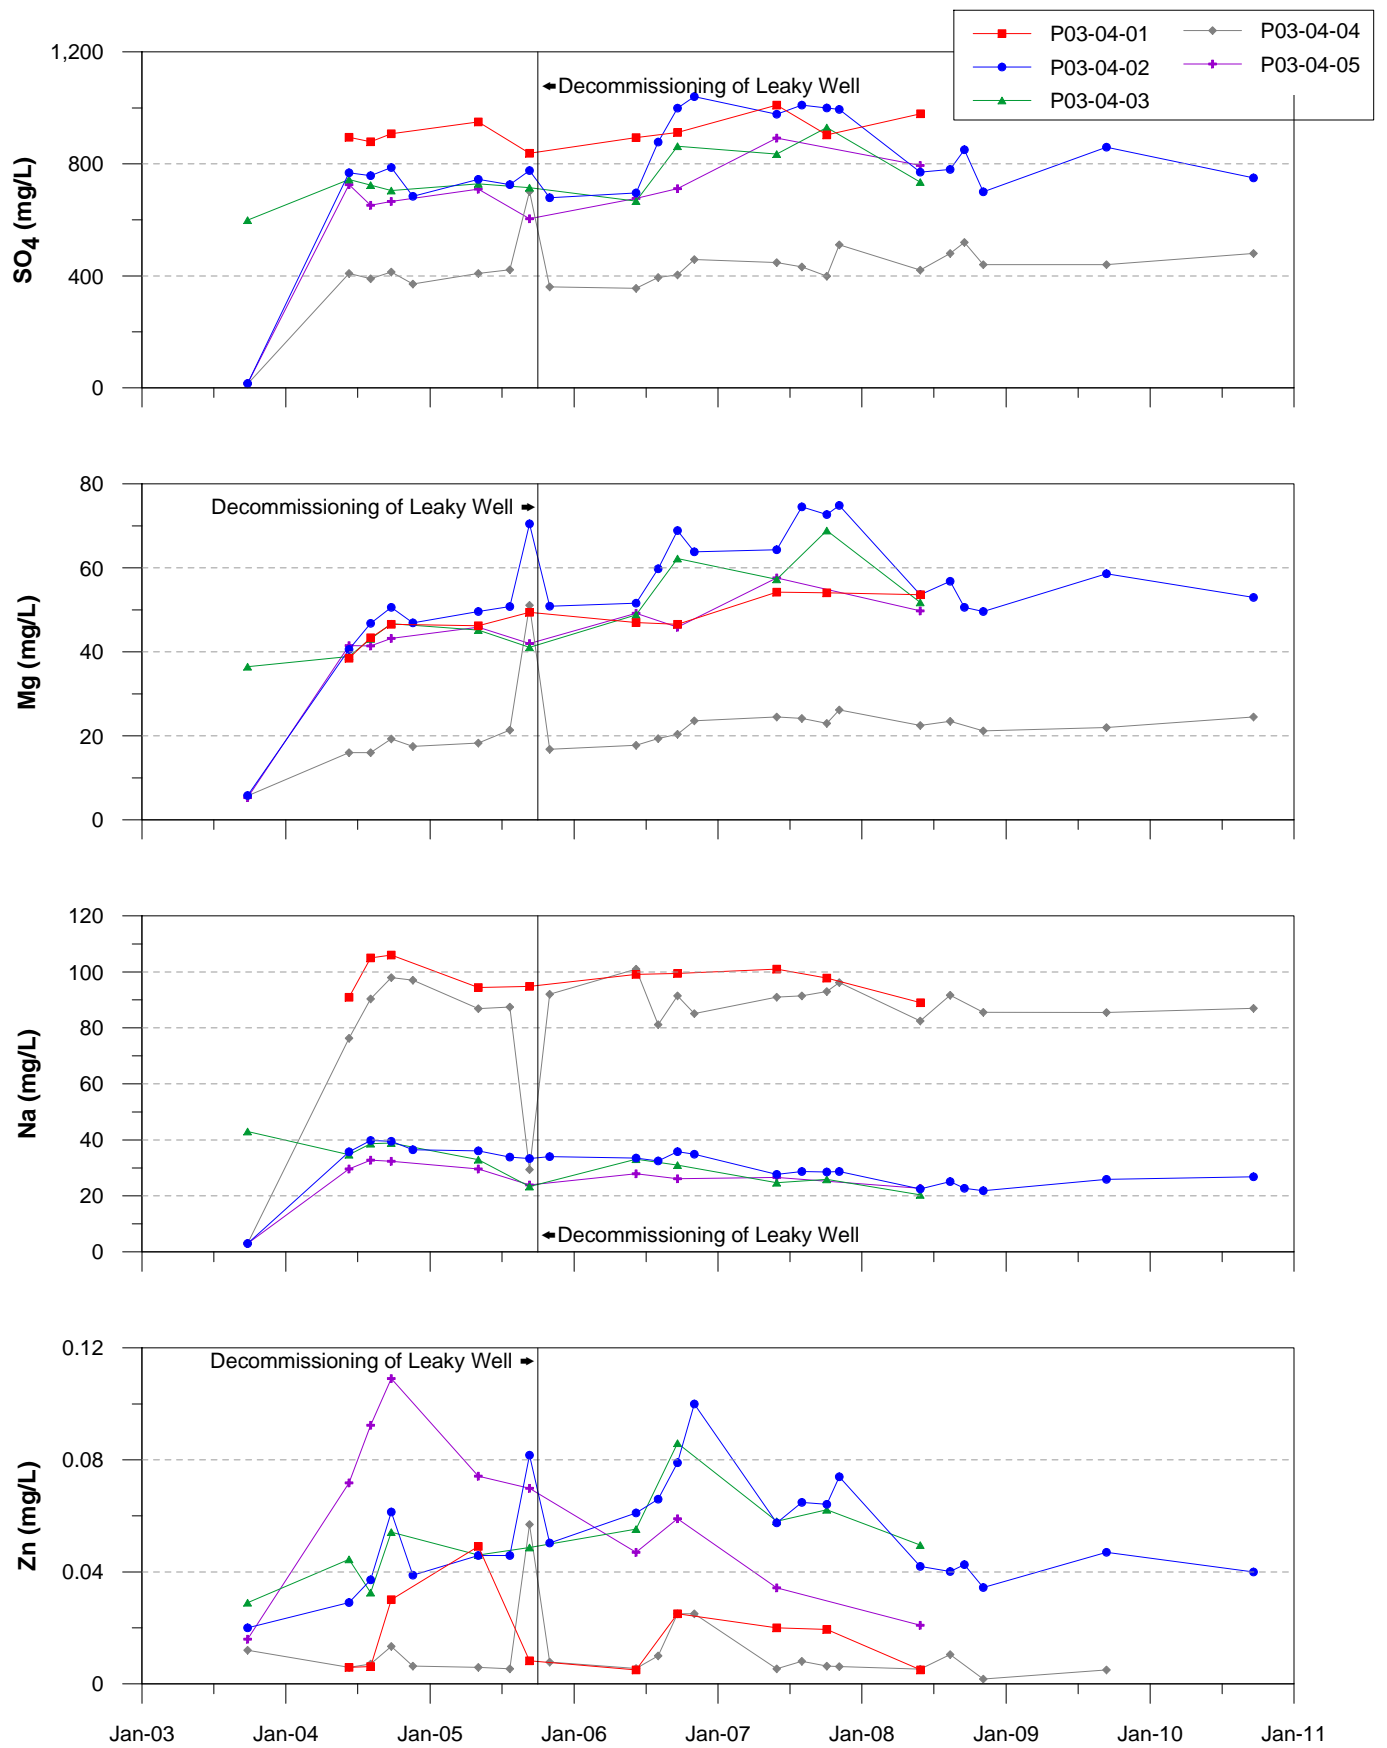
Figure 3-10c. Time trends for SO<sub>4</sub>, Mg, Na and Zn in P03-04 (aquifer only)

Time trends for pH, alkalinity, selected major ions, and metals of interest in nested wells at P03-04 are shown in Figure 3-10c/d. P03-04 is located ~140 m downgradient of the decommissioned “leaky wells” at P01-07 and roughly cross-gradient of P03-06 (see Figure 3-1). Groundwater quality in this area has not improved appreciably since “leaky well” P01-07 was decommissioned (although it has

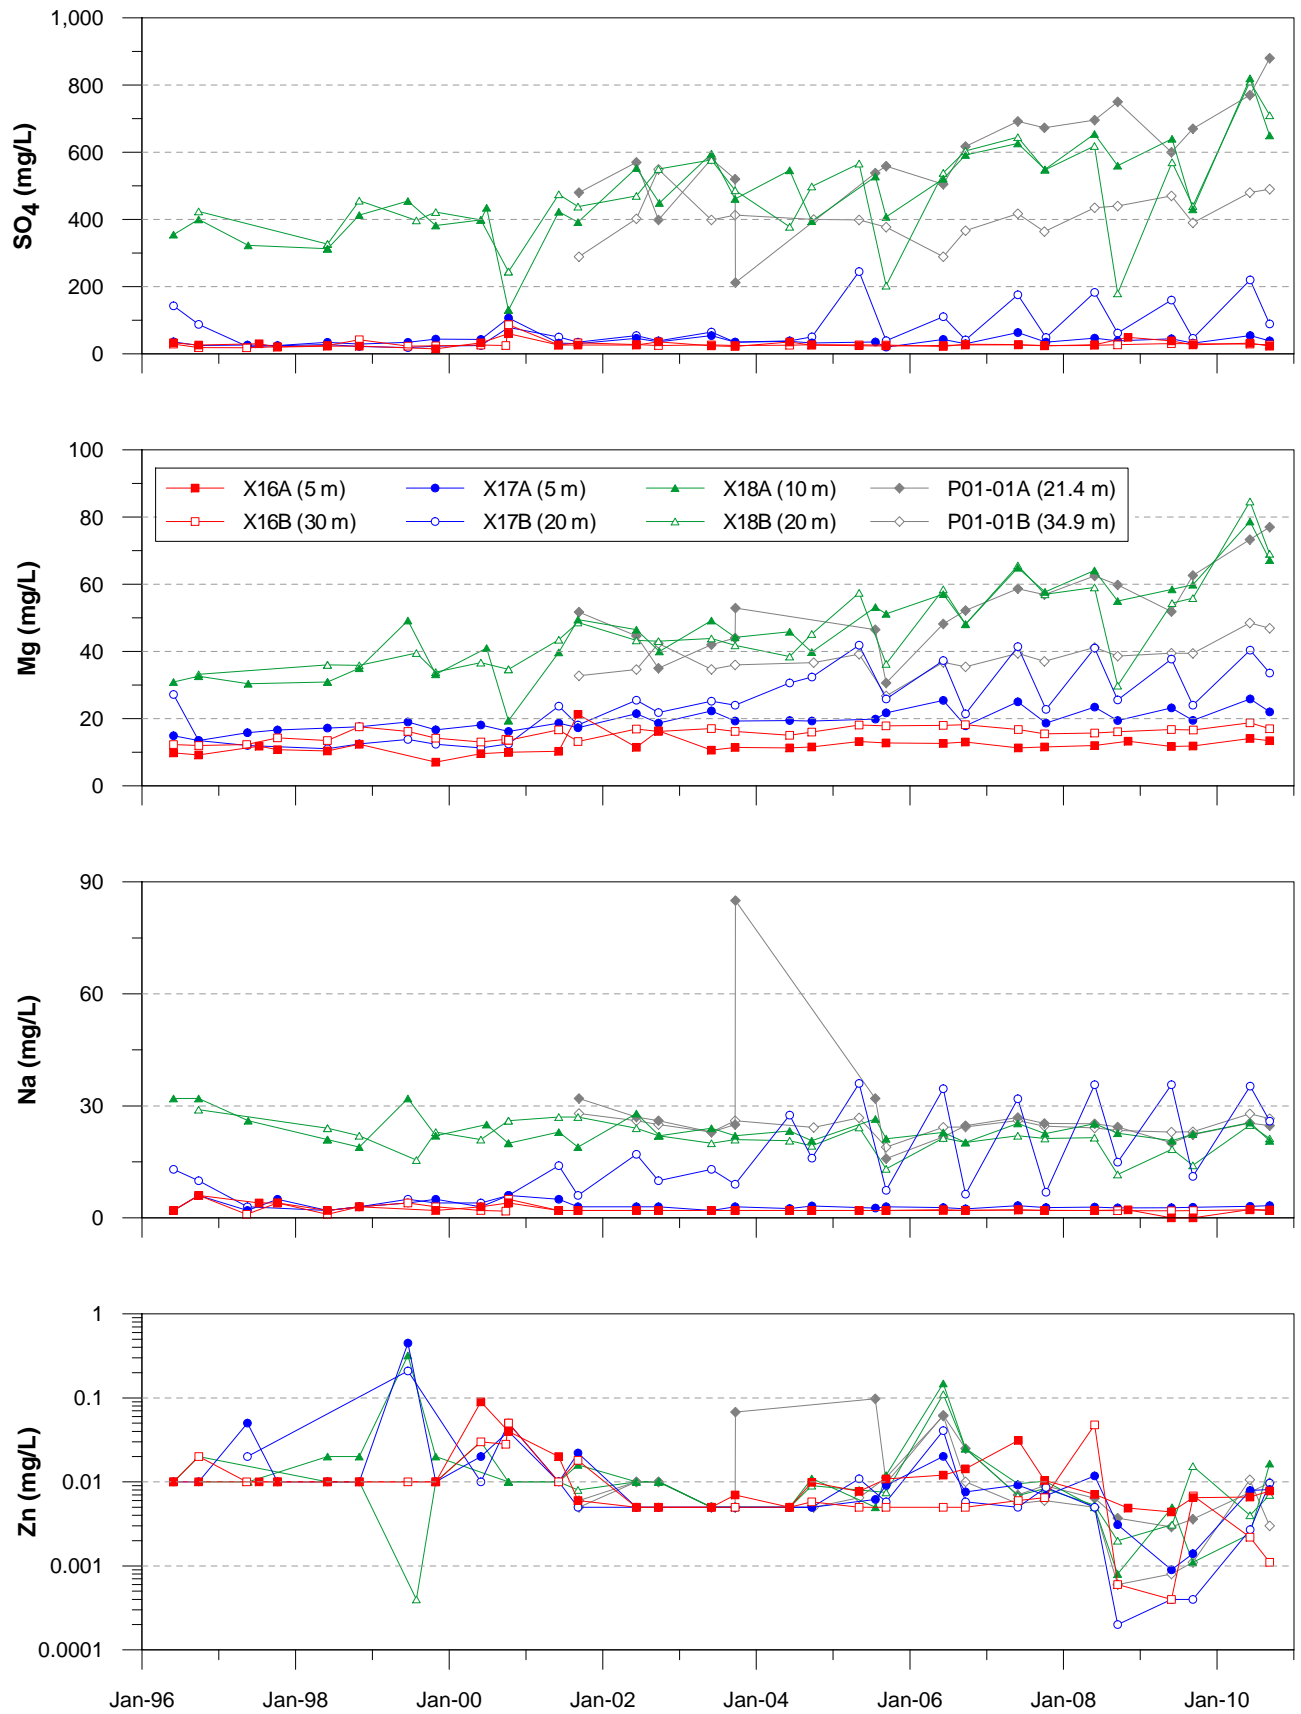
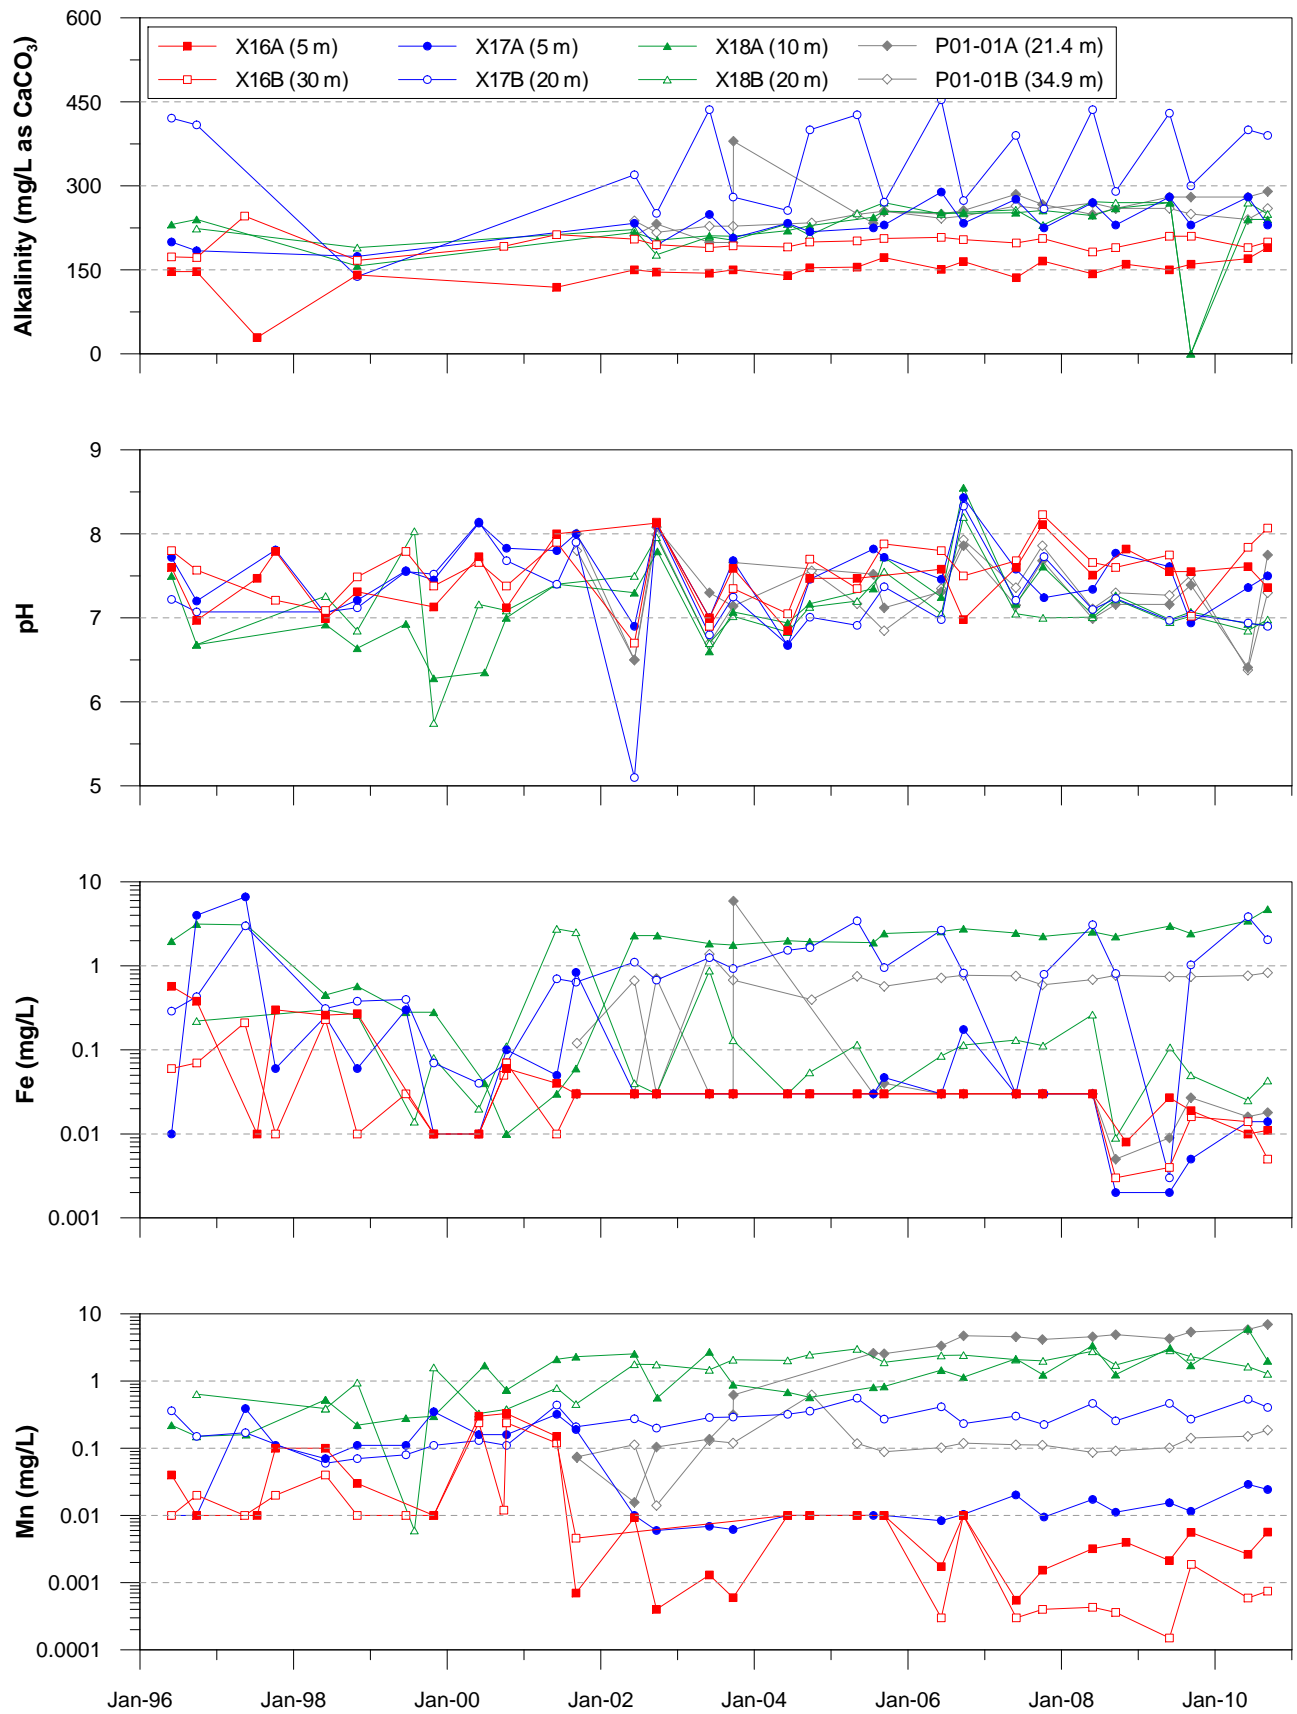
Figure 3-19a. Time trends for SO<sub>4</sub>, Mg, Na and Zn in wells downgradient of Cross Valley Dam

Figures 3-19a/b show time trends for pH, alkalinity, selected major ions, and metals of interest in wells X16A/B, X17A/B, X18A/B and P01-01A/B. In wells X18A/B and P01-01A/B (both located on the northern side of Rose Creek valley), concentrations of SO<sub>4</sub> and Mg continued to increase in 2010 as they have in recent years although metals concentrations remained very low. The increase in SO<sub>4</sub> and Mg in this area is thought to be caused by the leading edge of a TDS front that has been identified upgradient along the northern side of the Cross Valley Dam (at wells P01-11 and P05-01) and in the Intermediate Dam reach (at well X24) and likely originates from the Faro Creek canyon. Note that groundwater in the center of the valley (at X17A/B) and further downgradient at X16A/B is less impacted (if impacted at all). The lack of any significant groundwater impact by mine waste seepage in this area is believed to be a combination of upwelling and discharge to surface of impacted groundwater and dilution by seepage from the Rose Creek diversion.

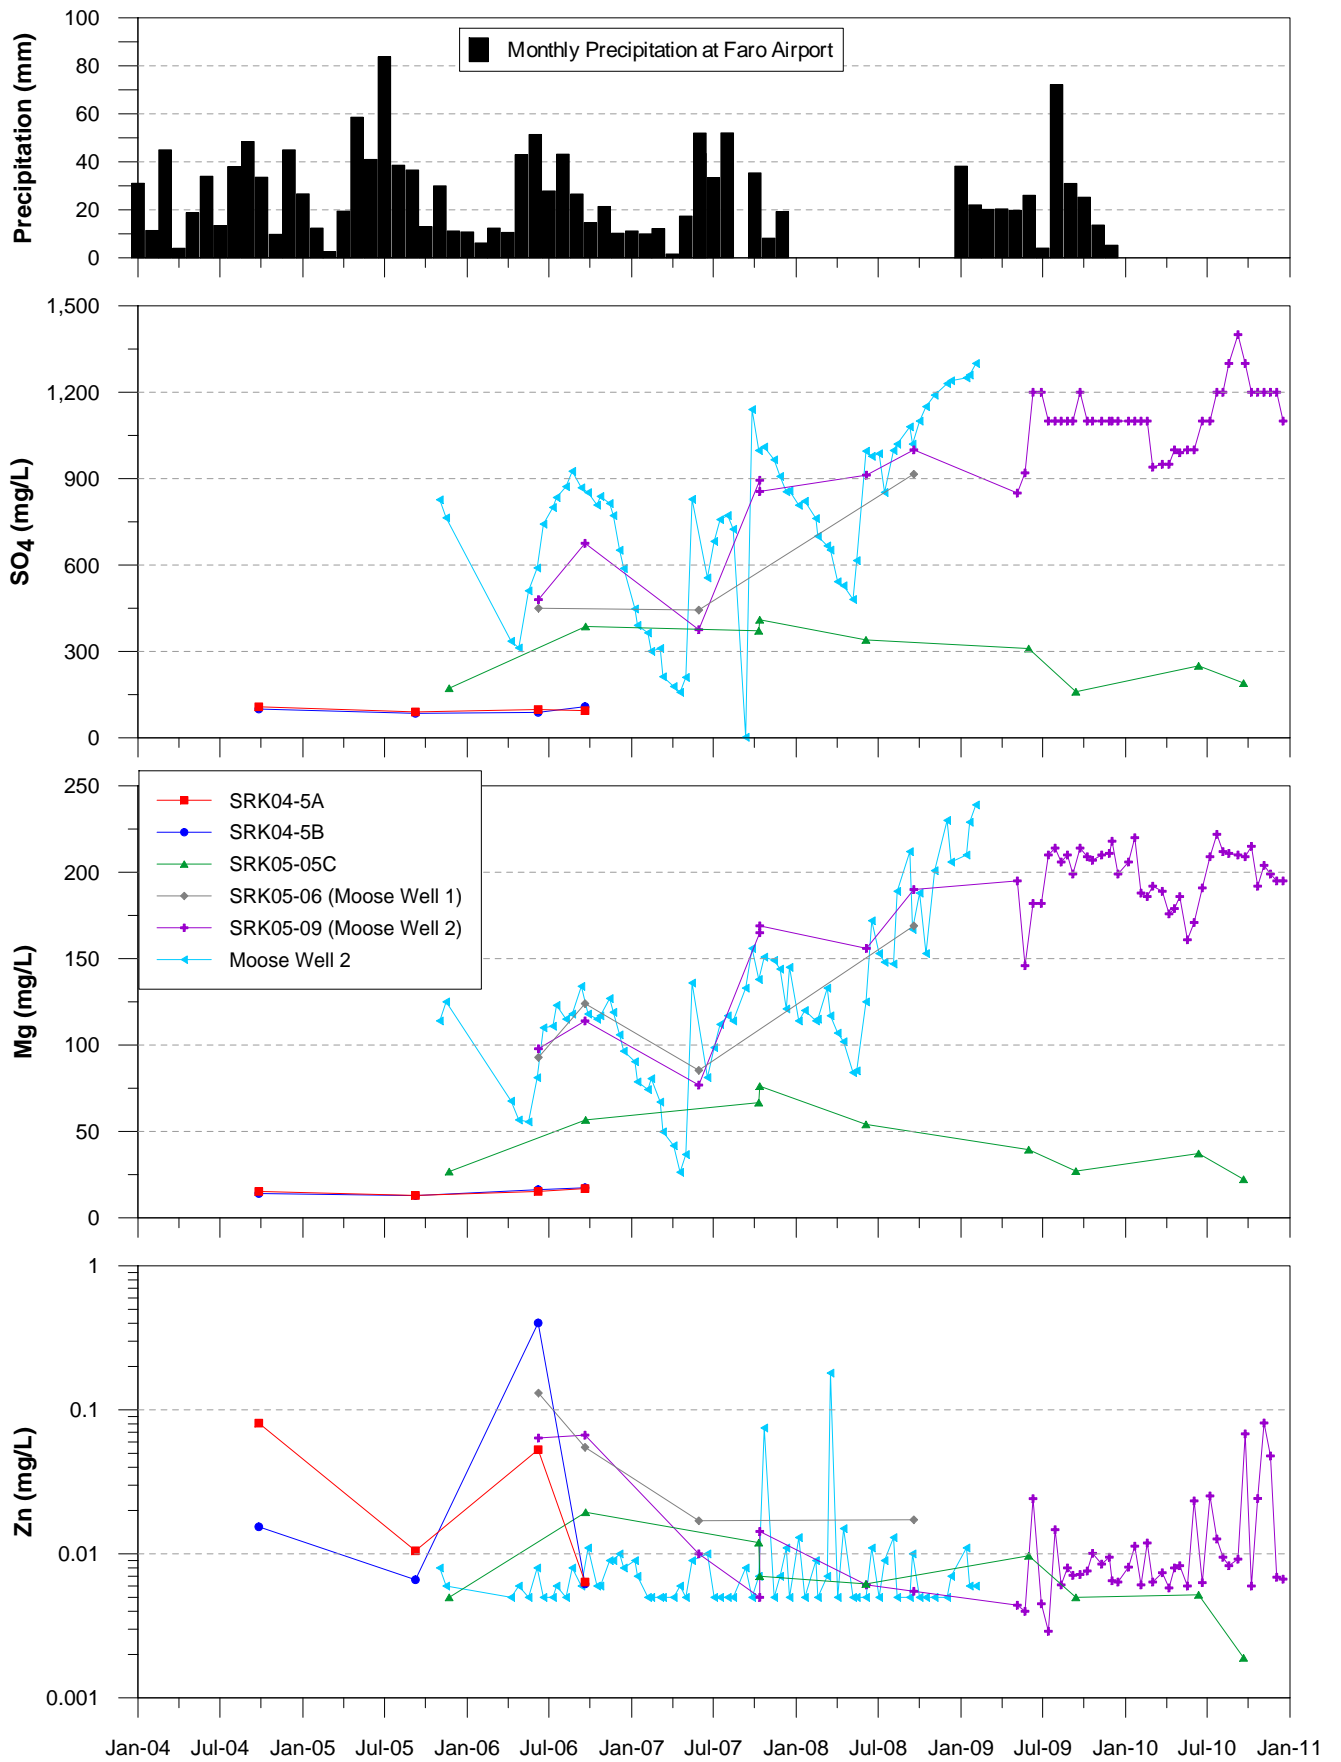
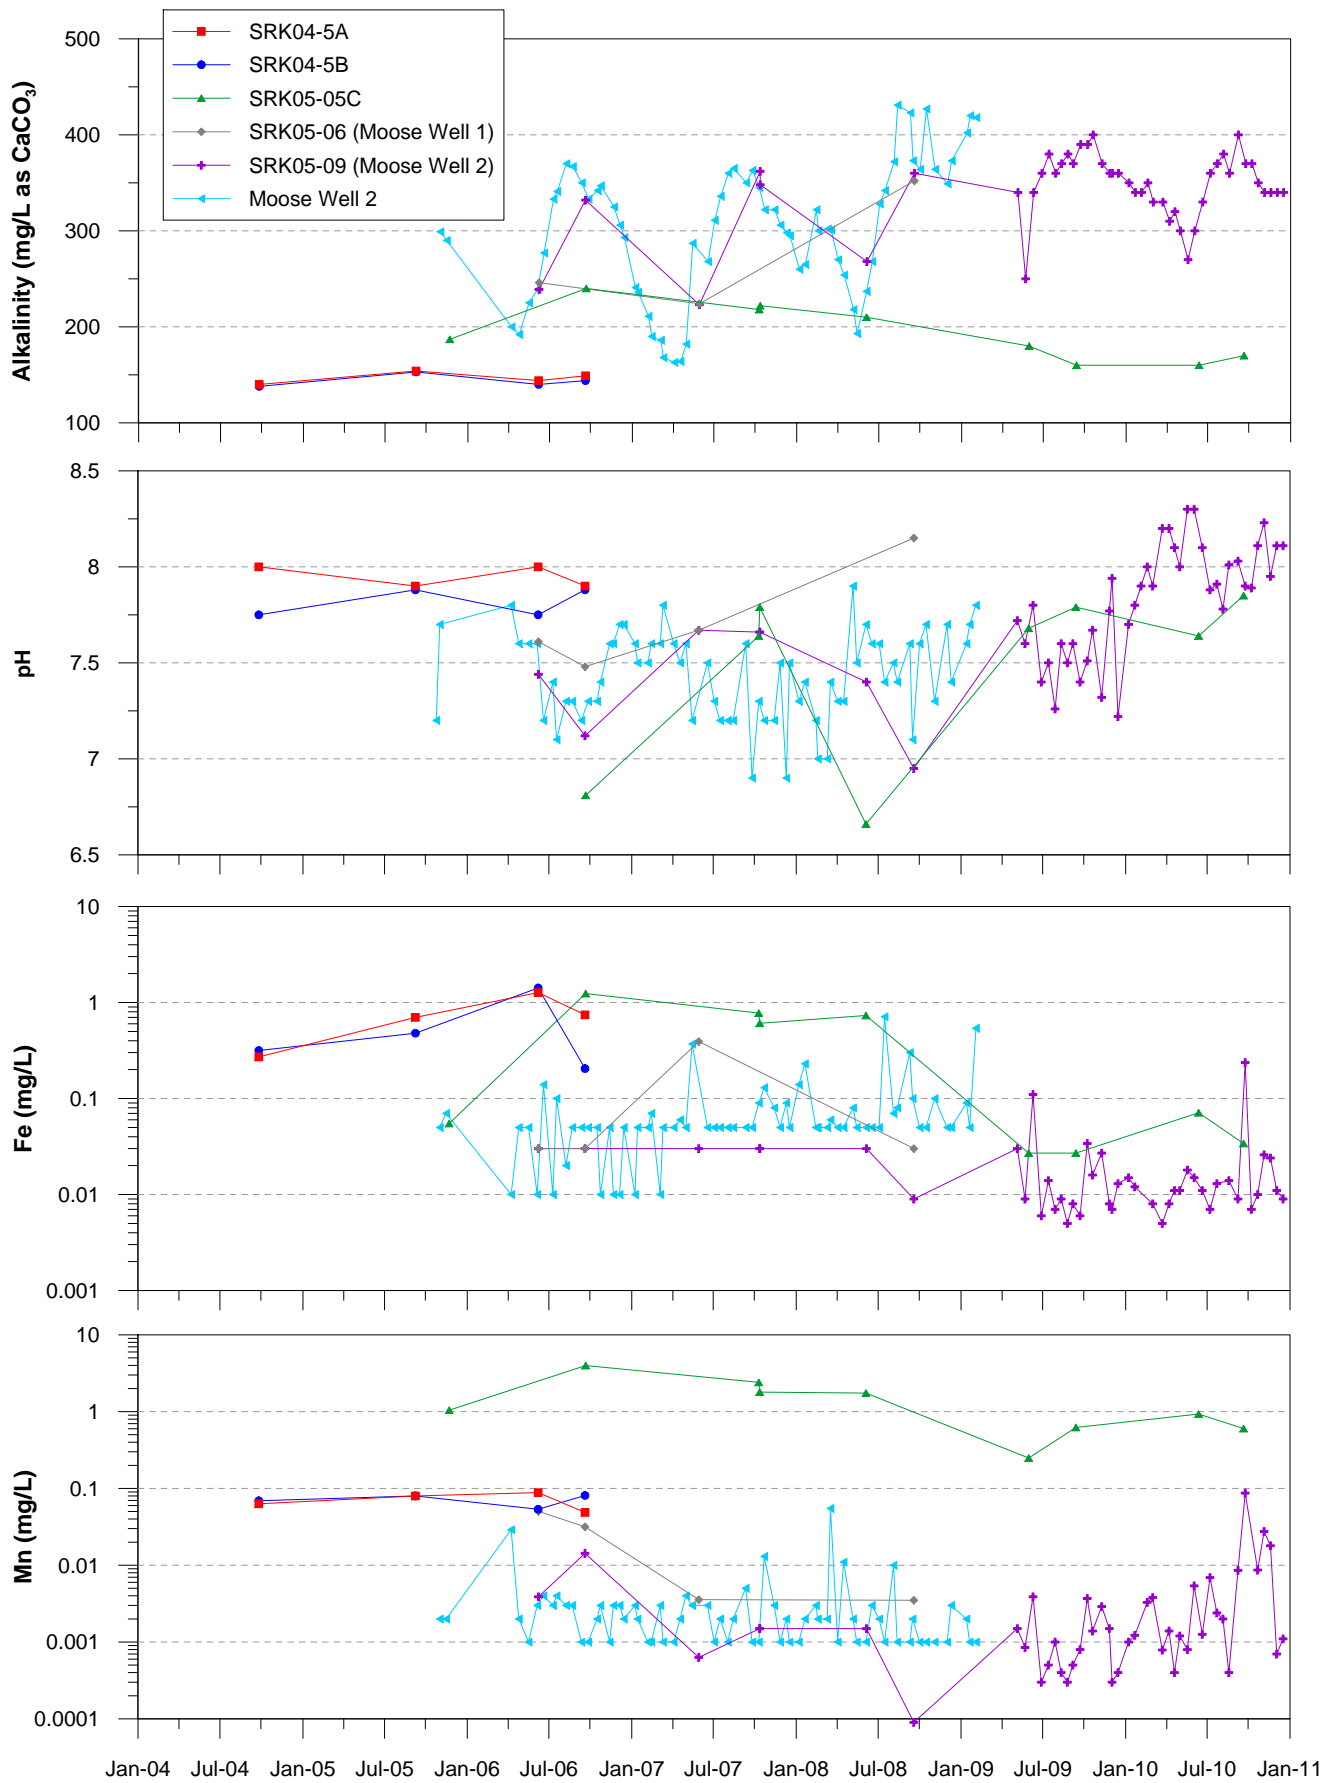
Figure 4-3a. Time trends for SO<sub>4</sub>, Mg and Zn in wells in Grum Creek drainage

Figure 4-3a/b shows time trends for pH, alkalinity, selected major ions, and metals of interest for the monitoring wells located near Grum Creek and downgradient of the Moose Pond. In the former Grum Creek drainage channel only monitoring well SRK05-05C screened in shallow overburden is routinely monitored. Shallow groundwater in SRK05-05C remains modestly-impacted by ARD. However, a small improvement in water quality has been observed in 2010 with a modest decline in  $\text{SO}_4$ , Mg and Zn concentrations.
