Report No. 118018/1

**2010 GROUNDWATER QUALITY REVIEW  
ANVIL RANGE MINING COMPLEX, YUKON TERRITORY**

**Assessment and Abandoned Mines**

March 2011

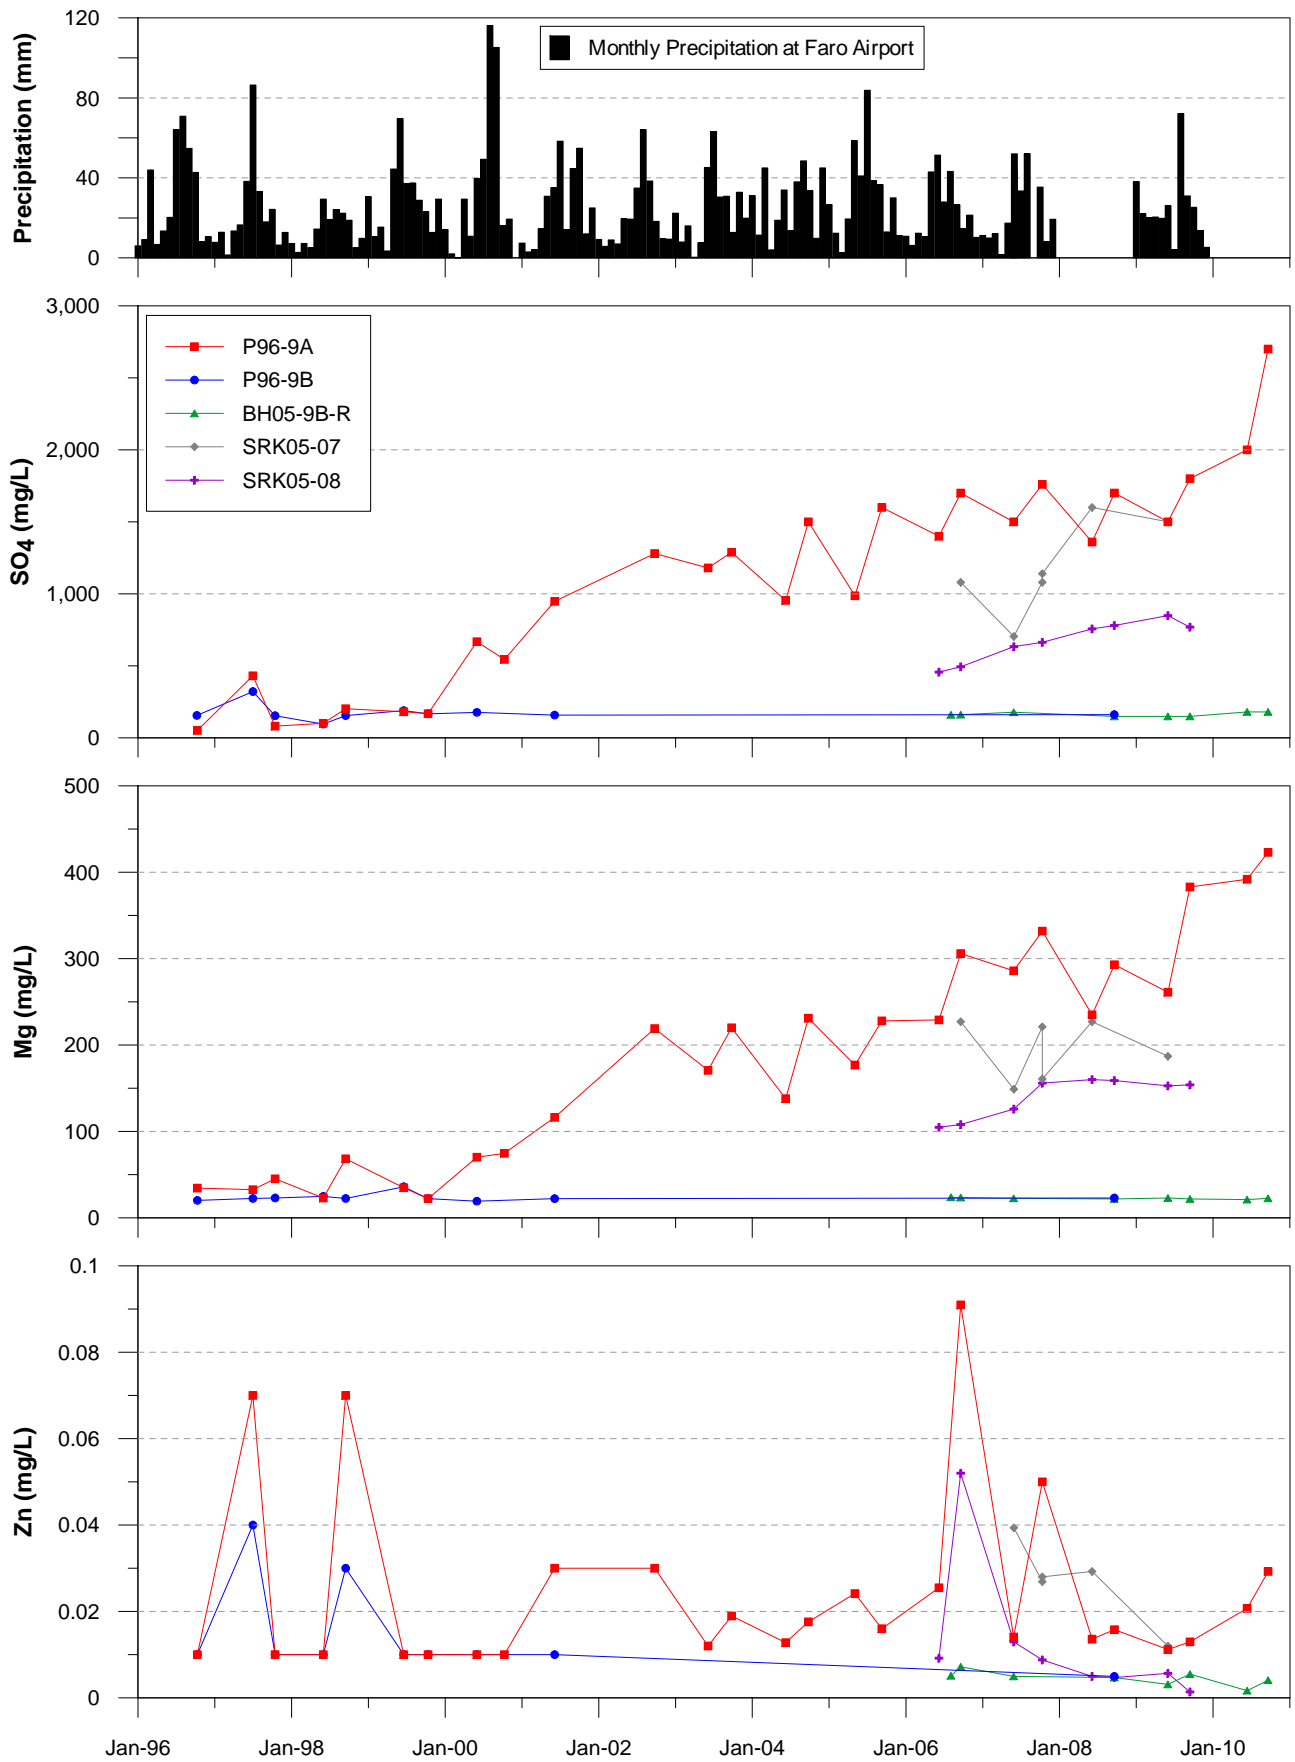
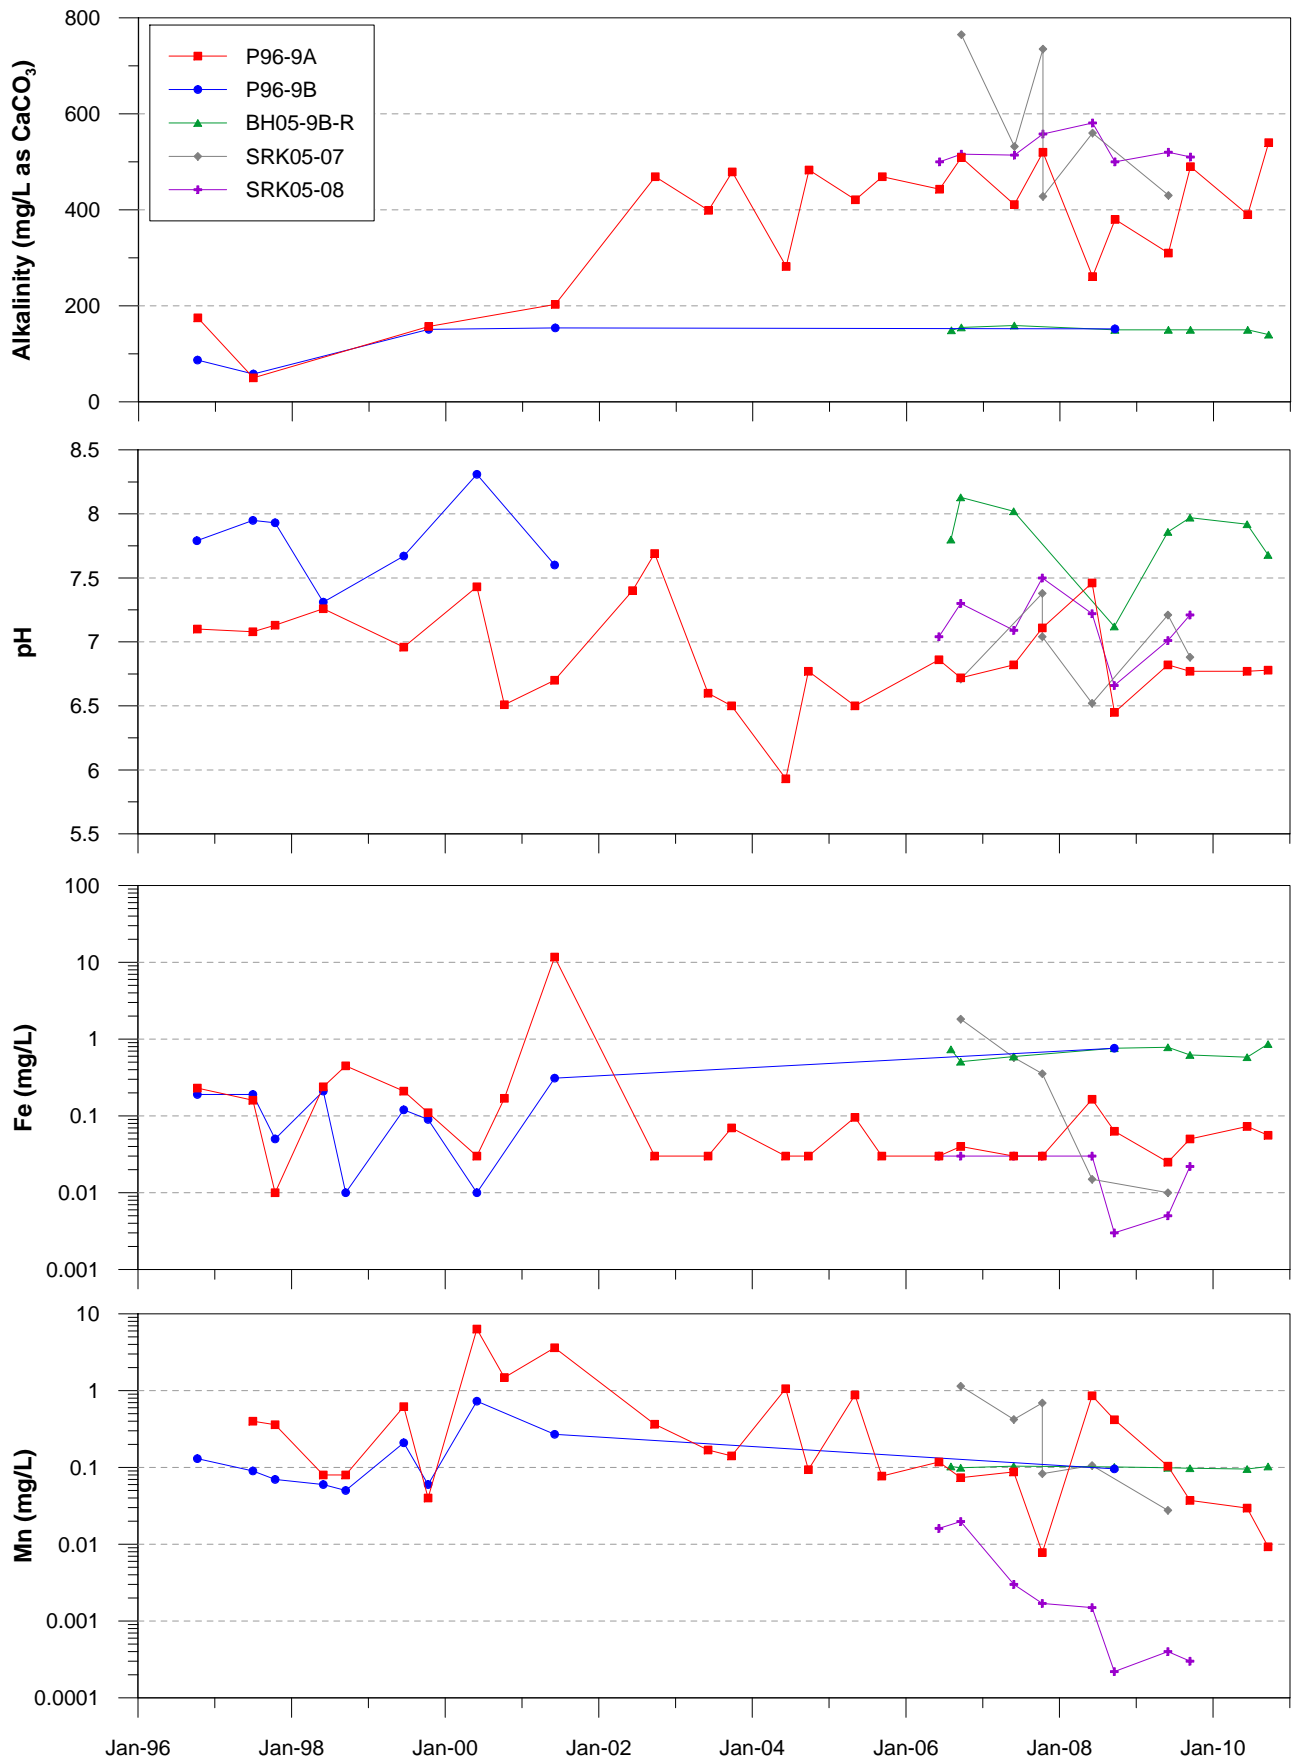
Figure 4-4a. Time trends for SO<sub>4</sub>, Mg and Zn in wells located west of Grum Creek

Time trends for pH, alkalinity, selected major ions, and metals of interest in wells located west of Grum Creek are shown in Figure 4-4a/b. Of particular interest are trends for wells P96-9A and BH05-9B-R (which are both located in a narrow side channel from Grum Creek but screened at different depths and in different materials). Deeper groundwater from bedrock screened by well BH05-9B-R remains modestly-impacted by mine waste seepage (i.e. 150 to 200 mg/L  $\text{SO}_4$ ) and there was no change in groundwater quality during the current monitoring period. In contrast,  $\text{SO}_4$  and Mg concentrations in shallow groundwater in overburden soils (screened by well P96-9A) are significantly higher and continued to increase during the current monitoring period (as they have for nearly ten years). Note that the increases in  $\text{SO}_4$  and Mg concentrations in 2010 were particularly abrupt and both contaminants reached all-time high concentrations (see Figure 4-4a). Moreover, a concurrent increase in Zn was evident although concentrations of Zn and other metals of interest do remain relatively low (i.e. <0.05 mg/L).

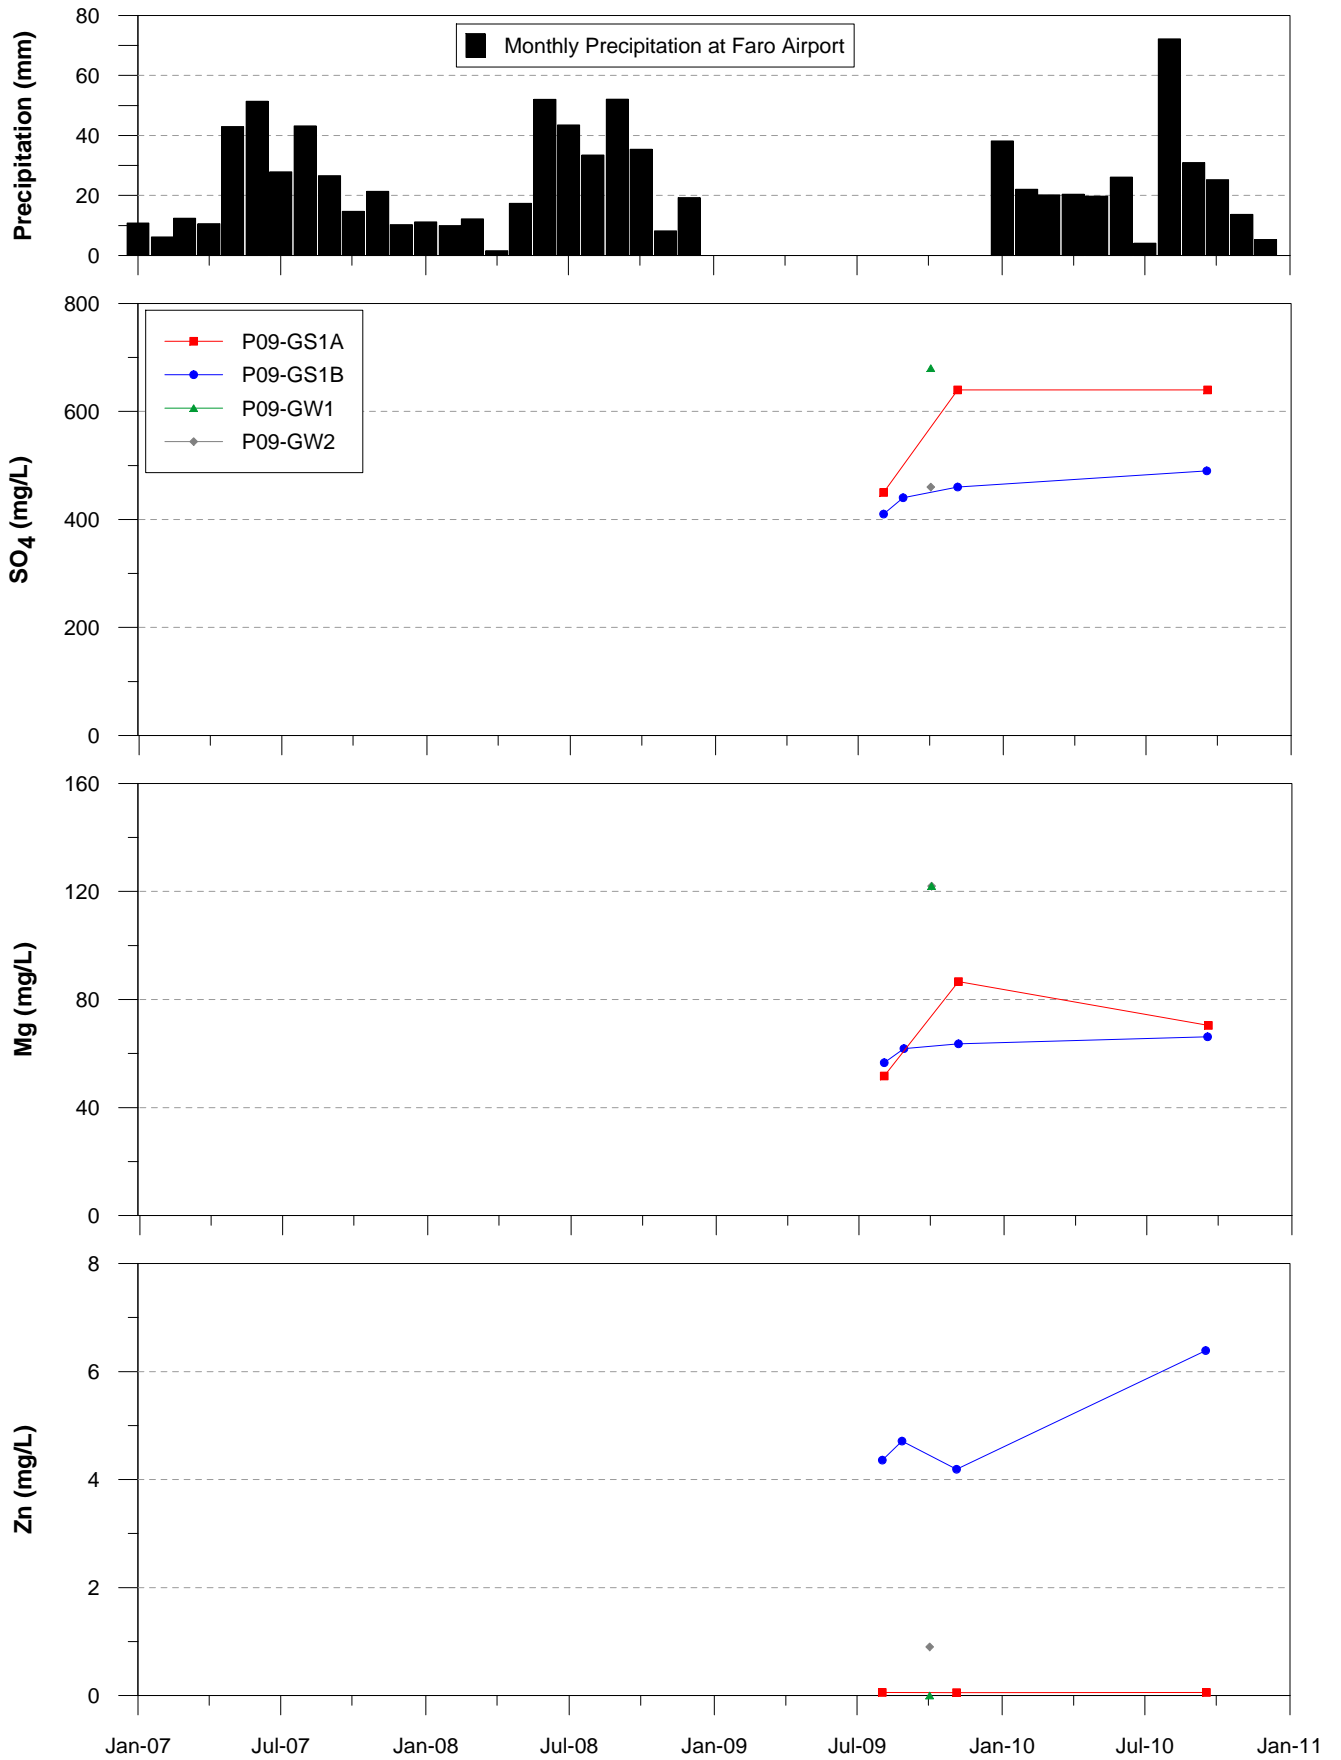
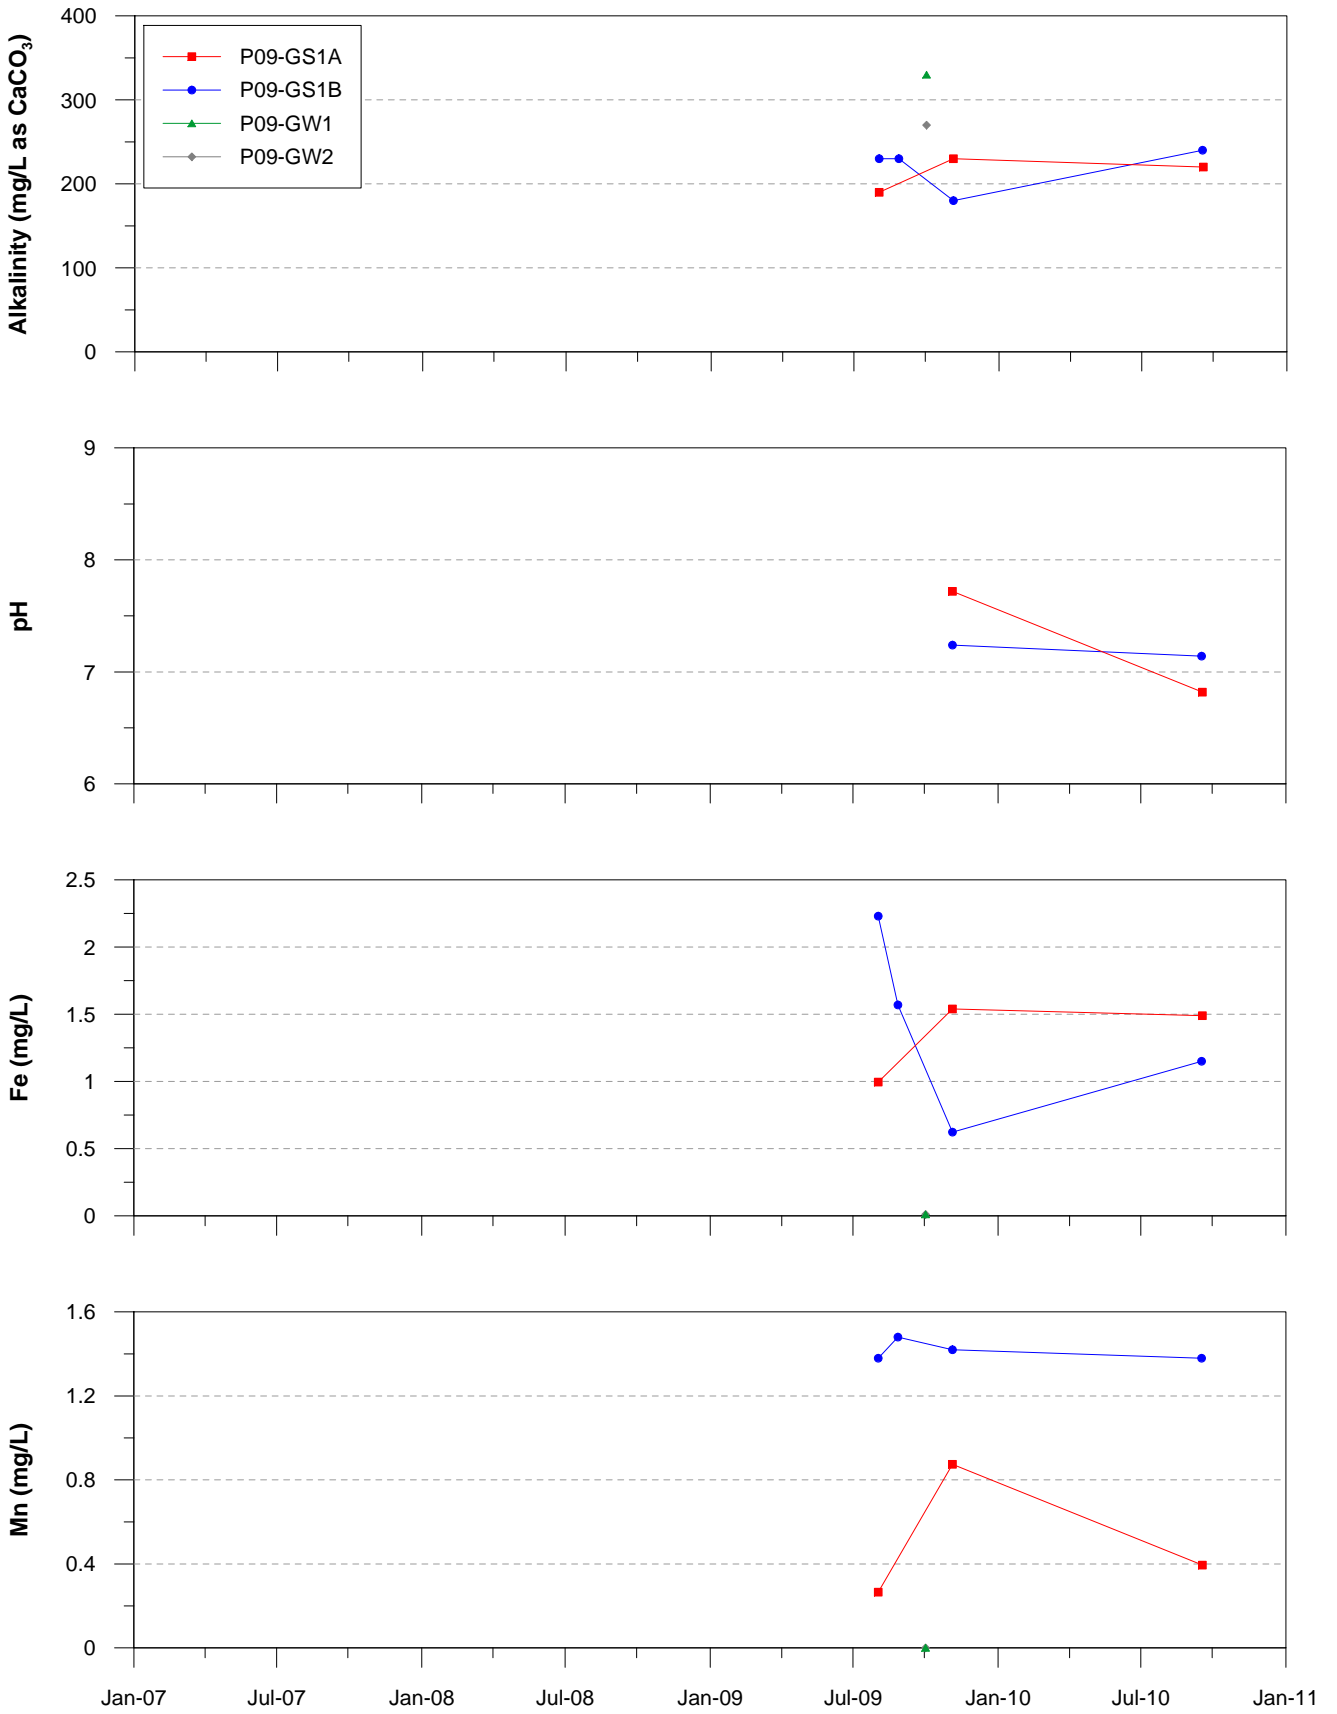
Figure 4-5a. Time trends for SO<sub>4</sub>, Mg, Na and Zn in wells located near Grum Slot and west of Grum Dump

Time trends for pH, alkalinity, selected major ions, and metals of interest in wells located near Grum Slot (and west of the Grum Dump) are shown in Figure 4-5a/b. Data collected since 2009 suggests that groundwater from wells P09-GS1A and P09-GS1B is moderately-impacted by mine waste seepage. Specifically,  $\text{SO}_4$  concentrations in groundwater from both wells are slightly elevated (400 to 600 mg/L) and higher than in standing water from the Grum Slot. Note that the Zn concentration in well P09-GS1B (screened in overburden) is 4 to 5 mg/L or about two orders of magnitude higher than in groundwater from well P09-GS1A. These high Zn concentrations are likely a result of *in situ* leaching of mineralized waste rock observed in the drill cuttings of P09-GS2 (SRK, 2010) and not the transport of ARD products in groundwater from upgradient.

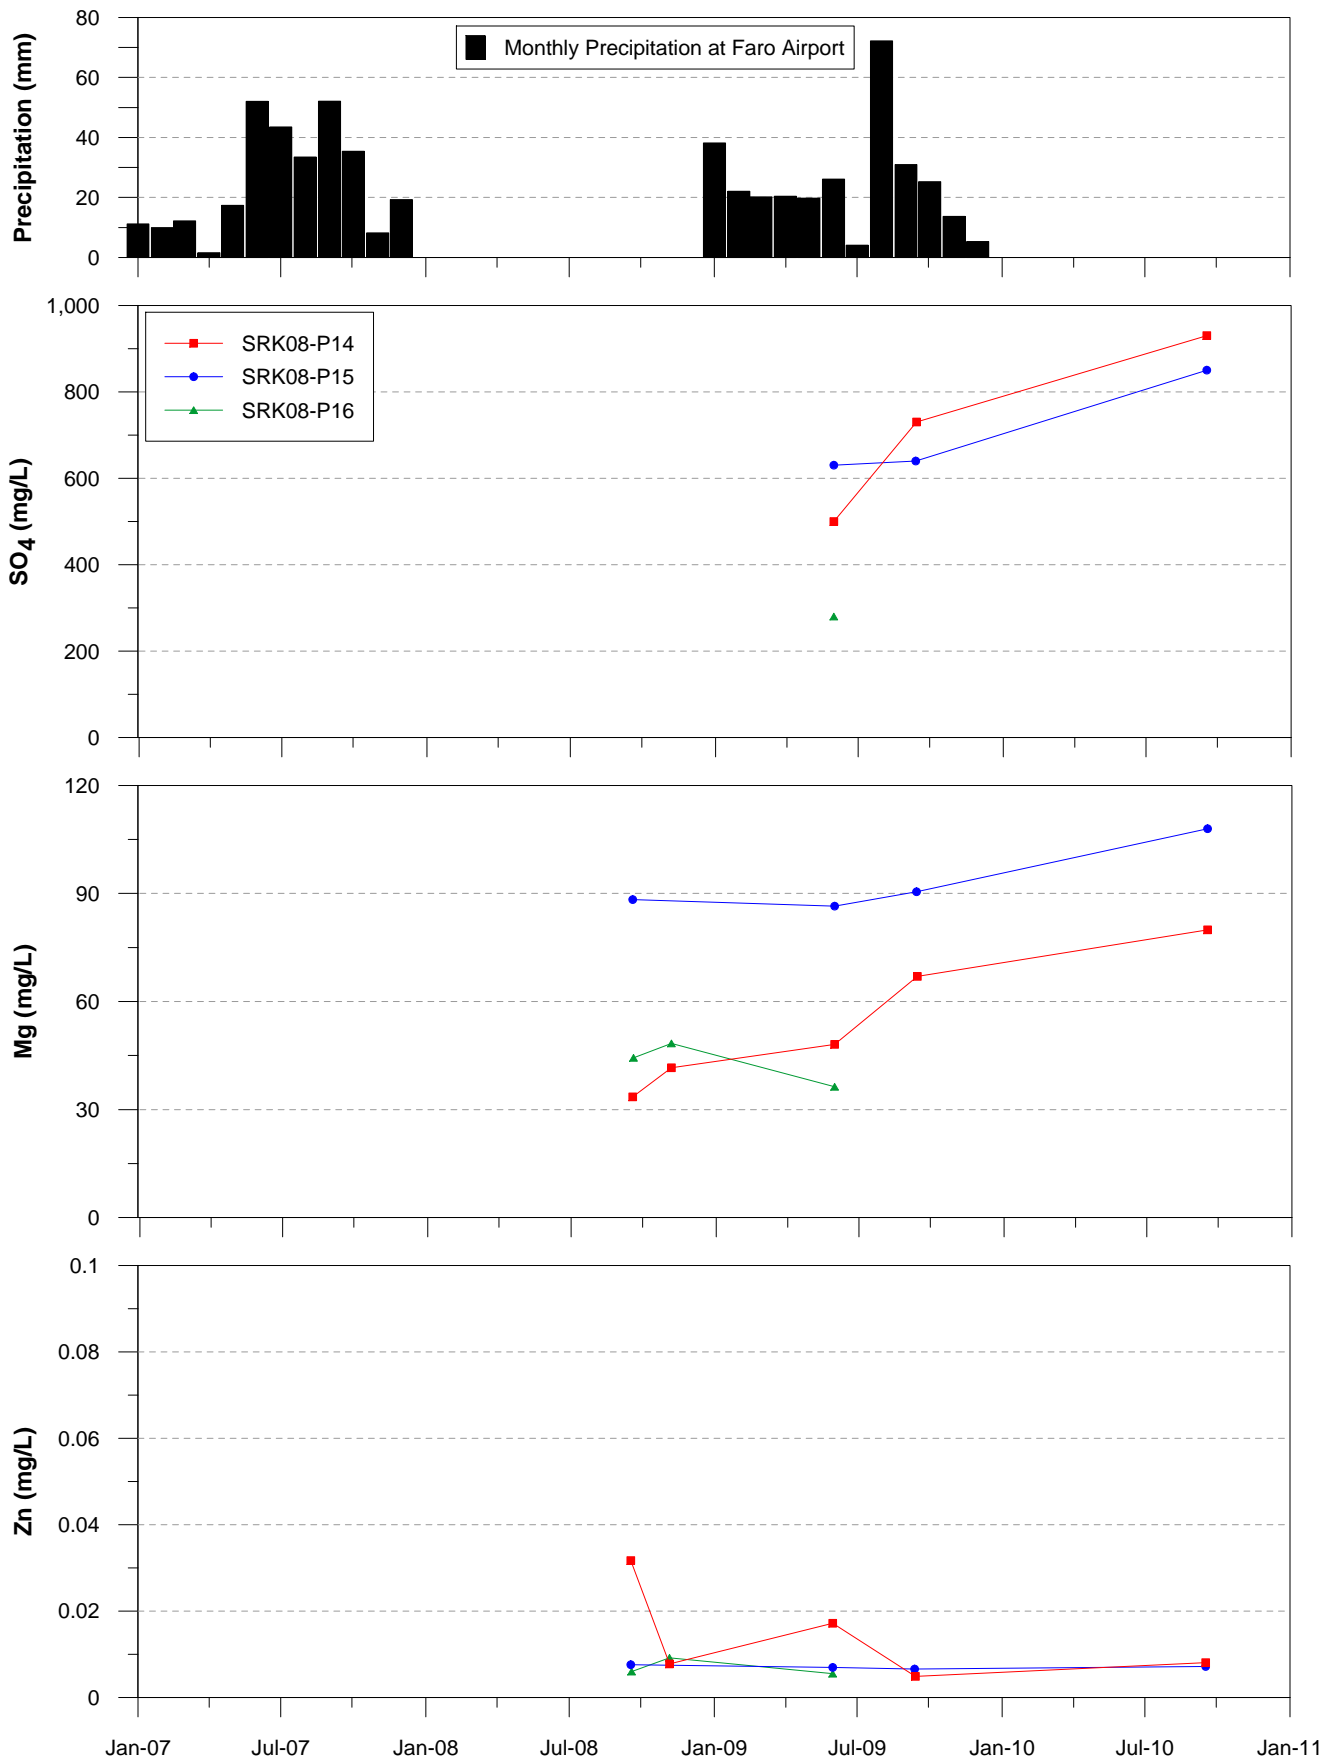
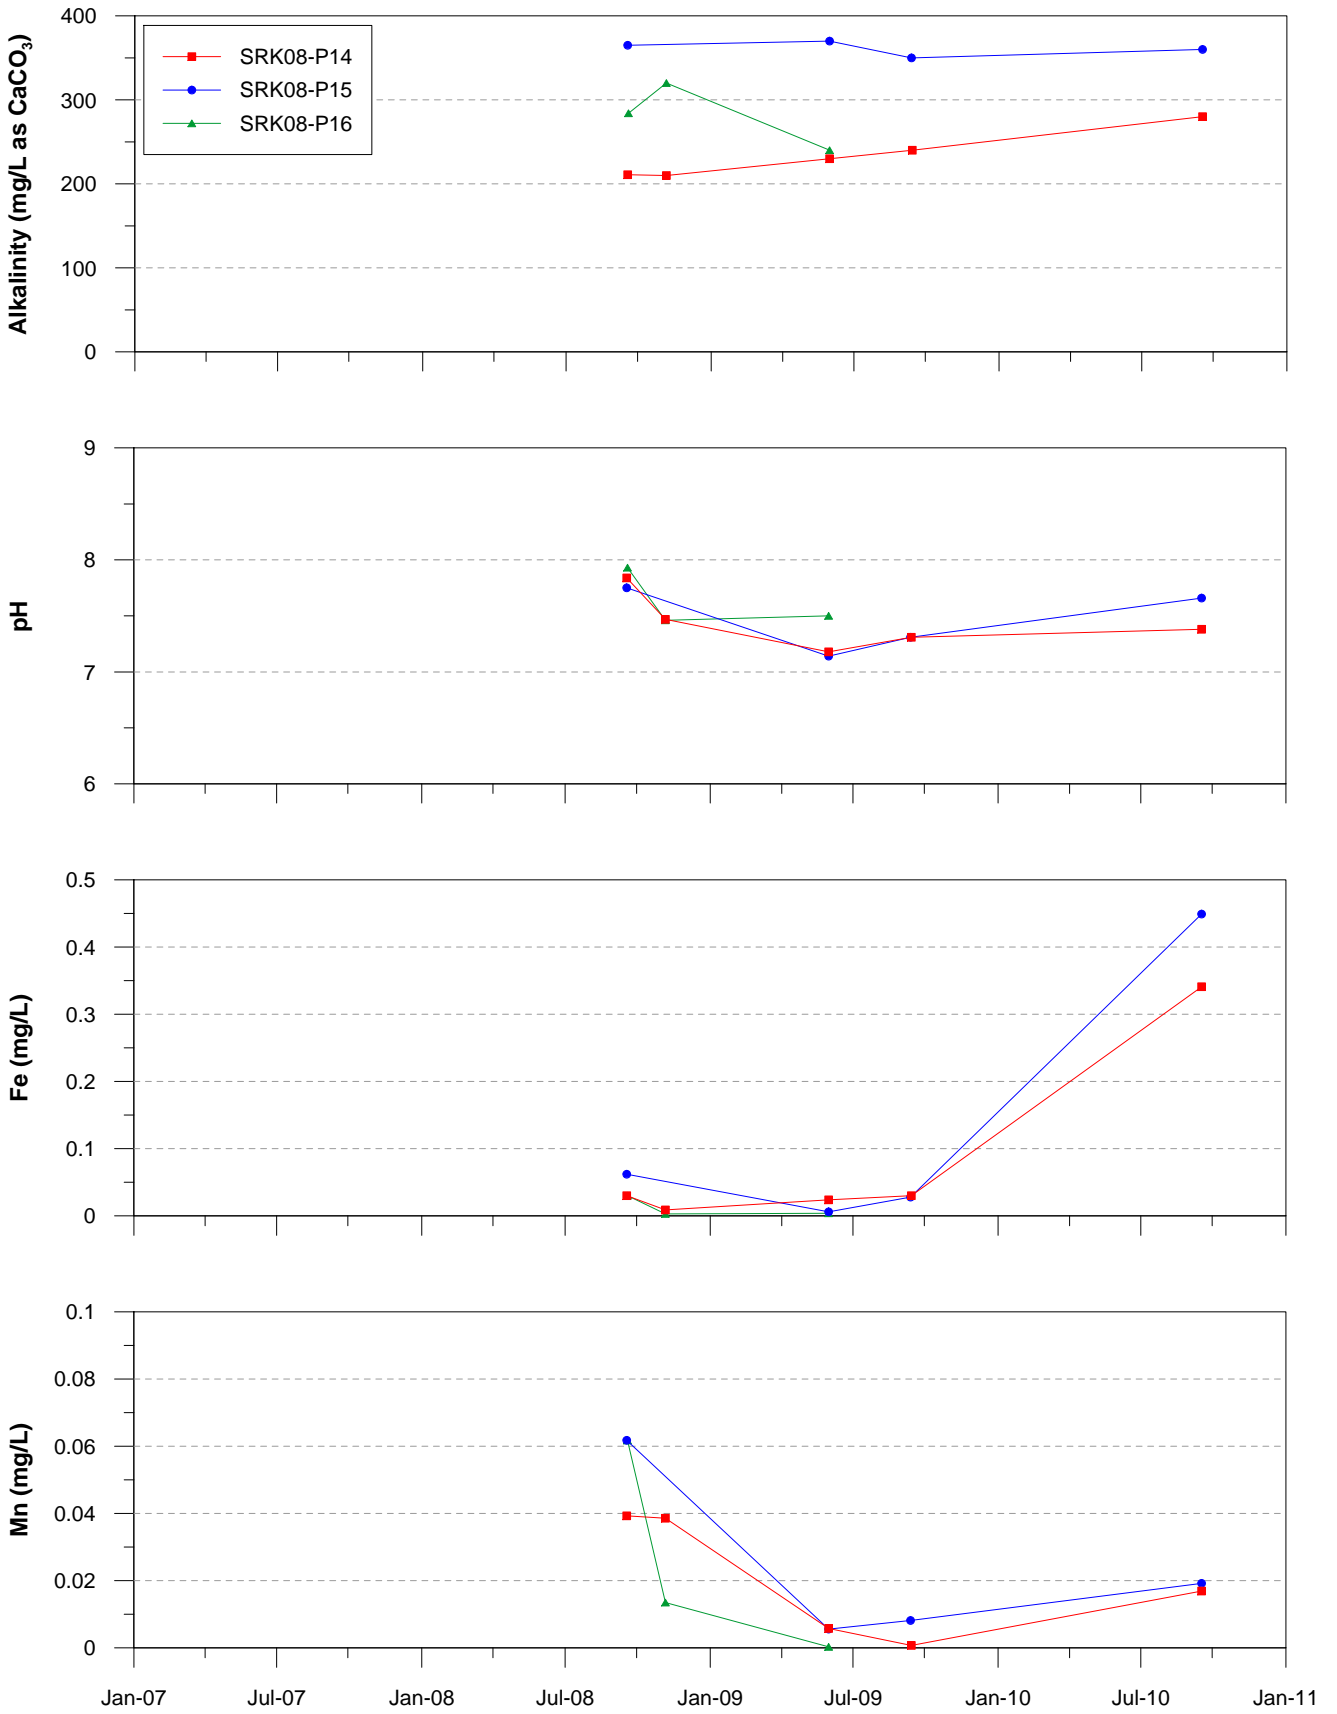
Figure 4-5c. Time trends for SO<sub>4</sub>, Mg, Na and Zn in SRK08 wells located southwest of Grum Dump

Wells SRK08-P14, SRK08-P15, and SRK08-P16 are located along the southwest toe of the Grump Rock Dump (Figure 4-2). Time trends for pH, alkalinity, selected major ions, and metals of interest in these wells are shown in Figure 4-5c/d. Note that monitoring well SRK08-P16 had insufficient water (in September 2010) to collect a sample.  $\text{SO}_4$  concentrations in wells SRK08-P14 and SRK08-P15 are close to 900 mg/L and have increased since the last monitoring period. The pH of groundwater remains neutral to slightly alkaline though and metals concentrations are still very low (<0.01 mg/L Zn). The condition of groundwater is therefore consistent with the presence of some mine waste seepage but at this point only the breakthrough of conservatively-transported species has occurred. Future monitoring data will be needed to identify whether  $\text{SO}_4$  and Mg concentrations will further increase and when the breakthrough of dissolved metals into groundwater occurs in this area.

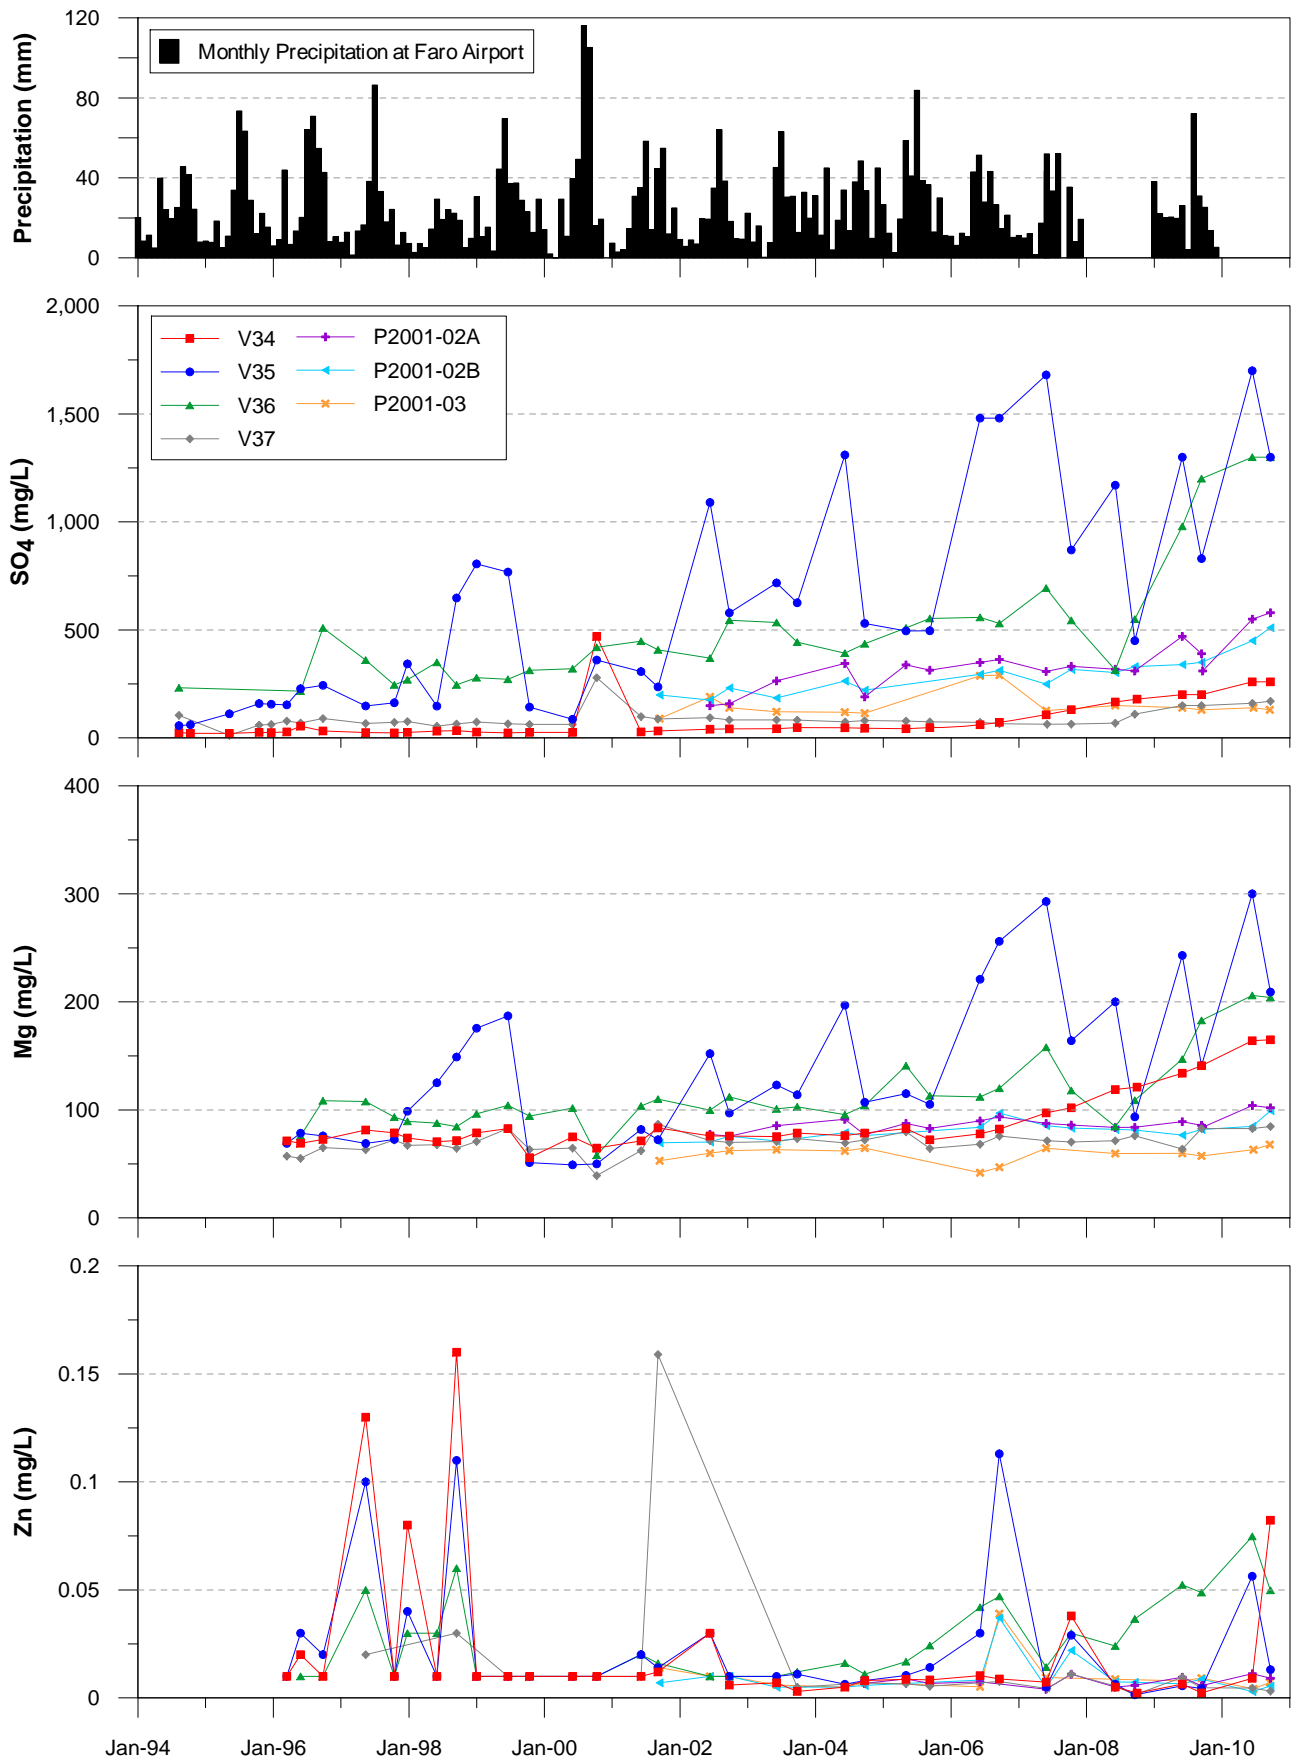
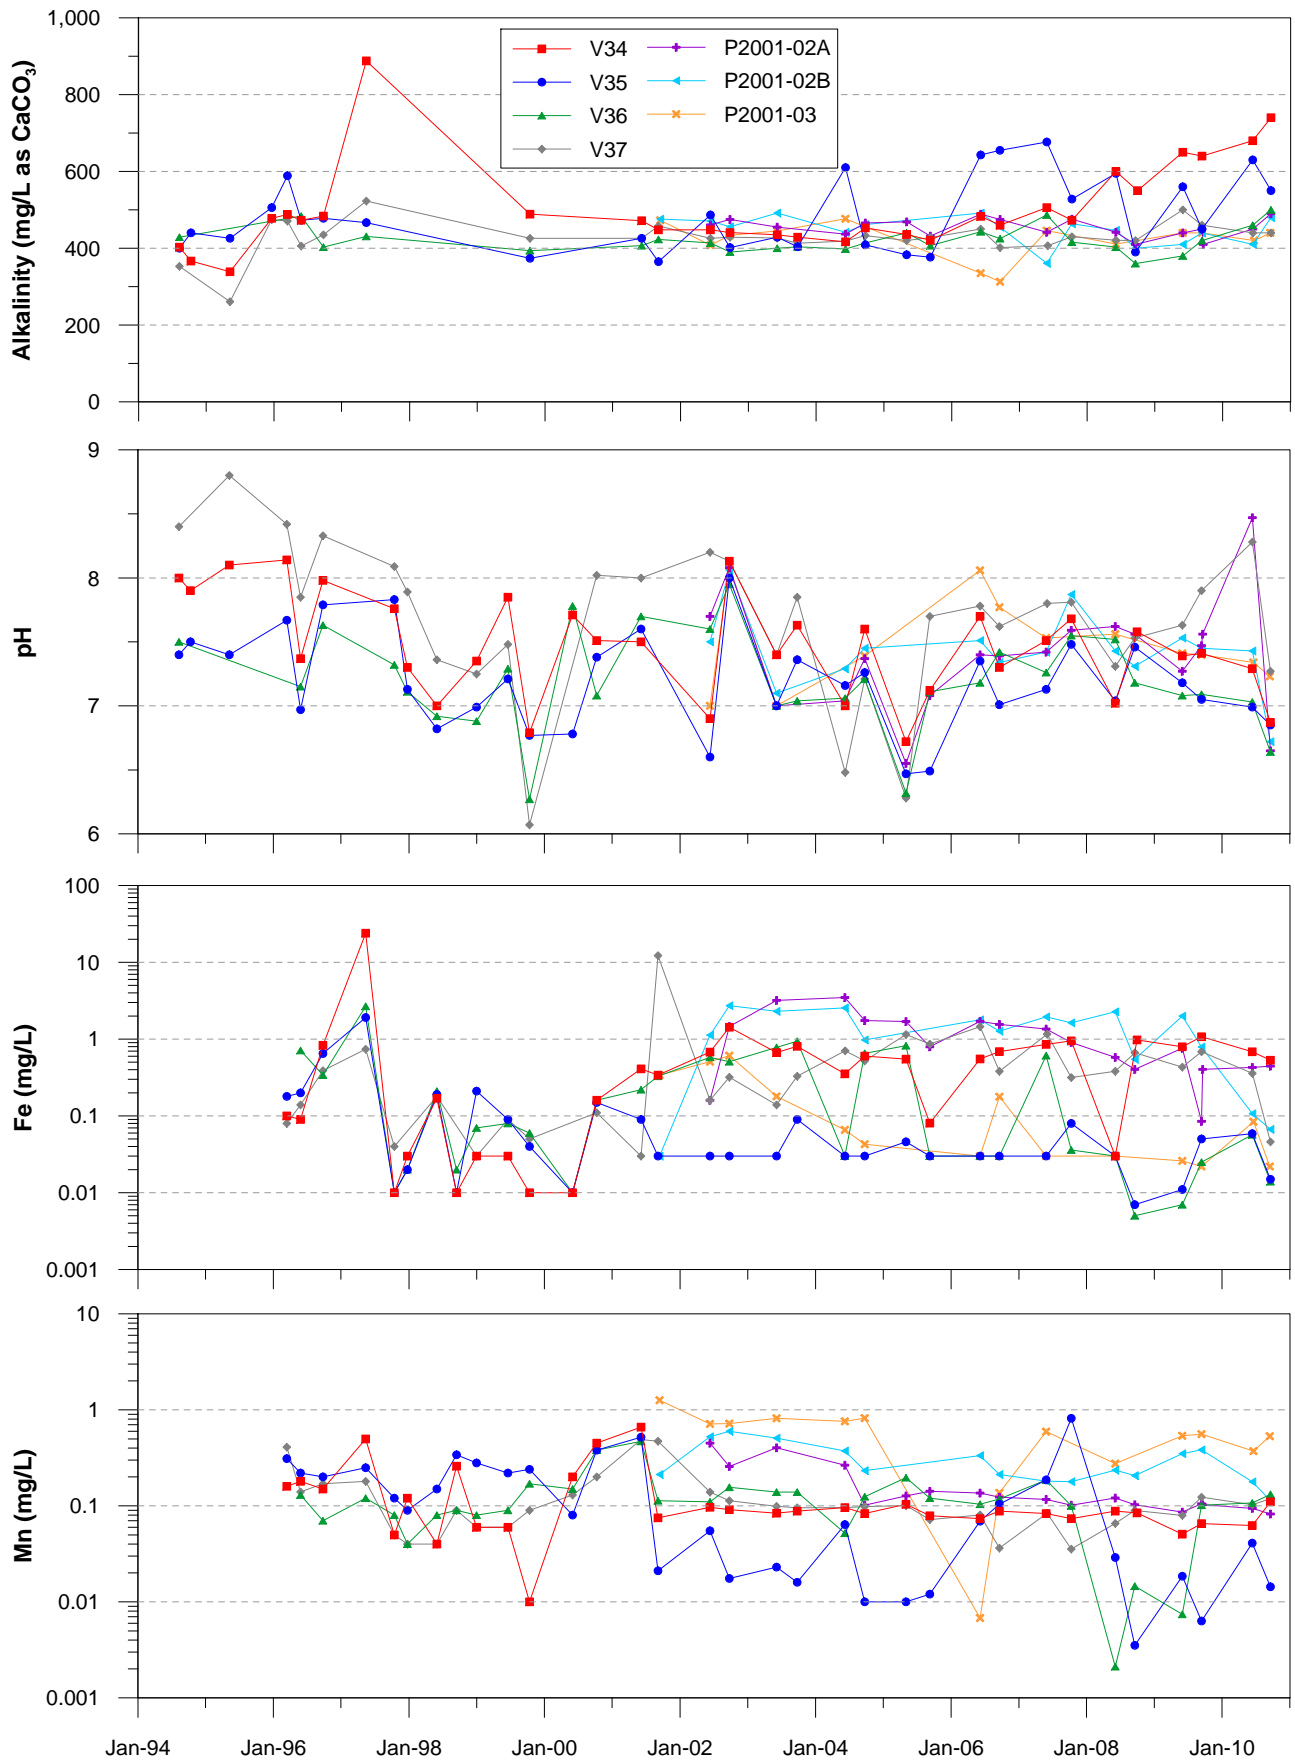
Figure 4-7a. Time trends for SO<sub>4</sub>, Mg and Zn in wells downgradient of Vangorda Rock Dump

Time trends for pH, alkalinity, selected major ions, and metals of interest in wells along the toe of the Vangorda Rock Dump are shown in Figure 4-7a/b. Groundwater quality immediately downgradient of the Vangorda waste rock dump has historically shown very little impact of waste rock seepage. However, recent water quality time trends showed first signs of a breakthrough of a TDS front (including SO<sub>4</sub> and Mg) and this trend continued during the 2010 monitoring period. Of particular interest is the rather abrupt increase in SO<sub>4</sub> and Mg concentrations (and decrease in pH) in samples from well V36 (which is located at the northwest toe of the Vangorda Rock Dump). Increases in SO<sub>4</sub> and Mg concentrations suggest the breakthrough of a TDS plume in this area. Note that zinc concentrations have also increased in this well and reached ~0.075 mg/L in 2010.

Although all other monitoring wells located downgradient of the Vangorda waste rock dump showed much lower contaminant concentrations than wells V35 and V37, a gradual increase in sulphate over the last 3-4 years and into 2010 is clearly evident in all wells in this area (see Figure 4-7a/b). Note also that Zn concentration in V34 (located to the south of the Vangorda dump) increased abruptly during the current monitoring period. It is therefore likely that waste rock seepage from the Vangorda dump will – over the long-term - impact most if not all groundwater in the area downgradient of the Vangorda dump.
