Report No. 118018/1

**2010 GROUNDWATER QUALITY REVIEW  
ANVIL RANGE MINING COMPLEX, YUKON TERRITORY**

**Assessment and Abandoned Mines**

March 2011

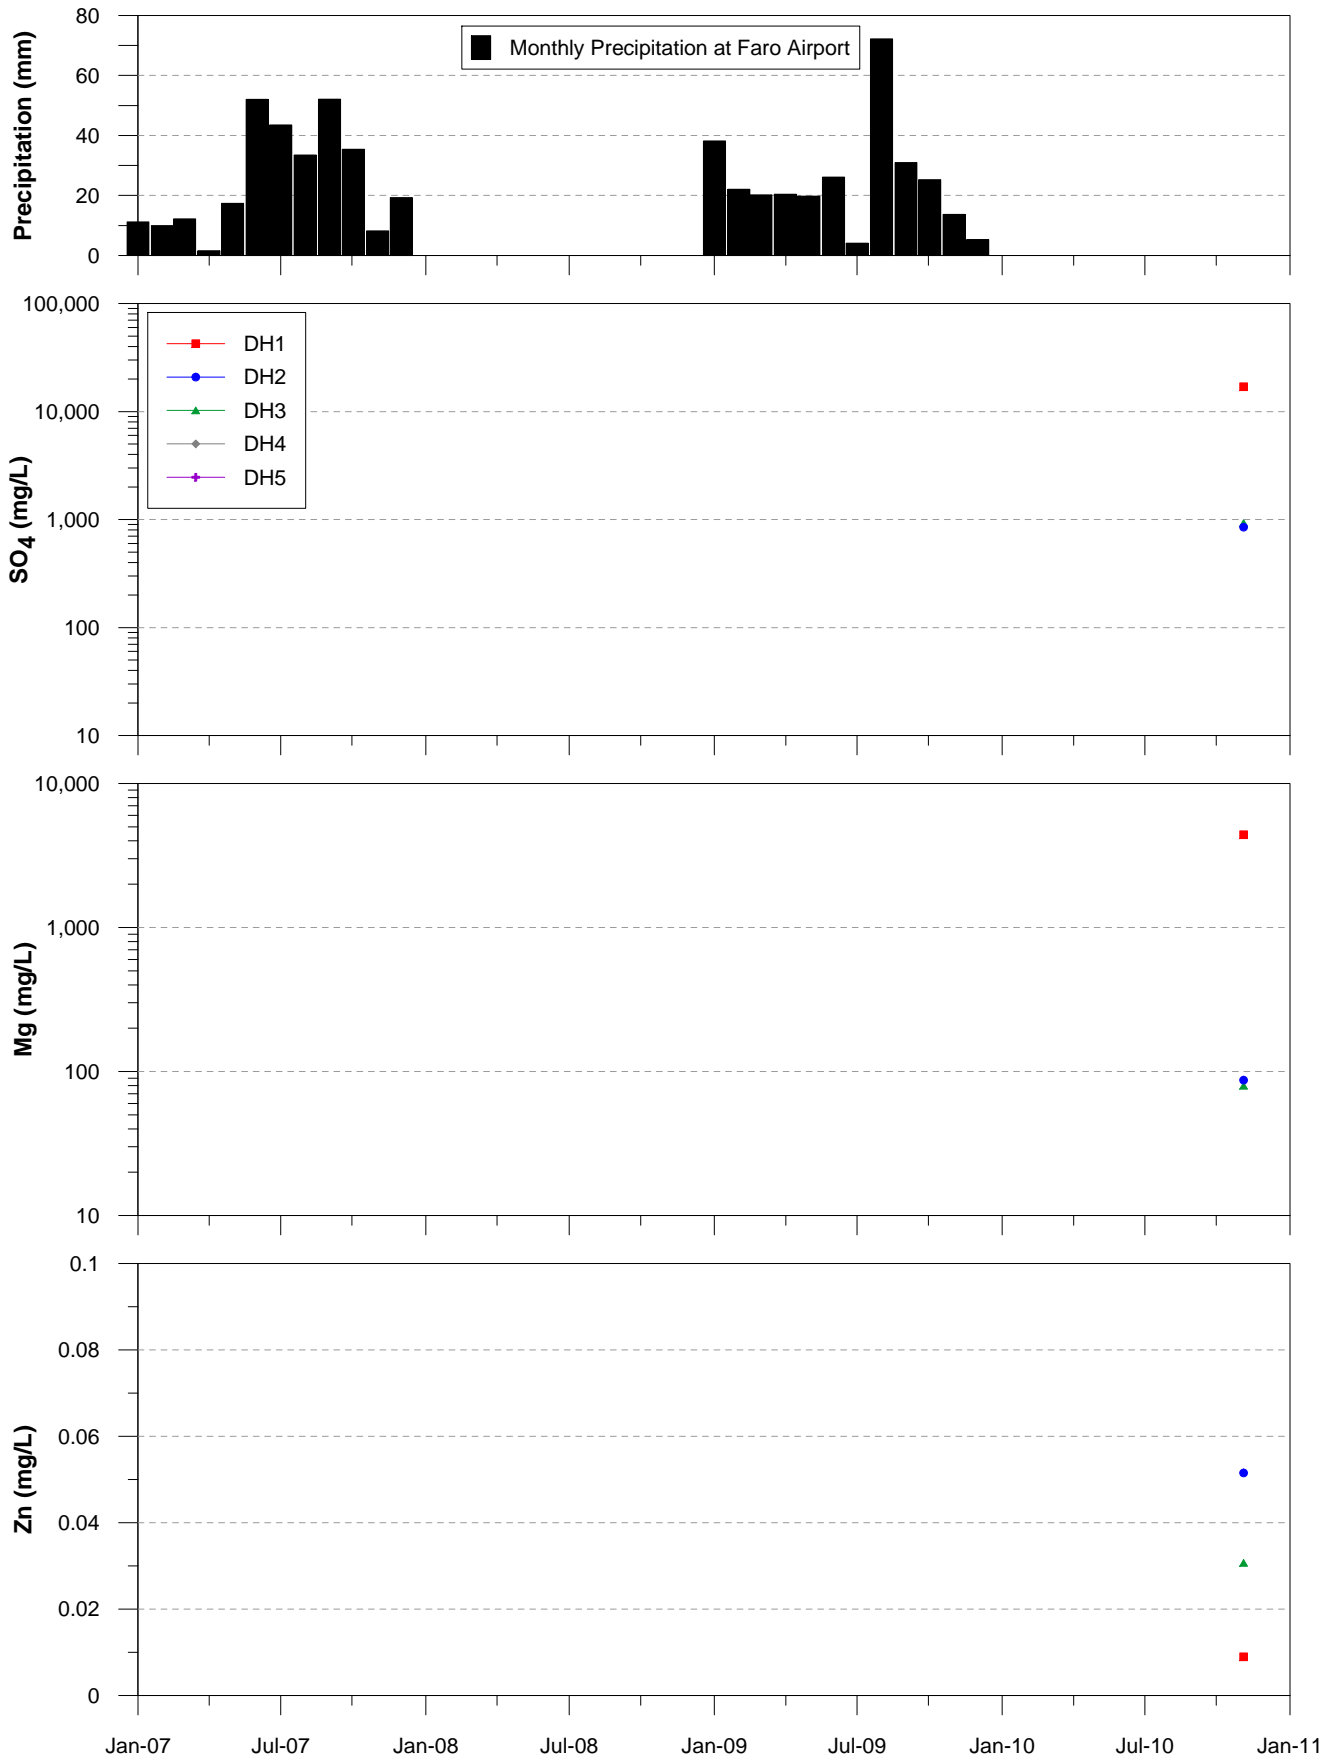
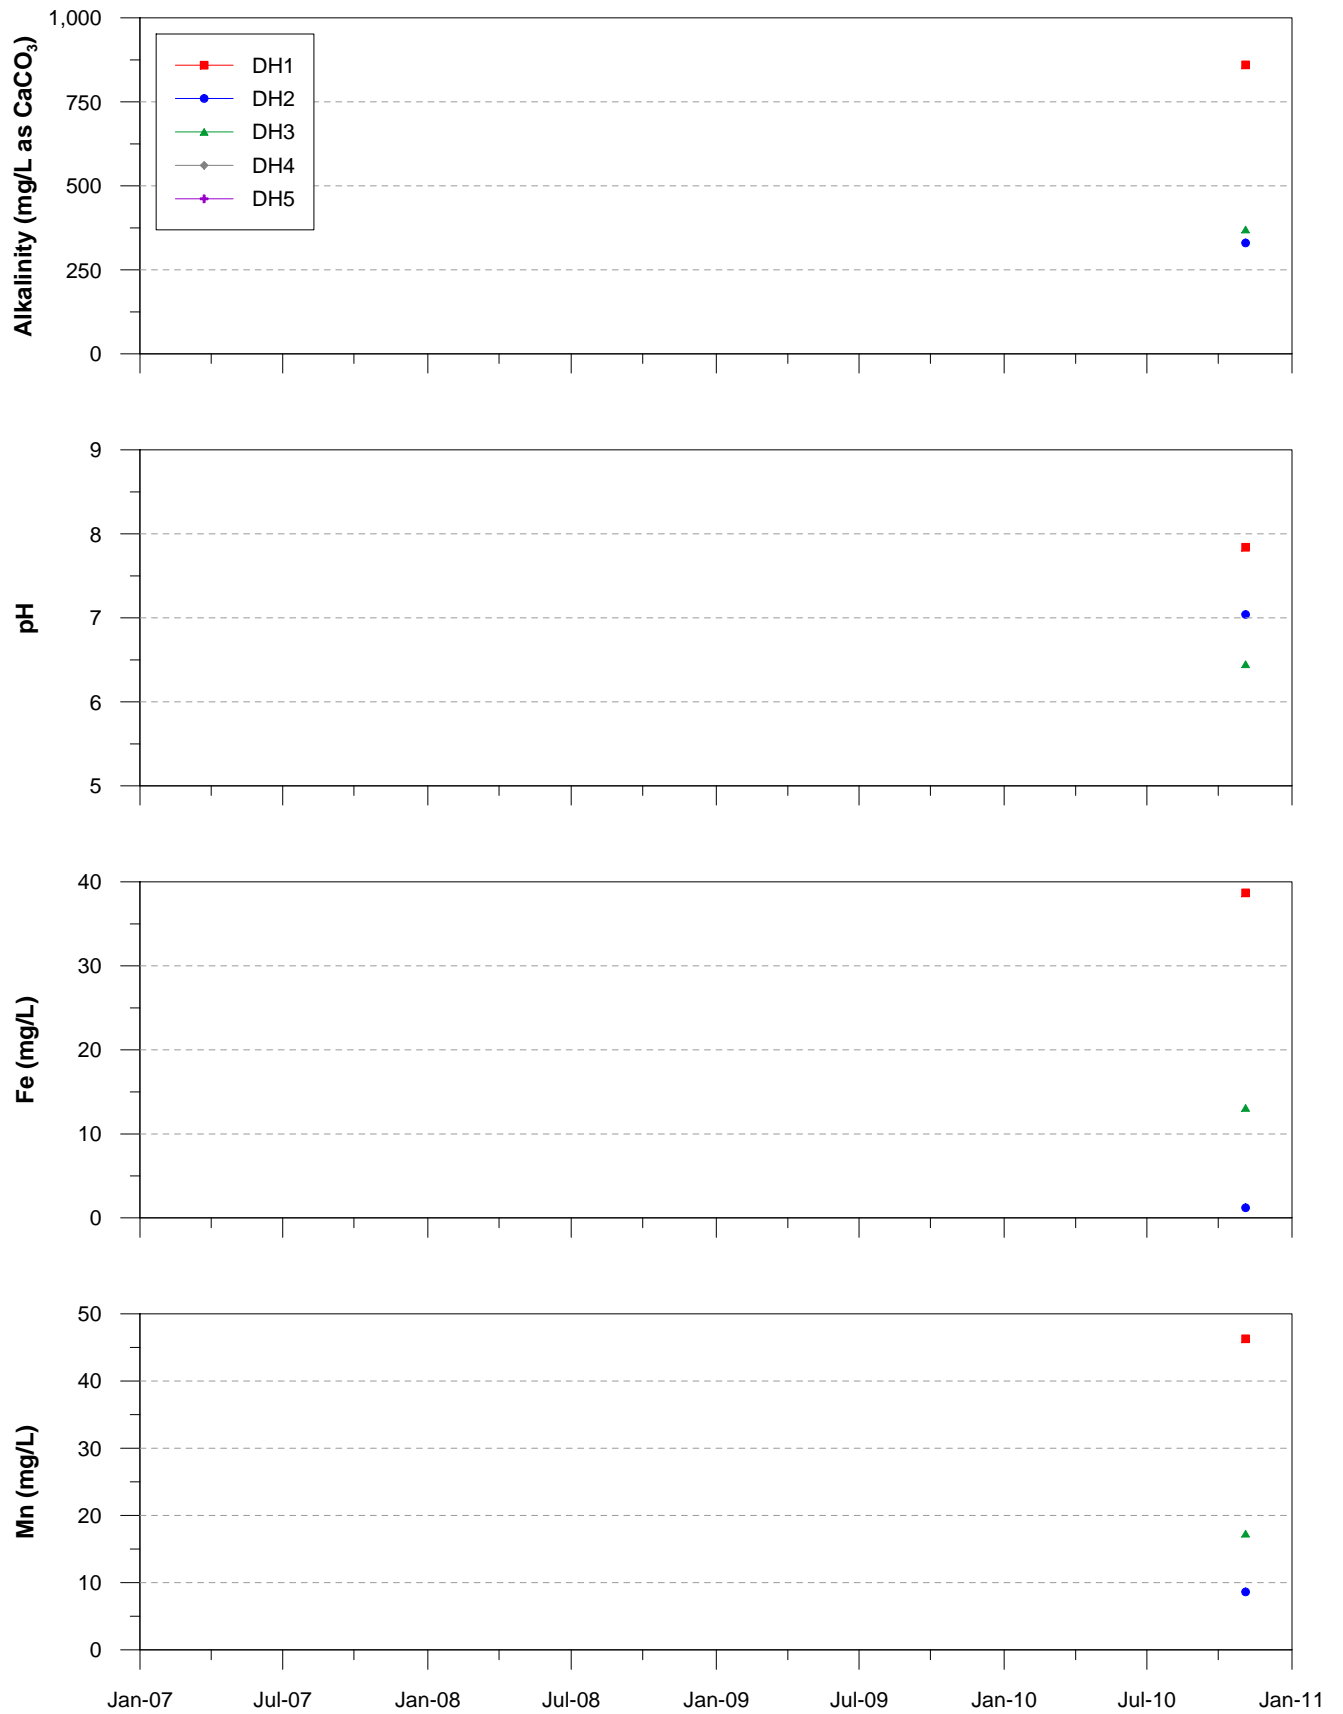
Figure 4-8a. Time trends for SO<sub>4</sub>, Mg, Na and Zn in Vangorda Waste Rock Dump Wells

Figure 4-8a/b shows initial water quality results in three of the five recovery wells recently completed within the Vangorda waste rock dump and first sampled in the fall of 2010 (“DH” series). According to

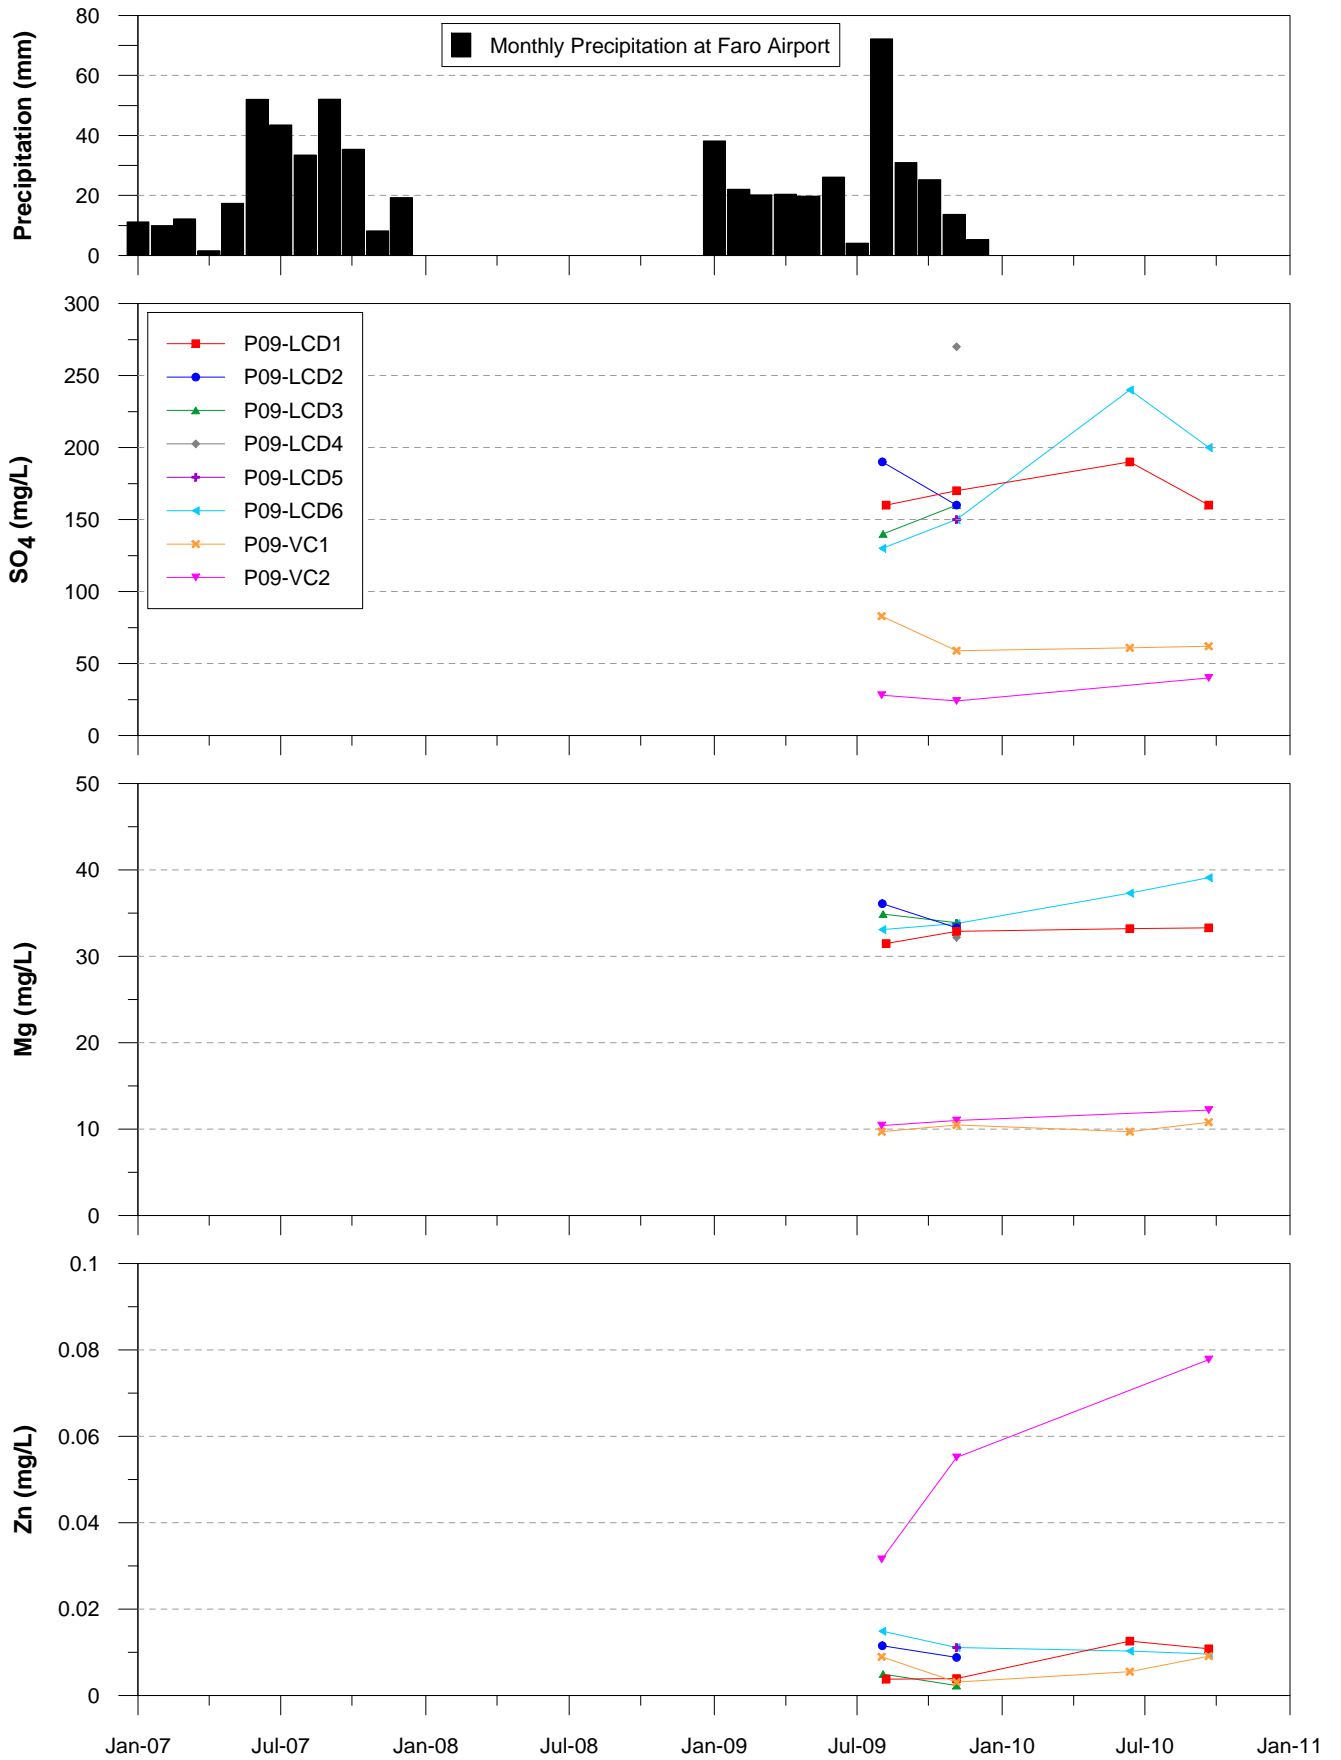
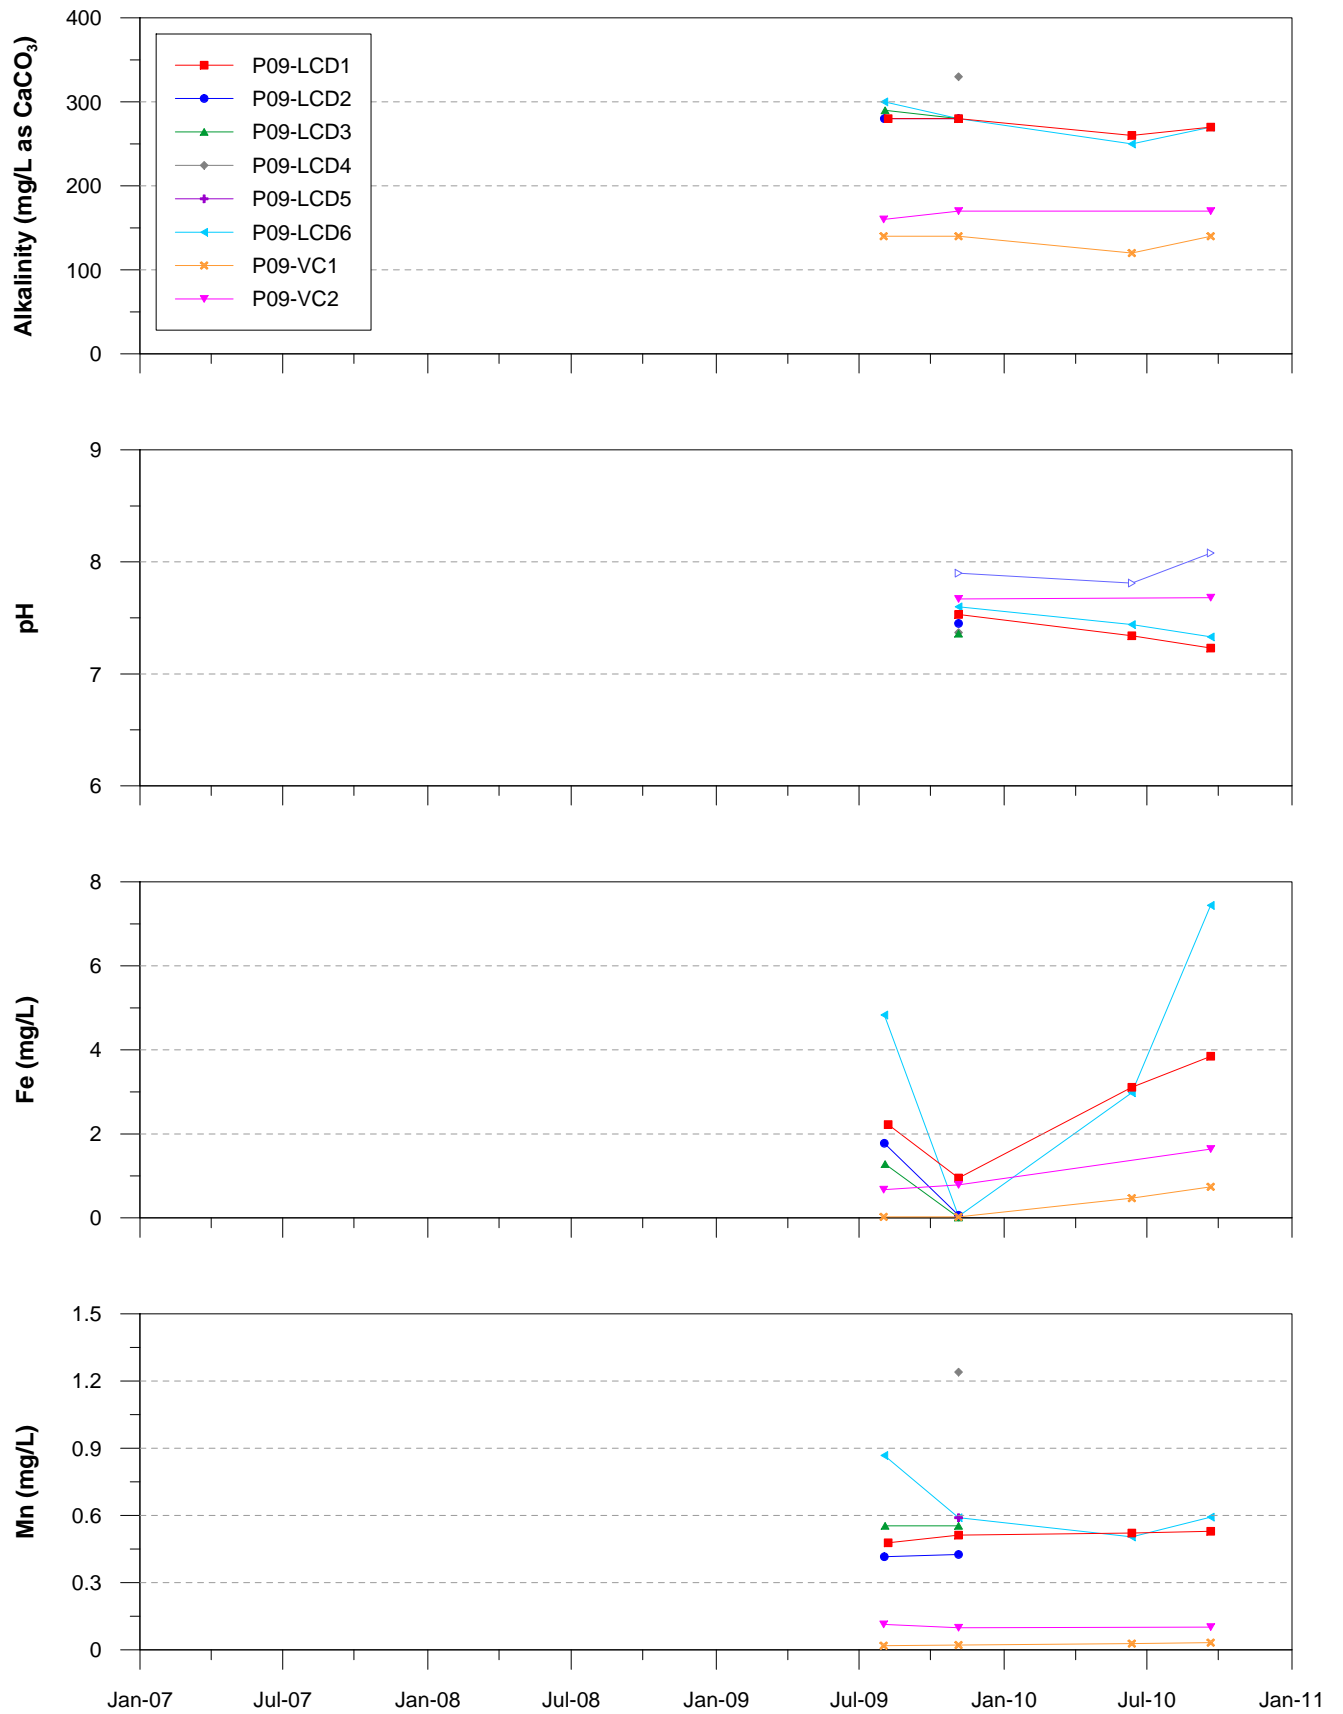
Figure 4-9a. Time trends for SO<sub>4</sub>, Mg, Na and Zn in wells near Vangorda Creek and Little Creek Dam

Time trends for pH, alkalinity, selected major ions, and metals of interest in monitoring wells located in the Little Creek Dam (LCD) area and near Vangorda Creek are shown in Figure 4-9a/b. Note that  $\text{SO}_4$  and Mg concentrations in groundwater from the 'P09-VC' and 'P09-LCD' well series are generally lower than in the other wells near the Vangorda Rock Dump and suggest only modest amounts of seepage is present in groundwater.
