Report No. 118022/1

**2011 GROUNDWATER QUALITY REVIEW
ANVIL RANGE MINING COMPLEX, YUKON TERRITORY**

June 2012

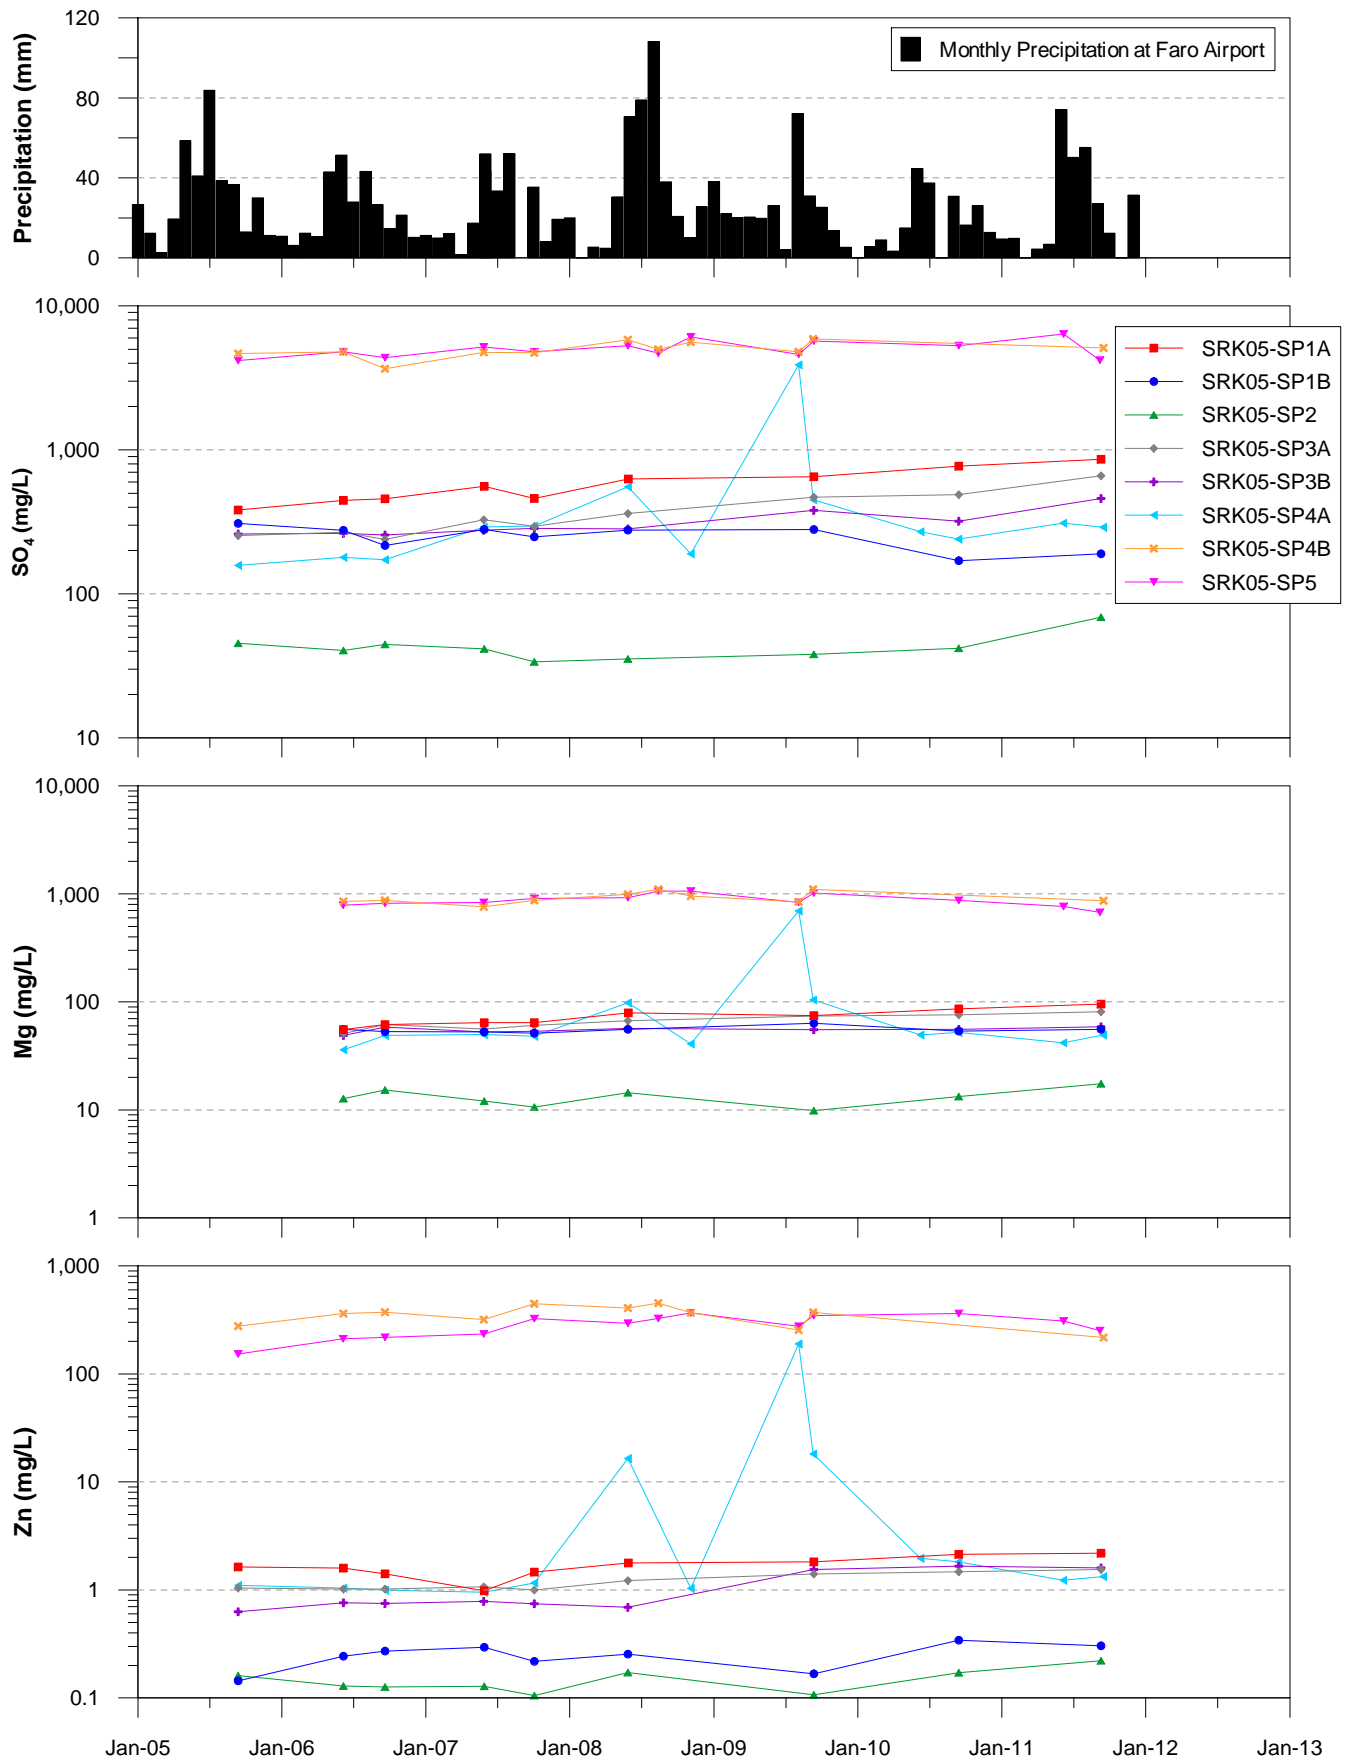
Figure 2-7a. Time trends for SO_4 , Mg and Zn in SRK-05 wells in S-Cluster Area

Figures 2-6a/b shows time trends for pH, alkalinity, selected major ions, and metals of interest in groundwater from the historic 'S' wells and well P96-7. Similar time trend plots for the 'SRK05-SP' and 'P09-SIS' well series are shown in Figure 2-7a/b and Figure 2-7c/d, respectively.

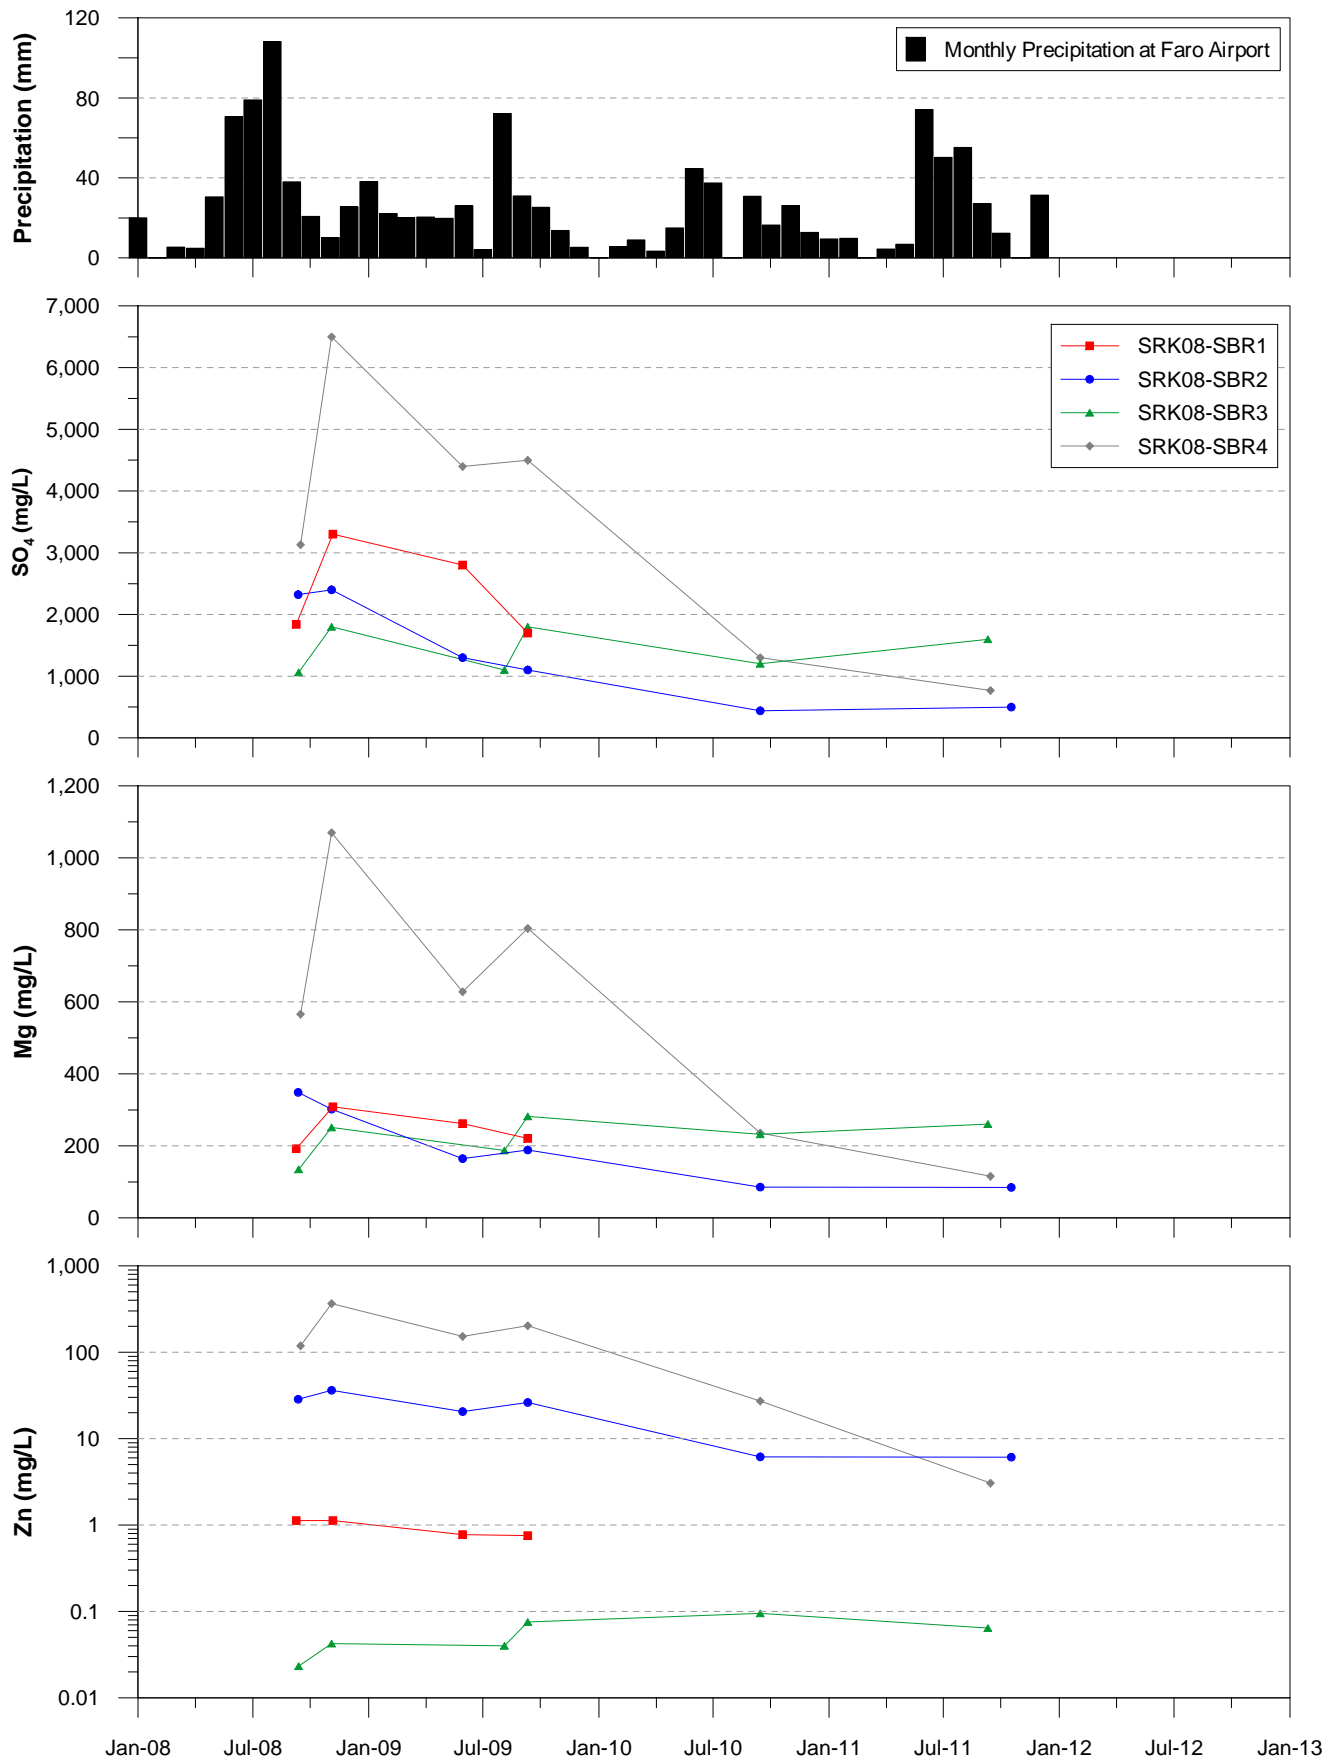
Figure 2-8a. Time trends for SO₄, Mg and Zn in SBR wells in S-Cluster Area

Time trends for the recently-installed bedrock wells in the S-Cluster area ('SBR' series) and wells further downgradient of the SIS (wells SRK08-SP7A/B and SRK08-SP8A/B) are shown in Figure 2-8a/b and Figure 2-8c/d, respectively.

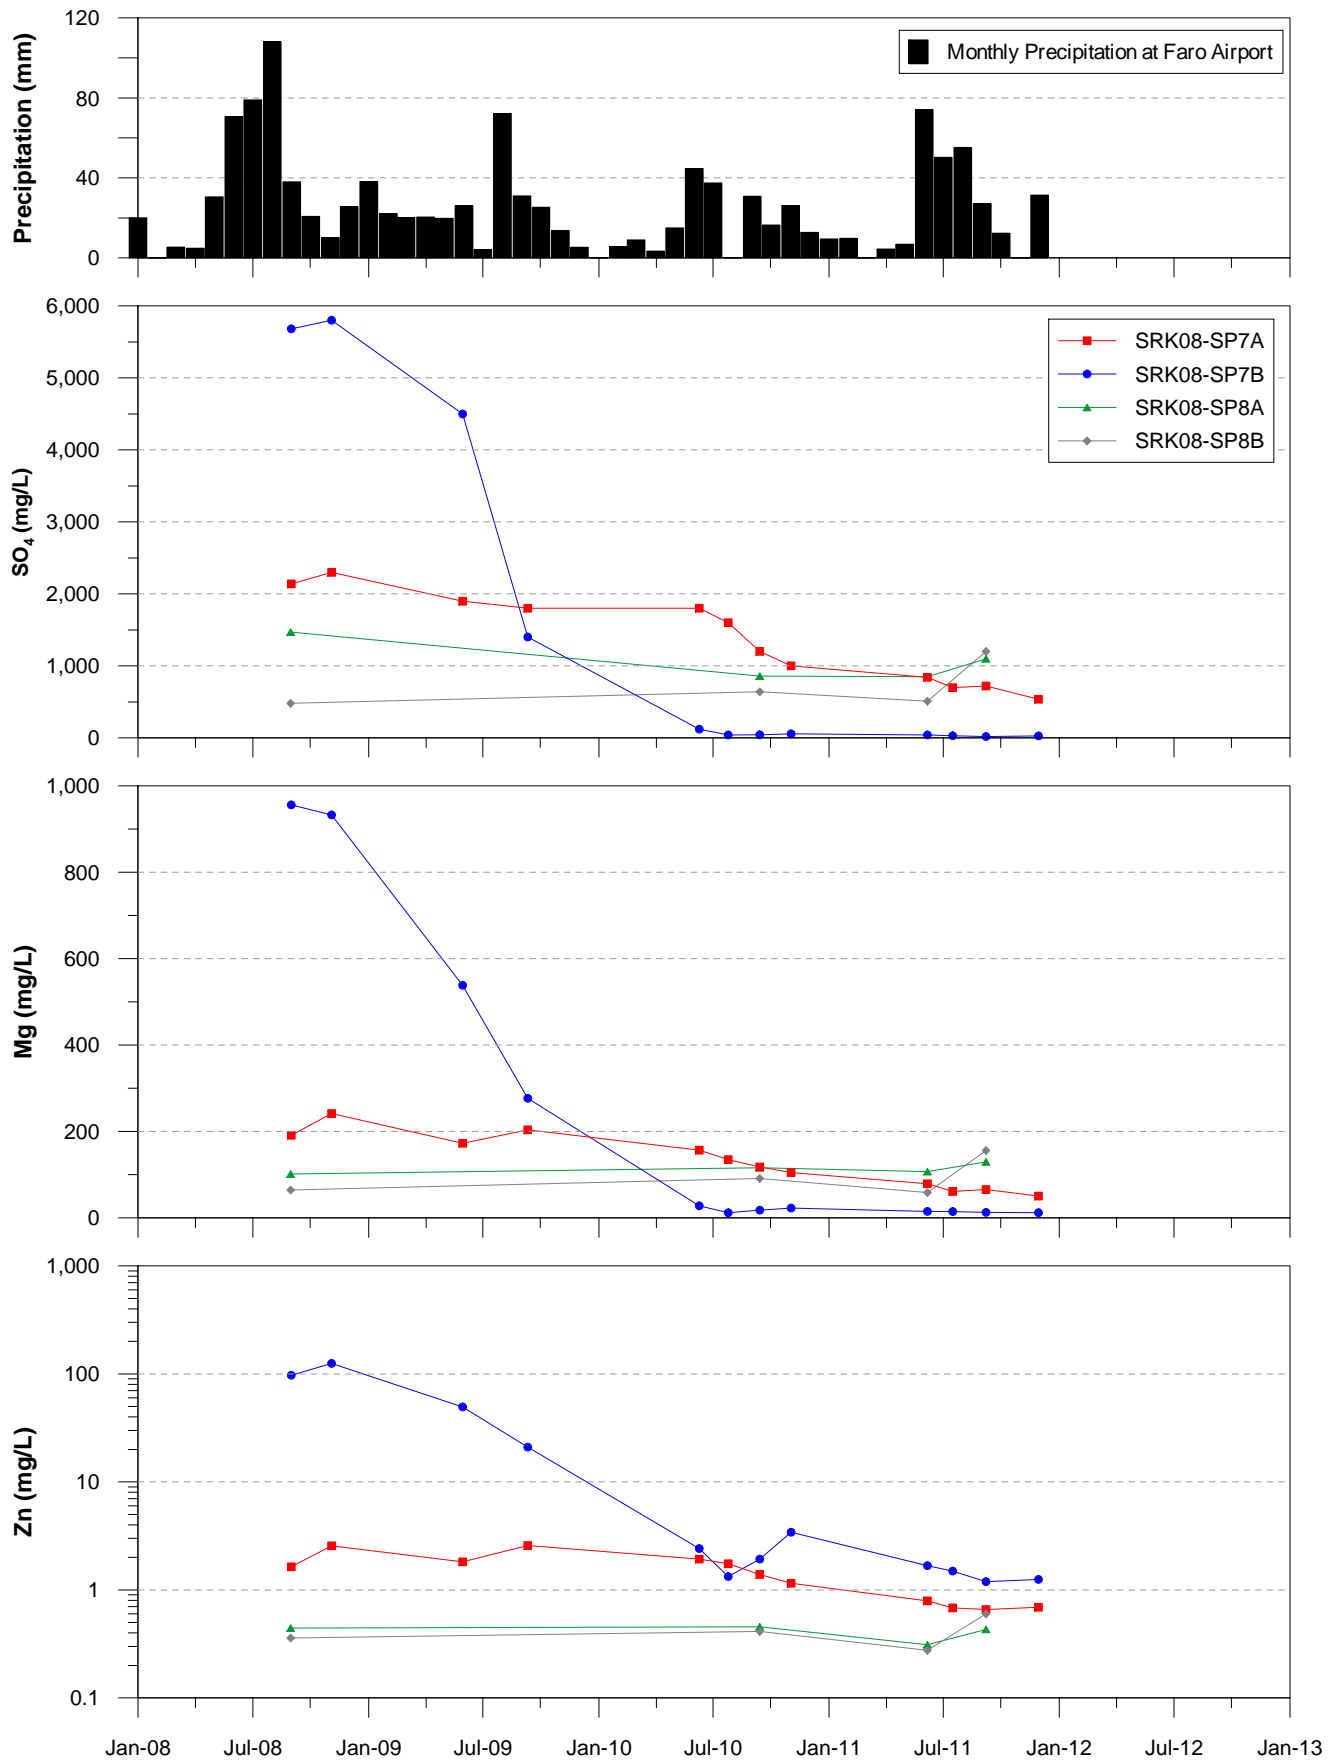
Figure 2-8c. Time trends for SO₄, Mg and Zn in SRK08-SP wells in S-Cluster Area

- comparable to those observed in 2009 (see Figure 2-7c); hence there is no definitive evidence that the interceptor trench is working as intended;
- Further downgradient of the SIS near the NFRC, groundwater quality conditions at wells SRK08-SP7A/B have improved significantly in recent years and contaminant levels remained low during the current monitoring period (see Figure 2-8c/d); the pronounced improvement in groundwater quality conditions in shallow overburden (at well SRK08-SP7B) is clearly caused by operation of the S cluster SIS; the relatively abrupt decrease in contaminant concentrations at SP7B would suggest that this area is fed by deeper groundwater which is now intercepted effectively by SPW2 (located 200m upgradient); groundwater in the deeper bedrock well SP7A shows a more gradual recovery suggesting poorer hydraulic connection to contaminated groundwater intercepted at SPW2¹.

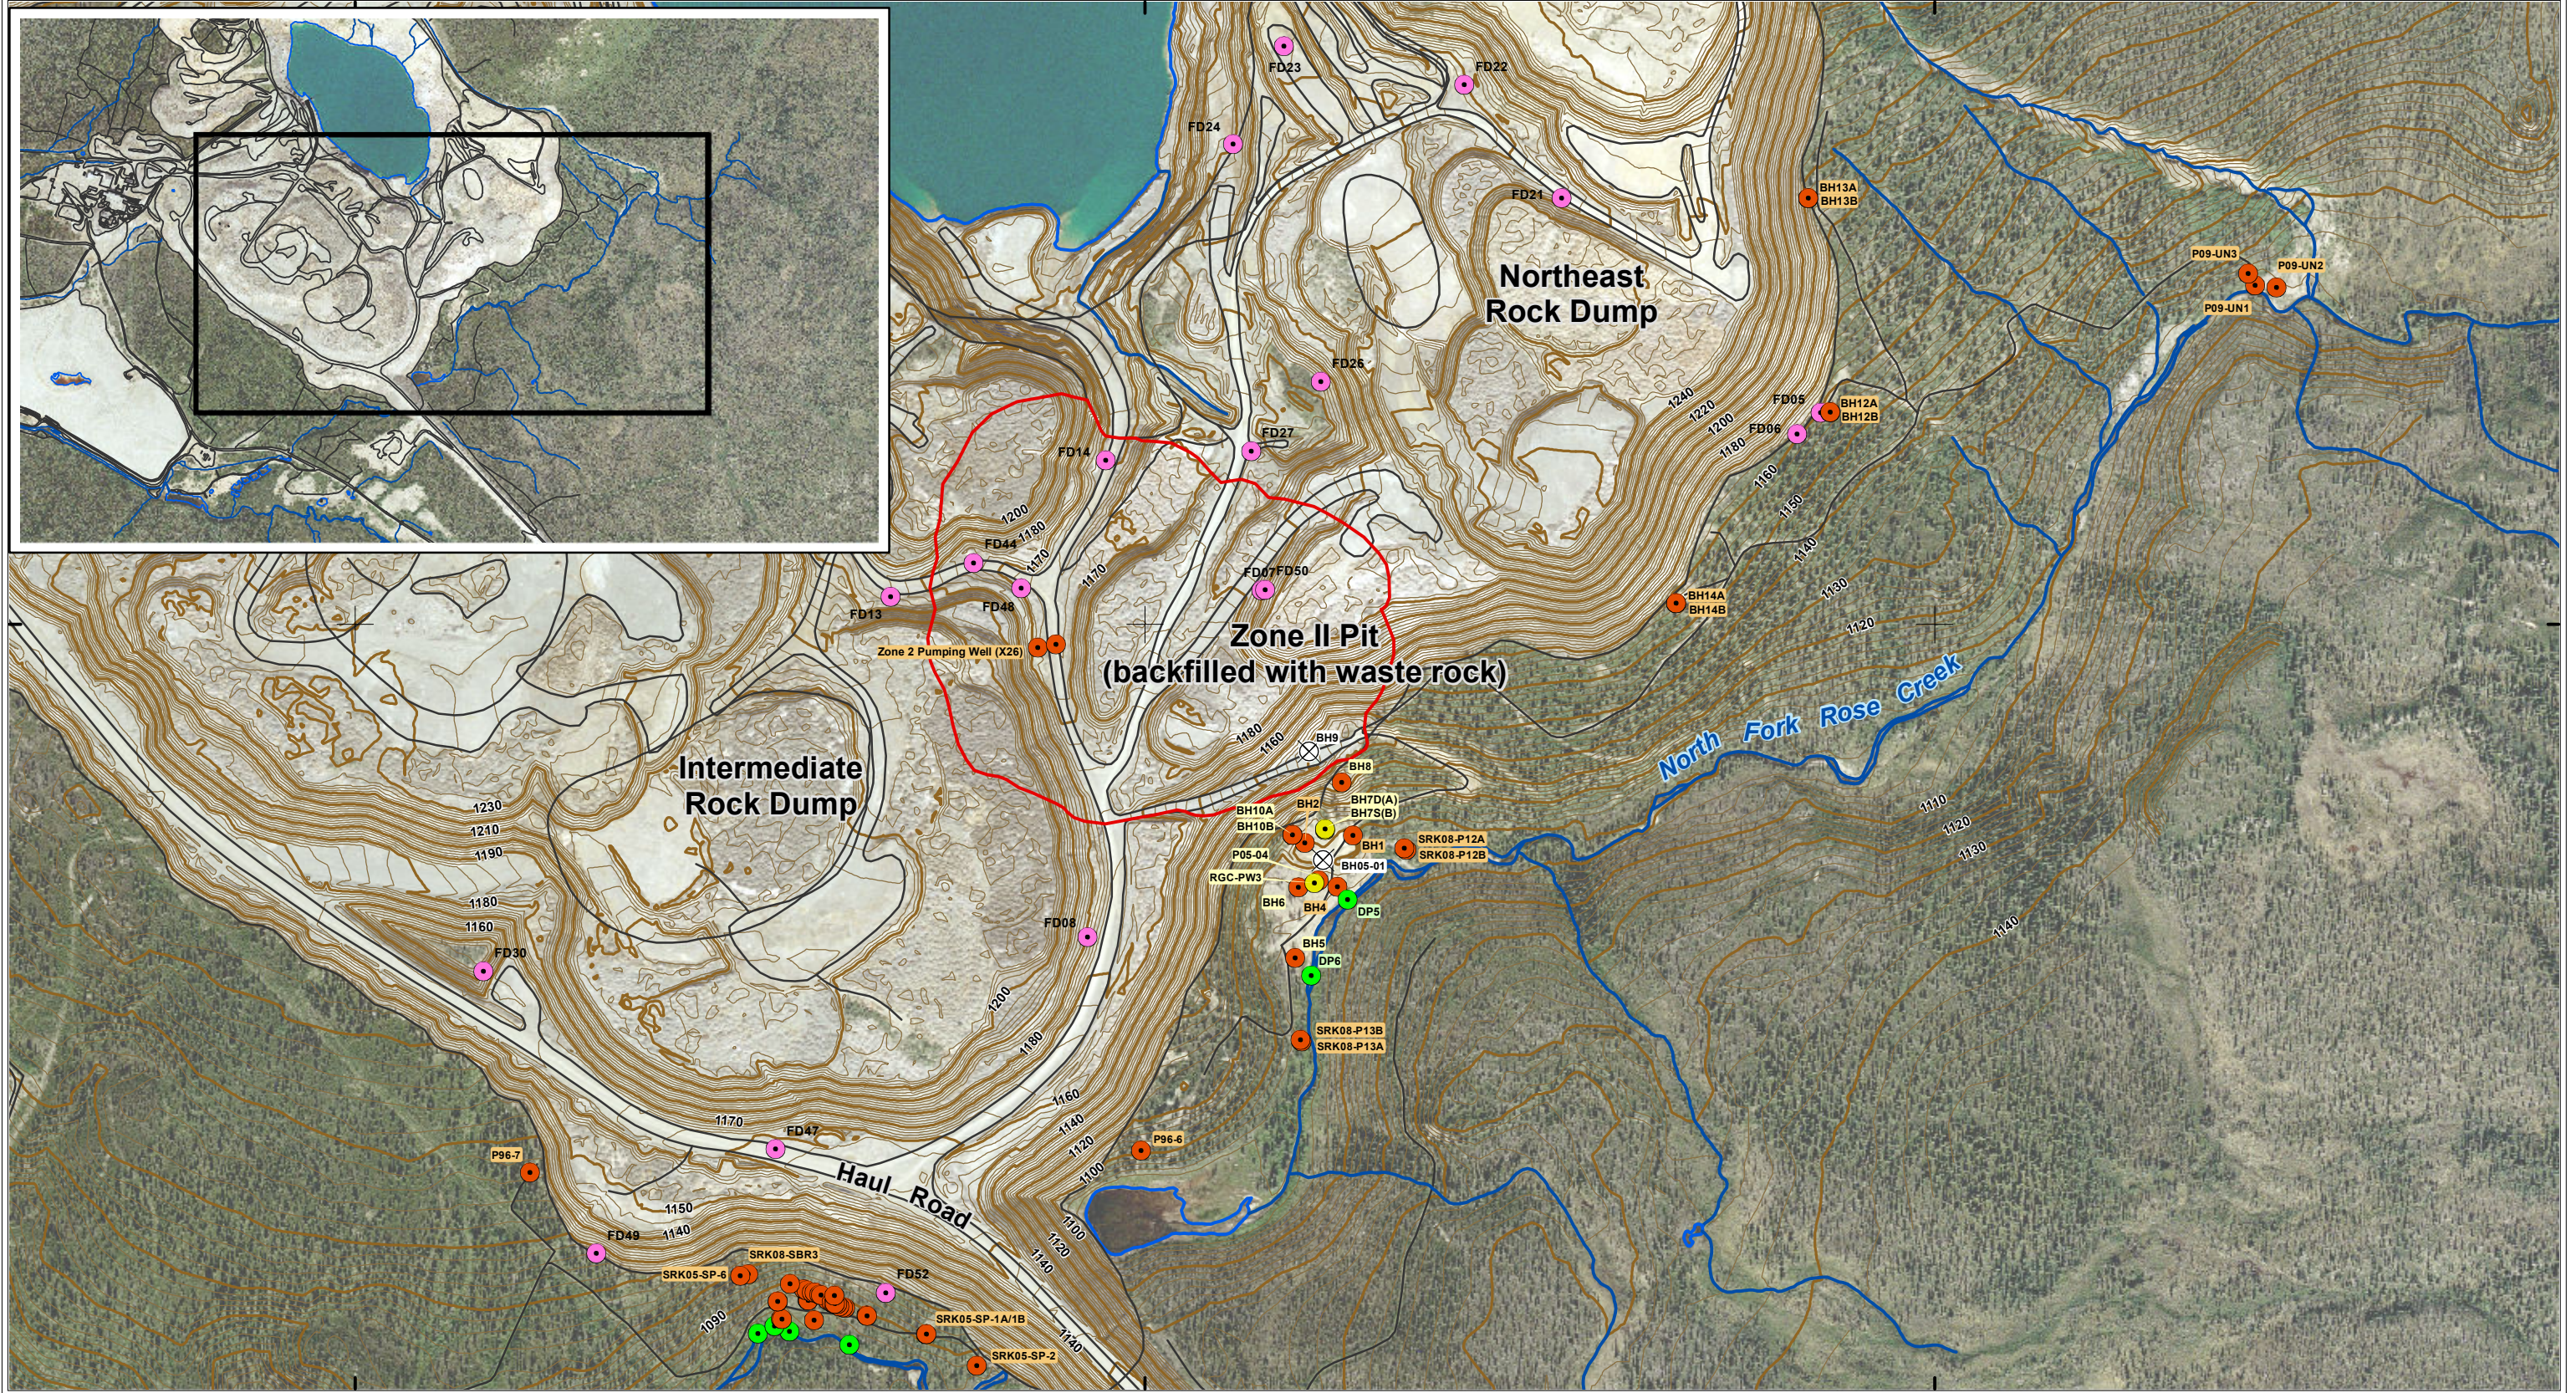
FIGURE: 2-9

Figure 2-9 shows the general layout of the North Fork of Rose Creek (NFRC) reach upstream of the rock drain. The NFRC reach can be subdivided as follows:

Most of the monitoring wells in the NFRC reach are located in the Zone 2 Pit outwash area (see Figure 2-10). Groundwater monitoring wells upgradient and downgradient of the Zone 2 Pit outwash area are shown in Figure 2-9. Pertinent information related to groundwater monitoring wells in the NFRC reach is provided in Table 2-3.

Time trends for pH, alkalinity, selected major ions, and metals of interest in groundwater from wells BH12A/B, BH13A/B, and BH14A/B are shown in Figure 2-12a/b. Each of these wells is located along the toe of the Northeast WRD (see Figure 2-9).

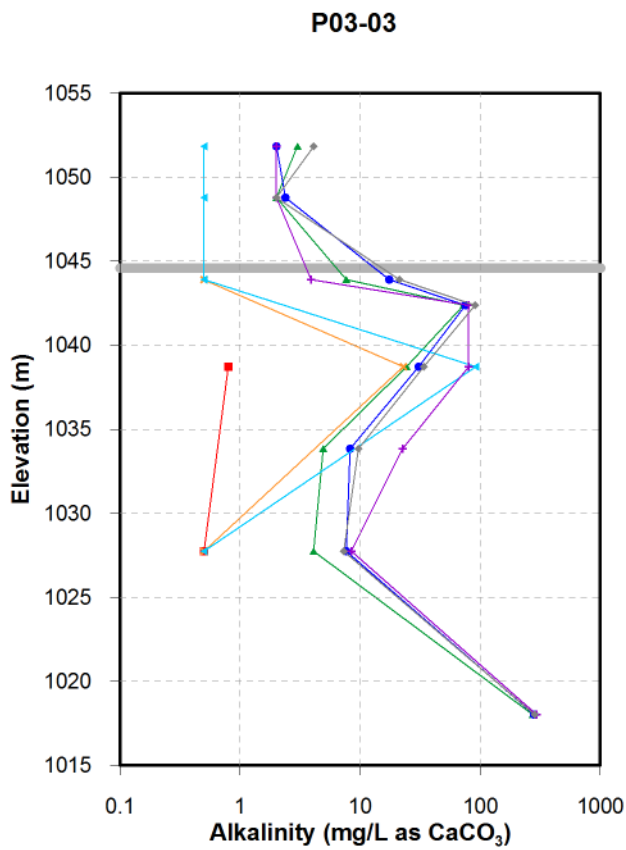
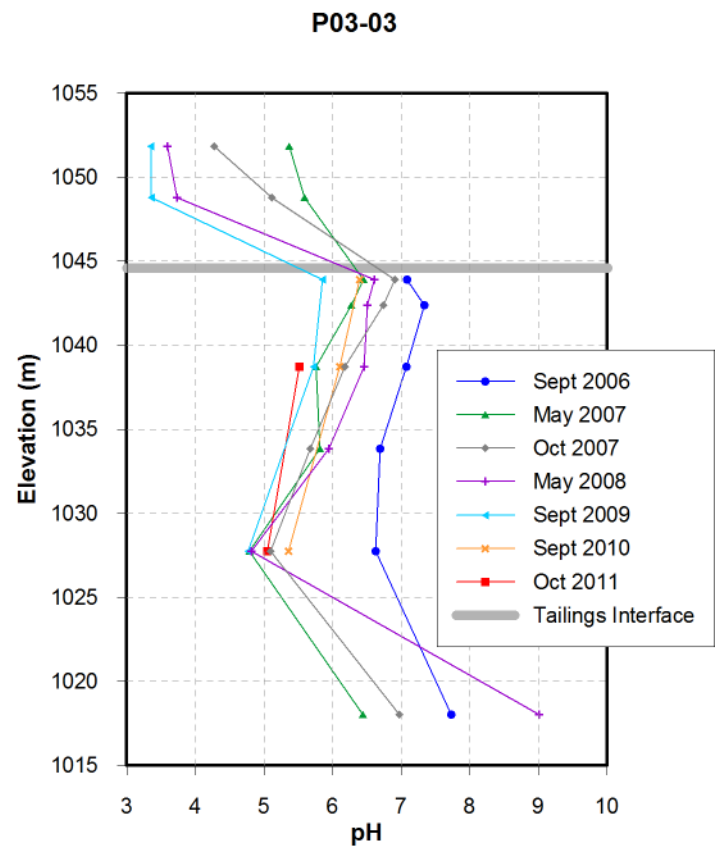
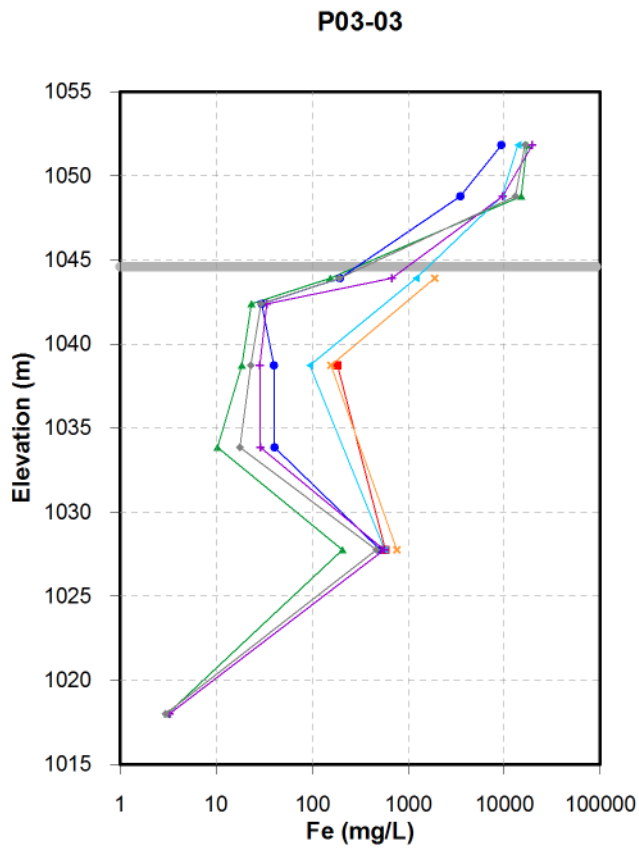
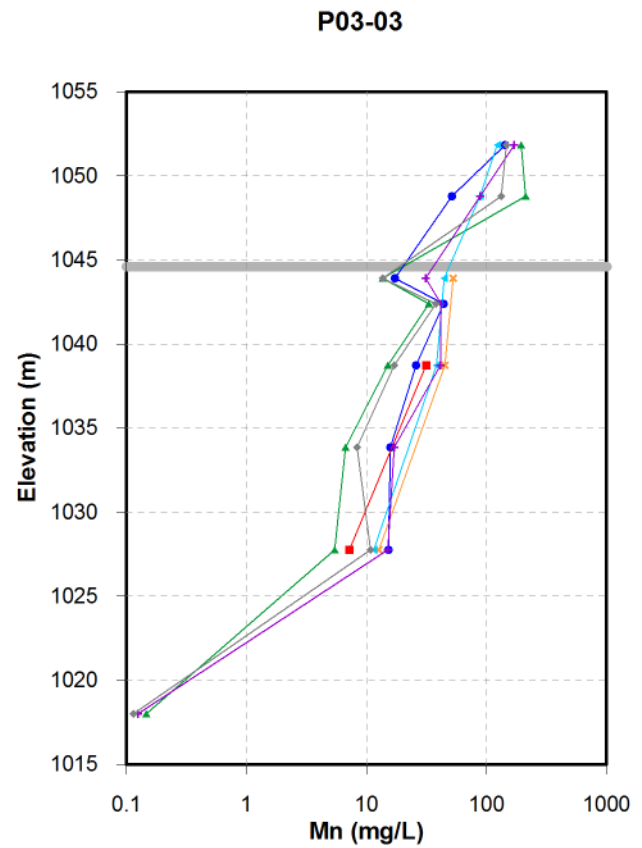
Figure 3-5a. Depth profiles for SO₄, Mg, Zn and Na in P03-03 (Second Impoundment)

Water quality profiles for multi-level piezometers P03-03 and P03-06 differ from the typical profile for the Second Impoundment. At P03-03, SO_4 concentrations are elevated throughout the aquifer and Zn concentrations actually increase at greater depths (see Figure 3-5a). At P03-06, SO_4 and Zn concentrations are elevated throughout the aquifer (Figure 3-8a). These depth profiles suggest a contribution of SO_4 and Zn from the overlying tailings profile and from an additional source located upgradient (see RGC, 2006a; RGC, 2008).

This upgradient source was previously thought to be seepage from the 'leaky wells' P01-09 (and P01-07) but no improvement in groundwater quality at P03-03 has occurred since these wells were decommissioned in October 2005. Instead, SO_4 and Mg concentrations have remained relatively consistent or actually increased at P03-03-06 (see Figure 3-9a/b). These results suggest that seepage from the highly-oxidized tailings in the coarse tailings beaches of the Second Impoundment (e.g. near well P03-01) is a more likely upgradient source of contaminants to the alluvial aquifer near P03-03.

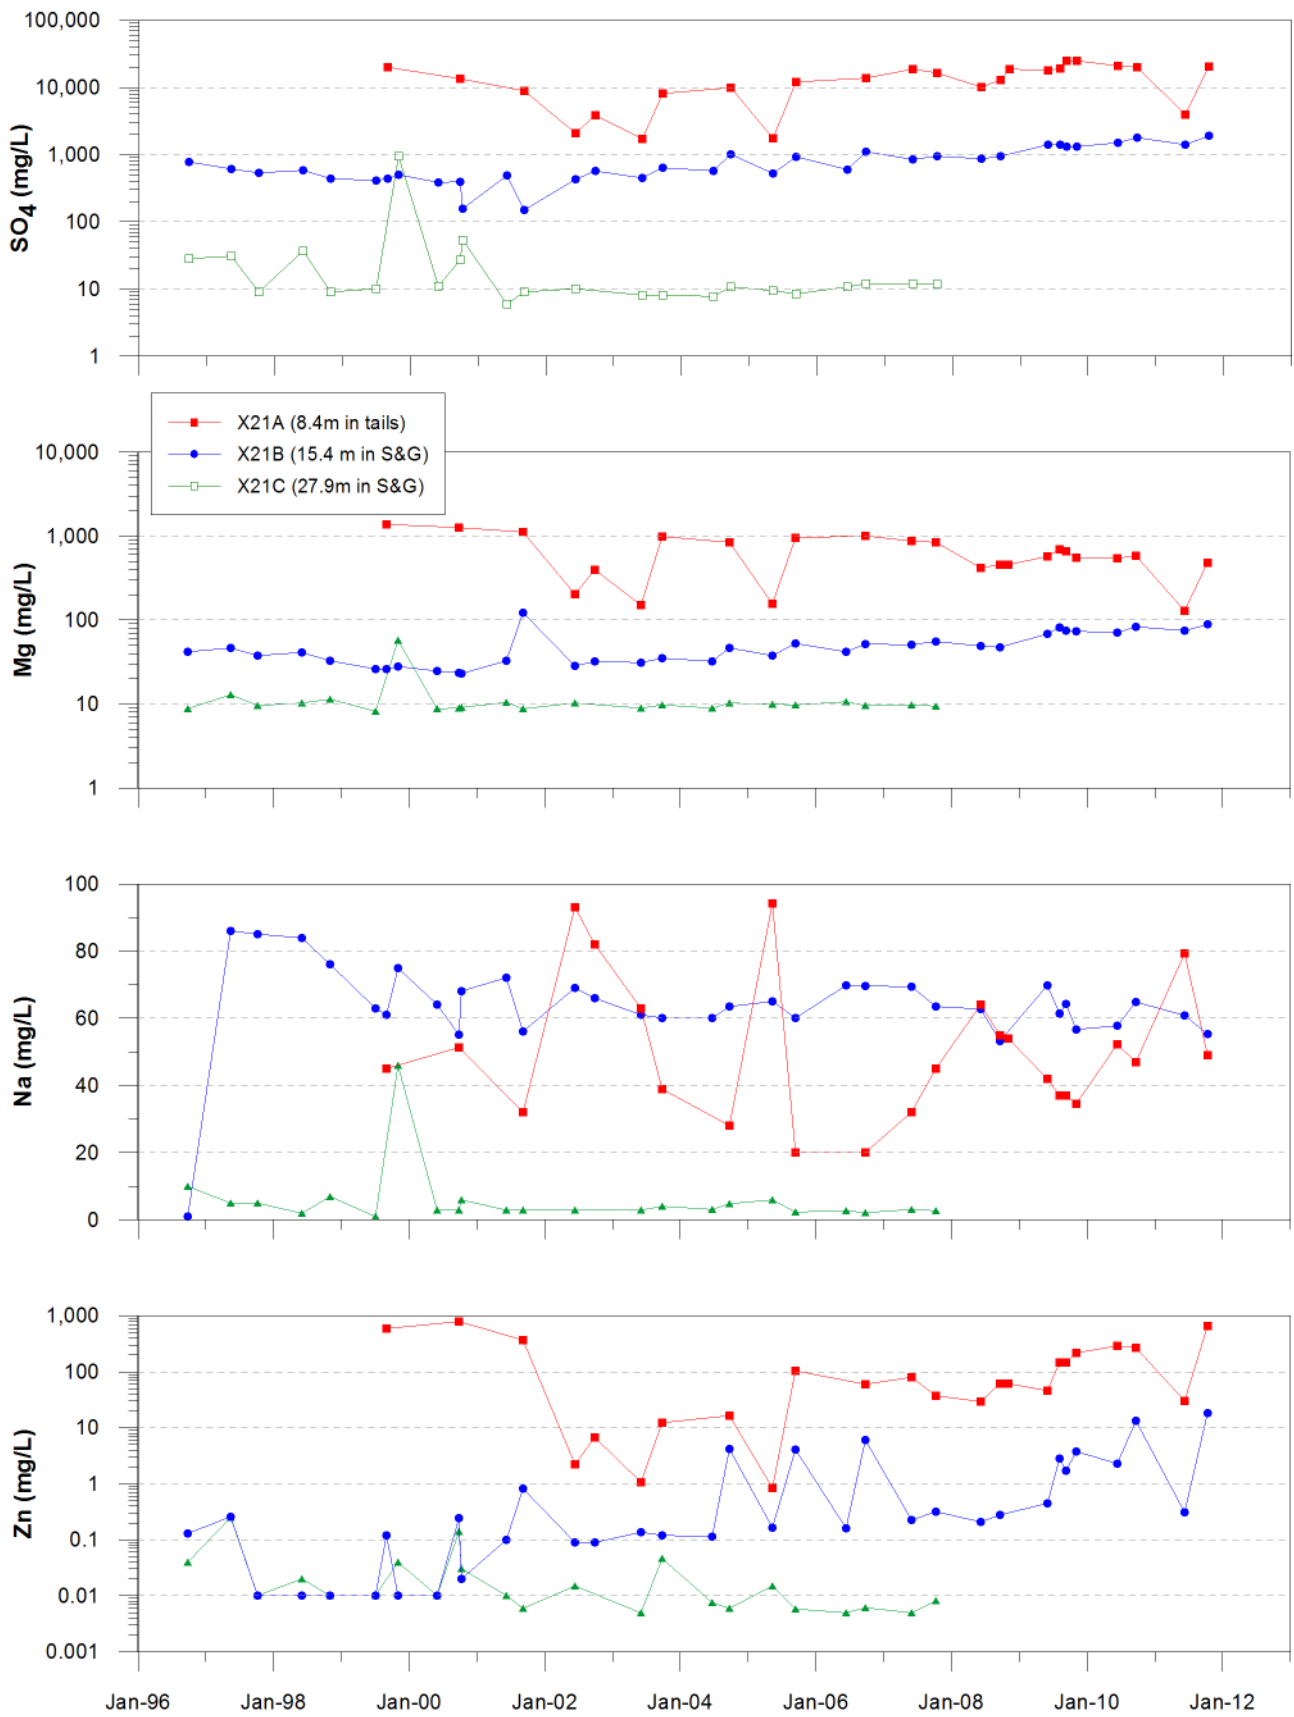
Figure 3-11a. Time trends for SO₄, Mg, Na and Zn in X21 (96), Intermediate Impoundment

Time trends for pH, alkalinity, selected major ions, and metals of interest for the 'X21' well series are shown in Figures 3-11a/b. Key findings are summarized as follows:

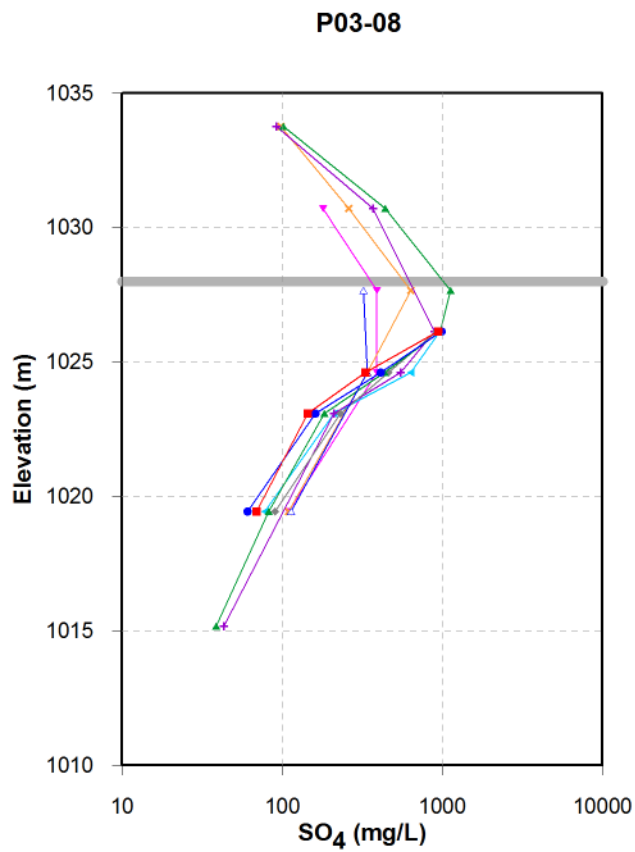
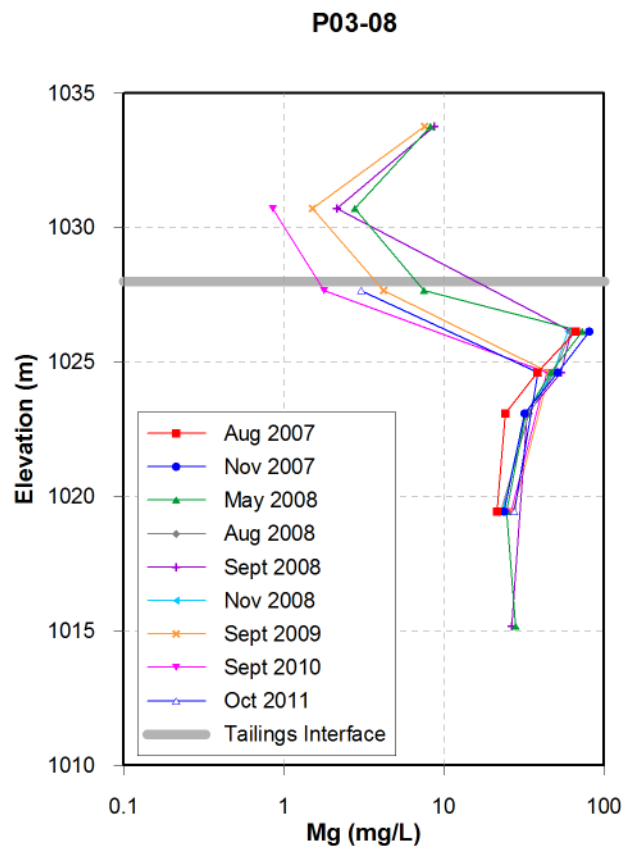
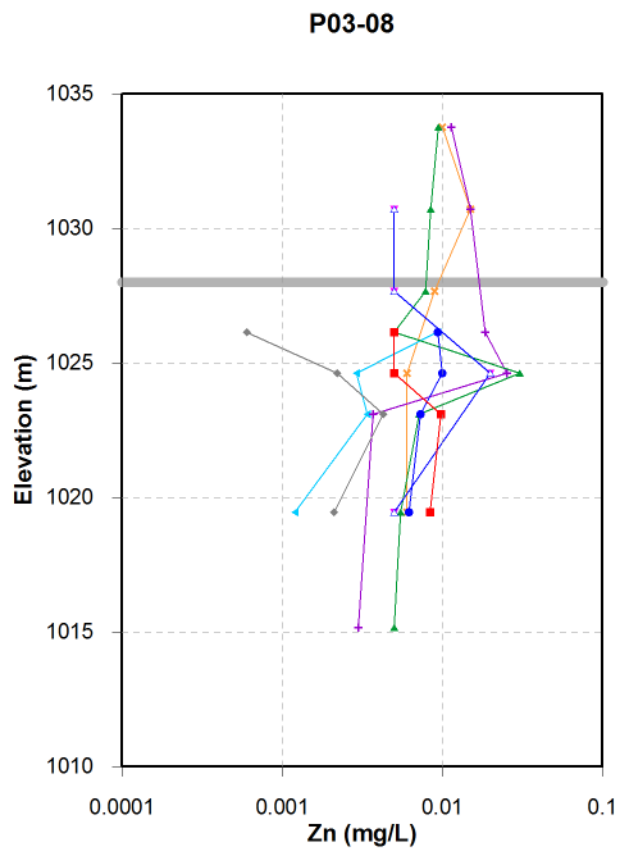
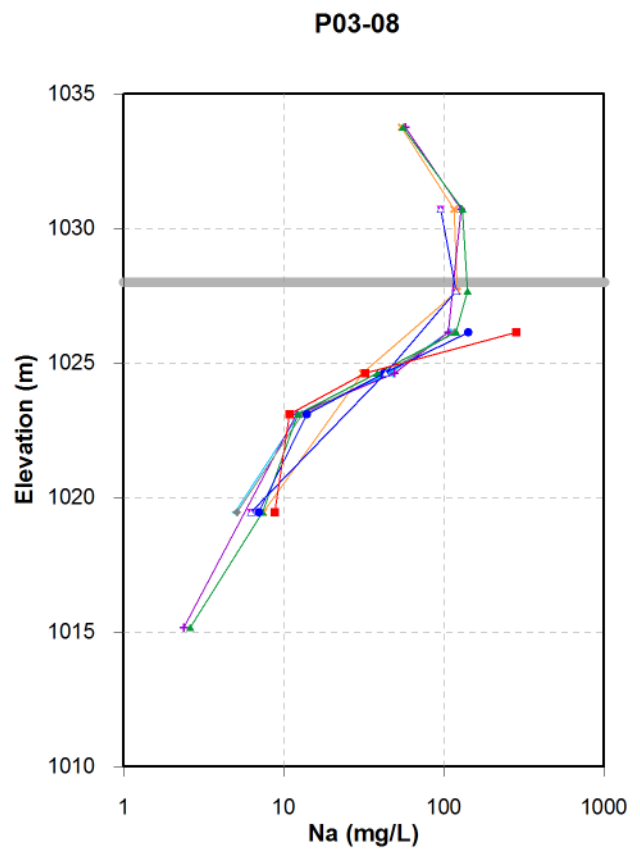
Figure 3-12a. Depth profiles for SO₄, Mg, Zn and Na in P03-08 (Intermediate Impoundment)

Depth profiles for pH, alkalinity, selected major ions, and metals of interest at P03-08 are shown in Figure 3-12a/b. This multi-level piezometer is located along the southern side of the Rose Creek valley near the Intermediate Pond and is the furthest downgradient in the Intermediate Impoundment. Depth profiles for the current monitoring period at P03-08 showed no appreciable changes in groundwater quality at this location.

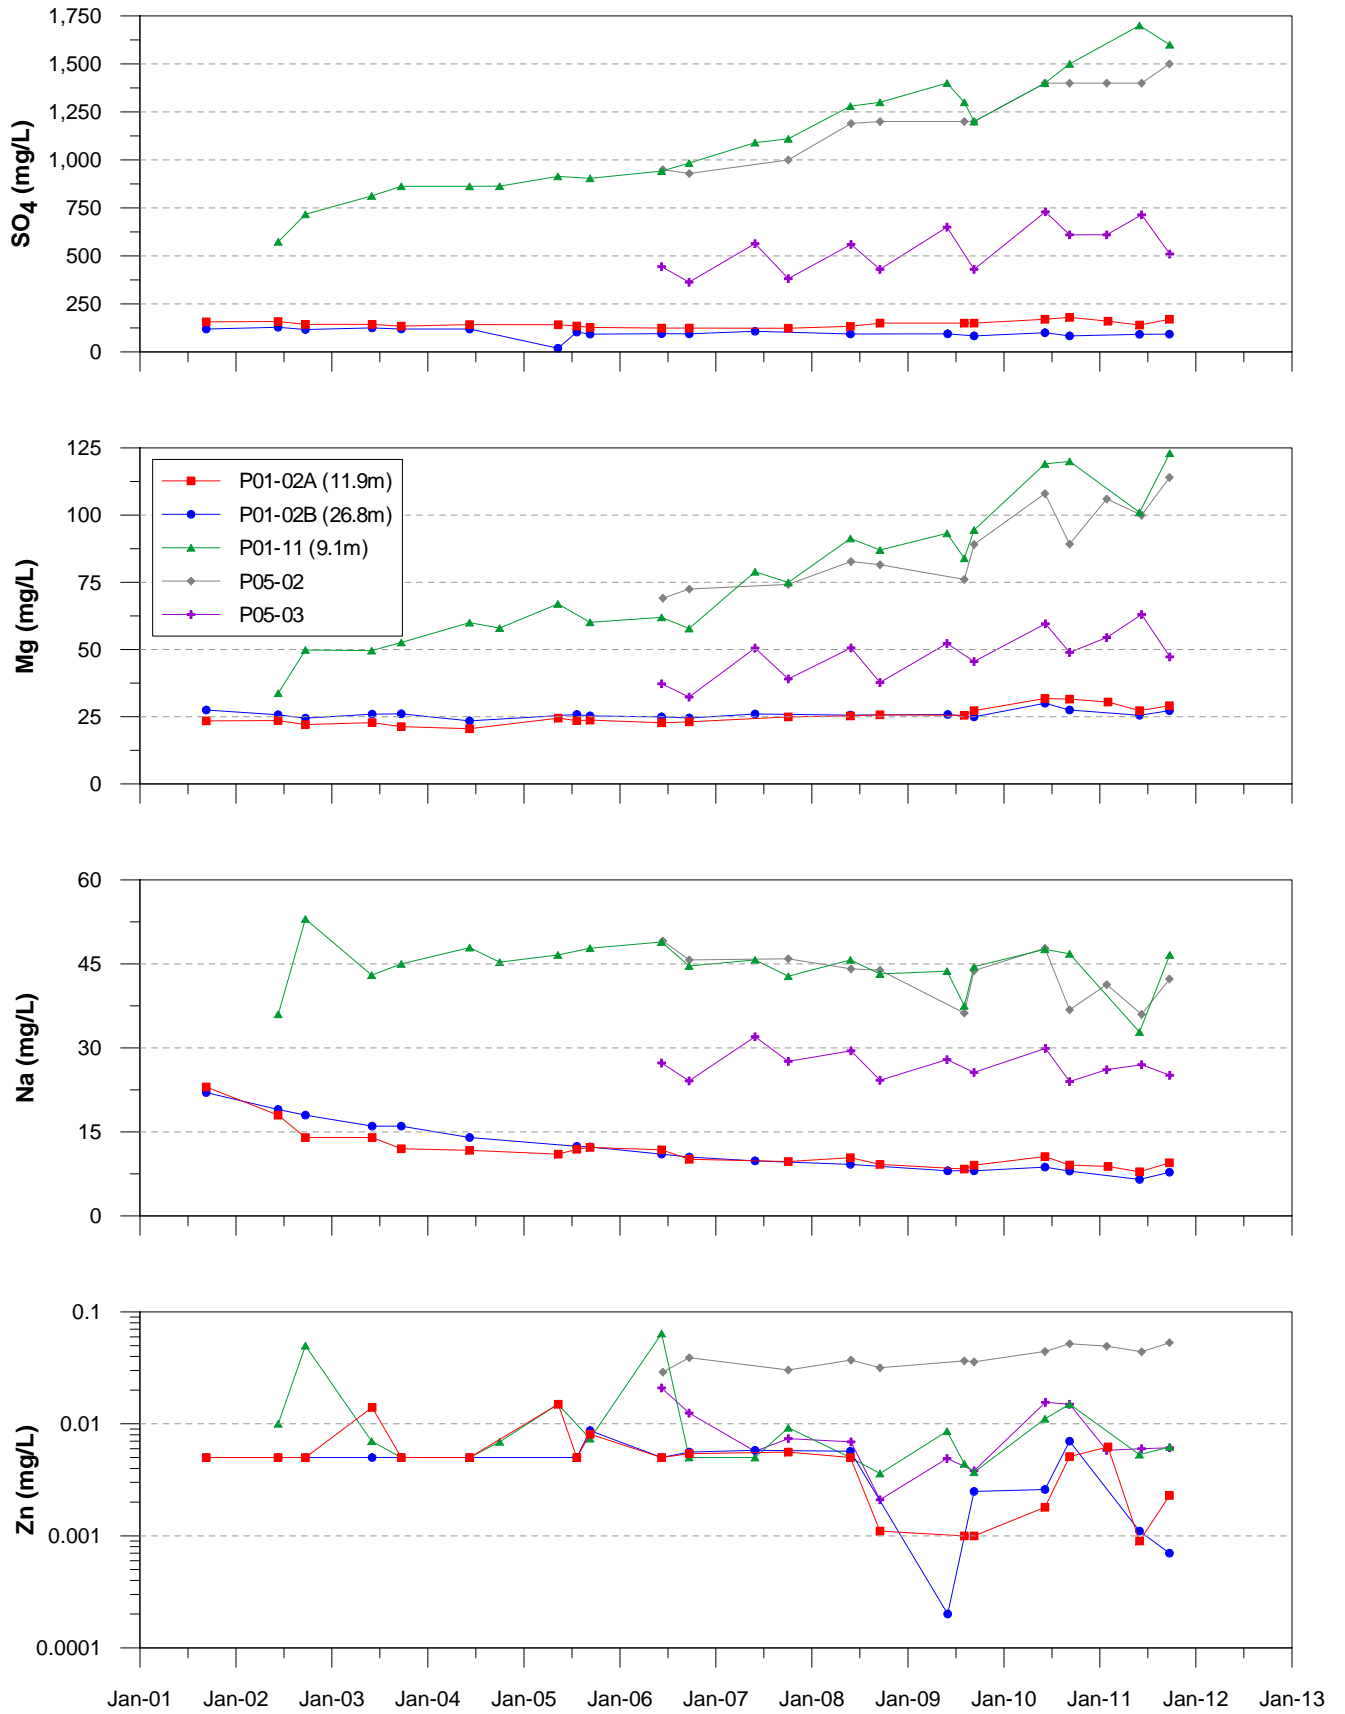
Time trends for pH, alkalinity, selected major ions, and metals of interest in groundwater near the toe of the Cross Valley Dam are shown in Figures 3-15a/b to 3-17a/b.

Figure 3-15a. Time trends for SO₄, Mg, Na and Zn in wells along toe of Cross Valley Dam

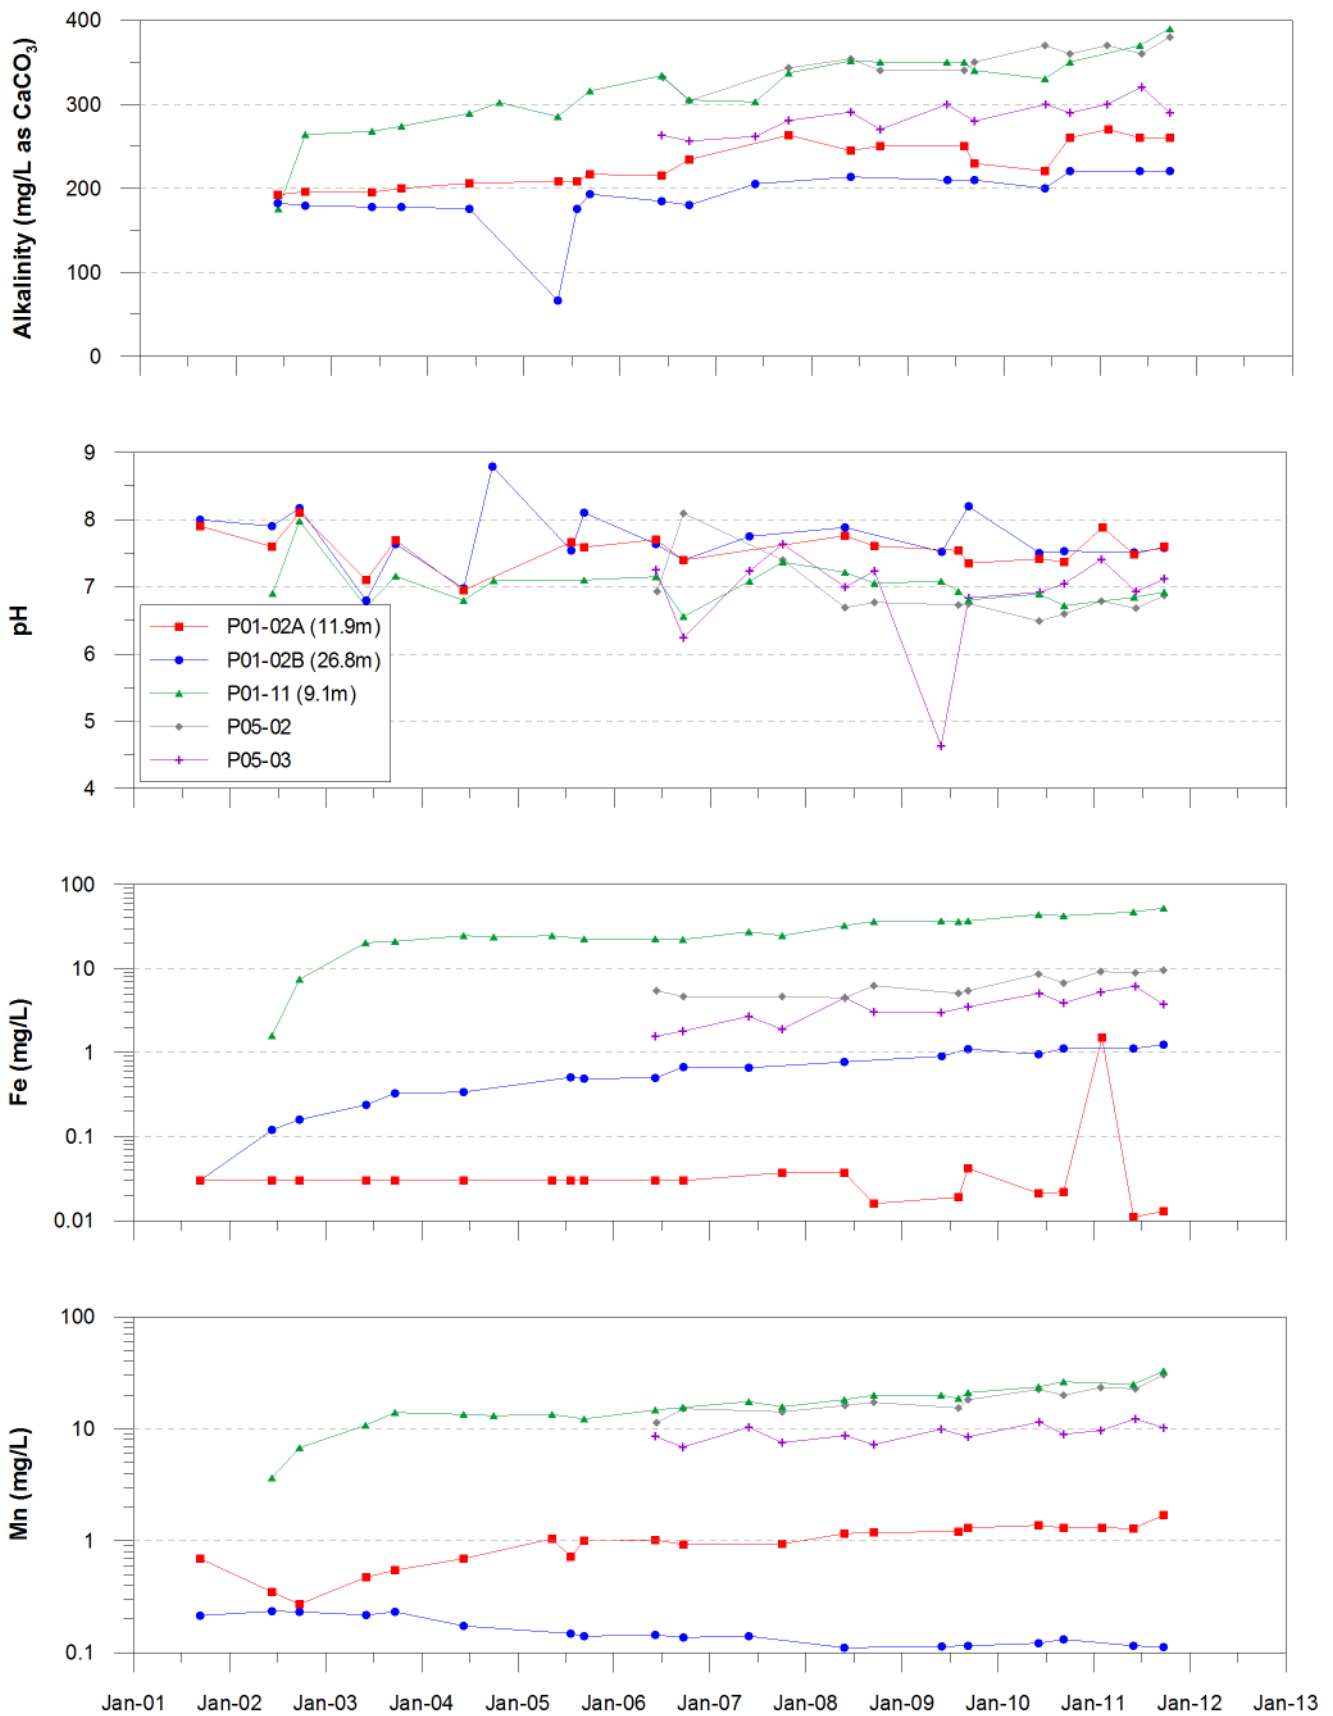
Figure 3-15b. Time trends for alkalinity, pH, Fe and Mn in wells along toe of Cross Valley Dam
