Report No. 118022/1

**2011 GROUNDWATER QUALITY REVIEW
ANVIL RANGE MINING COMPLEX, YUKON TERRITORY**

June 2012

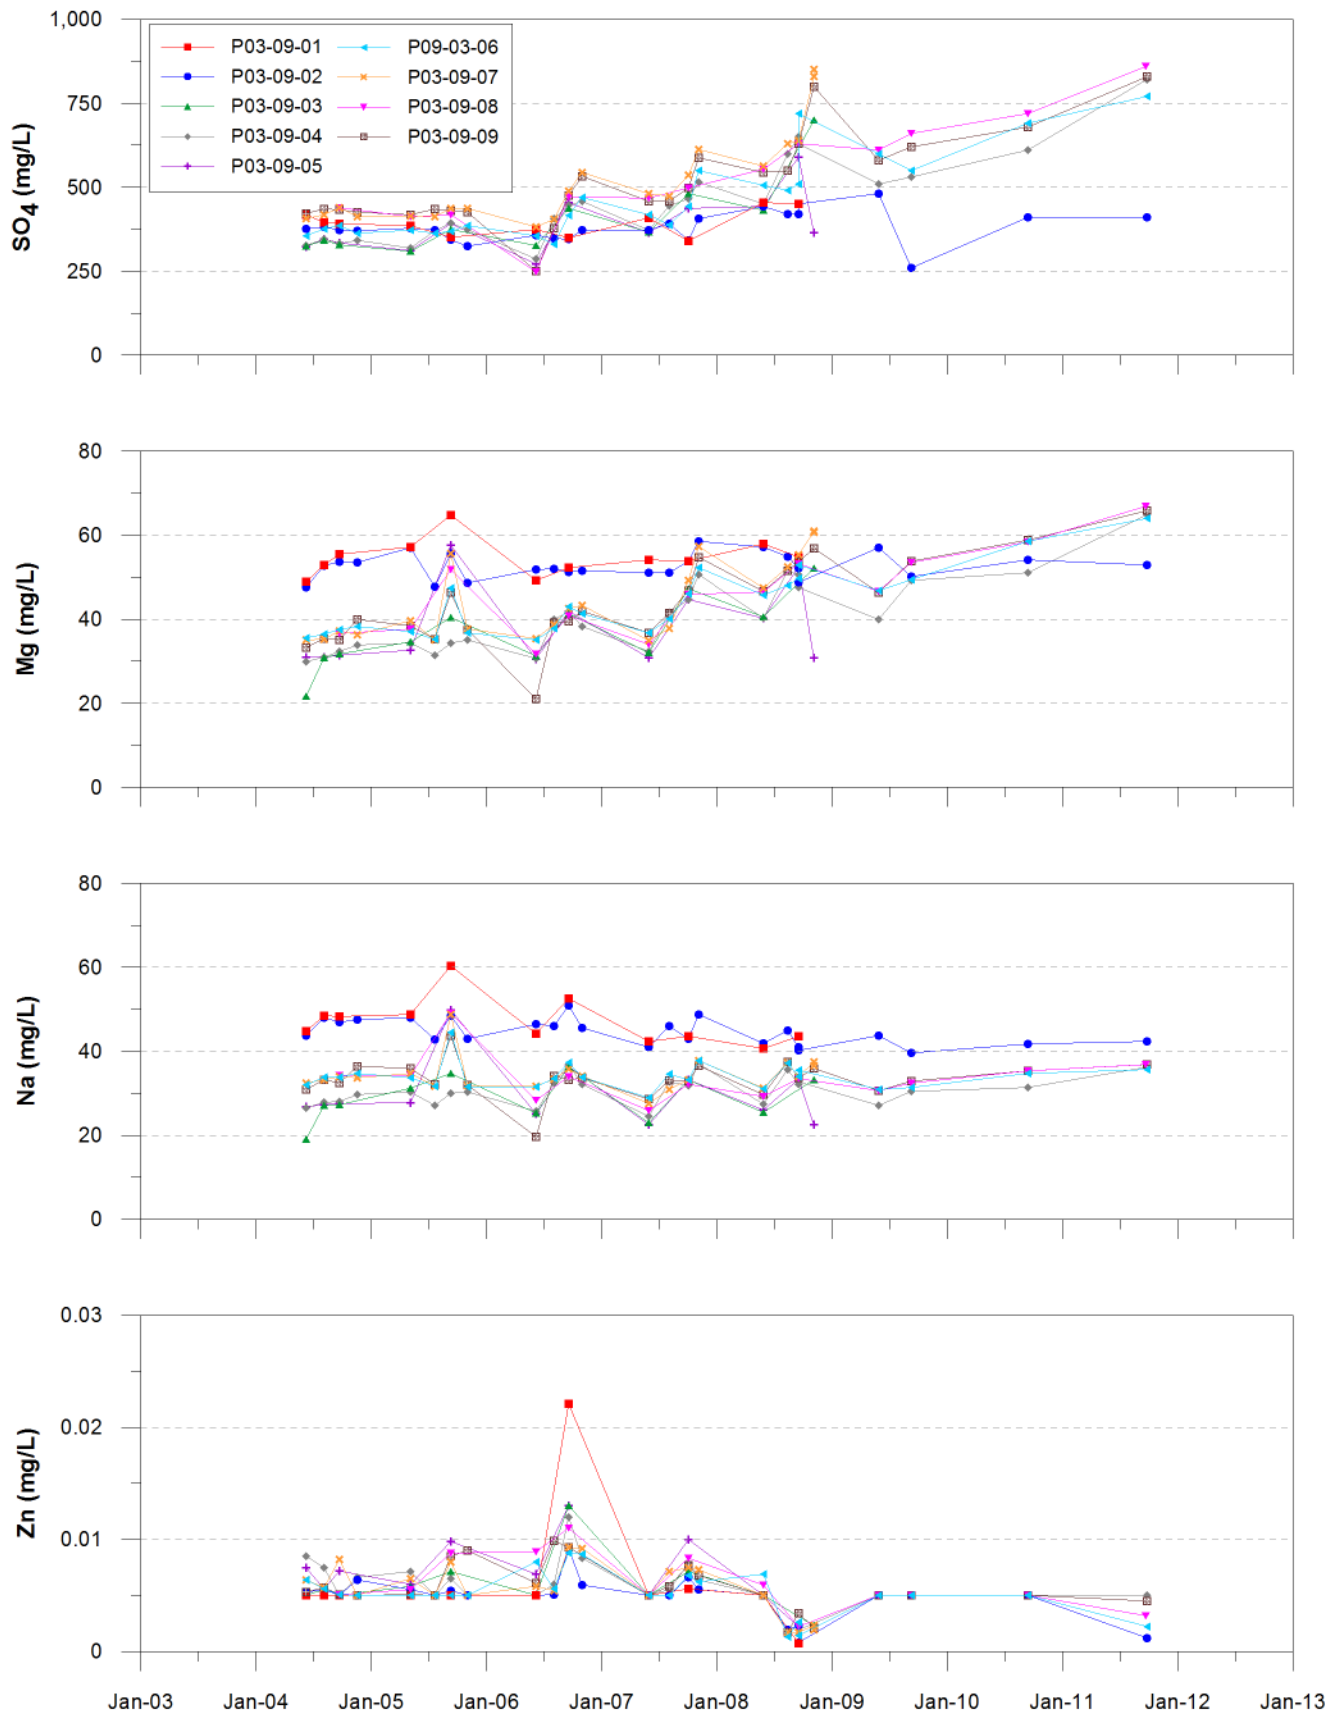
Time trends for pH, alkalinity, selected major ions, and metals of interest in the multilevel wells P03-09 and P05-01 are shown in Figures 3-16a/b and 3-17a/b, respectively. Groundwater at P05-01 is more impacted by ARD than groundwater at P03- in part to the FCS load delivered to the RCAA along the northern side of the Rose Creek valley in the Intermediate Dam reach. Note that SO₄ and Mg concentrations in both sets of piezometers continued to increase during the current monitoring period (as they have since 2004) but metals of interest (in particular Zn) remain low.

Figure 3-16a. Time trends for SO₄, Mg, Na and Zn in P03-09 (at Cross Valley Dam)

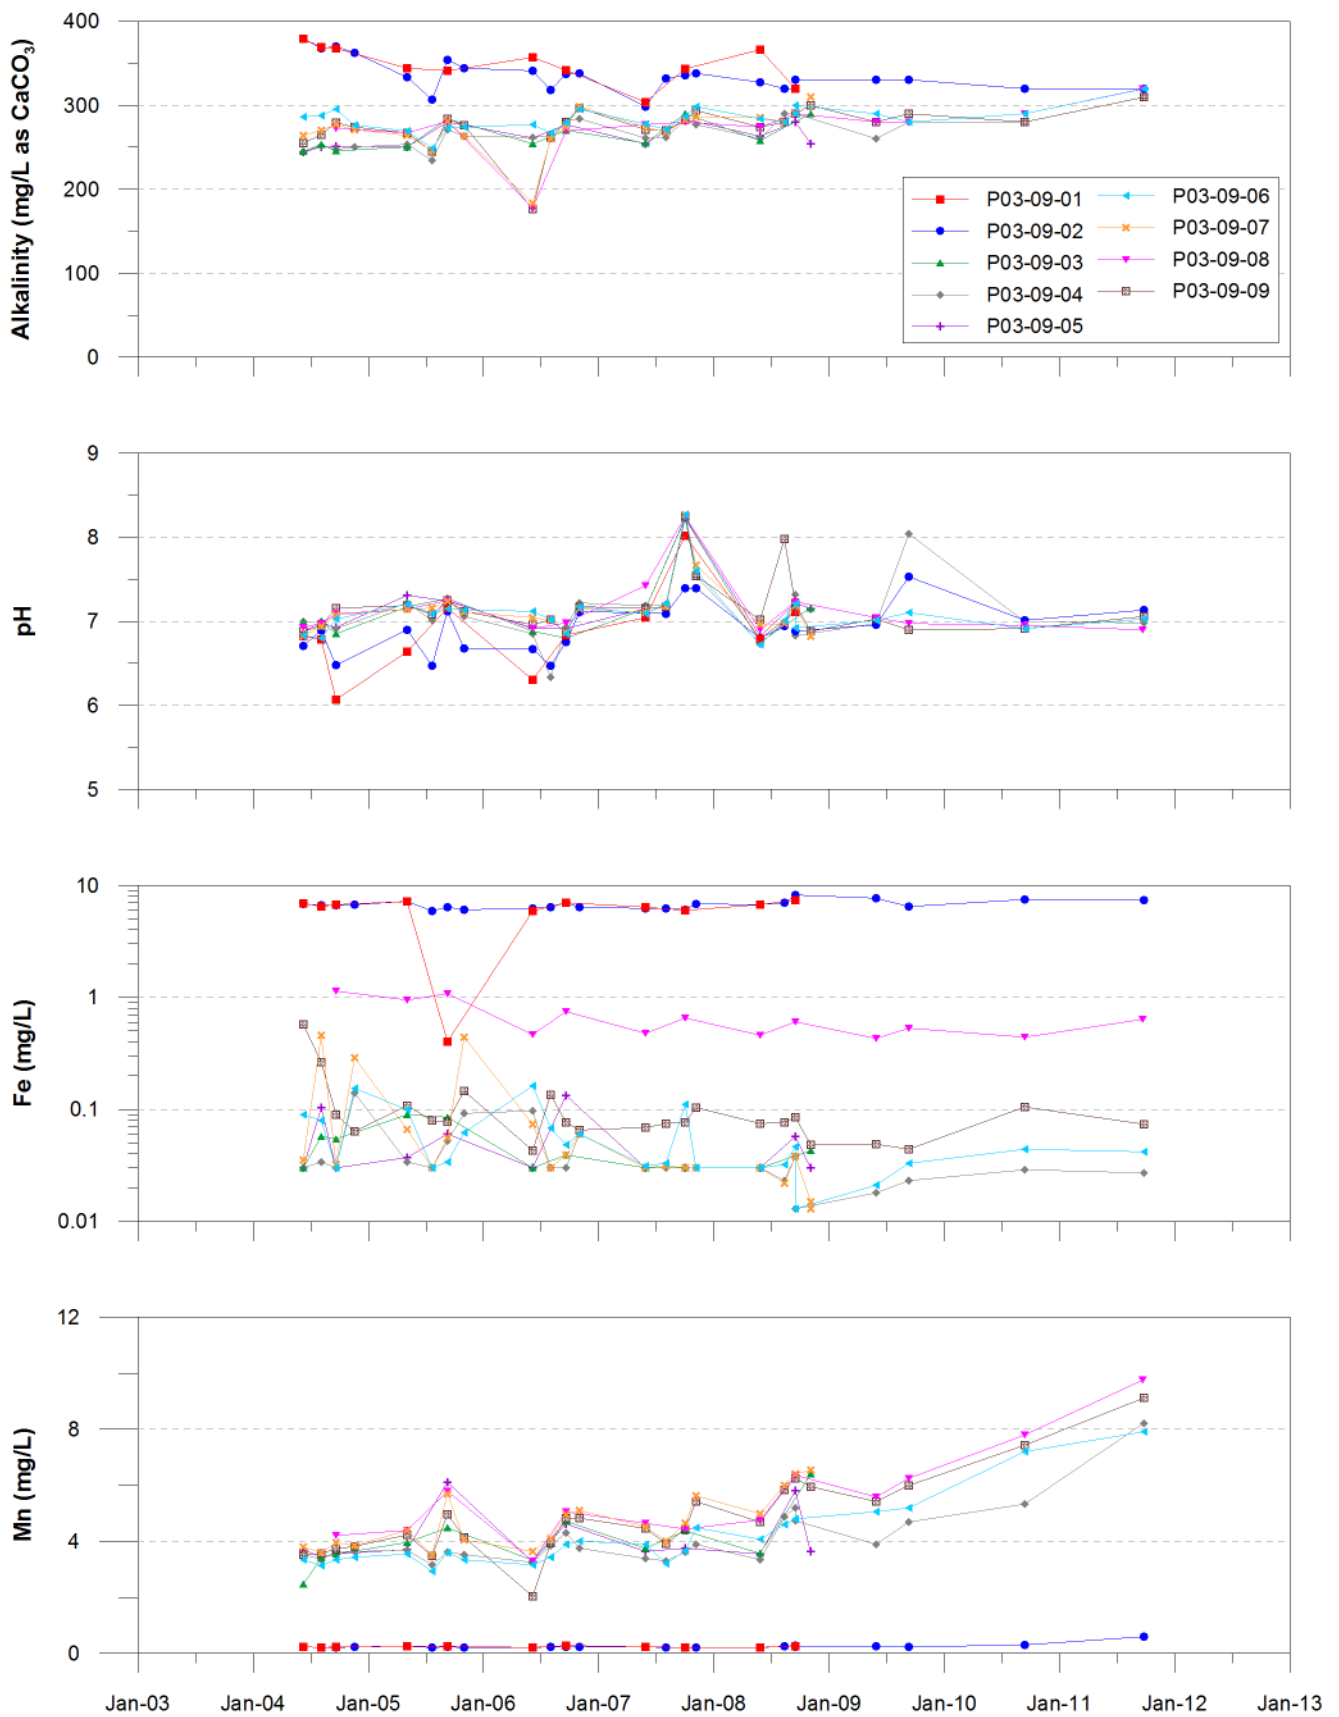
Figure 3-16b. Time trends for alkalinity, pH, Fe and Mn in P03-09 (at Cross Valley Dam)

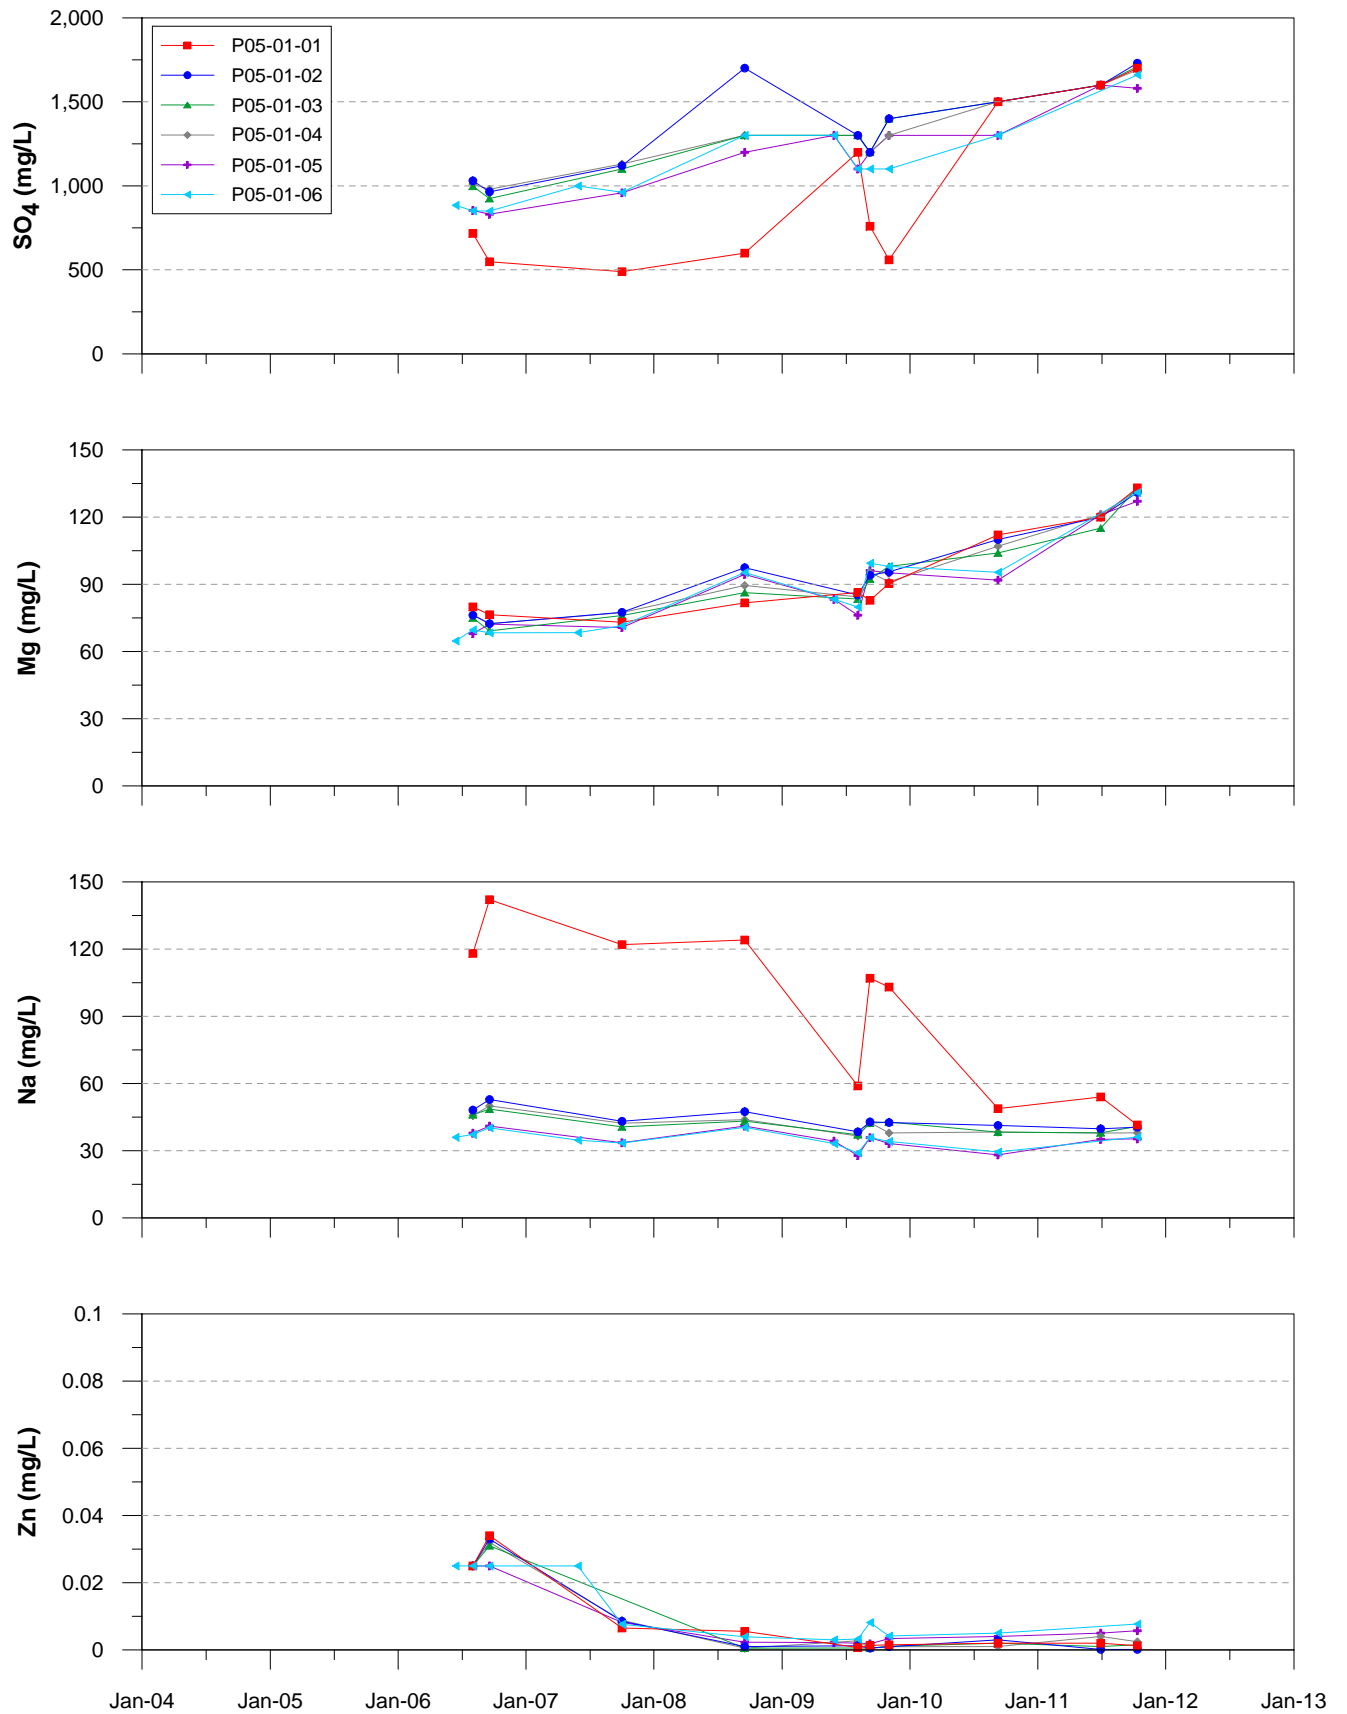
Figure 3-17a. Time trends for SO_4 , Mg, Na and Zn in P05-01 (at Cross Valley Dam)

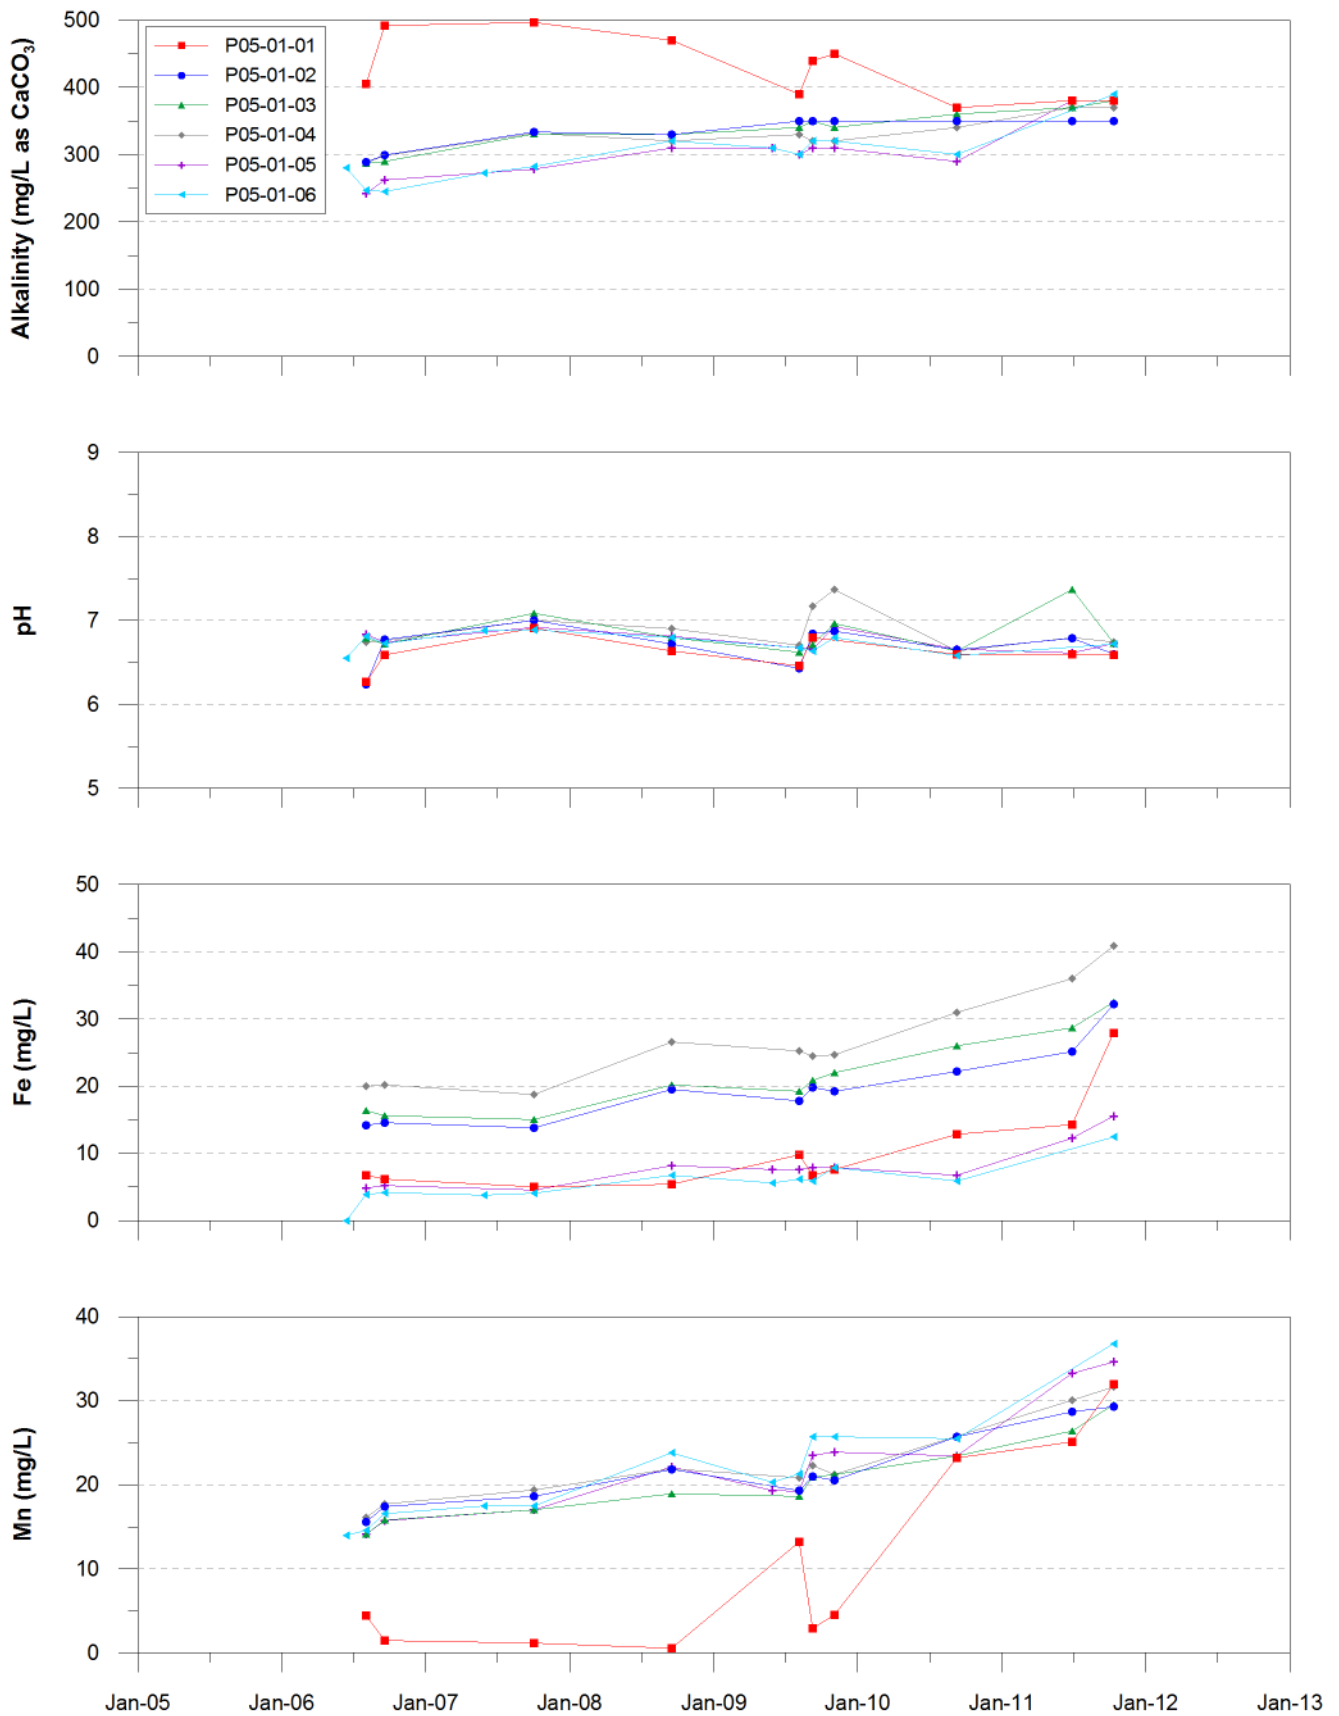
Figure 3-17b. Time trends for alkalinity, pH, Fe and Mn in P05-01 (at Cross Valley Dam)

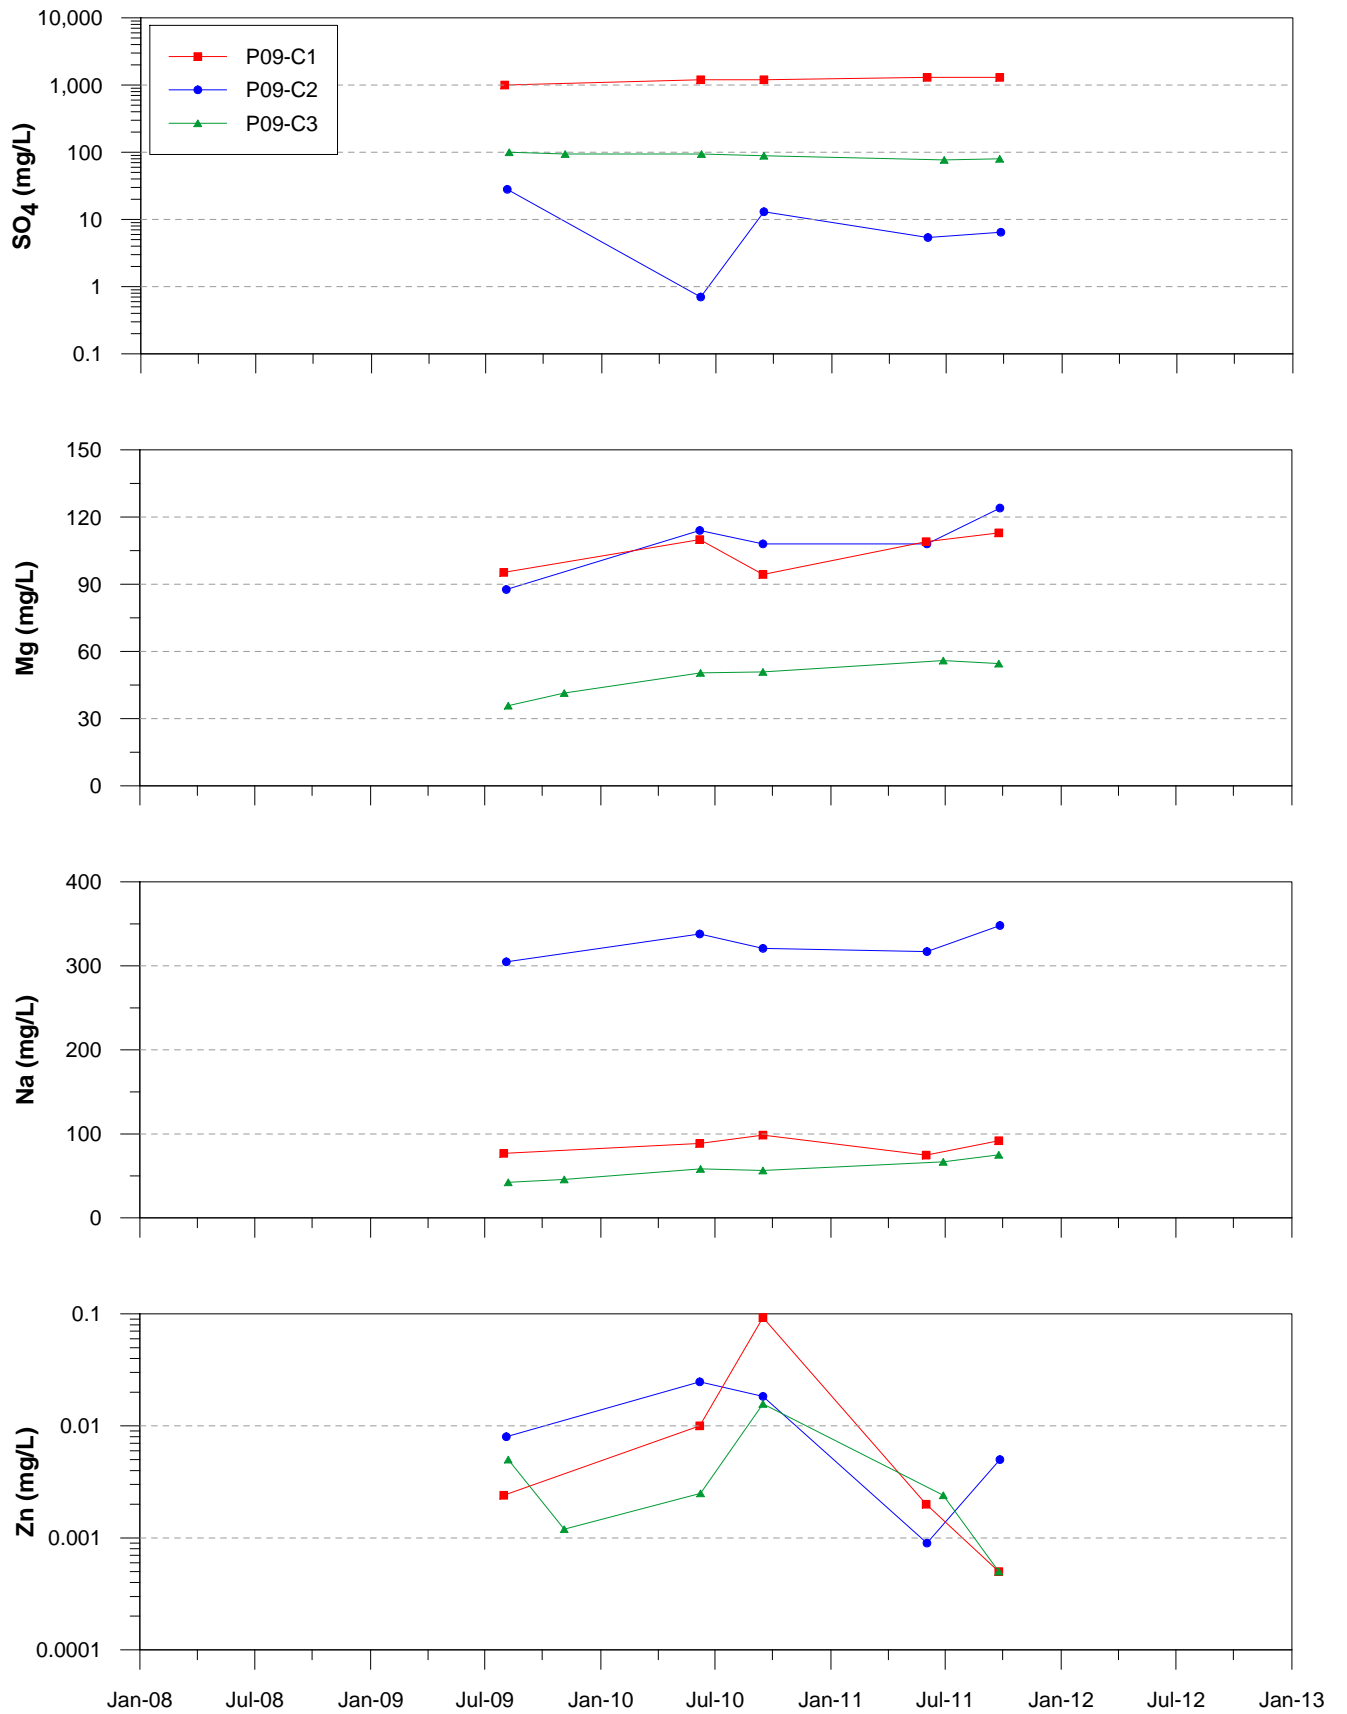
Time trends for pH, alkalinity, selected major ions, and metals of interest for the 'P09-C' well series are shown in Figure 3-18a/b. Groundwater in deep bedrock near the northern abutment of the Cross Valley Dam (at well P09-C1) is characterized by SO₄, Mg, Fe and Mn concentrations that are comparable to those in the shallow RCAA above. In contrast, groundwater in deep bedrock in the

Figure 3-18a. Time trends for SO₄, Mg, Na and Zn in wells at the toe of Cross Valley Dam

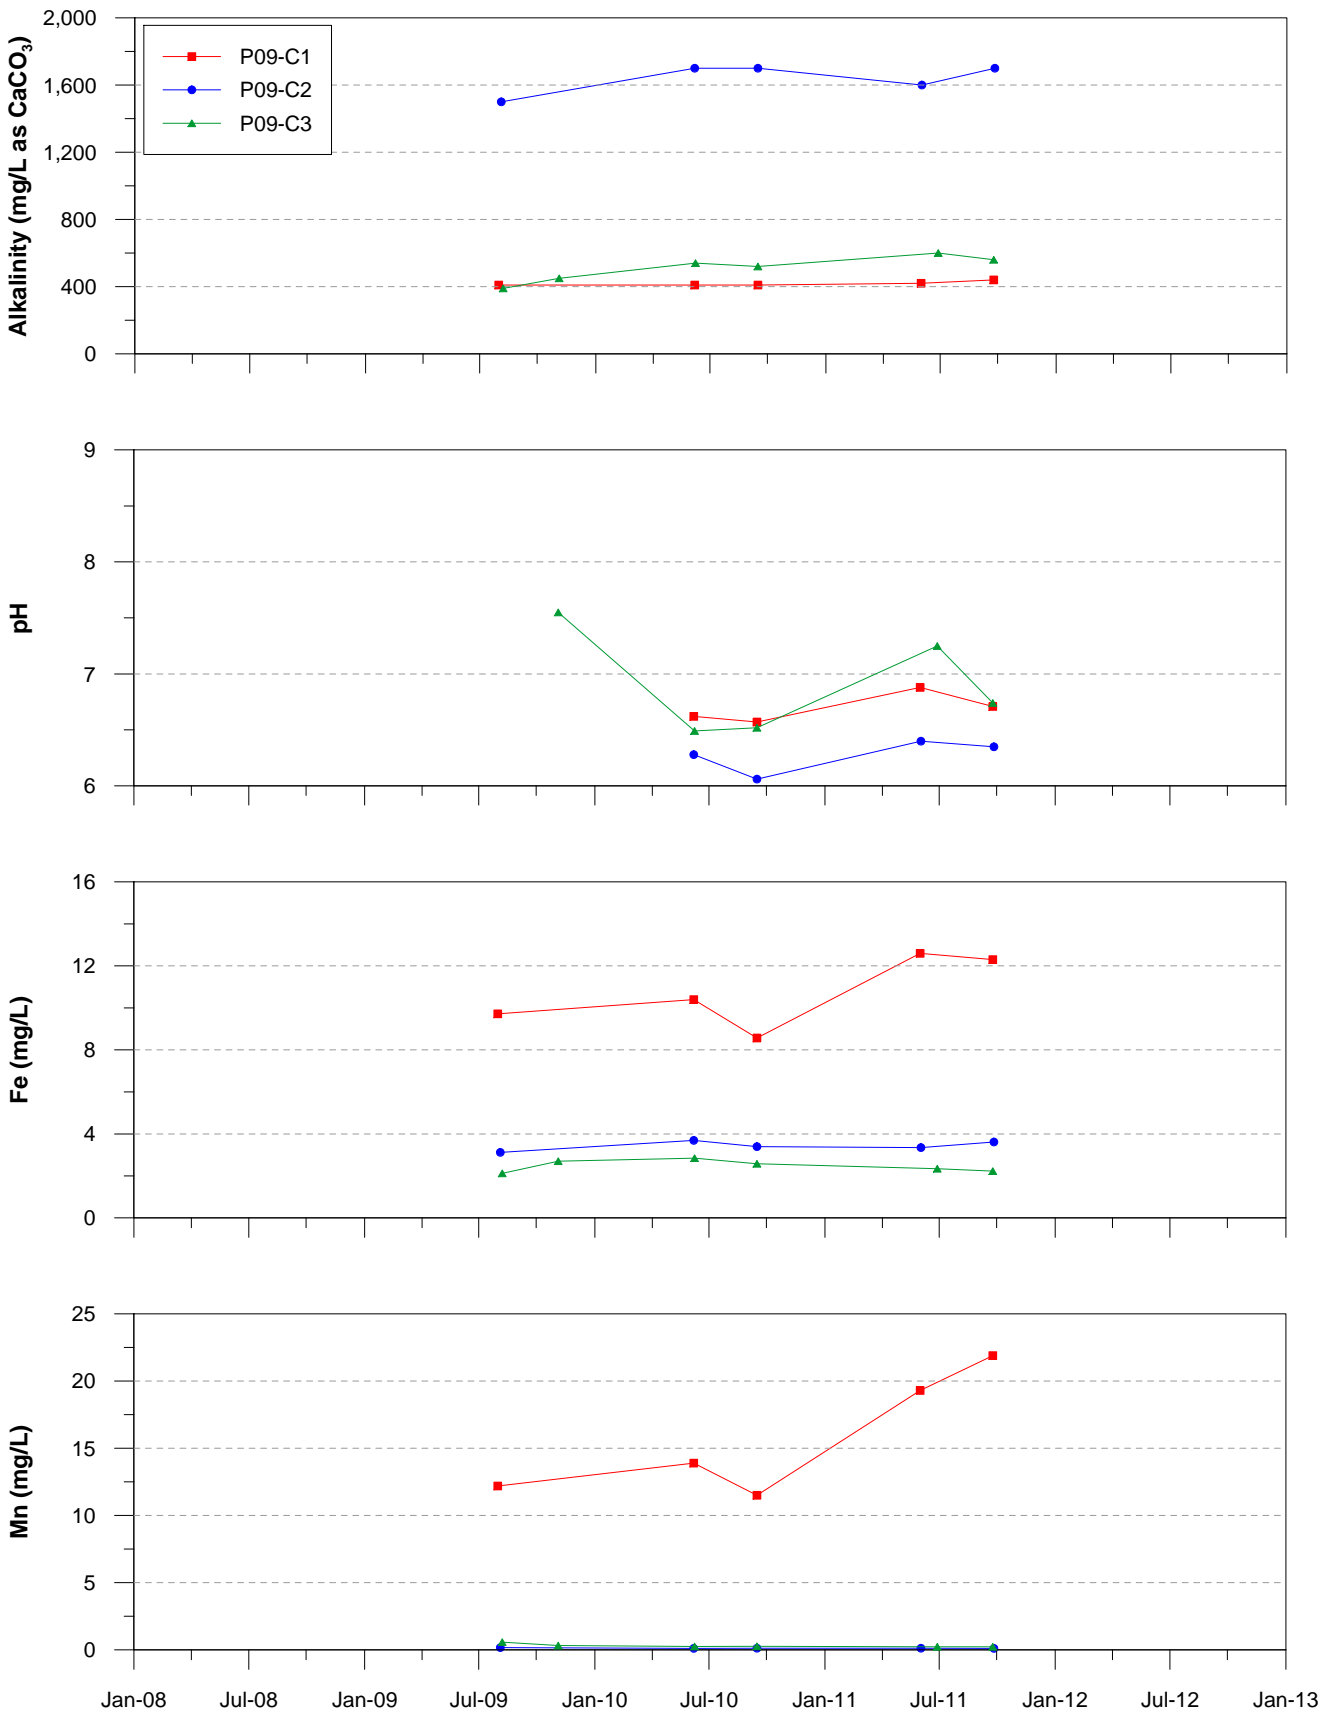
Figure 3-18b. Time trends for alkalinity, pH, Fe and Mn in wells at the toe of Cross Valley Dam

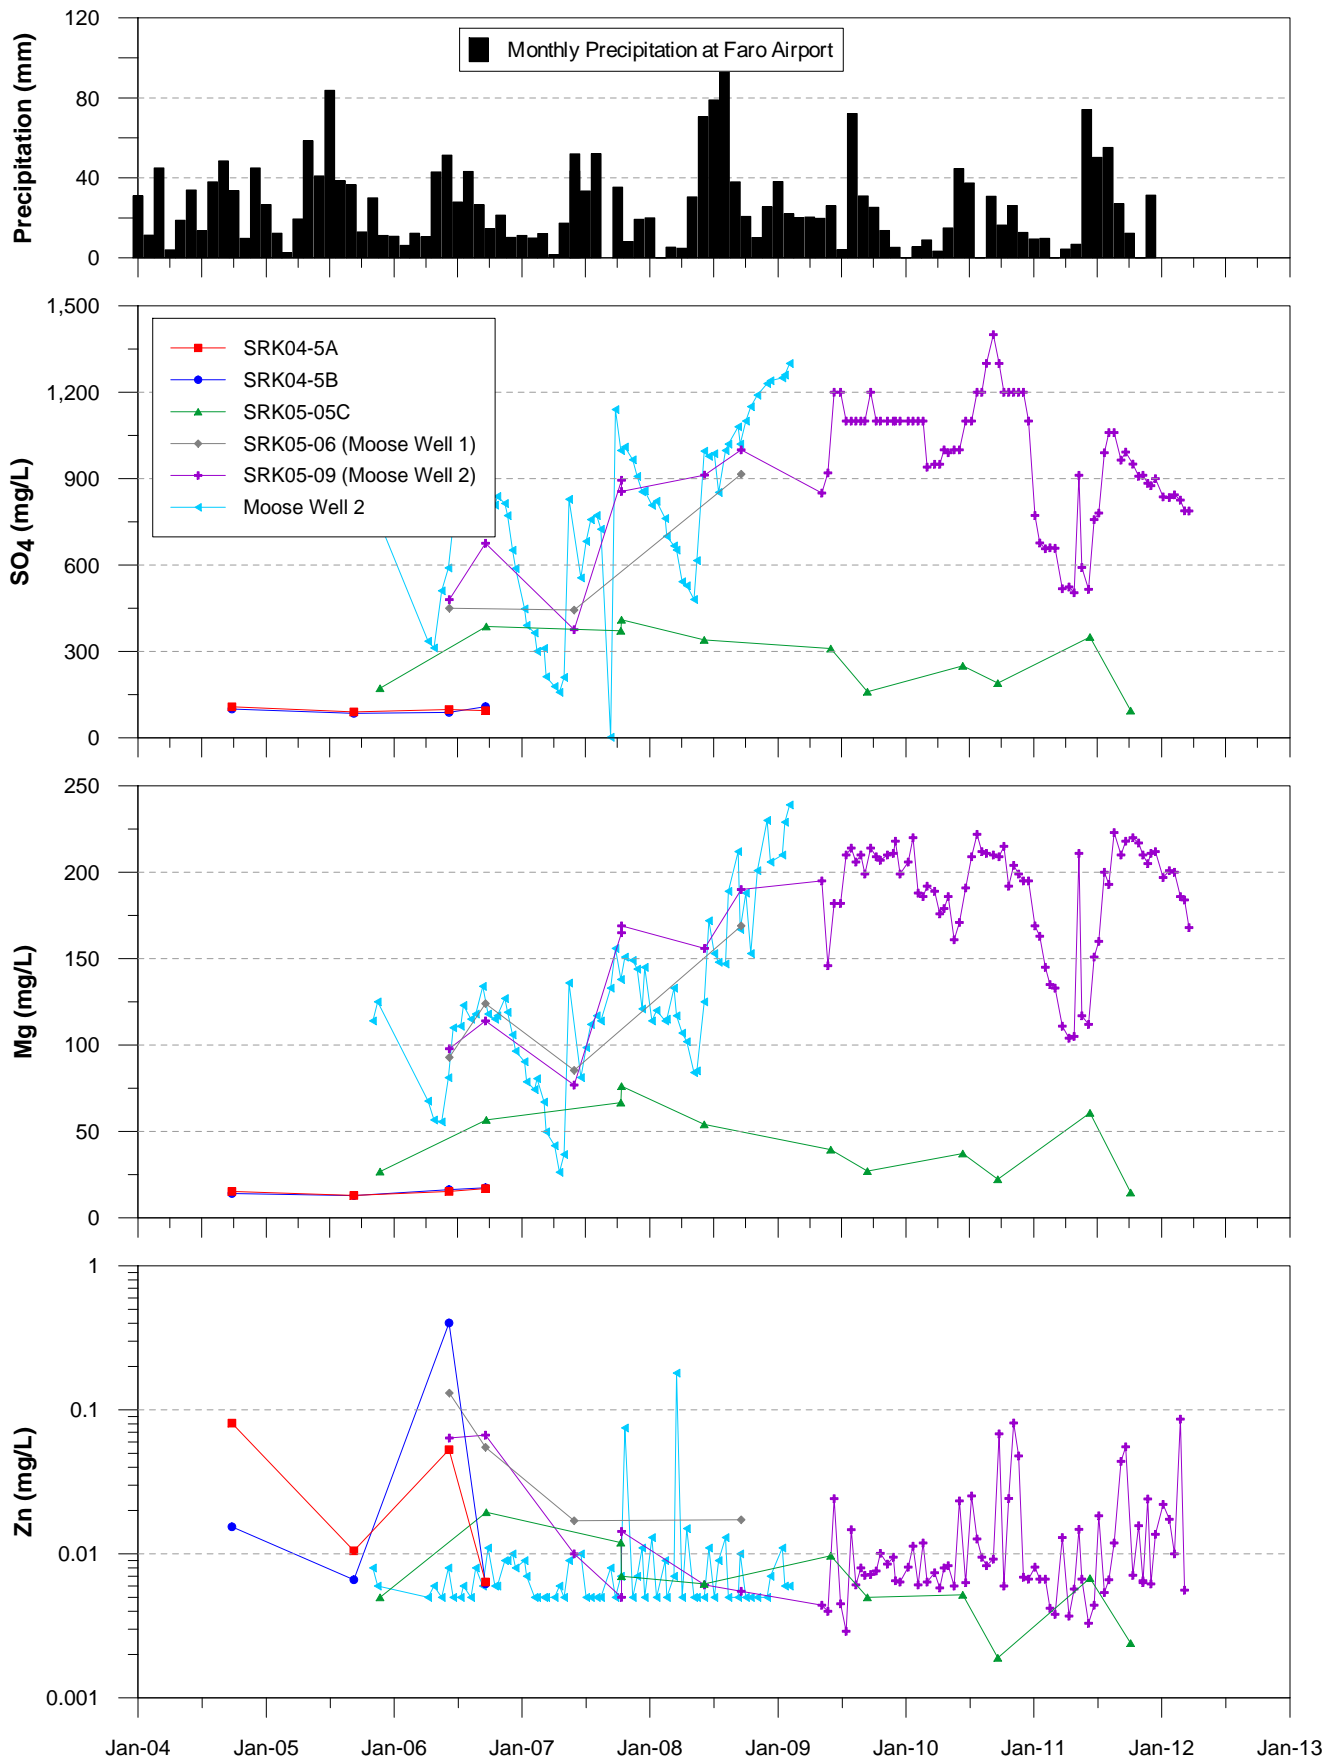
Time trends for pH, alkalinity, selected major ions, and metals of interest for the monitoring wells located near Grum Creek and downgradient of the Moose Pond are shown in Figure 4-3a/b.

At well SRK05-09 ("Moose Well #2"), SO₄, Mg, and alkalinity concentrations decreased significantly in early 2011 due to spring recharge before recovering somewhat by mid-summer. The overall trend for the current monitoring period was, however, towards lower concentrations of major ions. Concentrations of Zn (and other metals of interest) at well SRK09-05 are generally quite variable but there is no trend towards higher concentrations (see Figure 4-3a). Water quality data therefore suggest the breakthrough of conservatively-transported ARD species has occurred but that the leading edge of a metals plume remains upgradient (due to sorption by soils).

Figure 4-3a. Time trends for SO_4 , Mg and Zn in wells in Grum Creek drainage

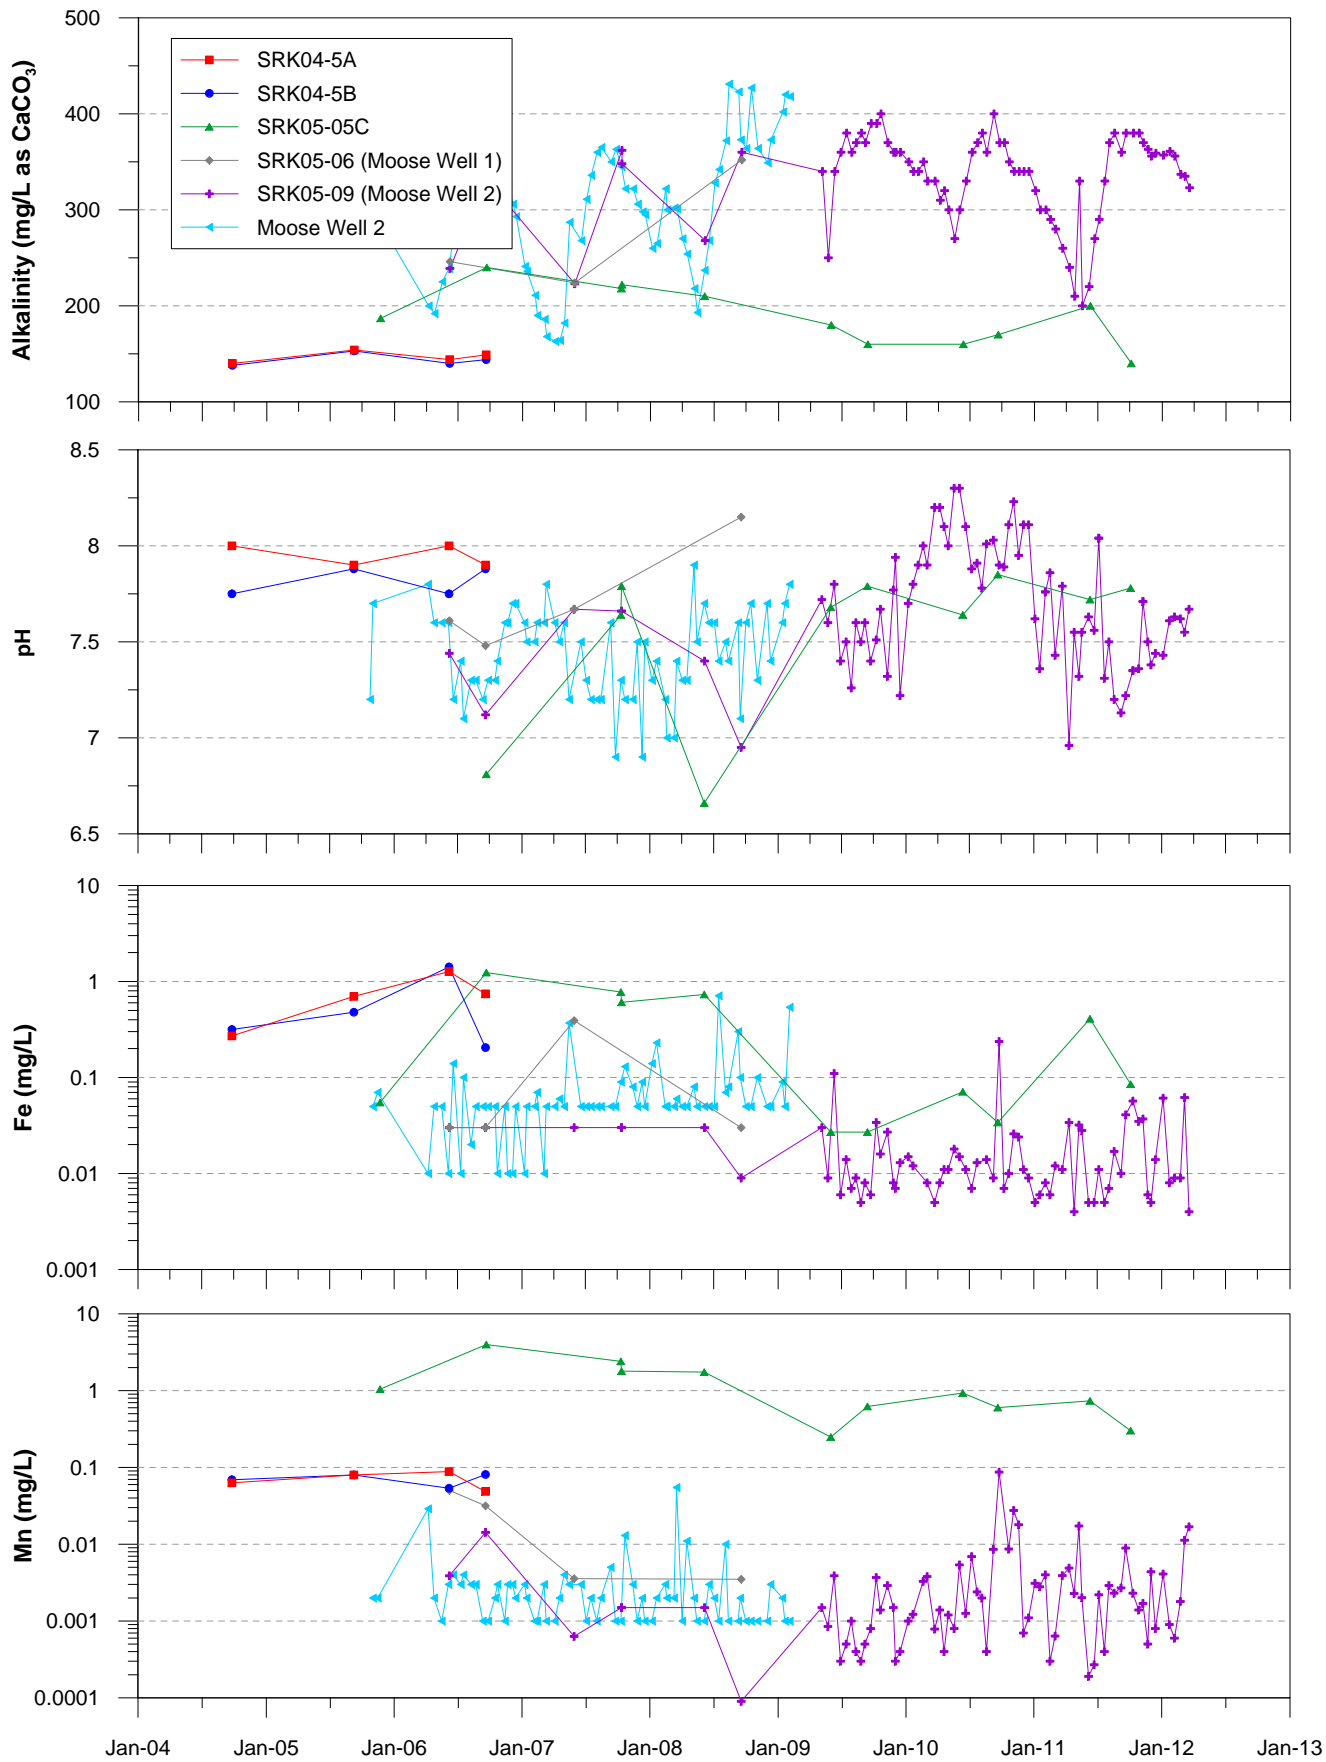
Figure 4-3b. Time trends for alkalinity, pH, Fe and Mn in wells in Grum Creek drainage

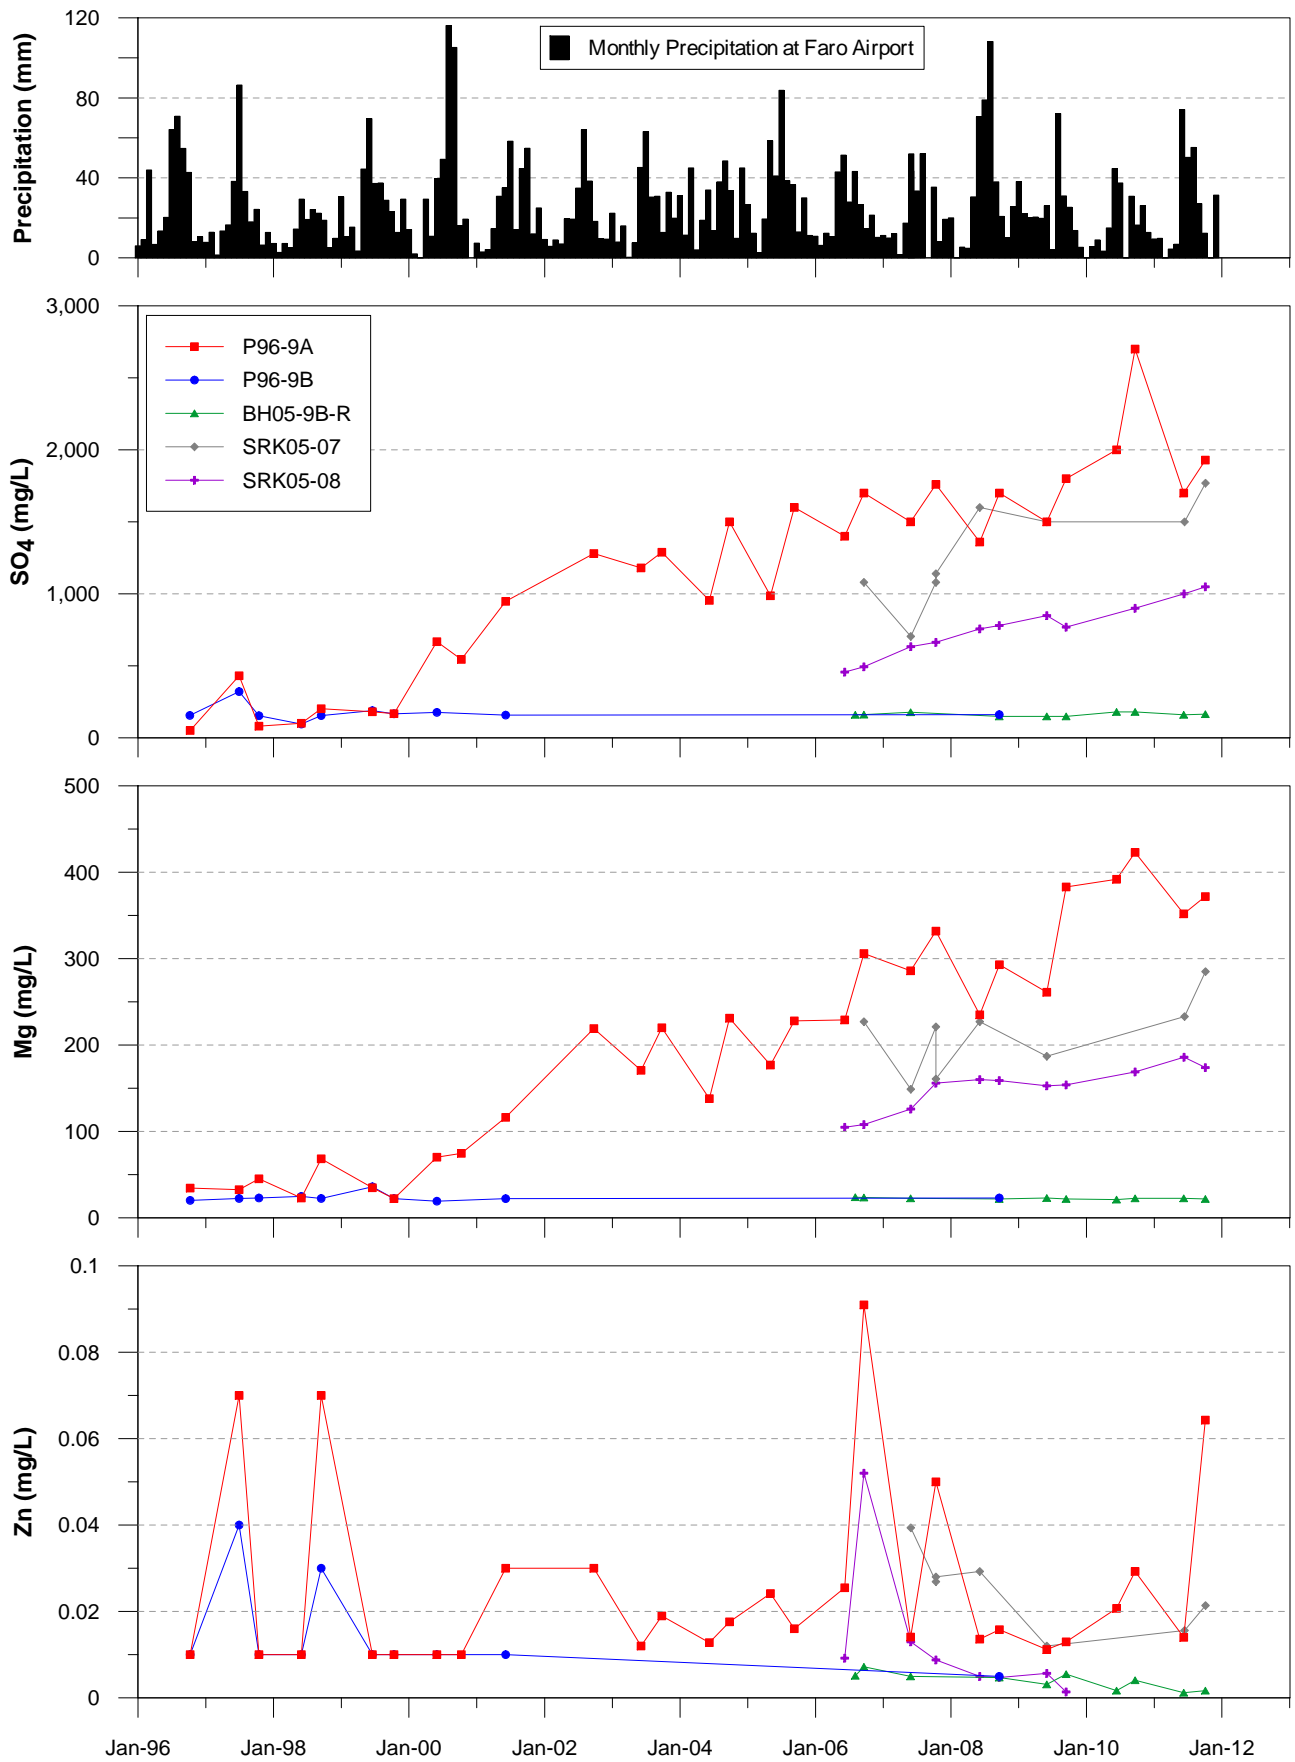
In a nearby side channel from Grum Creek, deeper groundwater (at well BH05-9B-R) remains only modestly-impacted by waste rock seepage (see Figure 4-4a/b). In contrast, groundwater quality in shallow groundwater (at well P96-9A) continued to deteriorate during the current monitoring period suggesting increased flushing of ARD products from the Grum WRD. At present, SO₄ concentrations in groundwater from well P96-9A exceed 2,000 mg/L and Zn concentrations in this shallow occasionally exceed 0.05 mg/L (see Figure 4-4a).

Figure 4-4a. Time trends for SO₄, Mg and Zn in wells located west of Grum Creek
