Report No. 118022/1

**2011 GROUNDWATER QUALITY REVIEW
ANVIL RANGE MINING COMPLEX, YUKON TERRITORY**

June 2012

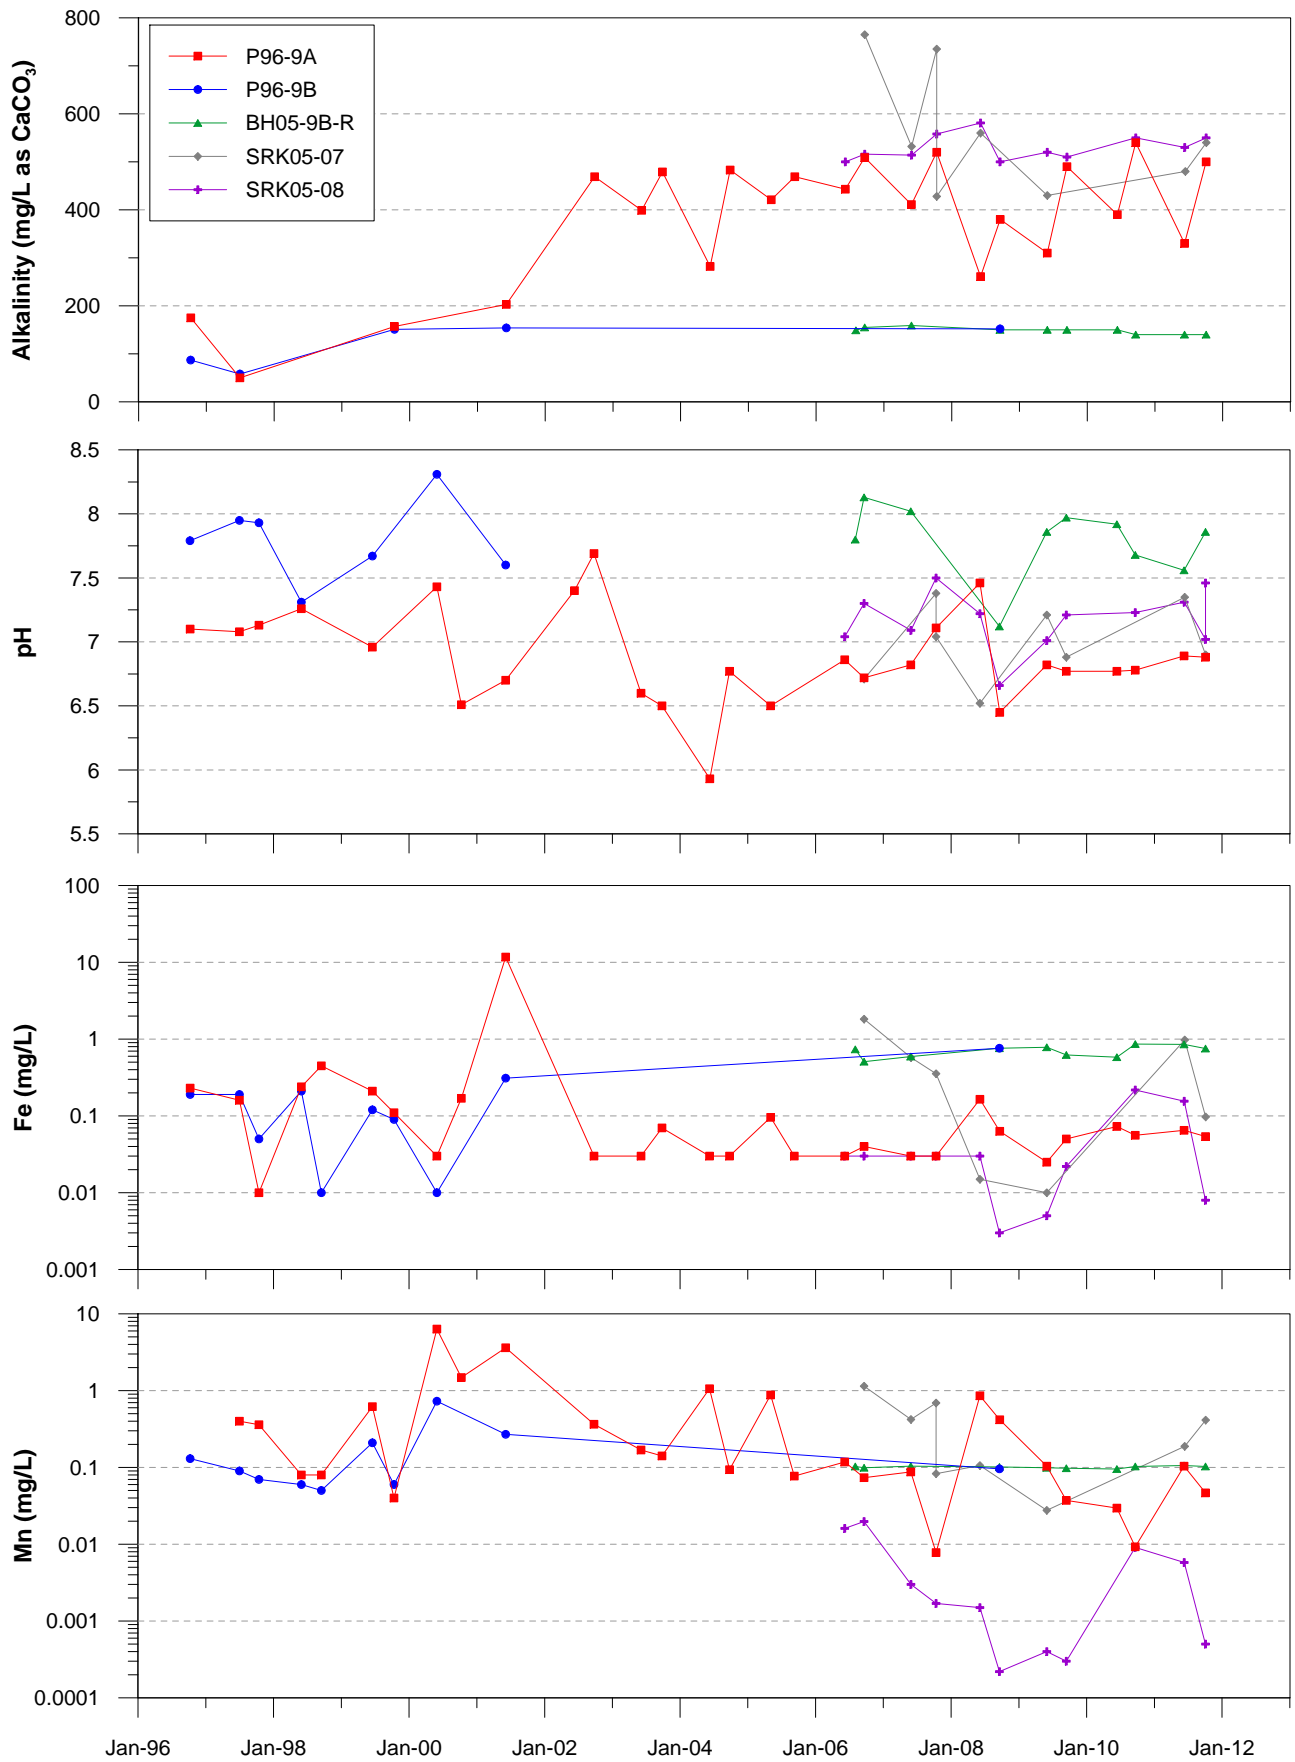
In a nearby side channel from Grum Creek, deeper groundwater (at well BH05-9B-R) remains only modestly-impacted by waste rock seepage (see Figure 4-4a/b). In contrast, groundwater quality in shallow groundwater (at well P96-9A) continued to deteriorate during the current monitoring period suggesting increased flushing of ARD products from the Grum WRD. At present, SO₄ concentrations in groundwater from well P96-9A exceed 2,000 mg/L and Zn concentrations in this shallow occasionally exceed 0.05 mg/L (see Figure 4-4a).

Figure 4-4b. Time trends for alkalinity, pH, Fe and Mn in wells located west of Grum Creek

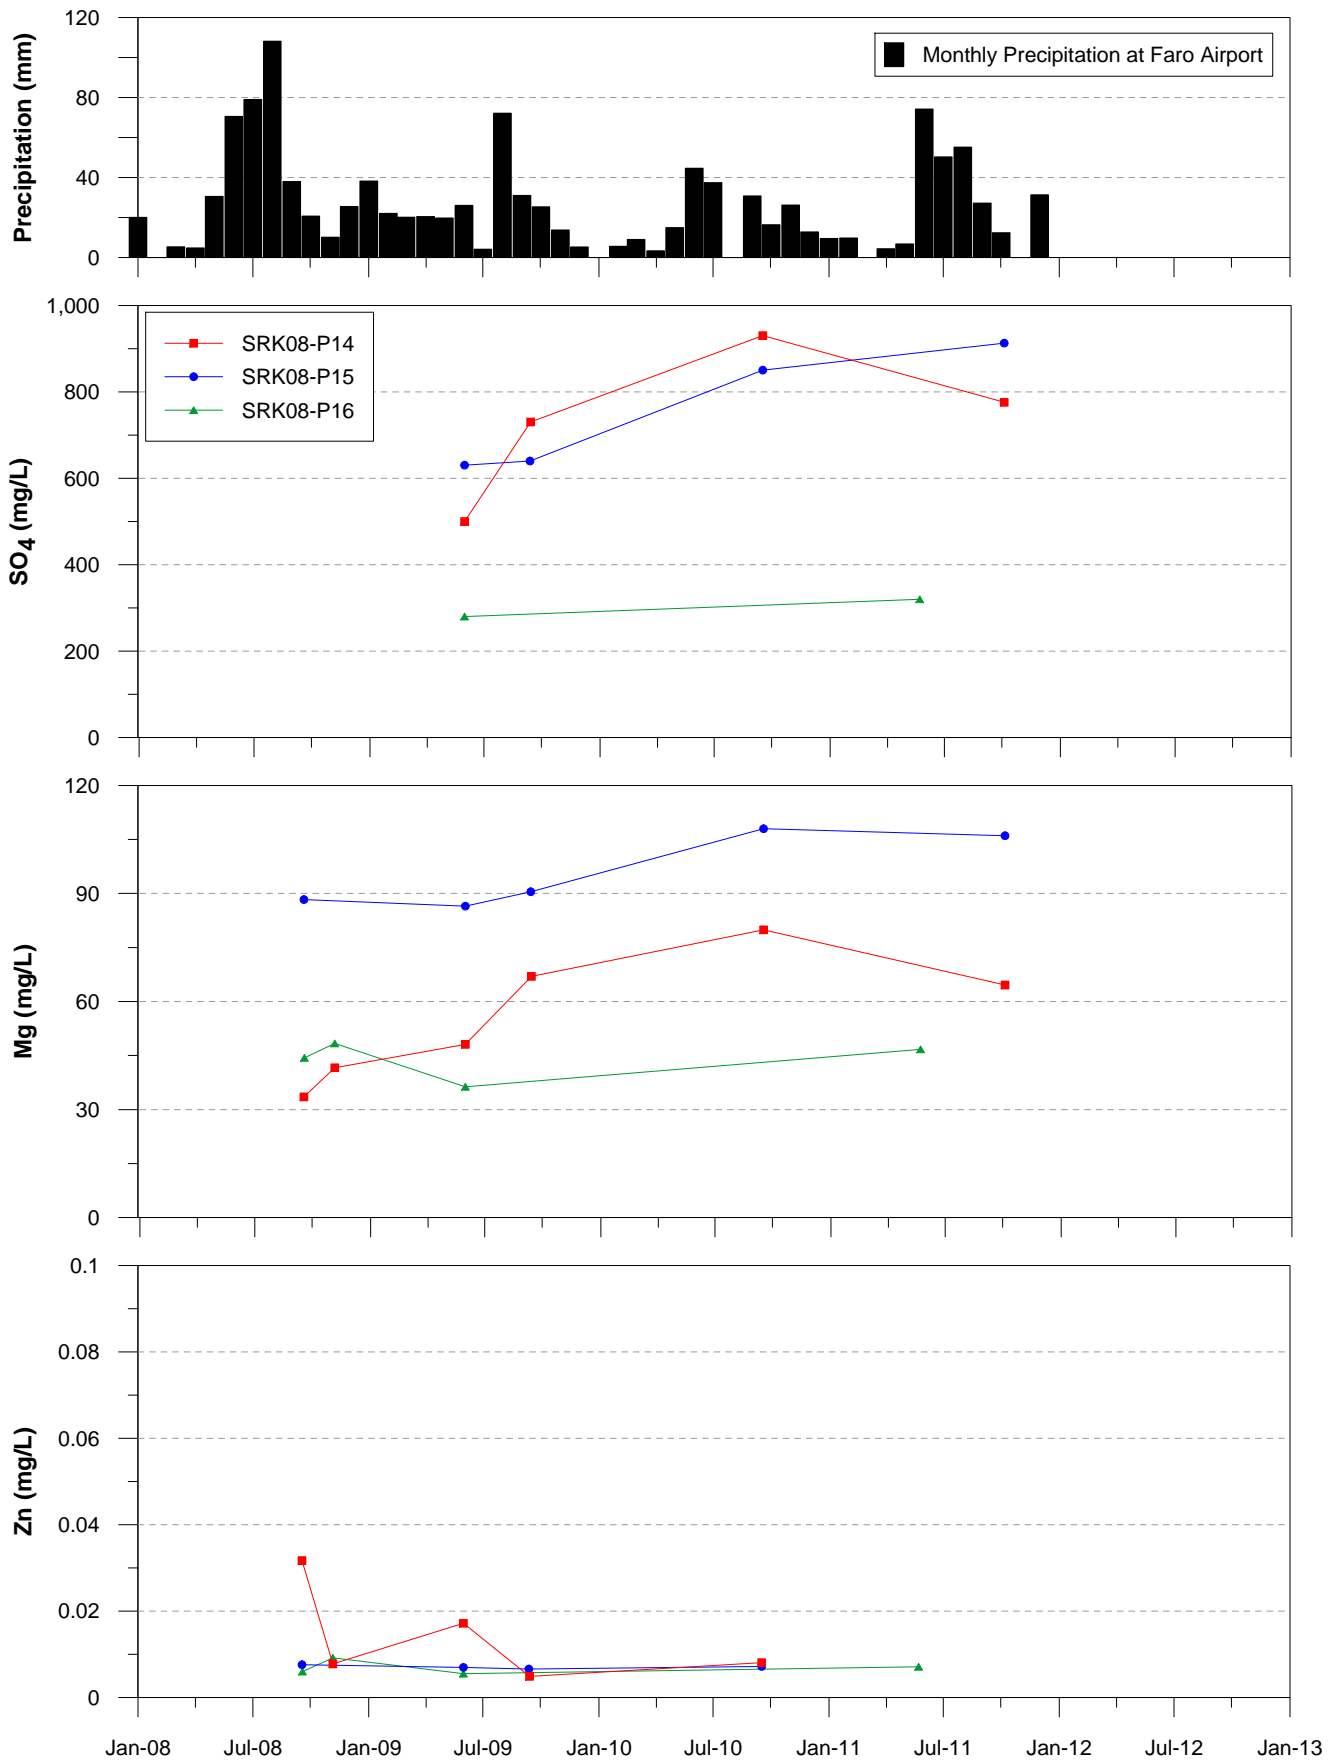
Wells P09-GW1 and P09-GW3 were not sampled during the current monitoring period due to insufficient water. Results from November 2009 suggest that groundwater in the vicinity of well P09-GW1 is moderately-impacted by ARD but that metals concentrations are relatively low. Groundwater along the western toe of the Grum WRD therefore appears to be impacted by a 'TDS front' but does not yet receive a substantial load of metals. Conditions are similar near the southwest toe of the Grump WRD (monitored by SRK08-P14 to -P16), as this area also features a gradual breakthrough of a TDS plume but the breakthrough of metals in groundwater has not yet occurred (see Figure 4-5c/d).

Figure 4-5c. Time trends for SO₄, Mg, Na and Zn in SRK08 wells located southwest of Grum Dump

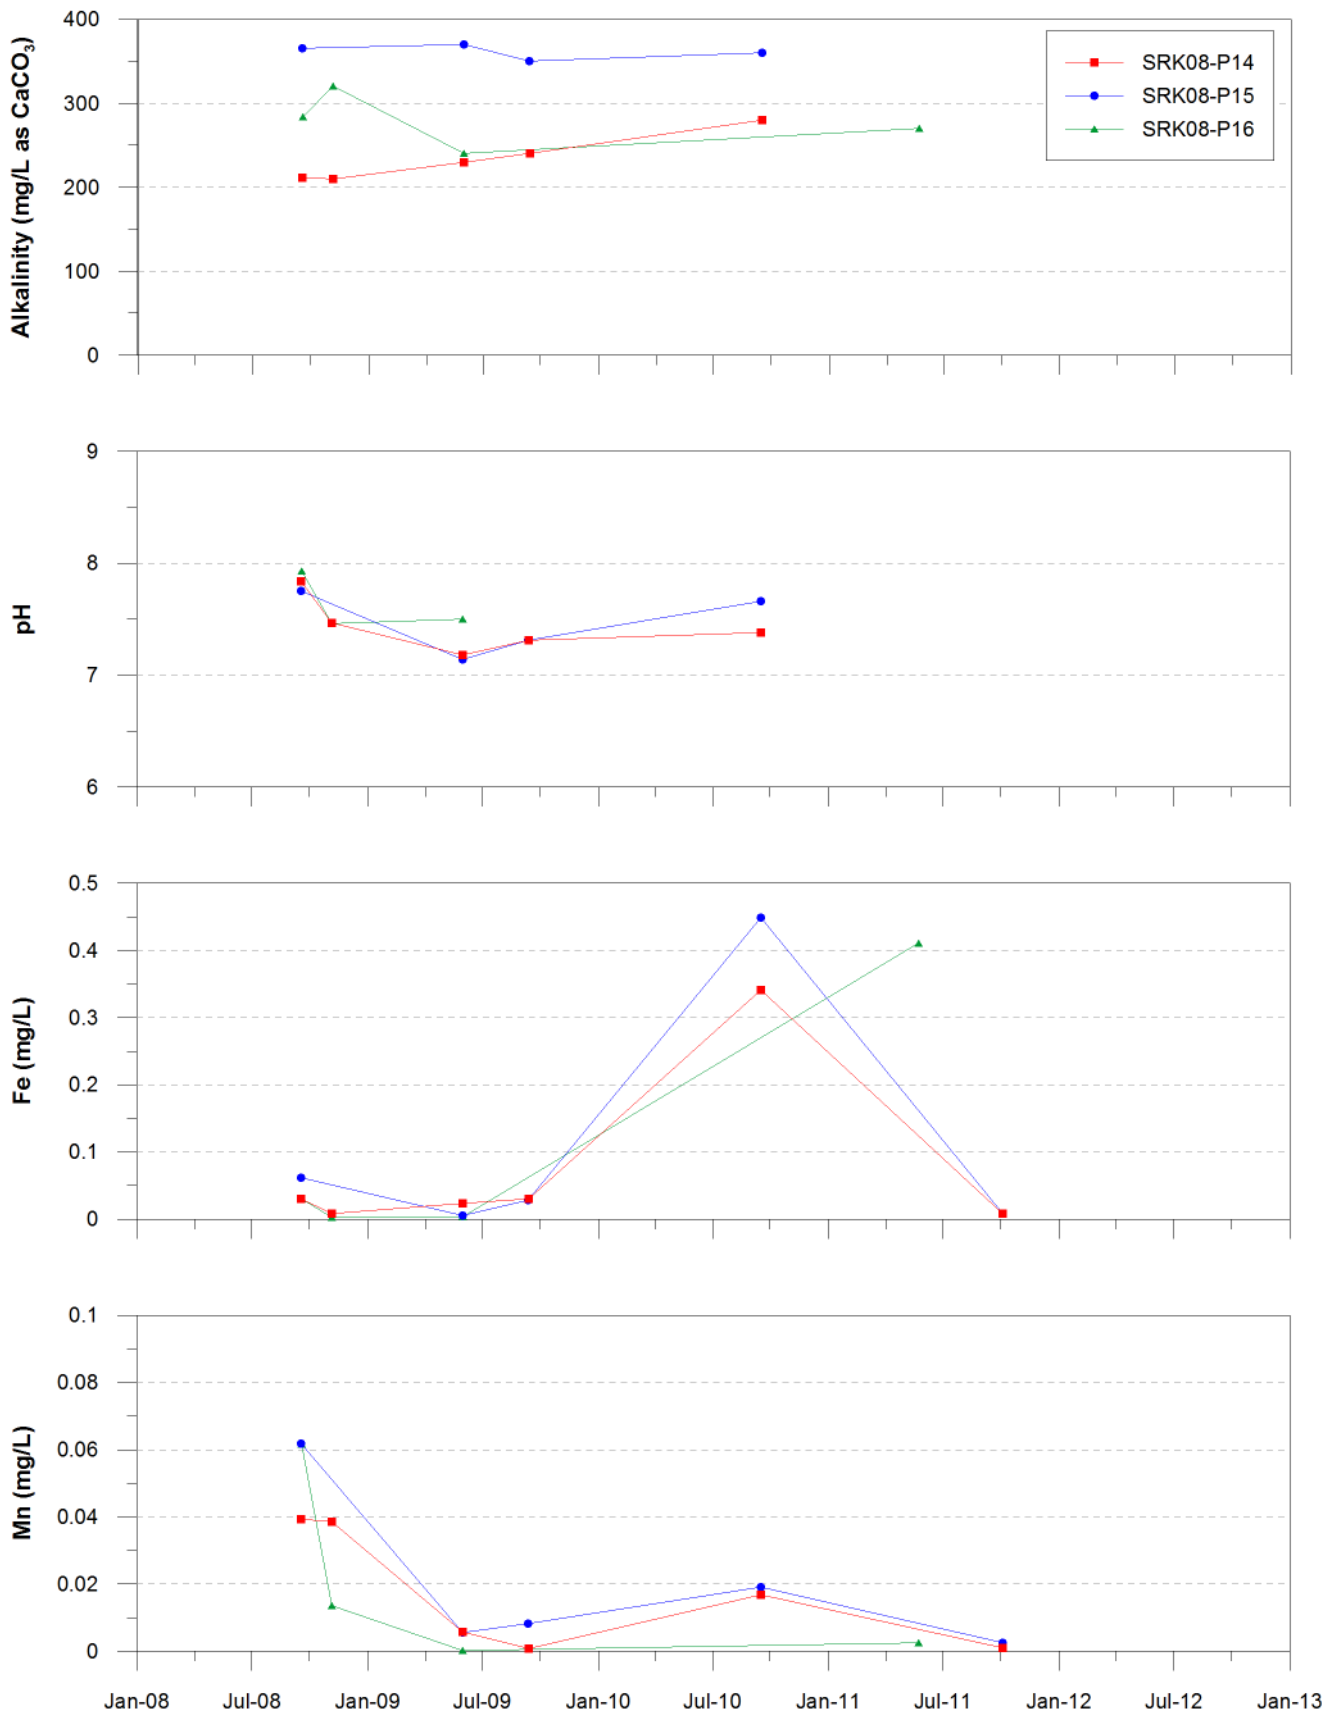
Figure 4-5d. Time trends for alkalinity, pH, Fe and Mn in SRK08 wells located southwest of Grum Dump

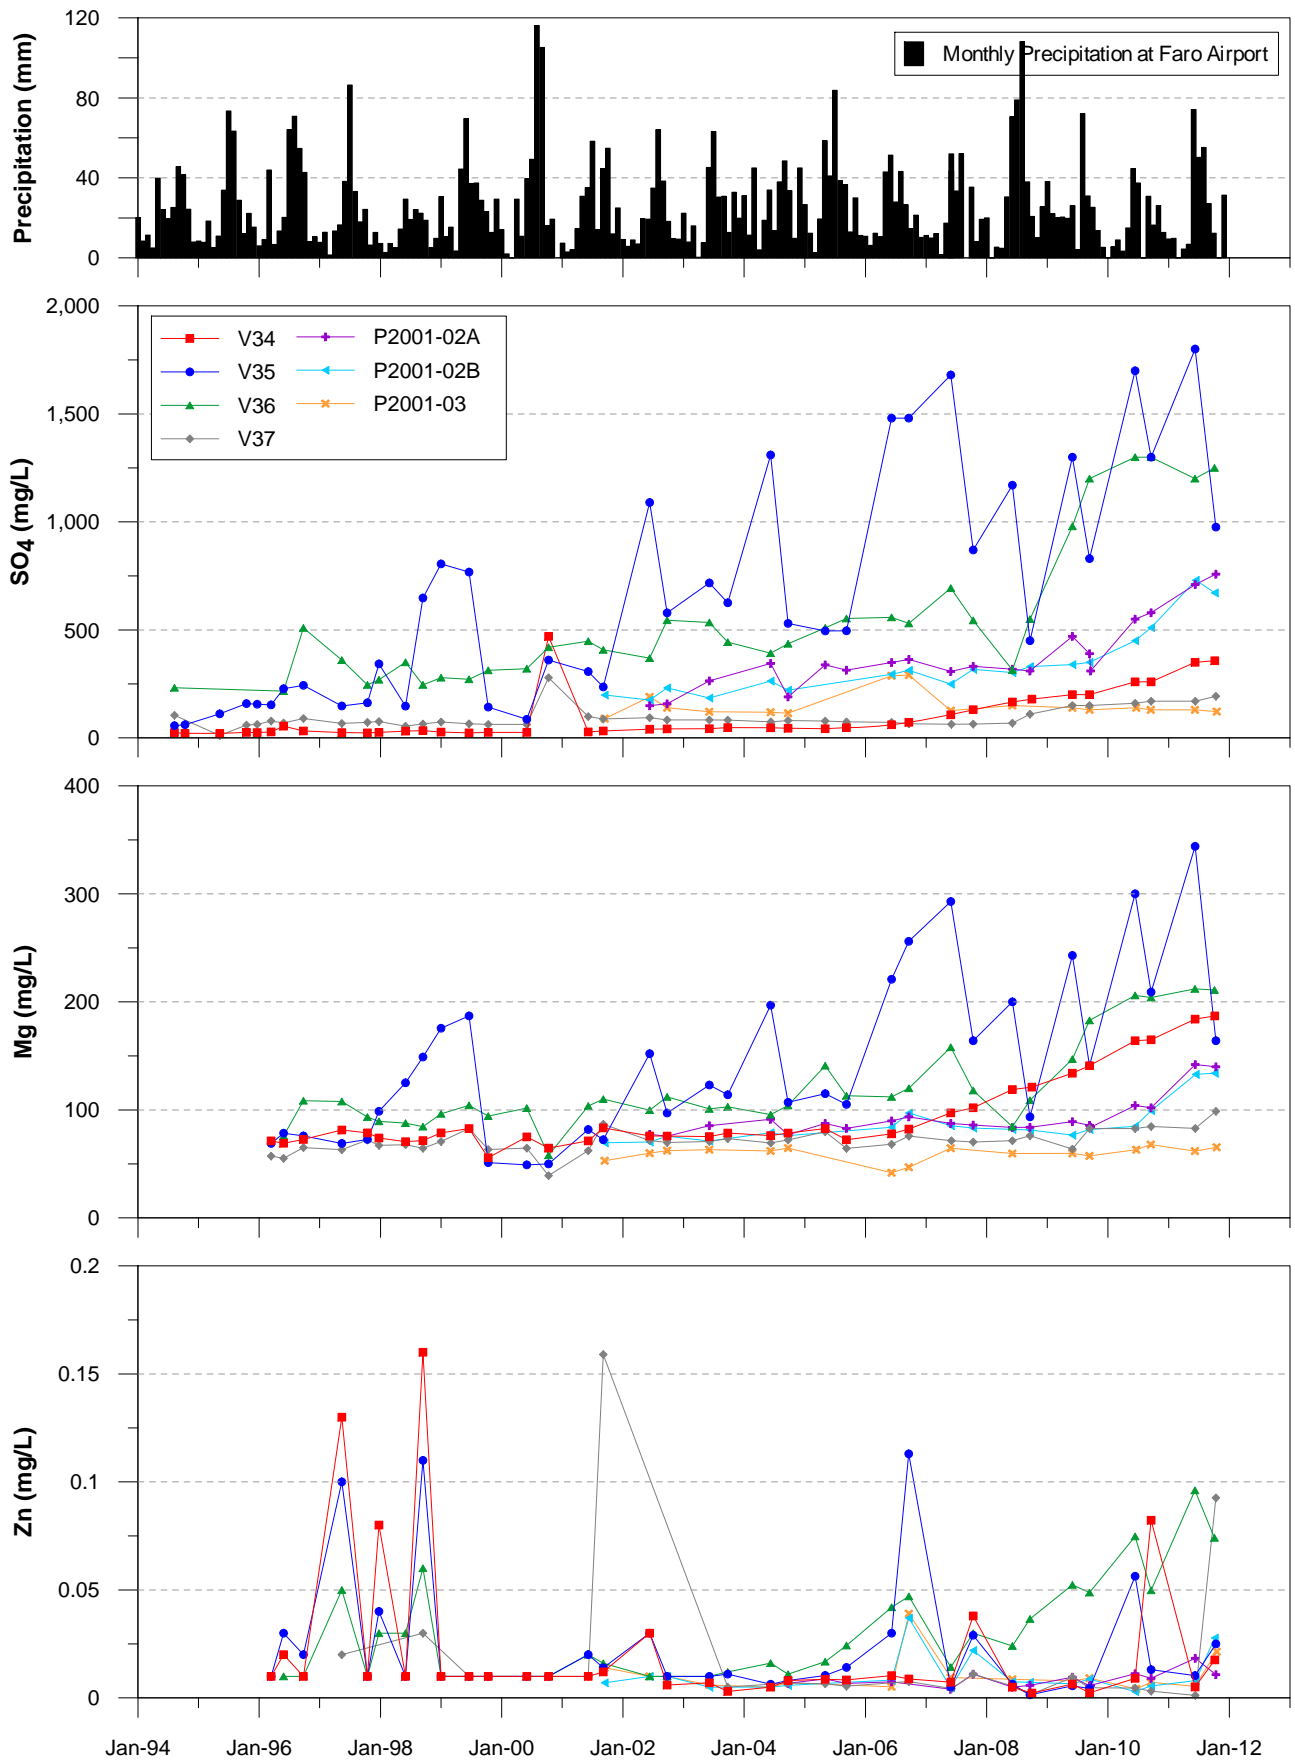
SO₄ and Mg concentrations in most of the wells located in this area have increased over the last five years (see Figure 4-7a/b). Zn concentrations (and other metals of interest) have generally remained low during this period (except near the western toe of the dump at well V36), suggesting that only the breakthrough of a TDS plume has occurred. Hydraulic testing in these monitoring wells indicated that V36 is screened in permeable alluvial sediments which would explain the preferred breakthrough of sulphate (and zinc) at this location. It is inferred that seepage from the Vangorda waste rock dump may follow preferred flow paths in this generally low permeability environment.

Figure 4-7a. Time trends for SO₄, Mg and Zn in wells downgradient of Vangorda Rock Dump

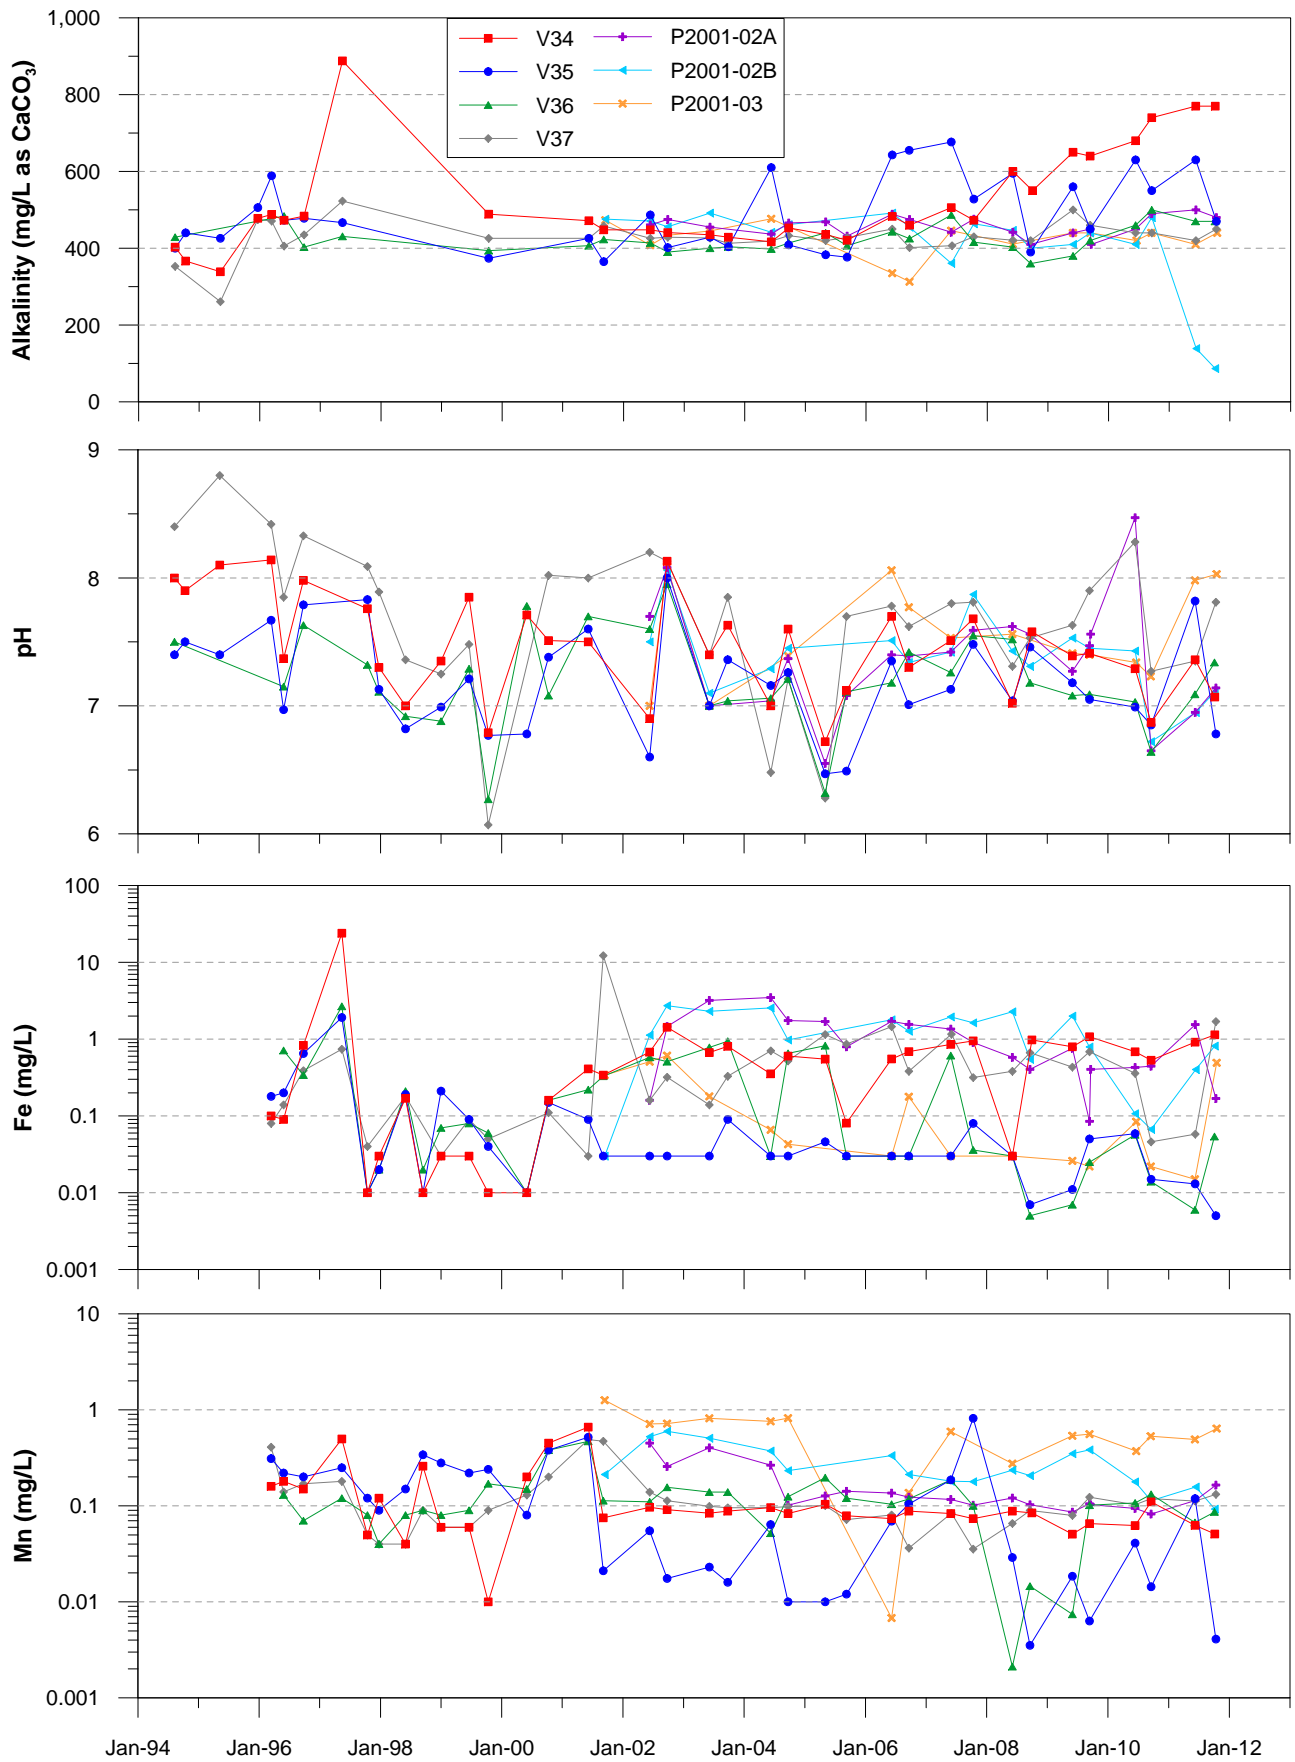
Figure 4-7b. Time trends for alkalinity, pH, Fe and Mn in wells downgradient of Vangorda Rock Dump

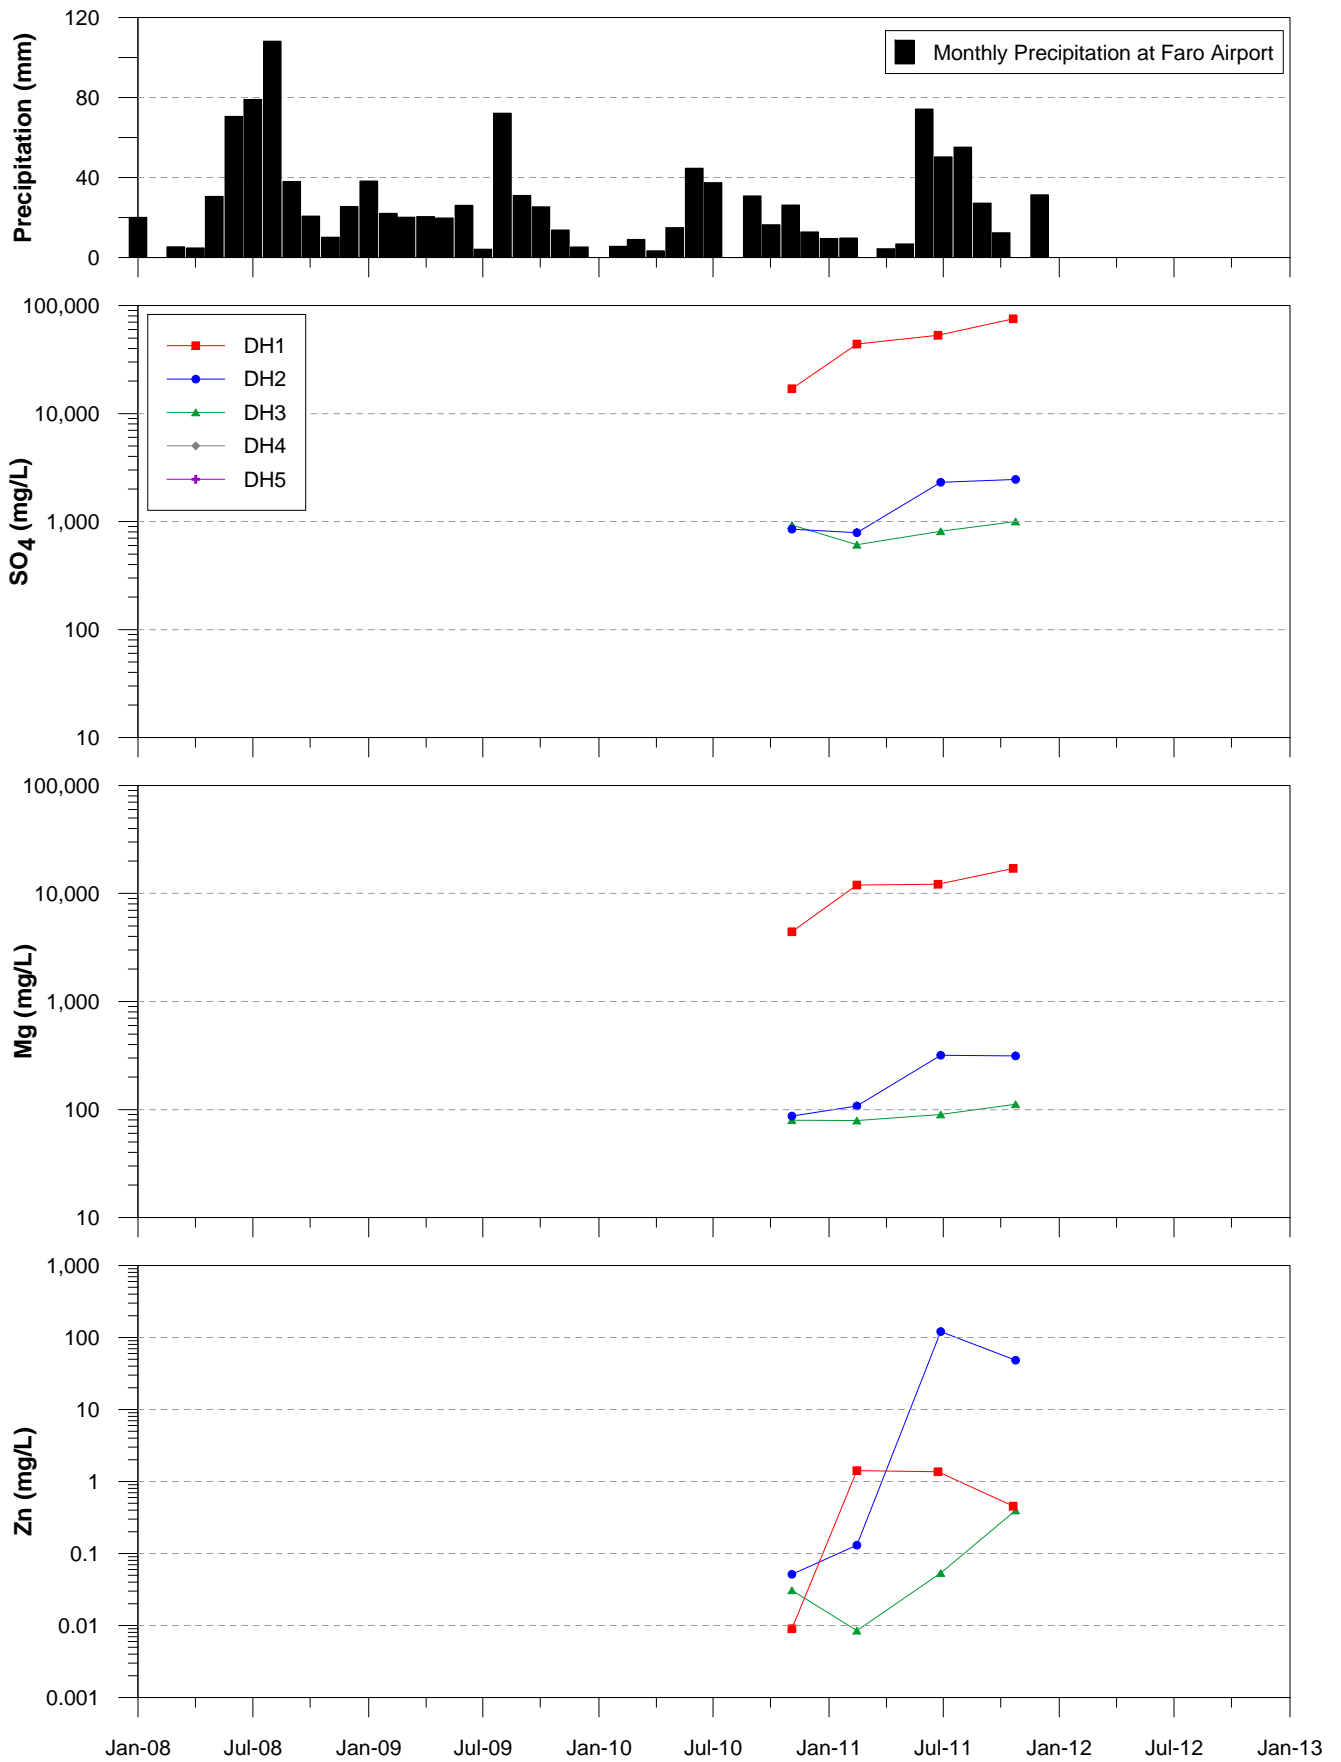
Seepage water quality at DH1, DH2, and DH3 deteriorated during the current monitoring period (see Figure 4-8a/b). These recovery wells are screened in low-K till beneath the Vangorda WRD (see SRK, 2011b). High concentrations of SO₄, Mg, alkalinity and selected metals are thought to be characteristic of neutralized waste rock seepage and differences in seepage water quality are attributed to the presence of more 'mature' waste rock seepage in some areas of the Vangorda Dump (i.e. from the sulphide cell).

Figure 4-8a. Time trends for SO₄, Mg, Na and Zn in Vangorda Waste Rock Dump Wells

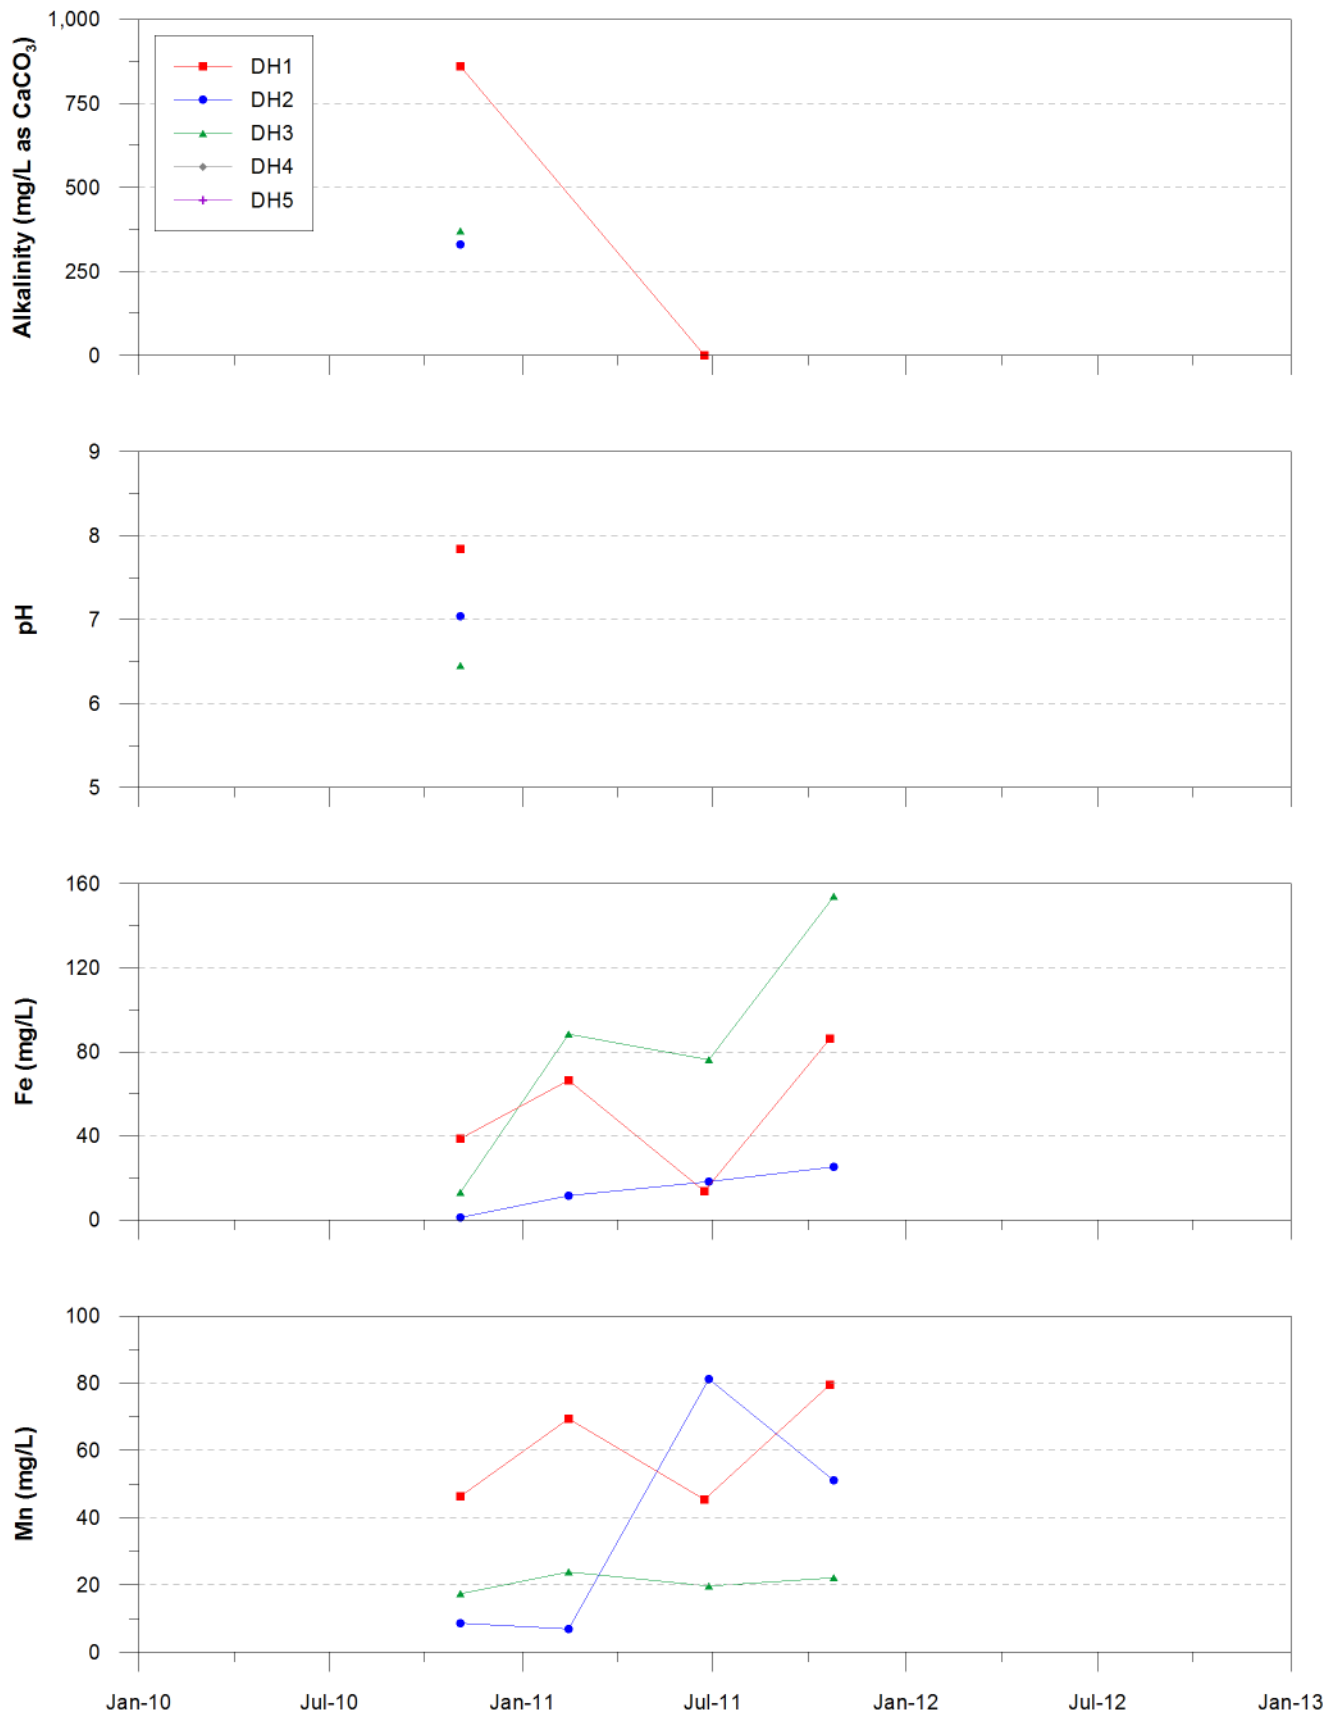
Figure 4-8b. Time trends for alkalinity, pH, Fe and Mn in Vangorda Waste Rock Dump wells
