## **YUKON GOVERNMENT**

### **GRUM SULPHIDE CELL COVER, FARO MINE**

### **2013 REVIEW**

PROJECT NO.: 0533-005  
DATE: December 9, 2013

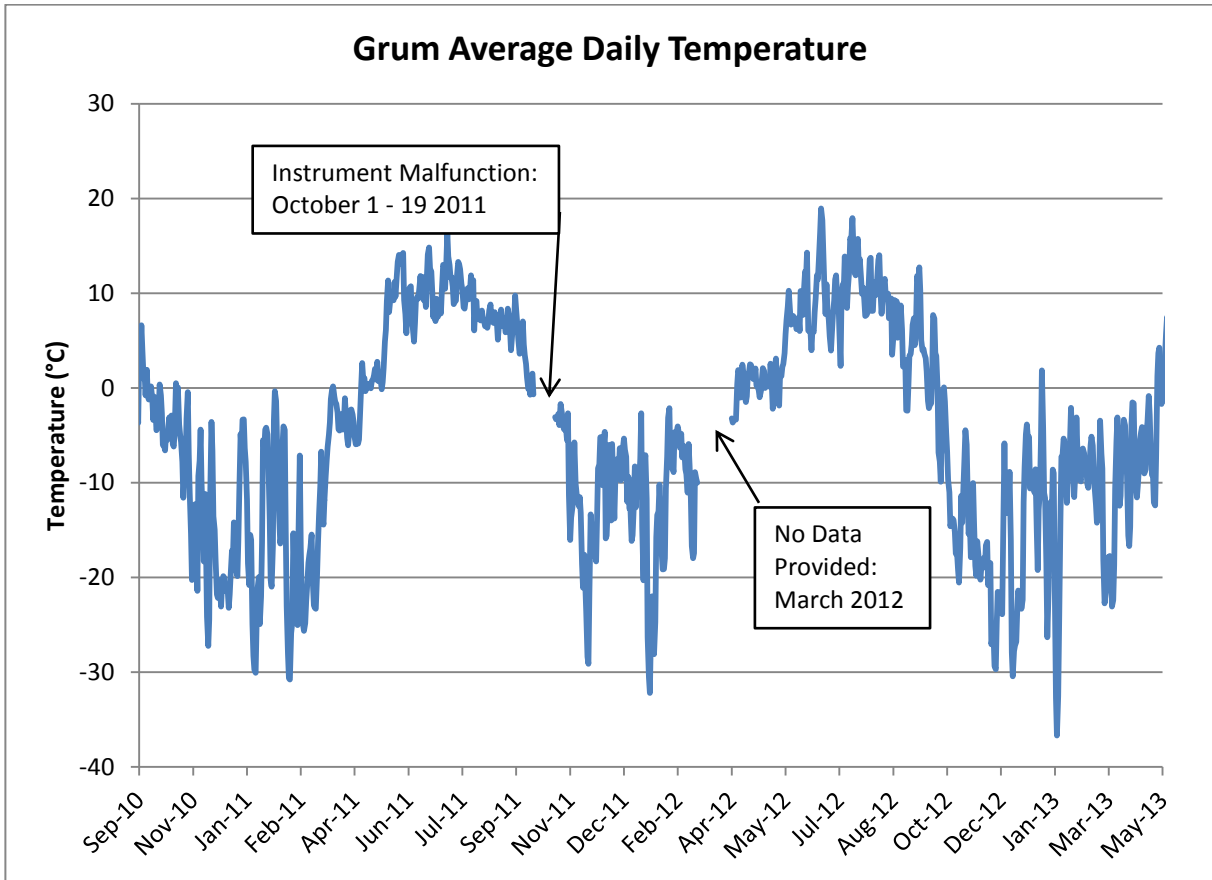
Figure 3-1. Grum Station Average Daily Temperatures

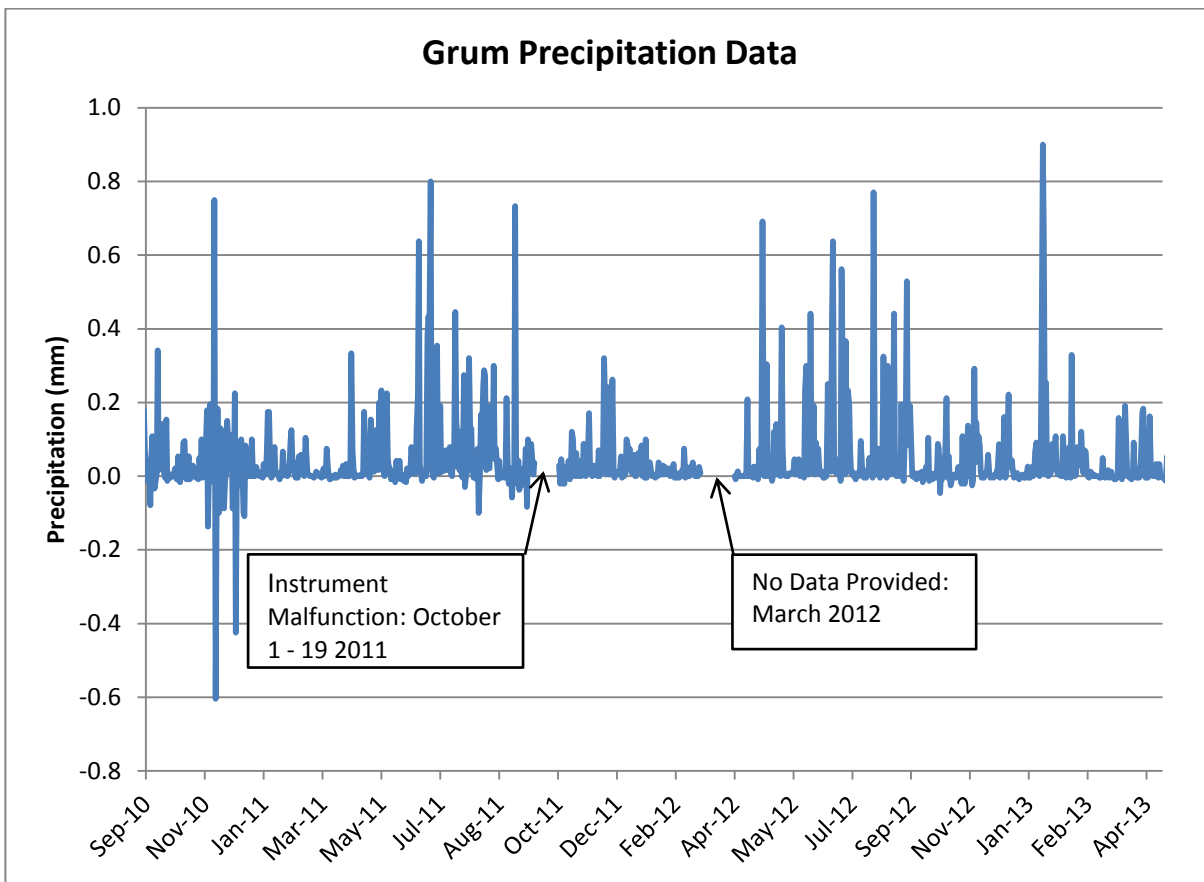
**Figure 3-2. Grum Station Daily Precipitation Values**

Based on subjective review of the data and the plots, there does appear to be a rainfall event that occurred in January 2013. This event may have had implications for the water content of the snow pack, which thawed in May 2013. It is difficult to determine if the winter 2012-13 snowpack was greater than typical, given lack of long term data for this station. Anecdotal information from YG suggest that the snow pack depth and distribution were similar in May 2012 and May 2013. Surficial observations of snowpack depth would not have been able to measure differences on water content of the different snow packs though.

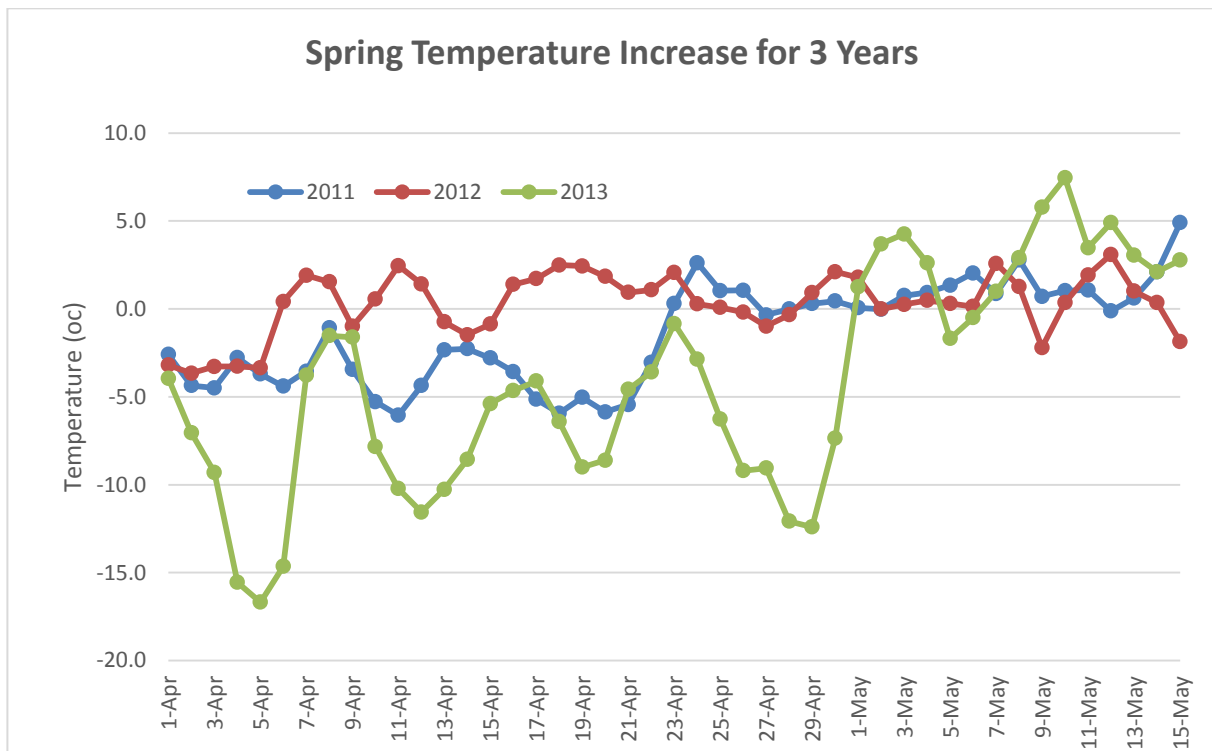
Alternatively, the temperature plot shows that in the springs of both 2011 and 2013, the air temperature rise from subzero to above zero was rather rapid (on the order of four days for 2011 and 2013), resulting in a rapid melting of the snowpack, as shown in Figure 3-3.

**Figure 3-3. Spring Temperature Daily Values for Three Years**

In May 2012 though, the daily temperatures oscillate around zero for weeks (perhaps on the order of 30 days), which may have been partially responsible for a slower melt of the snowpack, releasing run-off at a slower rate. Lastly, based on BGC’s experience on site, sloughs and slumping occurs in cut slopes on the Faro site after late season rainfall the previous fall. This mechanism would certainly lead to increased saturation levels in the subgrade materials, but the current Grum Station data does not provide any convincing

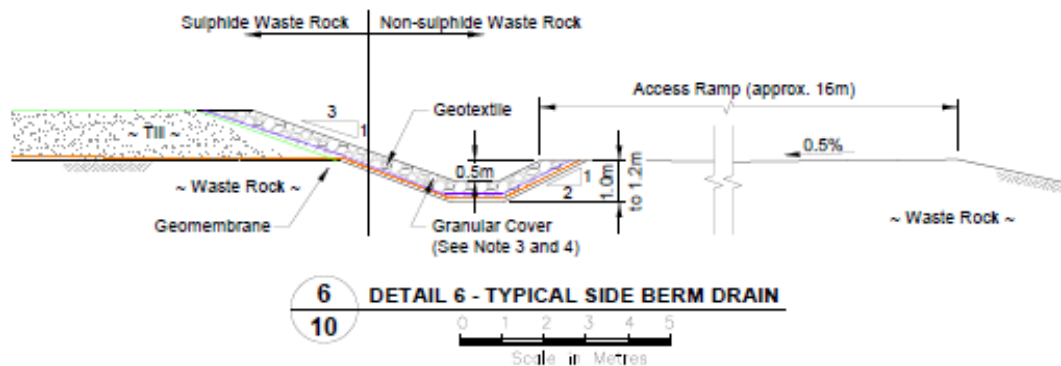
**Figure 3-4. Ditch Section from Drawing G-12 (after SRK 2011)**

The as-built ditch section displays a wide ditch with at least one side slope of 3H:1V. As displayed in Photo 3-6, the side slope for the ditch section is much steeper in select locations, potentially approaching 1H:1V with a narrow bottom width. Such a narrow ditch is more easily blocked by slough material on the “cover” side and there are a few locations where this sloughing has occurred, see Photo 3-6. If this slough does not fully block the channel, it does restrict the flow which would be more easily affected by snow and ice blockages.
