YUKON GOVERNMENT

GRUM SULPHIDE CELL COVER, FARO MINE

2015 REVIEW

PROJECT NO.: 0533-012
DATE: February 29, 2016

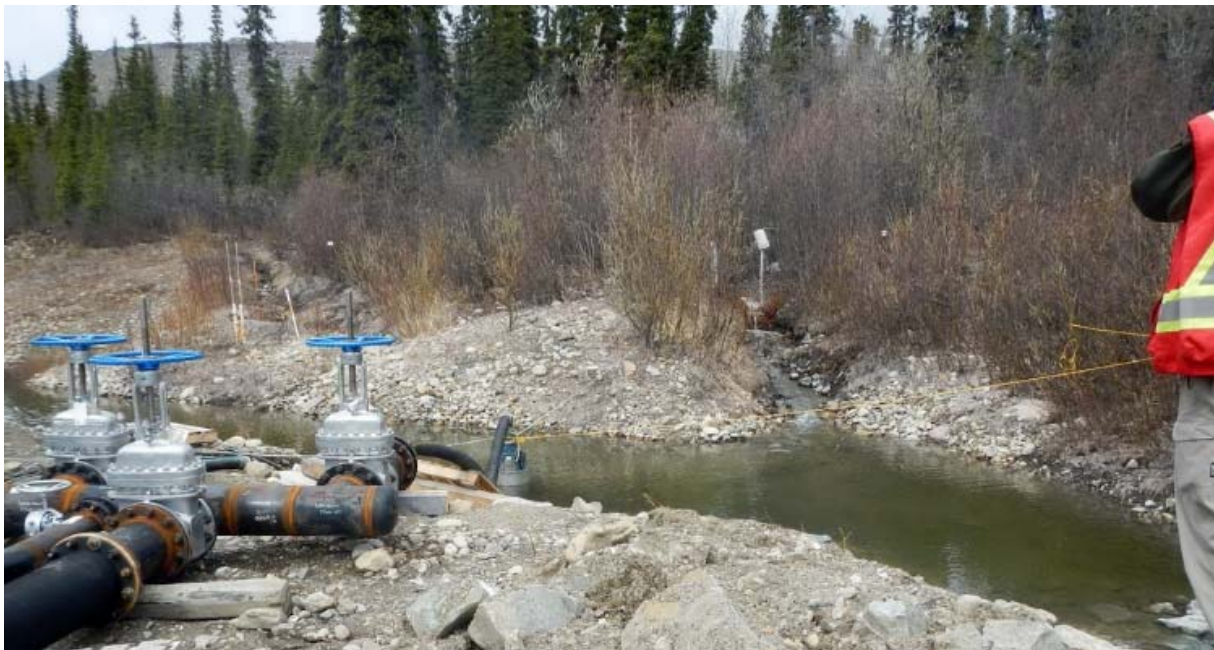
Photo 2-2. View of water collection and pumping elements at Pumping Station V15 at the confluence of V15 seep and Grum Creek seep (May 21, 2014). V15 water comes in from the southwest portion of the dump from the left channel. Grum Creek emerges from under the northeast corner of dump and flows over monitoring location GC Weir (white container marking channel at right-center of photo).

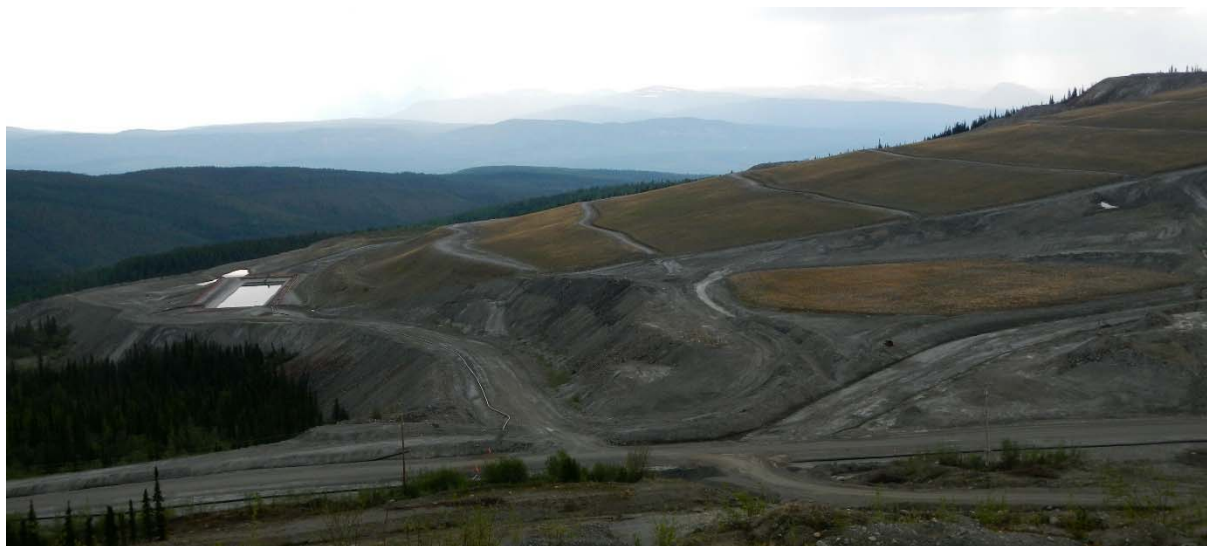
Photo 3-1. View of the lower portion of the GSC cover, with the Vangorda Access Road in the foreground. Vegetation cover now pronounced. Note the water retained in both the Lined and Unlined Ponds located at the toe of the cover (May 26, 2015).

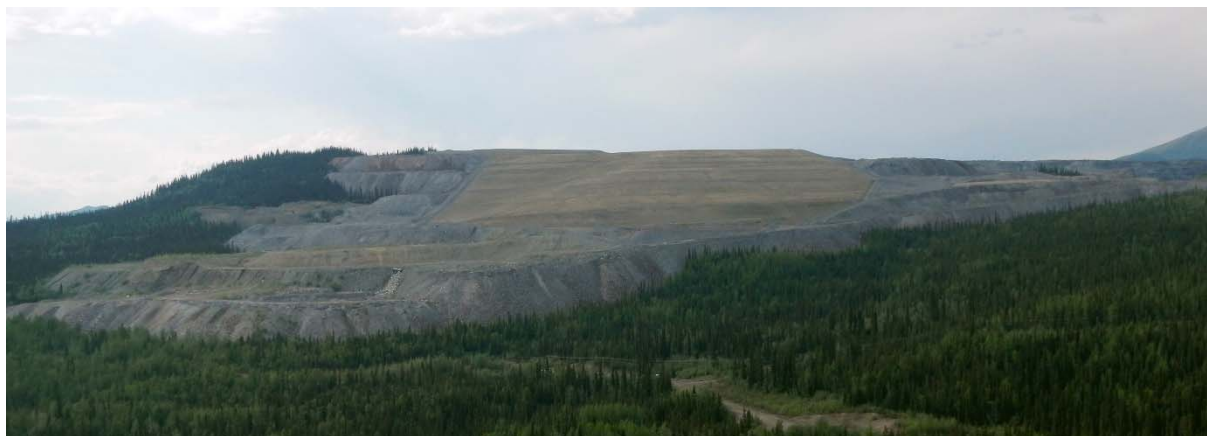
Photo 3-2. View of the GSC cover, taken from the Vangorda Waste Dump. Note the light gray original waste rock surface around the reclaimed olive brown GSC cover (May 26, 2015).

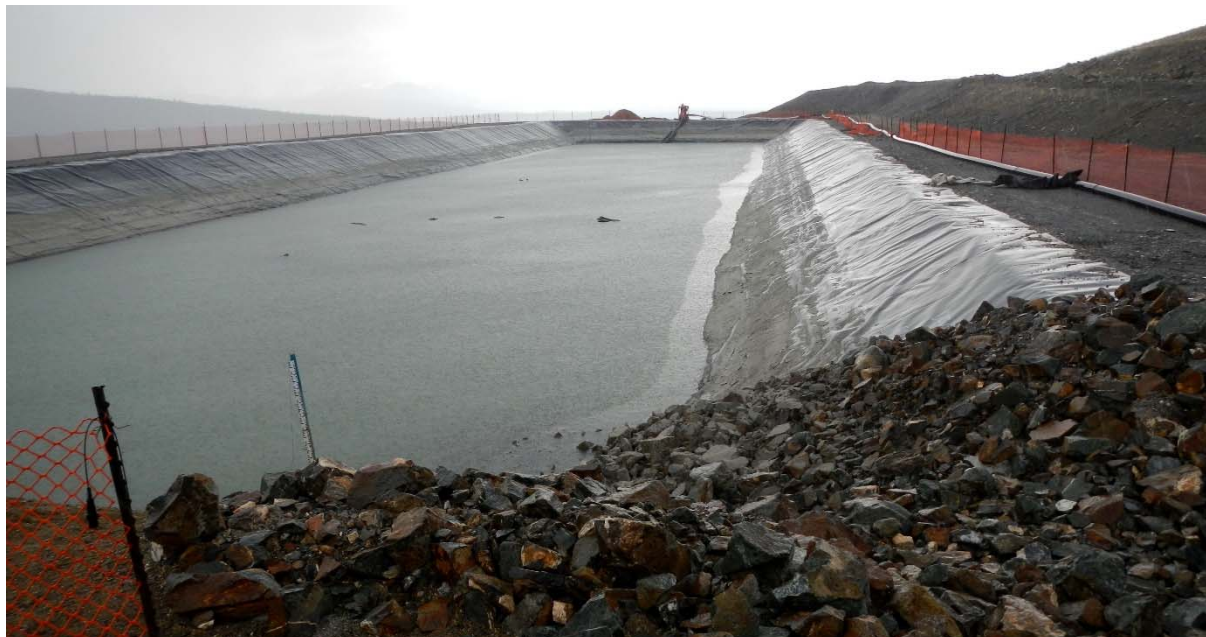
2. Run-off water flowed into the Lined Pond, shown on Photo 3-3, with all collected water pumped to the Vangorda Pit.

Photo 3-3. View of the Lined Pond and staff gauge (May 26, 2016).

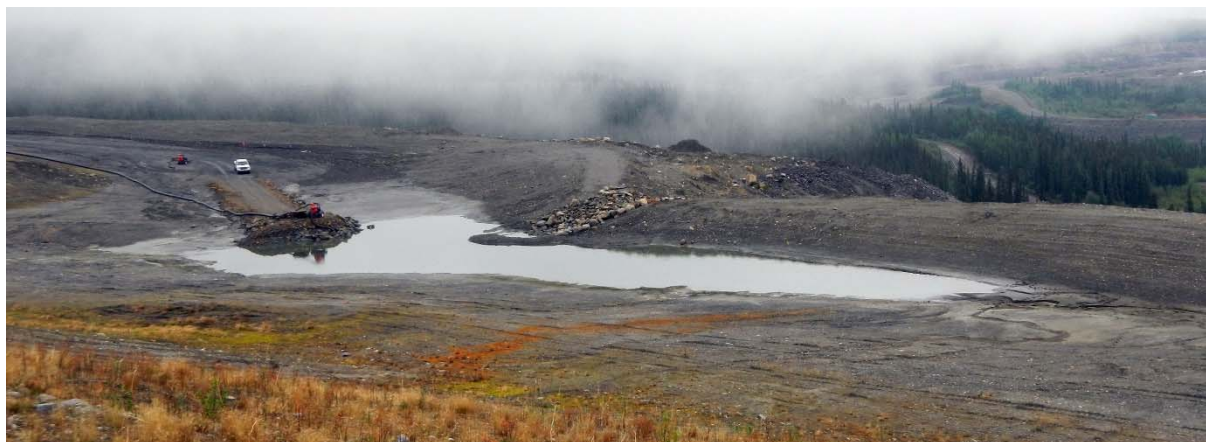
3. Following from that transfer, a small amount of run-off water collected within the Unlined Pond, as shown in Photo 3-4. No surface water was discharged from this pond to the environment.

Photo 3-4. View of the Unlined Pond and associated pump arrangement up to Lined Pond (May 27, 2015).

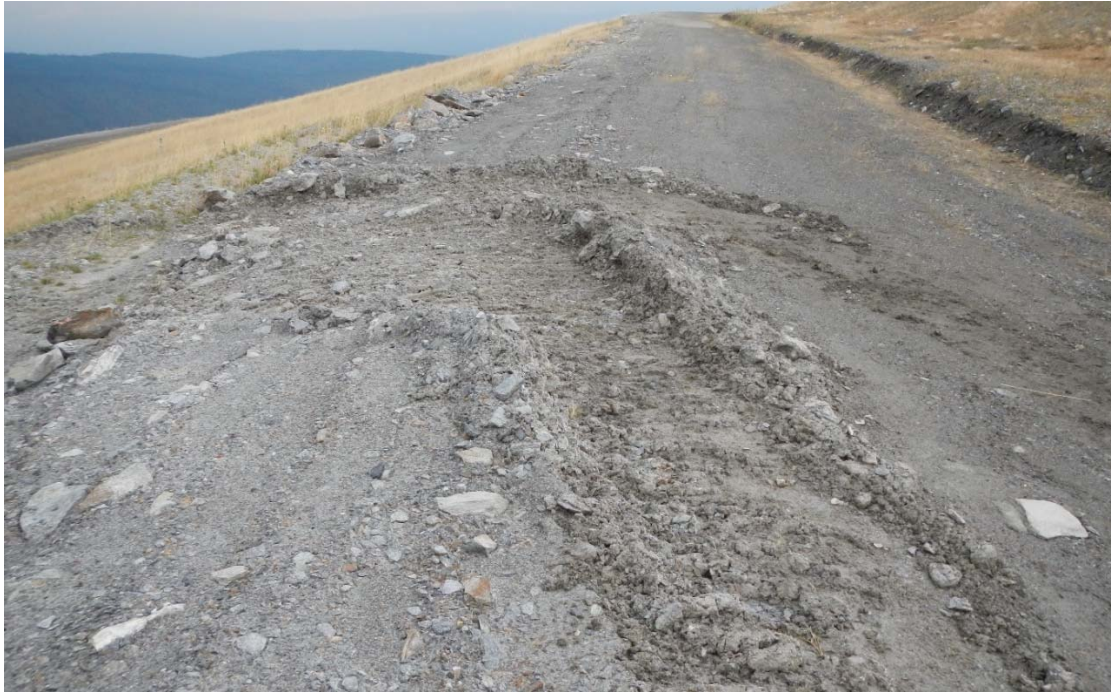
4. It appears that an excavator accessed the GSC cover during thaw season, presumably with the purpose of removing snow blockages from the benches that provide lateral drainage to the two perimeter ditches. Unfortunately, the excavator tracks has impacted the surface grade and vegetation cover on the first bench (all references from the top), third bench and fourth bench and regrading is necessary. In addition, soil backfill was placed within the East Access Ditch concurrent with the fourth bench level. This soil must

Photo 3-5. View of the excavator tracks and resultant bench disturbance on third bench and then heading left in downhill direction (May 27, 2015). This disturbance will interrupt surface water flow and lead to erosion in select locations.

2. Excavator tracks on the third bench also need to be graded smoothly.
 3. Excavator tracks on the fourth bench also need to be graded smoothly.
 4. The surface vegetation between the third and the fourth benches has been "crushed" or destroyed by the tracks in a vertical line between the benches. This is thought to be a concentrated pathway that could lead to erosion. Any machine work here would cause additional impact. Hand work is suggested to break down any track ridges. It is suggested that hand broadcasting of seed mix (and possible fertilizer) be undertaken to quickly re-establish vegetation on this track.

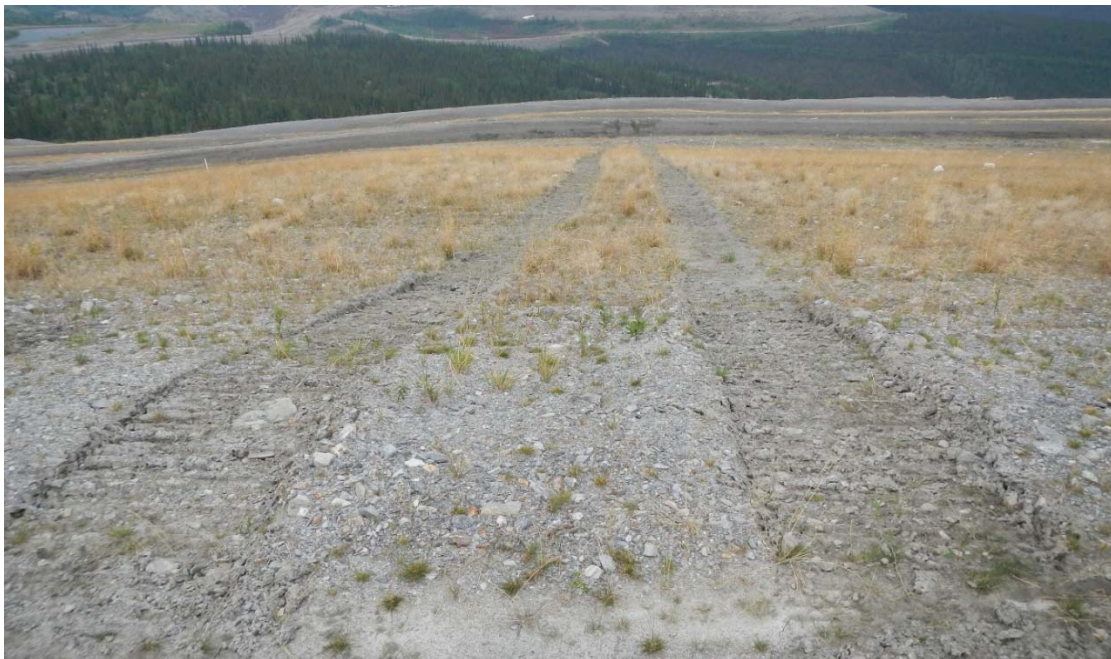
Photo 3-6. View of the excavator tracks from third bench looking down onto fourth bench. Note grass cover has been trampled under tracks, along with minor depressions have been formed (May 27, 2015).
