Re: EBA Engineering Report “Mount Nansen Instrumentation Inspections and Installation” (November 2012)

MOUNT NANSEN INSTRUMENTATION INSPECTIONS AND INSTALLATION

REPORT

NOVEMBER 2012
ISSUED FOR USE
EBA FILE: W23101555

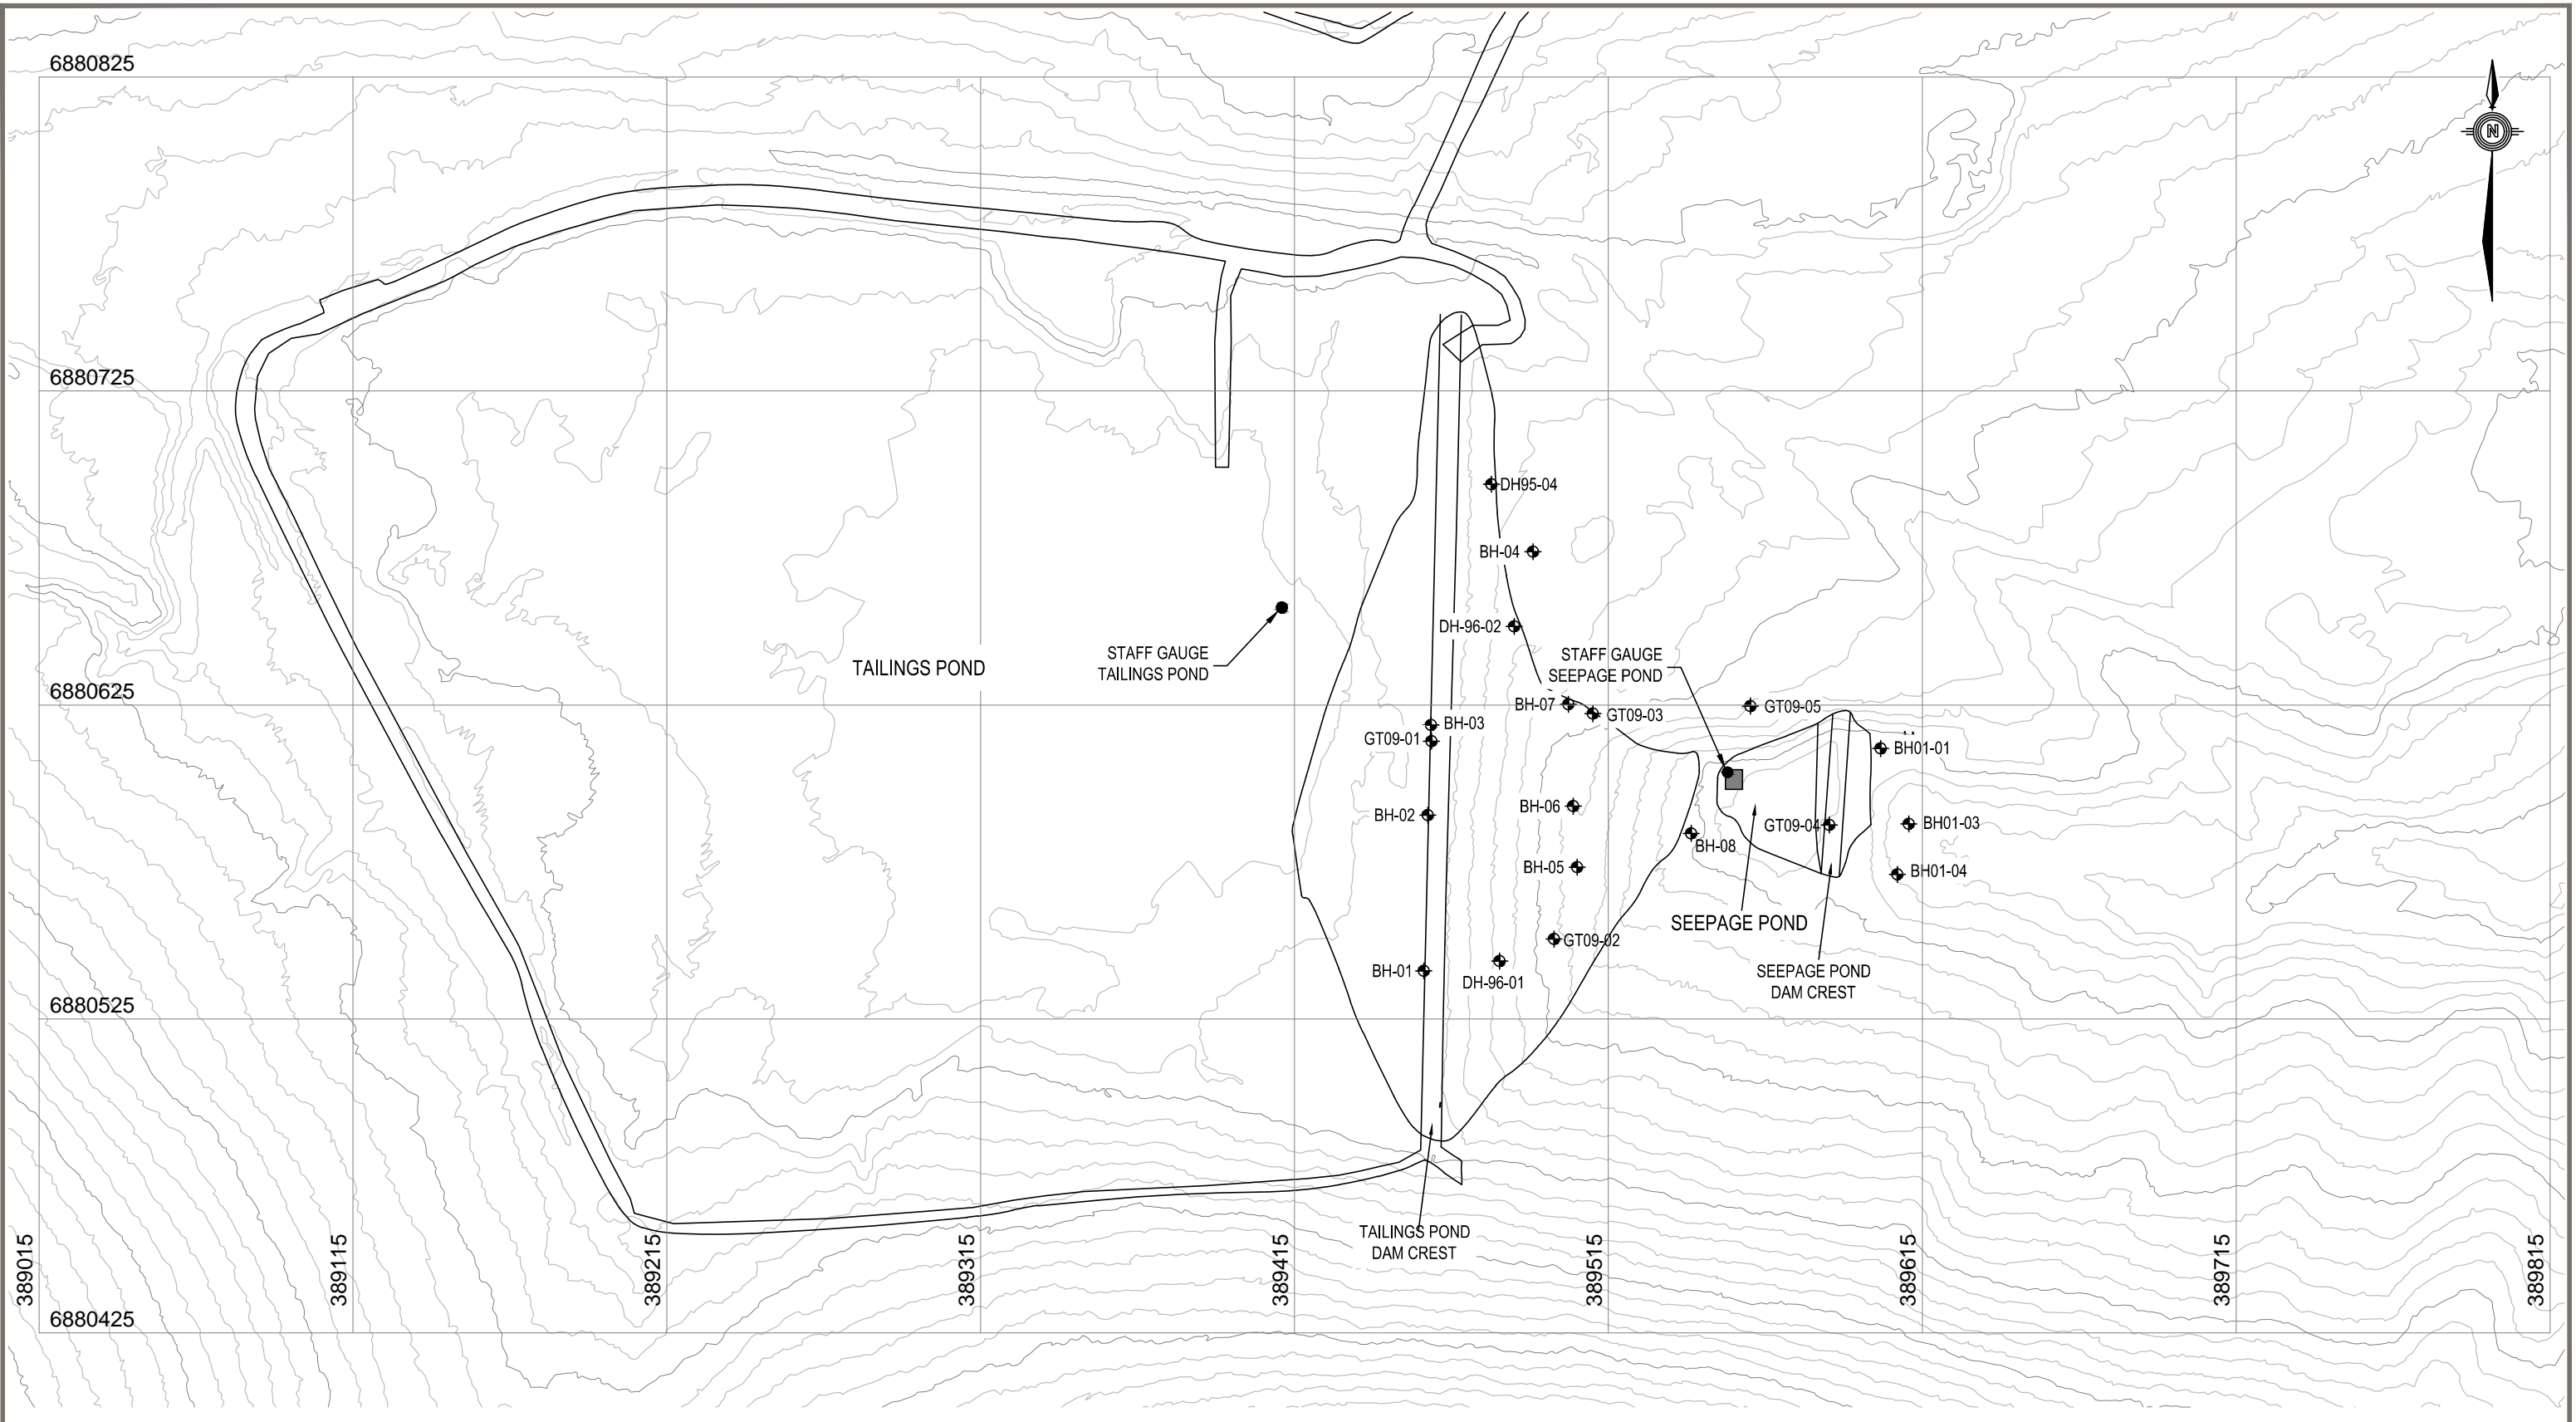
Figure 1

During the scoping field visit the field crew inspected all the thermistor cables and pneumatic piezometers between and adjacent to the tailings pond and seepage pond (Figure 1) and, where possible, collected data

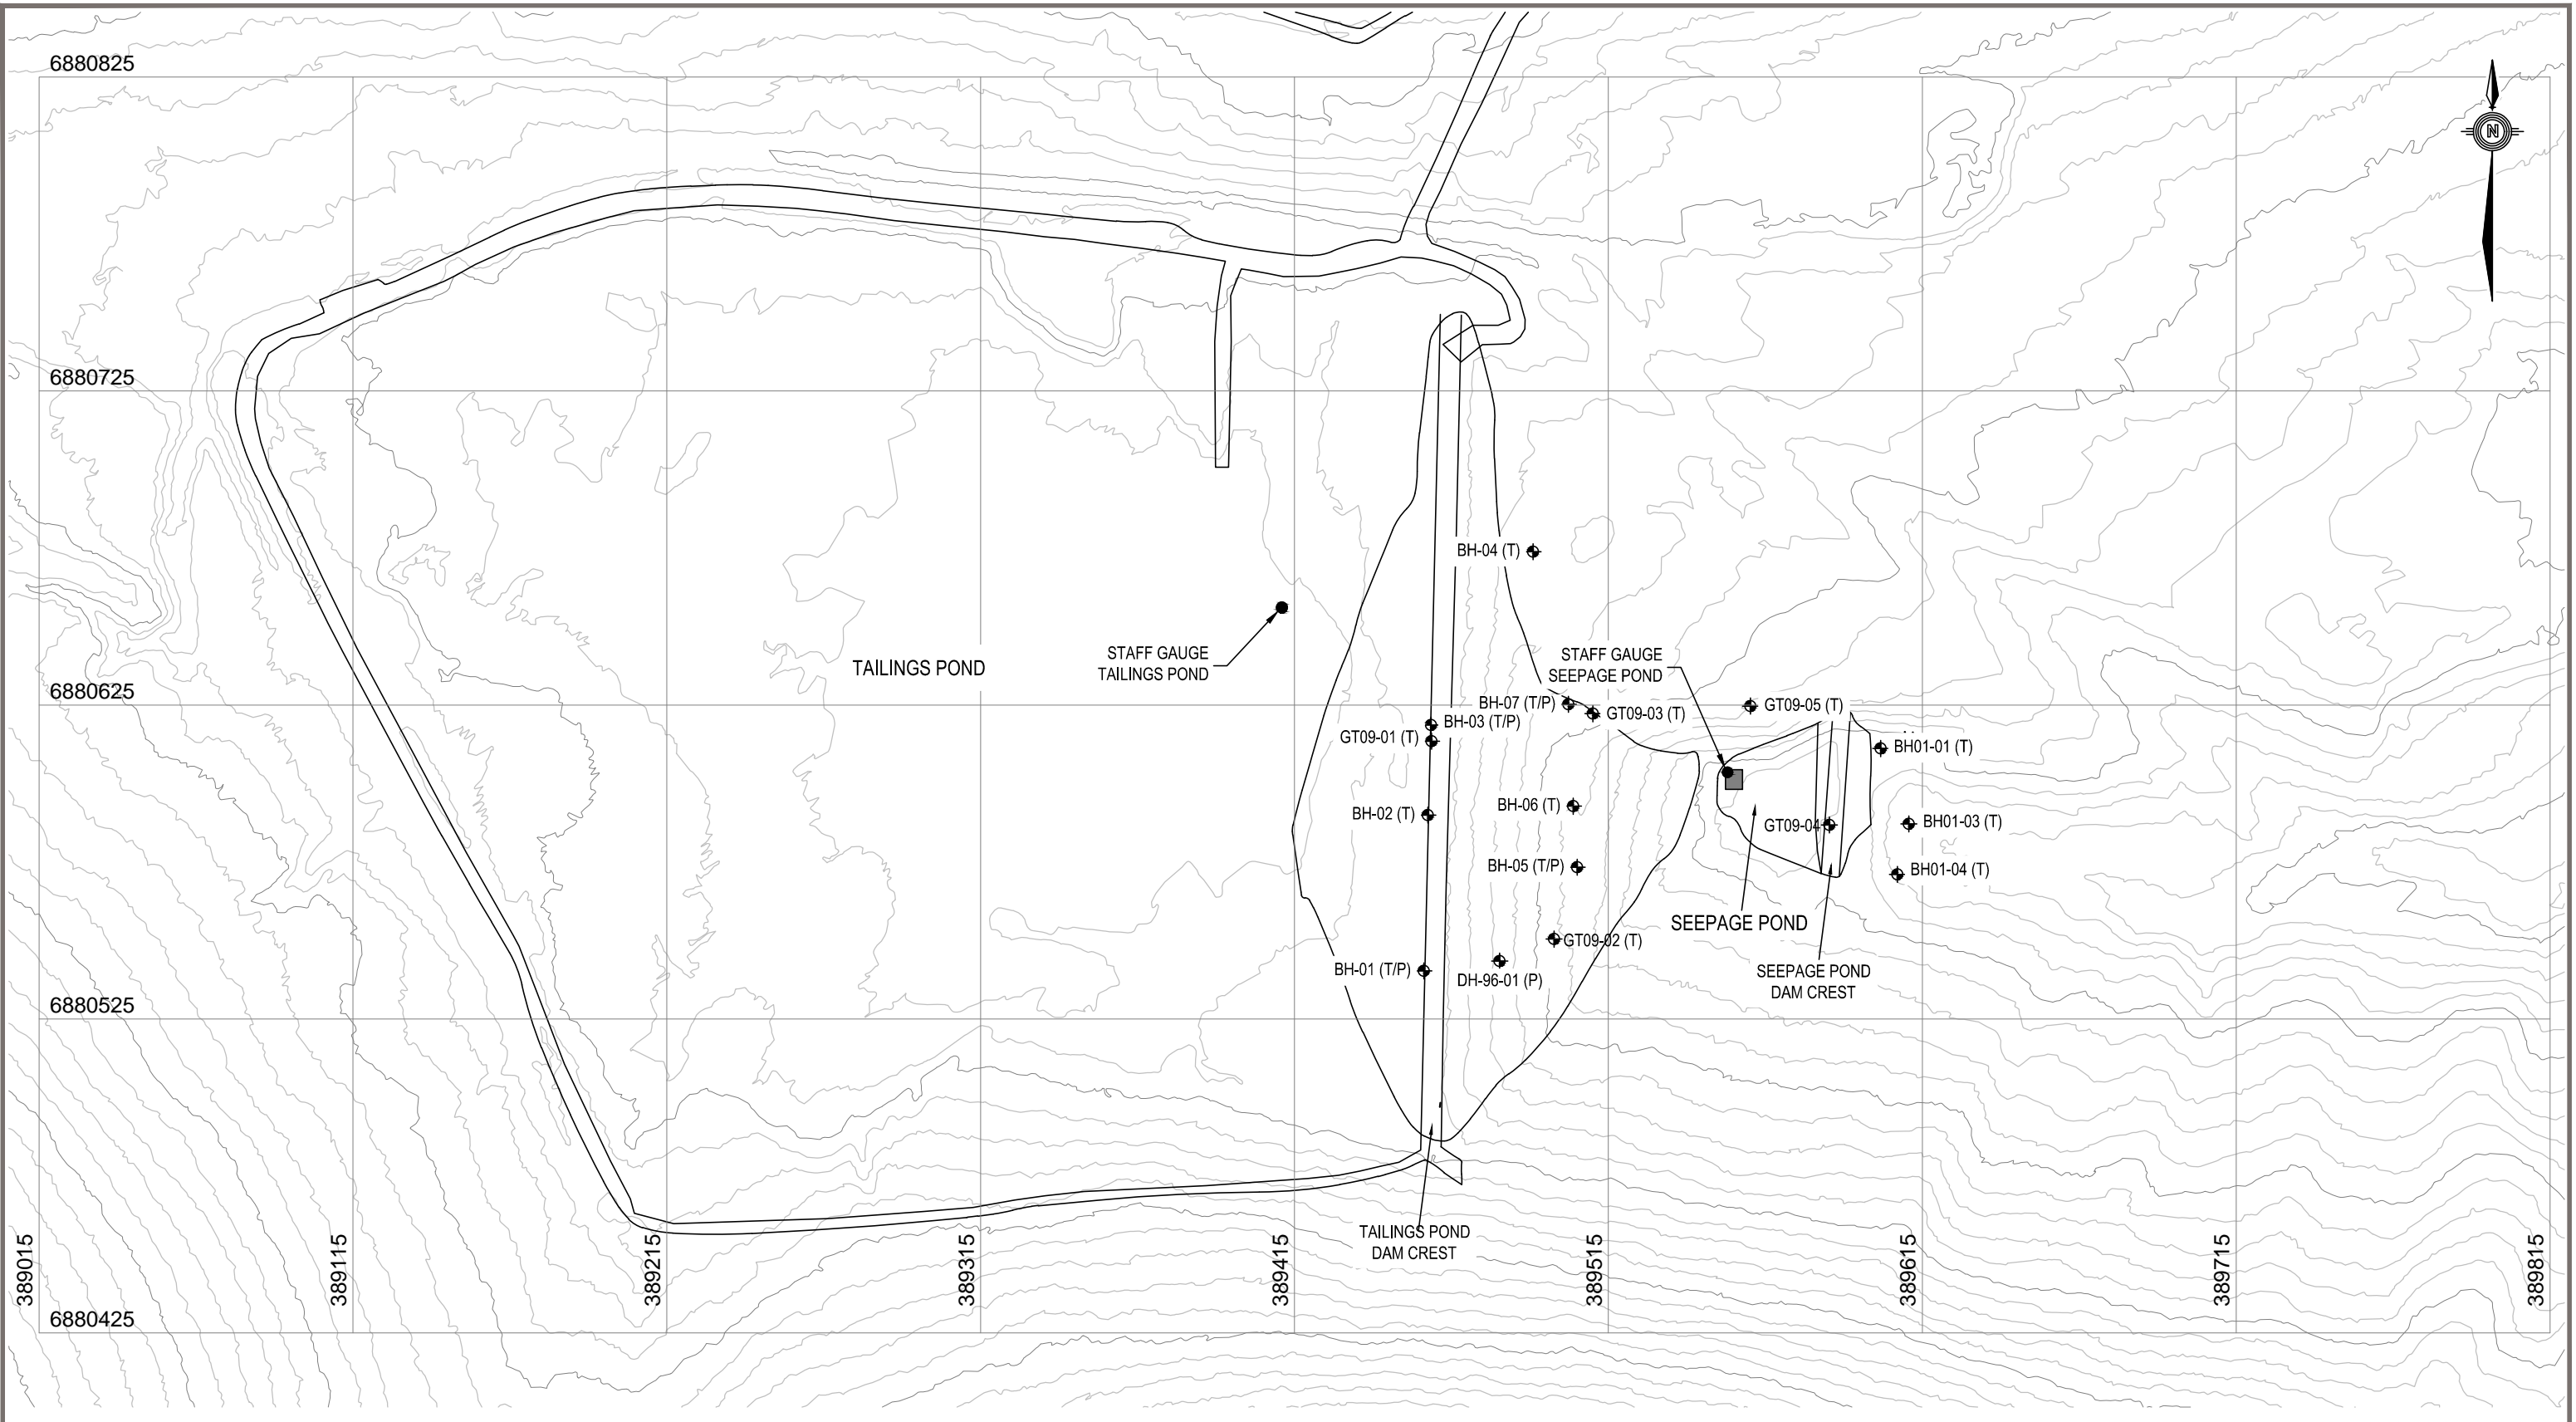
INSTRUMENTATION ASSESSMENT MOUNT NANSEN MINE SITE, YUKON				
STAFF GAUGE, FUNCTIONING PIEZOMETER AND THERMISTOR LOCATIONS				
PROJECT NO. W23101555	DWN CB	CKD GMR	REV 0	Figure 2
OFFICE EBA-WHSE	DATE July 30, 2012

In total, 17 thermistor cable connectors and 19 pneumatic piezometer connectors were tagged with brass tags that were attached to each instrument with tie wire. Each brass tag was stamped with the relevant consultant's project number and a unique instrumentation identification number that was taken from the consultant's original installation report. An example of a tagged thermistor cable and tagged pneumatic piezometer cable are presented in Photographs 3 and 4 respectively. If the thermistor cable or pneumatic piezometer cable were abandoned then the tag was also stamped with "ABANDONED JULY 2012". Figure 2 indicates the location of thermistors and piezometers that were working on May 22, 2012.
